Nunavut Impact Review Board Site Visit Report

Meliadine Gold Mine Project

Agnico Eagle Mines Limited

NIRB File No. 11MN034

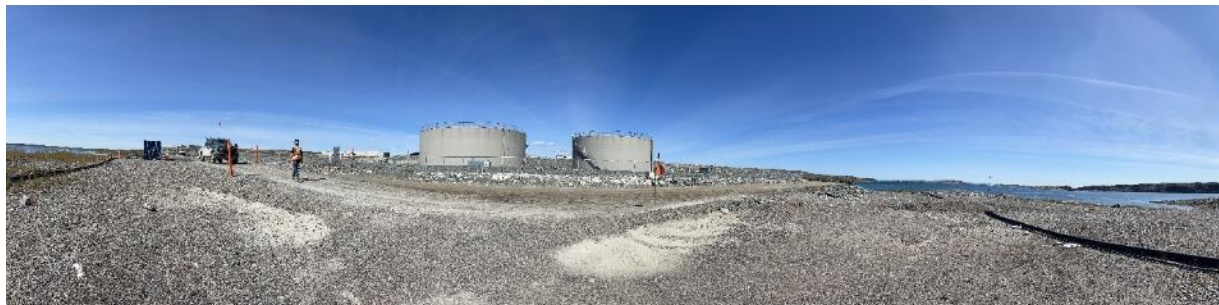
Photo 1: Overview of Itivia Site

- a) Container ships that are associated with the Meliadine project anchor just inside or just outside of Melvin Bay and dry cargo is lightered to shore on tug-barges, then unloaded using the gravel ramp in Itivia harbour. Agnico Eagle was not receiving materials or fuel at the time of the NIRB's site visit (see [Photo 1](#)).

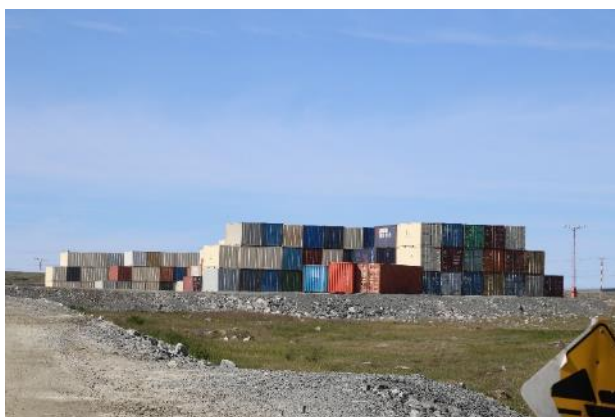
Photo 2. Organized Seacans

- b) The Itivia site was well organized and ready for the next load. Agnico Eagle's fuel barge had filled the fuel tanks and fuel trucks were taking fuel to site. ([Photo 2](#) and [Photo 3](#)).

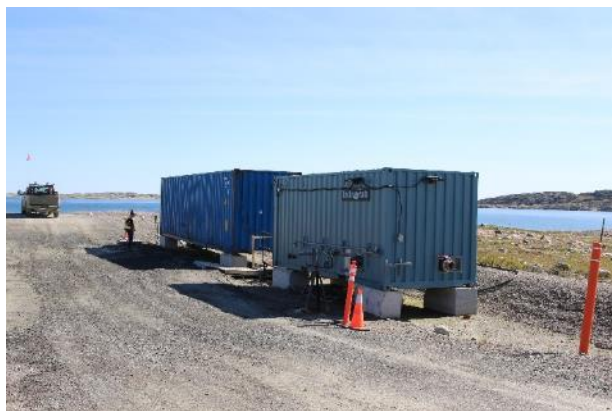
Photo 5: Saline Water Discharge Tank

- c) It was observed that the signage on the seacan wall was updated and clearly noted to the community the public dock access and the Agnico Eagle barge area (see [Photo 4](#)).
- d) The Saline Water Discharge tank was installed at the Itivia site (see [Photo 5](#)); however, in 2022 Agnico Eagle is storing the saline groundwater in Tiriganiaq 2 instead of trucking and discharging to Itivia Harbour. (Term and Condition 25)
- e) The snowmobile crossings within Agnico Eagle's Itivia area appeared to be in good repair (Photo 6).

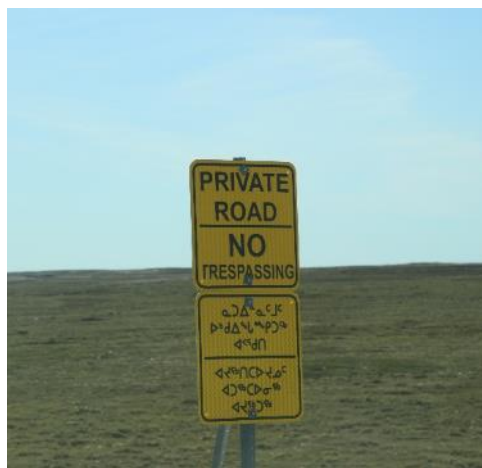
Photo 8: Signs in English and Inuktitut on the Bypass Road

- a) The Bypass Road had clear signs noting that the road is private in both English and Inuktitut (see [Photo 7](#) and [Photo 8](#)) (Term and Condition 125c).

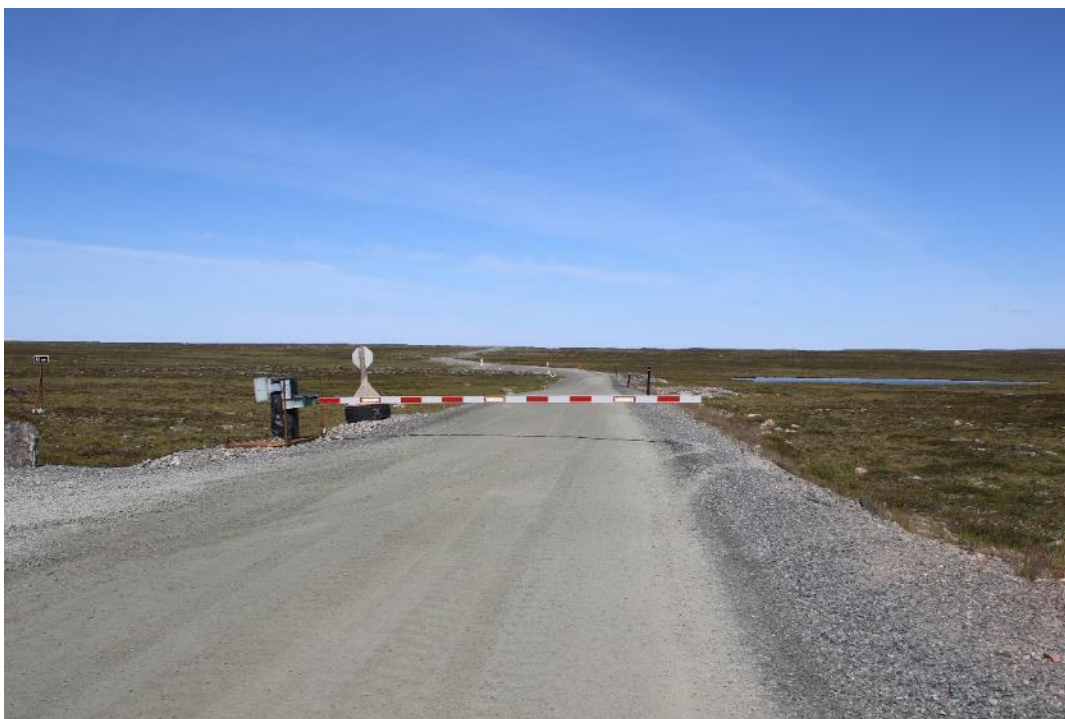
Photo 10: Gatehouse – Closed Gate at Gatehouse

A single gatehouse is now on the AWAR and has been relocated closer to the mine at a new location selected by the Kangiqliniq Hunters and Trappers Organization and the community. This Gatehouse maintains a log of mine related traffic and passing all-terrain vehicles (ATVs) (see [Photo 9](#) and [Photo 10](#)). Only private ATVs are allowed on the AWAR and are required to sign in and out and are asked where they are heading and how far they are planning to travel up the AWAR for safety reasons. No other private vehicles are currently allowed on the AWAR. The following observations were made along the AWAR:

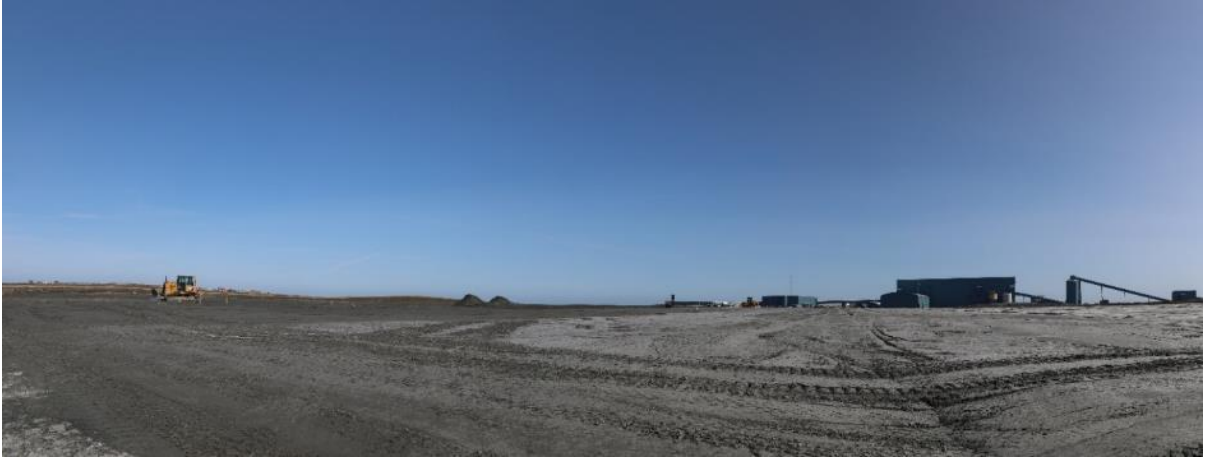
Photo 17: Meliadine Tailings Storage Facility (2019)

The NIRB staff also visited the Tailings Storage Facility (dry stack) located west of the mine site. [Photo 17](#) is the Tailings Storage Facility in 2019 and [Photo 18](#) is what the facility looked like in 2022.

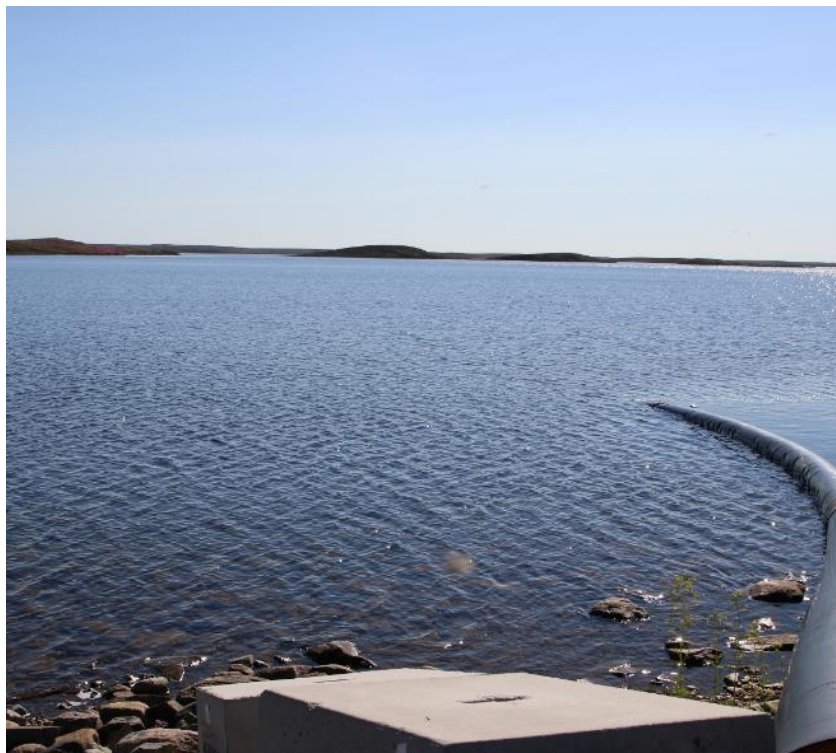
Photo 48: Treated Water Discharge into Meliadine Lake by Exploration Camp

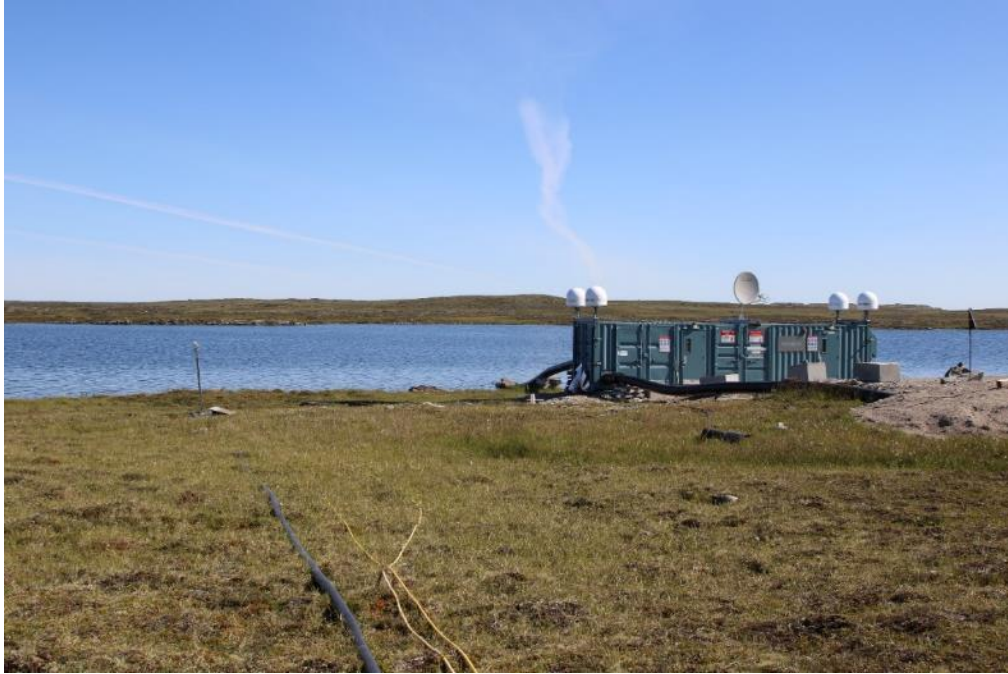
Photo 49: Water Intake from Meliadine Lake by Main Camp

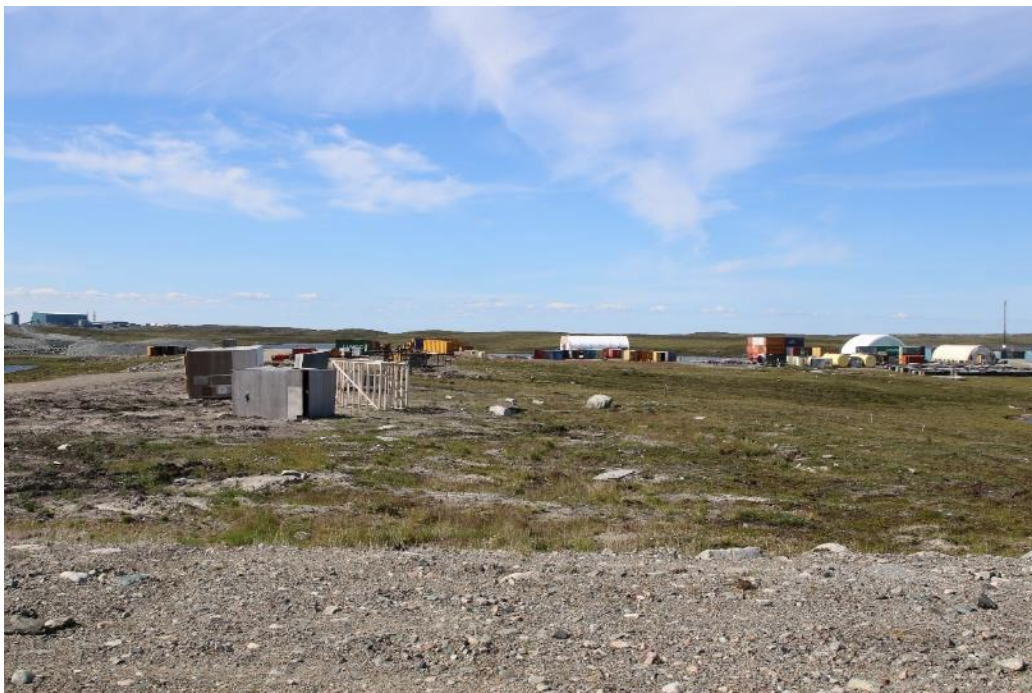
The 200-person exploration camp was decommissioned and only the accommodations trailers remain active as additional bed space for Agnico Eagle when required (see [Photo 68](#)).

Photo 69: Exploration Camp Area looking SW (2022)

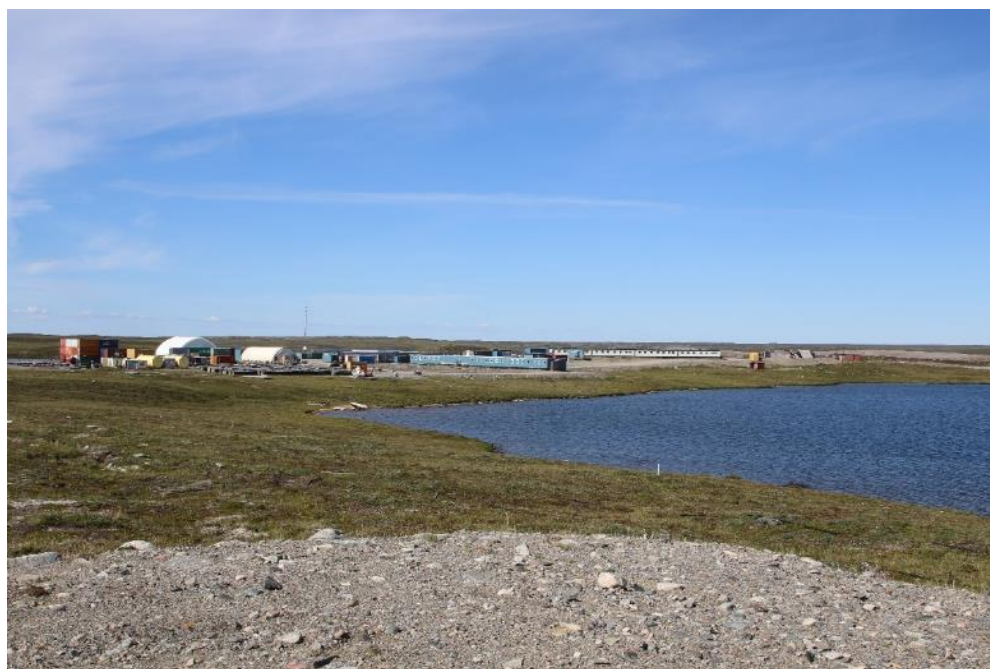
Photo 70: Exploration Camp Looking NW (2022)

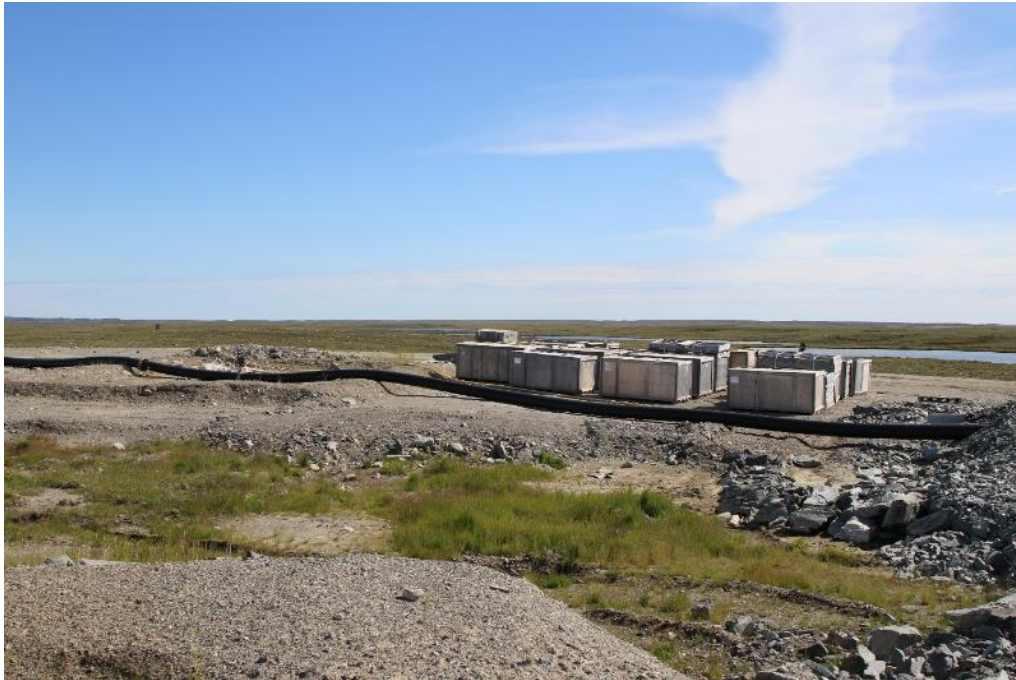
- The site visit viewed the exploration/temporary fuel tank storage farm and temporary landfarm. The tanks have been removed and is now a landfarm and remediation is underway (see Photo 72).

Photo 71. The Temporary Landfarm and Laydown Area by Exploration Area

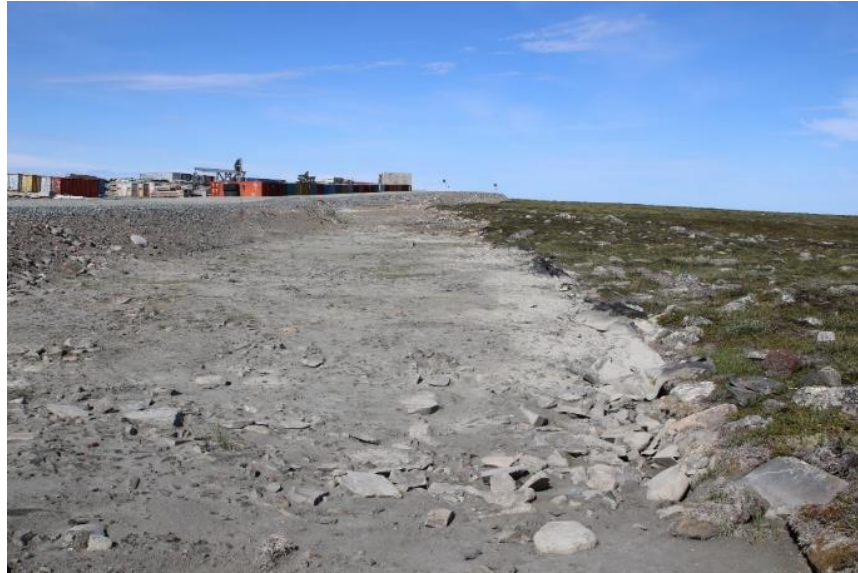
The NIRB observed erosion fences around the Meliadine Site, and this was an area that should be assessed for effectiveness of the fence and if any repairs are required.

Photo 73: Ditch by Construction Laydown Area

28	Sediment and Erosion Management	NIRB noted some erosion fences needed repairs and discussed this with Agnico Eagle. Will follow up in 2023.

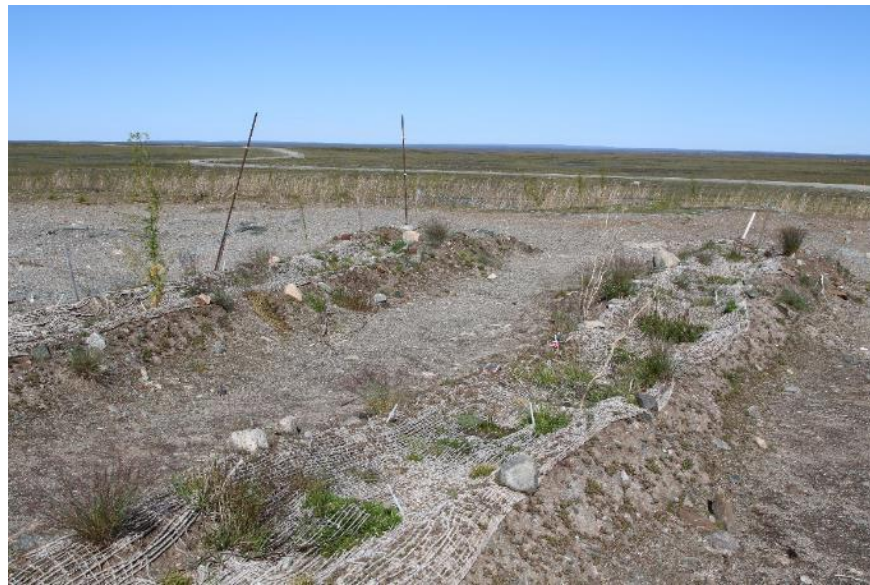
NIRB and Agnico Eagle staff visited the test plots that are used as part of a revegetation trial in collaboration with the University of Saskatchewan through a Natural Sciences and Engineering Research Council of Canada Collaborative Research and Development grant received in June 2019 (see [Photo 75](#)).

Photo 76: Test Plots Area 2
