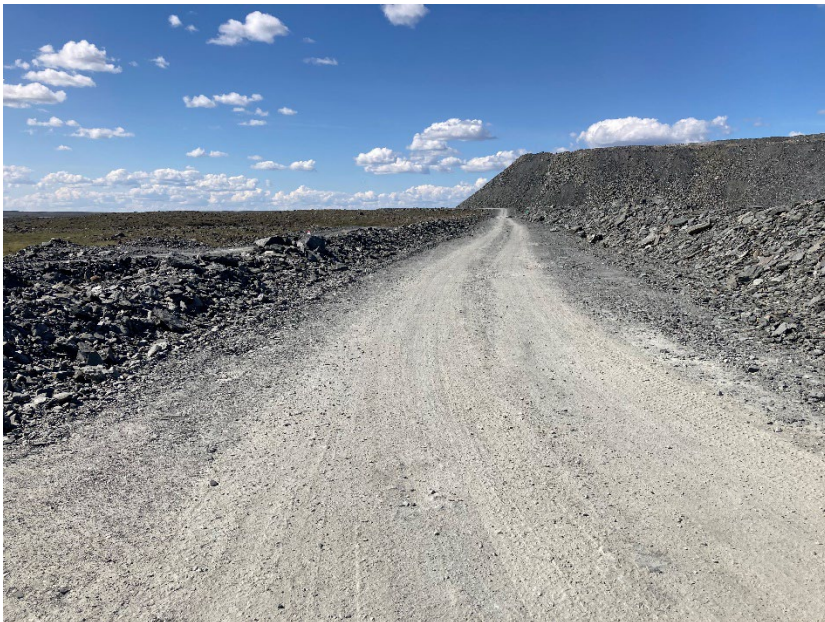
Photograph A7-2 WRSF Dike

Description: From approx. Sta. 0+350 (east abutment), looking west at the dike crest.

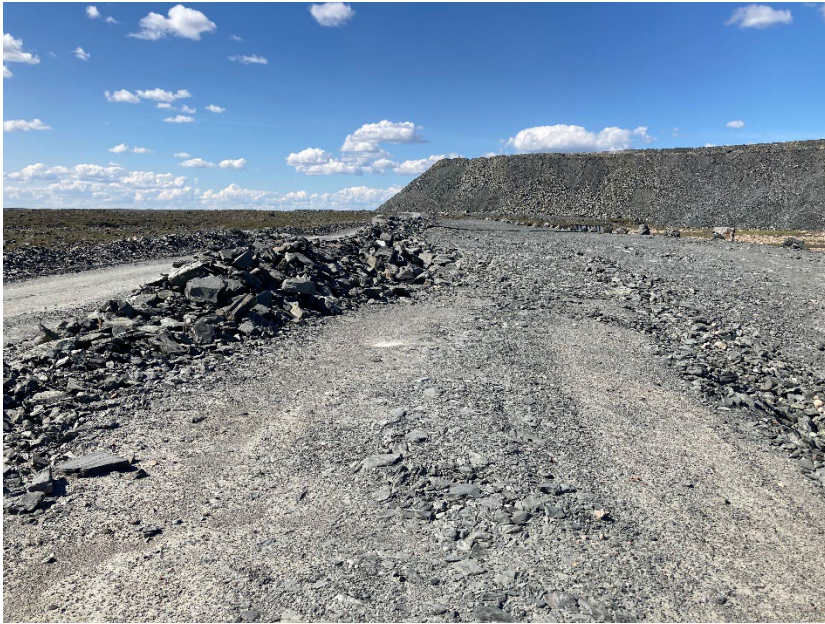
Photograph A7-3 WRSF Dike

Description: From approx. Sta. 0+350 (east abutment), looking west at the upstream thermal berm crest.

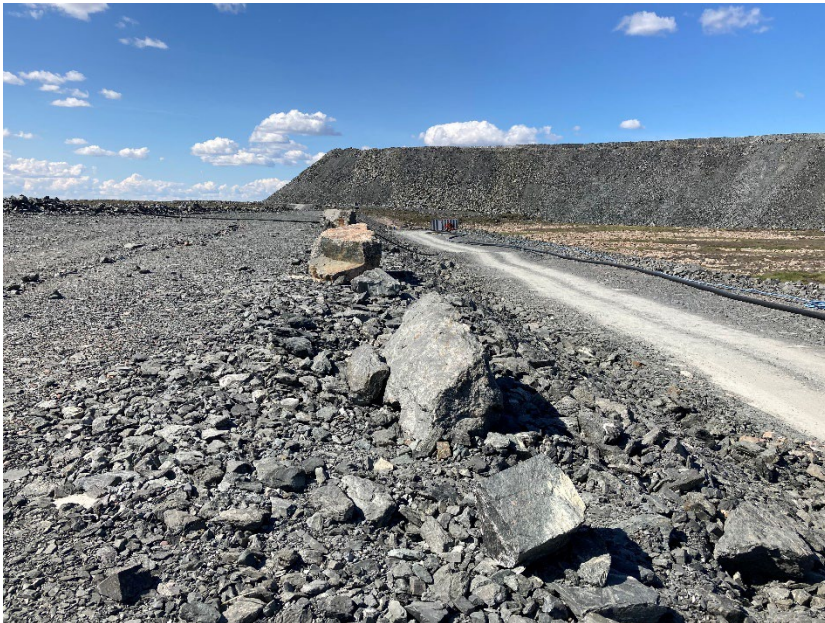
Photograph A7-4 WRSF Dike

Description: From approx. Sta. 0+350 (east abutment), looking west at the upstream thermal berm slope and dewatering ramp.

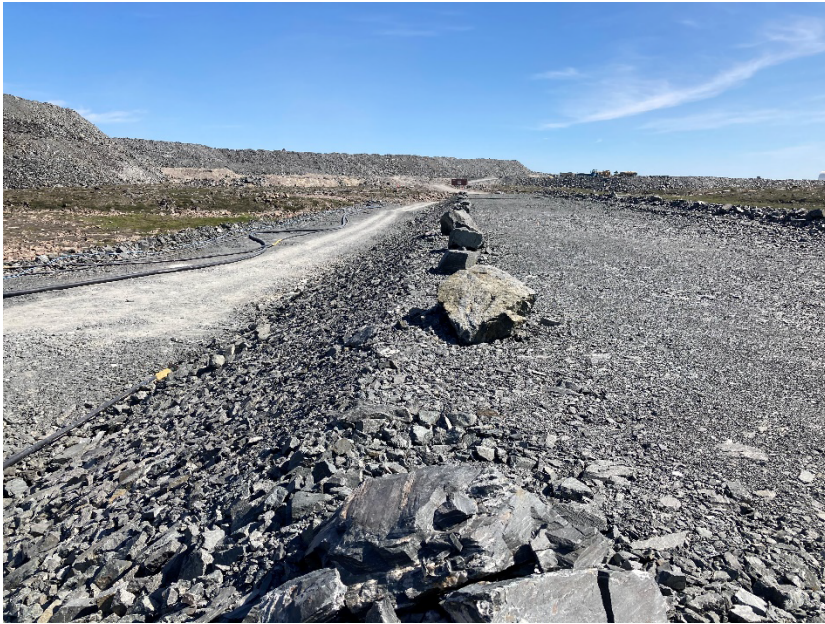
Photograph A7-5 WRSF Dike

Description: From approx. Sta. 0+210, looking east at the upstream thermal berm and dewatering ramp.

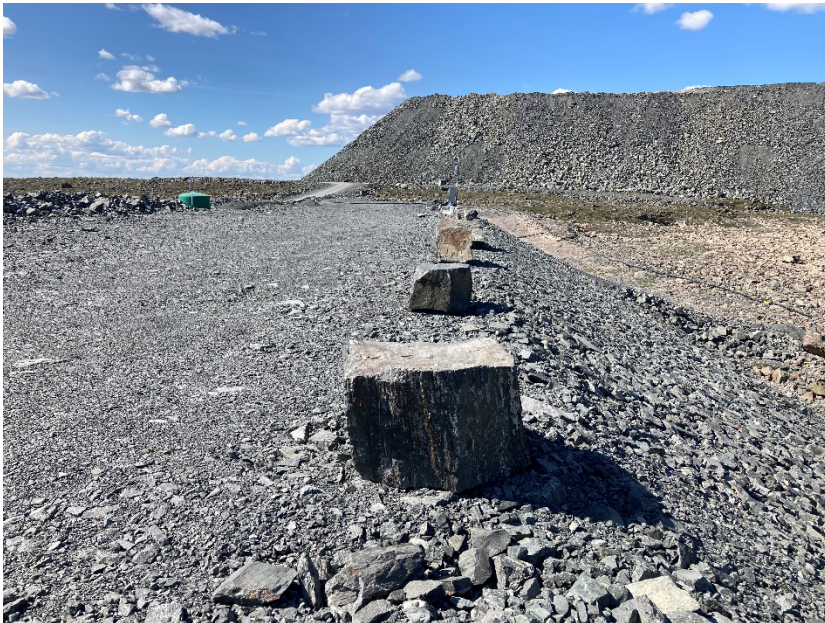
Photograph A7-6 WRSF Dike

Description: From approx. Sta. 0+210, looking west at the upstream thermal berm.

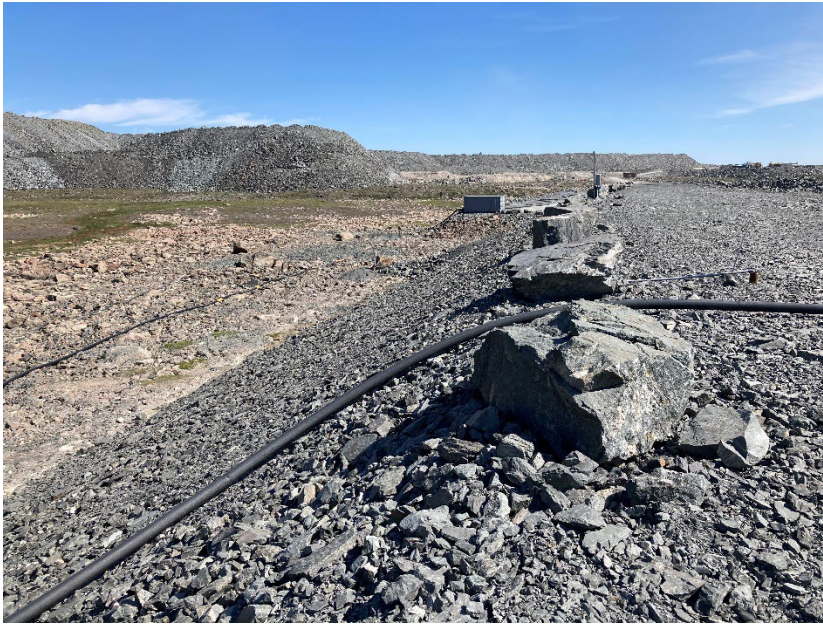
Photograph A7-7 WRSF Dike

Description: From approx. Sta. 0+080 (west abutment), looking east at the upstream thermal berm slope and the upstream toe.

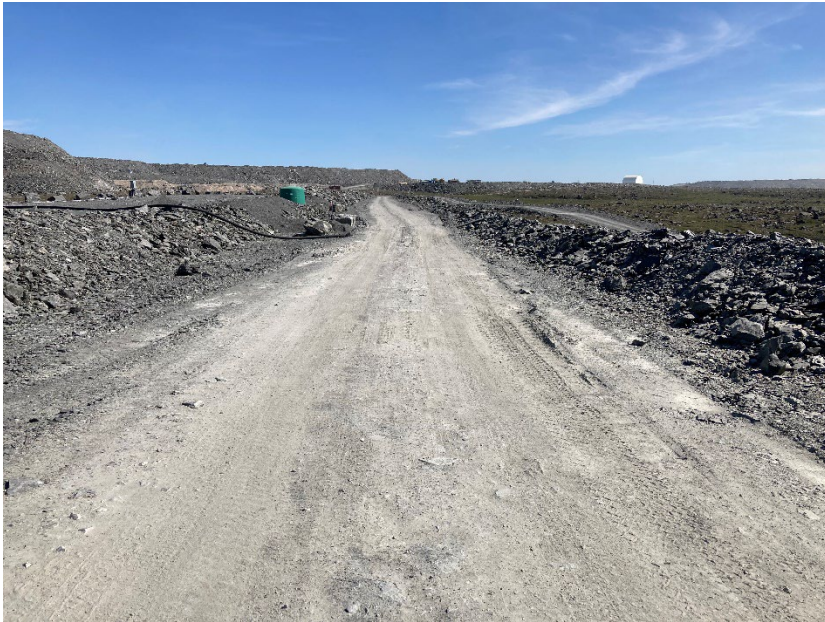
Photograph A7-9 WRSF Dike

Description: From approx. Sta. 0+080 (west abutment), looking east at the dike crest.

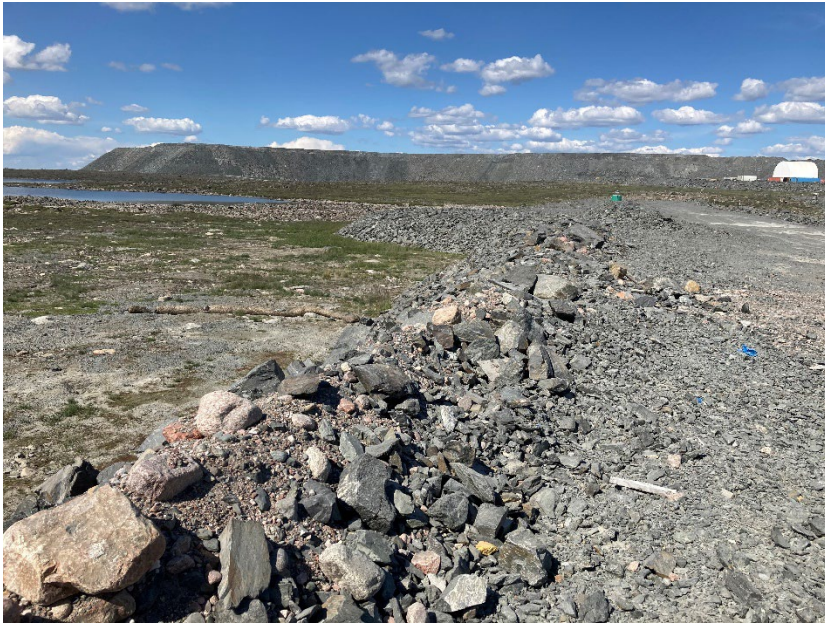
Photograph A8-1 Mammoth Dike

Description: From approx. Sta. 0+300 (south abutment), looking north to the crest and upstream liner tie-in.

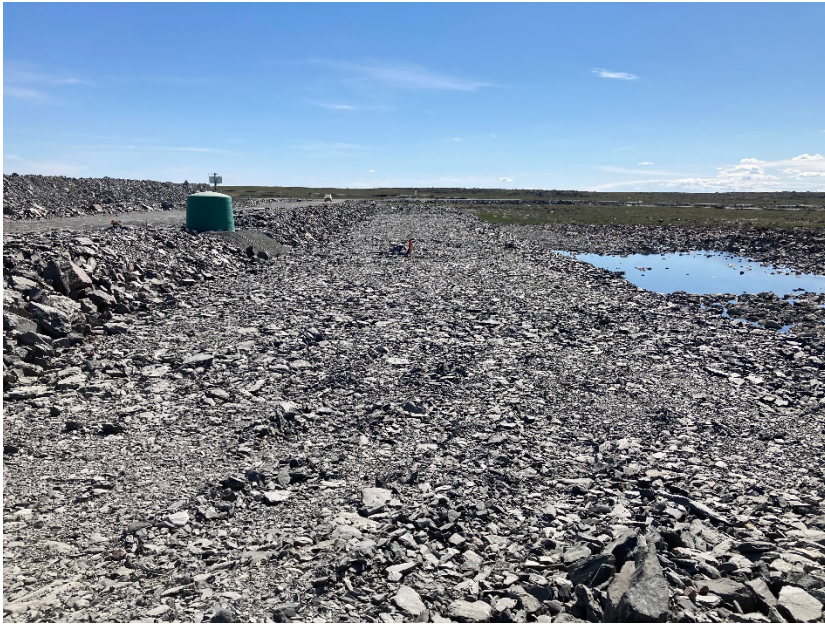
Photograph A8-5 Mammoth Dike

Description: From approx. Sta. 0+110 (north abutment), looking south to the upstream liner tie-in.

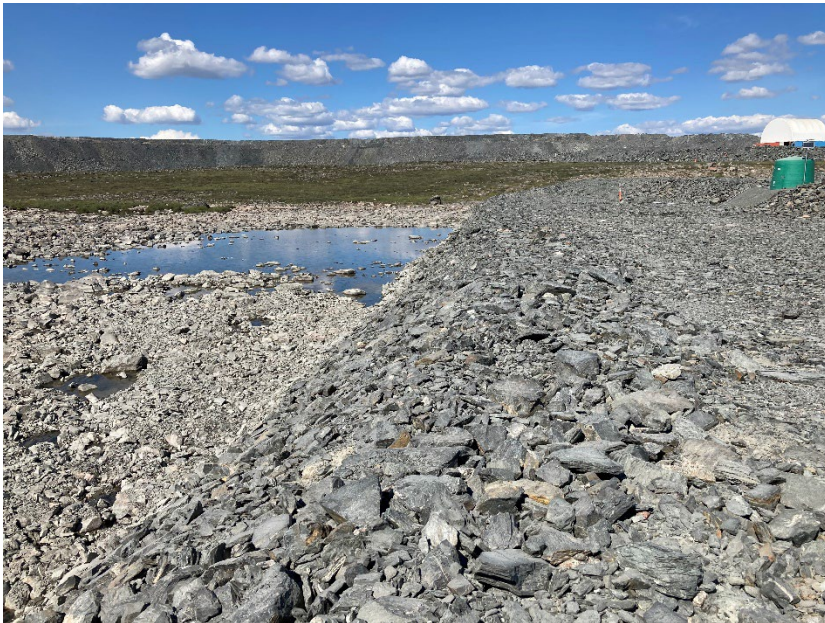
Photograph A8-6 Mammoth Dike

Description: From approx. Sta. 0+180, looking north to the upstream liner tie-in.

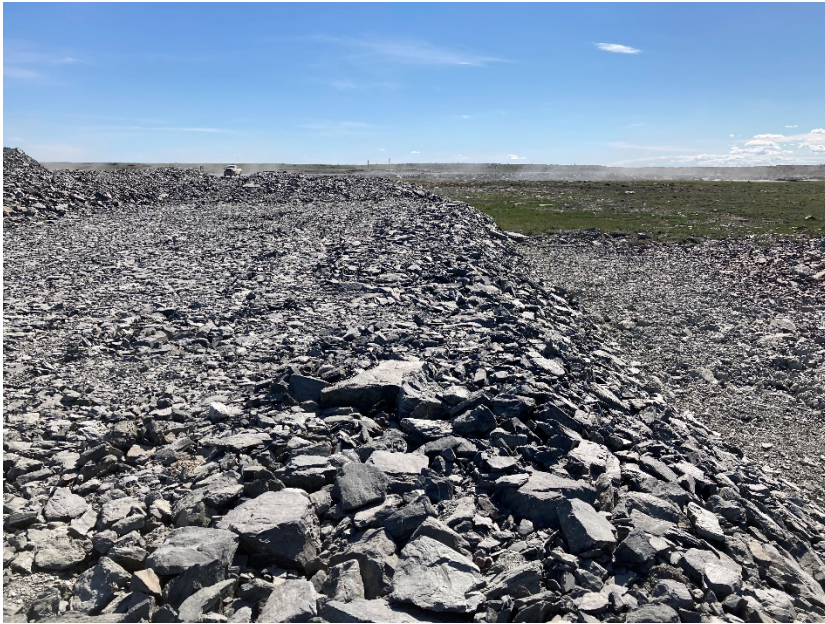
Photograph A8-7 Mammoth Dike

Description: From approx. Sta. 0+180, looking south to the upstream liner tie-in.

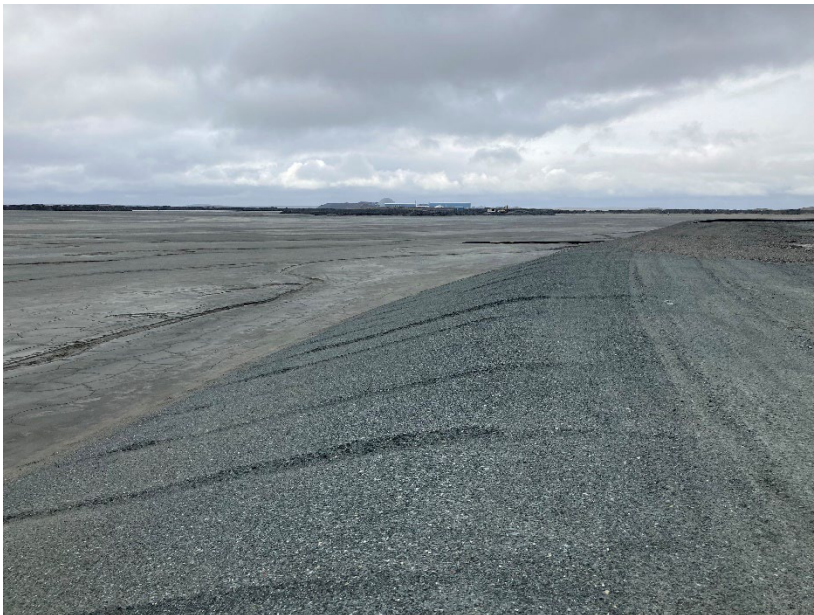
Photograph B1-2 Tailings Storage Facility

Description: From the North Cell Internal Structure, looking southwest toward the upstream slope and the North Cell.

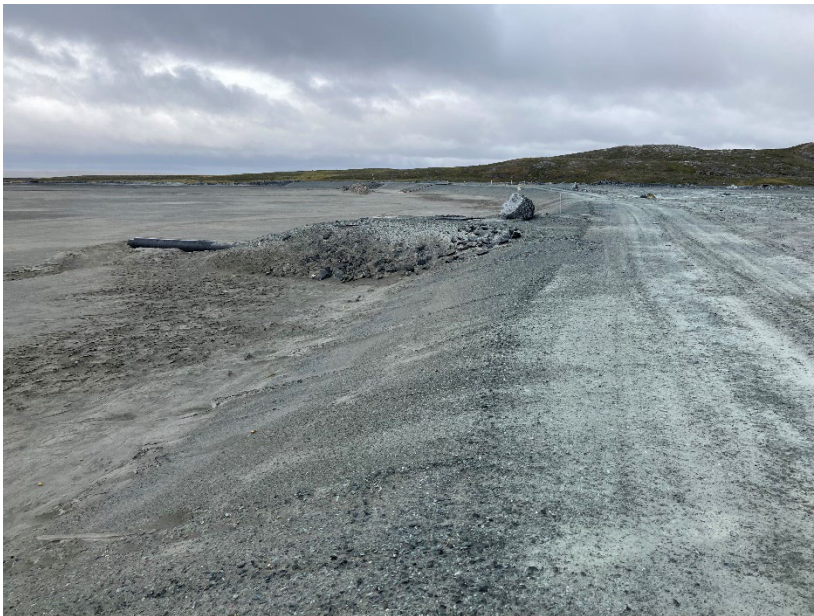
Photograph B1-4 Tailings Storage Facility

Description: From the North Cell Internal Structure, looking west at the North Cell and upstream slope.
