Saddle Dam 2

Client:	AEM	By:	Marion Habersetzer
Project:	Meadowbank	Date:	July 29, 2022
Location:	Saddle Dam 2	Reviewed:	Yves Boulianne

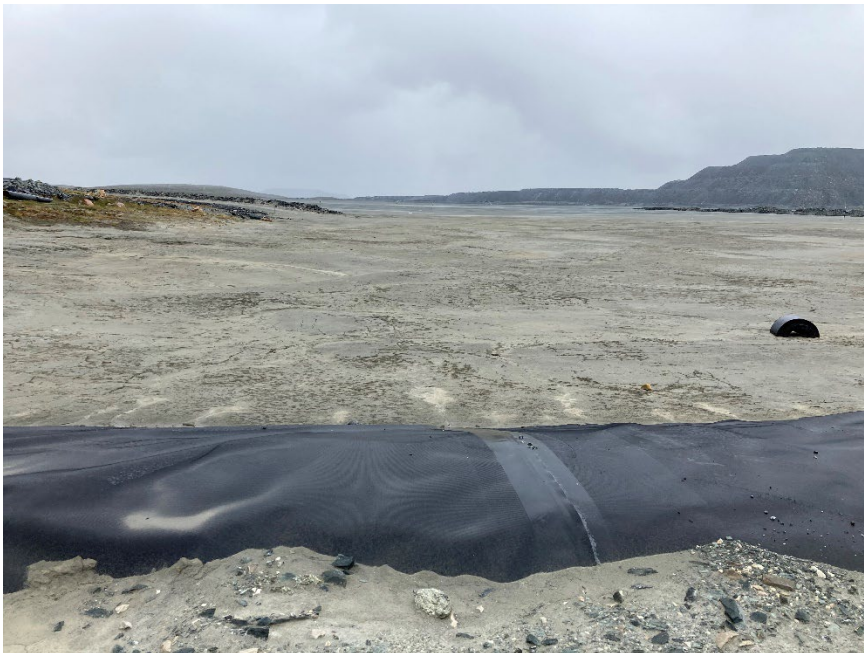
Photograph B3-2 Saddle Dam 2

Description: From Saddle Dam 2 (approximately Sta. 20+110) upstream, looking southeast at the North Cell. The tailings beach against SD2 is adequate.

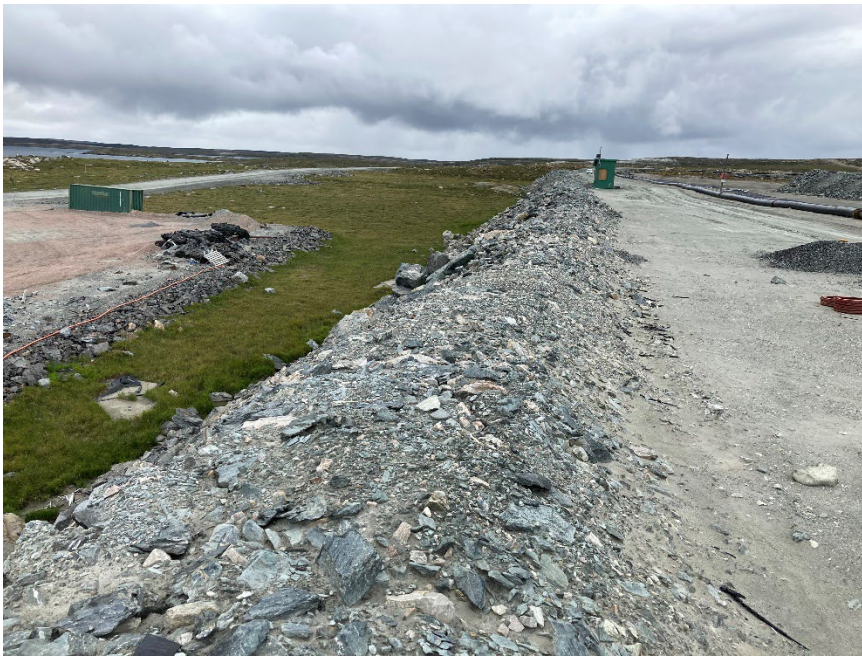
Photograph B3-7 Saddle Dam 2

4.4 Discoloration/staining	No		
4.5 Outlet operating problem (if applicable)	Not applicable		
4.6 Other unusual conditions	Yes		Limited water is still ponding within the rockfill embankment between 20+275 to 20+475 approximately.

Description: From Saddle Dam 2 (approximately Sta. 20+500) downstream, looking northwest at the downstream toe and slope of Saddle Dam 2.

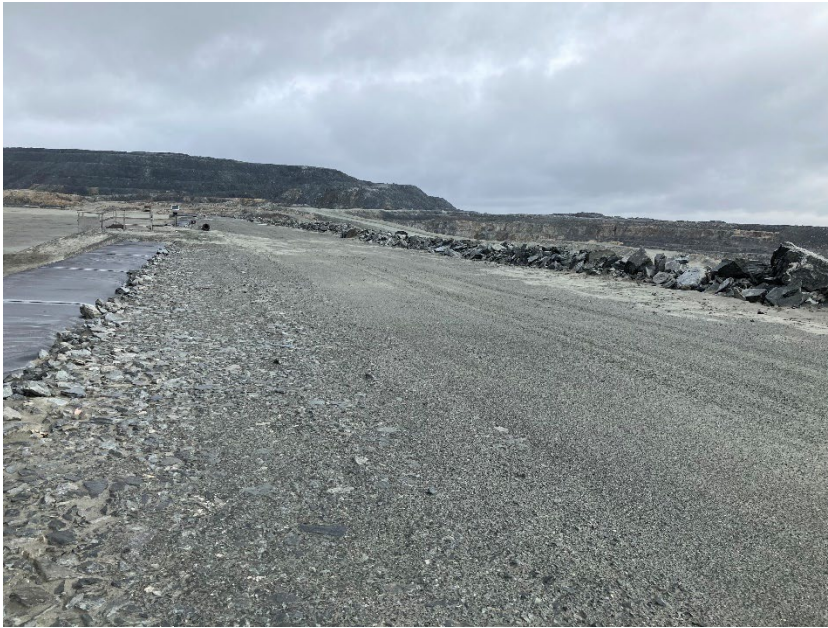
Photograph B7-5 Central Dike and Saddle Dam 5

Description: From approximately Sta. 0+720 looking north at the crest.

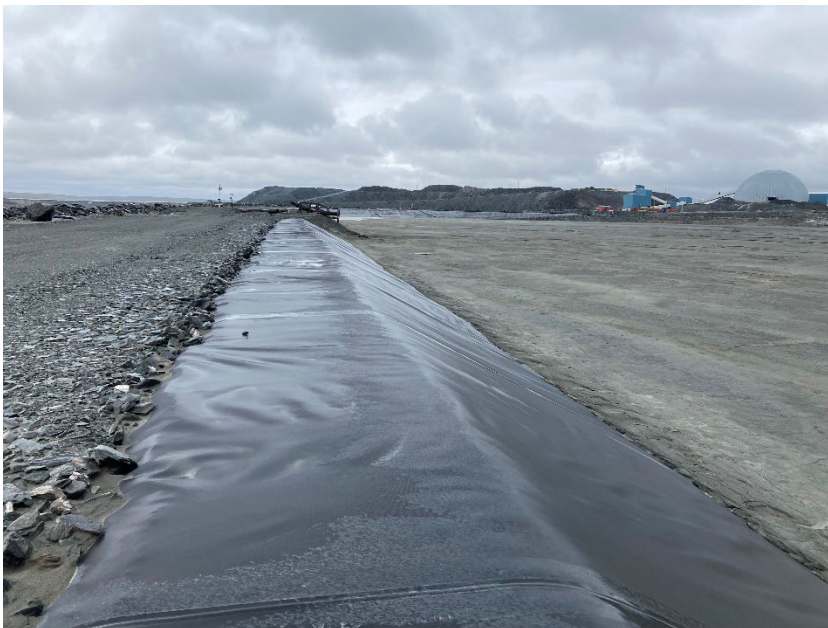
Photograph B7-6 Central Dike and Saddle Dam 5

Description: From approximately Sta. 0+720 looking south at the crest and the upstream slope.

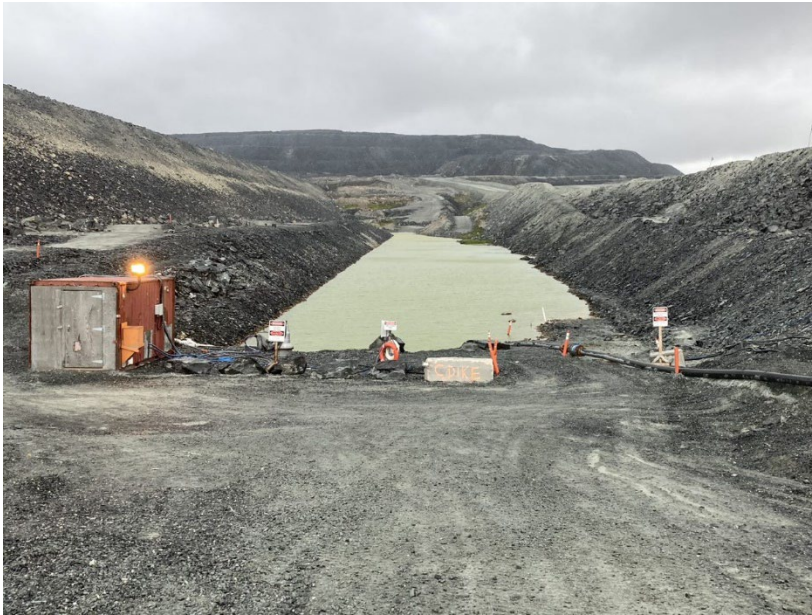
Photograph B7-11 Central Dike and Saddle Dam 5

Description: From approximately Sta. 0+900 downstream, looking north at the downstream pond.

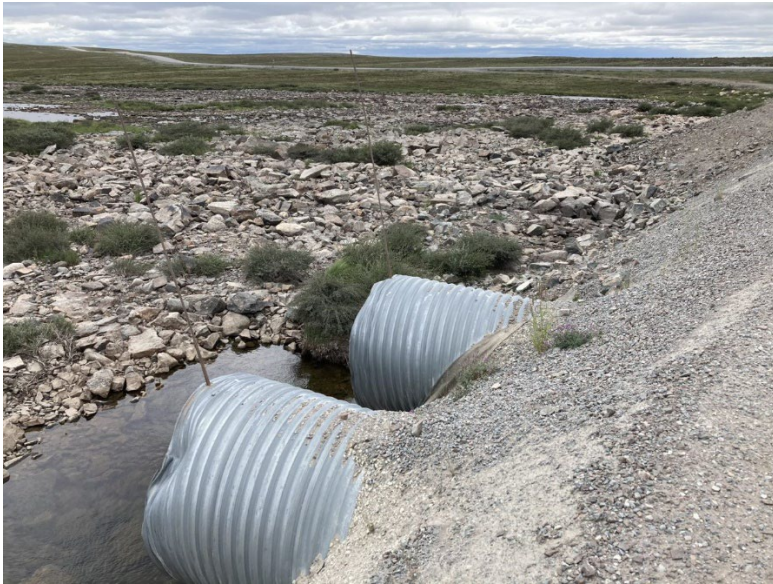
Photograph D2-1: PC-17A km 8+830

8+830	PC-17A	2X1800 mm CSP	Sign of erosion beneath the inlet and flow of water occurring beneath the culvert. The 1800 CSP were installed too high. While conditions are not perfect, they have proven stable over the past years. No sign of degradation from last year on both the inlet and outlet sides. Flow was observed beneath the culvert in the past, but in 2019 the flow moved further south (5-10 m from culvert). Stable, to keep monitoring for evolution.
8+850	PC-17	2x1200 mm CSP	In good condition

Description: View of the culvert outlets. No sign of degradation and the flow is stable south of the culverts (5-10 m away).

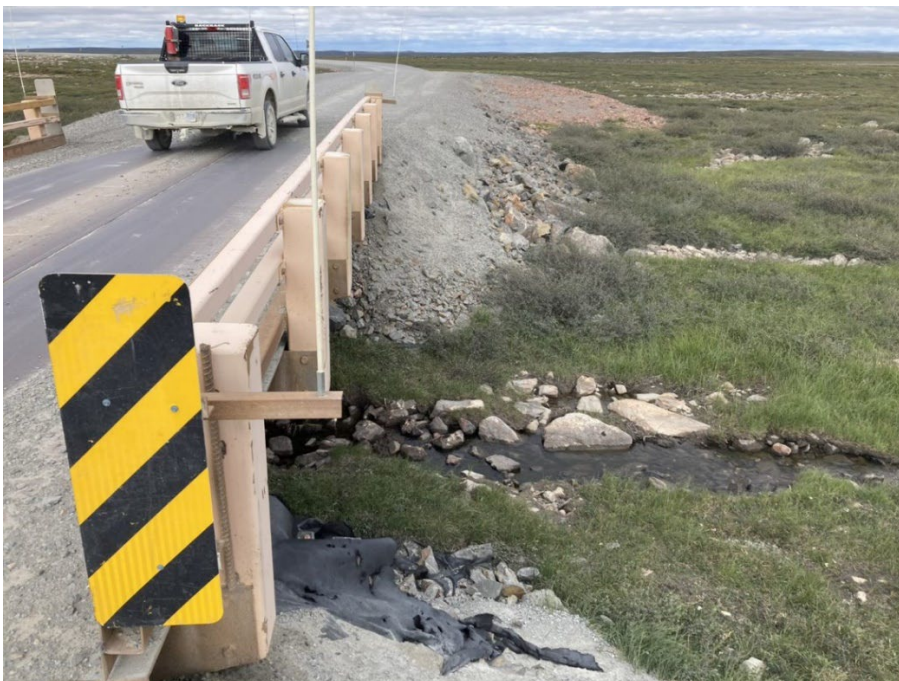
Photograph D3-14 Bridges 7 – R16 km 73+800

Description: Looking at the north abutment. In good condition.

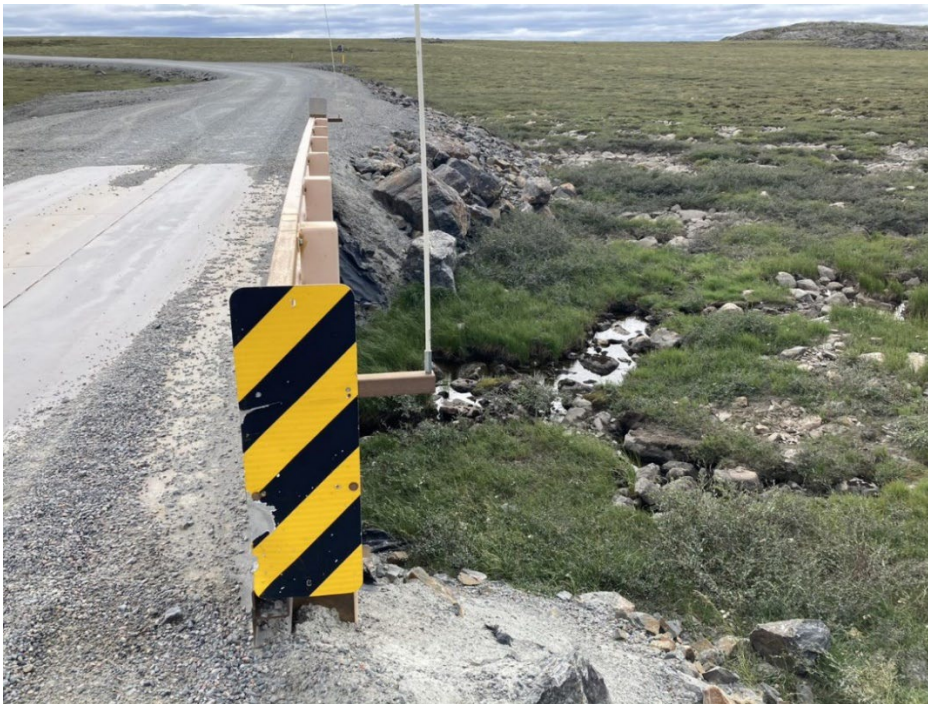
Photograph D3-15 Bridges 7 – R16 km 73+800

Description: Looking at the south abutment. In good condition.

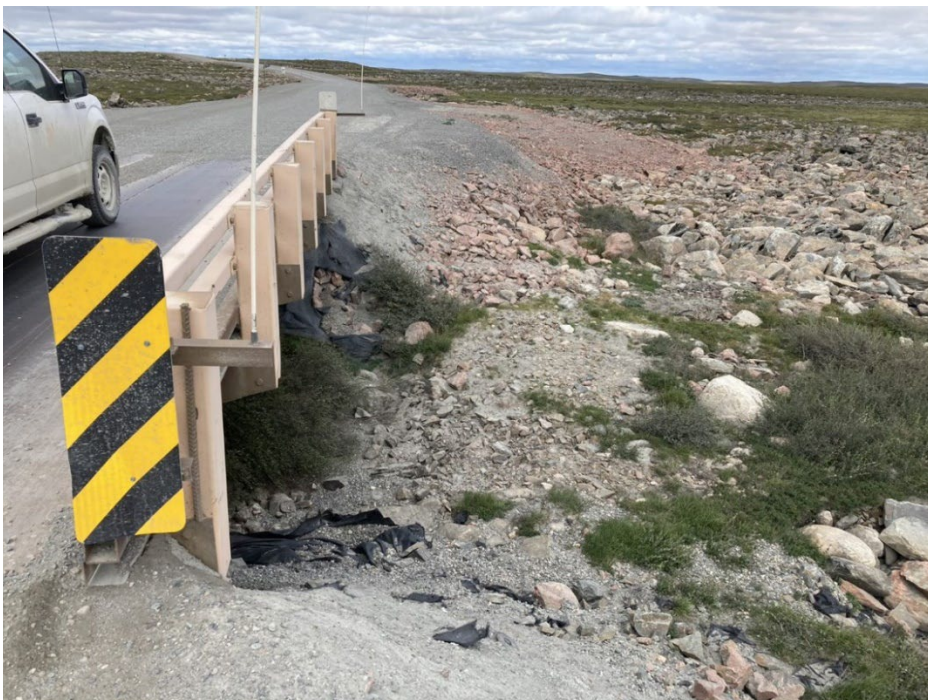
Photograph D3-16 Bridges 8 – R18 km 79+500

Description: Looking at the north abutment. In good condition.
