APPENDIX F
QUARRIES

APPENDIX G
BULK FUEL FACILITIES

APPENDIX H
OTHER FACILITIES

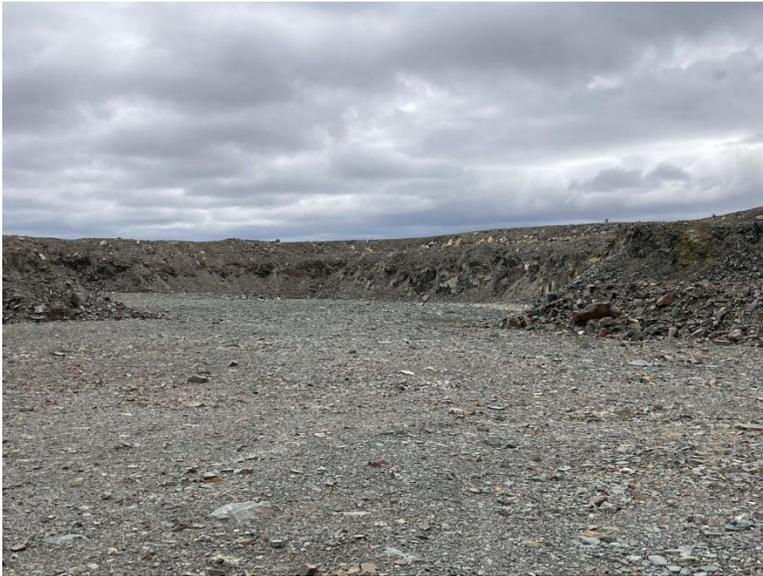
Photograph F-1: Quarry 12 – km 58+300

Description: View of north wall. Presence of loose blocks at the base of the wall.

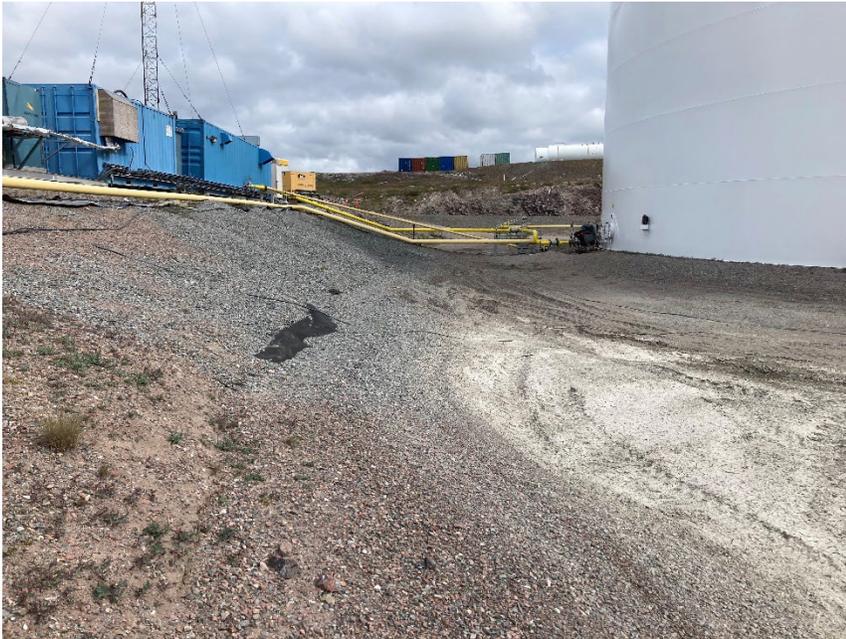
Photograph G1-1 Baker Lake Tank Farm

Description: From the south side of Tank 1, looking southeast at Tanks 1, 2, 3, and 4.

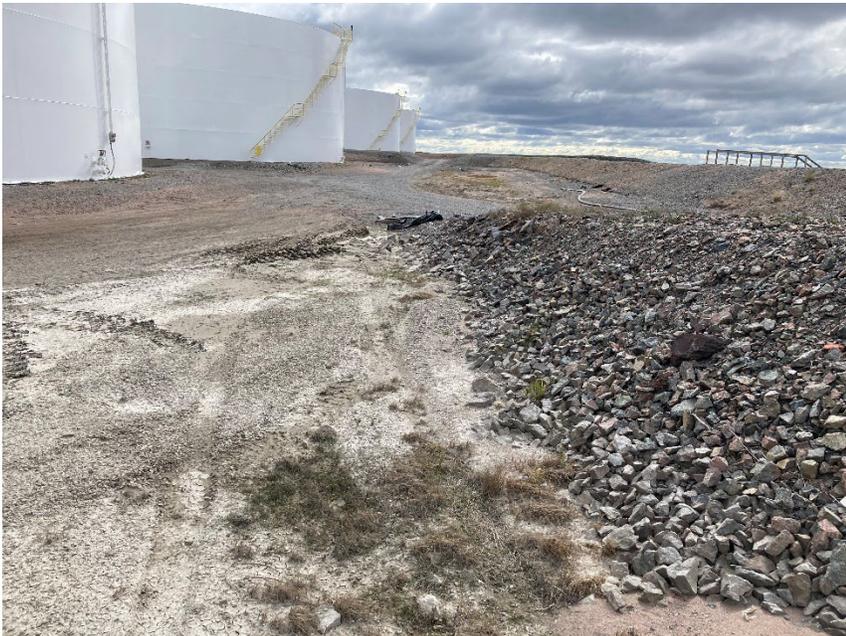
Photograph G1-2 Baker Lake Tank Farm

Description: Looking at the southwestern corner of Tank 1.

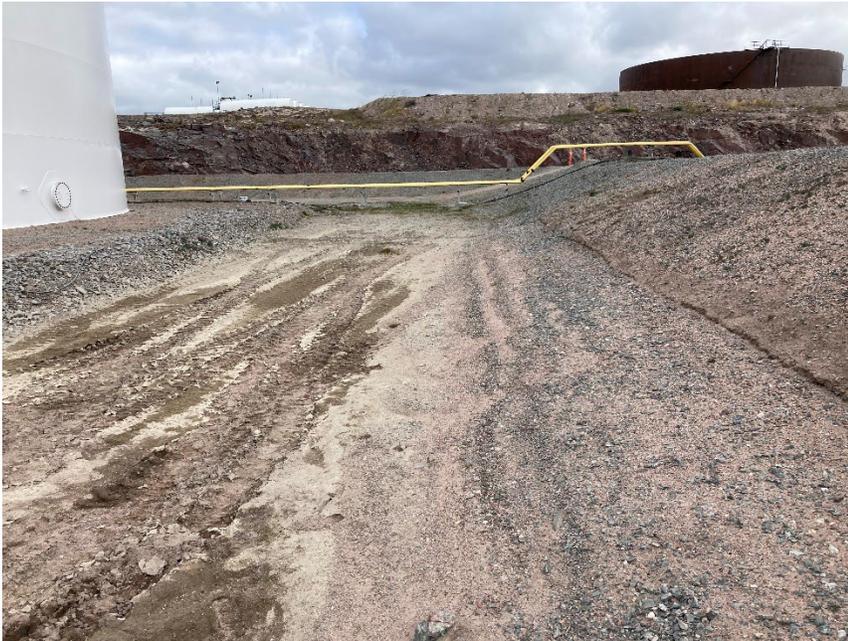
Photograph G1-3 Baker Lake Tank Farm

Description: Looking northwest toward the south wall of the tank farm.

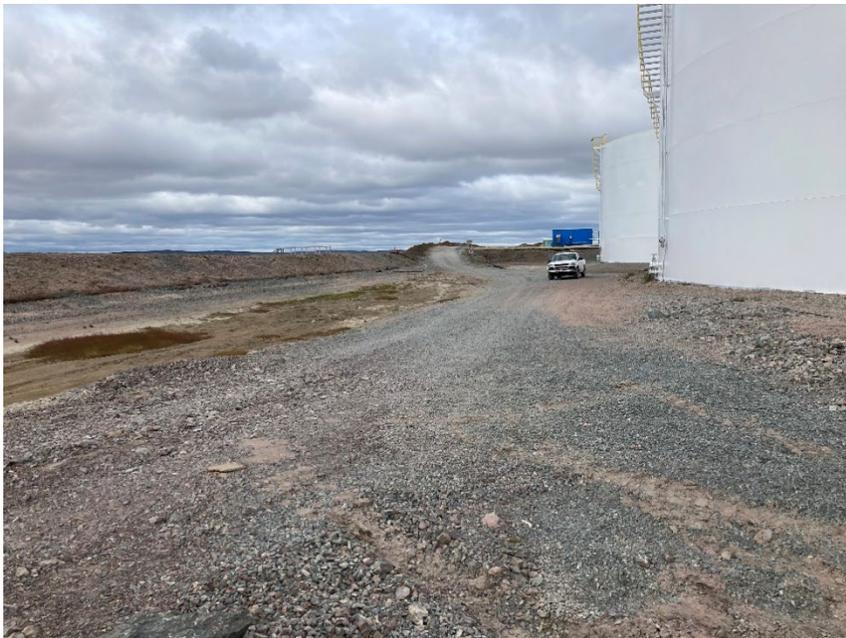
Photograph G1-4 Baker Lake Tank Farm

Description: Looking northeast toward Tank 2.

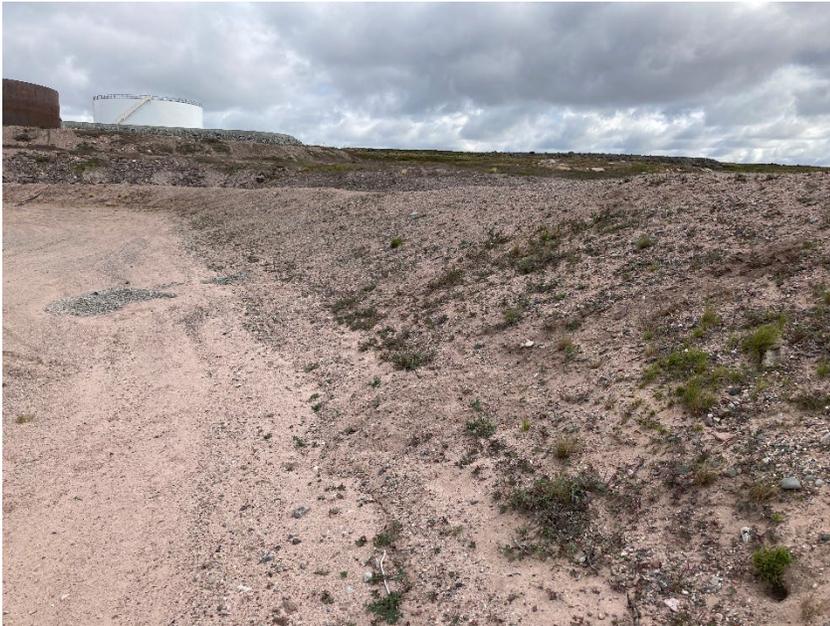
Photograph G1-9 Baker Lake Tank Farm

Description: From the south portion of the site looking northeast.

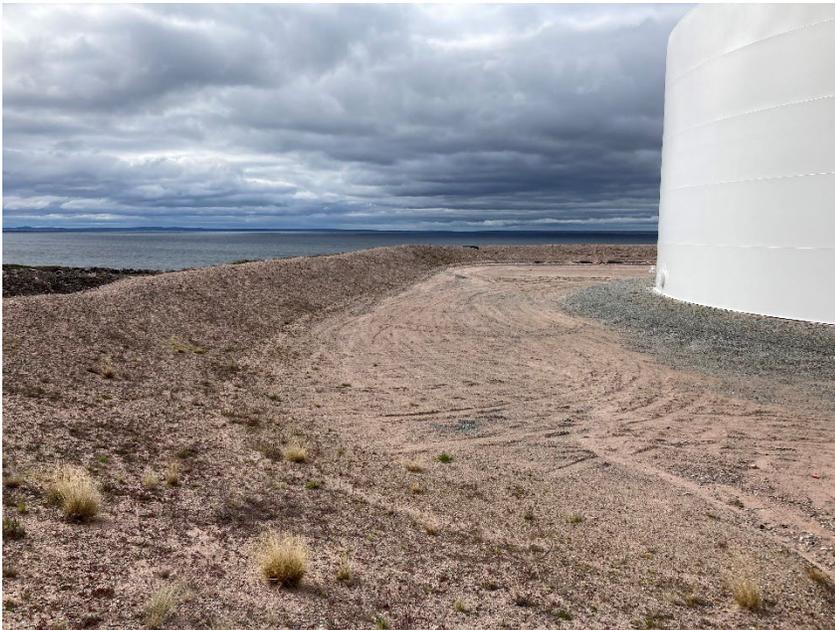
Photograph G1-10 Baker Lake Tank Farm

Description: From the northeastern corner of Tank 4 looking southwest.

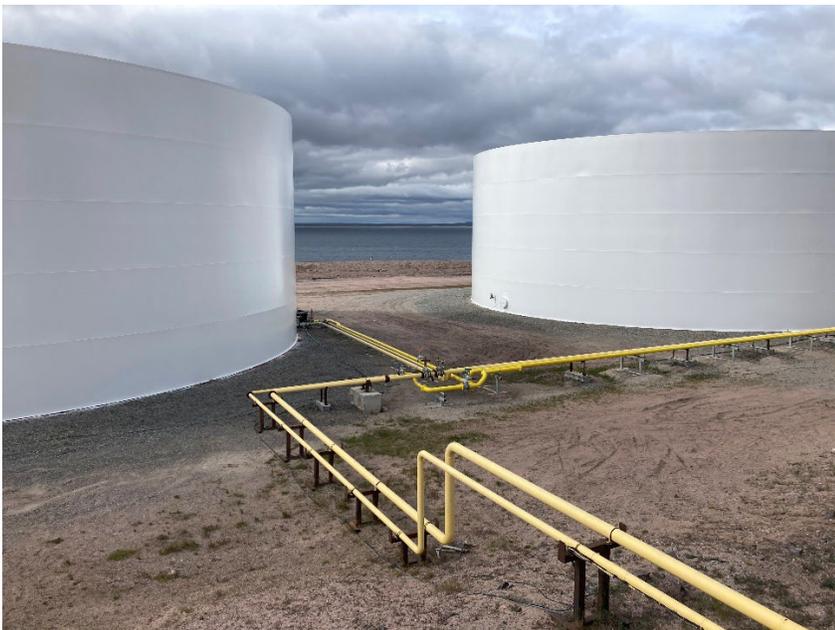
Photograph G1-12 Baker Lake Tank Farm

Description: From the northern side of Tank 4, looking southwest toward Tanks 3 and 4.

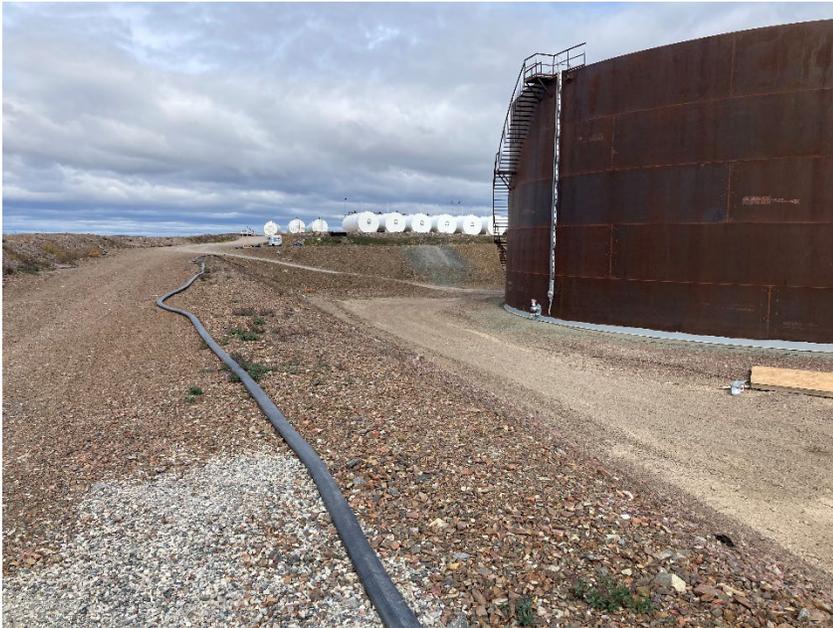
Photograph G1-13 Baker Lake Tank Farm

Description: Looking northwest at the southern and western sides of Tank 5.

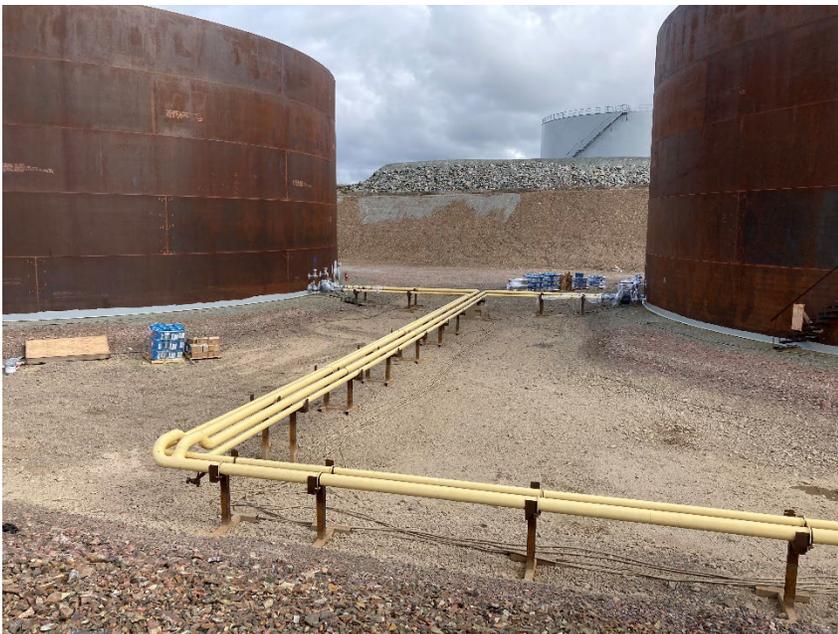
Photograph G1-14 Baker Lake Tank Farm

Description: Looking north between Tanks 5 and 6.

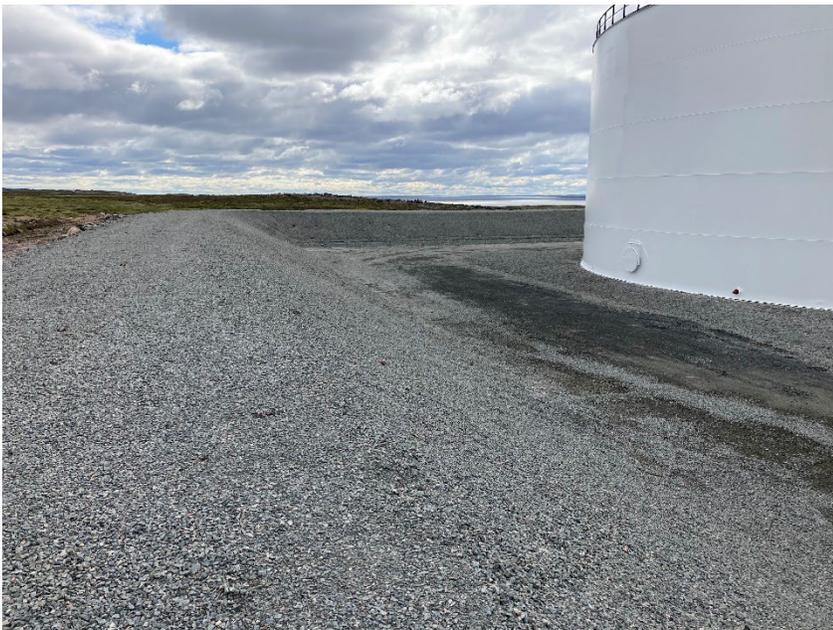
Photograph G1-18 Baker Lake Tank Farm

Description: Looking southwest at the crest on the northeast corner of Tank 8.

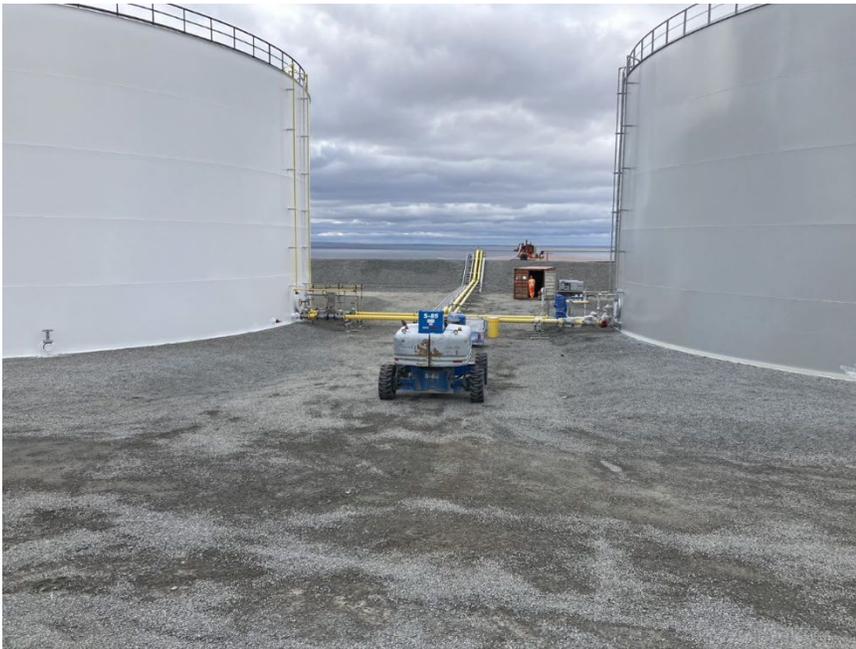
Photograph G1-19 Baker Lake Tank Farm

Description: Looking southwest between Tank 8 and Tank 7.

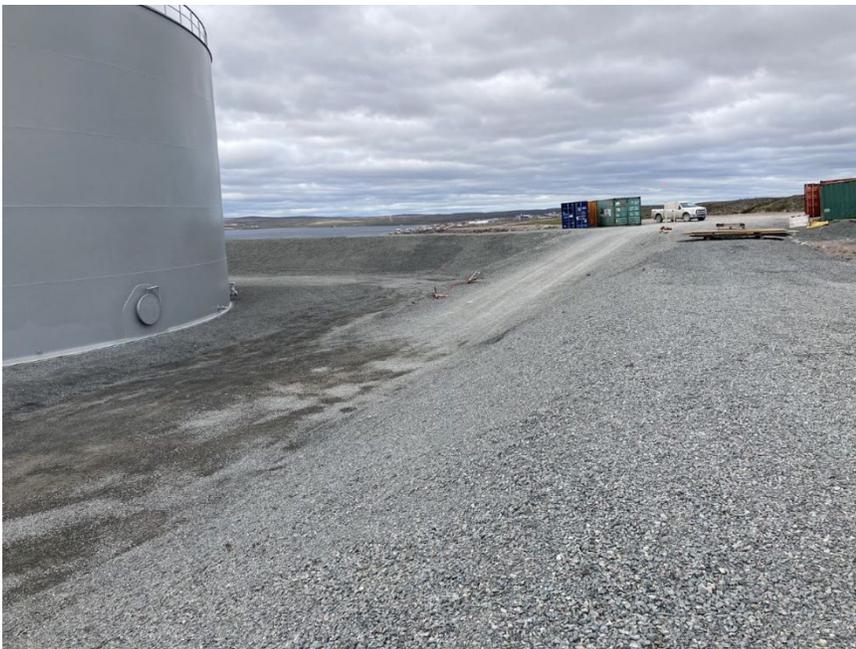
Photograph G1-20 Baker Lake Tank Farm

Description: Looking northwest at the crest on the northeast corner of Tank 7.

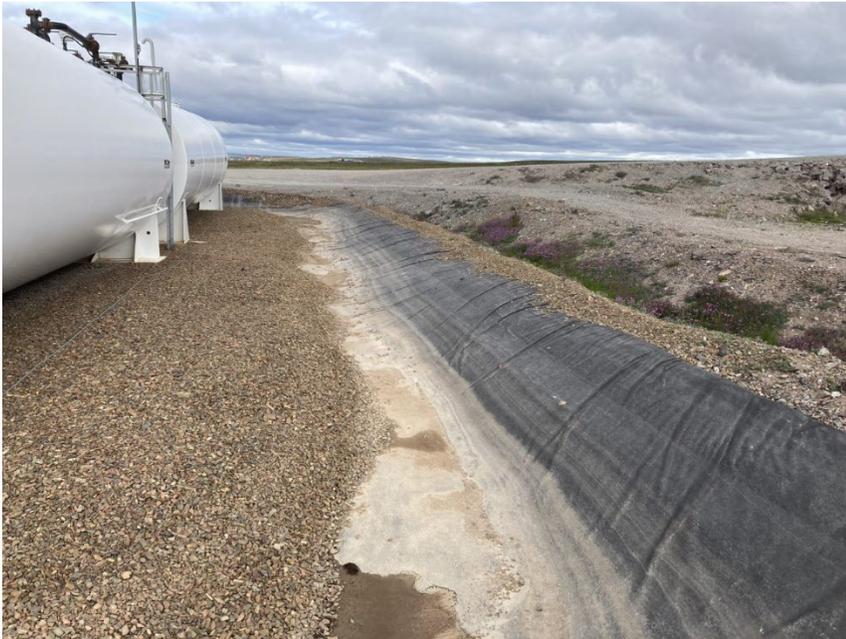
Photograph G1-23 Baker Lake Tank Farm

Description: From the northeastern corner of the Jet A fuel tanks looking west.

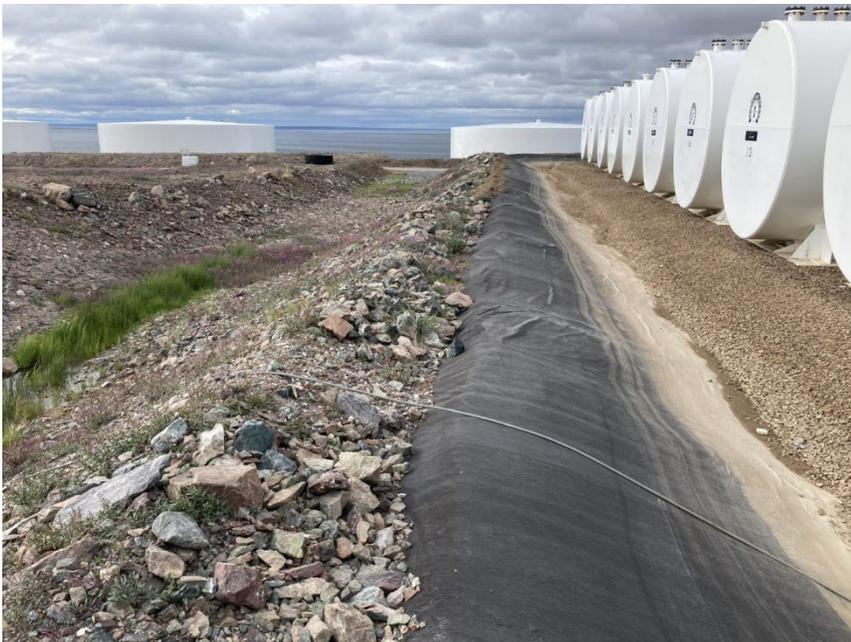
Photograph G1-24 Baker Lake Tank Farm

Description: From the northeastern corner of the Jet A fuel tanks looking south.

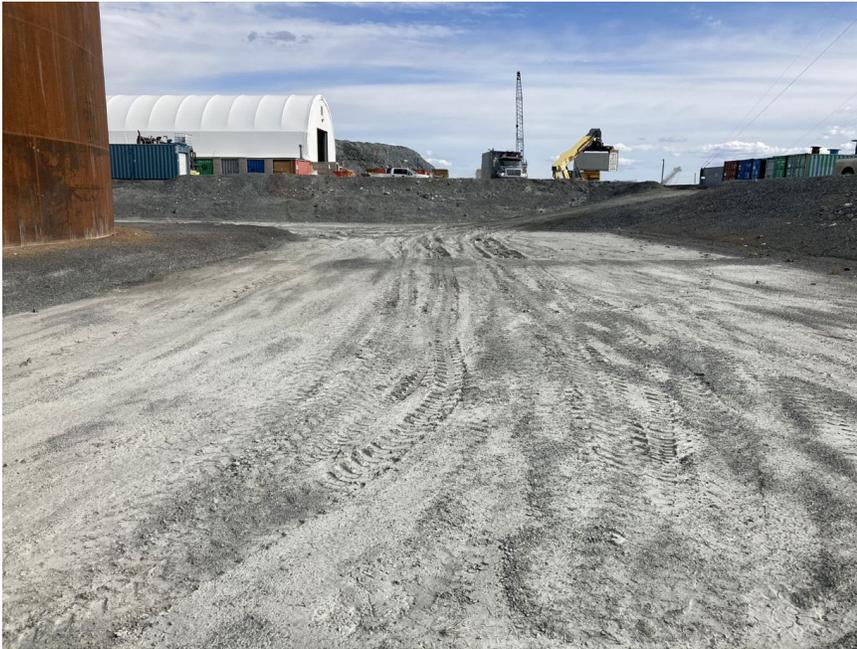
Photograph G2-1 Meadowbank Tank Farm

Description: From the western corner, looking southeast.

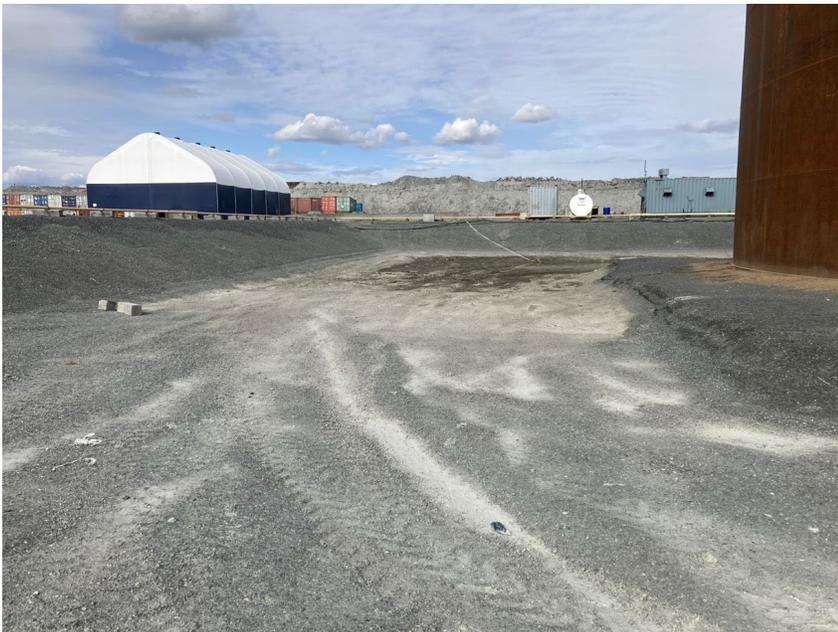
Photograph G2-2 Meadowbank Tank Farm

Description: From the western corner, looking northeast.

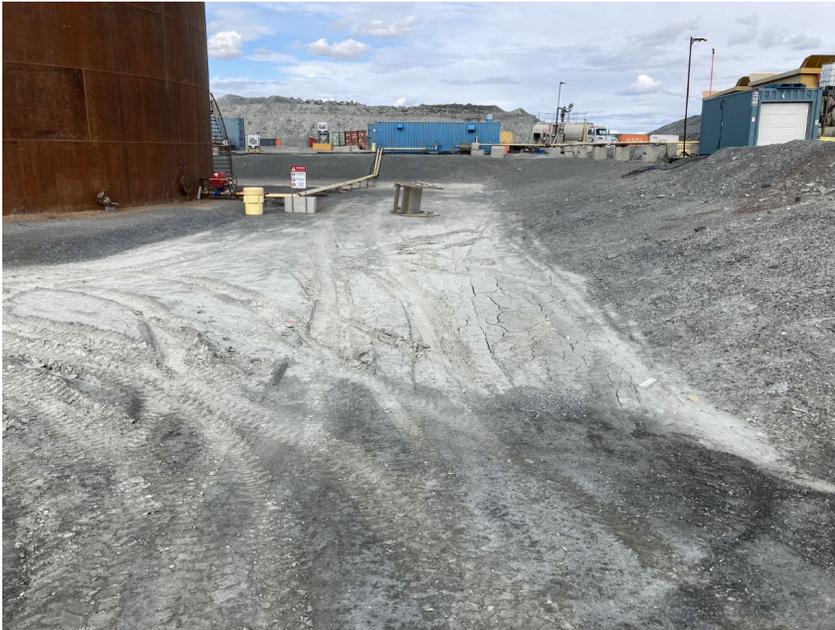
Photograph G2-3 Meadowbank Tank Farm

Description: Looking northeast from the southern corner.

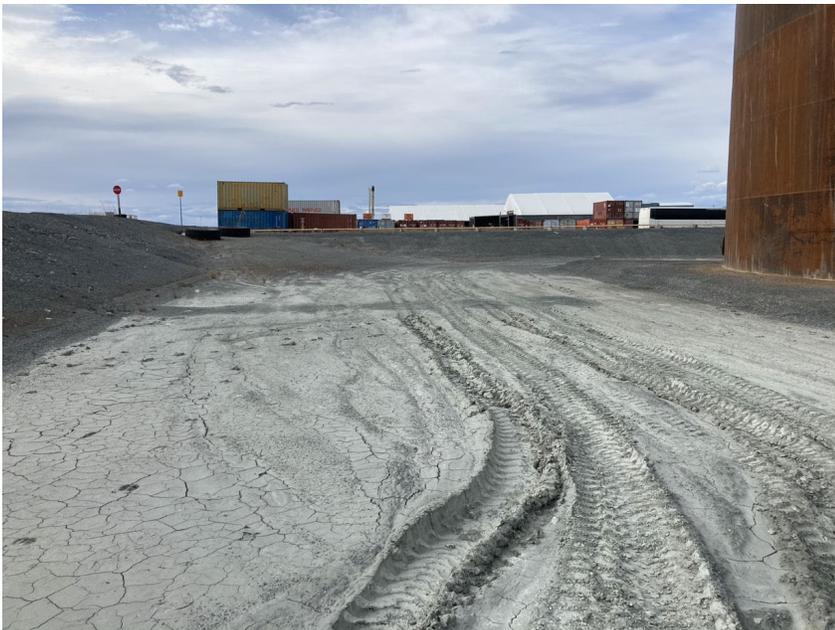
Photograph G2-4 Meadowbank Tank Farm

Description: Looking northwest from the southern corner.

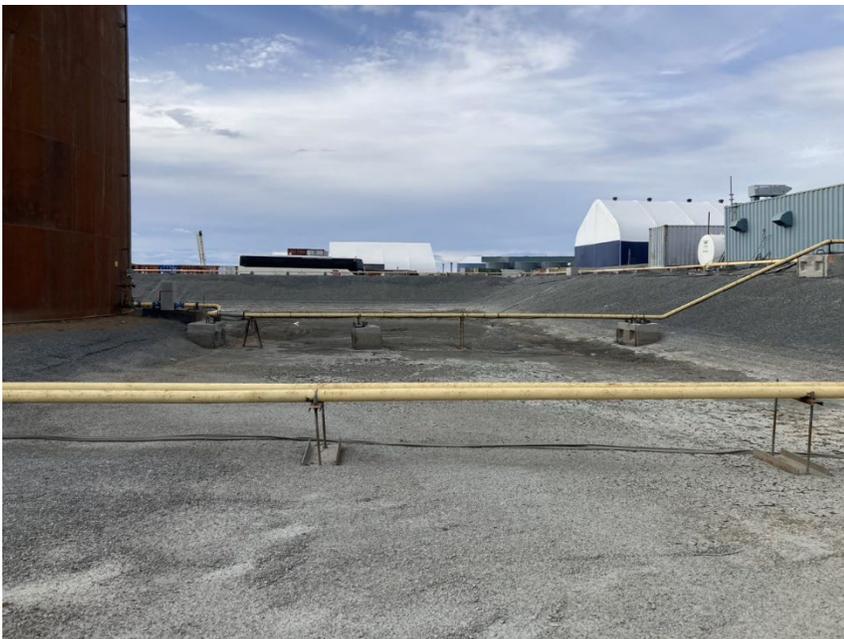
Photograph G2-6 Meadowbank Tank Farm

Description: Looking northwest from the southeastern side of the tank.

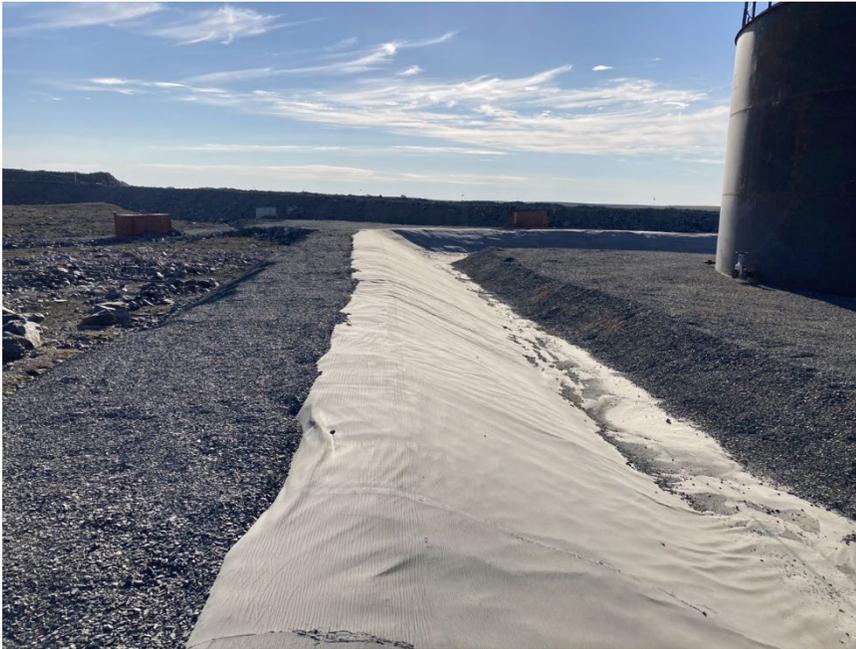
Photograph G3-3 Whale Tail Project Site Tank Farm

Description: From the northwest corner of the tank, looking east.

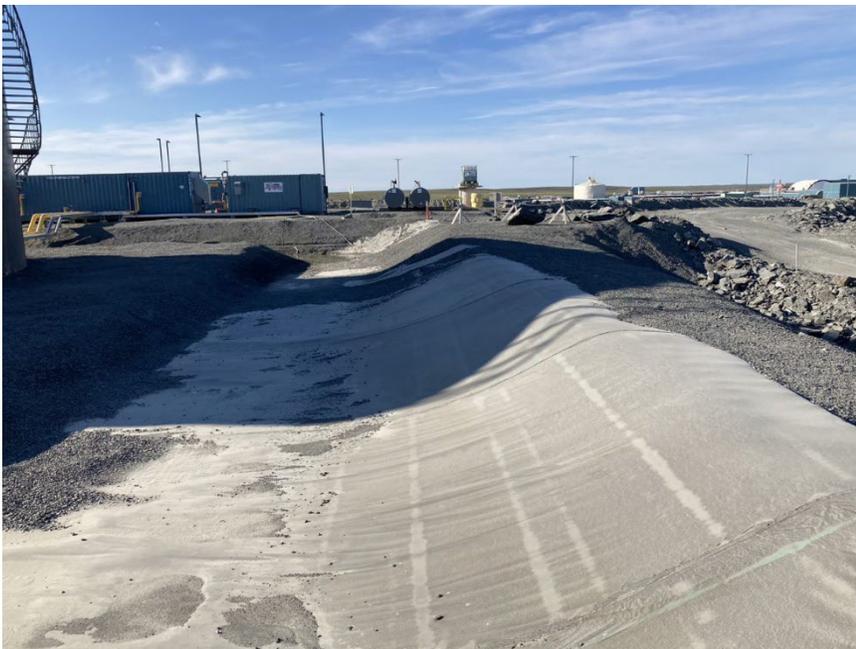
Photograph G3-4 Whale Tail Project Site Tank Farm

Description: From the northwest corner of the tank, looking south.

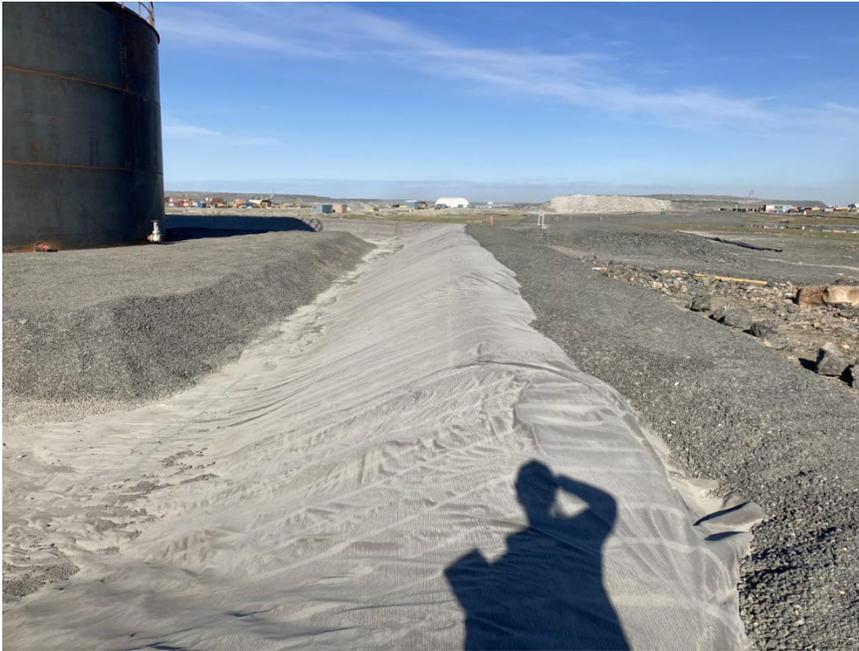
Photograph G3-5 Whale Tail Project Site Tank Farm

Description: From the northeast corner of the tank, looking west.

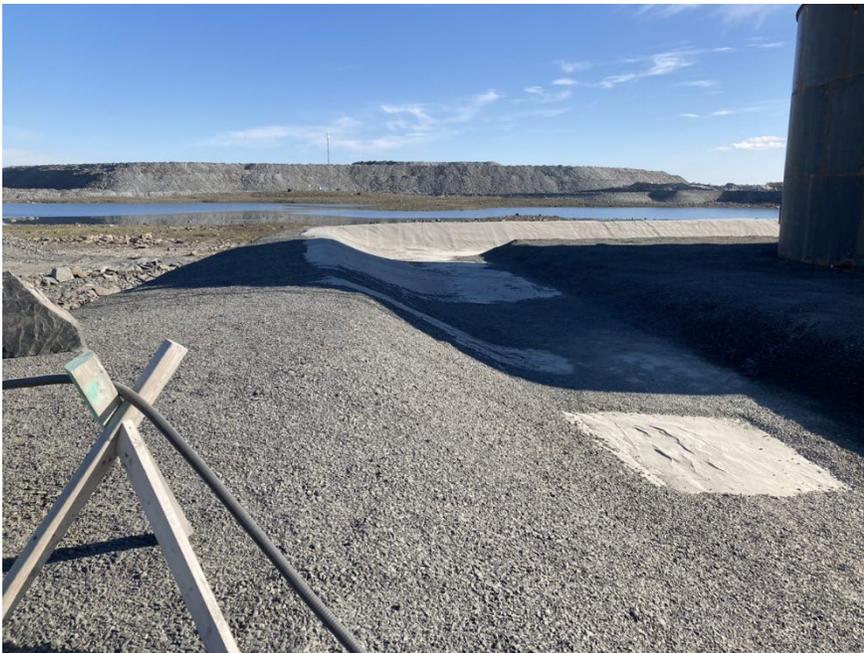
Photograph G3-6 Whale Tail Project Site Tank Farm

Description: From the southwest corner of the tank, looking north.

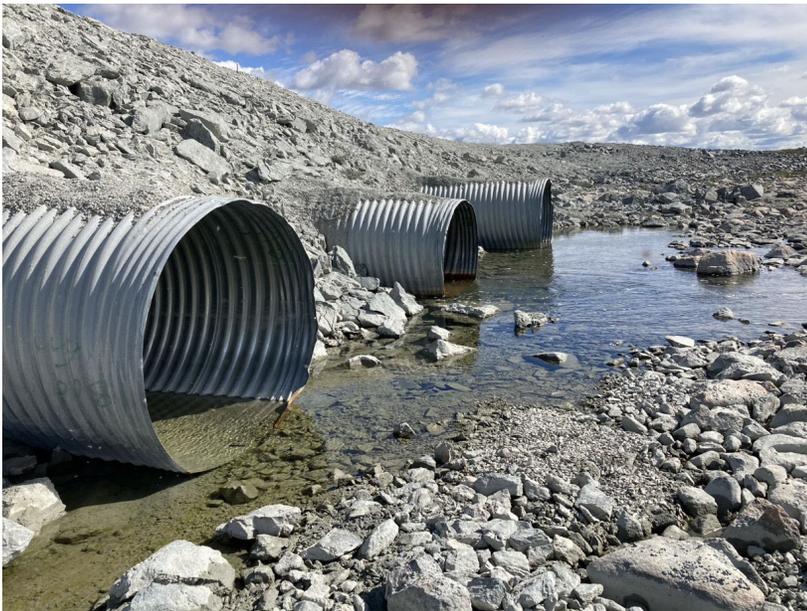
Photograph H1-1 Vault Road Culverts

Description: Looking at the outlet of the three culverts located on Vault Road at 640964E/7217466N. All of them are deformed in the middle.

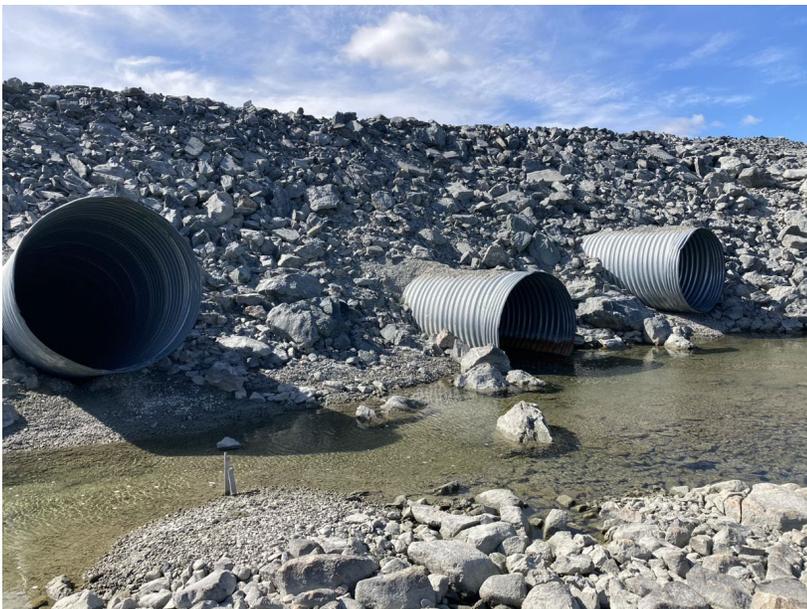
Photograph H1-2 Vault Road Culverts

Description: From the inlet side of the three culverts located on Vault Road at 640964E/7217466N. The culverts are slightly deformed on top in the middle.

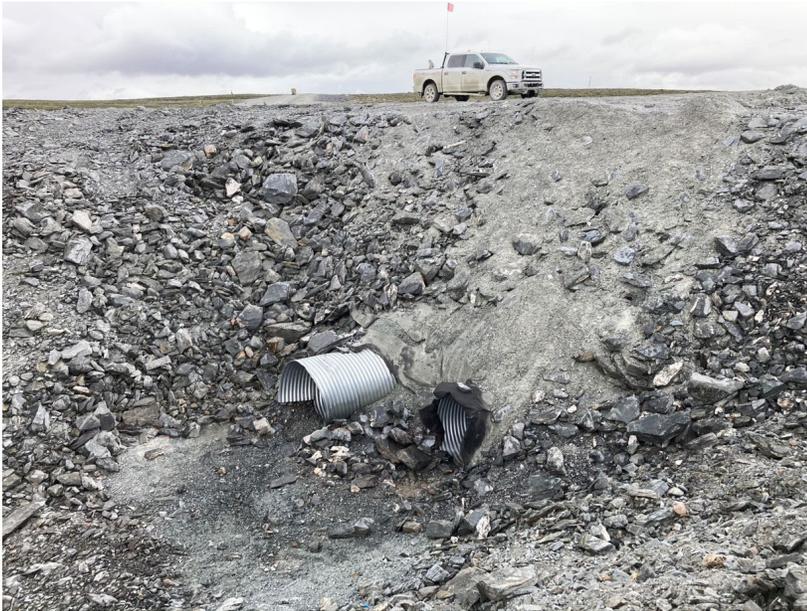
Photograph H2-1 Diversion Ditch and its Sediment and Erosion Protection Structure

Description: Looking east toward the inlet of the culverts beneath the road.

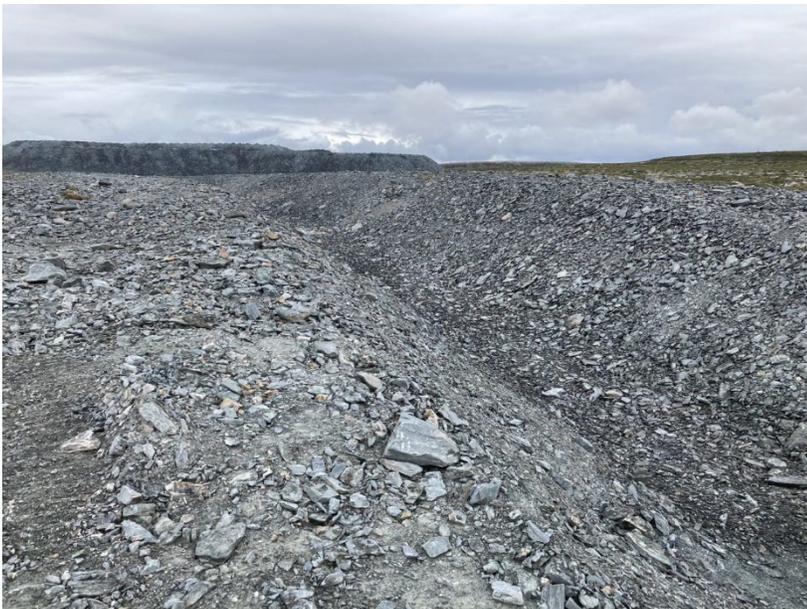
Photograph H2-2 Diversion Ditch and its Sediment and Erosion Protection Structure

Description: Looking west toward NP2 lake.

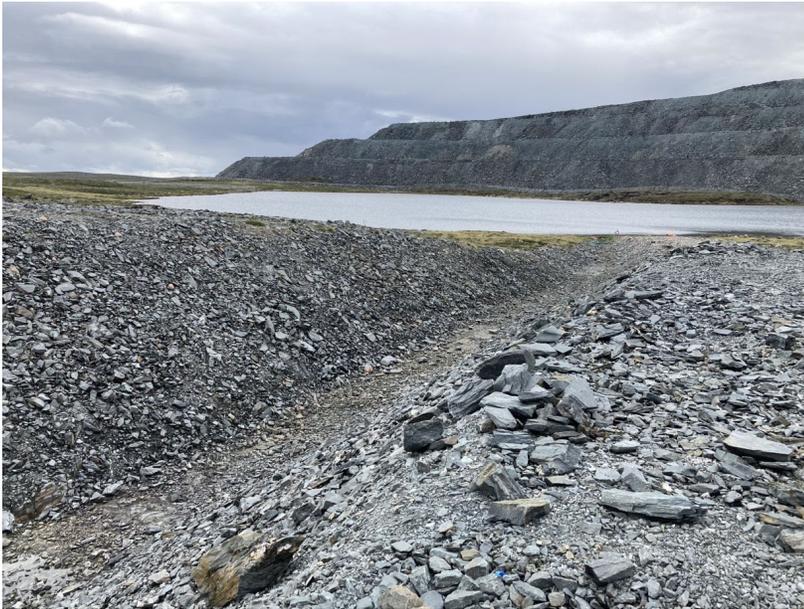
Photograph H2-3 Diversion Ditch and its Sediment and Erosion Protection Structure

Description: From the eastern diversion ditch looking south toward Lake NP2.

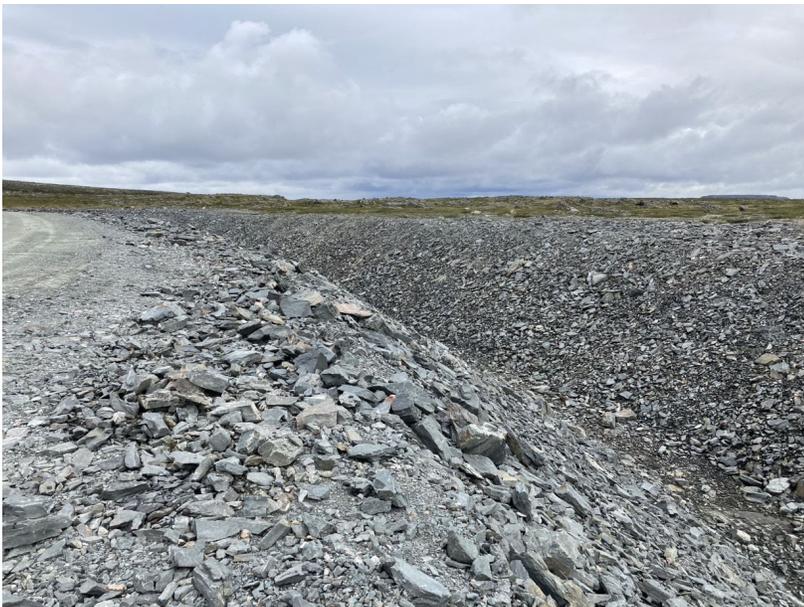
Photograph H2-4 Diversion Ditch and its Sediment and Erosion Protection Structure

Description: From the eastern diversion ditch looking northwest.

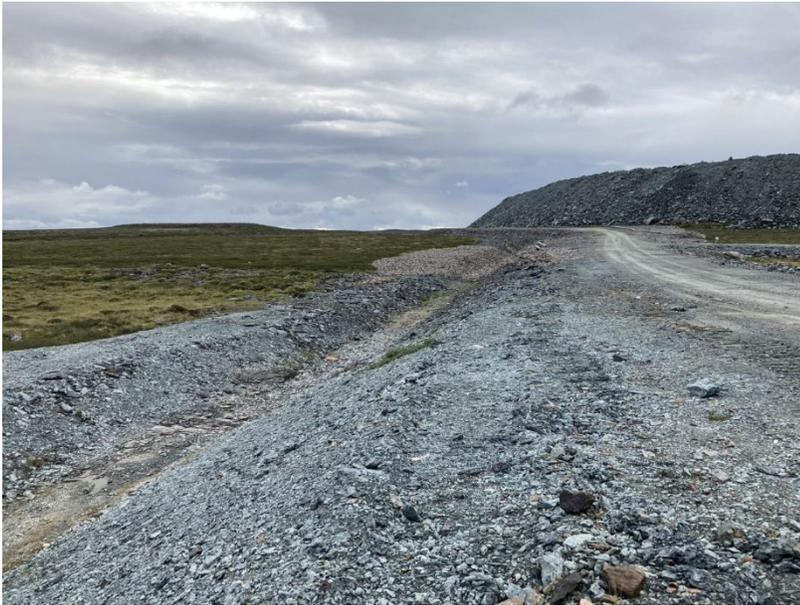
Photograph H2-5 Diversion Ditch and its Sediment and Erosion Protection Structure

Description: From the eastern diversion ditch, looking east.

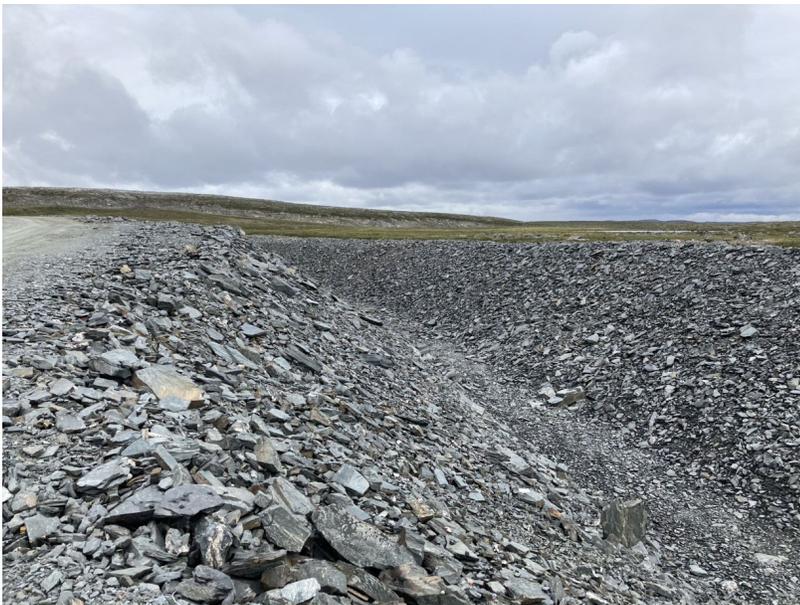
Photograph H2-6 Diversion Ditch and its Sediment and Erosion Protection Structure

Description: From the eastern diversion ditch, looking northwest.

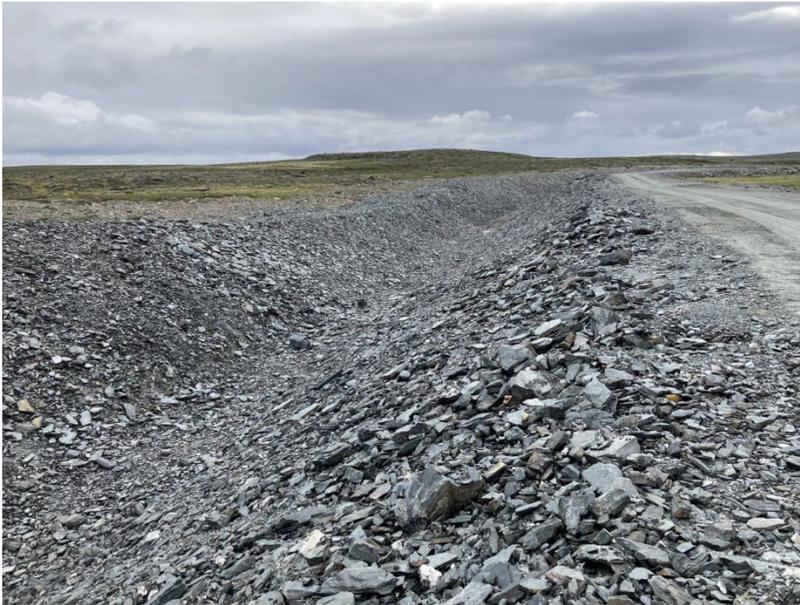
Photograph H2-7 Diversion Ditch and its Sediment and Erosion Protection Structure

Description: From the northern diversion ditch looking southeast.

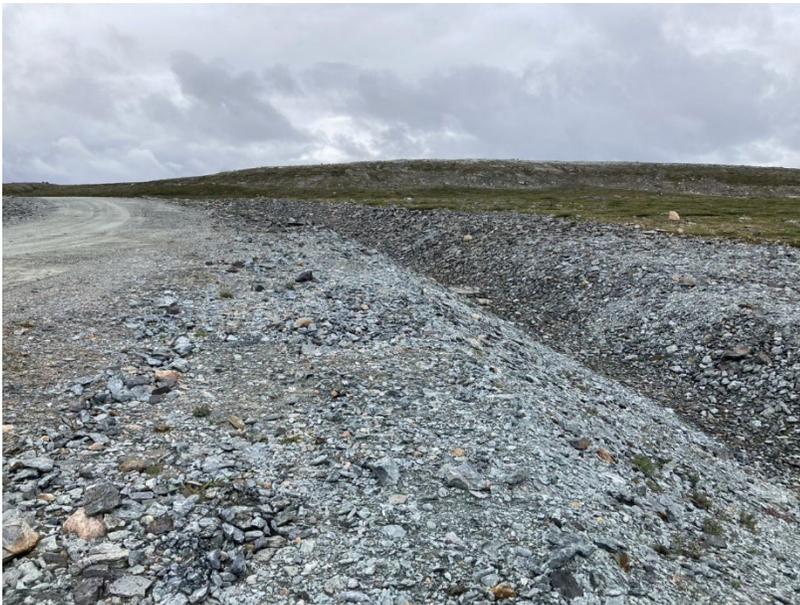
Photograph H2-8 Diversion Ditch and its Sediment and Erosion Protection Structure

Description: From the northern diversion ditch looking west.

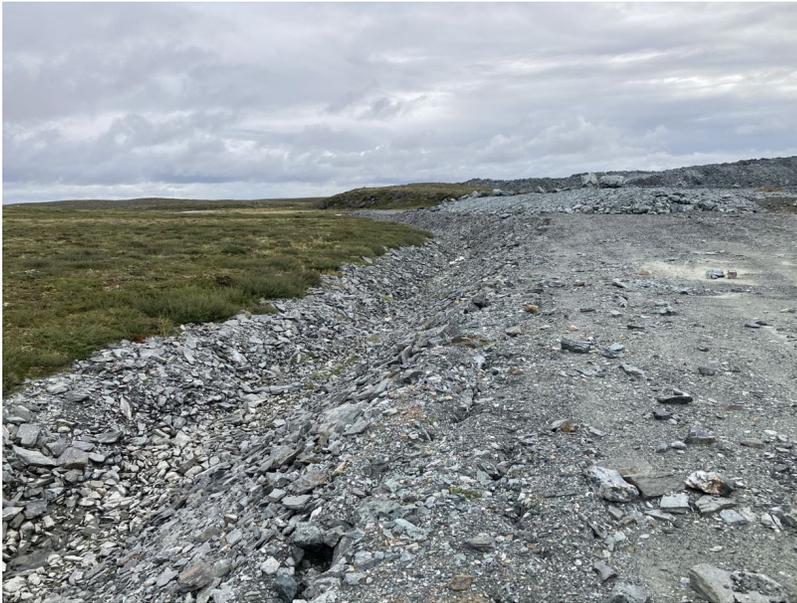
Photograph H2-9 Diversion Ditch and its Sediment and Erosion Protection Structure

Description: From the northern diversion ditch looking east.

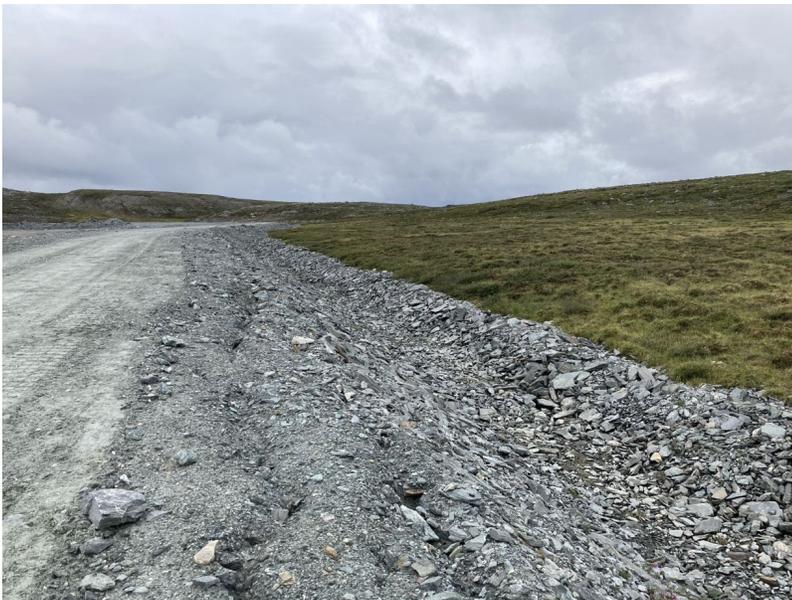
Photograph H2-10 Diversion Ditch and its Sediment and Erosion Protection Structure

Description: From the northern diversion ditch looking west.

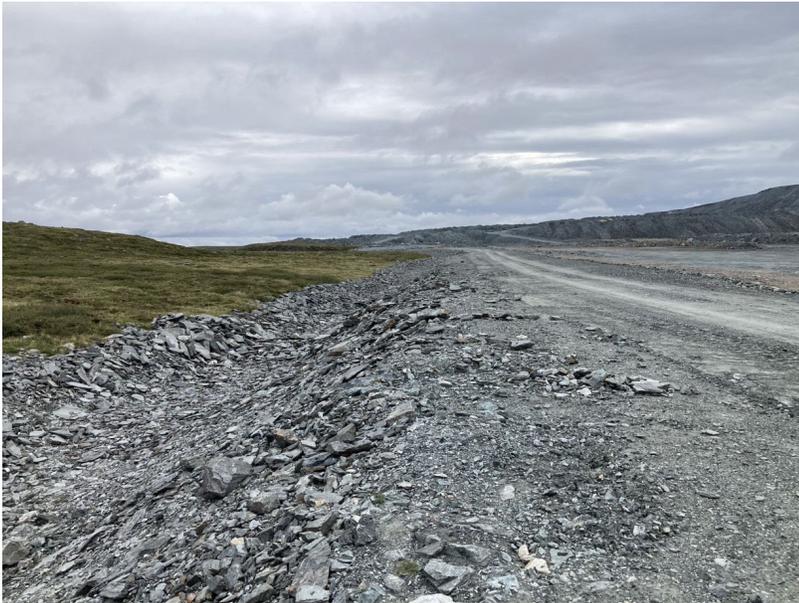
Photograph H2-11 Diversion Ditch and its Sediment and Erosion Protection Structure

Description: From the northern diversion ditch looking east.

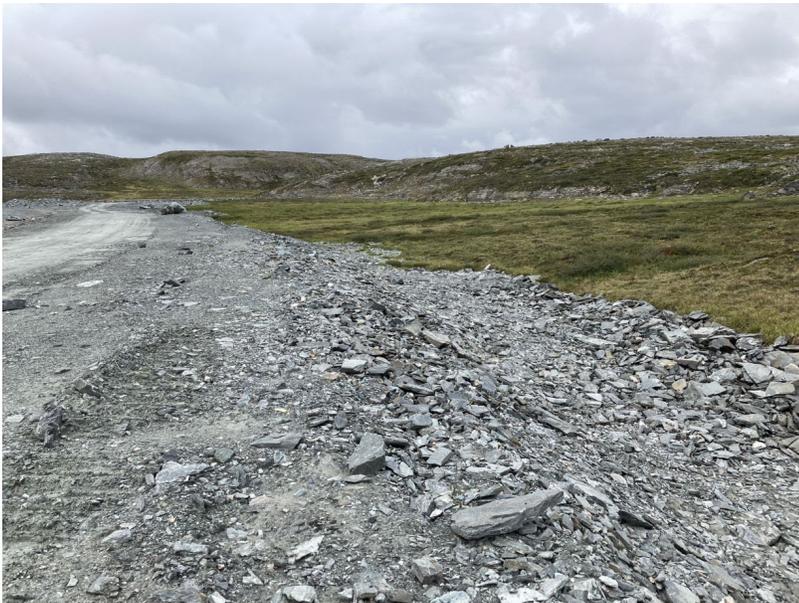
Photograph H2-12 Diversion Ditch and its Sediment and Erosion Protection Structure

Description: From the northern diversion ditch looking west.

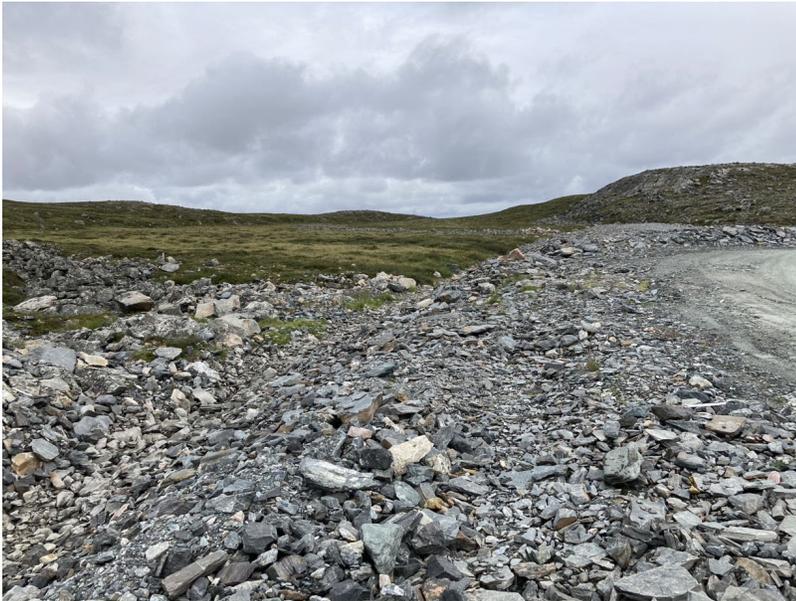
Photograph H2-13 Diversion Ditch and its Sediment and Erosion Protection Structure

Description: From 637281E/7216790N, looking north. View of the western diversion ditch.

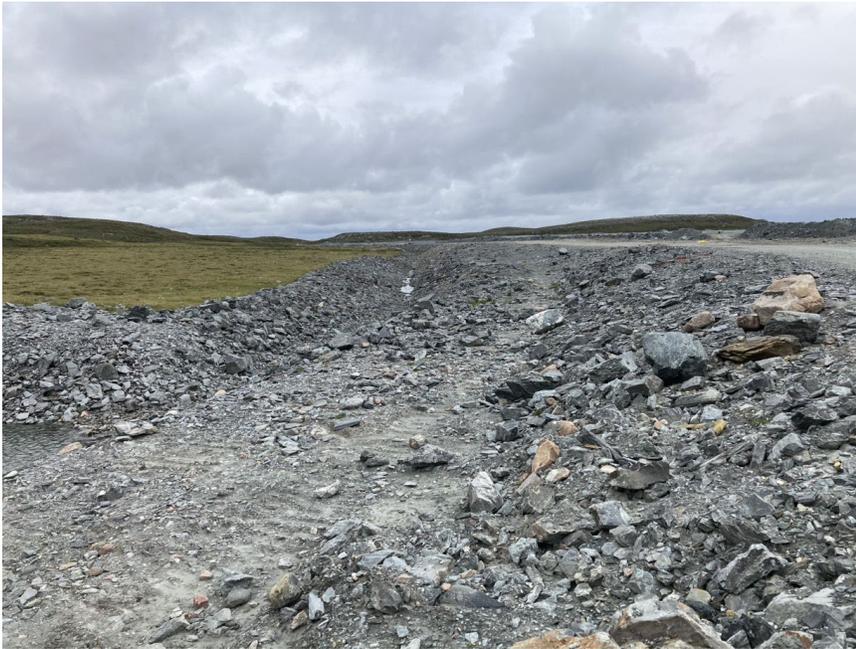
Photograph H2-15 Diversion Ditch and its Sediment and Erosion Protection Structure

Description: From 637251E/7216171N, looking north at the western diversion ditch.

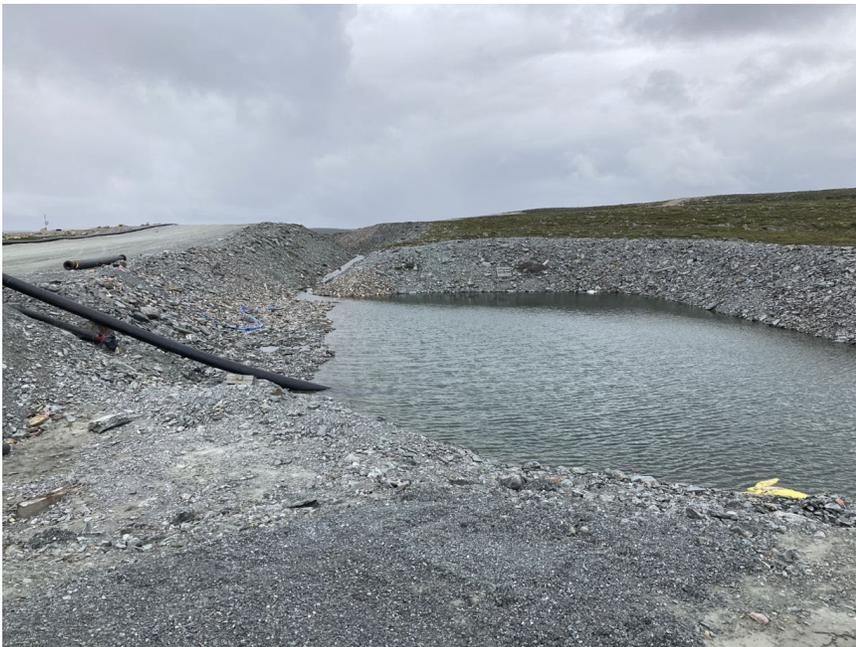
Photograph H2-16 Diversion Ditch and its Sediment and Erosion Protection Structure

Description: From 637251E/7216171N, looking southwest at the western diversion ditch and its retention basin.

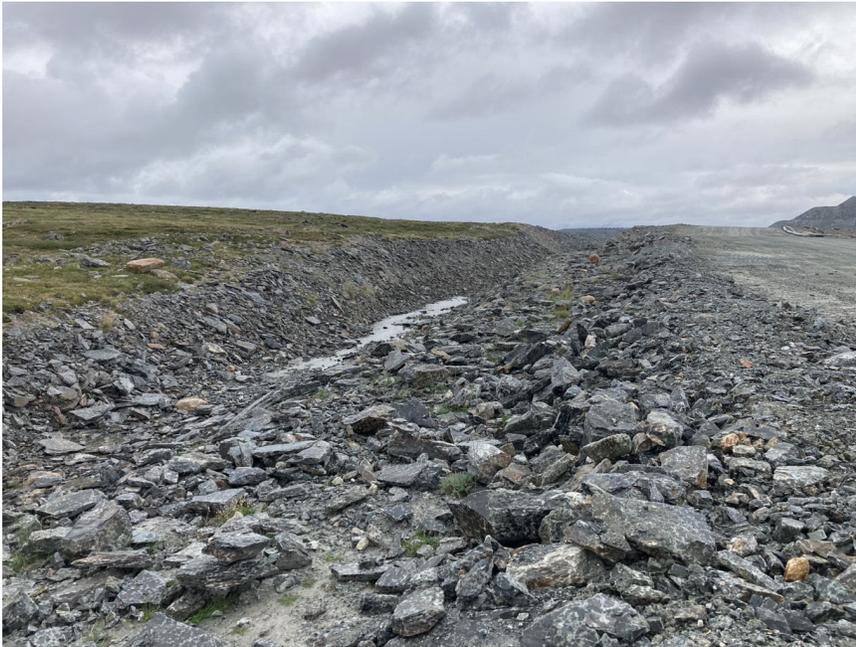
Photograph H2-17 Diversion Ditch and its Sediment and Erosion Protection Structure

Description: From 637074E/7216157N, looking east at the western diversion ditch.
