APPENDIX F
QUARRIES

APPENDIX G
BULK FUEL FACILITIES

APPENDIX H
OTHER FACILITIES

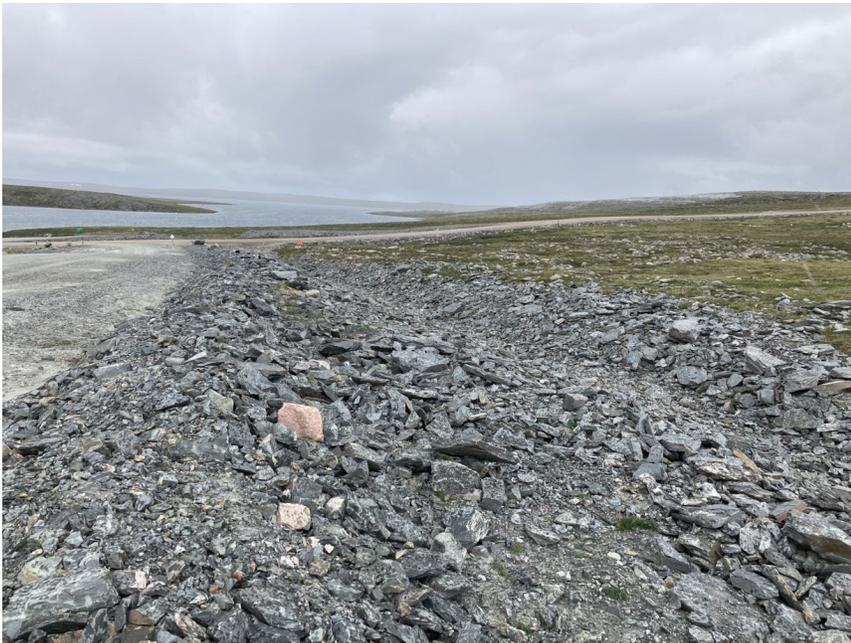
Photograph H2-18 Diversion Ditch and its Sediment and Erosion Protection Structure

Description: From 637074E/7216157N, looking west at the western diversion ditch.

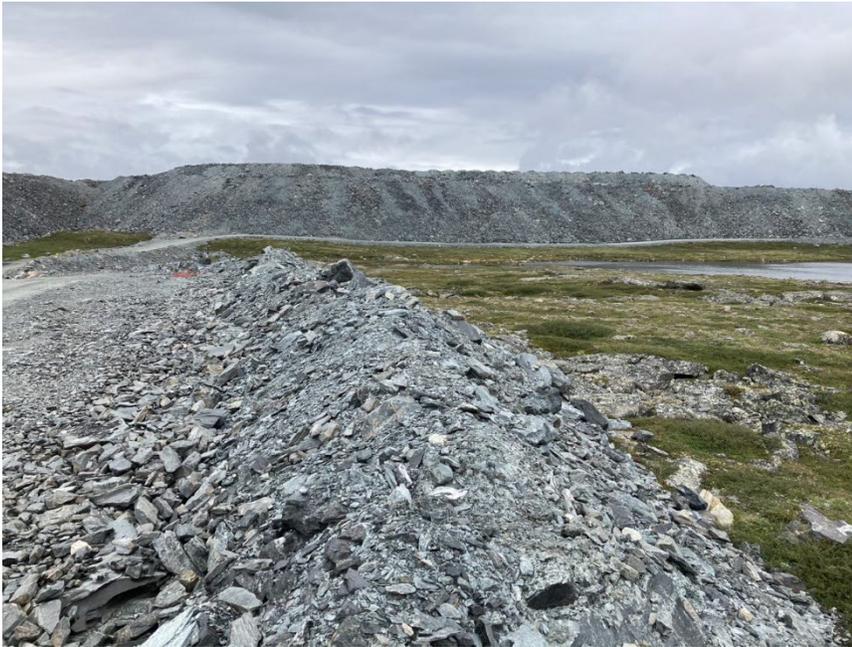
Photograph H3-1 RSF Till Plug

Description: From the south side of NP2 Lake (north of the diversion ditch) looking west at the RSF till plug.

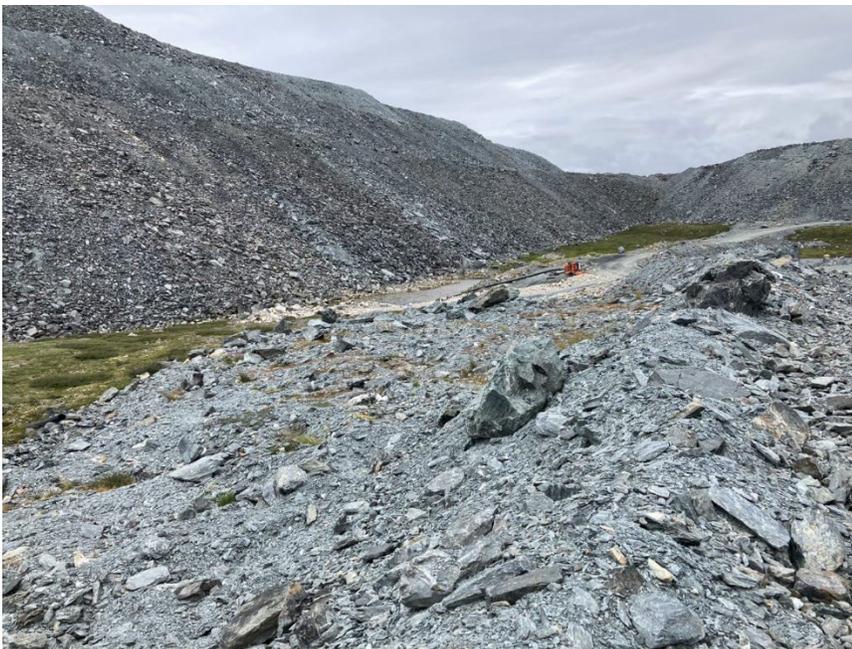
Photograph H3-2 RSF Till Plug

Description: From the south side of NP2 Lake (south of the diversion ditch) looking west at the RSF till plug.

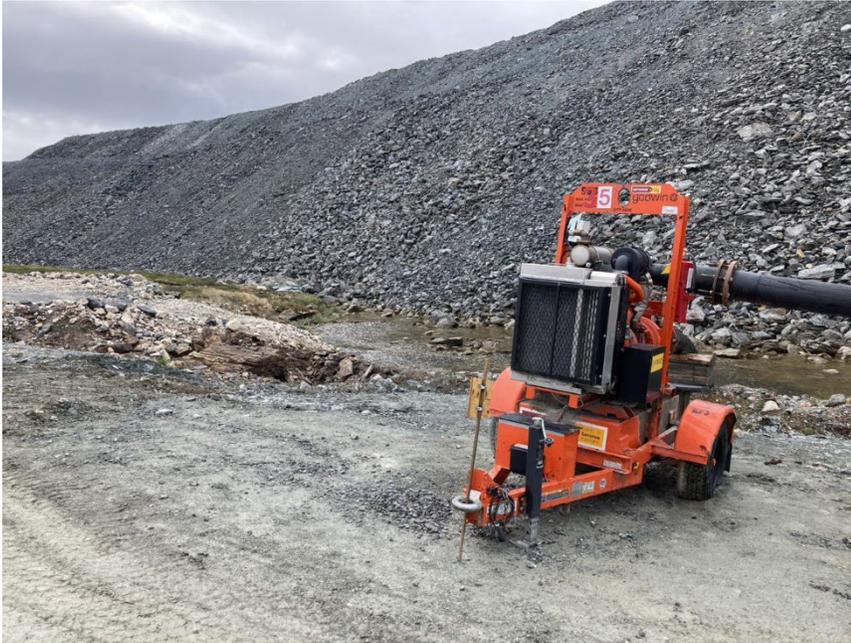
Photograph H3-3 RSF Till Plug

Description: From the south side of NP2 Lake (south of the diversion ditch) looking southeast at the RSF till plug.

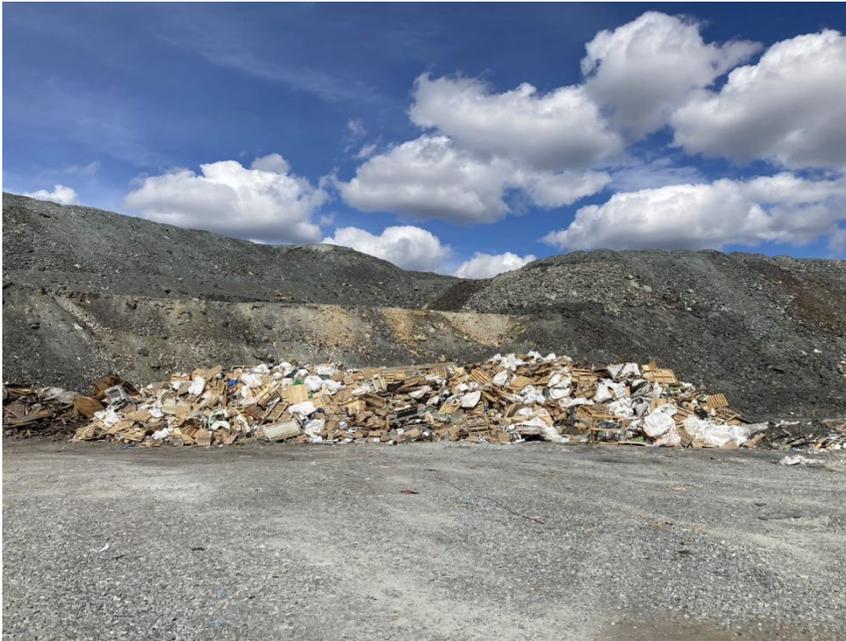
Photograph H4-1 Meadowbank Landfill

Description: From the 2020 landfill location within the Rock Storage Facility, looking southeast.

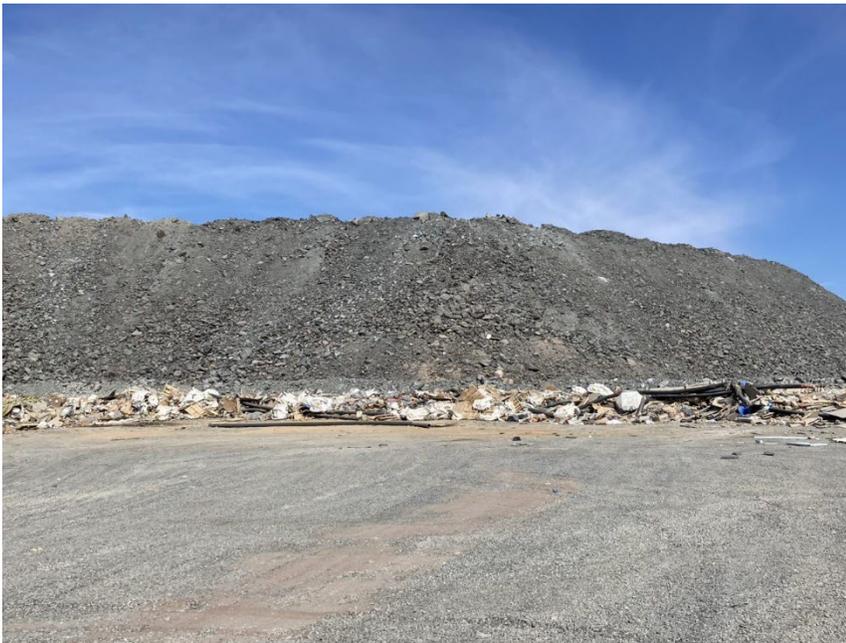
Photograph H4-2 Whale Tail Project Landfill

Description: From the new landfill location within the Whale Tail WRSF, looking north.

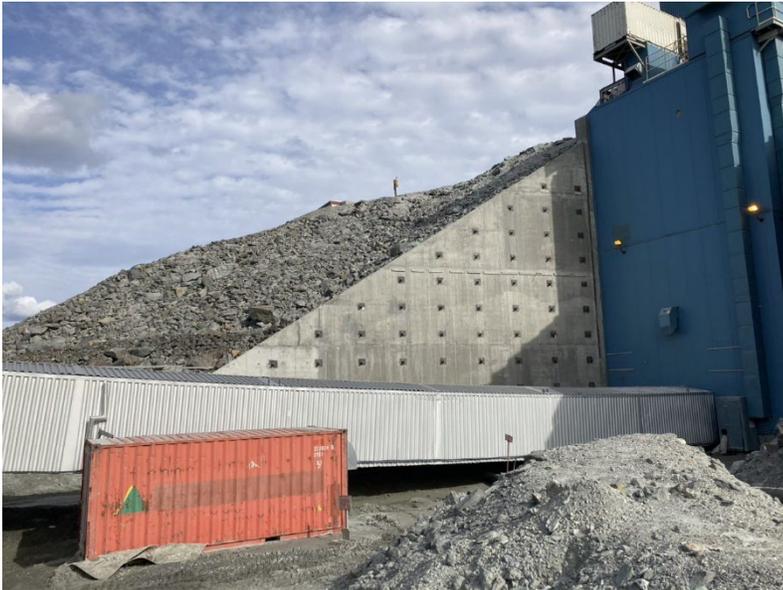
Photograph H6-1 Meadowbank Crusher Retaining Wall

Description: From the base of the wall, looking southeast.

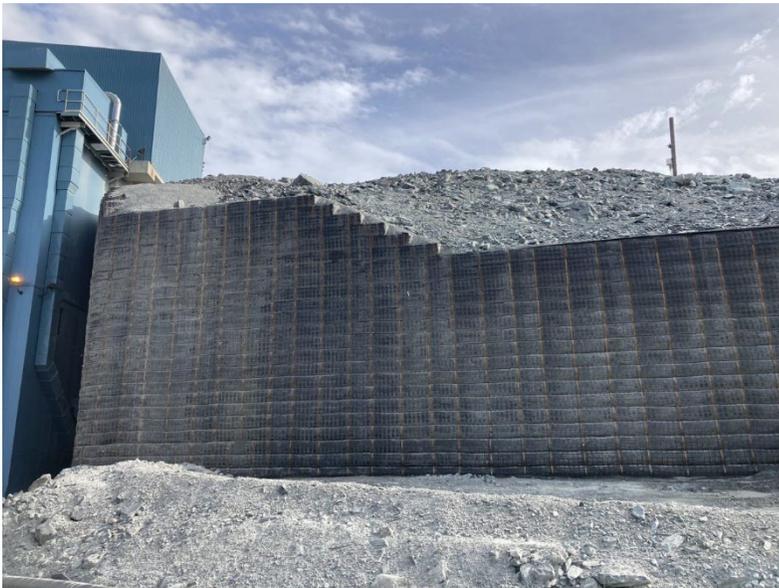
Photograph H6-2 Meadowbank Crusher Retaining Wall

Description: From the base of the wall, looking southeast.

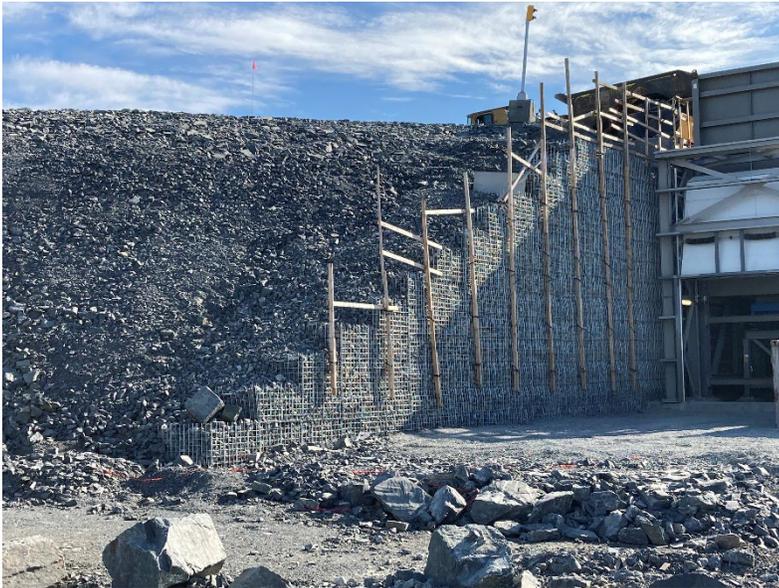
Photograph H6-3 Whale Tail Project Tramp Metal Removal Facility Retaining Wall

Description: From the base of the wall, looking north.

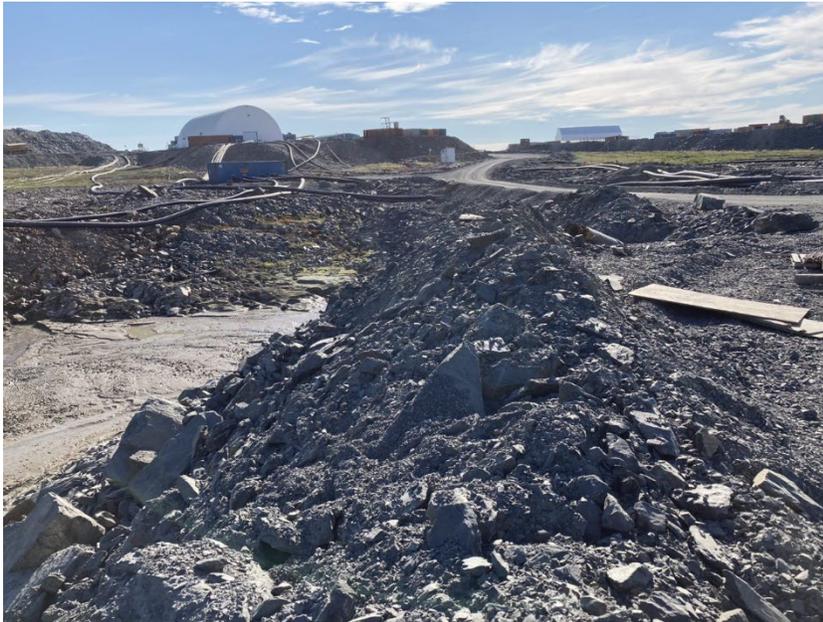
Photograph H7-1 Whale Tail Project Site Attenuation Pond Ramp

Description: From the pump pad, looking east at the ramp.

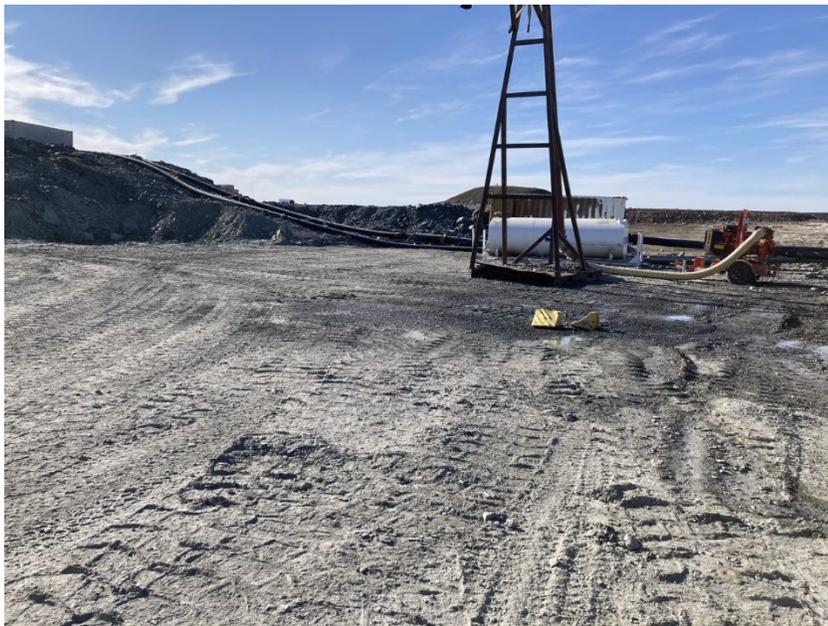
Photograph H7-2 Whale Tail Project Site Attenuation Pond Ramp

Description: From the pump pad, looking south at the pump pad.

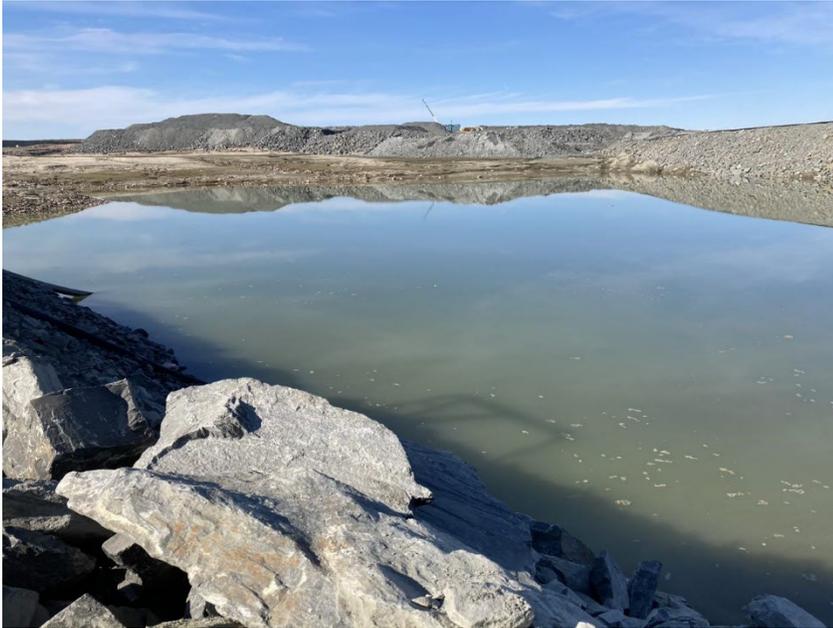
Photograph H7-3 Whale Tail Project Site Attenuation Pond Ramp

Description: From the pump pad, looking west at the Attenuation Pond.

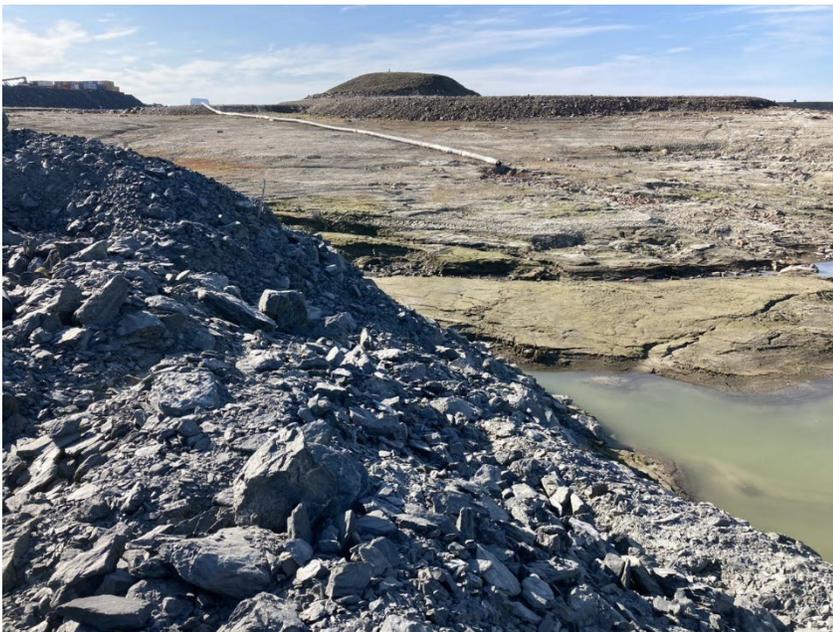
Photograph H7-4 Whale Tail Project Site Attenuation Pond Ramp

Description: From the pump pad, looking south at the Attenuation Pond.

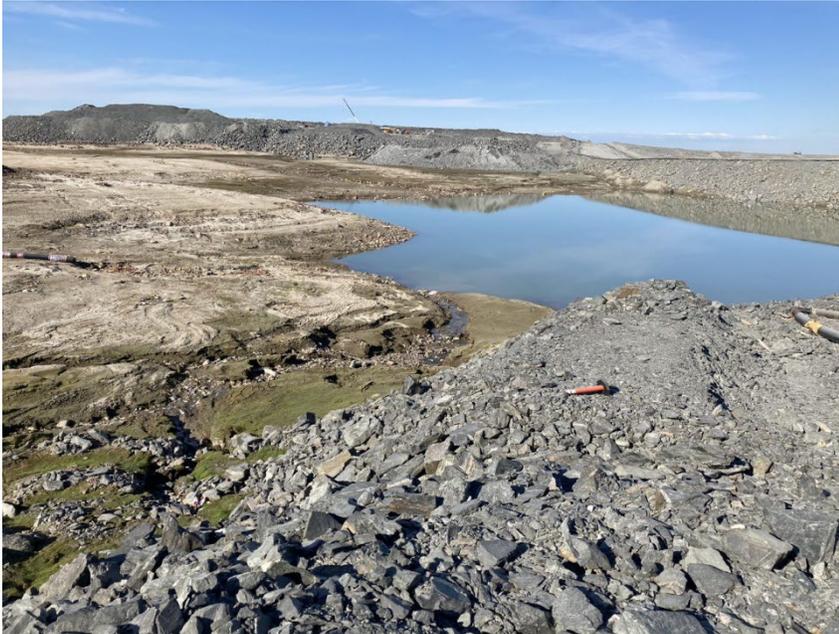
Photograph H7-5 Whale Tail Project Site Attenuation Pond Ramp

Description: From the pump pad, looking west at the primary attenuation pond ramp.

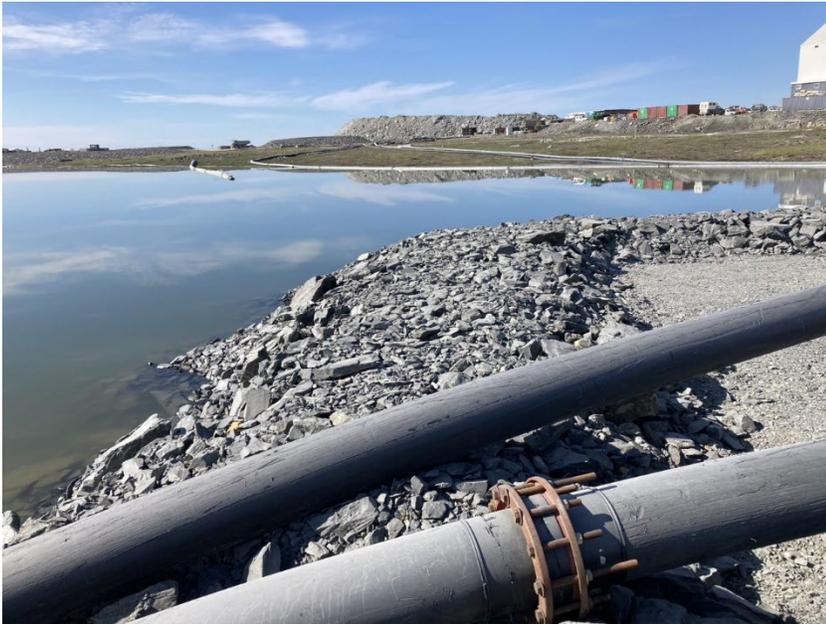
Photograph H8-1 Attenuation Pond Ramp

Description: From the pump pad, looking southwest at the Attenuation Pond.

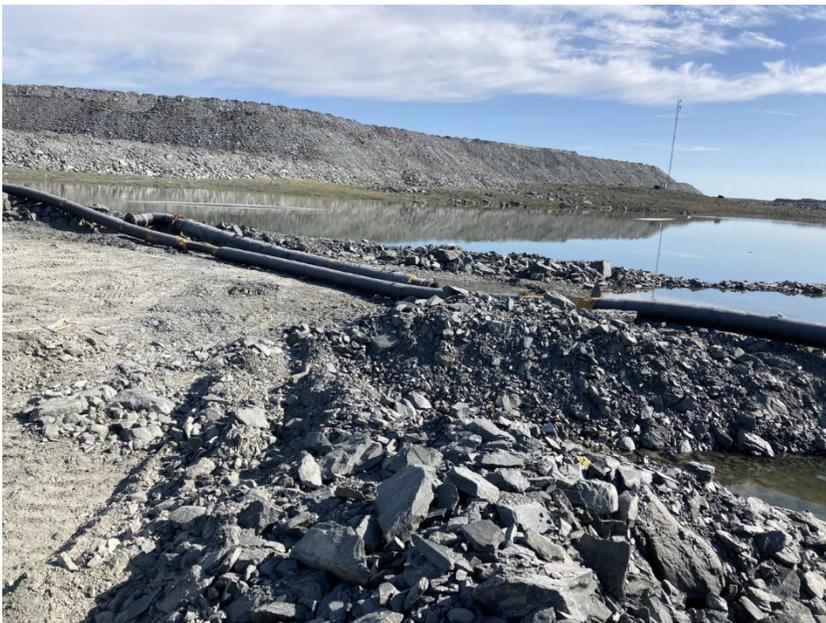
Photograph H8-2 IVR Attenuation Pond Ramp

Description: From the pump pad, looking northeast at the Attenuation Pond.

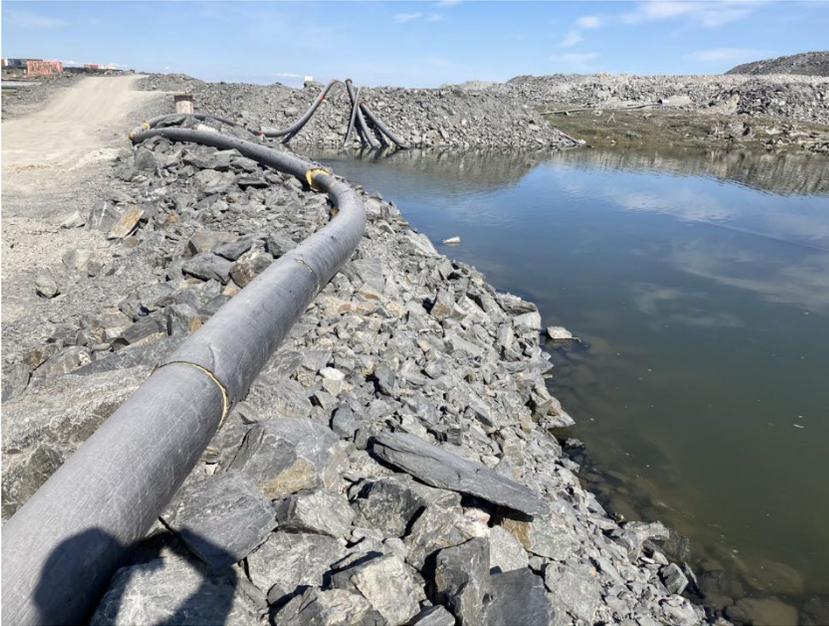
Photograph H8-3 IVR Attenuation Pond Ramp

Description: From the pump pad, looking northwest at the southern slope of the pump pad.

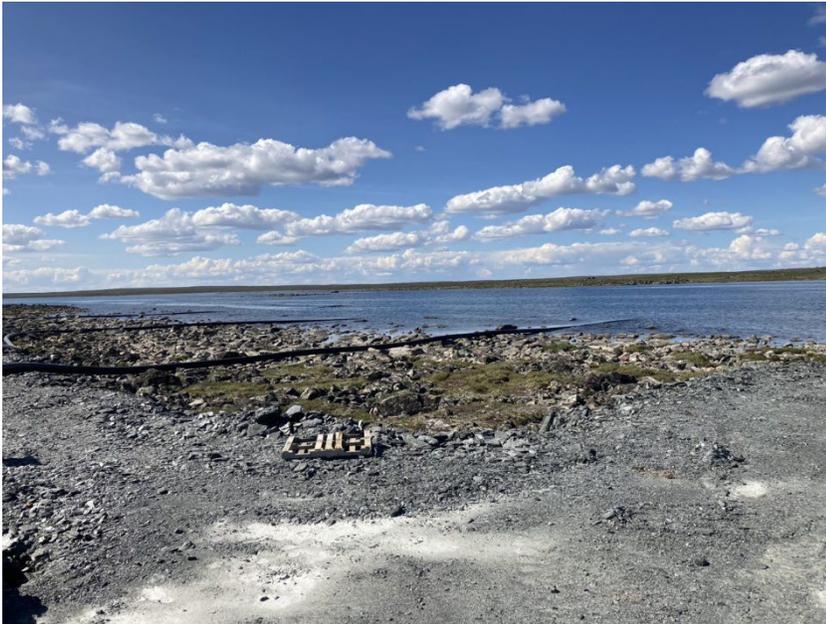
Photograph H9-1 Mammoth Lake Diffuser

Description: From the access road, looking west. Three diffusers are present and working normally.

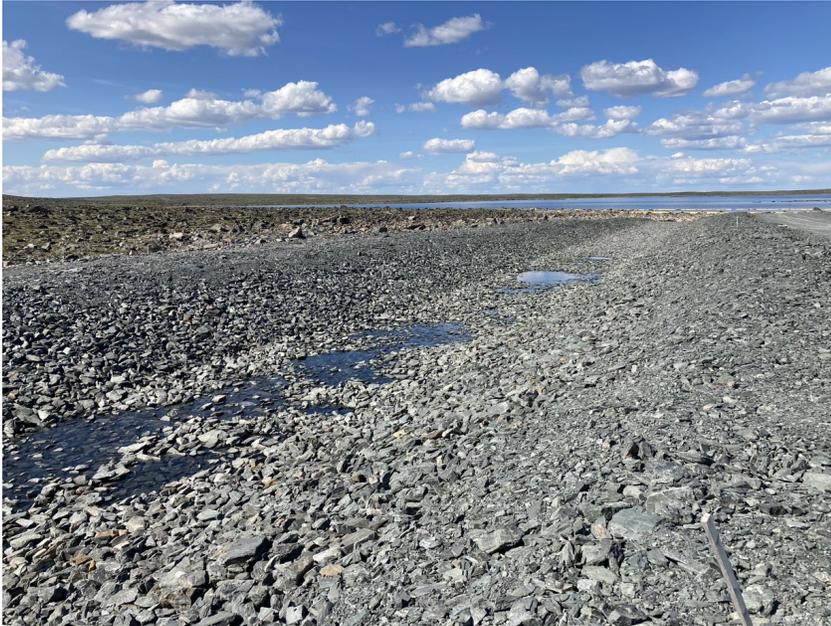
Photograph H10-3 South Whale Tail Channel

Description: From approx. Sta. 0+800, looking northwest.

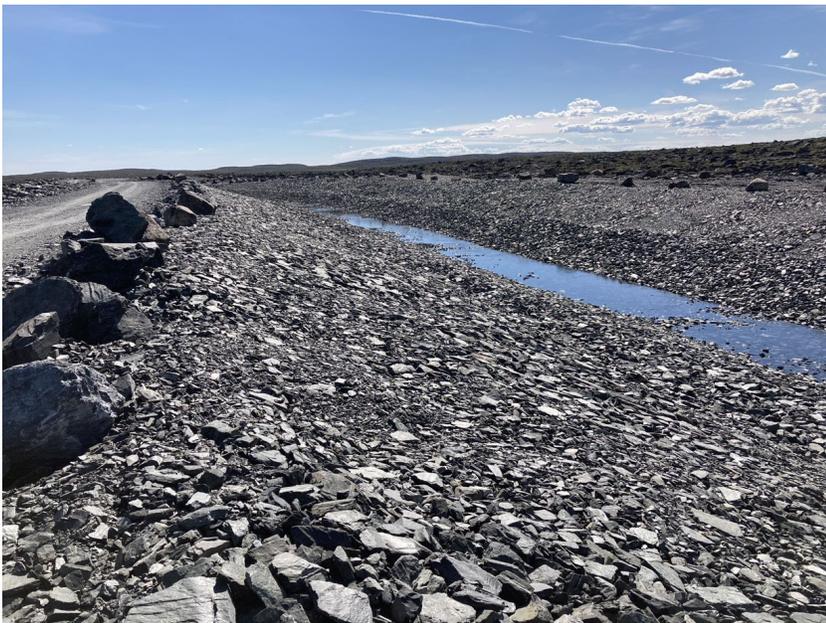
Photograph H10-4 South Whale Tail Channel

Description: From approx. Sta. 0+675, looking southeast.

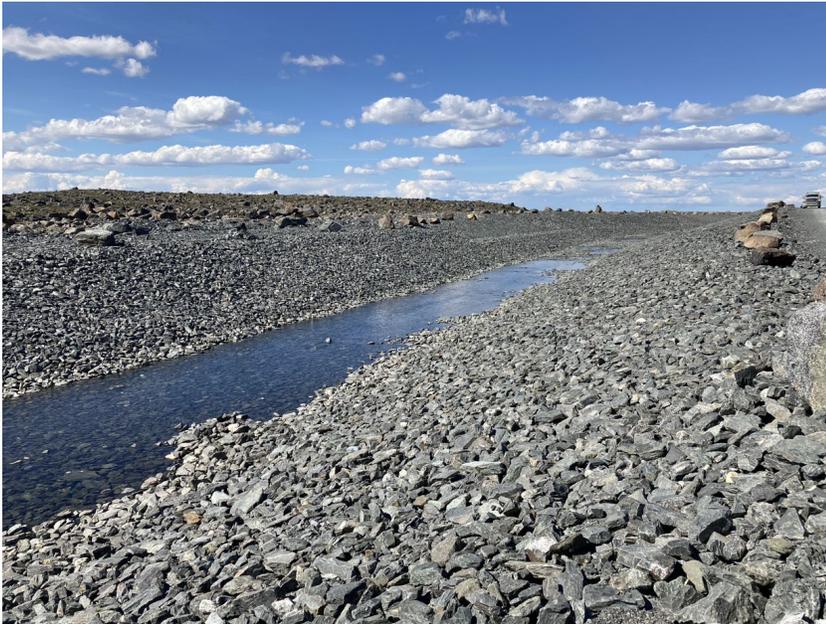
Photograph H10-5 South Whale Tail Channel

Description: From approx. Sta. 0+450 (Lake A45 area), looking northwest.

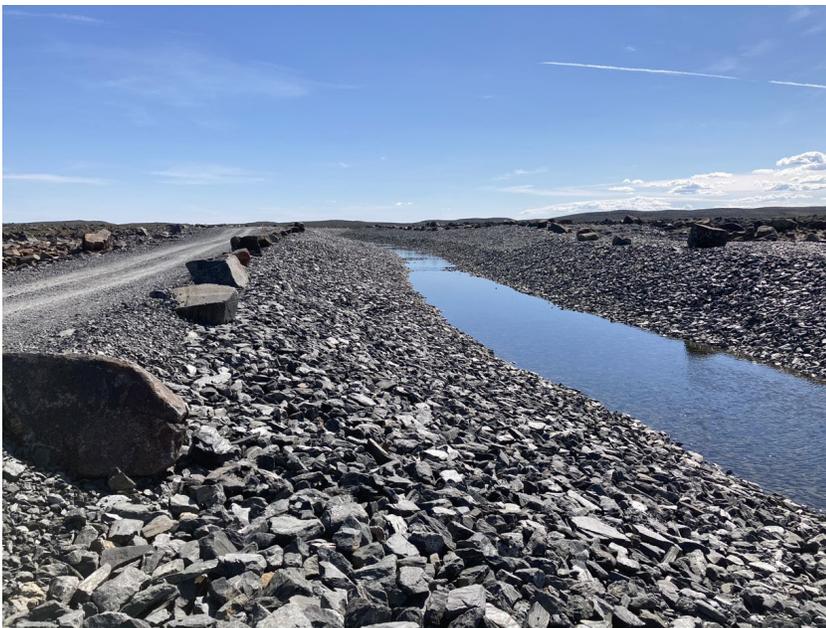
Photograph H10-6 South Whale Tail Channel

Description: From approx. Sta. 0+450 (Lake A45 area), looking southeast.

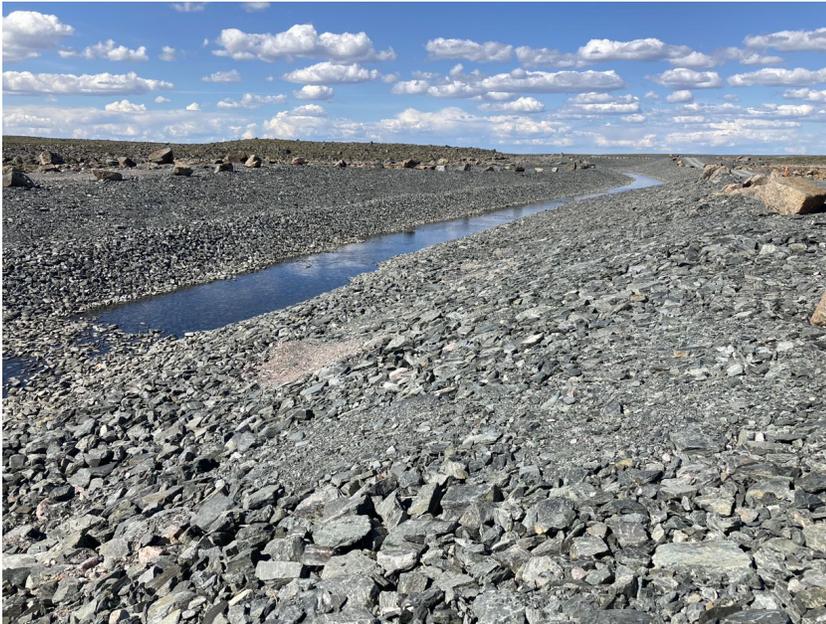
Photograph H10-7 South Whale Tail Channel

Description: From approx. Sta. 0+200, looking northwest.
