APPENDIX 14 2023 REPORTABLE SPILLS

Re: Follow-up Report Spill #2023-009 – Release of 5 L of Sewage at the Meliadine Gold Project

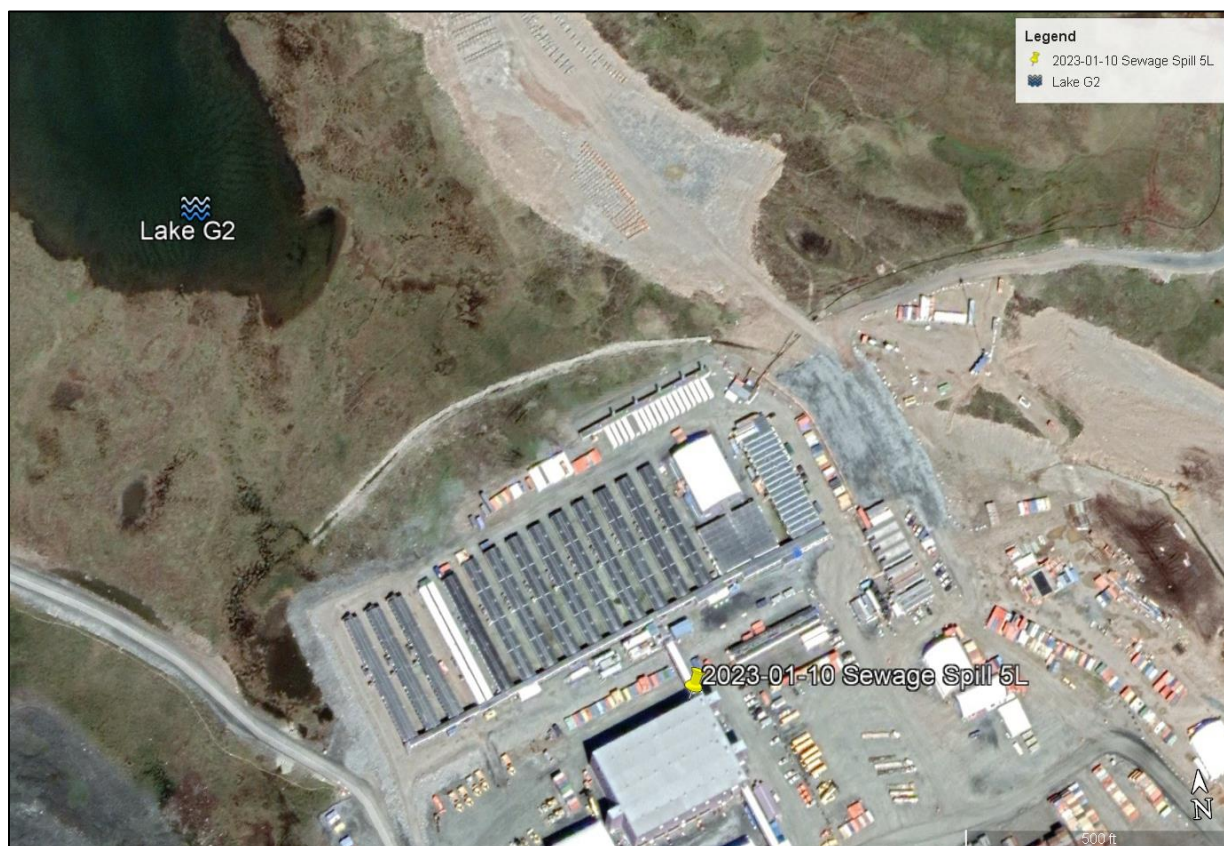
Figure 1: Location of the sewage spill and proximity to water bodies.

On January 10th, 2023, at approximately 1:00 pm, an estimated 5 L of sewage was spilled on the industrial pad at the multiple service building (MSB) lift station due to the vacuum truck operator deviating from an established procedure. The contents of the vacuum truck were emptied into the MSB lift station and the operator attempted to clear the hose. The operator deviated from the procedure when disconnecting the hose from the lift station and attempted to vacuum out the residual sewage from the hose. Due to the hose being disconnected from the lift station the remaining sewage in the line spilled to the industrial pad. The spilled sewage collected directly on the road behind the vacuum truck and was contained to the local area. No water bodies were impacted by this spill. The closest water body (G2) is approximately 300 meters north, as seen in Figure 1.

Upon observing the spill, the operator shutdown the pump to prevent further spillage. The impacted surface area was hand excavated and an estimated 5 kg of contaminated snow was brought to Landfarm A as per the Spill Contingency Plan.

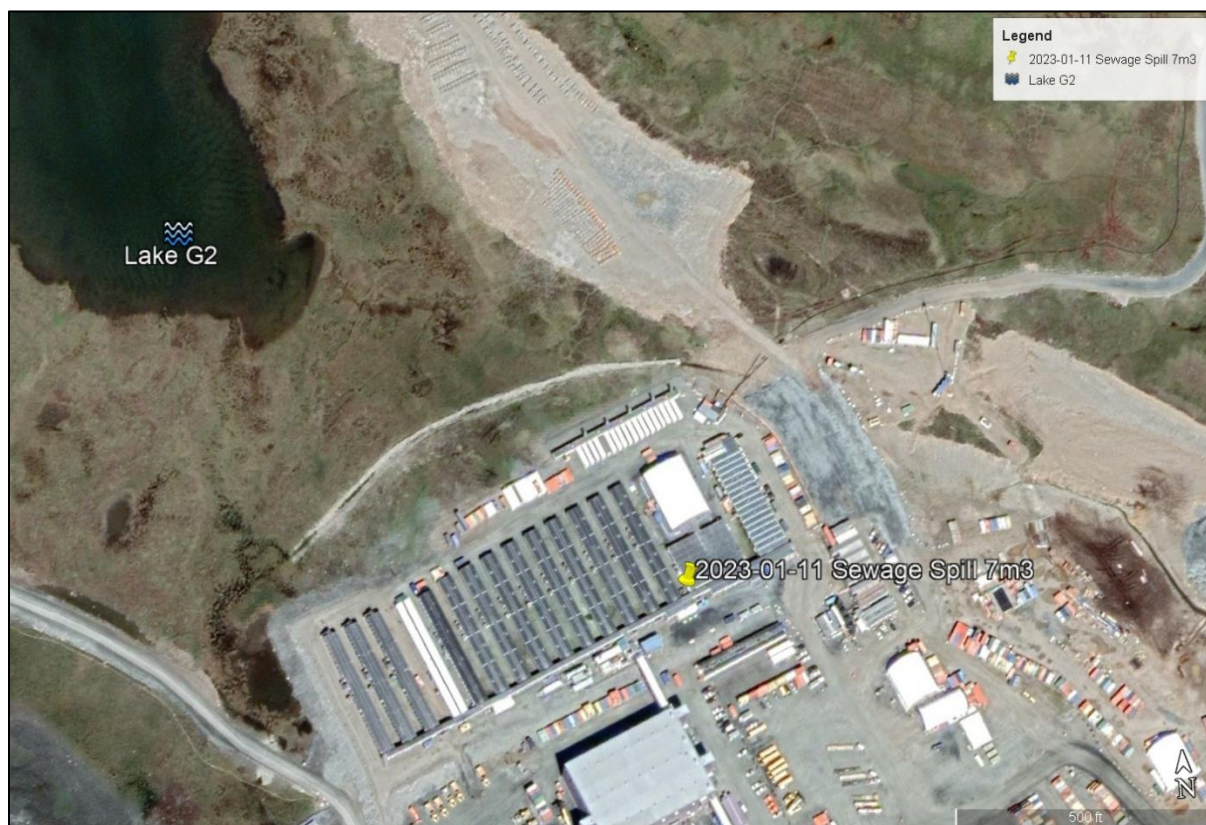
Figure 1: Location of the sewage spill and proximity to water bodies.

On January 11th, 2023, at approximately 8:00 am, an estimated 7 m³ of sewage was spilled to the industrial pad due to an equipment failure at the main camp lift station causing it to overflow. A worker discovered the spill occurring and notified their supervisor. The spilled sewage migrated south and collected in the multiple service building (MSB) parking lot. No water bodies were impacted by this spill. The closest water body (G2) is approximately 280 meters north, as seen in Figure 1.

- The float detection system failed, resulting in the overflow.

The Energy and Infrastructure Maintenance supervisor was notified that the spill was occurring and immediately sent an employee to stop the spill. The employee switched the pumping system into manual mode to lower the level in the tank to stop the overflow. The area was scrapped using a loader, and approximately 20 m³ of sewage-contaminated snow was brought to Landfarm A as per the Spill Contingency Plan.

- Installation of a new float mechanism.
- An improved ultrasonic level sensor has been ordered and will be installed in this list station.

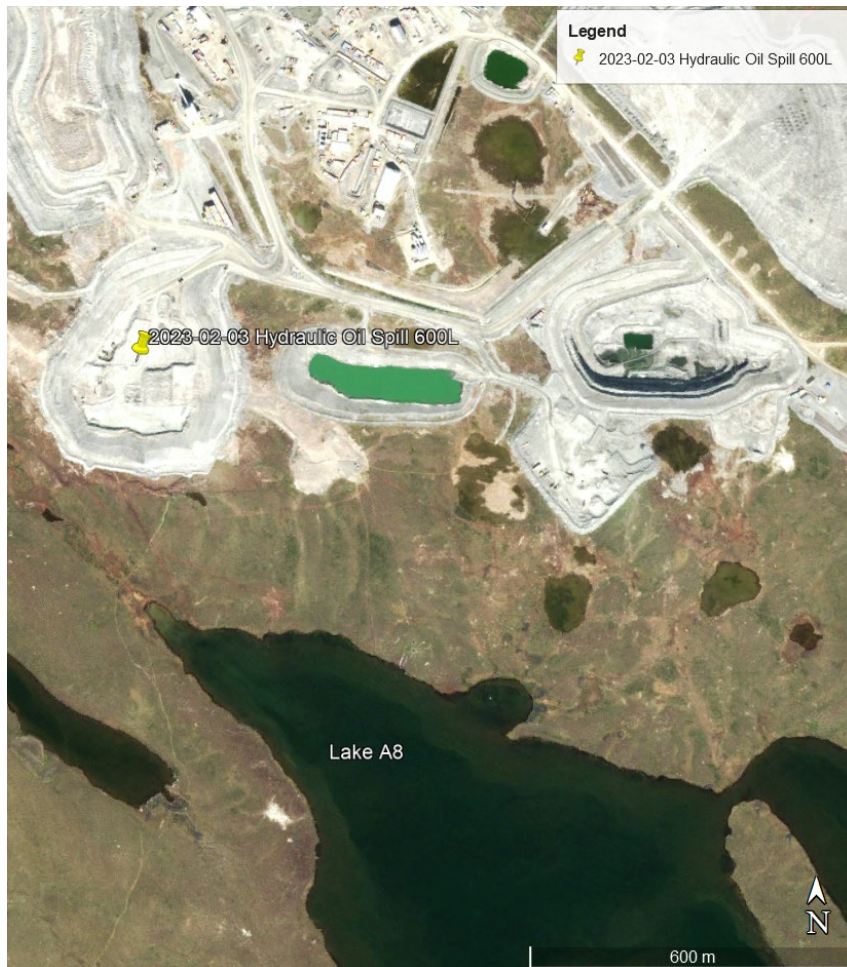
Figure 1: Location of the hydraulic spill and proximity to water bodies.

On February 3rd, 2023, at approximately 4:00 pm, an estimated 600 L of hydraulic oil was spilled on to Tiriganiaq pit 1 (Tiri-1). During normal operations, four bolts broke on the main line between the hydraulic oil pump and tank of an excavator, causing the contents of the tank to release. The initial NT/NU Spill Report indicated that 500 L was released but after further assessment it was determined that 600 L was released.

No water bodies were impacted by this spill. The closest water body (A8) is approximately 480 meters south, as seen in Figure 1.

- Extreme temperatures placed additional stress on the hydraulic system causing a system failure.
- Preventive maintenance inspection of the Hydraulic pump compartment and associated equipment was not included in the preventative schedule

- Frost fighter will be used on hydraulic compartment when starting up in cold temperatures.
- Preventive maintenance schedule has been updated to include visual inspection of the hydraulic pump compartment and associated equipment every 1000 hours.

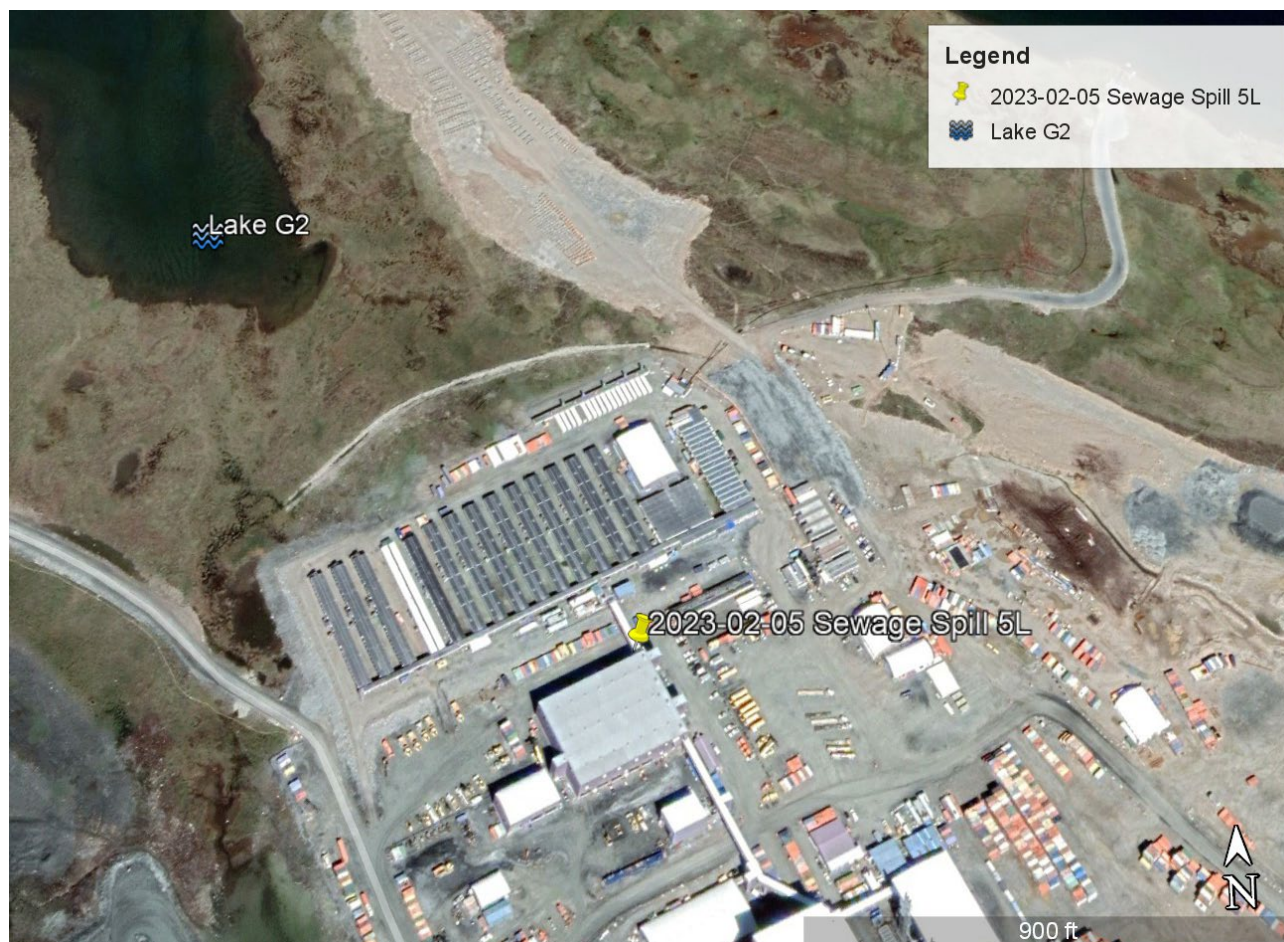
Figure 1: Location of the sewage spill and proximity to water bodies.

On February 5th, 2023, at approximately 2:30 pm, an estimated 5 L of sewage was spilled onto the industrial pad at the multi service building (MSB) lift station. The vacuum truck operator had finished emptying the sewage into the MSB lift station. The operator emptied the hose according to procedure and was preparing to put the hose back on the truck. It was at this time that residual sewage spilled out of the vacuum truck hose and onto the industrial pad. The spilled sewage collected directly on the road behind the vacuum truck and was contained to the local area. No water bodies were impacted by this spill. The closest water body (G2) is approximately 325 meters north, as seen in Figure 1.

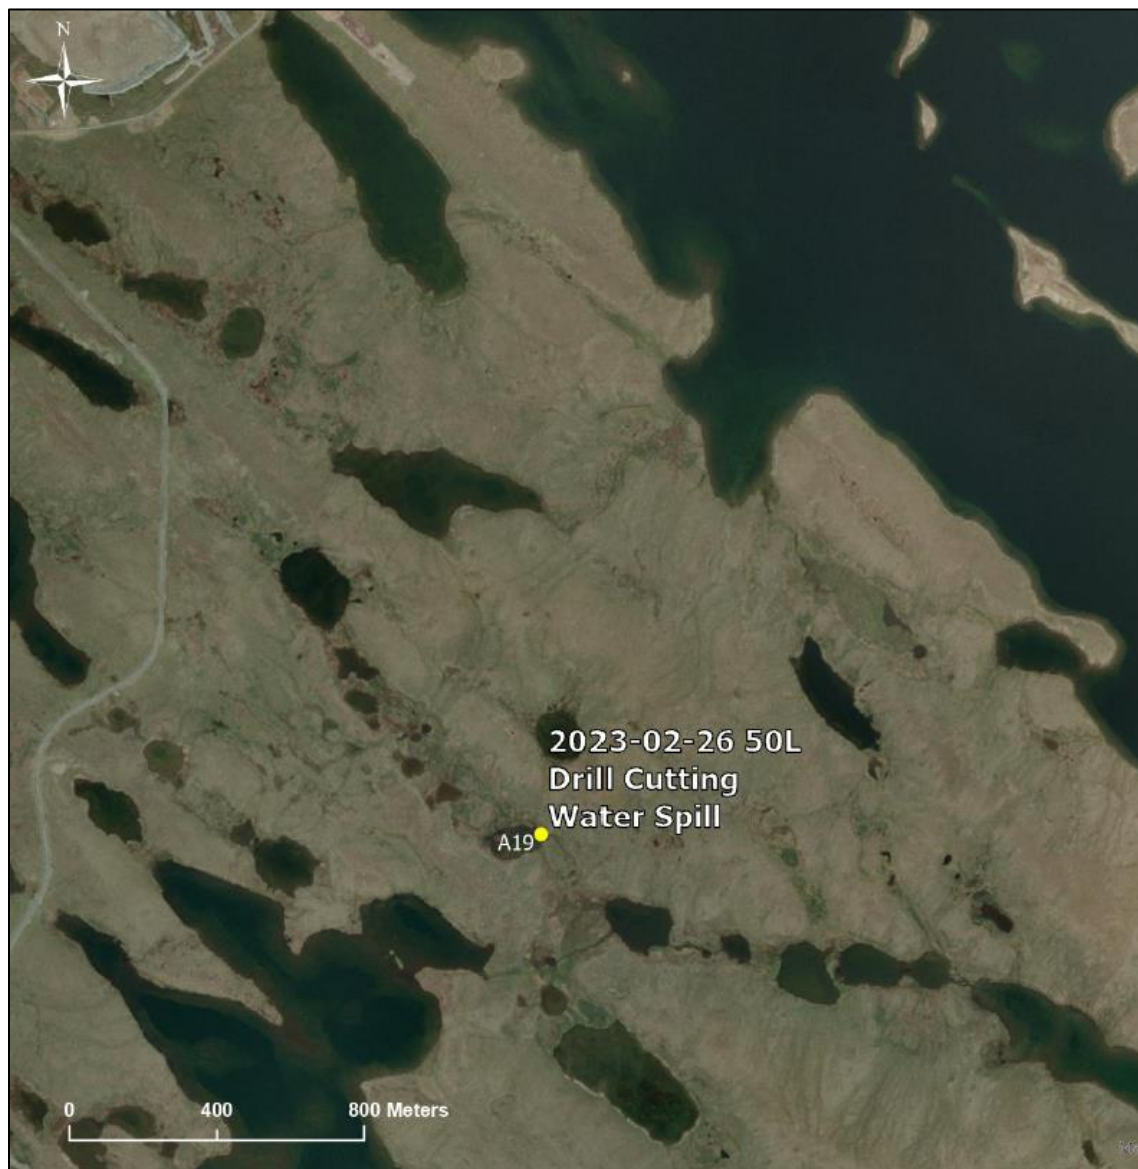
Figure 1: Location of the drill cuttings water spill.

On February 26th, 2023, at approximately 8:00 am, an estimated 50 L of drill cuttings water was spilled onto the ice surface on lake A19. The generator powering the water recovery pan pump failed allowing the water recovery pan to overflow. The spill was located on Lake A19, as seen in Figure 1.

- The failure of the drill site generator resulted in a power loss to the water recovery pan pump allowing it to continue to fill from the water pressure pump.
- Water contaminated fuel was identified in the fuel filter sight glass resulting in a generator failure.

repaired and restarted to lower the volume in the water recovery pan. Clean up of the spilled material occurred on March 14th, 2023, immediately after the drill setup was demobilized from this location. The impacted snow and ice was disposed of on the Waste Rock Storage Facility 3 (WRSF3).

- A signal light has been installed in the drills to notify the driller of a generator failure.
- Operating instructions to shut down the water pressure pump during a generator failure has been provided to all drilling employees.
- Direction has been provided to all drilling employees to inspect fuel nozzle to ensure there is no snow inside prior to refueling equipment, therefore preventing equipment failure.

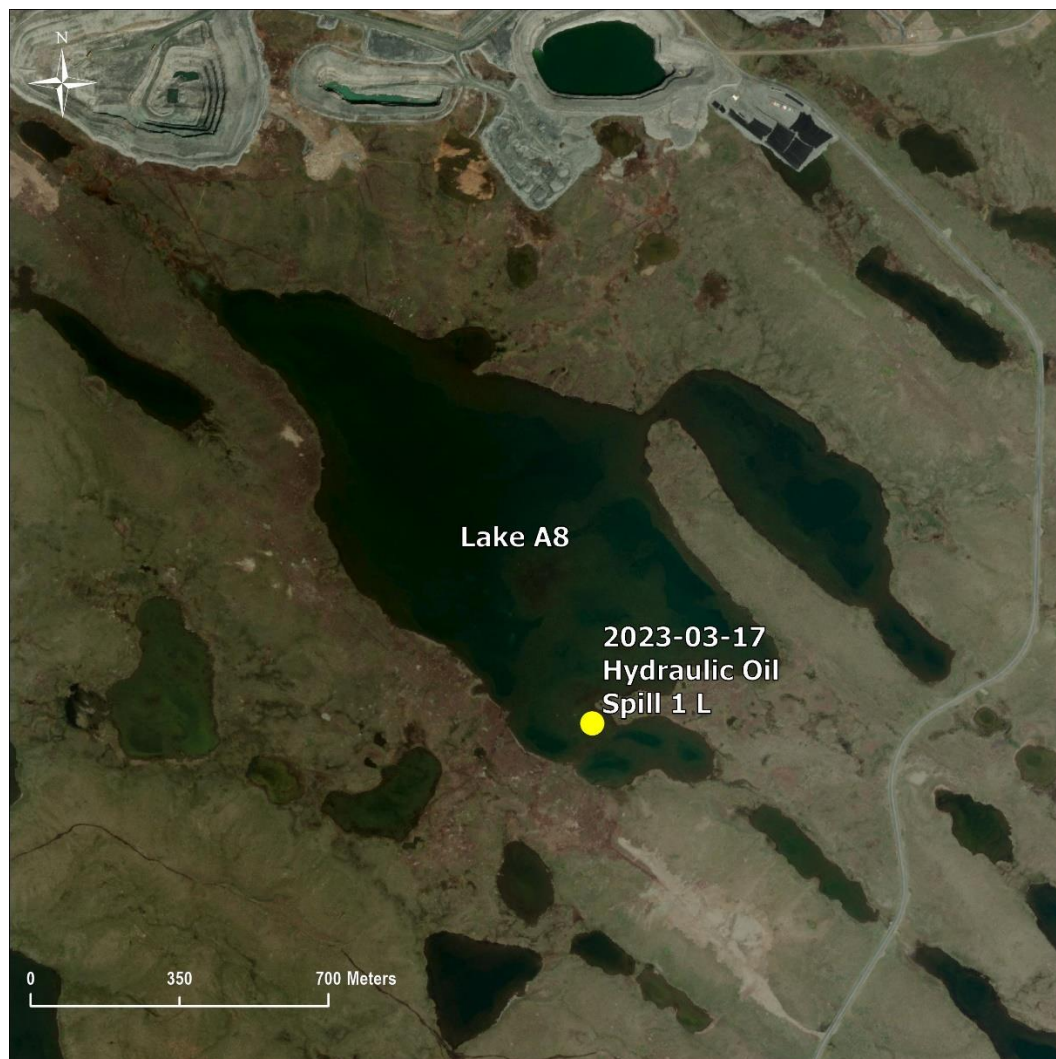
Figure 1: Location of the 1 L hydraulic oil spill.

On March 17th, 2023, at approximately 14:00, an estimated 1 L of hydraulic oil was spilled onto the ice surface on Lake A8 as seen in Figure 1. While lowering the drill tower to relocate the drill a hydraulic line was pinched spilling hydraulic oil within the drill and into the water recovery pan. After the water recovery pan was removed and the drill relocated, remnant oil from under the drill floor was observed on the snow.

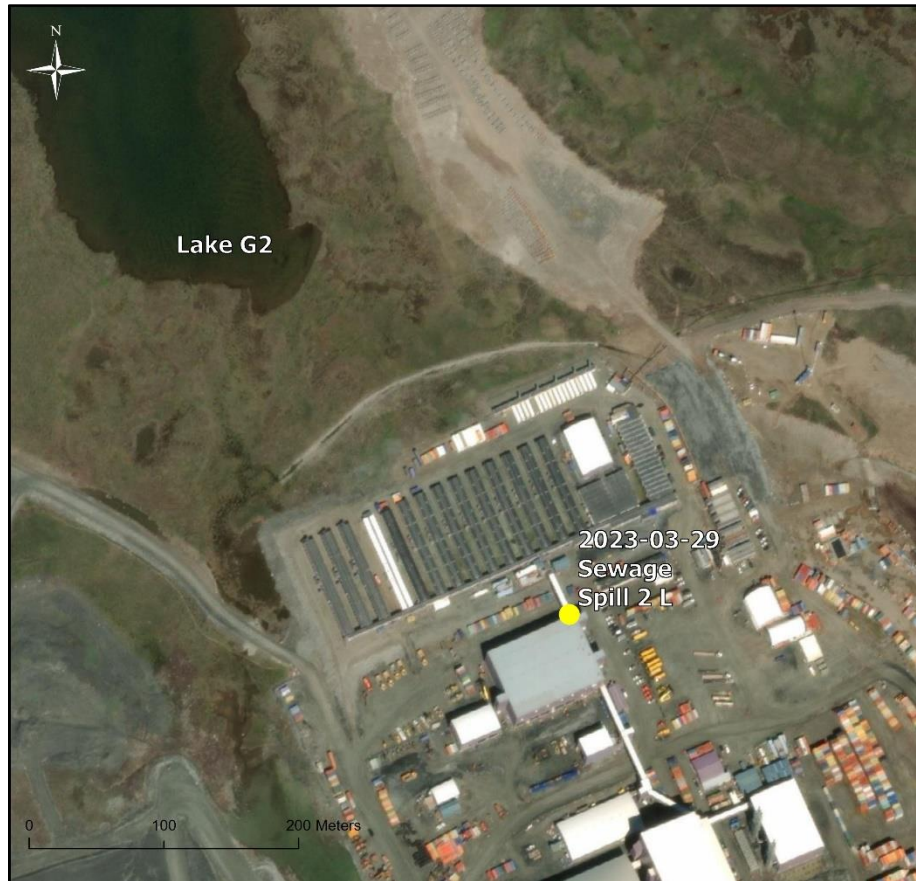
Figure 1: Location of the sewage spill and proximity to water bodies.

On March 29th, 2023, at approximately 13:25 pm, an estimated 2 L of sewage was spilled onto the industrial pad due to a condensation buildup in the air intake pipe of the vacuum truck. The contaminated material was cleaned up with a loader and the material has been placed in Landfarm A. The initial NT/NU Spill Report indicated that 5 L of sewage was released but after further assessment it was determined that 2 L was released. No water bodies were impacted by this spill. The closest water body (G2) is approximately 325 meters northwest, as seen in Figure 1.

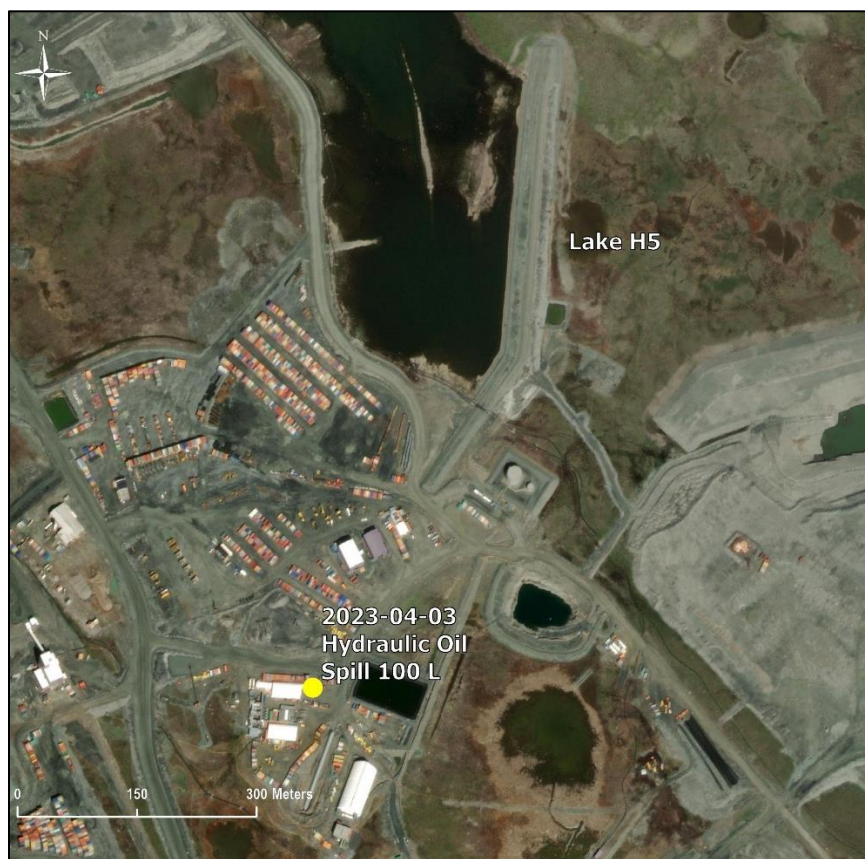
Figure 1: Location of the hydraulic spill and proximity to water bodies.

On April 3rd, 2023, at approximately 9:00 pm, an estimated 100 L of hydraulic oil was spilled on the ground at the front entrance of Dome 3. While arranging equipment around the dome, an underground haul truck came in contact with a tote, causing a small crack on the tote and flipping it on its side.

No water bodies were impacted by this spill. The closest water body (H5) is approximately 620 meters north northeast, as seen in Figure 1.

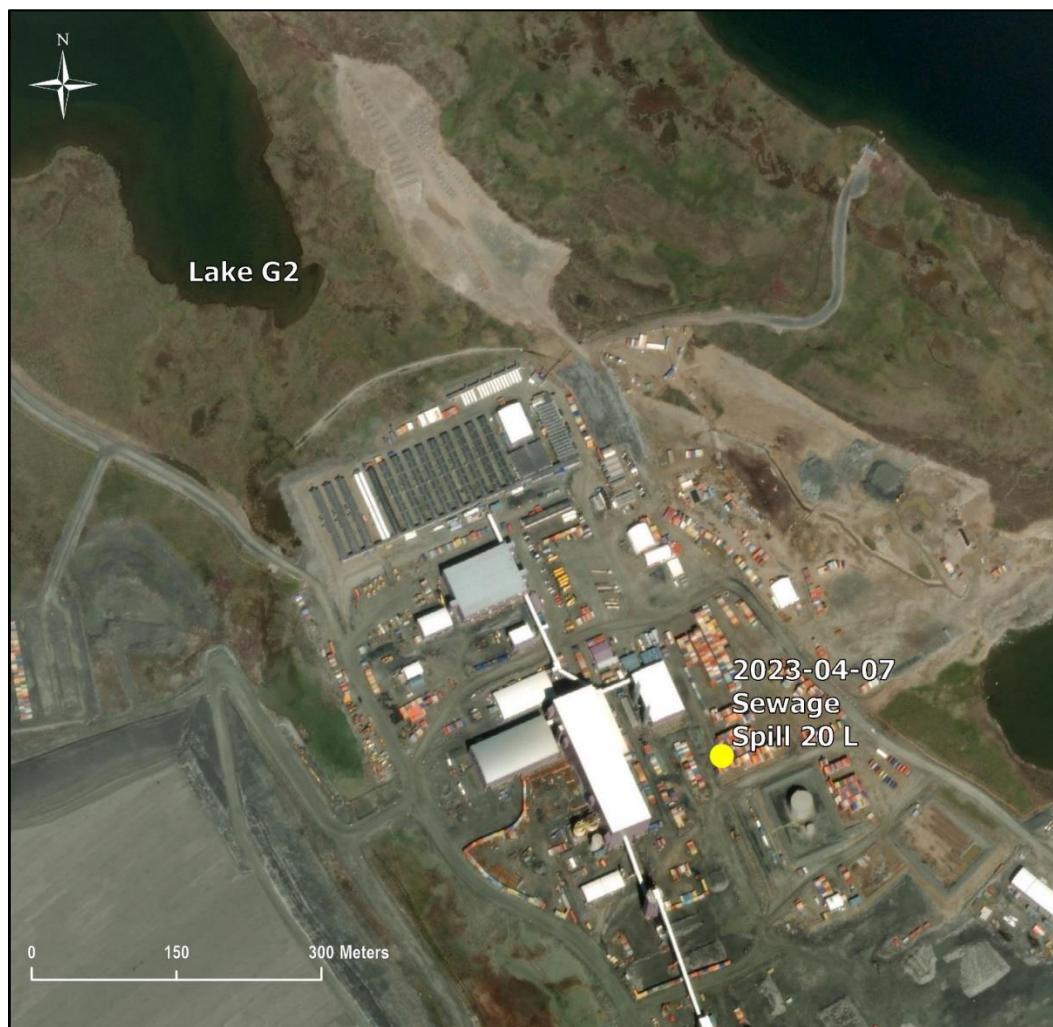
Figure 1: Location of the sewage spill and proximity to water bodies.

On April 7th, 2023, at approximately 13:30pm, an estimated 20 L of sewage was spilled onto the industrial pad by the powerplant wash car due to a miscommunication between the vacuum truck operators. During normal operations, both vacuum truck operators failed to confirm if hose was connected to the truck prior to transferring material from the lift station. No water bodies were impacted by this spill. The closest water body (G2) is approximately 595 meters northwest, as seen in Figure 1.

- Lack of communication between operators. Both employees had radios but did not use them to confirm that the hose between the lift station and the vacuum truck was secure before the sewage transfer.

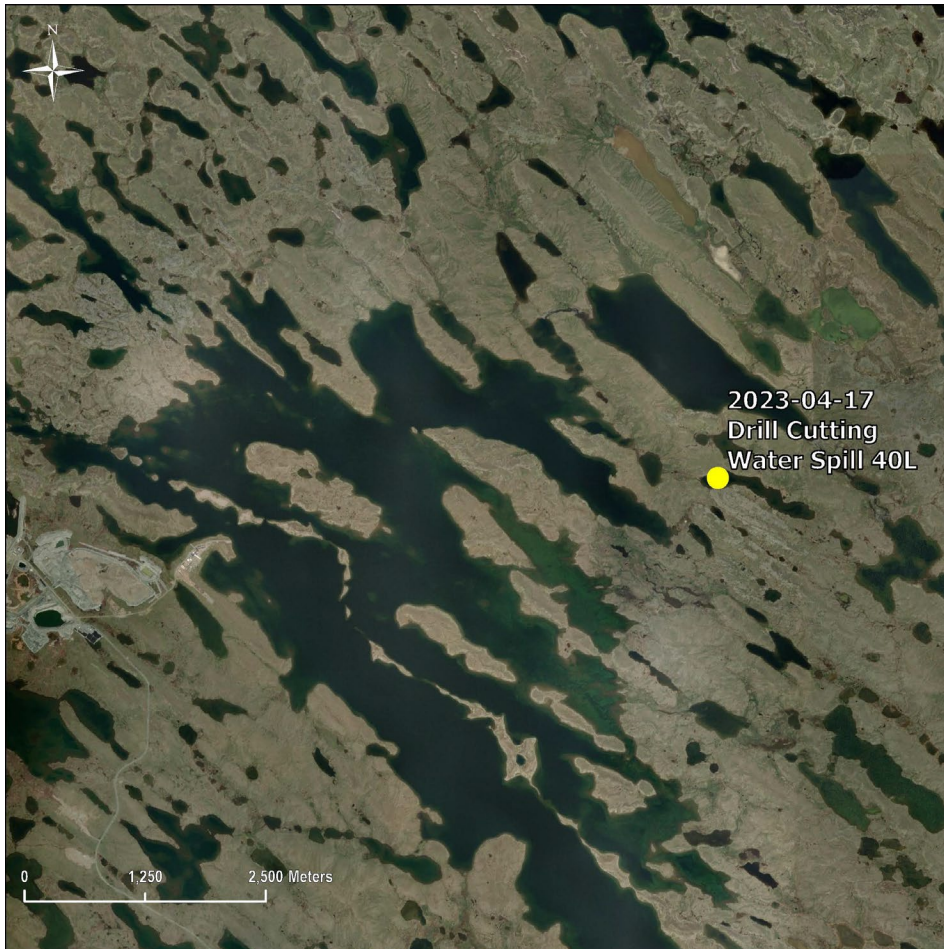
Figure 1: Drill Cuttings Spill Location.

On April 16th and 17th, 2023, Orbit Garant Drilling was removing their drilling equipment from the ice surface of an unnamed waterbody approximately 7.5 kilometers east of the Meliadine Gold Mine industrial pad. At approximately 3:30 am on April 17th, the drill crew prepared to drag two skid-mounted units of drilling equipment, chained in series, behind a tractor. The last unit in the train was the cuttings recirculation unit. Due to the lack of daylight and the cuttings recirculation unit being at the back of the train, the drilling crew did not notice the spill of 40 L of drill cuttings to the ice surface as the equipment left the site. The spill was discovered during the post-drilling inspection on April 17th, 2023, at approximately 15:30. The location of the spill is shown in Figure 1.

As Agnico Eagle has not assessed this waterbody for fish presence, it is assumed to be frequented by fish, however, at the time of the incident the water body was frozen to bottom.

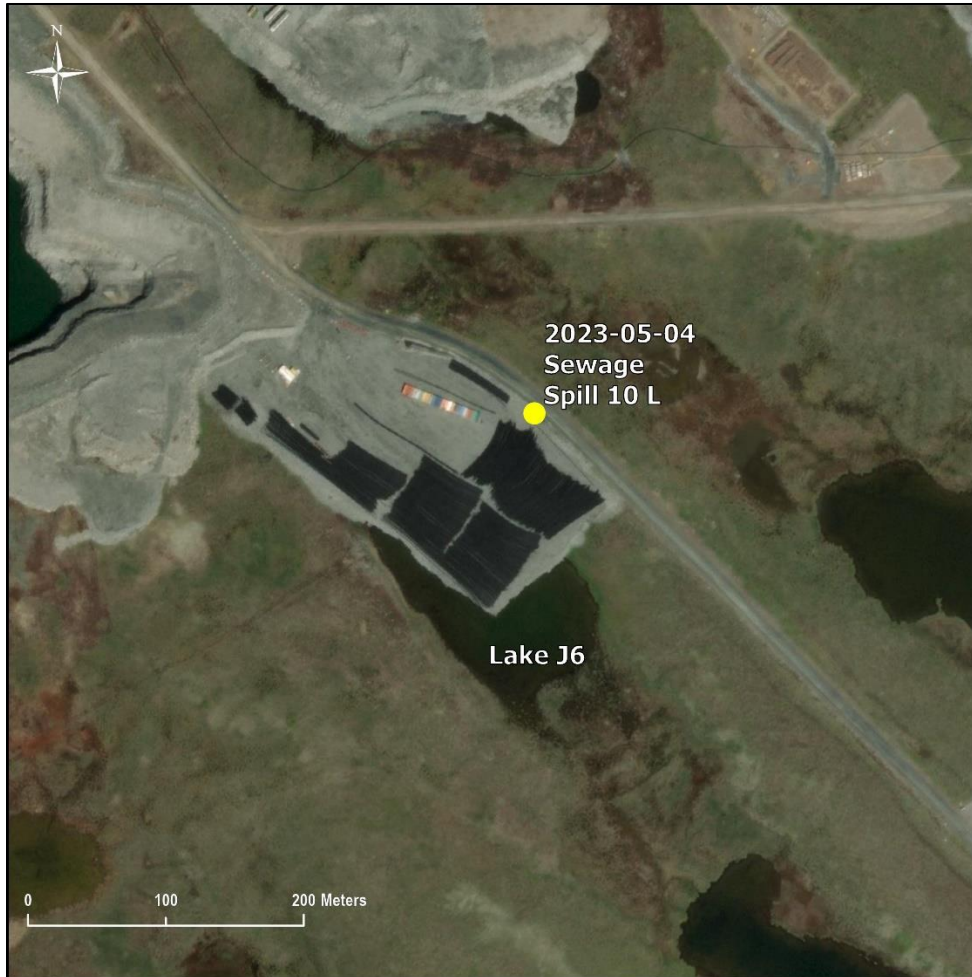
Figure 1: Location of the sewage spill and proximity to water bodies.

On May 4th, 2023, at approximately 23:00, an estimated 10 L of sewage was spilled onto the fusion pad by the fusion pad wash car due to a fracture in the sewage line. No water bodies were impacted by this spill. The closest water body (J6) is approximately 108 meters south, as seen in Figure 1.

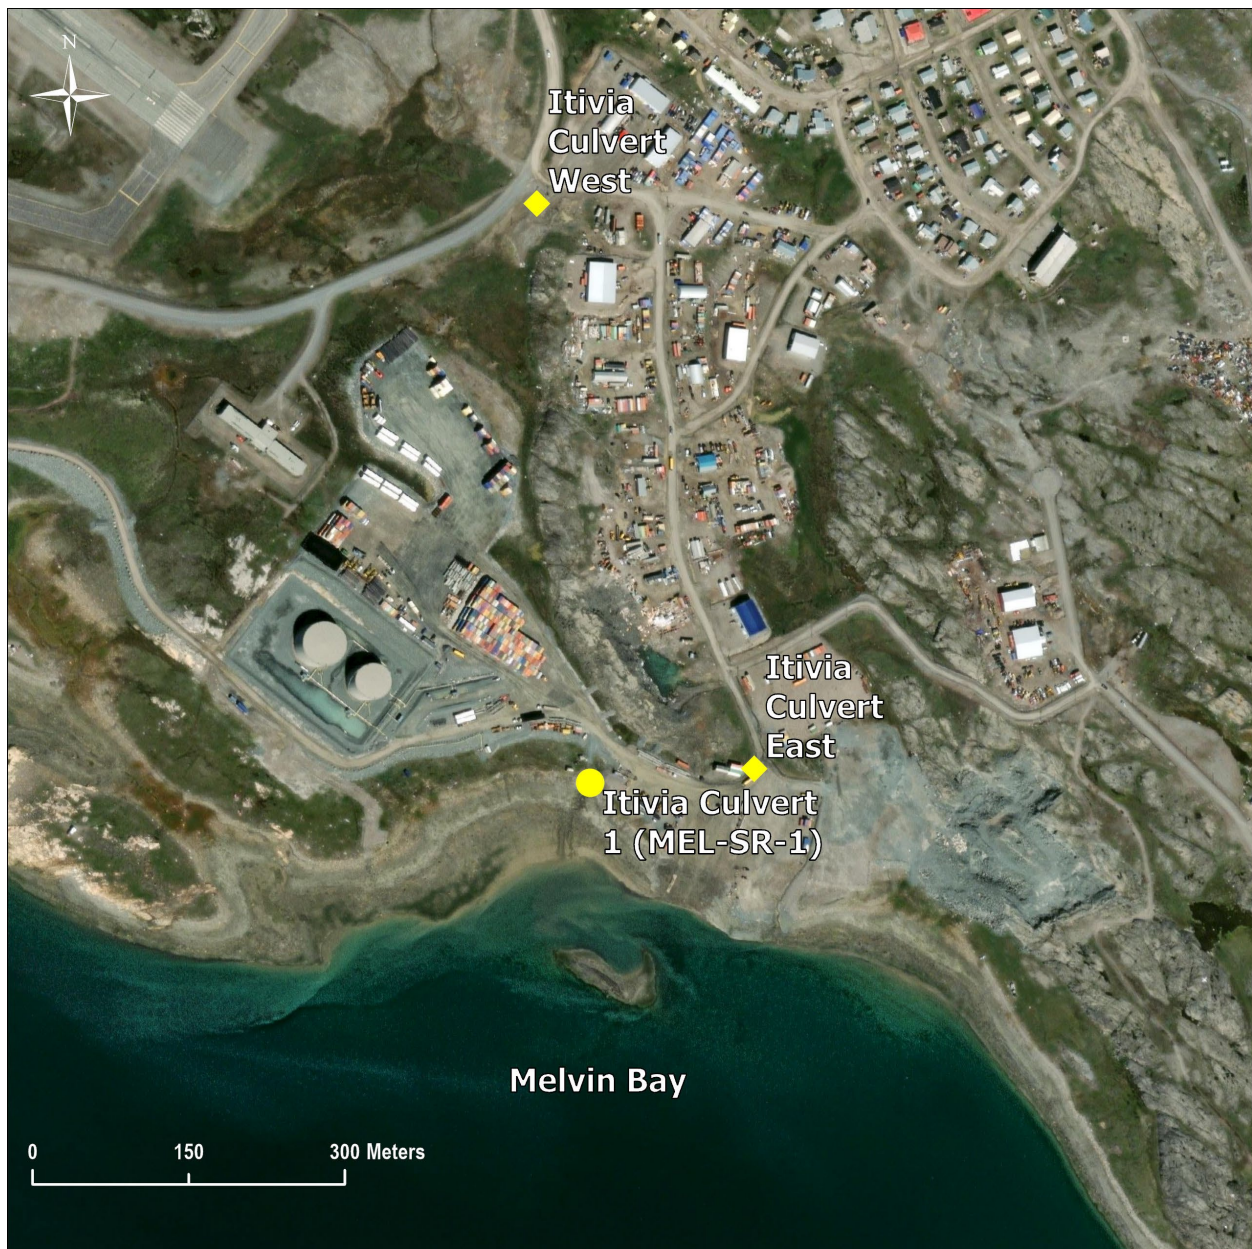
Figure 1: Location of the MEL-SR-1 and upstream monitoring locations.

Discharge from the MEL-SR-1 monitoring location combines surface runoff from Rankin Inlet and the Itivia site. Runoff passes through a series of rock check dams and a settling basin designed to

reduce water velocity and allow suspended solids to settle out prior to flowing through the MEL-SR-1 culvert to Melvin Bay.

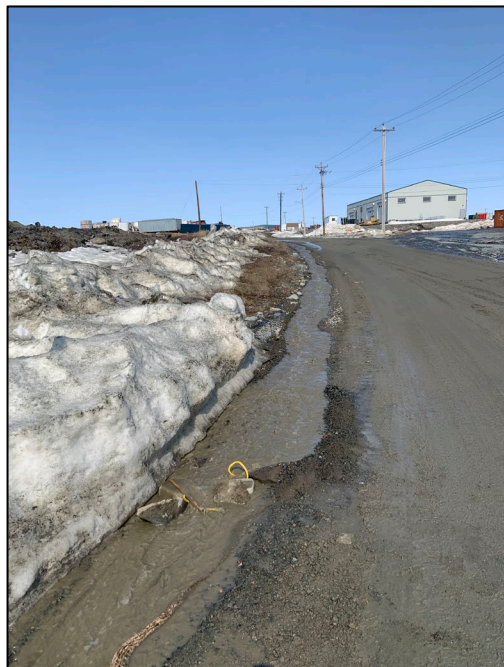
Photo 1 – Upstream east of Itivia site.

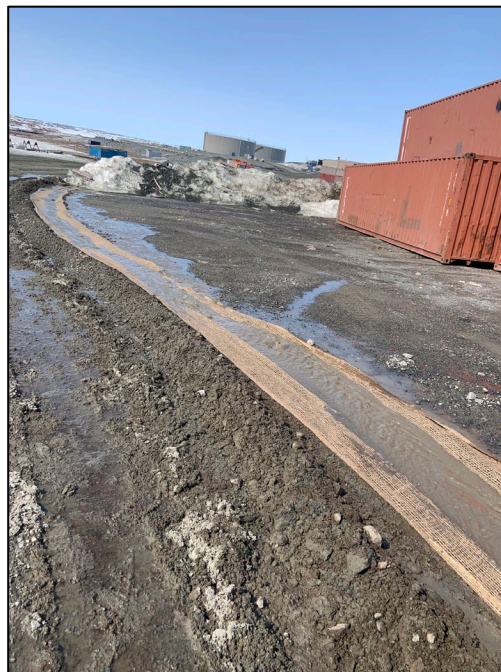
Photo 2 – Upstream east entering Itivia site.

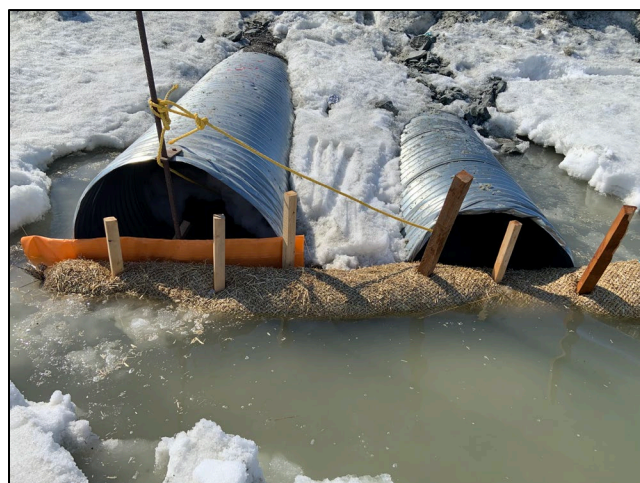
Photo 3 – Upstream of MEL-SR-1.

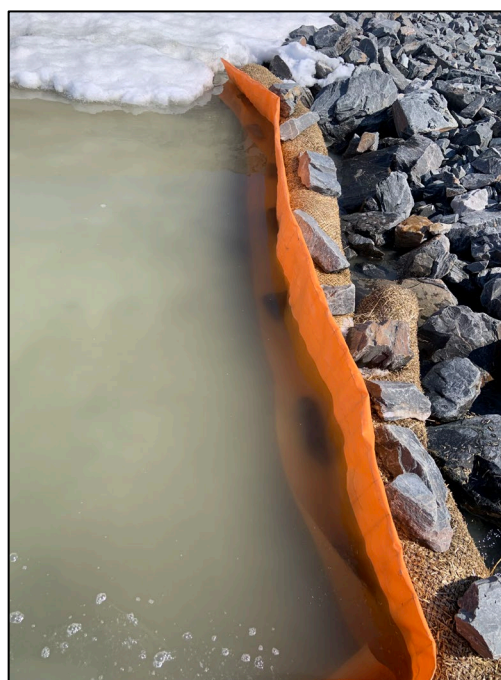
Photo 4 – Rock check dam at settling basin.
