NT-NU SPILL REPORT

Re: Follow-up Report Spill #2023-211 – Release of 200 L of Sewage at the Meliadine Gold Mine

On May 22nd, 2023, the Nunavut Spill Line was notified by Agnico Eagle personnel via email (spills@gov.nt.ca) of a spill of approximately 200 L of sewage at the Meliadine Gold Mine site (spill location coordinates: 63° 2' 21.73" N, 92° 13' 40.84"W). This follow-up report provides supplemental information based on the results of the incident assessment and is being provided in accordance with:

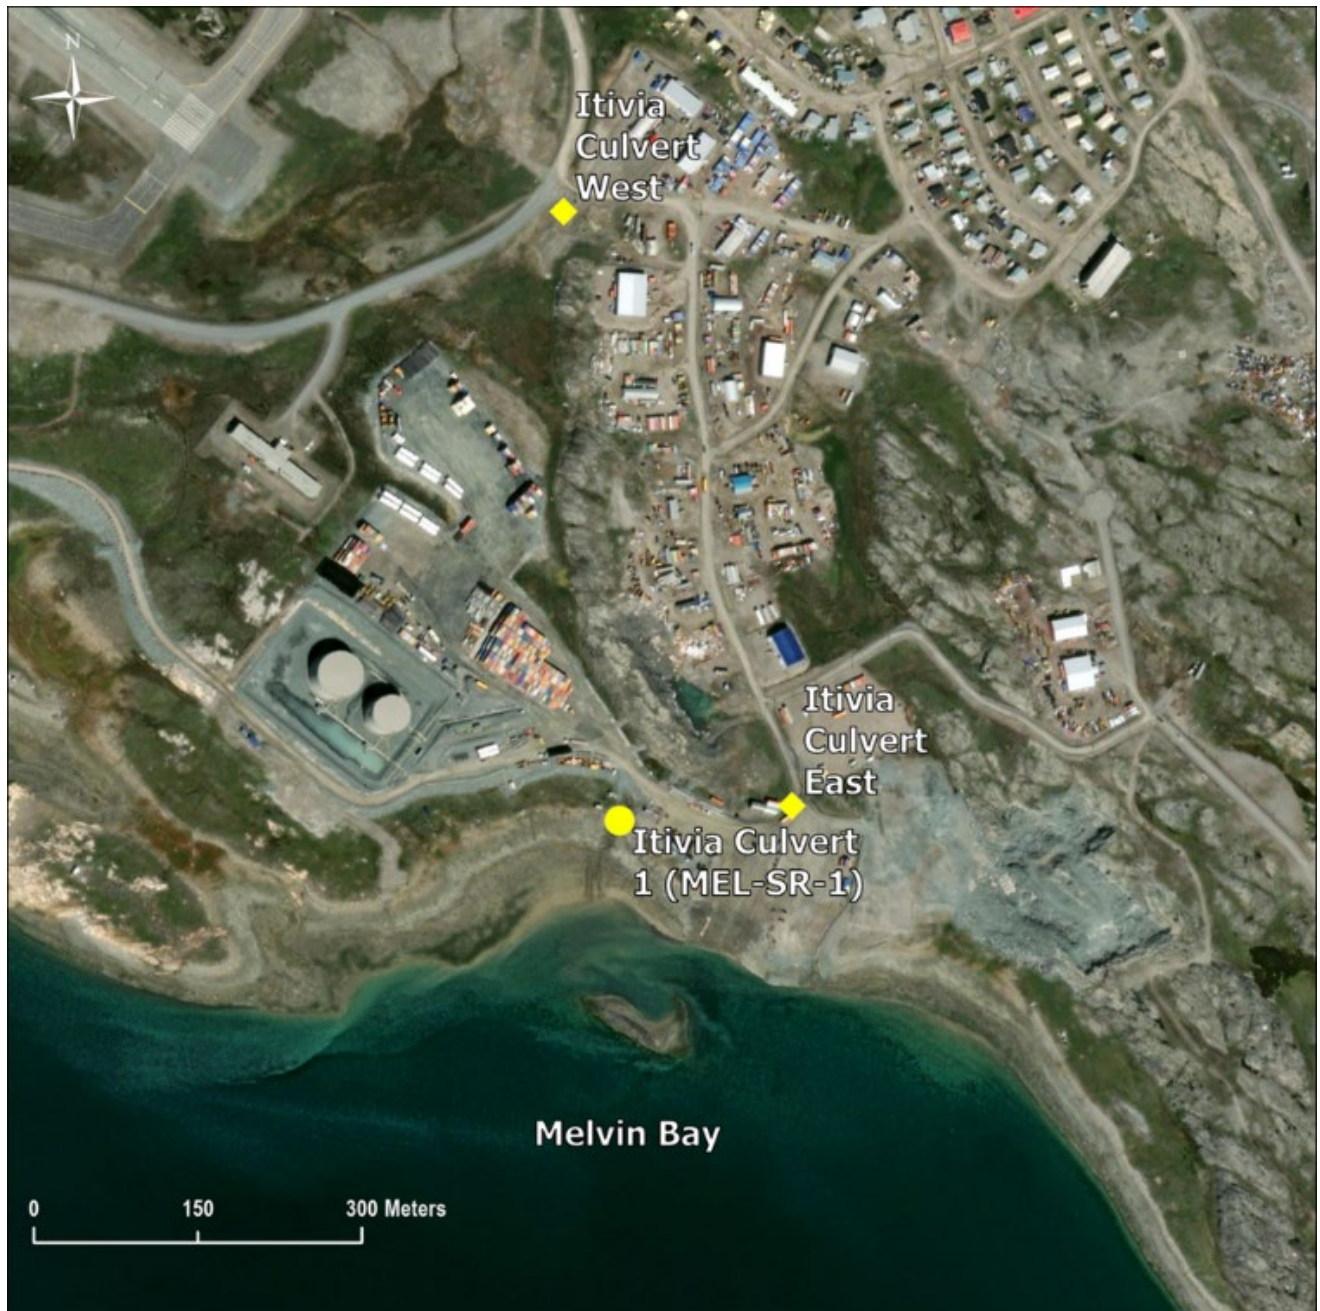
On June 7th, 2023, at approximately 4:00 am, the two culverts situated at Itivia sustained damage during a 1 in 50-year rainfall event. Due to substantial water accumulation within the catchment basin, the buoyancy force of air within the submerged culverts exceeded the weight of the culverts and cover resulting in uplift of the upstream portions of the culverts. Water could no longer be conveyed through the culverts and an unknown volume of water flowed over the roadway upstream of sample location MEL-SR-1. The MEL-SR-1 monitoring station is located at the southern end of Itivia and flows out to Melvin Bay approximately 75 meters to the south.

Field measurements of turbidity indicated a potential exceedance of the Total Suspended Solids (TSS) effluent quality limits specified under Part D Item 18 of the 2AM-MEL1631 Water Licence.

Figure 1: Location of the MEL-SR-1 and upstream monitoring locations.

- Cut off damaged inlets to allow water flow through culverts until permanent repairs or replacements can be made (completed);
- Until the culverts are repaired or replaced, ensure that a pump with sufficient pumping capacity will be left at the culvert and be ready to operate as soon as an extreme event is forecasted;
- Repair or replace culverts during dry season (fall/winter);
- Consider designing the repaired or replaced culverts to manage rainfall events of greater magnitude, relative to original design;
- Ensure that design and associated construction provide sufficient cover of upstream culvert portions to prevent damage if flooding within the upstream basin occurs again;
- Ensure there is no potential for culvert inlets to become obstructed by sediment and erosion controls during large runoff events;

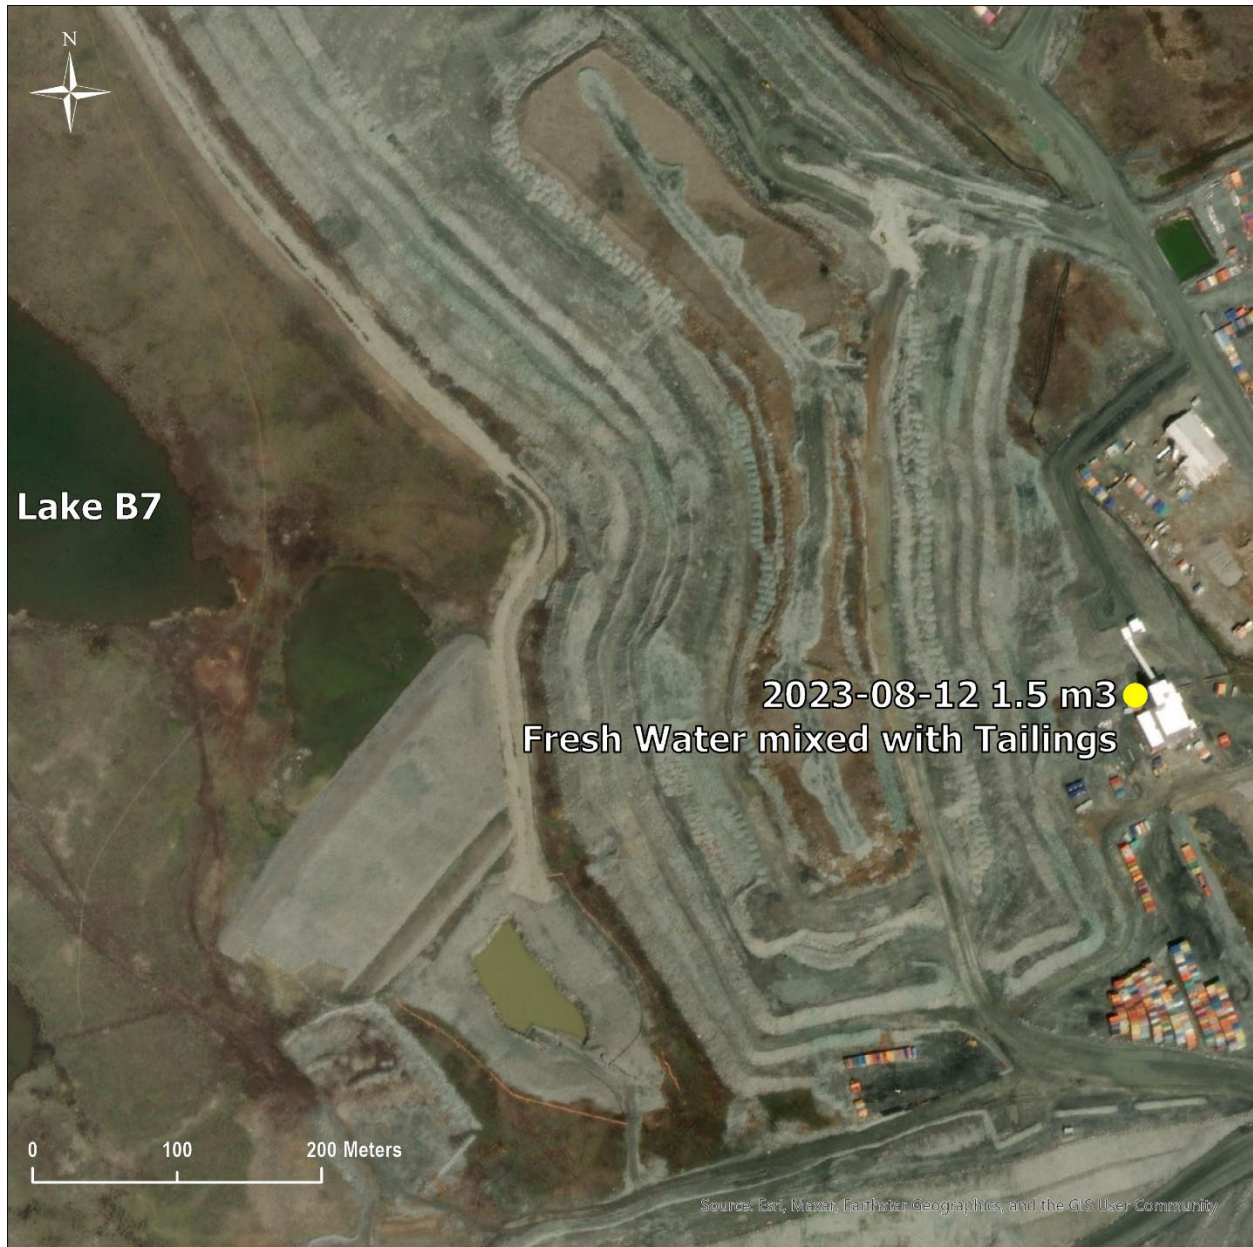
On August 12th, 2023, at approximately 2:30 a.m., there was an inadvertent release of approximately 1.5m³ of tailings and fresh water outside the paste plant facility. The incident resulted from an overflow within the solid tailings hopper due to a malfunctioning sensor. In response, the plant operator undertook remedial actions, which involved hosing down the affected area. This action inadvertently led the mixture of tailings and fresh water to migrate from a maintenance door outside the facility.

No water bodies were impacted by the spill. The closest water body (B7) is approximately 630 meters west, as seen in Figure 1.

Figure 1: Location of the spill and proximity to water bodies.

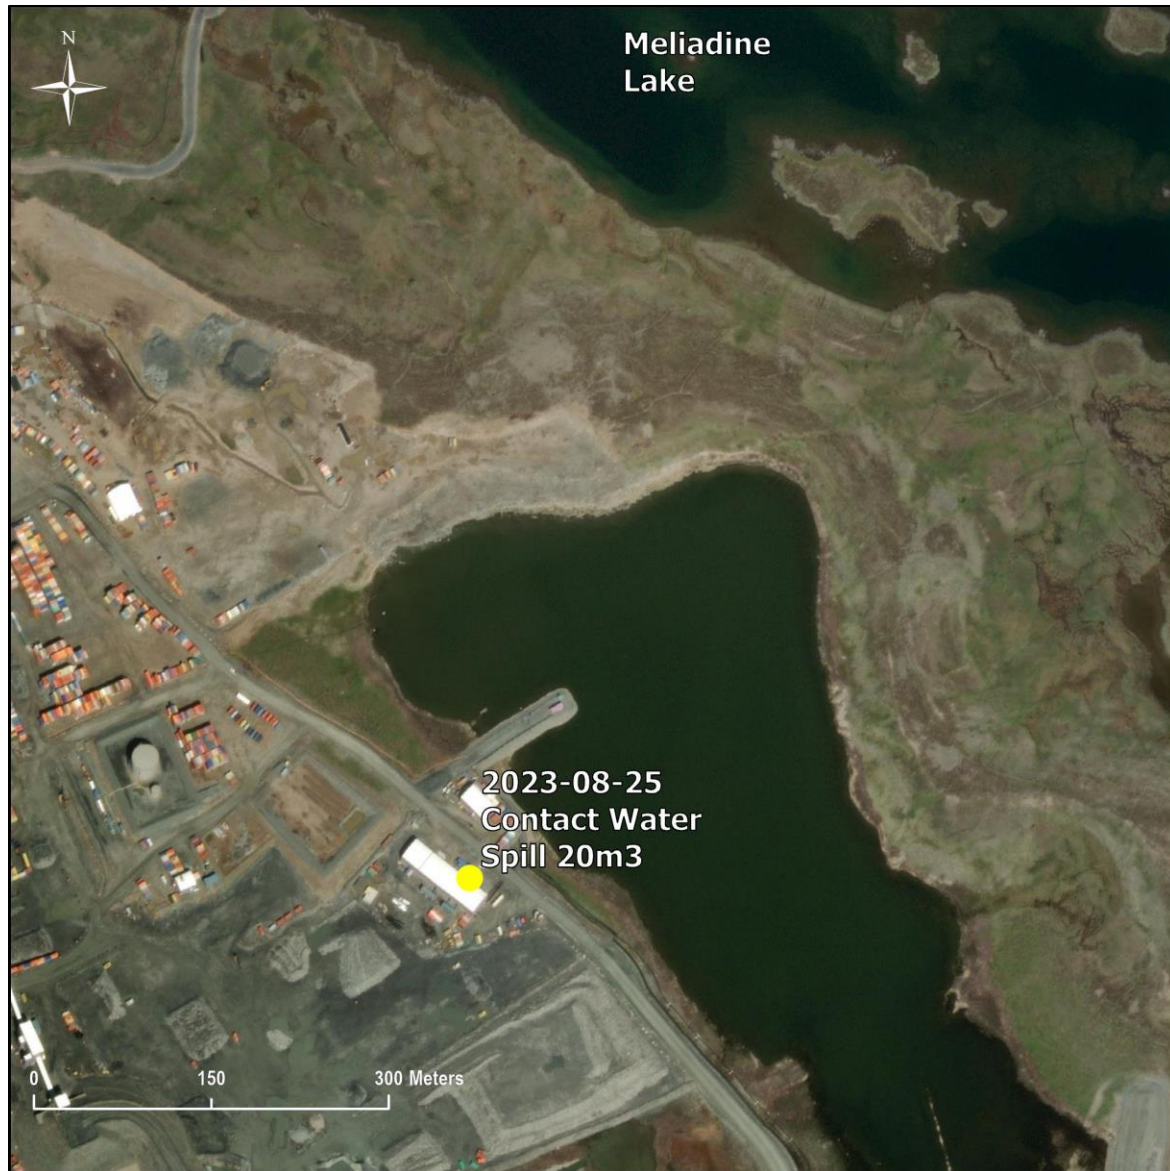
On August 25th, 2023, at approximately 10:00 am, there was an inadvertent release of approximately 20 m³ of contact water outside the Water Treatment Complex (WTC) during the Saline Effluent Treatment Plant (SETP) commissioning activities. A High-Density Polyethylene (HDPE) influent line that transitions to a Polyvinyl Chloride (PVC) coupler as it enters the WTC was conveying saline contact water from Tiriganiaq Open Pit 2 (Tiri 02) to the SETP. The contraction of the HDPE line caused the vertical portion of the coupling to shift, then break due to additional stress, resulting in a spill of contact water. Due to the location of the spill, contact water flowed into Collection Pond 1 (CP1), a part of the site's surface contact runoff management system.

No water bodies were impacted by the spill. The closest water body (Meliadine Lake) is approximately 585 meters northeast, as seen in Figure 1.

Figure 1: Location of the contact water spill and proximity to water bodies.

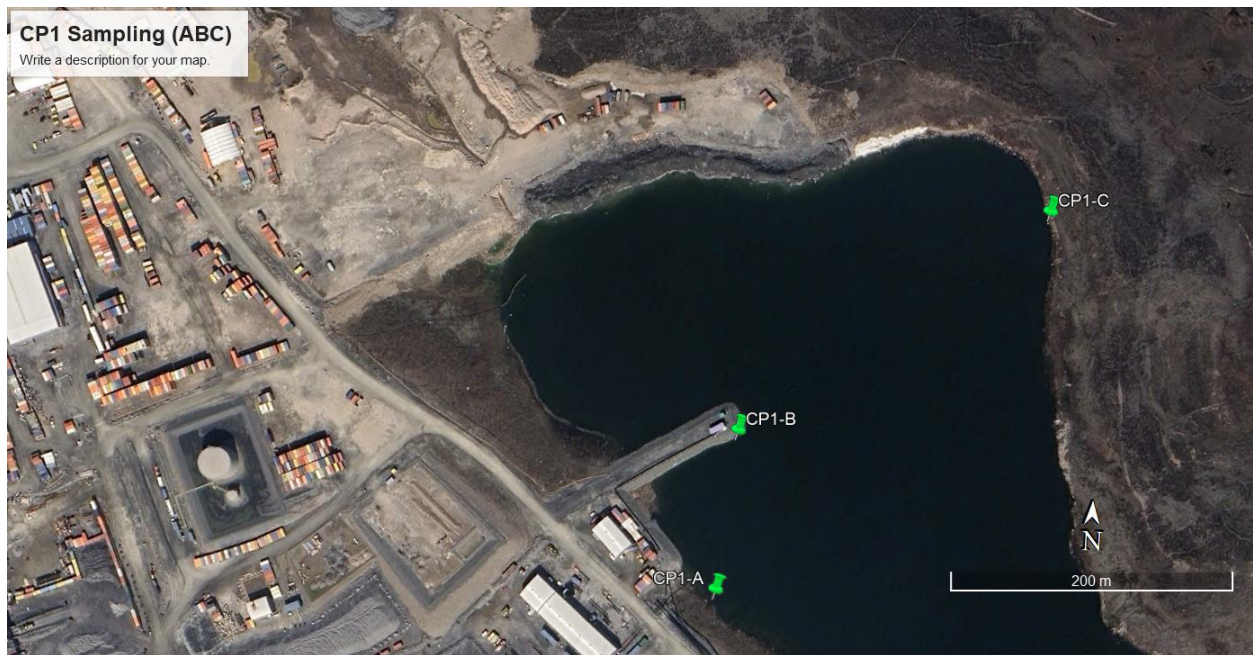
Figure 2: Location of sampling efforts.

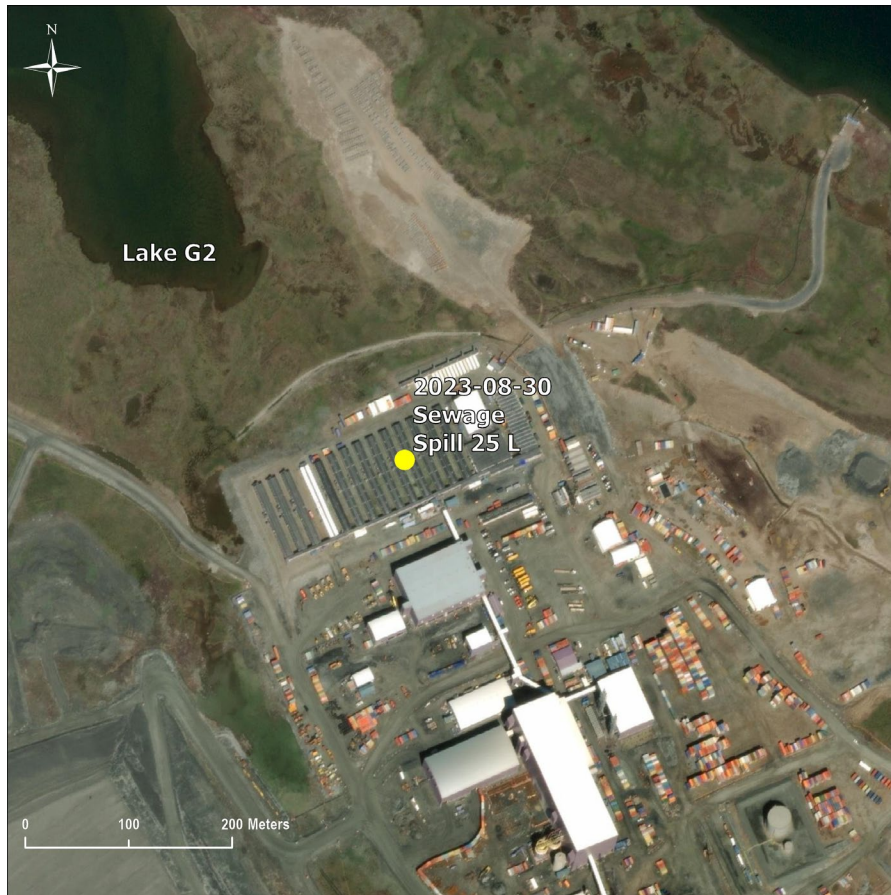
On August 30th, 2023, at approximately 05:00, an estimated 25 L of sewage was spilled onto the industrial pad by wing 4 lift station. A power failure at wing 4 de-energized the lift station and caused the spill. No water bodies were impacted by this spill. The closest water body (Lake G2) is approximately 225 meters northwest, as seen in Figure 1.

Figure 1: Location of the sewage spill and proximity to water bodies.

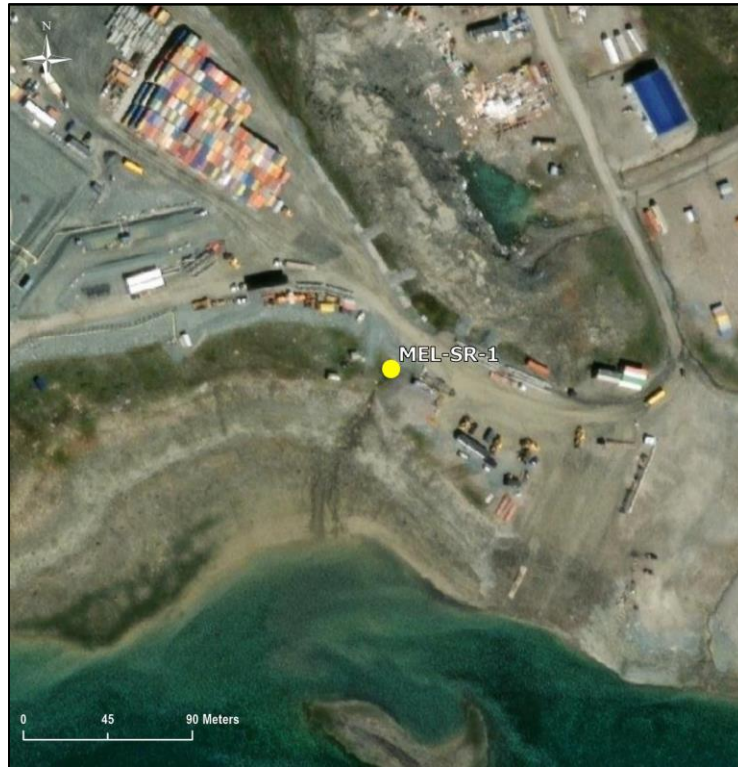
On November 4th, 2023, construction work was underway to replace two culverts at the Itivia laydown area which sustained damage following a significant rainfall event on June 7th, 2023. To

facilitate the placement of riprap on the upstream side of the partially installed culverts, an area of ice and soil was excavated, resulting in the upwelling of unfrozen water present beneath the ice.

Figure 1: MEL-SR-1 monitoring location.

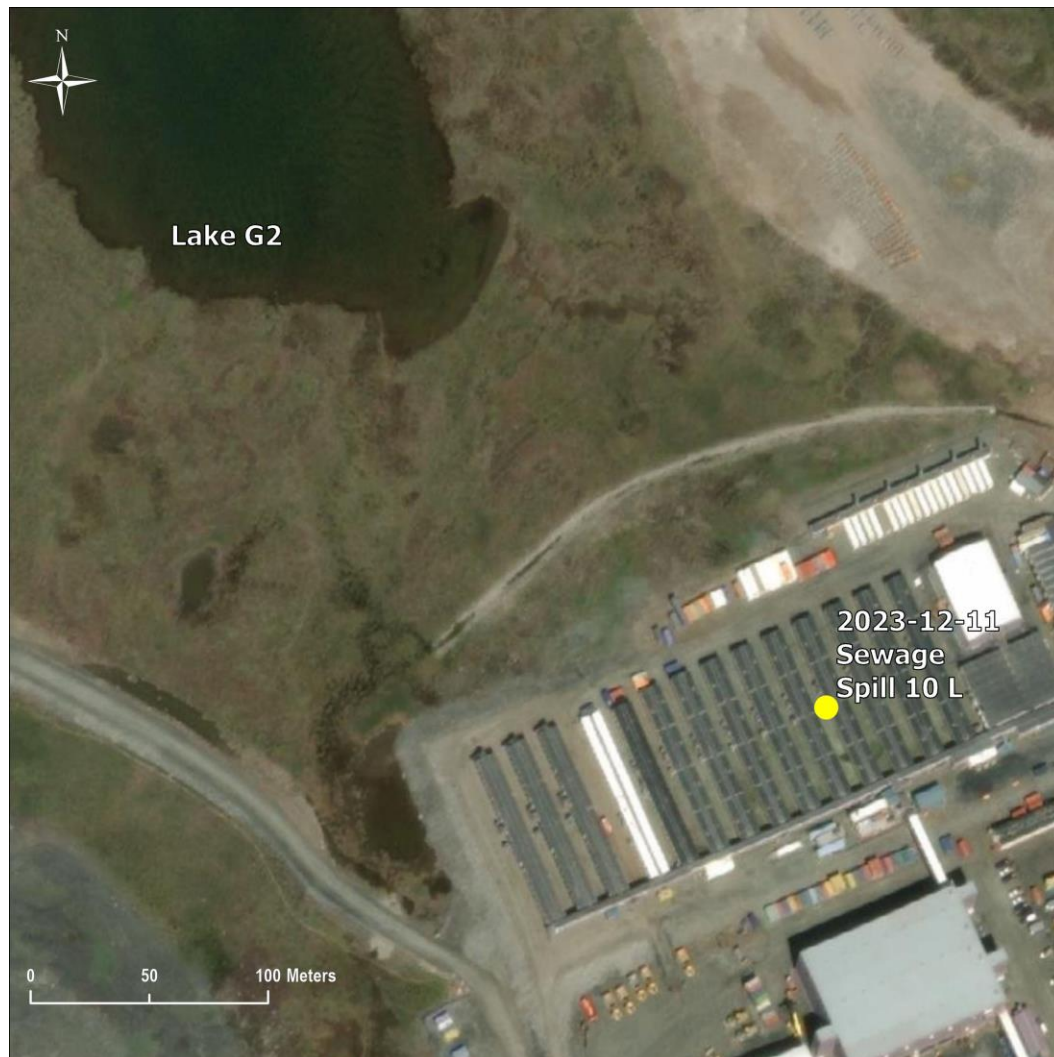
On December 11th, 2023, at approximately 11:30, an estimated 10 L of sewage was spilled onto the industrial pad at the wing 4 lift station. Due to a site power outage, the transfer pump did not engage allowing the lift station holding tank to overflow. No water bodies were impacted by the spill. The closest water body (Lake G2) is approximately 220 m northwest, as seen in Figure 1.

Figure 1: Location of the sewage spill and proximity to water bodies.
