Submission of Annual Geotechnical Inspection – 2024, Mary River Project – Nunavut, Project # CA0039374.4332

The 2024 geotechnical inspection was conducted by Laszlo Bodi, M.Sc., P.Eng., Senior Principal Civil/Geotechnical Engineer with WSP Canada Inc. The inspection focused on waste and water retention infrastructure located at the Mary River Project as required by Type "A" Water Licence No: 2AM-MRY1325 – Amendment No.1 Part I, Item 12. In addition to Part I, Item 12 requirements, Baffinland elected to voluntarily inspect water and waste conveyance structures as well as select bridge and culvert infrastructure.

September 27, 2024

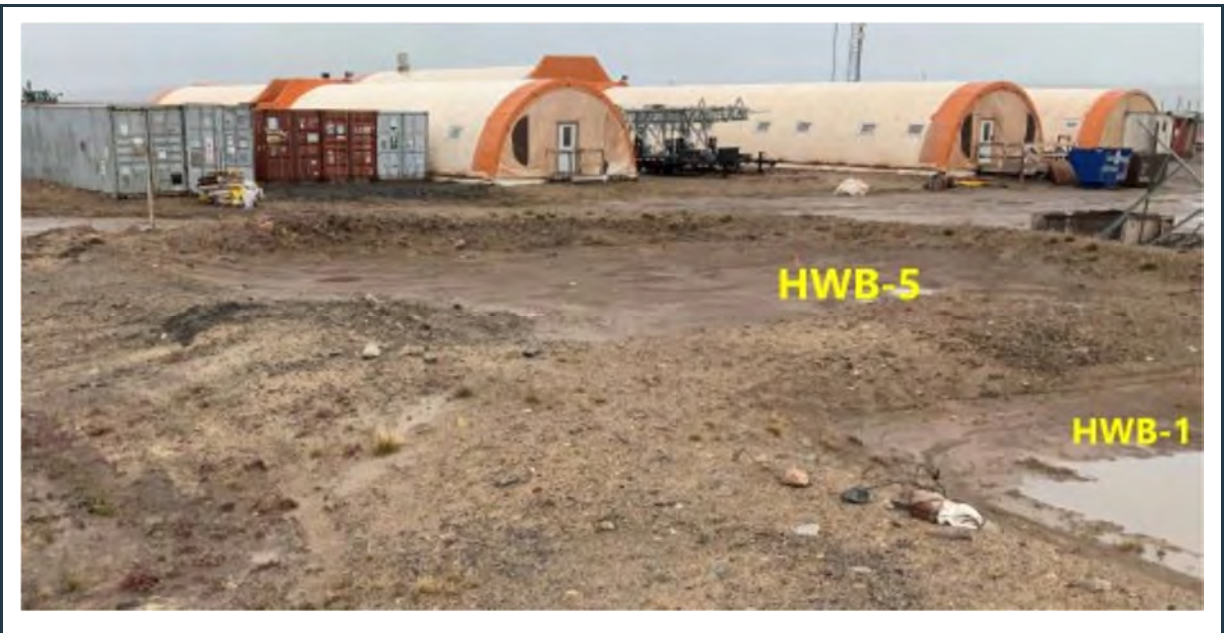
d) HWB-5

As shown in Figure 21, this cell is currently empty and has not been in use for years. The shallow berms around the cell appear to be stable, although the result of some surface erosion on the slopes is visible. No ponding water is visible in this cell indicating potential liner damage. As mentioned earlier for HWB-1, these two cells (1 and 5) could be reconstructed as one large new cell with new berms and liner, should additional storage requirements become necessary at the site.

Figure 21: View of the empty HWB-5 cell, which has not been in use for years (like HWB-1).

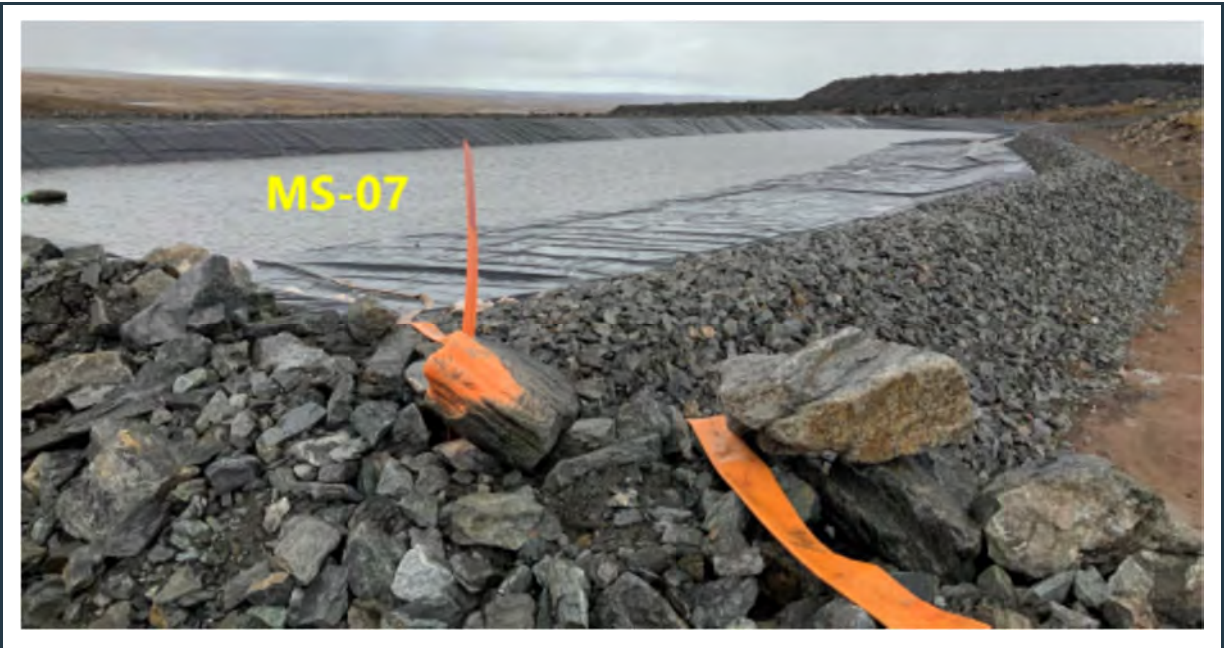
The MS-07 surface water management pond is located adjacent to the KM-106 ore stockpile area. The pond has robust, stable perimeter berm and intact geomembrane liner, as shown in Figure 27. No stability or seepage related problems were observed at this pond during the August 2024 site visit.

Figure 27: View of the robust, stable perimeter berm and intact liner at the MS-07 surface-water management pond at KM106.

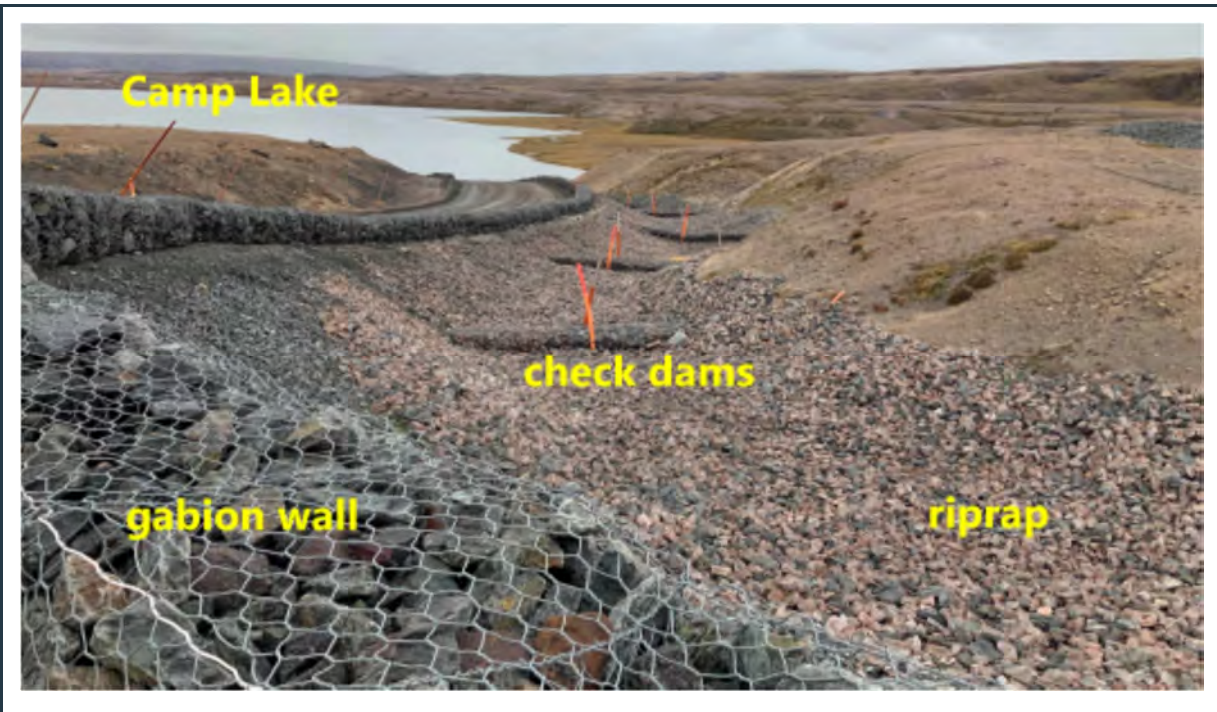
Figure 45: View of the upgraded Camp Lake check dams and new gabion wall in good conditions, constructed along the road to the lake.

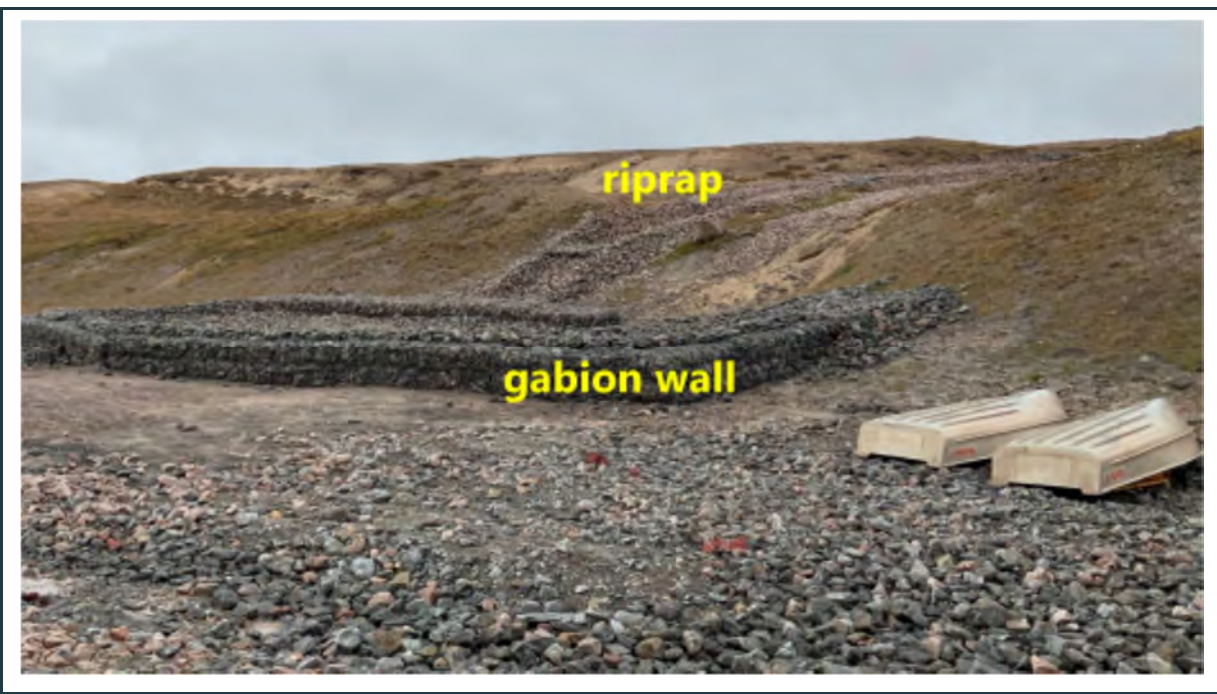
Figure 46: View of the new gabion wall and riprap adjacent to Camp Lake to capture suspended solids potentially eroding from the airfield area and to prevent siltation in the lake.

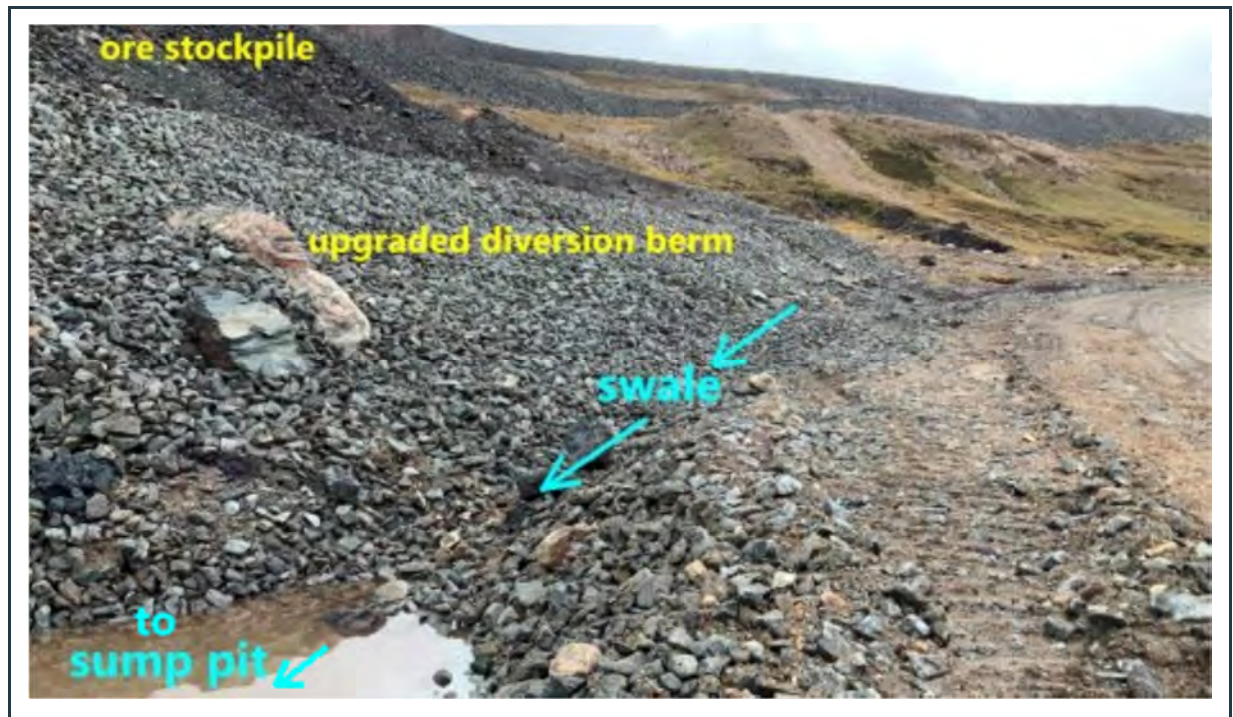
Figure 51: View of the new, recently upgraded diversion berm and drainage ditch/swale south of the ore stockpile area.

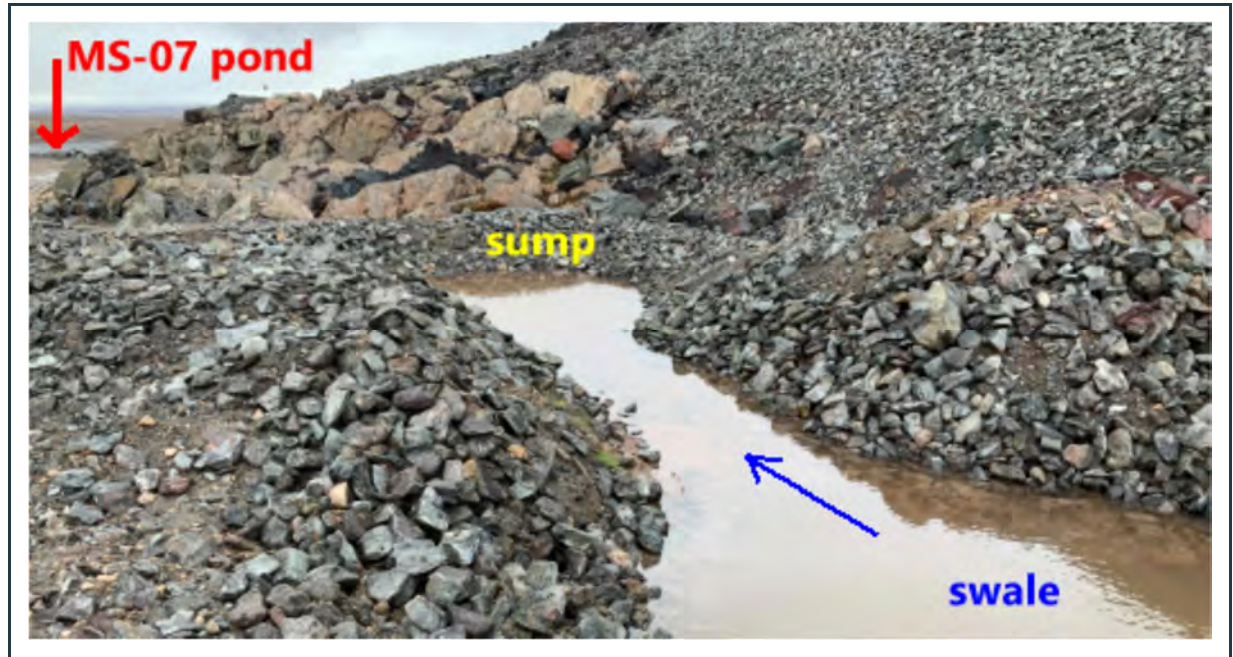
Figure 52: View of the new drainage ditch/swale and sump pit south of the KM-106 ore stockpile area, collecting local run-off. Note the recently completed riprap erosion protection along the sides of the swale and sump. Water from the sump is pumped into the nearby MS-07 pond.

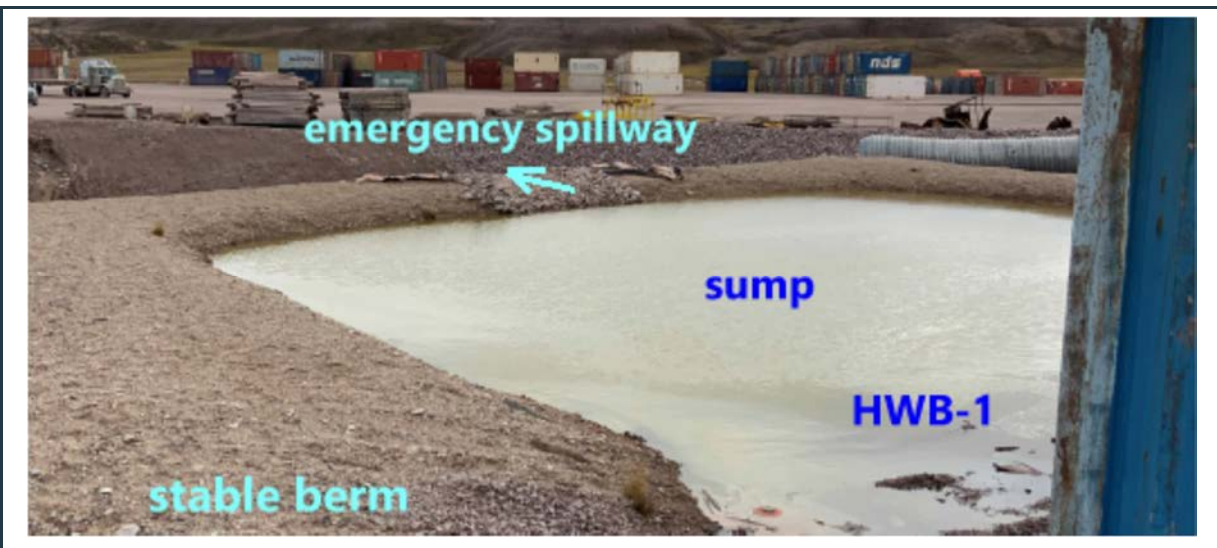
Figure 54: View of the sump and emergency spillway at the back of the HWB-1 cell with stable berm.

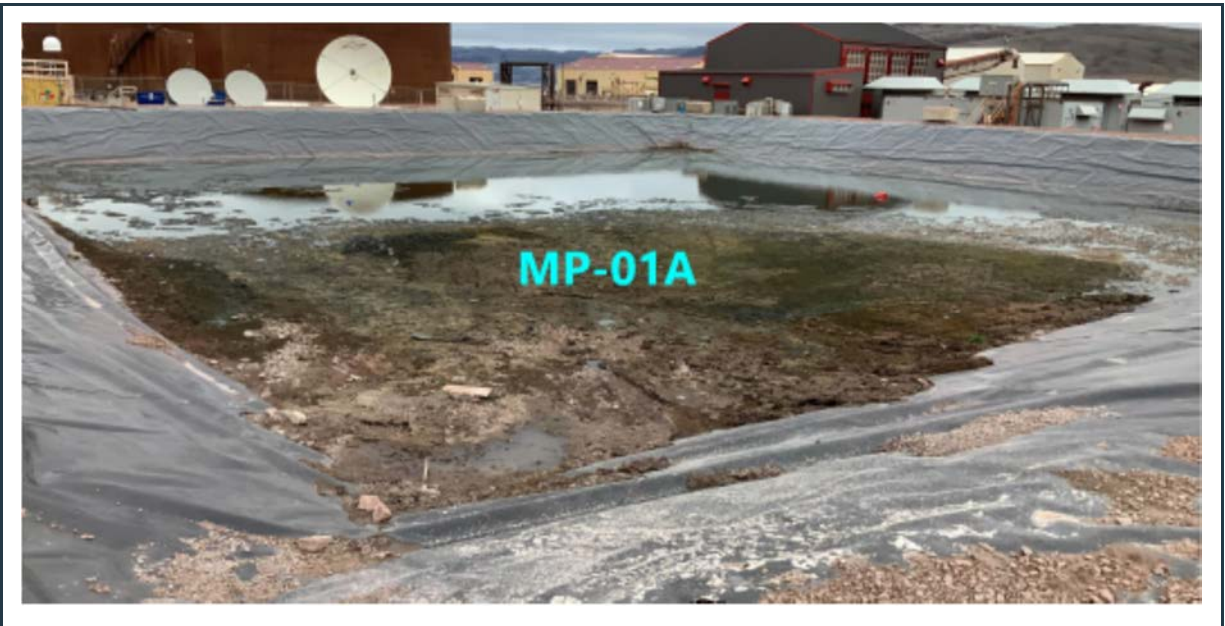
The MP-01A polishing pond is located immediately south of the MP-03 fuel storage facility. As shown in Figure 57, the robust, stable perimeter berm around the pond is in excellent condition and the liner within the cell appears to be intact. No sign of slope instability, settlement or seepage from the pond was noted during the field inspection. As shown in the image, the pond is currently empty. Should the removal of the sediment from the cell become necessary, it should be carried out using a hydrovac equipment, to maintain the integrity of the liner.

Figure 57: View of the robust, stable berm and intact liner at the practically empty MP-01A pond.

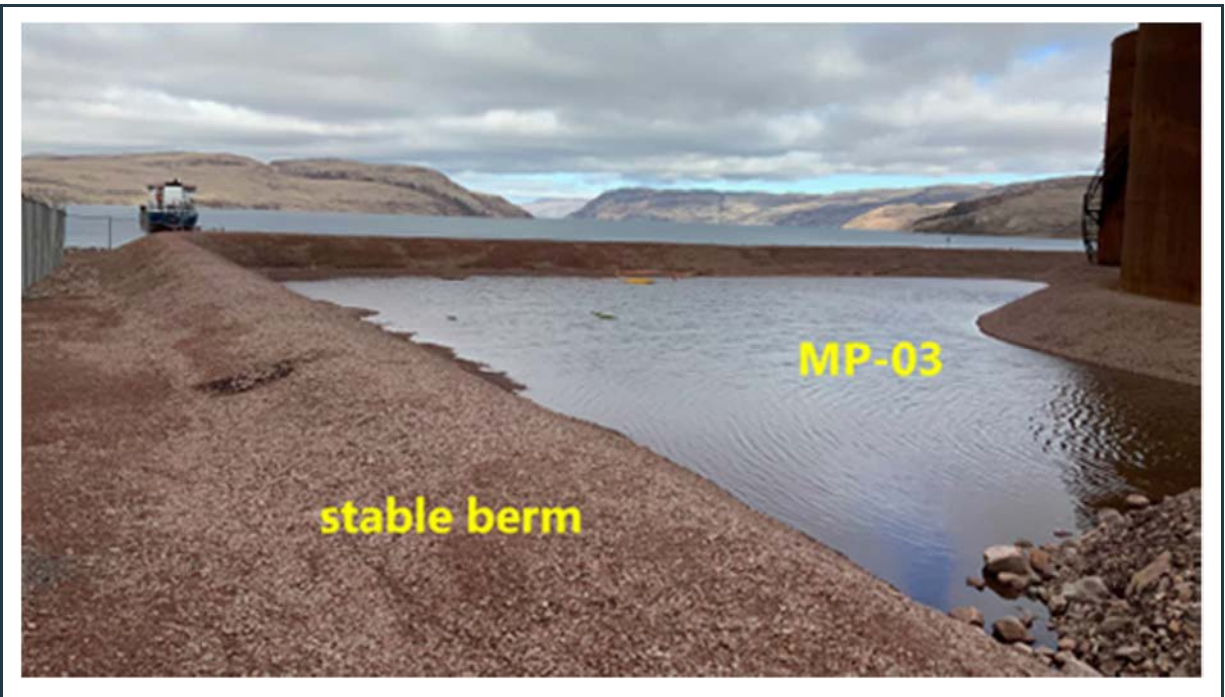
The MP-03 fuel tank farm occupies a large area in the center of the Milne Inlet Port. As shown in Figure 58, the facility is well maintained and the perimeter berm around the site is in excellent condition. The presence of ponding water in the facility is an indication of good liner performance. The site is fenced in, and no indication of instability or seepage was noted at and around the robust berm at this facility.

Figure 58: View of the well-maintained stable perimeter berm around the lined MP-03 fuel tank farm. The ponding water indicates good liner performance.

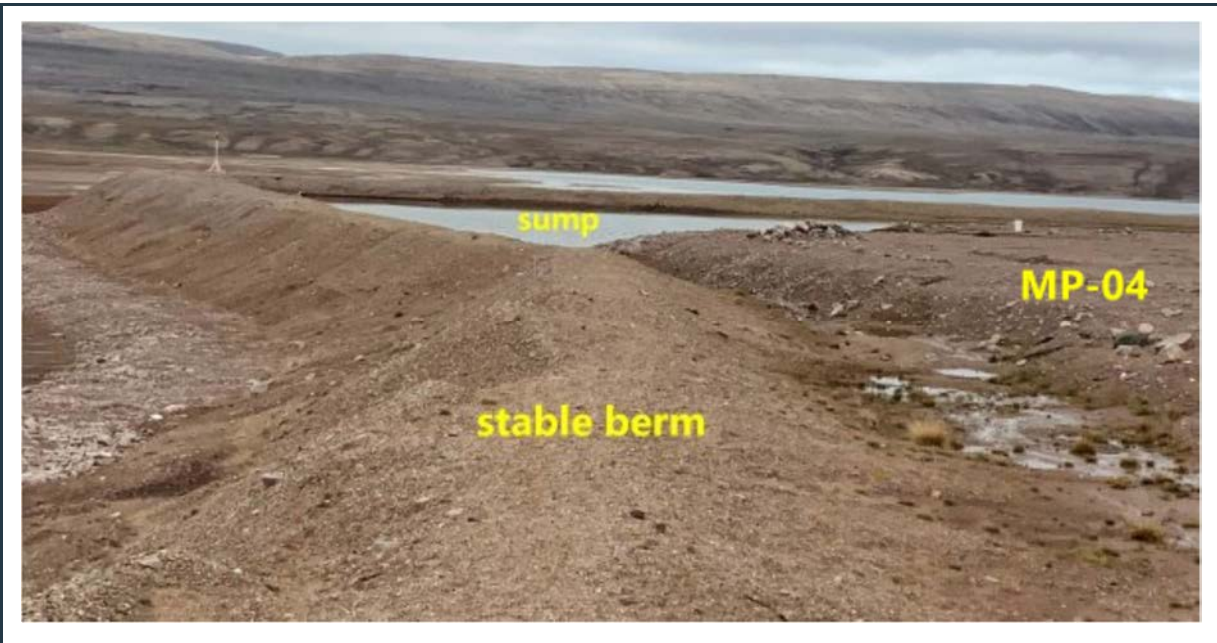
The MP-04 landfarm is in the southern zone of the Port at higher elevation (on the top of a hill), adjacent to the Q01 rock quarry. It is a large cell that stores potentially contaminated soils, as shown in Figure 59.

Figure 59: View of stable perimeter berm around the MP-04 landfarm, with ponding water in one corner of the cell (sump). Note the standard soil cover over the buried solid waste.
