TOTE ROAD CV-225

BAFFINLAND IRON MINES
MARY RIVER PROJECT

APPENDIX C

Erosion and Sediment Controls implemented in 2024

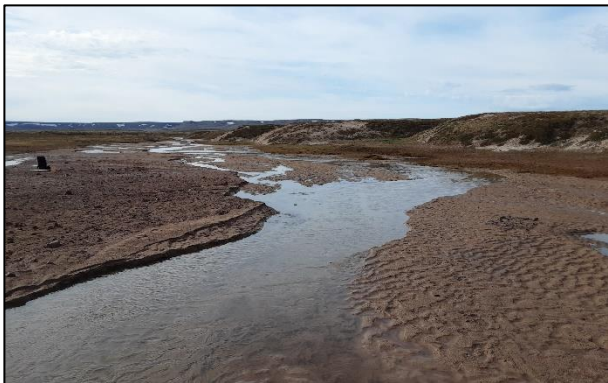
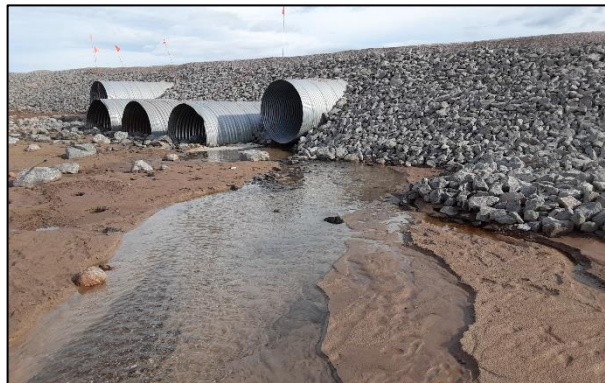
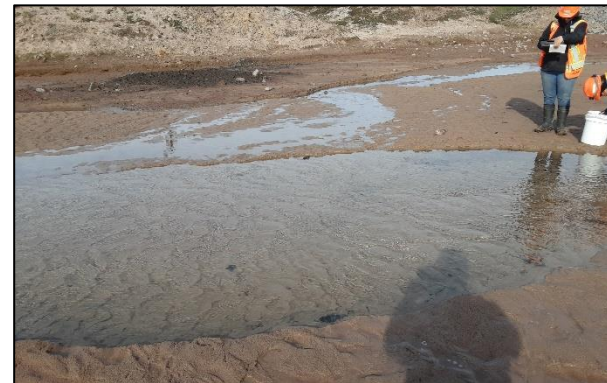
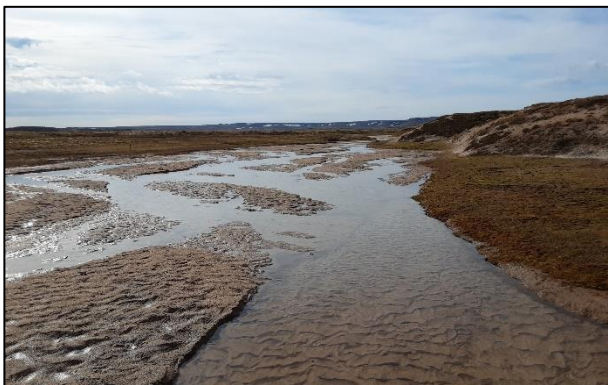
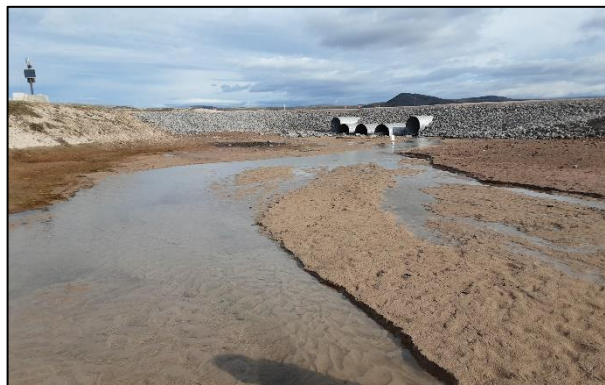
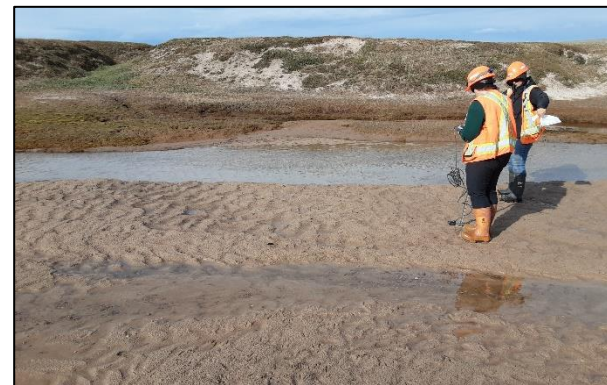
Photos 1-2. Photos taken 20 m upstream (top) and 60 m upstream (bottom) in spring 2024: (A,D) facing upstream; (B,E) facing downstream; and (C,F) across (left bank looking at right bank).

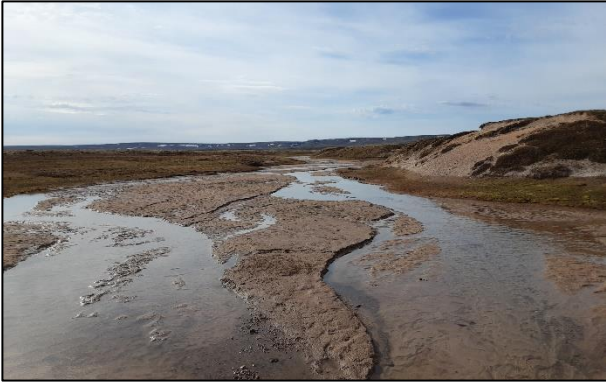
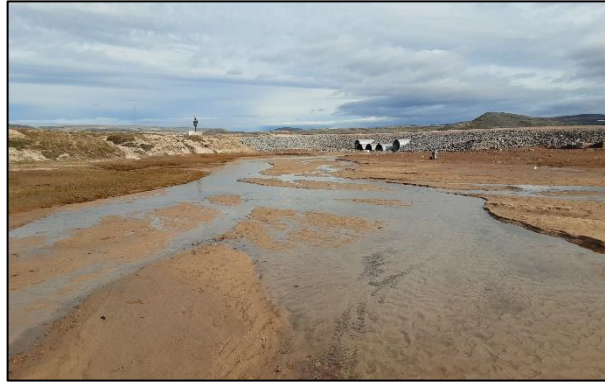
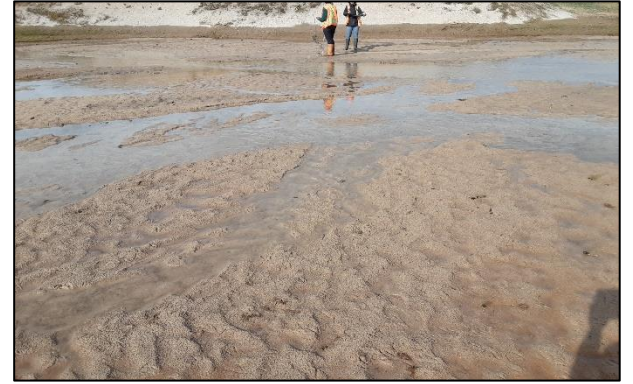
Photos 1-3. Photos taken 100 m upstream in spring 2024: (A) facing upstream; (B) facing downstream; and (C) across (left bank looking at right bank).

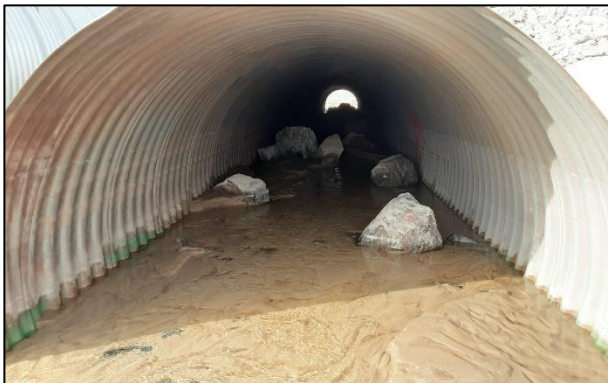
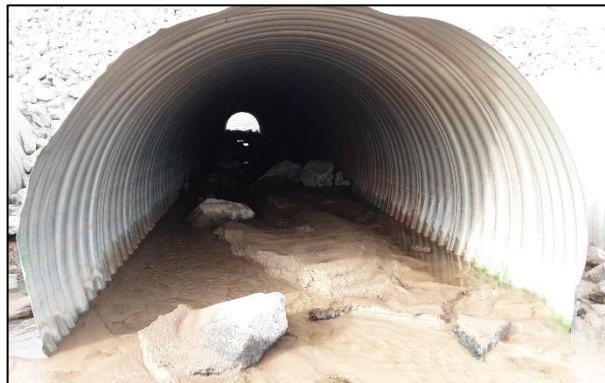
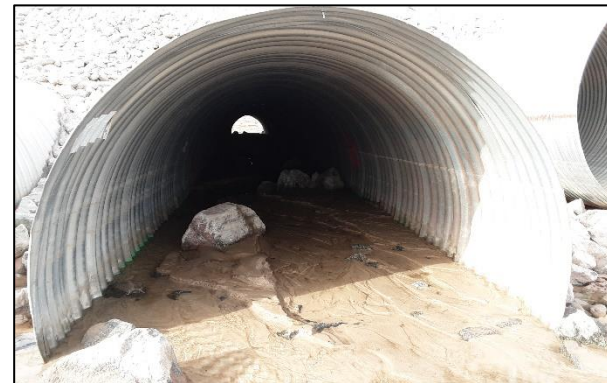
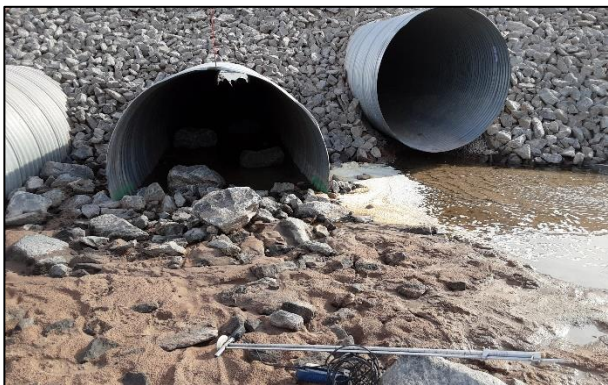
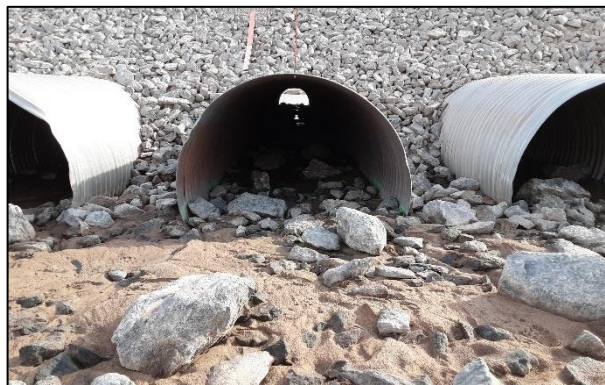
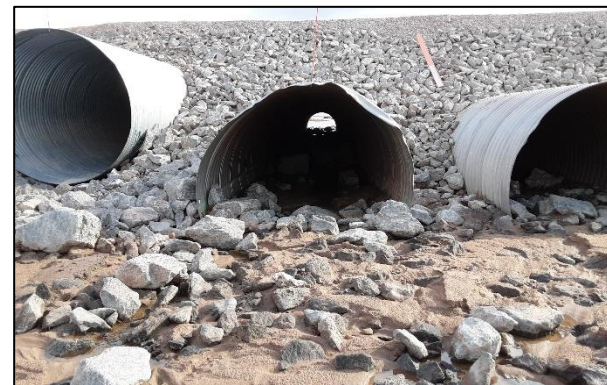
Photos 1-4. Photos taken of the fish passage culverts at the downstream (top) and upstream (bottom) ends in spring 2024: (A,D) lefthand culvert; (B,E) middle culvert; and (C,F) righthand culvert.

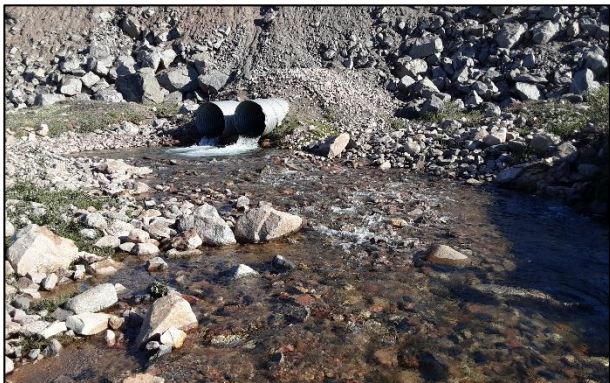
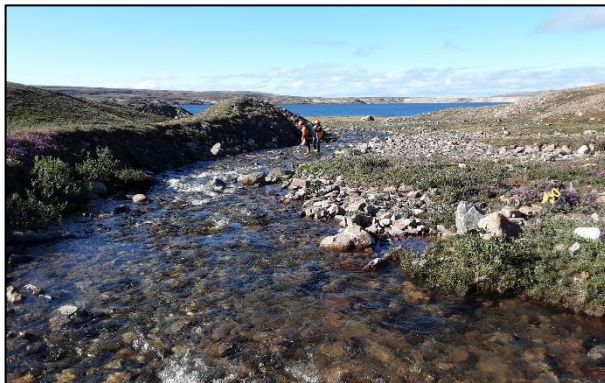
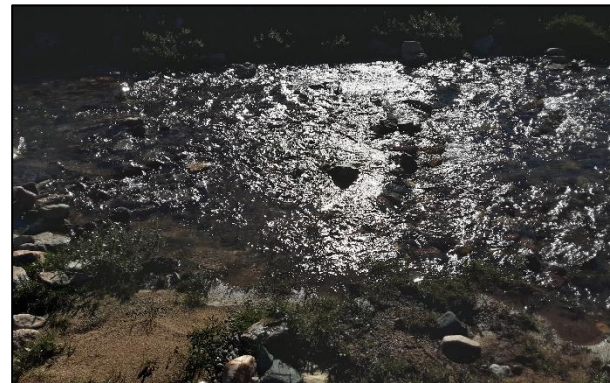
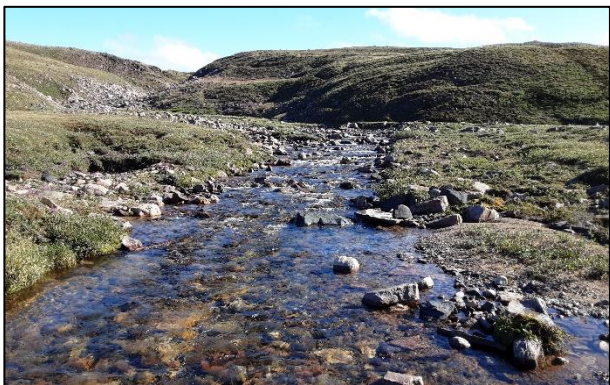
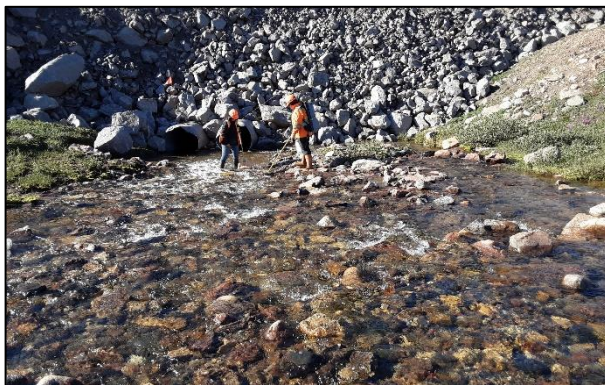
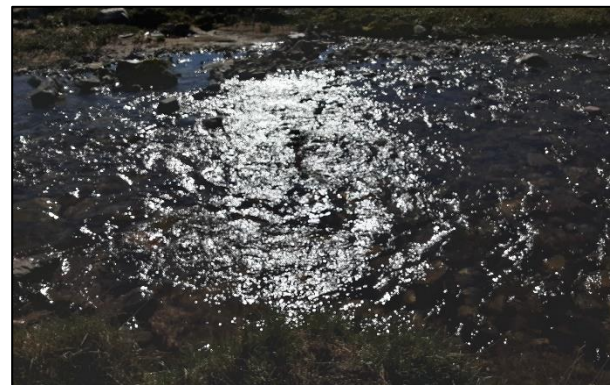
Photos 1-1. Photos taken 20 m downstream (top) and 20 m upstream (bottom) in spring 2024: (A,D) facing upstream; (B,E) facing downstream; and (C,F) across (left bank looking at right bank).
