N2021C0004
2023 CIRNAC LAND USE ANNUAL REPORT

FOR THE ASTON BAY PROPERTY
(ALSO KNOWN AS THE STORM PROPERTY)
NUNAVUT, CANADA

Prepared by: APEX Geoscience Ltd.
410-800 West Pender Street
Vancouver BC V6C 2V6
Canada

March 2024

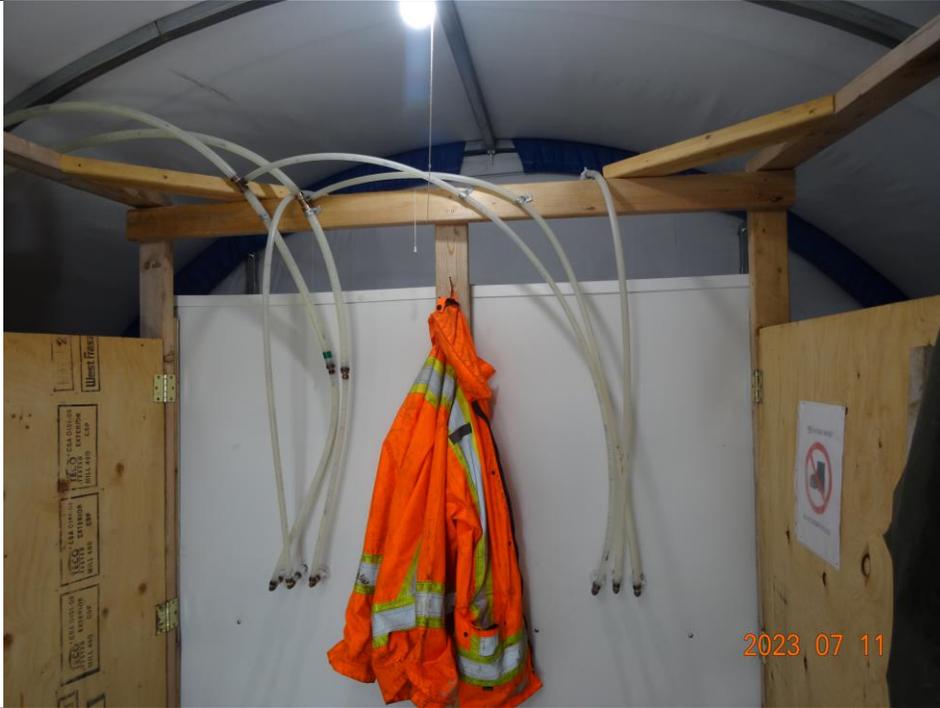
Photo 8

3. Raw water is stored outside in two 225 gallon storage tanks outside of the main facilities (Photo 2).
4. Along with the tanks outside, there are 2 different water storage tanks inside of 2 different cabins. "Tank 2" is 350 gallons and is located in the cabin that also has the UV filter system and the Micron filter system (Photo 3). Inspector Bolt has also taken a photo of the water use logs located inside the filtration cabin (Photo 4).
5. "Tank 1" is in the cabin next to the filtration cabin and is a smaller 250 gallon tank (Photo 5).
6. Inspectors observed 2 hot water heaters on site (Photo #3, #5).
7. 3 washing machines, 3 sinks and 6 showers were observed on site (Photo 7 and Photo 8).

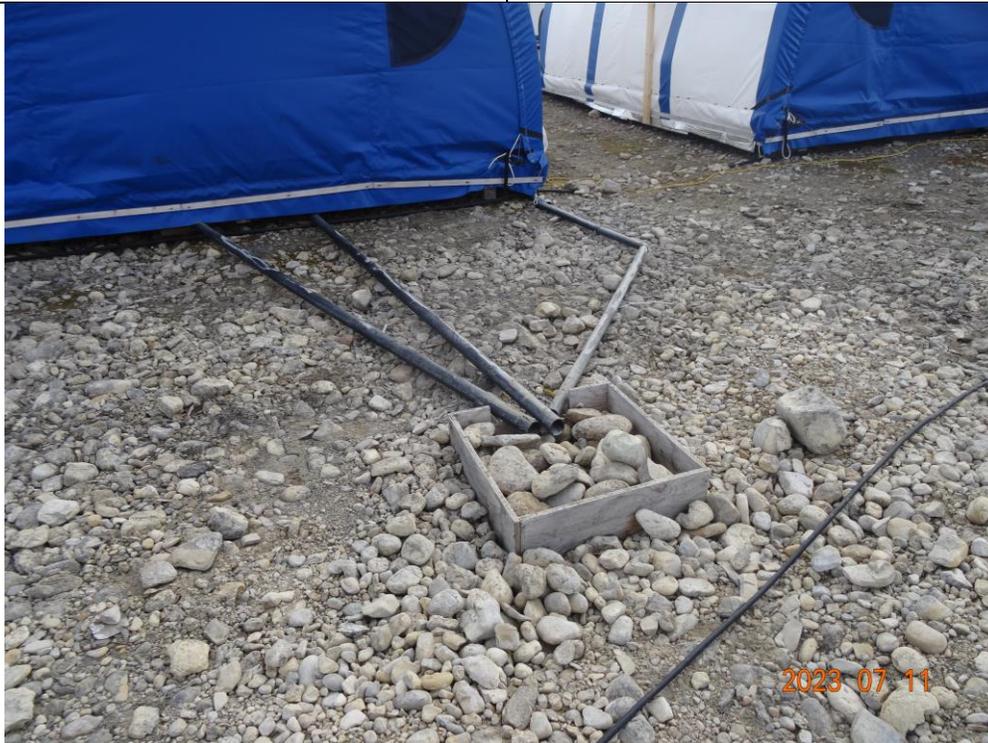
Photo 9

8. Grey water from the use of washing machines, sinks and showers is directed to pits located on the North side of the tents and cabins. The grey water pipes converge to a small pit which is filled with rocks to mitigate erosion. Grey water seeps into the ground and exfiltrates (photo 9).
9. The kitchen has a grease trap/sump located inside the building (photo 11). This sump is to catch sludge and grease that settles to the bottom and allows water to flow out.
10. On the south side of camp behind the sleeping quarters is a stand up latrine (Photo 12). There is a rock pile in the latrine to mitigate erosion. This pee then flows into the ground to exfiltrate (photo 13).
11. A Pecto toilet was observed on site (photo #14). Plastic bags line the toilets, which is then packed down by the operator and the bag is removed and stored in buckets for removal off site.

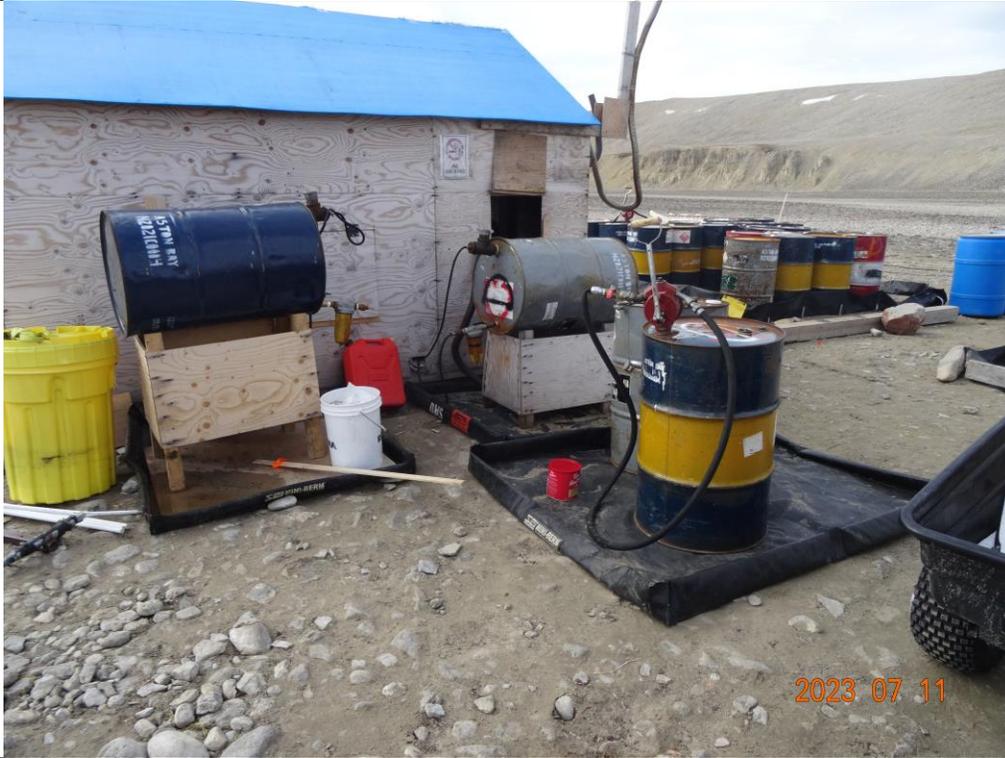
Photo No.
Photo 26

16. There was one spill kit present on site (Photo 26). More spills kits should be placed close to fuel storage berms.

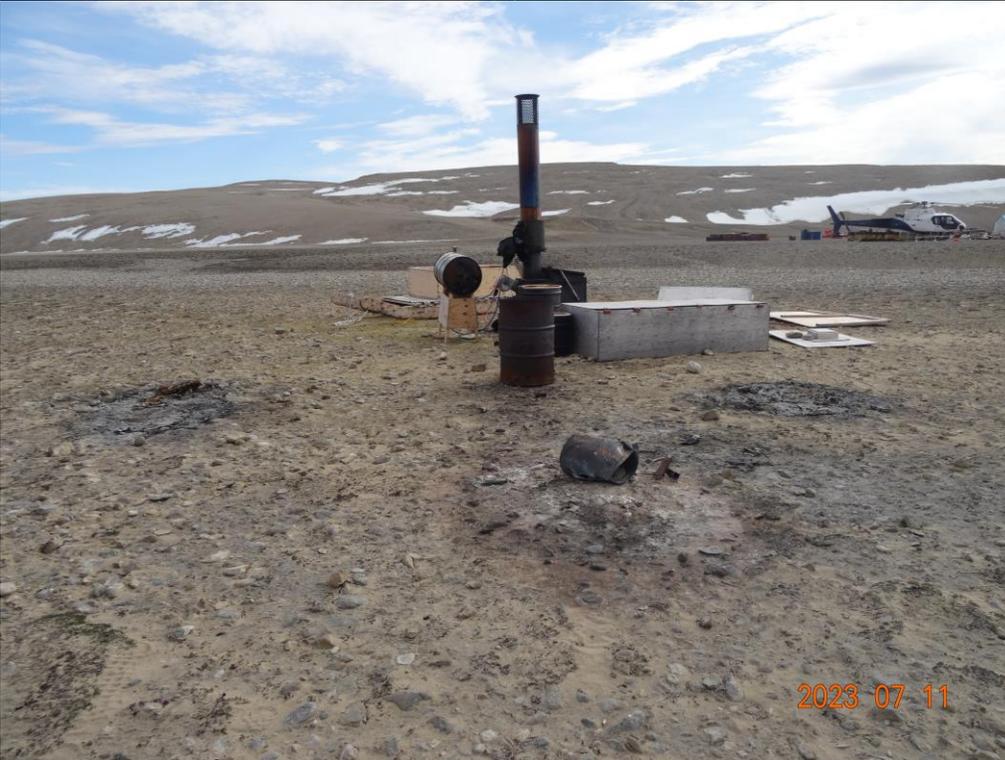
Photo No.
Photo 27

17. Aston Bay project is not authorized to practice on-site landfilling. All domestic waste is hauled off site.
18. An incinerator was observed on site at the time of inspection. The incinerator had plastic rope, and a can found inside at the time of inspection. The can had been burned previously. Part D, Item 5 of the issued water license reads –*"The Licensee shall not open burn plastics, wood treated with preservatives, electric wire, Styrofoam, asbestos or painted wood to prevent the deposition of waste materials of incomplete combustion and/or leachate from contaminated ash residual, from impacting any surrounding waters, unless otherwise approved by the Board in writing."*
19. Inspectors observed 3 piles of ash on the ground near the incinerator (Photo 27). The ash from incineration should be placed into ash bins and disposed of off site.
