On July 24-25, 2026, NIRB staff conducted a site visit to Agnico Eagle's Meadowbank Complex projects, accompanied by Agnico Eagle environmental staff. The visit focused on observing site activities, environmental management practices, and implementation of Project Certificate requirements. During the visit, NIRB staff observed ongoing operational activities and held discussions with the Proponent regarding environmental monitoring, mitigation measures, and adherence to Project Certificate requirements (Table 3-1 and Table 3-2).

### 3.1. Meadowbank

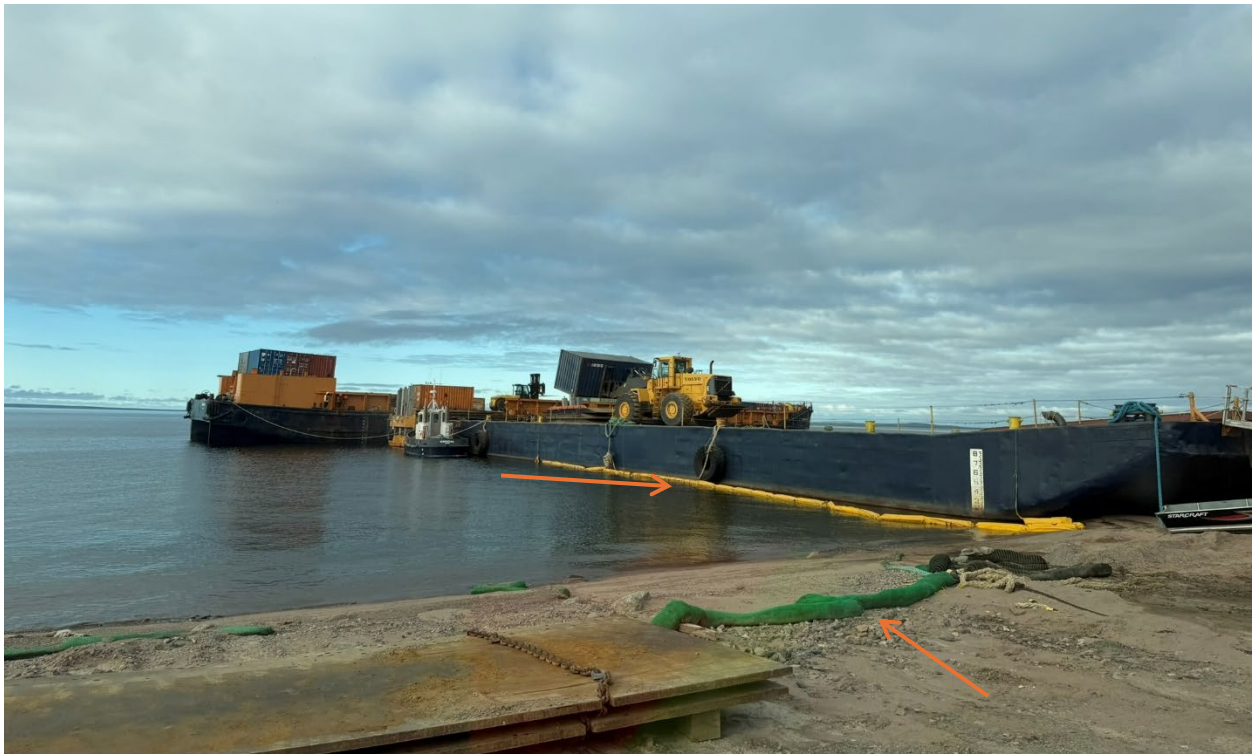
| 26 | Ensure spills are cleaned up and the site is maintained clean of debris | Observed general site housekeeping and organization of the laydown and marshalling areas (Photo 1 and Photo 6), the contaminated soil area (Photo 52), and waste segregation within the camp (Photo 61). Erosion and sediment controls at the barge landing included silt socks along the shoreline, silt fences and riprap (Photo 3, Photo 4, and Photo 5). |

| <b>44</b> | Spill Contingency and Emergency Response Plan | Observed the spill response seacan at the Baker Lake Marshalling Facility (Photo 2 and Photo 3) and emergency response seacans at bridge crossings along the AWAR (Photo 15). Observed the historical spill area at KM 87, which Agnico Eagle advised continues to be monitored, with results remaining stable (Photo 26). |

**Photo 3: Erosion control and spill contingency measures at the barge landing, including silt socks along the shoreline and a floating containment boom deployed around the barge**

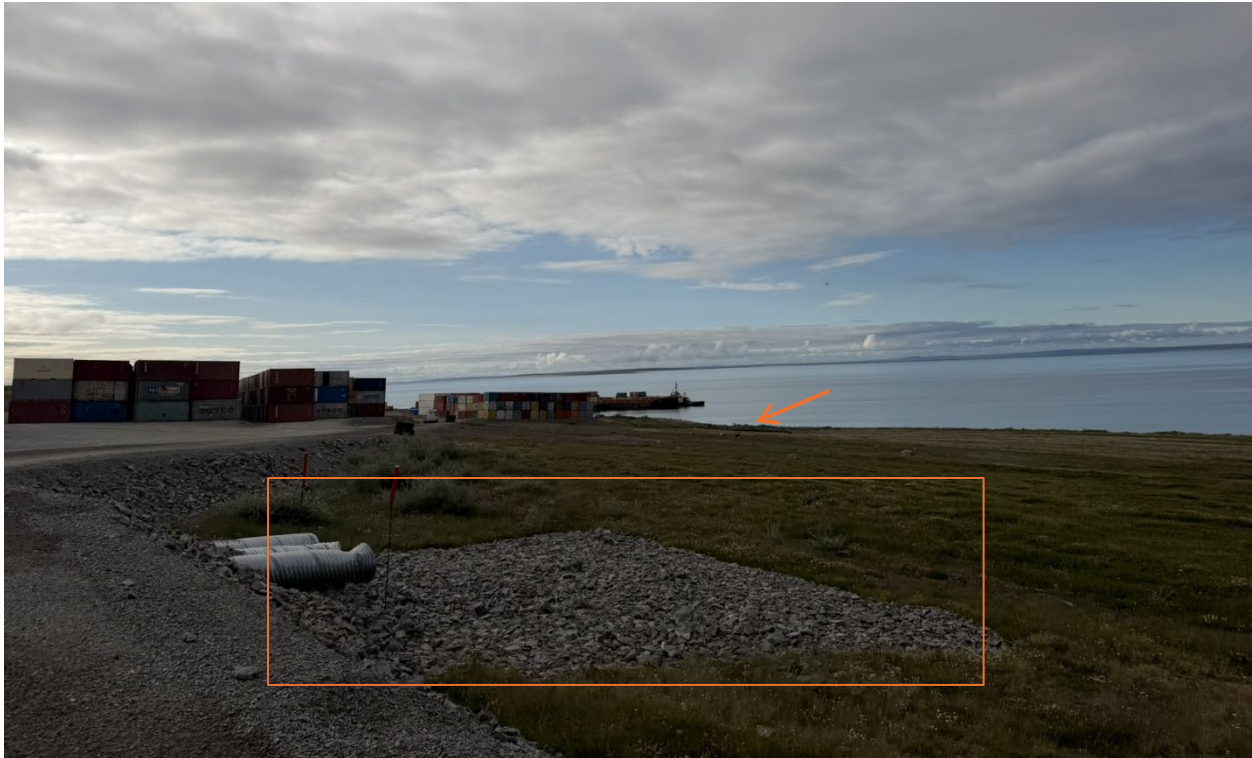
**Photo 4: Riprap and silt fences implemented to mitigate erosion and control sediment runoff**

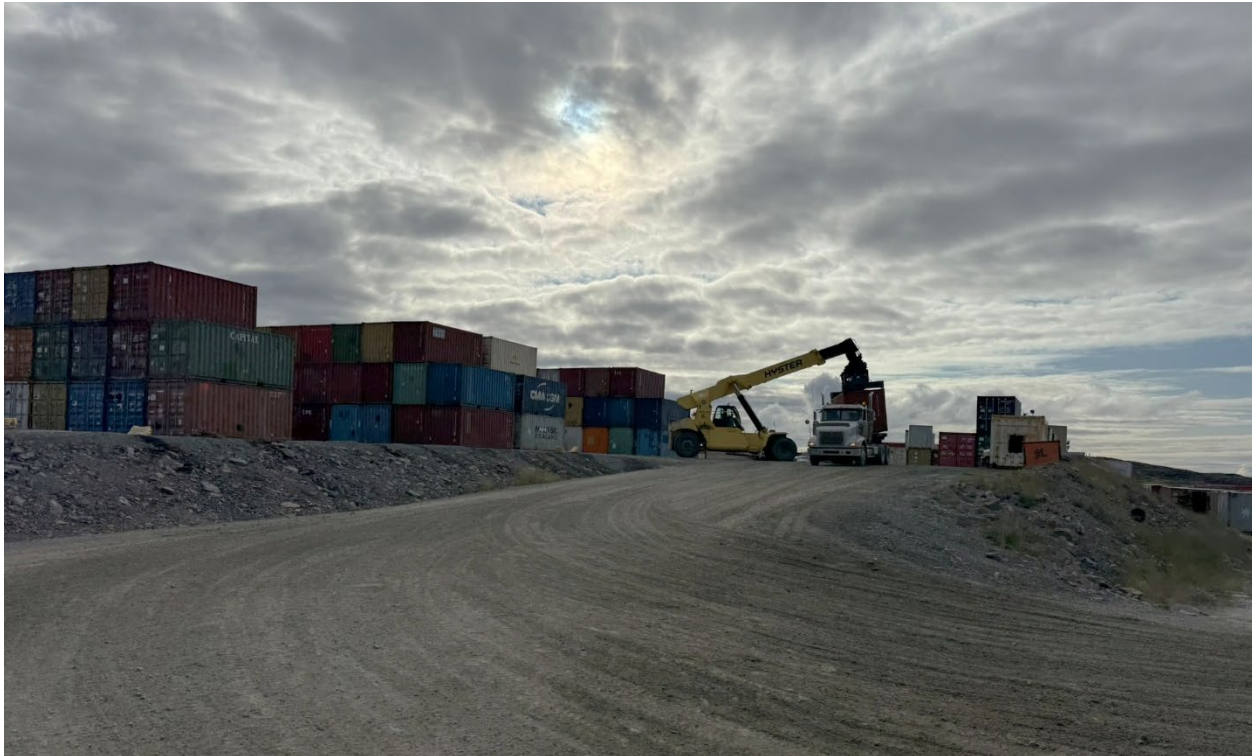
**Photo 6: Laydown area operations showing seacans being loaded and dispatched to site**

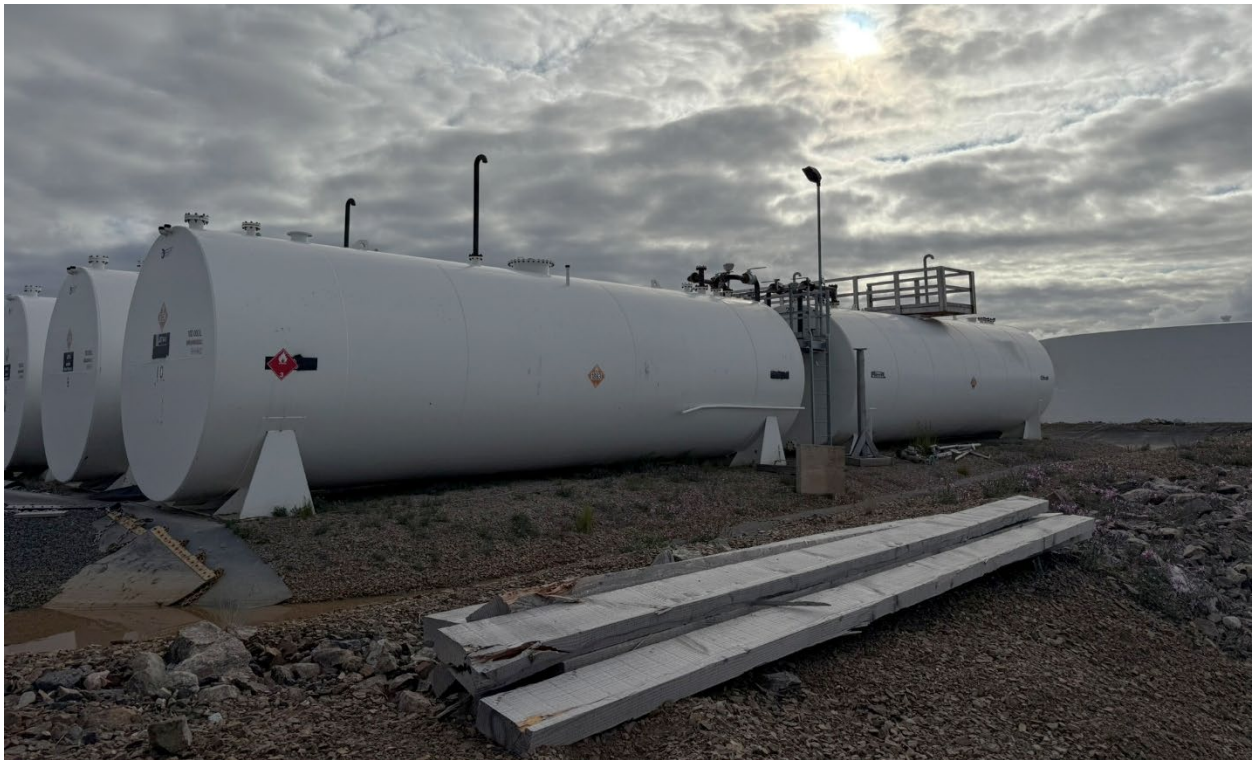
| 27 | Ensure fuel and hazardous materials are contained using safe, environmentally protective methods based on best engineering practices | At the Baker Lake Marshalling Facility, observed the rigid fuel transfer line running from shore to the storage tanks (Photo 7), fuel dispensing modules (Photo 8), horizontal fuel tanks within secondary containment (Photo 9) and vertical fuel tanks and containment berm (Photo 12). Sections of the containment liner were observed exposed, with vegetation growth and standing water adjacent to the horizontal fuel tanks (Photo 10 and Photo 11). Also observed the on-site tank farm and fuelling station (Photo 56), the Vault waterline including pressure relief housing at a high point on the line (Photo 35), and the HAZMAT storage seacans (Photo 54). |

**Photo 9: Horizontal fuel tanks in secondary containment**

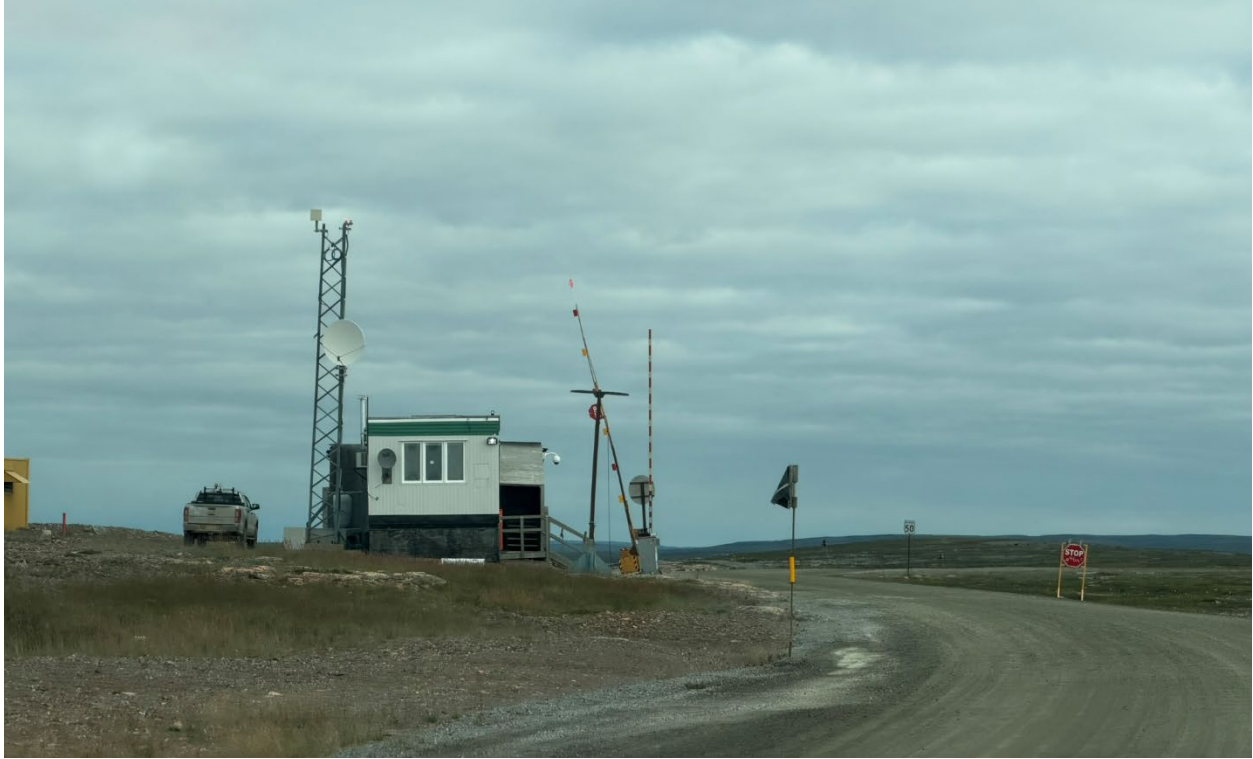
| <b>32, 34</b> | Operate the AWAR as a private access road with limited access, a staffed gate at km 5, English/Inuktitut signage, and a road safety and search-and-rescue capacity | Observed the staffed gatehouse at KM 5, where all users check in, sign the road safety policy and are required to wear high-visibility clothing (Photo 14). Public trucks are not permitted on the road; haul traffic was observed travelling the AWAR (Photo 24). Community members were observed travelling by ATV wearing high-visibility clothing, with road traffic notified of their presence by radio (Photo 20). Observed the designated snowmobile crossing at KM 10 (Photo 17) and fire and hunting restriction signage at KM 86 (Photo 25). |

**Photo 14: Staffed gatehouse at KM 5**

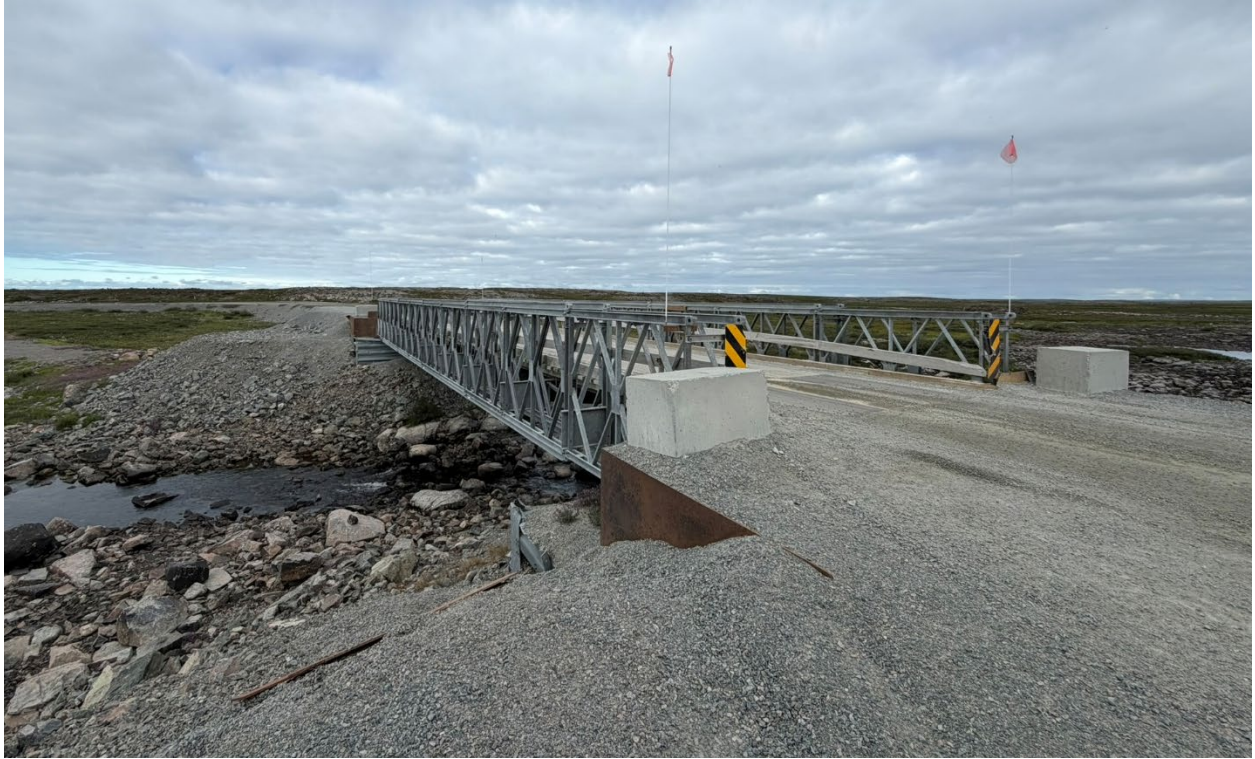
| 31 | Provide stream crossing design criteria along with a maintenance | Observed the bridge crossings along the AWAR (Photo 15, Photo 16, and Photo 22). Metal plates have been installed to close the |

Bridges and watercourse crossings were observed to be in good repair. Metal plates have been installed to close the gaps along the sides of the bridge decks, preventing road material and debris from falling into the watercourses below. Emergency response seacans were observed at each bridge crossing.

**Photo 16: KM 8 bridge**

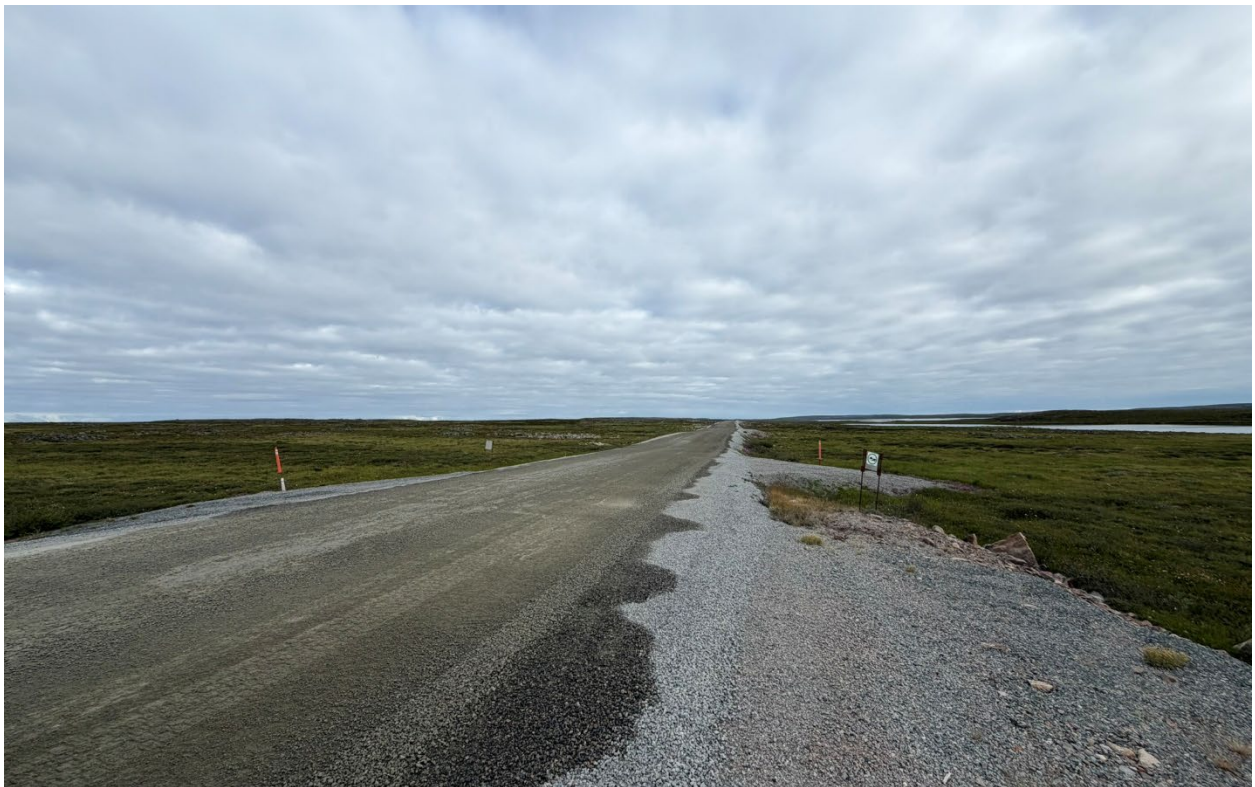
**Photo 17: Snowmobile Crossing at KM 10 along the AWAR**

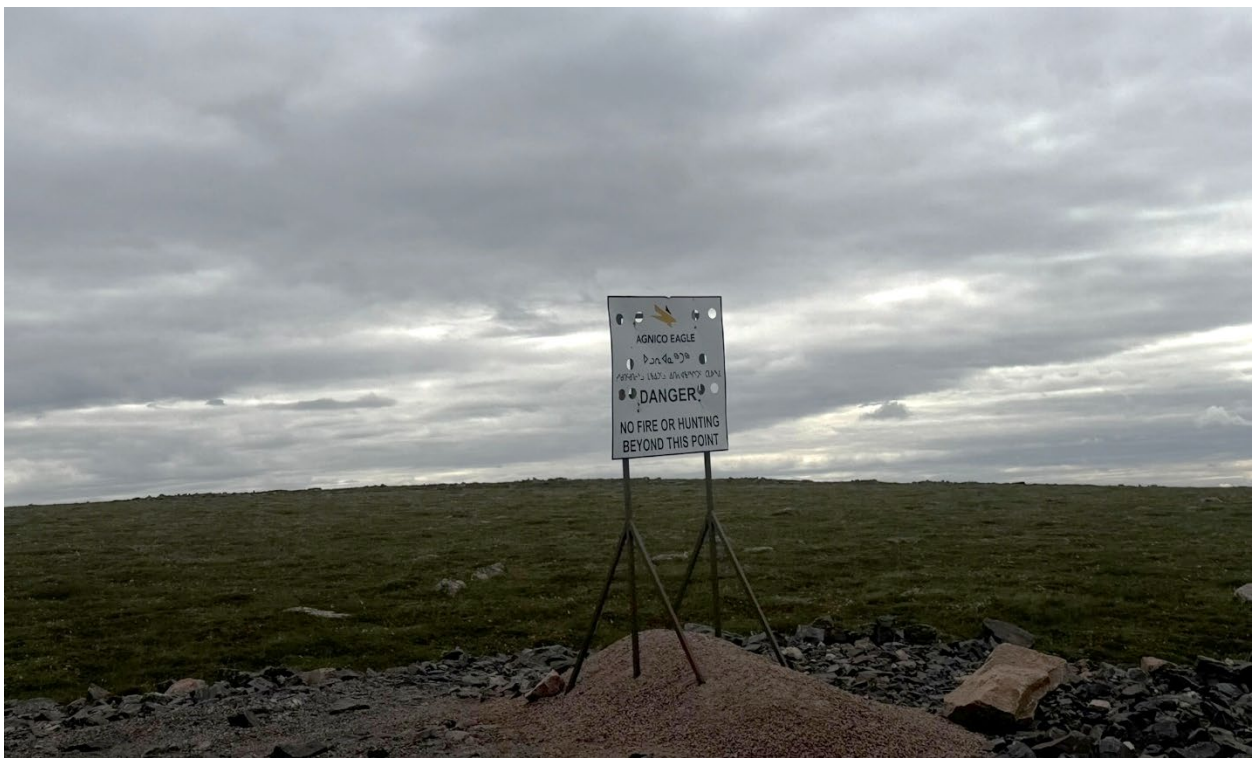
**Photo 25: KM 86, fire/hunting restriction sign**

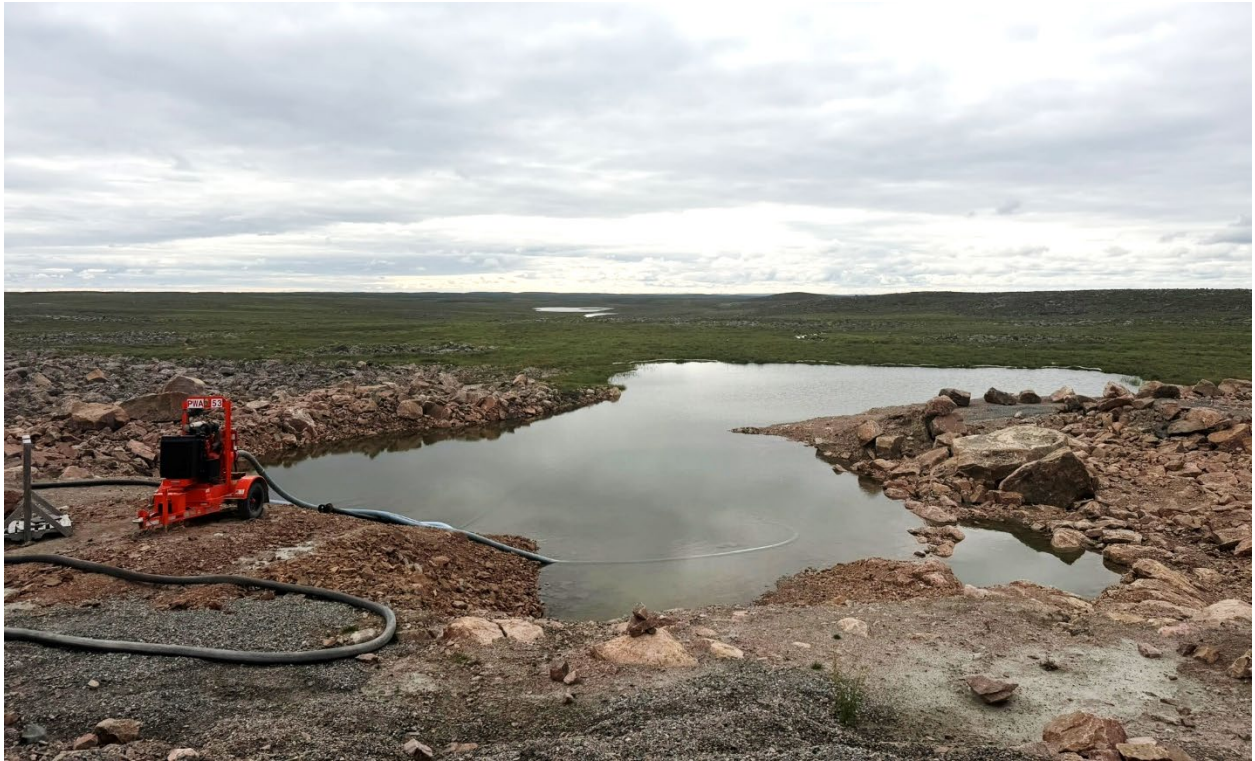
**Photo 26: Historical spill area at KM 87; Agnico Eagle continues to monitor the site for residual effects, with results remaining stable**

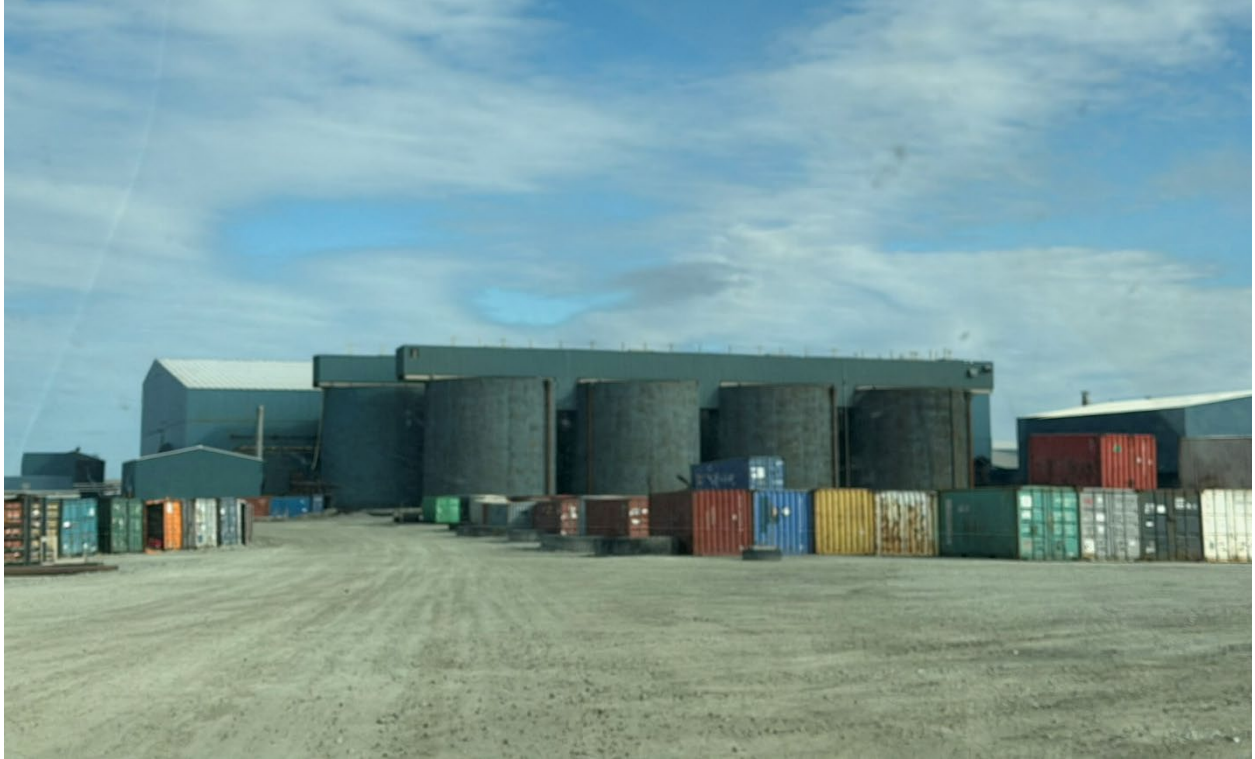
| 28 | Signatory to the International Cyanide Management Code (ICMC) | Observed the processing mill and cyanide leaching tanks (Photo 32). |

**Photo 32: The Processing Mill and Cyanide Leaching Tanks**

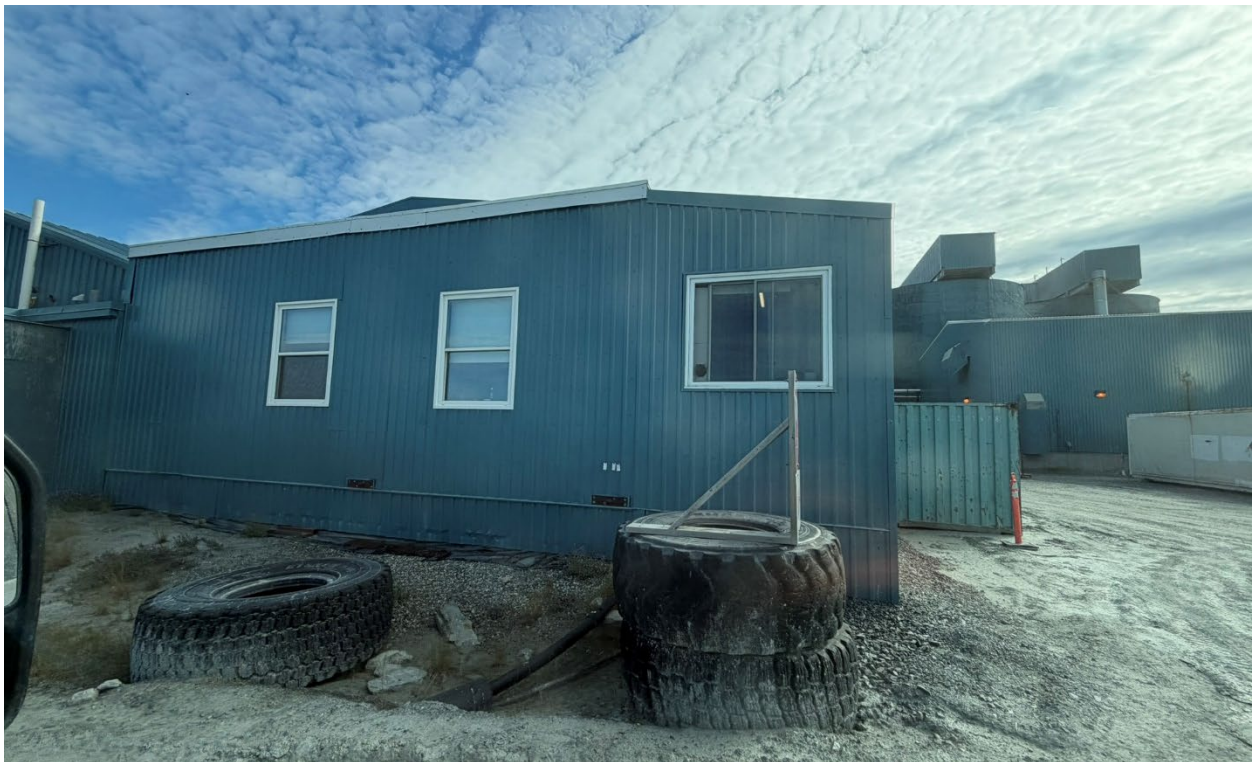
| 22 | Fund an on-site laboratory capable of monitoring parameters at a type and frequency acceptable to the NWB and ECCC at all site discharge points | Observed the on-site assay laboratory, which remained functional (Photo 33). Agnico Eagle advised that regulatory samples continue to be sent to an off-site accredited laboratory. |

**Photo 33: Onsite Assay Lab**

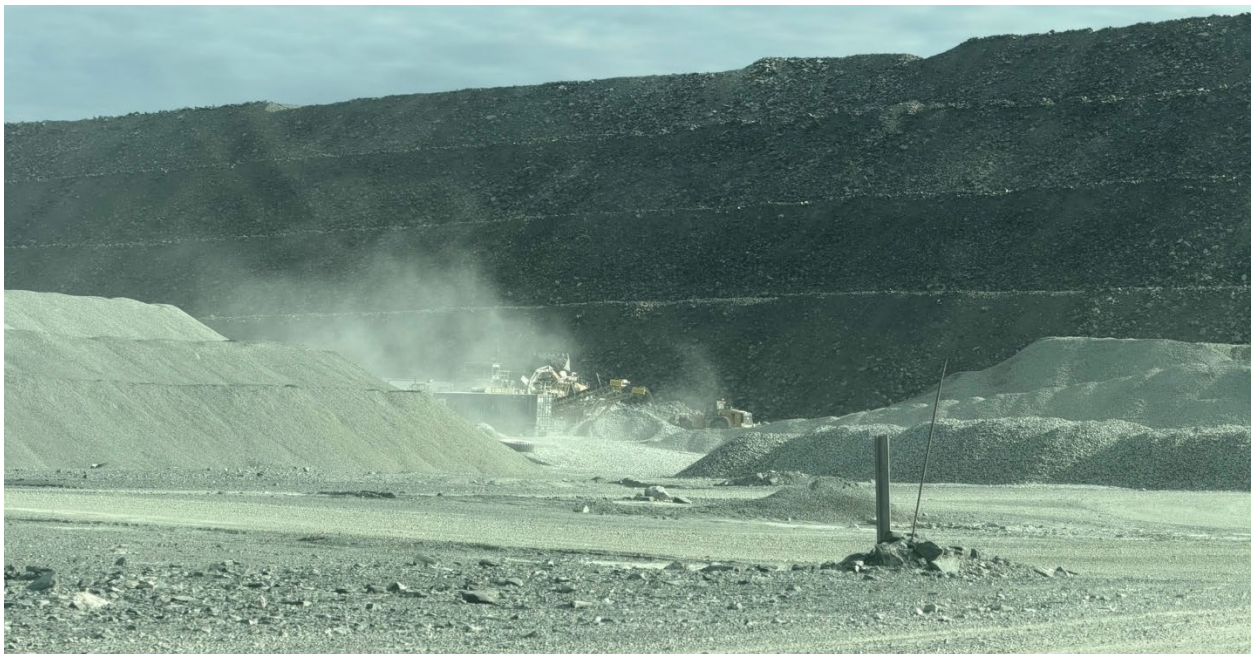
| 15 | Characterize mine waste materials, including the Vault area, for acid generating potential, metal leaching and non-metal constituents | Observed the Vault Waste Rock Storage Facility and the Portage Rock Storage Facility, including segregation of NAG material and crushing operations for aggregate production (Photo 36, Photo 37, and Photo 47). |

**Photo 37: Crushing operations at the Vault WRSF**

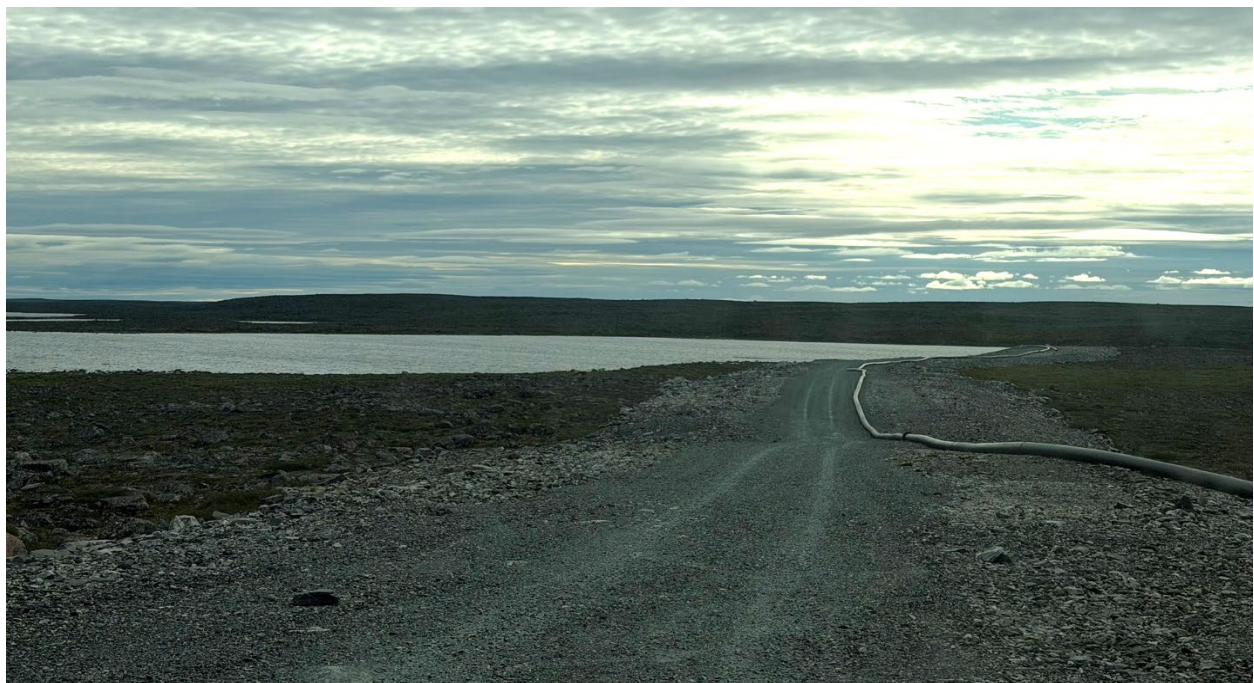
| T&C No. | Topic / summary | Site Observation |
|---|---|---|
| 11, 13 | Effluent outfall configuration for Wally Lake; meet water discharge requirements for Wally Lake and Third Portage Lake | Observed Wally Lake and the associated discharge line (Photo 39). |

**Photo 39: Wally Lake and Discharge Line**

<sup>3</sup> The Vault attenuation pond discharges to Wally Lake, and Agnico Eagle has identified this discharge as the Meadowbank site's final discharge point with the greatest potential to adversely affect the receiving environment. Deposition of fugitive dust from the crushing operation into the attenuation pond therefore has the potential to affect water quality at the point of discharge.

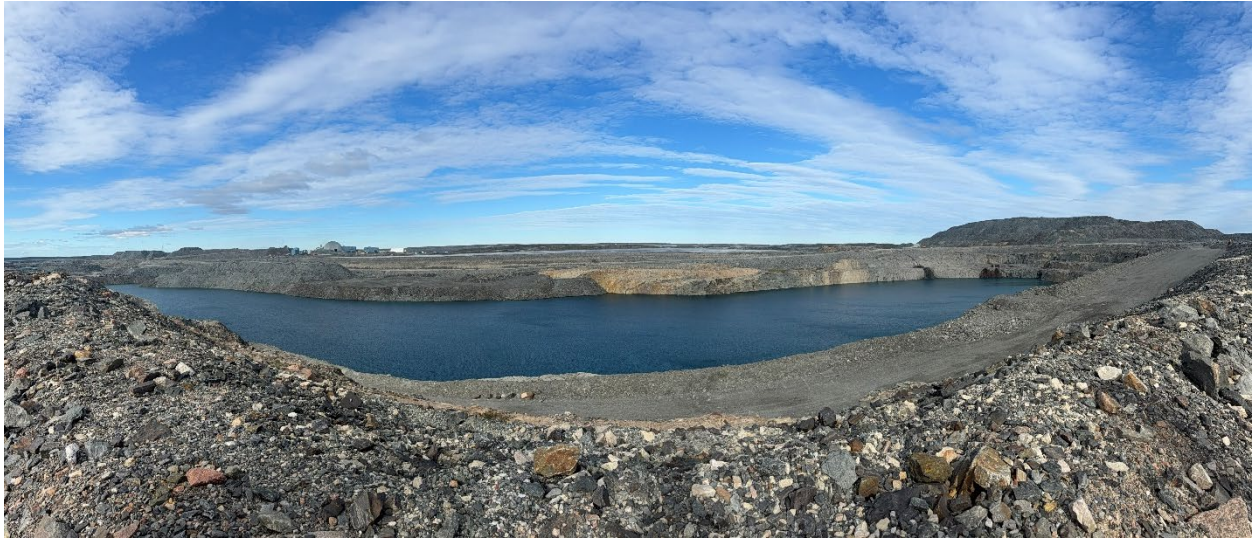
| 18 | Commit to a pro-active tailings management strategy through active monitoring, inspection and mitigation | Observed the Vault, Phaser, Portage A, Portage E and Goose pits (Photo 34, Photo 41, Photo 42, Photo 44, and Photo 45). Tailings deposition was active in Portage Pit A at the time of the visit, where in-pit deposition has continued since December 2024 (Photo 43). Goose Pit is capped beneath 35 to 40 m of water. |

**Photo 42: Panoramic view of Portage Pit A<sup>5</sup>**

<sup>5</sup> Portage Pit A is a mined-out open pit at the Meadowbank site used for in-pit tailings deposition. Deposition commenced in December 2024 and continued through 2025. Under the current deposition plan, Pit A is to receive tailings through to June 2027.

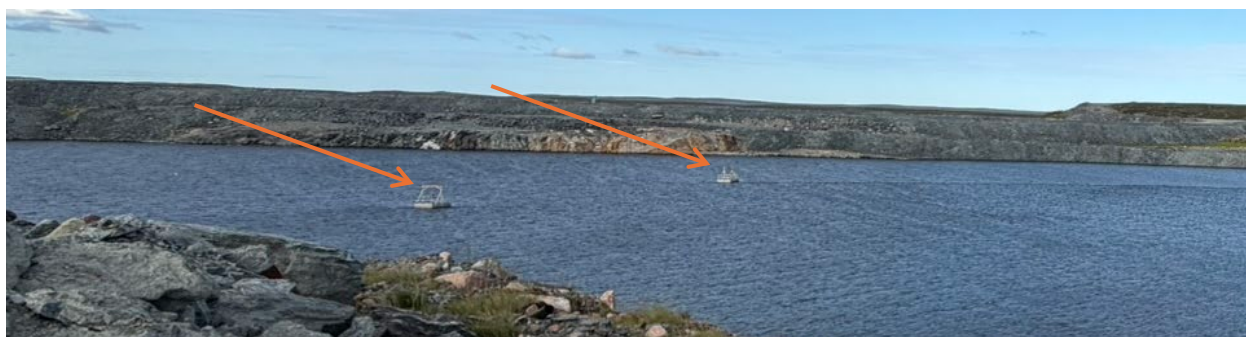
| T&C No. | Topic / summary | Site Observation |
|---|---|---|
| 9 | Provide plans for water treatment for the tailings (reclaim pond) discharge and, on a contingency basis, for the attenuation pond discharge(s) and the pits | Observed the Vault and Phaser attenuation ponds (Photo 38 and Photo 40) and aerators installed in Goose Pit as part of the in-pit semi-passive water treatment system (Photo 46). |

**Photo 46: Goose Pit-aerators installed as part of the in-pit semi-passive water treatment system**

<sup>7</sup> Goose Pit is a mined-out open pit at the Meadowbank site that received tailings from July 2019 to August 2020. Agnico Eagle is developing a closure water treatment system for the Portage and Goose Pits, including semi-passive in-pit treatment to improve nitrogen compound degradation.

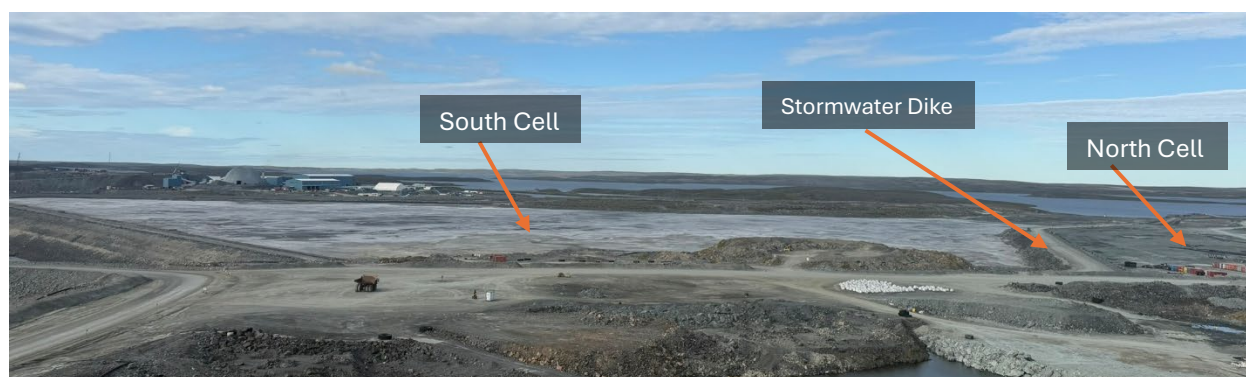
| 19 | Meet tailings cover requirements for the Tailings Storage Facility and In-Pit Tailings; report annually on freezeback effectiveness | Observed the North and South Cells of the Tailings Storage Facility (Photo 48 and Photo 49). Placement of the cover over the North Cell was active at the time of the visit (Photo 50). |

**Photo 48: Tailings Storage Facility - South Cell<sup>8</sup>**

<sup>8</sup> The Tailings Storage Facility comprises the North Cell and the South Cell. Tailings deposition in the North Cell ceased in November 2014, at which point deposition and the reclaim water intake were transferred to the South Cell. Progressive closure of the facility is ongoing, and active placement of the non-potentially acid generating (NAG) cover over the deposited tailings was observed at the time of the visit. Agnico Eagle advised that construction of the NAG cover over the tailings in the South Cell was completed in 2025.

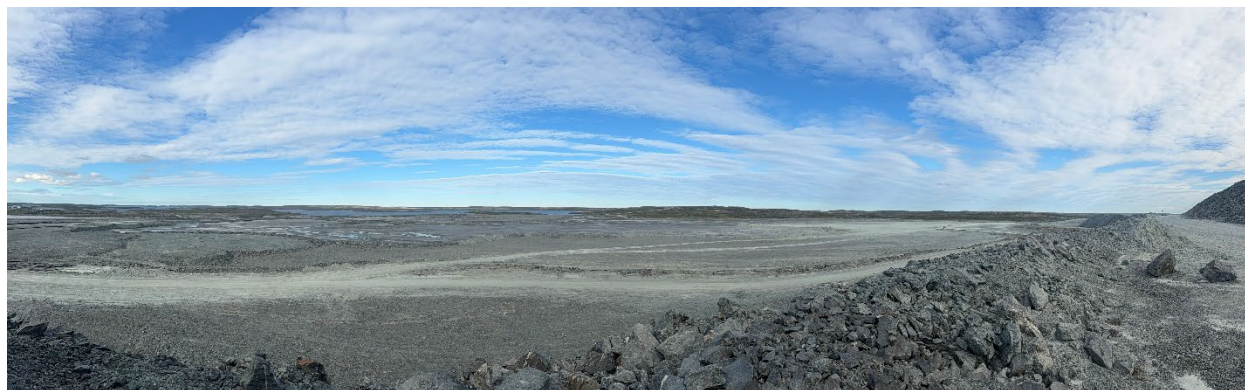
**Photo 49: Tailings Storage Facility - North Cell**

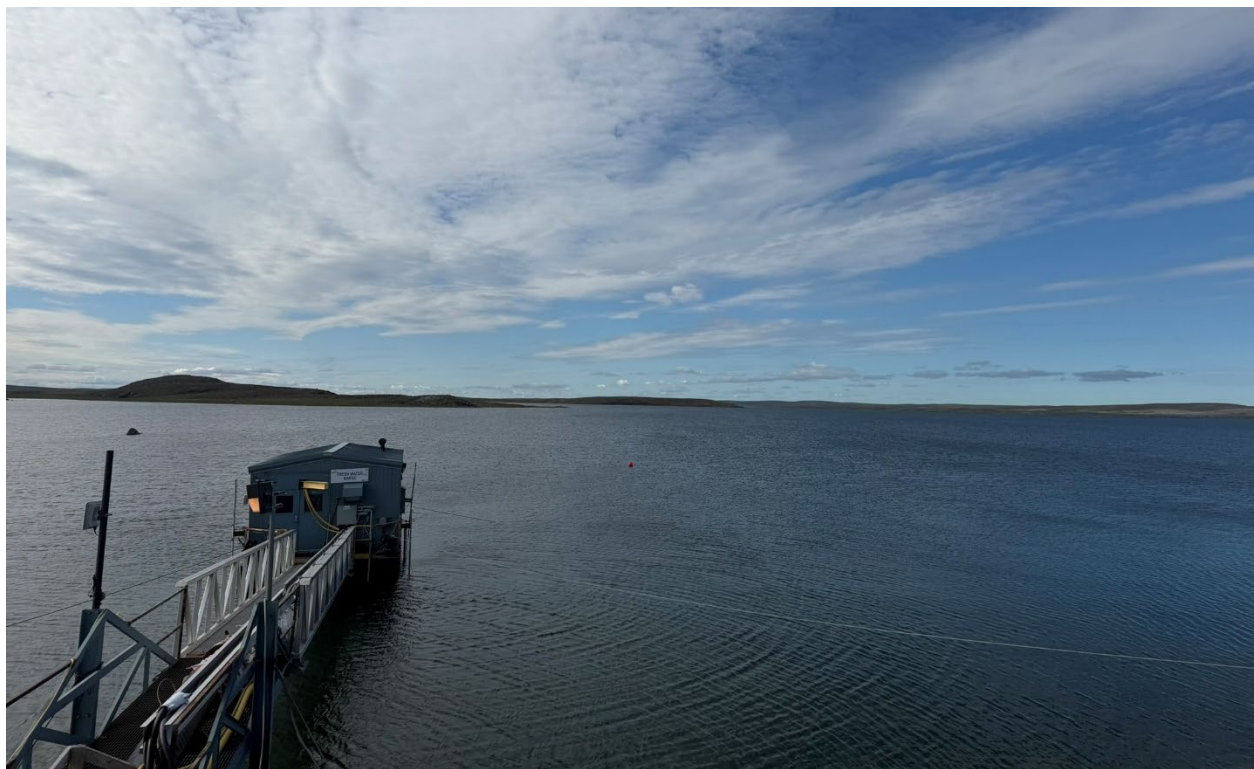
| <b>46</b> | Freshwater intake pipe requirements and design | Observed the freshwater intake barge on Third Portage Lake (Photo 57). |

**Photo 57: Freshwater Intake Barge on Third Portage Lake**

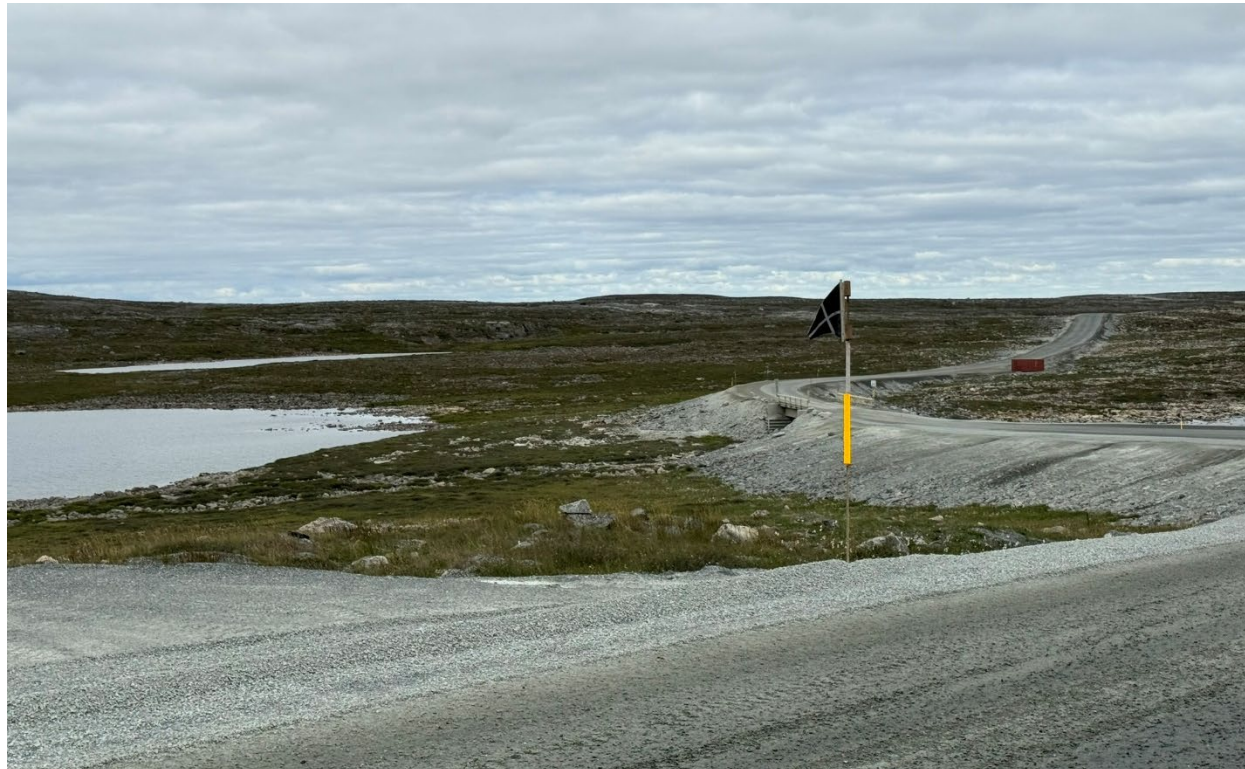
| <b>PC<br/>004<br/>44</b> | Spill Contingency and Emergency Response Plan | Observed the emergency response seacan adjacent to the bridge crossing at KM 102 (Photo 62). |

**Photo 62: Bridge crossing at WTHR KM 102 and adjacent emergency response seacan**

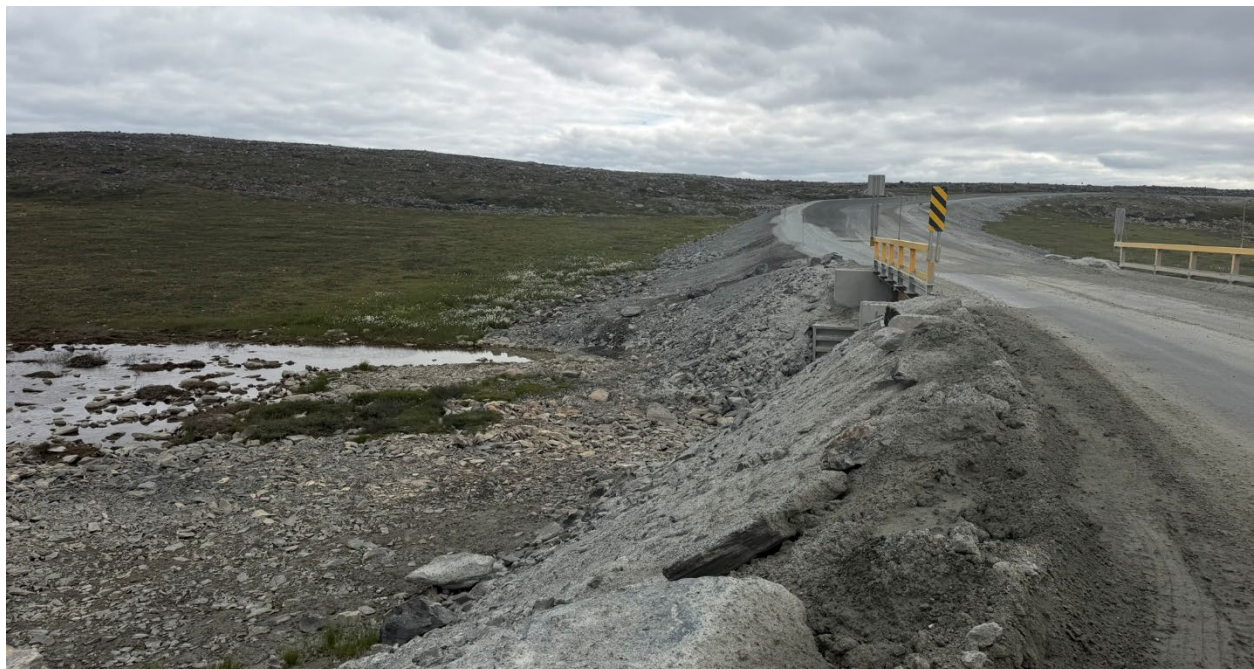
| T&C No. | Topic / summary | Site Observation |
|---|---|---|
| 11 | Erosion Management Plan | Observed the IVR diversion ditch (Photo 90), the Kangislulik (Mammoth) Lake dike (Photo 94) and the Whale Tail dike (Photo 97). At the bridge crossing at KM 102, accumulated road material and debris were observed on the embankment slope above the watercourse (Photo 64). At the culvert crossing at KM 133, erosion channels were observed on the embankment slope above the outlet, with riprap placed at the toe (Photo 73). |

Bridges and watercourse crossings were generally observed to be in good repair, with clear fish passage, though debris accumulation was noted at KM 102 bridge and KM 133 culvert crossings. Emergency response seacans were observed at bridge crossings.

**Photo 64: Bridge crossing at WTHR KM 102, showing accumulated road material and debris on the embankment slope above the watercourse<sup>10</sup>**

<sup>10</sup> Debris accumulation on embankment slopes at watercourse crossings has the potential to contribute sediment and material to the receiving waterbody.

At the bridge crossing at KM 102, accumulated road material and debris were observed on the embankment slope above the watercourse (Photo 64). At the culvert crossing at KM 133, erosion channels were observed on the embankment slope above the culvert outlet, with fine granular road material displaced down the slope face (Photo 73). Fisheries and Oceans Canada (DFO) has previously raised concerns regarding culvert condition and sedimentation along project roads. NIRB staff encourage Agnico Eagle to ensure that water crossings remain in good repair and fish passage is clear of obstruction.

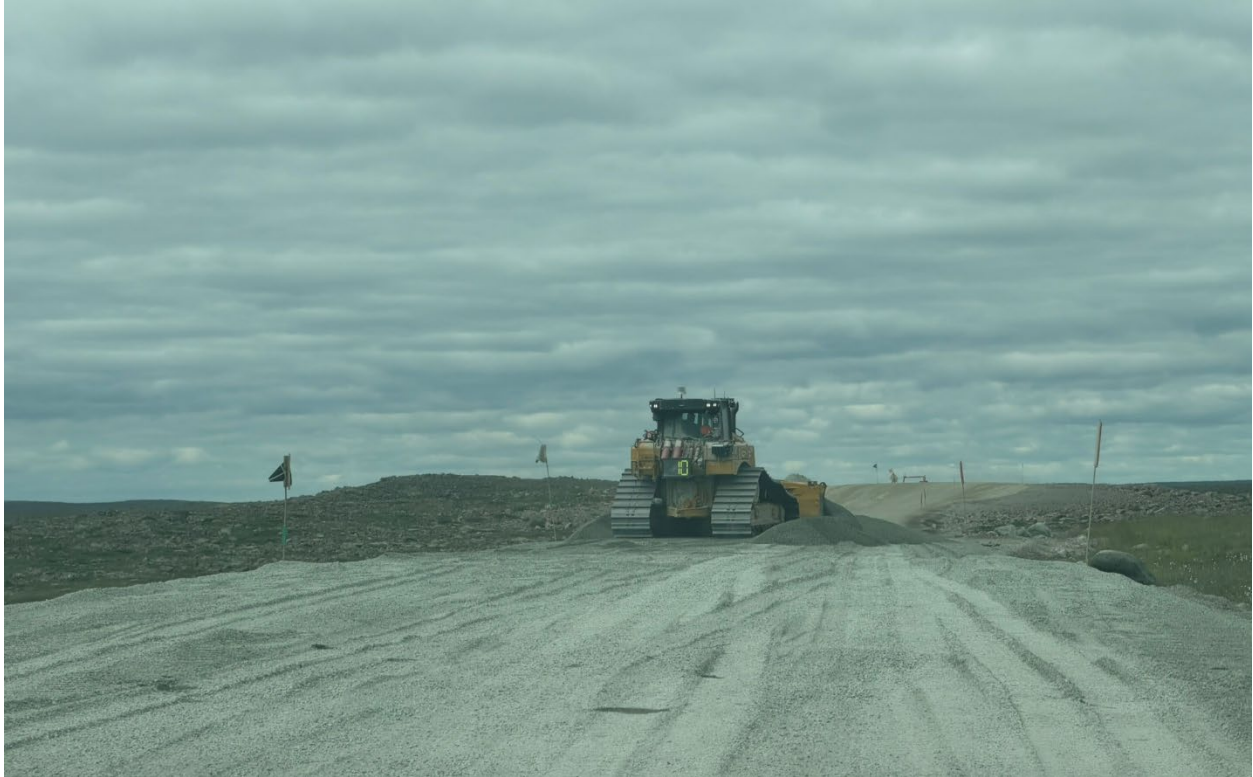
**Photo 69: Road maintenance activities on the WTHR**

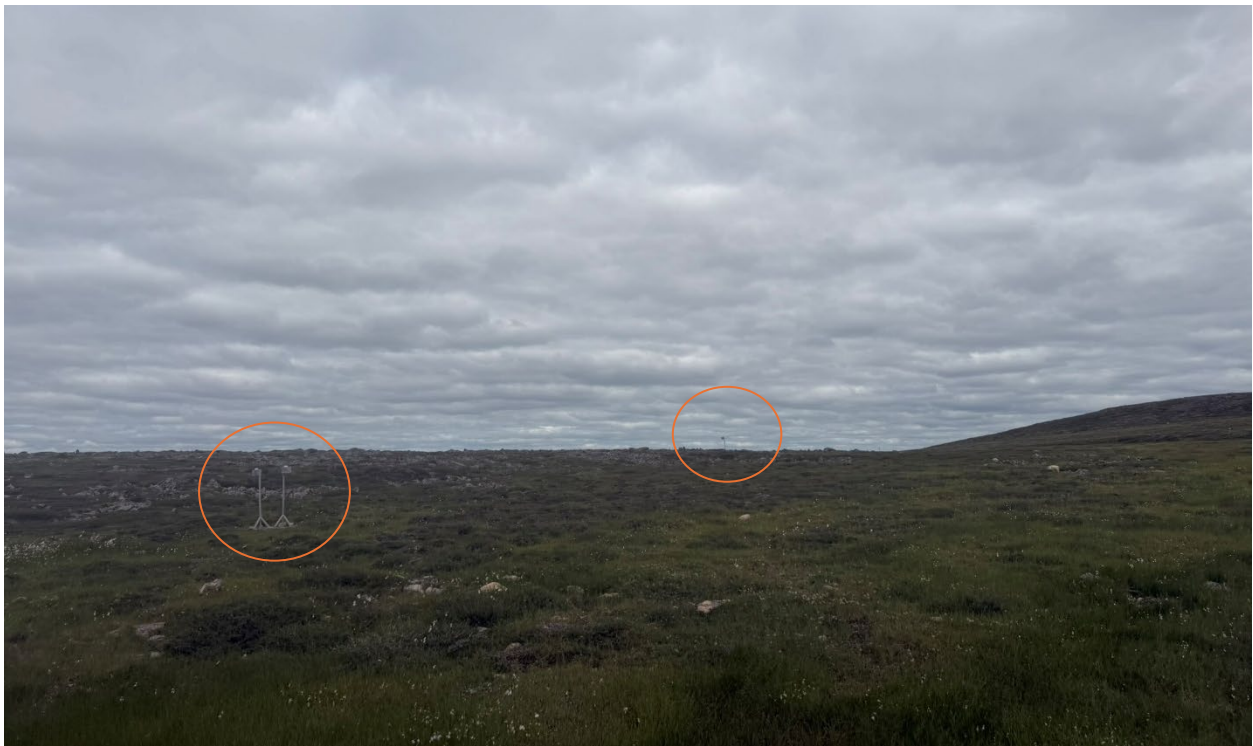
| T&C No. | Topic / summary | Site Observation |
|---|---|---|
| 2 | Mitigate dust impacts on project roads, including dust suppression on all project roads | Calcium chloride dust suppressant was being actively applied along the Whale Tail Haul Road at the time of the visit (Photo 75). Application was ongoing and had not been completed along the full length of the road; dusty conditions were observed in untreated sections and near the IVR Rock Storage Facility (Photo 76), and in areas where road maintenance was underway (Photo 69). Dustfall monitoring transects were observed along the road, with collection canisters positioned at set distances from the road edge (Photo 70). |

**Photo 70: Dust monitoring transects along the WTHR, with canisters positioned at set distances**
