On July 24-25, 2026, NIRB staff conducted a site visit to Agnico Eagle's Meadowbank Complex projects, accompanied by Agnico Eagle environmental staff. The visit focused on observing site activities, environmental management practices, and implementation of Project Certificate requirements. During the visit, NIRB staff observed ongoing operational activities and held discussions with the Proponent regarding environmental monitoring, mitigation measures, and adherence to Project Certificate requirements (Table 3-1 and Table 3-2).

### 3.1. Meadowbank

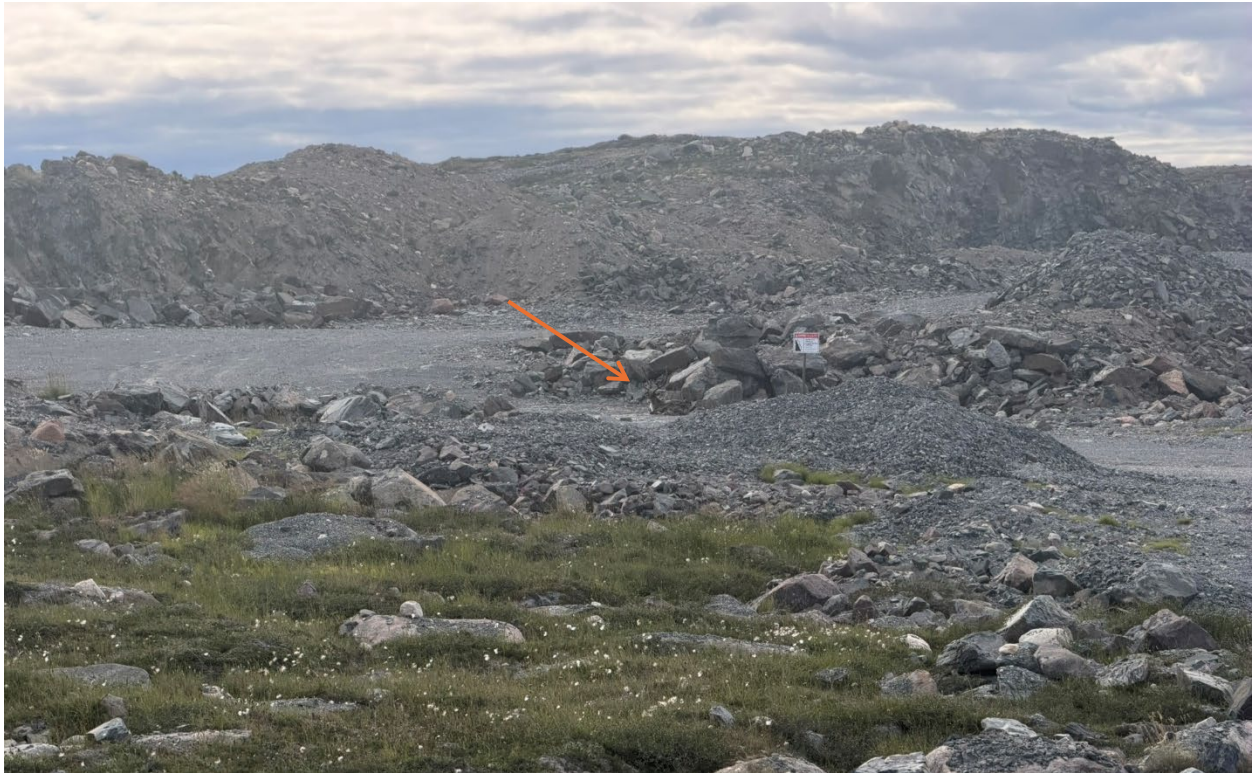
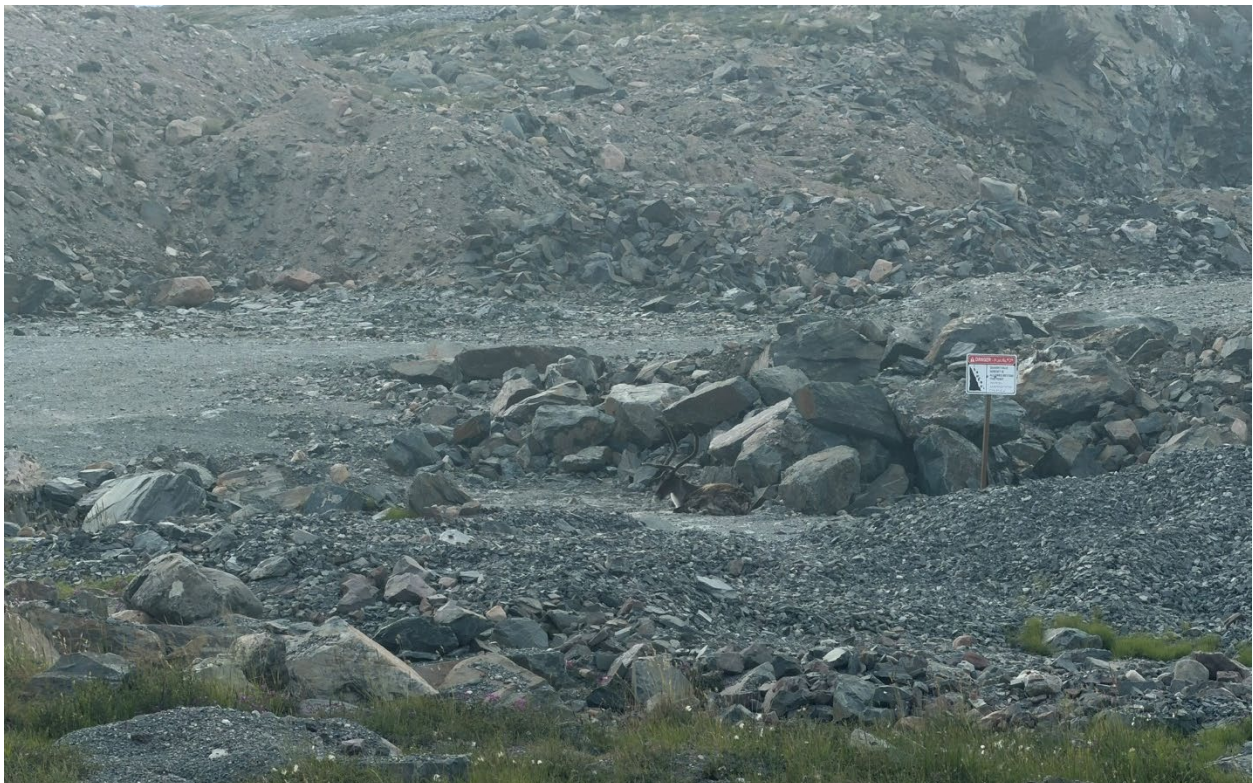
| <b>30, 31, 32, 65</b> | Caribou group size thresholds triggering mitigation; monitor traffic levels via the Road Access Management Plan; ensure infrastructure does not interfere | Caribou were observed resting at the entrance to the quarry at KM 127, adjacent to the re-slope completed to facilitate caribou crossing (Photo 71 and Photo 72). Observed haul traffic travelling to the Meadowbank site |

**Photo 71: Caribou resting at the entrance of the quarry at KM 127**

**Photo 72: Caribou resting at the entrance of the quarry at KM 127**

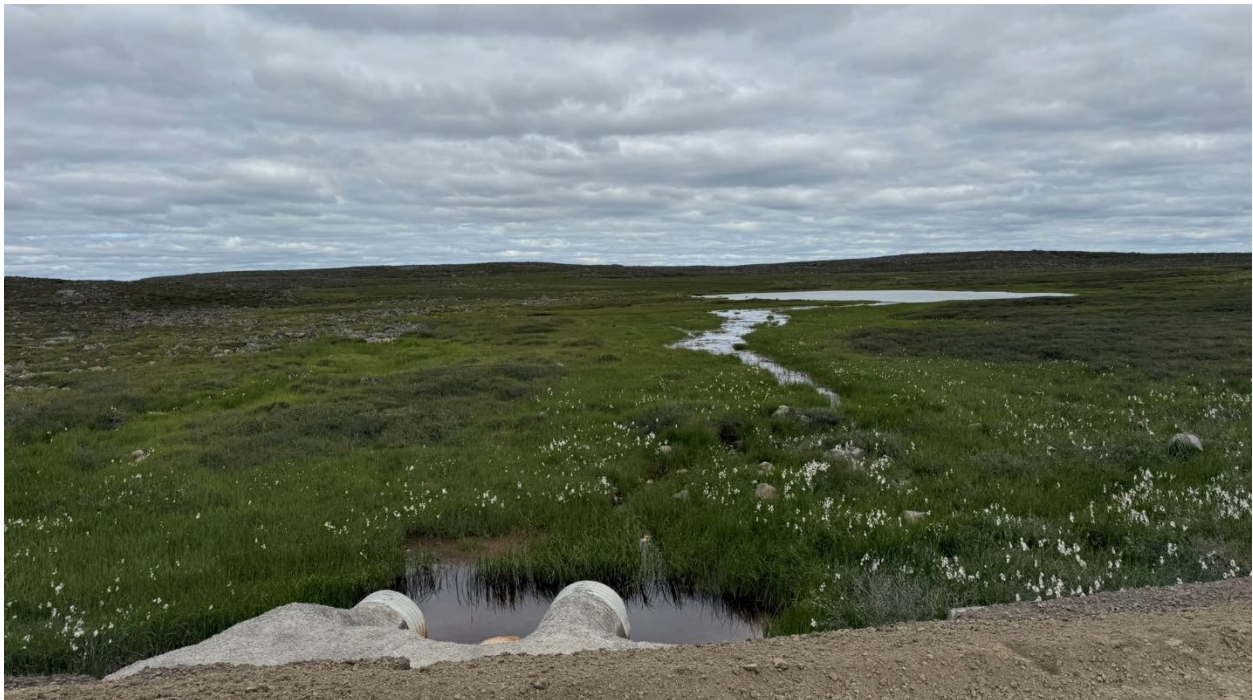
**Photo 74: culvert outlets at KM 133, draining through a defined channel across the surrounding wetland toward the downstream waterbody**

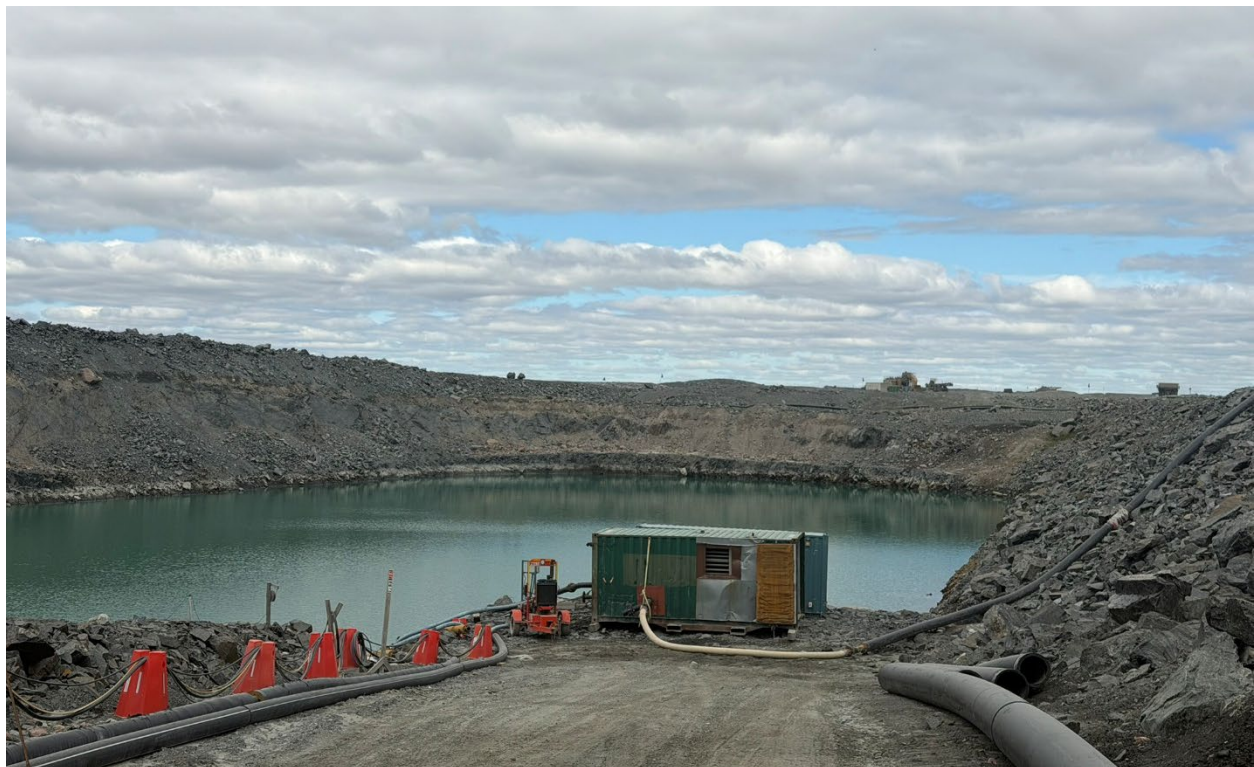
| <b>15, 16</b> | Groundwater Monitoring Plan, including hydrogeological characterization to assess potential arsenic diffusion from the wall of the Whale Tail Pit | Observed Groundwater Storage Pond 1 (Photo 85) and Groundwater Storage Pond 2 (Photo 86). |

**Photo 85: Groundwater Storage Pond (GSP) – 1**

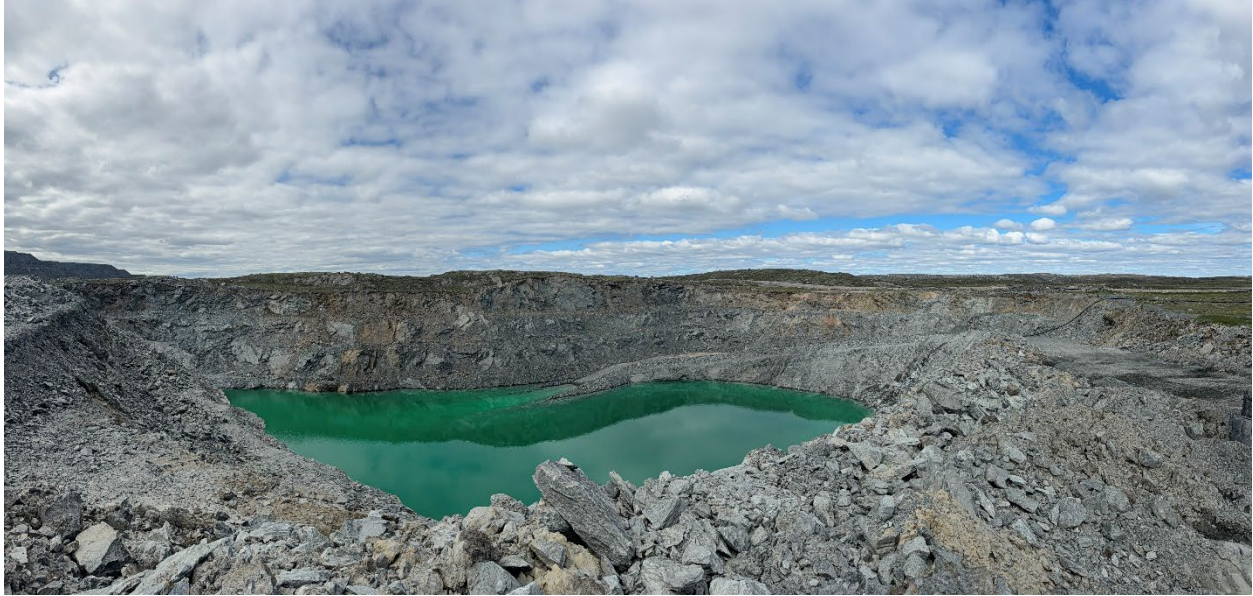
**Photo 86: Groundwater Storage Pond (GSP) – 2<sup>14</sup>**

<sup>14</sup> The Whale Tail GSP-2 Storage Pond Design Report was submitted to the Nunavut Water Board in November 2025 for approval prior to construction and was approved in January 2026. GSP-2 had been constructed at the time of the site visit.

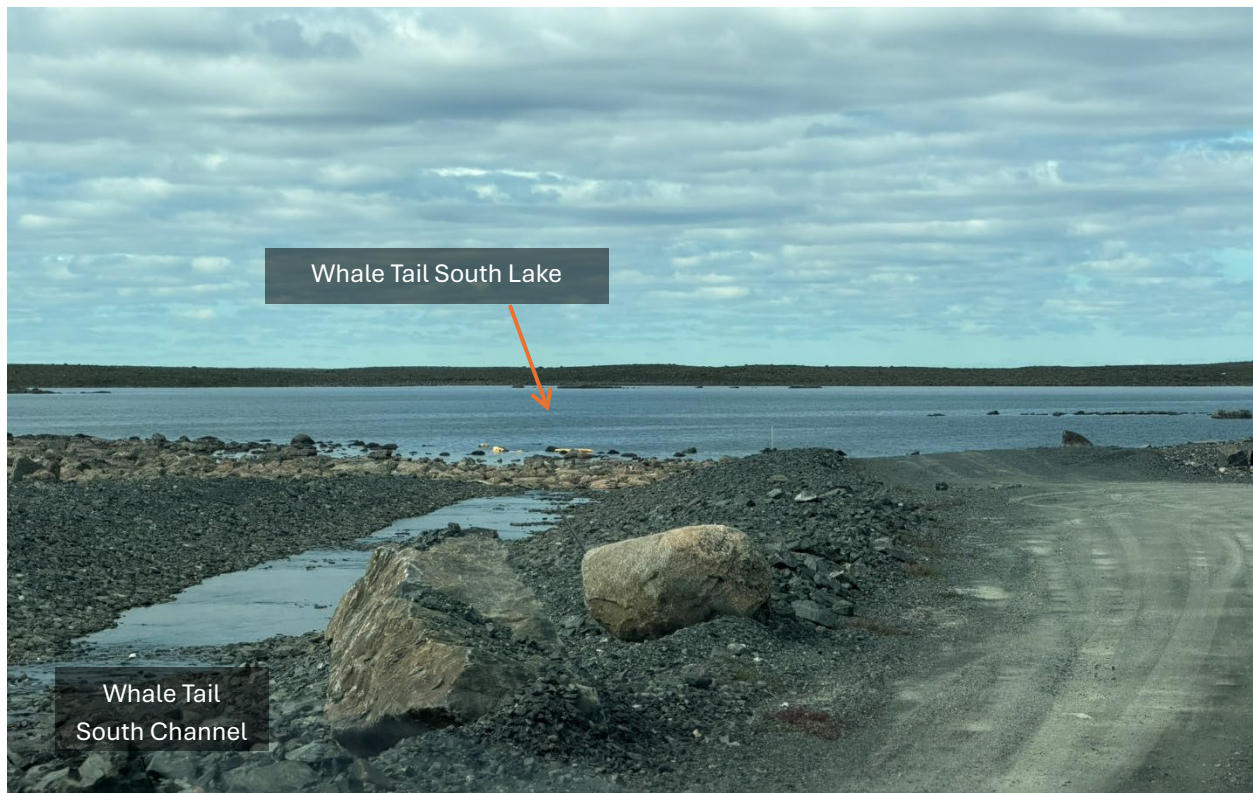
| <b>17, 19, 23</b> | Monitor surface water quality; Core Receiving Environment Monitoring Program (CREMP); Kangislulik (Mammoth) Lake trophic status monitoring | Observed Kangislulik Lake (Photo 94), Whale Tail South Lake (Photo 96) and the Whale Tail South Channel, which conveys water from Whale Tail South Lake to Kangislulik Lake (Photo 95). CREMP sampling locations were discussed with Agnico Eagle staff. |

**Photo 96: Whale Tail South Lake**

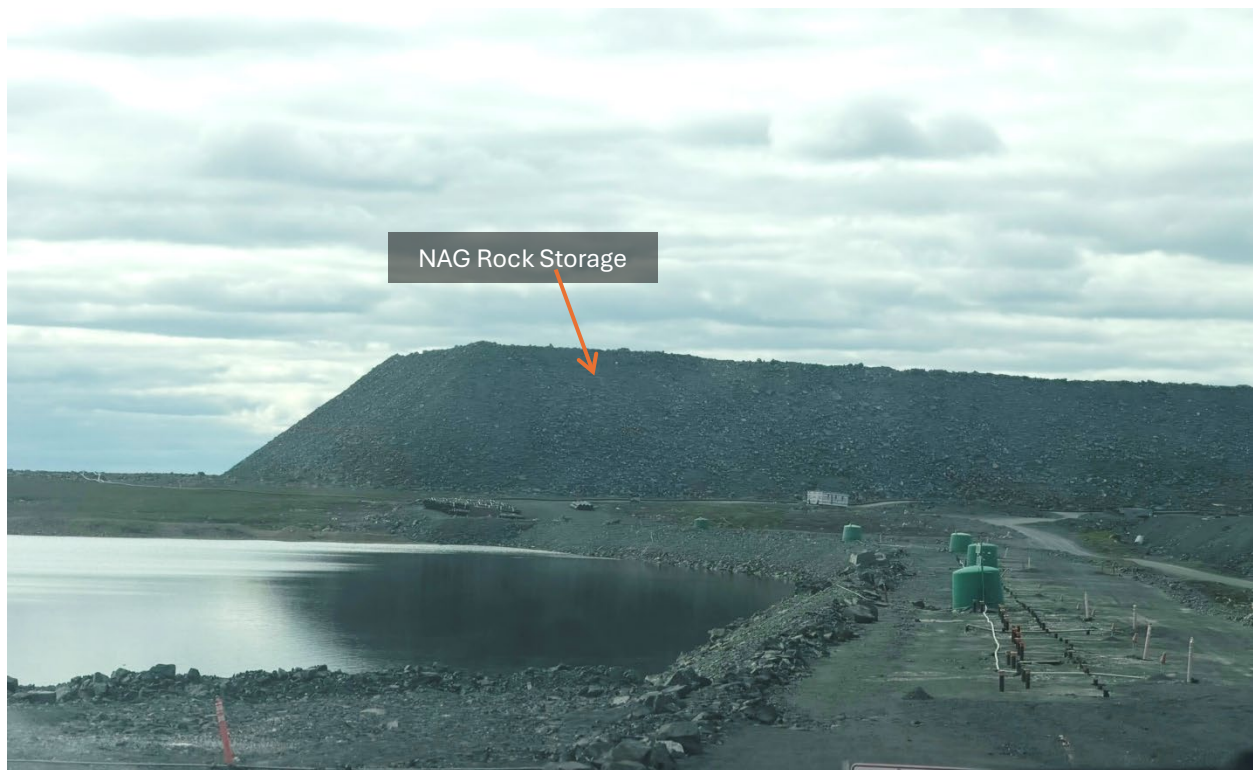
**Photo 97: Whale Tail Dike**

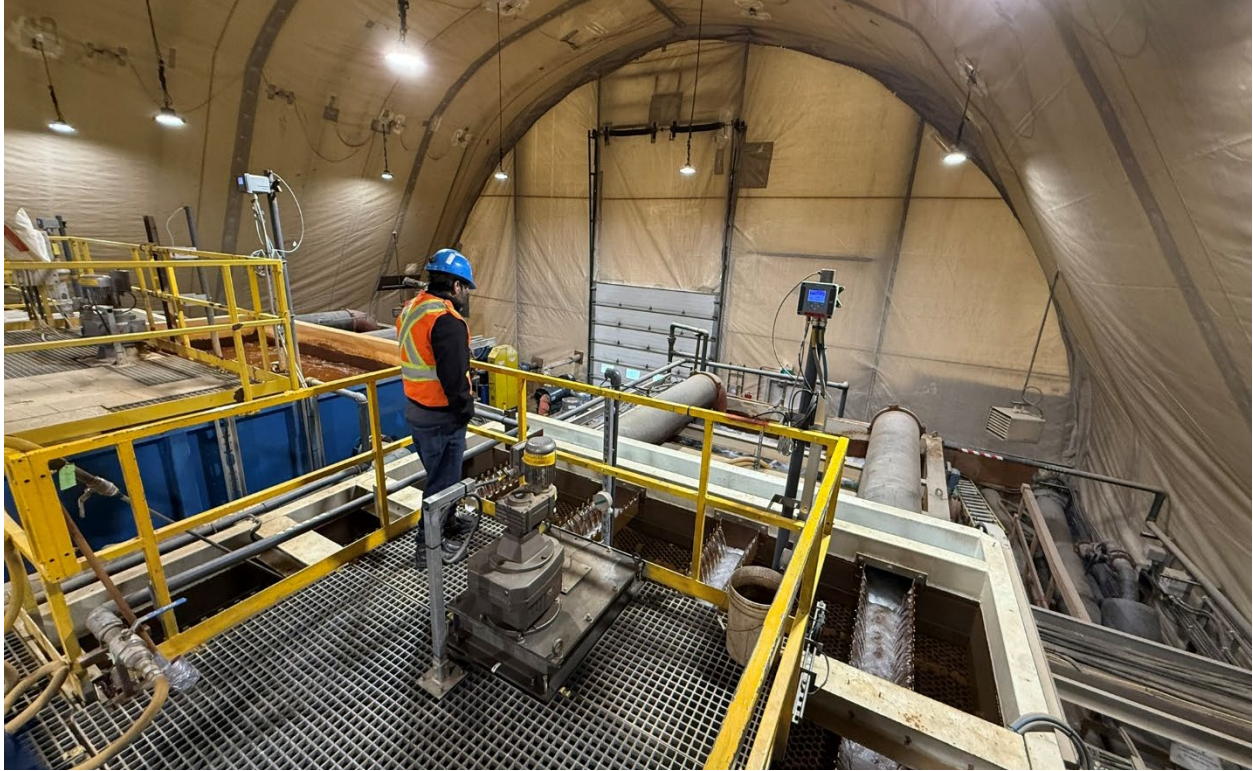
| <b>16, 18</b> | Maintain a Site Water Monitoring and Management Plan to minimize and manage contact water | Observed the Whale Tail and IVR attenuation ponds (Photo 89 and Photo 91), and the Final Water Treatment Plant (Photo 98), where contact water is treated prior to discharge to Kangislulik and Whale Tail South lakes via submerged diffusers. Also observed Nemo Lake and the freshwater intake located there, which supplies the Whale Tail camp and construction and operations use (Photo 92 and Photo 93). |

Photo 98: Interior of the Final Water Treatment Plant

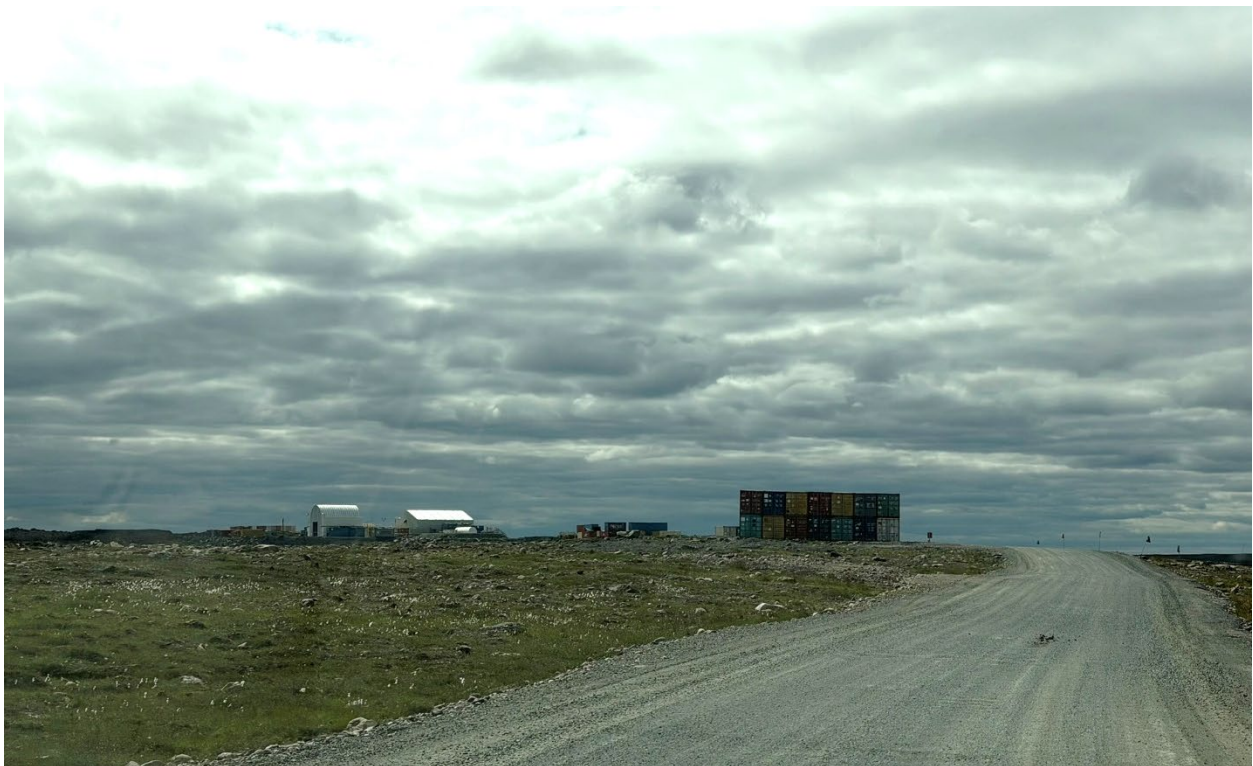
| <b>PC<br/>004<br/>28</b> | Signatory to the International Cyanide Management Code (ICMC) | Observed the emulsion plant and the ammonium nitrate storage seacans (Photo 99). |

Photo 99: Emulsion Plant, and Ammonium Nitrate (AN) storage seacans

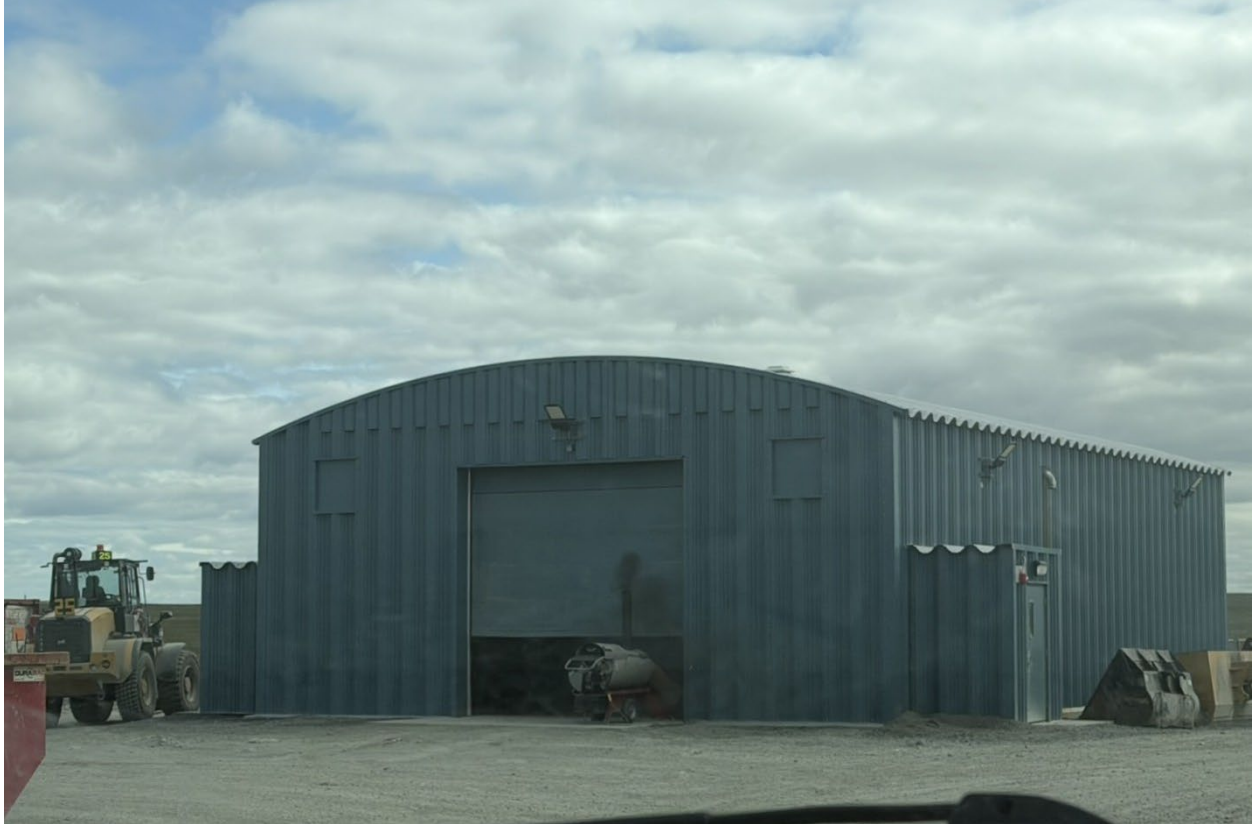
| <b>PC<br/>004<br/>72</b> | On-site incinerators to comply with standards; annual stack testing | Observed the composter building at the Whale Tail camp (Photo 100). |

Photo 100: Composter Building

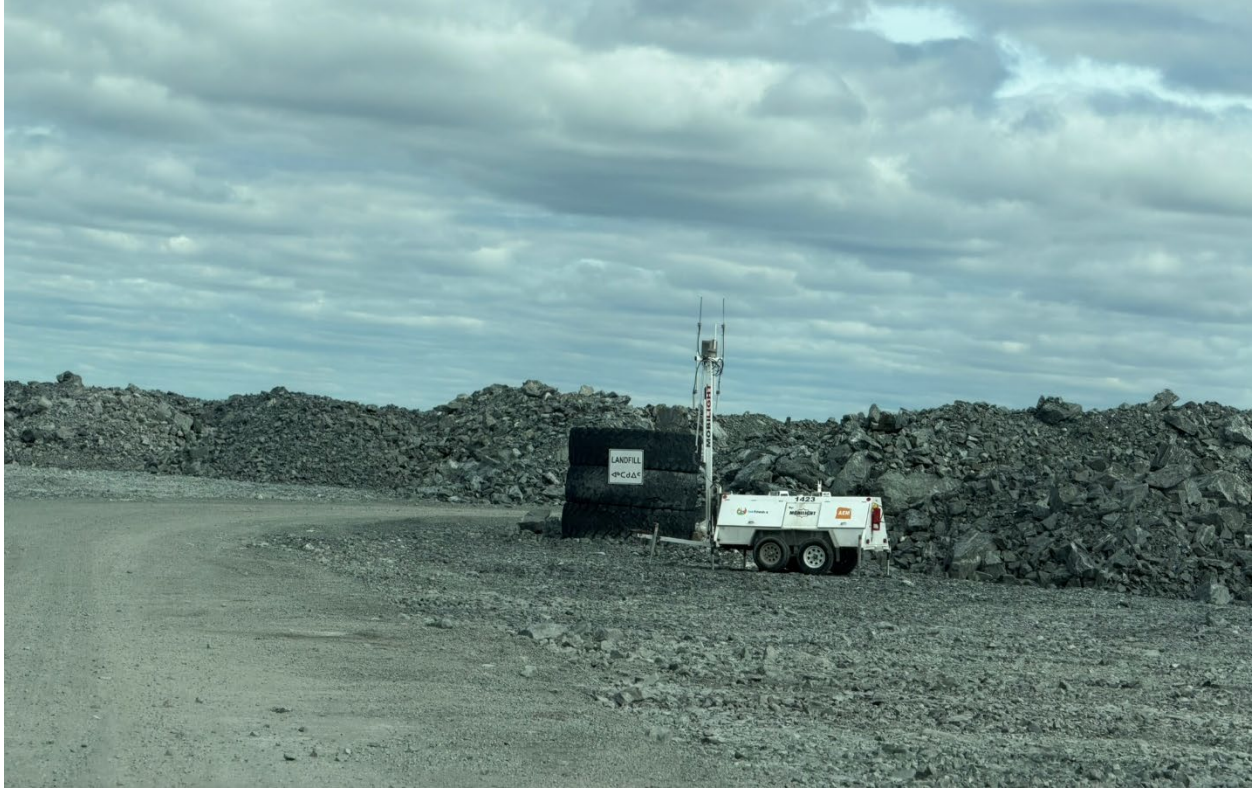
**Photo 102: Landfill area and signage**

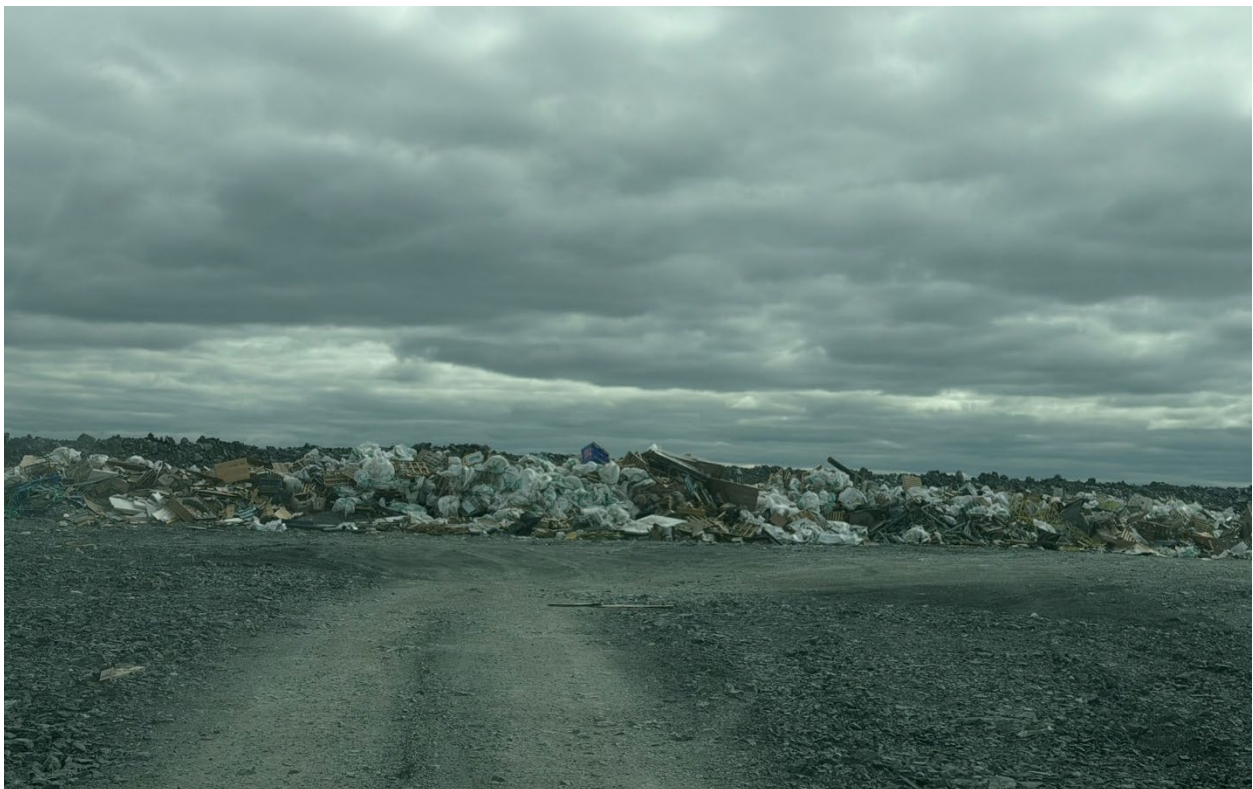
| <b>PC 004 24, 25</b> | Landfill design and management; manage attraction of carnivores and/or raptors at landfills and waste storage areas | Observed the Whale Tail landfarm (Photo 88) and landfill (Photo 103). |

**Photo 103: Landfill**

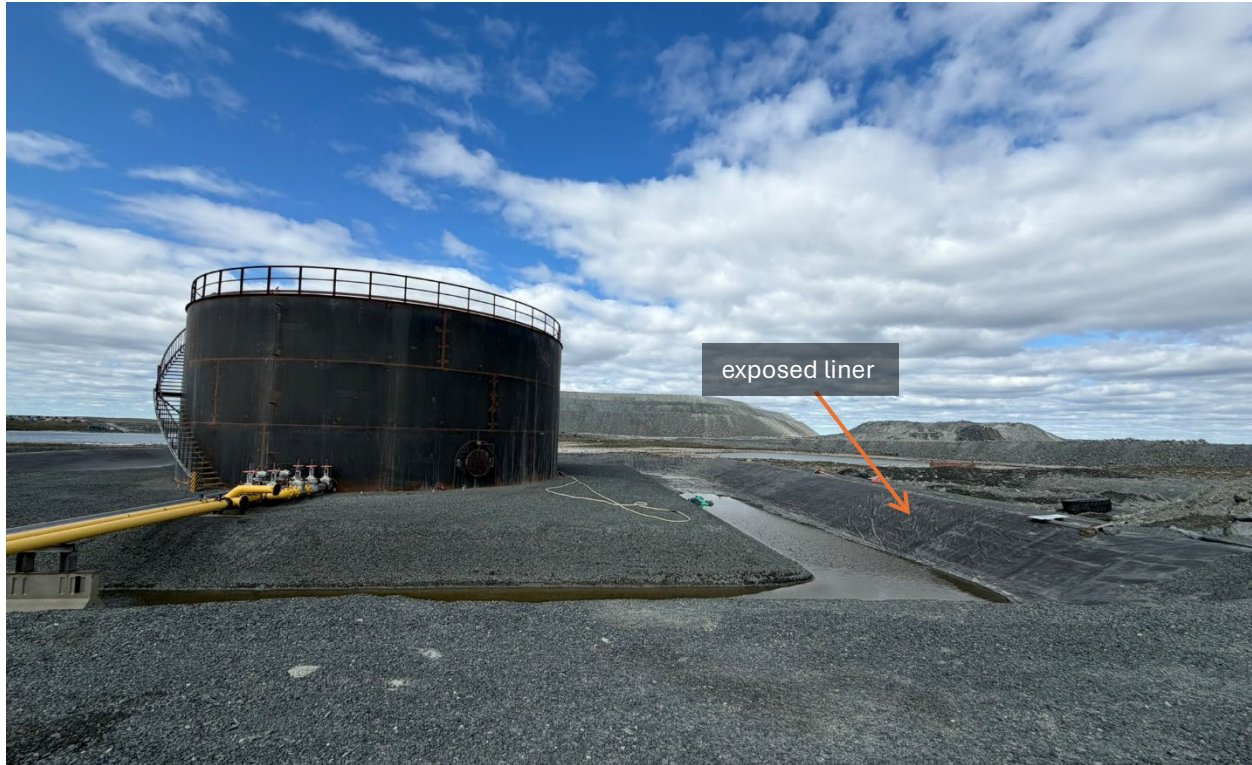
| <b>PC<br/>004<br/>27</b> | Ensure fuel and hazardous materials are contained using safe, environmentally protective methods | Observed the HAZMAT storage seacans adjacent to the composter building, which appeared well organized (Photo 101), and the fuelling station (Photo 105). At the single-tank fuel farm, the secondary containment liner was observed exposed (Photo 104). |

**Photo 104: Single-Tank Fuel Farm within secondary containment, with the containment liner exposed**

Exposed liner, vegetation growth and standing water were observed at the horizontal fuel tanks at Baker Lake (Photo 10 and Photo 11) and at the single-tank fuel farm at Whale Tail (Photo 104). This has recurred since 2022, and ECCC's review of the 2025 Annual Report noted holes, tears, water accumulation and elevated water levels. NIRB staff encourage Agnico Eagle to describe inspection frequency, repairs completed, and measures to prevent recurrence (T&C 27).

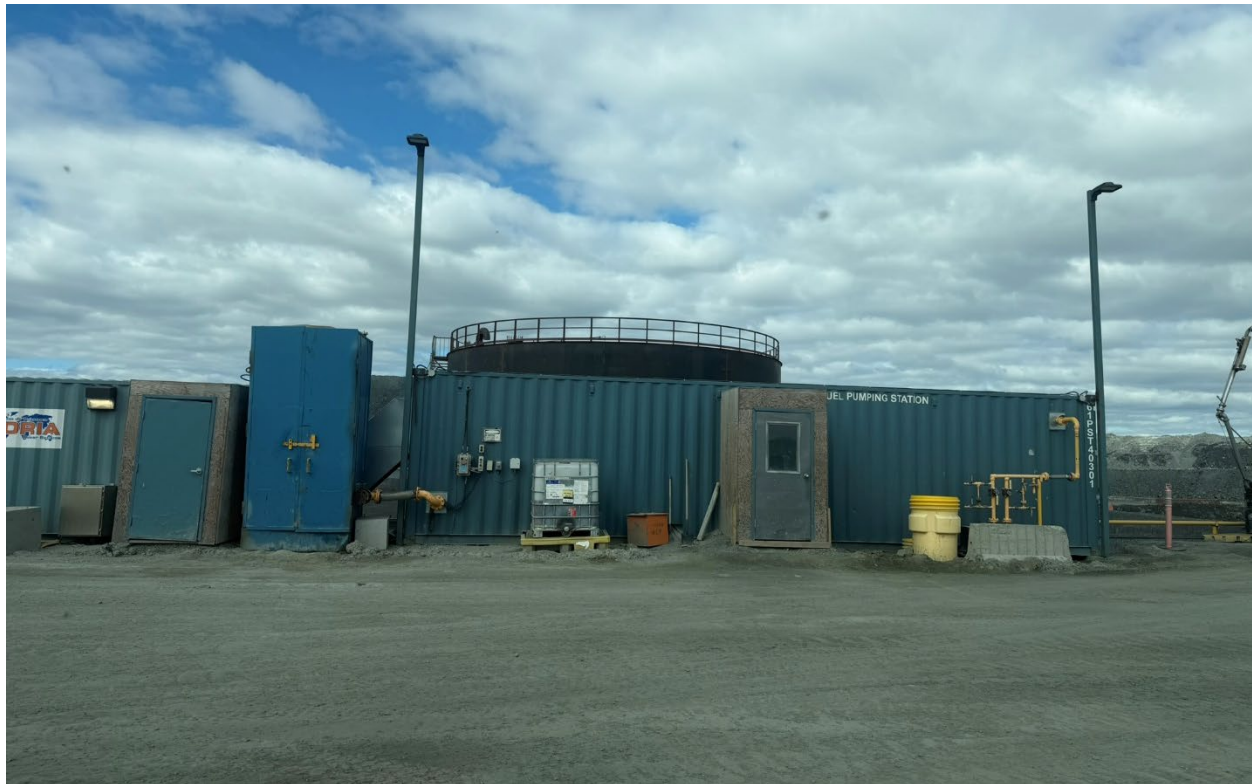
**Photo 105: Fueling station**

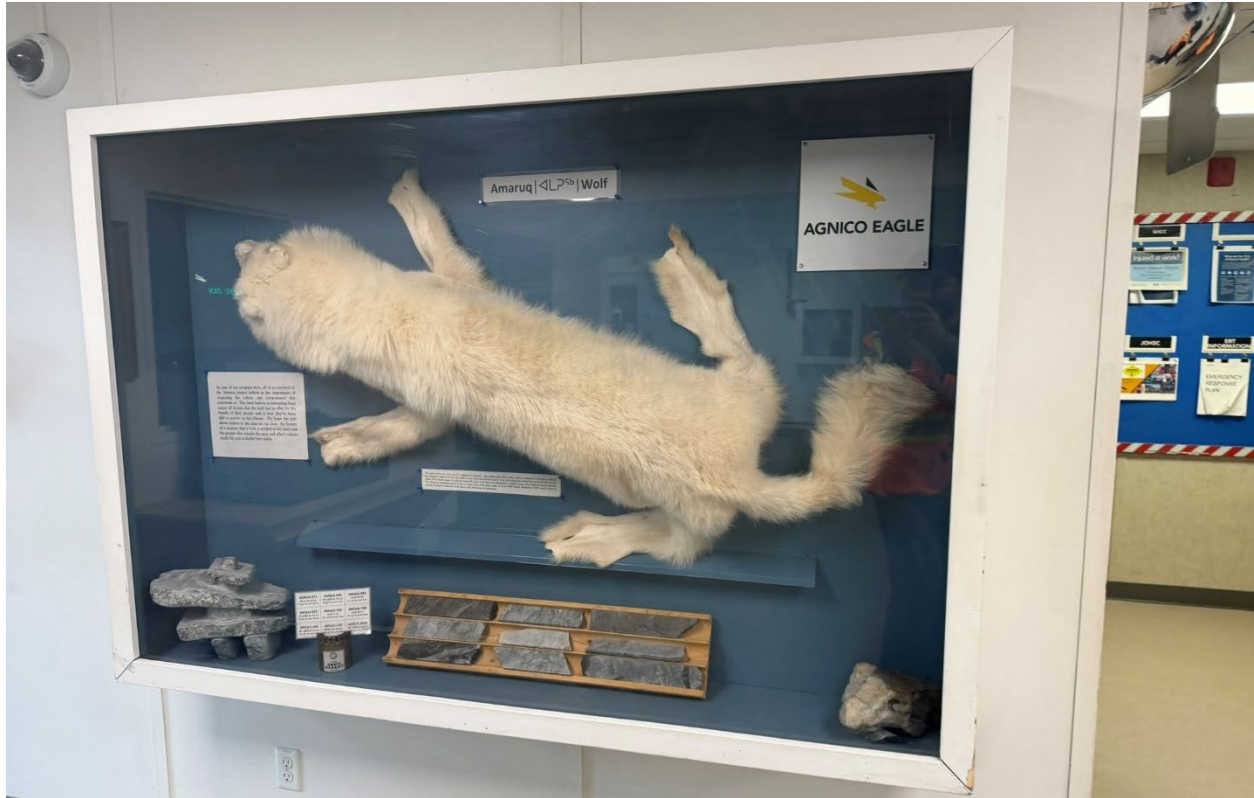
| <b>54</b> | Integration and incorporation of Inuit Qaujimaningit into monitoring plans | Observed the Amaruq and core display at the camp entrance (Photo 106), the country food kitchen (Photo 107) and Inuktitut signage throughout the camp. |

Photo 106: Amaruq and core display at camp entrance

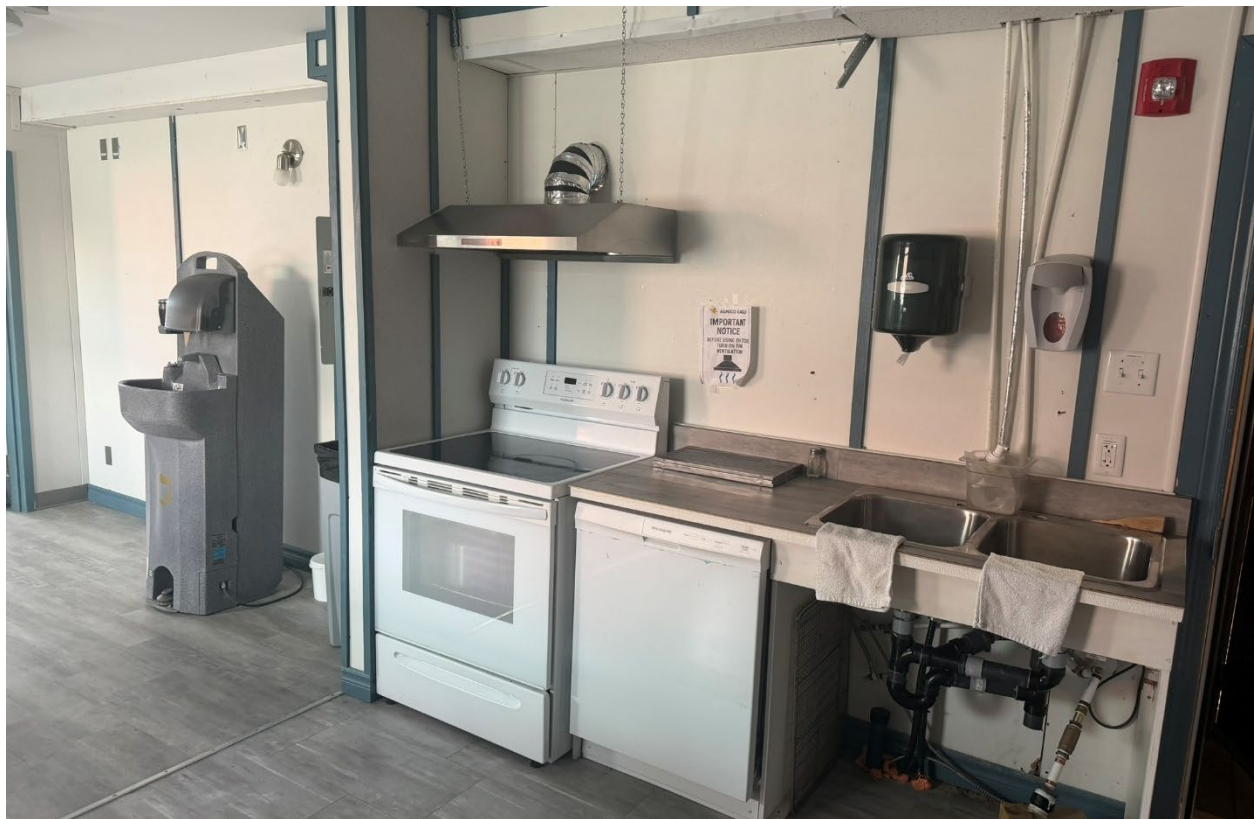
Photo 107: Country Food Kitchen

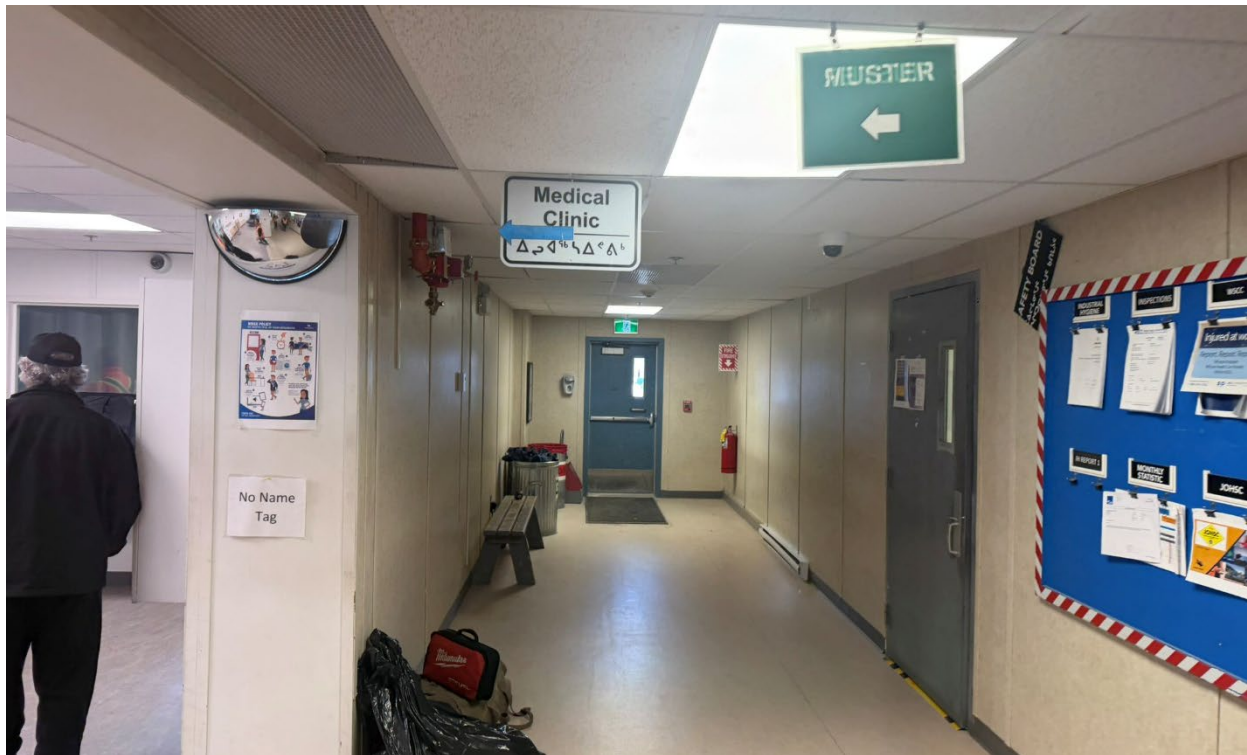
| <b>57, 58</b> | Update the Occupational Health and Safety Plan to include sexual health and well-being information; subcommittee for health services | Observed the on-site medical clinic (Photo 108) and camp recreation facilities. |

Photo 108: Onsite medical clinic

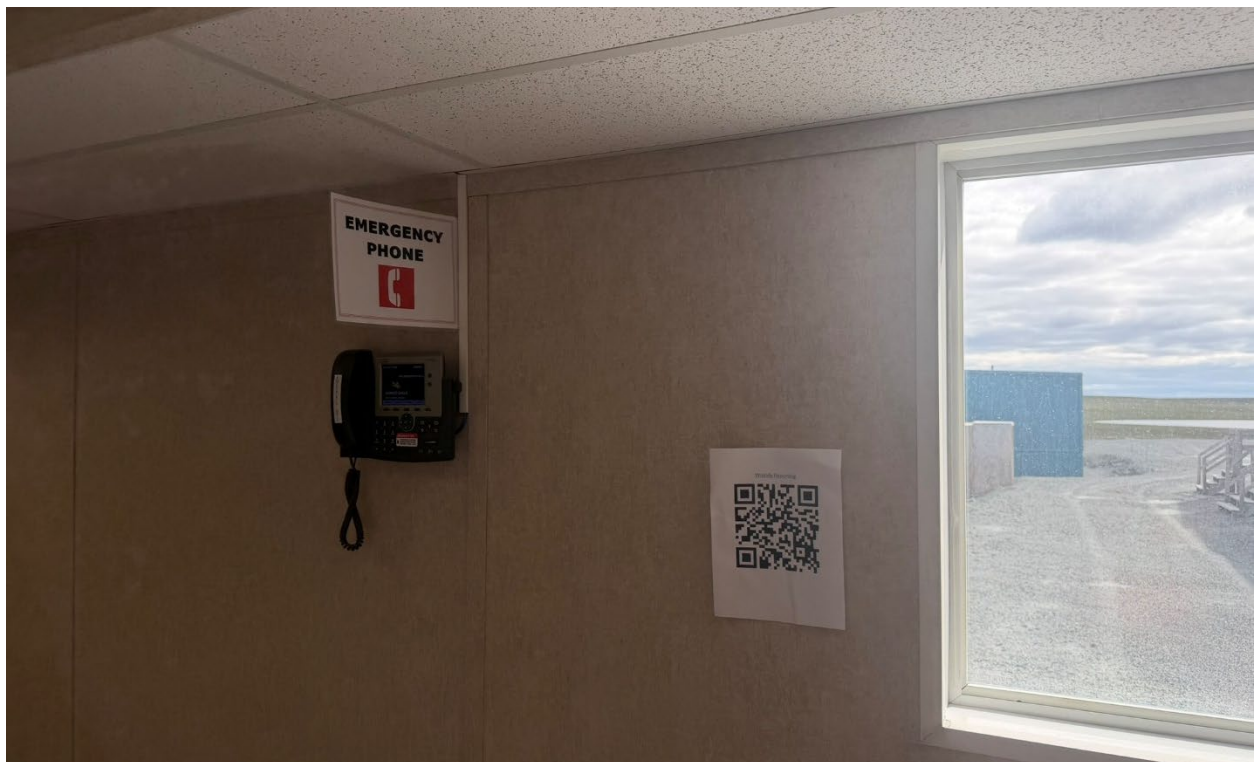
| <b>33</b> | Report all wildlife incidents and mortalities to the appropriate authorities in a timely fashion and annually to the NIRB | Observed the emergency phone and wildlife reporting QR code posted in the camp hallway (Photo 109). Actions taken following road-related wildlife mortalities were discussed with Agnico Eagle staff. |

Photo 109: Emergency Phone and Wildlife Reporting QR Code in camp hallway
