## 2026 Site Visit Report

# MELIADINE GOLD MINE PROJECT

Site visit report of the Meliadine Gold Mine Project for the 2025-2026 reporting year

**Site Visit Date:** July 20, 2026

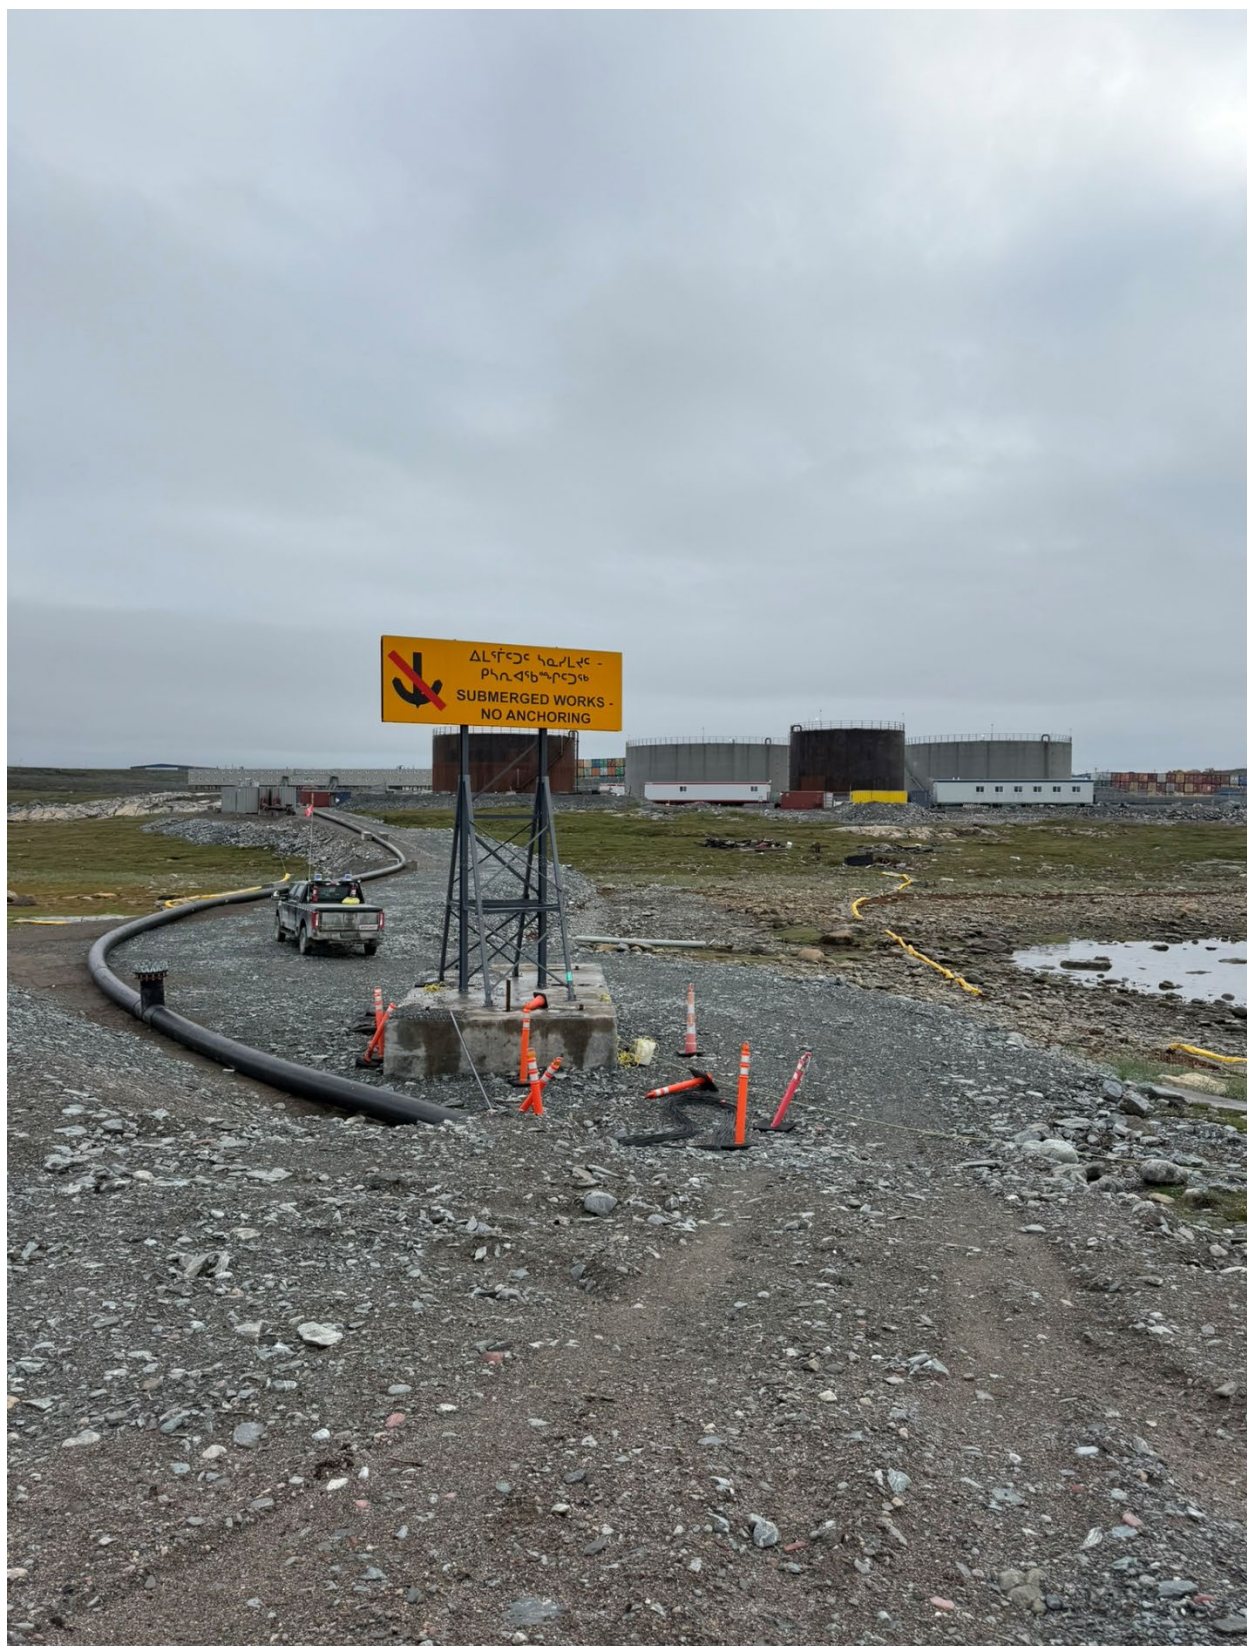
The diffuser area of the saline effluent waterline was observed from a distance, from elevated ground overlooking the discharge area. Signage advising against anchoring in the vicinity of the submerged works was observed posted at the site.

**Photo 7: No Anchoring signage and the saline effluent waterline extending toward the offshore diffuser area**

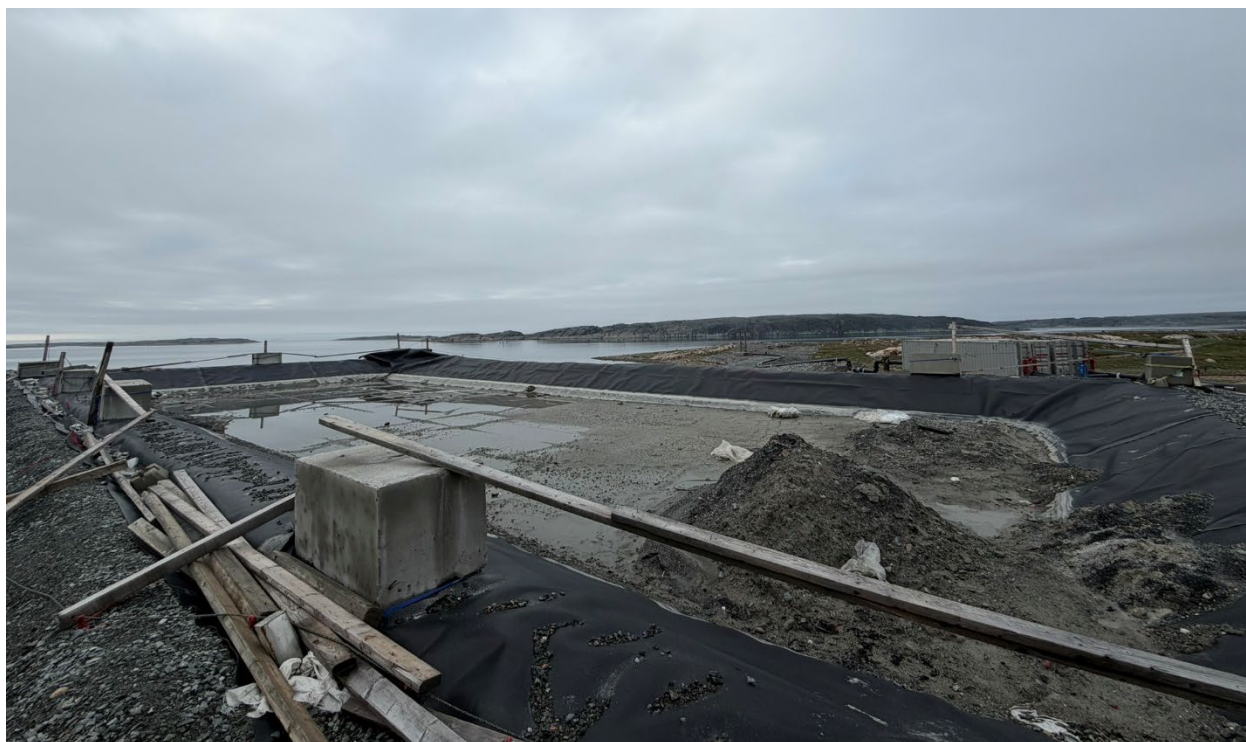
**Photo 9: Temporary contact water management pond at Itivia, which is planned to be decommissioned as the works for HDD is over**

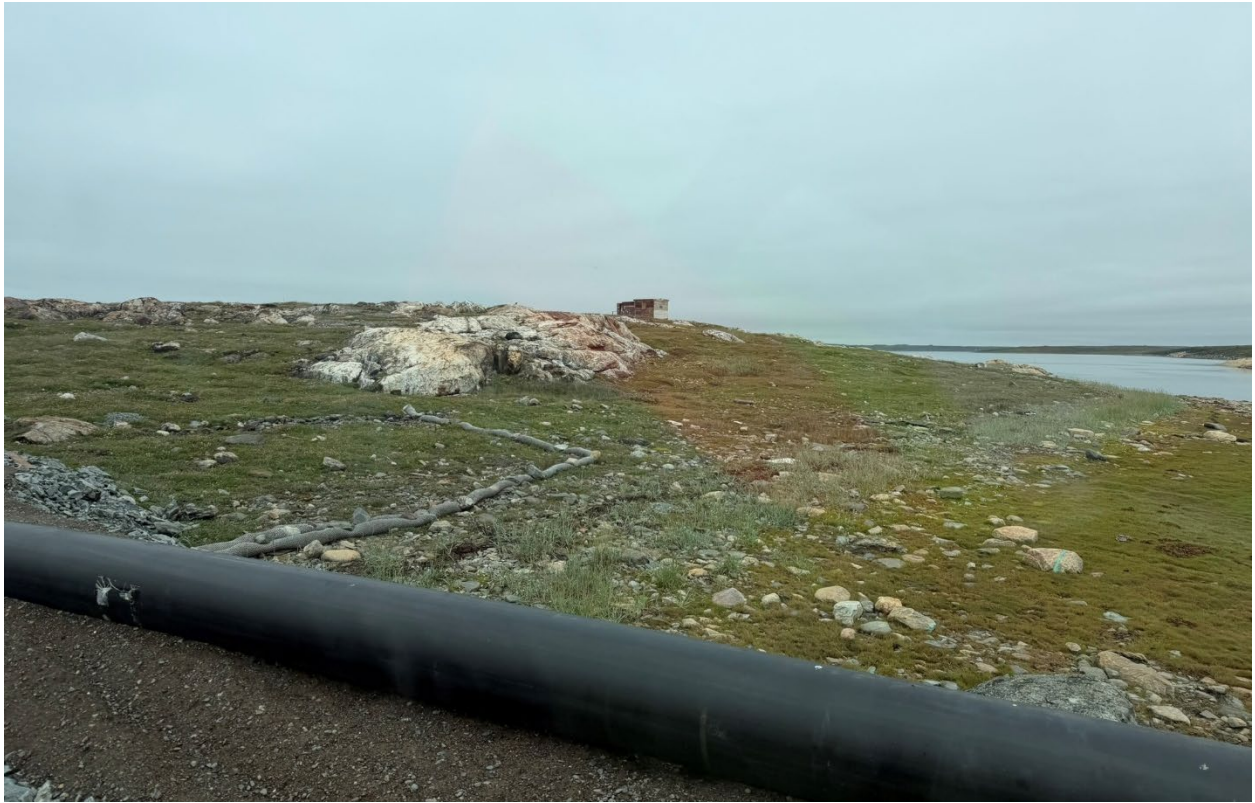
At the fuel tank farm, the tanks were observed within secondary containment. The rigid fuel transfer line running from the barge landing to the storage tanks was observed in place. Erosion and sediment controls, including silt socks, were observed along the shoreline and around the disturbed areas of the site.

**Photo 10: Erosion and sediment controls**

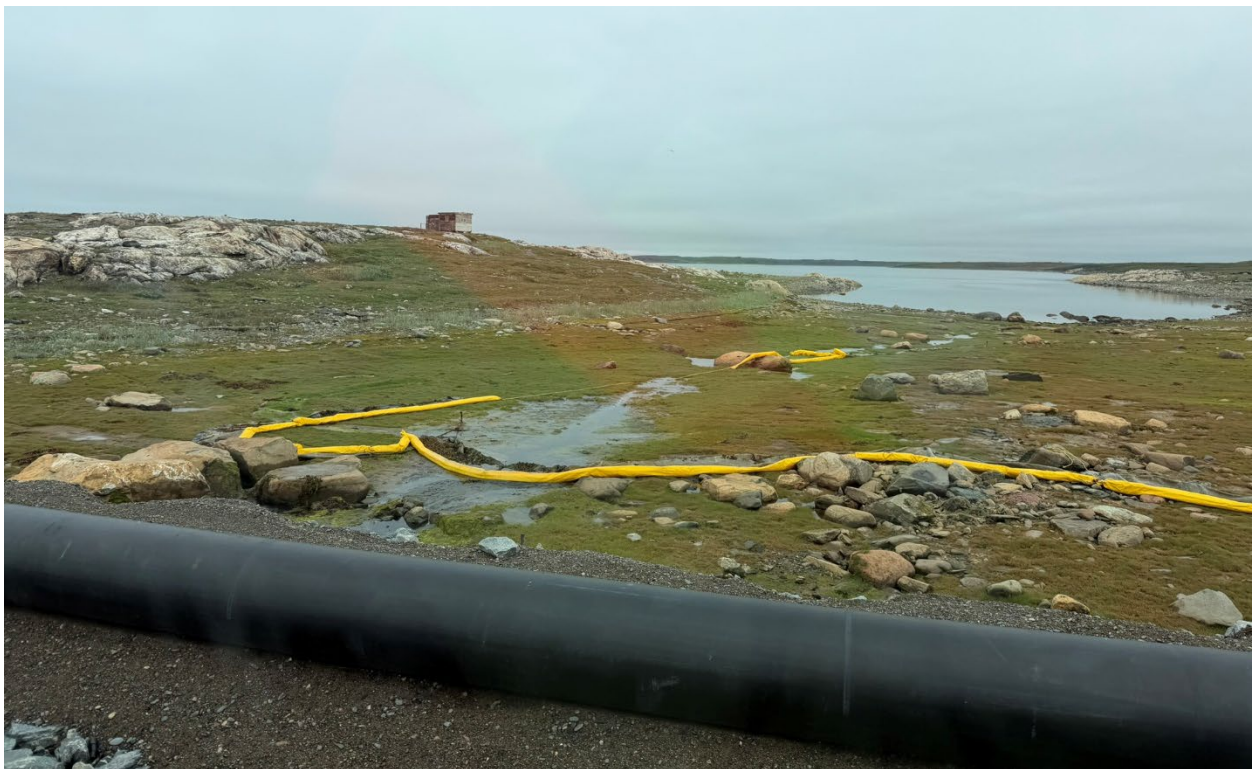
**Photo 11: Erosion and sediment controls**

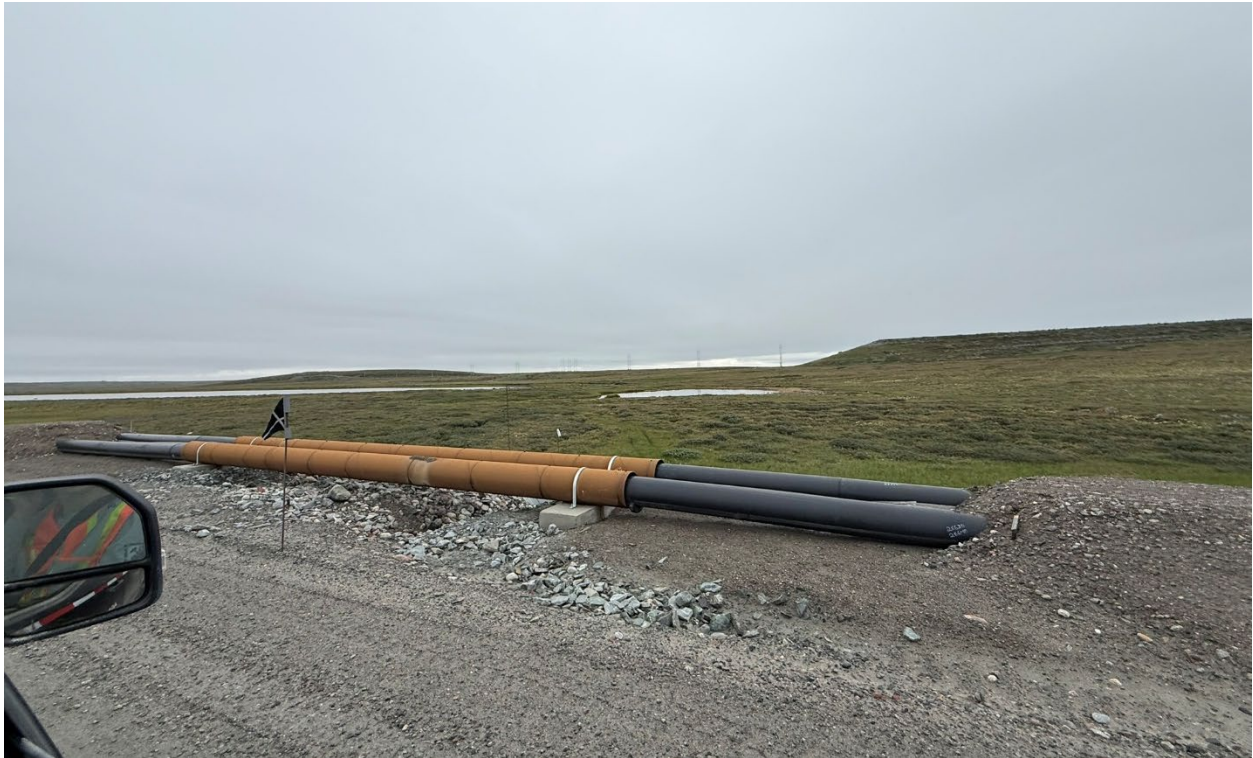
The saline effluent waterline was observed running along the road corridor. Sections of the waterline remained uncovered at the time of the visit, and signage had not yet been installed at these locations. NIRB staff noted that the uncovered sections continue to represent a potential hazard to members of the public travelling the corridor by ATV, particularly with snow accumulation in winter. This observation is consistent with the 2025 site visit, during which exposed sections of waterline and concrete anchors without signalling were identified. Agnico Eagle advised that the signage is arriving during the current shipping season and that installation is planned before winter.

**Photo 16: Exposed waterline section at KM 3 with no signage present**

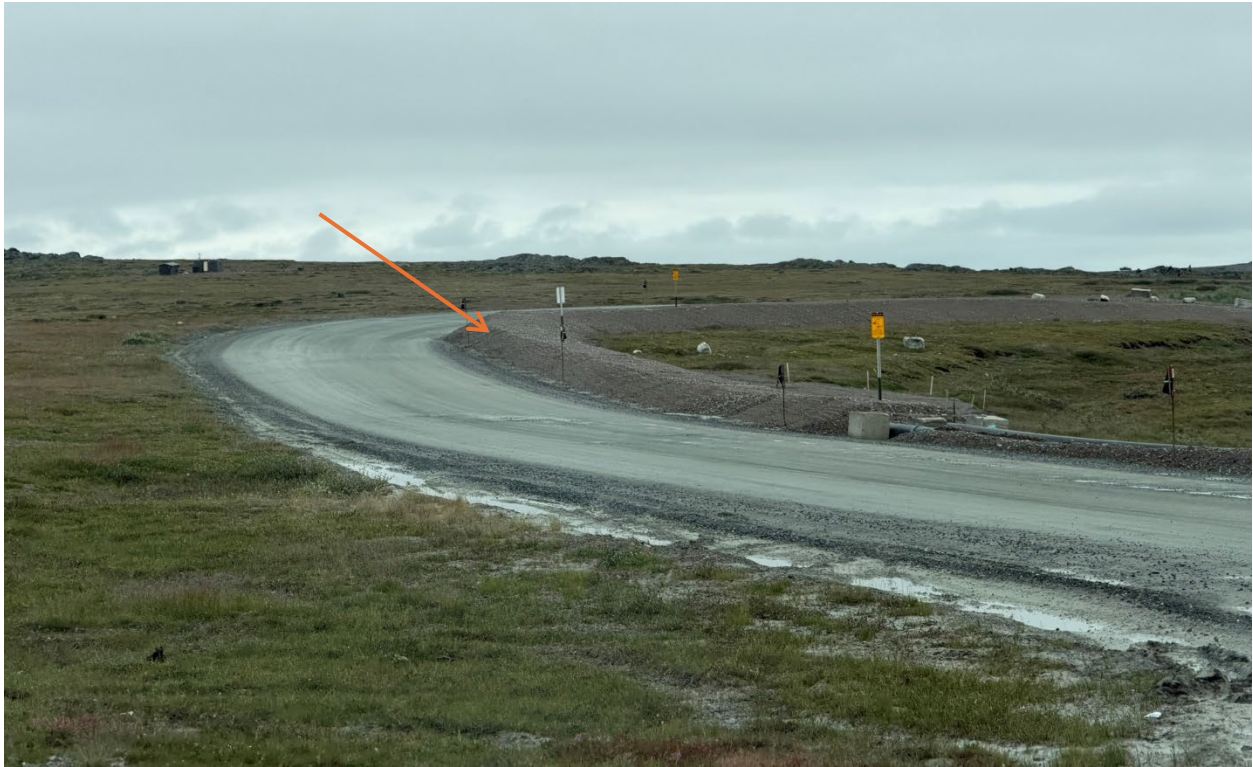
**Photo 18: Covered waterline at KM 4.5 with bilingual warning signs**

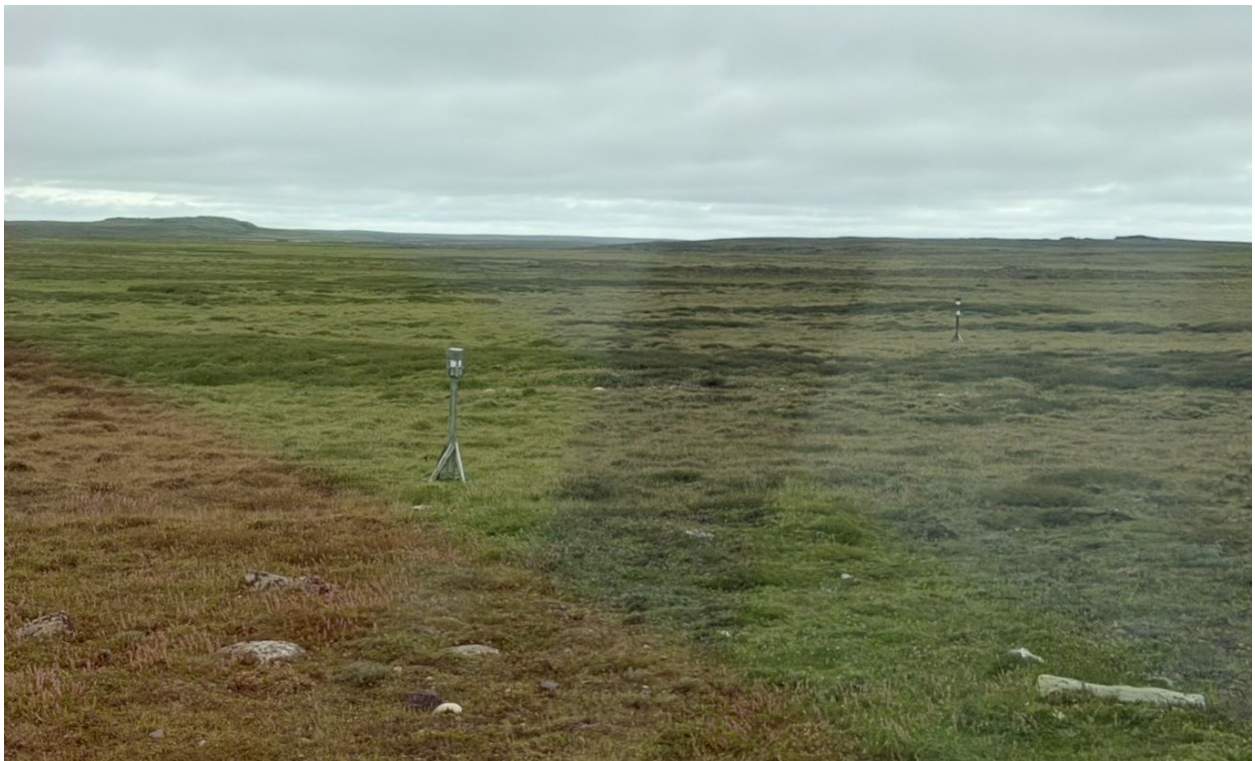
| T&C No. | Topic / summary | Site Observation |
|---|---|---|
| <b>3</b> | Dust management and Monitoring Plan | Observed dustfall monitoring transects along the RIBR/AWAR corridor, with collection canisters positioned at set distances from the road edge (Photo 23 and Photo 30). No visible dust was observed along the RIBR/AWAR corridor during the site visit.<br><br>Agnico Eagle advised that calcium chloride dust suppressant is applied along most of the AWAR and RIBR. |

**Photo 23: Dustfall collectors at KM 10**

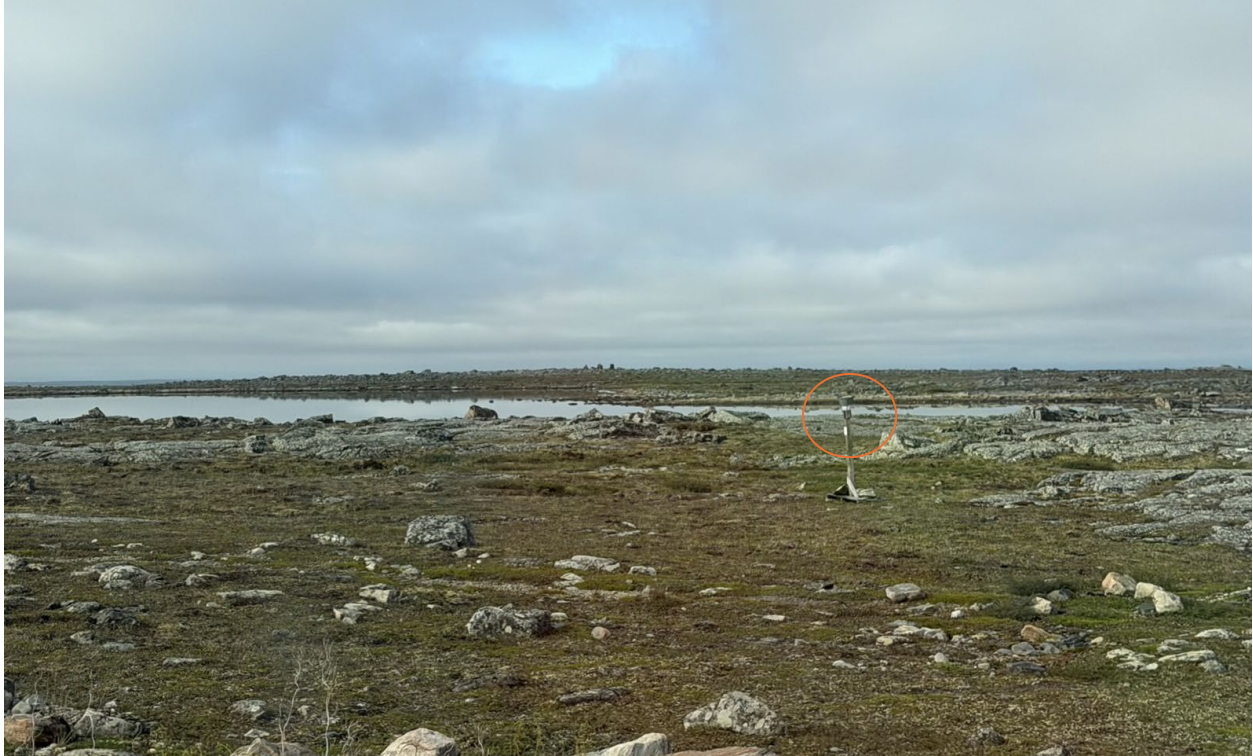
**Photo 30: Dustfall collectors at ~ KM 20**

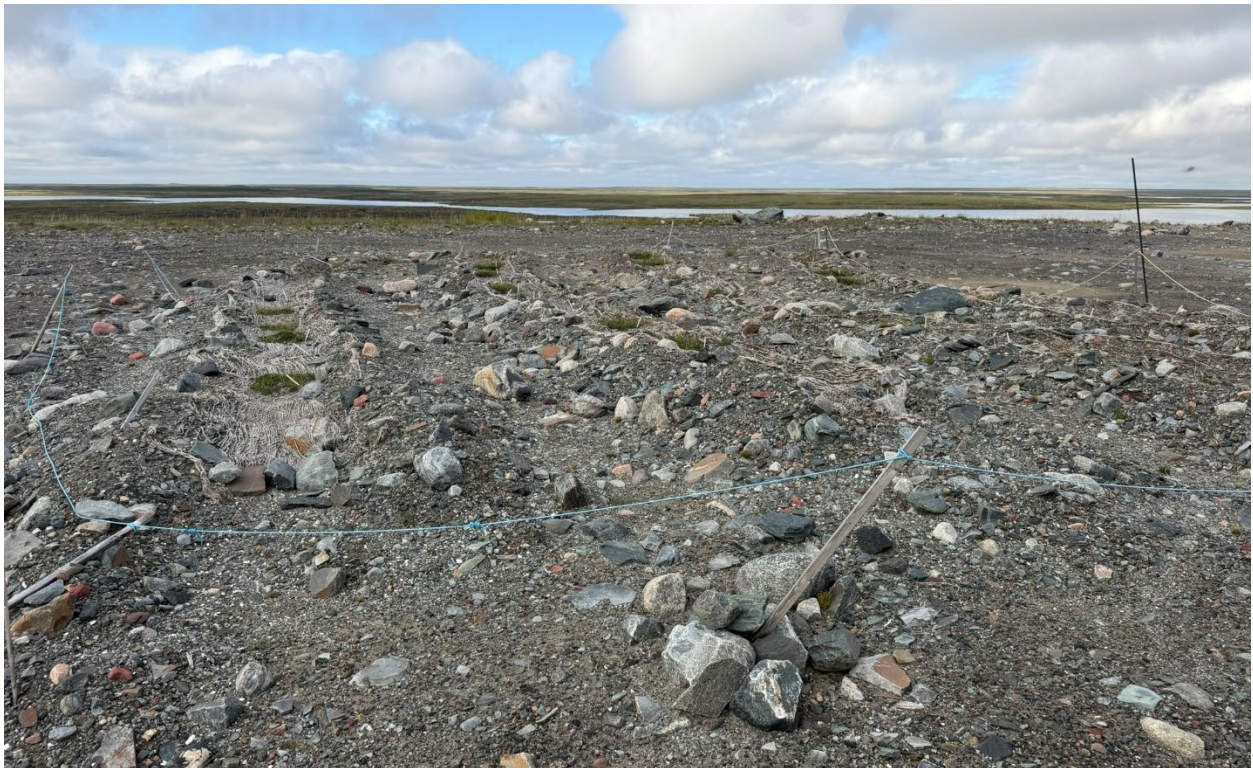
| <b>50, 73</b> | strategy for progressive recovery of terrestrial wildlife habitat; monitoring of terrestrial habitat losses | of the KM 27 quarries along the AWAR (Photo 31). |

**Photo 31: Revegetation restoration trial plots at KM 27, last study was done in 2021**

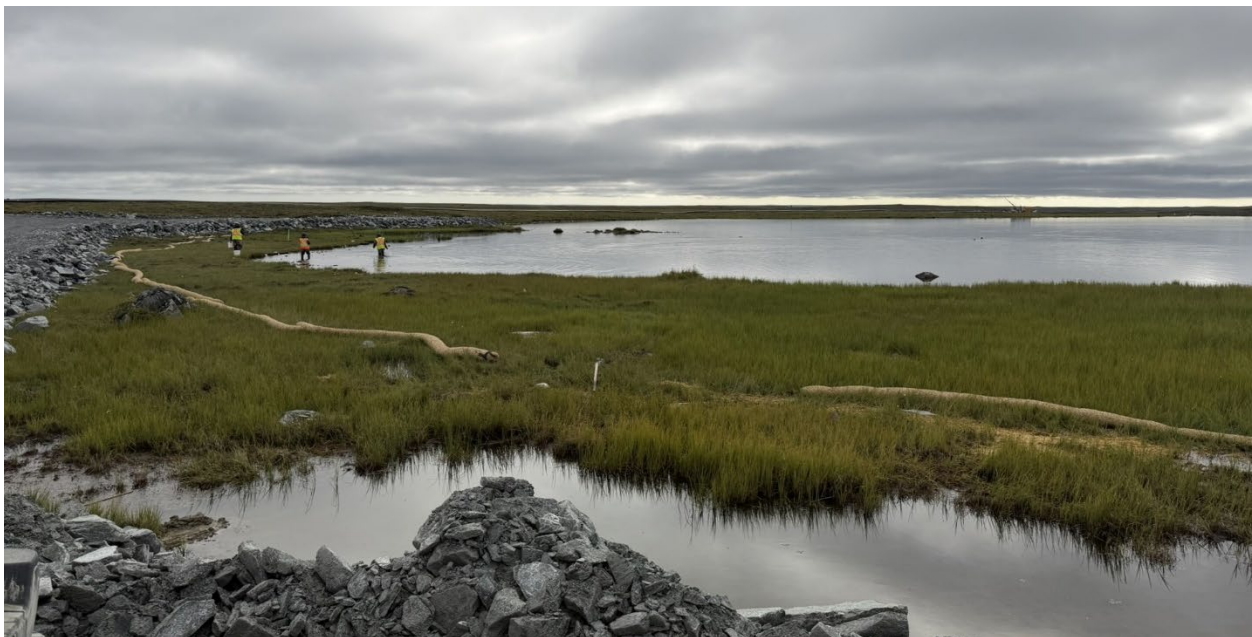
**Photo 33: Lake A6, erosion and sediment control measures were in place**

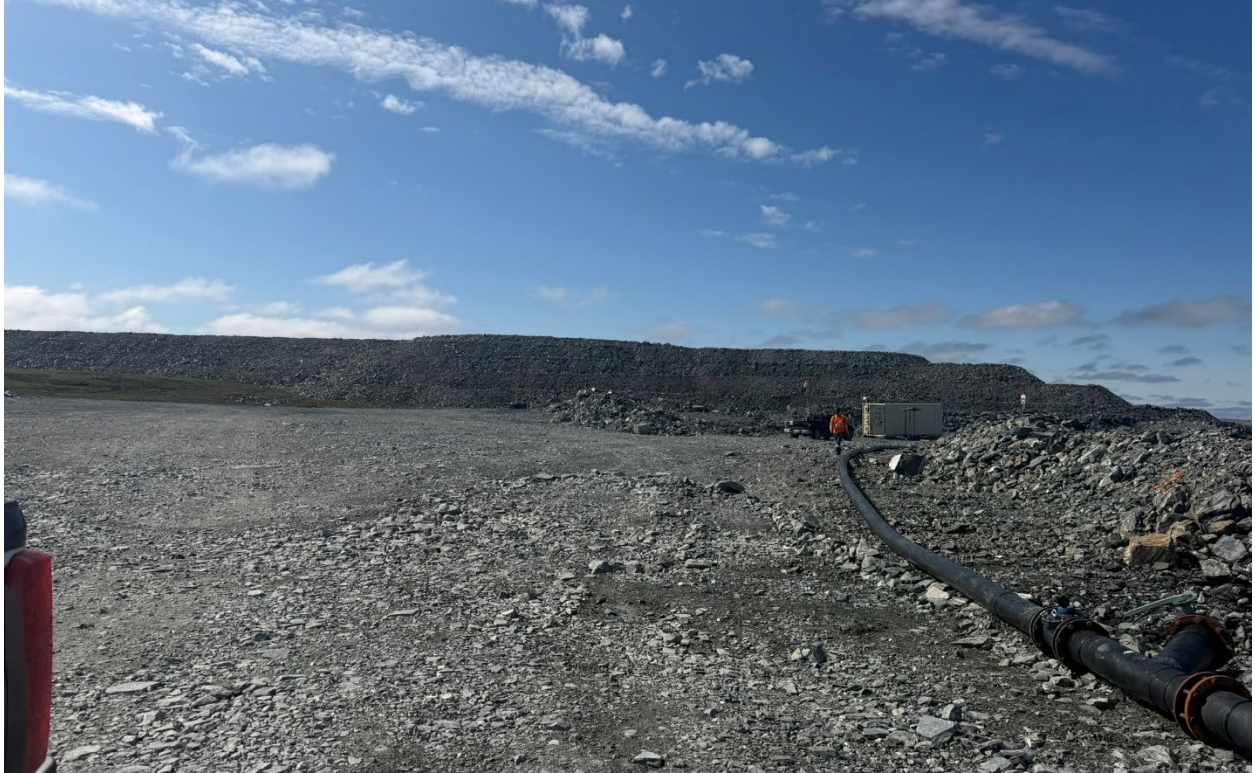
| <b>13, 14, 19</b> | Geotechnical investigations on sensitive landforms; thermal analysis for dike and TSF design; monitoring of thermal and structural condition of the TSF and WRSF | Observed Tailings Storage Facility, including the eastern perimeter slope and dry tailings compaction in progress (Photo 66, Photo 67, and Photo 68). WRSF1, WRSF3 and WRSF6 were observed as well (Photo 37, Photo 53, and Photo 54). |

**Photo 37: Waste Rock Storage Facility (WRSF) 6**

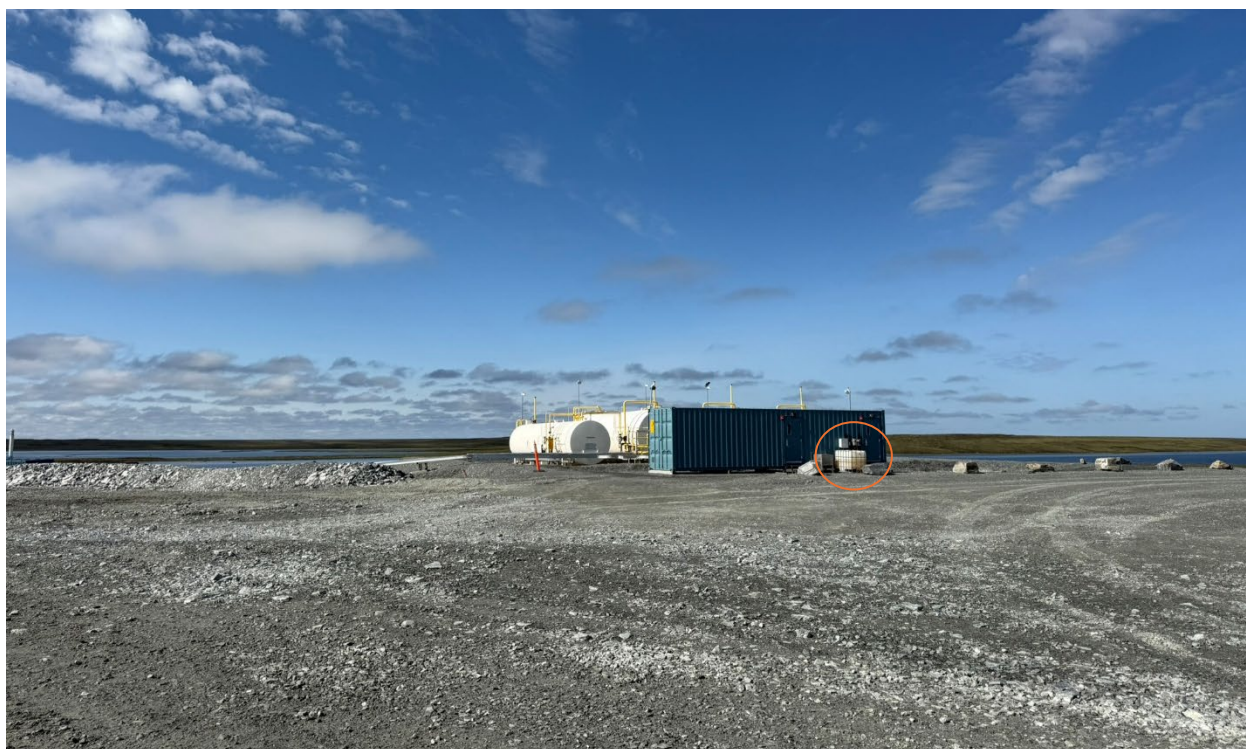
**Photo 42: Manual fuel station near the West Vent Raise, with the DEF storage tank located outside secondary containment**

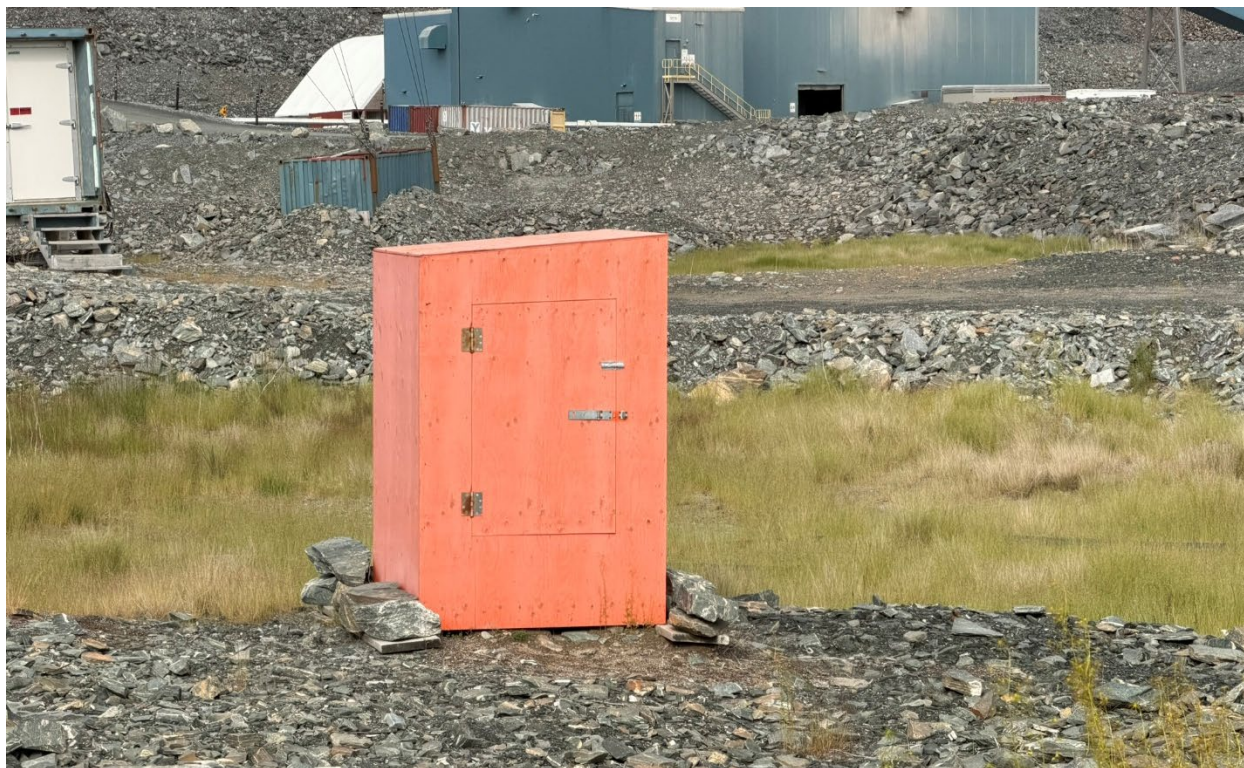
| <b>10, 11, 33</b> | Noise and Vibration Abatement Plan; noise and vibration monitoring at accommodation sites; blasting guidelines | Observed the permanent surface blast and vibration monitoring station at Tiriganiaq (TIRI01), located east of the telecommunications tower (Photo 50). |

**Photo 50: Surface blast and vibration monitoring station, monitors peak particle velocity and overpressure from blasting at TIRI01**

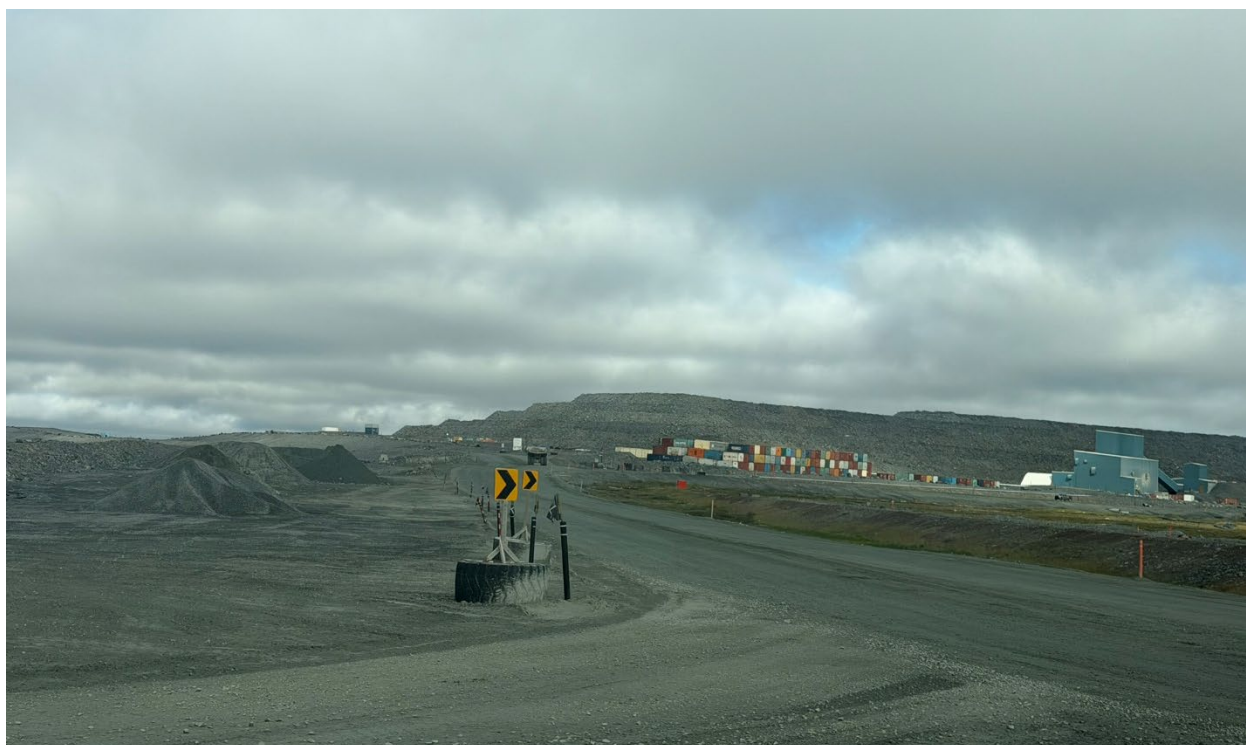
**Photo 53: Distant view of WRSF 1**

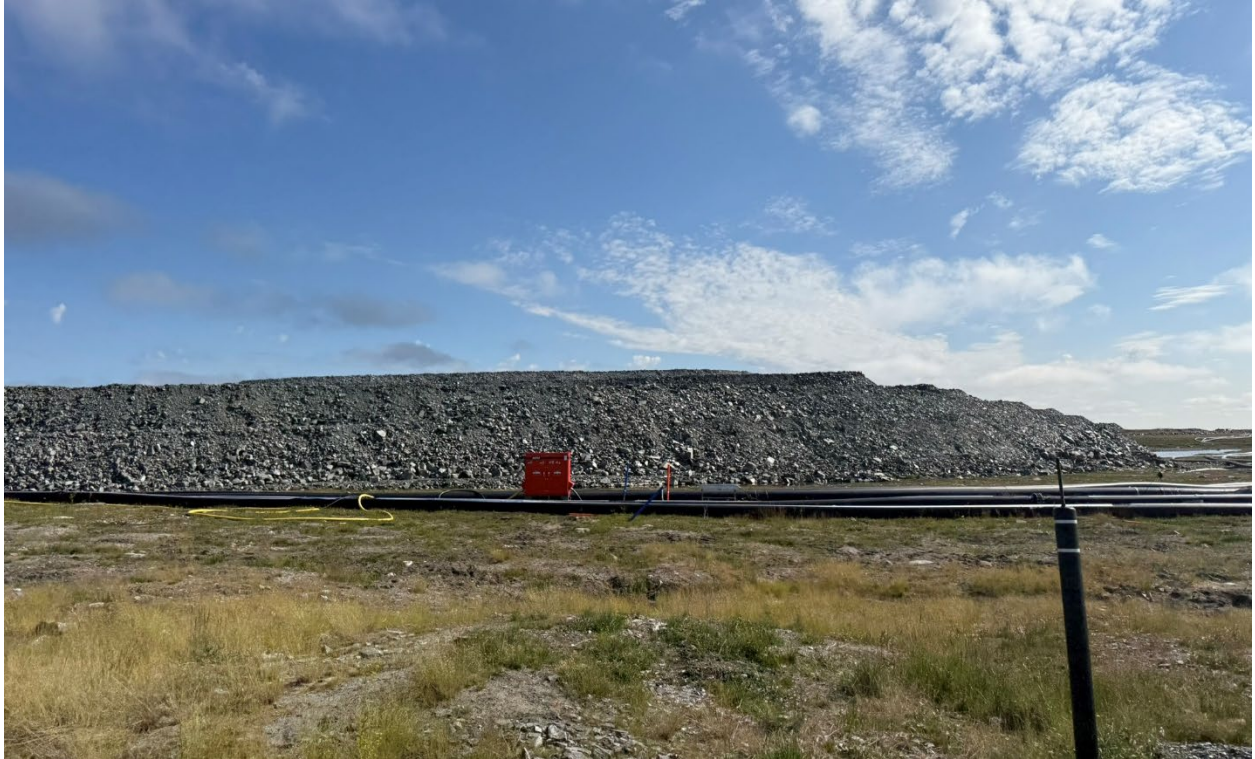
**Photo 54: WRSF 3**

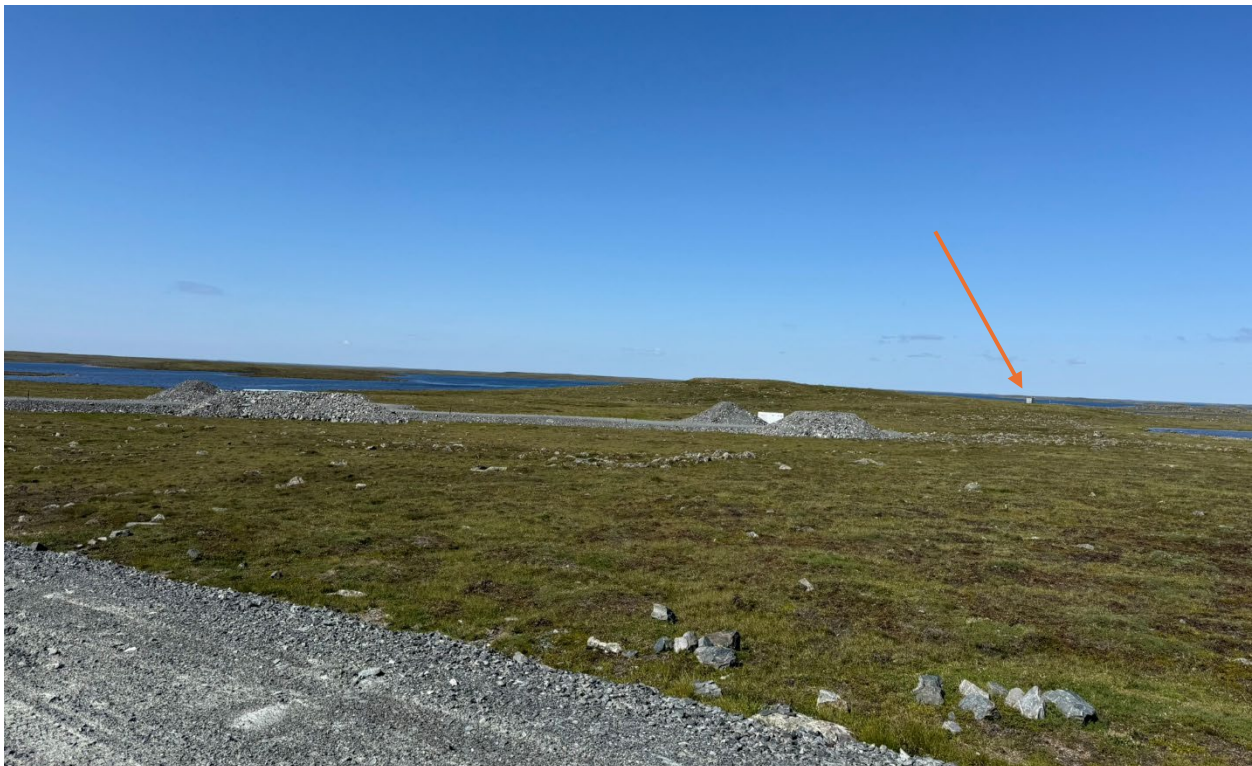
| T&C No. | Topic / summary | Site Observation |
|---|---|---|
| <b>1, 2, 116</b> | Air Quality Monitoring Plan; emissions monitoring; air quality component of the environmental and health risk monitoring program | Observed the ambient air quality monitoring stations, including the partisol samplers at the Dyno plant and at the Exploration Camp. (Photo 63 and Photo 100) |

**Photo 63: Air Quality Monitoring Station, monitoring background suspended particulates, SO<sub>2</sub> and NO<sub>2</sub>**

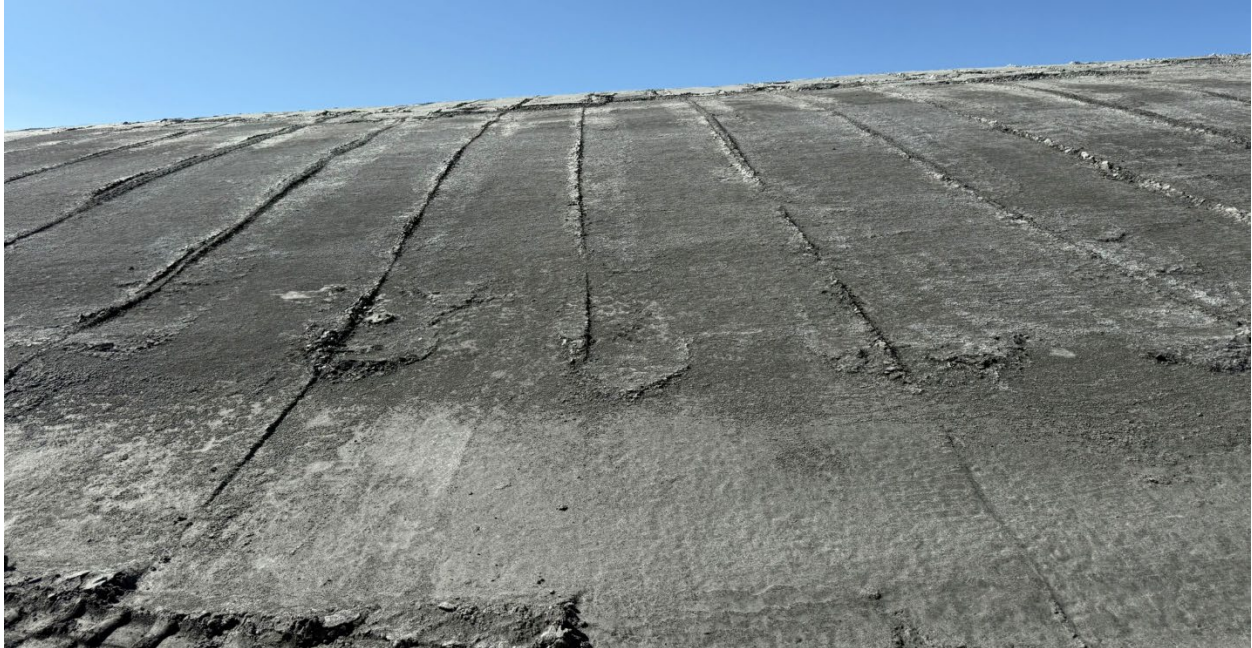
**Photo 66: Eastern perimeter slope of the Tailings Storage Facility, viewed from the TSF access road**

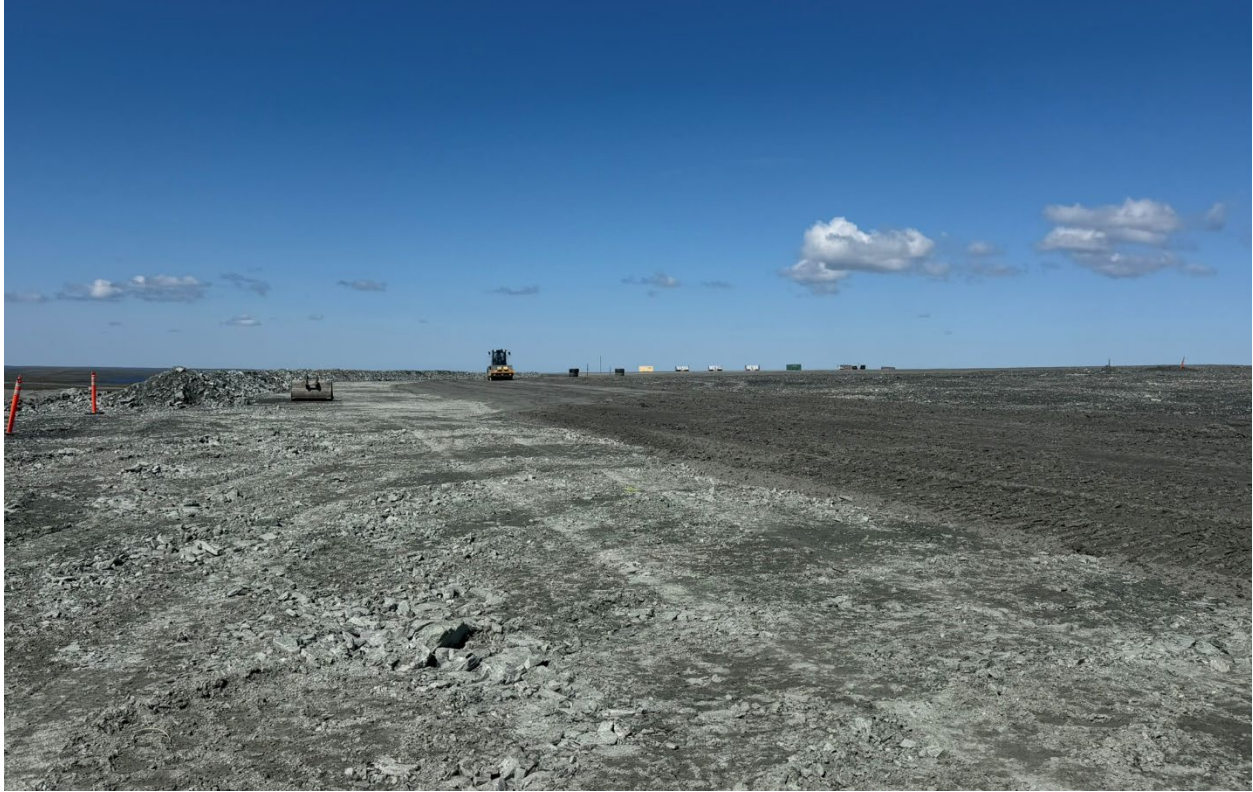
**Photo 68: Roller compacting dry tailings**

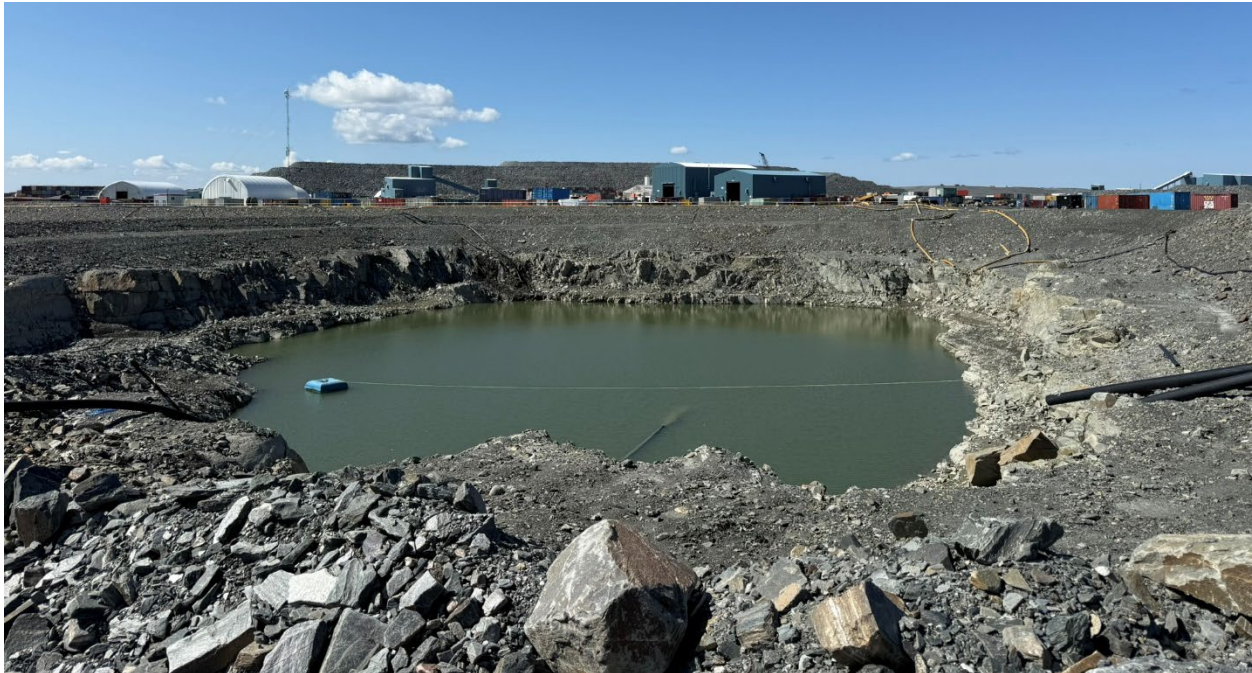
| <b>24, 25, 26</b> | Groundwater flow characterization; Groundwater Management Plan and adaptive management for saline groundwater; pit refill rates | Observed the saline water storage pond (SP1) (Photo 72) and Tiriganiaq Open Pit 2 from the Tiri 02 lookout, which continues to be used for storage of saline effluent (Photo 52). Agnico Eagle advised that no saline effluent was discharged to Melvin Bay in 2025, pending commissioning of the waterlines. |

**Photo 72: Saline Pond 1 (SP1)<sup>8</sup>**

<sup>8</sup> Saline Pond 1 (SP1) collects excess saline contact water from the underground mine. Water stored in the saline ponds is isolated from the surface runoff collection system and is not discharged to Meliadine Lake.

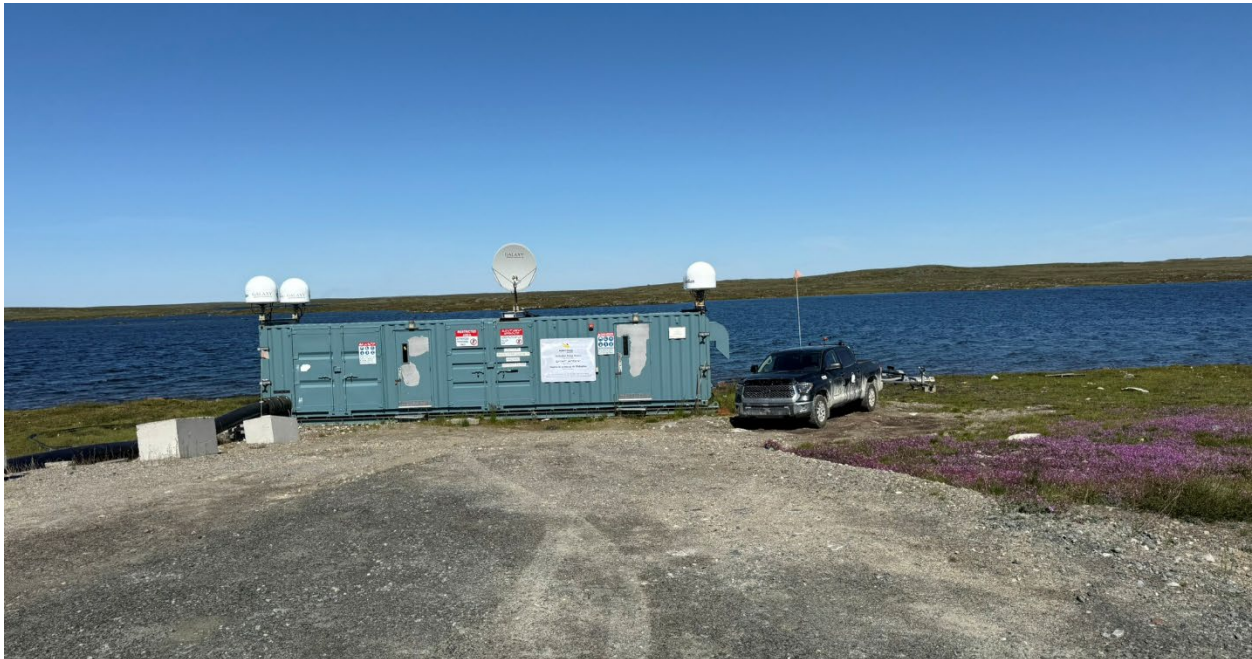
| <b>27, 30, 74</b> | Aquatic Effects Monitoring Plan, including surface water, snowpack and dustfall monitoring; measures to prevent use of water attenuation ponds by waterfowl | Observed the collection ponds across the site, including CP1, CP2, CP3, CP4, CP5, CP6, CP8/B7 North and CP9, and the associated dustfall monitoring stations located around the ponds. Also observed the freshwater intake (Photo 83). |

**Photo 83: Freshwater Intake on Meliadine Lake**

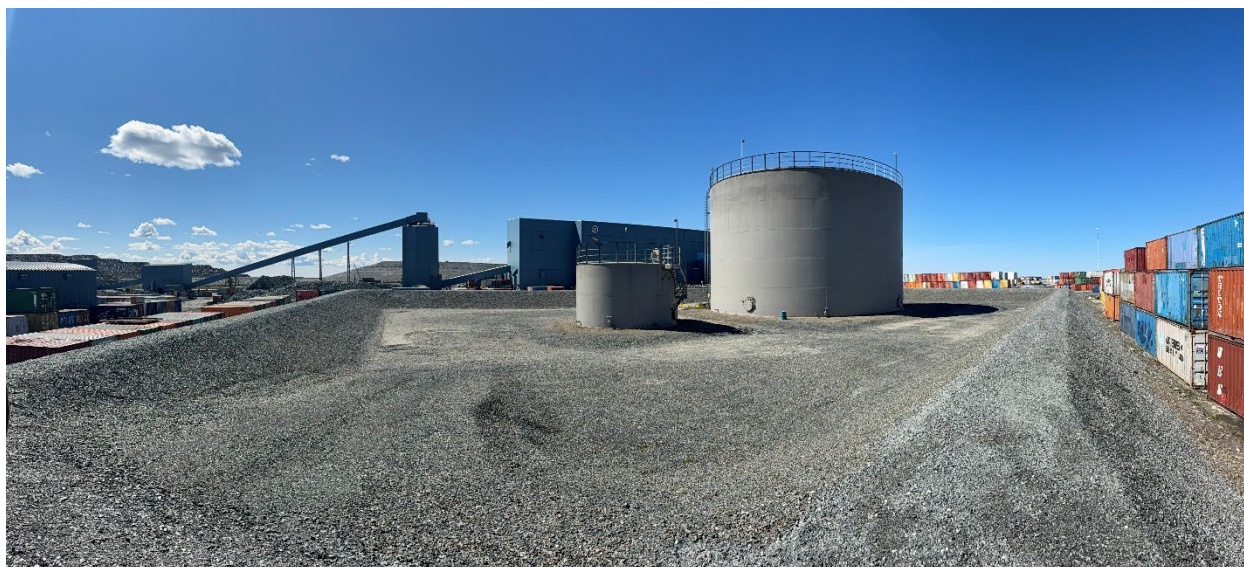
| <b>77, 123</b> | Fuel and hazardous materials containment | Observed the fuel tank farm at Itivia Harbour within secondary containment (Photo 5). At the mine site, observed the 6M litre and 3M litre fuel farms (Photo 85 and Photo 87) and the hazardous waste laydown area. Diesel exhaust fluid storage was noted outside secondary containment at the 3M Pumping Station and at the manual fuel station near the West Vent Raise (Photo 42, Photo 86, and Photo 88). Chemical waste tote at the RO plant was noted outside containment (Photo 74). |

**Photo 87: Fuel Tanks within secondary containment at onsite 6M Fuel Tank Farm**
