## 2026 Site Visit Report

# MELIADINE GOLD MINE PROJECT

Site visit report of the Meliadine Gold Mine Project for the 2025-2026 reporting year

**Site Visit Date:** July 20, 2026

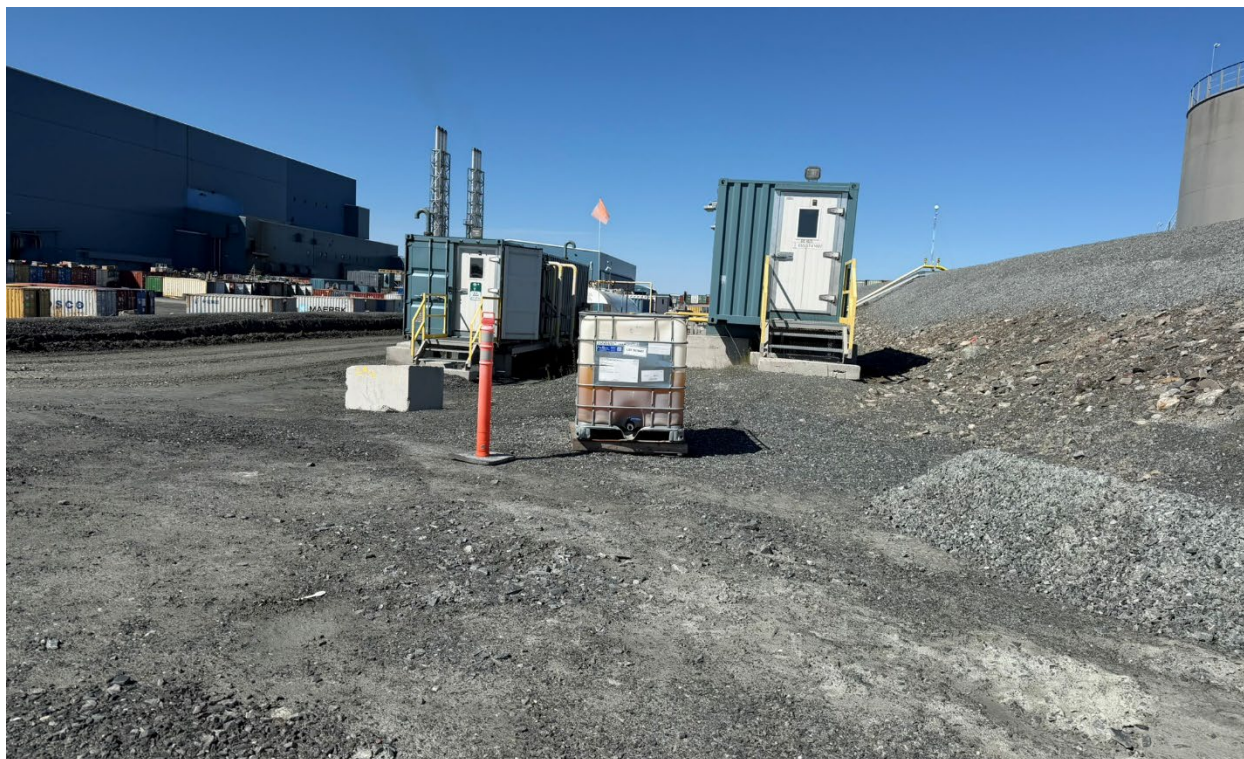
| <b>77, 123</b> | Fuel and hazardous materials containment | Observed the fuel tank farm at Itivia Harbour within secondary containment (Photo 5). At the mine site, observed the 6M litre and 3M litre fuel farms (Photo 85 and Photo 87) and the hazardous waste laydown area. Diesel exhaust fluid storage was noted outside secondary containment at the 3M Pumping Station and at the manual fuel station near the West Vent Raise (Photo 42, Photo 86, and Photo 88). Chemical waste tote at the RO plant was noted outside containment (Photo 74). |

The 6M litre and 3M litre fuel farms were viewed. At the 3M and 6M Pumping Stations, diesel exhaust fluid totes were noted stored outside of secondary containment. At the hazardous waste laydown adjacent to the incinerator facility, where hazardous materials are stored in dedicated seacans, a number of hazardous material totes and bulk bags were noted staged on open ground outside of the seacans and without secondary containment. The waste management facilities were viewed, including the landfill, the landfarm and the incinerator.

**Photo 88: 6M Pumping Station, with the DEF storage tank located outside secondary containment**

Diesel exhaust fluid (DEF) storage was observed outside secondary containment at the 3M Pumping Station and at the manual fuel station near the West Vent Raise (Photo 42, Photo 86, and Photo 88). Chemical waste at the reverse osmosis plant (Photo 74) was similarly noted outside containment, as were hazardous material totes and bulk bags staged on open ground adjacent to the incinerator seacans (Photo 93) and at the landfarm cells (Photo 96). NIRB staff note that hazardous and chemical materials stored outside of secondary containment present a risk of release to the surrounding environment, and encourage Agnico Eagle to review storage practices across the site to ensure that all such materials are held within appropriate containment (T&C 77, 123).

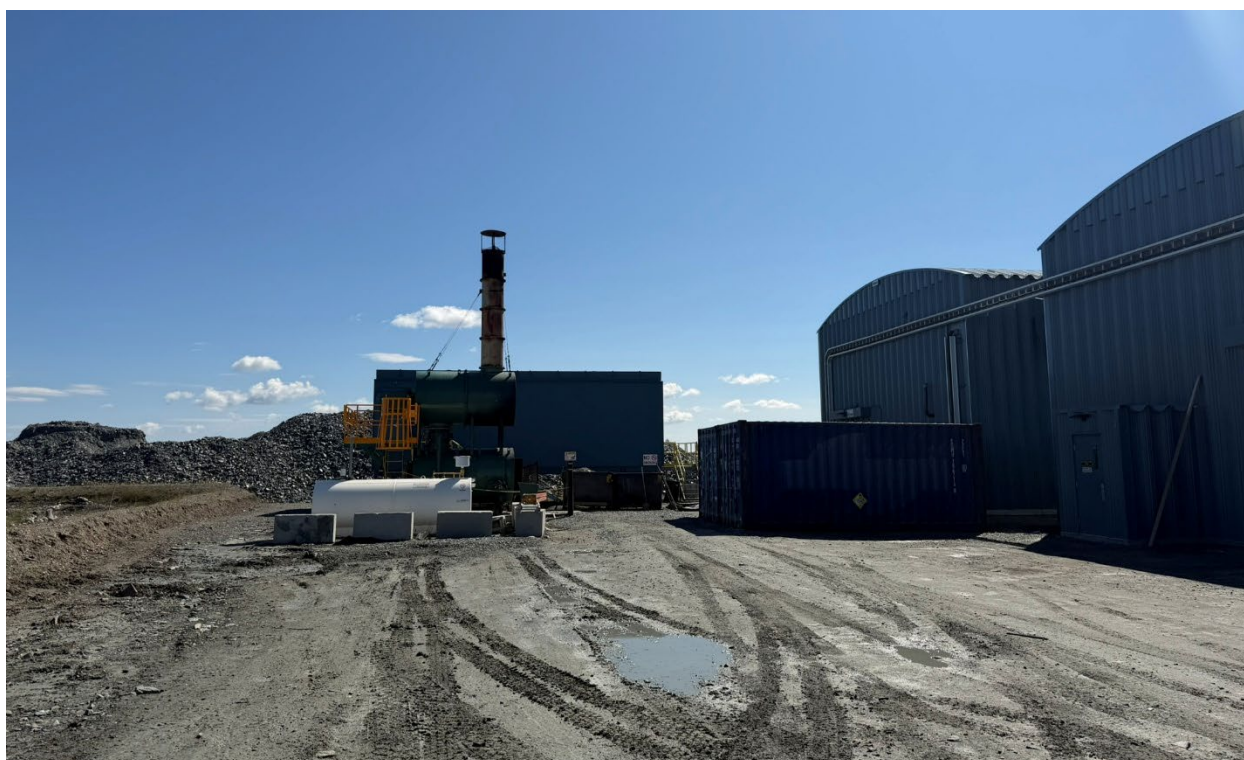
| T&C No. | Topic / summary | Site Observation |
|---|---|---|
| <b>4, 5</b> | Incineration Management Plan; stack testing results | Incinerator facility observed. Bagged waste was noted accumulated on the floor of the incinerator building awaiting processing. Hazardous material totes and bulk bags were noted staged outside the dedicated seacans without secondary containment (Photo 89, Photo 90, Photo 91, Photo 92, and Photo 93). |

**Photo 89: Incinerator Buildings**

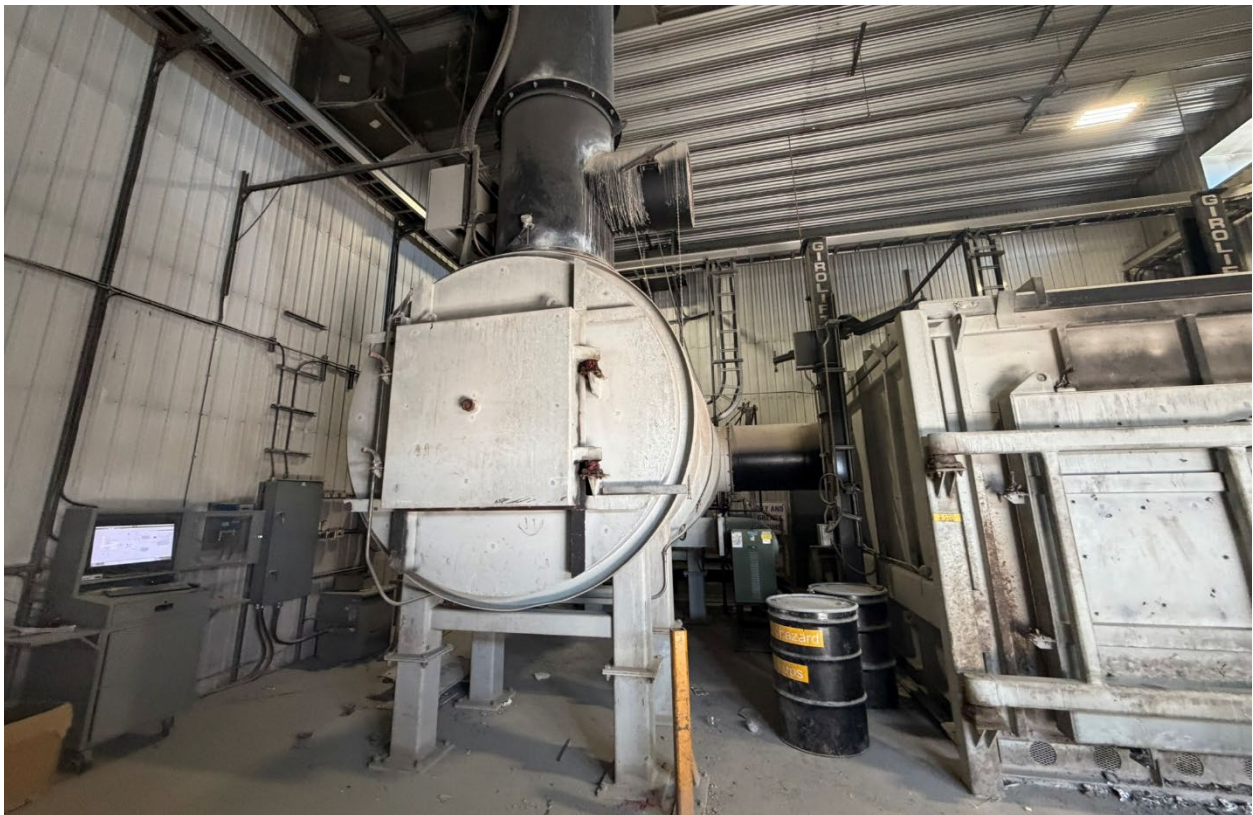
**Photo 91: Incinerator housed within Incinerator Building**

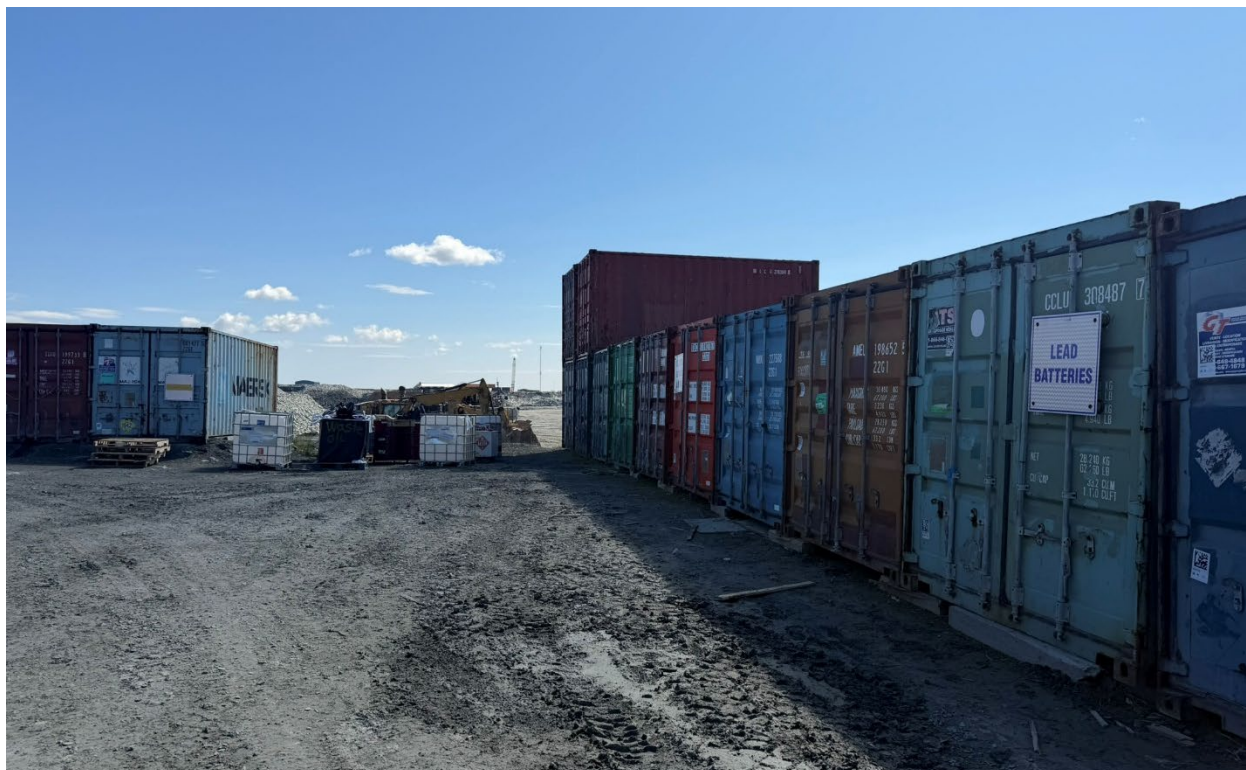
| <b>55, 75</b> | Monitor wildlife mortality; limit attraction of predators and scavengers to Project facilities | Observed waste segregation practices within the camp (Photo 104), the landfill (Photo 97) and the hazardous waste laydown area (Photo 92). |

**Photo 92: Hazardous materials stored in dedicated seacans adjacent to Incinerator Buildings**

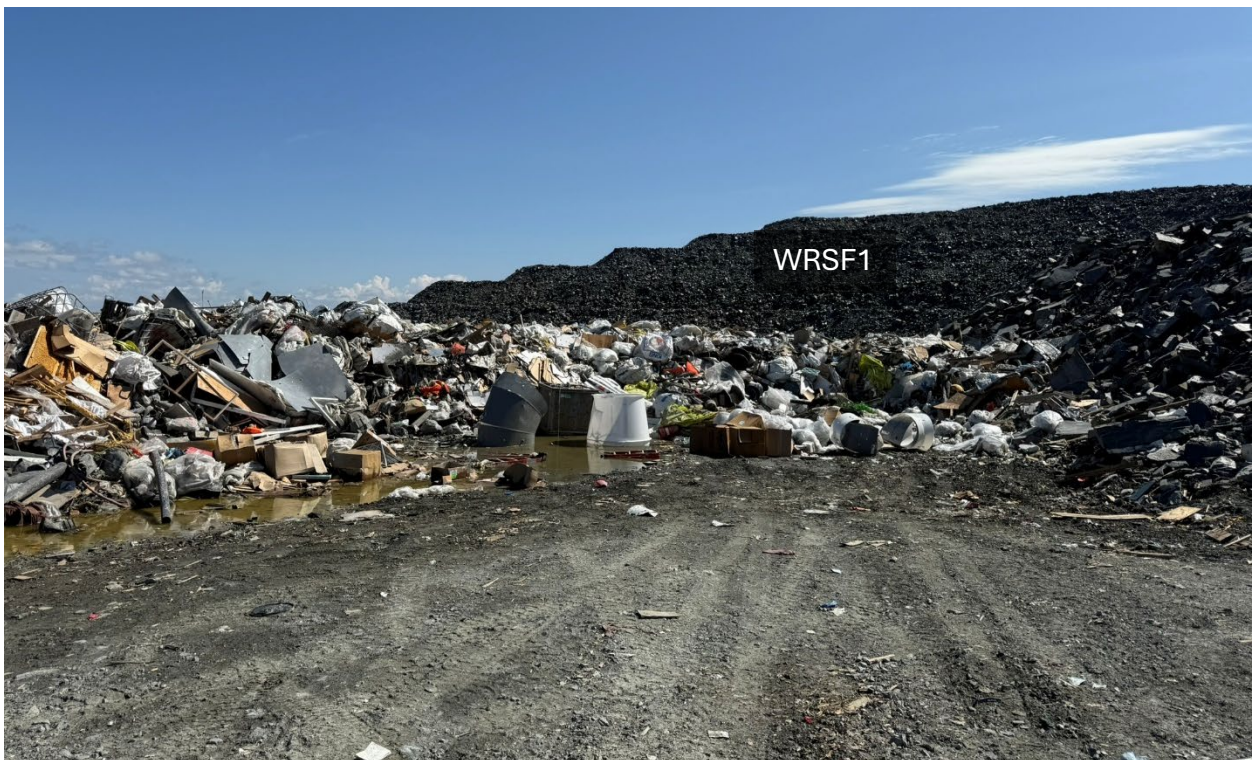
| T&C No. | Topic / summary | Site Observation |
|---|---|---|
| <b>6, 21, 22</b> | Waste Management Plan for Project landfills; dust suppression at landfill; adaptations to the Mine Waste Management Plan | Observed the landfill (Photo 97) and the wider waste management area. |

**Photo 97: Onsite Landfill**

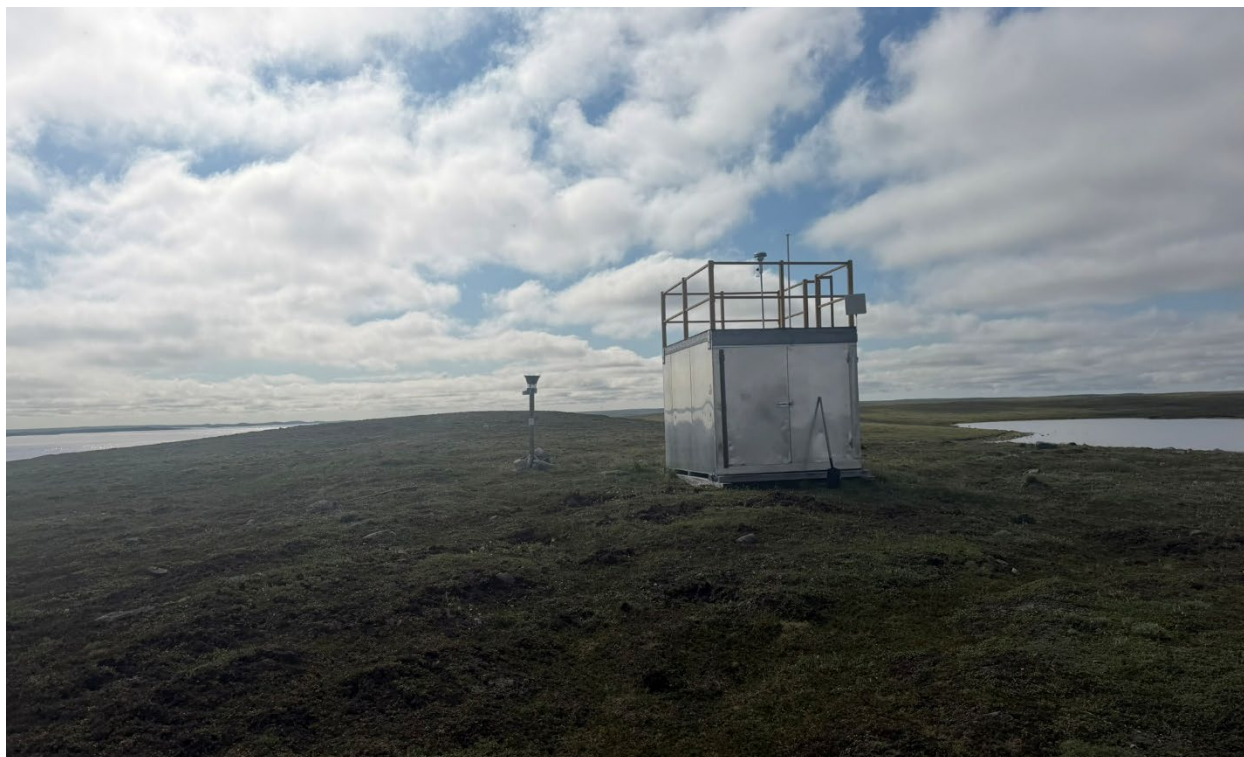
| T&C No. | Topic / summary | Site Observation |
|---|---|---|
| <b>1, 2, 116</b> | Air Quality Monitoring Plan; emissions monitoring; air quality component of the environmental and health risk monitoring program | Observed the ambient air quality monitoring stations, including the partisol samplers at the Dyno plant and at the Exploration Camp. (Photo 63 and Photo 100) |

**Photo 100: Air Quality Monitoring Station DF-5, monitoring dustfall, suspended particulates, SO<sub>2</sub> and NO<sub>2</sub>**

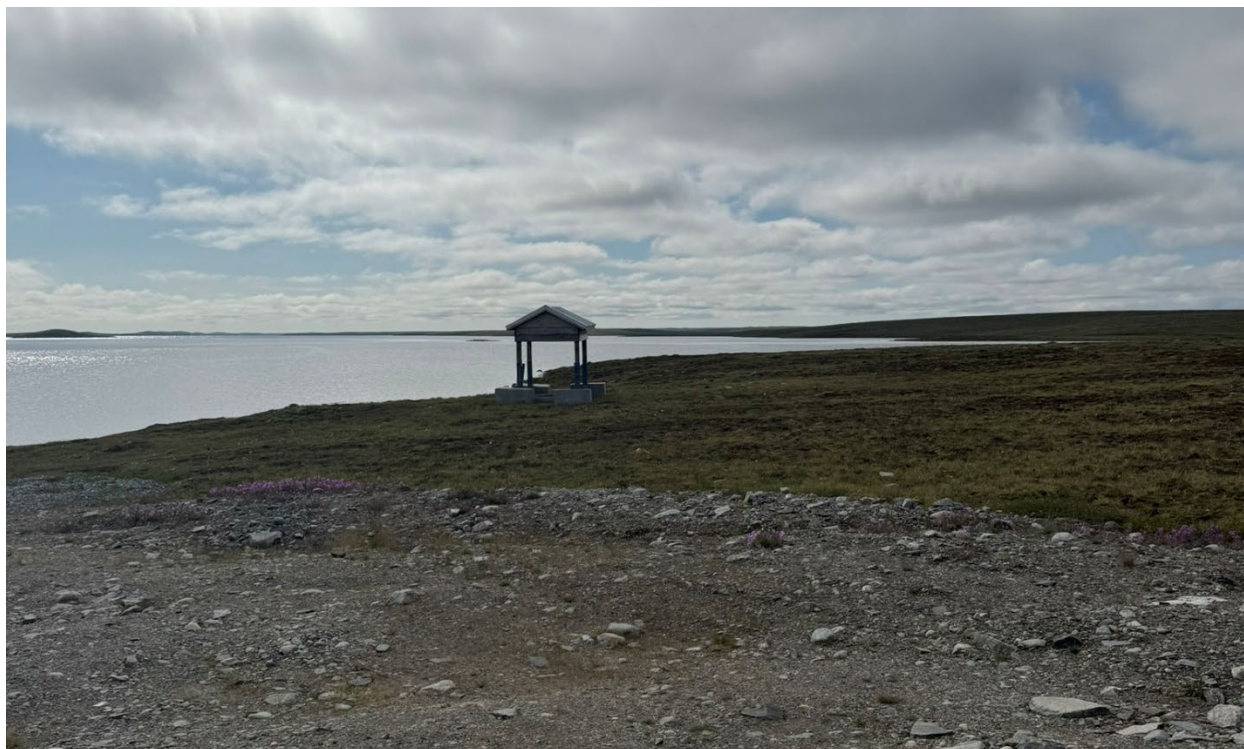
| <b>58, 59, 61, 62, 71</b> | Bird awareness training; zones of avoidance and nest setbacks; nesting deterrents and pre-clearance surveys; mitigation and monitoring for migratory birds | A falcon nest was observed on a bench on the northeast side of TIRI01, which had hatched at the time of the visit (Photo 48); Agnico Eagle advised the nest was being monitored and the area avoided. A bird house built for barn swallows was observed at the Exploration Camp adjacent to Meliadine Lake (Photo 101). |

**Photo 101: Bird house for a barn swallow at Exploration Camp, adjacent to Meliadine Lake**

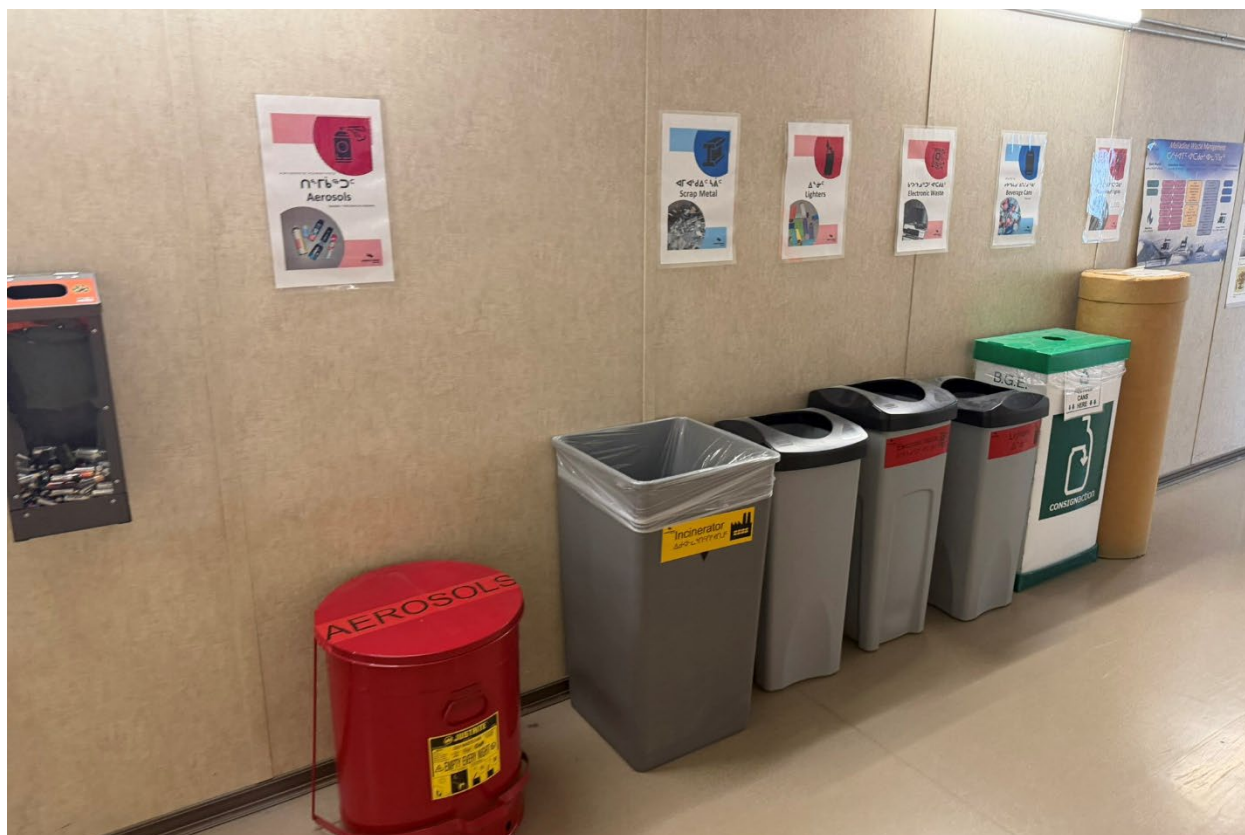
Photo 104: Waste segregation bins in camp hallway
