## 2026 Site Visit Report

# DORIS NORTH GOLD MINE & PHASE 2 HOPE BAY BELT (HOPE BAY PROJECTS)

File Nos. 05MN047 & 12MN001  
Project Certificates 003 & 009

Site visit report of the Hope Bay Projects for the 2025-2026 reporting year

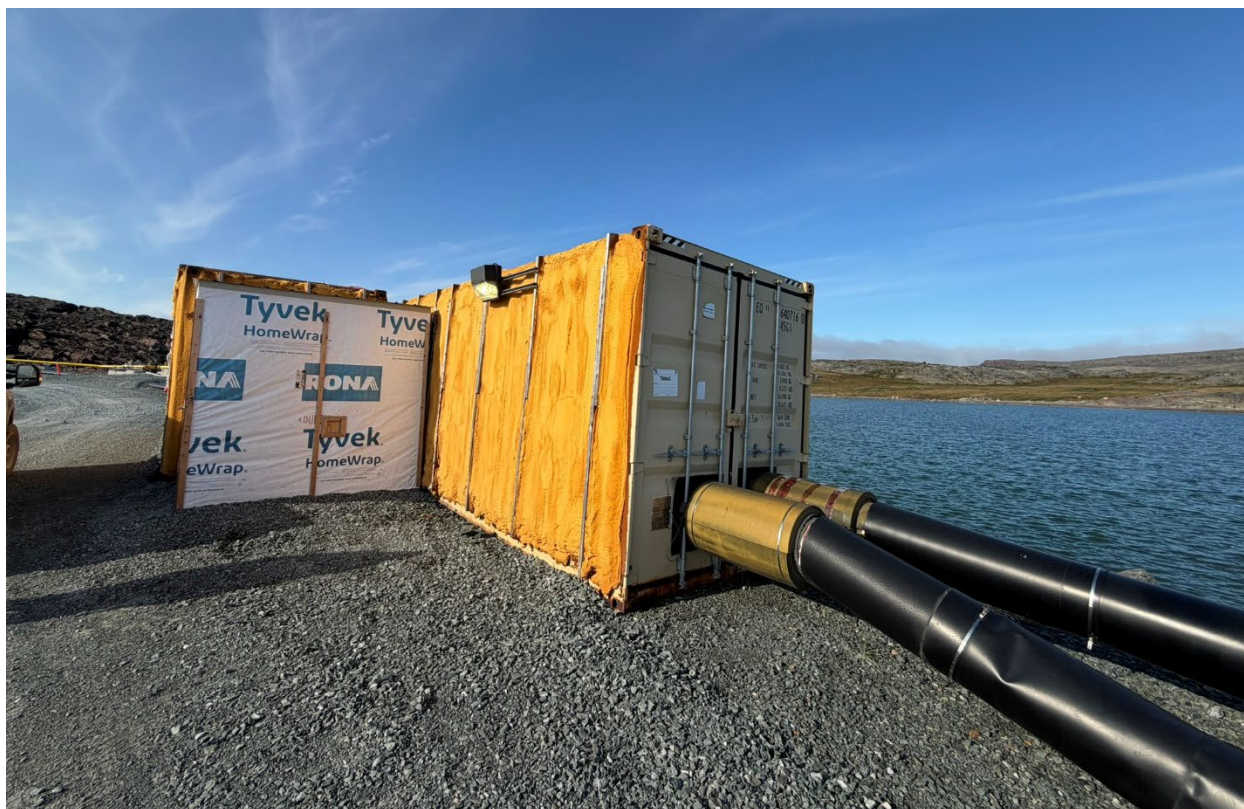
**Photo 4: Treated effluent discharge pumphouse**

| | in compliance with applicable regulatory approvals or requirements. | (Photo 58), along with the treated effluent discharge pipeline, pumphouse and diffuser at Roberts Bay (Photo 4, Photo 5, and Photo 6). |

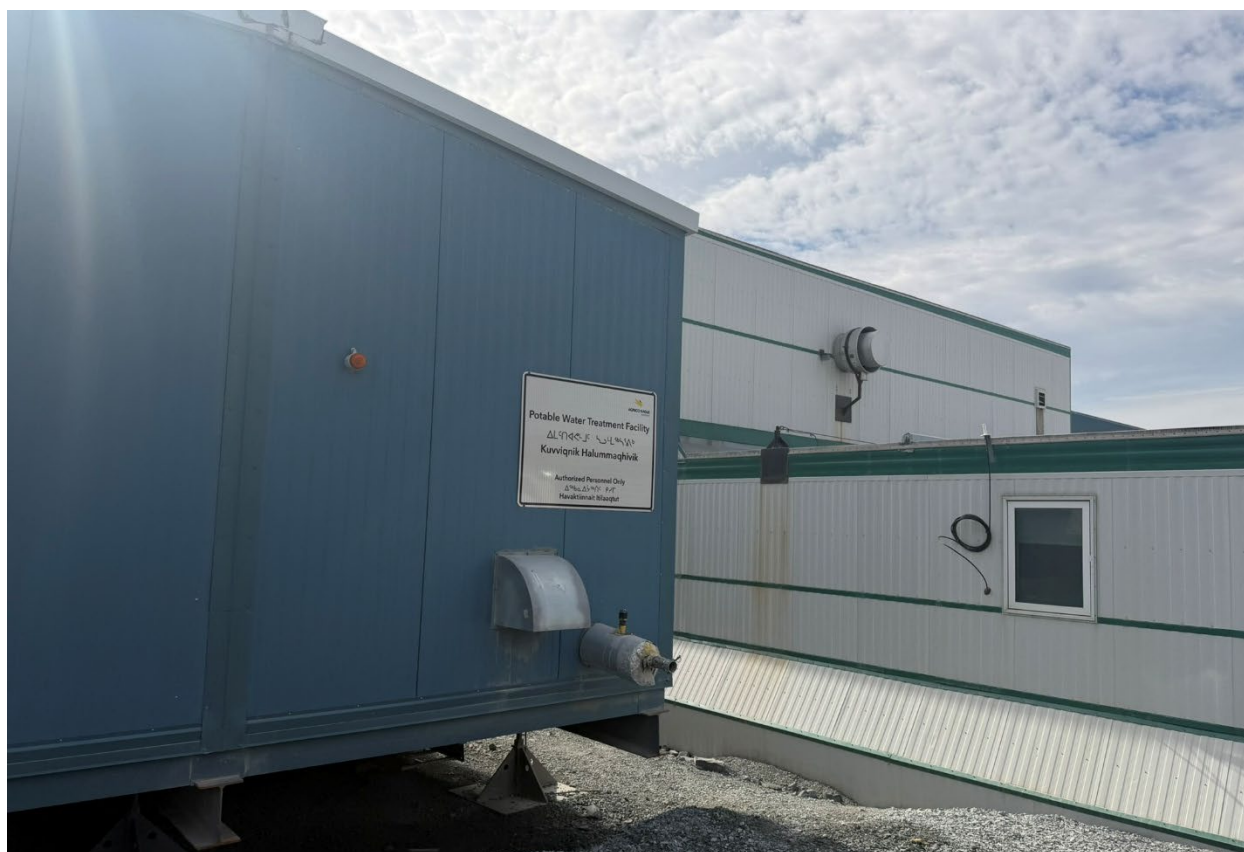
**Photo 49: Potable Water Treatment Facility**

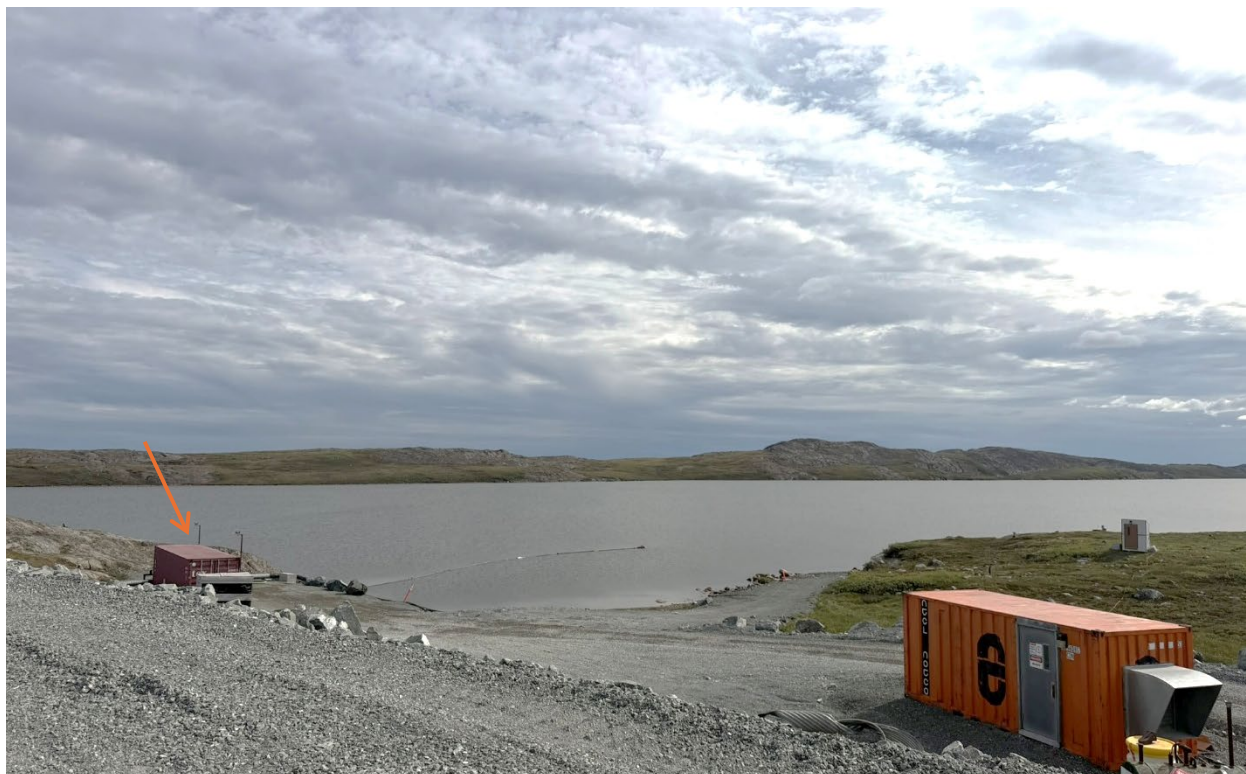
**Photo 50: Doris Lake and freshwater intake facility<sup>2</sup>**

<sup>2</sup> Doris Lake is withdrawn for potable and process water use at the site.

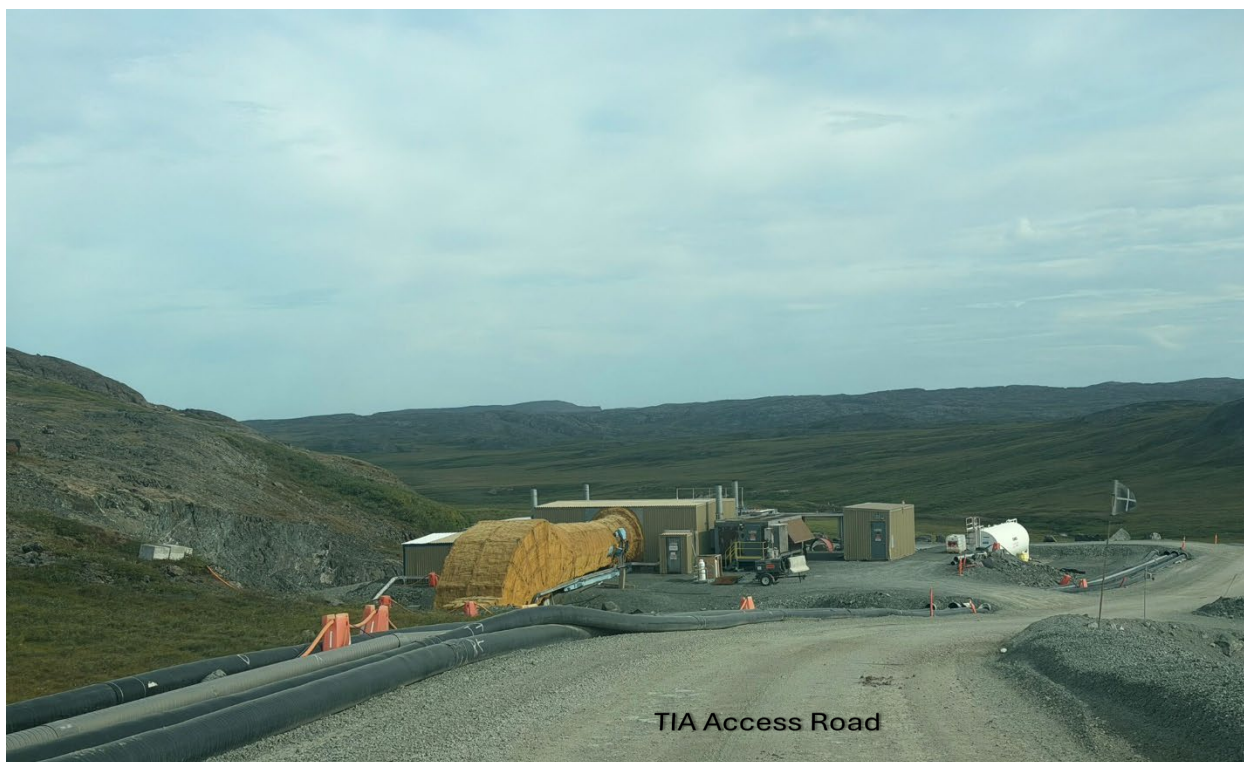
**Photo 53: Primary Vent Raise**

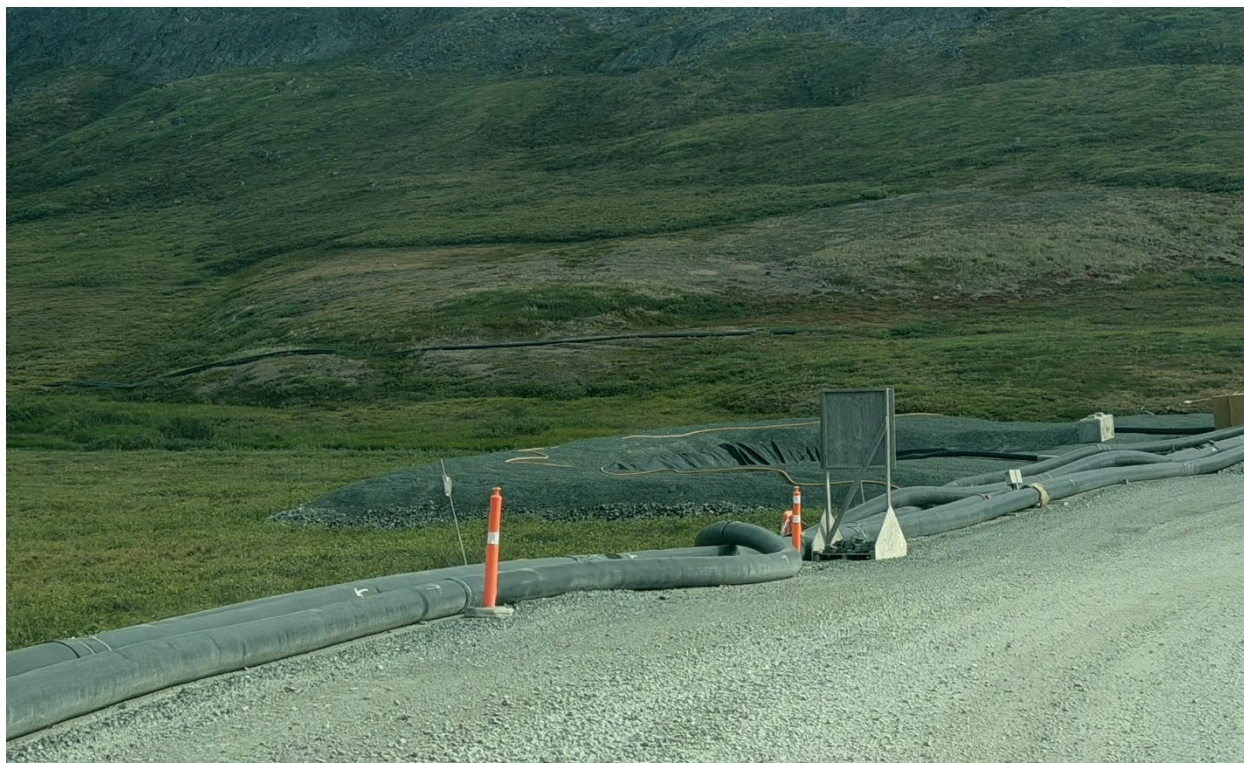
| T&C No. | Topic / summary | Site Observation |
|---|---|---|
| 10, 15, 36 | Monitor discharge from the Tailings Impoundment Area (TIA) into Doris Creek and compare to predicted impacts. Ensure water discharged into Doris Creek does not exceed discharge criteria. Monitor Doris Lake Water levels during construction and operations. | Doris Creek, Doris Lake and the two catch basins at the Doris Creek Bridge were observed (Photo 54, Photo 55, and Photo 56). |

**Photo 54: Catch Basin 1 - one of two catch basins located on opposite sides of Doris Creek Bridge for emergency discharge**

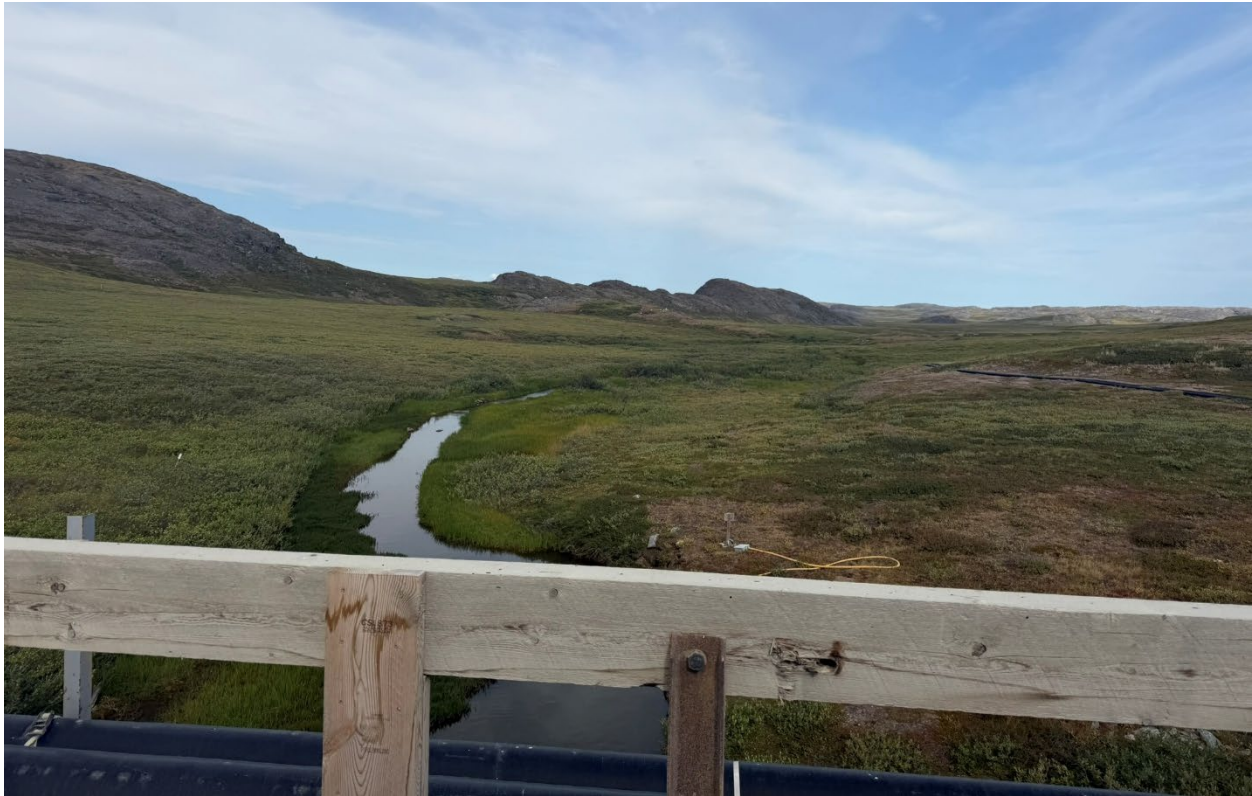
**Photo 56: Doris Creek, looking north from Doris Creek Bridge**

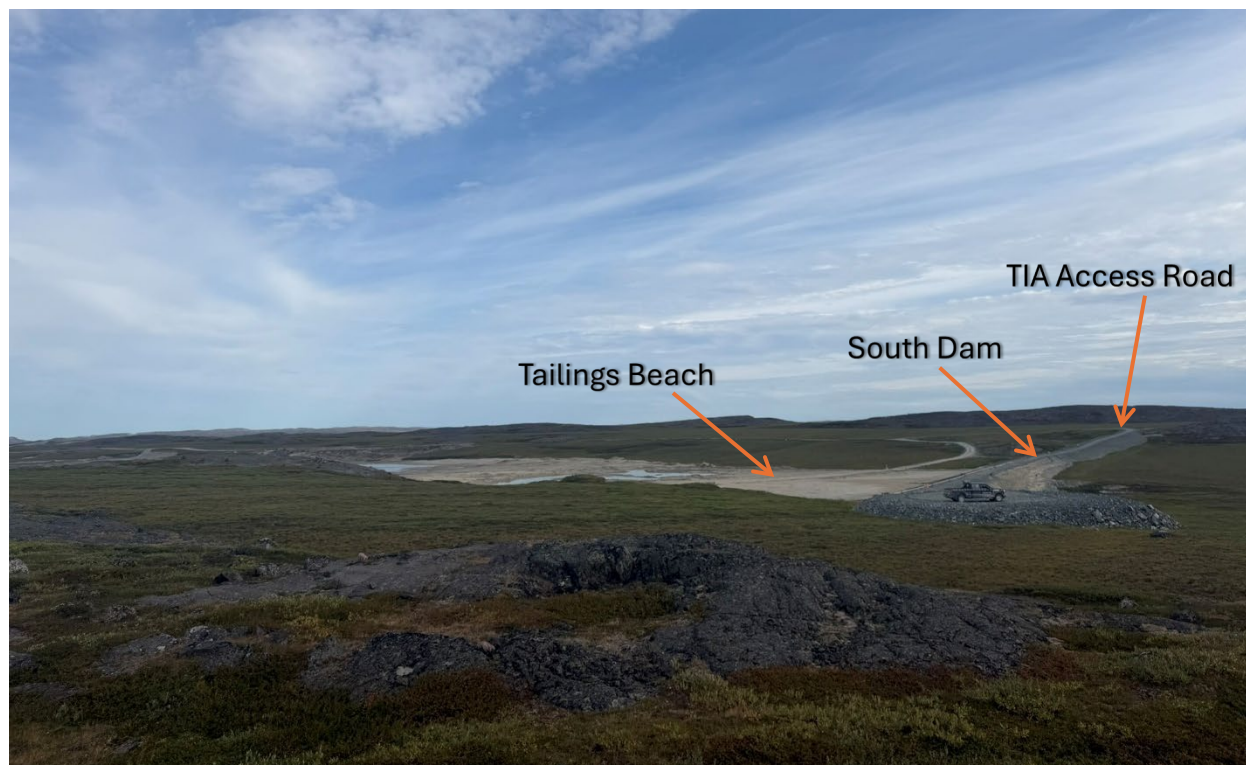
| <b>T&amp;C No.</b> | <b>Topic / summary</b> | <b>Site Observation</b> |
|---|---|---|
| <b>6, 9</b> | Undertake site-specific geotechnical investigations, permafrost monitoring, mapping and thermal analysis. Implement a Thermal Monitoring Plan to identify potential changes in talik distribution and flow paths. | The North Dam and thermosyphon cooling system, South Dam, toe berm and tailings beach, and the interim dike were observed (Photo 57, Photo 59, and Photo 60). Thermistors are installed and monitored across the site and in the TIA dam. |

**Photo 60: Tailings Impoundment Area – South Dam, distant view facing northeast**

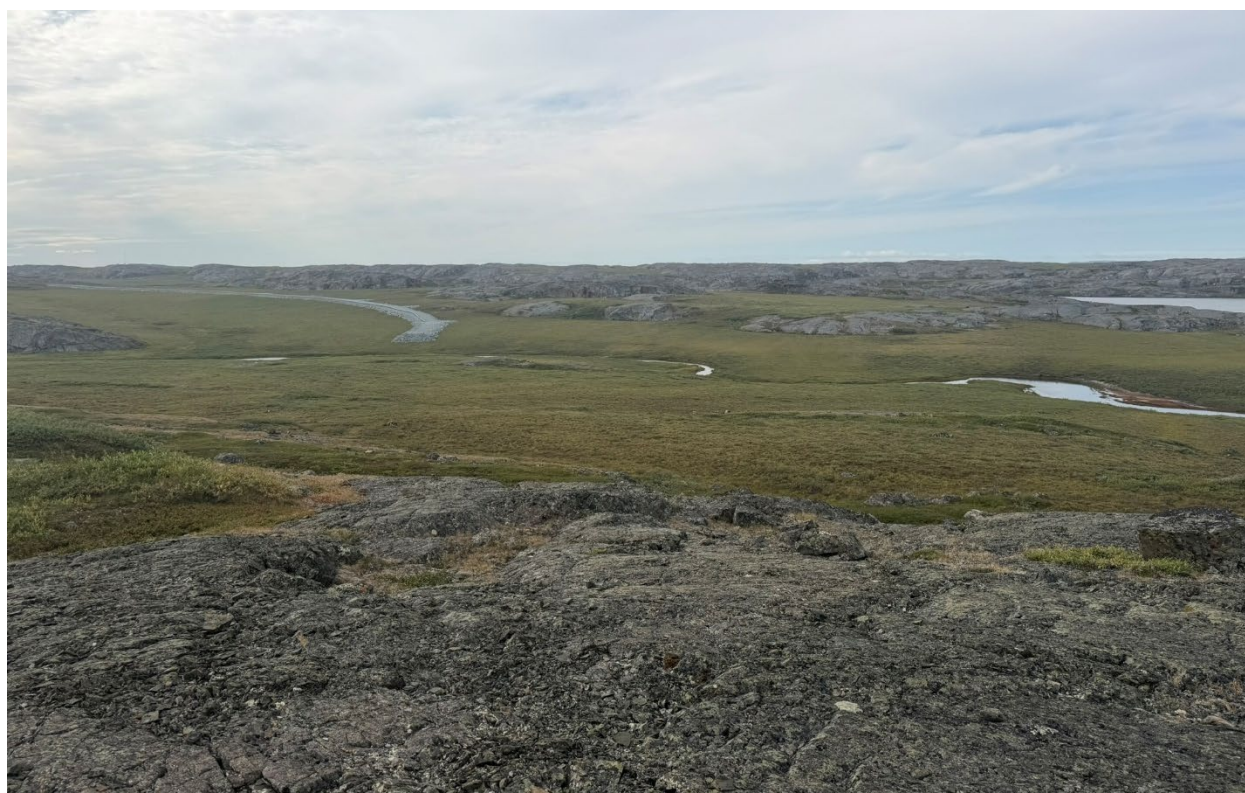
**Photo 61: Madrid-TIA Road under construction and will connect to TIA South Dam through a new bridge over the creek, southwest of TIA**

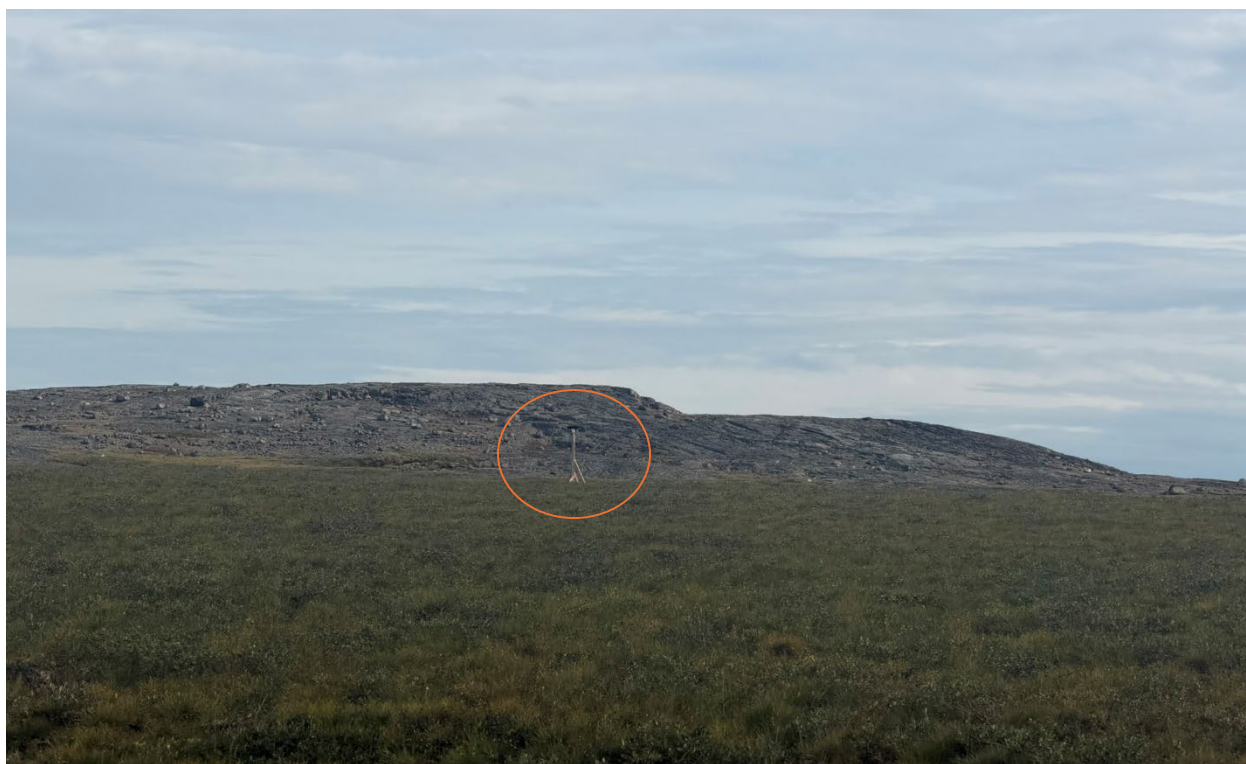
**Photo 63: Dustfall samplers located along the TIA Access Road**

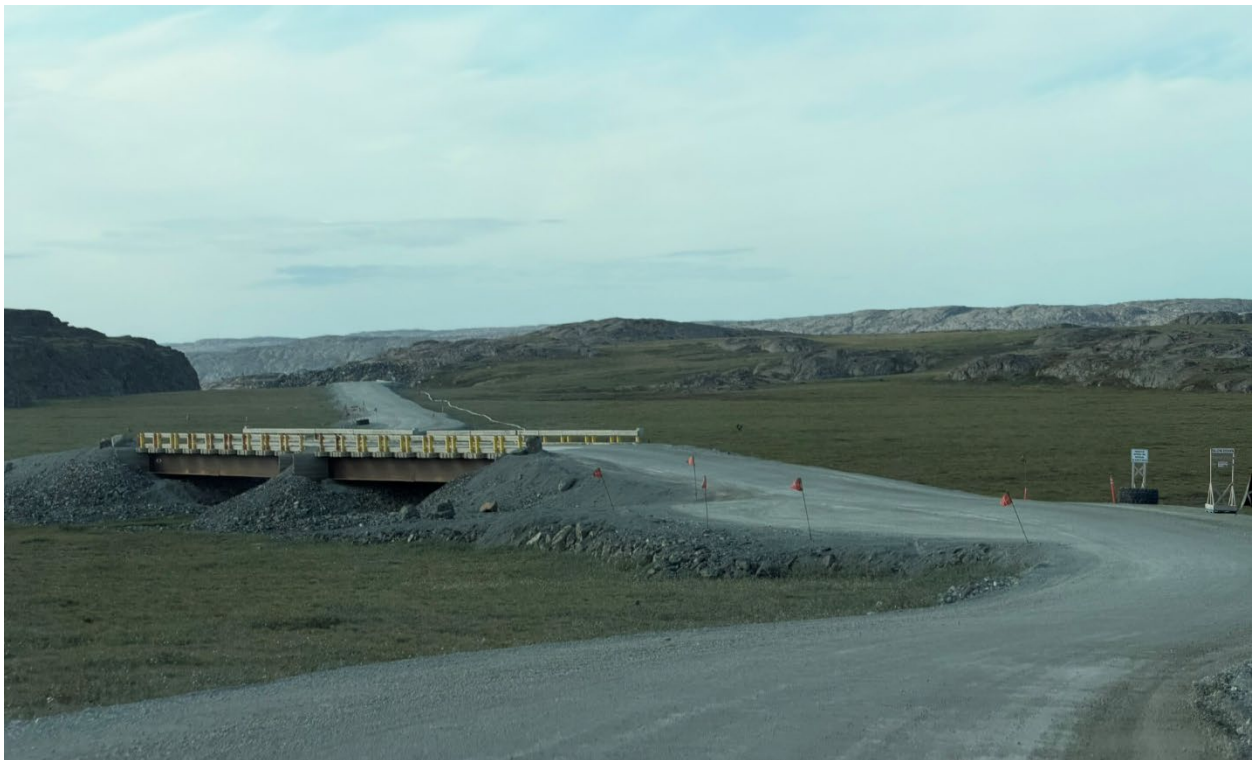
**Photo 65: Bridge on Doris-Windy All-Weather Road**

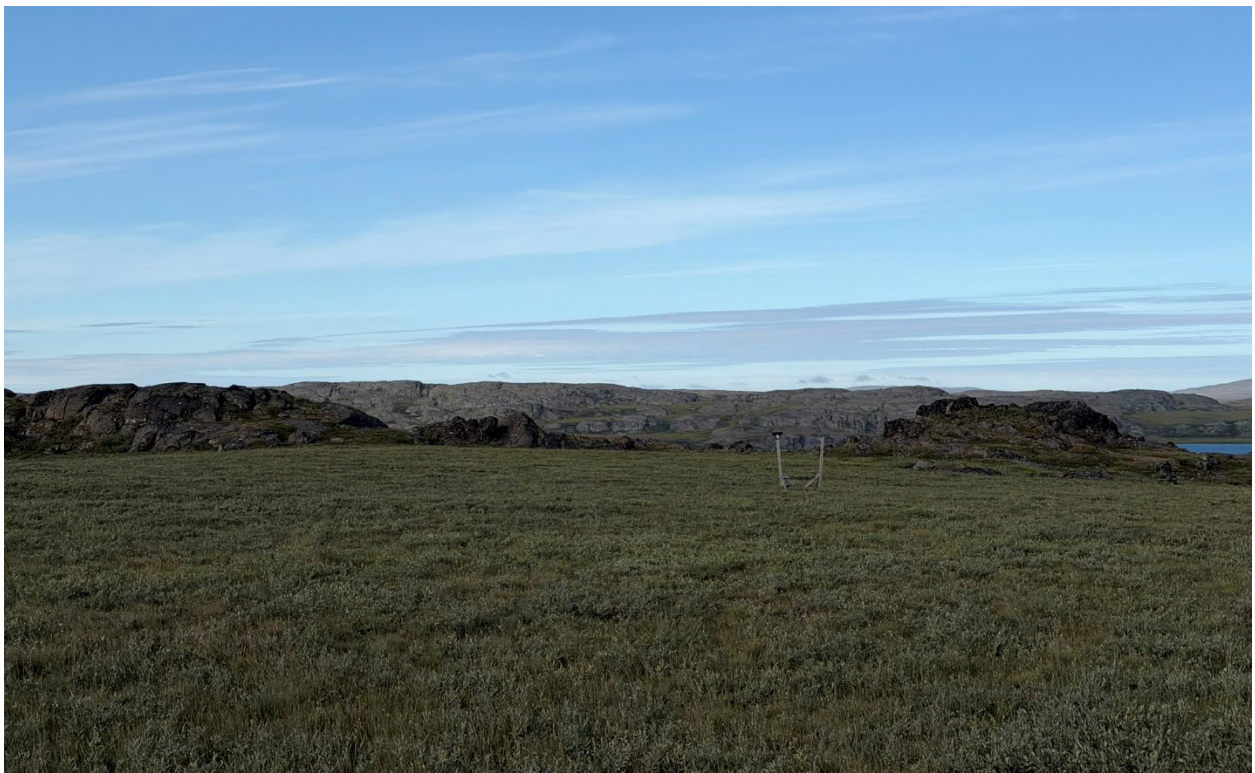
**Photo 67: Dustfall samplers along the Doris-Windy All-Weather Road**

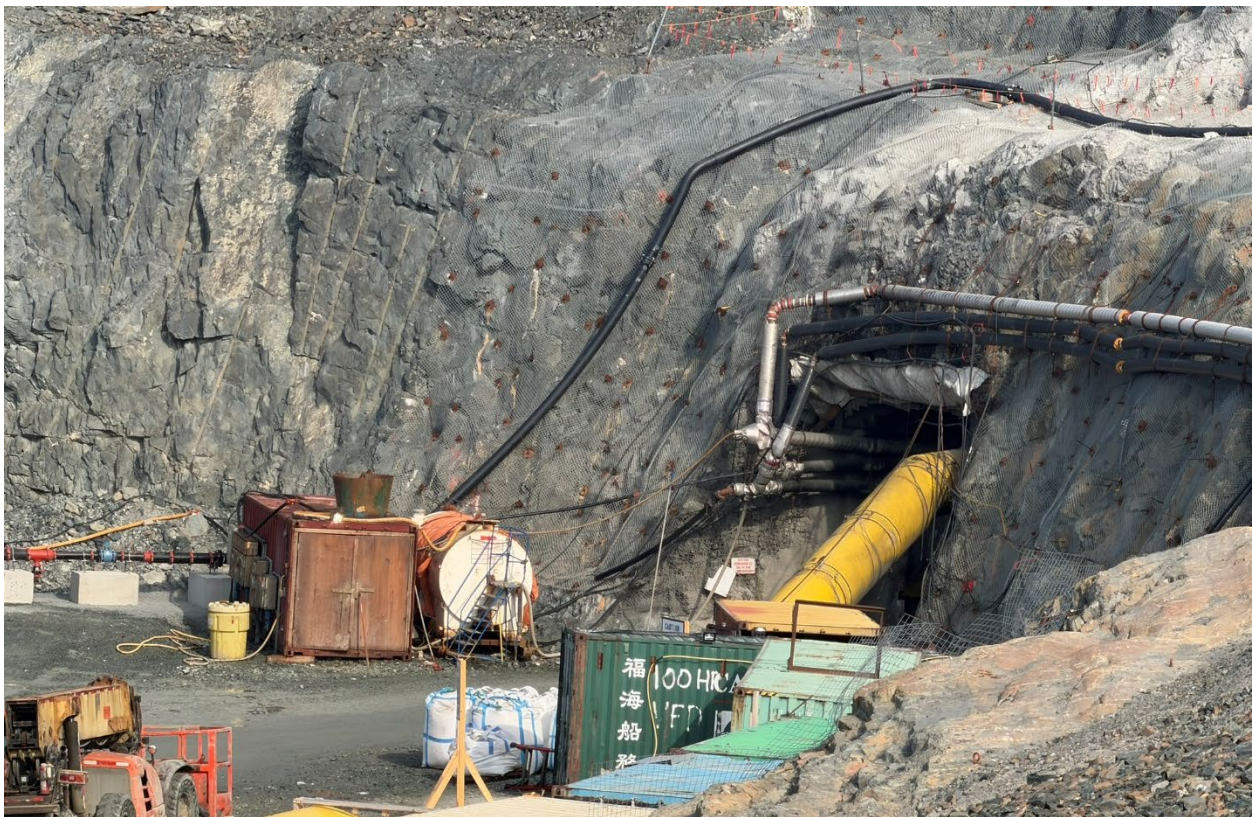
**Photo 72: Close up: Underground Portal**

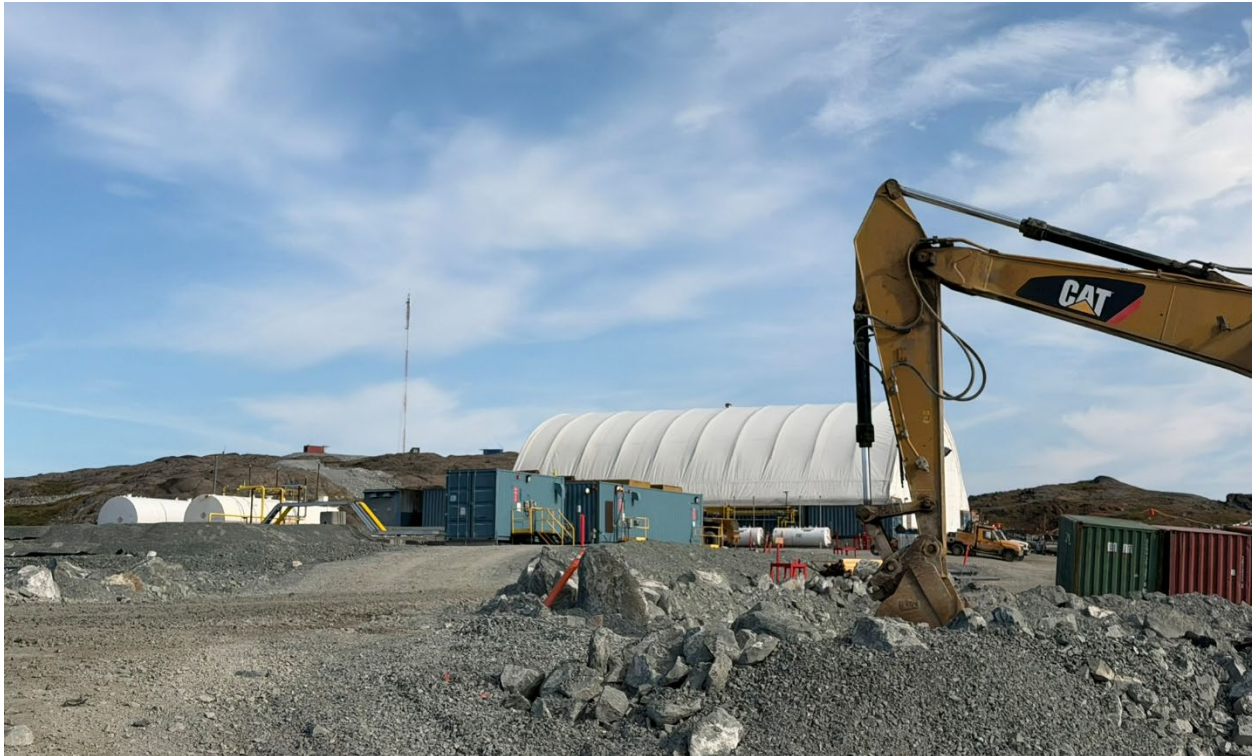
**Photo 73: Naartok East CPR Laydown Pad**

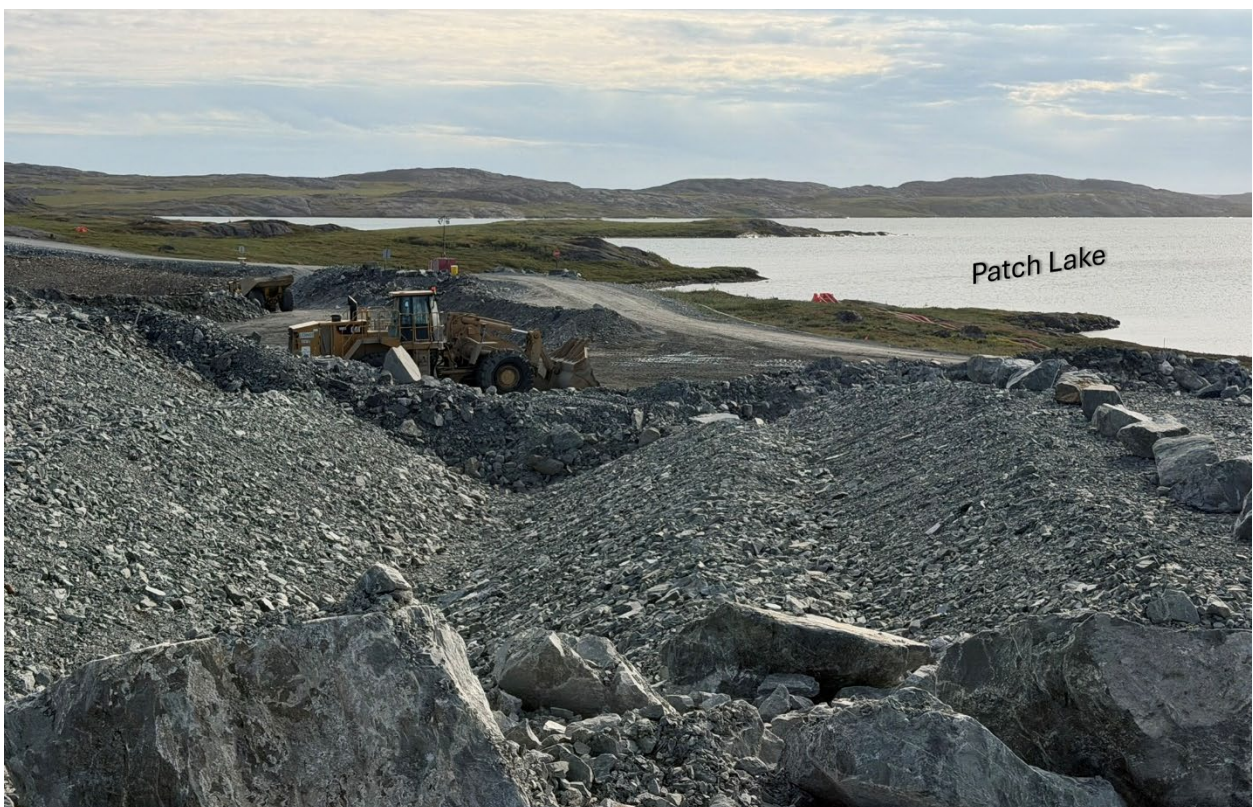
**Photo 74: Crown Pillar Recovery Trench (CPRT) and sump**

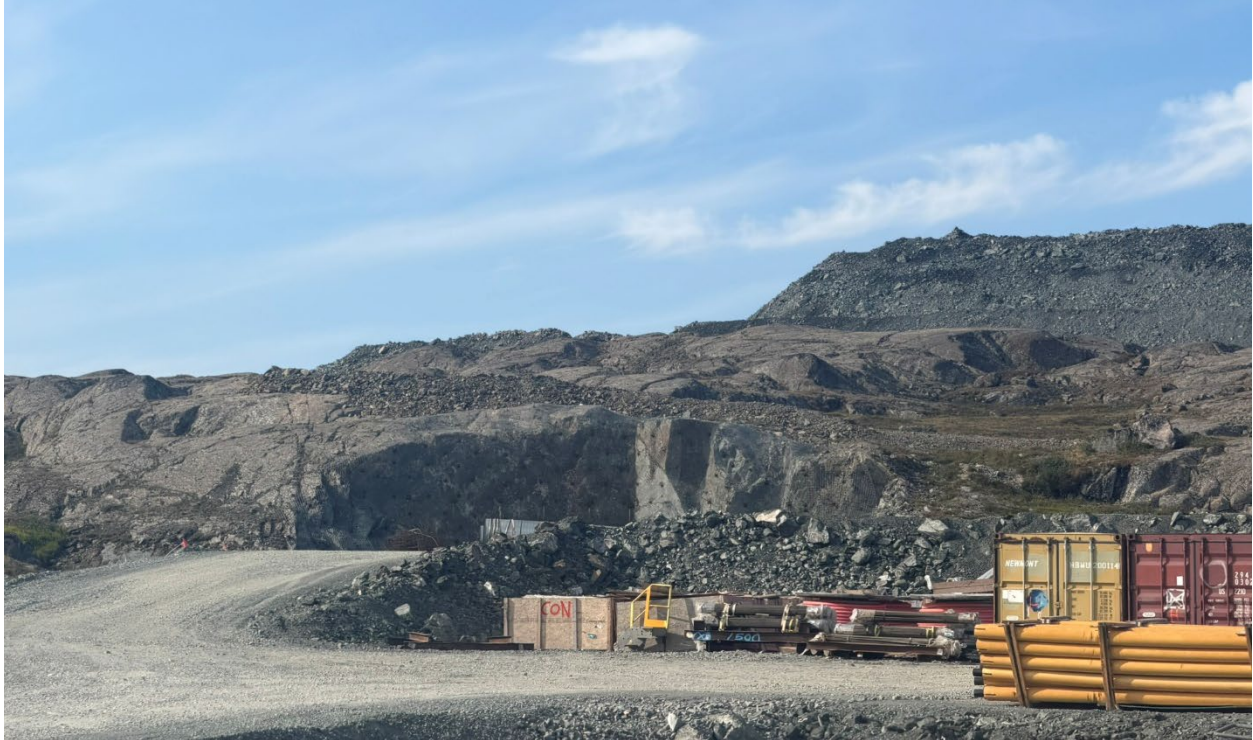
| <b>T&amp;C No.</b> | <b>Topic / summary</b> | <b>Site Observation</b> |
|---|---|---|
| <b>8</b> | Progressive reclamation | Agnico Eagle has decommissioned Windy Camp and continues to limit their site footprint to avoid unnecessary disturbance. Also, the Madrid North Portal was backfilled in 2025 (Photo 75). |

**Photo 75: Former Madrid North Portal, which was backfilled in 2025**

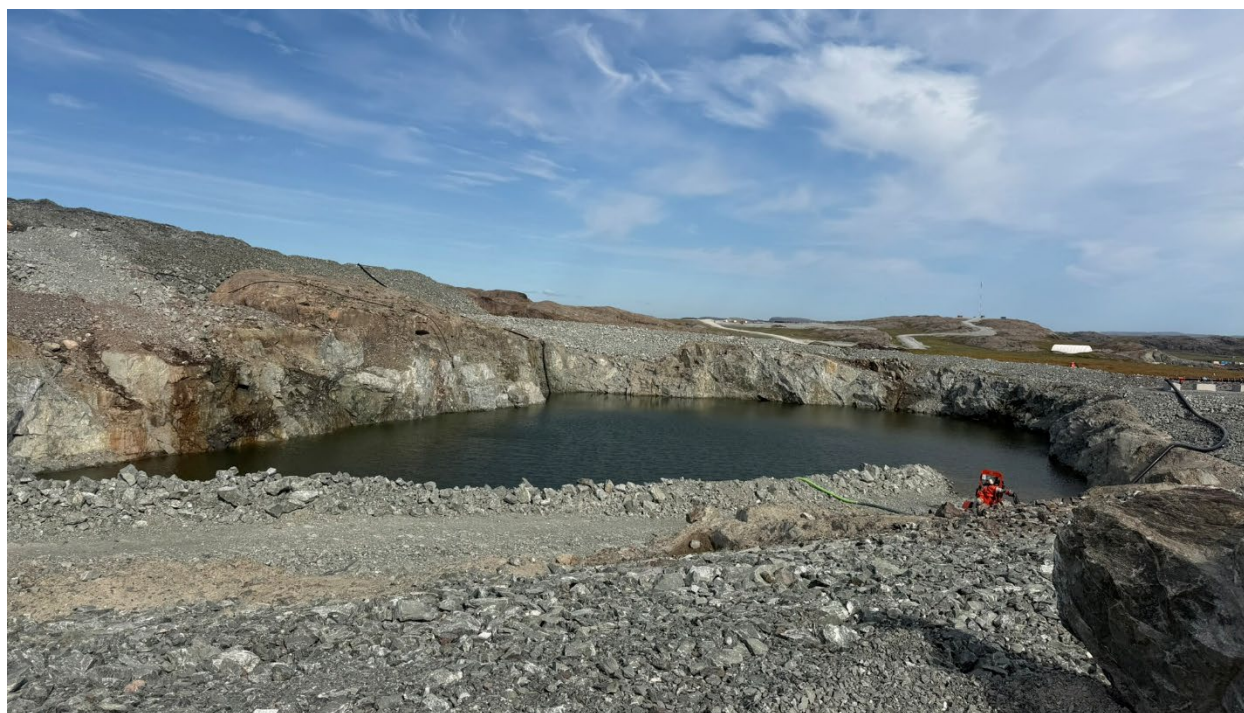
At the Madrid Waste Rock Storage Facility, NIRB staff observed the stormwater management sumps around the pile. At Contact Water Pond 2 (CWP2), the CWP2 sump collecting leakage and the planned replacement of CWP2 with Madrid North Sump 1C were discussed. The Emulsion Plant Pad, the Naartok East overburden stockpile, and the Madrid North weather station were also observed.

**Photo 80: CWP2 Sump - used for collecting leakage from Contact Water Pond 2**
