Appendix 6: 2022 Annual Geotechnical Inspection Report

2022 Annual Geotechnical Inspection Meliadine Gold Project, Rankin Inlet, Nunavut

FEBRUARY 17, 2023
ISSUED FOR USE
FILE: 704-ENG.EARC03140-31
AGNICO EAGLE DOCUMENT NUMBER: 65-600-230-TCR-001

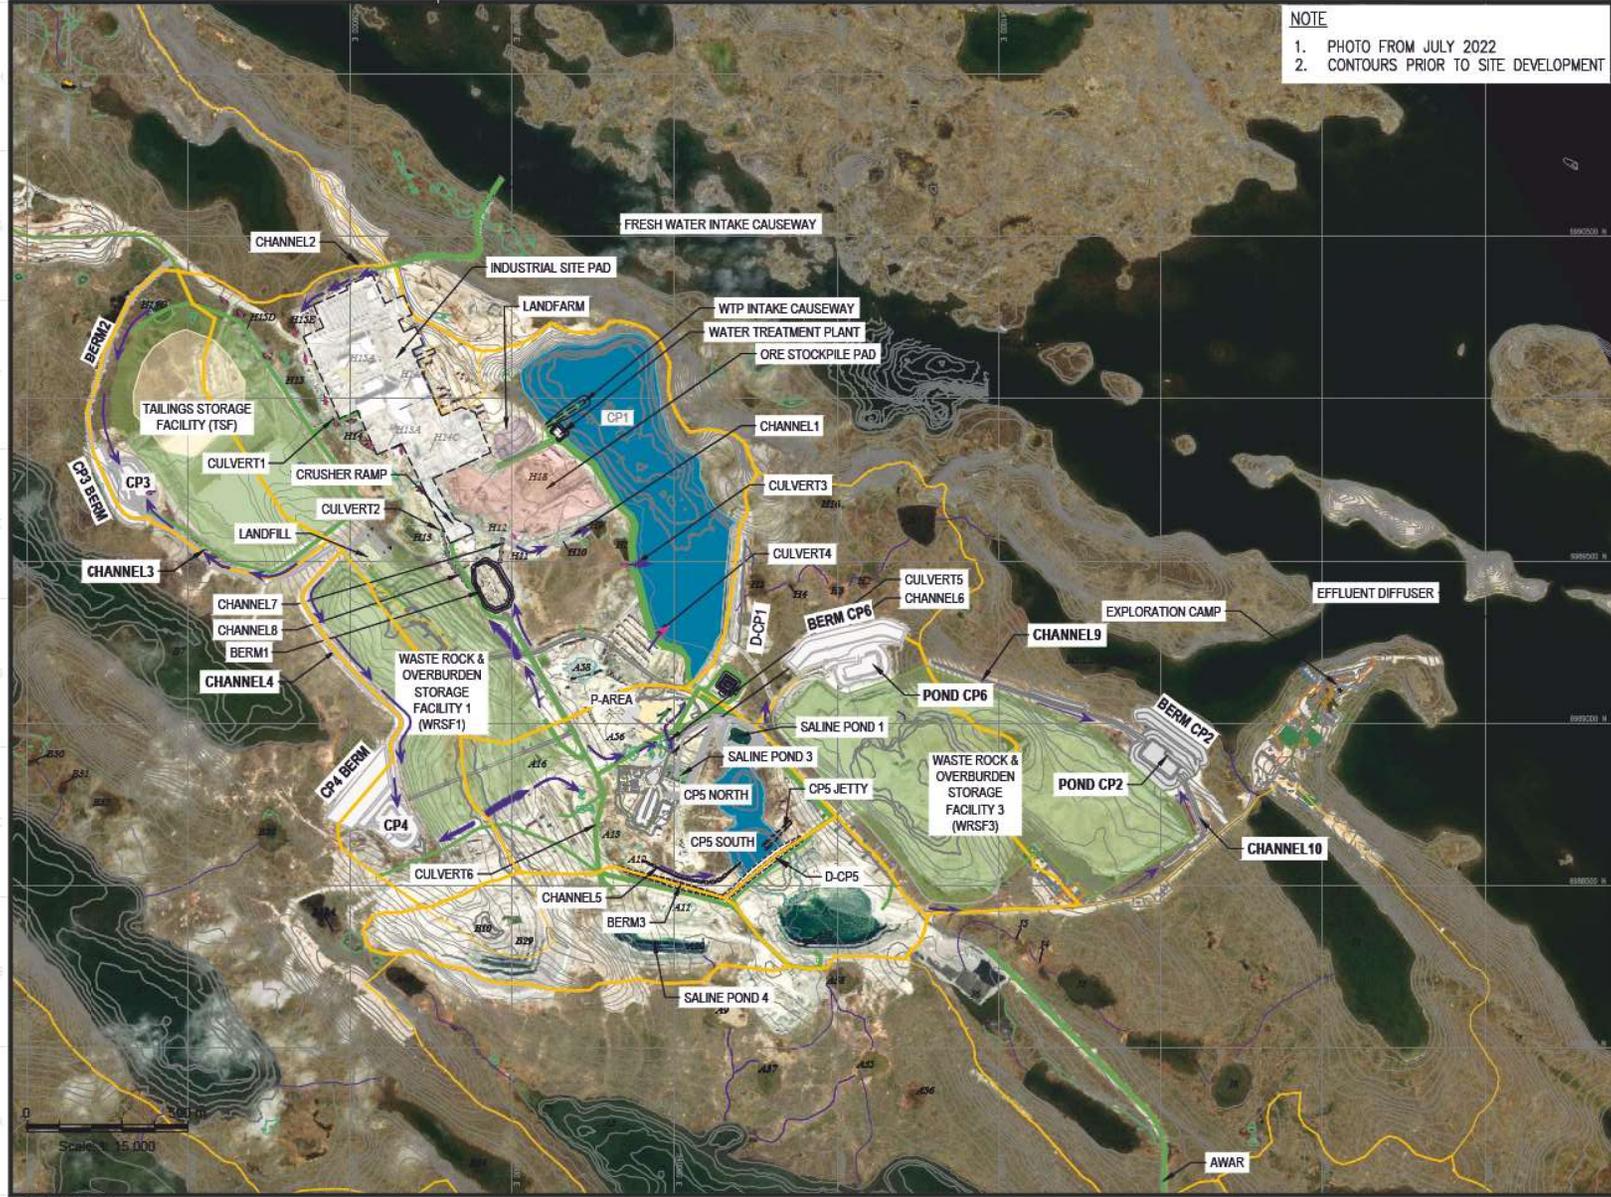
FIGURE 1
GENERAL SITE LAYOUT

NOTE
1. PHOTO FROM JULY 2022
2. CONTOURS PRIOR TO SITE DEVELOPMENT

The facilities at the main mine site and exploration camp areas are shown in Figure 1. The planned final layout of the main site, including water management structures is shown on Figure 2. It should be noted that some development for the project as shown in Figure 2, including Channel 6 are not expected to be constructed as shown.

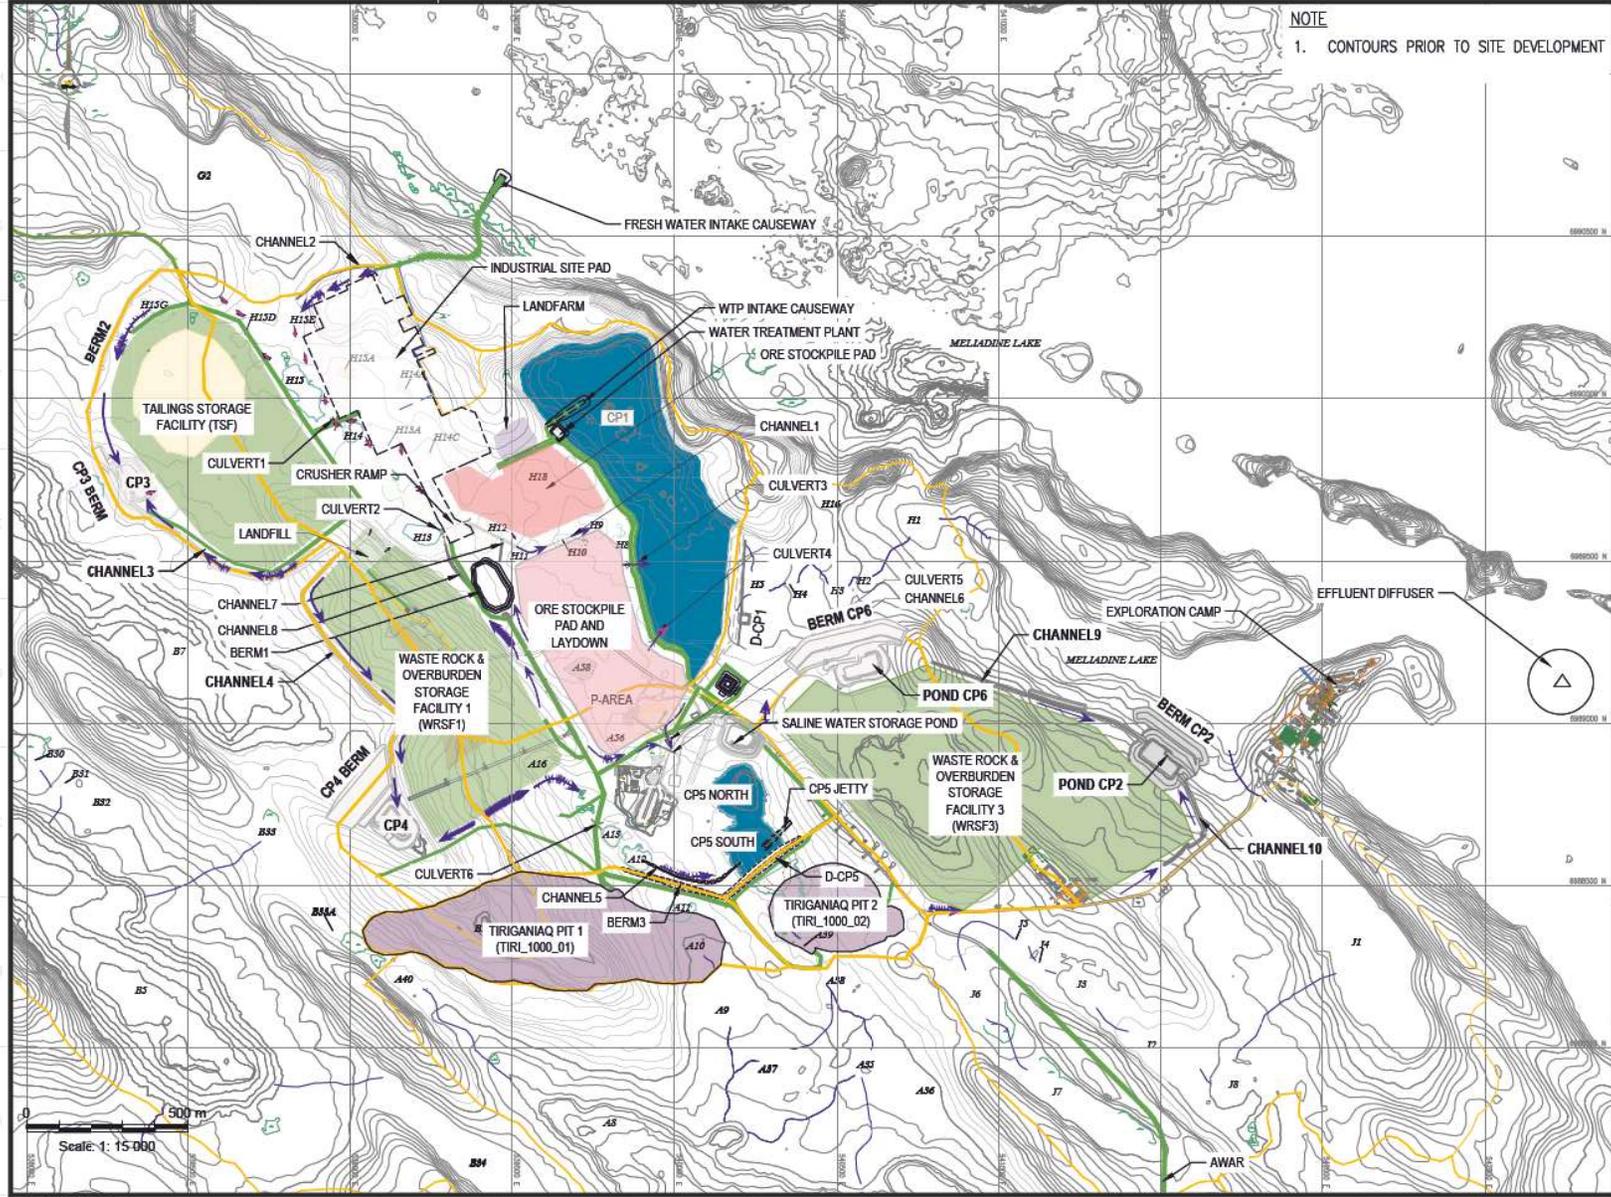
FIGURE 2
GENERAL SITE LAYOUT – YEAR 7

NOTE
1. CONTOURS PRIOR TO SITE DEVELOPMENT
