Meadowbank Tailings Storage Facility OMS Version 10

TAILINGS MANAGEMENT

**Operation, Maintenance and
Surveillance Manual**

Version 10
July 2021

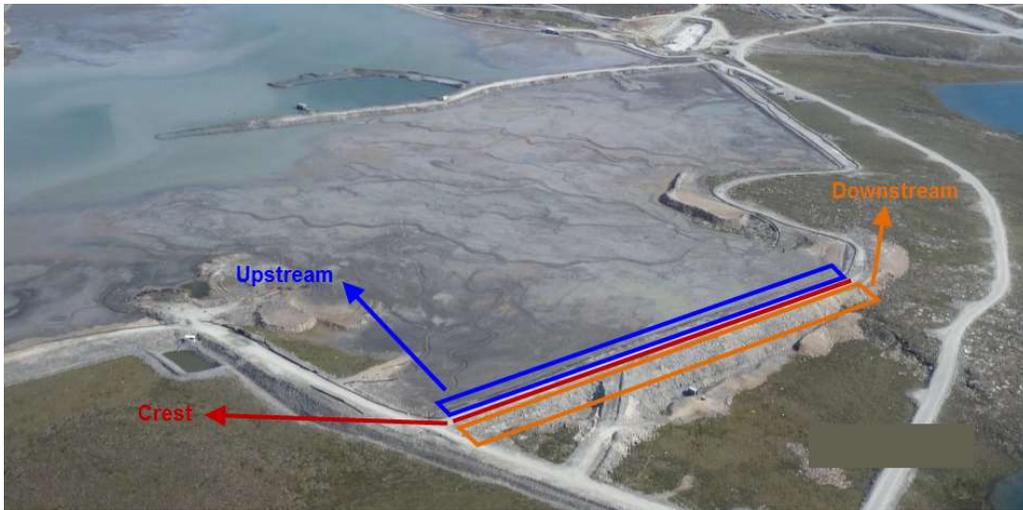
Figure 3-2 : Aerial View of Saddle Dam 1

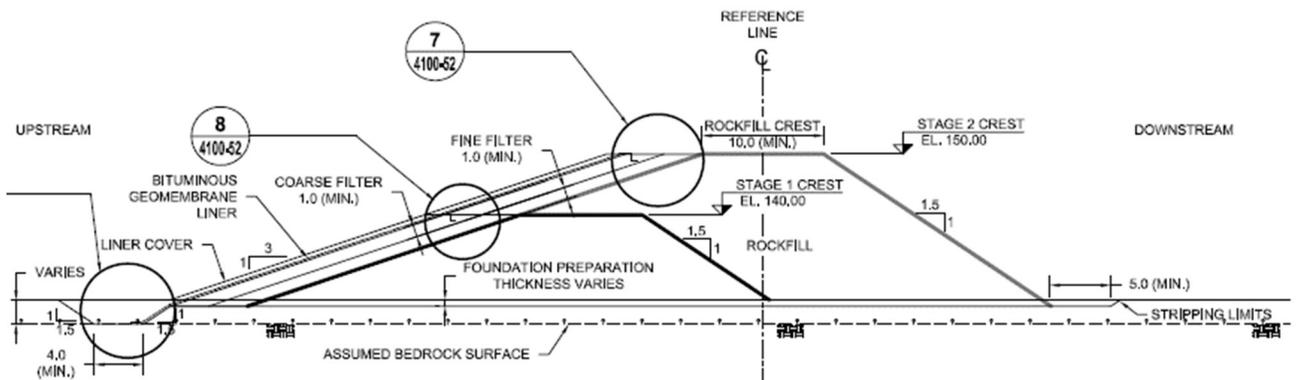
Figure 3-3: Typical Cross-section of Saddle Dam 1

Saddle Dam 1
Designer : Golder Construction Period : 2009-2010 (2 stage using downstream method) Operation Period : 2009 - 2026 Planned Closure Period : 2026-2042
Design Criteria: Refer to Table 3-2
Part of the TSF North Cell. Zoned rockfill dike with an upstream low-permeability element (LLDPE liner) with an upstream toe liner tie-in. The structure is in operation.
Operation Highlight <ul style="list-style-type: none"> North Cell inactive since 2019
No risk assessment performed on this structure Design Factor of Safety in Appendix B

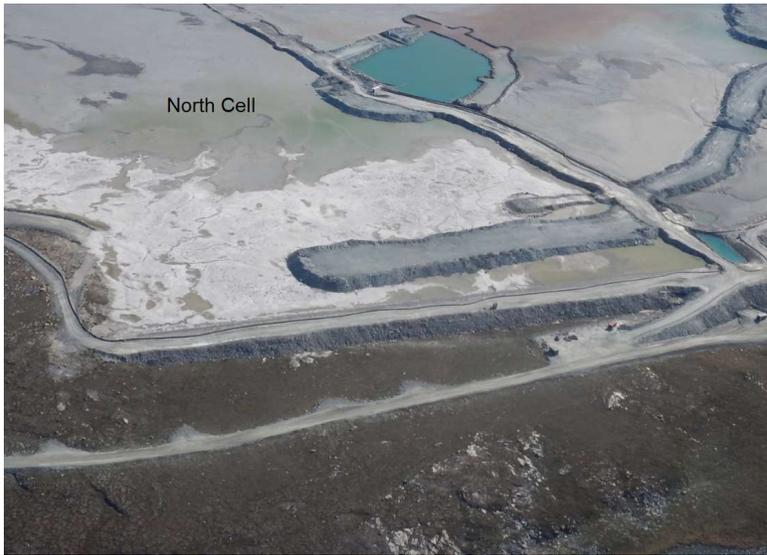
Figure 3-4 : Aerial View of Saddle Dam 2

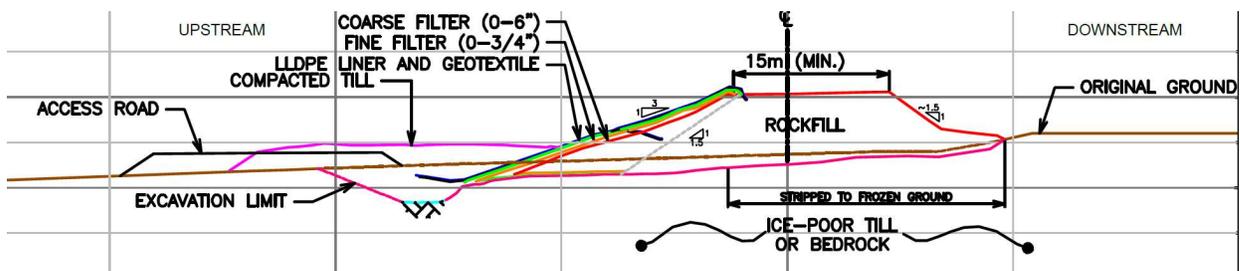
Figure 3-5: As-built Cross-section of Saddle Dam 2

Saddle Dam 2 was constructed in two stage to El. 150 m in 2010 and 2011. The upstream foundation of the dike and abutments are primarily founded on bedrock; however, some portions of the structure, underneath the inverted filter, are founded on ice-poor soil. During construction, a thin layer of low permeability till was placed and compacted along the toe liner tie-in connection with bedrock. A thin layer of crushed aggregate (0-22 mm) mixed with dry bentonite powder was also placed under the thin layer of low permeability till in areas where open fractures were observed within the bedrock. The toe liner tie-in was then covered with till.

Saddle Dam 2
Designer : Golder Construction Period : 2010 & 2011 Operation Period : 2011 - 2026 Planned Closure Period : 2026-2042
Design Criteria : Refer to Table 3-2
Part of the TSF North Cell. Zoned rockfill dike with an upstream low-permeability element (LLDPE liner) with an upstream toe liner tie-in. The structure is in operation.

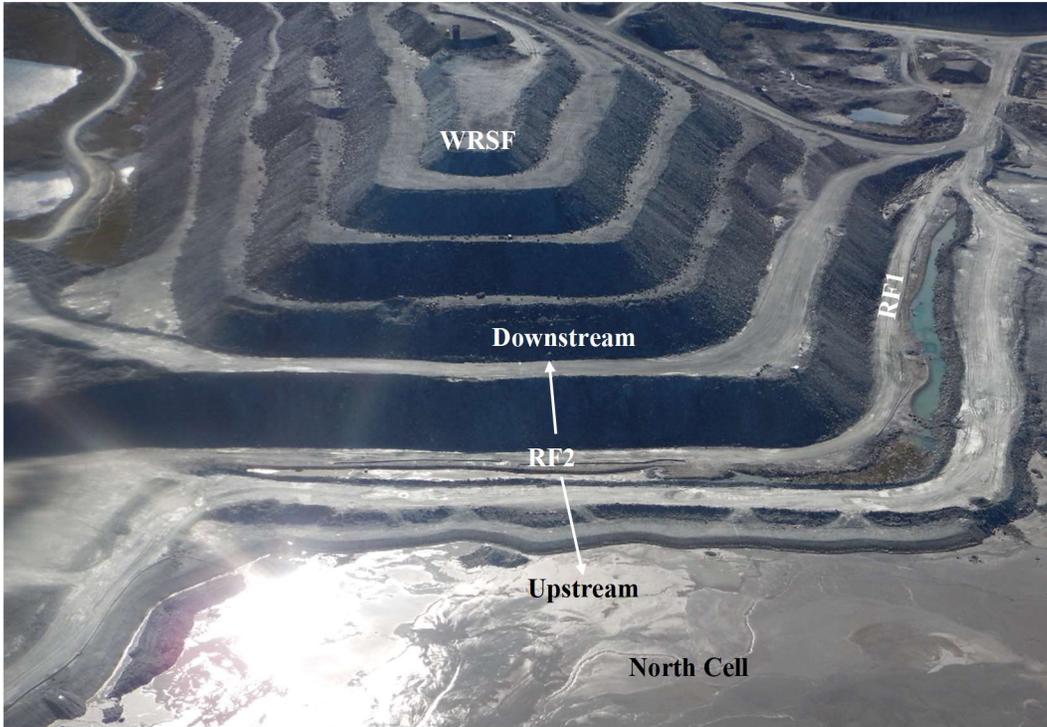
Figure 3-6 : Aerial View of RF1/RF2

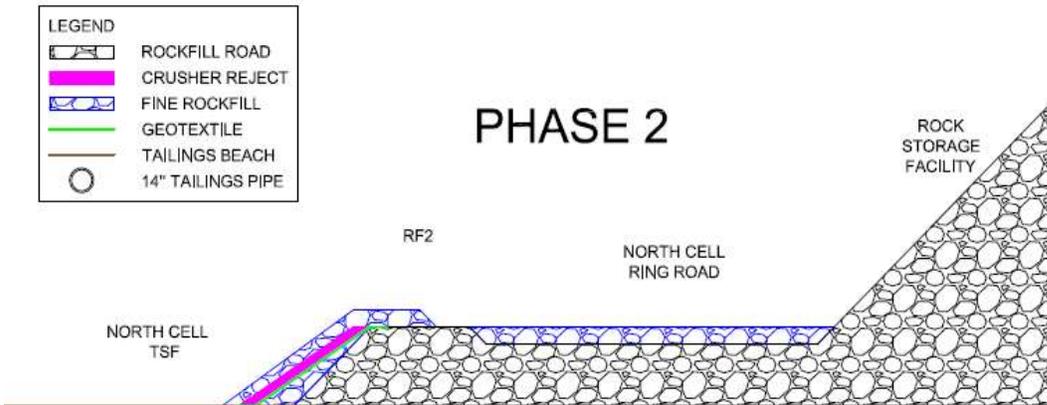
Figure 3-7: Typical Cross-section of RF1/RF2 (not representative of actual as-built condition of upstream filter)

These access roads were not designed as a containment structure but during the operation of the North Cell, water and tailings ponded against them. In June 2013 water going through these structures infiltrated the Portage WRSF and then reached Lake NP2. Following this seepage event, a filter system was constructed in August 2014 on the upstream side of RF1 and RF2 to promote the build up of a tailings beach and prevent water exfiltration from the TSF at that location. The constructed filter berm consisted of till and/or coarse filter, geotextile and fine filter. Since the construction of that structure a

RF1/RF2
Designer : AEM
Construction Period : 2009 & 2010 (rockfill road) / 2014 (upstream filter)
Operation Period : 2013 - 2026
Planned Closure Period : 2026-2042
Design Criteria : No documented design criteria
Part of the TSF North Cell. Rockfill dike/road with an upstream filter. The structure is in operation.
Operation Highlight
<ul style="list-style-type: none"> • Seepage observed in 2013 from this area. Upstream filter added in 2014 to promote tailings beach build-up • North Cell inactive since 2019
No risk assessment performed on this structure
Design Factor of Safety in Appendix B

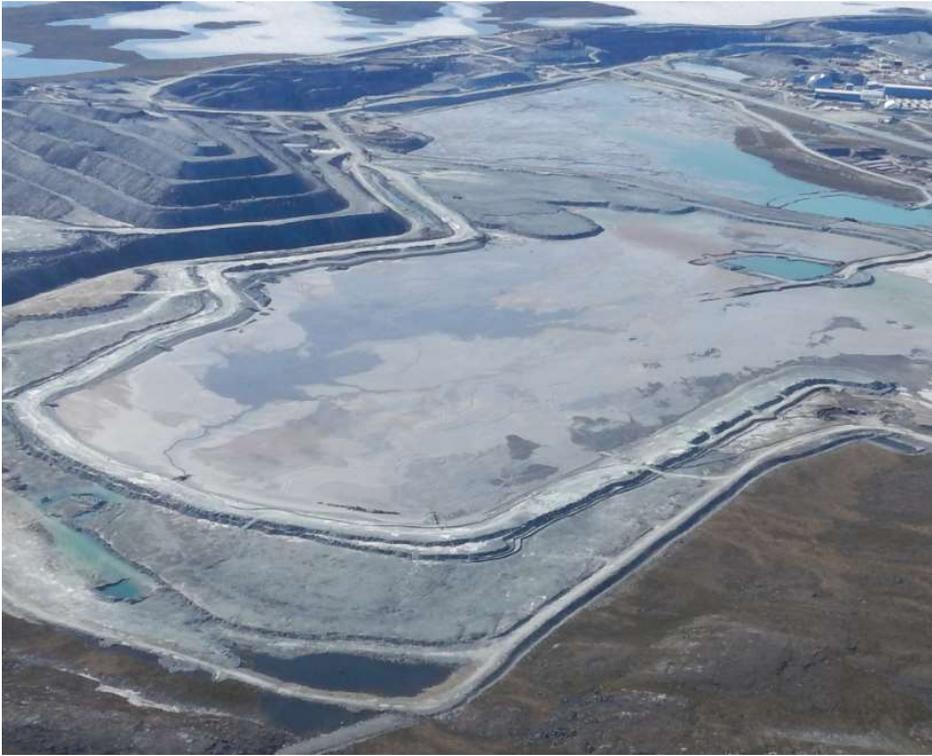
Figure 3-8 : Aerial View of the North Cell Internal Structure

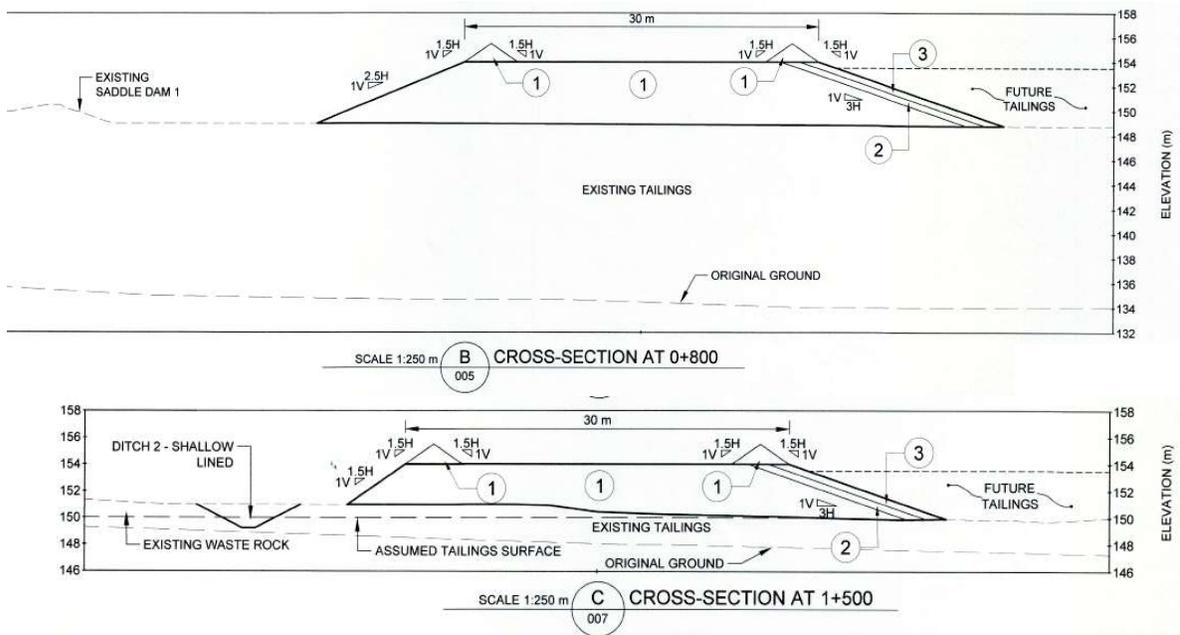
Figure 3-9: Typical Cross-section of the North Cell Internal Structure

Channelling of water has been observed since 2019 at the upstream toe of the eastern part of the dike. The water flow is eroding fine filter material at the toe. Sloughing, deformation and tension cracks in the upstream filter layer has been observed since 2020 in the eastern area and are caused by water eroding and undercutting the toe of the filters.

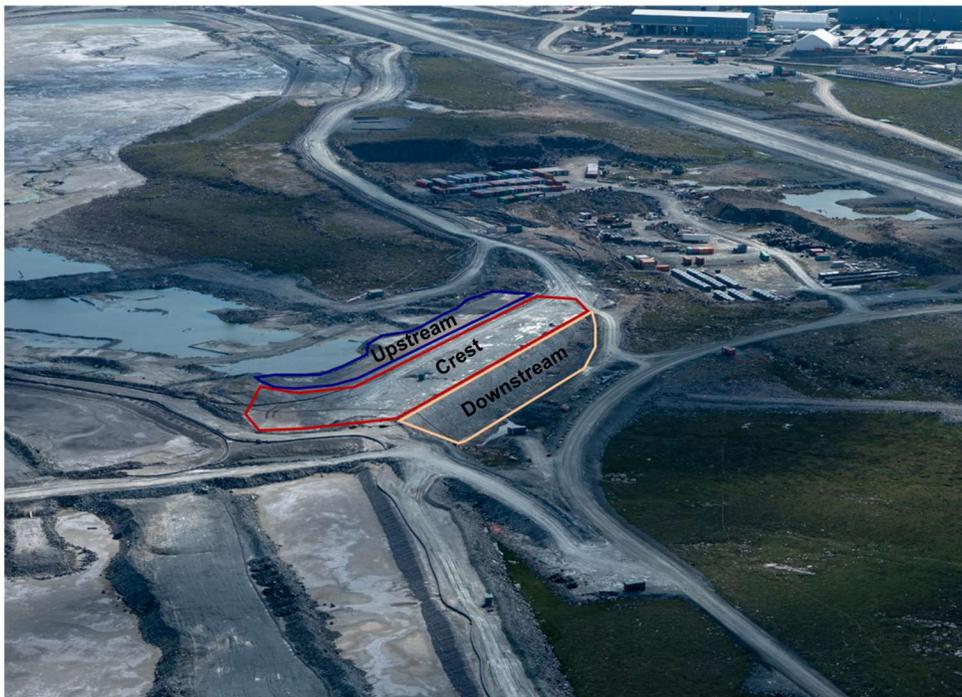
Figure 3-10 : Aerial View of Saddle Dams 3

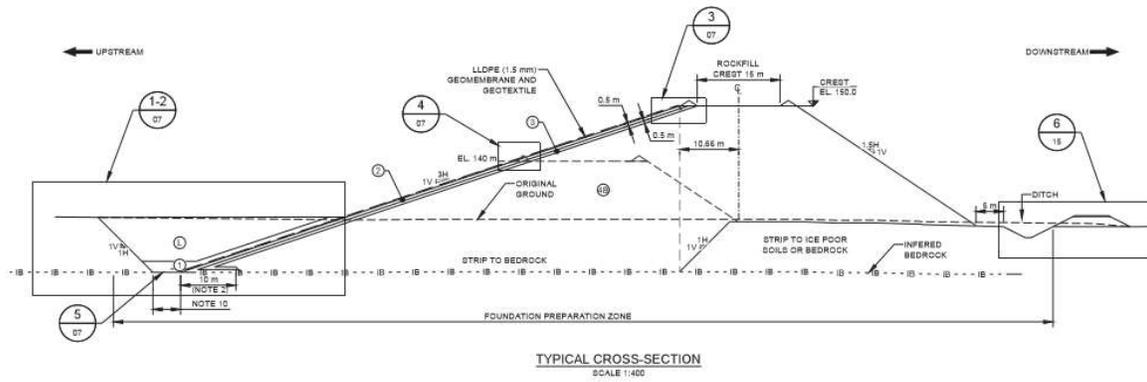
Figure 3-12: Typical Cross-section of the Saddle Dams 3/4/5

Saddle Dams 3, 4, and 5 are designed and constructed as zoned rockfill dams with filter zones, low permeability upstream liners, and upstream toe liner tie-in key trenches. Cross-sections of Saddle Dams 3, 4 and 5 consist of a rockfill embankment, constructed from run-of-mine waste rock, placed in lifts and compacted. The upstream faces are designed at a 3H:1V slope and the downstream faces are designed at a 1.5H:1V slope. The upstream faces of Saddle Dams 3, 4 and 5 are comprised of two granular filter zones and a LLDPE liner extending along the upstream foundation. The filter zones are meant to keep the tailings inside the facility in a case of liner puncture, but mainly act as appropriate bedding for the liner. An upstream liner tie-in key trench excavated to bedrock and filled with compacted till is located along the upstream area of the structures.

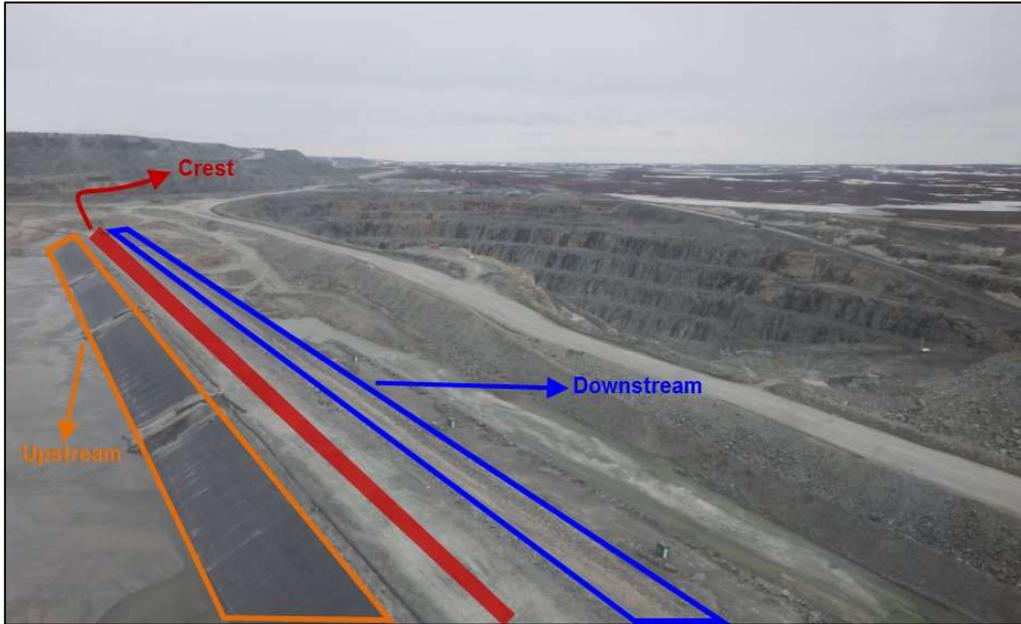
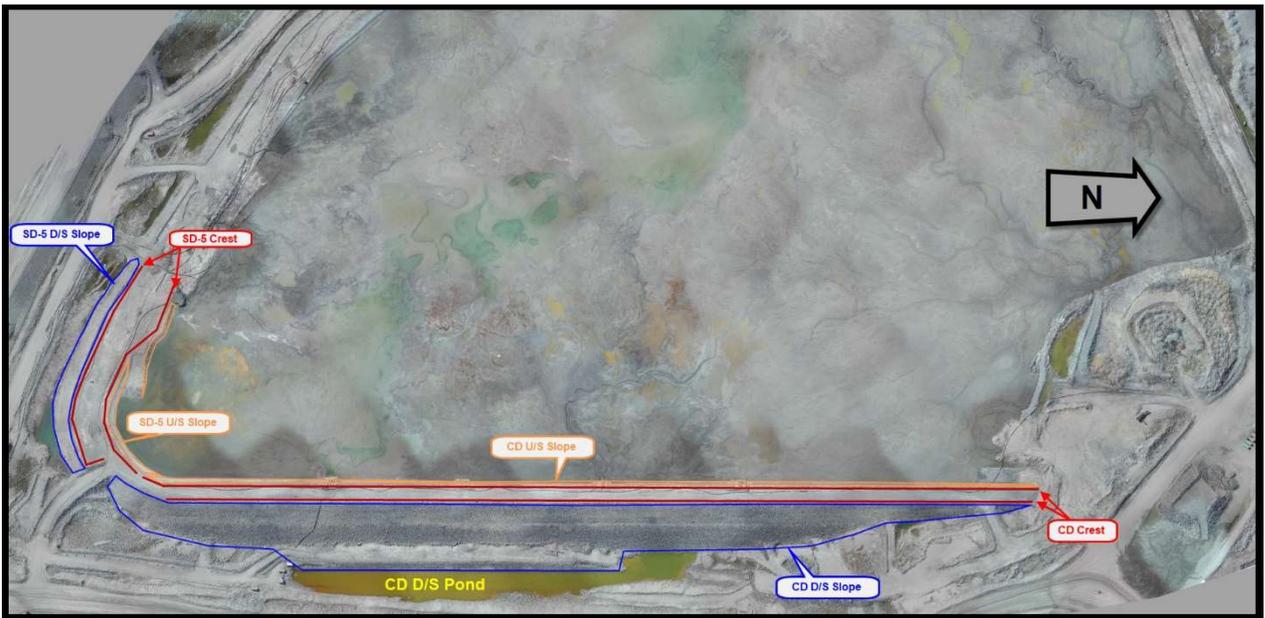
Figure 3-13 : Aerial View of Central Dike and SD5

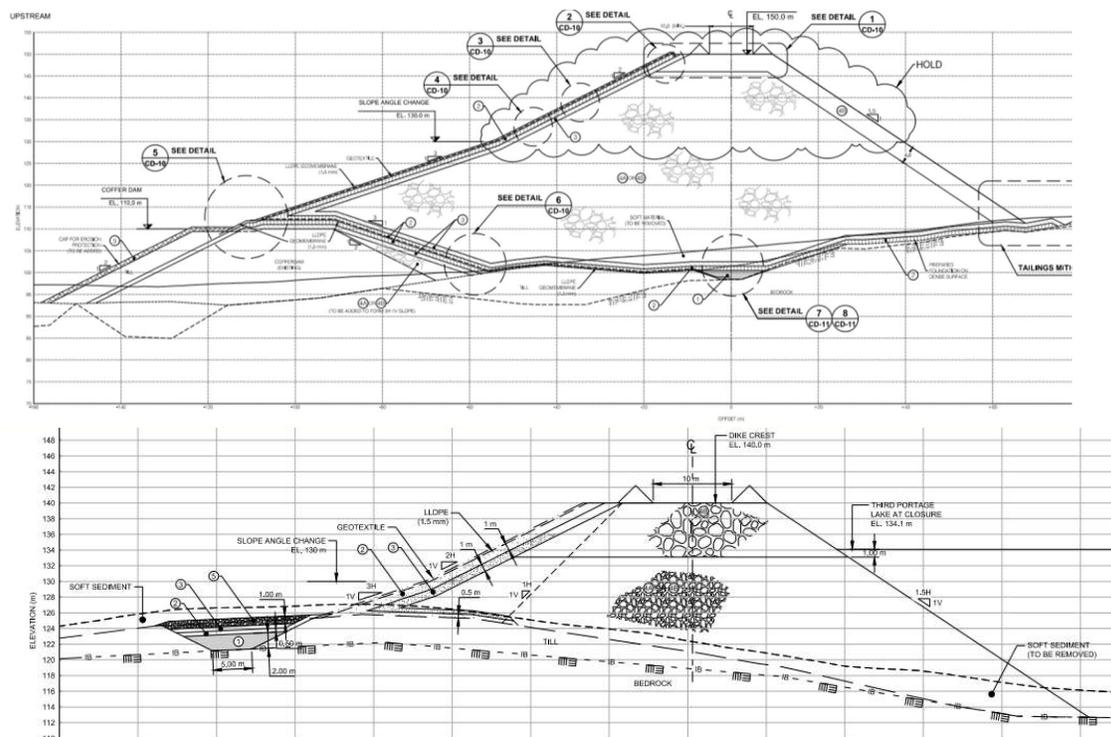
Figure 3-14: Typical Cross-sections of the Central Dike (top: highest dike section, bottom: section with upstream liner tie-in).

Central Dike design includes a compacted rockfill embankment with an upstream seepage barrier, granular filters and a key trench along the centerline of the dike transitioning on the upstream toe near both abutments. The foundation soils include lakebed sediments and till overlying bedrock. Soft and ice-rich soils were removed from the Central Dike footprint during construction.

Central Dike is designed to be able to be raised to El. 150 m and the final crest elevation is subject to review by AEM. The completed crest length is approximately 900 m.

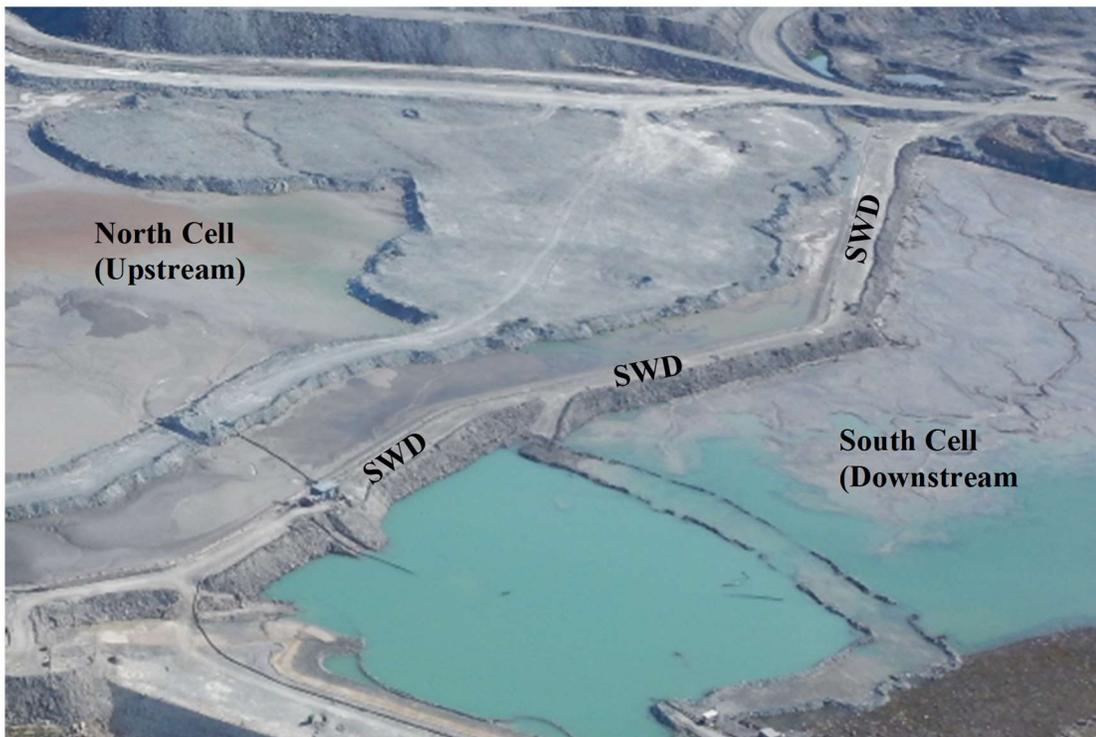
Figure 3-15 : Aerial View of Stormwater Dike (2019)

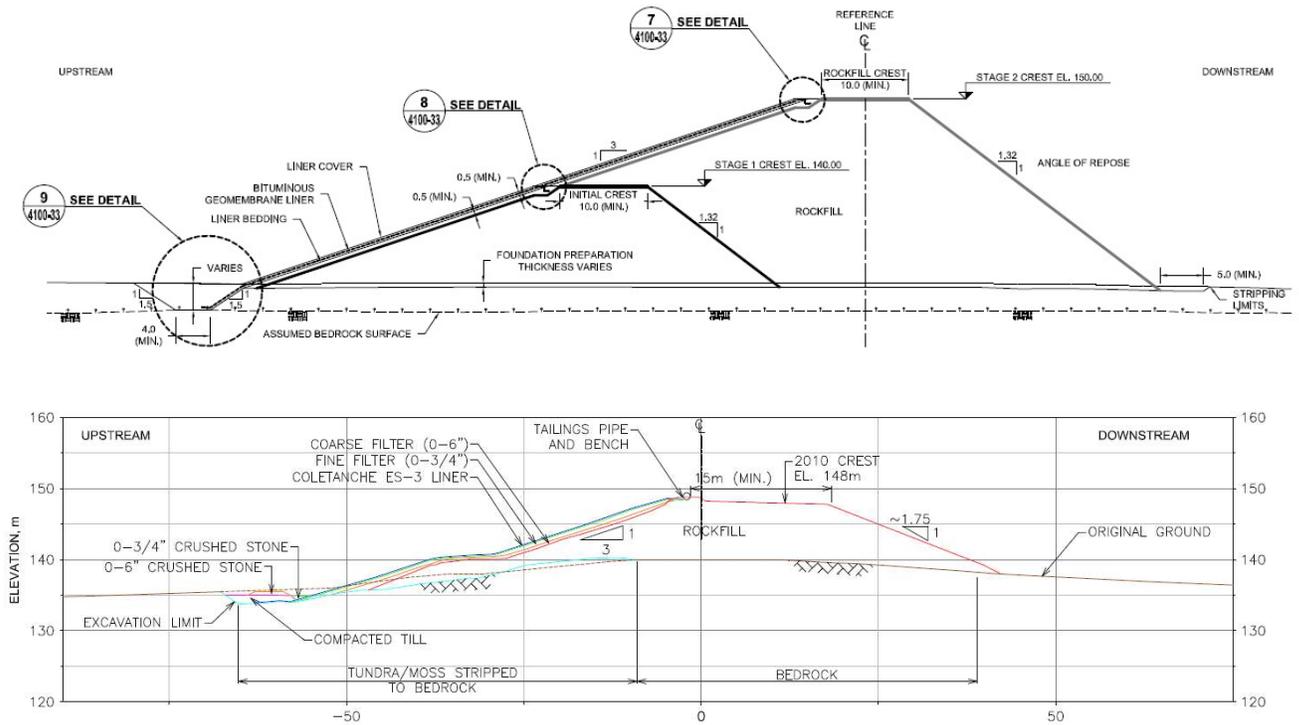
Figure 3-16: Typical Cross-section of Stormwater Dike (top). As-built section of Phase 2 (bottom)

Stormwater Dike is a rockfill embankment structure founded on lakebed soils. The upstream slope is approximately 3H:1V and the downstream slope is about 1.3H:1V. A bituminous geomembrane liner has been installed above the graded filters on the upstream face of the dike. Low permeability till was placed and compacted along the upstream toe of the dike, above the liner. Stormwater Dike was initially designed as a temporary structure that would be encapsulated in tailings to equal elevation on both side. With the change in tailings deposition strategy there is a 5 m difference in tailings elevation between the upstream and downstream area and this structure cannot be considered as a temporary one anymore.

The majority of the dike is seated on dense till from the former lakebed within the talik while the abutments are generally founded on bedrock. The foundation preparation of Stage 2 was completed in winter conditions. It was generally done above water except in an area where water ponding was present (between Sta.10+500 and 10+750 approximately). This pond was located where the topography suggests that the soft lakebed sediment thickness may be greater than at other locations along the dike. Due to the presence of water, the ice crust was cracked with the excavator and only minimal foundation preparation was possible. As a result, most of the lakebed sediment probably remained in place in this area.

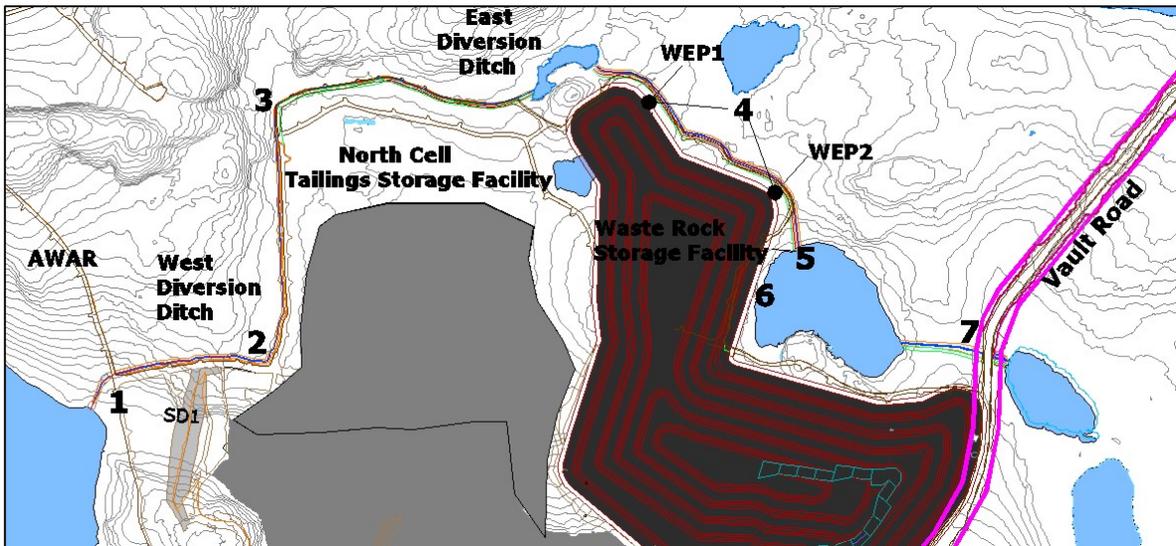
Figure 3-17 – Diversion Ditches and related infrastructure

The diversion ditches (West and East), located around the perimeter of the North Cell TSF and the Portage RSF, are designed to collect the non-contact water runoff from the surrounding watershed before they reach the TSF area. The ditches are composed of the west section that divert water to the western interception sump and then Portage Lake and the east sections that divert water to NP2 Lake and then from another section to NP1-N Lake. These ditches were constructed in 2012 and are 2622 m long. In the summer of 2014 and 2015 sloughing damage and erosion damage were observed in the channel slopes. These events were corrected by reprofiling the channel slope and adding additional material. Since then the North Cell diversion has been performing adequately.

After flowing through the AWAR culvert the water discharges across the tundra into Third Portage Lake. WEP1 and WEP2 sumps were constructed in September 2015 to manage water around the northeast side of the RSF and to ensure that all water ponding behind the RSF is transferred back to the North Cell TSF. Water collected at WEP1 is pumped to WEP2 which in turn is pumped to ST-16 (RSF seepage pumping system). Water collected at the latter is pumped back into the North Cell TSF. These infrastructures are shown in Figure 3-17.

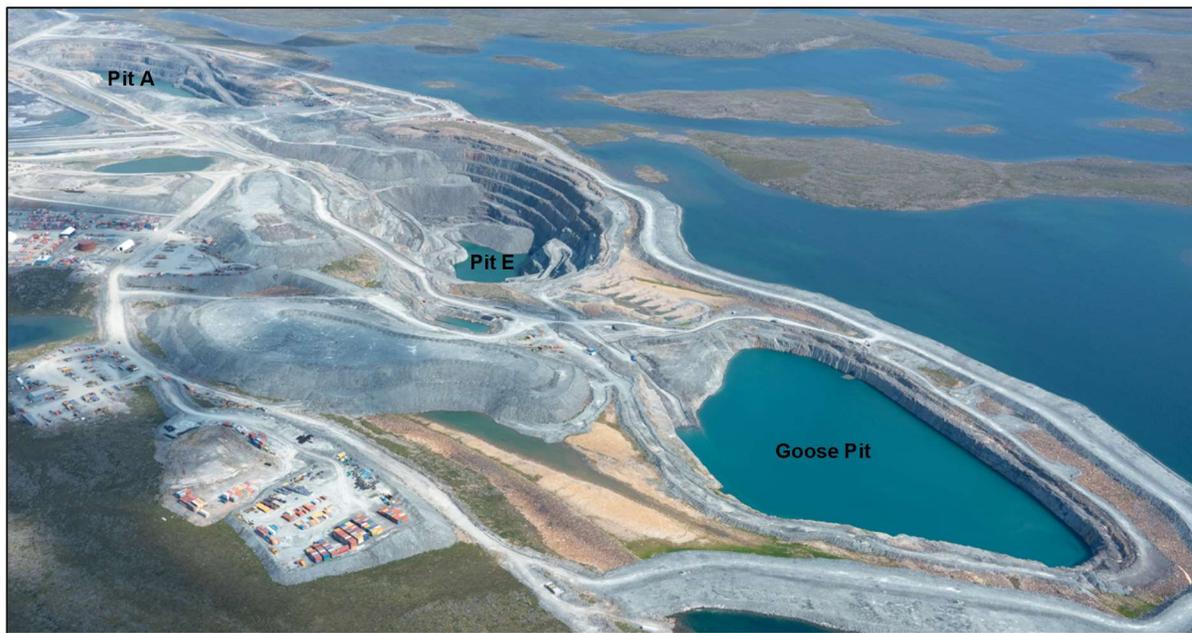
Figure 3-18: In-Pit Area for Tailings Management (Summer 2020)

In-Pit tailings deposition has started in the summer of 2019 with the deposition of tailings in Goose Pit. Deposition of tailings has switched to Portage Pit E in the fall of 2020. Water is reclaimed to the mill from Pit A. Water is transferred from Goose Pit to Pit A as required.

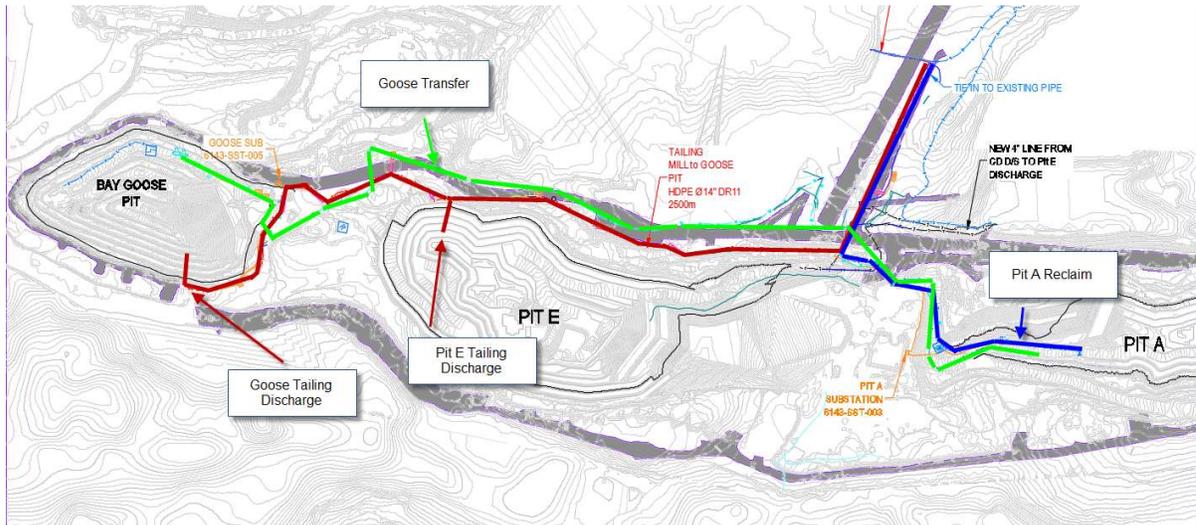
Figure 3-19: Plan view of In-Pit Area and Related Infrastructure (as of Fall 2020)

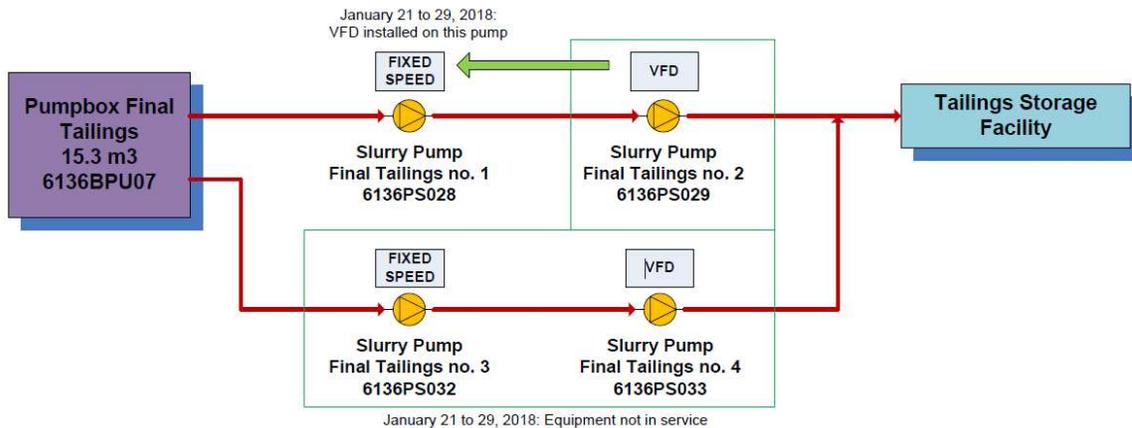
Figure 3-20: Schematic Diagram of the Final Tailings Installation System at the Process Plant

From the tailings pumpbox tailings are pumped to designed tailings management area using the process plant tailings slurry pumps. A simplified flow sheet of the process plant flow diagram is included in Appendix C. A schematization of the tailings pumpbox system is included in **Error! Reference source not found..**

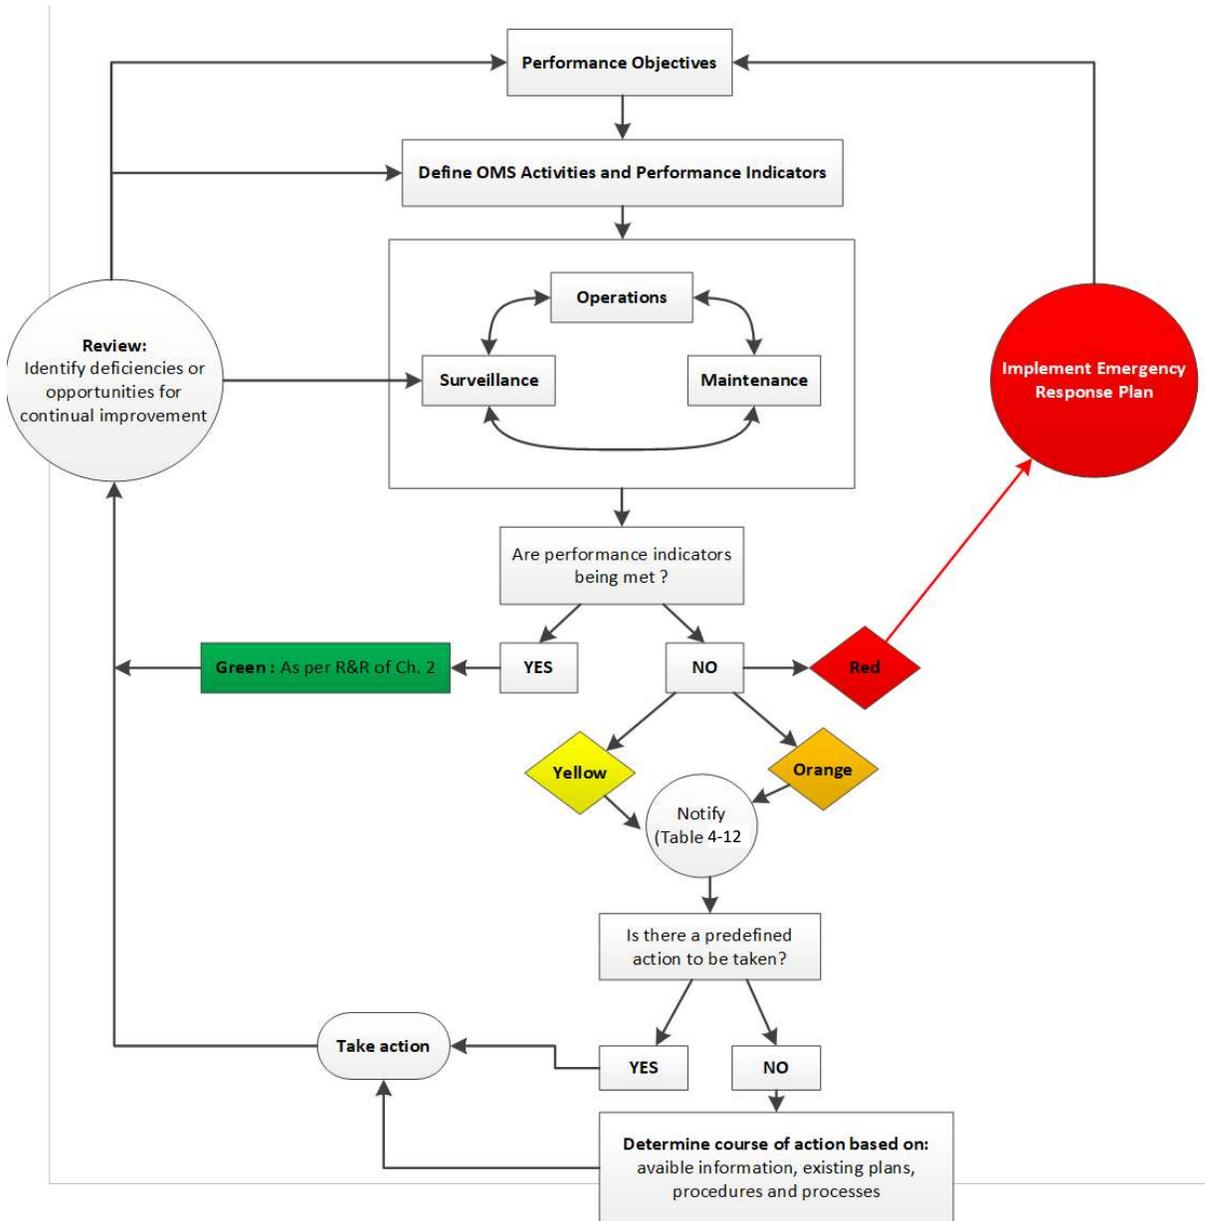
Figure 4-1: Communication and Decision Process for Water Management Infrastructure TARP

Error! Reference source not found. indicates the communication and decision processes when the threshold criteria are met and when pre-defined action need to be implemented. Table 4-13 indicates the communication procedure to follow when changing the TARP level.

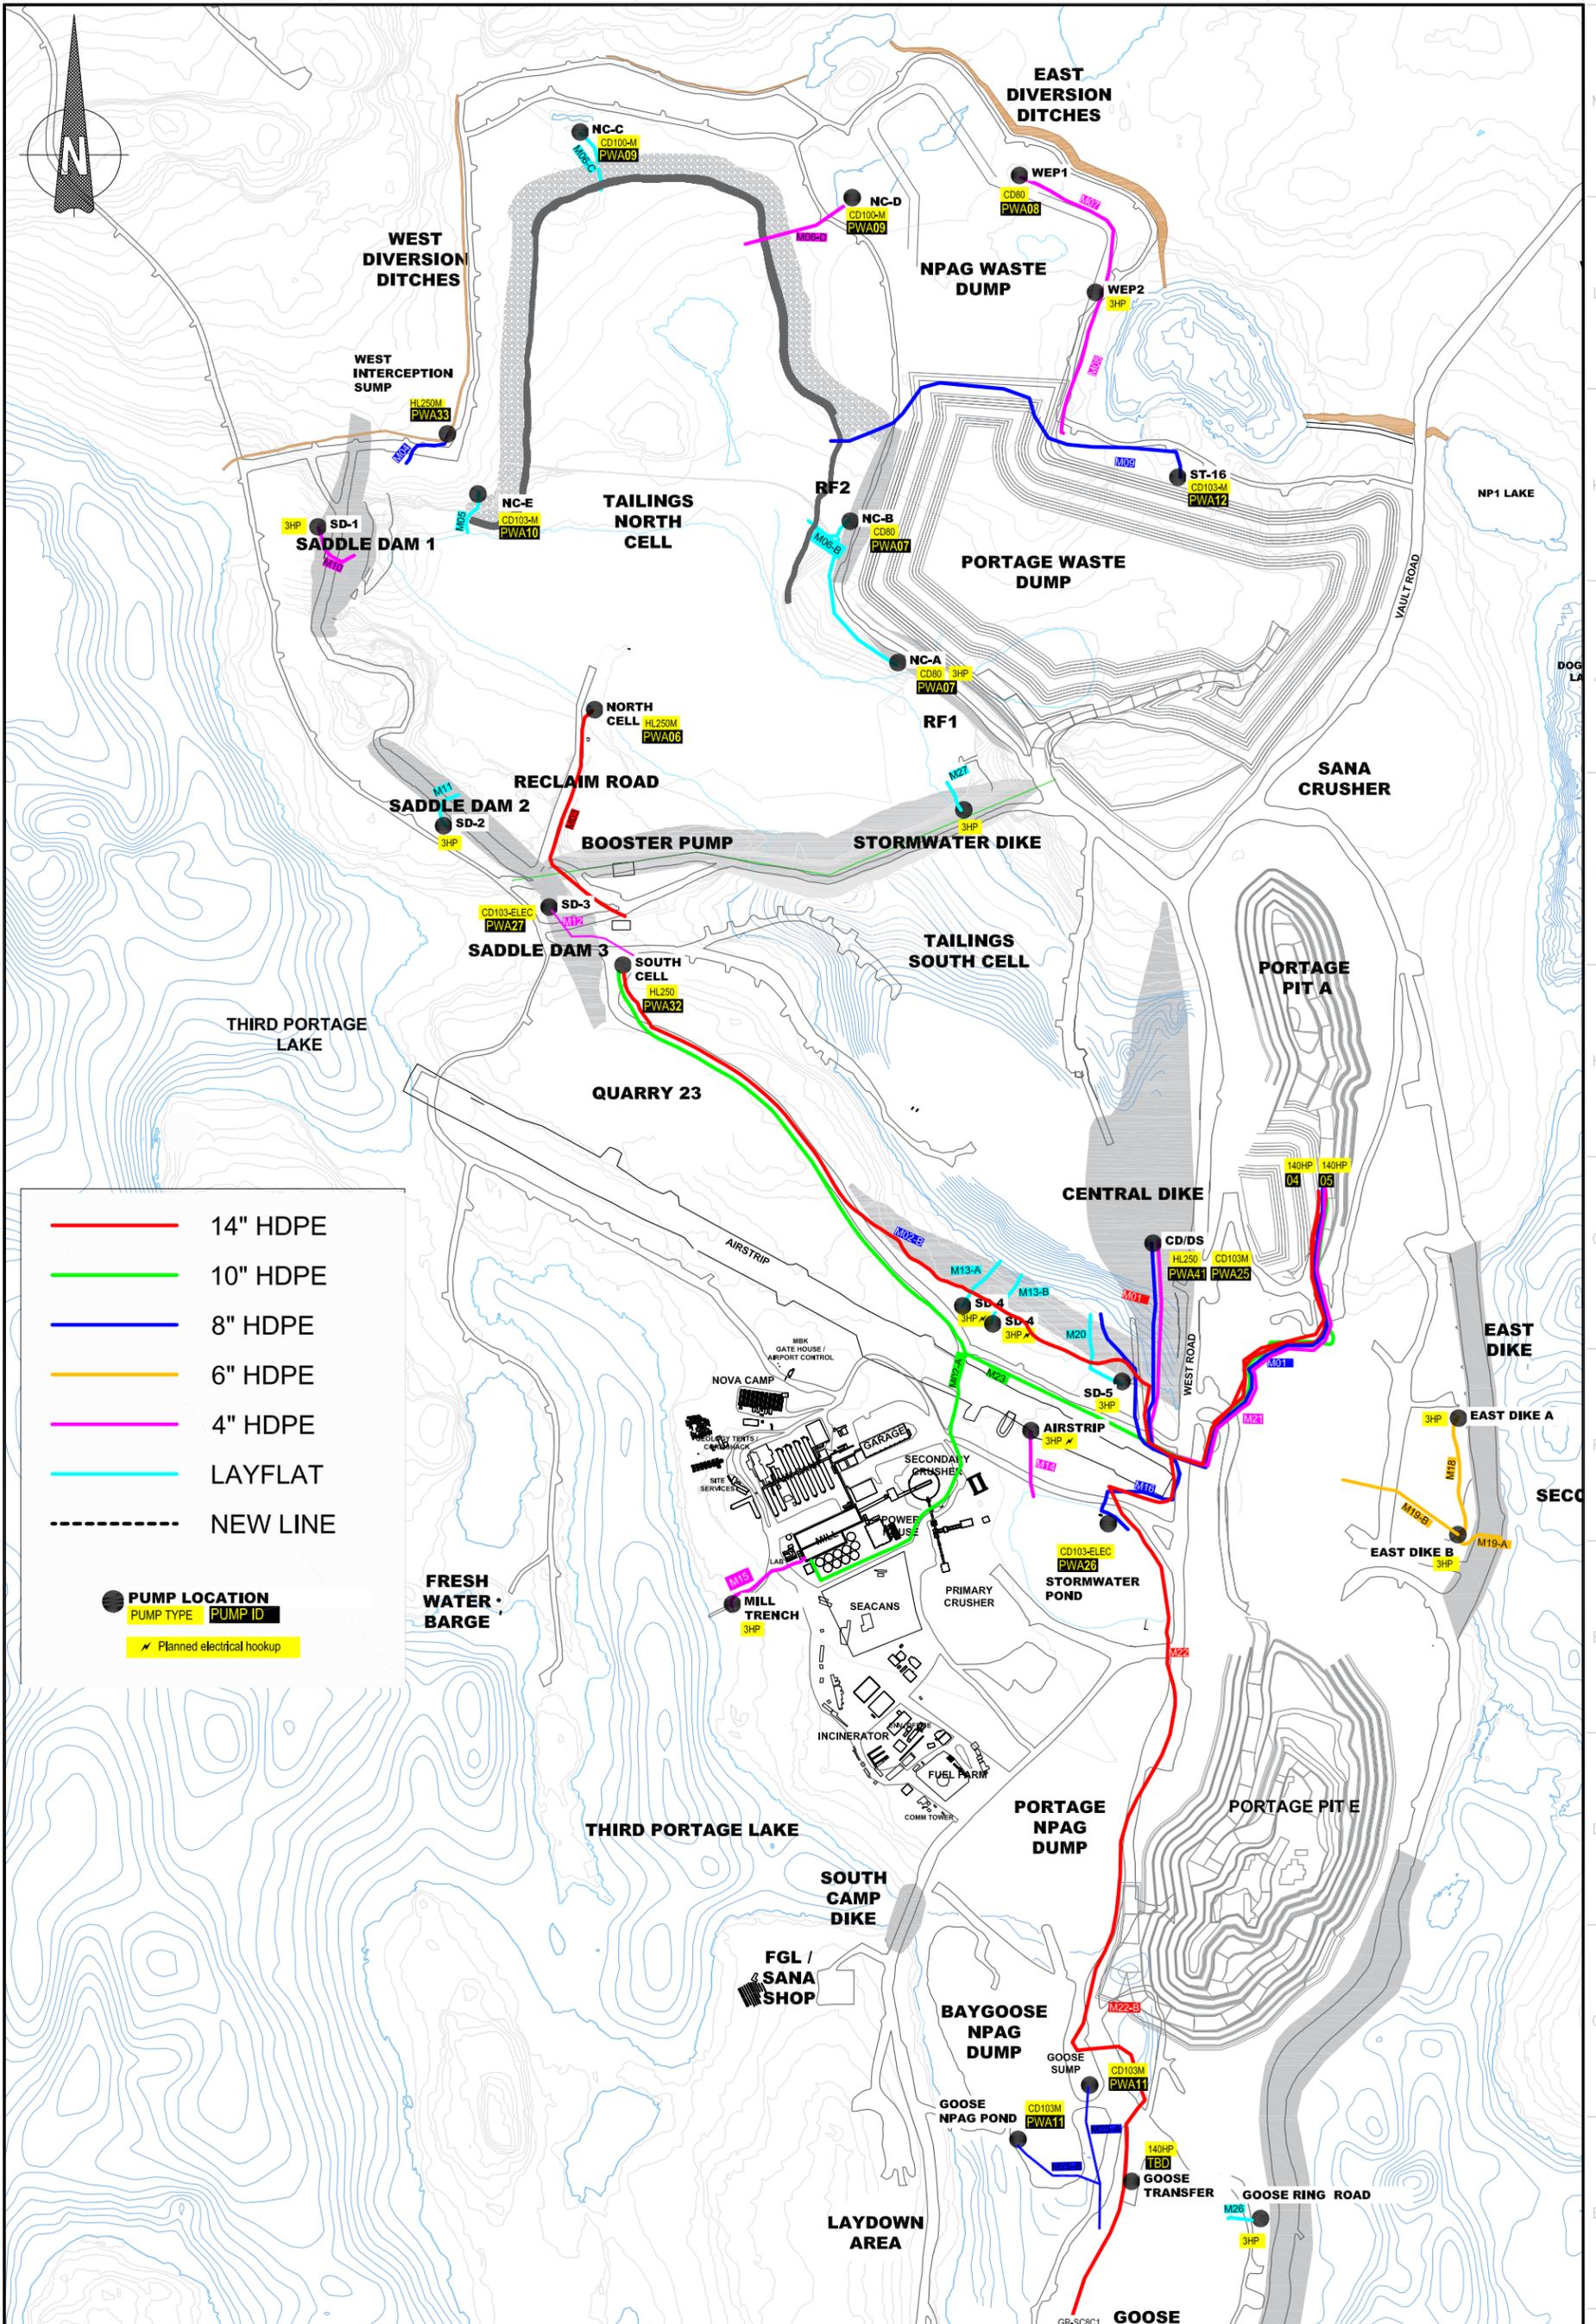
Meadowbank 2021 Detailed Freshet Flowsheet

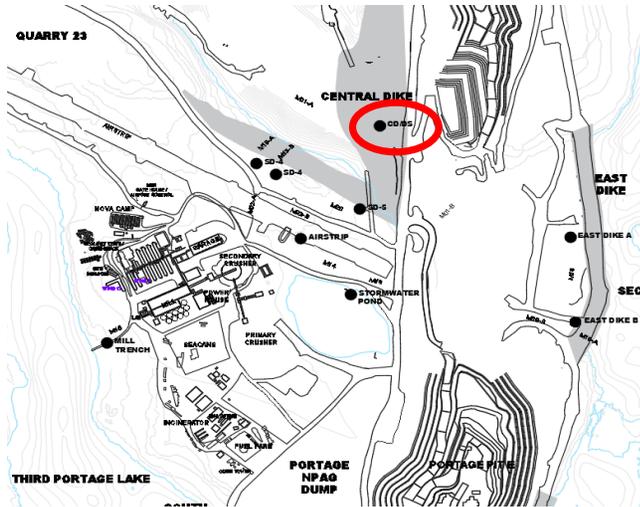
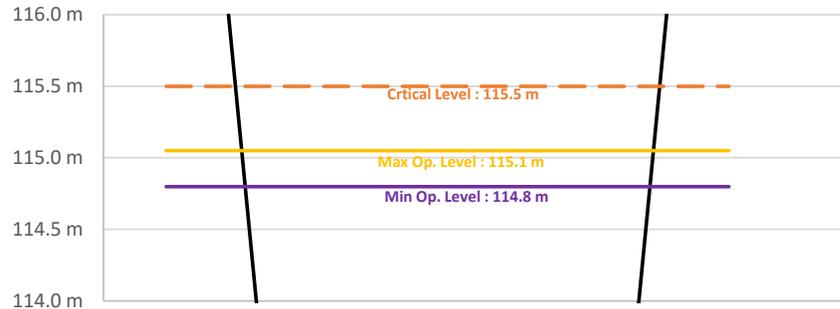
Central Dike D/S Pond - Operational Guidelines

Critical Level : 115.5m
Max Op. Level : 115.1m
Min Op. Level : 114.8m
Approx Bottom : 107.0m

Base of West Road (116 m) : Flooding of pump pad and potential for West Road instability and uncontrolled flow into Portage Pit A. Deploy measure to ensure infrastructure integrity.

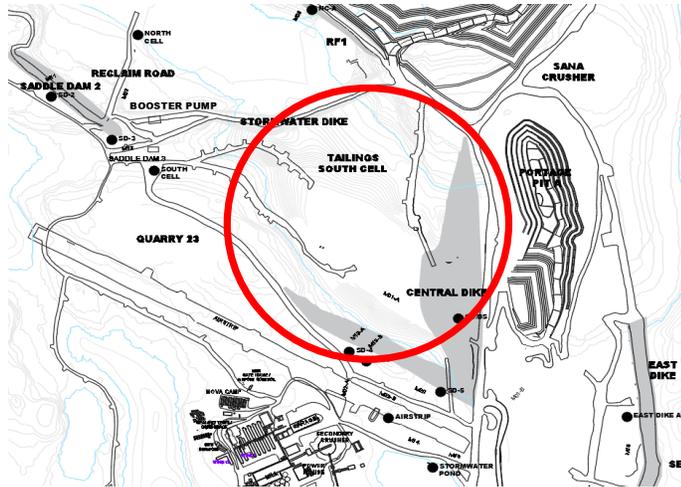
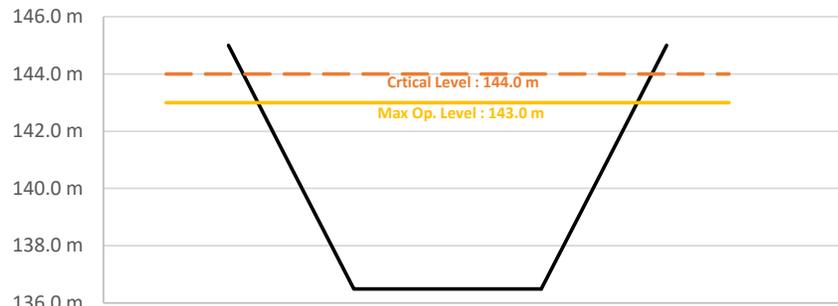
South Cell - Operational Guidelines

Critical Level : 144.0m
 Max Op. Level : 143.0m
 Approx Bottom : 136.5m

South Cell Dike Liner Elevation (145 m) : Dike crest overtopping, spill into site. Deploy mesure to contain spill, ensure structure integrity and ensure worker safety.

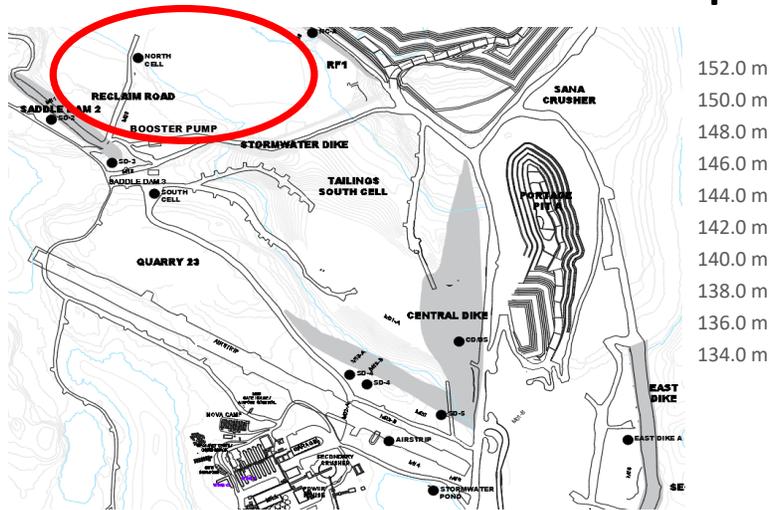
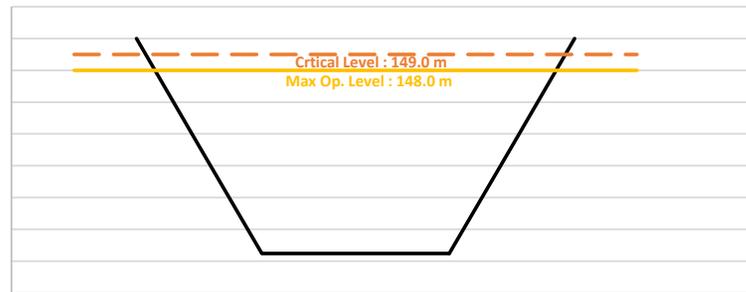
North Cell - Operational Guidelines

Critical Level : 149.0m
Max Op. Level : 148.0m
Approx Bottom : 136.5m

North Cell Dike Liner Elevation (150 m) : Dike crest overtopping, spill into Env and South Cell. Deploy measure to contain spill, ensure structure integrity and ensure worker safety.

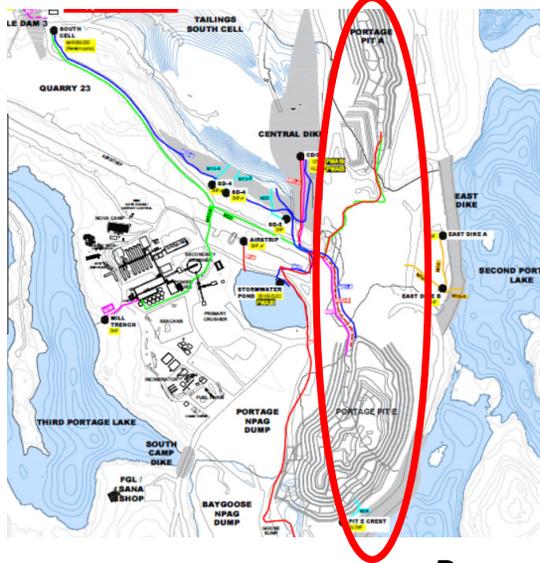
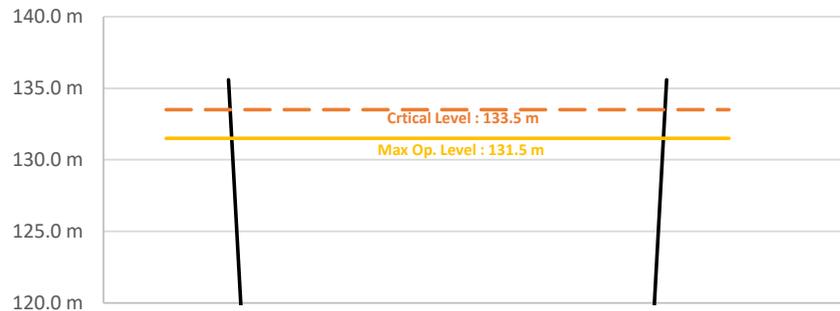
In-Pit Tailings Deposition - Operational Guidelines

Critical Level : 133.5m
Max Op. Level : 131.5m
Approx Bottom : -24.0m
