Meadowbank Tailings Storage Facility OMS Version 10

TAILINGS MANAGEMENT

**Operation, Maintenance and
Surveillance Manual**

Version 10
July 2021

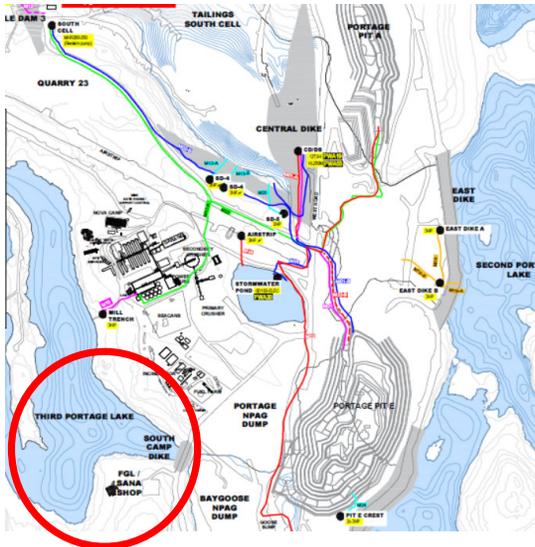
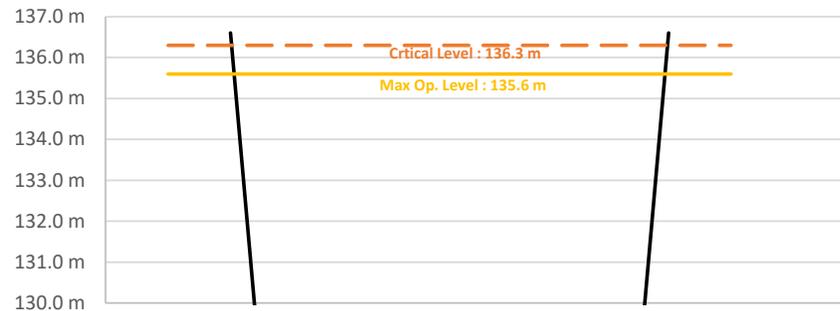
Third Portage Lake - Operational Guidelines

Critical Level : 136.3m
 Max Op. Level : 135.6m
 Approx Bottom : 102.0m

Above Max Op. Level (135.6 to 136.3 m) : Investigate cause. Inform stakeholder as per communication chart. Liner installed at El.136.1 m. Engineering, E&I and Env to develop path forward with Water & Tailings Superintendent.

South Camp Dike Thermal Cap (136.6 m) : Overtopping of thermal cap of South Camp Dike. Uncontrolled inflow into site. Deploy measures to ensure structure integrity and protect workers.

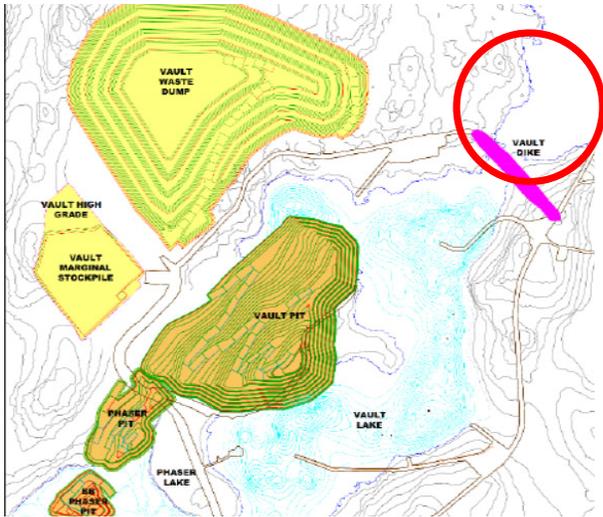
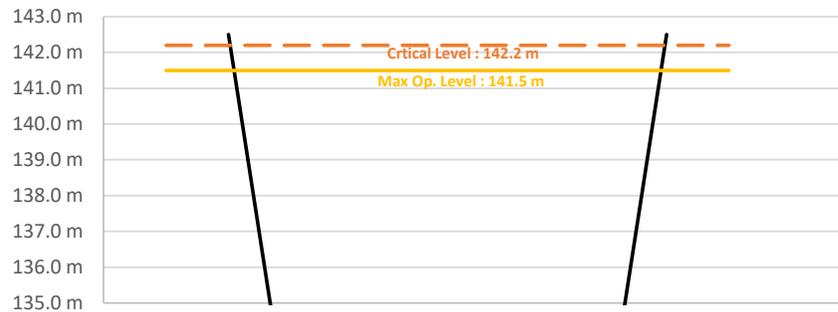
Wally Lake - Operational Guidelines

Critical Level : 142.2m
Max Op. Level : 141.5m
Approx Bottom : 120.0m

Above Max Op. Level (141.5 to 142.2 m) : Investigate cause. Inform stakeholder as per communication chart. Liner installed at El.136.1 m. Engineering, E&I and Env to develop path forward with Water & Tailings Superintendent.

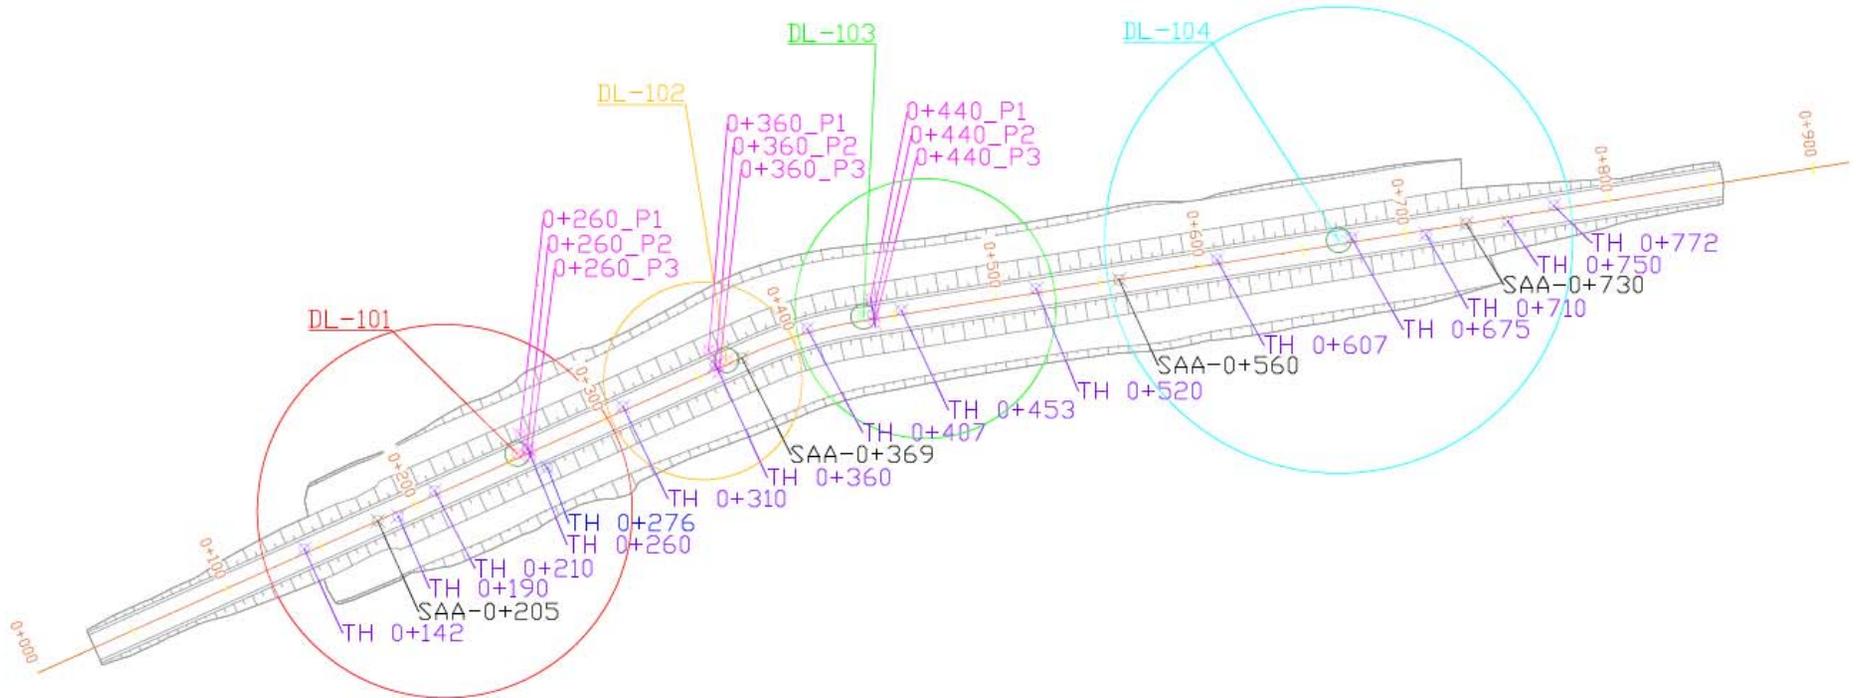
Figure 1 – Dike instruments overview

DIKE VISUAL INSPECTION REPORT
