**BACK RIVER PROJECT**  
**Responses to 2021 Annual Report Comments**

**August 19, 2022**

## Responses to 2021 Annual Report Comments

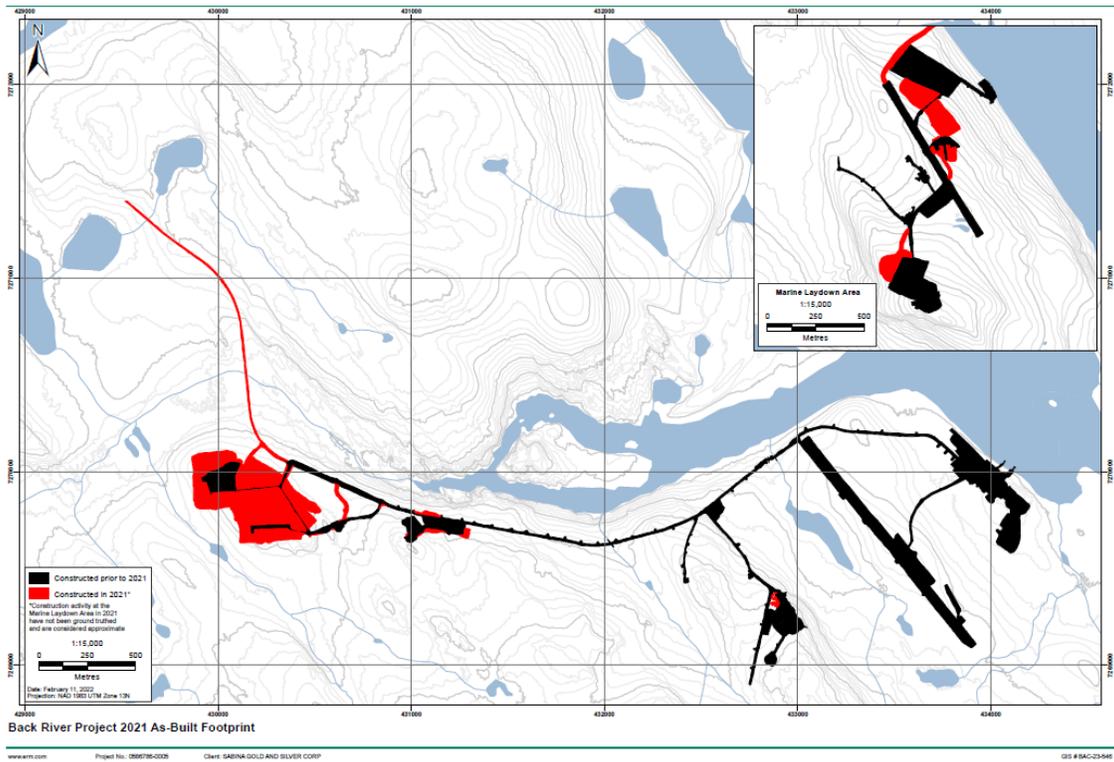
An updated figure 4.5.9-1 is provided below.

PC Condition No. 32 requires annual reporting of the current Project footprint, including the loss or alteration of vegetation associated with Project activities. Table 4.5.9-1 and Figure 4.5.9-1 show the cumulative habitat loss at the Goose Property and MLA Property as of 2021. It would be informative to also show, numerically and graphically/spatially, the difference in habitat loss between 2020 and 2021, such that specific areas of new disturbance can be identified. Based on the 2020 Vegetation Monitoring Plan (VMP), Table 5-1, one of the objectives of footprint monitoring is to show a “spatial comparison of the previous footprint to the current year’s footprint.”

- Please present ecosystem/vegetation loss in 2021 compared to 2020, as specified in the 2020 VMP. Please update Table 4.5.9-1 and Figure 4.5.9-1 to show the quantitative and spatial data, respectively.
- Please explain why the ‘undifferentiated tundra’ vegetation association is missing from Table 4.5.9-1. Please also explain and correct the inconsistencies noted between Table 4.5.9-1 and habitat loss information within the Vegetation Monitoring Program and WMMP reports.
- Please complete a trend analysis for vegetation monitoring data from 2018 to 2021 or provide science-or statistics-based rationale for when trend analyses will be possible.
