OPERATIONS, MAINTENANCE AND SURVEILLANCE MANUAL: HOPE BAY DORIS TAILINGS IMPOUNDMENT AREA

REVISION 6

HOPE BAY, NUNAVUT

MARCH 2023

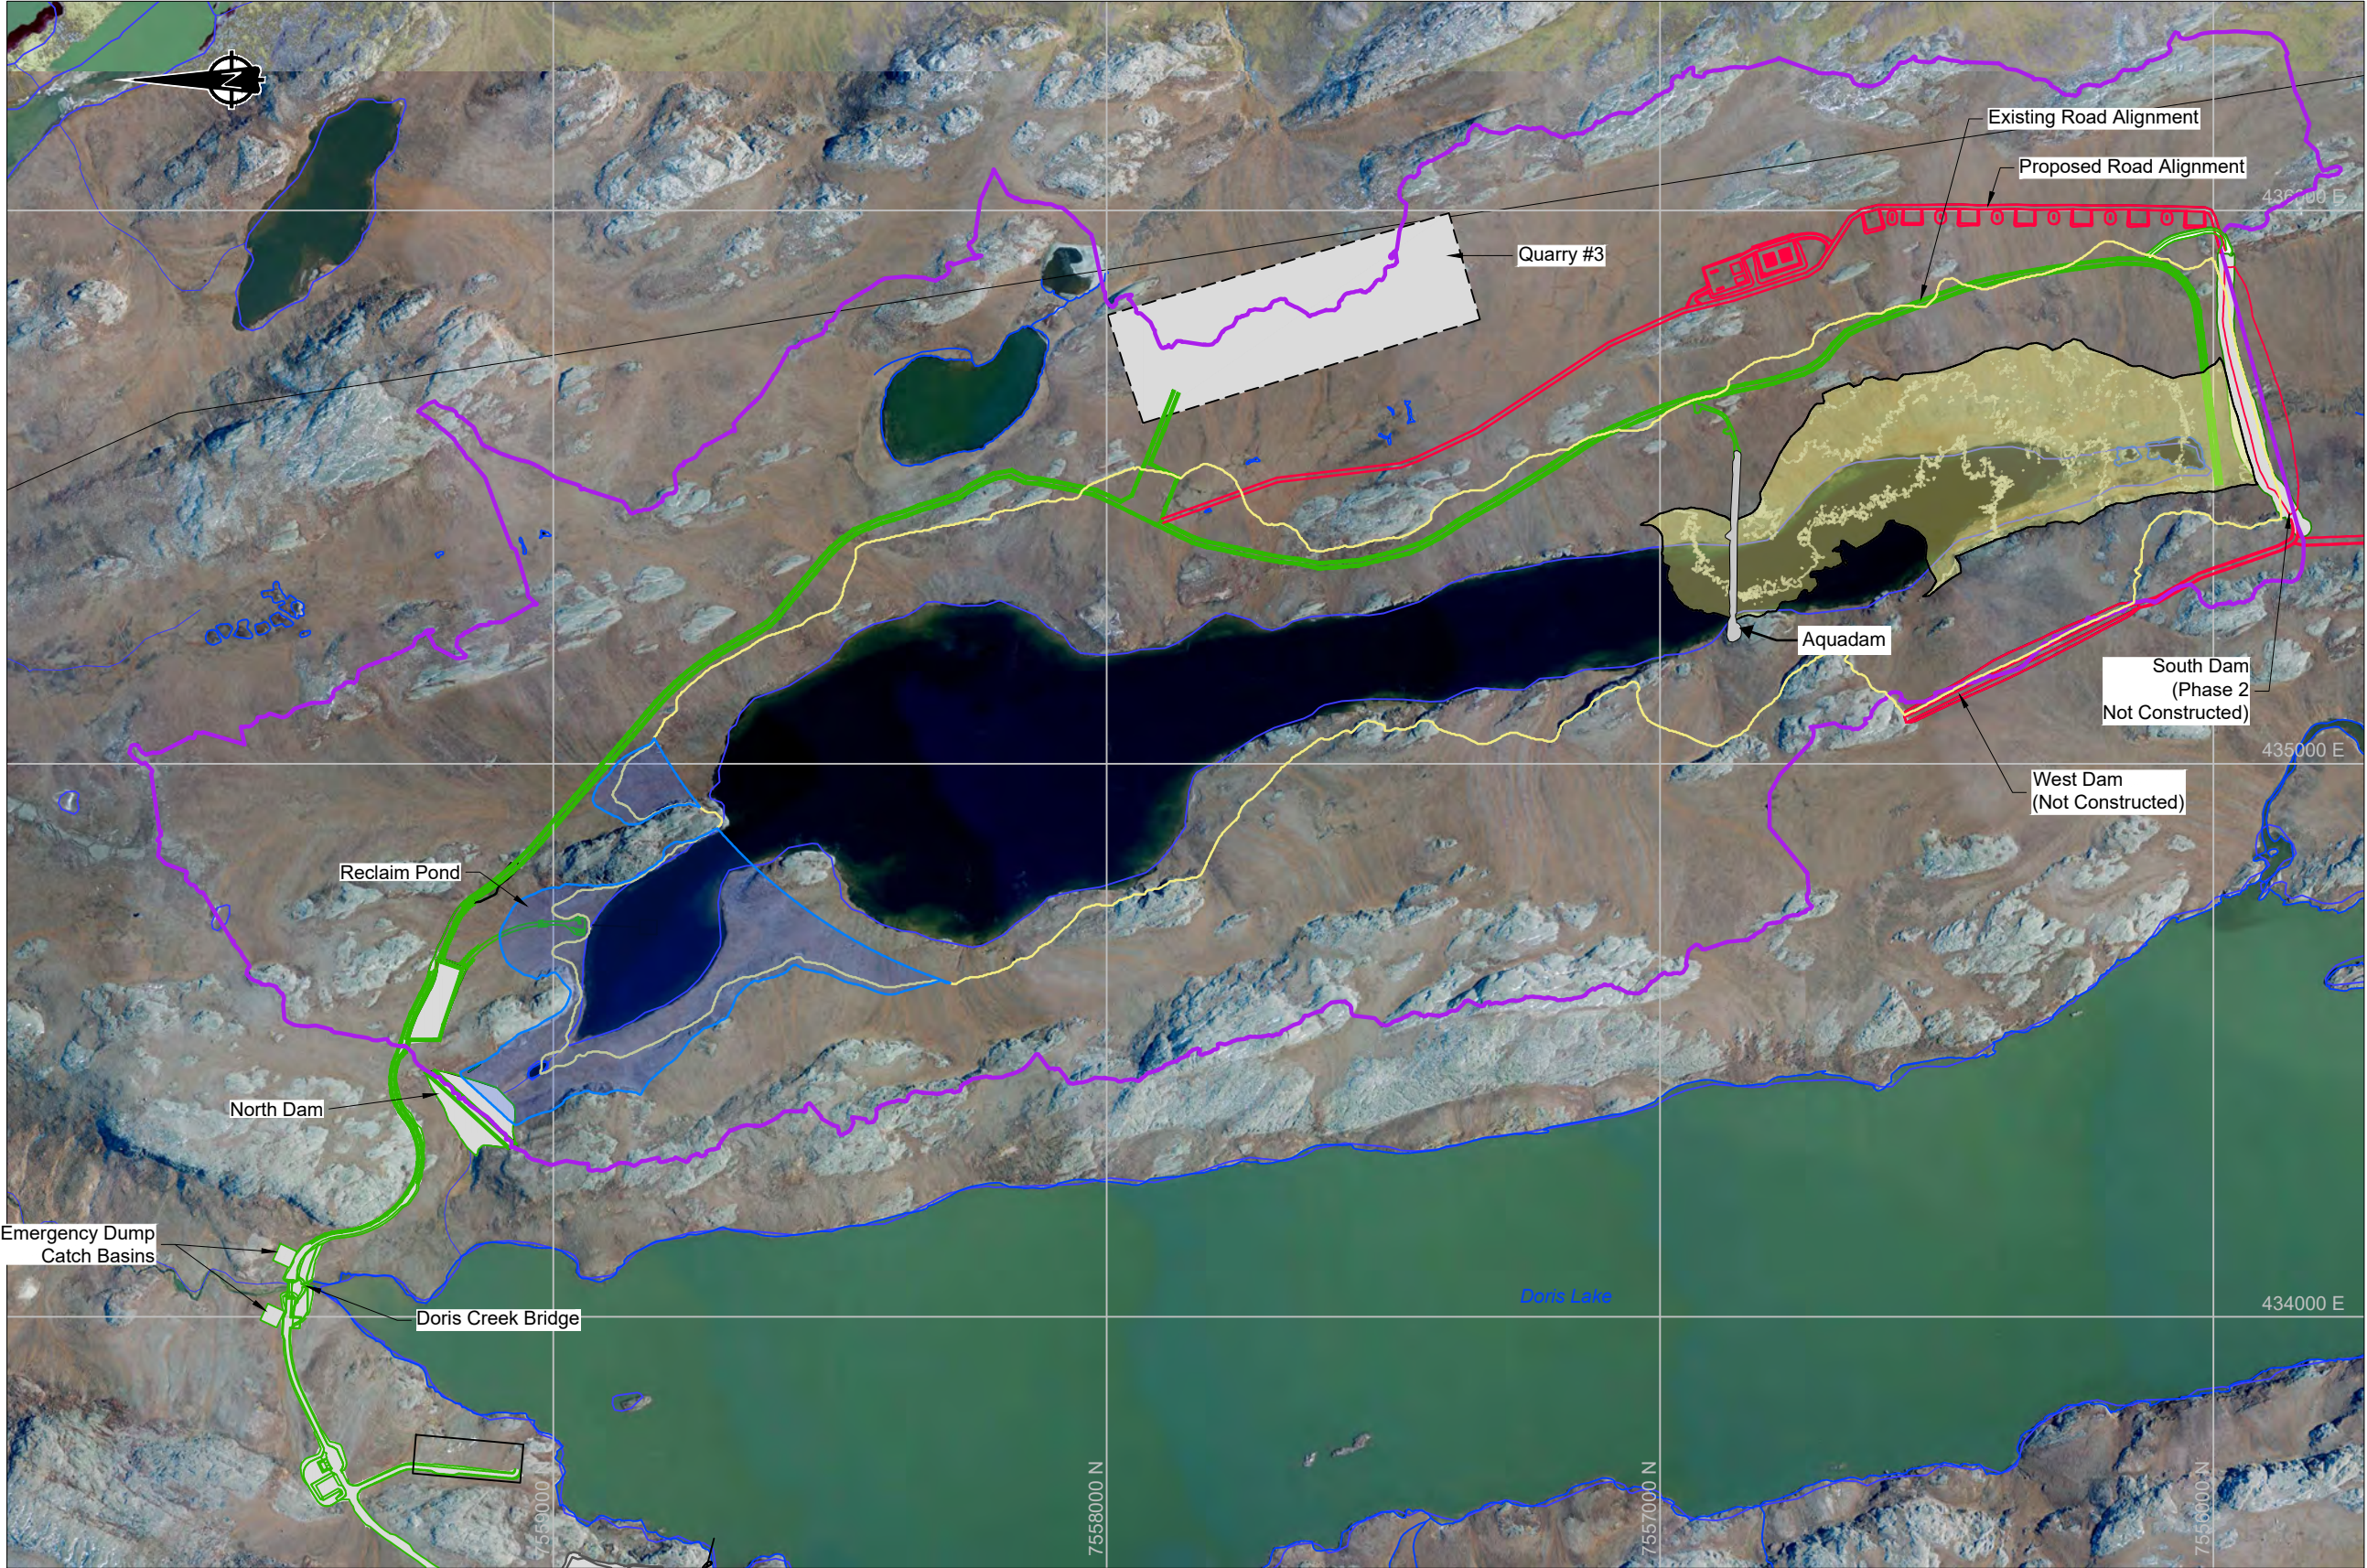
| | Site General Arrangement | | |

- Existing Infrastructure
- Proposed Road Realignment
- Ultimate Tailings Extent
- Dam / Dike
- Ultimate Reclaim Pond Extent
- Watershed Boundary
- Quarry (not developed)
- Subaerial Tailings Beach 2021

| Mineralization Areas | <p>The Project is a gold mining and milling undertaking that consists of three distinct areas of known mineralization plus extensive exploration potential and targets (Figure 2): Doris, Madrid, and Boston.</p> |

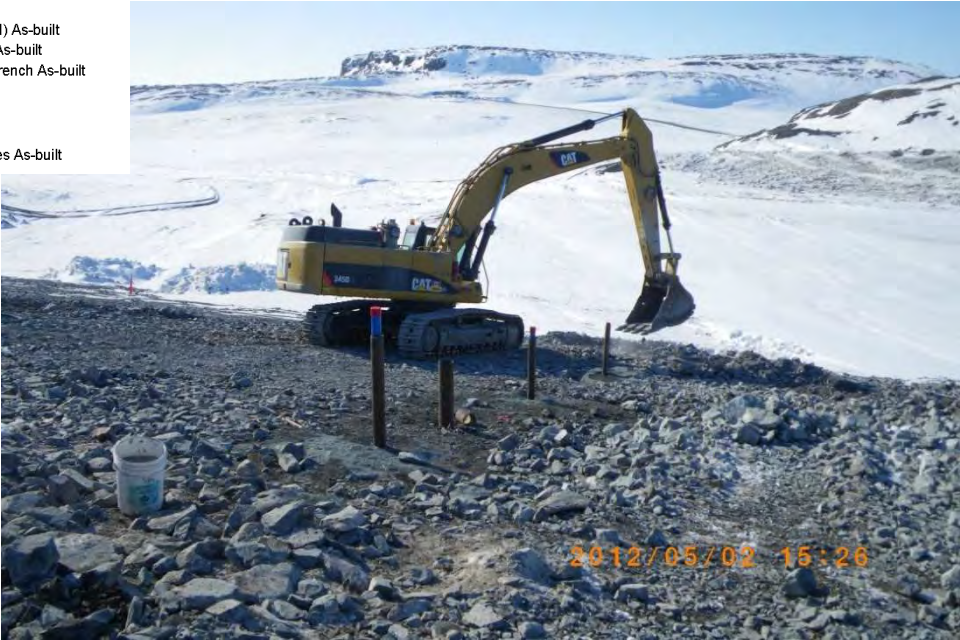
| HOPE BAY PROJECT | Date: March 2023 | Approved: BJ | Figure: 12 |

- Core Material
- Transition Material
- Run of Quarry (ROQ)
- Surfacing Material
- Bedrock
- Peat
- GCL As-built
- Core Material As-built
- Core Material (2011) As-built
- Levelling Course (Core Material) As-built
- Instrumentation Trench Cover As-built
- Key Trench / Instrumentation Trench As-built
- GCL Cover Material As-built
- Transition Material As-built
- ROQ Material As-built
- Thermosyphon Evaporator Pipes As-built

Example of as-built instrumentation installed on the downstream of dam.

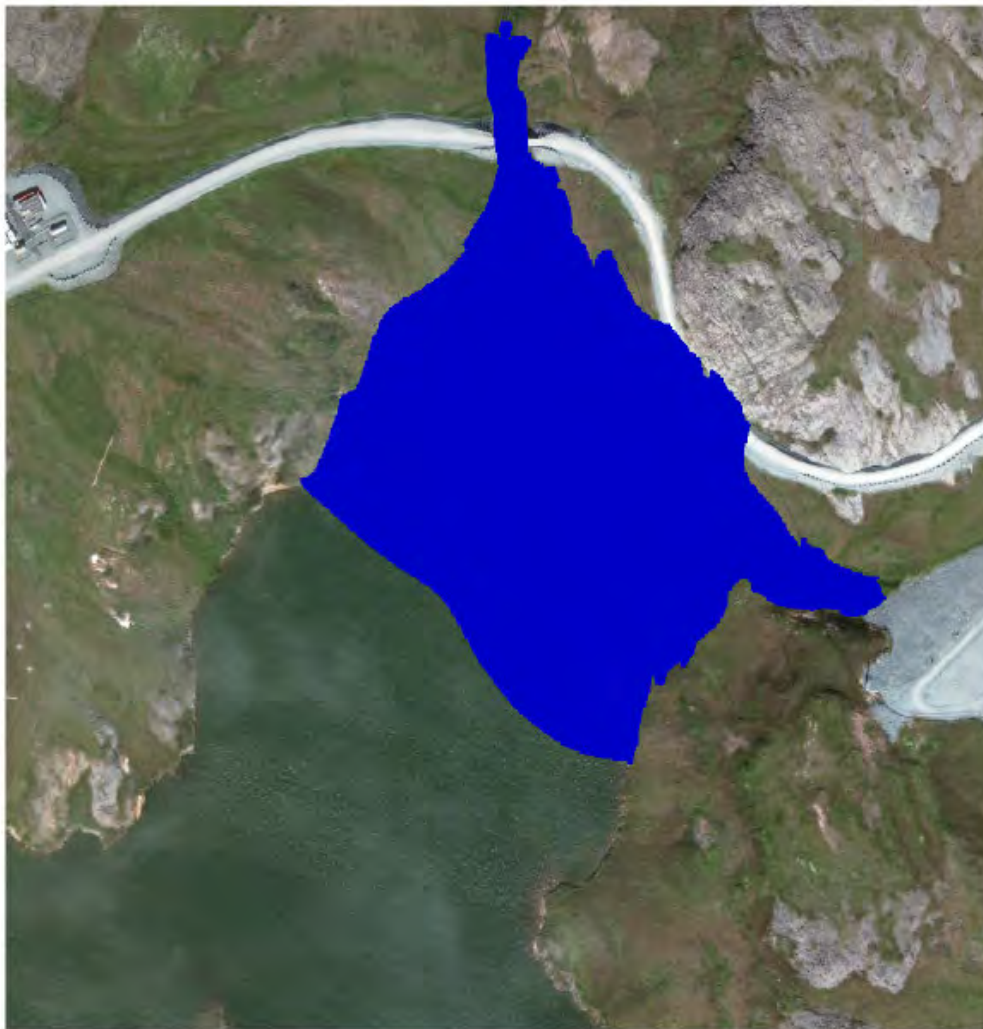
Grid Element Flow Depth (3600 sec.) [1:0:0]

~ 60 mins
