**WHALE TAIL PIT PROJECT**

## **Marine Mammal Management and Monitoring Plan**

**APRIL 2018  
VERSION 1**

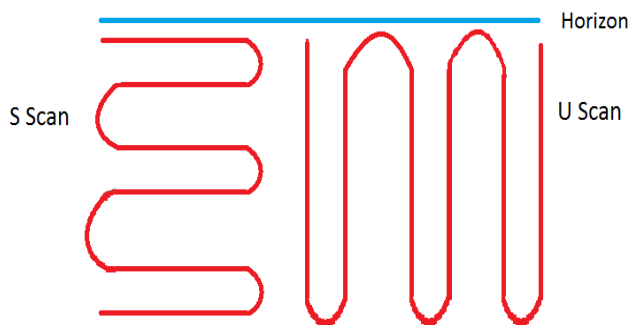
The following scan routine should be conducted throughout the marine mammal observation period. Scan the water with the naked eye and use binoculars only to focus on possible sightings. Perform S and U scans of the observation field about every 20 seconds (Figure 3). The most important aspect of marine mammal observing is to constantly scan the observation field to capture animals that could be located in the peripheral view for brief moments (e.g., surfacing). Scans should be made from the middle of the vessel (for one MMSO) and cover the scan area shown in Figure 2 with a focus on the water ahead and to the side to the moving vessel (e.g., focused scan area in Figure 2). If the vessel is stationary (e.g., anchored) scans should be conducted over the entire scan area (e.g., blue and green in Figure 2) in a uniform fashion. When the vessel is stationary, less priority can be attributed to marine mammal observations.

Figure 3: S & U scanning techniques

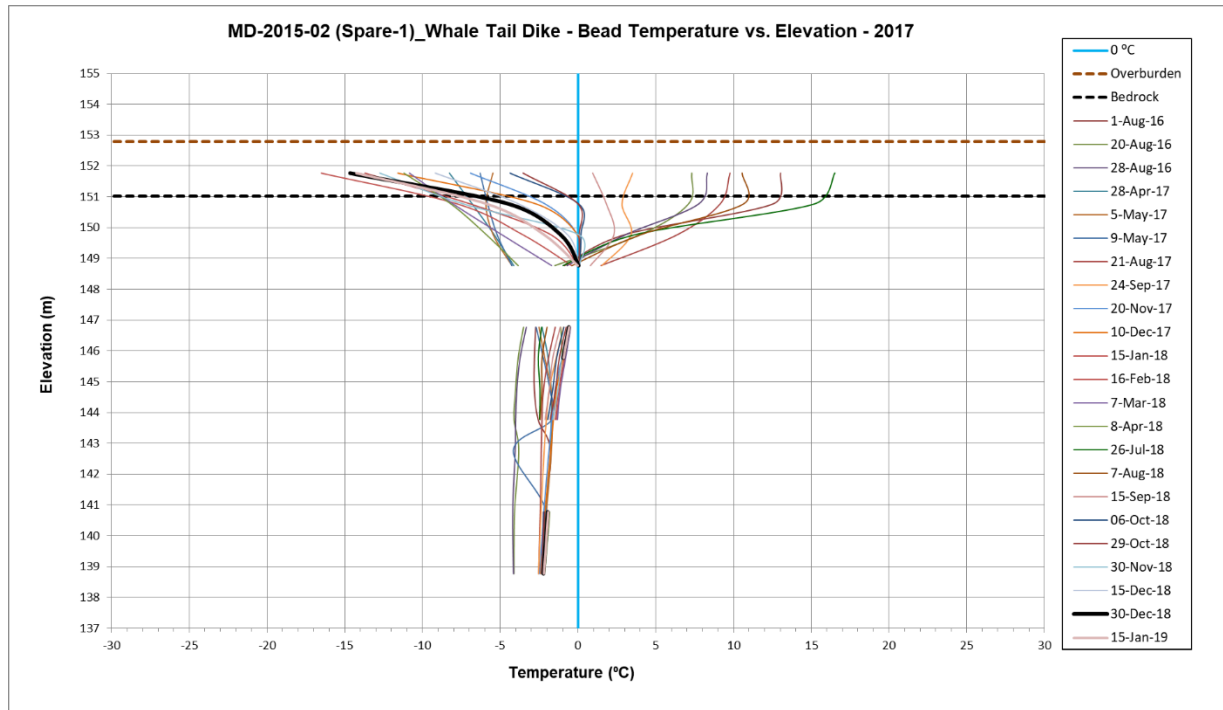
**Figure 4: Temperature profile (Celsius) as a function of elevation (masl) from installation to January 2019 for thermistor MD-2015-02**

- Active layer: 4.3m (from elev. 152.8 to 148.5 )
- Depth of zero annual amplitude: 11.8m (from elevation 152.8 to 141)
- Steady permafrost temperature of around -2.1°C down to bottom of hole (elev 138.7)
- Geothermal gradient: Thermistor not deep enough to evaluate gradient
- Permafrost thickness: > 9.8m; Thermistor not deep enough to reach bottom of permafrost layer.
- Annual variation in ground temperature: Similar from 2017 to 2018. 2016 data looks offset by -1 °C
