## **Appendix 54**

### **Meadowbank and Whale Tail 2018 Regulators inspection reports**

## **Inspection Report - Water Licence 2AM-MEA1526**

WATER LICENCE INSPECTION FORM

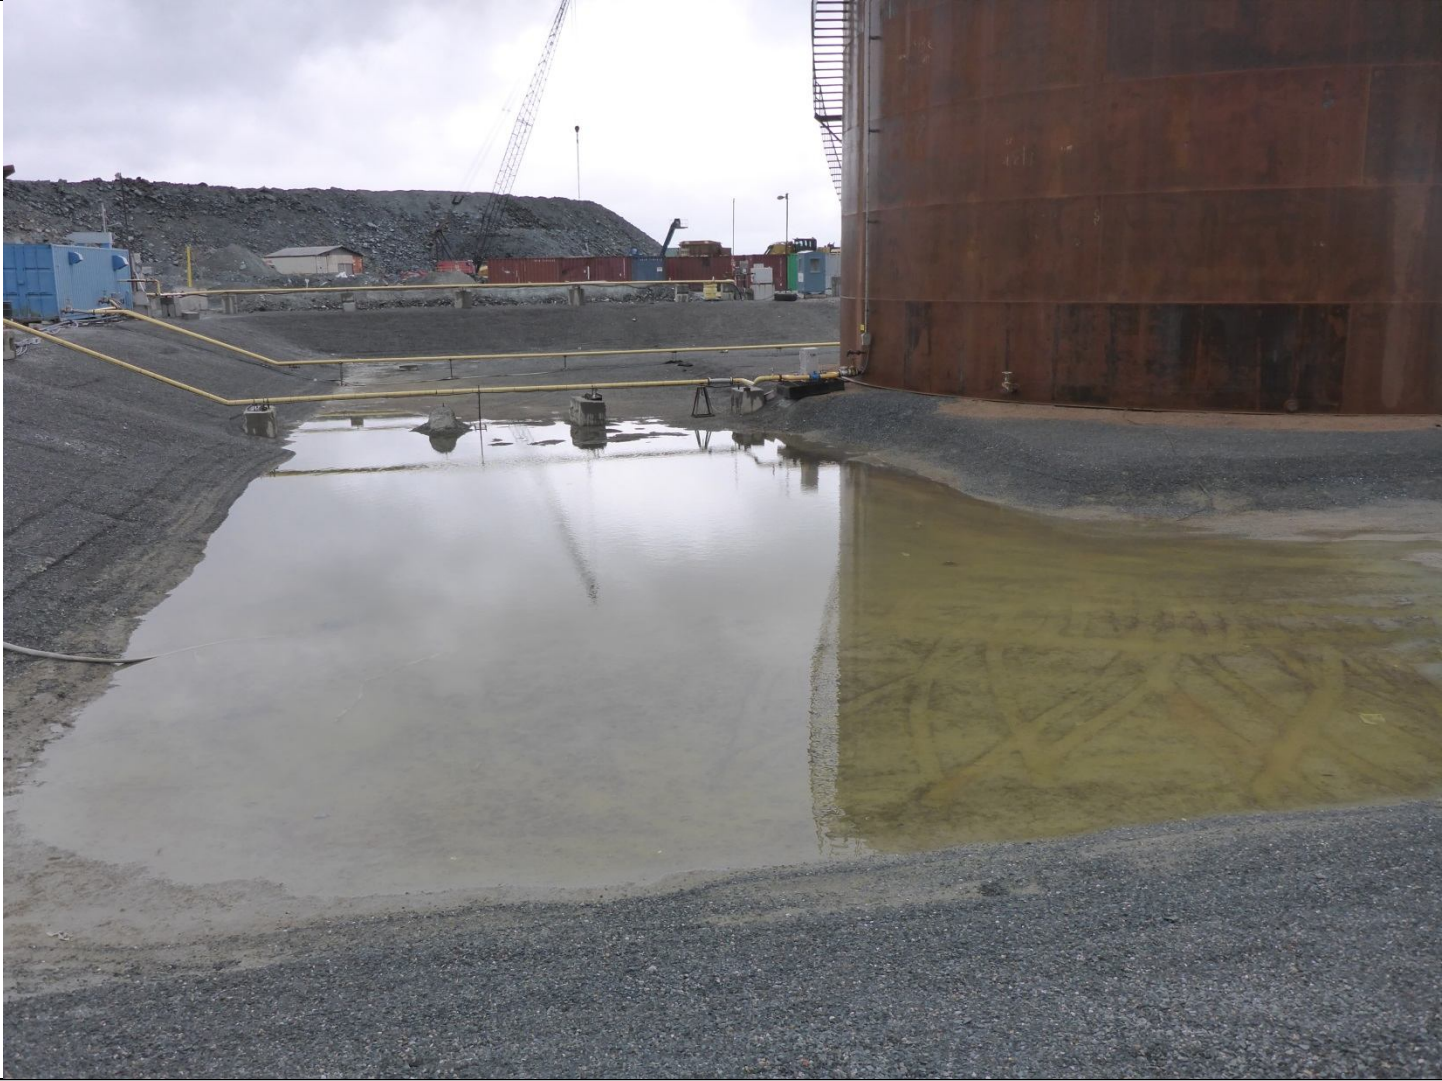
Date:	Authorization Number:	Camera/Model:	Inspector
August 29 <sup>th</sup> , 2018	2AM-MEA1525	Panasonic Lumix DMC-TS5	WRO Morton
Photo No.	Lat/Long (DD.MM.SS.SS, NAD83)		
Photo 2

2. The main tank farm consisted of one 4.5 million liter tank that is located within a lined secondary containment bermed structure. The water from the berm is pumped out in the spring and once again in the fall if required. There was a minimal amount of water present within the berm at the time of the inspection (Photo #2).

**Description:**  
Minimal water within the main tank farm berm.

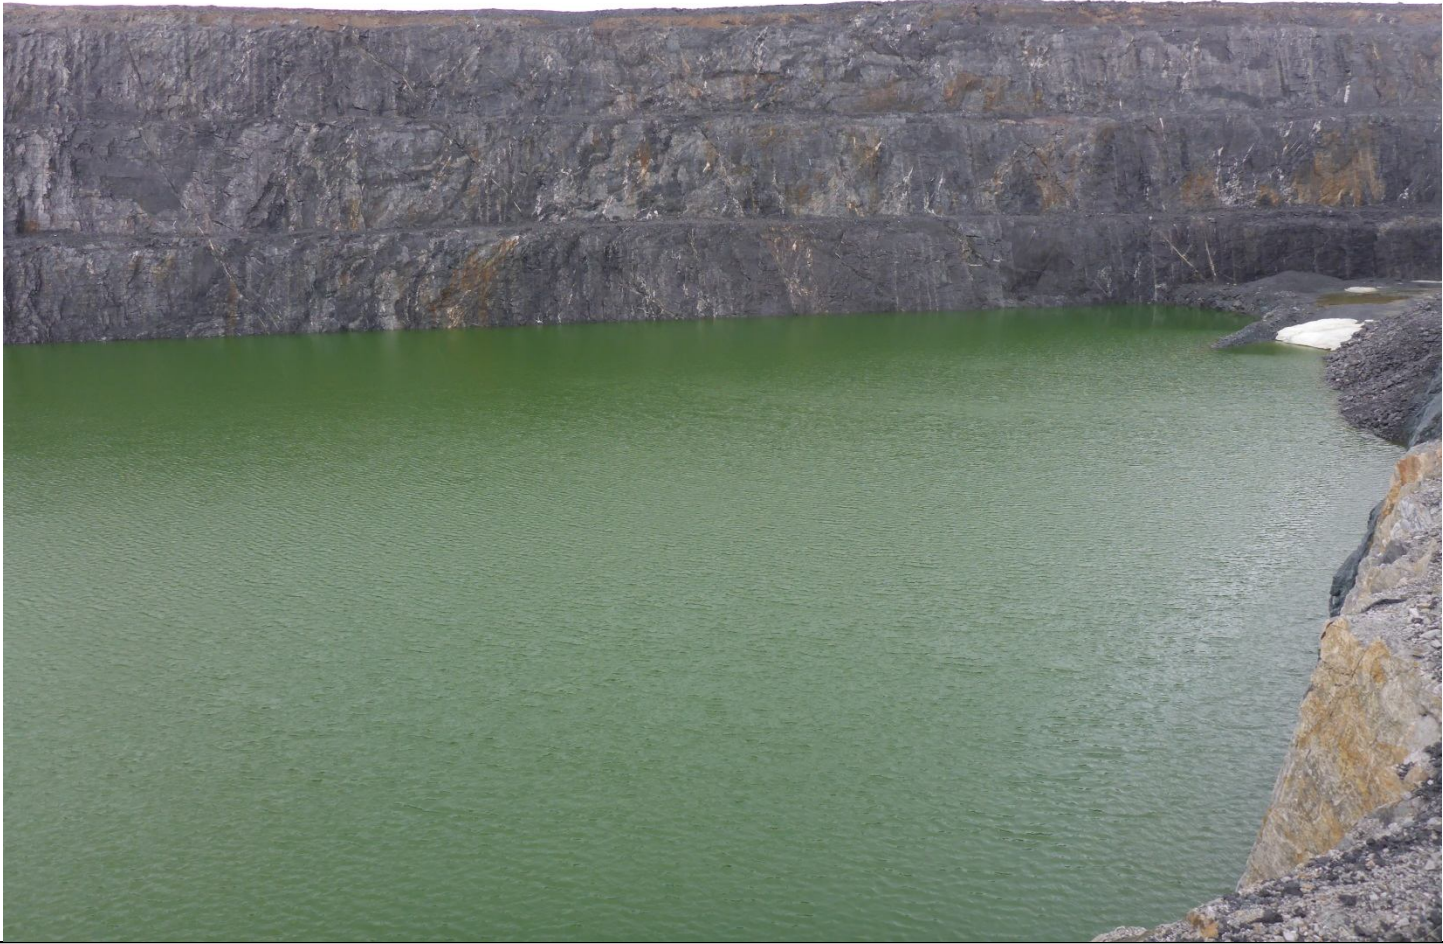
Date:	Authorization Number:	Camera/Model:	Inspector
August 29 <sup>th</sup> , 2018	2AM-MEA1525	Panasonic Lumix DMC-TS5	WRO Morton
Photo No.		Lat/Long (DD.MM.SS.SS, NAD83)	
Photo 3

**Description:**  
Free board remaining in Goose Pit.

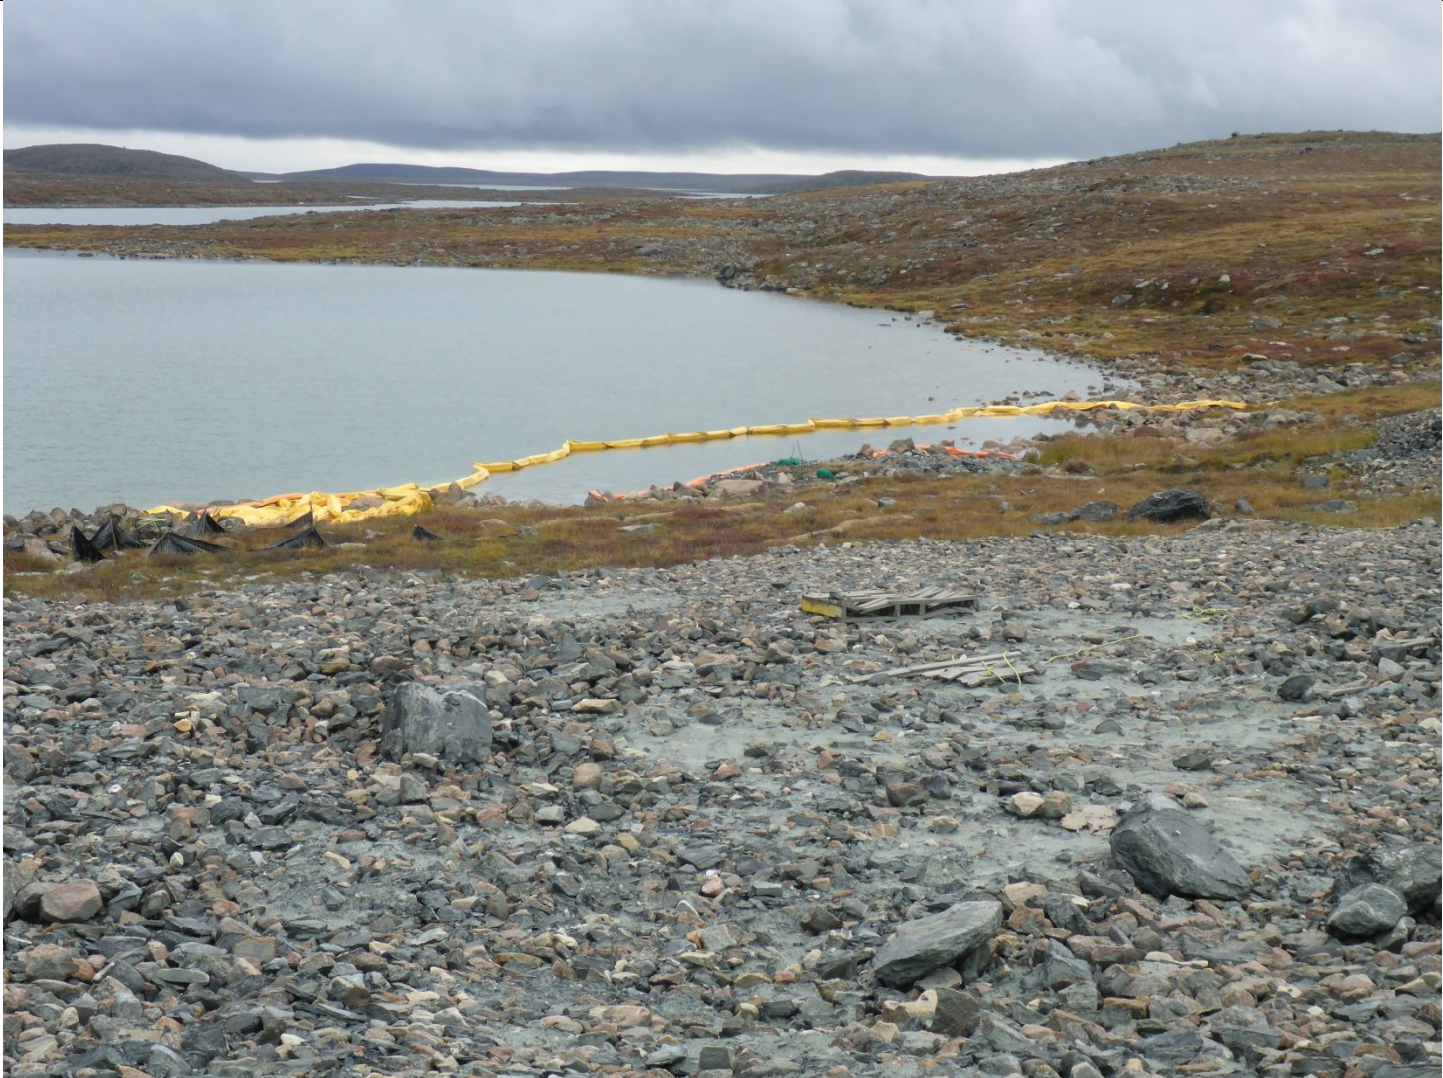
Date:	Authorization Number:	Camera/Model:	Inspector
August 29 <sup>th</sup> , 2018	2AM-MEA1525	Panasonic Lumix DMC-TS5	WRO Morton
Photo No.		Lat/Long (DD.MM.SS.SS, NAD83)	
Photo 4

Description:
Overview of NP-1 Lake shoreline.

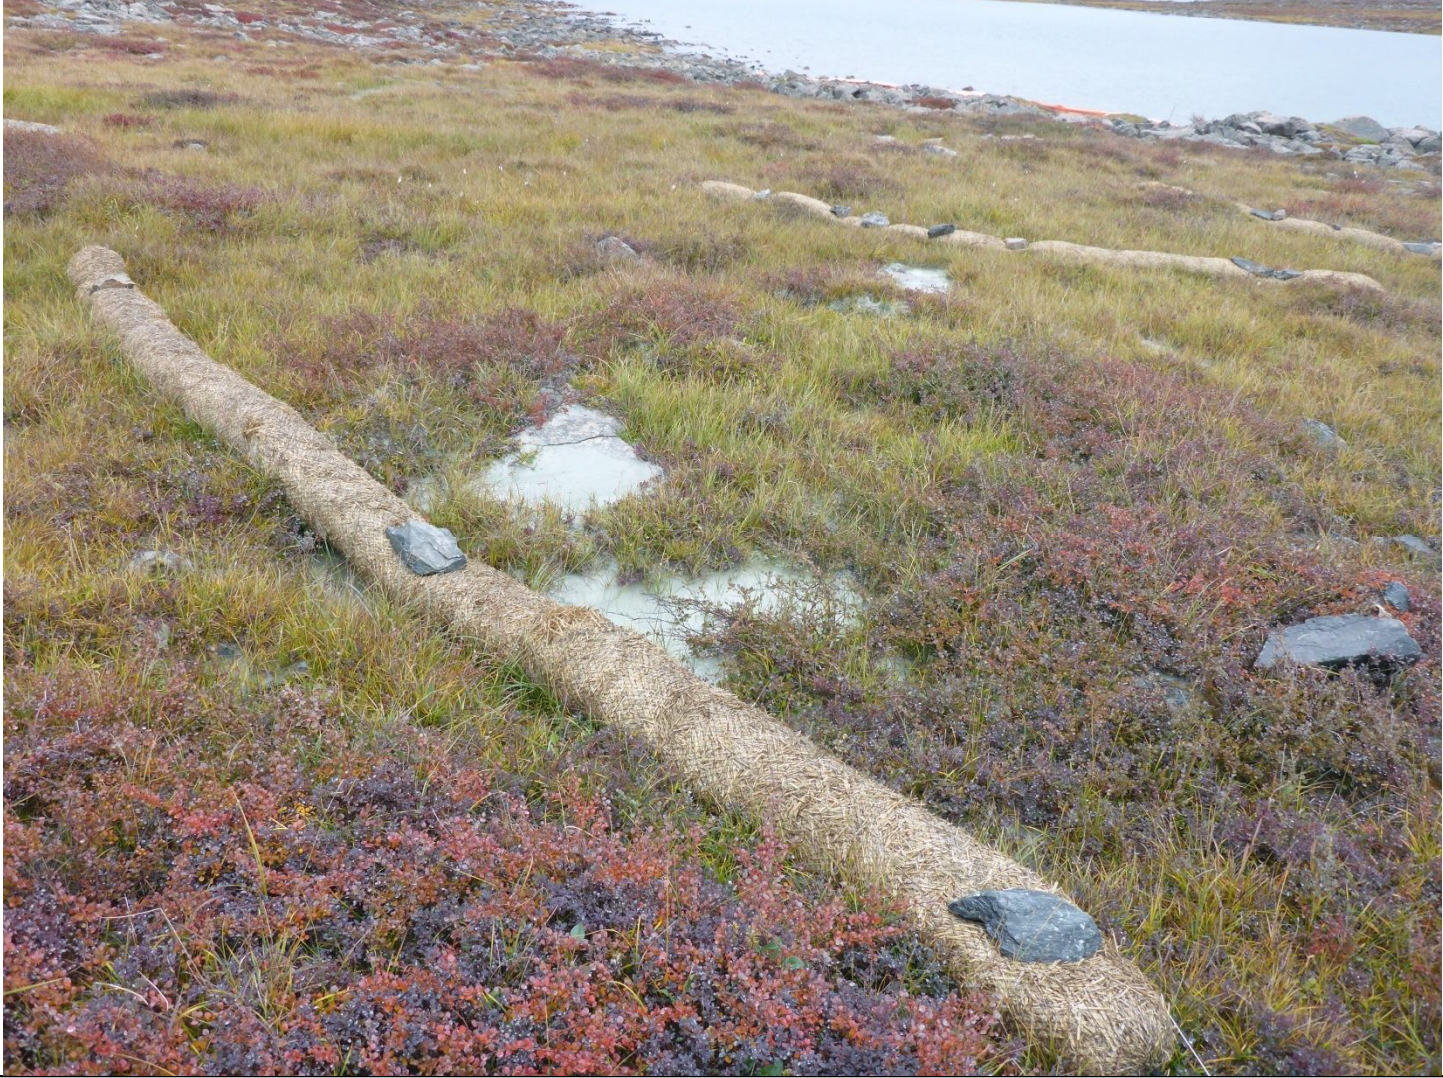
Date:	Authorization Number:	Camera/Model:	Inspector
August 29 <sup>th</sup> , 2018	2AM-MEA1525	Panasonic Lumix DMC-TS5	WRO Morton
Photo No.		Lat/Long (DD.MM.SS.SS, NAD83)	
Photo 5

5. The Vault Road area where sediment released into NP-1 Lake was inspected to ensure that no further sediment was reaching the shoreline. The Inspector found hay waddles and sediment curtains installed between the road and the lake shore (Photos #4 & #5). Mr. Allard stated that no snow is pushed in the Vault roads eastern ditch to help limit the amount of sediment that reaches the shoreline during freshet. Three sediment curtains were installed within NP-1 Lake to ensure there is no impact to Dogleg Lake.

Description:
Straw waddles installed between NP-1 Lake and the Vault Road.

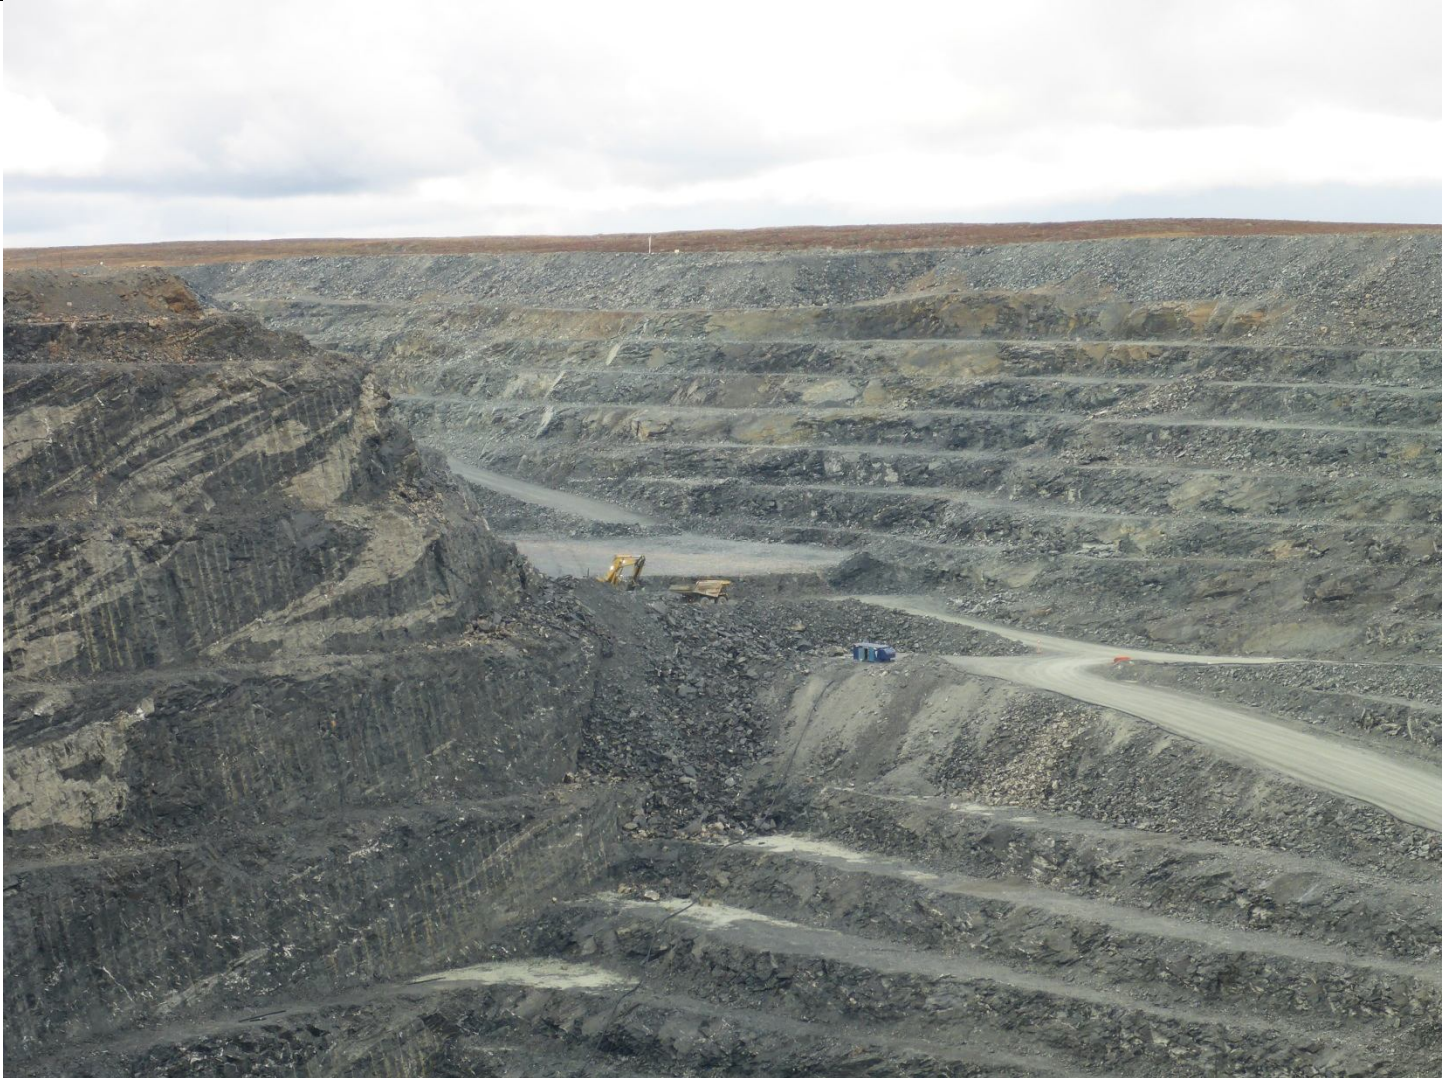
Date:	Authorization Number:	Camera/Model:	Inspector
August 29 <sup>th</sup> , 2018	2AM-MEA1525	Panasonic Lumix DMC-TS5	WRO Morton
Photo No.		Lat/Long (DD.MM.SS.SS, NAD83)	
Photo 6

Description:
Overview of connection between Vault Pit and Phaser Pit.

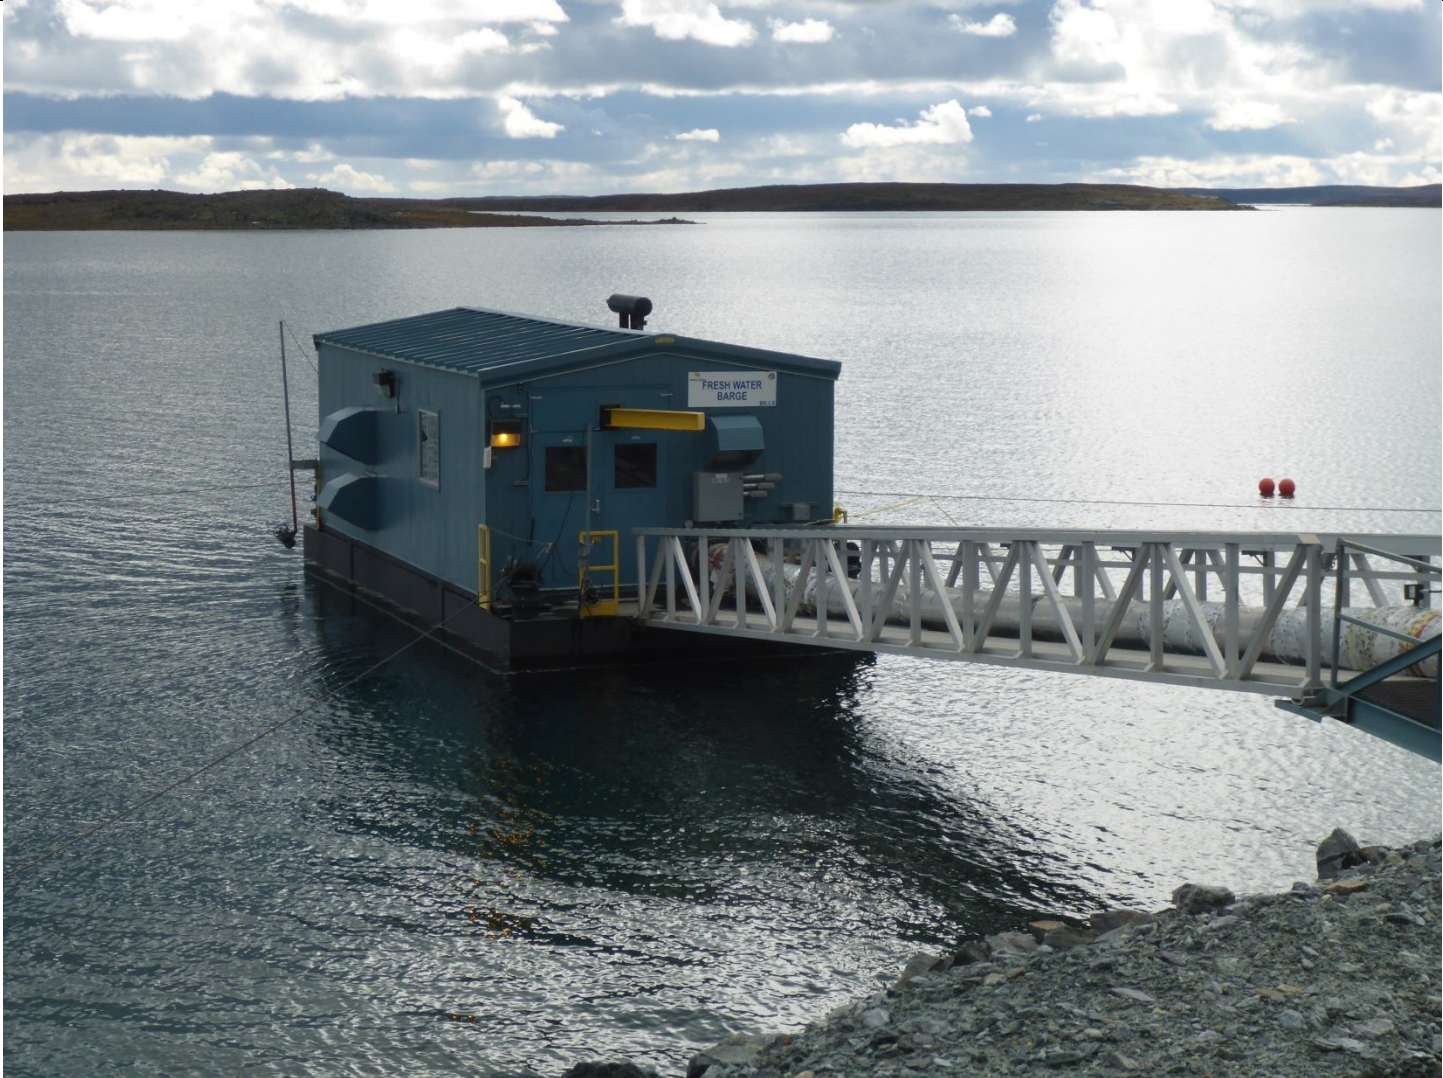
Date:	Authorization Number:	Camera/Model:	Inspector
August 29 <sup>th</sup> , 2018	2AM-MEA1525	Panasonic Lumix DMC-TS5	WRO Morton
Photo No.		Lat/Long (DD.MM.SS.SS, NAD83)	
Photo 8

Description:
Overview of the fresh water intake barge located on third portage lake.

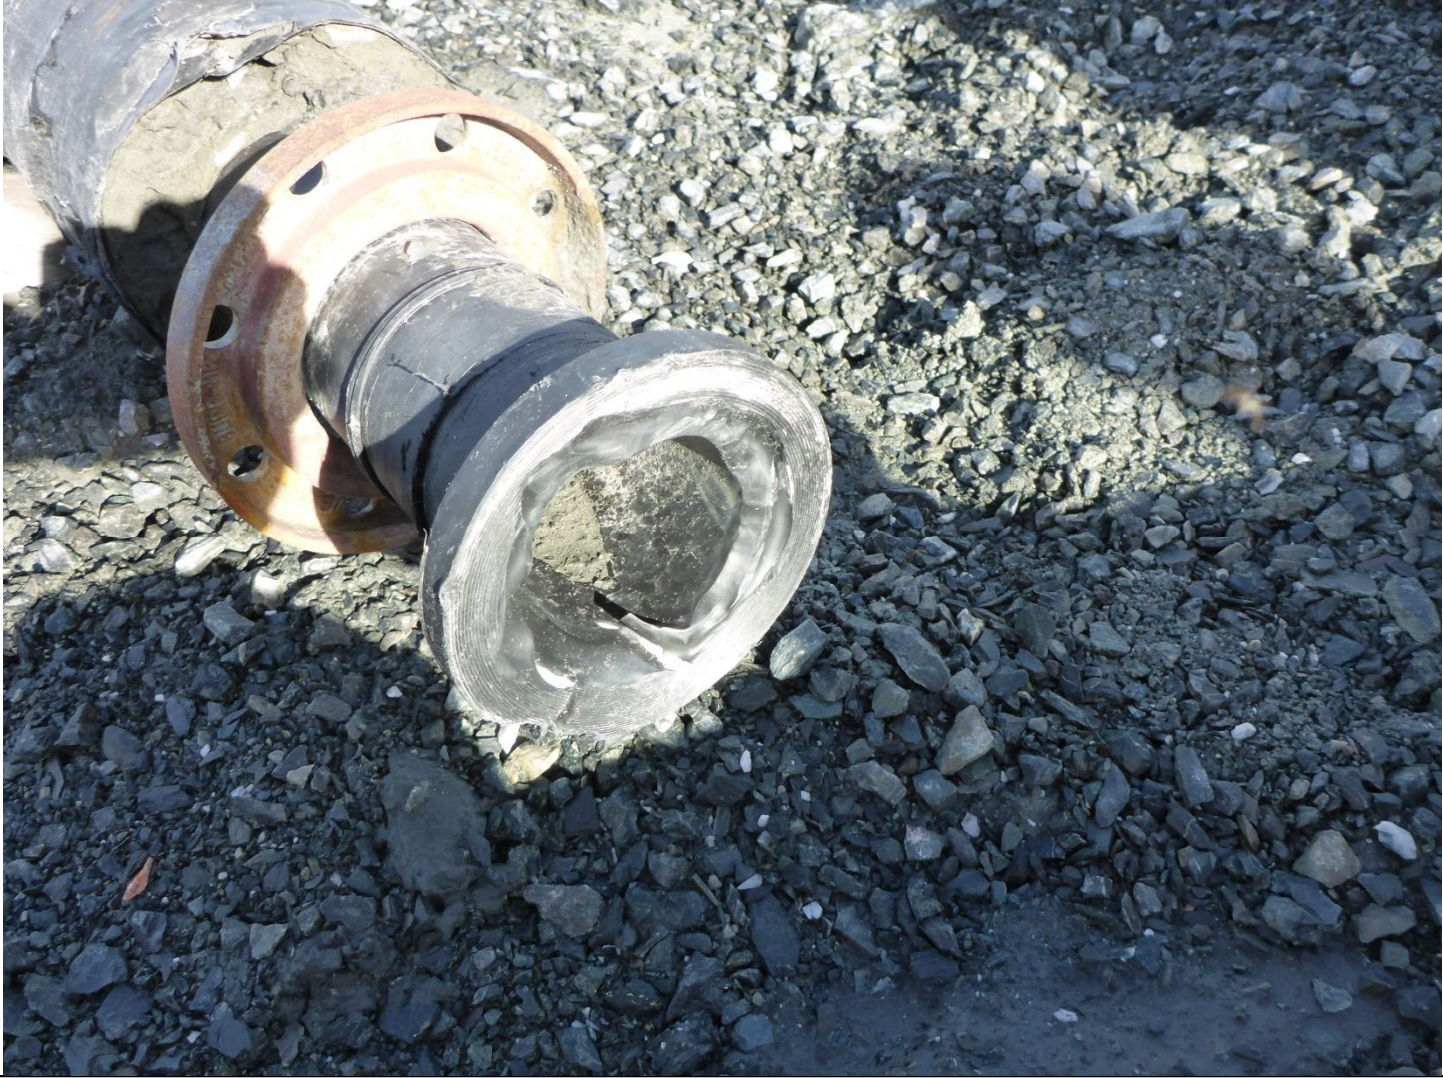
Date:	Authorization Number:	Camera/Model:	Inspector
August 29 <sup>th</sup> , 2018	2AM-MEA1525	Panasonic Lumix DMC-TS5	WRO Morton
Photo No.	Lat/Long (DD.MM.SS.SS, NAD83)		
Photo 9

10. The South Cell Tailings Pond had a release of approximately 3,000 liters of tailings from the 14" discharge pipe. The discharge was caused by a gasket that wore out between the 14" pipe and the 4" pipe and sent tailings towards the tailings pond (Photo #9). There was no risk to the environment as all of the tailings entered the tailings pond. The Inspector explained to Mr. Allard that the release will need to be reported to the spill line as it was an uncontrolled and unauthorized release. Mr. Allard reported the spill on August 29<sup>th</sup> 2018 and is documented as spill 2018-353. No further cleanup or action is required by AEM to address this spill.

Description:
Gasket that caused the tailings spill reported as 18-353.

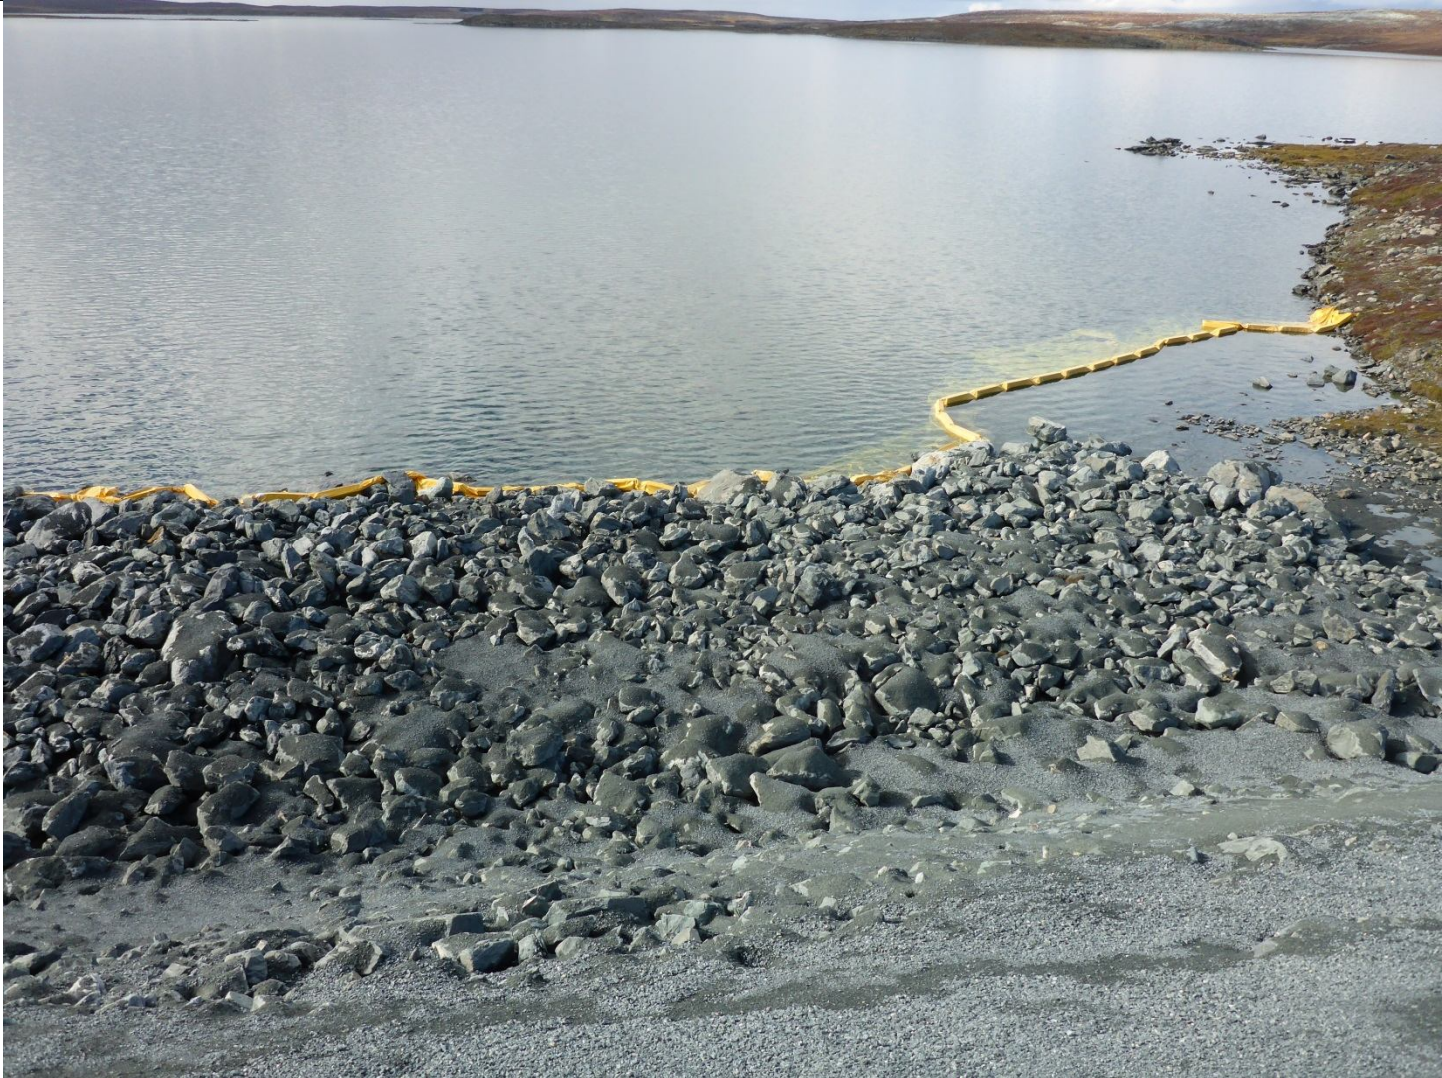
Date:	Authorization Number:	Camera/Model:	Inspector
August 29 <sup>th</sup> , 2018	2AM-MEA1525	Panasonic Lumix DMC-TS5	WRO Morton
Photo No.		Lat/Long (DD.MM.SS.SS, NAD83)	
Photo 10

12. The Northwest end of the runway was inspected to follow up with concerns noted during the last inspection by WRO WILSON. AEM staff installed sediment booms on the shoreline and will monitor the area to ensure that no sediment enters Third Portage Lake (Photo #10).

**Description:**  
Sediment booms installed at the Northwest end of the runway.

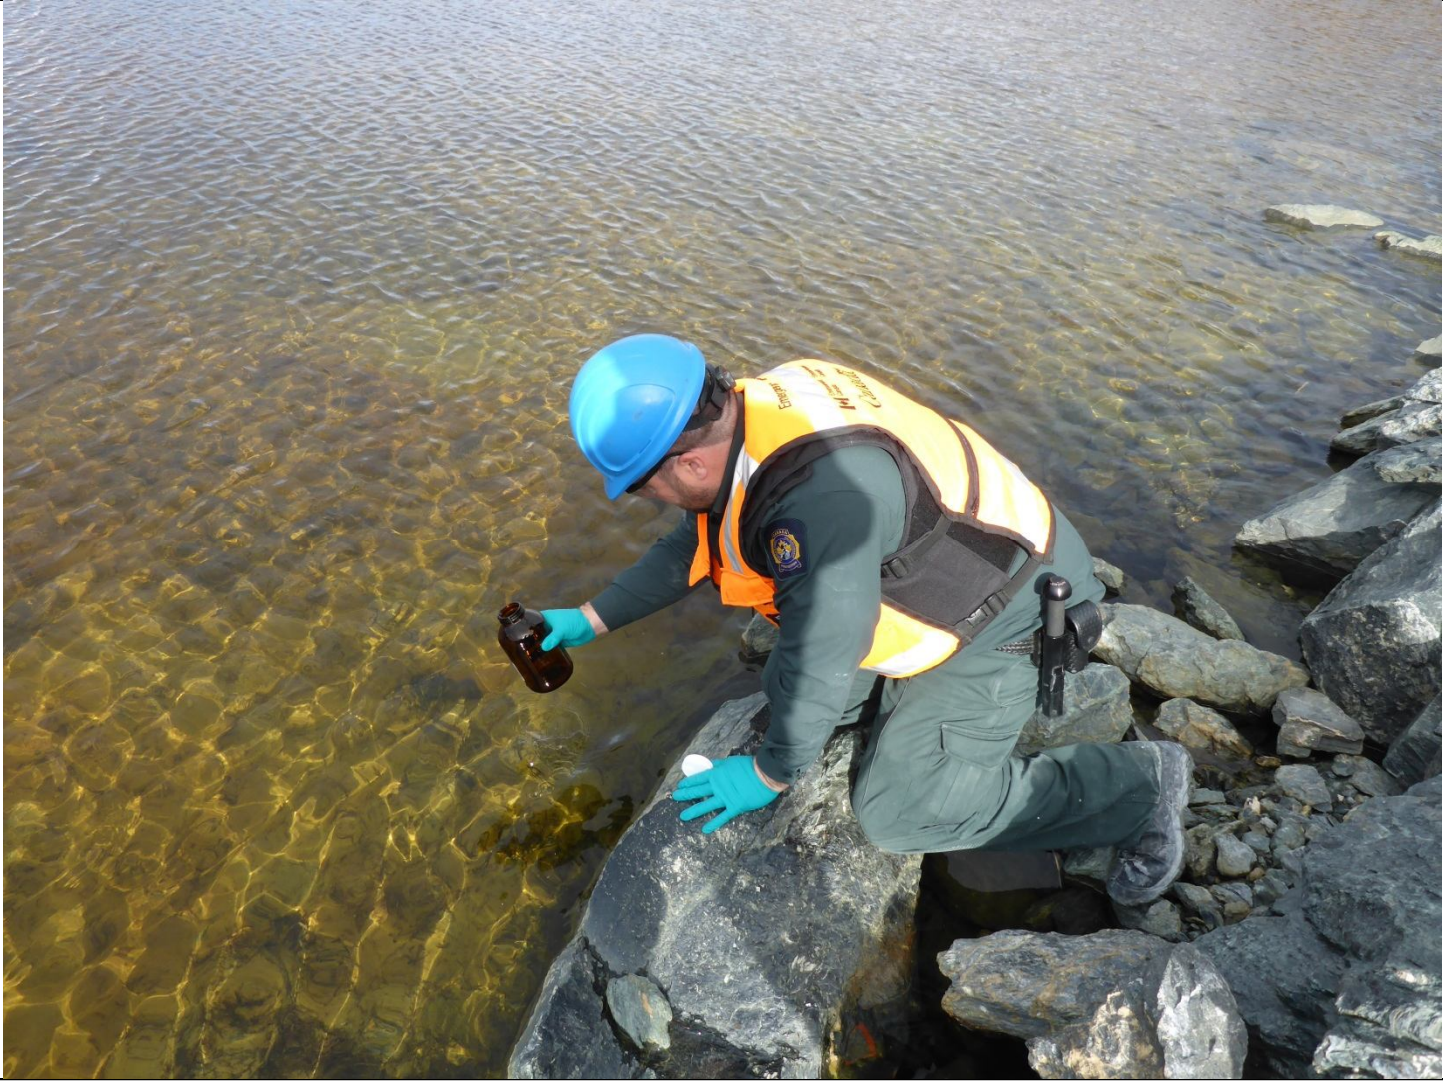
Date:	Authorization Number:	Camera/Model:	Inspector
August 29 <sup>th</sup> , 2018	2AM-MEA1525	Panasonic Lumix DMC-TS5	WRO Morton
Photo No.	Lat/Long (DD.MM.SS.SS, NAD83)		
Photo 11

**Description:**  
ECCC conducting sampling at the shoreline of NP-2 Lake

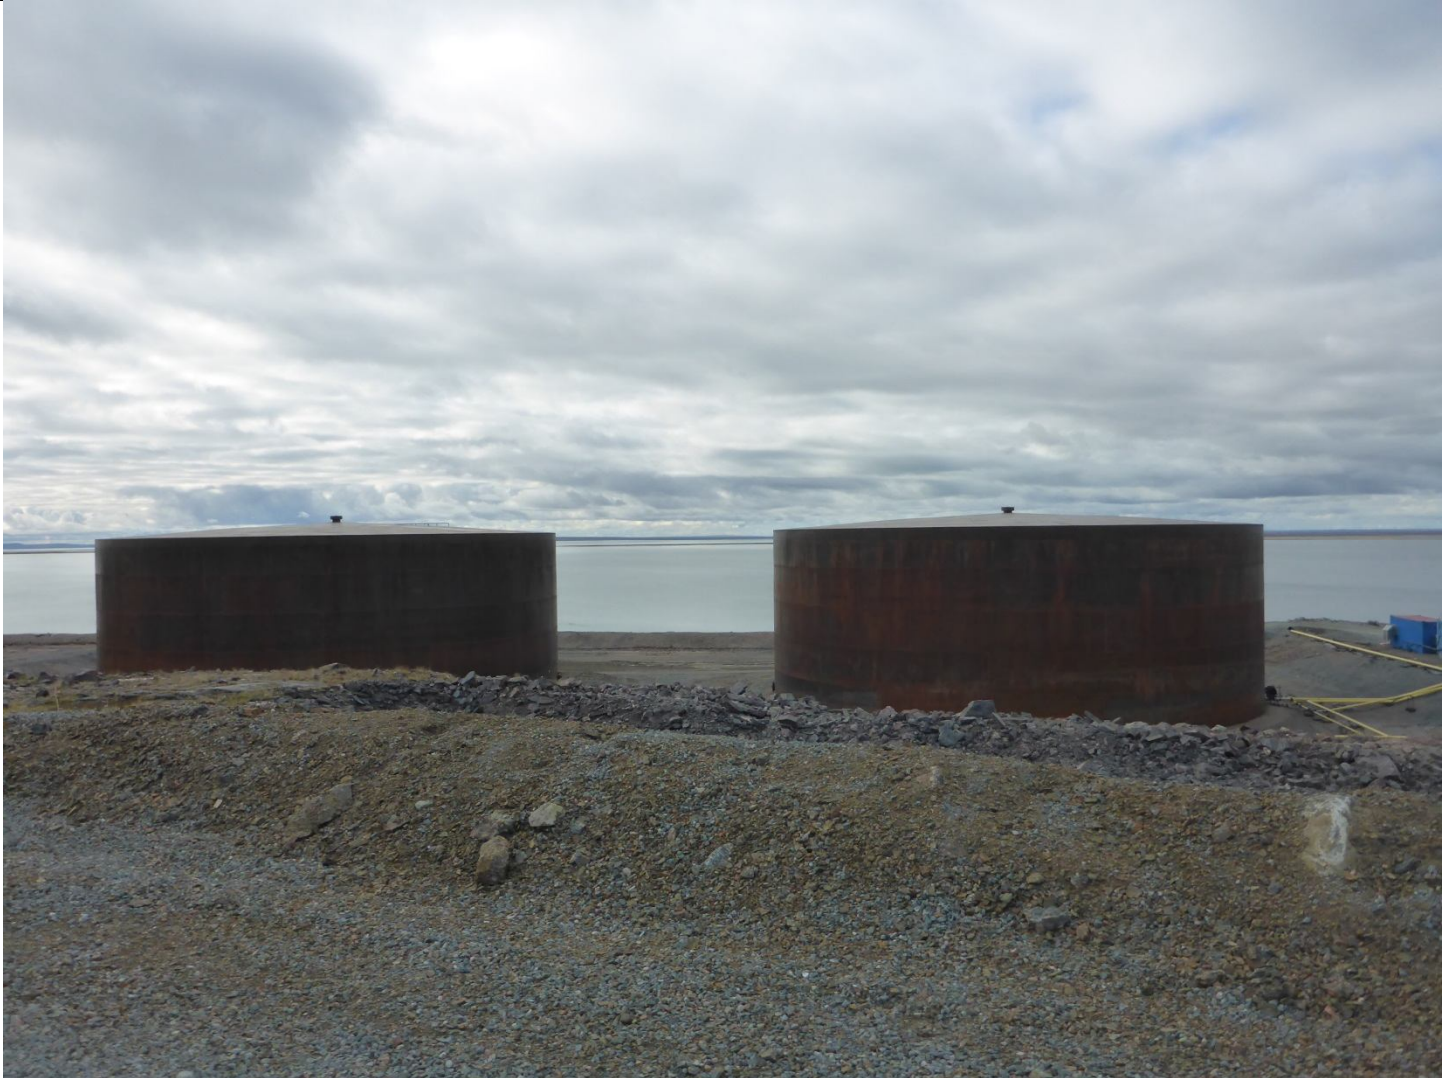
Date:	Authorization Number:	Camera/Model:	Inspector
August 29 <sup>th</sup> , 2018	2AM-MEA1525	Panasonic Lumix DMC-TS5	WRO Morton
Photo No.		Lat/Long (DD.MM.SS.SS, NAD83)	
Photo 13

**Description:**  
Overview of the 10,000,000 liter tanks located in Baker Lake.

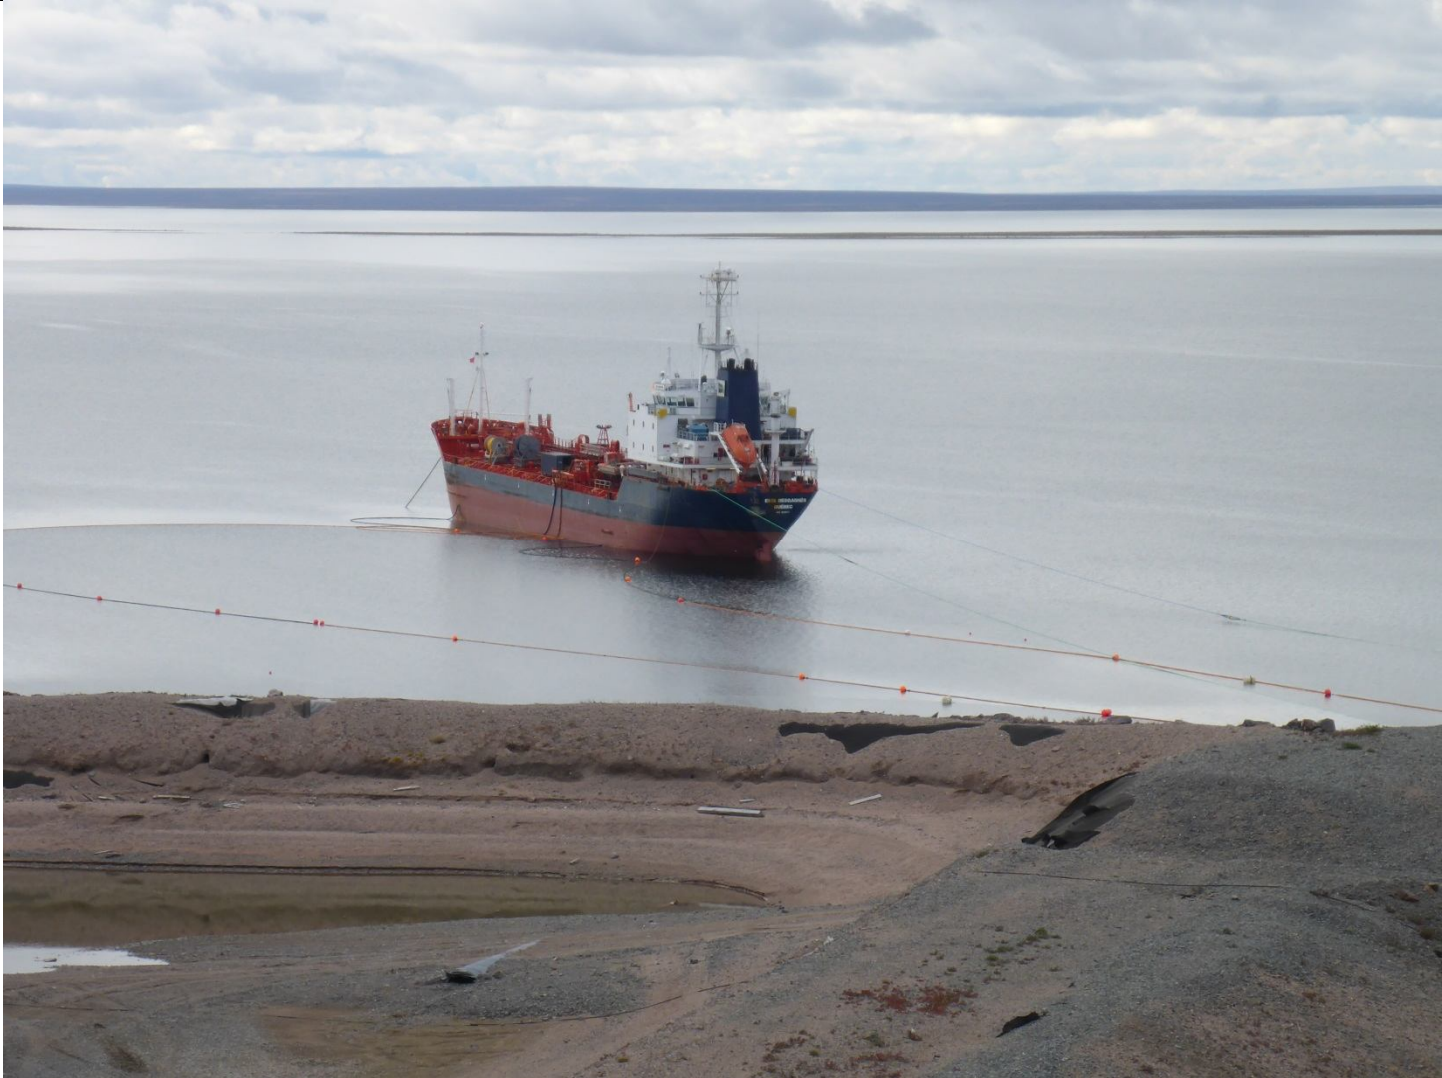
Date:	Authorization Number:	Camera/Model:	Inspector
August 29 <sup>th</sup> , 2018	2AM-MEA1525	Panasonic Lumix DMC-TS5	WRO Morton
Photo No.		Lat/Long (DD.MM.SS.SS, NAD83)	
Photo 14

Description:
The vessel 'Esta Desgagnes' offloading fuel.

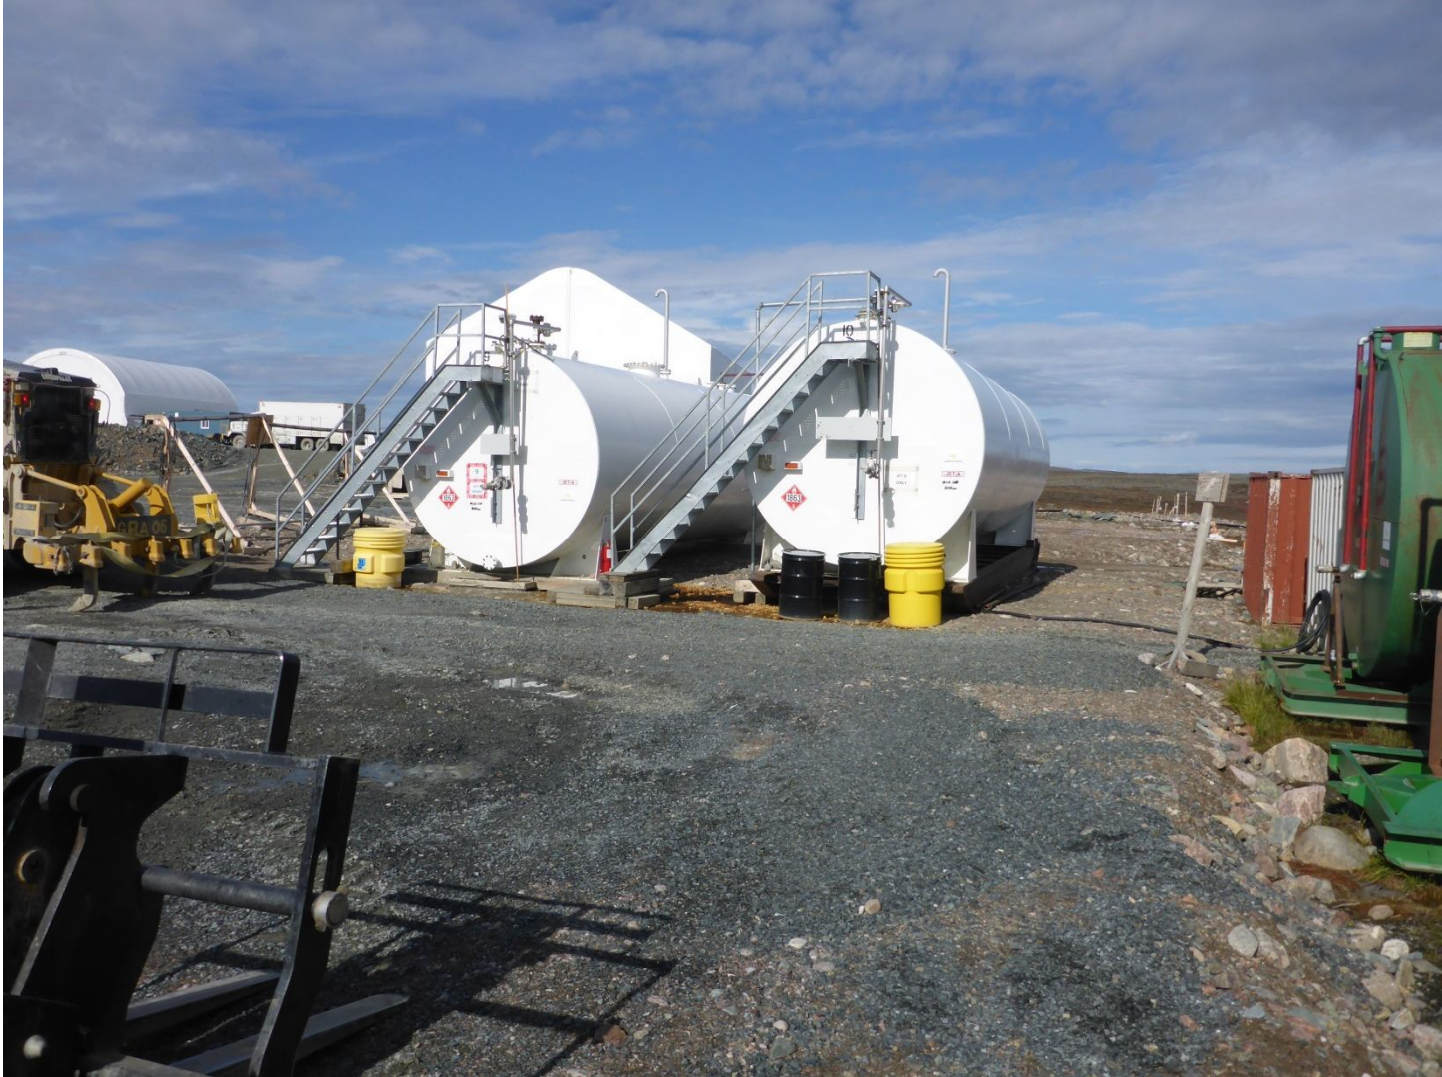
Date:	Authorization Number:	Camera/Model:	Inspector
August 28 <sup>th</sup> , 2018	2BB-MEA1828	Panasonic Lumix DMC-TS5	WRO Morton
Photo No.	Lat/Long (DD.MM.SS.SS, NAD83)		
Photo 1

**Description:**  
Fuel storage area located northeast of the Amaruq camp.

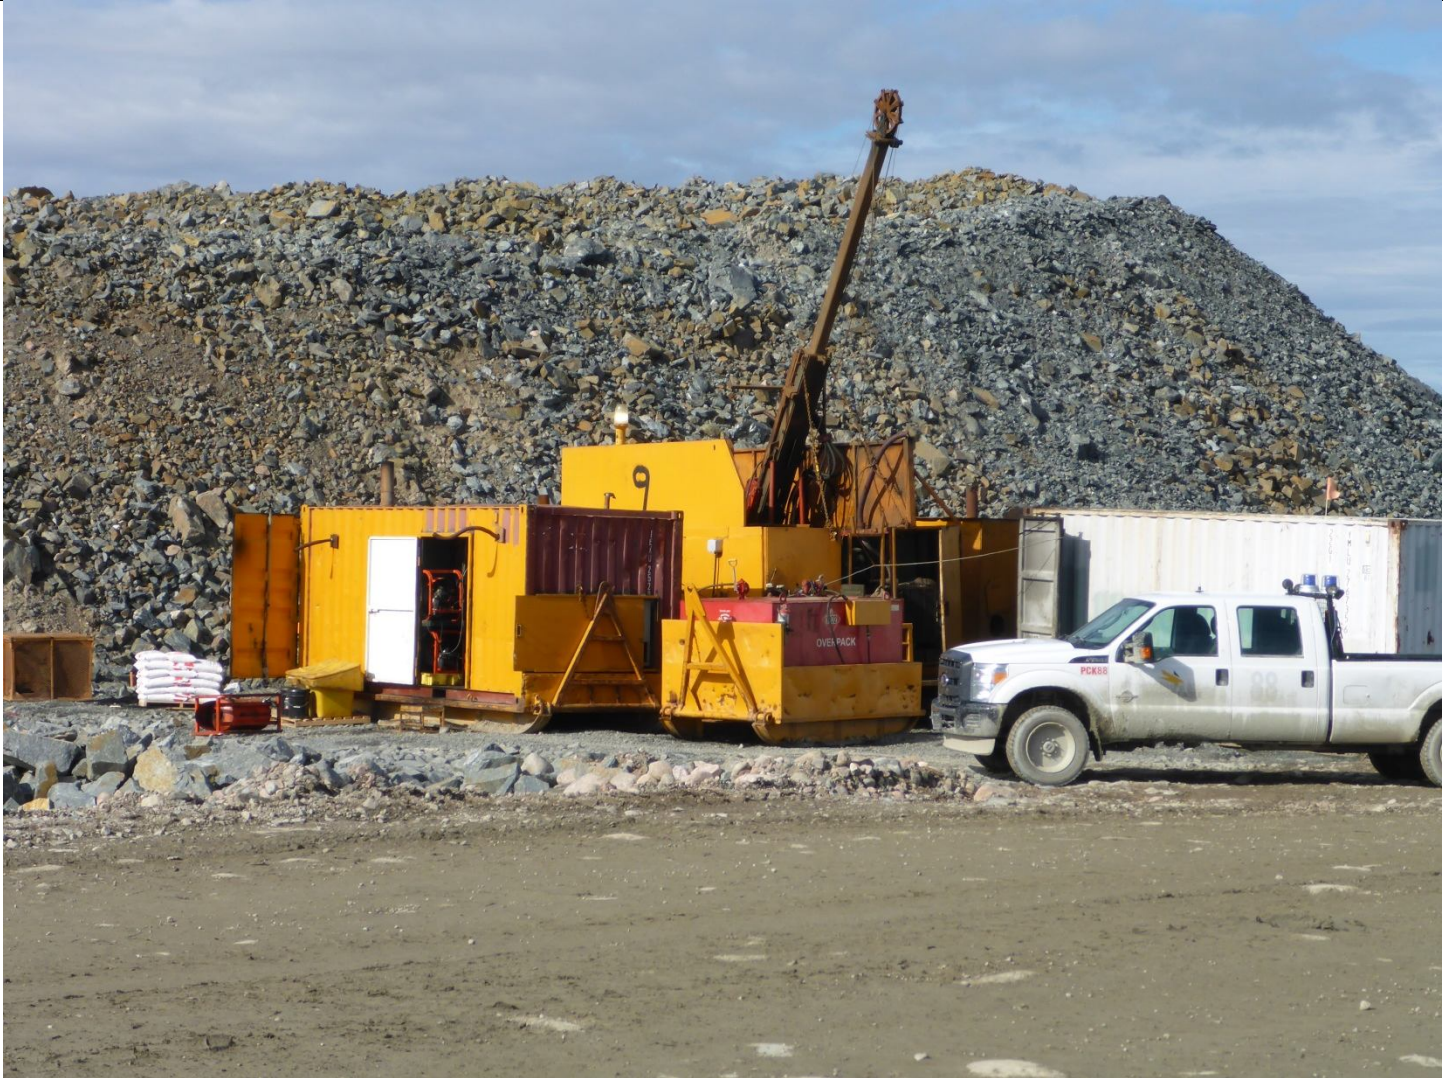
Date:	Authorization Number:	Camera/Model:	Inspector
August 29 <sup>th</sup> , 2018	2BB-MEA1828	Panasonic Lumix DMC-TS5	WRO Morton
Photo No.		Lat/Long (DD.MM.SS.SS, NAD83)	
Photo 4

**Description:**  
Overview of drill located near the Amaruq Camp.

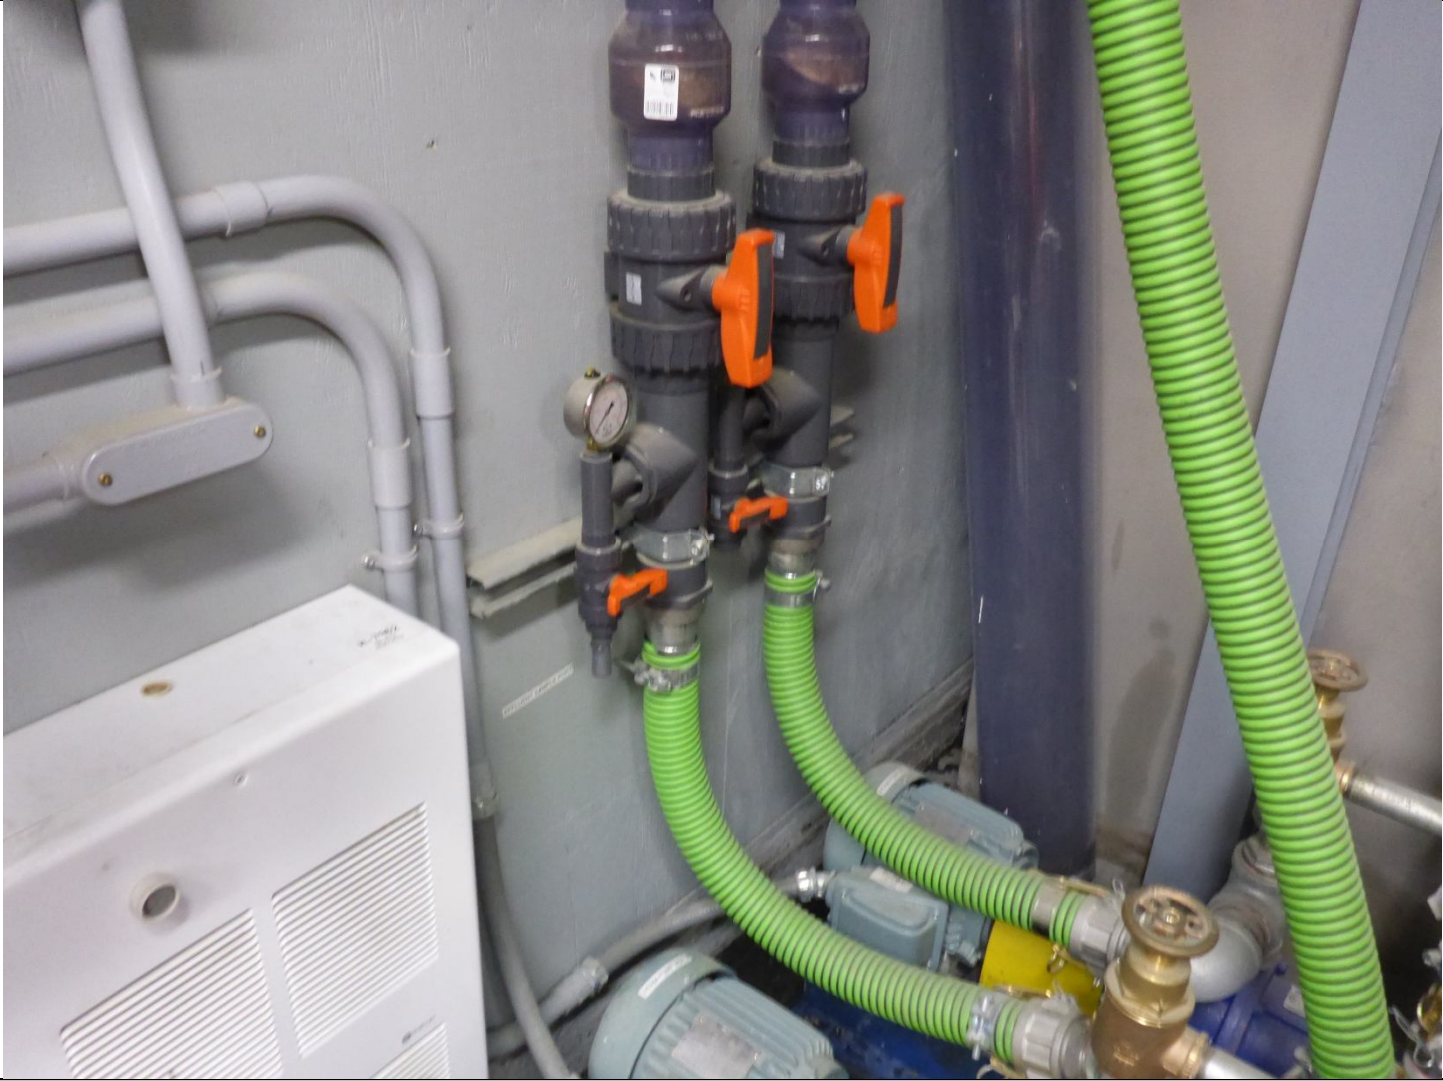
Date:	Authorization Number:	Camera/Model:	Inspector
August 29 <sup>th</sup> , 2018	2BB-MEA1828	Panasonic Lumix DMC-TS5	WRO Morton
Photo No.	Lat/Long (DD.MM.SS.SS, NAD83)		
Photo 7

**Description:**  
MEA-2 discharge sampling location.
