## **Appendix 54**

### **Meadowbank and Whale Tail 2018 Regulators inspection reports**

## **Inspection Report - Water Licence 2AM-MEA1526**

WATER LICENCE INSPECTION FORM

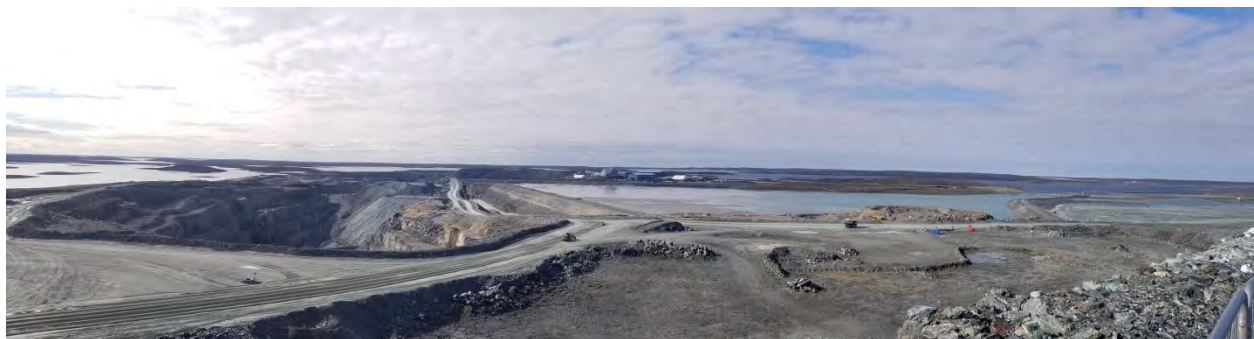
**Photo 1: Overview of Meadowbank Mine Site**

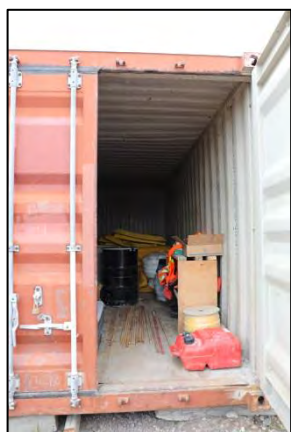
- a. The Monitoring Officer observed that the environmental emergency seacans containing booms, shovels, absorbent pads, and other miscellaneous spill response equipment were located at the Baker Lake laydown facility (see [Photo 2](#)). At the time of the site visit, a barge was at the Baker Lake dock facility and offloading equipment and the marshalling facility was very busy with the movement of supplies from the barge (see [Photo 3](#) and [Photo 4](#)).

**Photo 2: Environmental Emergency Seacan at the Baker Lake Marshalling Facility**

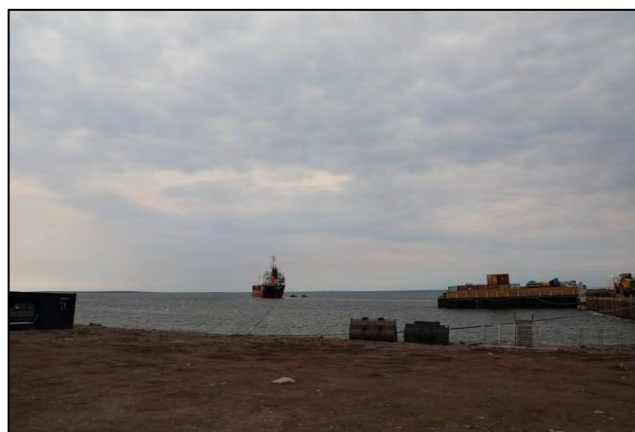
**Photo 3: Barge at Baker Lake Facility**

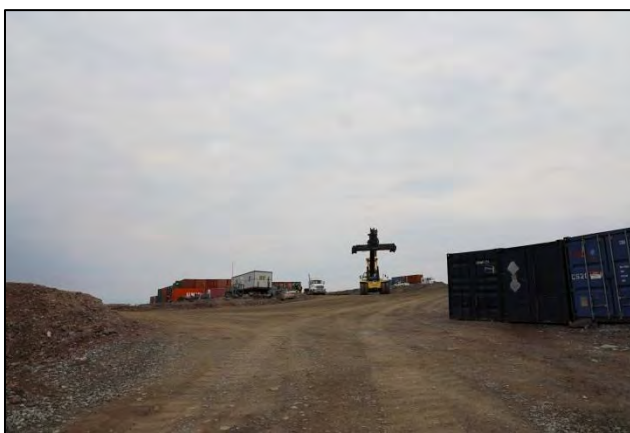
**Photo 4: Baker Lake Marshalling Facility**

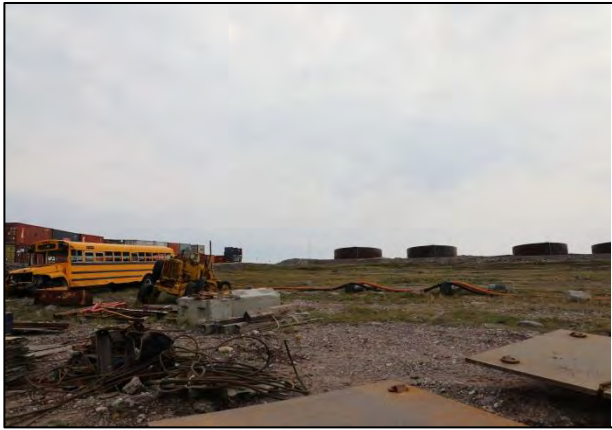
- b. It was further noted that the lower all-terrain vehicle (ATV) trail that goes through the Baker Lake bulk fuel storage facility/marshalling area was blocked seacans limiting access to the community members ability to travel to their cabins along the shoreline (see [Photo 5](#) and [Photo 6](#)).

**Photo 5: Tires blocking lower ATV trail along the Baker Lake shoreline**

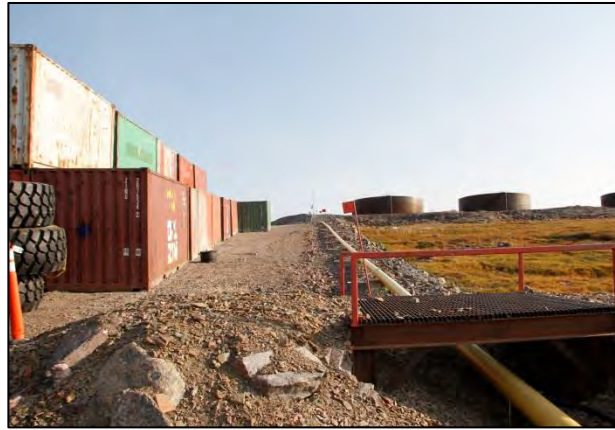
**Photo 6: Little bridge to ensure access to ATV trail (photo from 2017)**

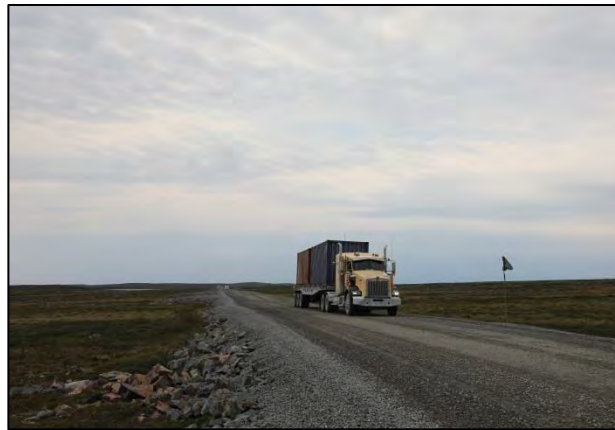
- d. While travelling along the AWAR, the Monitoring Officer noted that this time the road was not extensively used by Baker Lake community members but was extremely busy with haul trucks traveling up to the Meadowbank site (see [Photo 9](#), [Photo 10](#) and [Photo 11](#)) with sometimes 10 haul trucks on the road at once.

**Photo 10: Haul truck on AWAR**

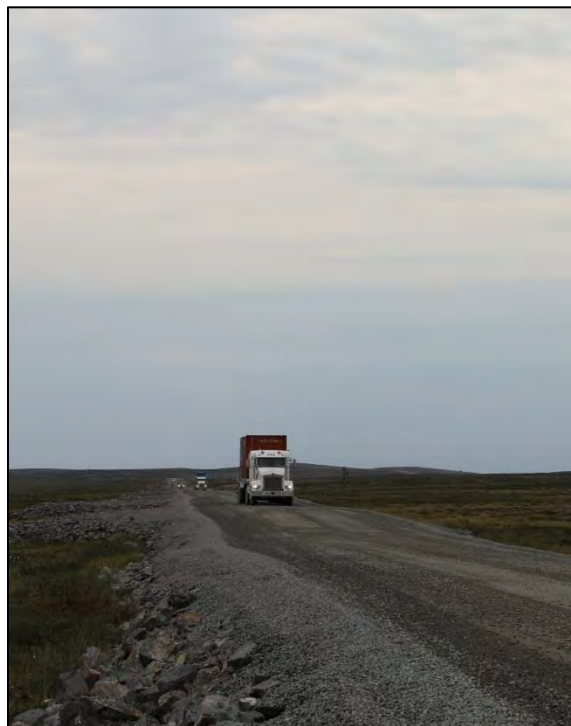
**Photo 11. Several Haul Trucks Travelling to Meadowbank**

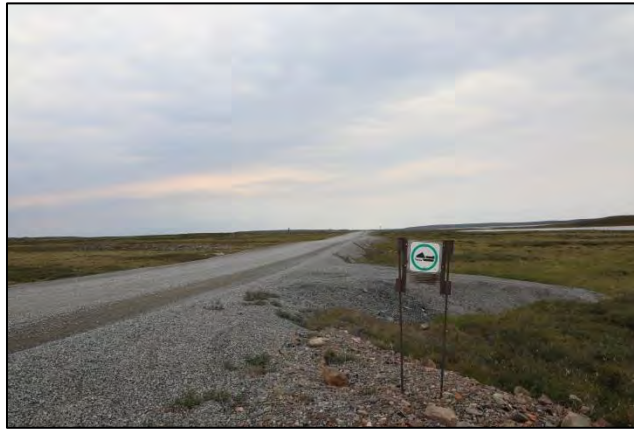
- e. Two snowmachine crossings are located along the AWAR, one near km 10 and the second near km 98 (previously near km 82). There were no signs of extreme slopes or rocks along the side of the AWAR (see [Photo 12](#)).

**Photo 12: Snowmachine crossing near km 10**

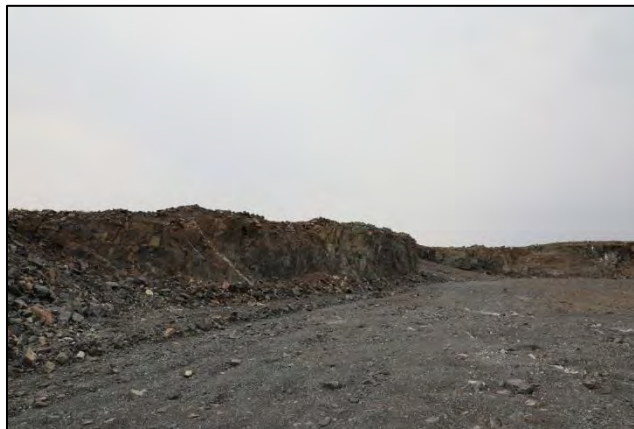
- f. Environmental emergency seacans were located at all bridge crossings.
- g. Agnico Eagle indicated that remediation is ongoing at Quarry 22 following storage of contaminated hydrocarbon soil in previous years at this quarry site as the soil/gravel still tested positive for hydrocarbons (see [Photo 13](#)). No remediation work was conducted in 2018 due to active Peregrine Falcon nests at this quarry but plans were in place to continue the remediation work in 2019 but none were completed at the time of the site visit.

**Photo 13: Quarry 22**

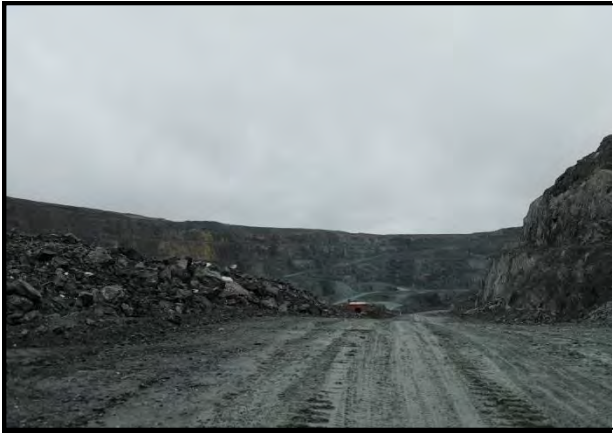
- h. Active drilling was ongoing at Portage Pit (see [Photo 14](#) and [Photo 15](#)) and at Vault Pit ([Photo 16](#) and [Photo 17](#)), while blasting was being conducted at the Phaser Pit and BB Phaser Pit area during the site visit (see [Photo 18](#) and [Photo 19](#)). During the site visit it was noted that an ice sheet has formed on the walls of the Vault Pit (see [Photo 17](#)) and Agnico Eagle noted that it has been spraying the ice sheet with water to keep it from growing and potentially breaking off and falling into the pit.

**Photo 14: View of Portage Pit (South Portage)**

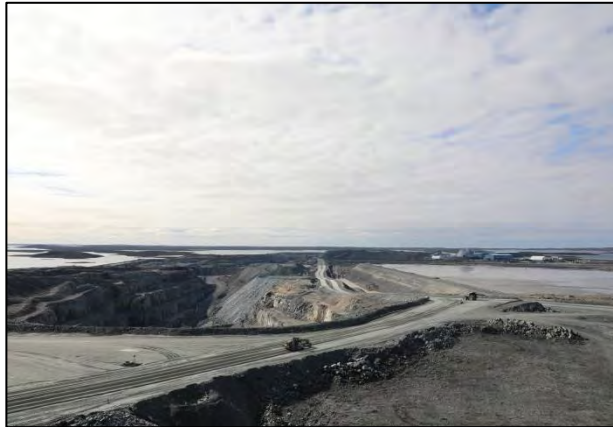
**Photo 15: Portage Pit from viewpoint**

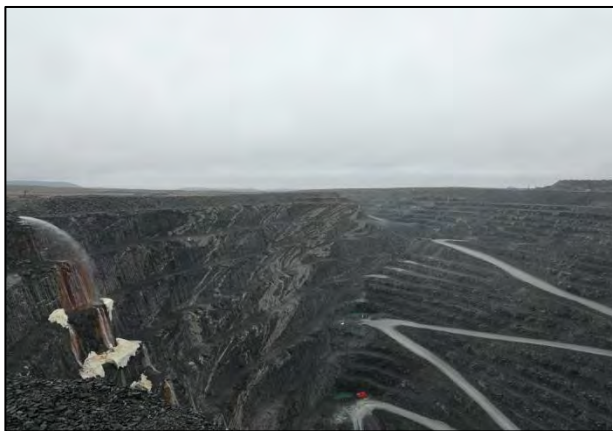
**Photo 16: View of Vault Pit – looking west**

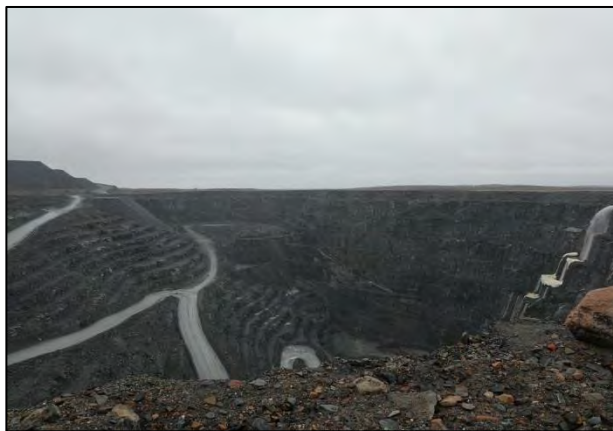
**Photo 17: View of Vault Pit – looking east**

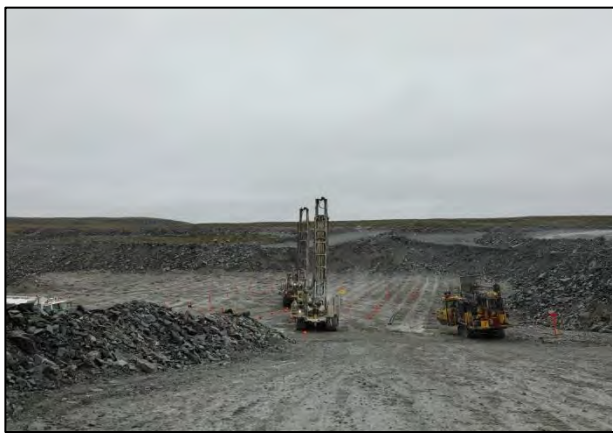
**Photo 18: Phaser and BB Phaser – looking north**

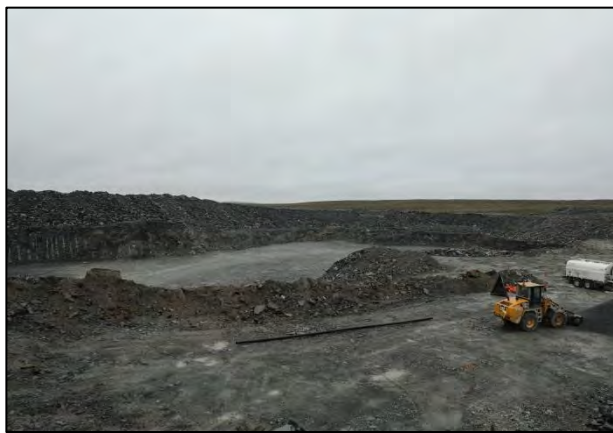
**Photo 19: Phaser and BB Phaser – looking west**

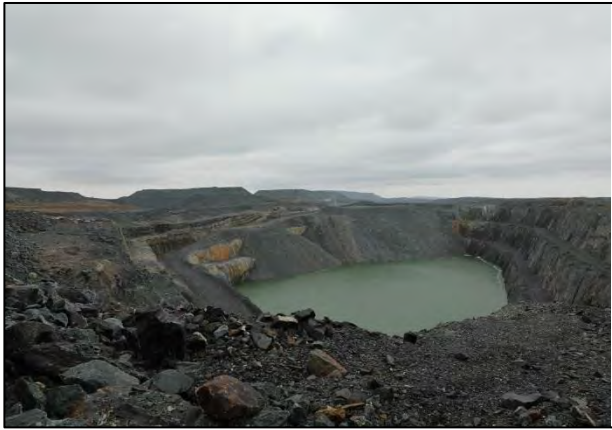
- i. The Monitoring Officer was previously notified that mining at the Bay-Goose Pit had ended in early 2015 and the pit has been allowed to slowly fill in naturally with water (see [Photo 20](#) and [Photo 21](#)). During the 2017 site visit, the Monitoring Officer was informed that the pit will be filled with water during the fall but this did not occur as observed during the 2018 site visit and as noted in the photos (see [Photo 21](#)) as Agnico Eagle was proposing to use the Bay-Goose Pit as an in-pit tailings facility at the time of the site visit.

**Photo 20: View of Bay-Goose Pit – looking north**

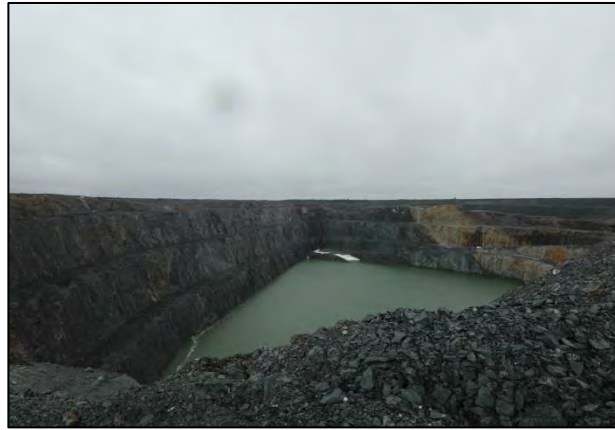
**Photo 21: Bay-Goose Pit looking south**

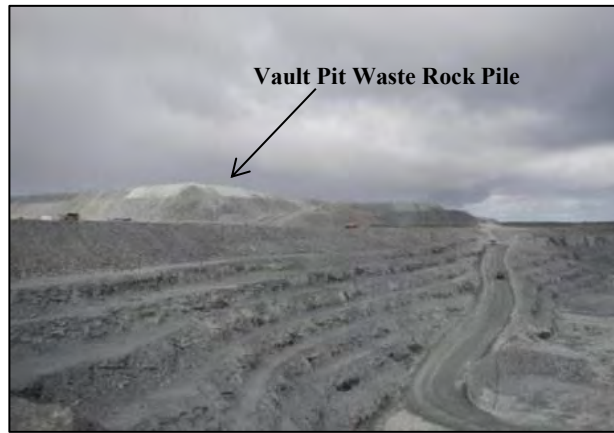
- j. The Vault Pit waste rock storage facility has increased in size since the 2017 site visit (see [Photo 22](#) through [Photo 25](#)) and the Agnico Eagle staff noted that waste rock from the Vault Pit has been tested to be non-potentially acid forming (NPAG rock). The NPAG rock is stored in the Vault marginal stockpile for re-use on-site.

**Photo 23: Vault Pit waste rock storage facility in 2016**

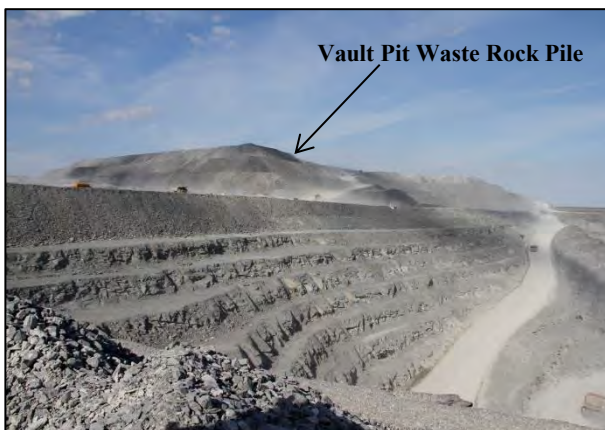
**Photo 24: Vault Pit waste rock storage facility in 2017**

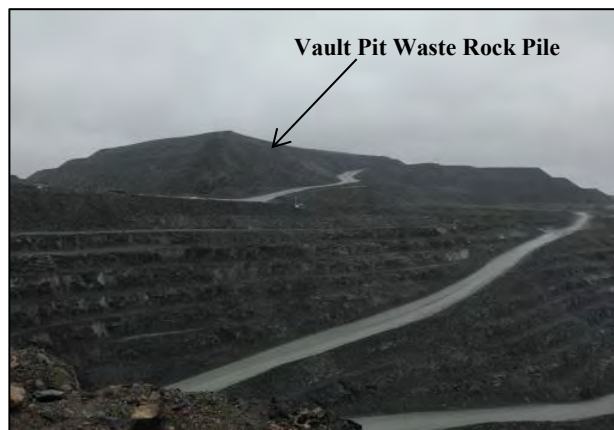
**Photo 25: Vault Pit waste rock storage facility in 2018**

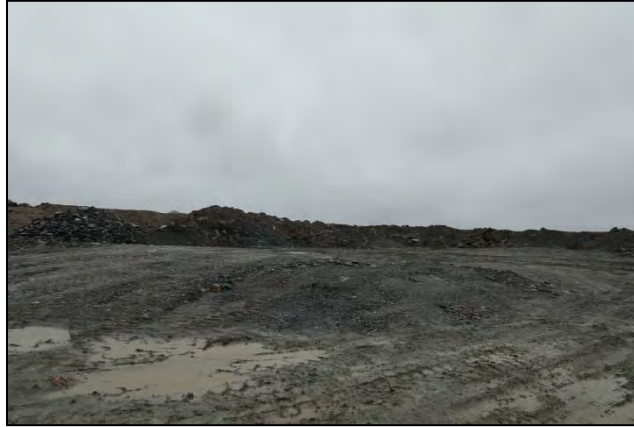
- k. Agnico Eagle started a new landfarm site in 2017 to treat all contaminated hydrocarbon soil on site, while the old landfarm, which was located next to the South Cell, was flooded as the tailings deposition continues. The remediation program at the Meadowbank site, which commenced in 2013, uses on-site nutrients (sewage sludge) to initiate biodegradation of all contaminated hydrocarbon soil on site and appears to be successful (see [Photo 26](#)).

Photo 26: Landfarm

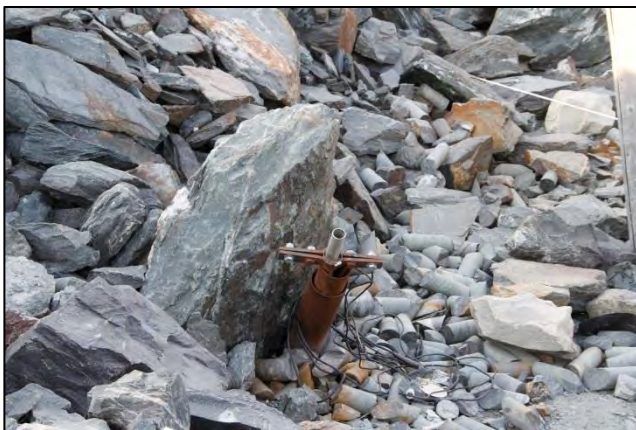
During the 2017 site visit, Agnico Eagle staff noted that Agnico Eagle was attempting a different technique to ensure the groundwater wells stay open and do not freeze or are damaged. This technique involves the installment of a seacan on top of the groundwater wells and ensuring a heat trace could be installed down the well. A consultant from SNC Lavalin has audited the revised groundwater monitoring protocols and it appears to be working well. At the time of the 2018 site visit, five (5) groundwater monitoring wells was operational: MW-08-02 (see [Photo 27](#)), MW-16-01 (see [Photo 28](#)), MW-IPD-01, MW-IPD-07 (see [Photo 29](#)), and MW-IPD-09.

**Photo 27: Groundwater monitoring well MW-08-02  
(photo from 2017)**

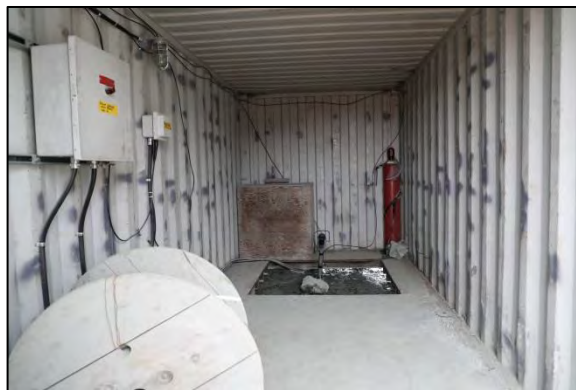
**Photo 28: Groundwater monitoring well MW-16-01**

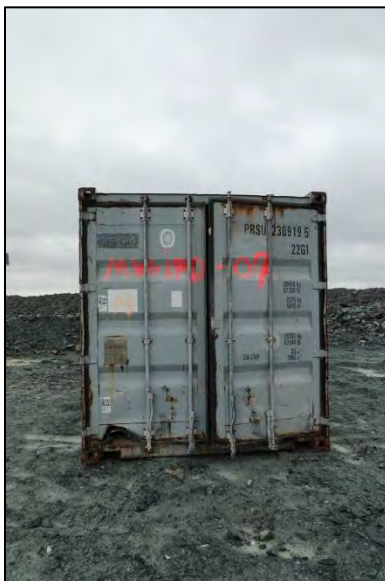
**Photo 29: Groundwater monitoring well MW-IPD-07**

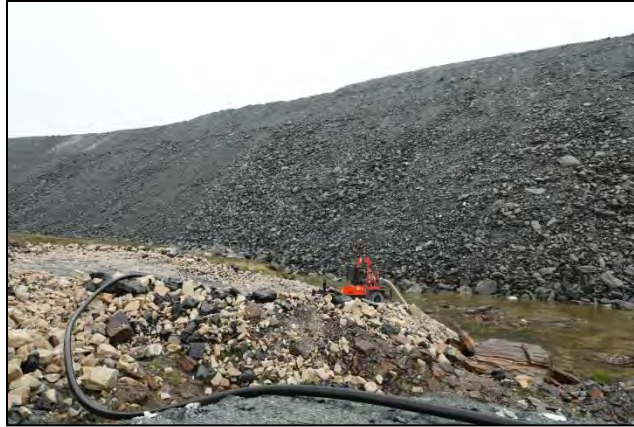
In 2013, Agnico Eagle noted seepage from the Portage waste rock storage facility with potentially acid generating rock (which has a high sulphur content, heavy metals, and other contaminants) at a location near the south shore of a fish bearing lake (referred to as North Pole 2 or NP-2 lake) (see [Photo 30](#)). Agnico Eagle staff stated monitoring of the seepage is ongoing during the open water season and that accumulated water is pumped directly back to the North Cell tailings storage facility. It was previously indicated that no seepage have been observed since the North Cell was raised during the summer of 2016 as the assumption is that the tailings storage facility was built on an old riverbed system and may have seeped through this system.

**Photo 30: Ongoing monitoring of seepage from the Portage waste rock storage facility**

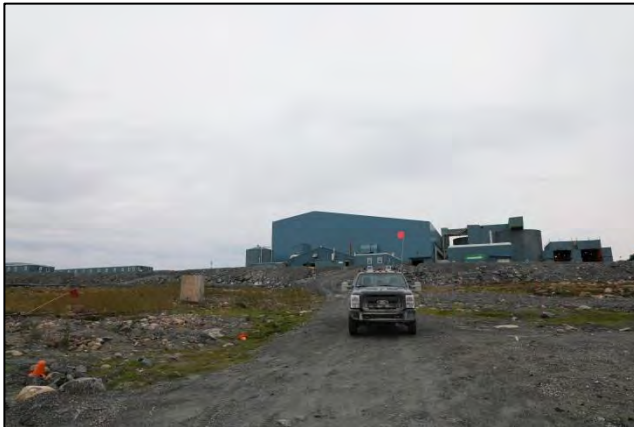
**Photo 31: Assay Laboratory**

In 2013, Agnico Eagle discovered water seeping through the road in front of the Assay laboratory towards Third Portage Lake where cyanide destruction in tailings occurred (see [Photo 31](#)). Following investigation, Agnico Eagle determined that the seepage was coming from the process plant, specifically leakage from containment structures through test results of the seepage water that indicated levels of cyanide, iron, and copper.

In April 2014, a trench was constructed to intercept any potential water seepage during freshet and pumped back to the mill (see [Photo 32](#)) and following repairs and sealing of the containment structures within the mill no levels of cyanide, iron, and copper were detected within the tested water. Water from the trench continues to be pumped back for use at the mill and continues to be tested.

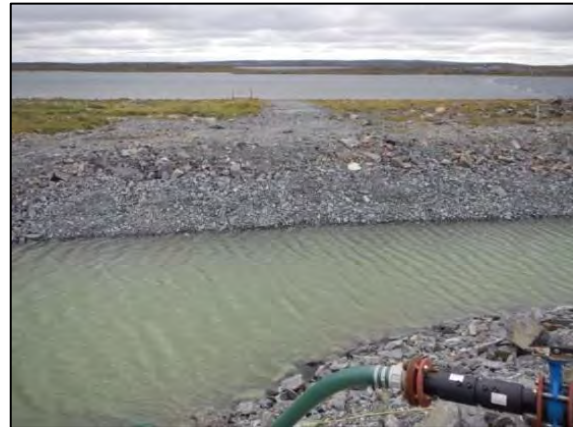
**Photo 32: Trench below Assay Laboratory to prevent water from entering lake**

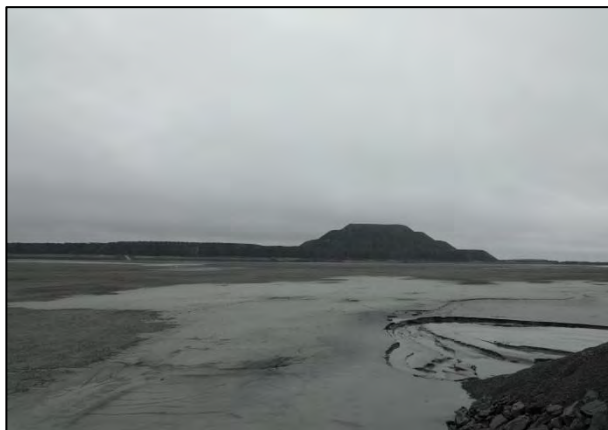
**Photo 34: Tailings Storage Facility (North Cell)**

The tailings facility at Meadowbank consist of the North and South cells (see [Photo 33](#)). Progressive reclamation commenced at the North Cell of the tailings storage facility in the winter of 2015 by capping the tailings following the completion of tailings deposition in this cell. When viewing the North Cell of the tailings storage facility, the Monitoring Officer observed the thermistors, installed in 2012 to measure freezeback, and did not observe any apparent rips in the exposed lining of Saddle Dams 1 and 2 or at the Stormwater Dike (see [Photo 34](#)). Tailings have been deposited into the South Cell of the tailings facility (see [Photo 35](#)) since 2016. The construction of the different phases of the Central Dike and Saddle Dams were ongoing during the site visit.

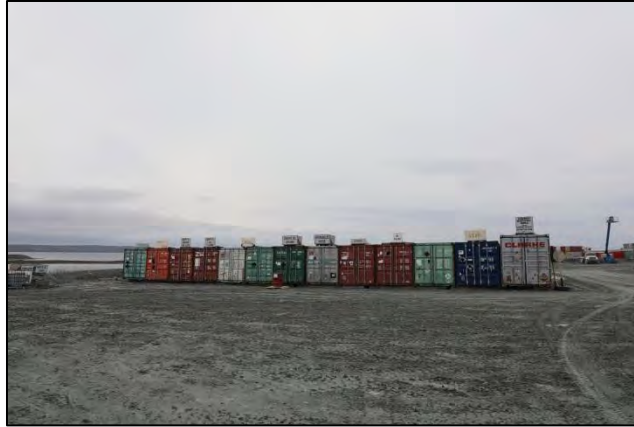
**Photo 36: Seacans used for waste segregation and storage area**

As per previous NIRB site visits, the Monitoring Officer noted during the 2018 site visit that Agnico Eagle continues to segregate and store all domestic, hazardous, and combustible wastes in marked seacans prior to these materials being incinerated or shipped to the appropriate and approved off-site disposal facilities (see [Photo 36](#)).

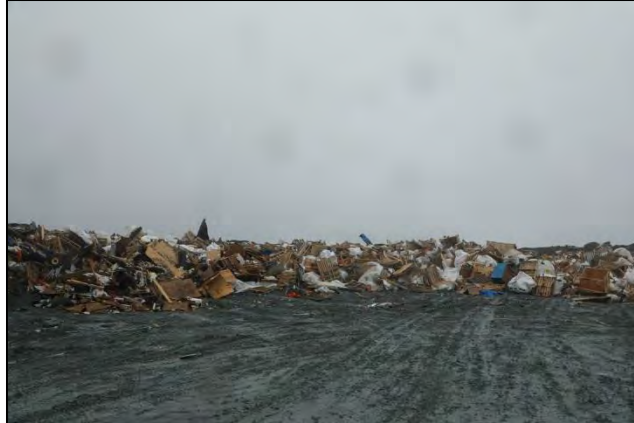
**Photo 37: Landfill at Meadowbank mine site**

In 2014, Agnico Eagle started a pallet recycling program where pallets not needed at site are transported in seacans to the high school in Baker Lake for use as building materials in the woodshop. In 2018, Agnico Eagle noted that it has discontinued to supply the high school with pallets for their woodshop program but still continues to donate pallets to community members for personal use (see [Photo 37](#) of the Meadowbank landfill).

Agnico Eagle further stated that the landfill is frequently inspected by employees to ward off any wildlife that may be present, and to ensure wastes are segregated appropriately and that wastes designated to the incinerator or metal do not end up in the landfill.

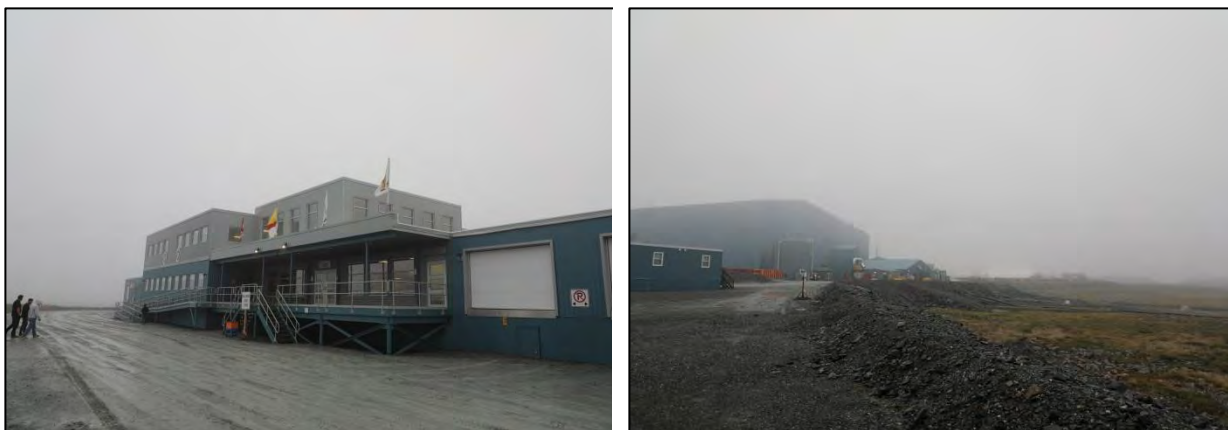
**Photo 38: Meadowbank Mine Site**

During the 2018 visit to the Meadowbank site, the Monitoring Officer observed that all areas were kept in a clean state, with no obvious spills. There was no evidence of wind-blown material viewed around the Meadowbank site and at the ancillary facilities in Baker Lake (see [Photo 38](#)).

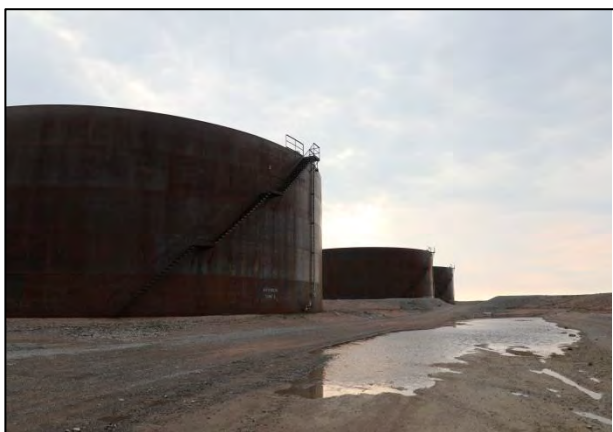
**Photo 39: Baker Lake Fuel Tank Farm Facility**

During the 2018 site visit, the Monitoring Officer noted that fuel and hazardous materials associated with Agnico Eagle’s Meadowbank project appeared to be stored in a safe and environmentally protective manner (see [Photo 39](#) to [Photo 41](#)). Any observed water in the containment berms had no visible sheen on the water or discernable hydrocarbon odours at either the Baker Lake or the Meadowbank site fuel facilities (see [Photo 40](#)).

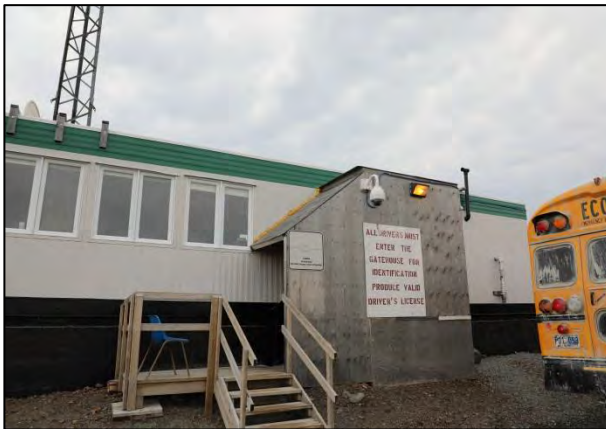
**Photo 42: Gatehouse at kilometre 5, near Baker Lake**

Agnico Eagle maintains one (1) gatehouse at kilometre 5 of the access road, and second gatehouse at the entrance to the mine site and camp at Meadowbank. Only the gatehouse at kilometre 5 is manned by Agnico Eagle staff who monitors the safety and security of all personnel using the road. All traffic (including public traffic) is required to check-in (via radio or in person) with the employee at the gatehouse prior to proceeding along the road (see [Photo 42](#)) from either the mine site or from Baker Lake. The Agnico Eagle employee manning the kilometre 5 gatehouse maintains a daily logbook of all persons travelling the access road for non-mine use, and members of the public travelling along the road are required to sign an indication of having read Agnico Eagle’s *All Weather Private Access Road Safety Rules & Procedures for Road Access* policy prior to being granted access to the road (see [Photo 43](#)).

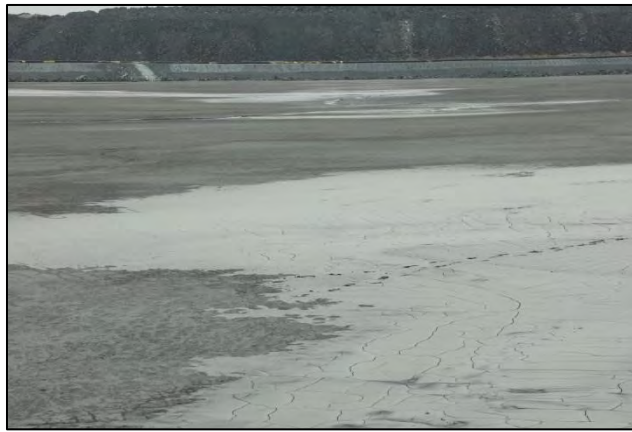
**Photo 44: Wildlife tracks on the North Cell of the Tailings Facility**

During the site visit, the Monitoring Officer noted wildlife tracks on the North Cell of the tailings facility (see [Photo 44](#)).

muskox, caribou, wolves, and birds) had been observed around the site and along the AWAR, and that migratory birds would use the tailings storage facility during the spring time. Wildlife tracks have been noted by the Monitoring Officer at the tailings storage facility during previous site visits and during the 2018 site visit which provide evidence that wildlife are accessing the tailings storage facility.

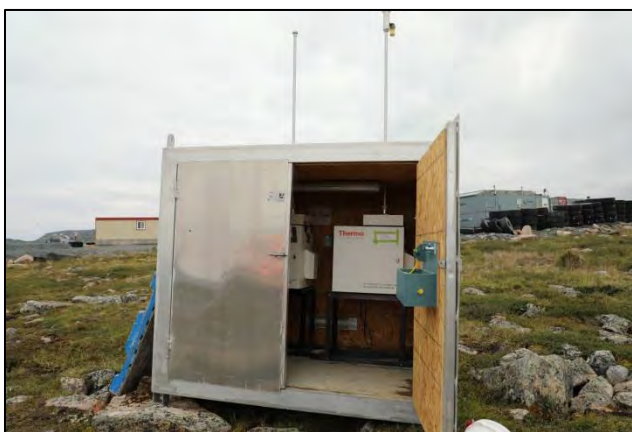
**Photo 45: Air and partisol monitoring station near the emulsion station**

The NIRB staff viewed the air and partisol monitoring stations at the northern corner of South Camp Island (see [Photo 45](#)). Agnico Eagle staff stated that both dustfall and partisol monitoring occurs year-round.

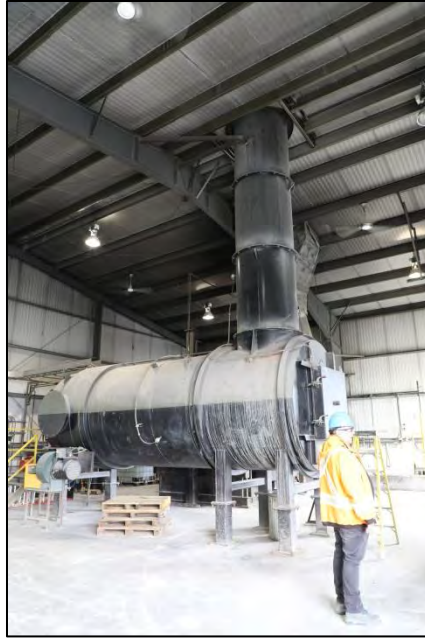
**Photo 46: Incinerator at Meadowbank mine**

The Meadowbank site dual chamber forced air incinerator remains in service for the combustion of all non-hazardous, combustible materials at the site (see [Photo 46](#)). During the site visit, Agnico Eagle noted ongoing education is required to ensure that wastes such as metal cans are not incinerated and to ensure wastes are segregated appropriately.

The Monitoring Officer noted during the site visit that Agnico Eagle's updates to their protocol procedures appear to be working ensuring the incinerator temperatures in the secondary chamber reach 1000 °C for complete combustion and to minimize the formation and release of contaminants. Protocol updates included ensuring the first chamber reaches 700 °C and new instruments were installed to monitor the temperature in both chambers to ensure the chambers do not drop below the required temperatures.

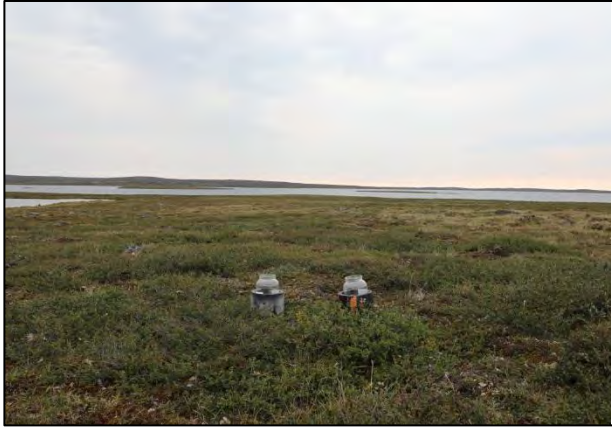
**Photo 47: Dust Sampling Station**

As in previous years, Agnico Eagle staff noted that dust sampling stations were placed along the Awaruk Road at various distances from both the east and west sides of the road in two (2) duplicate transects (see [Photo 47](#)) to monitor dust deposition distance from the road. Dust canisters are placed 25, 50, 100, 150, 300, and 1000 metres away from the Awaruk Road.

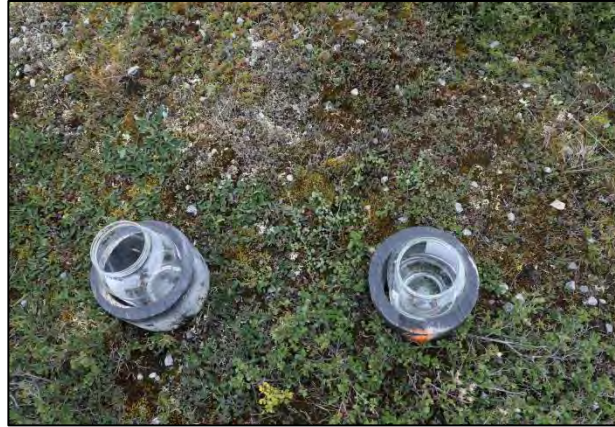
**Photo 48: Dust canister located on the tundra**

Mr. Archambault also noted that Agnico Eagle continues to apply TETRA flakes (calcium chloride) along three (3) critical areas on a two (2) km section of the Awaruk Road as agreed upon with the local Hunters and Trappers Organization (see [Photo 48](#)). Along each of the three (3) sites, Agnico Eagle continues to conduct additional dust sampling.

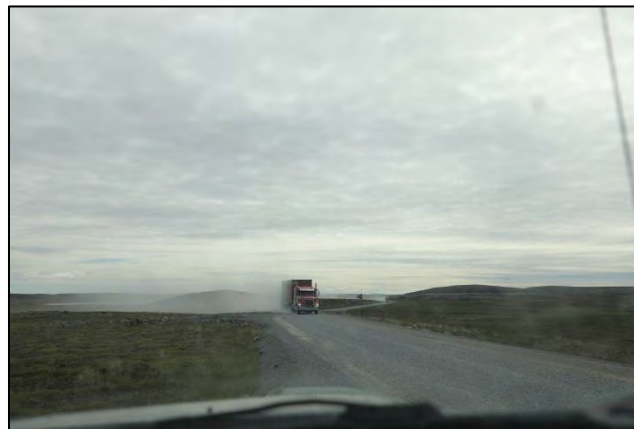
**Photo 49: Dust created by vehicles along the AWAR**

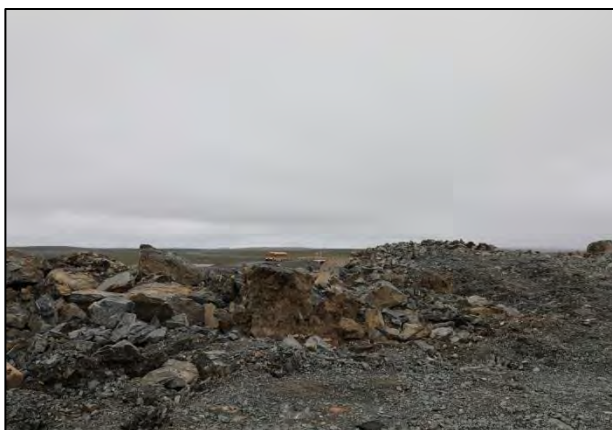
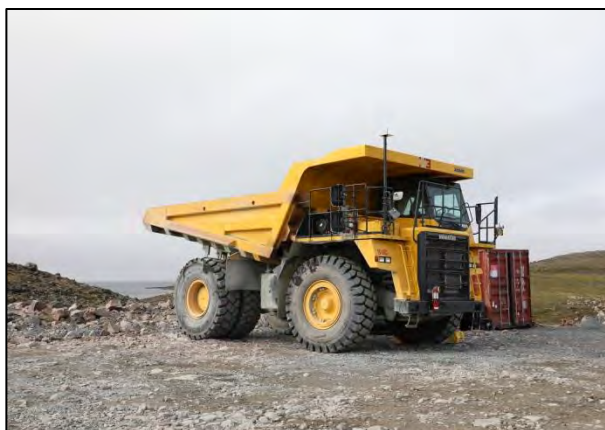
- a. The NIRB staff were driven along the Amaruq haul road to the exploration site and future Whale Tail Pit Project. Heavy construction was ongoing during the trip for the expansion of the haul road from 6 metres to 9 metres in width as recently approved under Project Certificate No. 008 (see [Photo 51](#) and [Photo 52](#)).
- b. The Monitoring Officer observed that environmental emergency spill kits were not available at all the bridges along the haul road to Amaruq. In questioning Mr. Archambault on this, it was noted that seacans containing booms, shovels, absorbent pads, and other miscellaneous spill response equipment will be located at all the bridges once the road construction has been completed. A few bridges contained spill kits as can be observed in [Photo 53](#).

**Photo 51: View of the Amaruq Haul Road from Quarry #10.5**

**Photo 52: 605 Haul/Dump Truck**

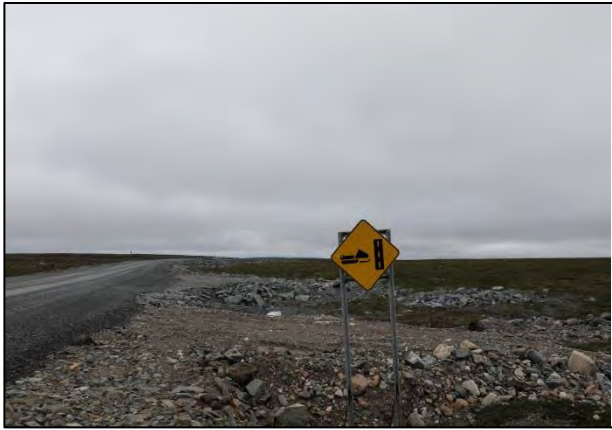
**Photo 55: Snowmachine crossing near km 12**

- d. One (1) snowmachine crossing is located along the haul road near km 12. There were no signs of extreme slopes or rocks along the side of the AWAR (see [Photo 55](#) and [Photo 56](#)).

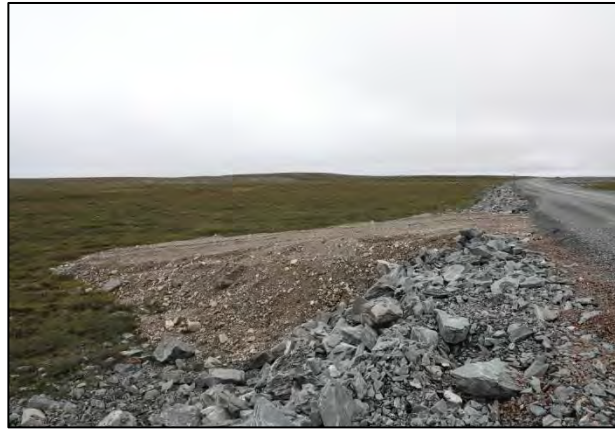
**Photo 56: Slope on the other side of the snowmachine crossing near km 12**

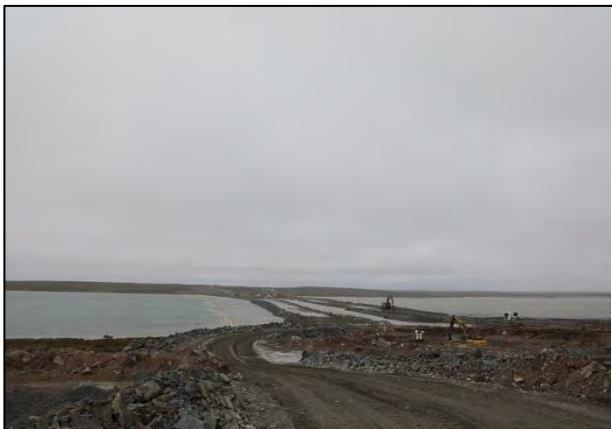
- e. The Whale Tail site was extremely active with development of the site in full construction mode. The berm separating the North Basin with the South Basin was being completed, the fish-out program started a week earlier and the pilings were being put in place for the new mine camp (see [Photo 57](#) through [Photo 61](#)) while NIRB staff were at site. Exploration activities were also ongoing with haul trucks moving rock and ore from the underground via the portal (see [Photo 62](#) through [Photo 64](#)).

**Photo 57: View of the Berm separating the North Basin and South Basin of Whale Tail Lake**

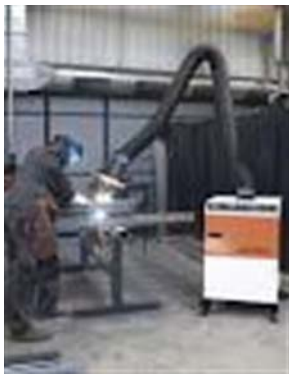
The local exhaust ventilation will capture pollutants as close as possible to their emission sources and remove them from the workplace. Since most emissions occur near the arc, the local exhaust ventilation is more effective than general ventilation. The system of local exhaust ventilation is designed to capture fumes and gases before the welder breathes it. However, the performance of the local exhaust systems may be greatly affected by air currents and the distance between the contaminant source and the sensor arm (90% efficiency at 22 inches).

Example of a “smoke eater” as used by welders

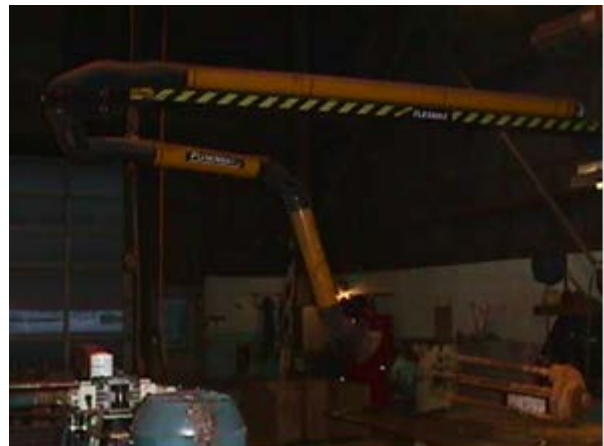
The extension arms are inspected periodically to determine the system performance. This assessment takes place every six (6) months and is made by the industrial hygienist. The data collected is stored in the log book.

Example of an extension arm with a fume captor

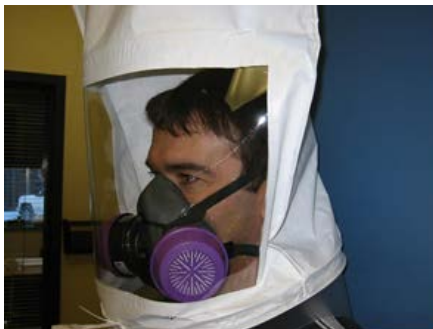
Once the initial fit test done (when issuing the respirator), additional fit testing is required only when one has suffered of a facial morphology (ex. scarring, loss of weight, acne, etc.). He/she must be fit

*Example of a quality fit test*

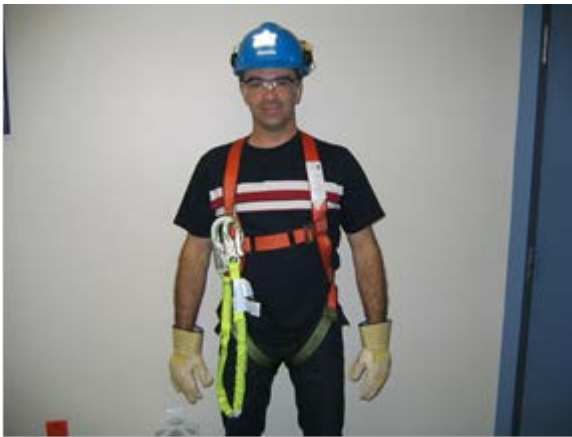
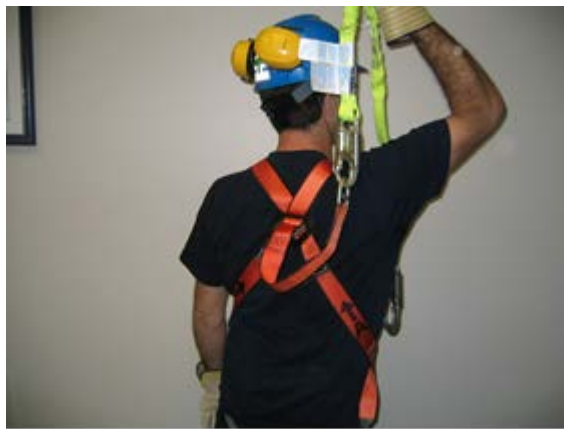
The safety harness is used with an energy absorber which is connected to a lanyard not allowing a free fall of more than 1.2 meters (3.9 feet) or a retractable lifeline (also known as SALA BLOCK name) which includes the energy absorber.

**Only harnesses classified class A (according to CSA-Z259.10) with straps for shoulders and thighs are used on the site.**
