**Preliminary Geotechnical Investigation Report  
Revision 1**

Proposed New Landfill Facility  
Iqaluit, NU

OTT-00248813-A0

July 26, 2019

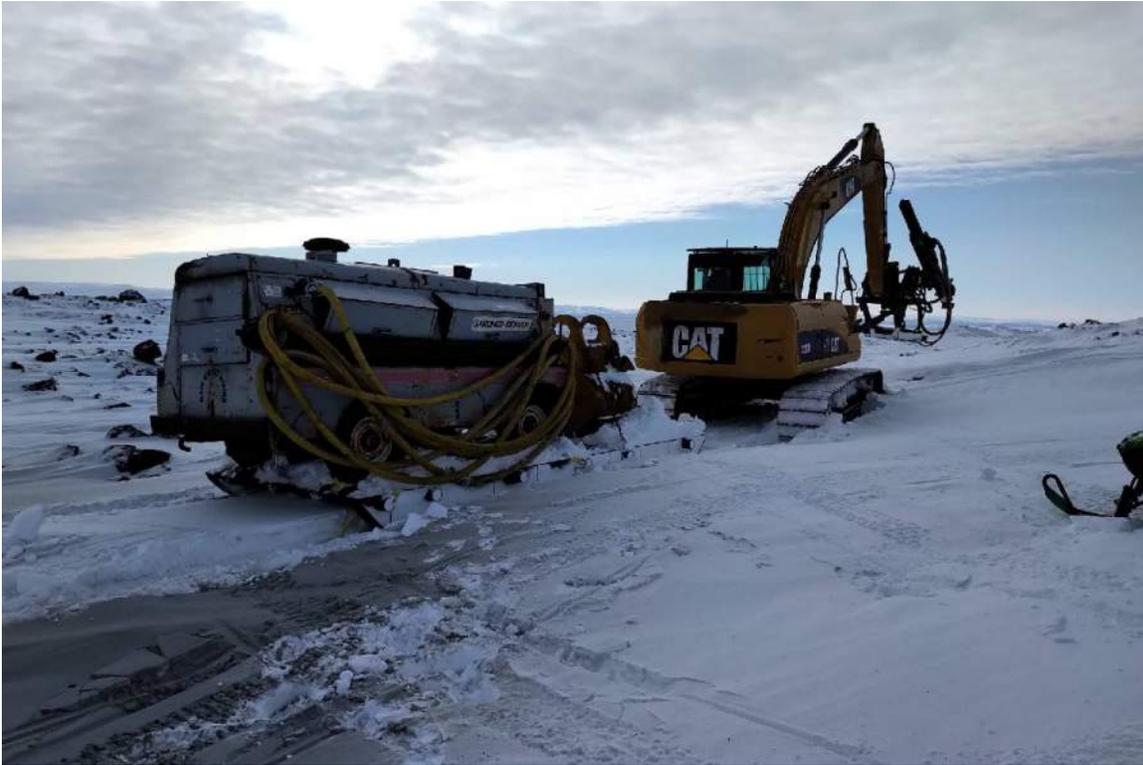
Photo 1 – Typical Air Track Mounted on a Mechanical Shovel and Compressor

The fieldwork for this project was undertaken between March 26 and April 4, 2019 using an air-track drill mounted on a mechanical shovel rented from Canadrill. The fieldwork was supervised on a full-time basis by a senior geotechnician from EXP experienced with permafrost soils and northern construction techniques.

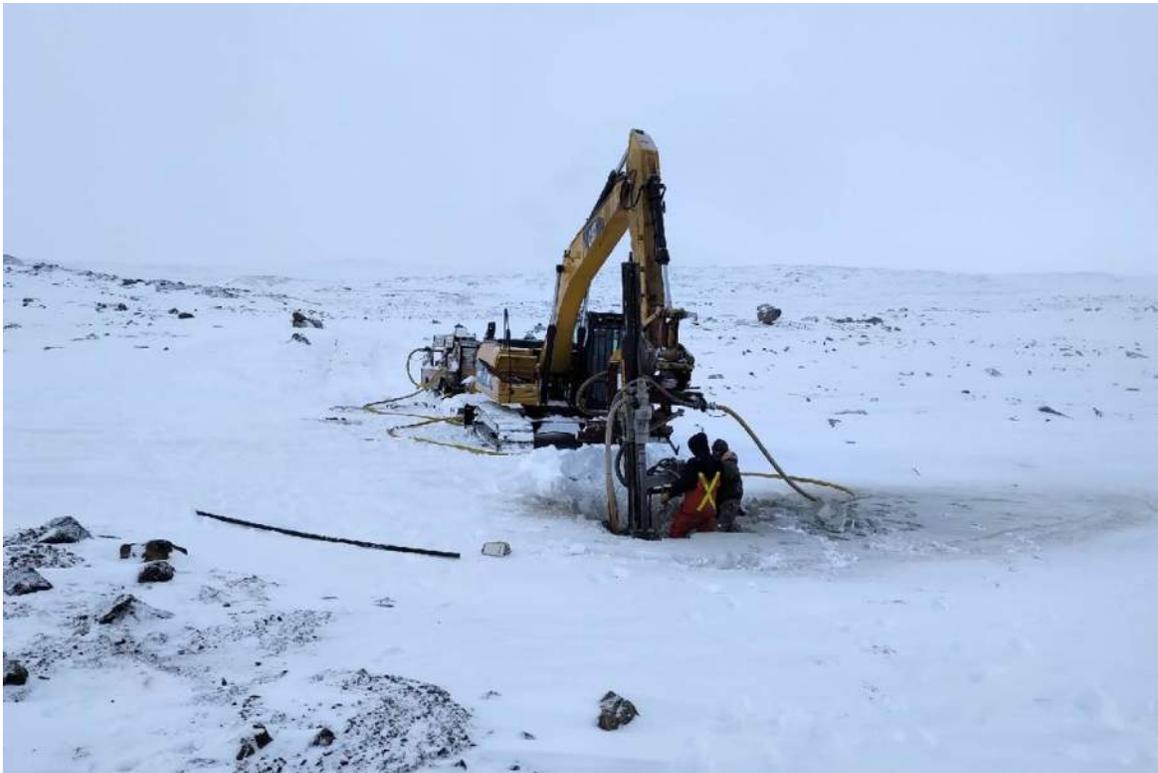
Photo 2 – Borehole Drilling Operation - Typical

The boreholes were drilled using an air-track drill rig, which breaks down the soil and bedrock to fine cuttings. The cuttings area spewed to the surface. As a result, the cuttings were mixed and it is not possible to accurately establish the bedrock depth, type or its condition. Therefore, the depth to bedrock indicated is approximate.

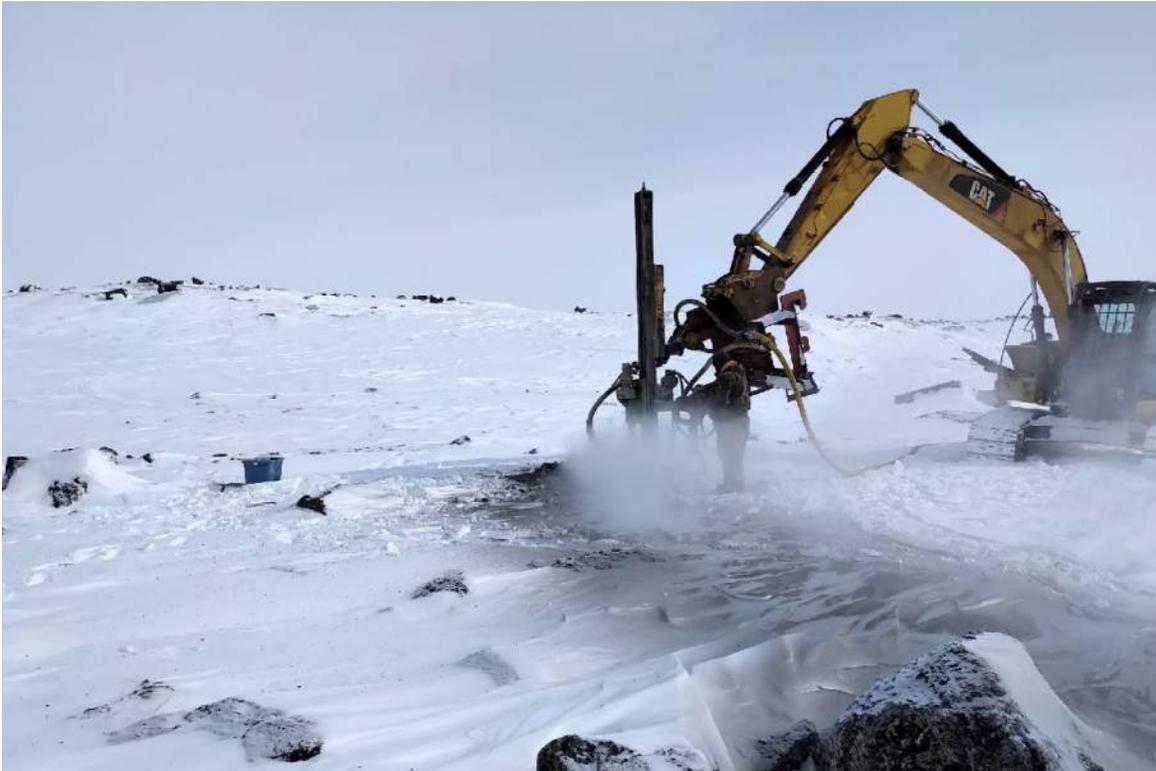
Photo 3 – Borehole Drilling Operation - Typical

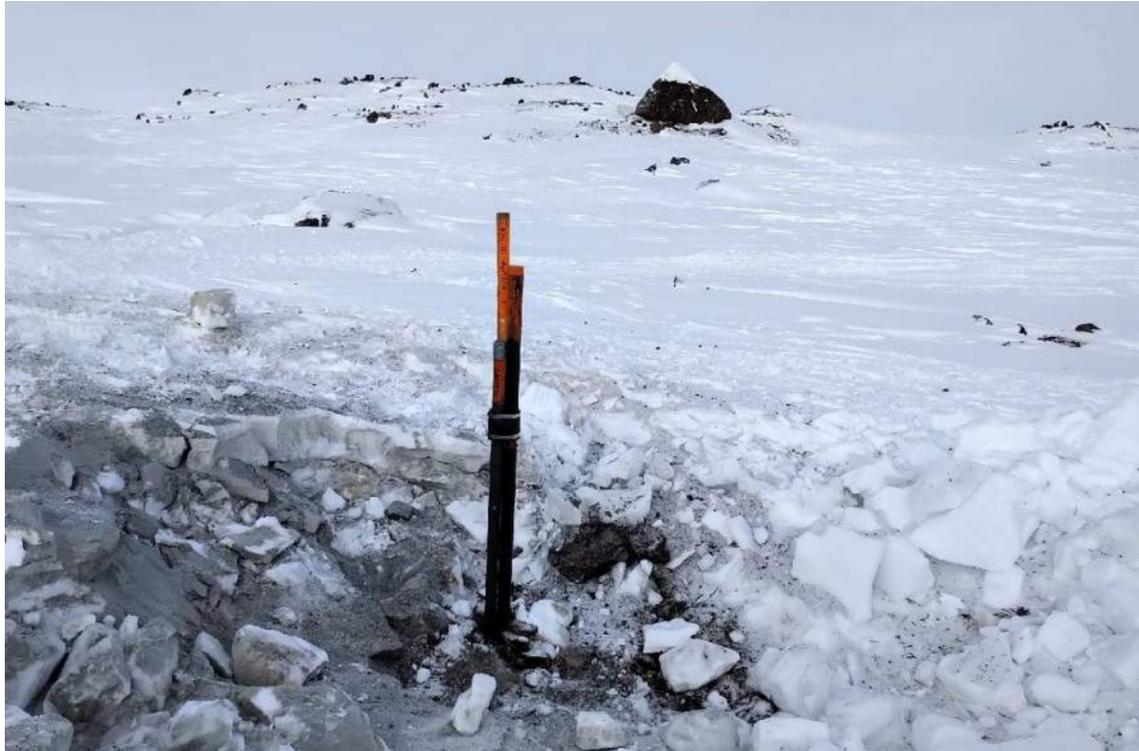
Photo 4 – Temperature and Groundwater Monitoring Installation in TH110/W-110 (Typical)

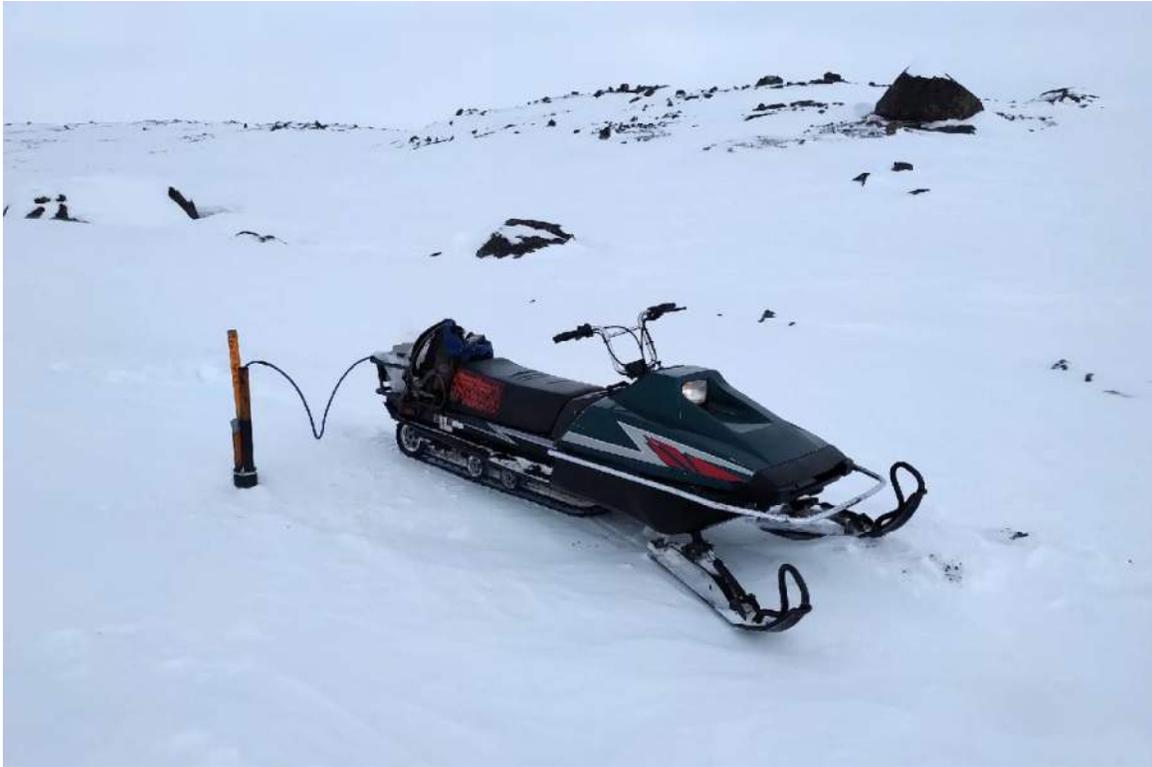
Photo 4 – Temperature Monitoring in TH-110 - Typical

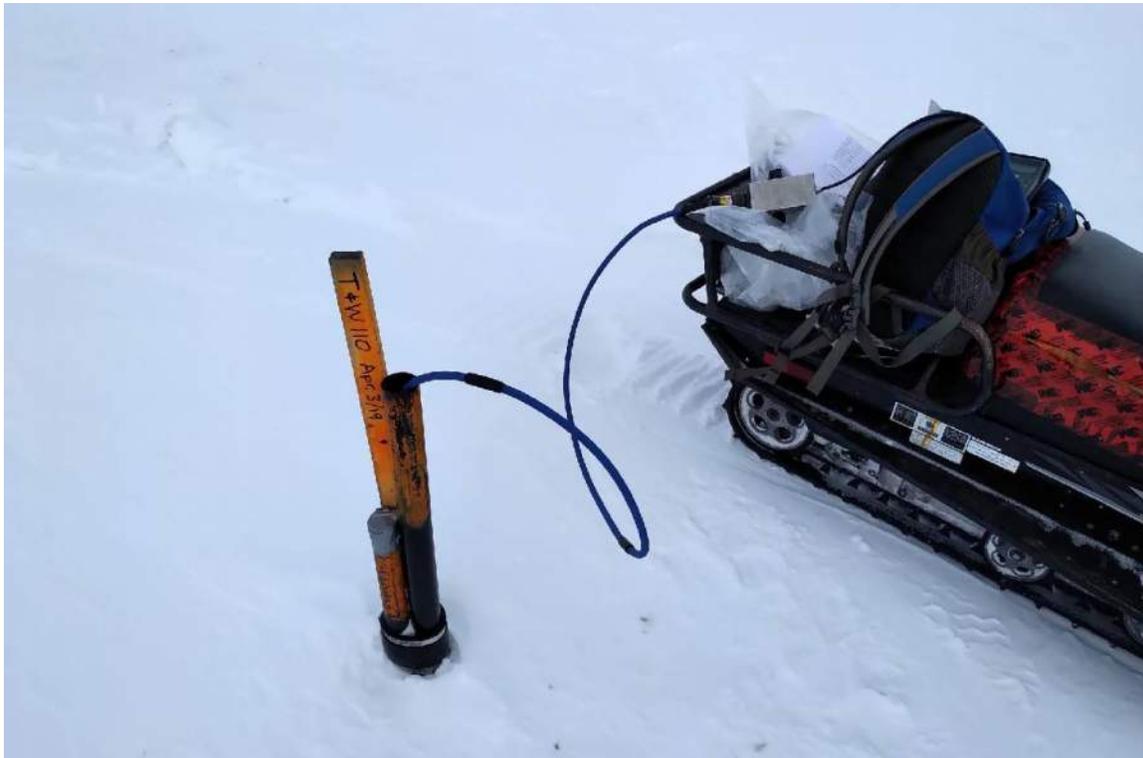
Photo 5 – Temperature Monitoring in TH-110 - Typical
