Project Certificate Inspection Report

Organization	Representative
Agnico Eagle Gold Mines	Eric Haley
Authorization No. / Expiry	Representative's Title
Project Certificate 4 & 8	Environment and Critical Infrastructures Superintendent
Inspection Date	Inspector
Nov 2-8, 2023	RMO Kyle Amsel
Other Authorization/s	
66H/08-01, 66H/08-02, 66A-8-71, 66A-8-72, 2AM-WTP1830, 2AM-MEA1530.	
Activities Inspected	
<input checked="" type="checkbox"/> Camp, Commercial <input type="checkbox"/> Drilling <input checked="" type="checkbox"/> Mining <input checked="" type="checkbox"/> Construction <input type="checkbox"/> Reclamation <input checked="" type="checkbox"/> Fuel Storage <input type="checkbox"/> Roads/Hauling <input type="checkbox"/> Winter Hauling <input type="checkbox"/> Camp, Private <input type="checkbox"/> Other <small>Click or tap here to enter text.</small>

Between November 2nd and 8th 2023 Resource Management Officer Kyle Amsel (Inspector) of Crown-Indigenous Relations and Northern Affairs Canada (CIRNAC) conducted an inspection of Project Certificate 4 Condition 54 and Project Certificate 8 Condition 28 to ensure compliance and make observations for the Terrestrial Ecosystem Manageme

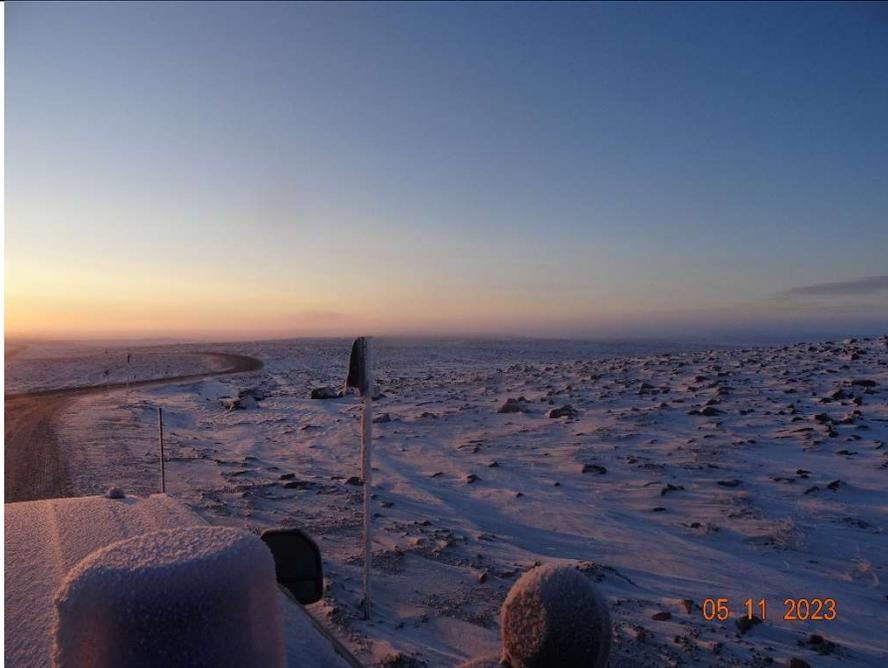
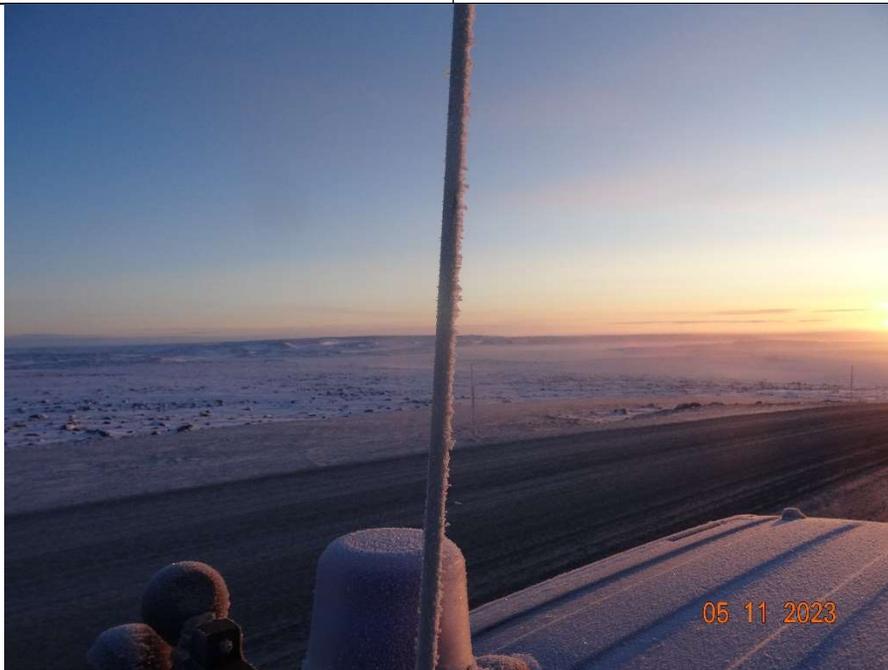
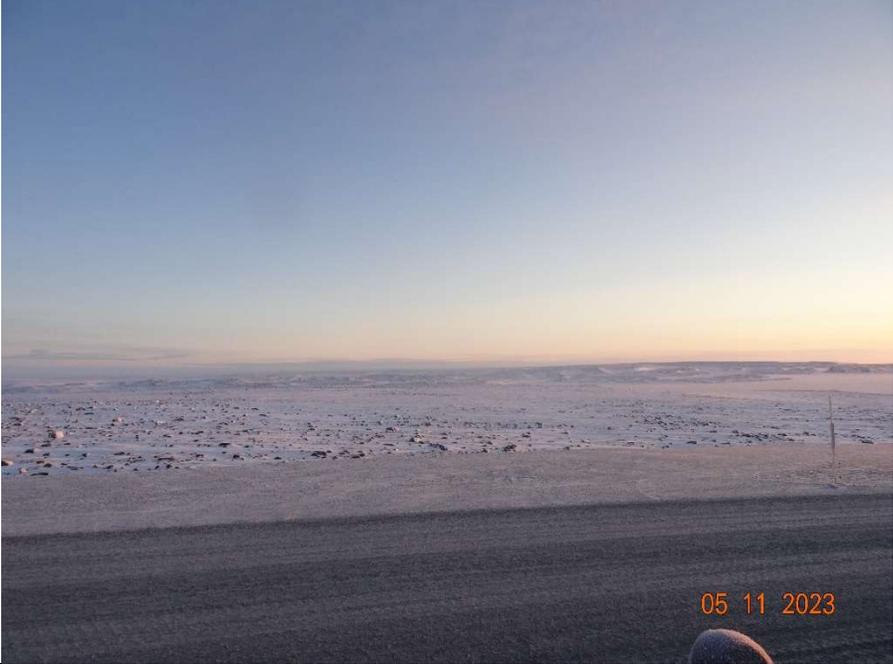
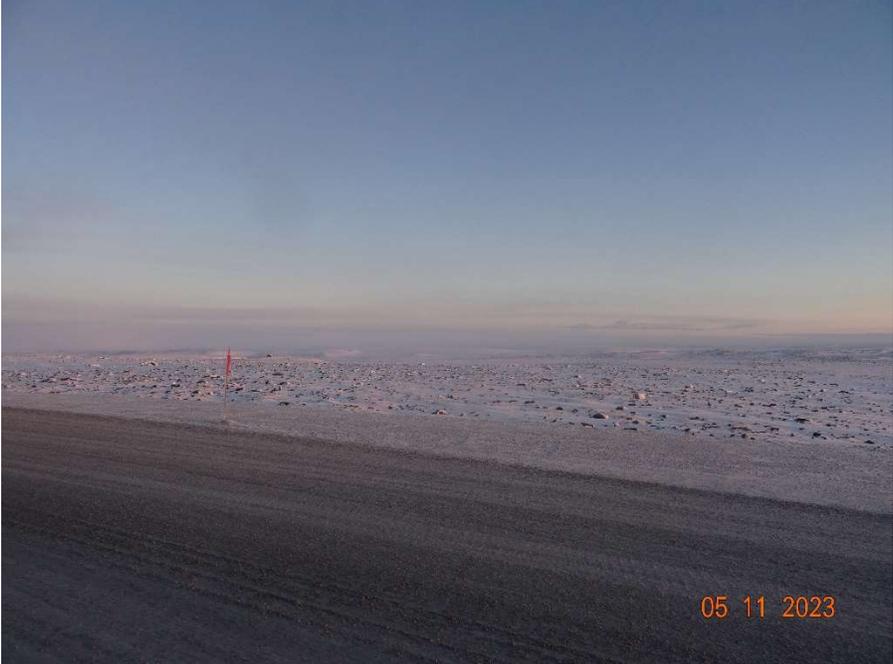
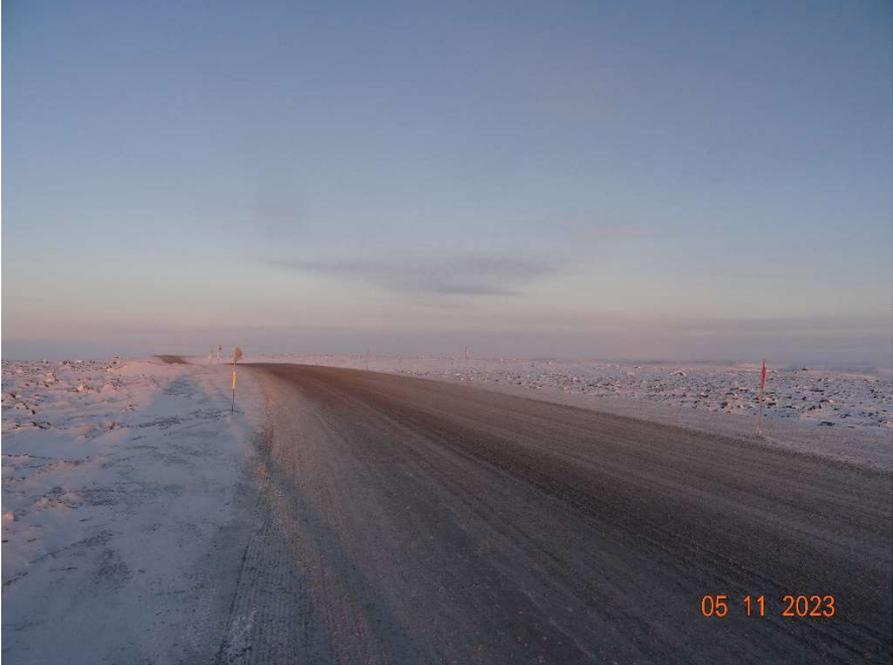
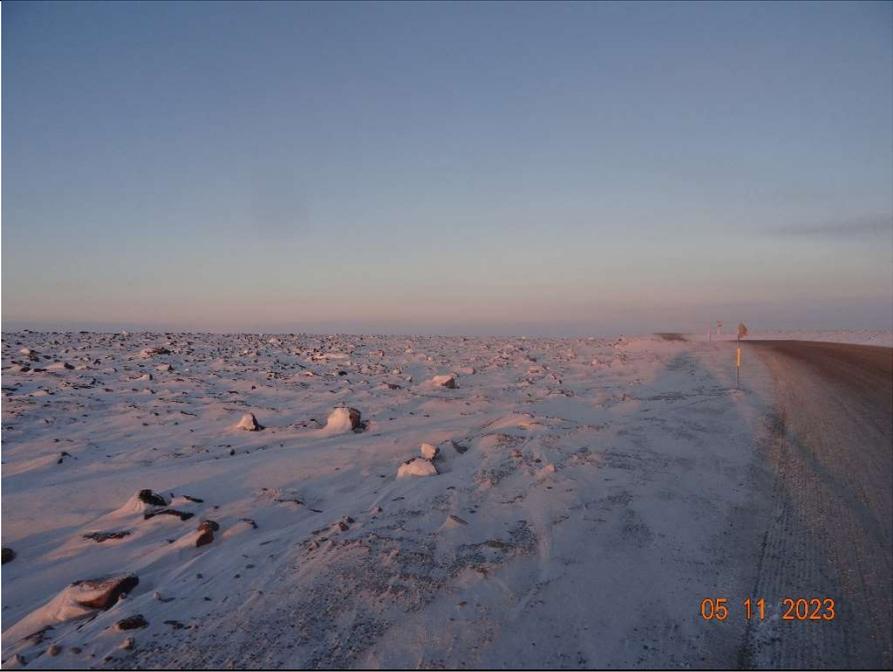
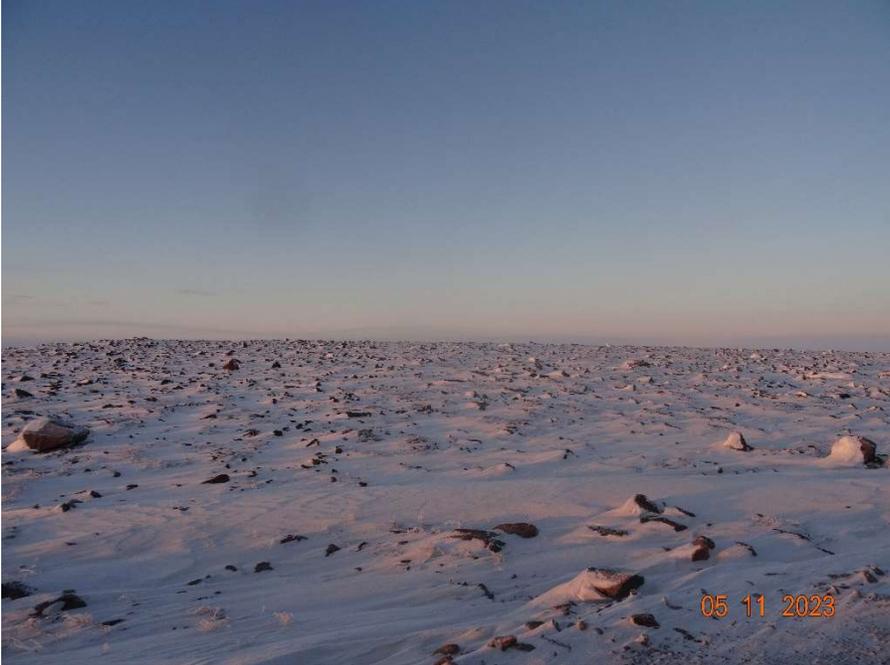
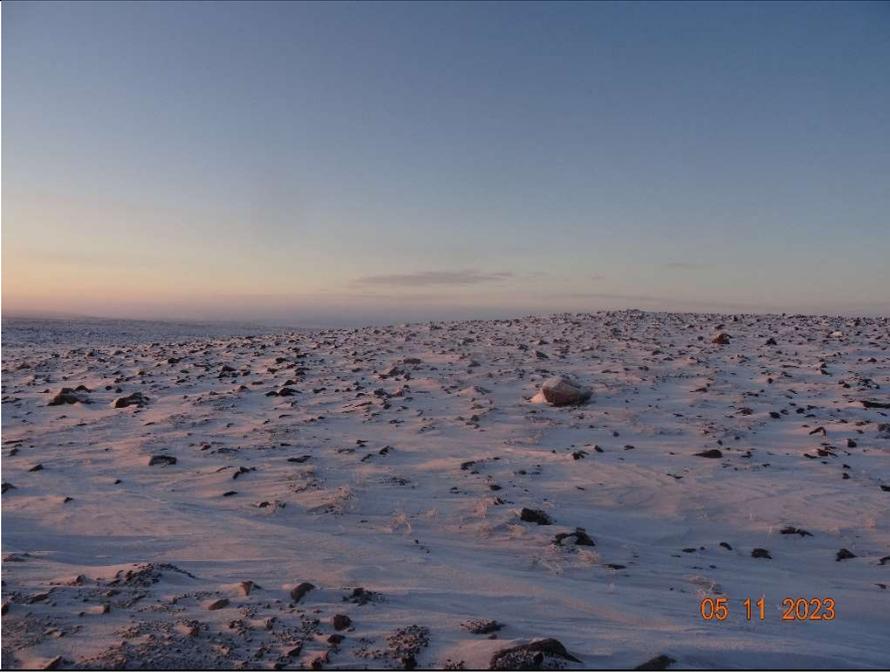
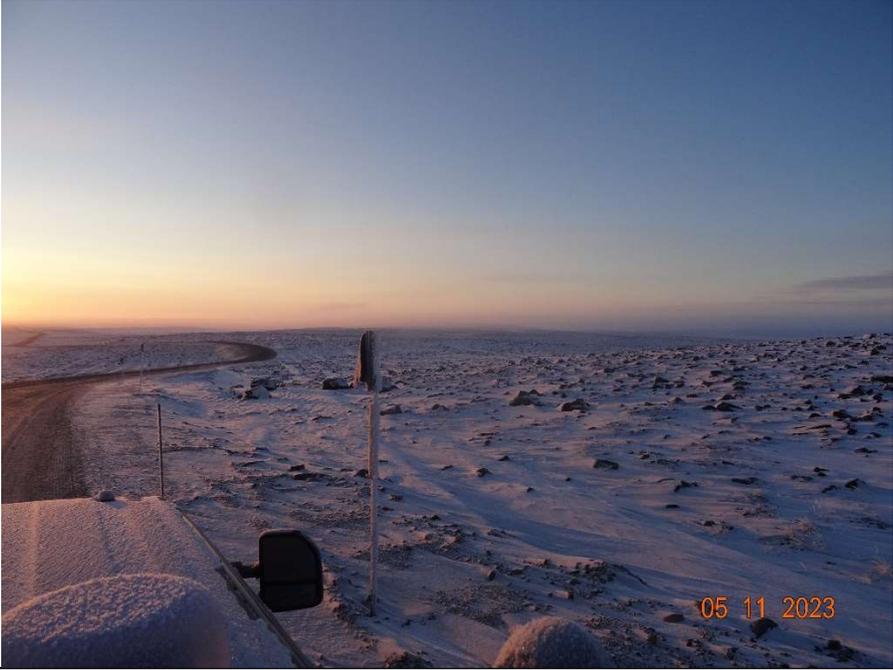
- iii. The current Viewshed surveys are designed to be conducted from a central point at a geographically advantageous position, however the methods used by staff are to park on the crest of the Viewshed survey point/hill for the survey creating errors in observable area not accounted for. In practice the use of the center point on the hill does not provide the best viewable area as indicated in the document. Proponent staff stated that you can see the next vantage point and therefore won't miss any caribou. (Photo 1-9 offer360 view from utilized Viewshed survey point)

Description:
1 of 9 360° View from viewpoint at km 169

Description:
2 of 9 360° View from viewpoint at km 169

Description: 3 of 9 360° View from viewpoint at km 169

Description: 4 of 9 360° View from viewpoint at km 169

Description: 5 of 9 360° View from viewpoint at km 169

Description: 6 of 9 360° View from viewpoint at km 169

Description: 7 of 9 360° View from viewpoint at km 169

Description: 8 of 9 360° View from viewpoint at km 169

Description:	
9 of 9 360° View from viewpoint at km 169

- The Viewshed Survey's currently conducted would have an increase effectiveness if staff did them from outside of the vehicle so the vehicle does not pose an obstruction of view.
