Nunavut Impact Review Board

2025 Site Visit Report

Doris North and Phase 2 Hope Bay
Projects

Project Certificates 003 and 009

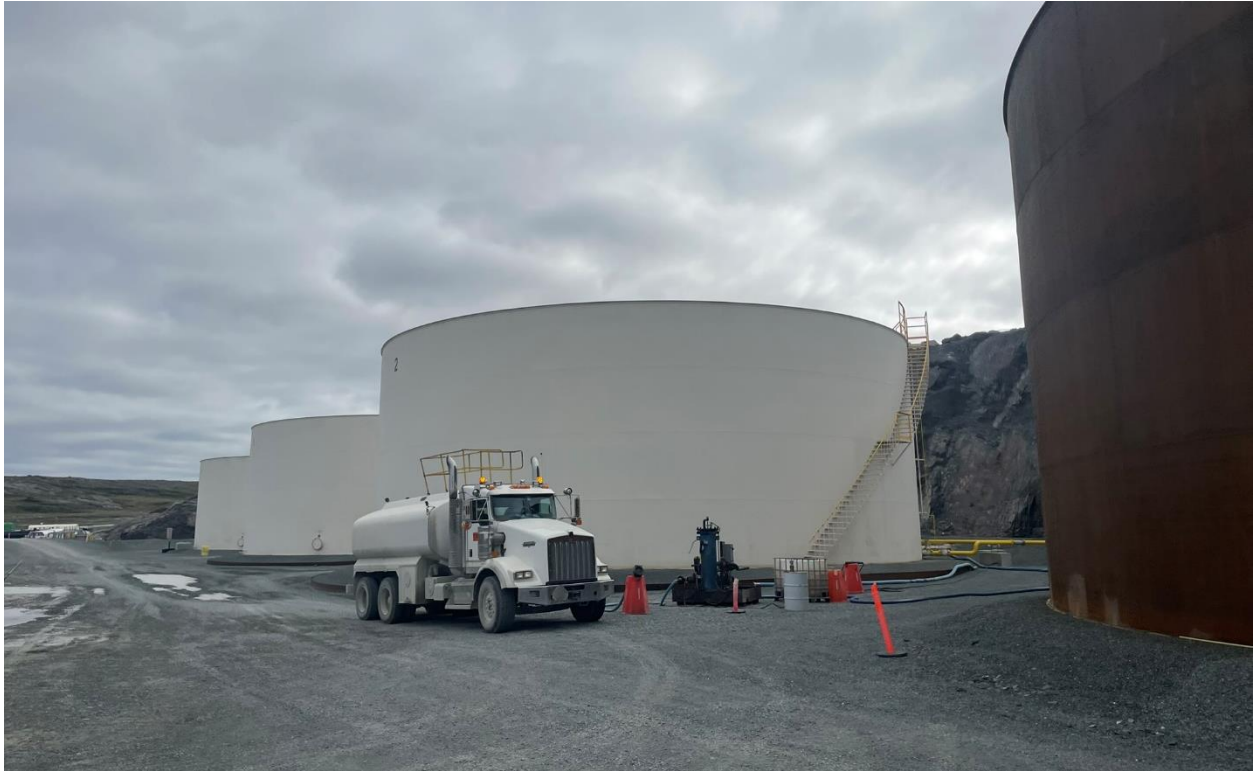
Photo 5: Roberts Bay Tankfarm

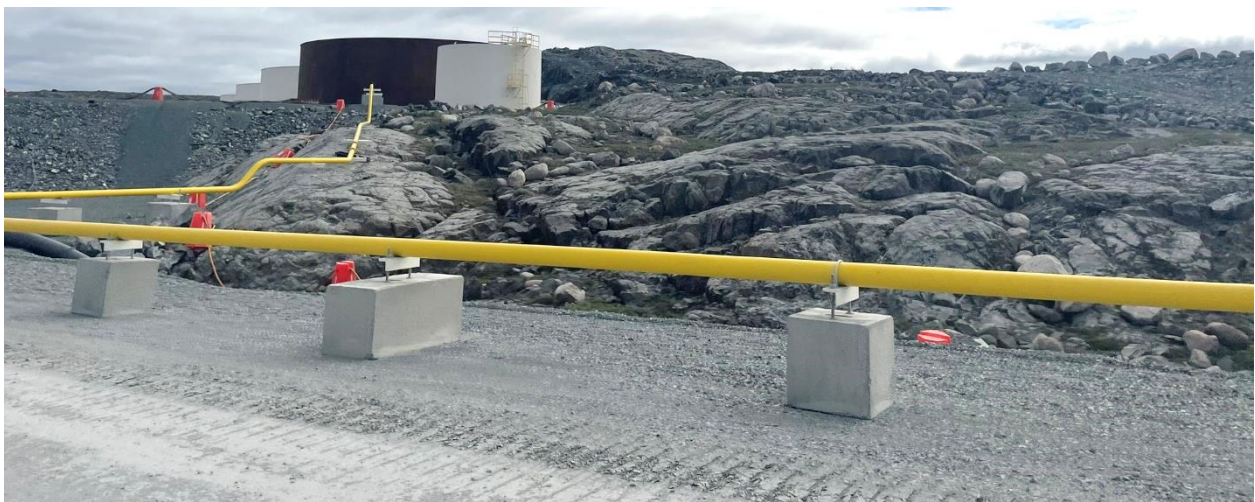
Photo 6: Fuel Line at Roberts Bay

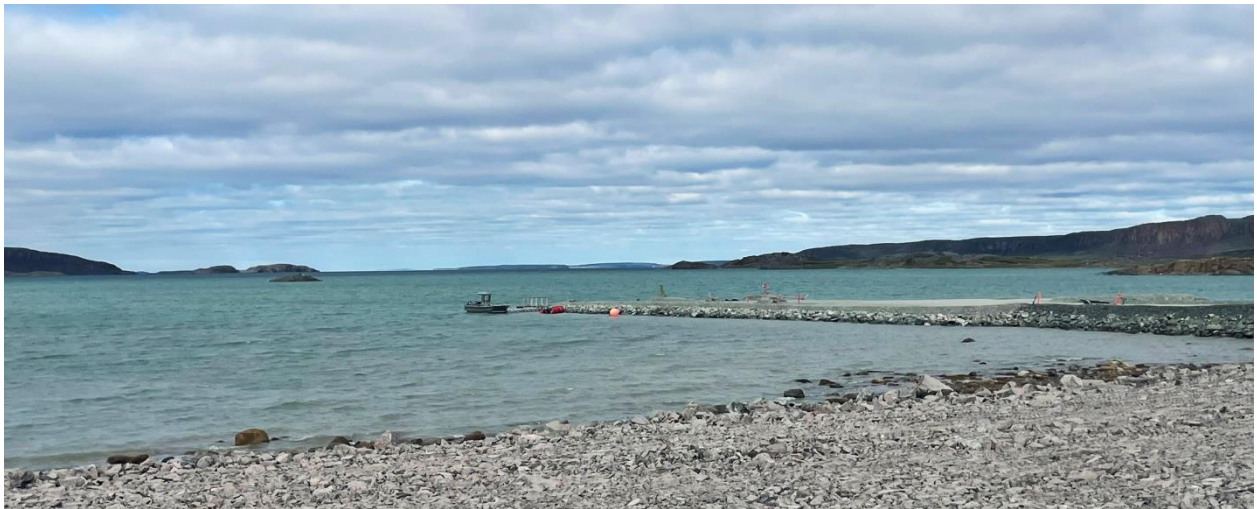
Photo 10: Roberts Bay Jetty

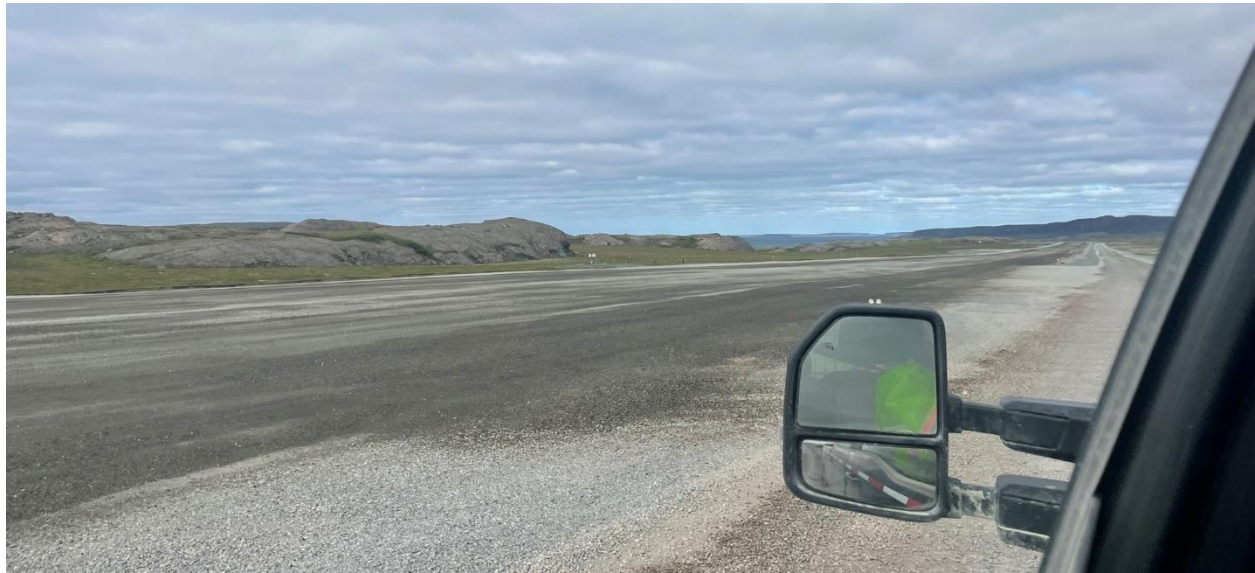
Photo 13: Airstrip and Primary Road

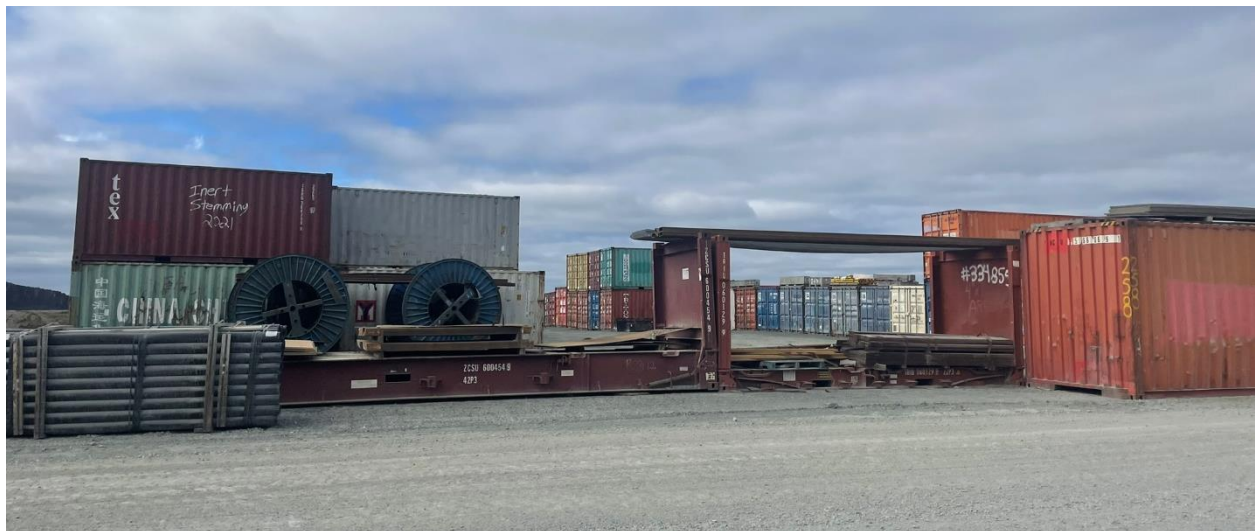
Photo 14: Laydown Area along the Primary Road

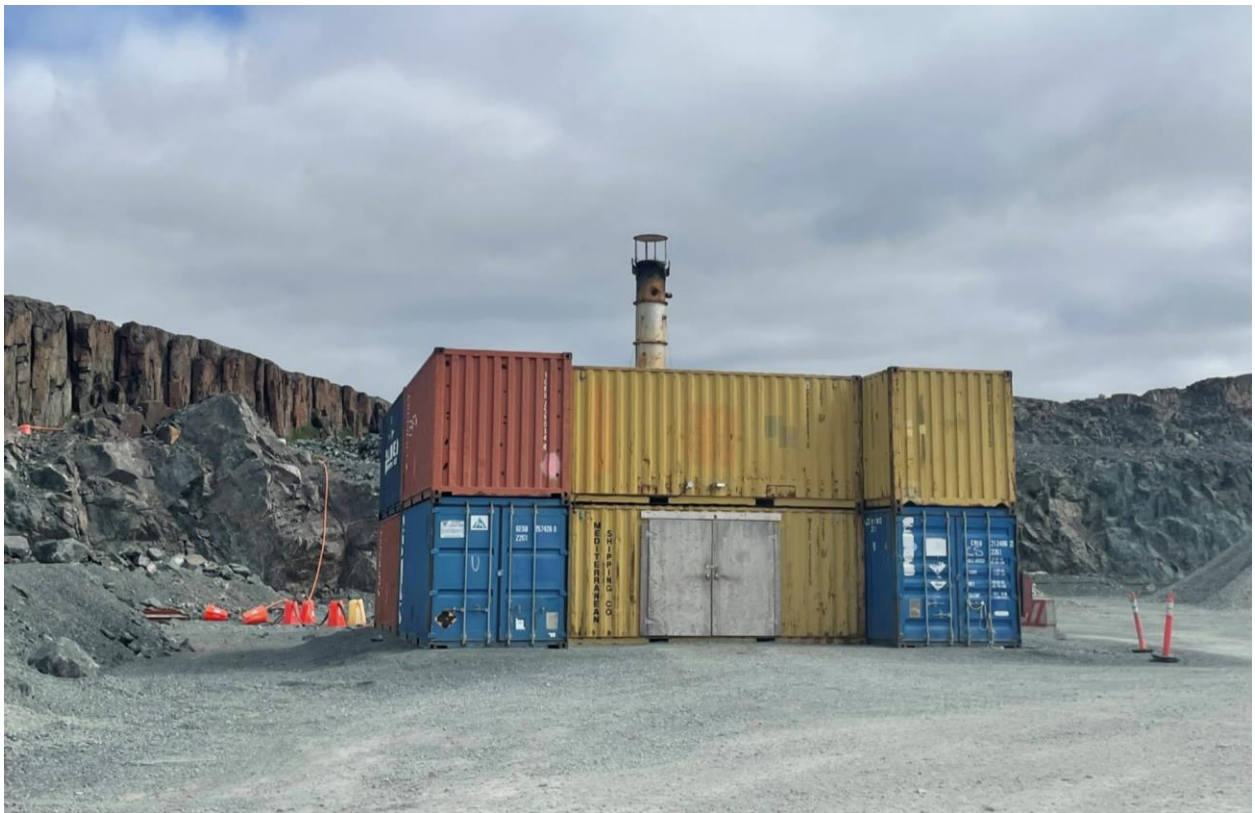
Photo 16: Incinerator Building

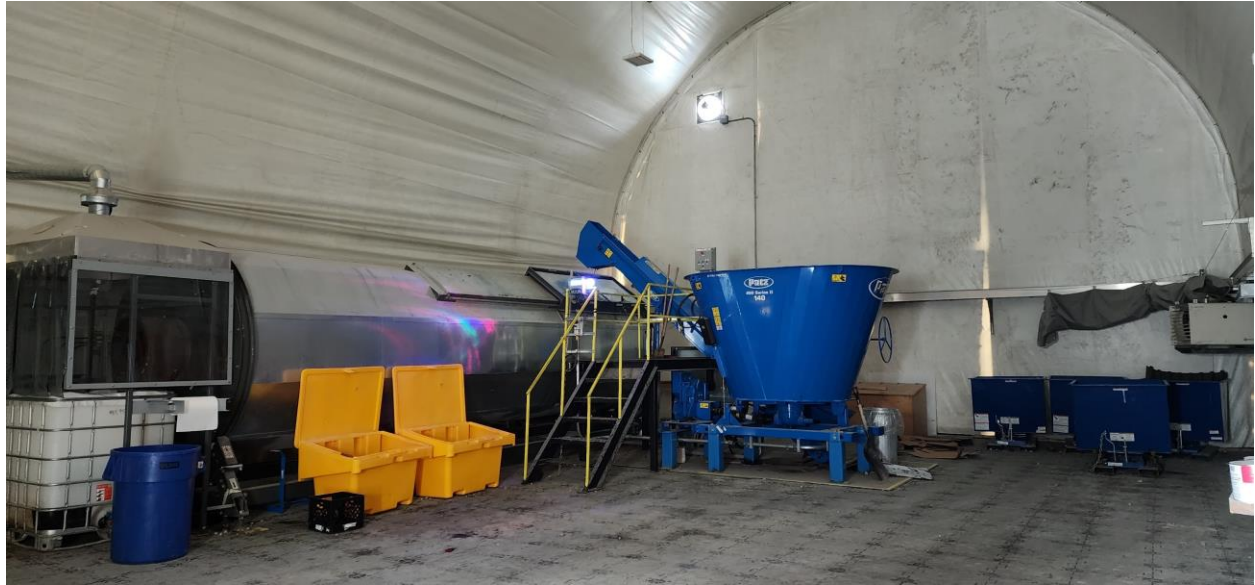
Photo 17: Composter

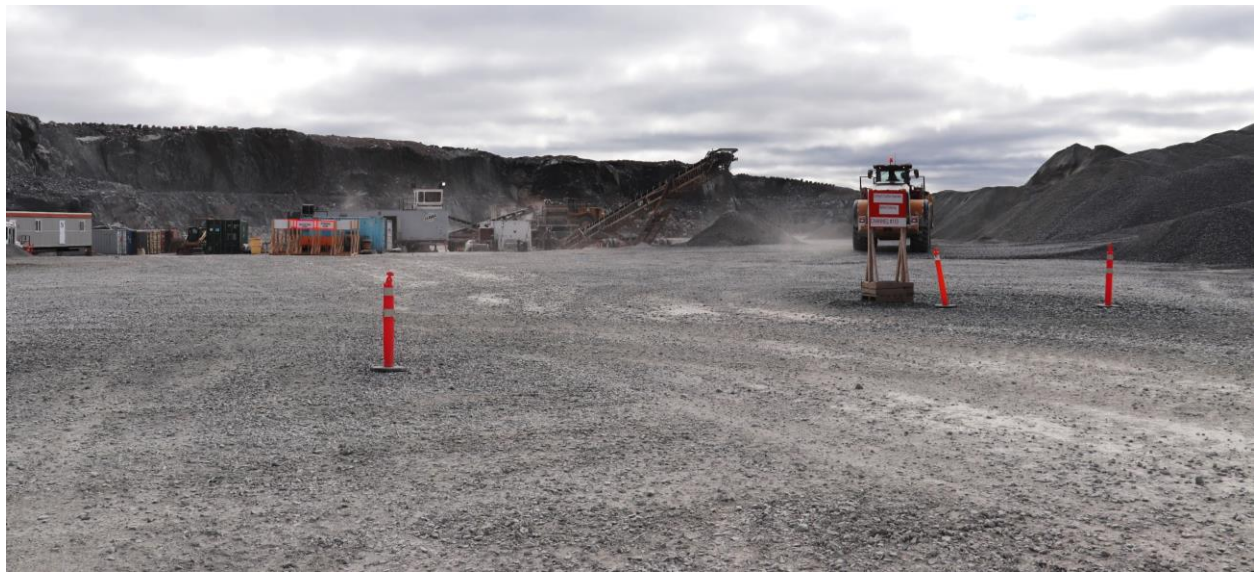
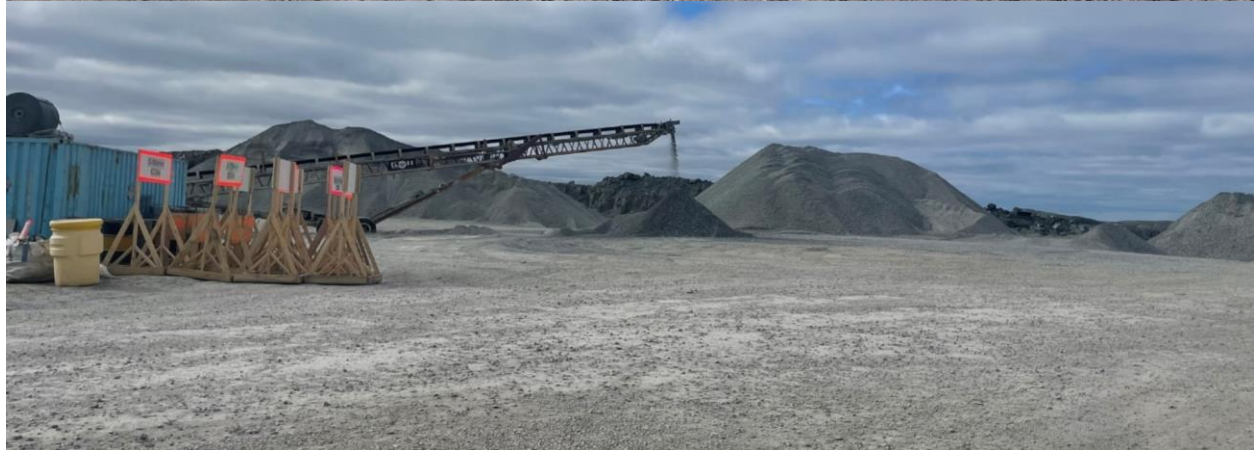
Photo 18: Quarry 2

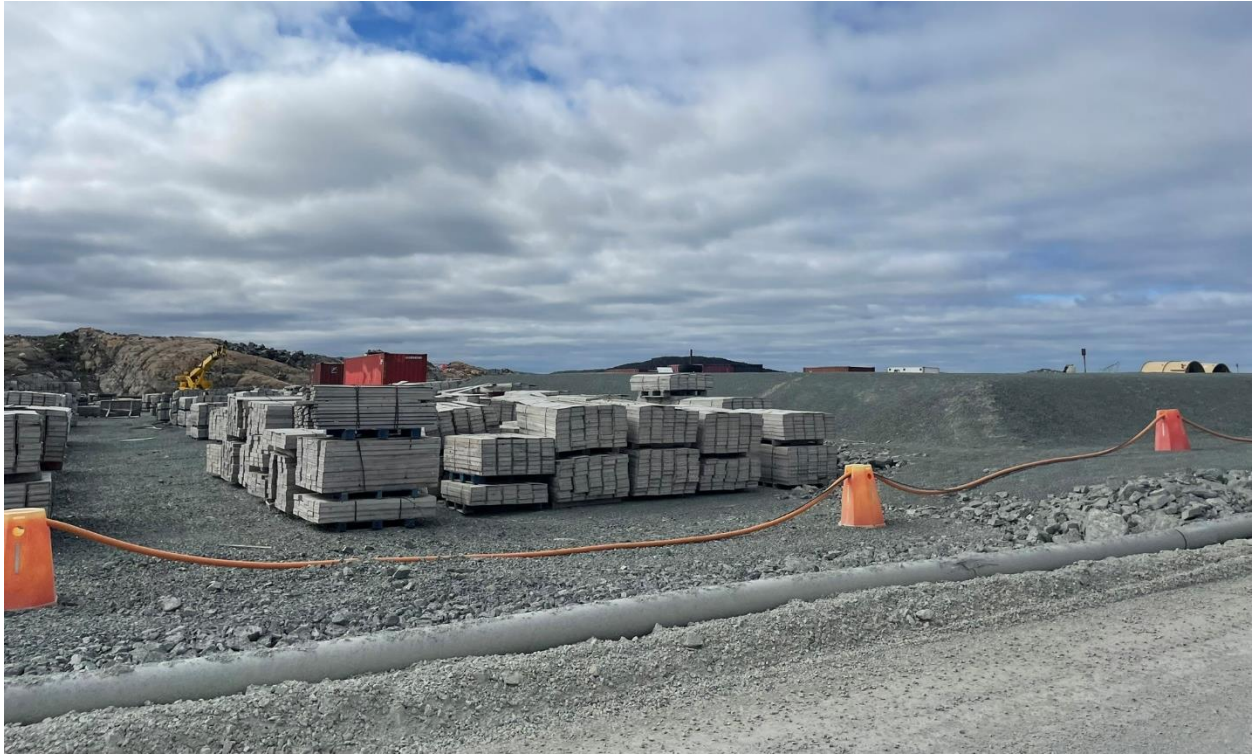
Photo 19: Core Storage Pad

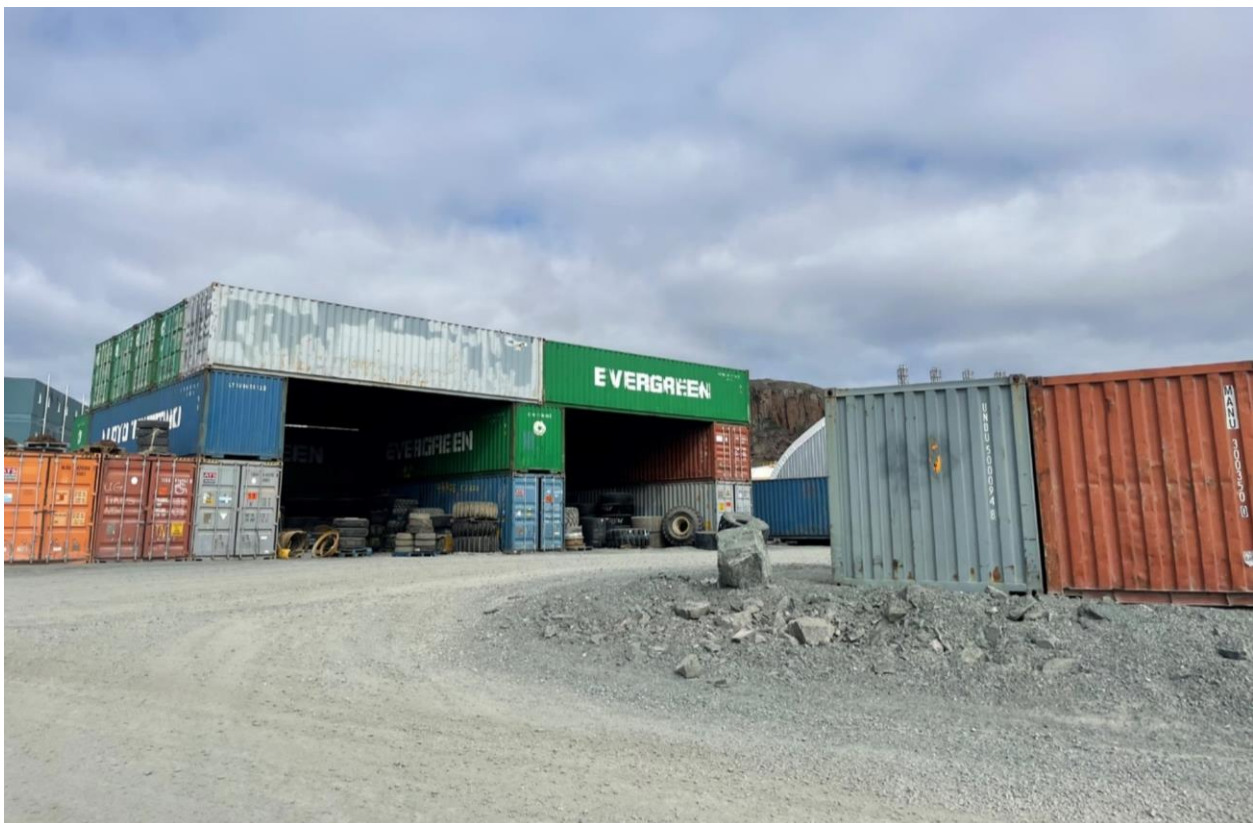
Photo 20: Maintenance Shop

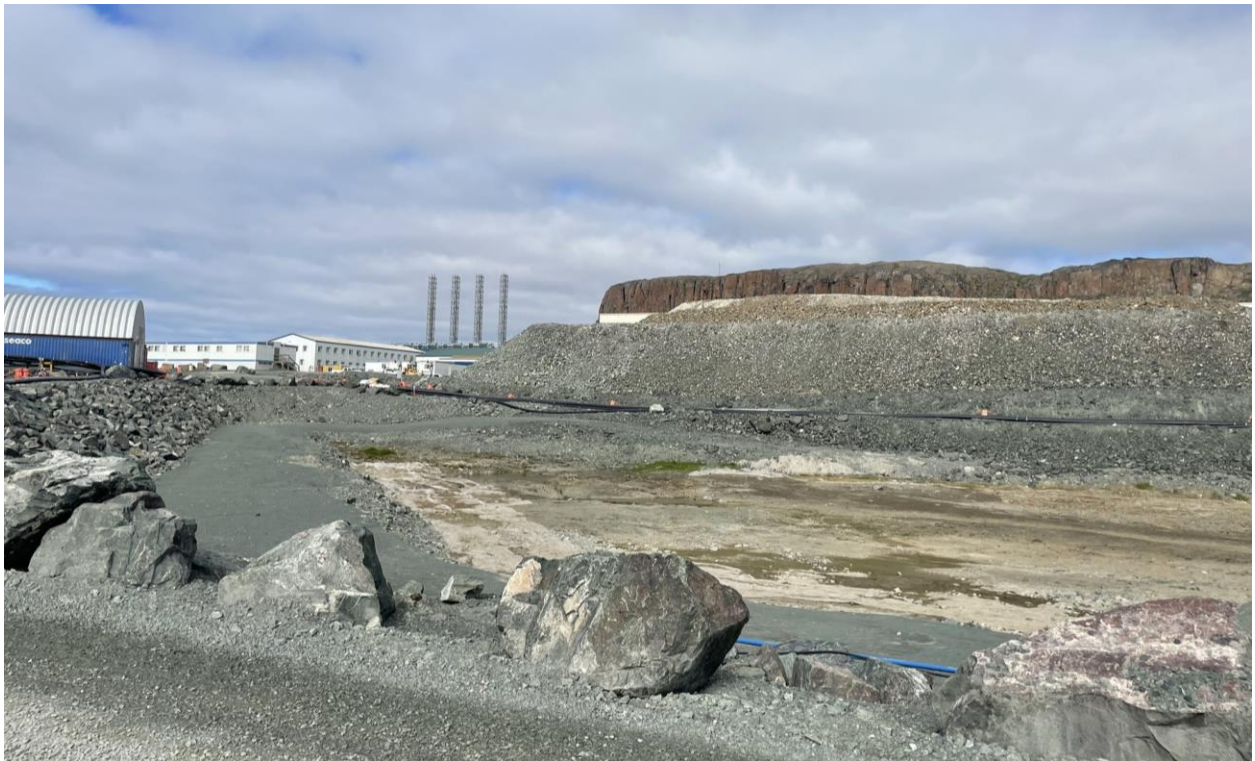
Photo 22: Pollution Control Pond

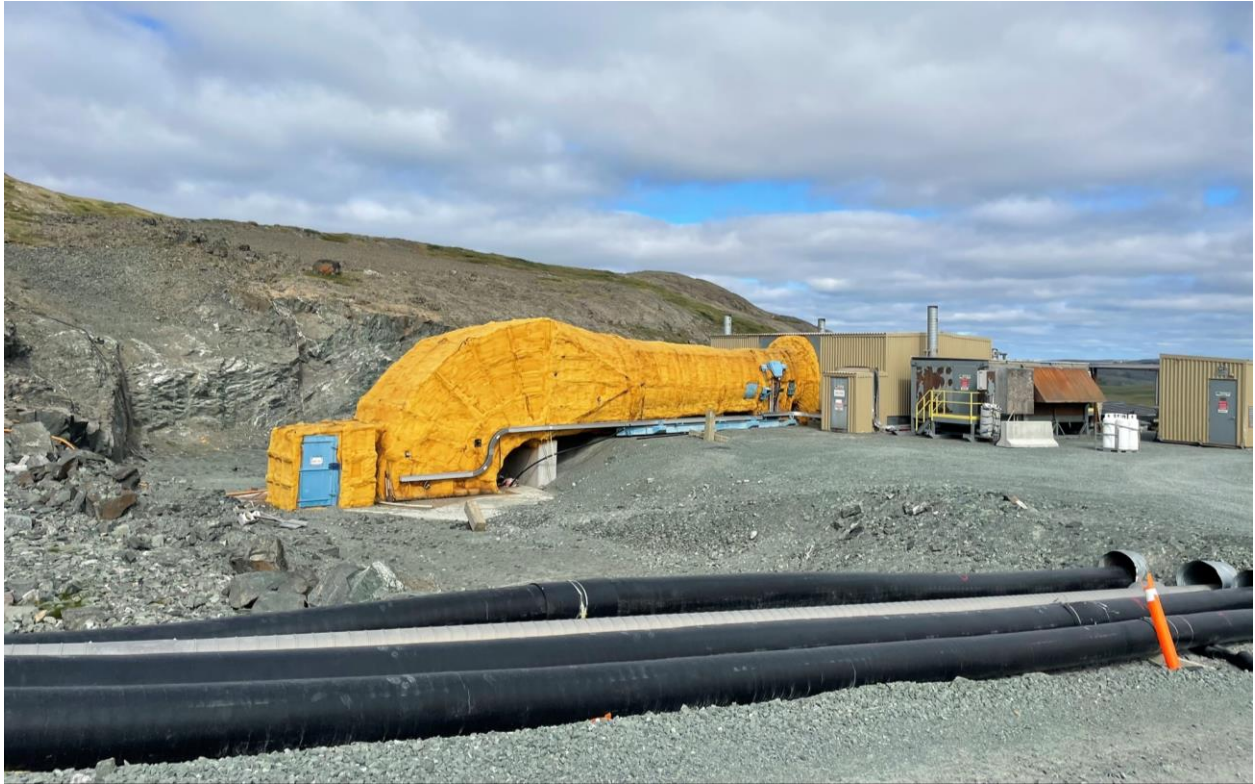
Photo 30: Primary Vent Raise

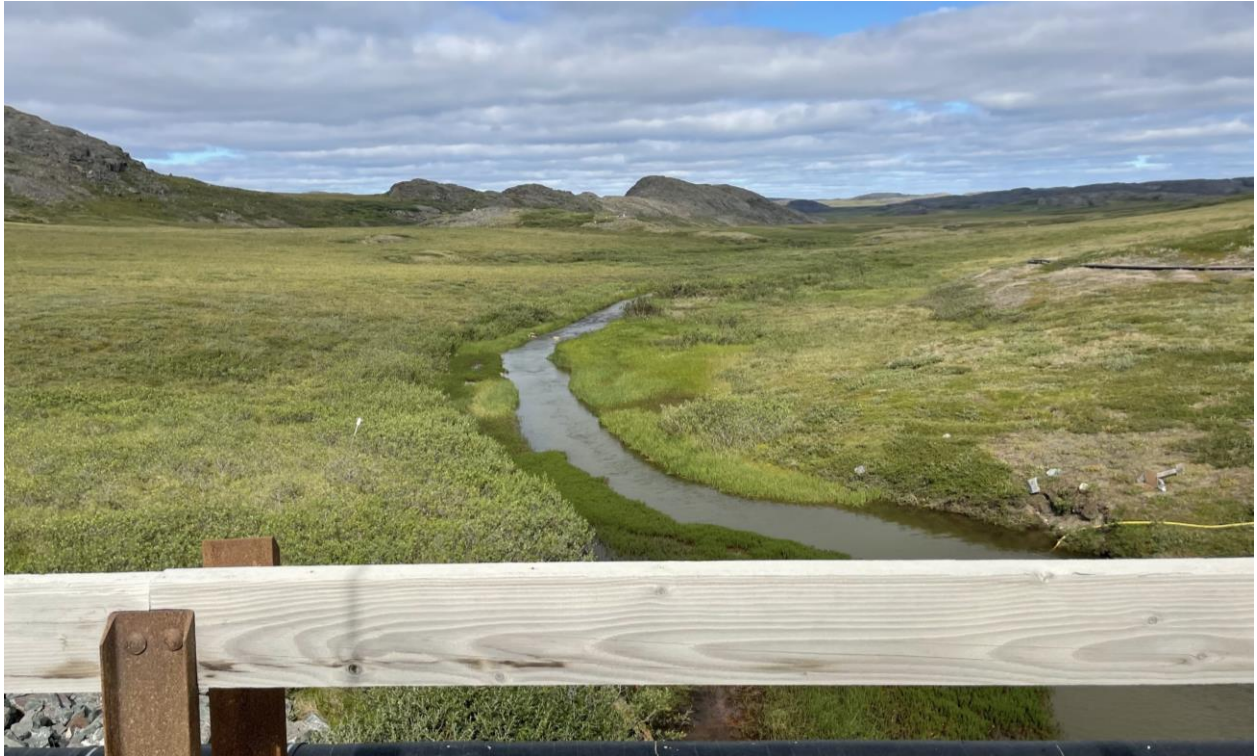
Photo 32: Doris Creek looking north from Doris Creek Bridge

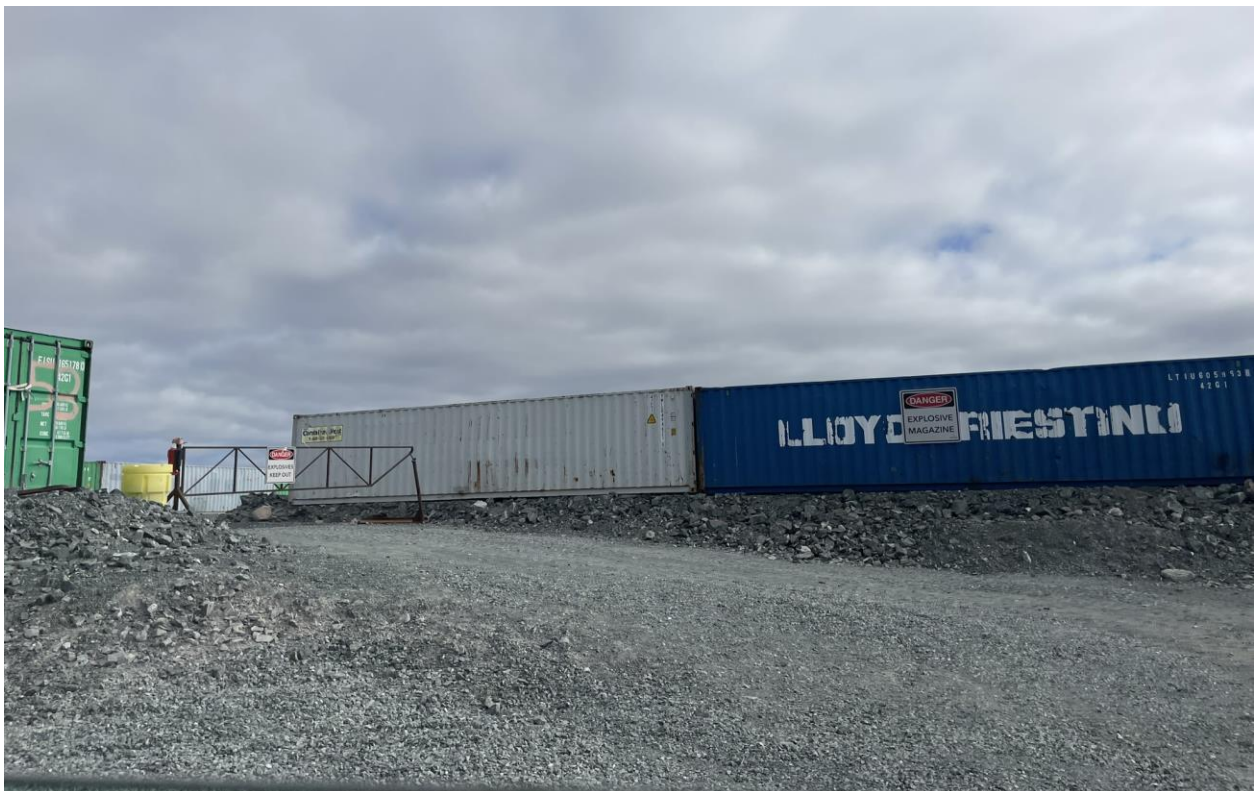
Photo 33: Explosives Storage Facility east of TIA Reclaim Pond

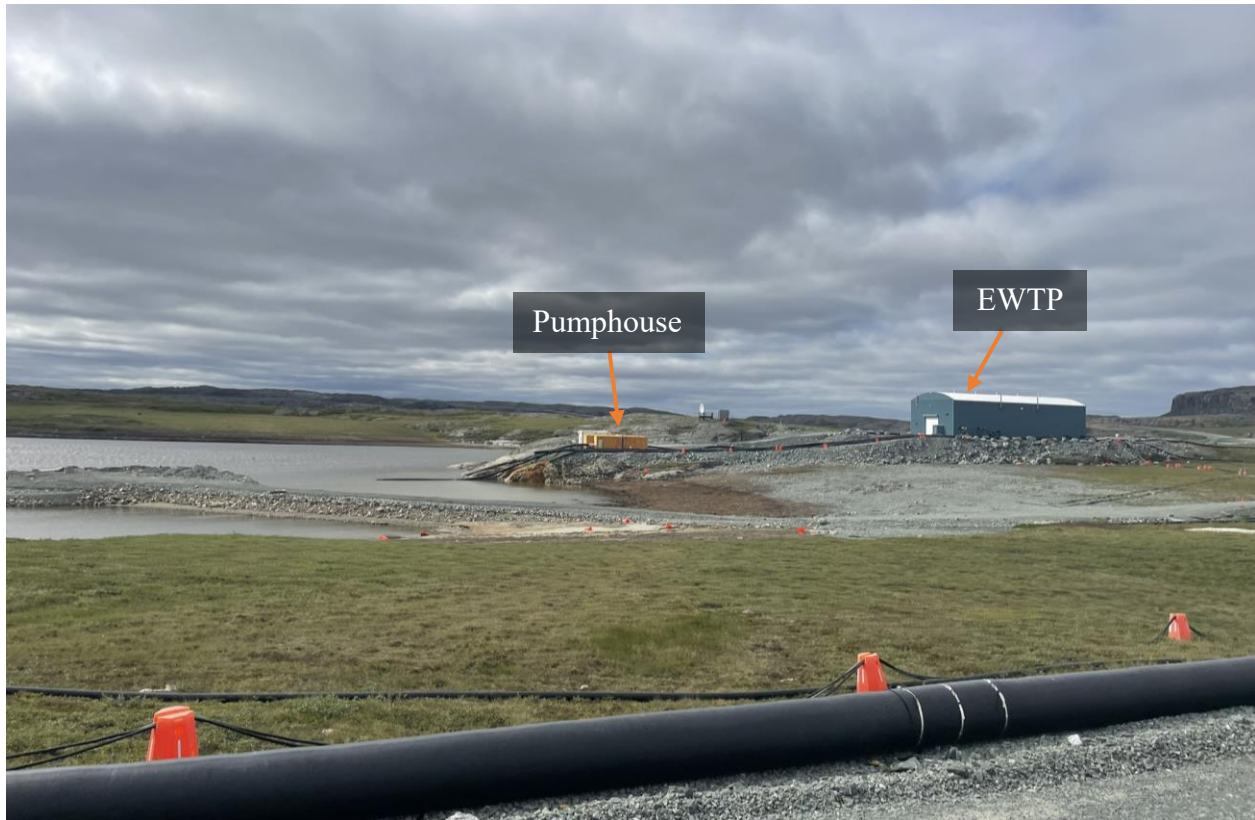
Photo 35: Effluent Water Treatment Plant (EWTP) Reclaim Pump House and Reagent Pad

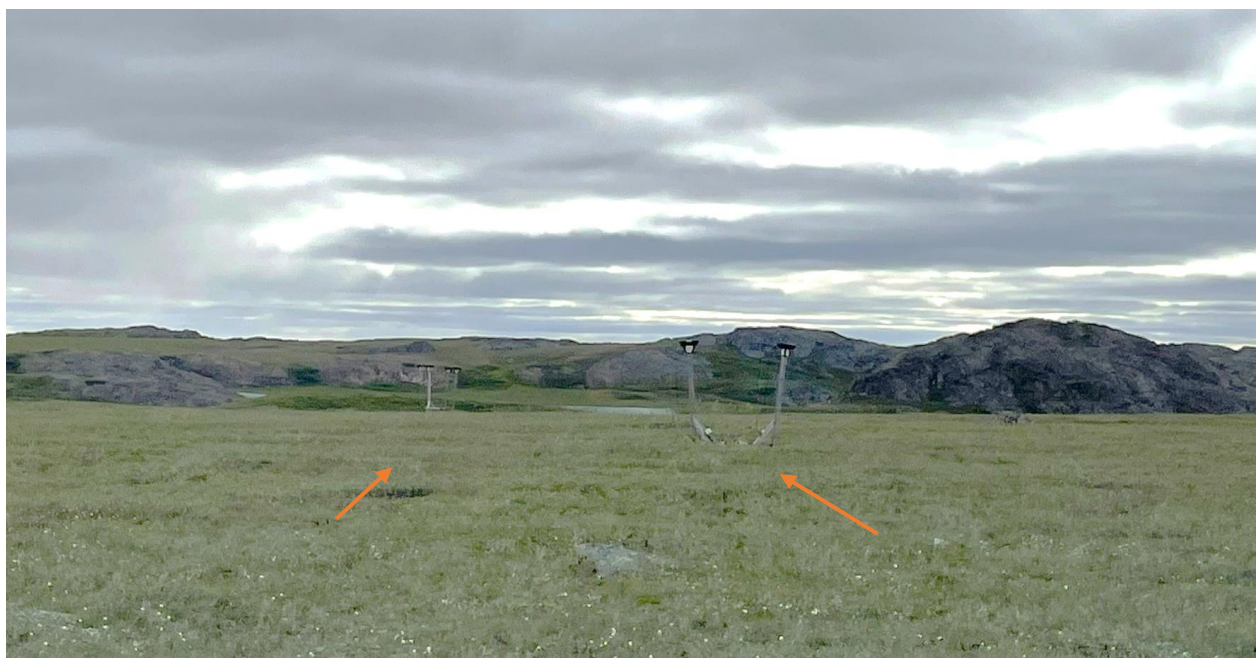
Photo 41: Dust samplers facing east on Doris–Windy All-Weather Road

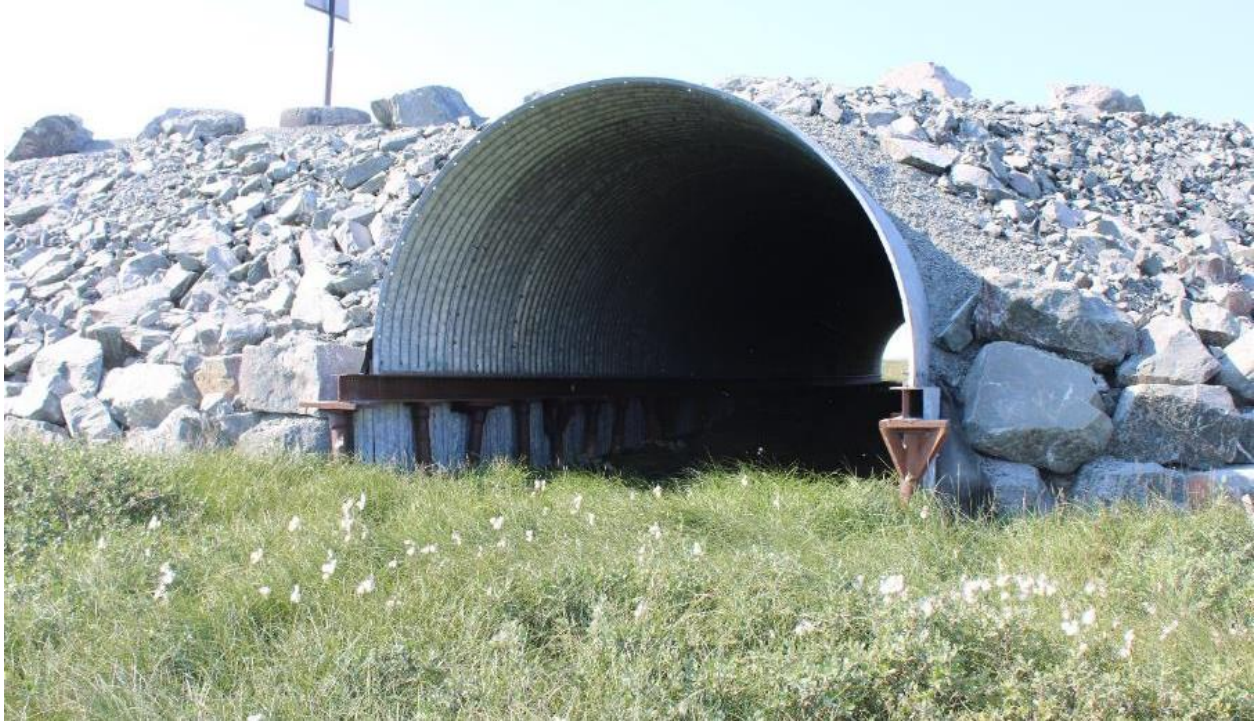
Photo 48: Wildlife Passage under Windy Road going to Madrid (2024)

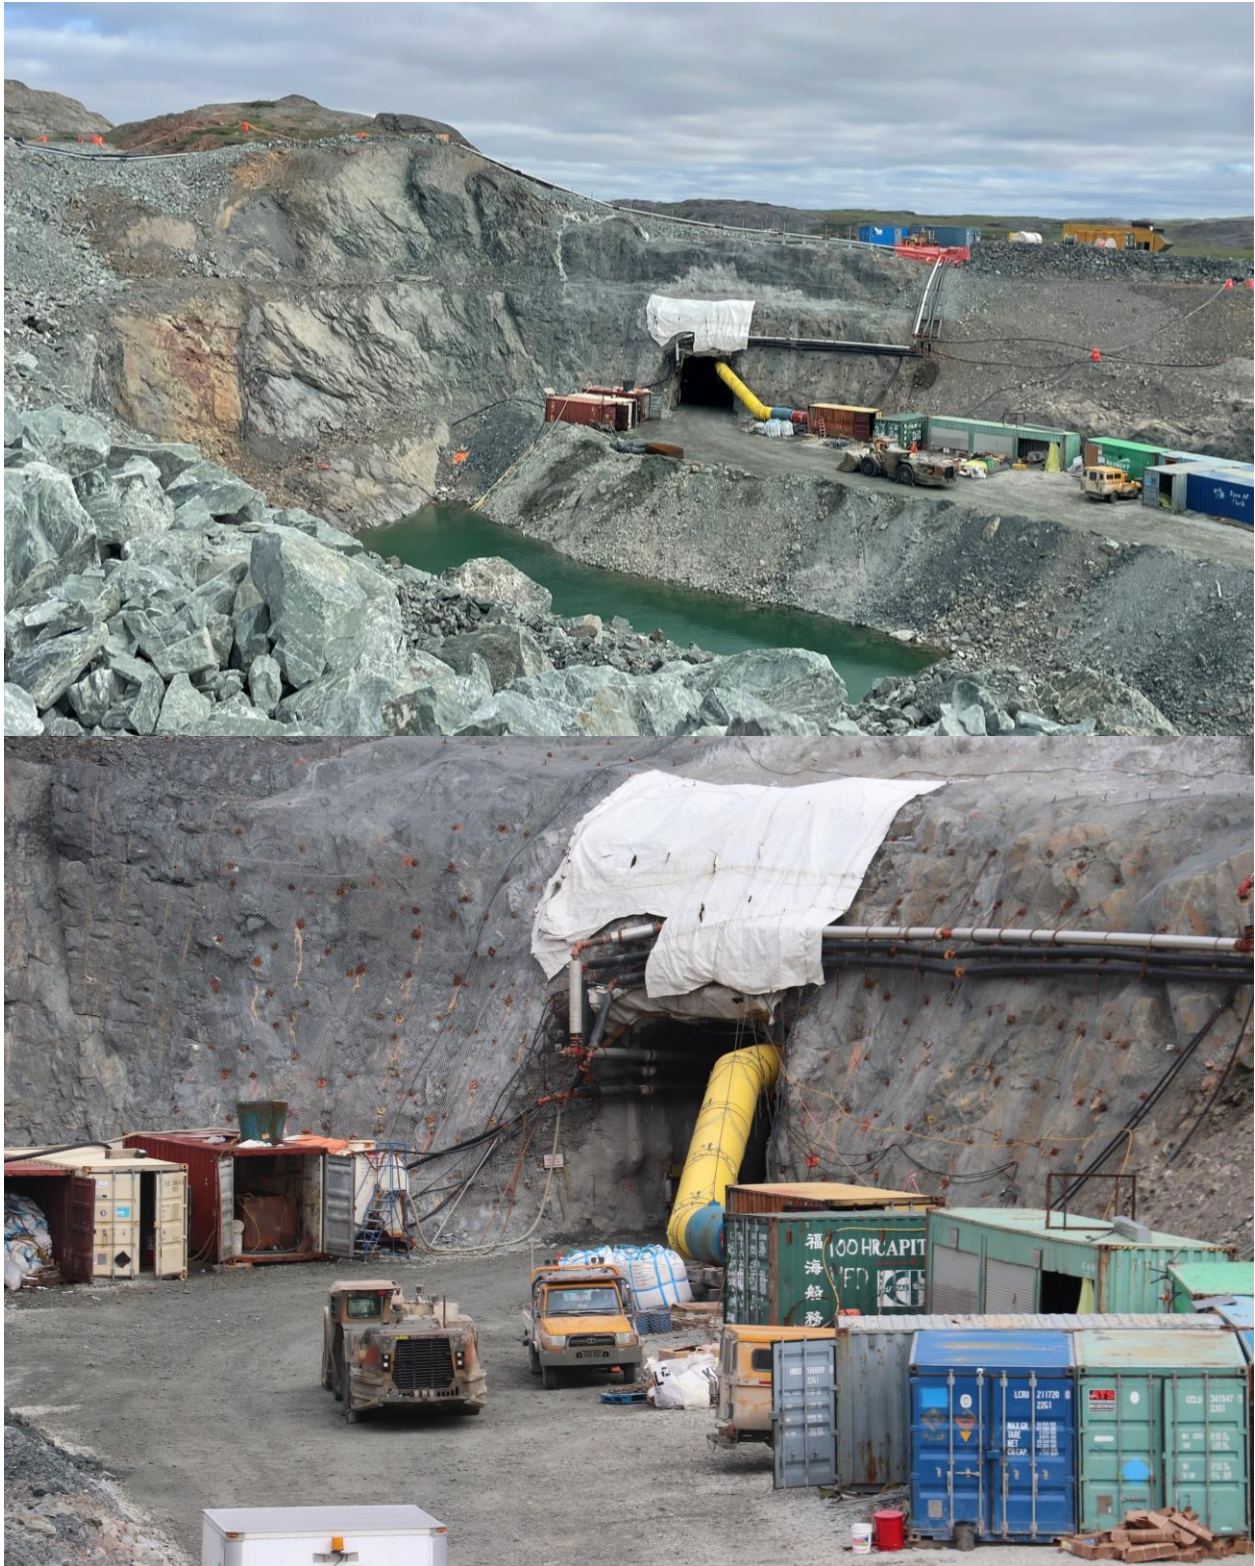
Photo 50: Naartok East Crown Pillar Pit and Underground Portal

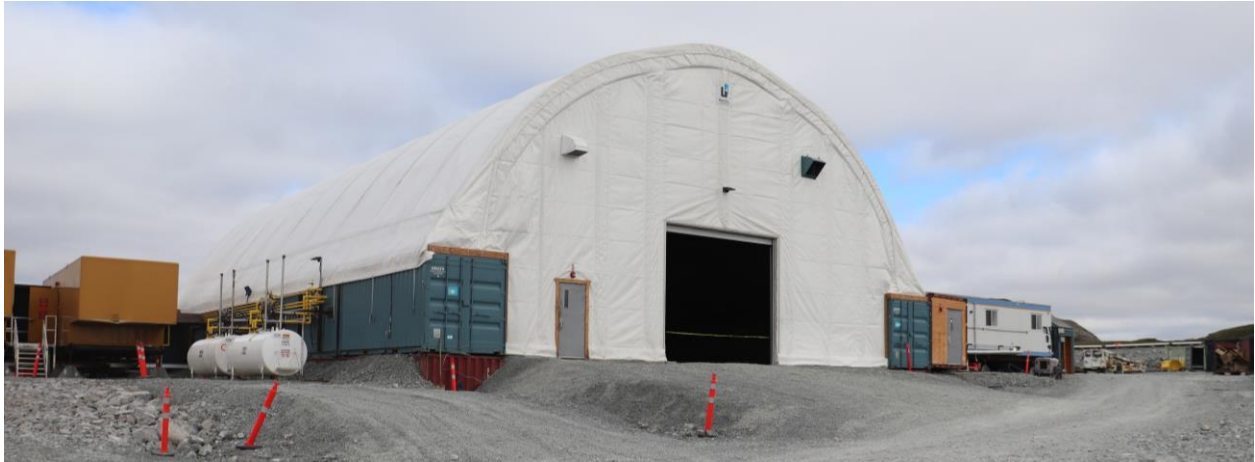
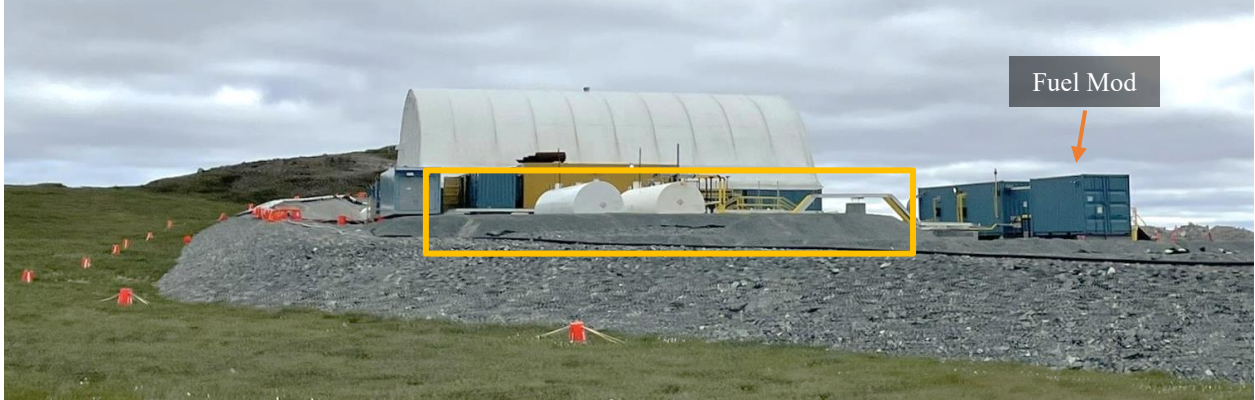
Photo 51: Infrastructure Pad adjacent to Naartok CPRT with fuel tanks in containment

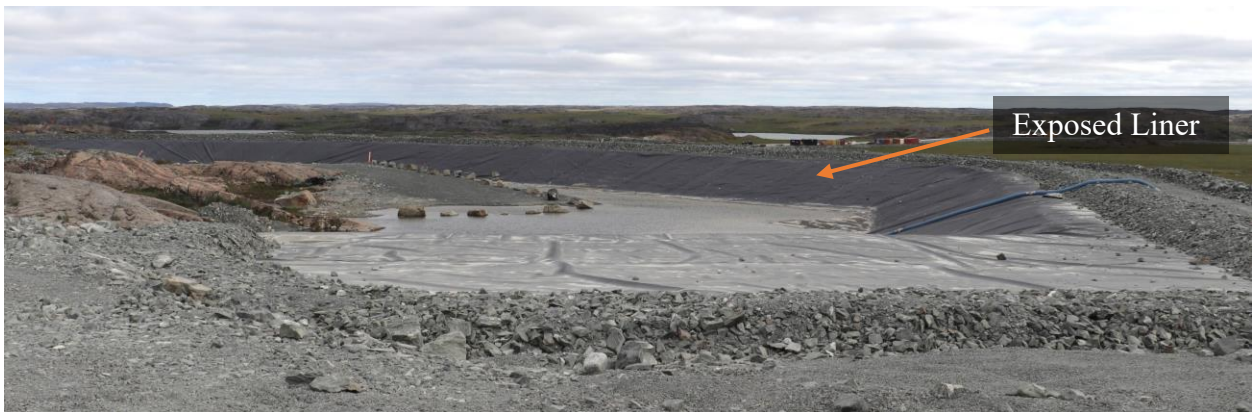
Photo 54: Madrid North Contact Water Pond (CWP2)

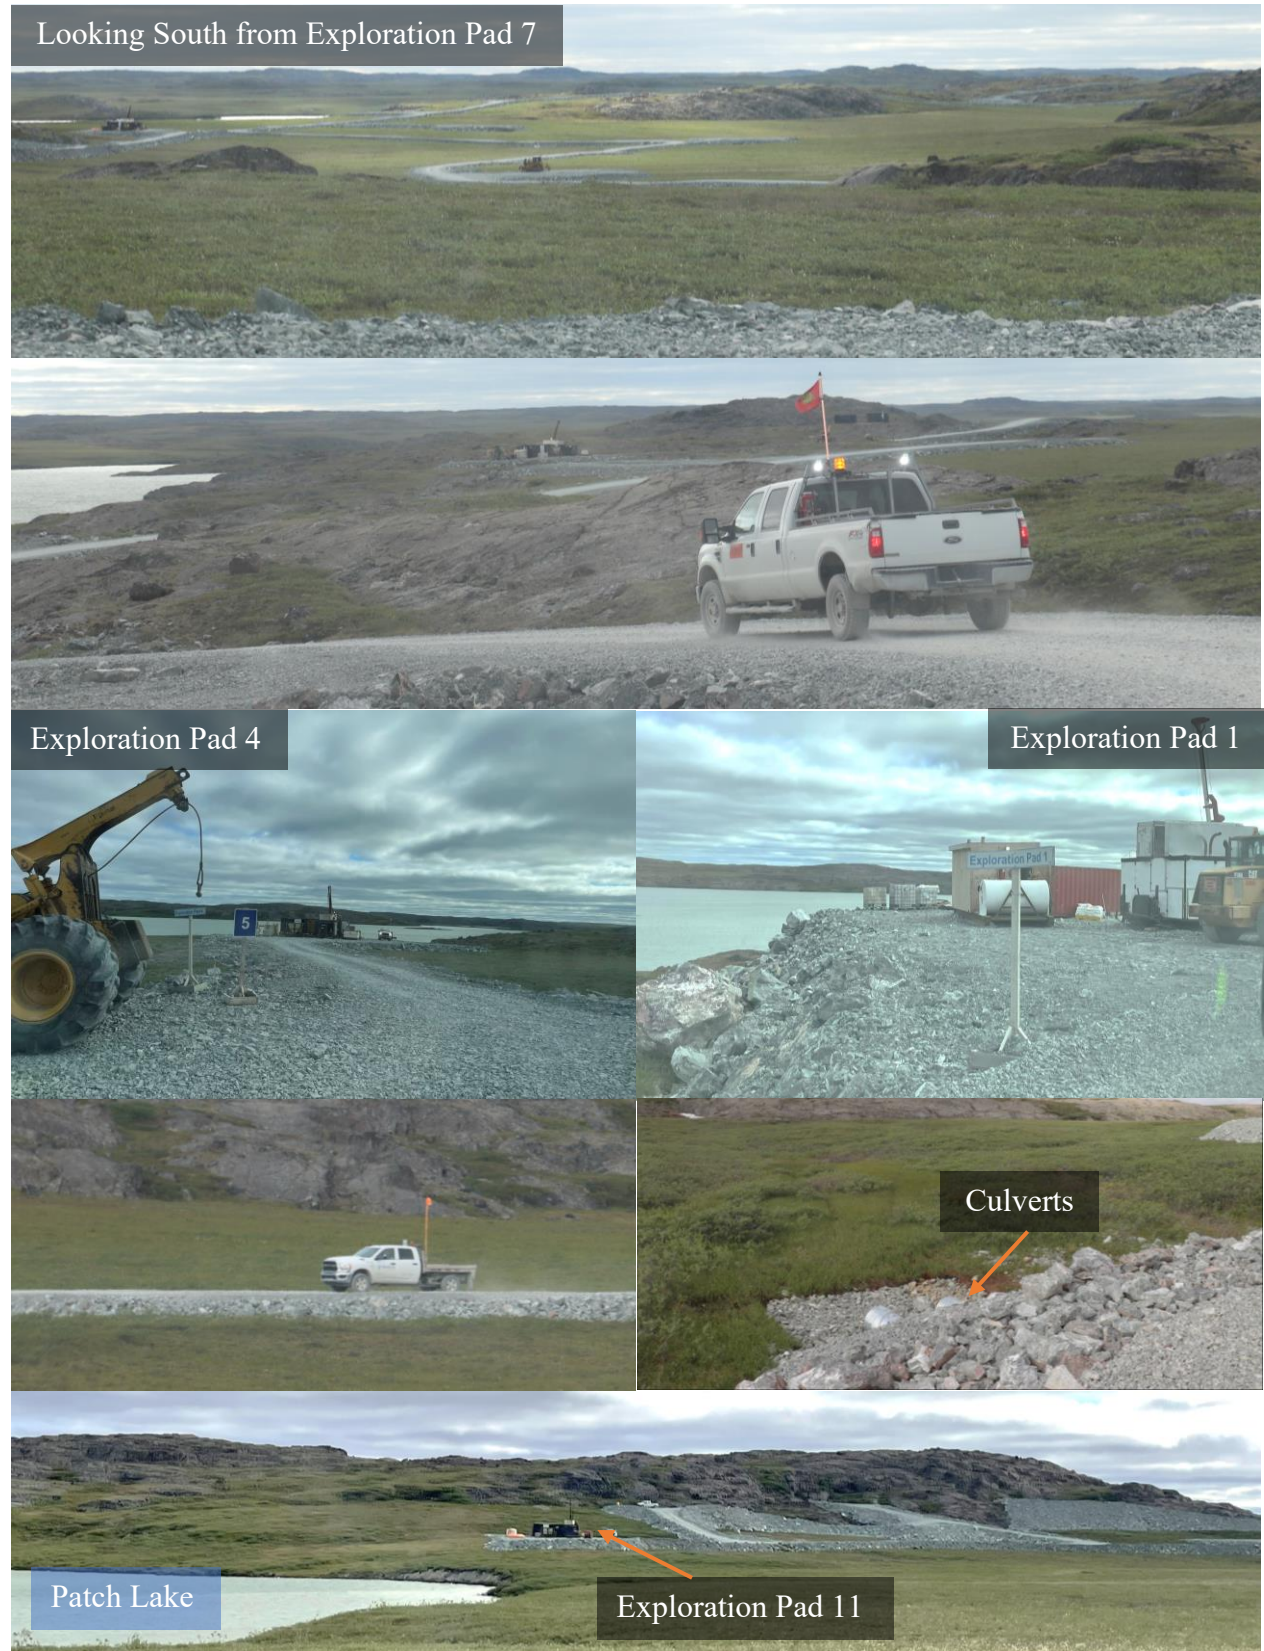
Photo 60: Exploration Trail - Exploration Pads and Patch Lake
