2023 Annual Geotechnical Inspection		
		Gander Crossing		
Job No: CAPR003105 Filename: BackRiver_Goose_2023AGI_PhotoLog.pdf	Back River Project	Date: 2024-02-28	Approved: JBK	Figure: A.1-39

Back River Project

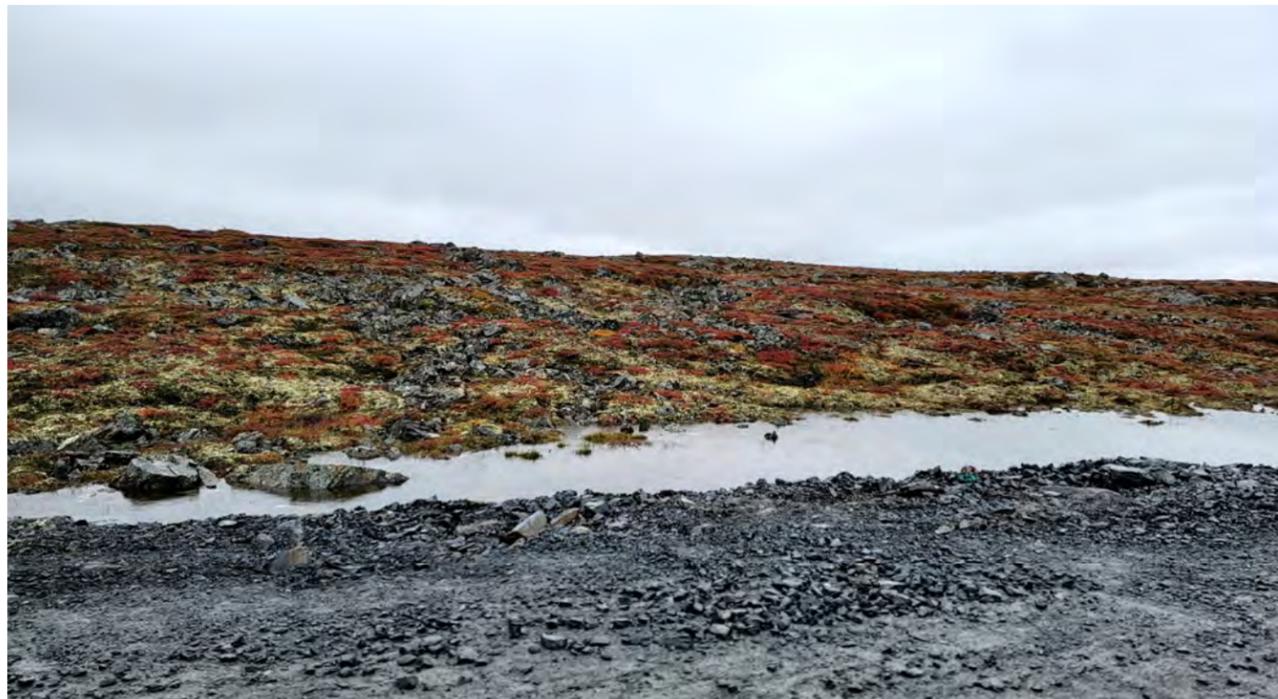
G-107. – Ponding waters along the toe of the Echo Diversion

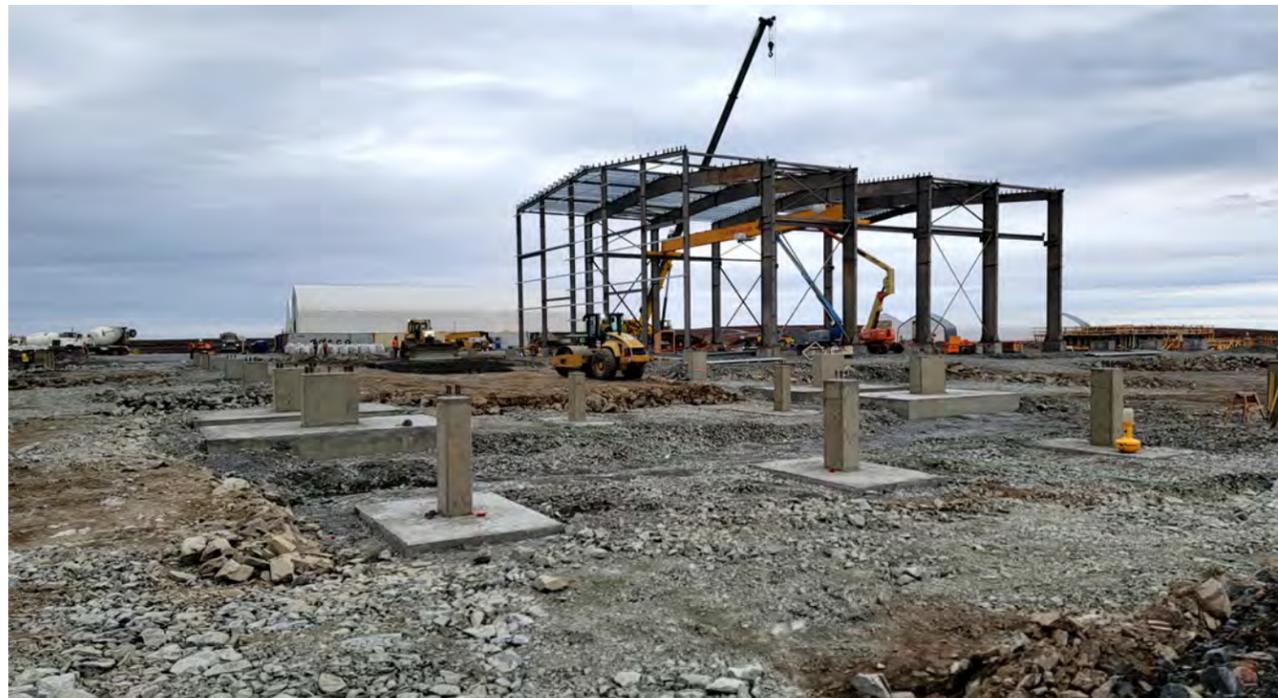
G-122. – Processing Plan: construction of the footings

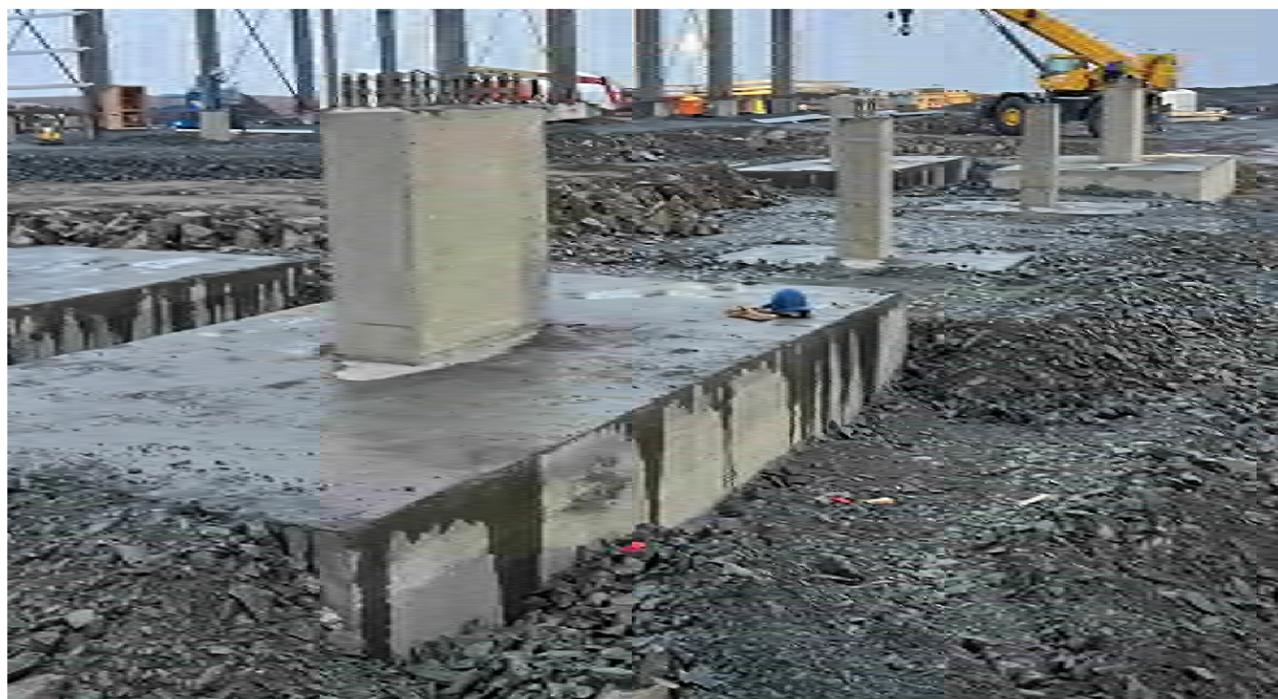
G-124. – Processing Plant: construction of the footings

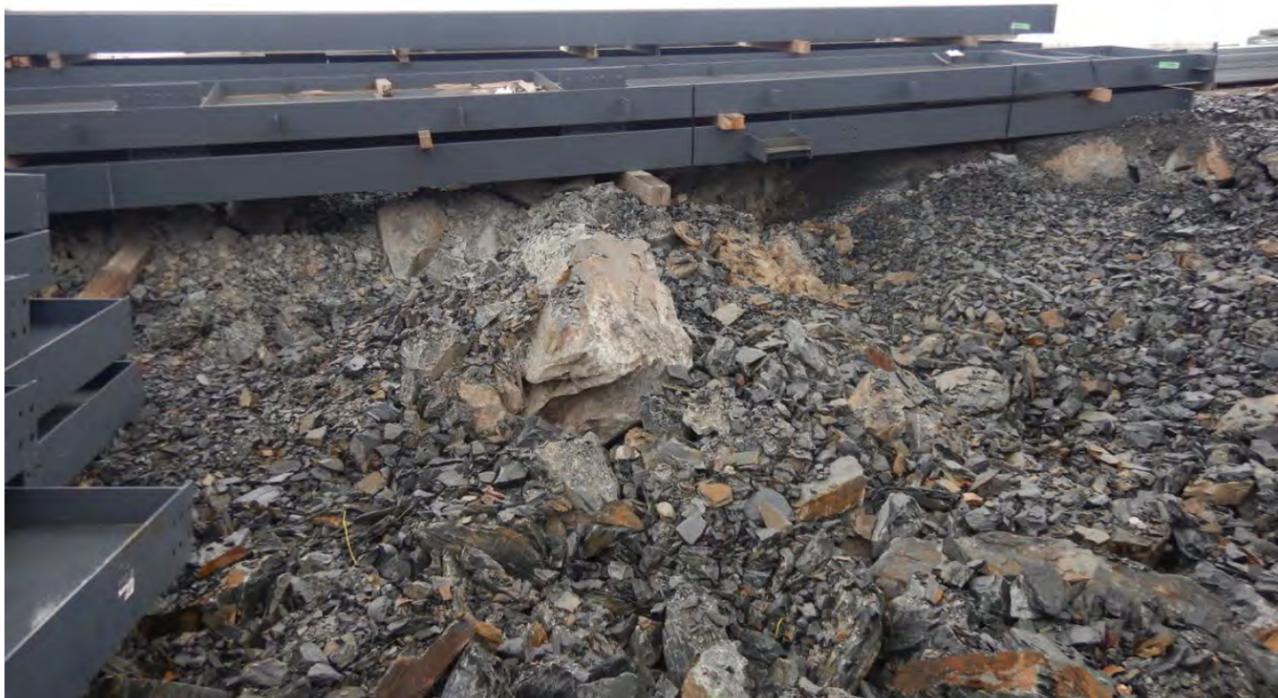
G-131. – Southern slope of the Plant Site Pad, looking north. Note some voids in the fill material

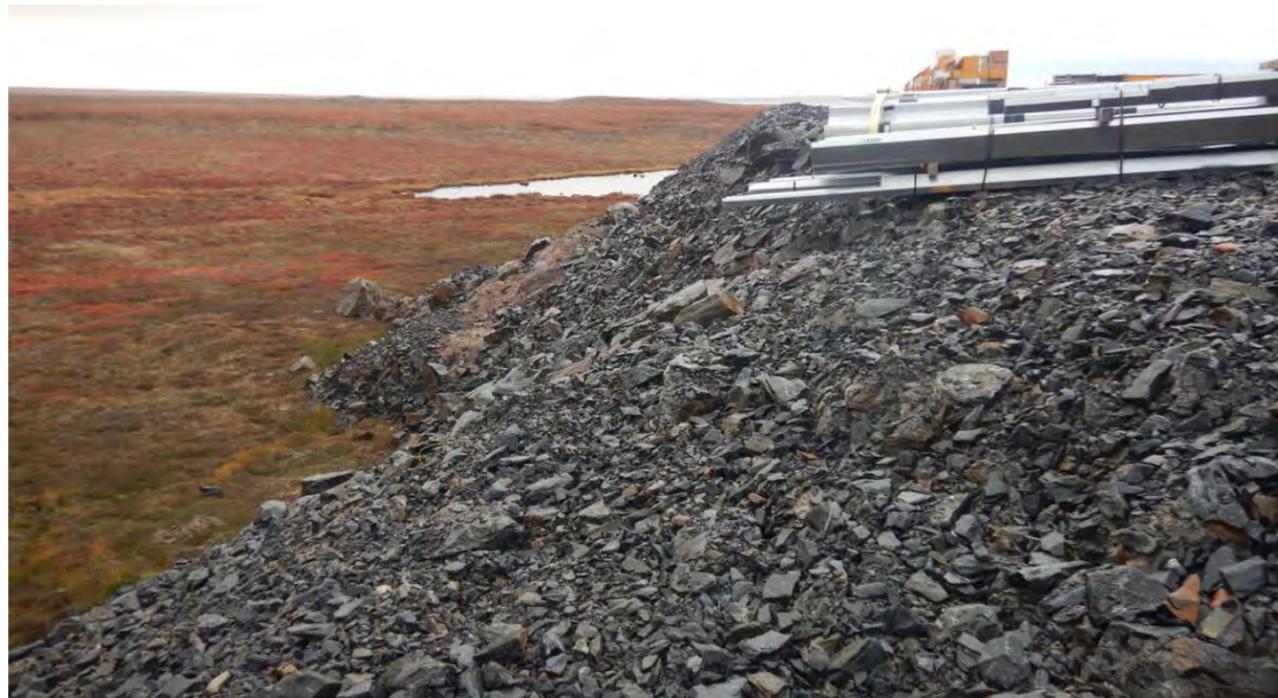
G-132. - Southern slope of the Plant Site Pad, looking west.

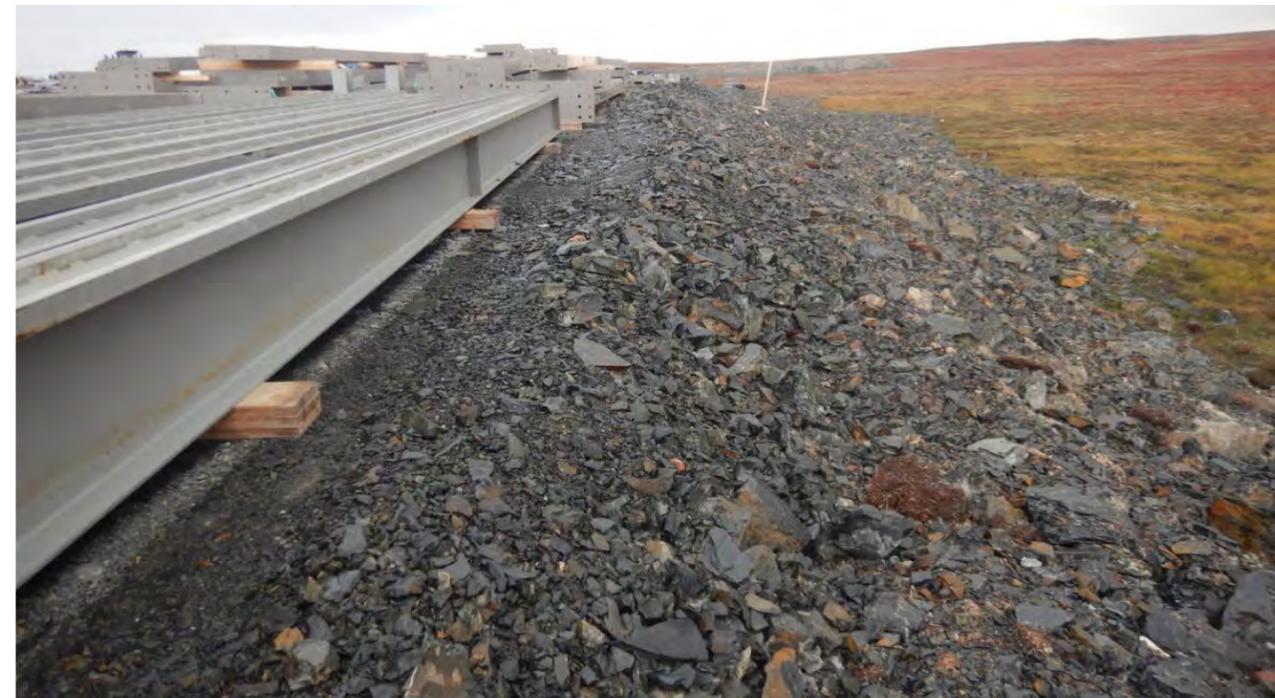
G-133. - Southern slope of the Plant Site Pad, looking east.

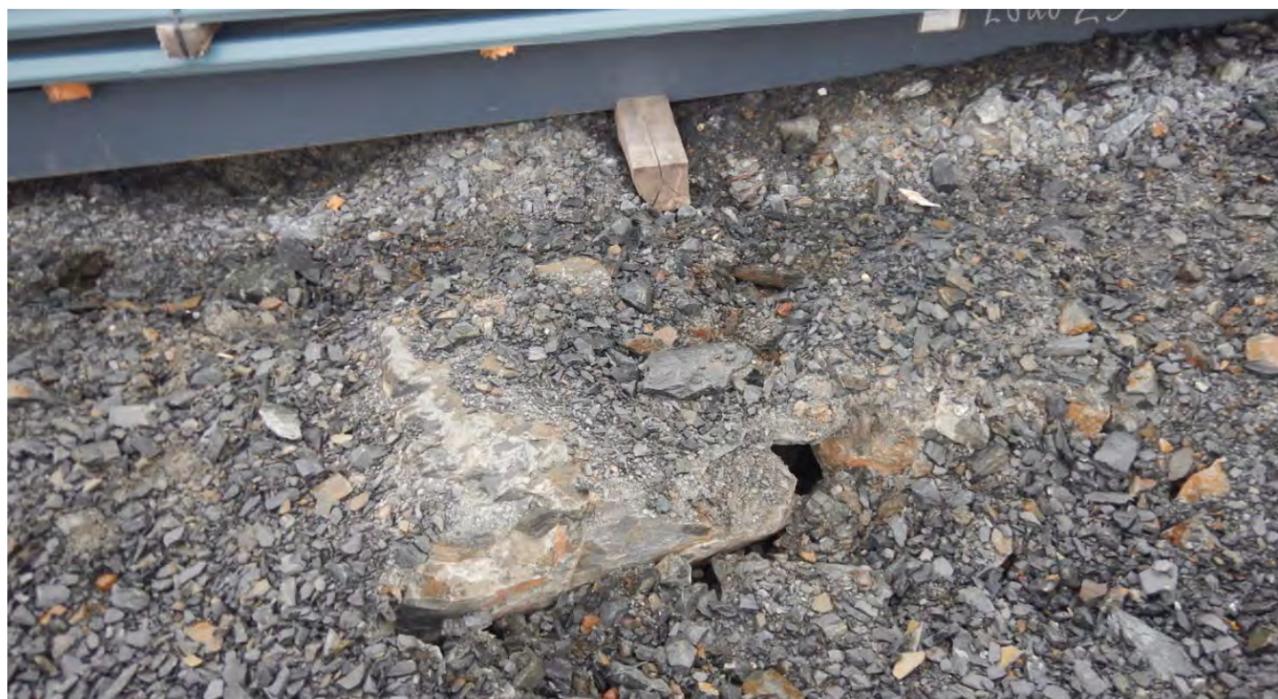
G-134. - Southern slope of the Plant Site Pad, looking north. Note some voids in the fill material

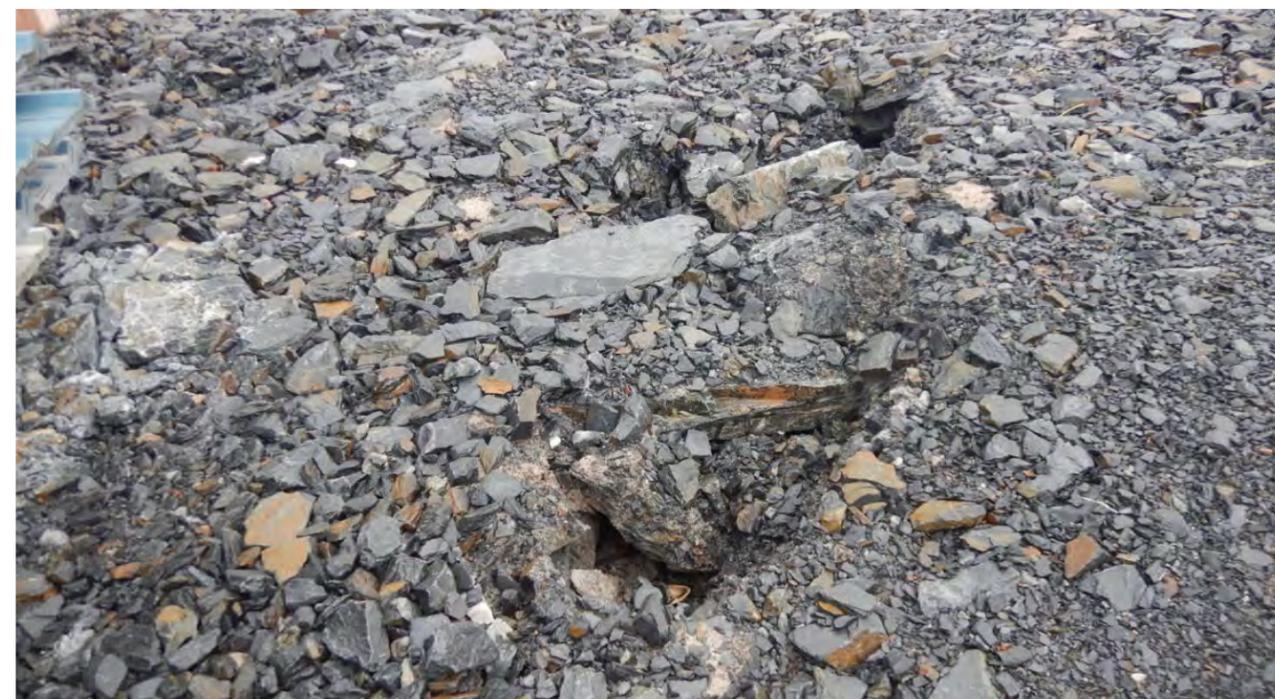
G-135. - Southern slope of the Plant Site Pad, looking north. Note some voids in the fill material

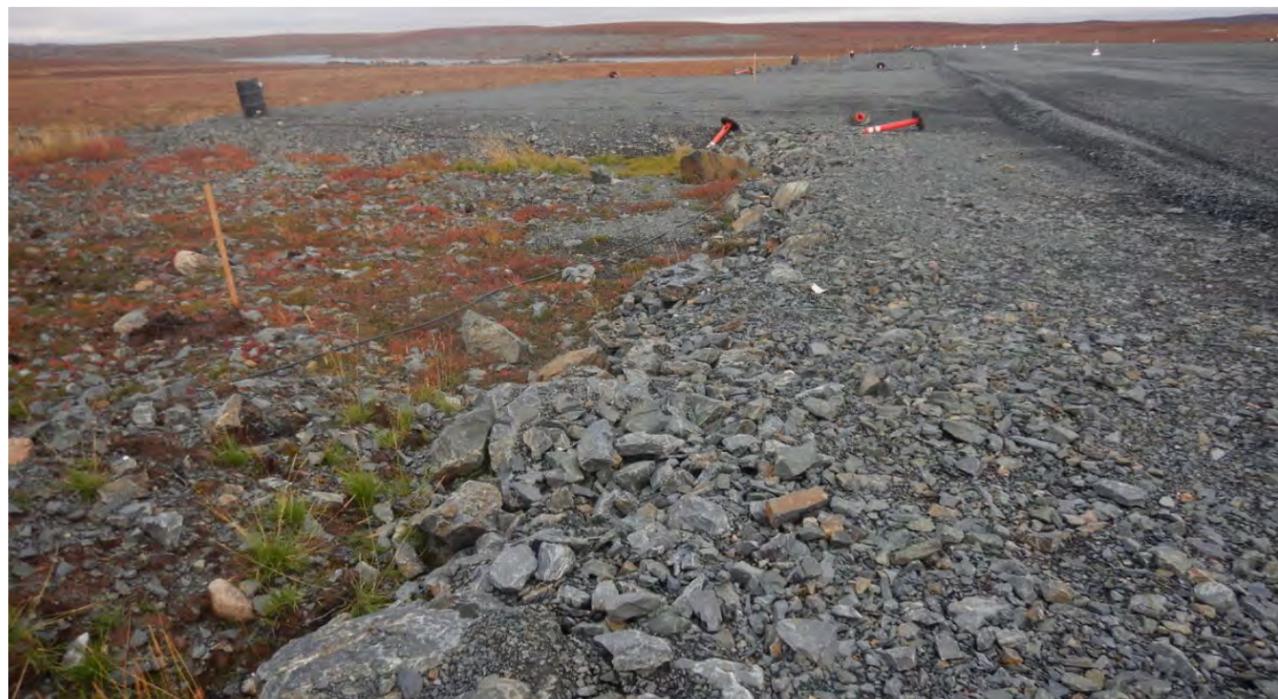
G-138. - Western side of the airstrip, looking NW. Note the thickness of the pad

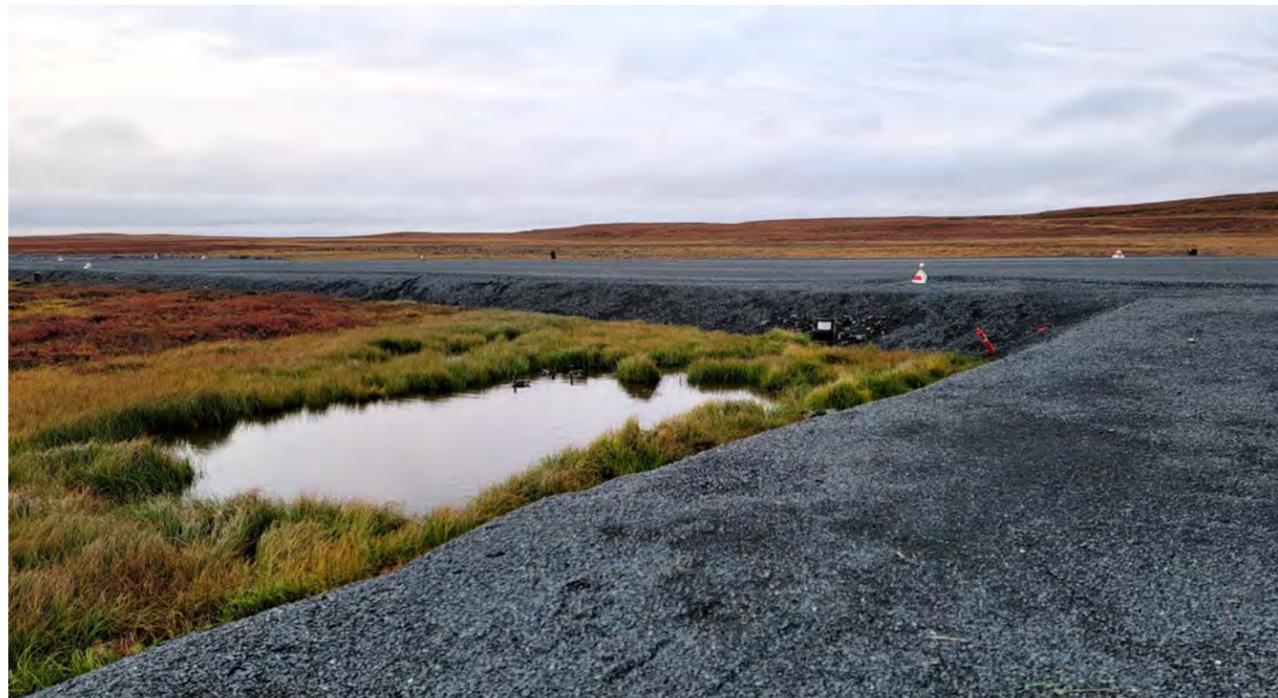
G-140. – Ponding waters on the eastern side of the pad, looking north. Note the thickness of the pad

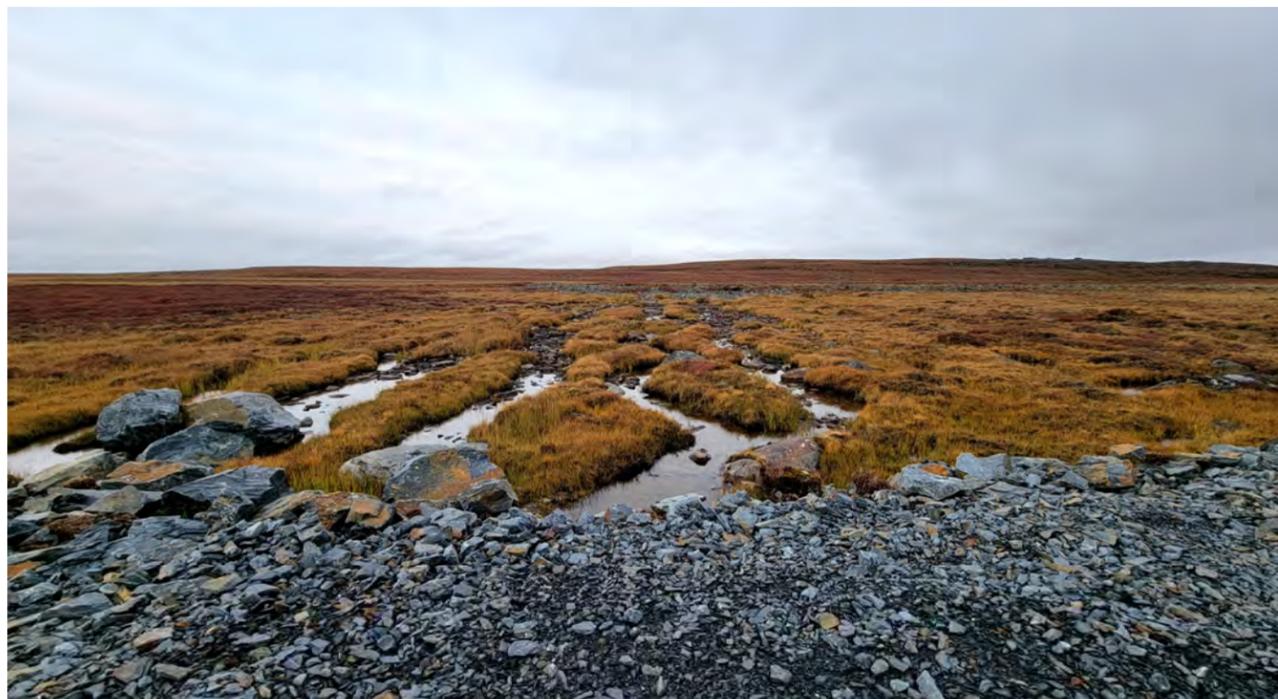
G-142.- Ponding waters at the SE end of the airstrip, looking east

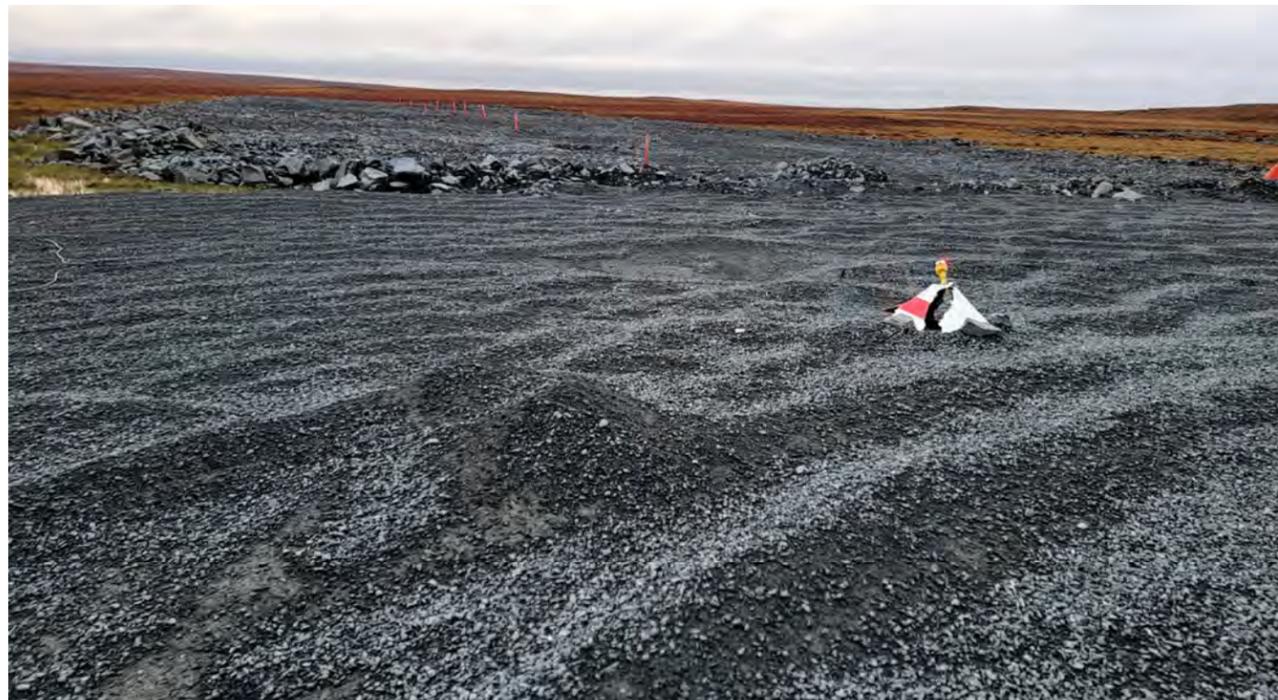
G-145. - Construction of the SE extension of the pad

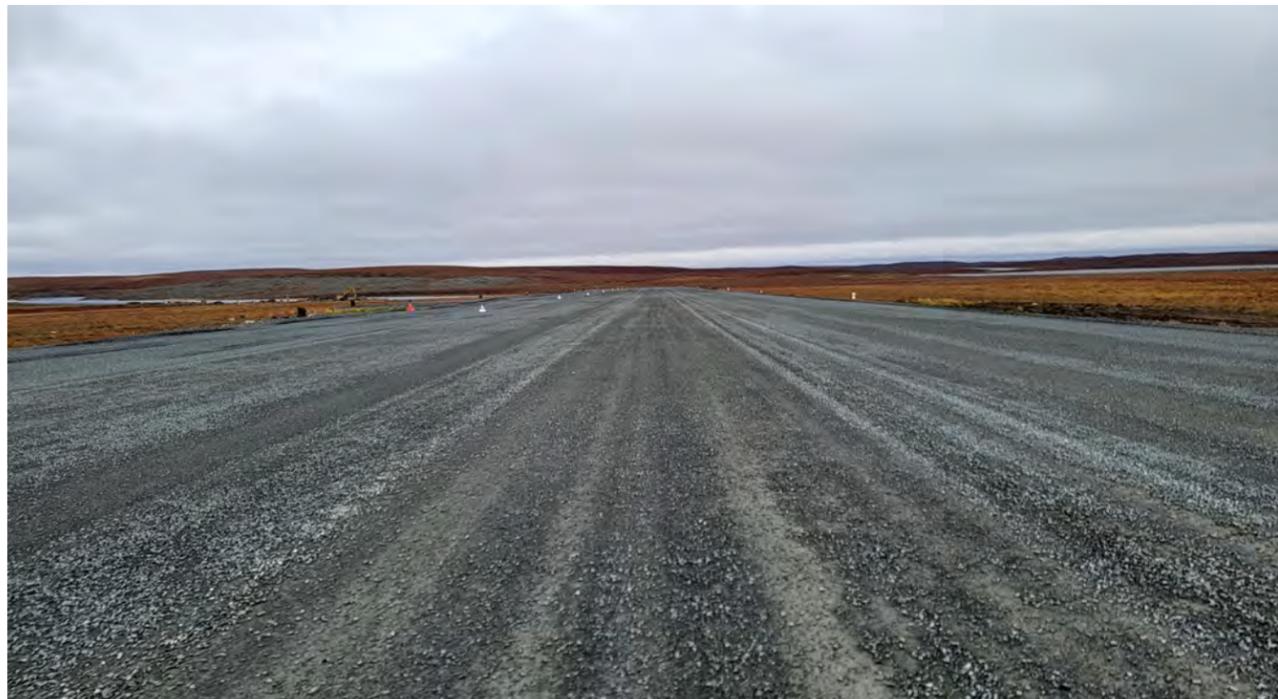
G-147. Overview of the surface of the airstrip pad, looking NW

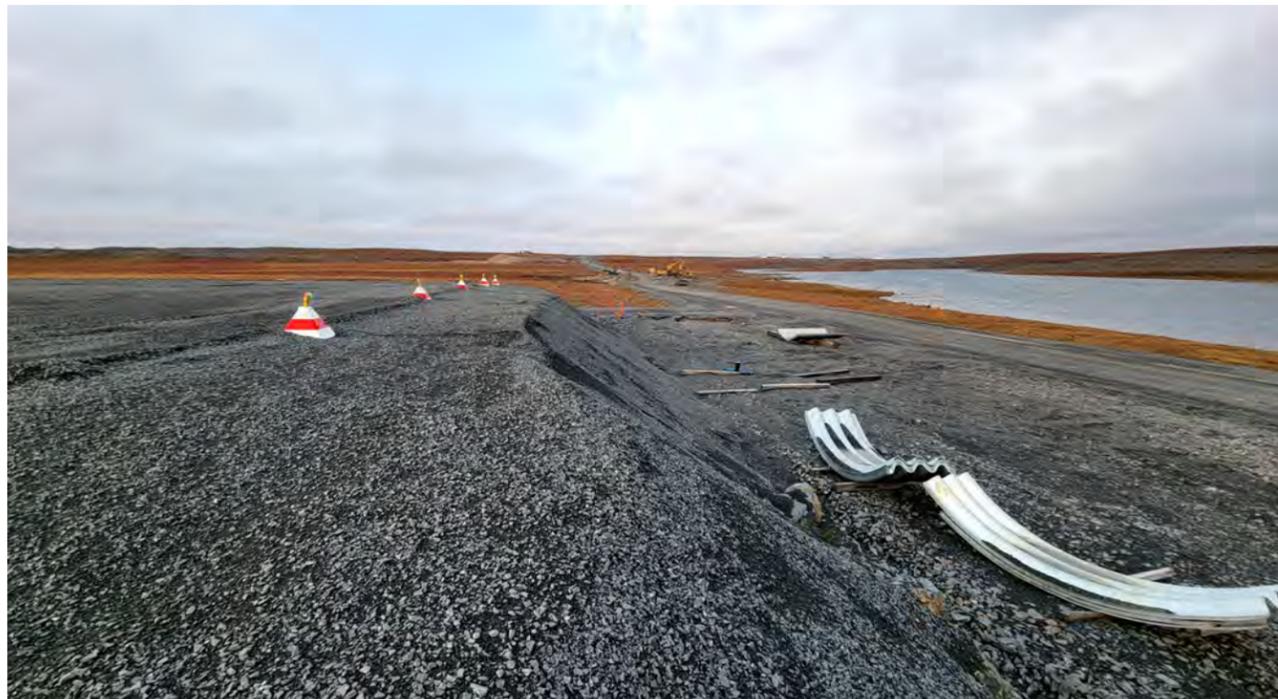
G-151. – NW end of the airstrip.

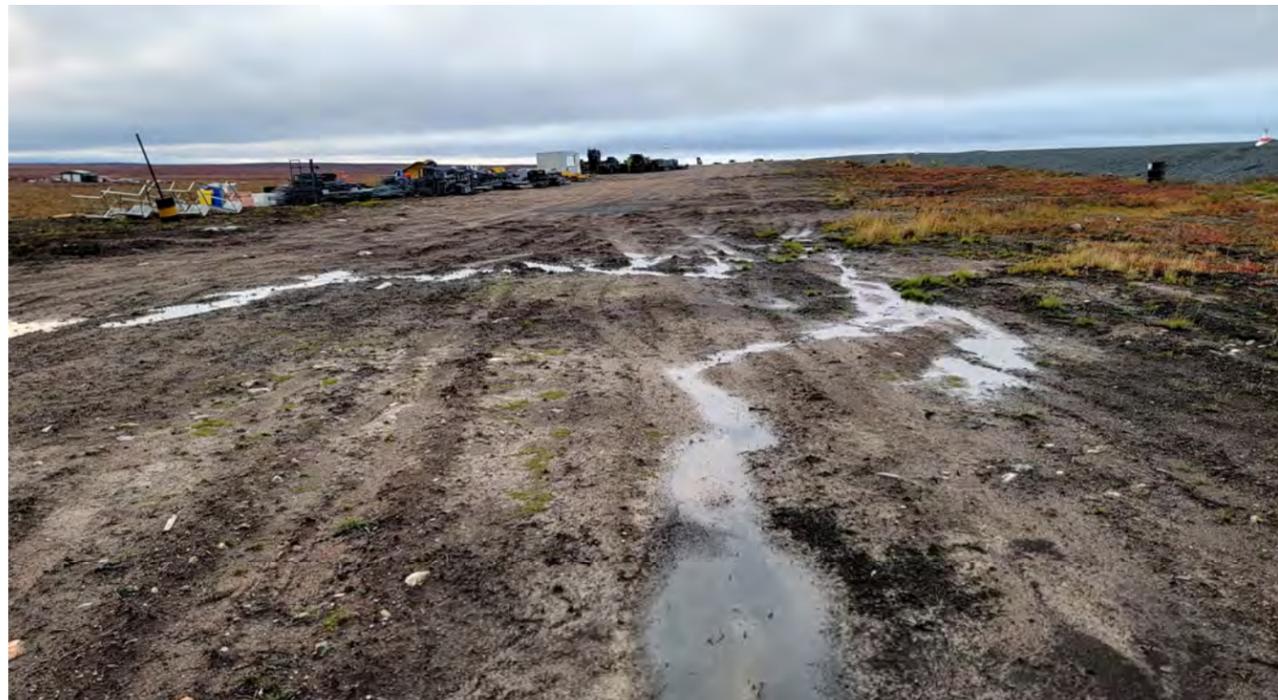
G-153. – Laydown area along the eastern side of the airstrip, looking SE

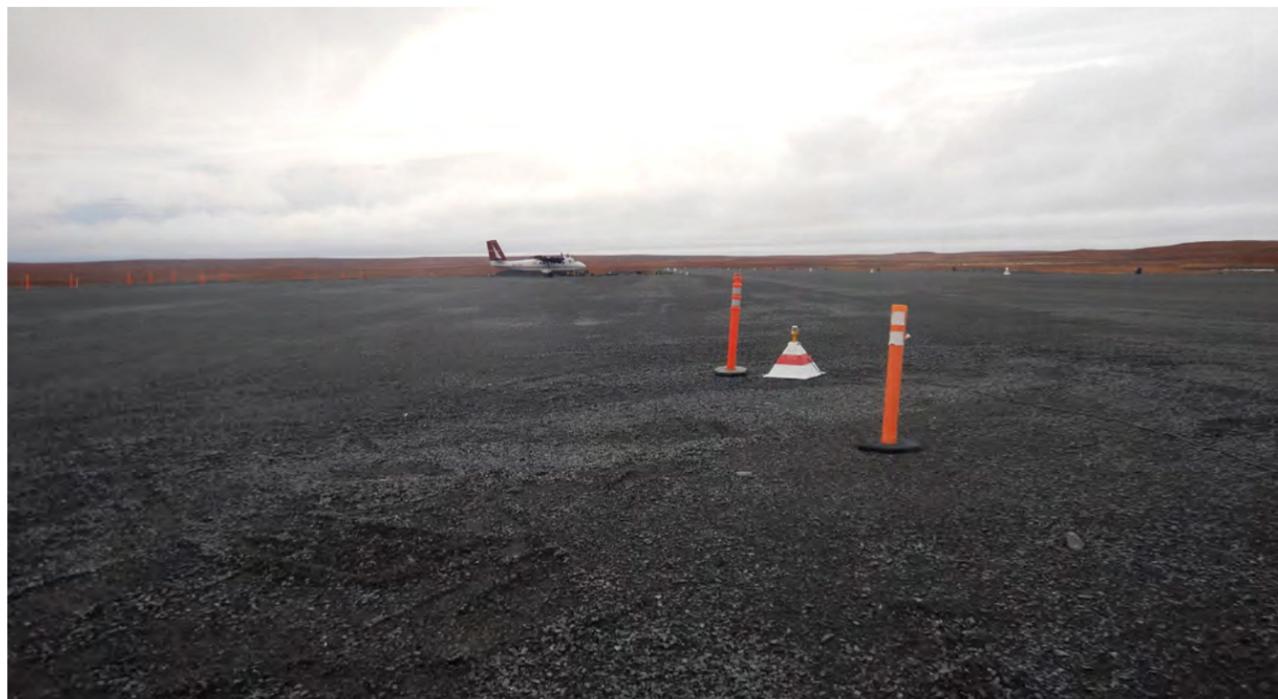
G-155. - Plane parking area, looking east

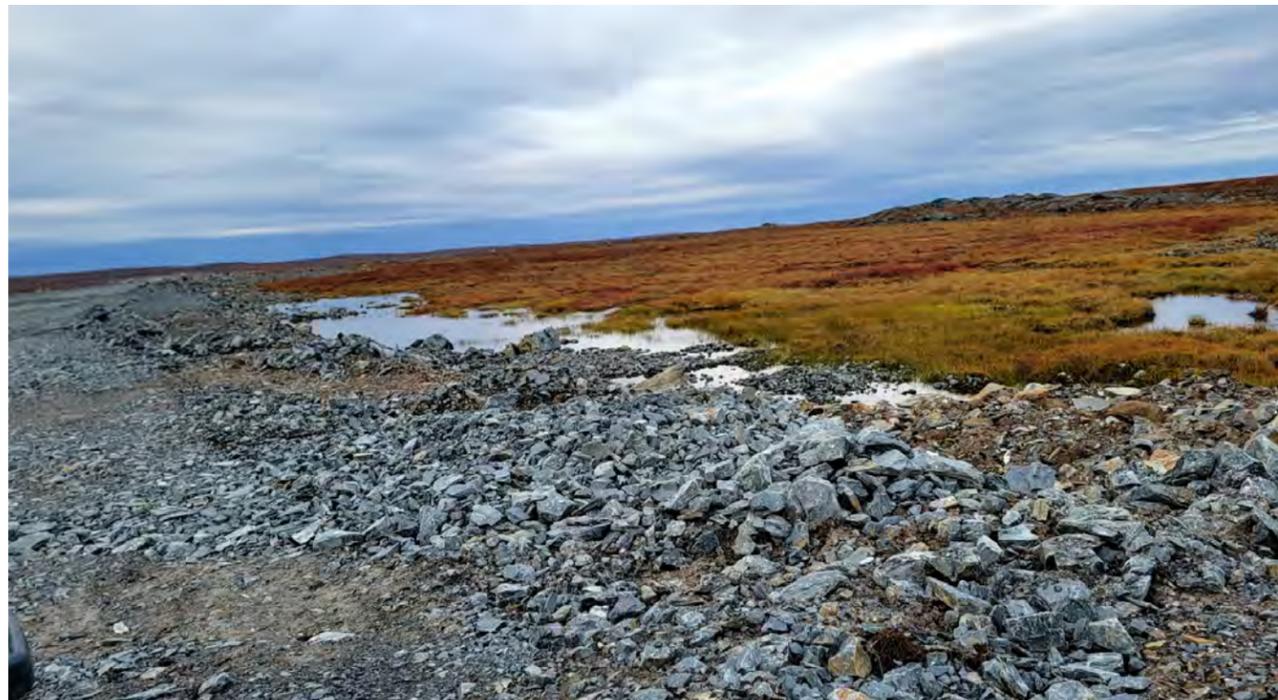
G-157. - Ponging water along the road. The photo is taken looking south

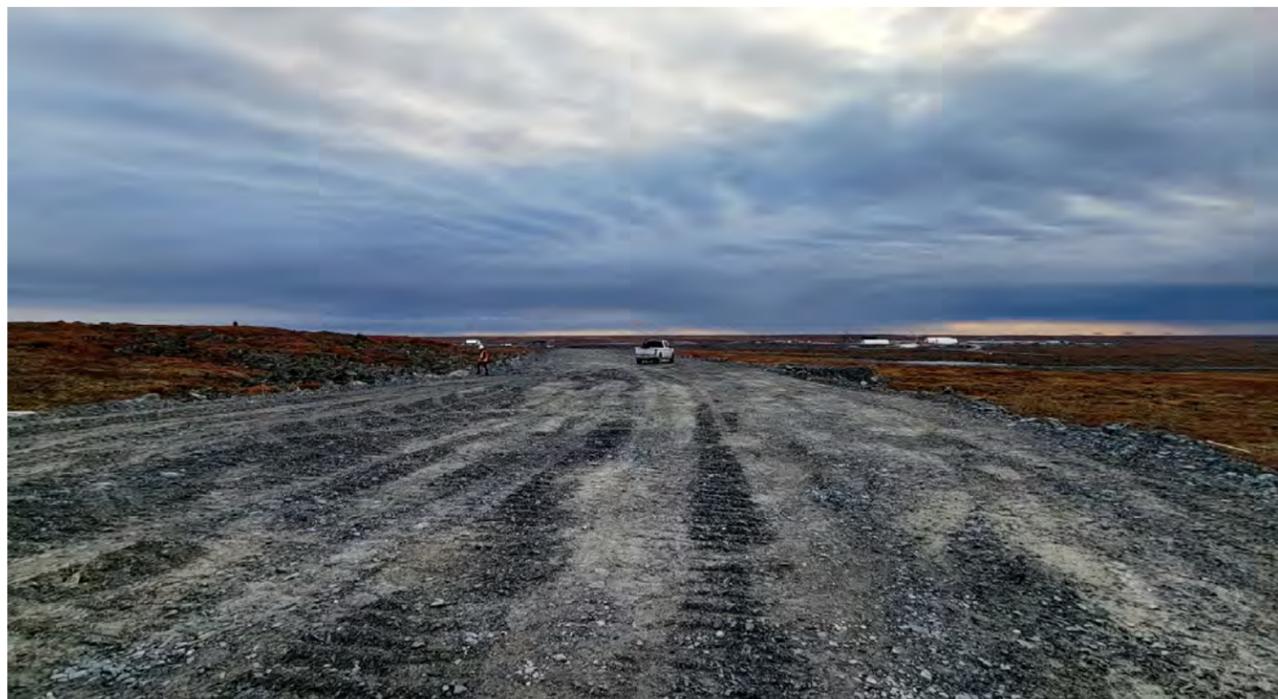
G-159. - Example of the fill material used for road construction. The photo was taken looking south

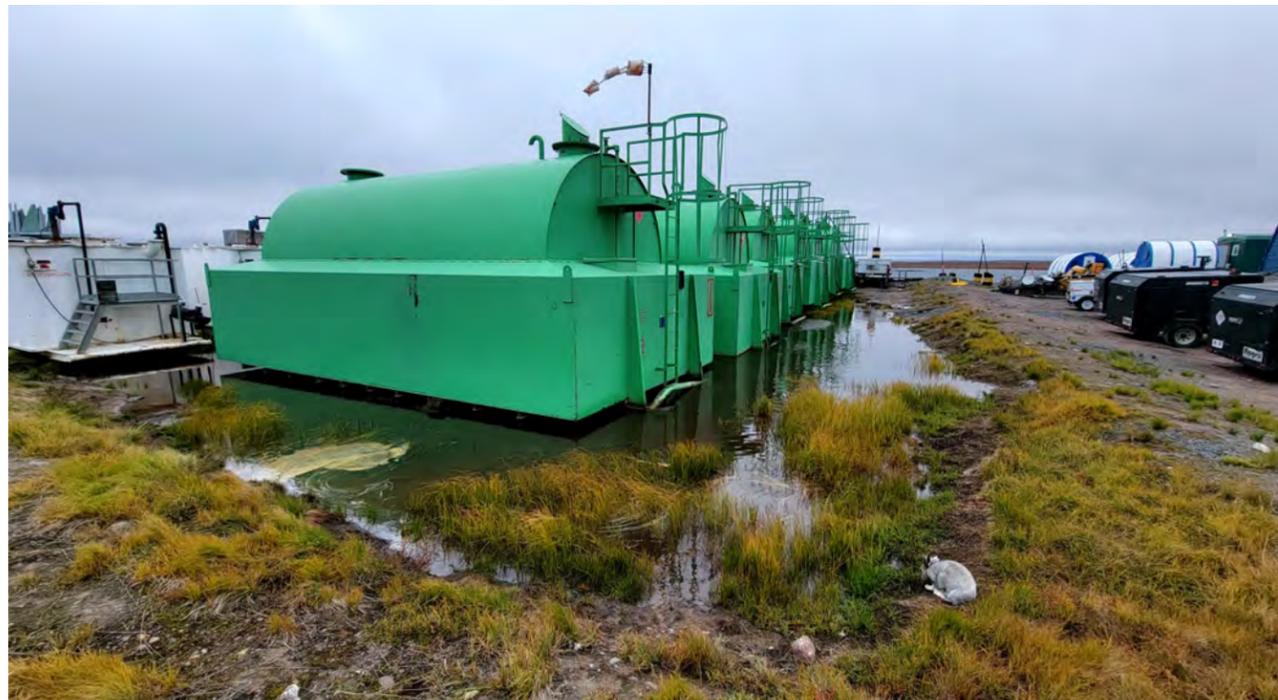
G-161. – Temporary Fuel Storage Facility

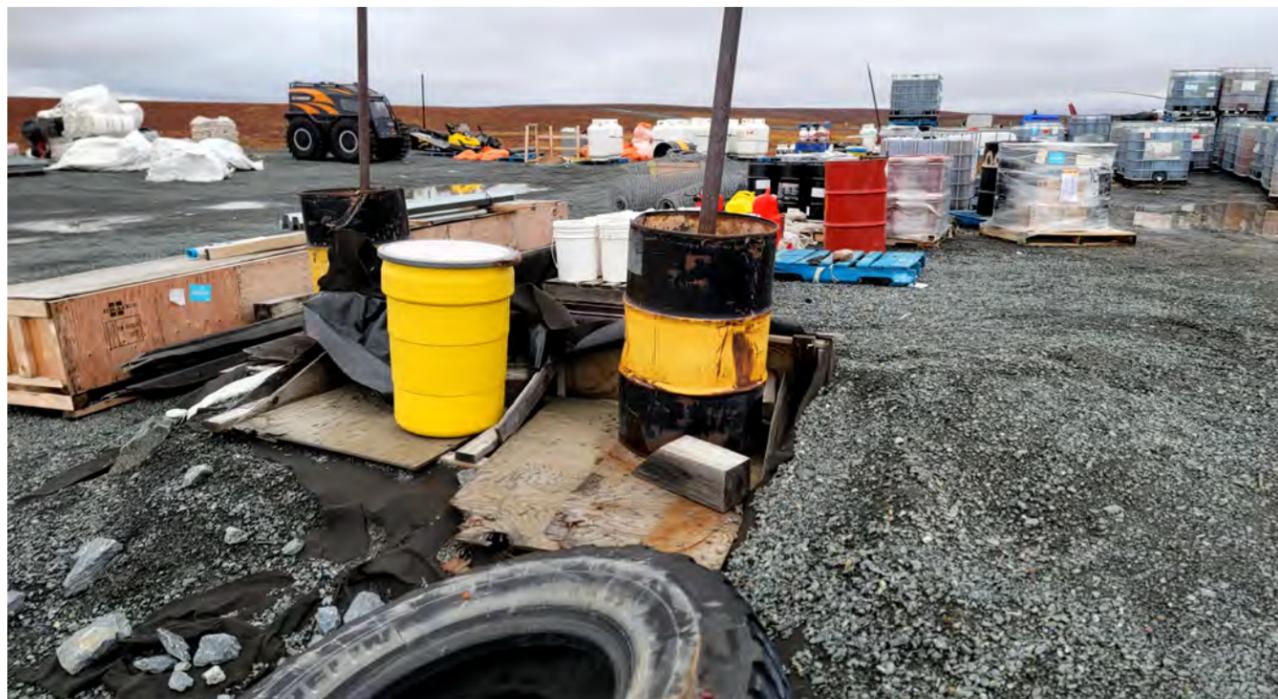
G-163. - Laydown area

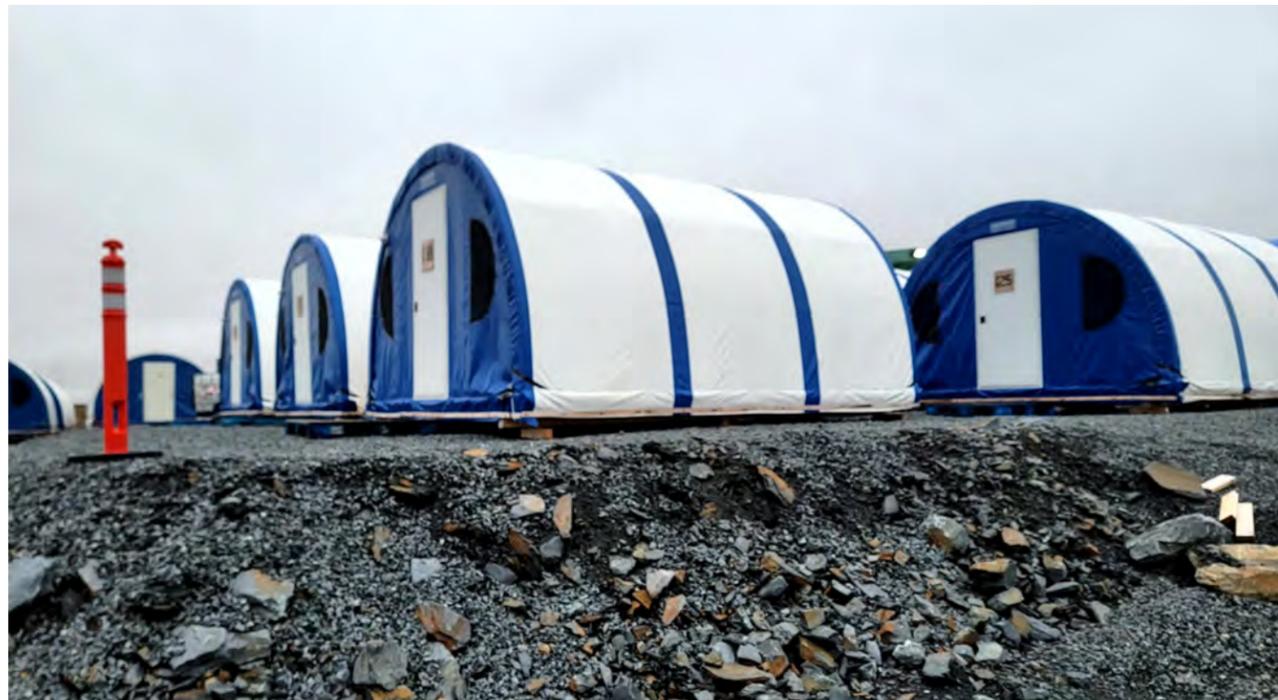
G-165 .- Explication Camp Pad

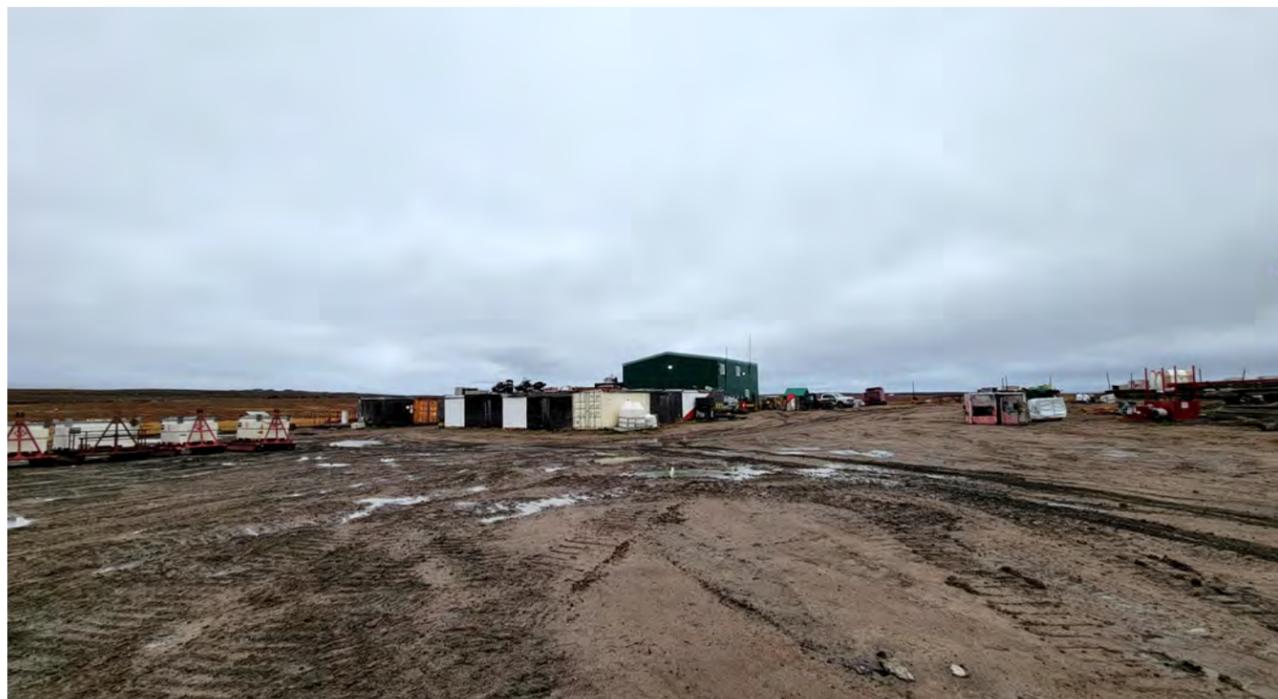
G-167. – Incinerator facility

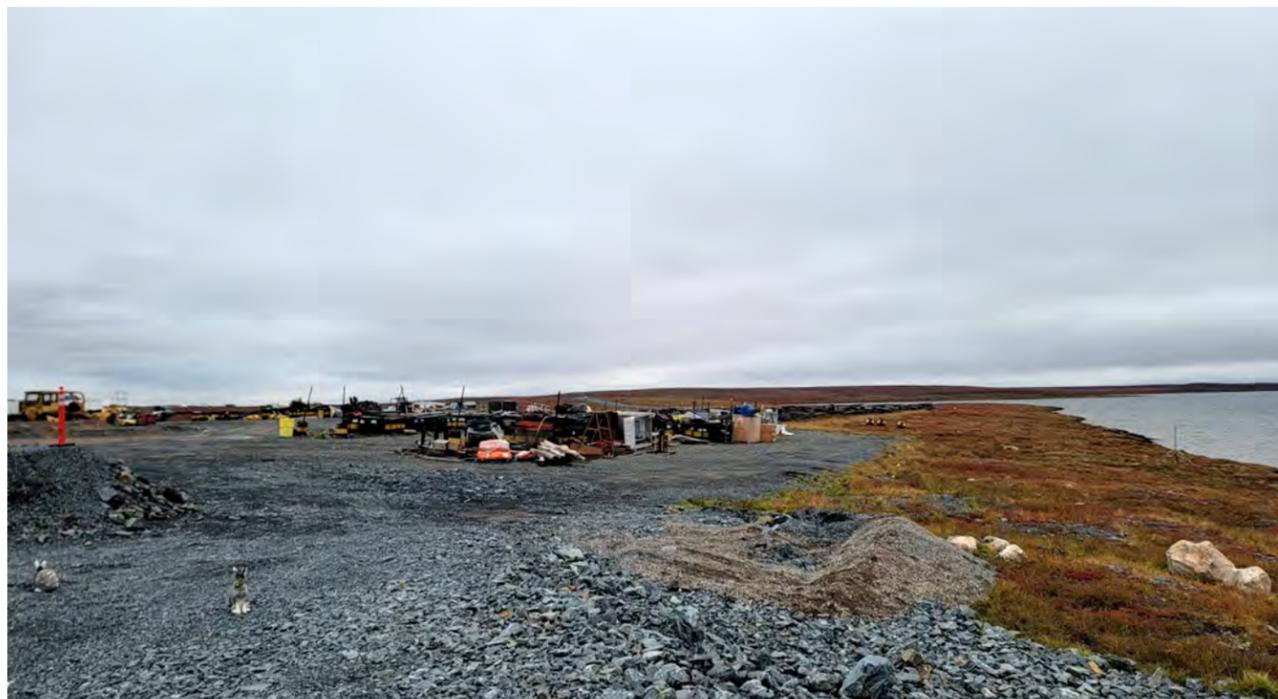
G-171. - SW side of the exploration camp

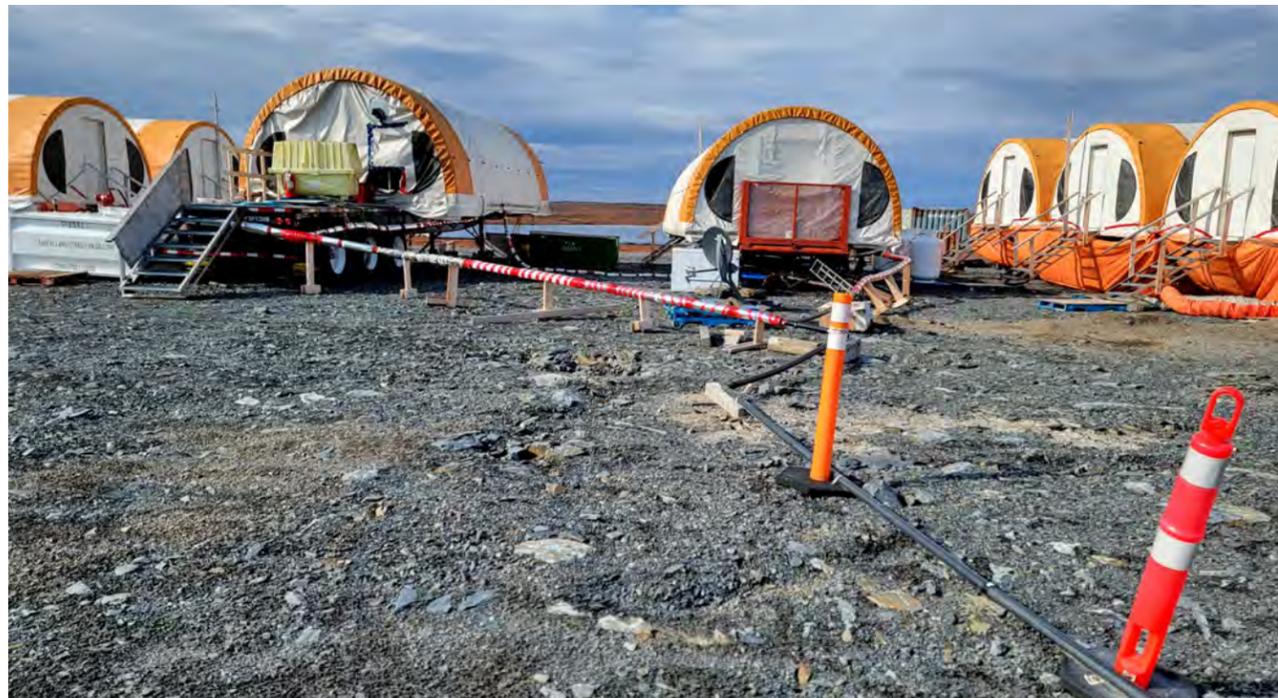
G-173. – Forward Camp pad, looking east

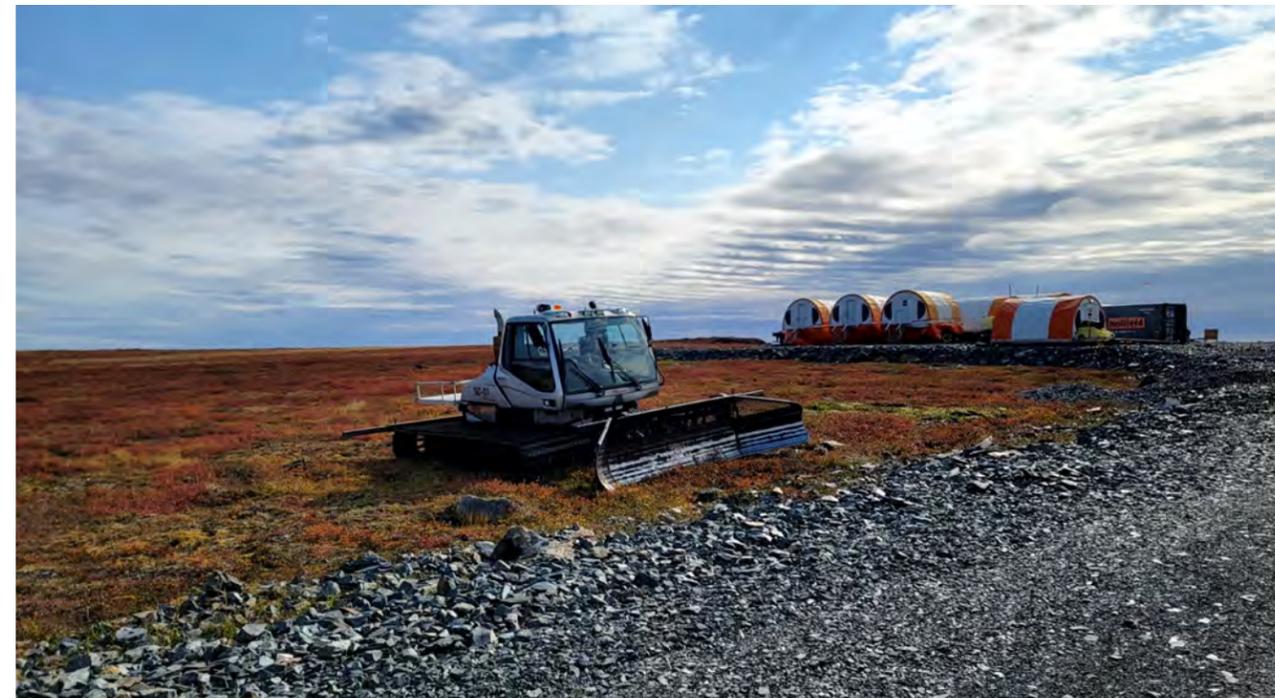
G-174. - Access road from the Forward Camp to the Llama Lake, looking SE
