2023 Annual Geotechnical Inspection		
		Gander Crossing		
Job No: CAPR003105 Filename: BackRiver_Goose_2023AGI_PhotoLog.pdf	Back River Project	Date: 2024-02-28	Approved: JBK	Figure: A.1-39

Back River Project

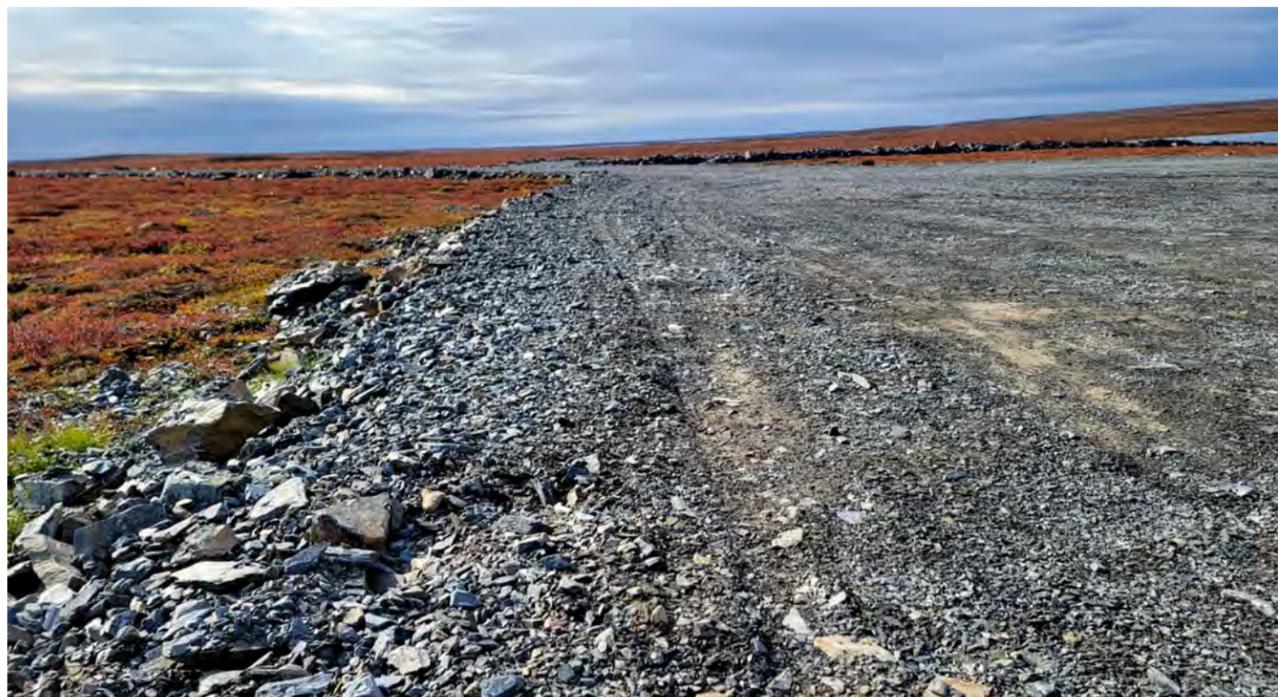
G-175. – Western side of the Camp Pad, looking north

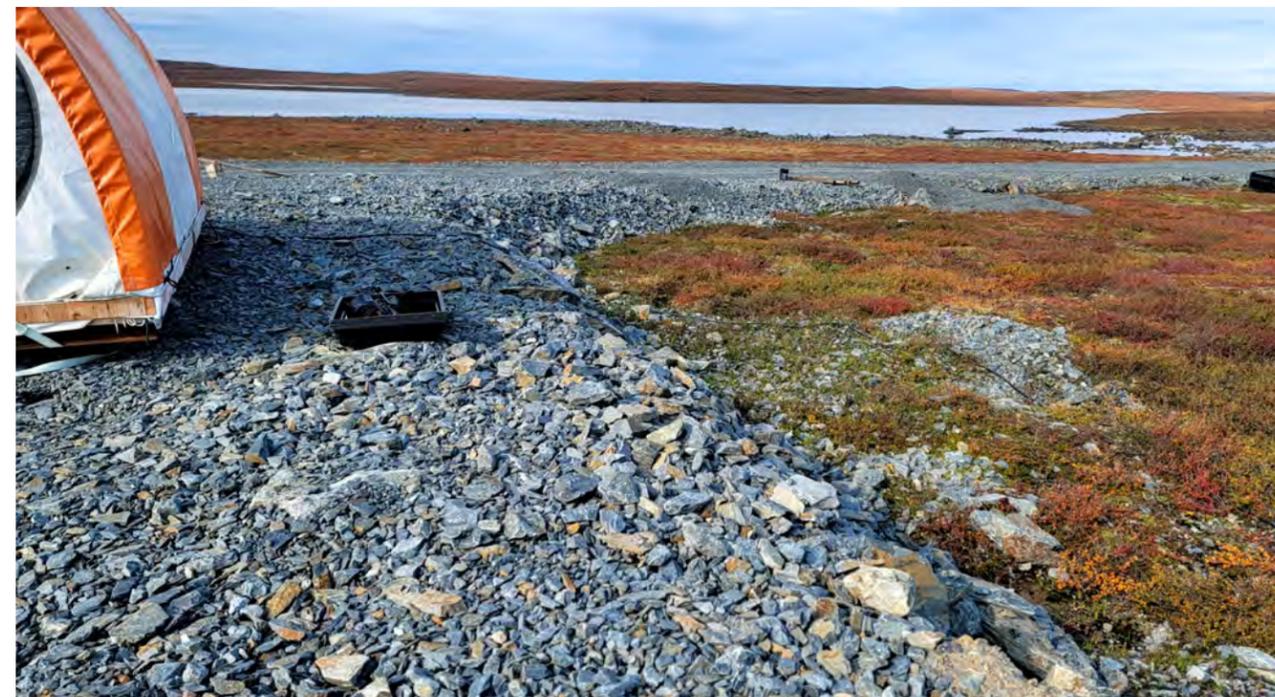
G-176. – Northern edge of the Camp Pad, looking west

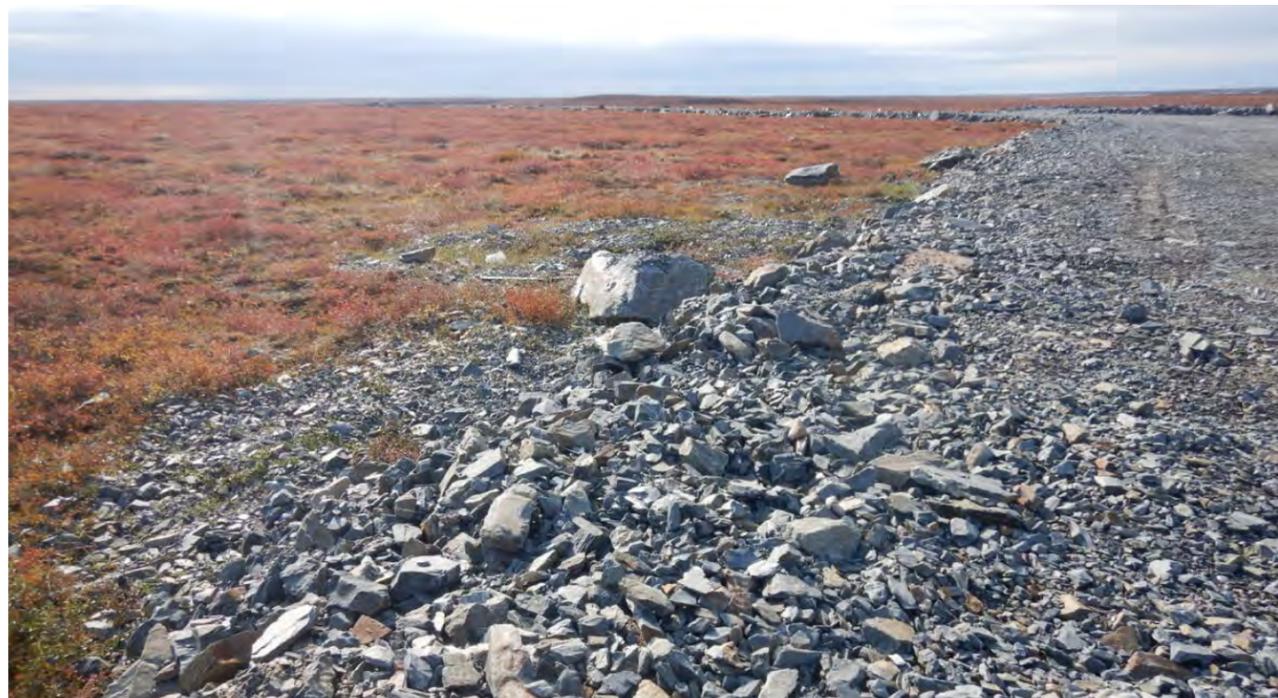
G-177. – Southern edge of the temporary access road, looking north, note thickness of the pad

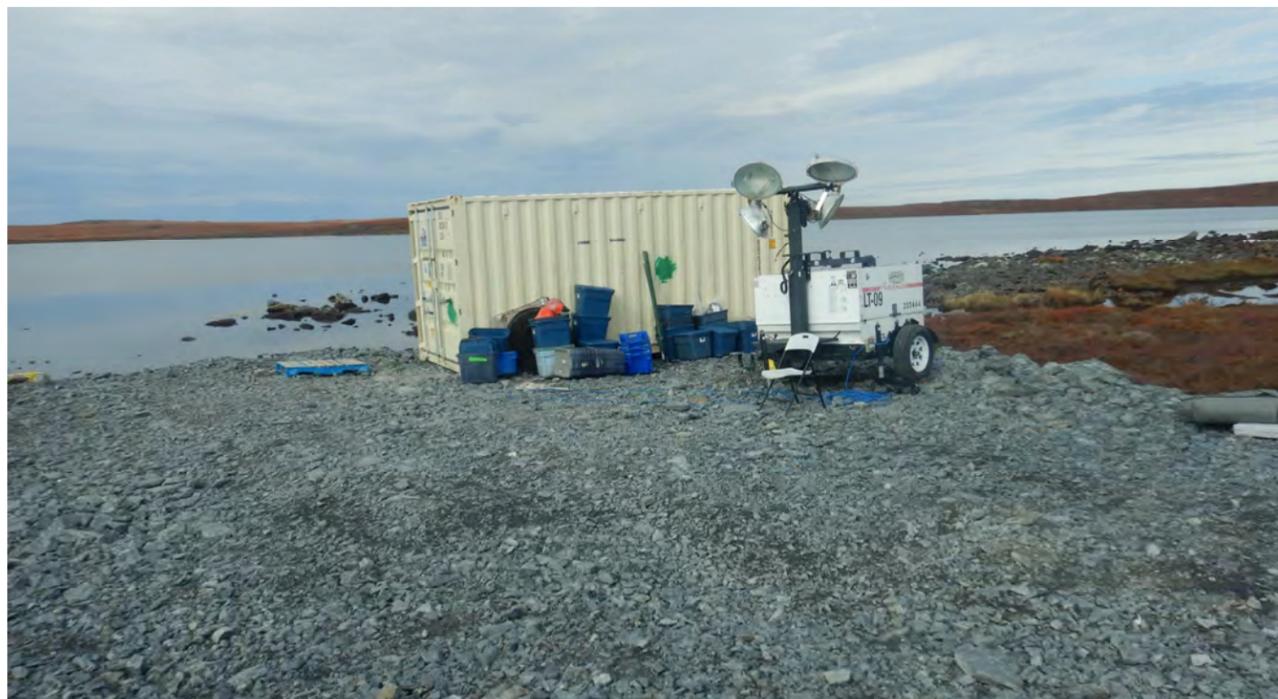
G-179. – Temporary pad at Llama Lake

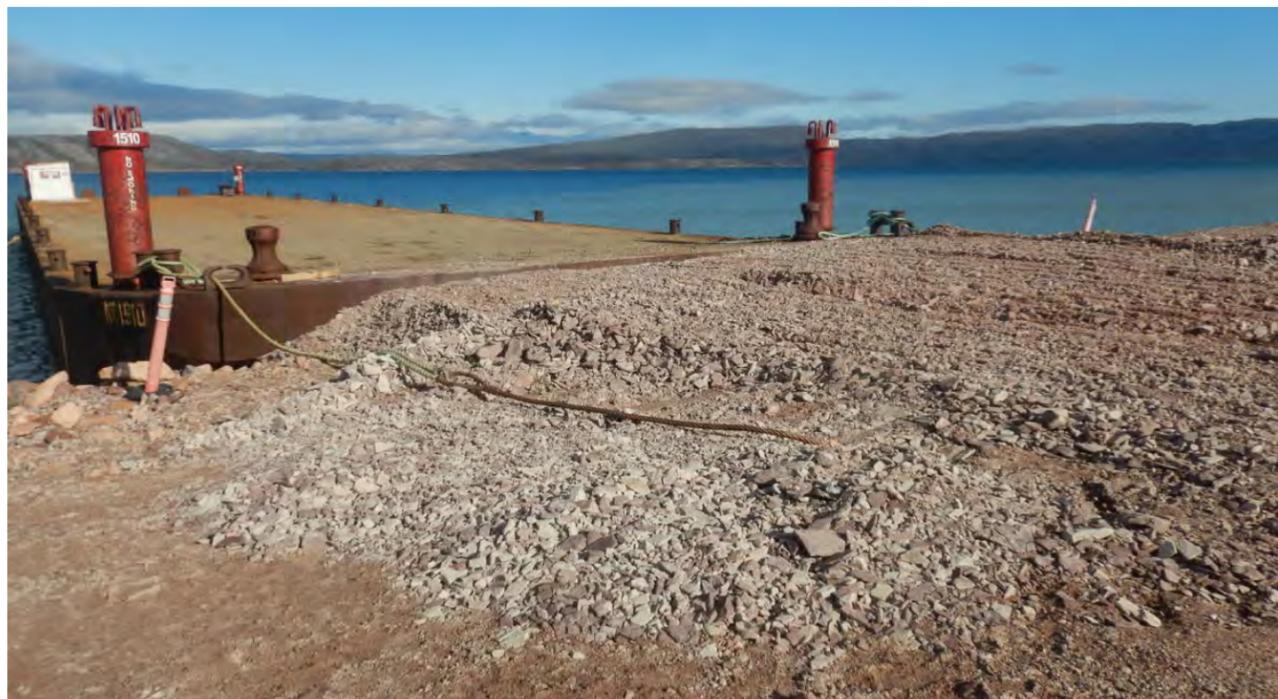
M-6. – Central part of Shoreline Pad

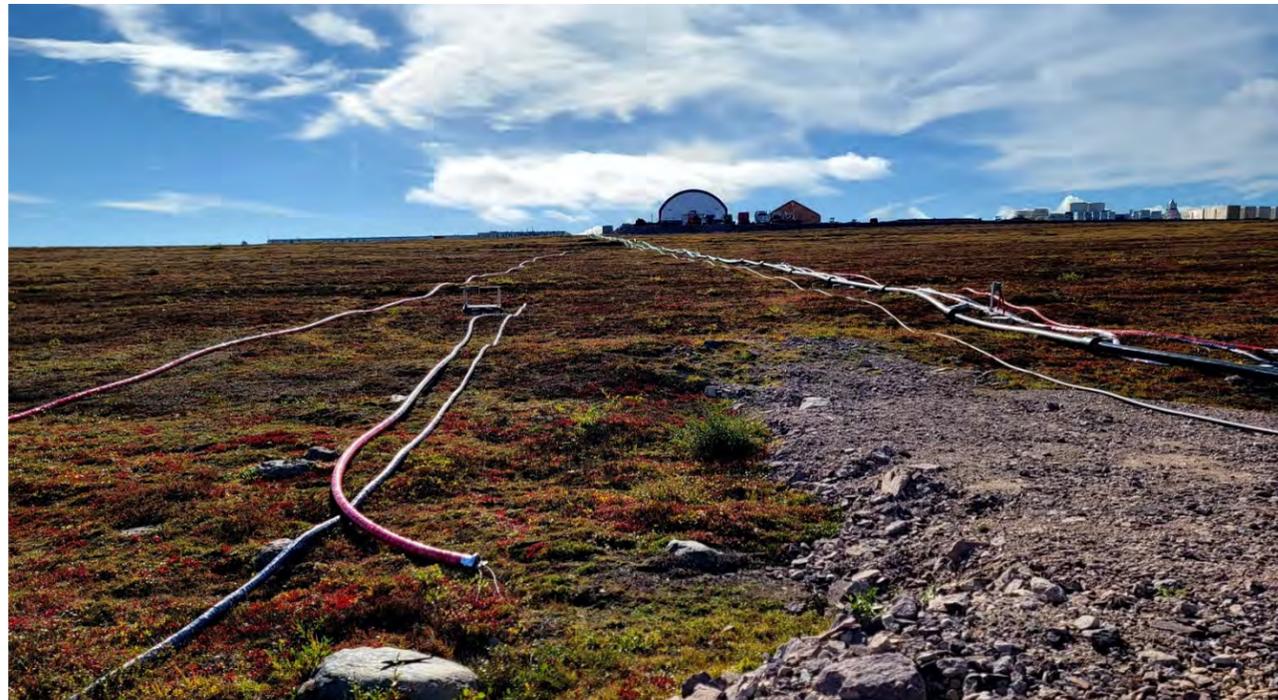
M-11. – A set of hoses and pipes on the tundra. Photo was taken looking southwest

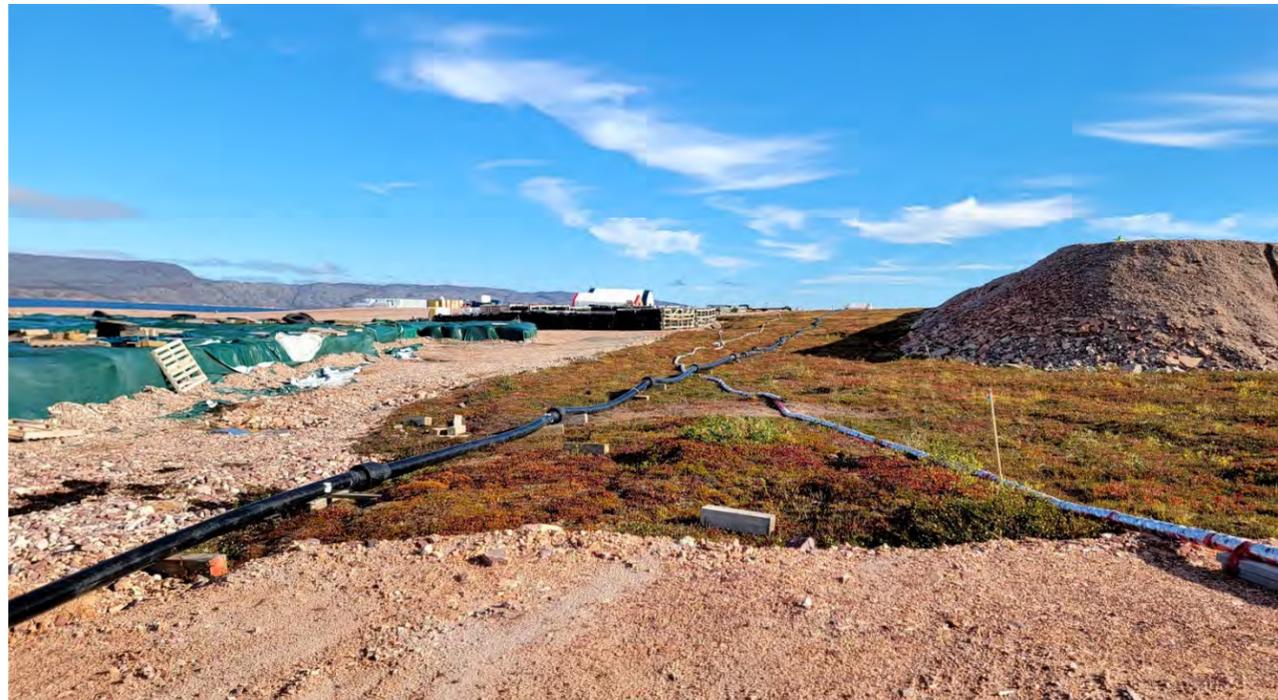
M-15. – Pipeline along the SSE edge of the Freight Storage Pad

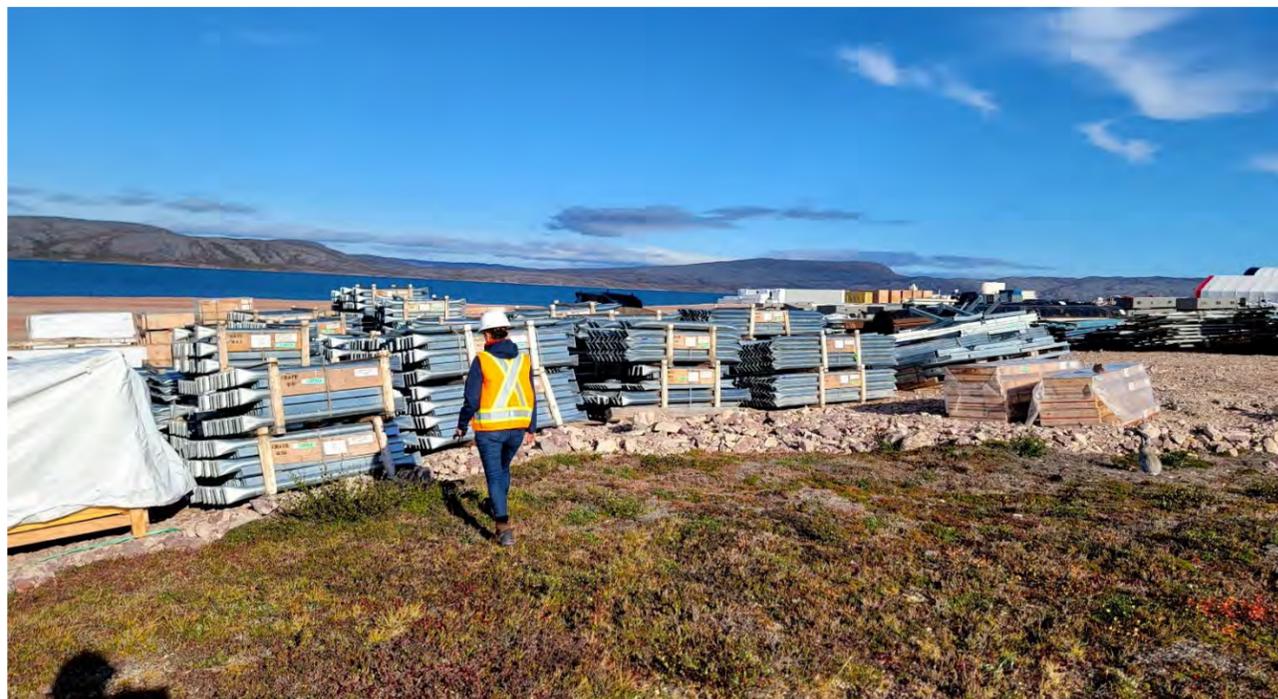
M-17. – Northeast side of the Freight Storage Pad. Note that the fill thickness is less than 0.3m
