2023 Annual Geotechnical Inspection		
		Freight Storage Pad		
Job No: CAPR003105 Filename: BackRiver_MLA_2023AGI_Photos.pdf	Back River Project	Date: 2024-02-28	Approved: JBK	Figure: A.2 -8

Back River Project

2023 Annual Geotechnical Inspection

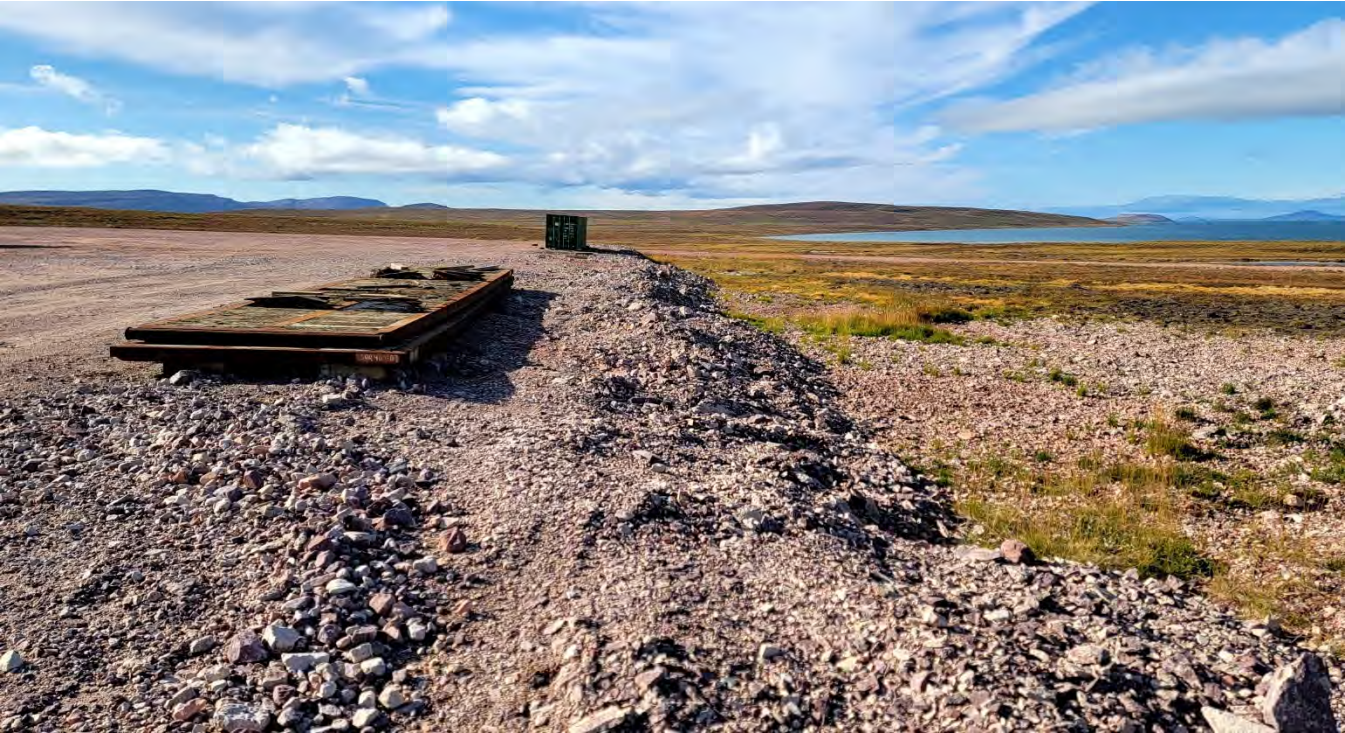
M-20. - Northern side of the Freight Storage Pad

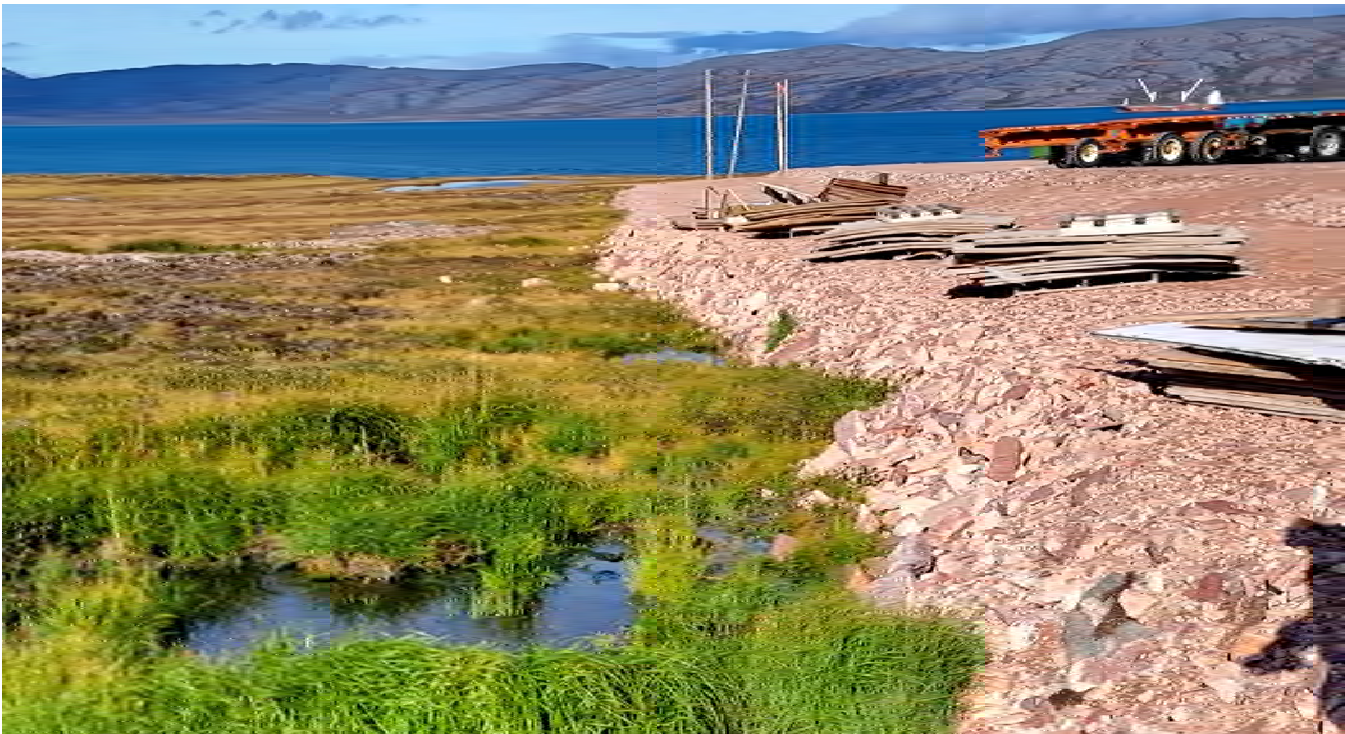
M-22. – Eastern side of the Freight Storage Pad. Note ponding waters along the toe of the pad

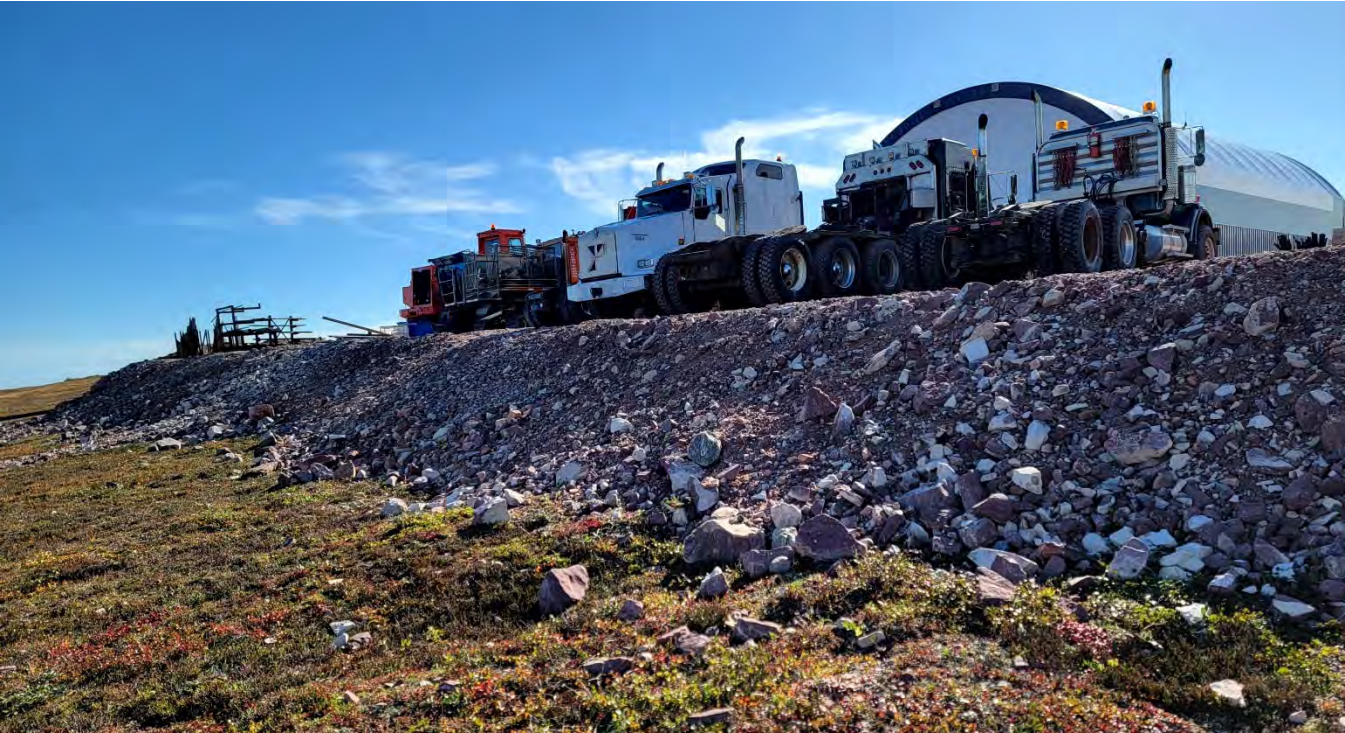
M-24. – Eastern corner of the Freight Storage Pad looking west.

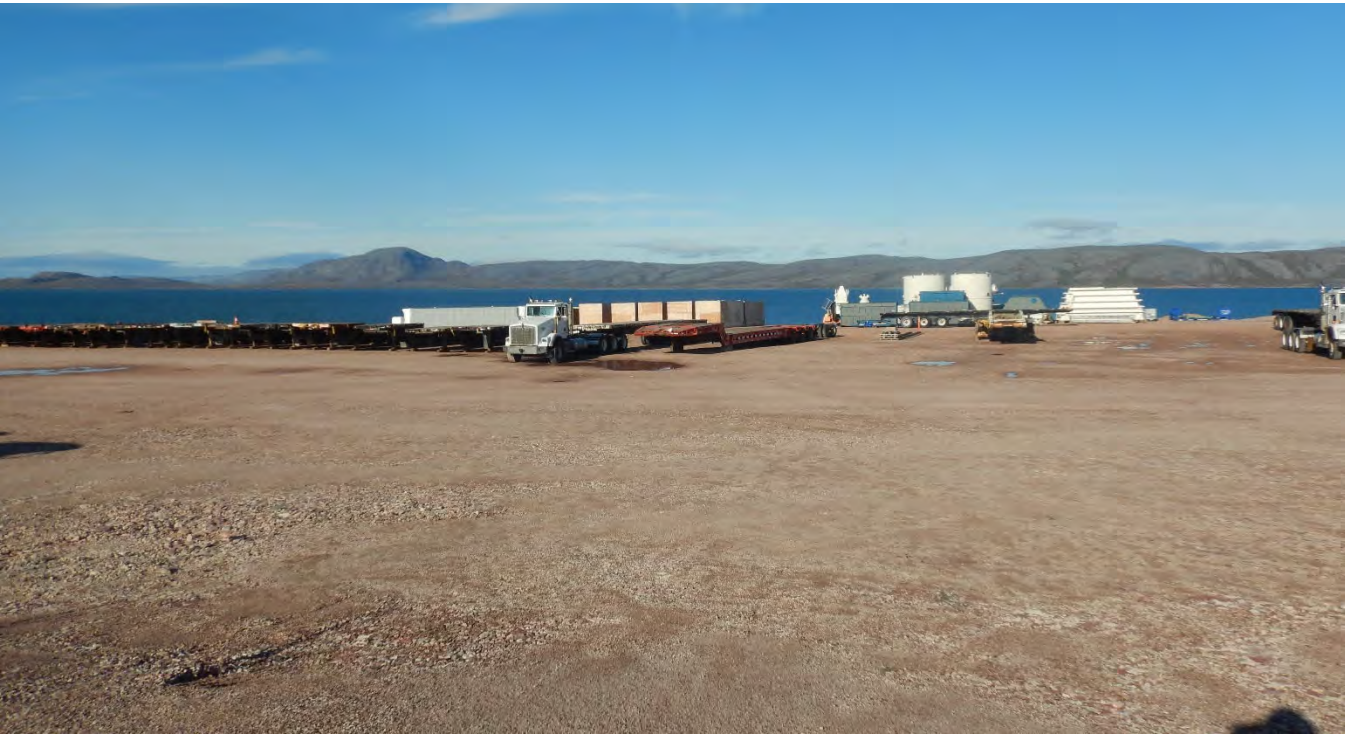
M-26. – Overview of the Freight Storage Pad surface.

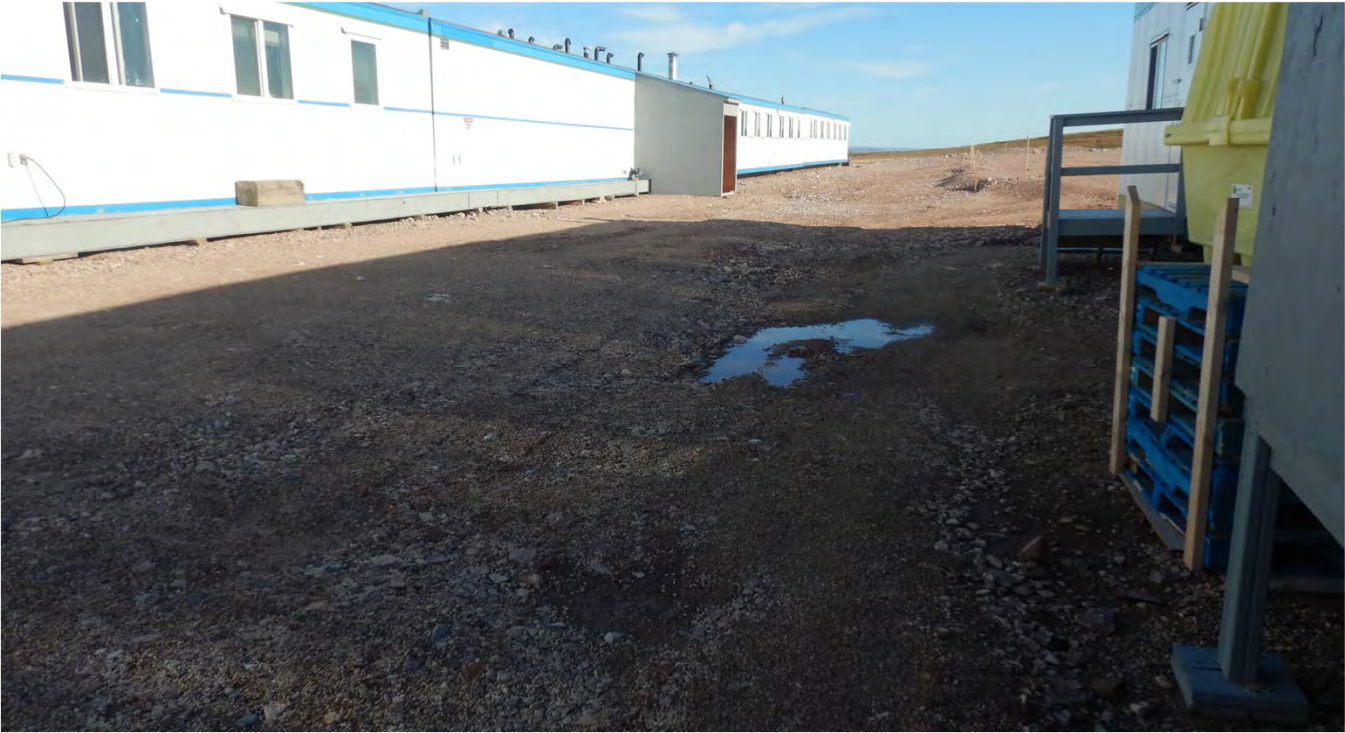
M-28. – Surface undulation at the Camp Pad.

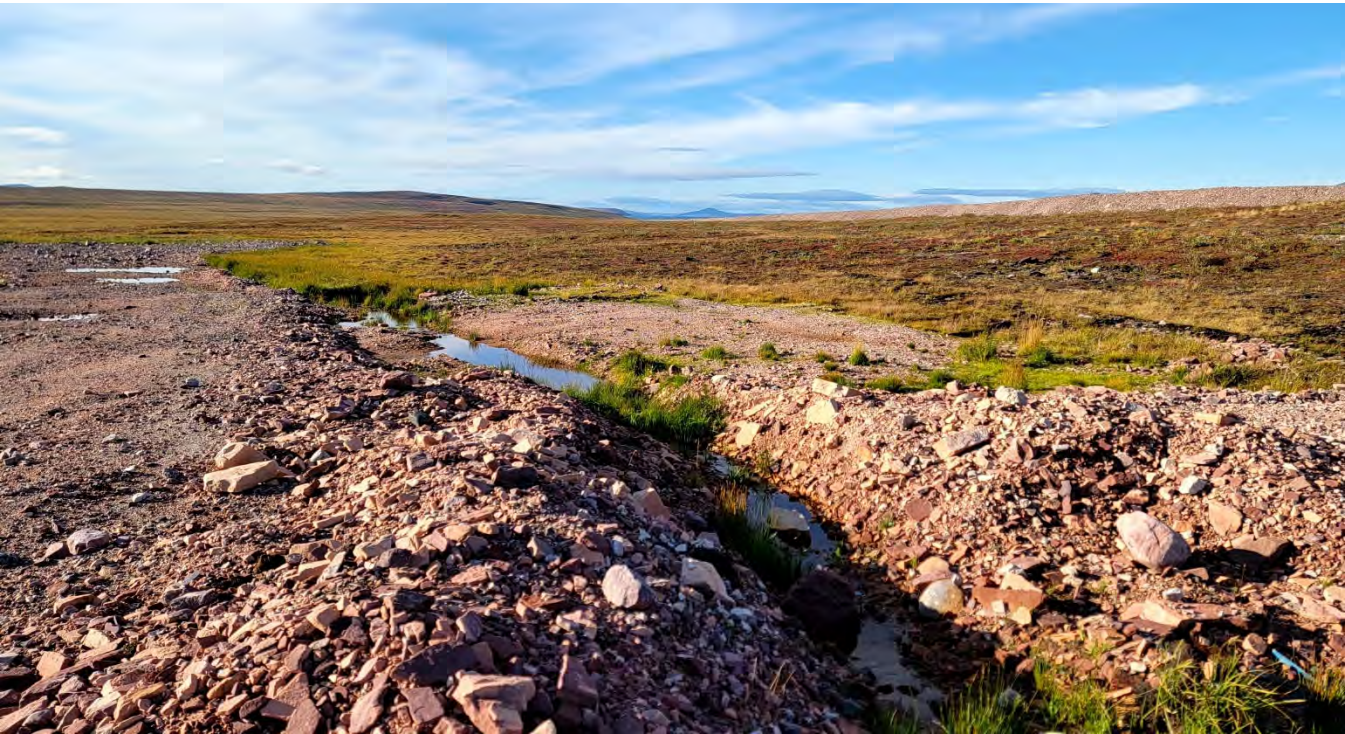
M-45. – A stream and ponding water along the northern side of the Former Temporary Fuel Containment Area

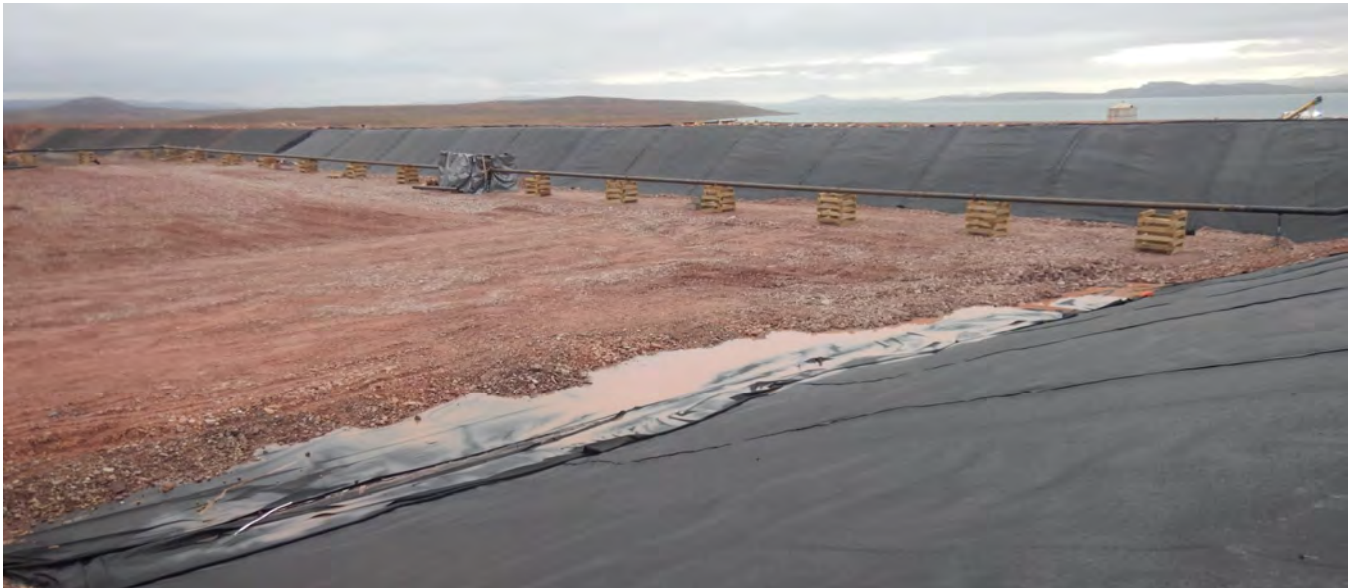
M-59. – Ponding water at the base of the NE corner along the toe of the western berm of the containment area, looking N.

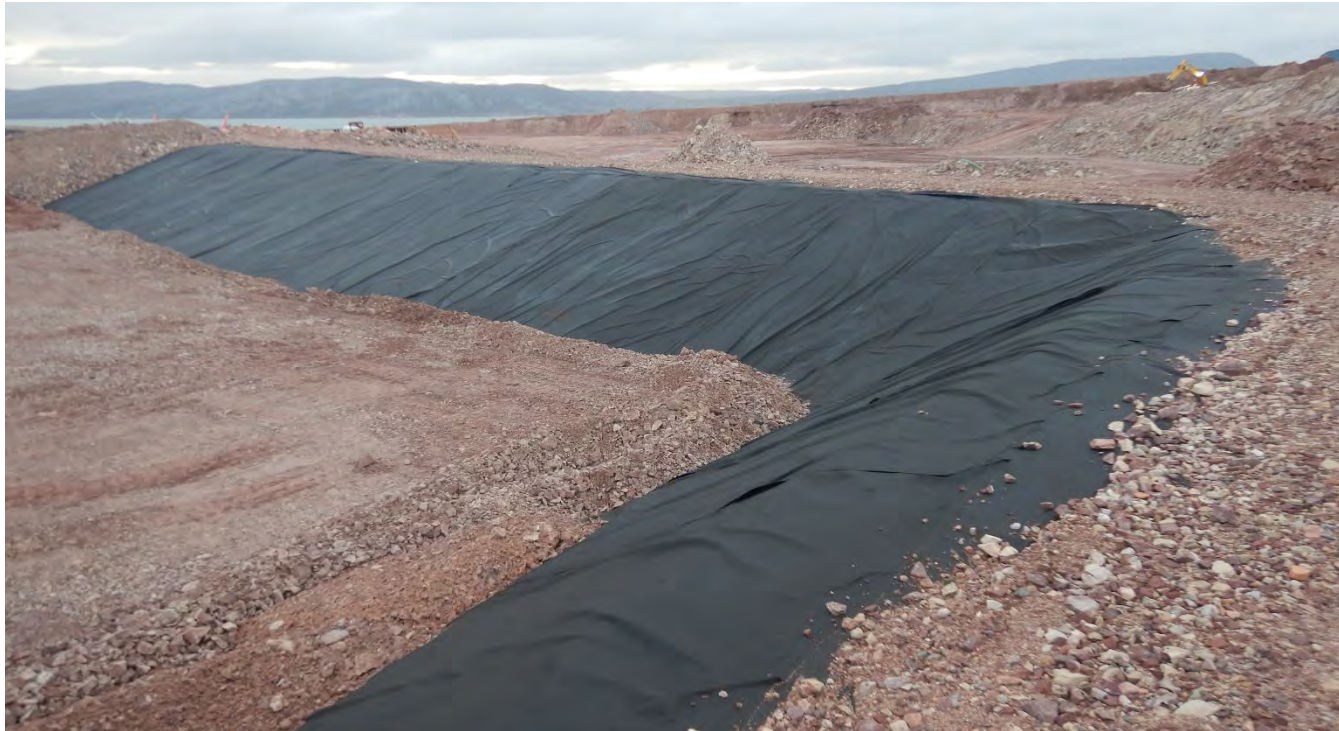
M-60. – SE corner and eastern berm of the containment area. Note that the HDPE liner is not backfilled.

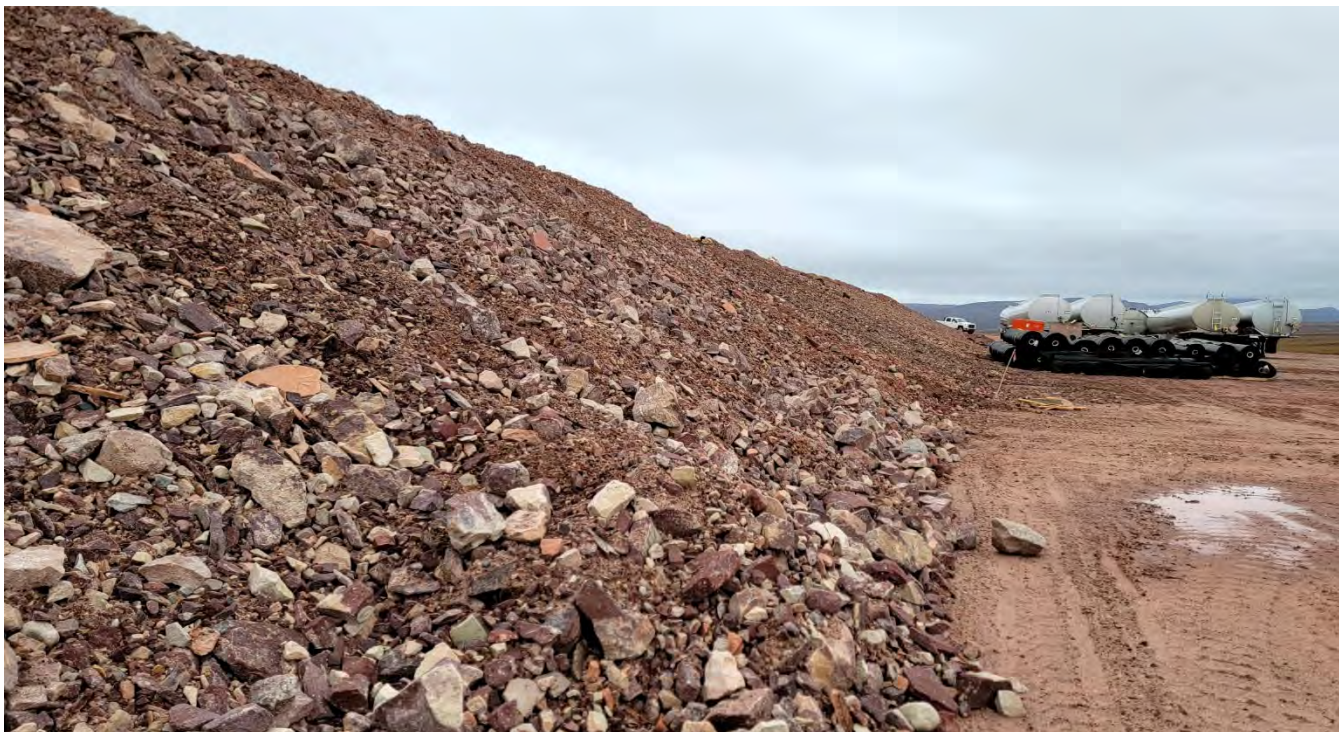
M-62. – Outer slope of the northern berm of the containment area

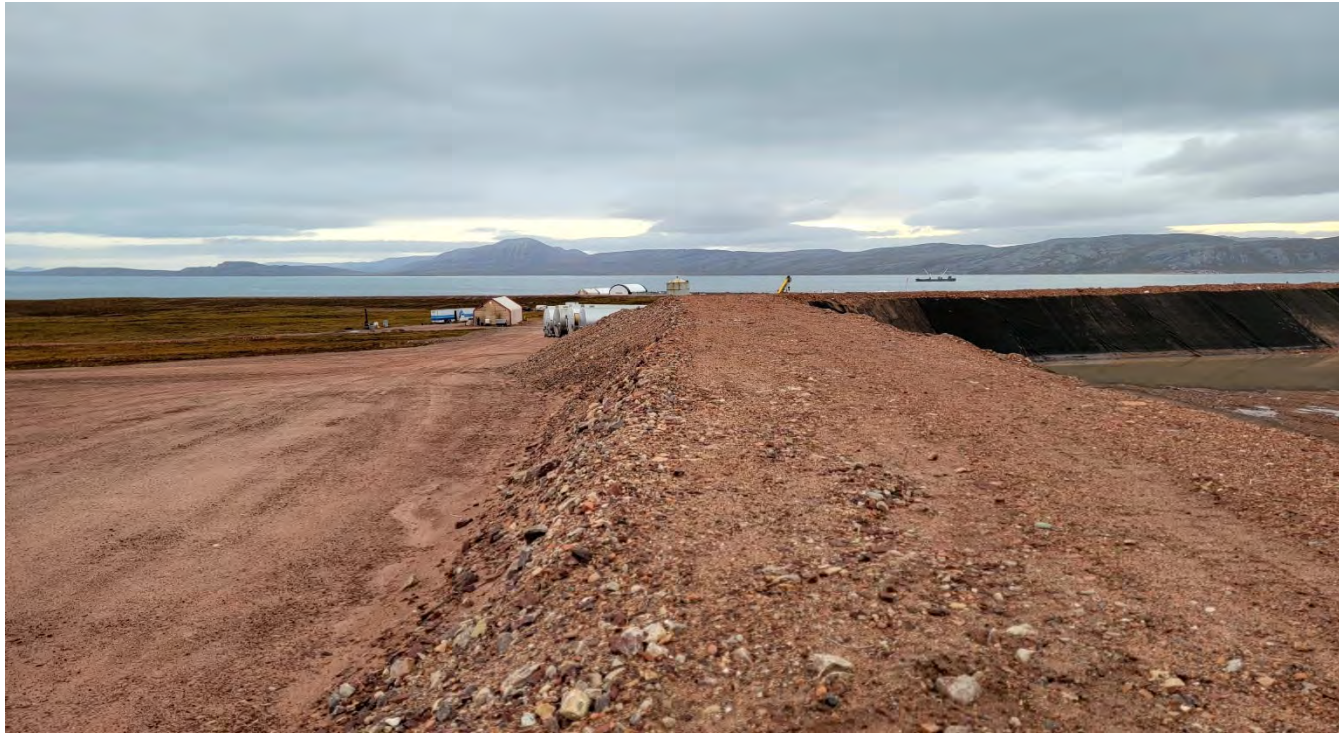
M-64. – Outer slope of the western berm

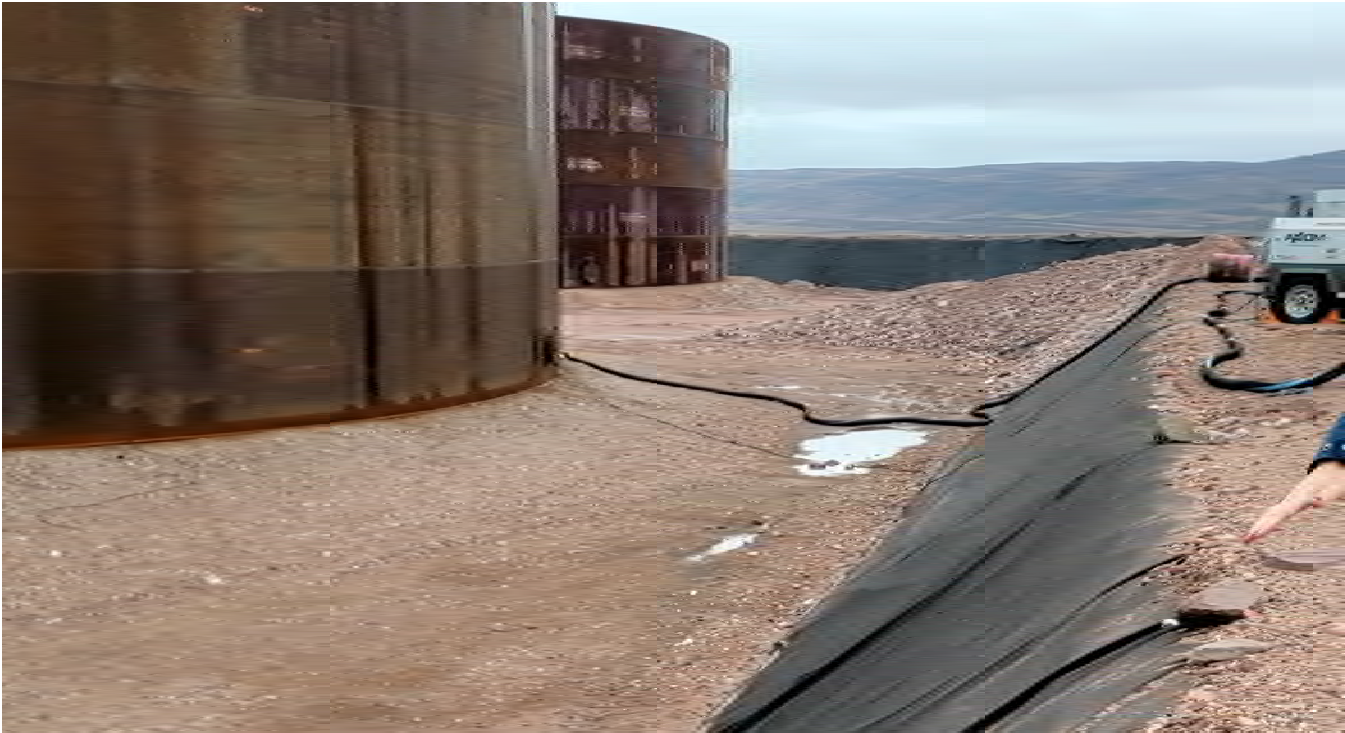
M-69. – Pedestal of Tank #1. Western slope and western berm of the containment area, looking south.

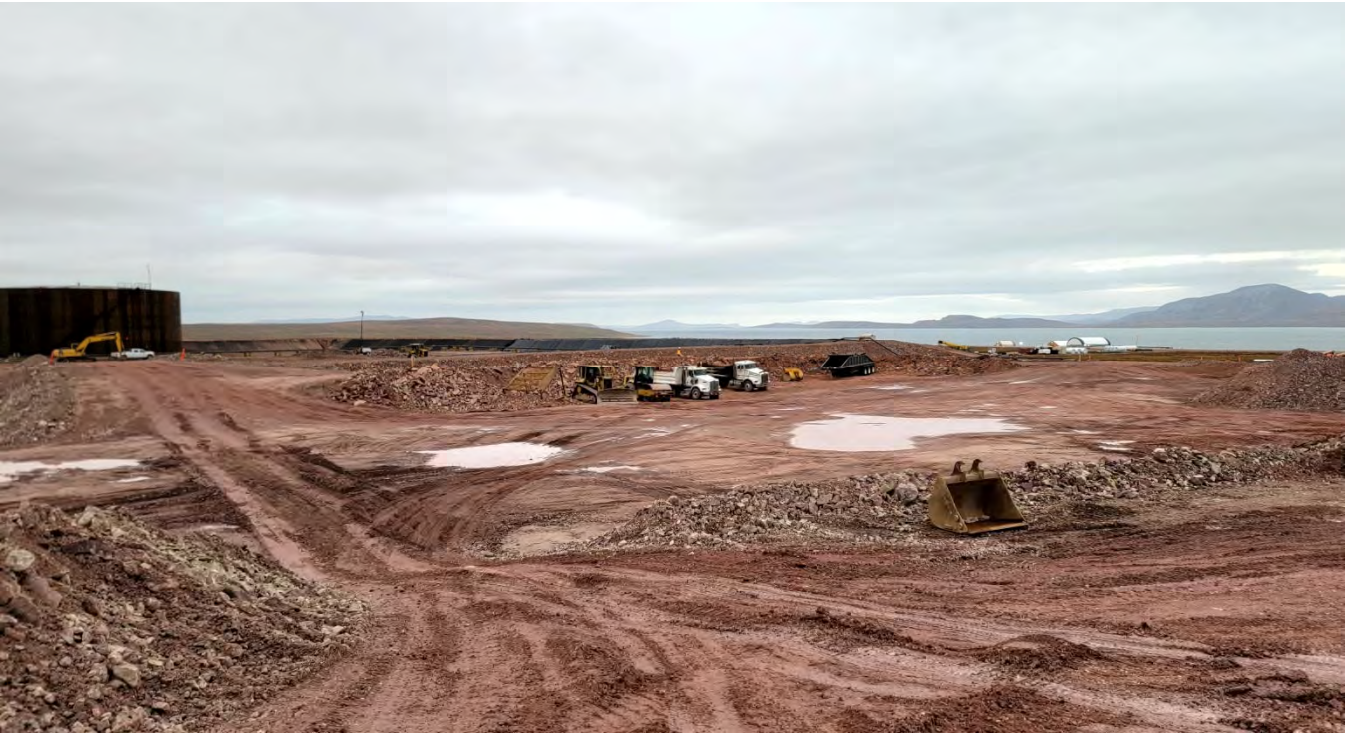
M-81. – Laydown area adjacent to the eastern side of the MLA Tank Farm, looking NW. Note some depressions at the base contain water.

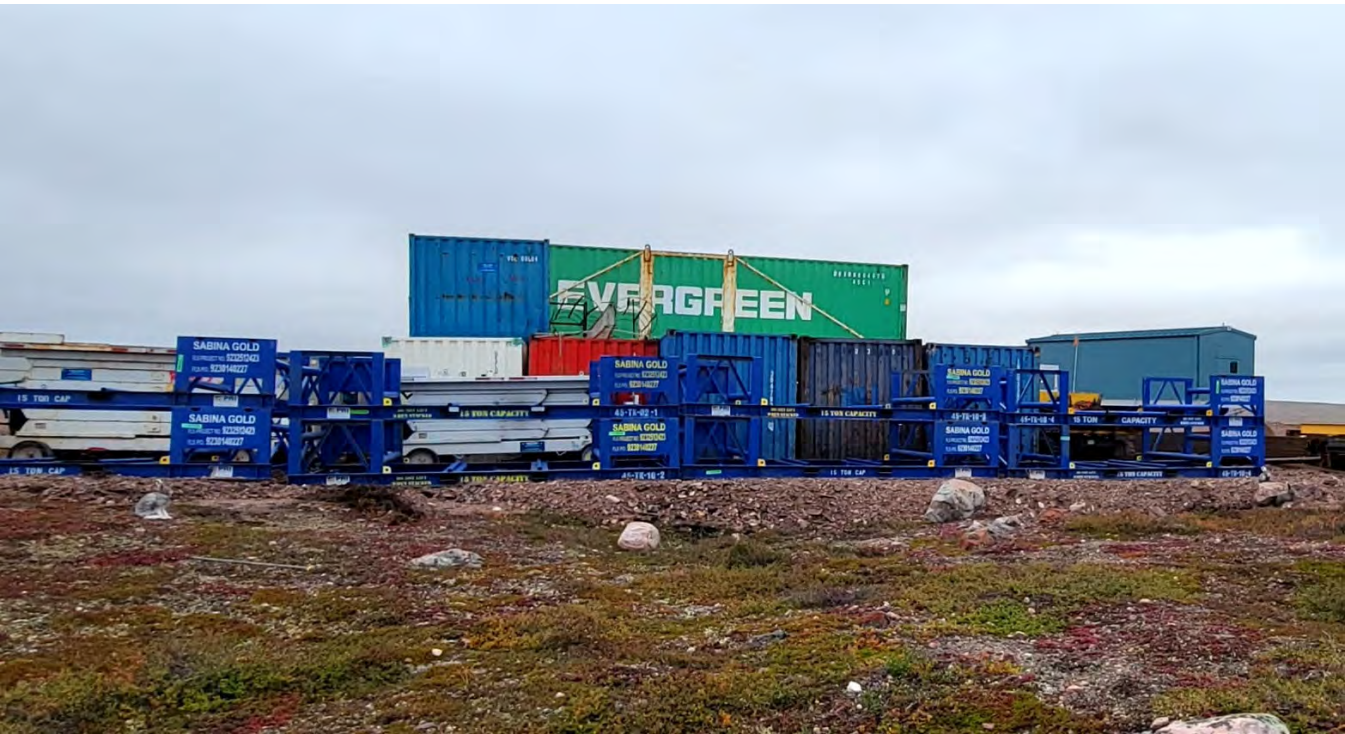
M-83. – Eastern side of the Upper laydown Area, looking NW. Note that the thickness of the pad is less than 1m and materials are stored to close to the crest.

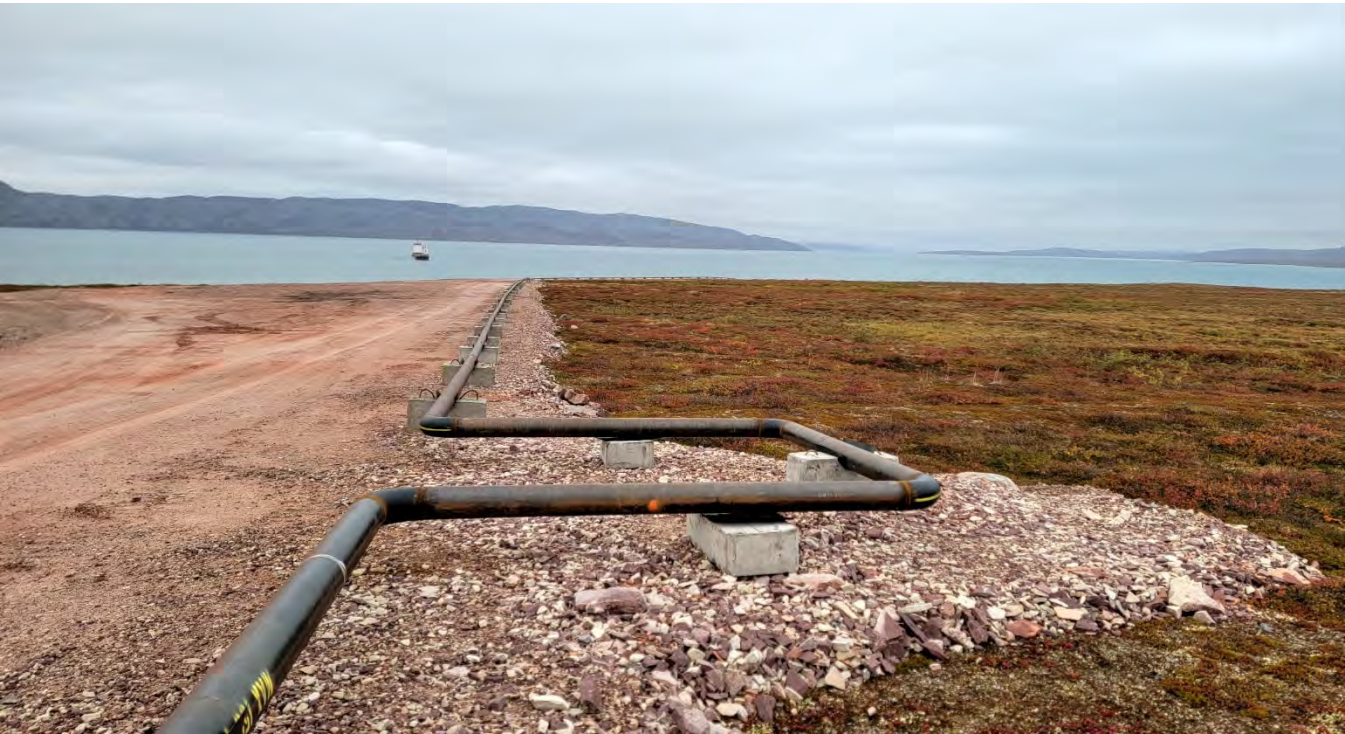
M-87. - Fuel Offload Access road. Note the thickness of the embankment

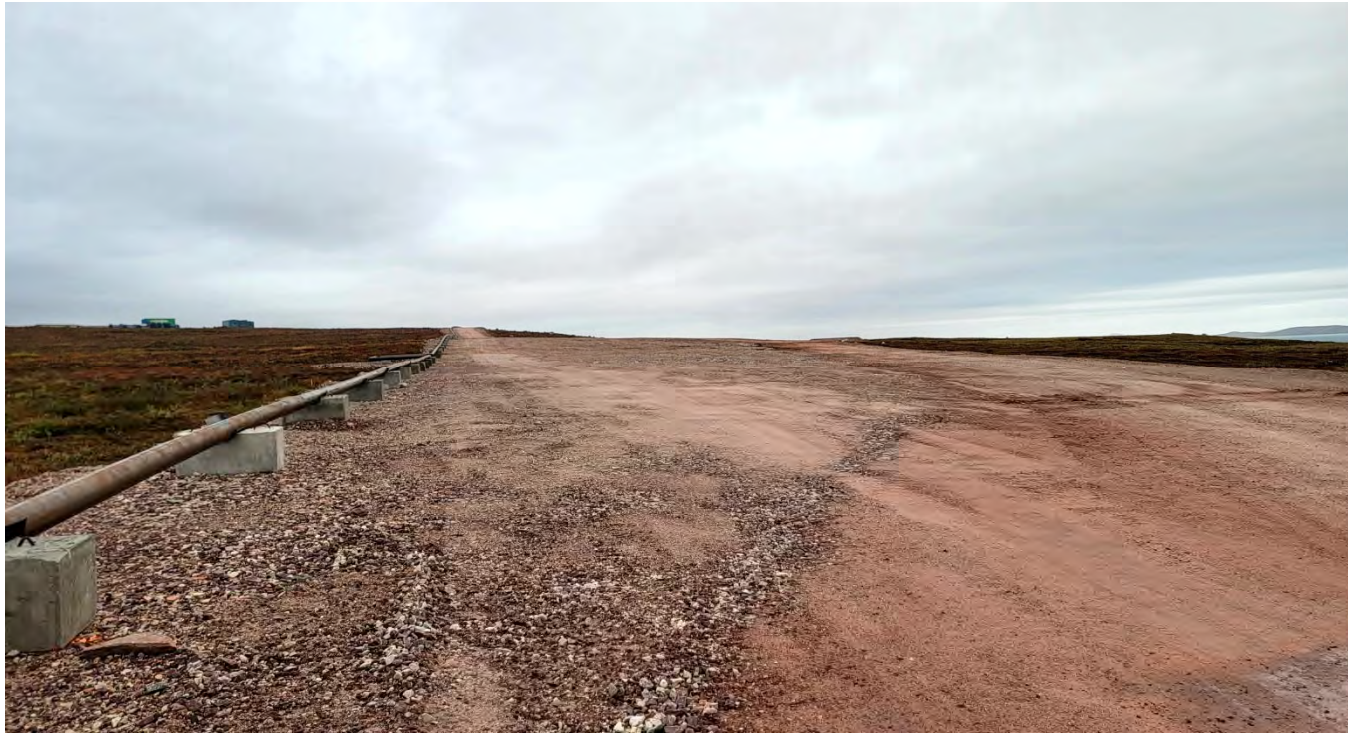
M-88. – Fuel Offload Access road. Note that the edges of the road lack proper compaction of the fill material.

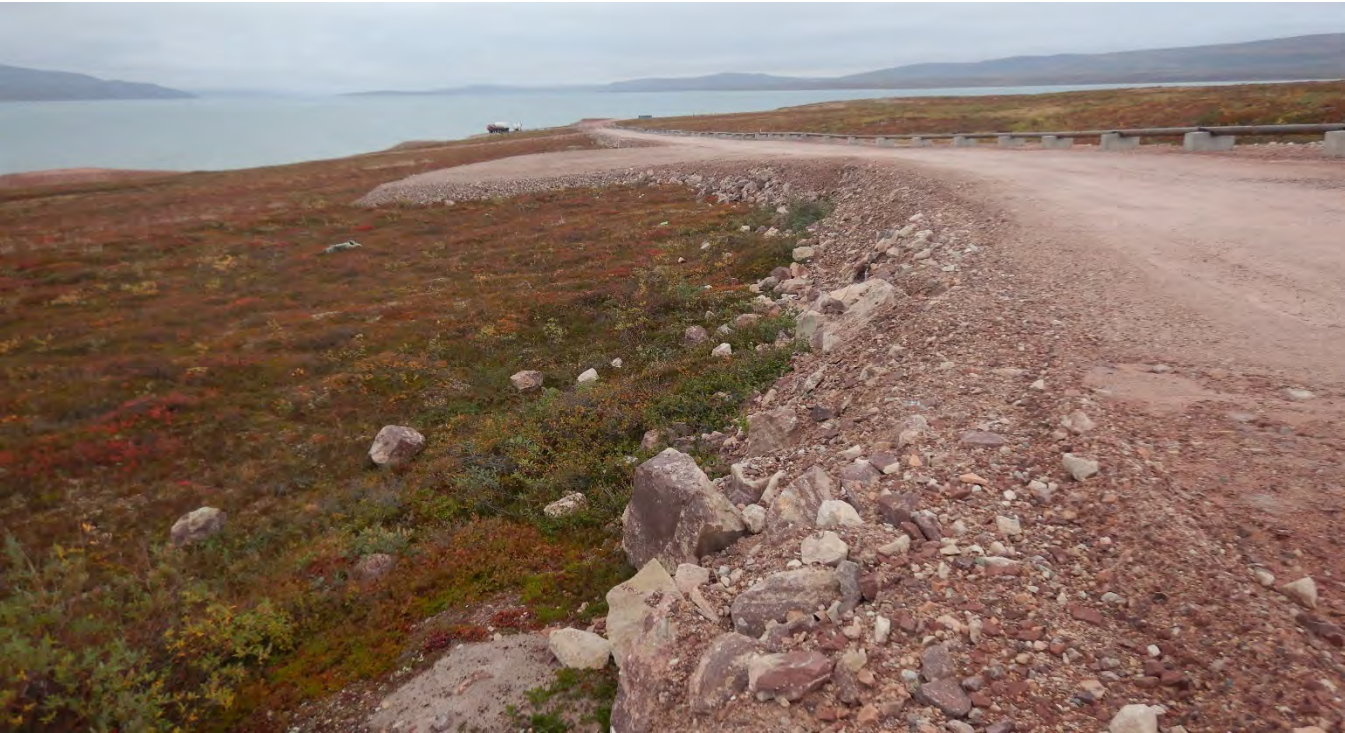
M-89. – Fuel Offload Access road.

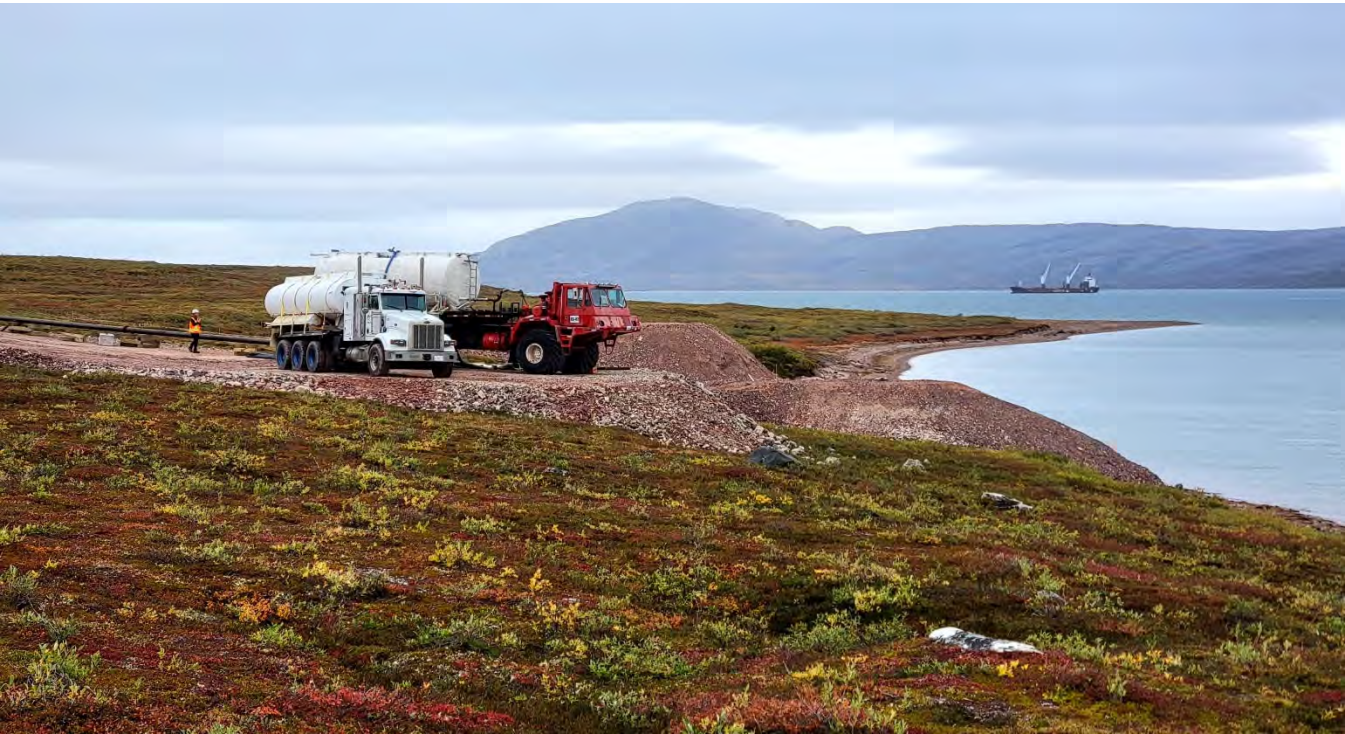
M-91. – Offload pads, looking NE. Note that the thickness of the pad is less than 1m.
