Nunavut Impact Review Board

Site Visit Report

Meadowbank Gold Mine &

Whale Tail Pit Projects

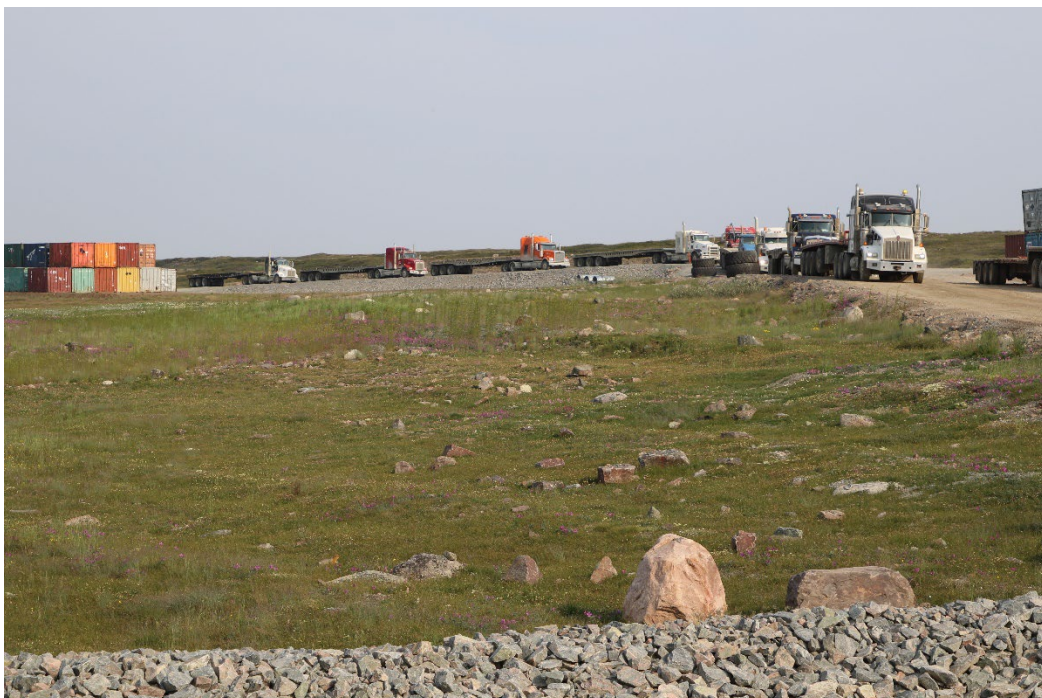
Photo 5: View of the convoy moving cyanide from Baker Lake to Meadowbank Mine Site.

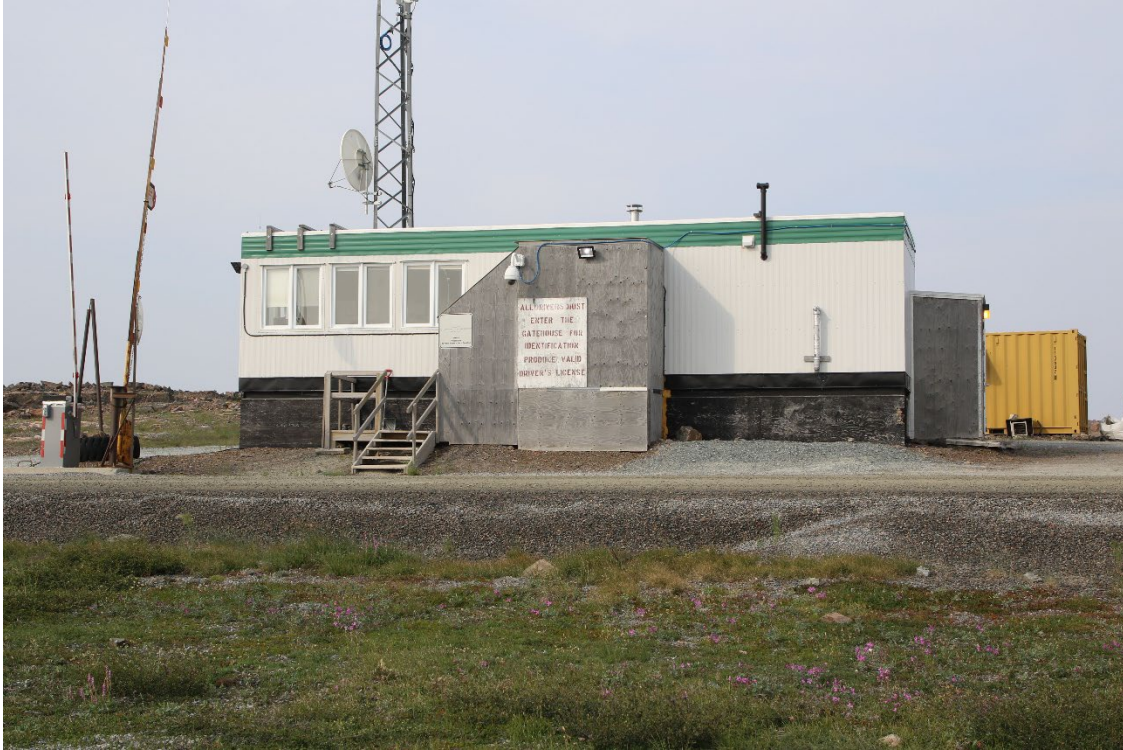
Photo 8: Gatehouse at kilometre 5 of the AWAR. The Gatehouse is staffed 24 hours per day and community members used the road must check in with Gatehouse staff.

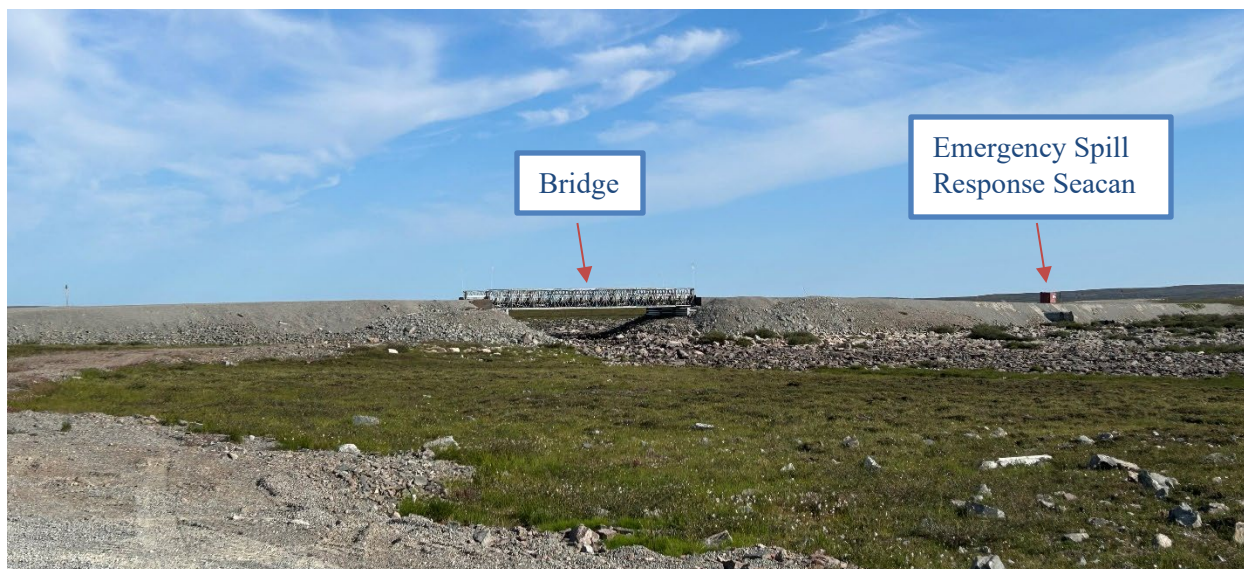
Photo 10: A bridge on the AWAR with associated Emergency Spill Response Seacan (2023). These seacans were observed at each bridge in 2024.

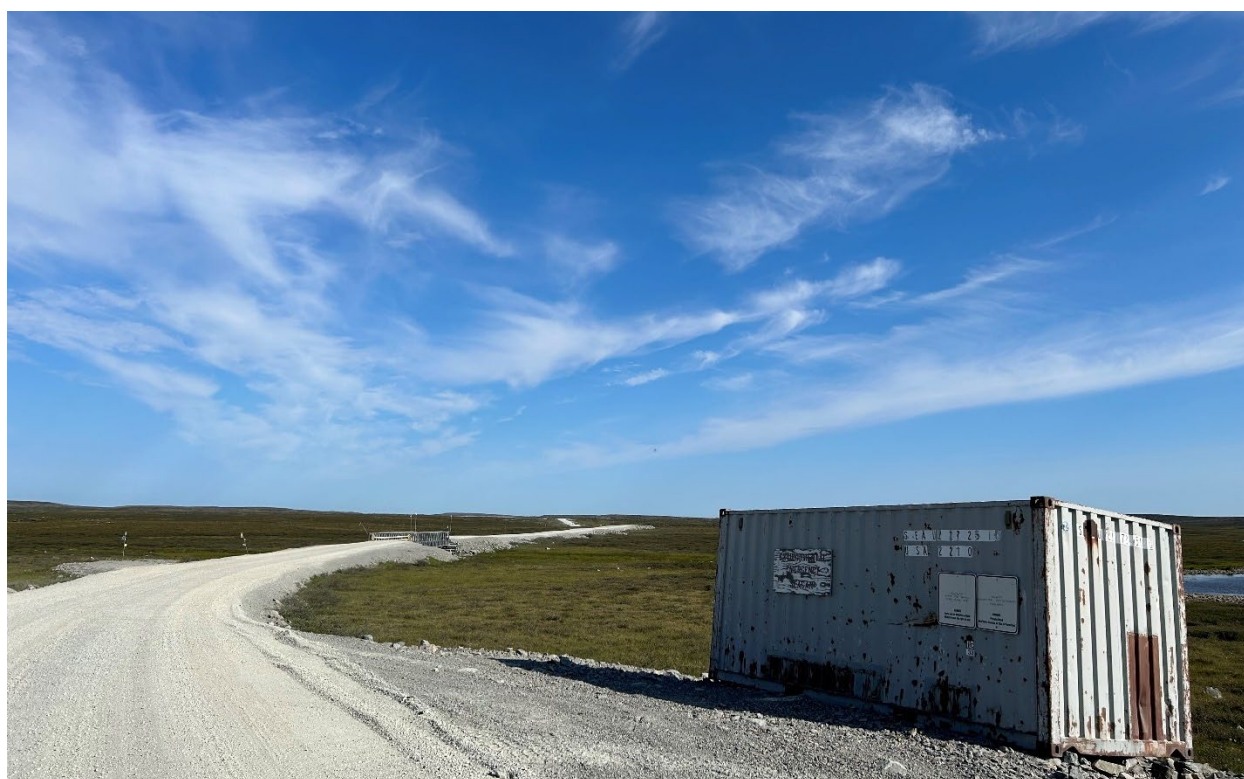
Photo 11: Emergency Spill Response Seacan on the AWAR (2023).

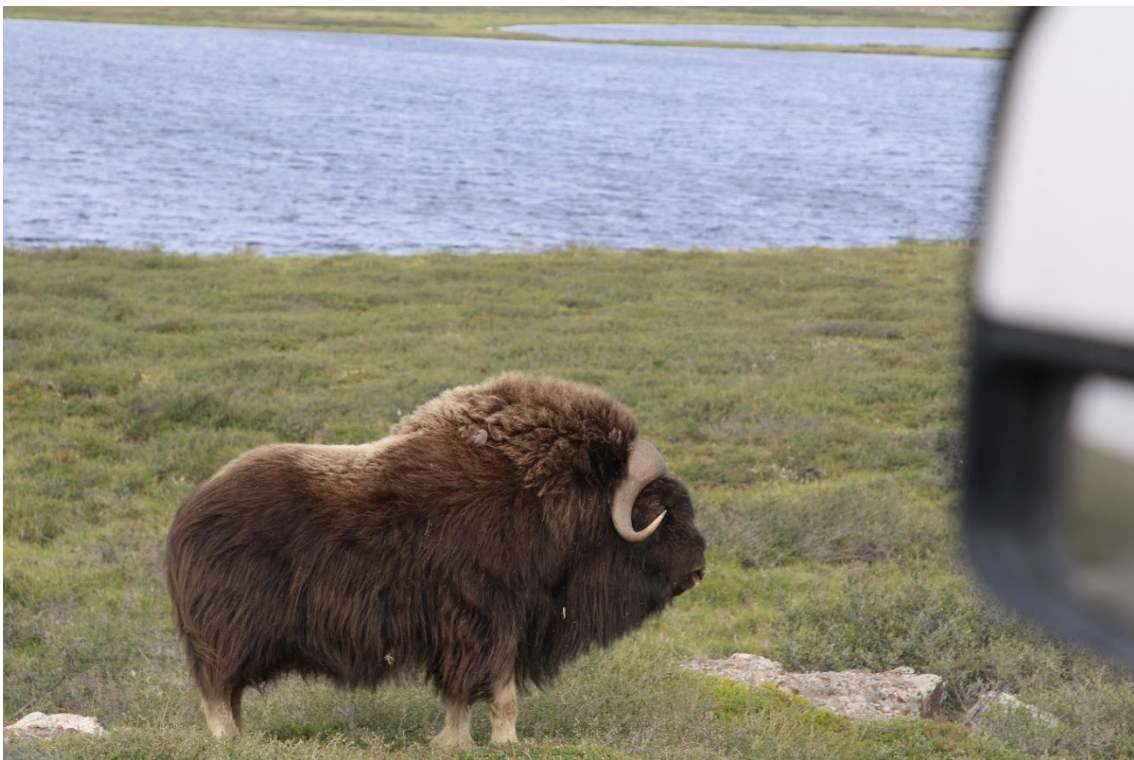
Photo 13: Wildlife have the right of way on all Project roads. Agnico Eagle staff followed procedures to park their vehicles and report when wildlife was encountered.

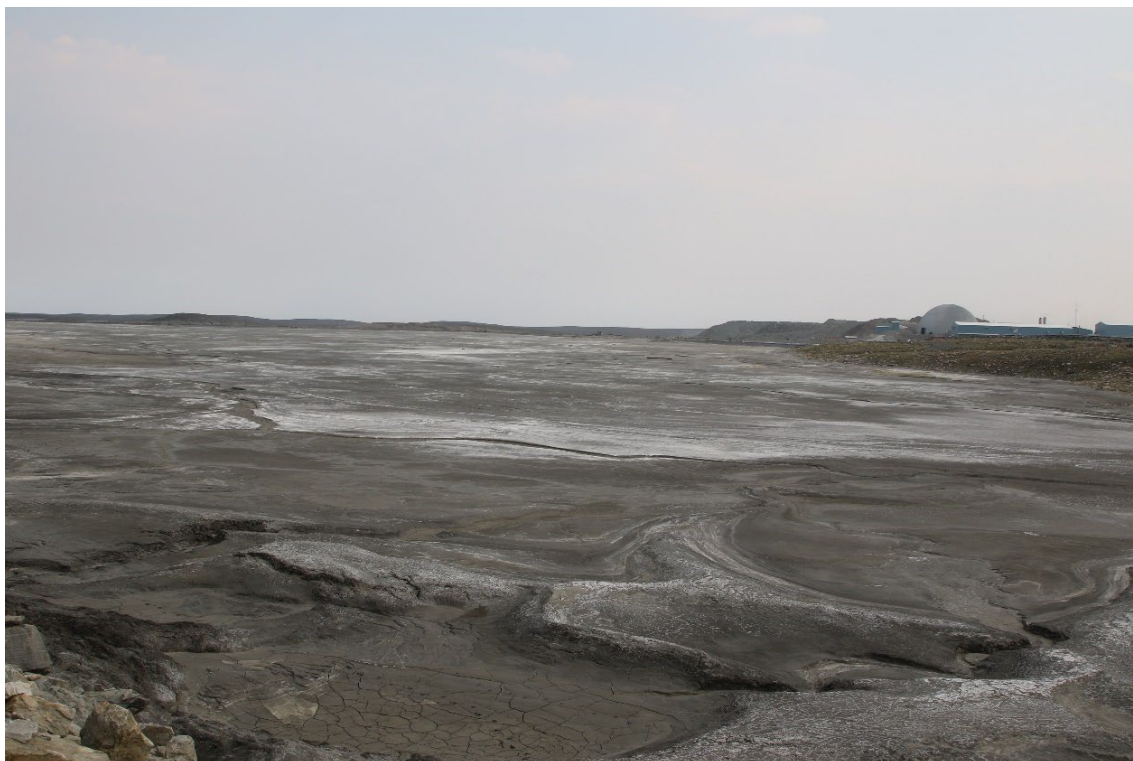
Photo 20: Tailings Storage Facility North Cell, view east.

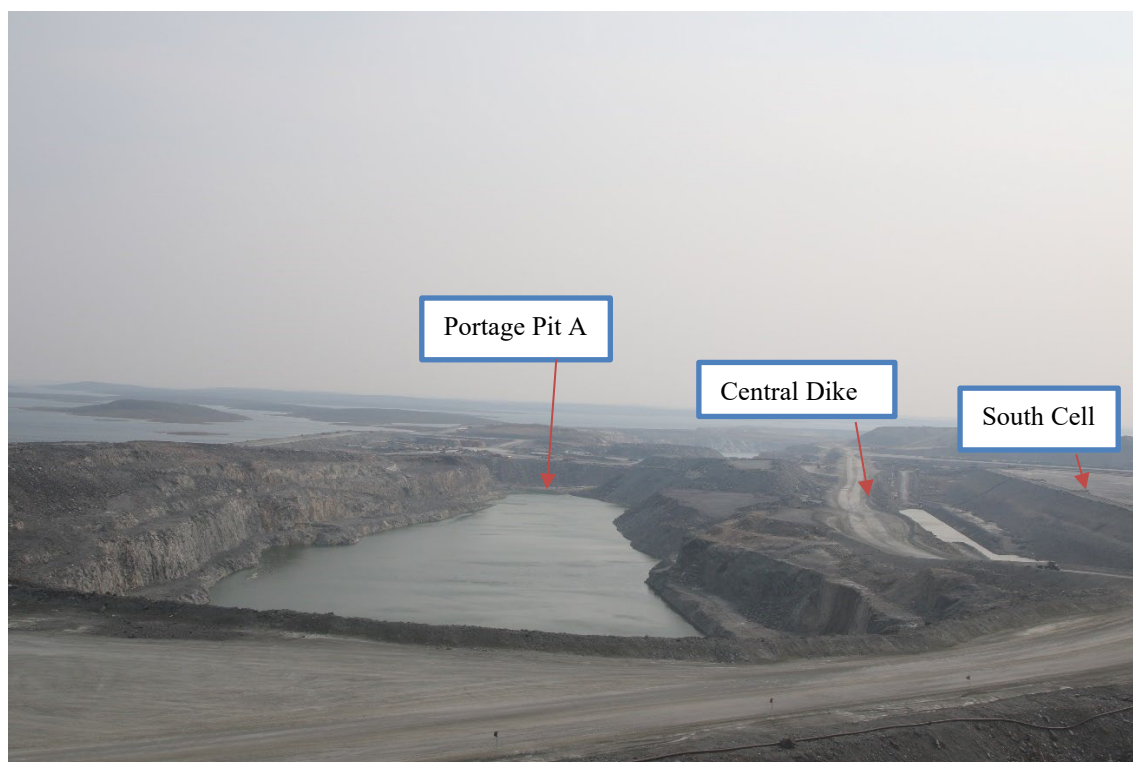
Photo 21: Portage Pit A and Central Dike.

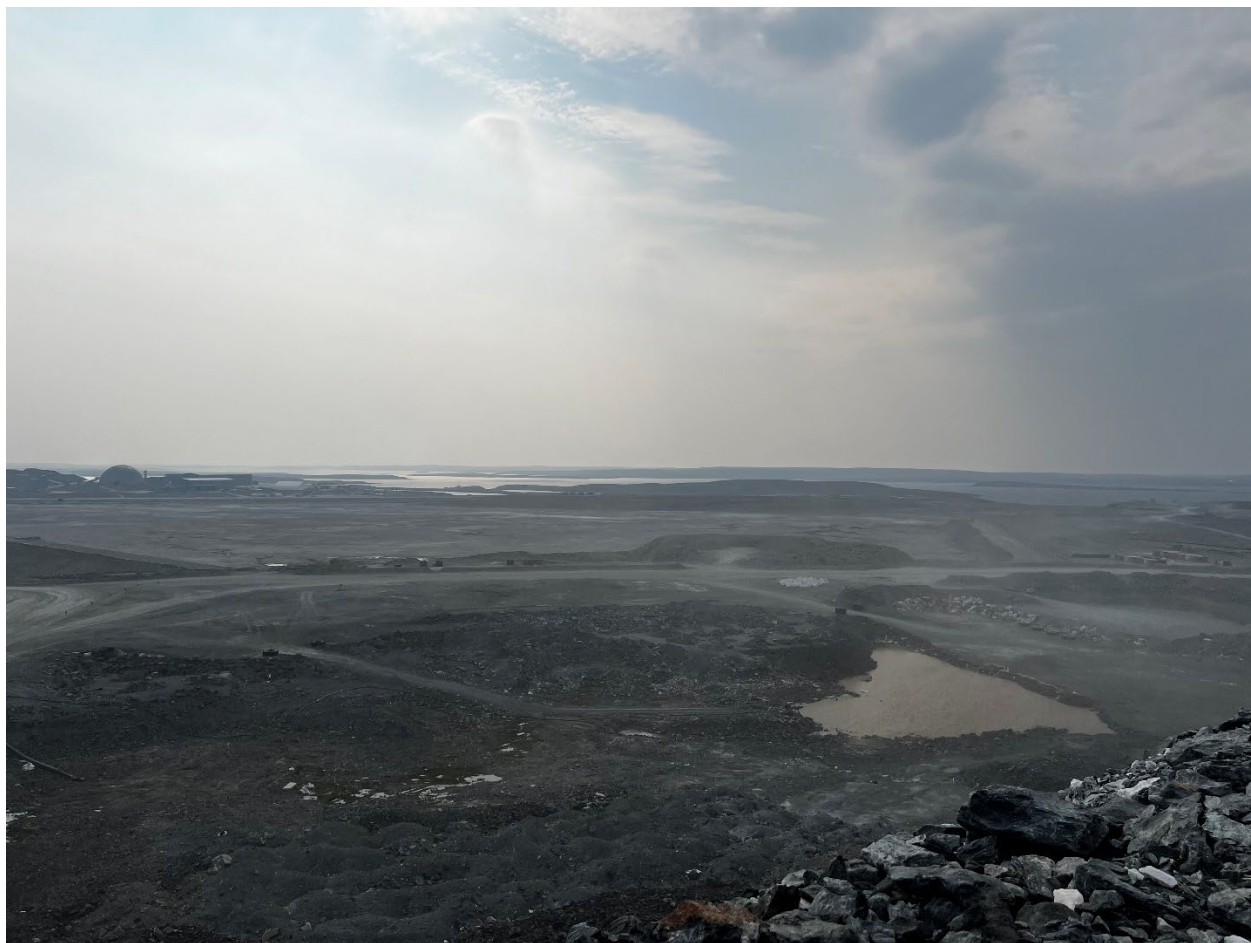
Photo 22: Tailings Storage Facility South Cell.

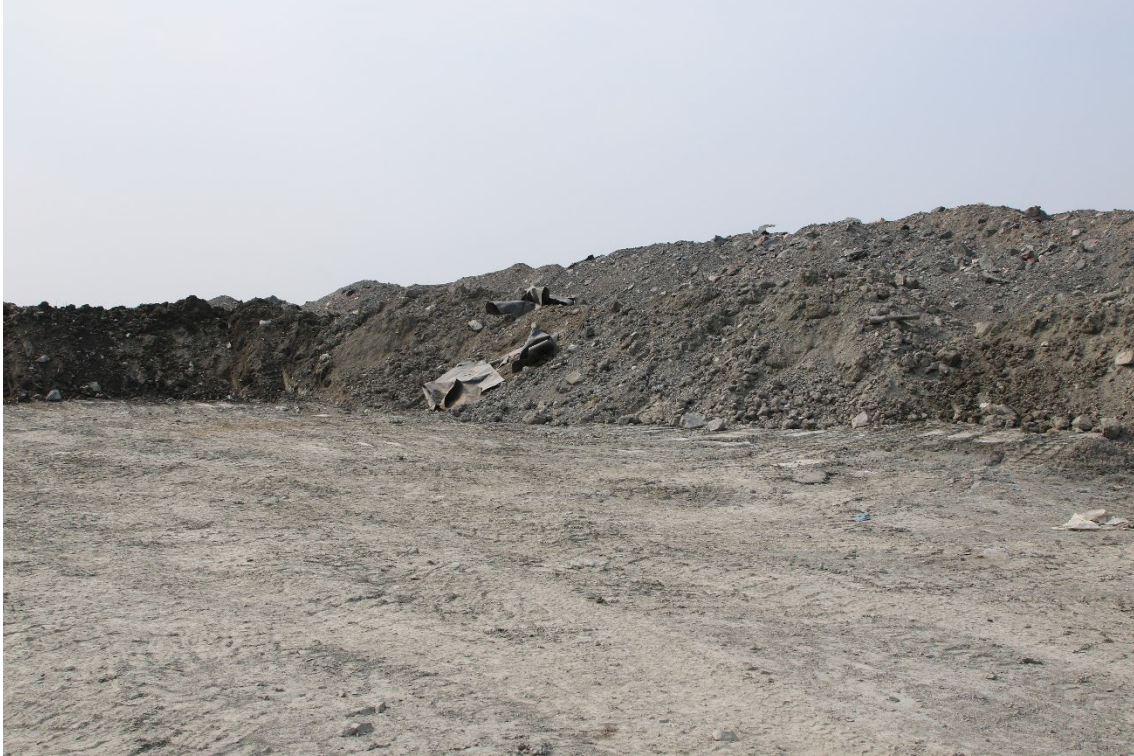
Photo 24: Meadowbank Landfarm.

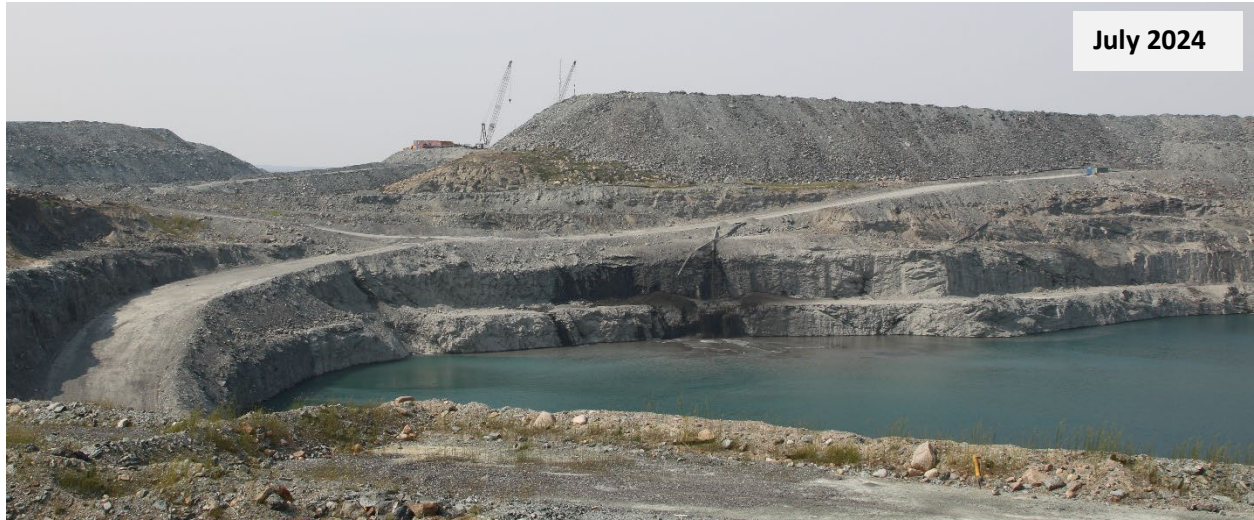
July 2024

Photo 26: Portage Pit E in 2024. This pit is the primary storage area for tailings in 2024.

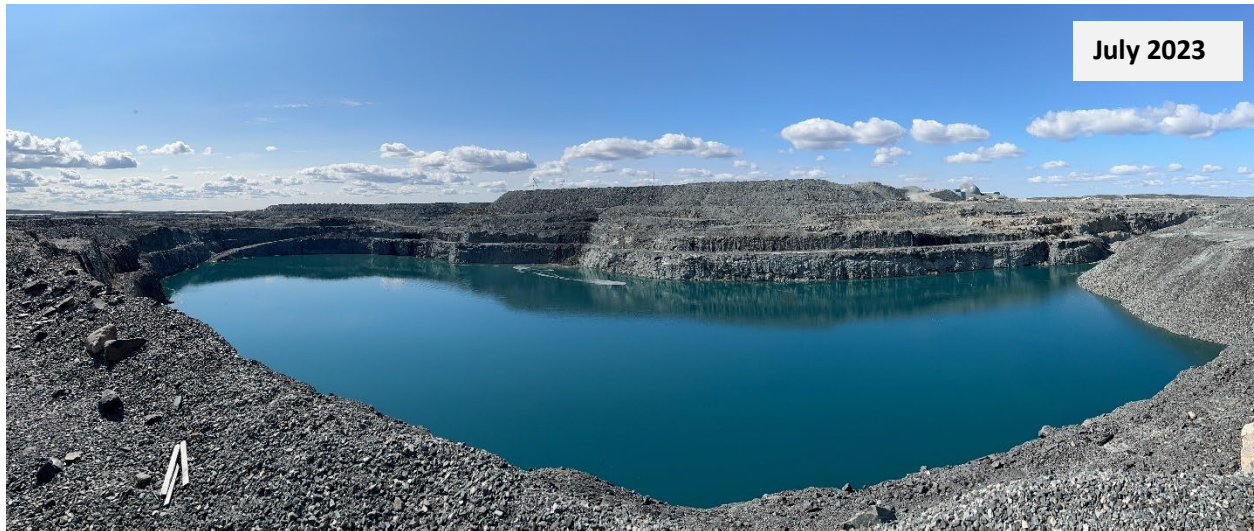
July 2023

Photo 27: Portage Pit E in 2023. This pit is the primary storage area for tailings in 2023.

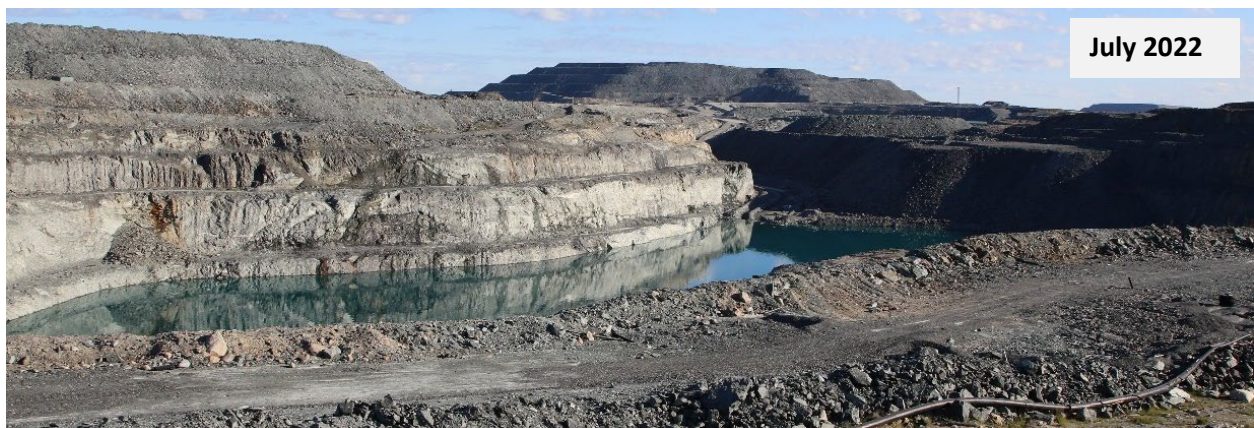
July 2022

Photo 28: Comparison photo of Portage Pit E from the 2022 Site Visit.

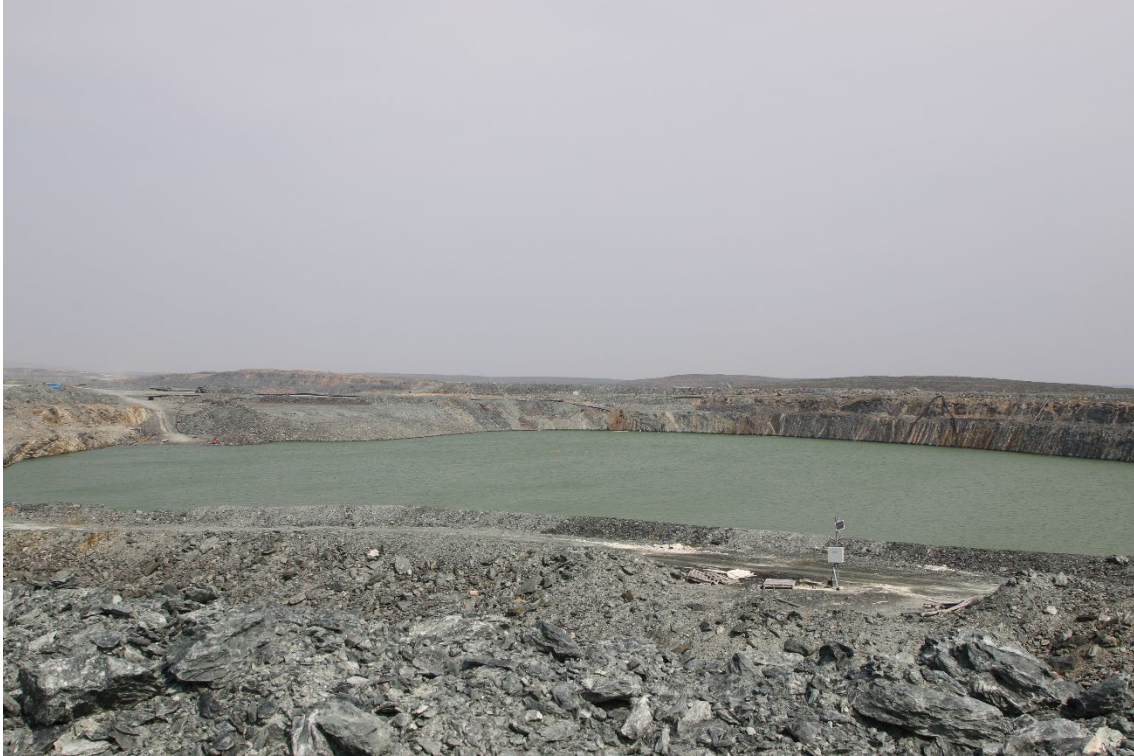
Photo 29: Goose Pit. This pit previously received tailings deposition and is now capped with 35-40 metres of water.

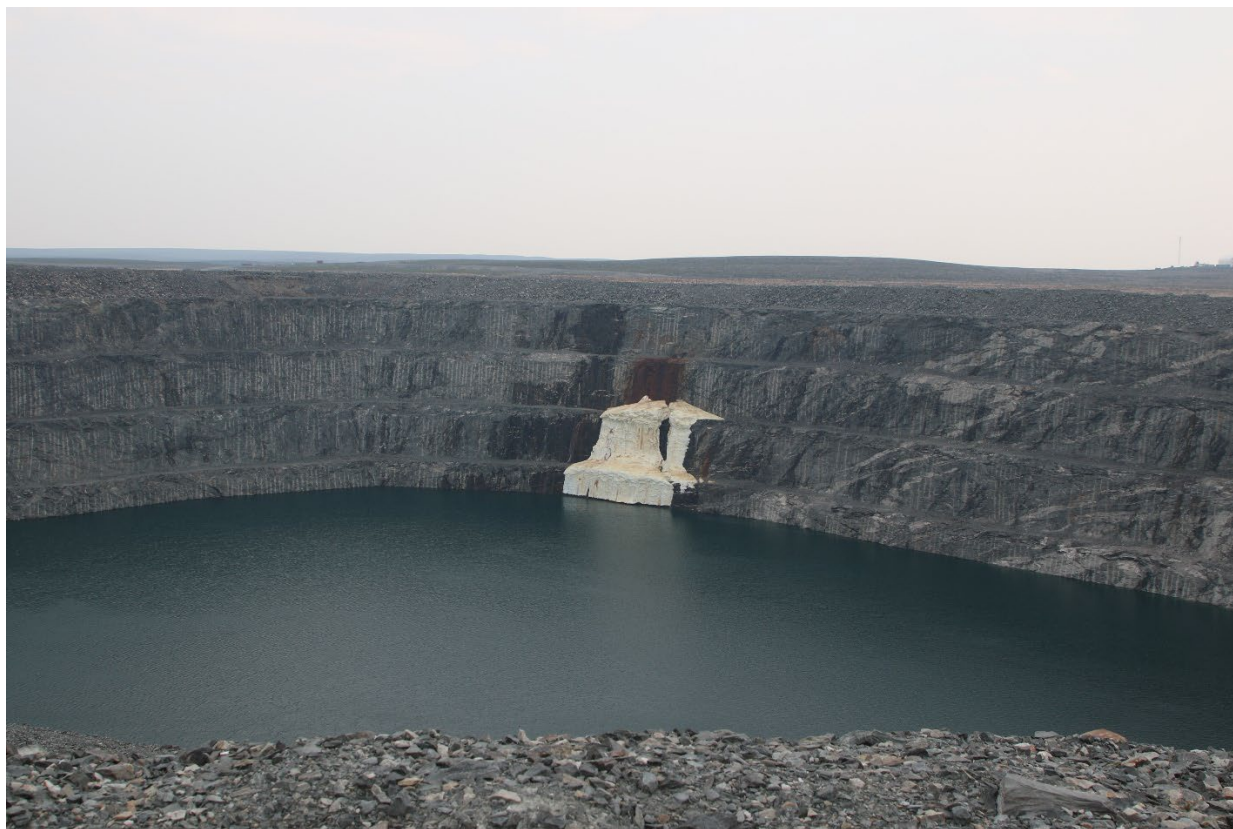
Photo 31: Vault Pit 2024.

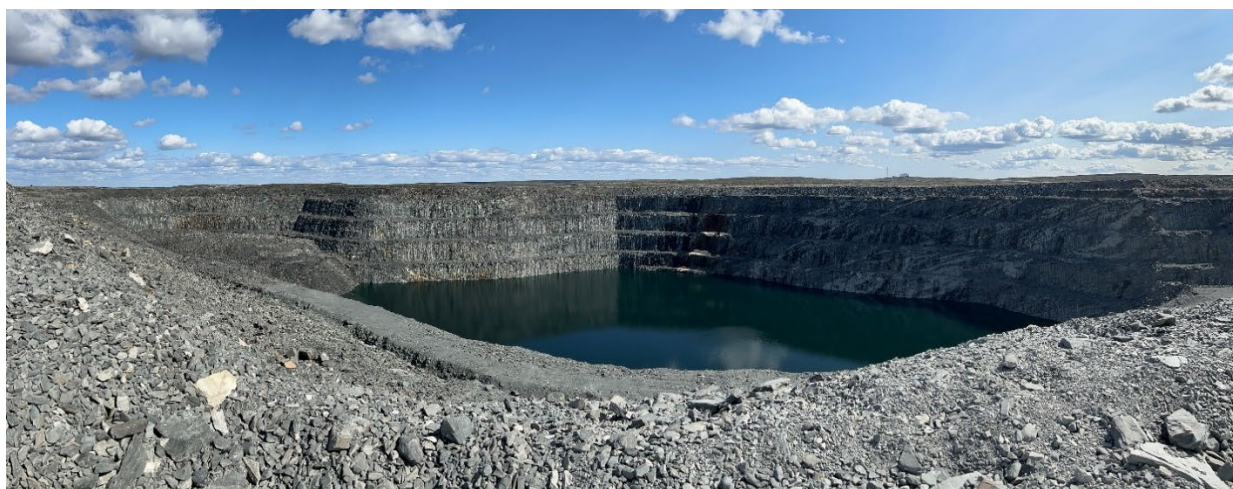
Photo 32: Vault Pit 2023 – refilling naturally with water since 2019.

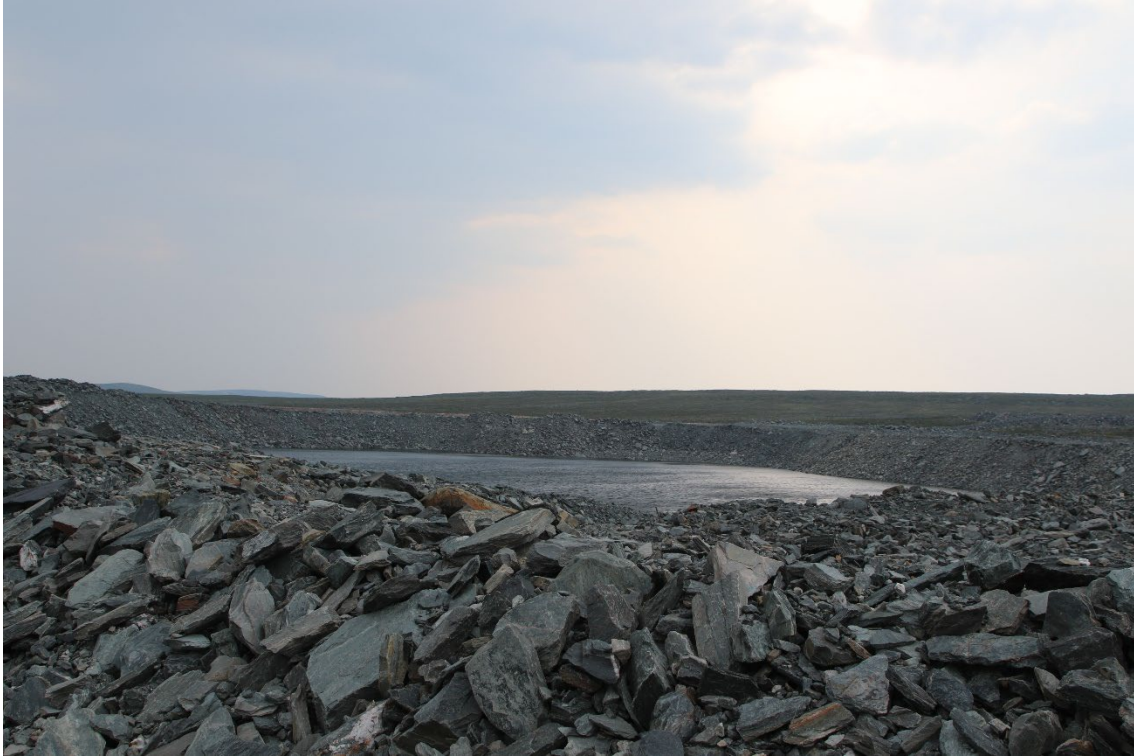
Photo 33: BB Phaser Pit. Caribou tracks were found on the ramp to the pit.

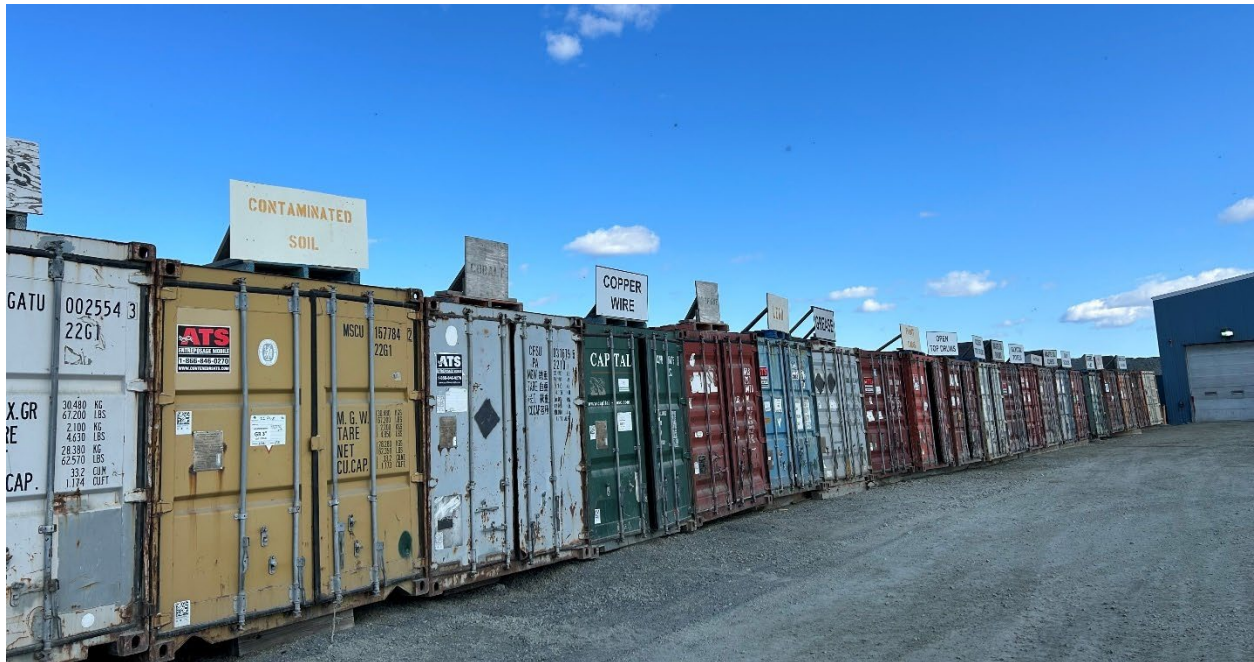
Photo 35: Hazardous materials storage seacans at the Meadowbank Site (2023).

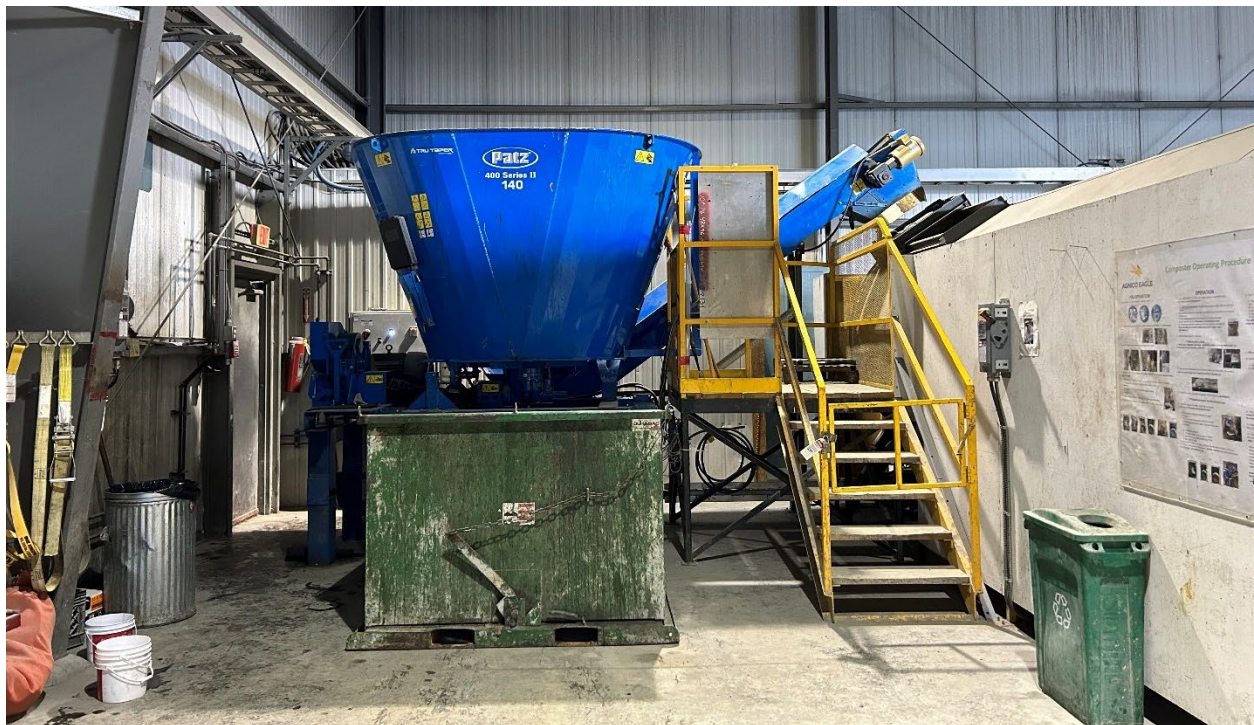
Photo 36: Composter at the Meadowbank Site (2023).

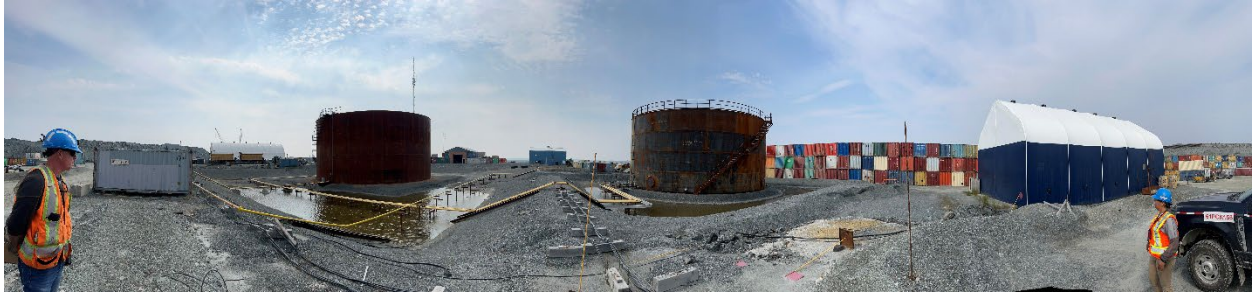
Photo 37: New fuel tank constructed in 2023. The purpose of this tank is to increase onsite fuel storage capacity to reduce reliance on trucking fuel from Baker Lake during caribou migration road closures.

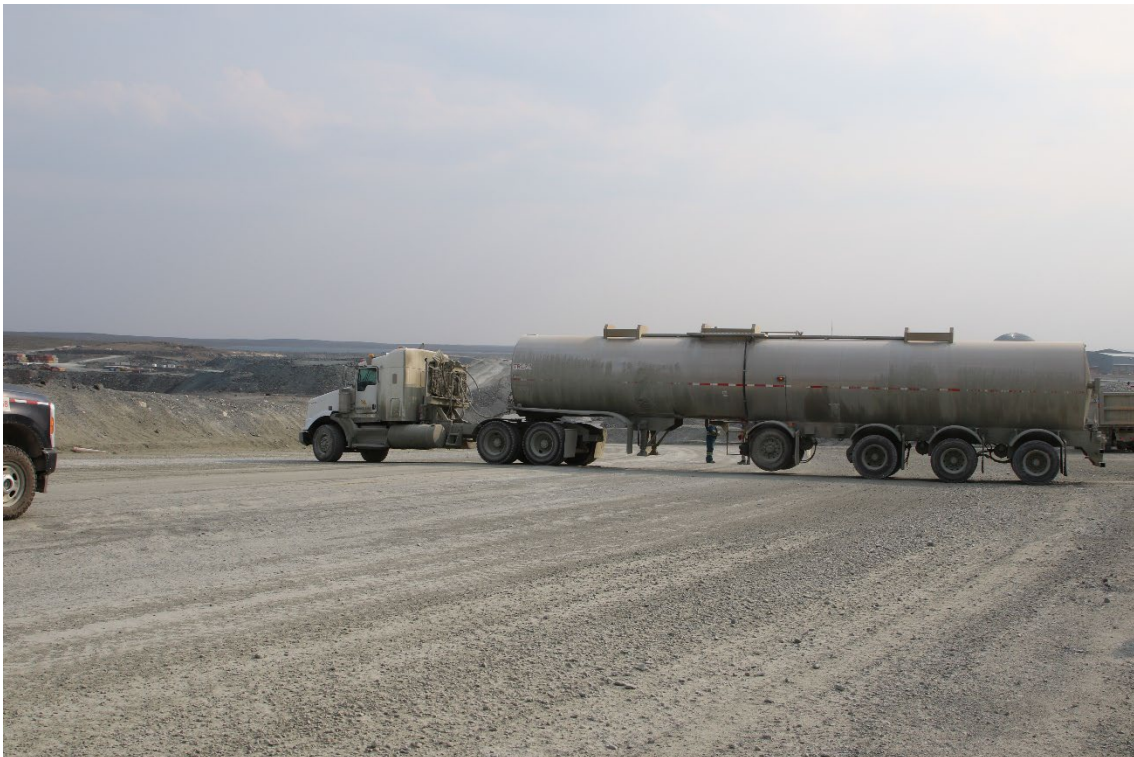
Photo 38: Cyanide Blockade, no one is allowed to move around Meadowbank when cyanide is brought to site as per regulations.

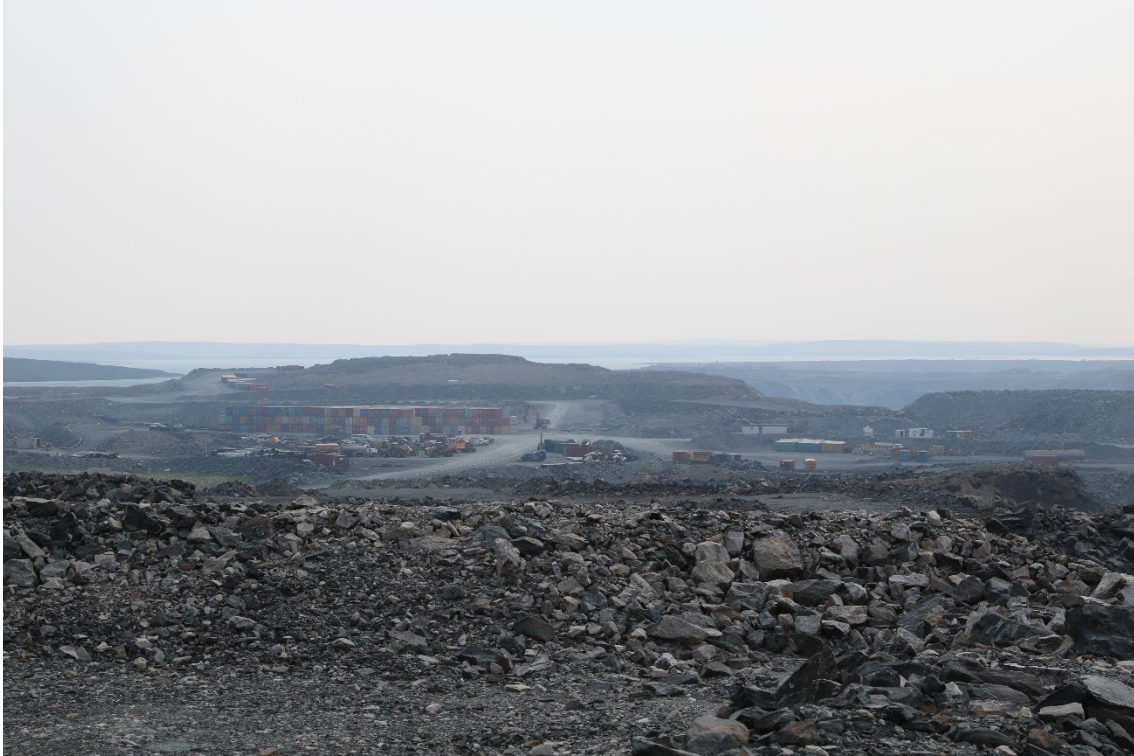
Photo 39: Progressive reclamation area, located at the south end of Pit A.

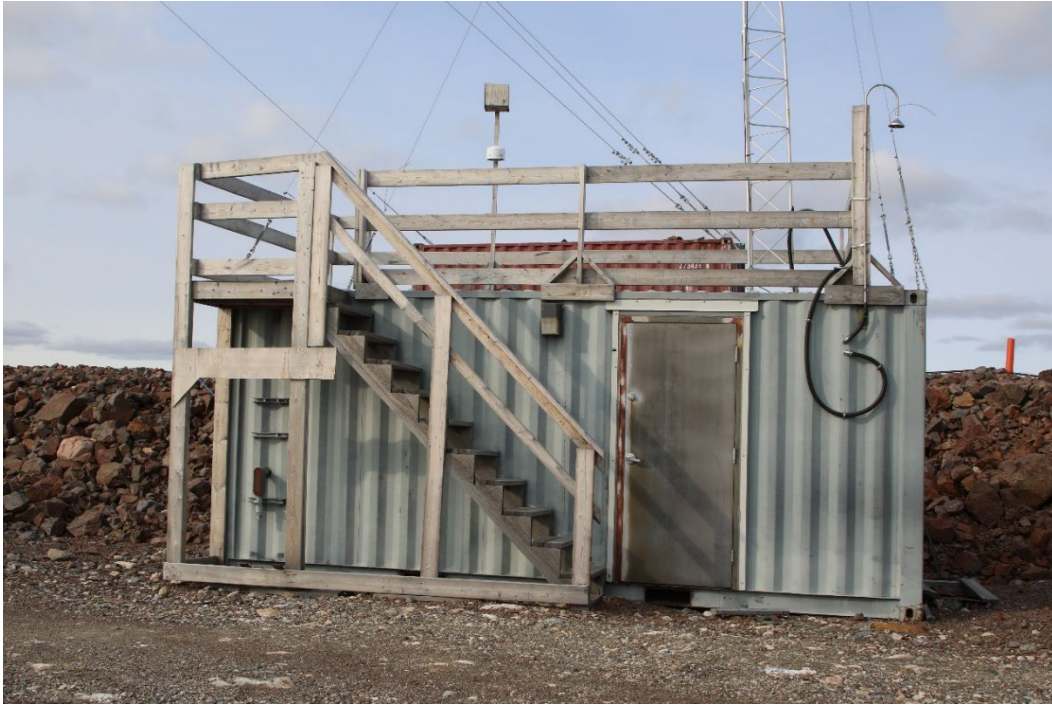
Photo 41: Seacan housing the active NO₂ monitoring equipment with a Passive NO₂ monitor on the roof.

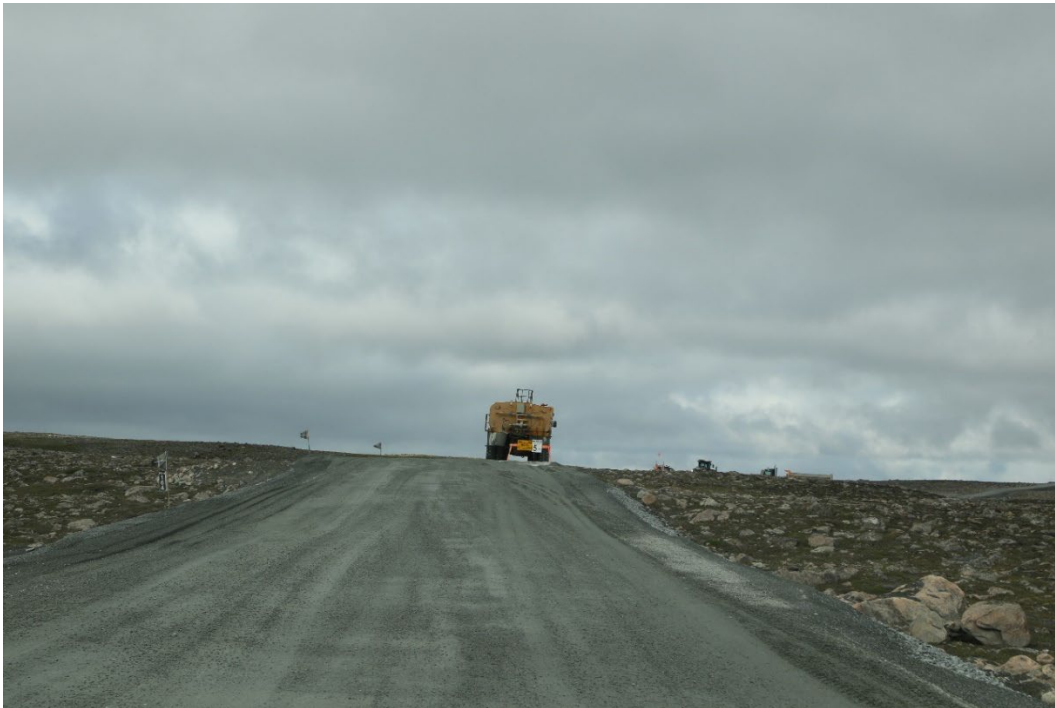
Photo 42: The entirety of the WTHR receives chemical dust suppression treatment.

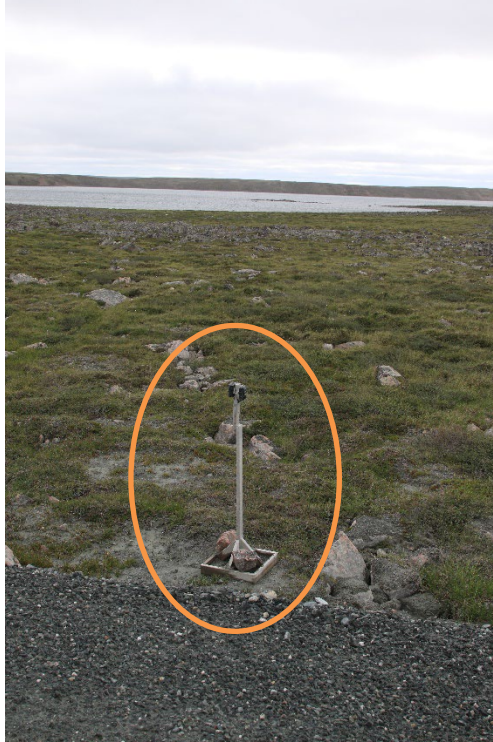
Photo 43: Wildlife cameras in place at several locations along the WTHR.

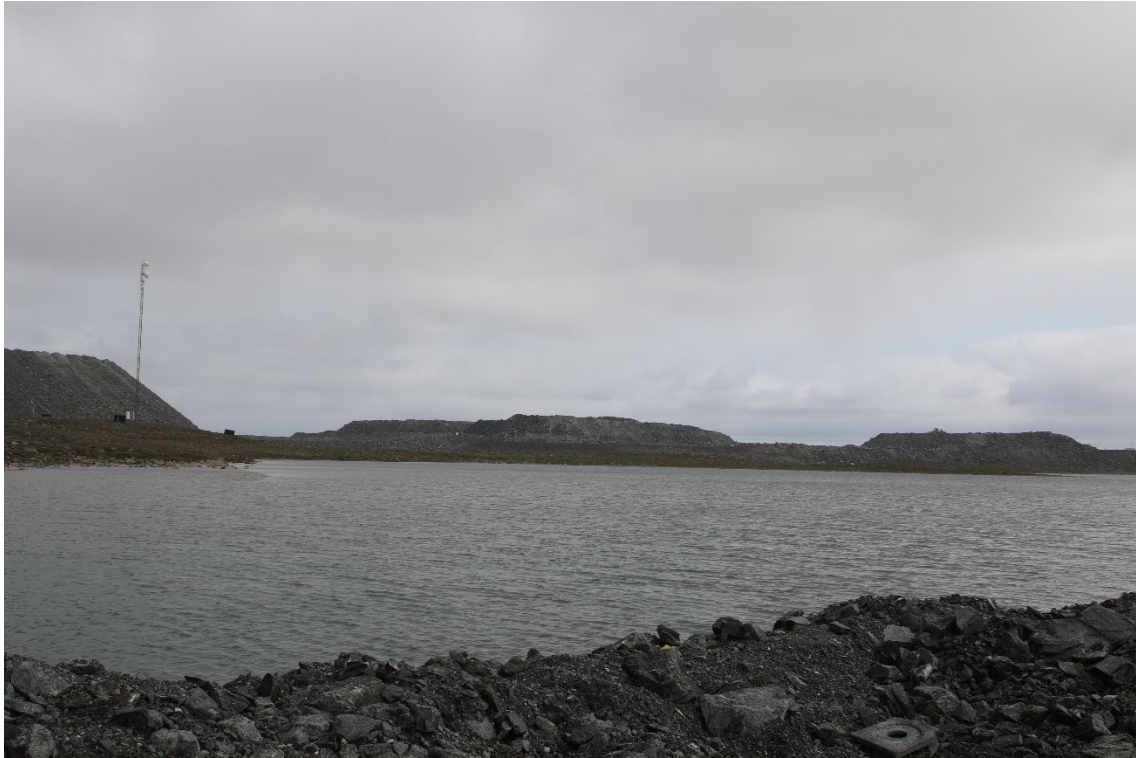
T&C No.*	Topic	Site Observation
Noise and Vibration		
5	Noise Monitoring Stations	Noise monitoring stations were operational and in use at the time of the NIRB site visits.
Geological Features, Soils and Permafrost		
11	Erosion Management	NIRB and Agnico Eagle discussed the erosion control at site and installed erosion controls were in working order.
Hydrogeology and Groundwater Quantity and Quality		
15	Groundwater Monitoring Plan	At the time of the site visit, Agnico Eagle staff stated that the monitoring wells were installed and regularly checked.
16	Mine Contact Water Quality	Whale Tail Attenuation Pond (Photo 46) and IVR Attenuation Pond collect contact water for the site. Contact water is transported to above-listed Treatment Facilities for discharge into Kangislulik (Mammoth) or Whale Tail Lakes.
18	Site Water Monitoring	The NIRB observed the Whale Tail Attenuation Pond (Photo 47), IVR Attenuation Pond, and the Water Treatment Facilities at the Whale Tail site.

Photo 47: Whale Tail attenuation pond.

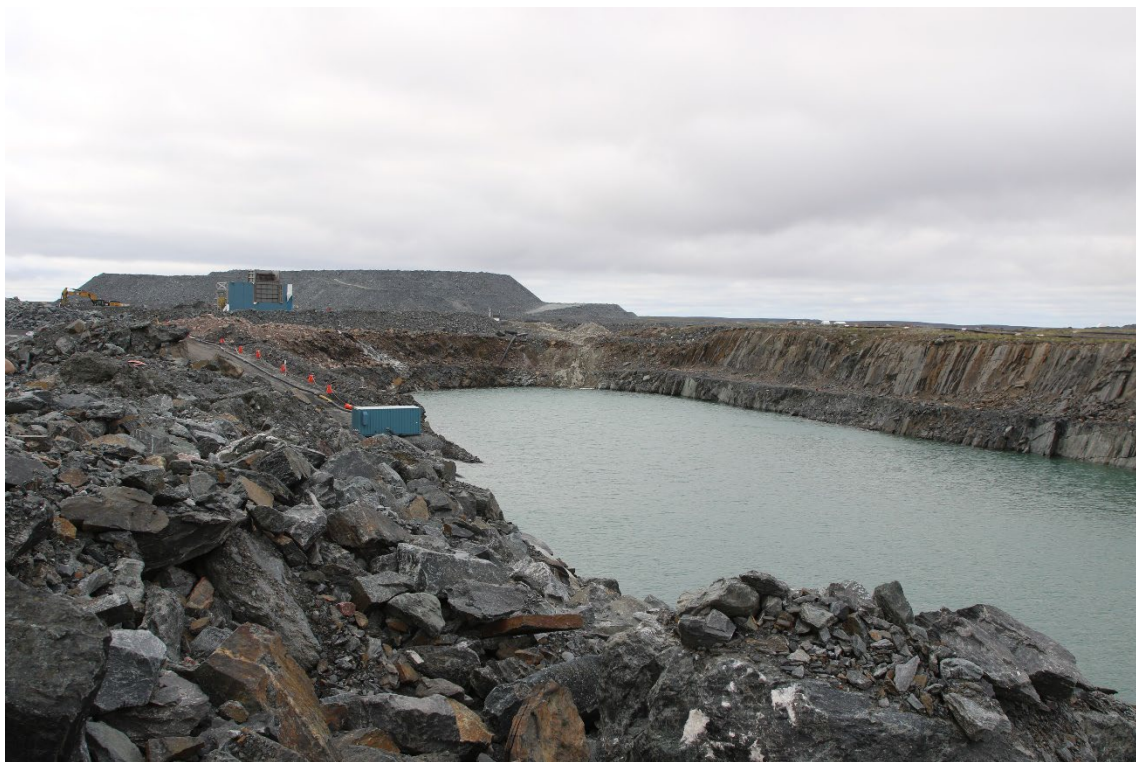
Photo 48: Underground groundwater storage pond.

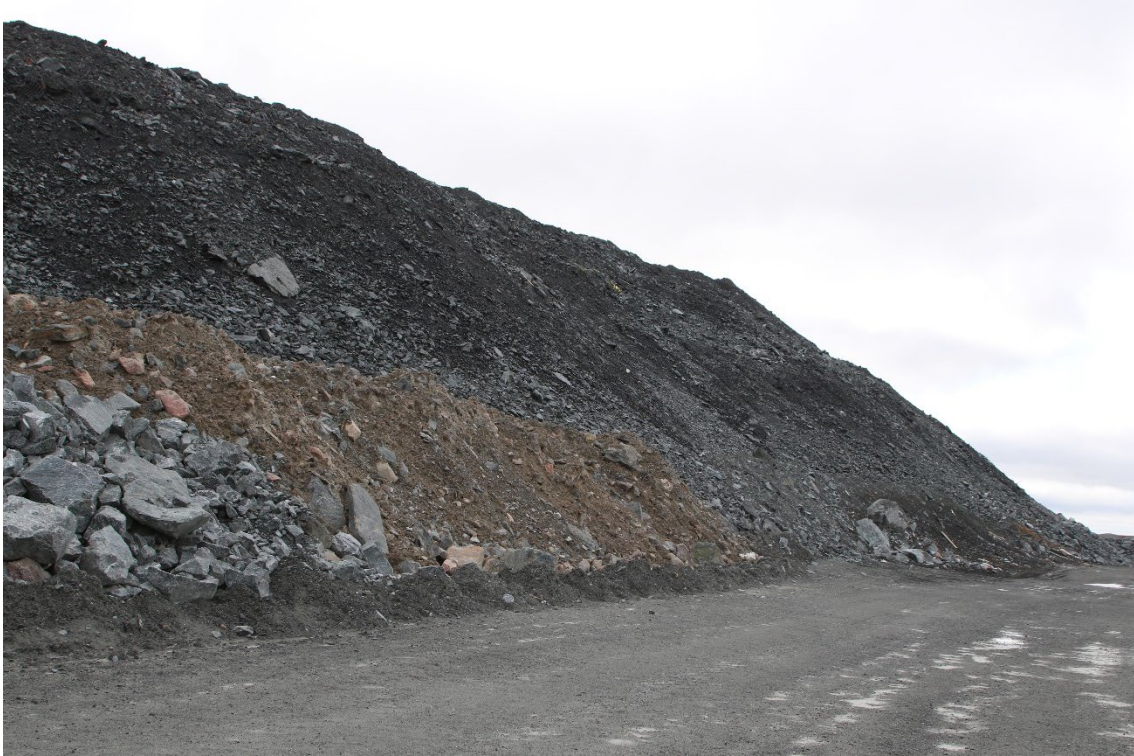
Photo 49: Underground waste rock pile.

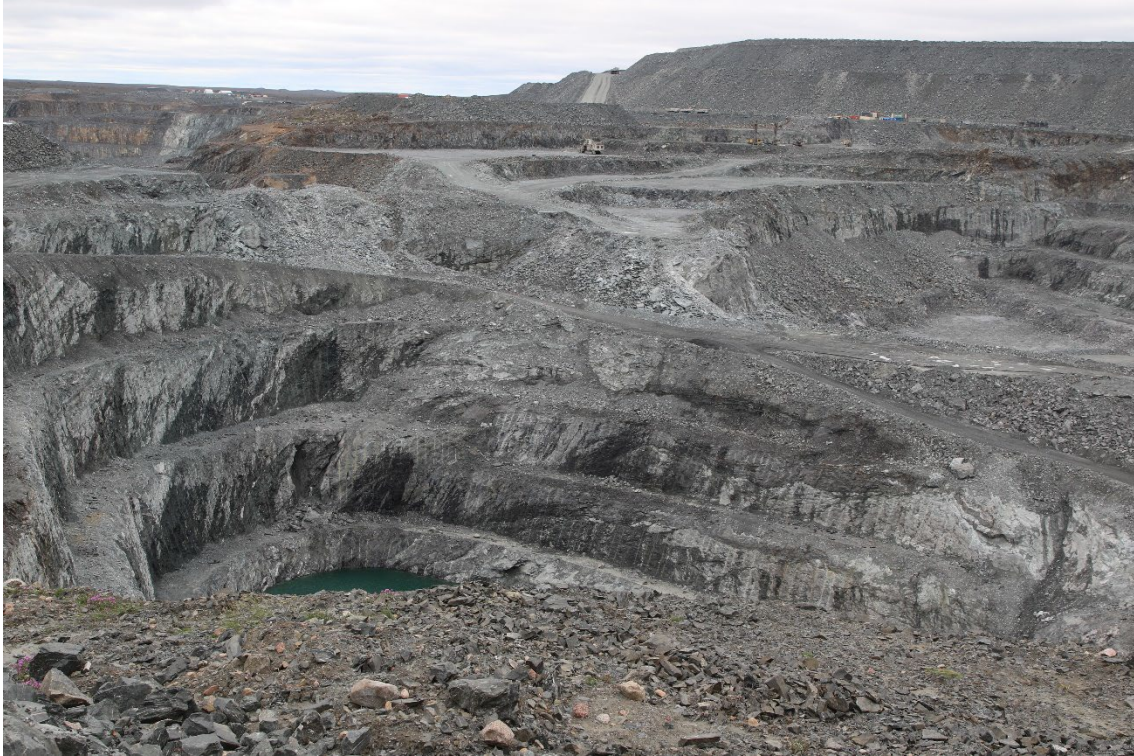
Photo 51: IVR Pit – temporary storage of saline fluid as described in the 2023 modification.
