Nunavut Impact Review Board

Site Visit Report

Meadowbank Gold Mine &

Whale Tail Pit Projects

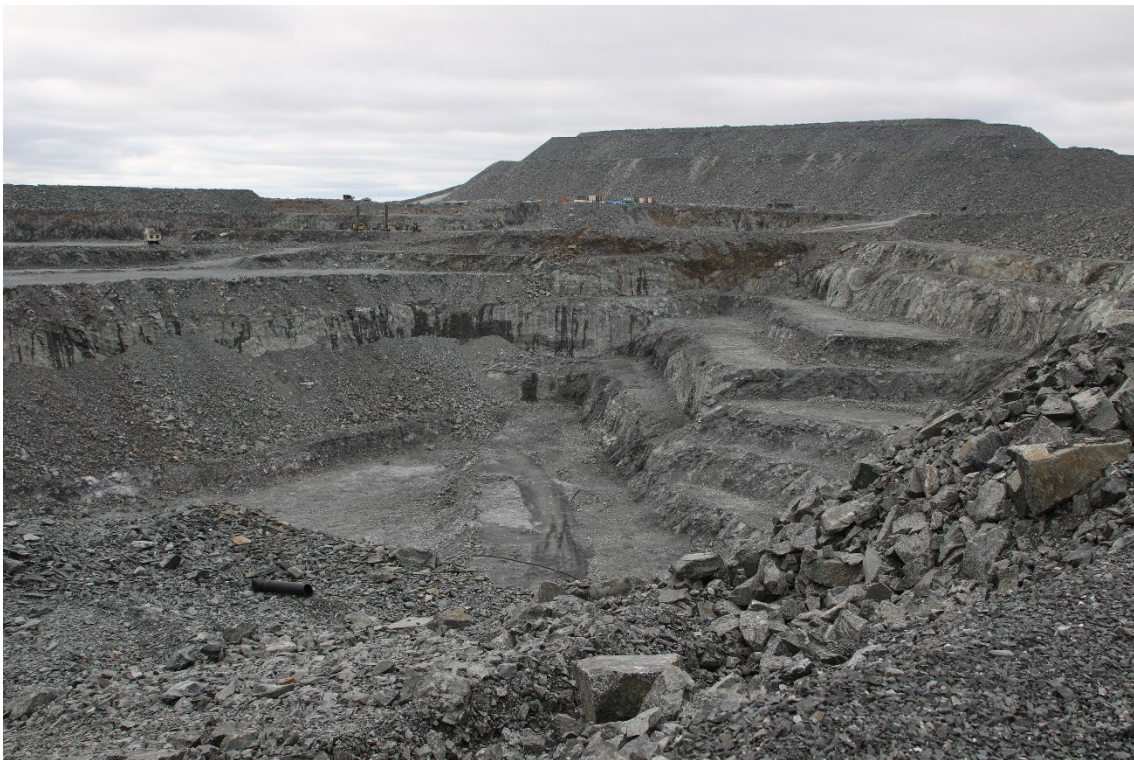
Photo 52: IVR Pit pushback area as per the 2021 Pushbacks Modification.

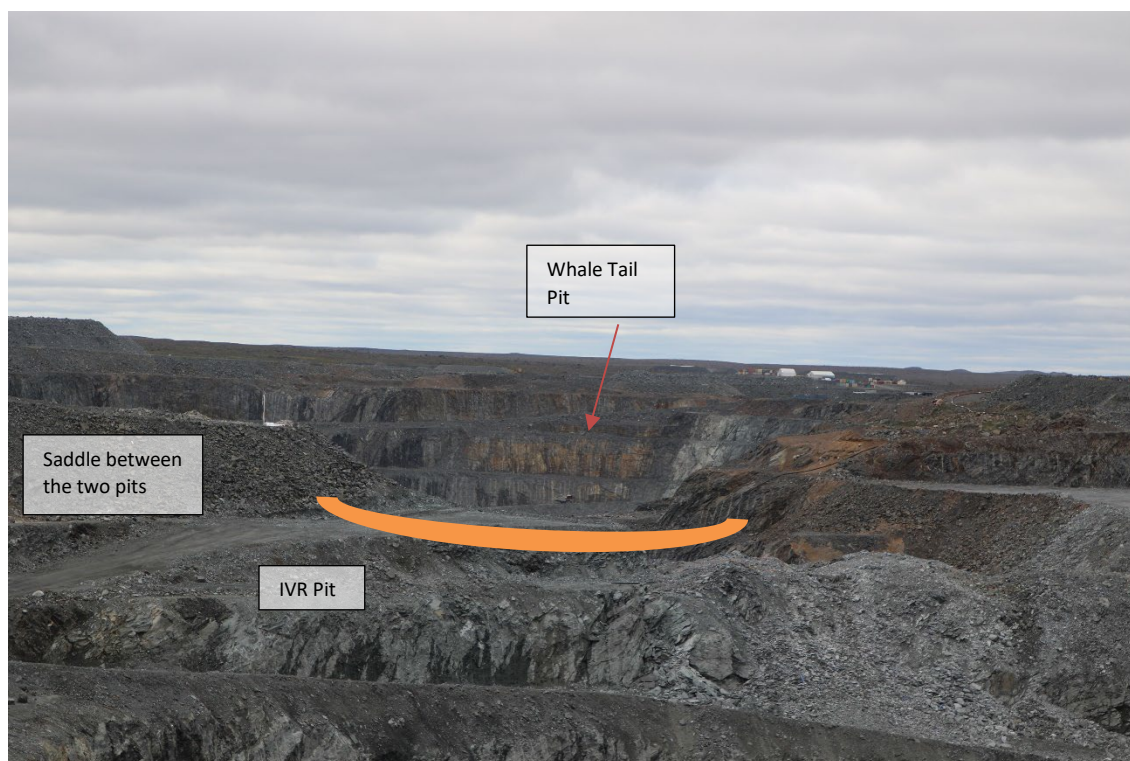
Photo 53: Pushback between IVR and Whale Tail Pit, view from IVR Pit.

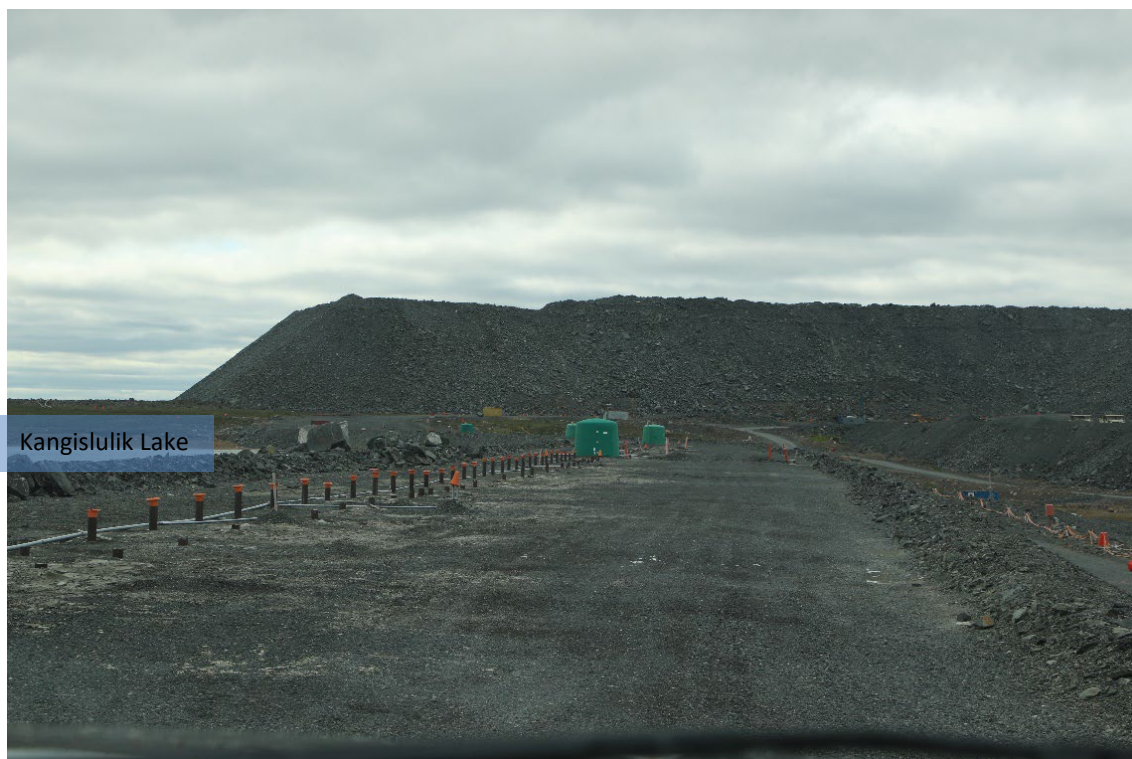
Photo 59: Mammoth Dike.

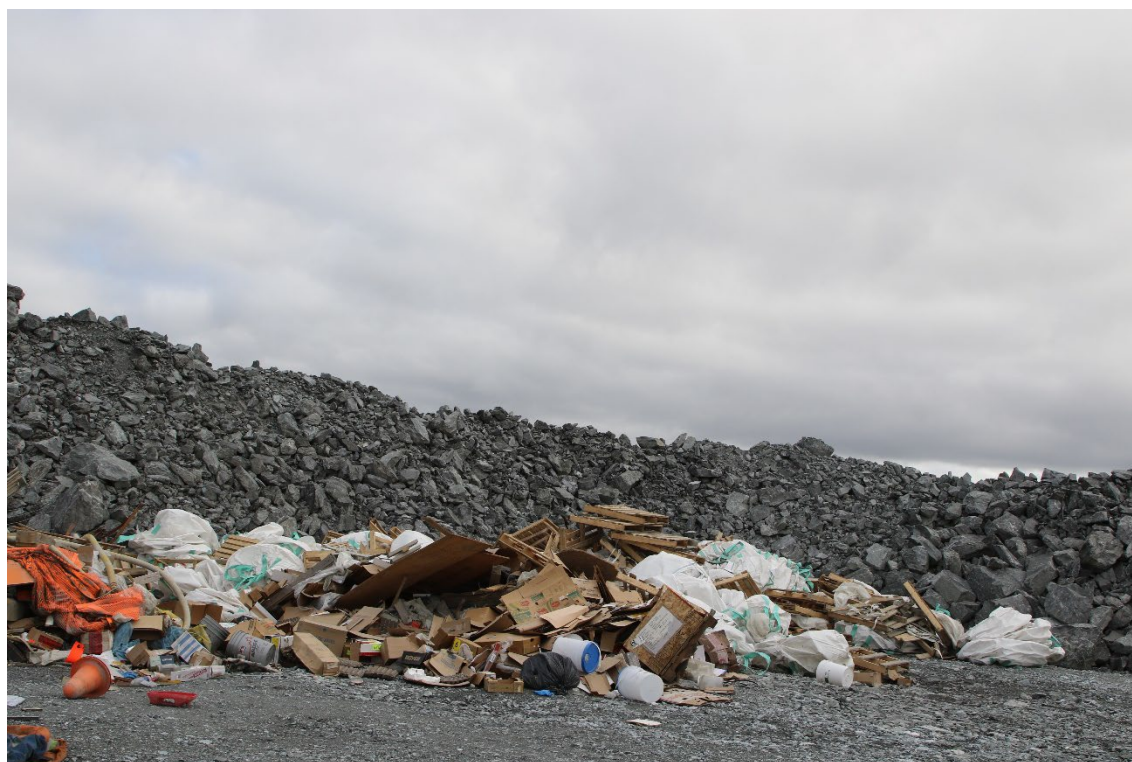
Photo 60: Whale Tail Landfill.

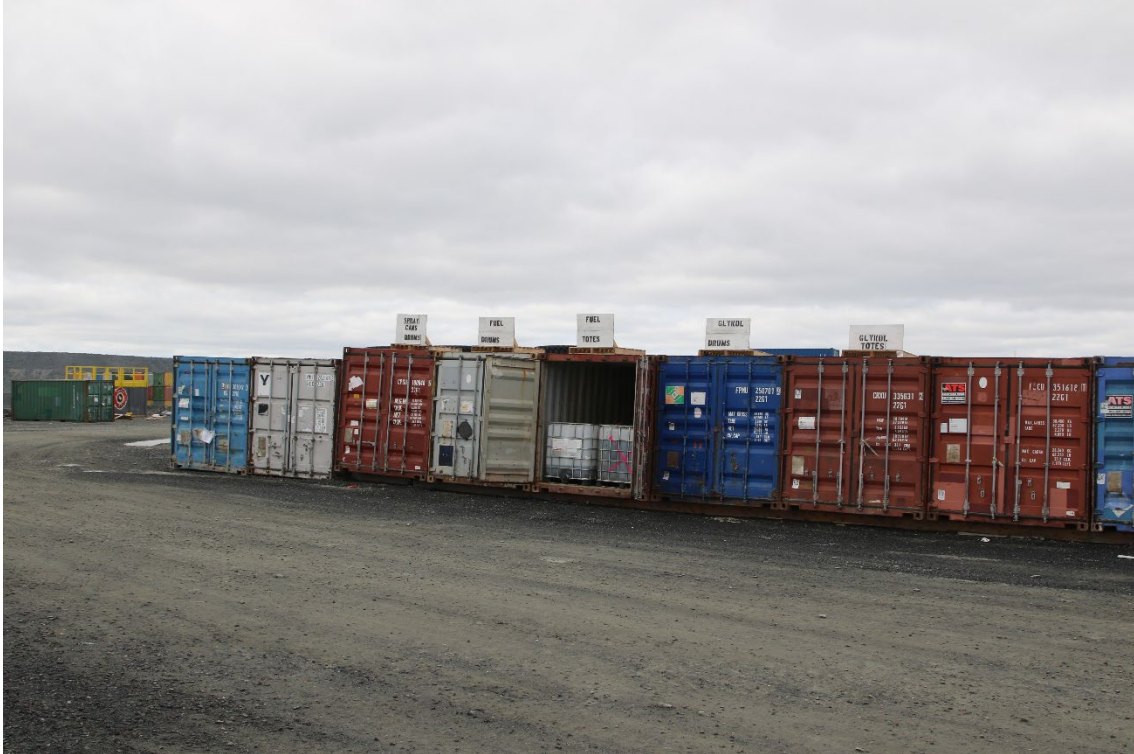
Photo 61: Hazardous Materials storage area.
