# Goose & MLA Project Sites – 2025 Annual Geotechnical Inspection

Back River Project, Nunavut, Canada  
B2Gold Back River Corp.

SRK Consulting (Canada) Inc. ■ CAPR004312 ■ March 2026

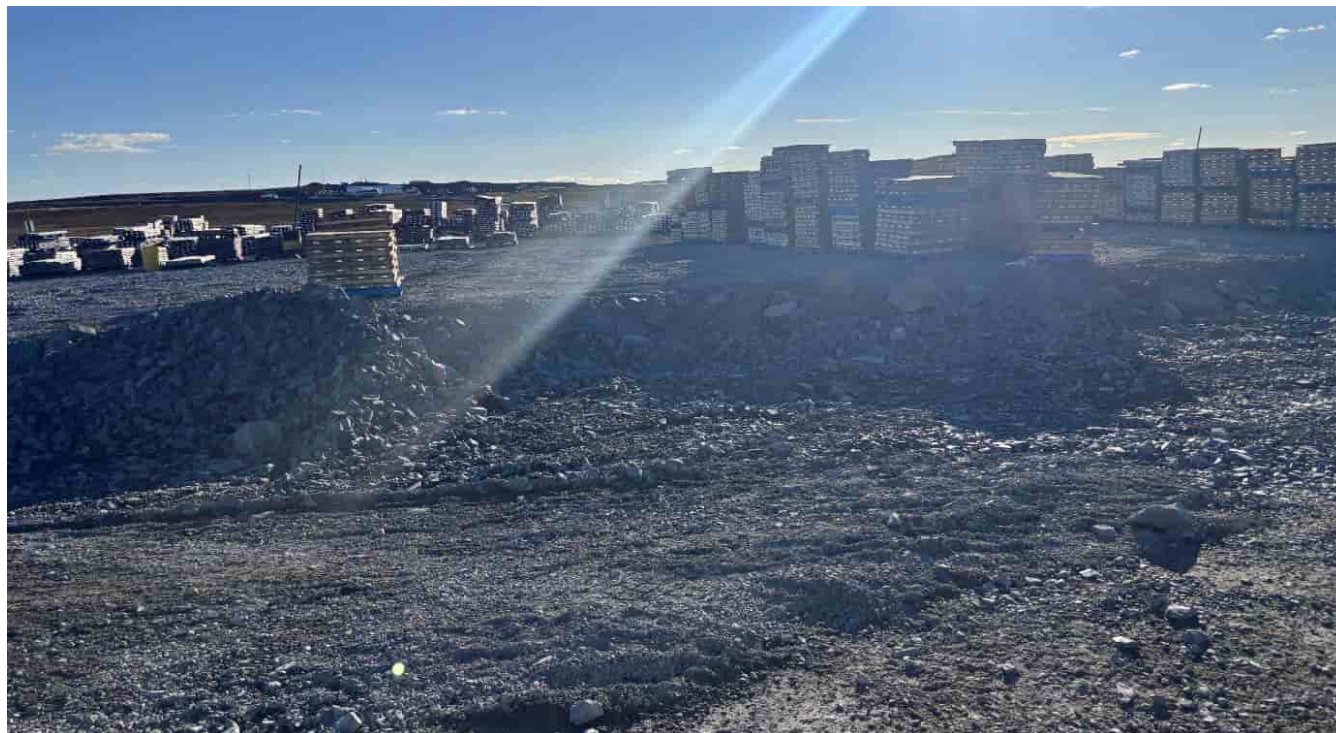
G-1: Exploration camp laydown area, looking SW

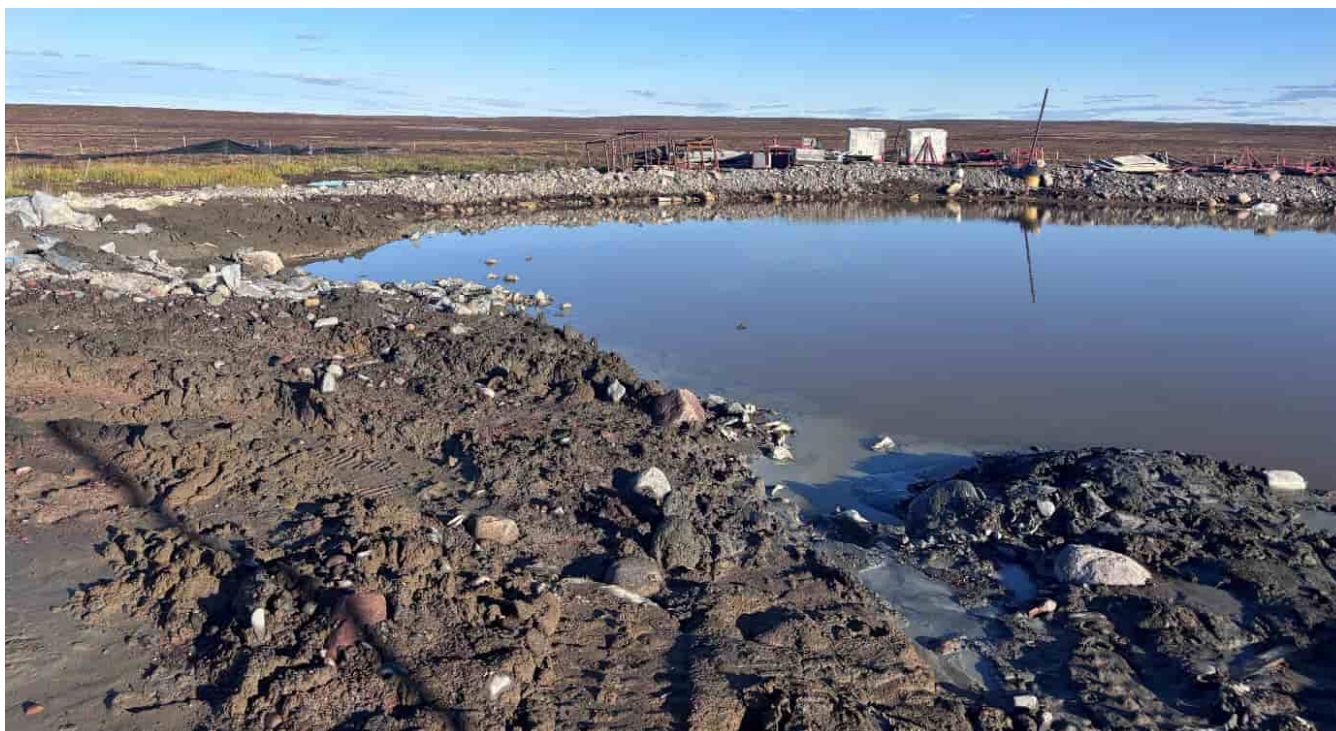
G-3: Historic ponded water areas near exploration camp - in future main pit footprint, looking NE

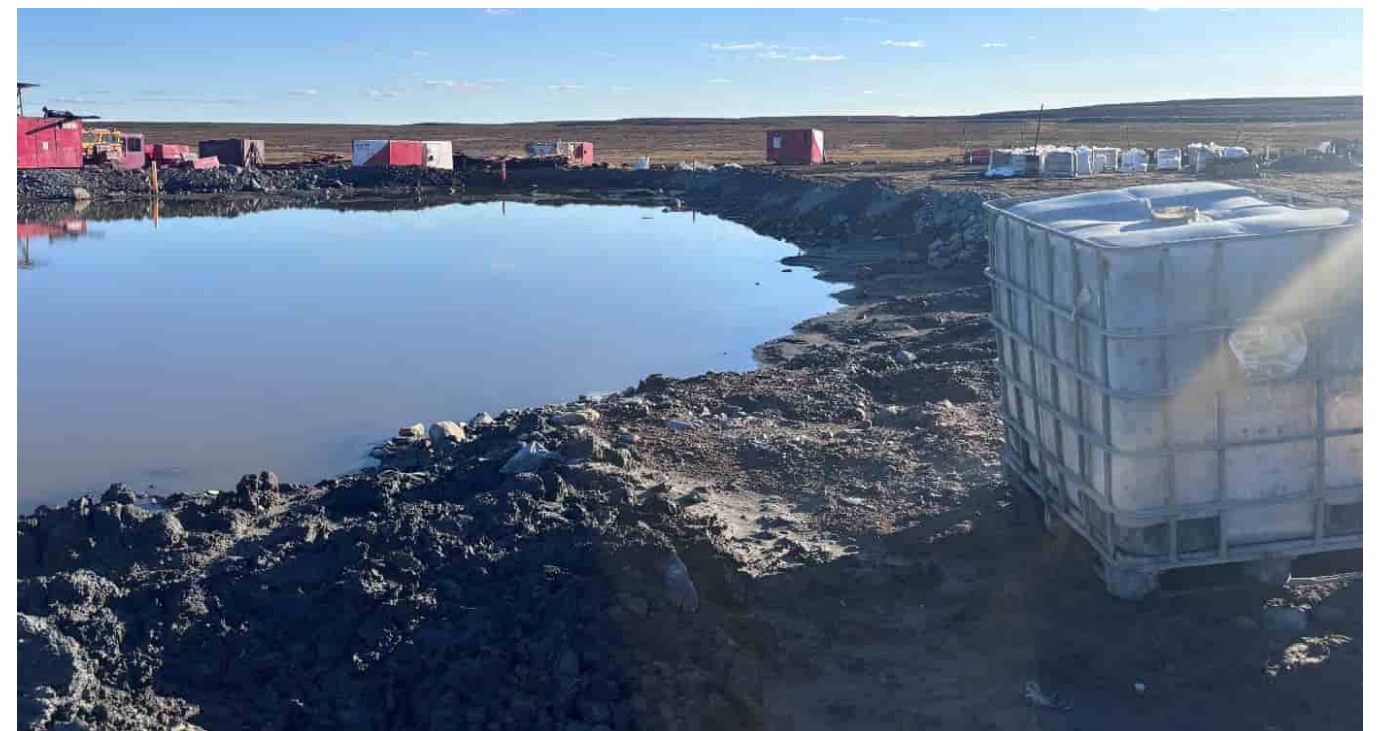
G-4: Historic ponded water areas near exploration camp – in future main pit footprint looking SE

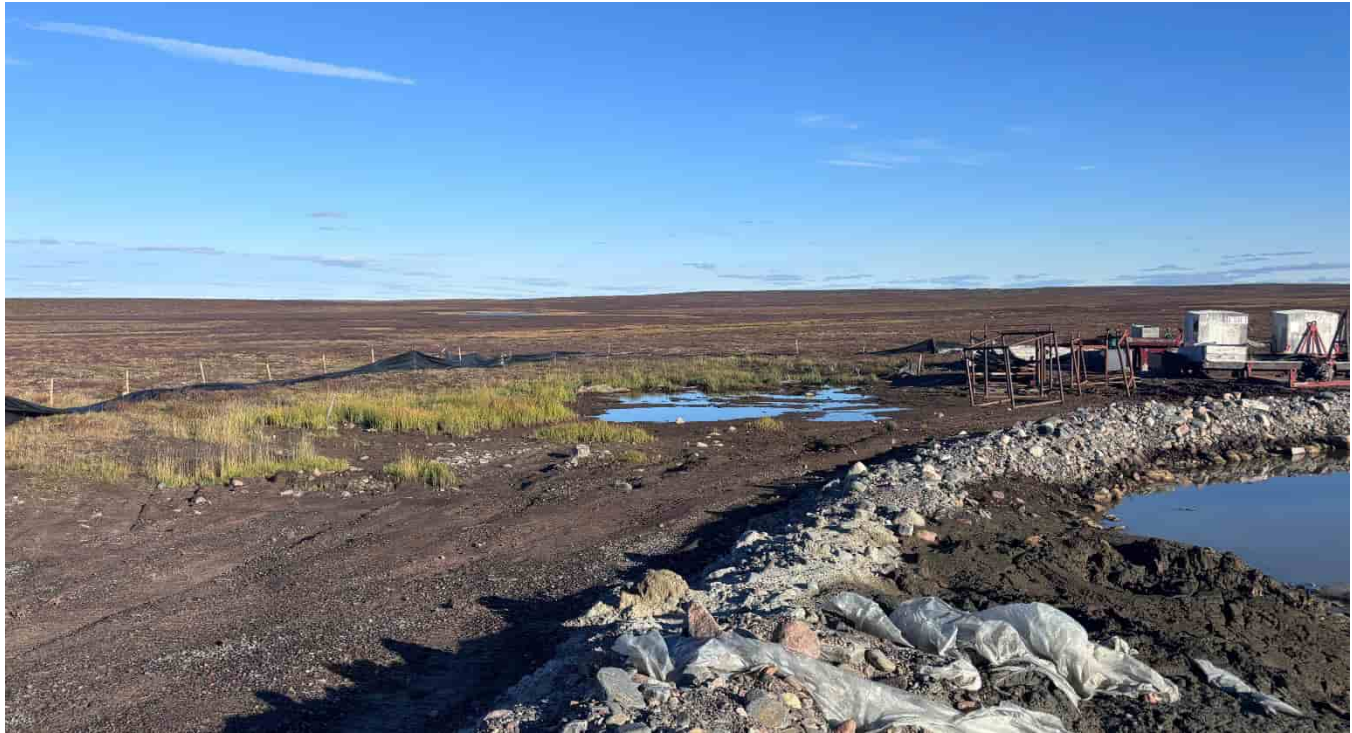
G-5: Ponding water north of pond in main pit footprint

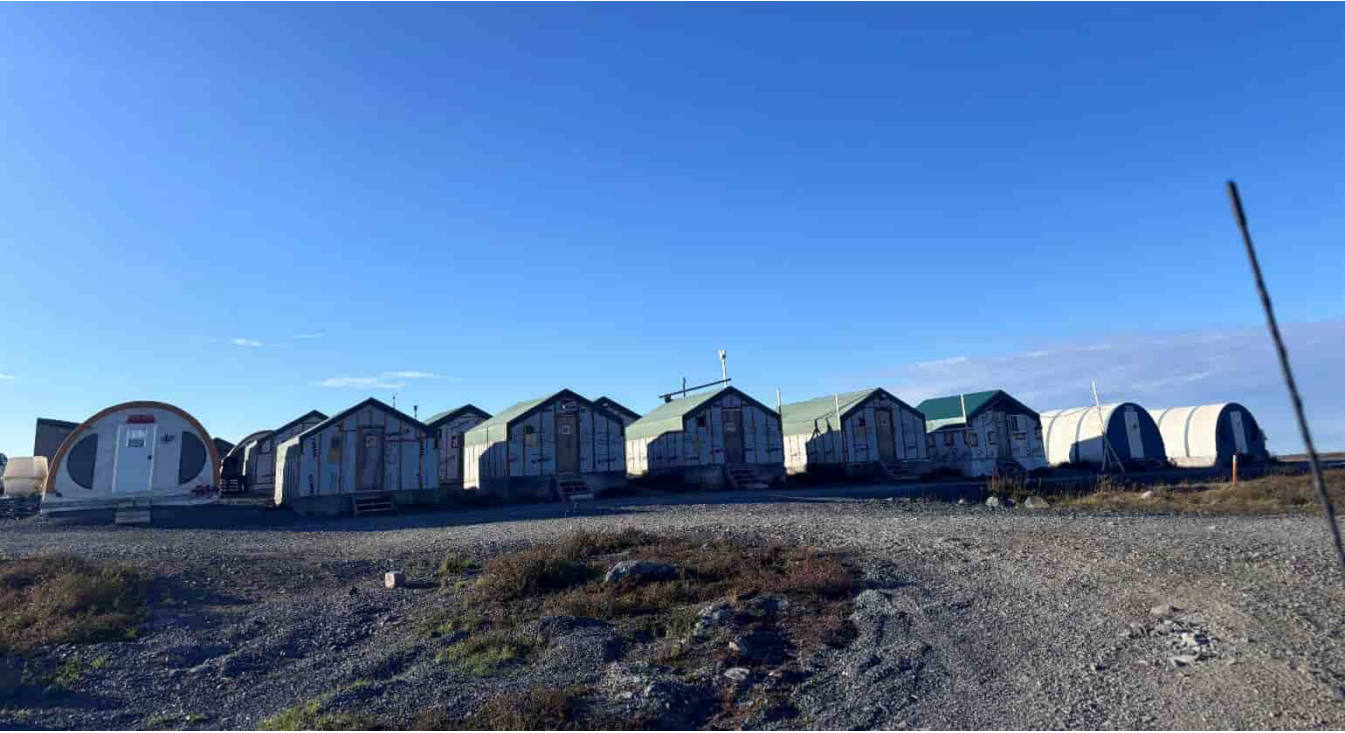
G-8: Exploration camp, looking N

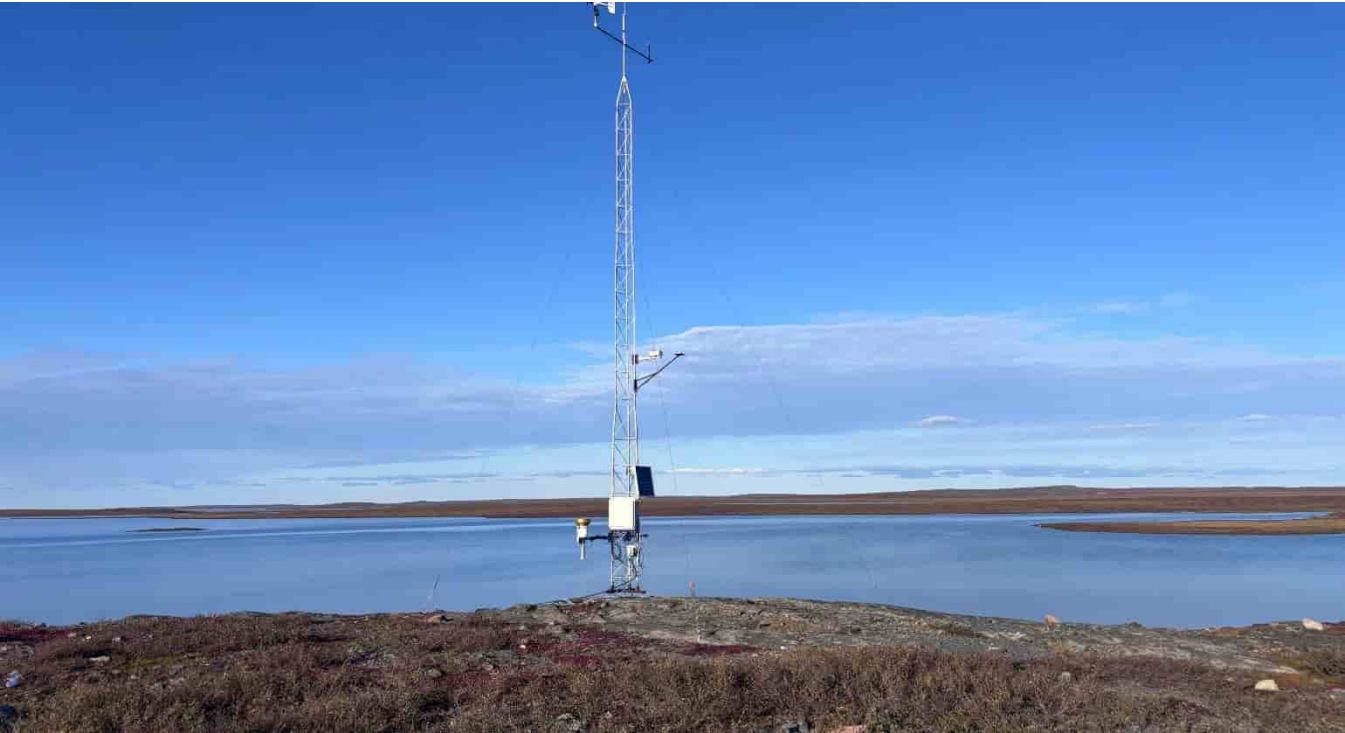
G-10: Goose Lake and tower viewed from exploration camp

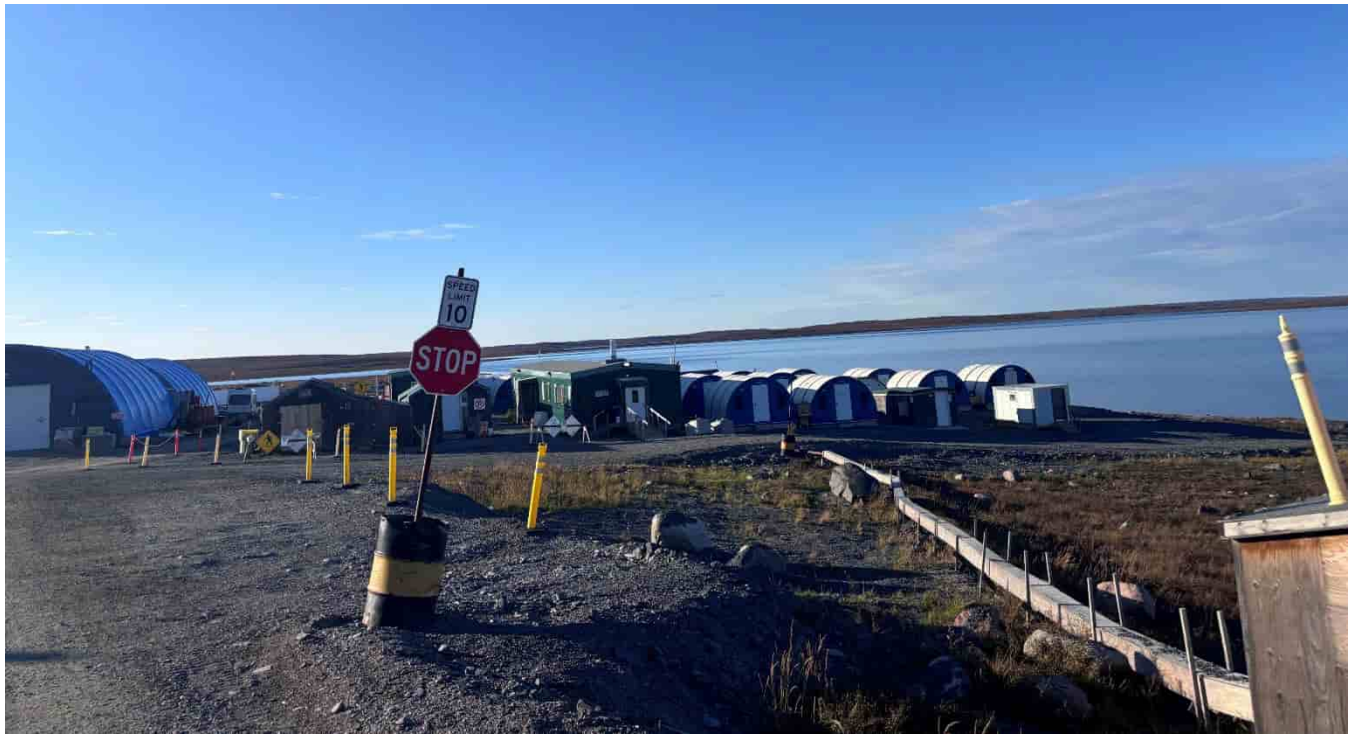
G-11: Exploration camp, looking N

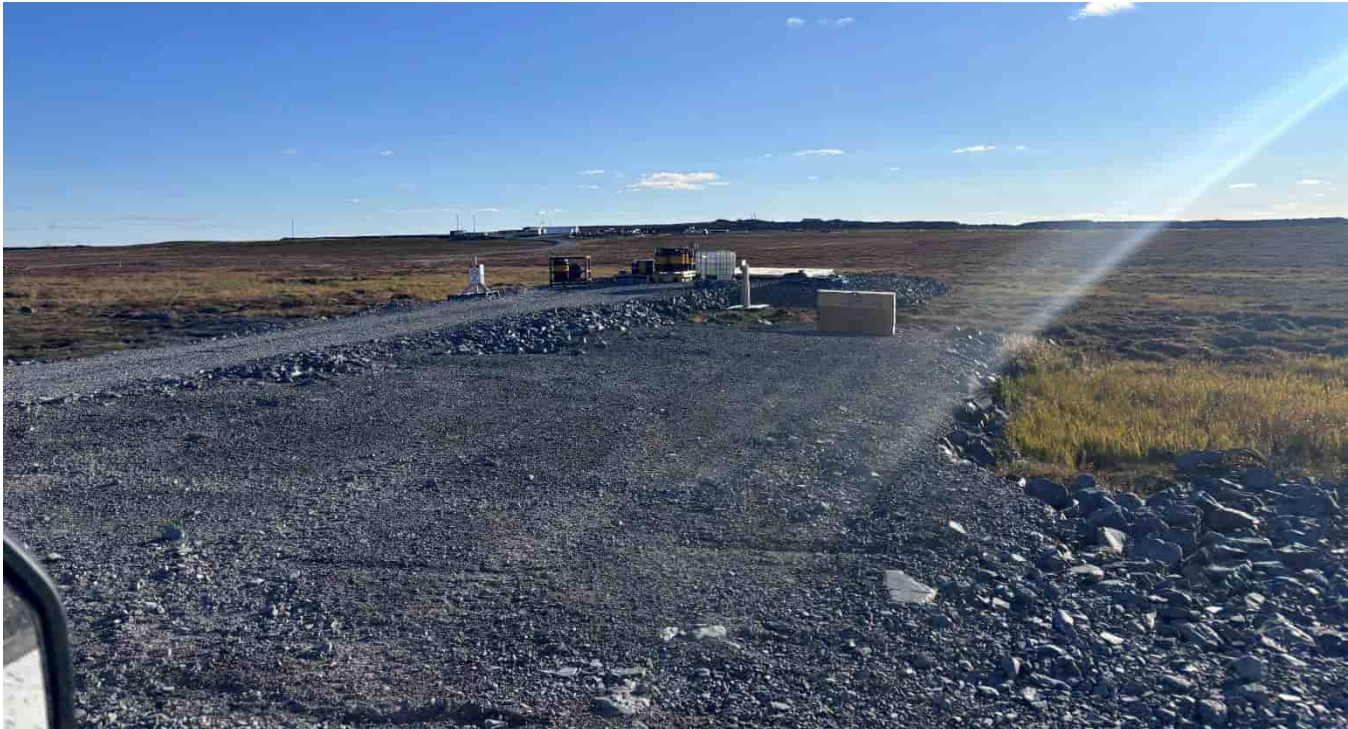
G-18: Helipad

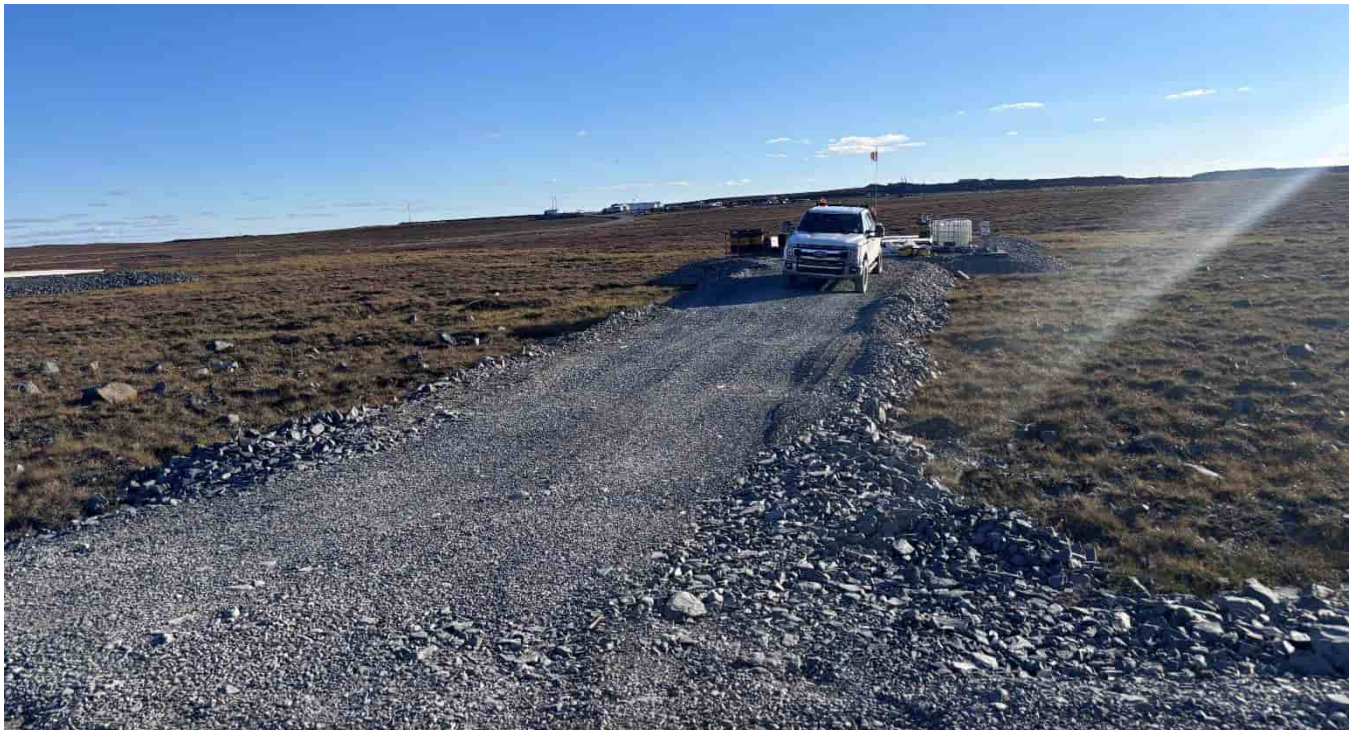
G-19: Helipad

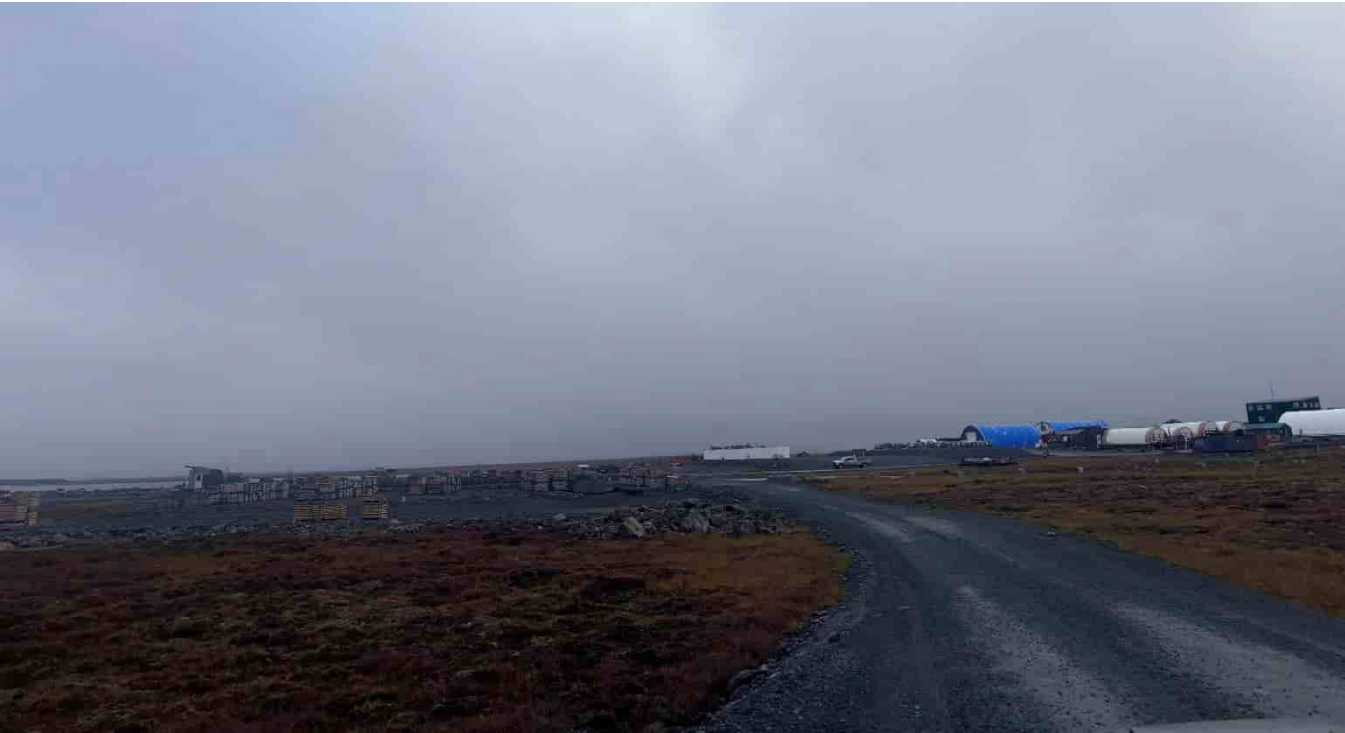
G-22: Exploration camp viewed from airstrip access road

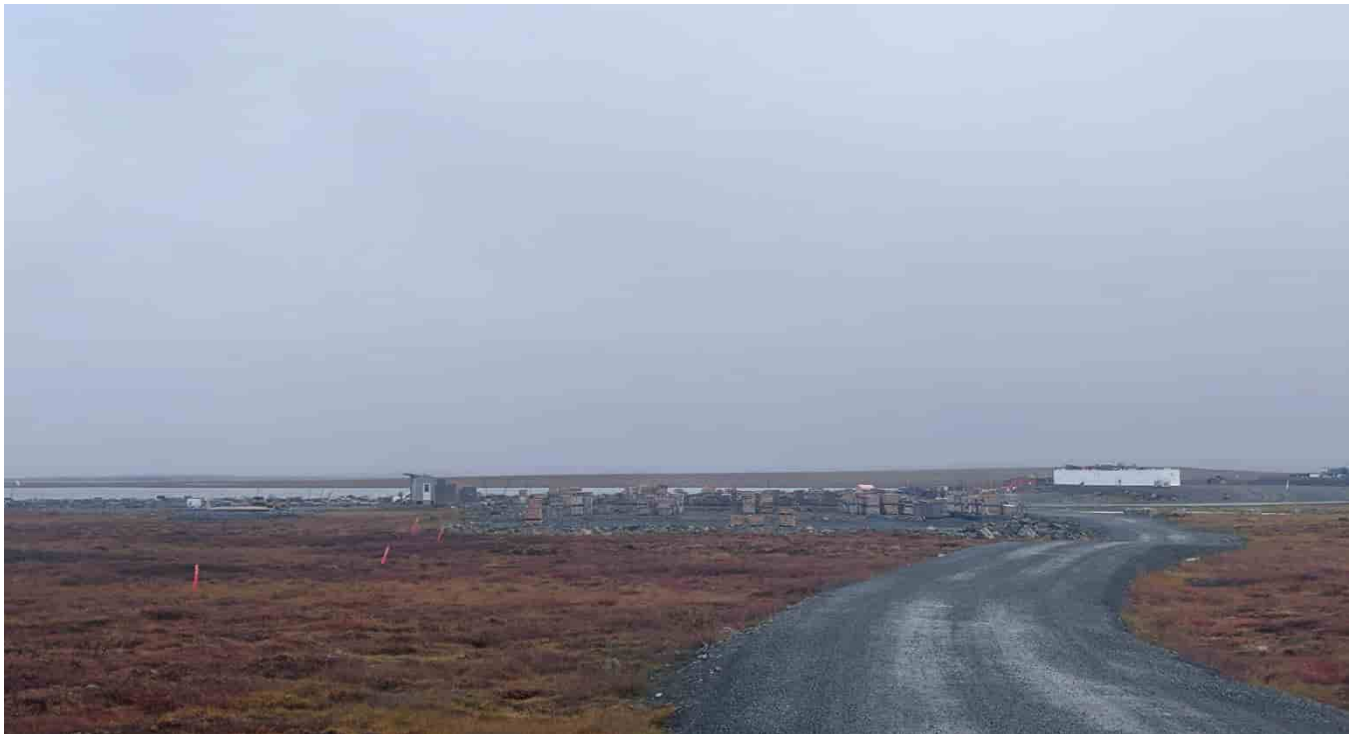
G-23: Airstrip Road, looking towards exploration camp

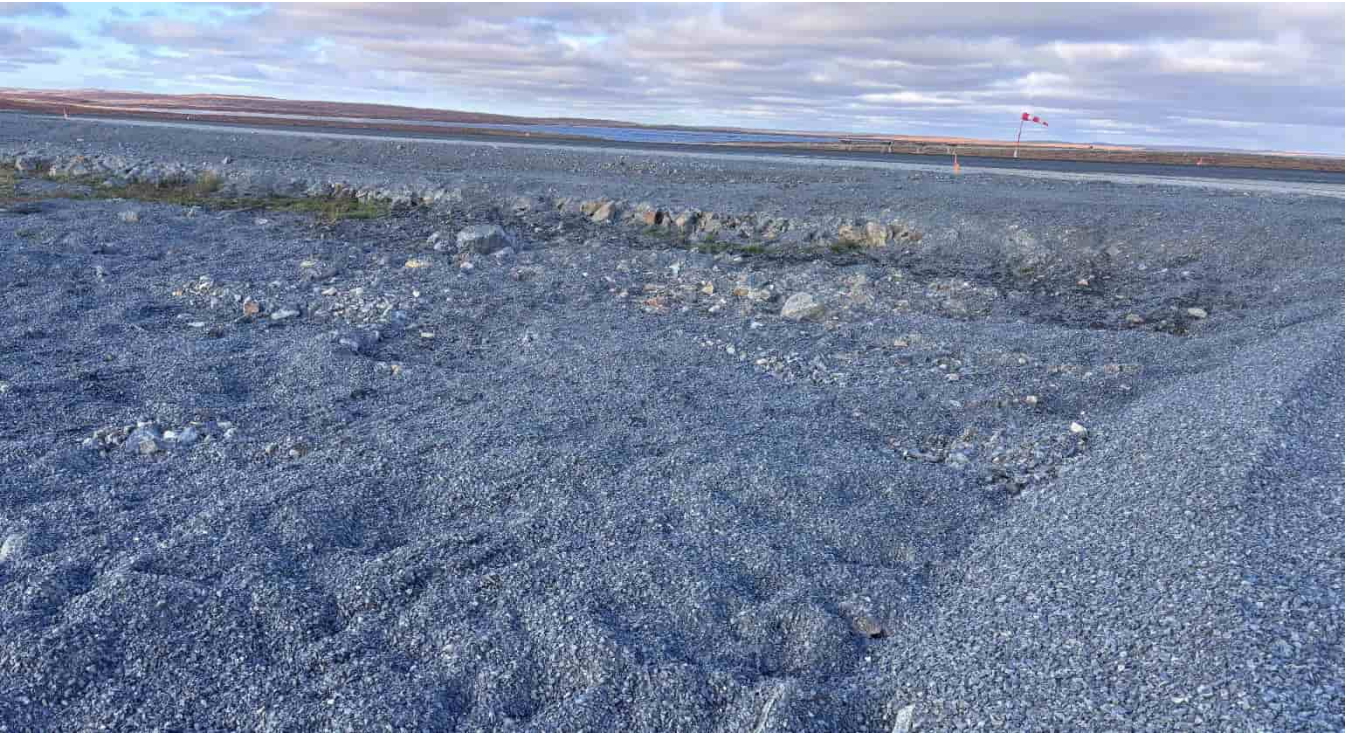
G-44: Looking N across runway

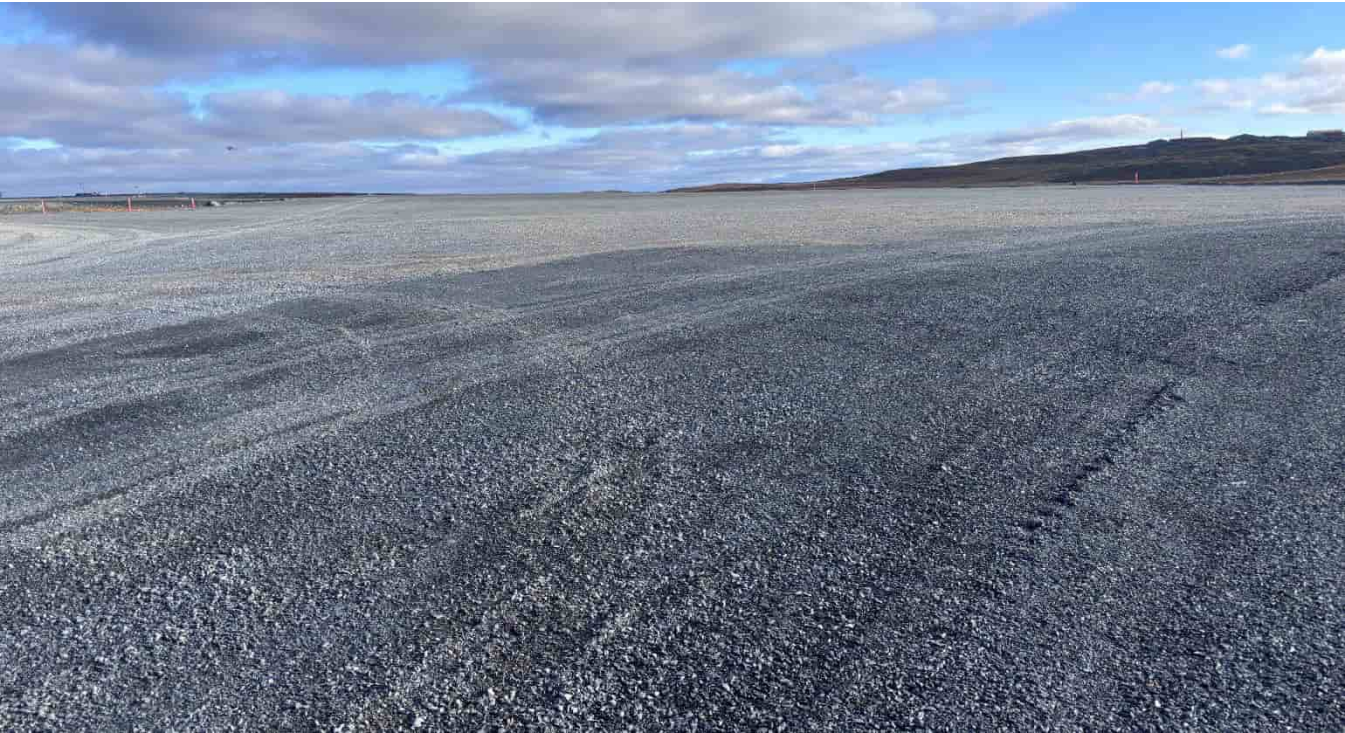
G-48: SW airstrip apron, looking SE

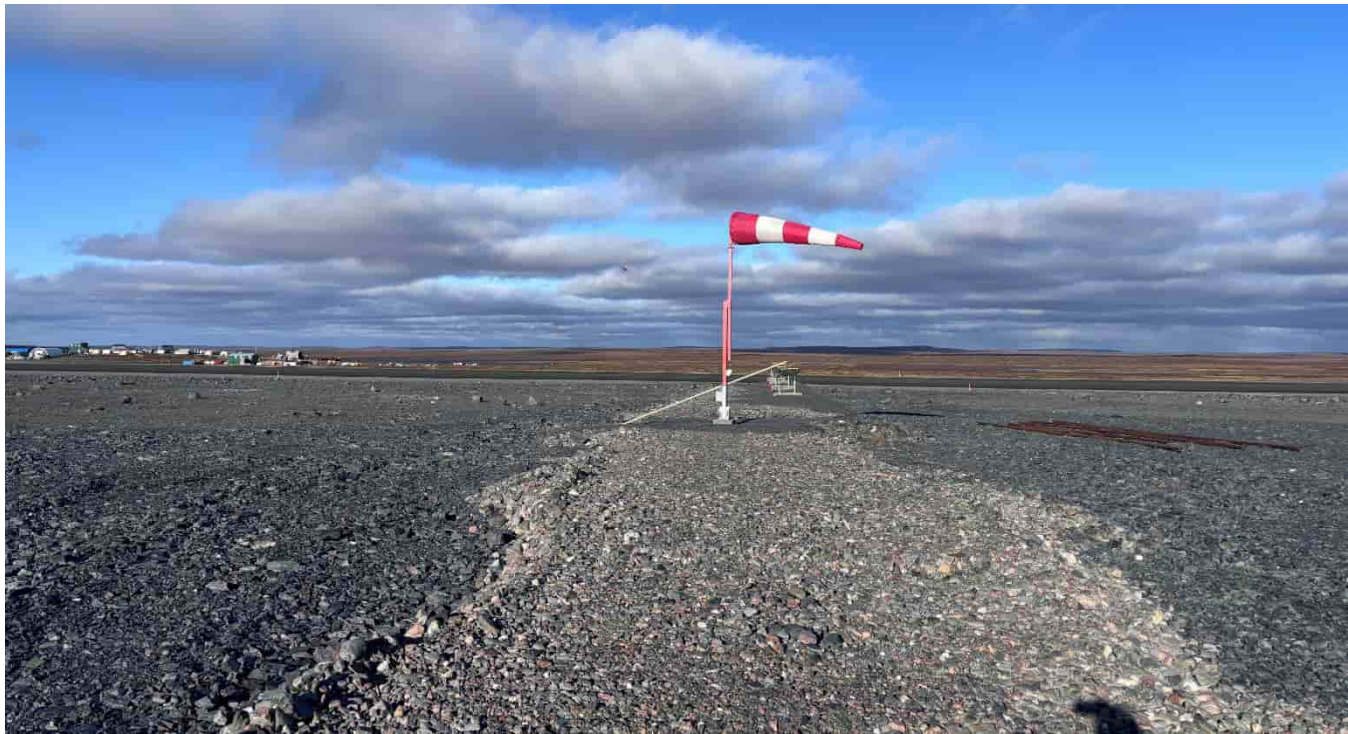
G-53: View towards exploration camp from airstrip

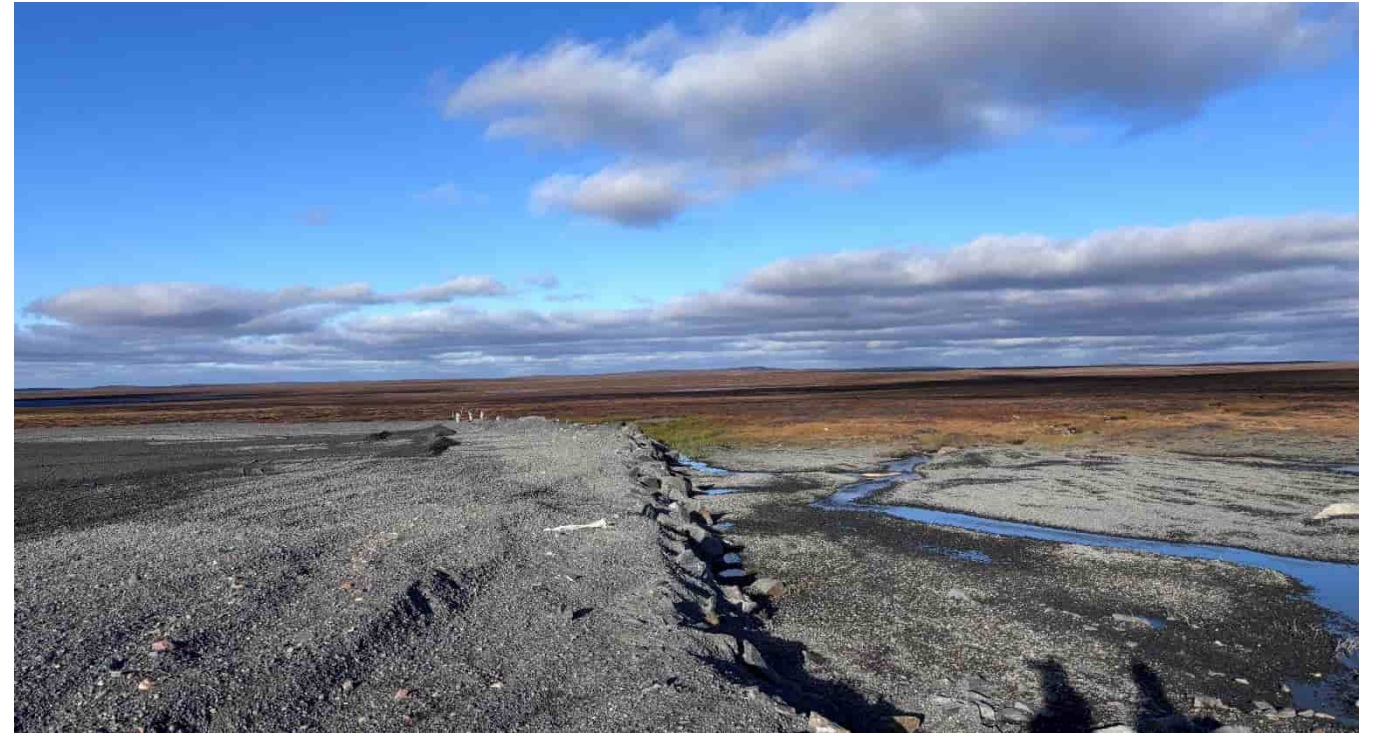
G-60: Stream beside SE end of runway, looking NE

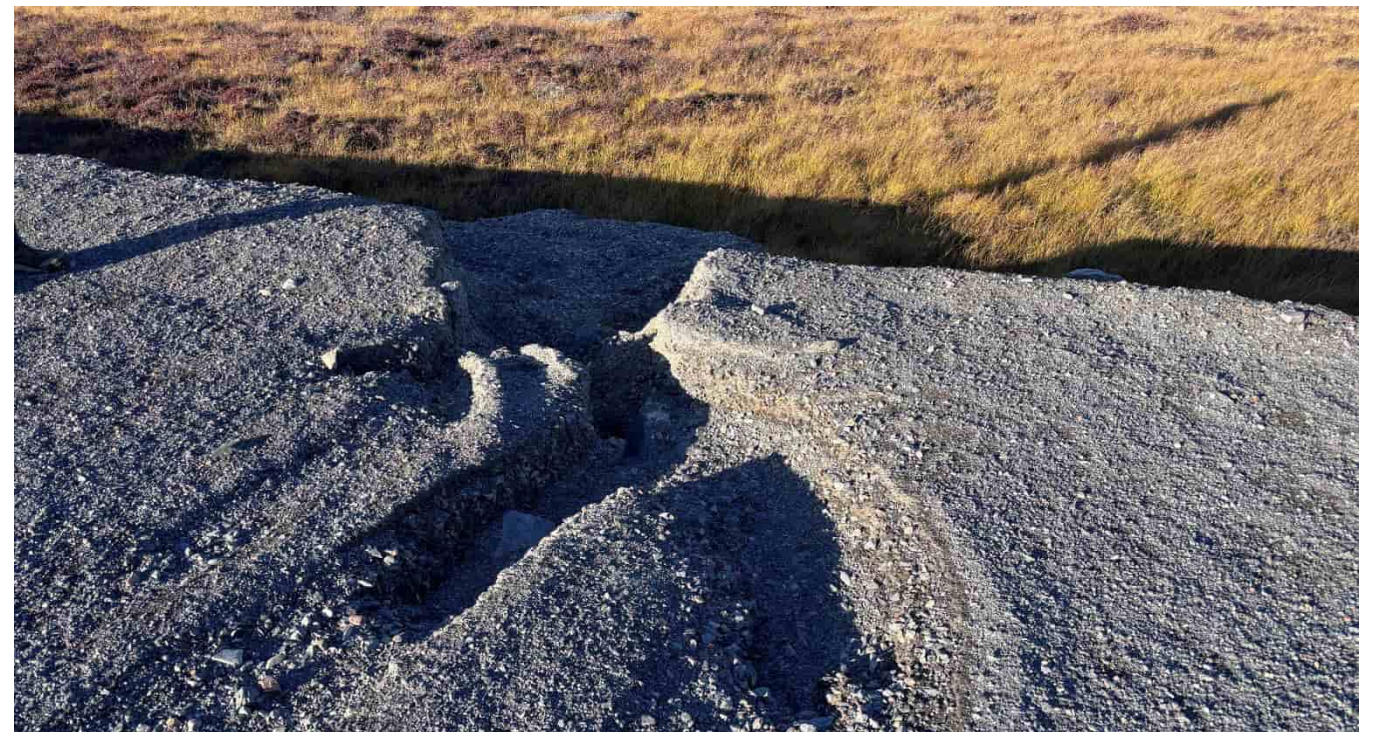
G-62: NE side of airstrip – Looking NE at the shoulder

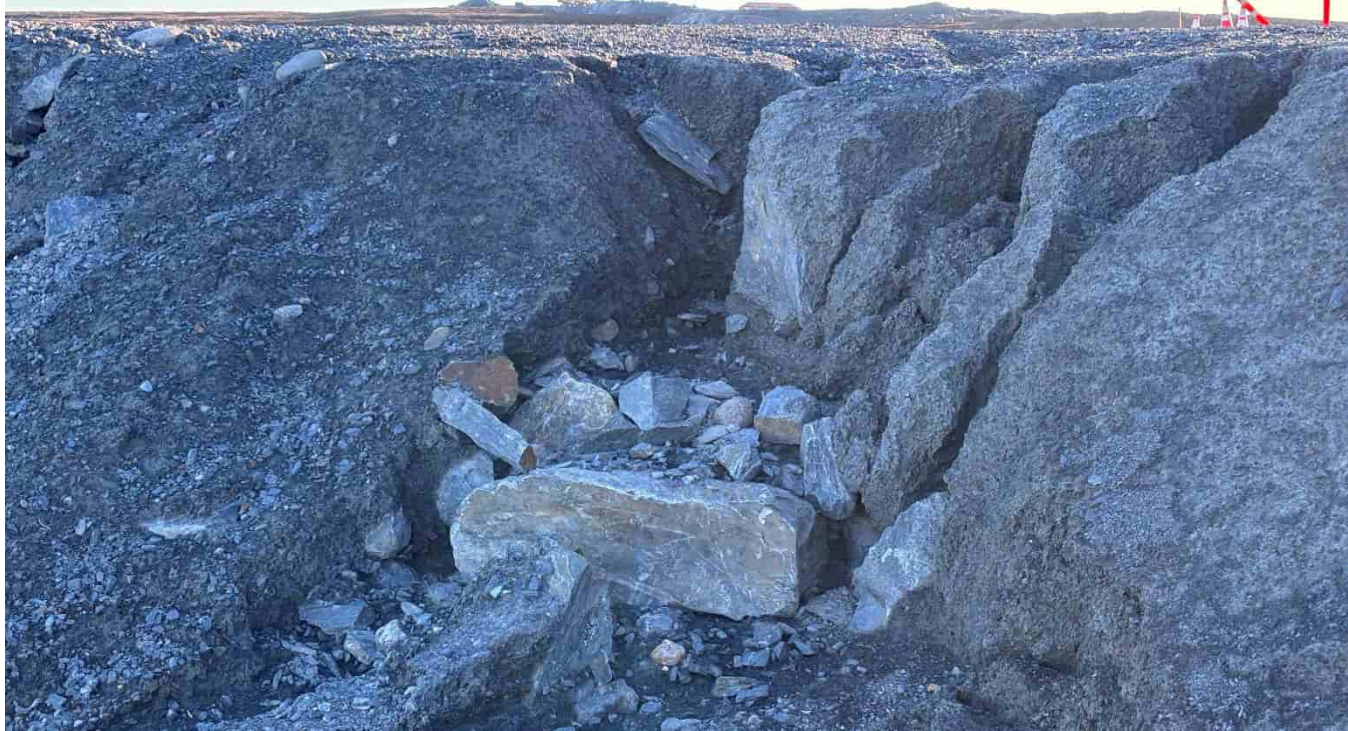
G-71: Erosion pathway on NE apron

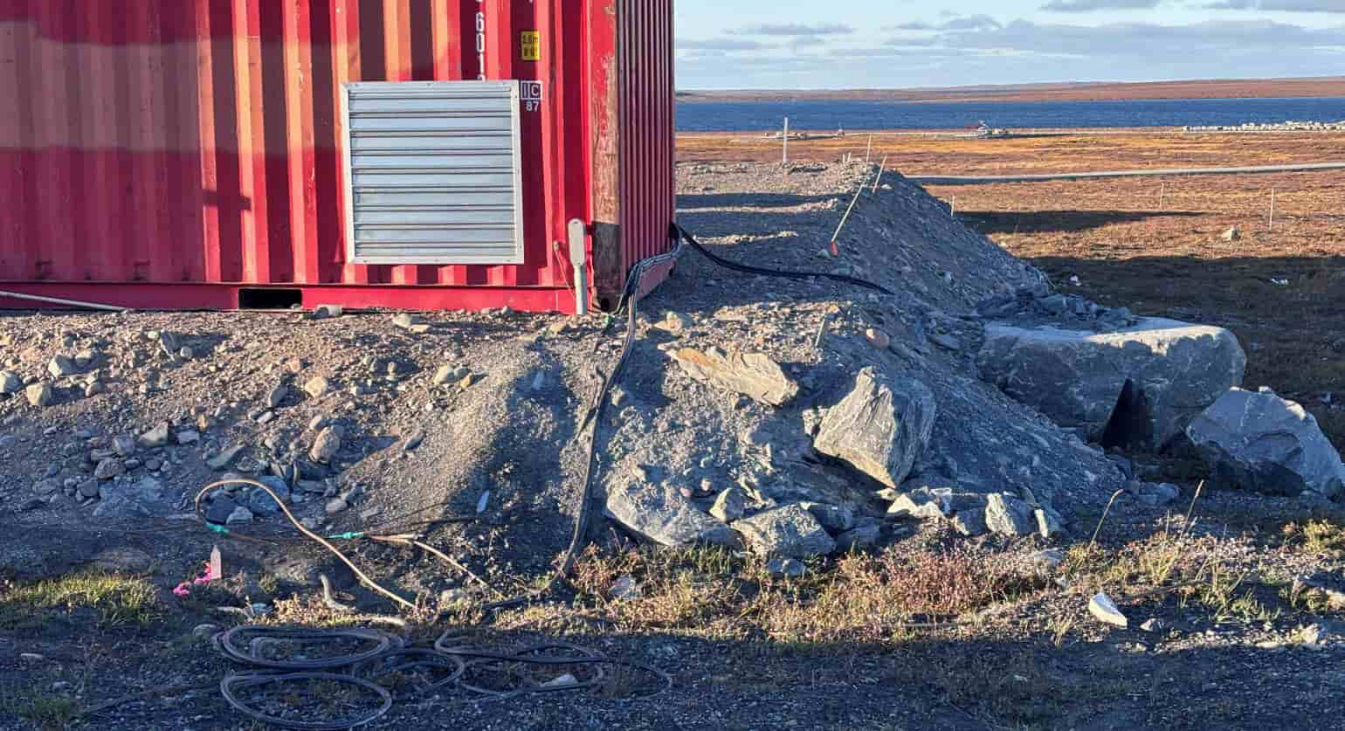
G-72: Shipping container near edge of pad

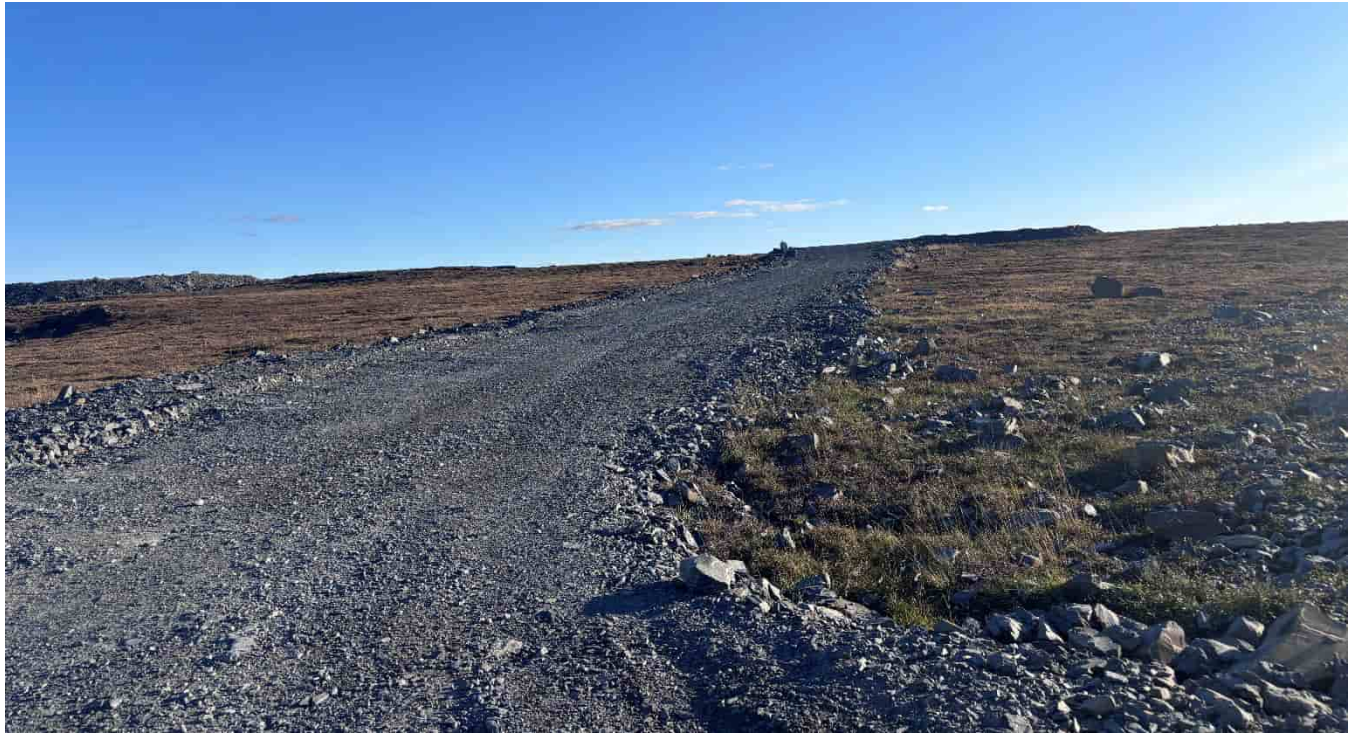
G-101: Road to old explosive storage, looking SW – Thin access road

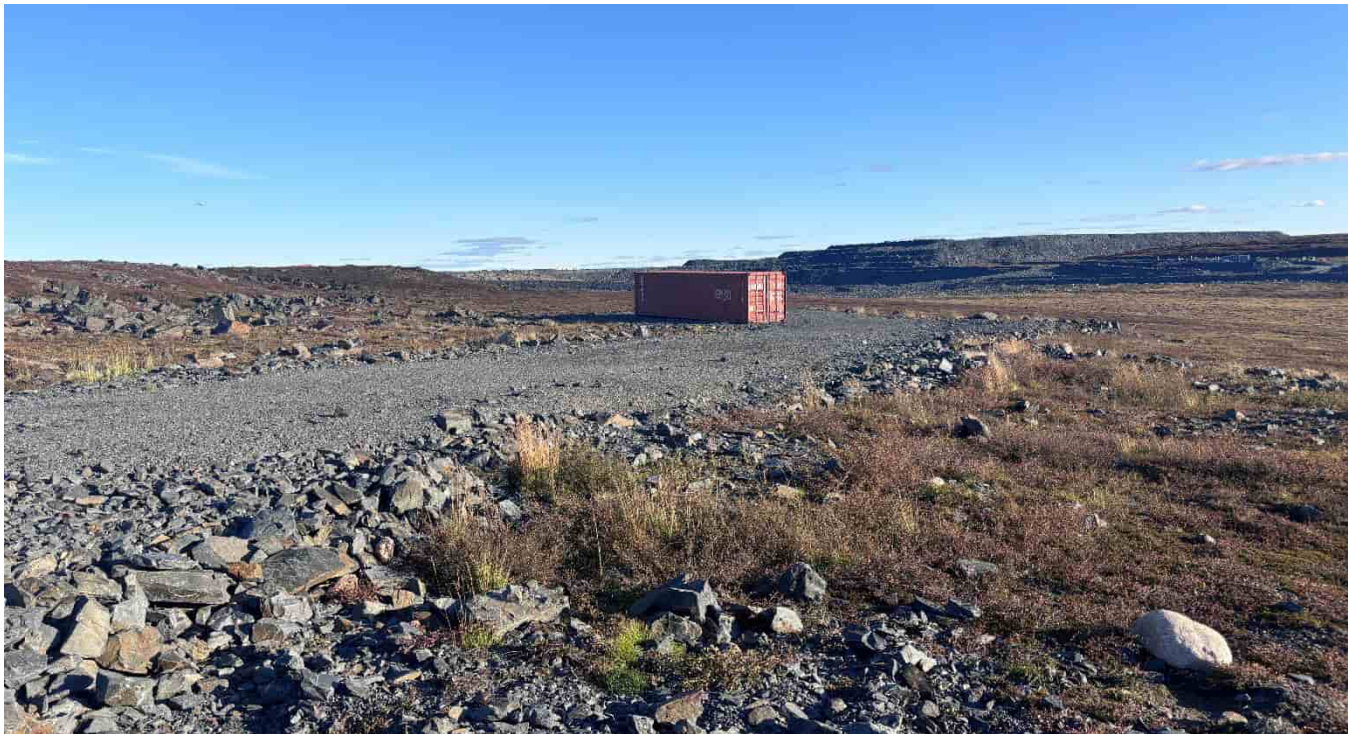
G-103: Seacan at end of old explosive storage access road – thin access road

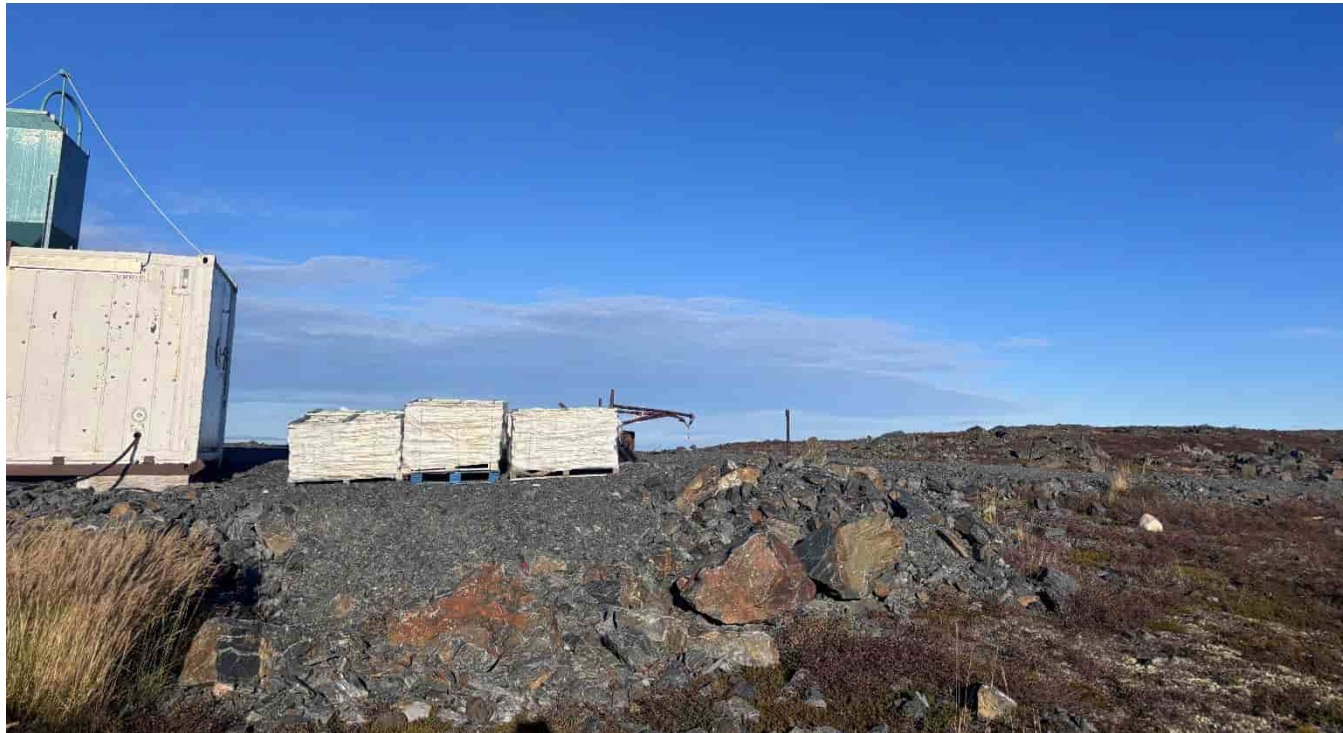
G-105: Old explosive storage pad and laydown, looking N

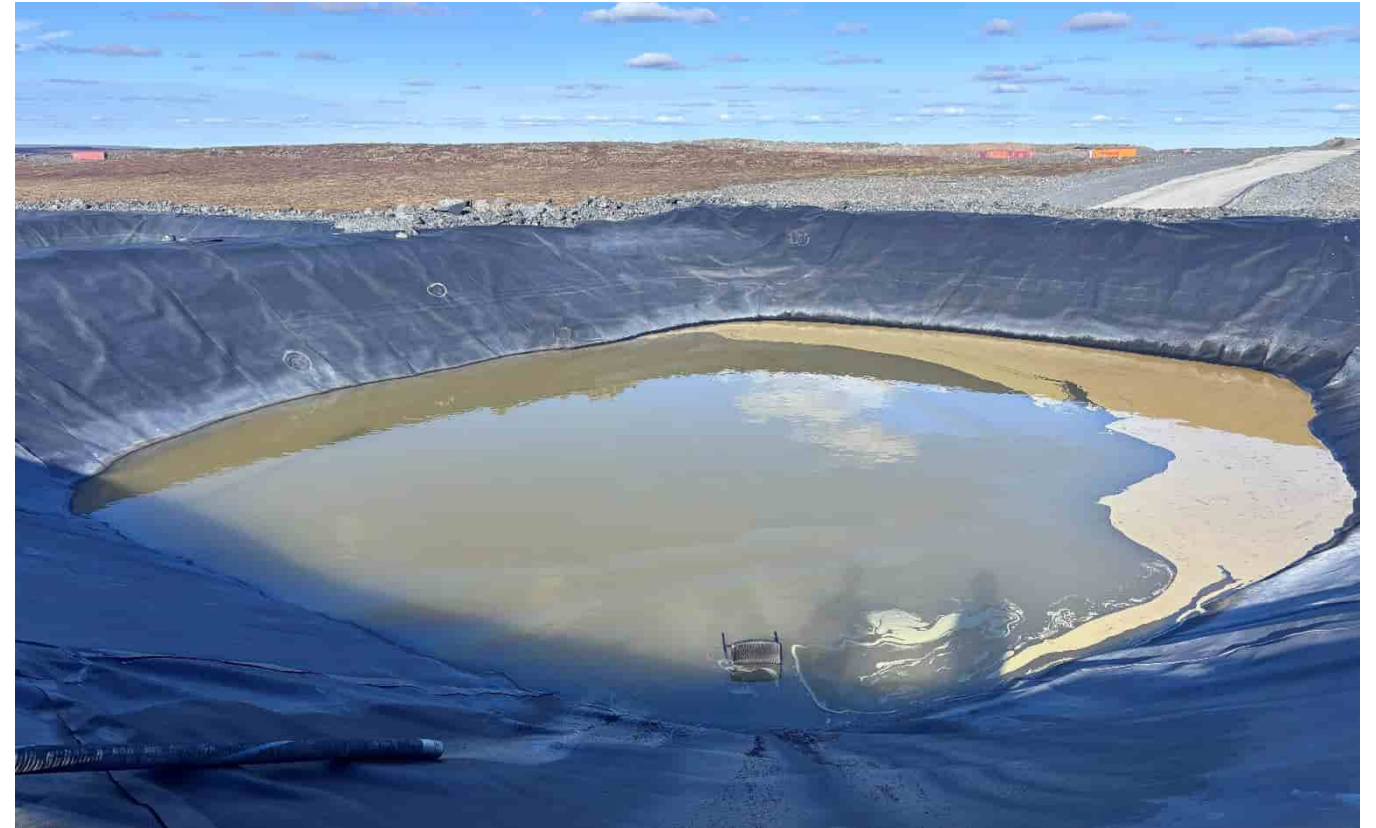
G-147: Treatment pond

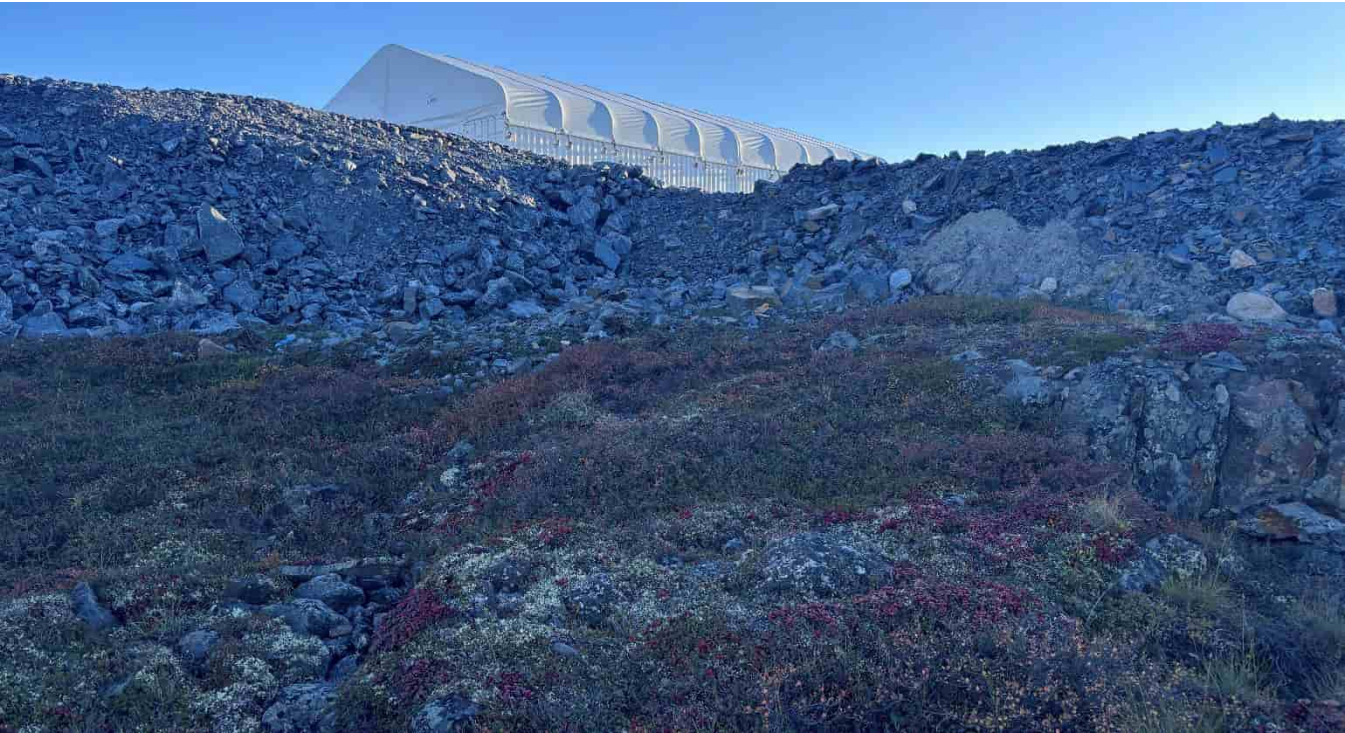
G-196: Slope besides laydown area, looking NW
