# Goose & MLA Project Sites – 2025 Annual Geotechnical Inspection

Back River Project, Nunavut, Canada  
B2Gold Back River Corp.

SRK Consulting (Canada) Inc. ■ CAPR004312 ■ March 2026

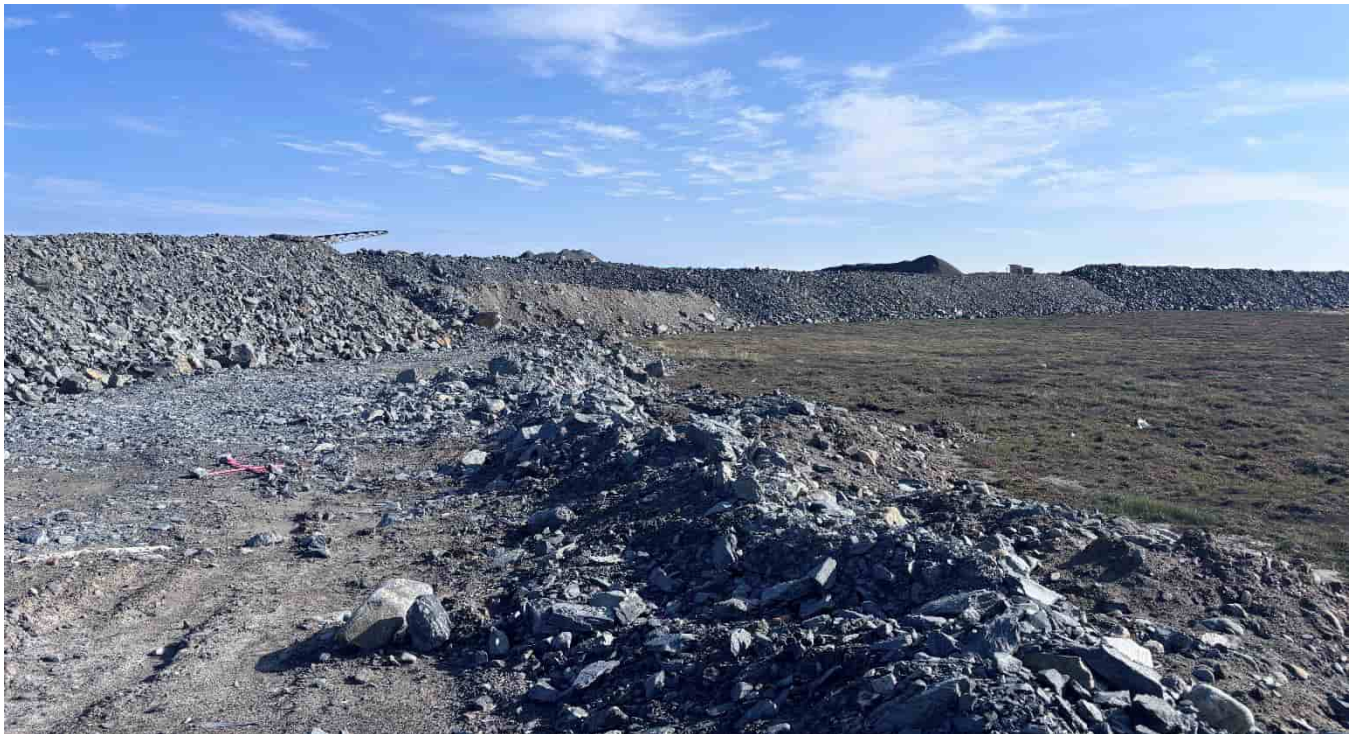
G-221: ROM stockpiles as seen from W side, looking E

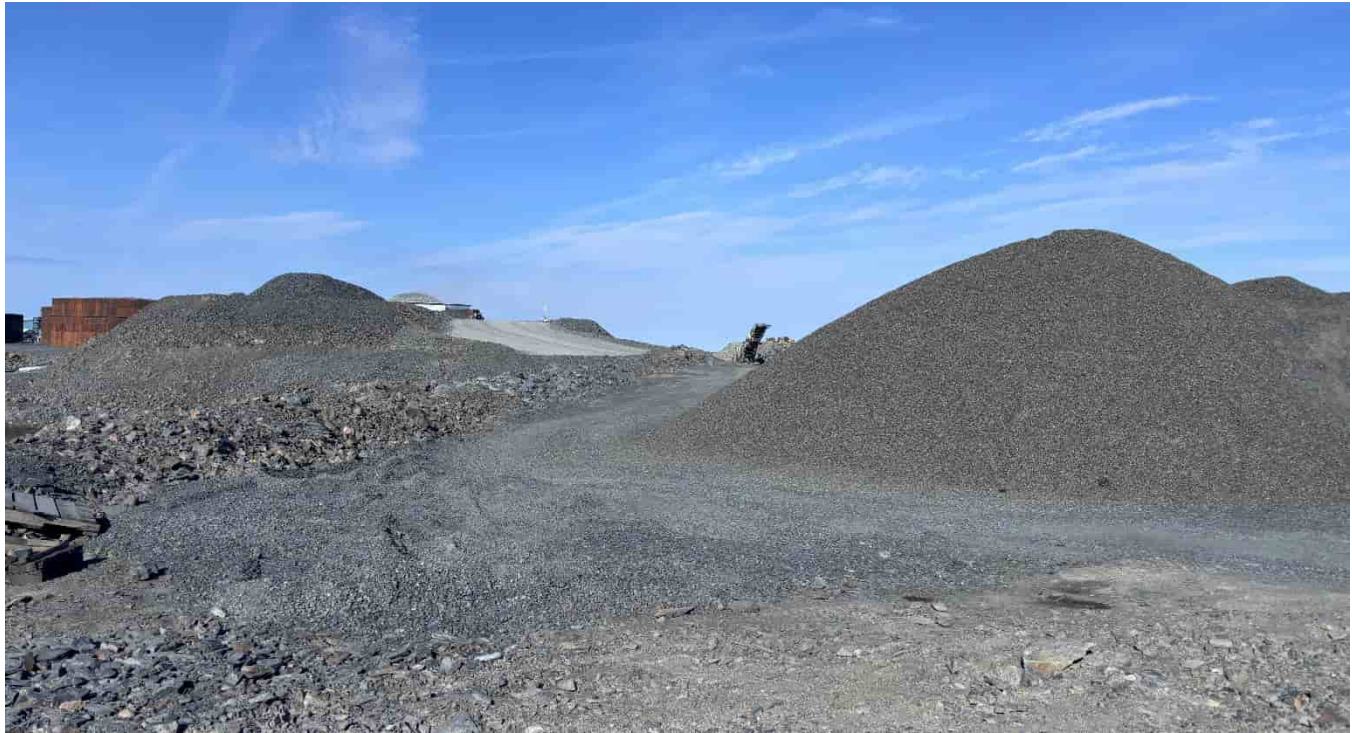
G-223: ROM stockpiles, looking N

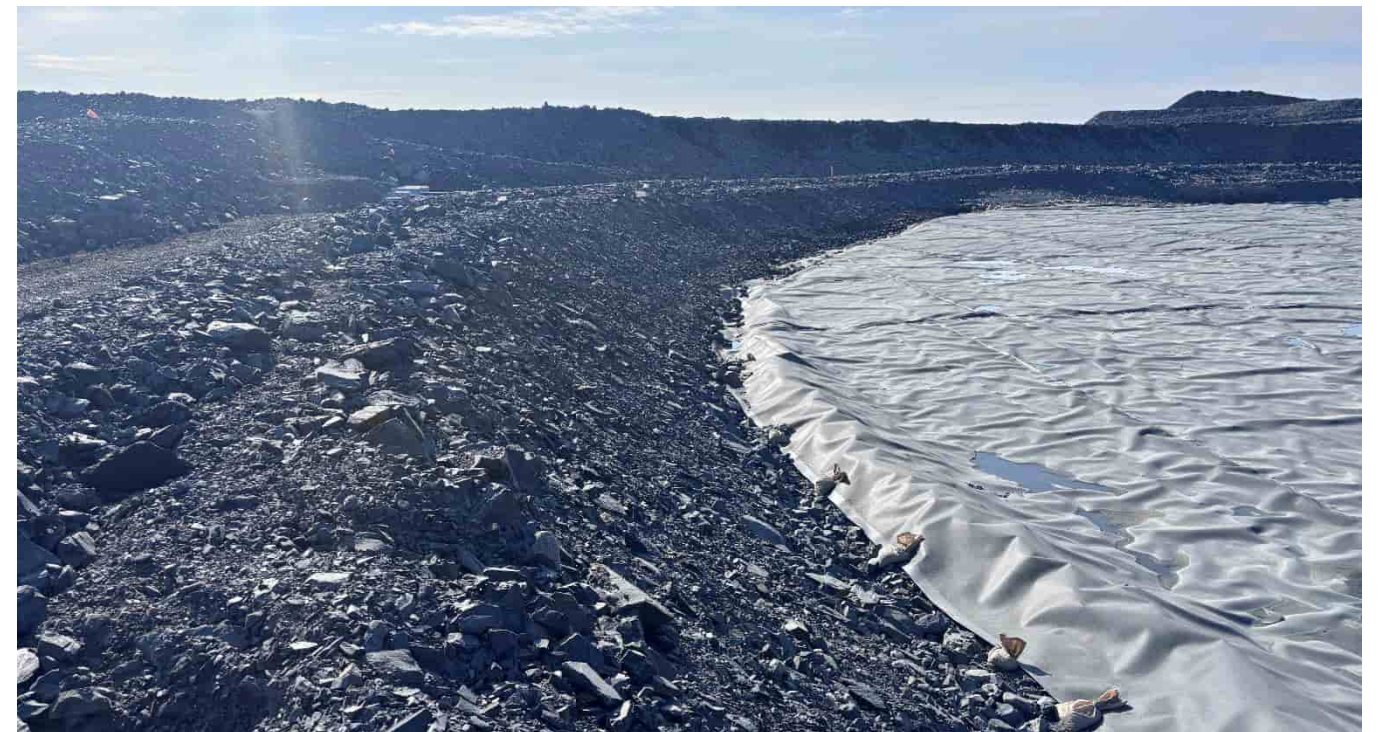
G-232: Eastern pond slope, looking S

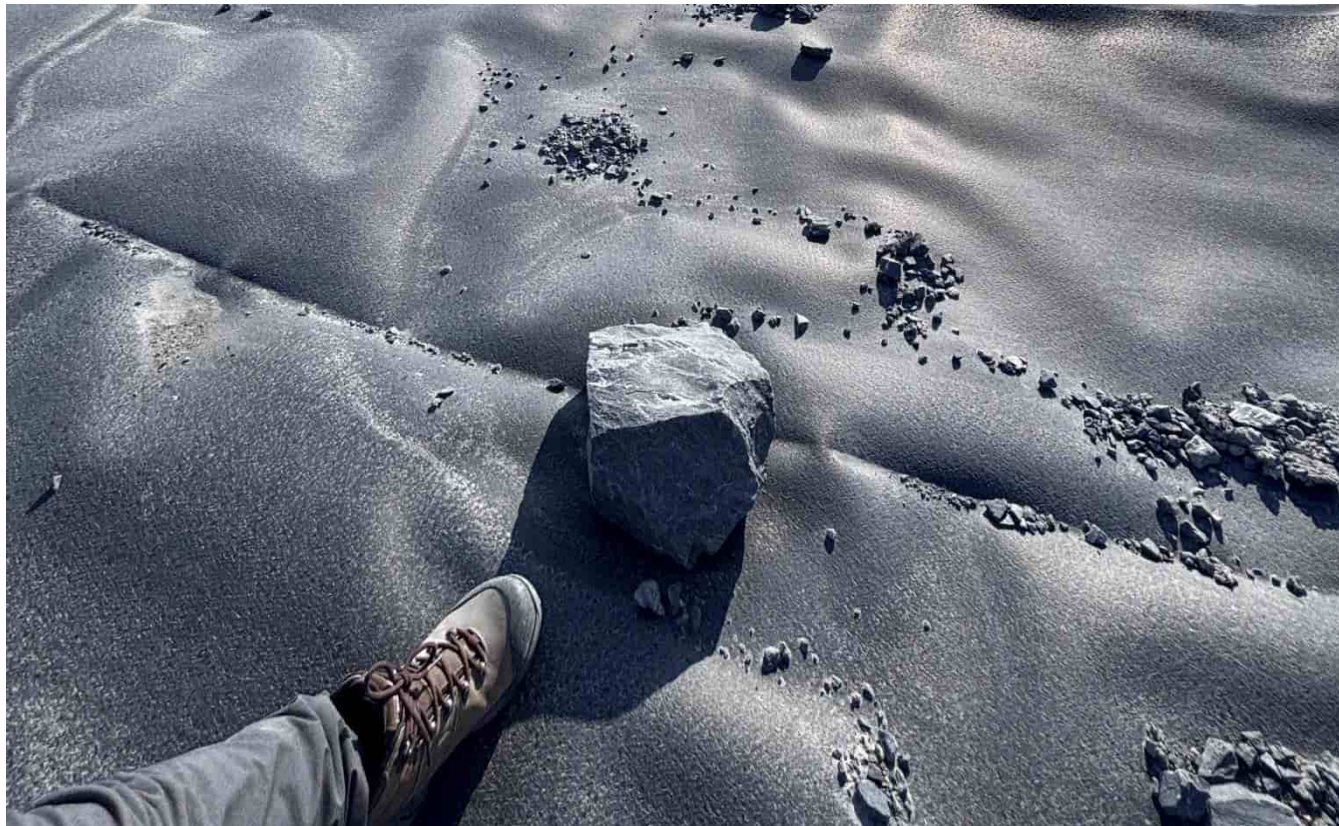
G-238: Liner at NW end of pond
