| | | 2025 Annual Geotechnical Inspection | | |
| Job No: CAPR004312<br>Filename: Back River_Goose_2025_AGI_Photoslog.pdf | Back River Project | Date:<br>February 2026 | Approved:<br>JBK | Figure:<br>79 |

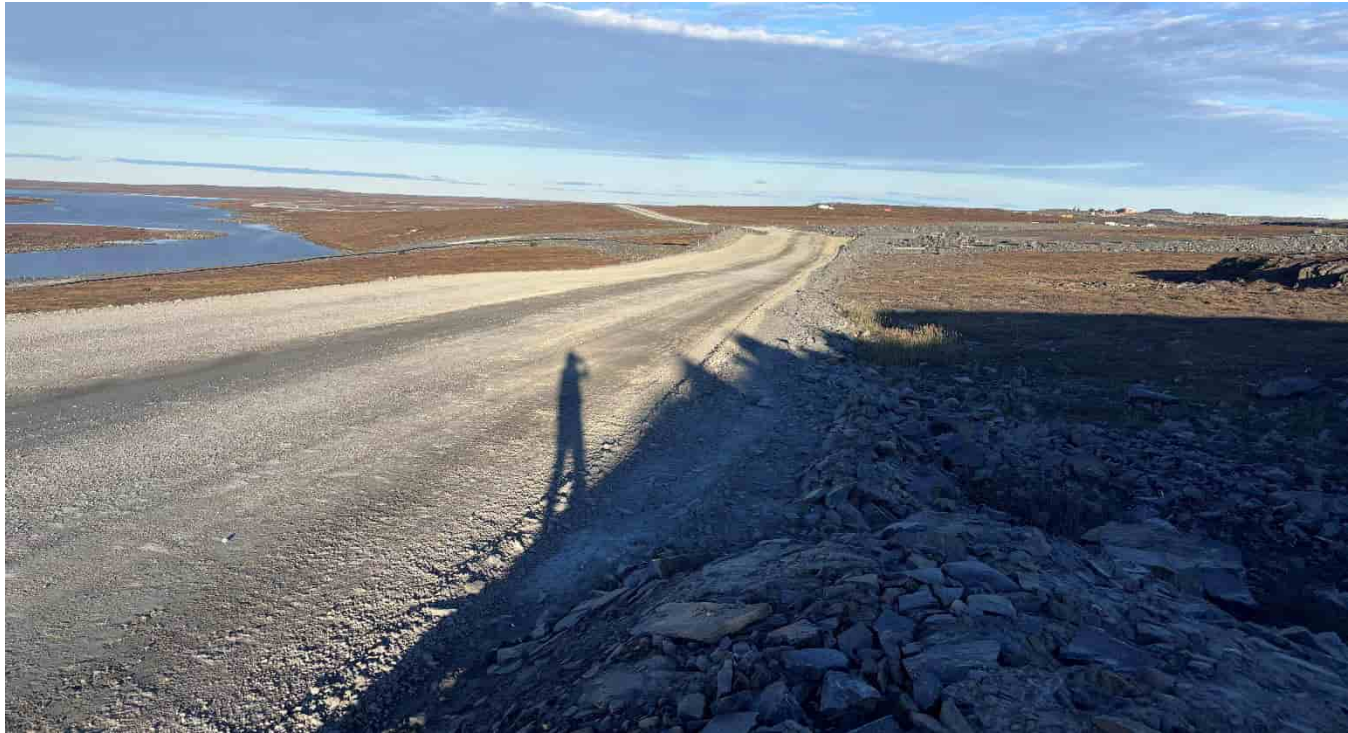
G-244: All-Weather Road, looking W

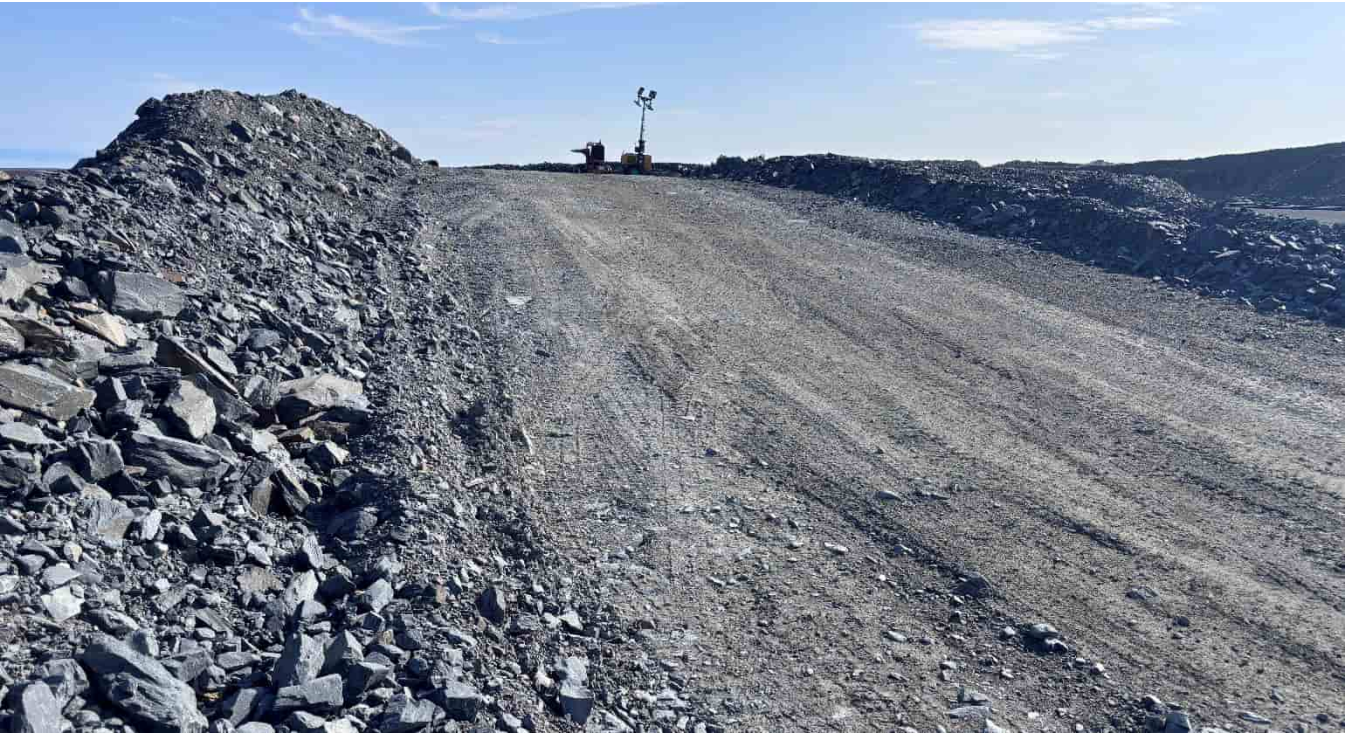
G-245: Entrance to camp pad contact water pond, looking E

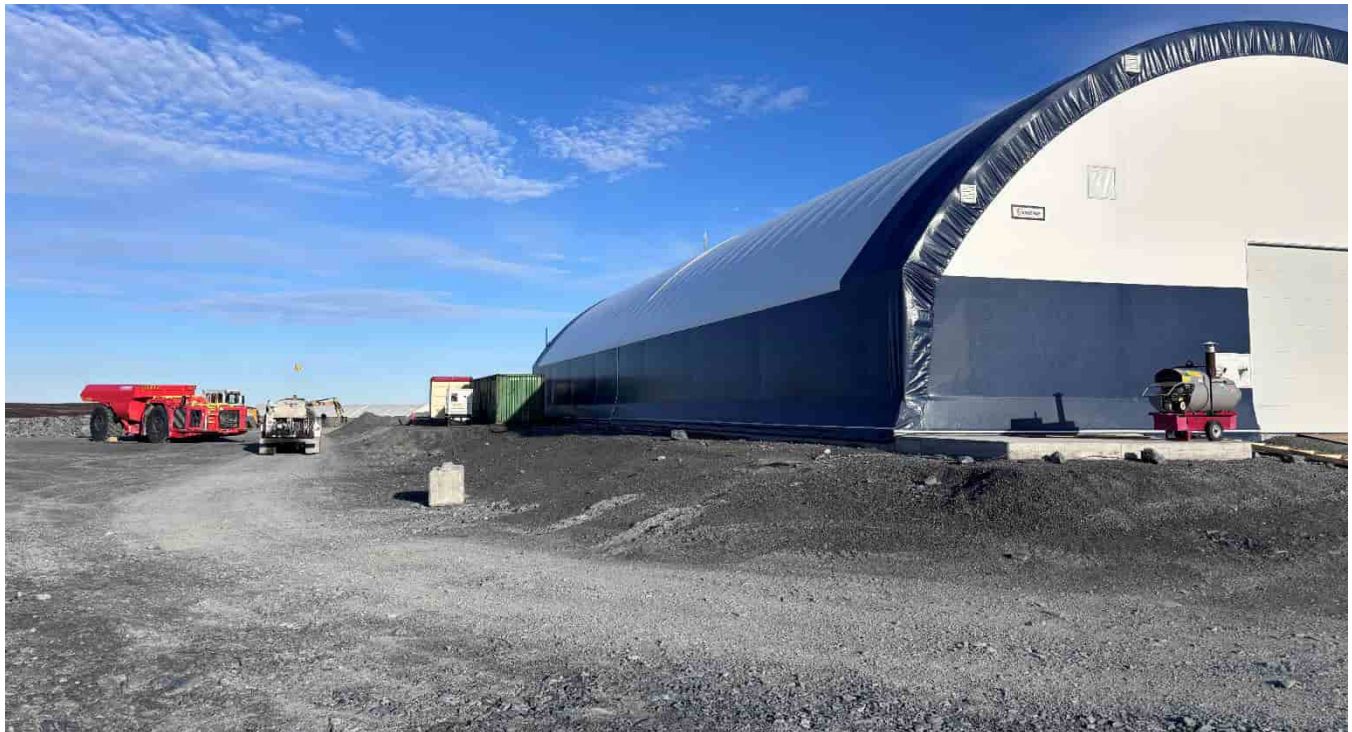
G-260: North end of main camp area, looking E

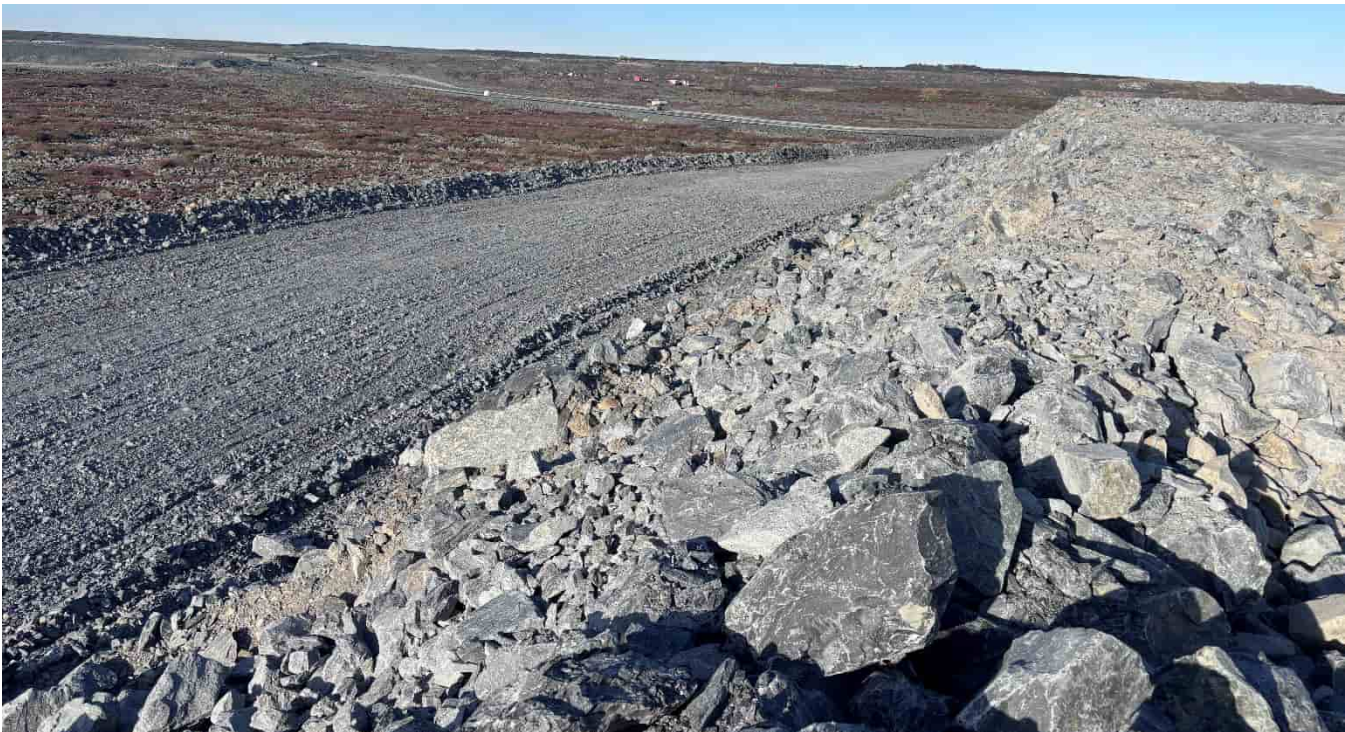
G-261: Camp pad NW slope, looking NE

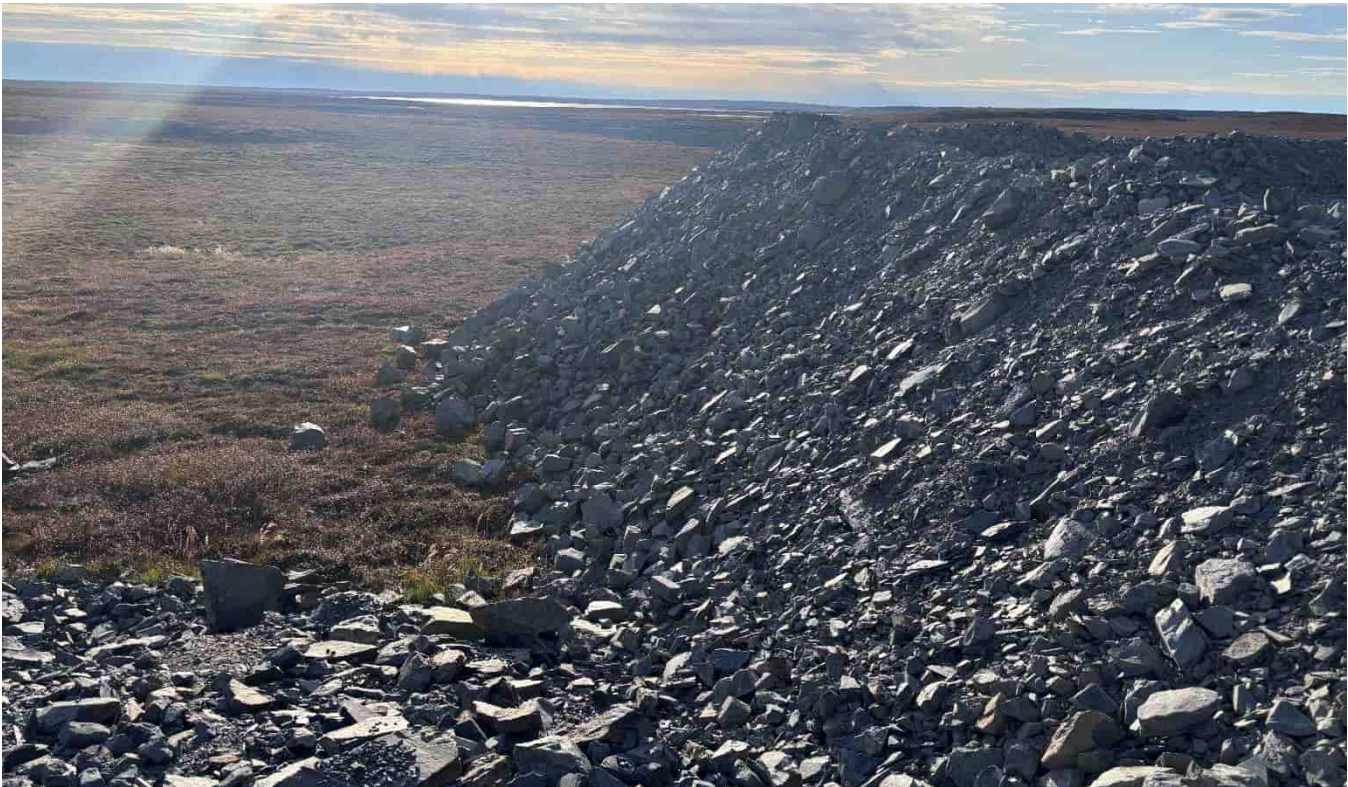
G-264: Camp pad W slope, looking W

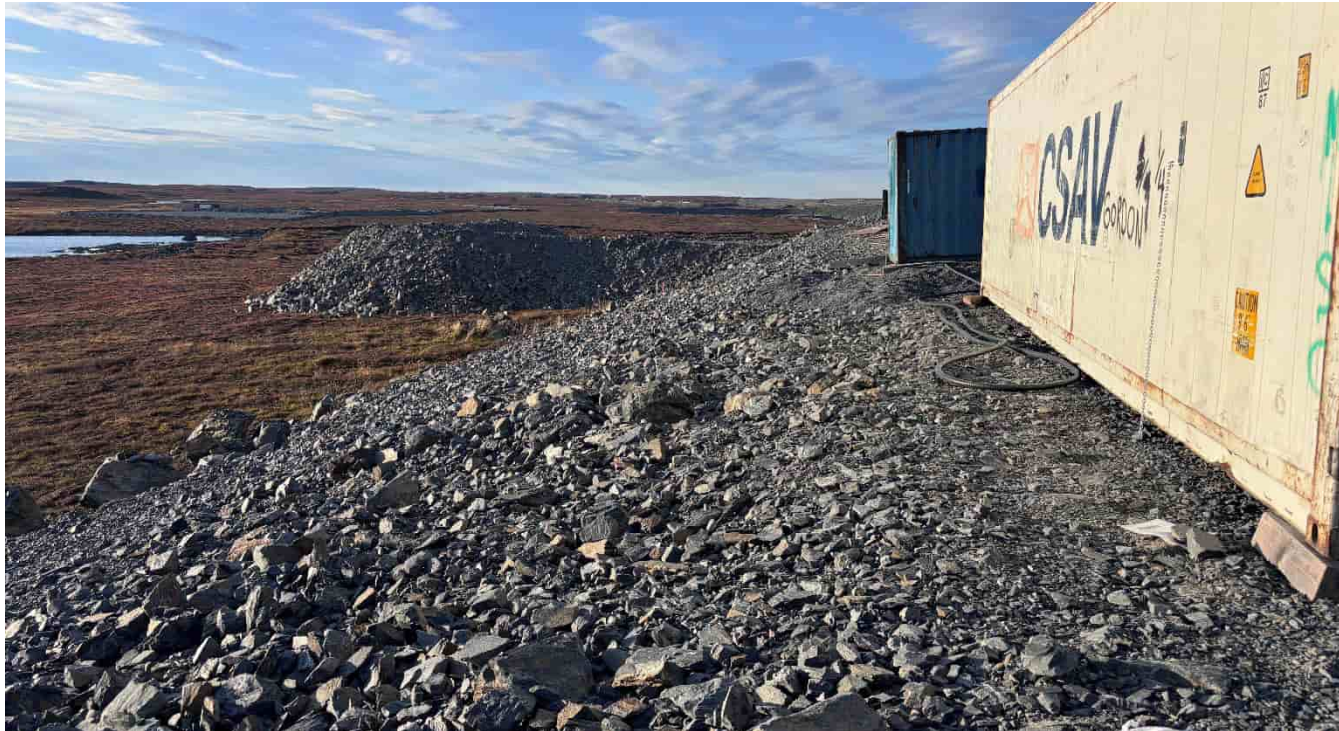
G-269: Seacans close to W camp pad edge

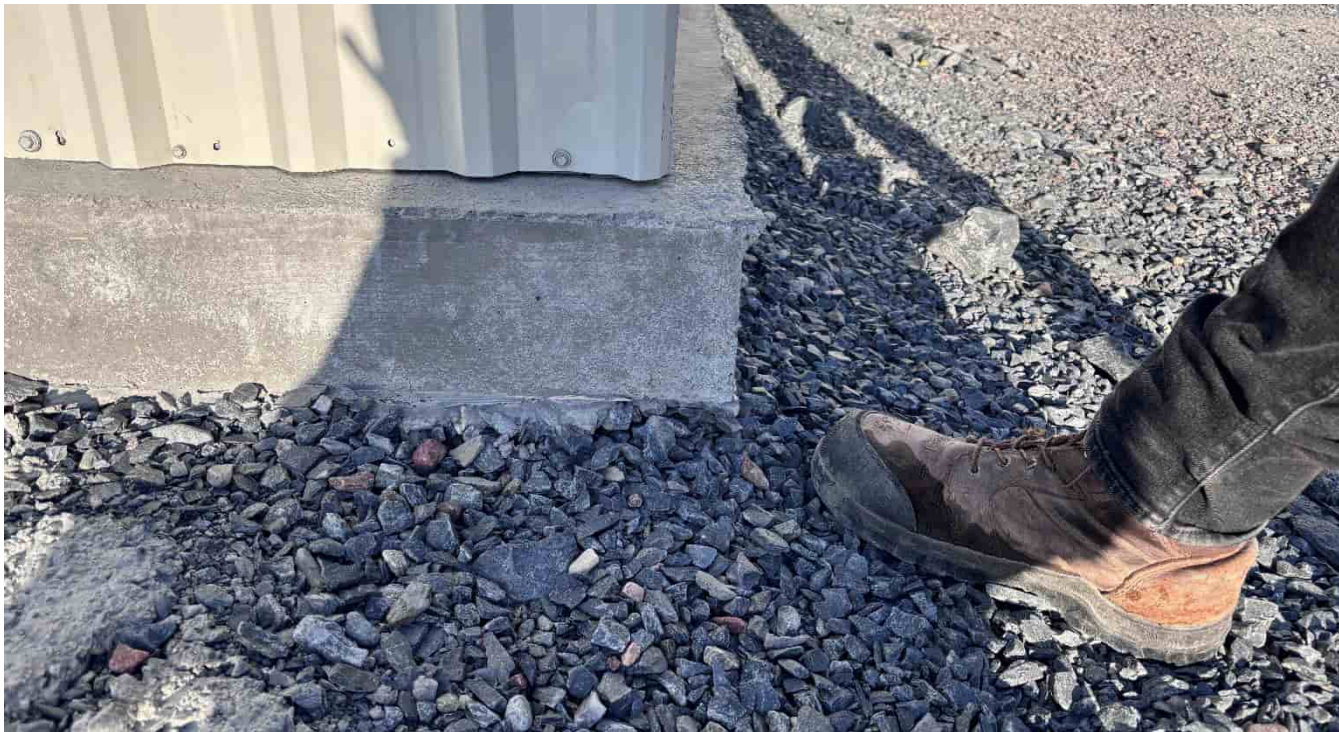
G-271: Typical foundation slab height above pad surface

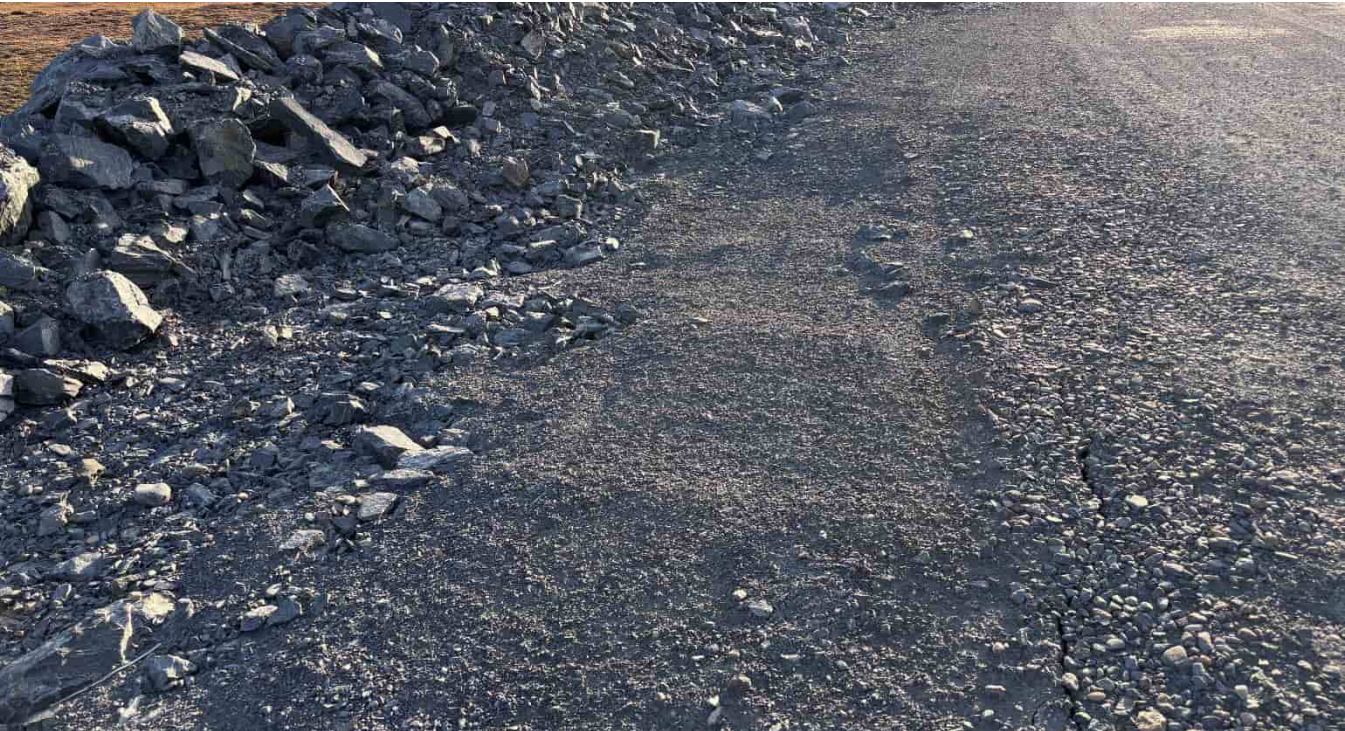
G-274: Camp pad southern side, looking W

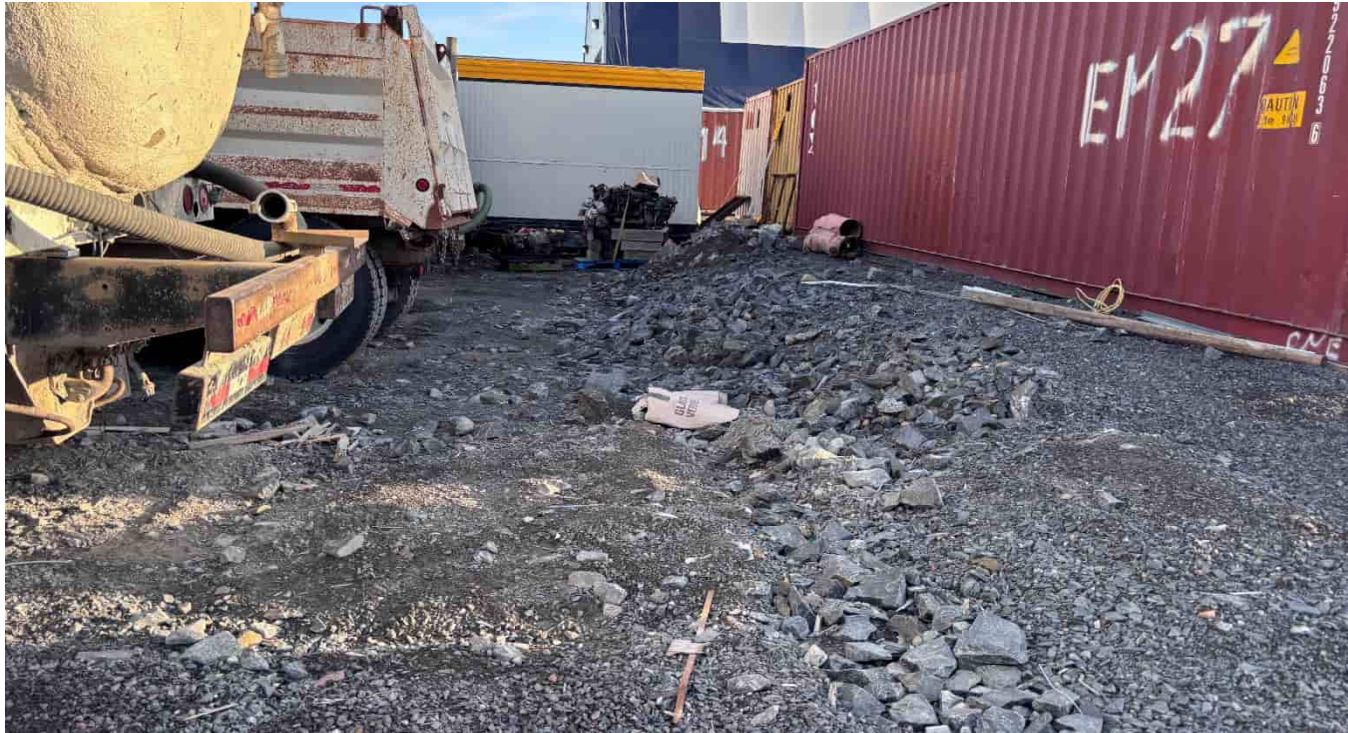
G-276: Storage area S of main camp, looking S

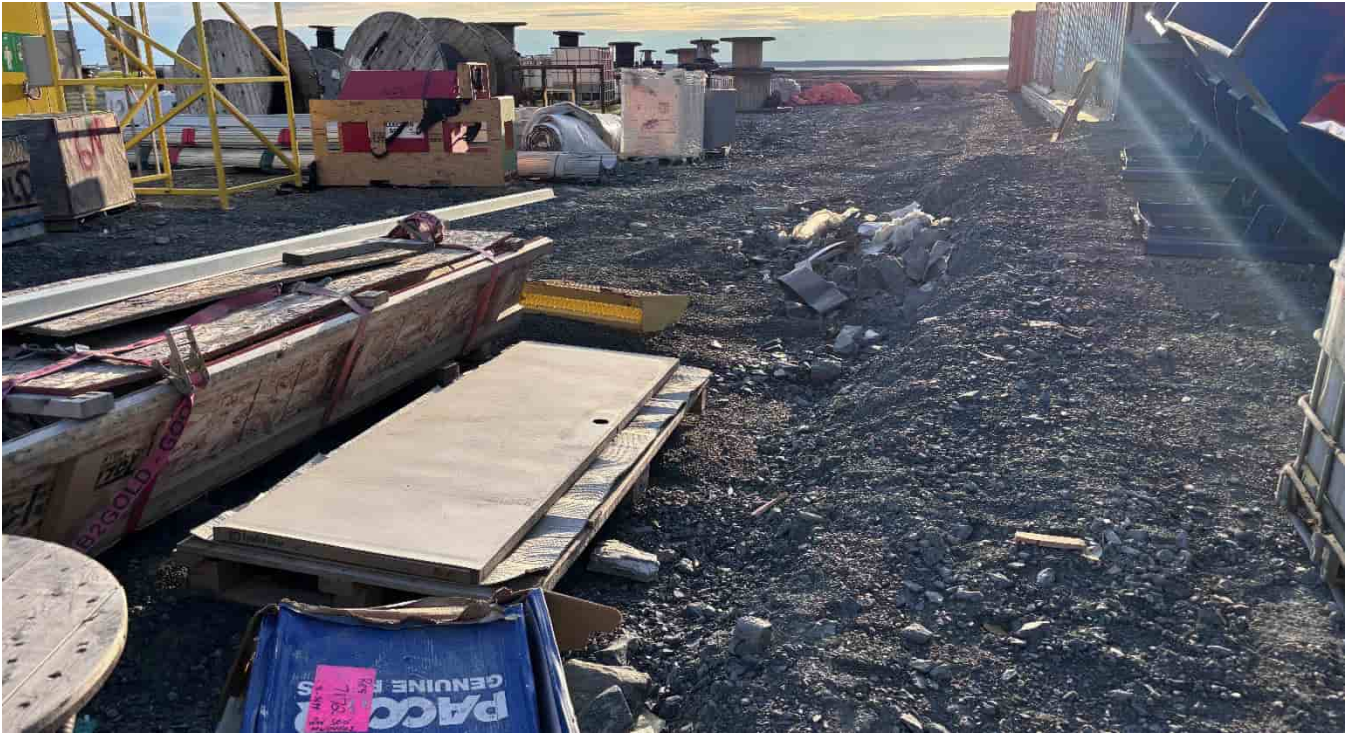
G-277: Laydown S of main camp, looking W

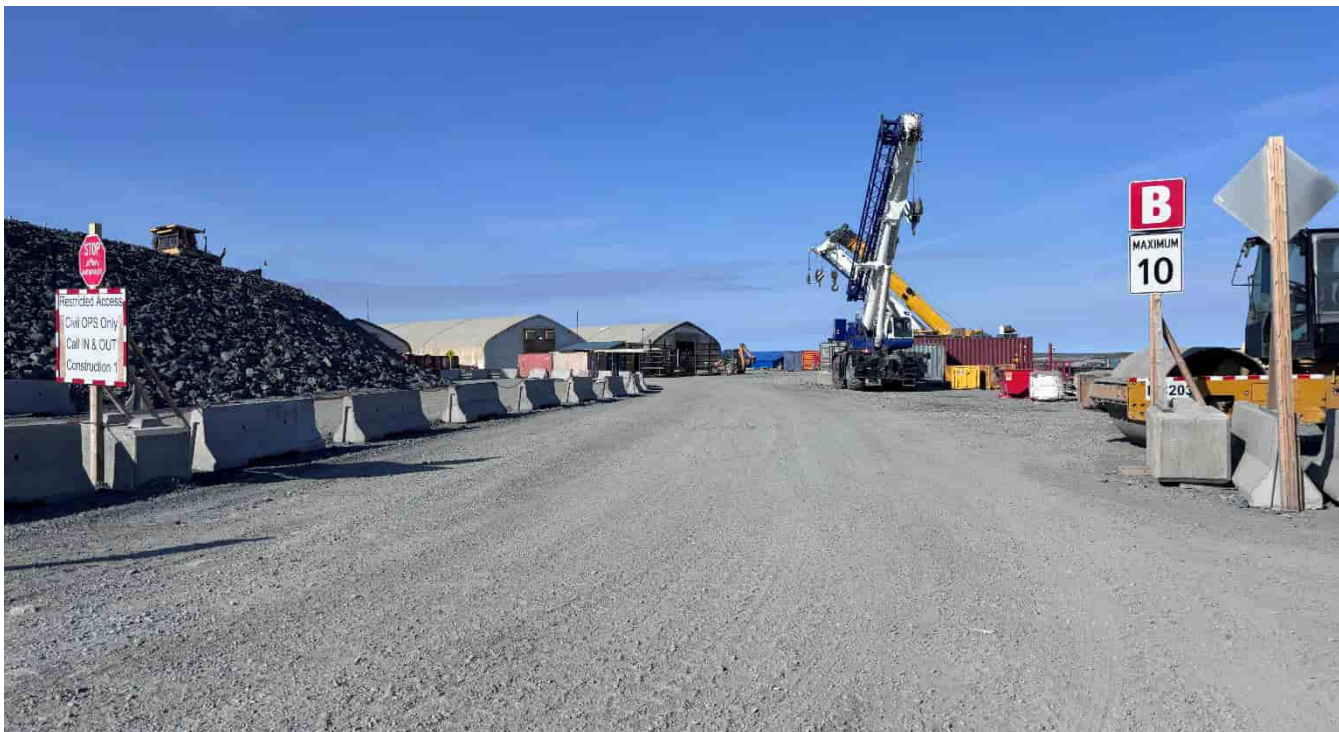
G-294: Entrance to plant area

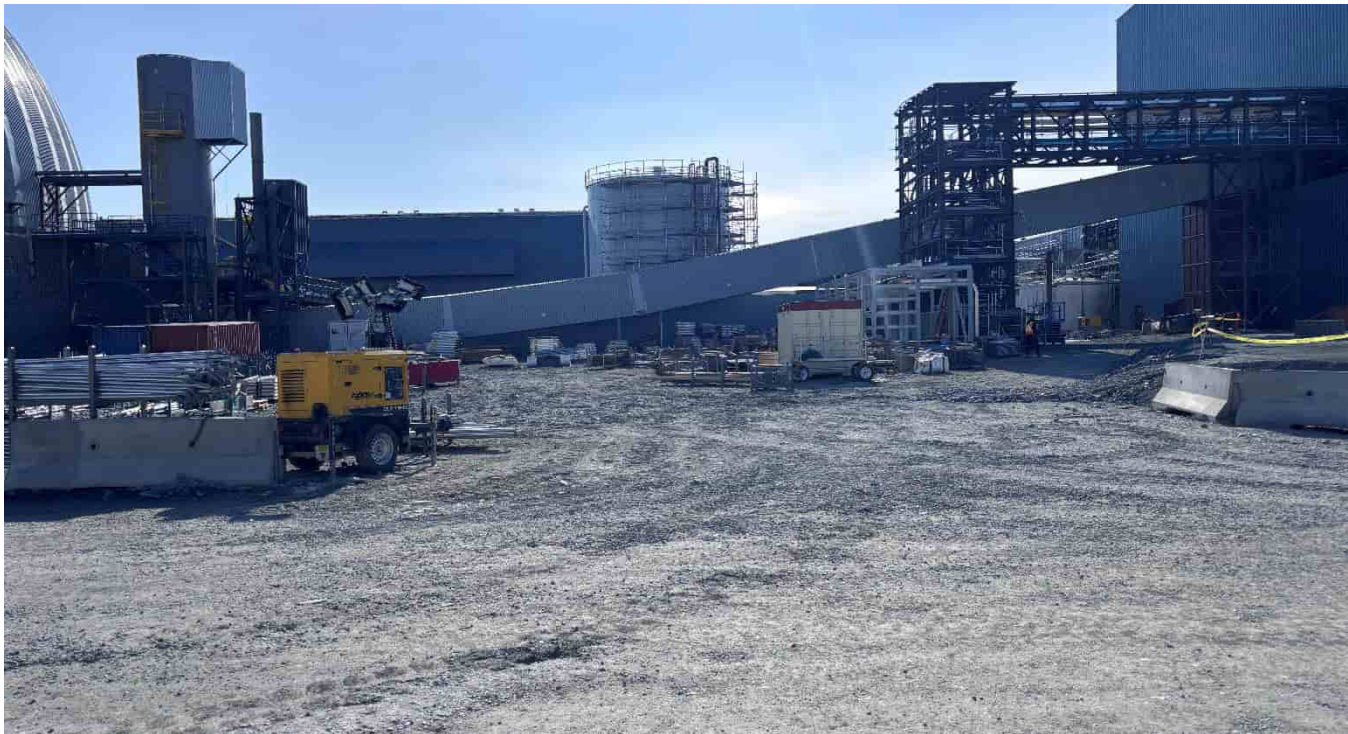
G-298: View towards process plant from road, looking S

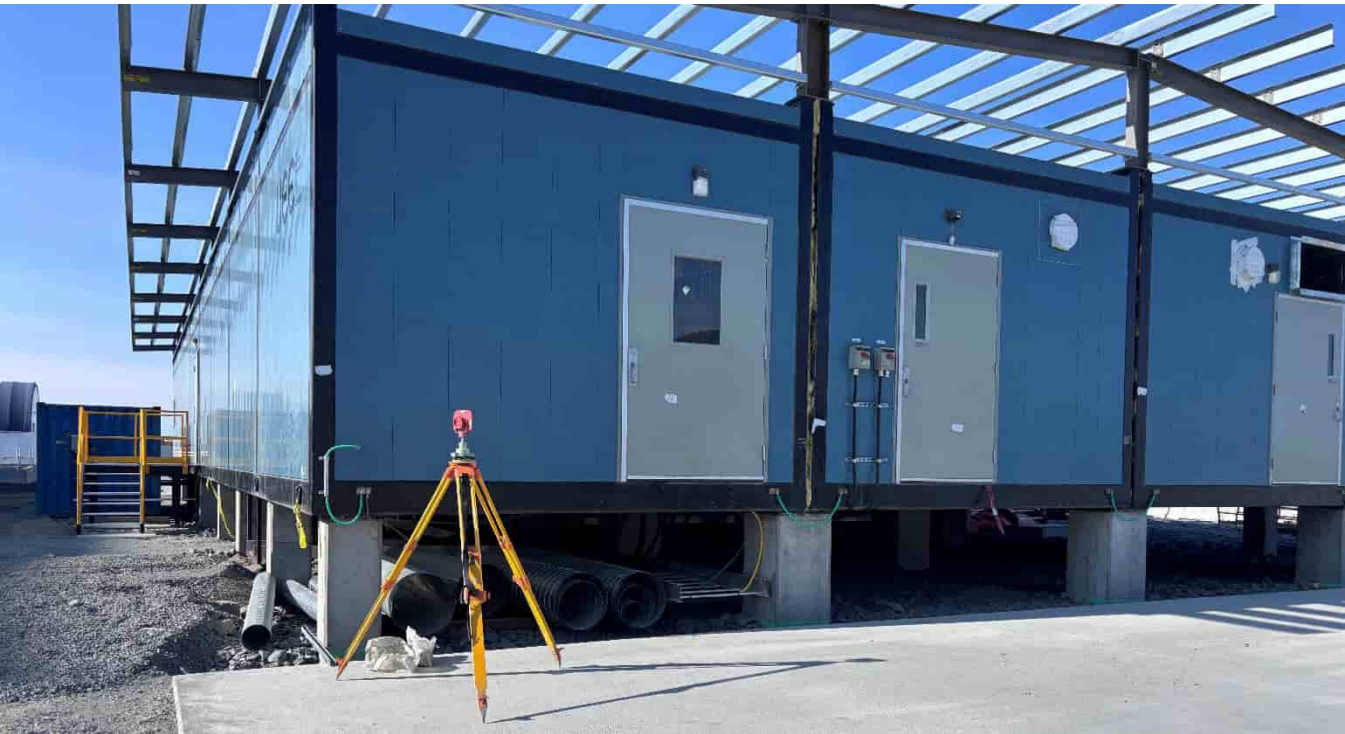
G-299: Assay lab typical construction

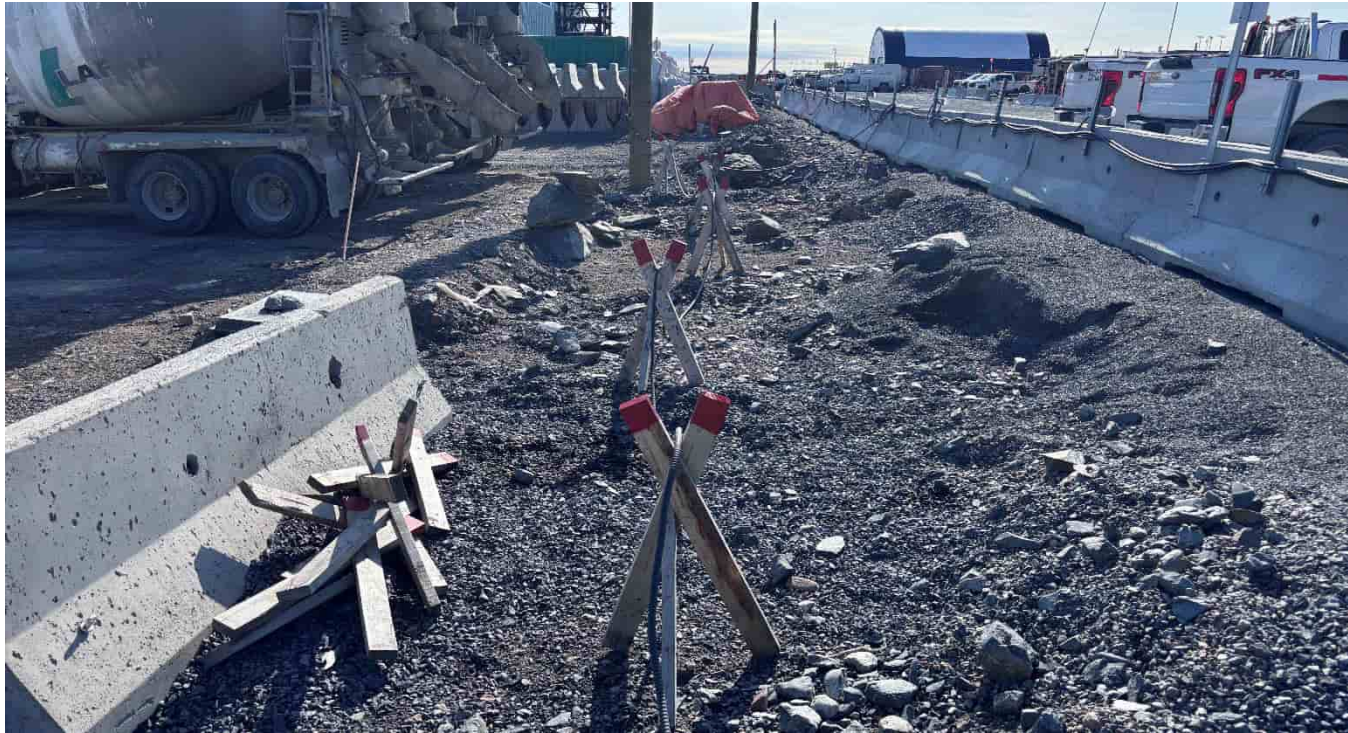
G-300: Laydown area E of main camp, looking N

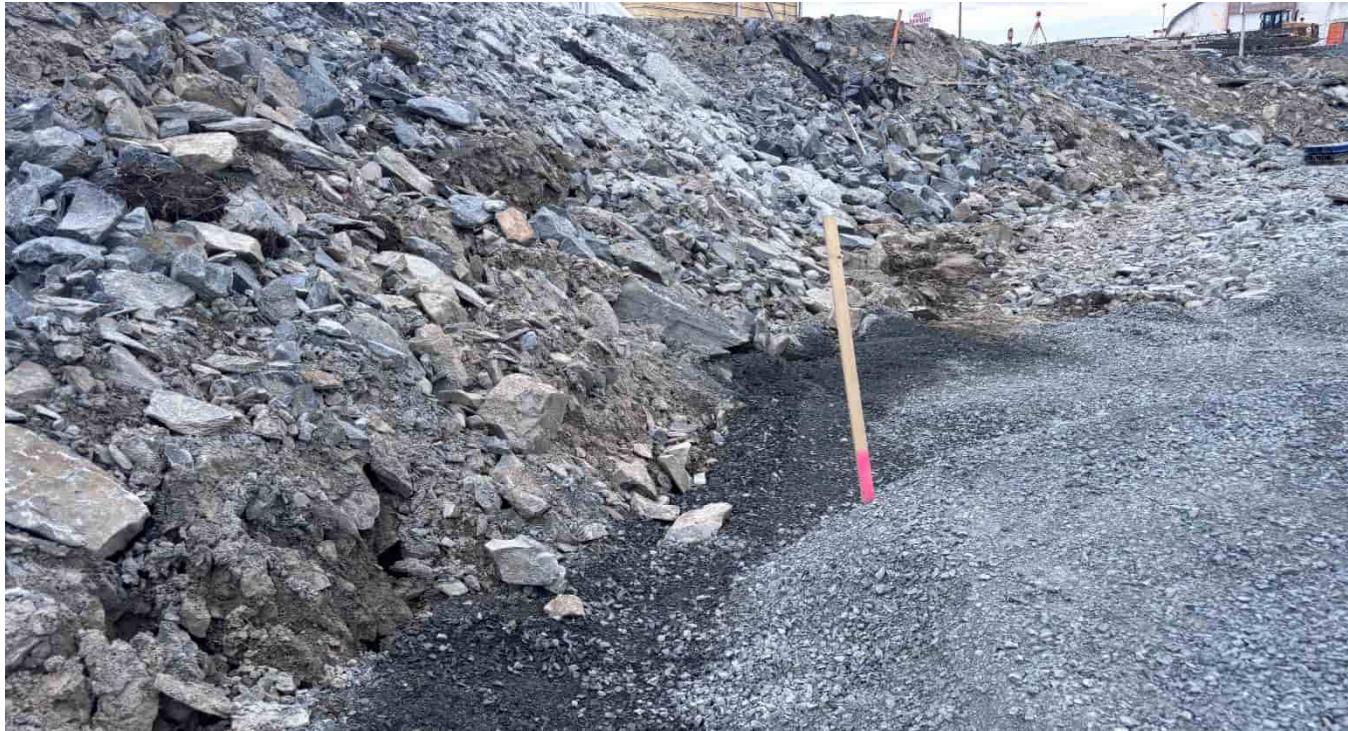
G-304: Toe of slope beside vent raise, looking SW

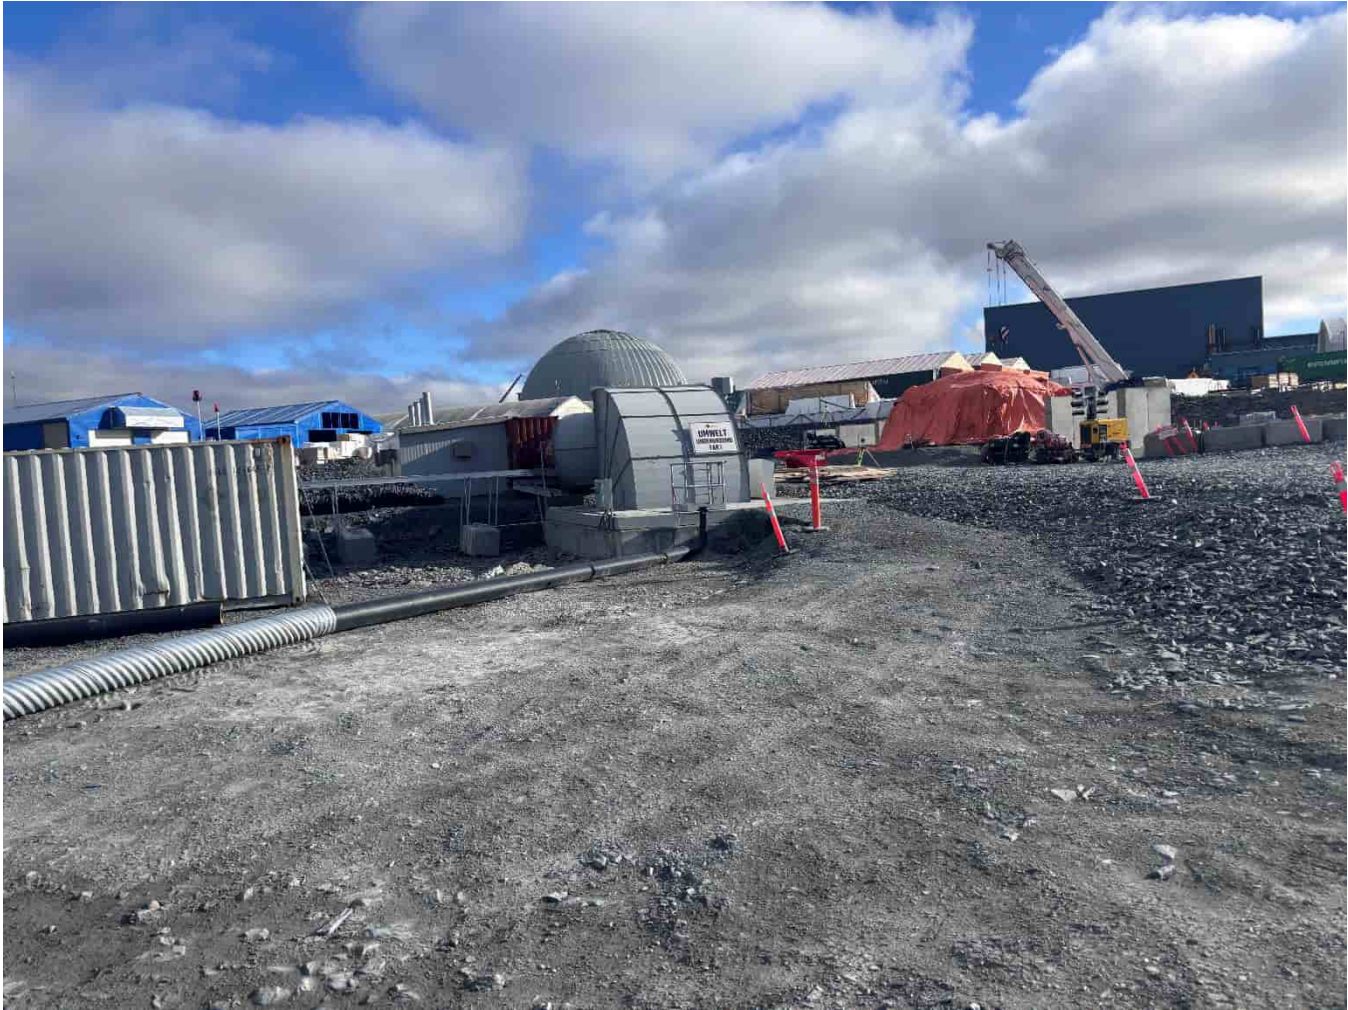
G-309: Vent raise, looking SE

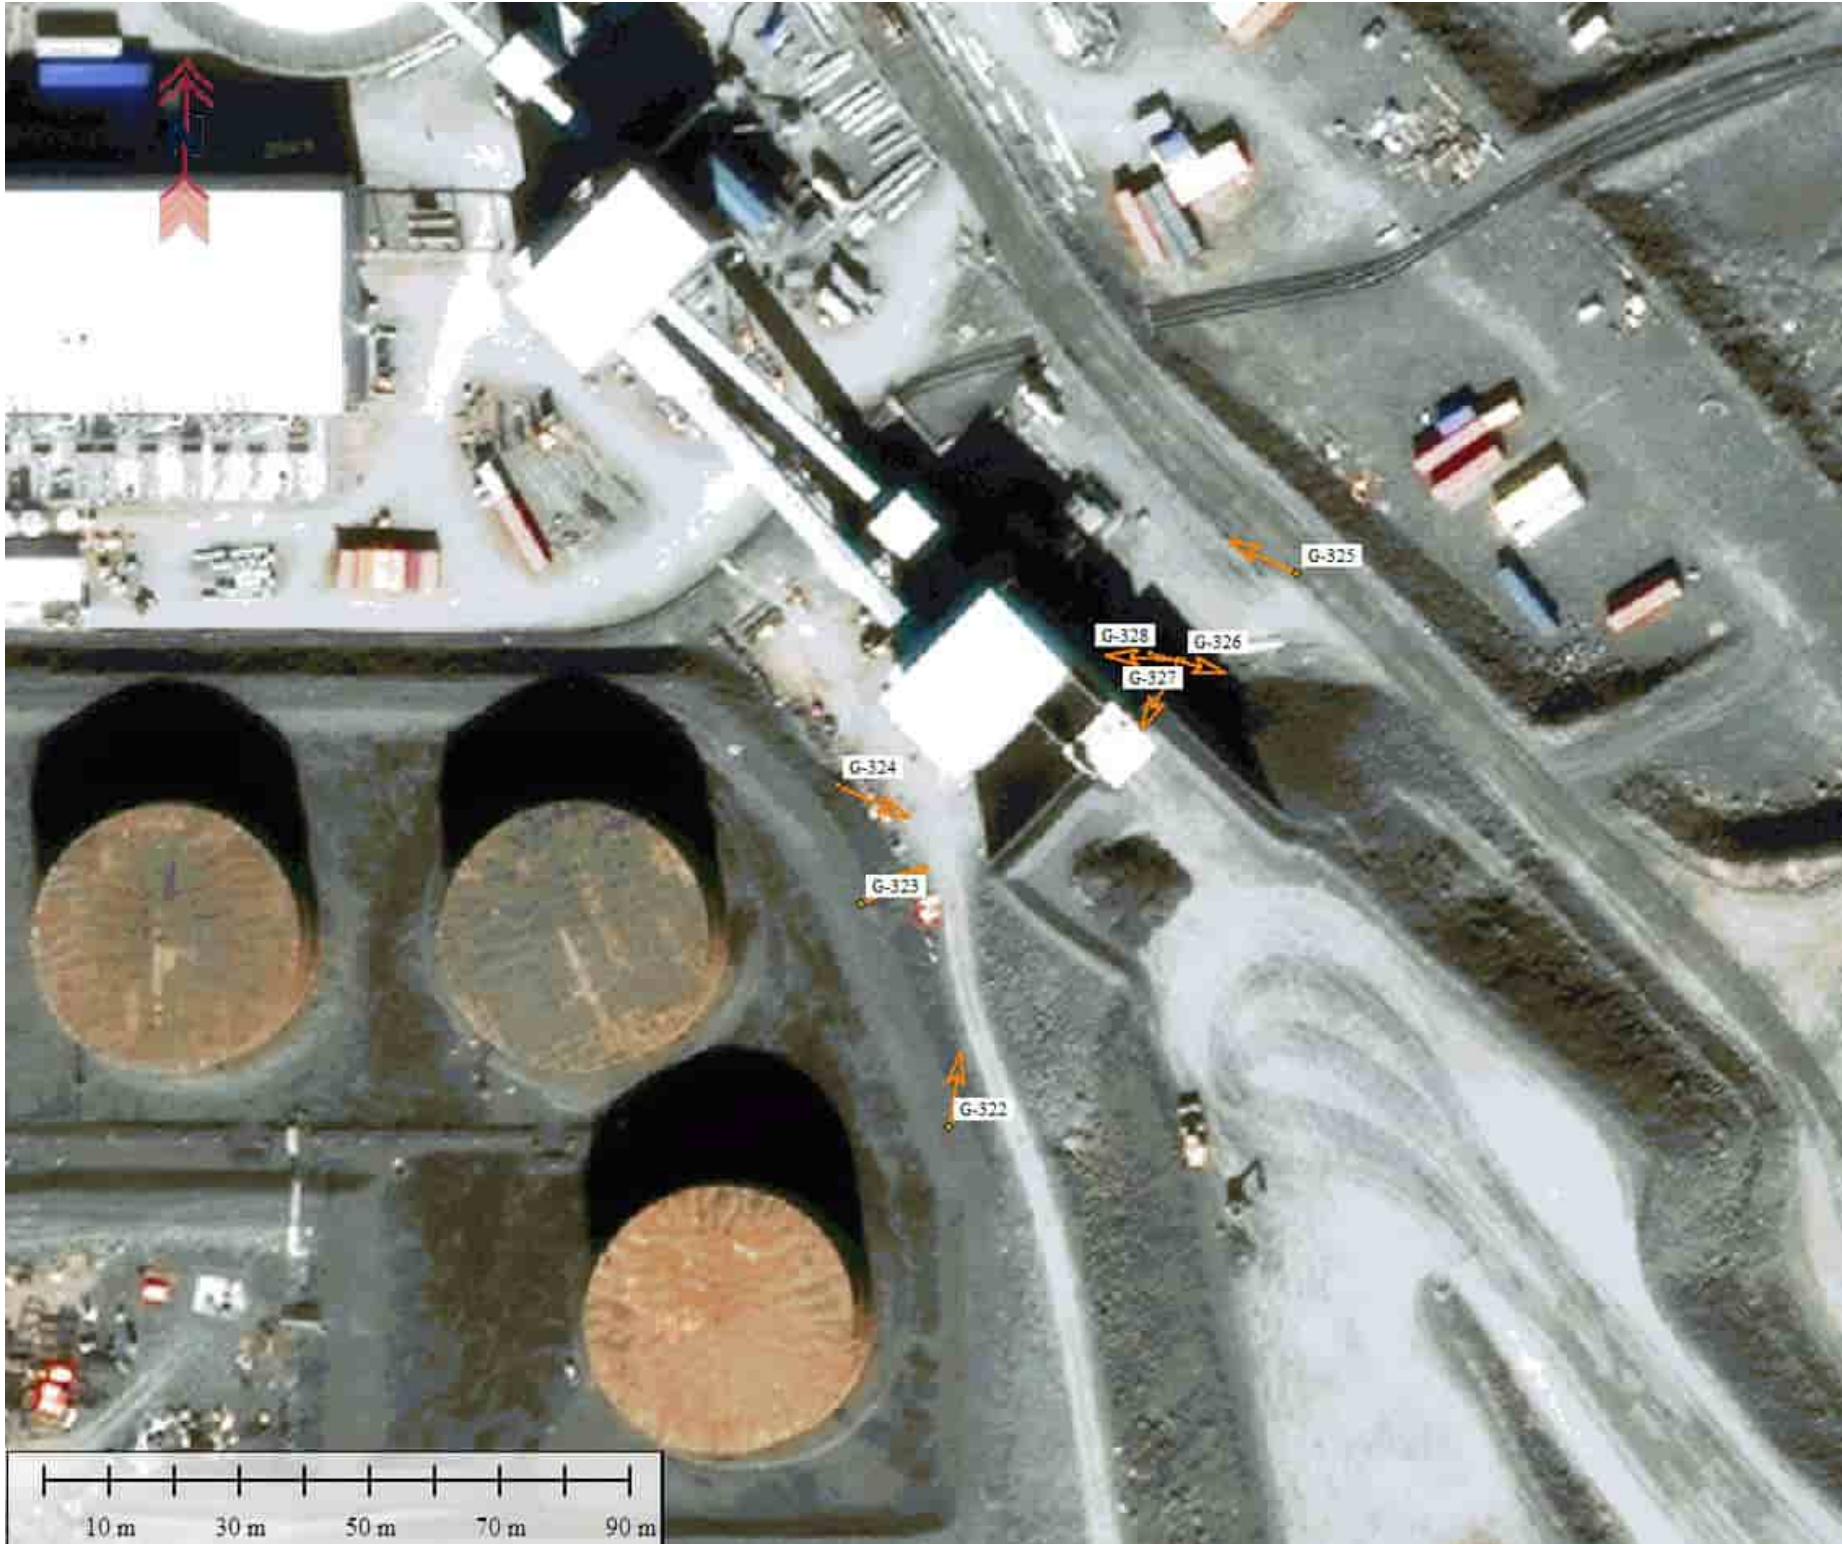
G-321: Slope approaching MSE wall, looking N

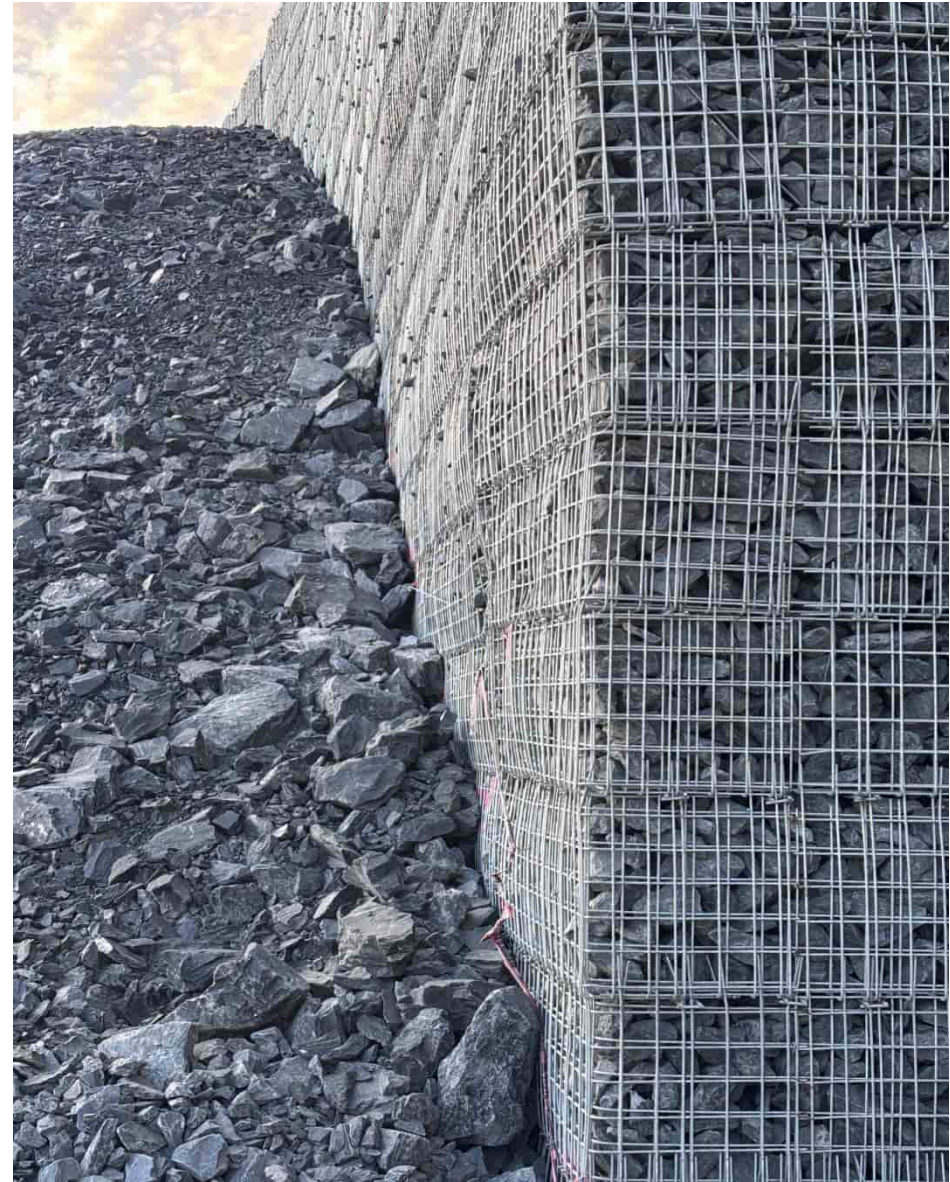
G-328: Typical MSE wall construction and tie-in with eastern slope

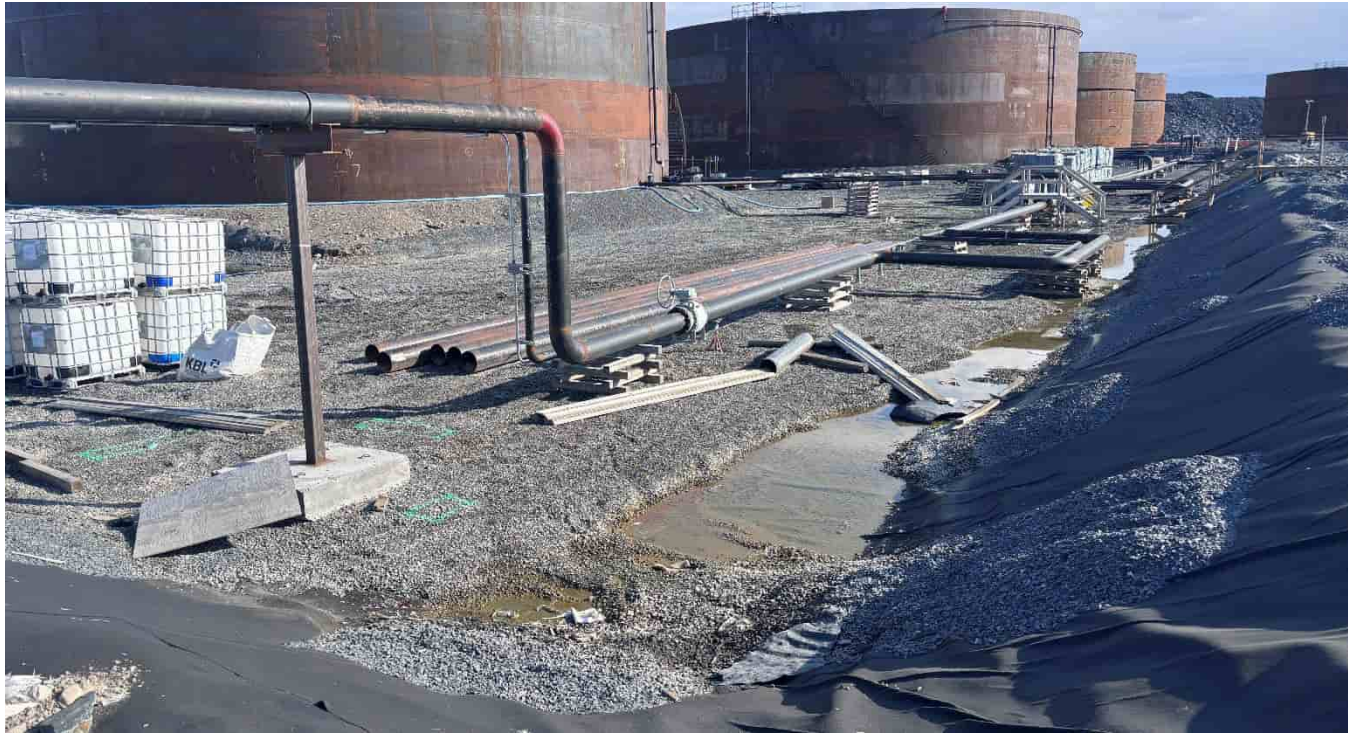
G-350: SW corner of tank farm (Phase 1)

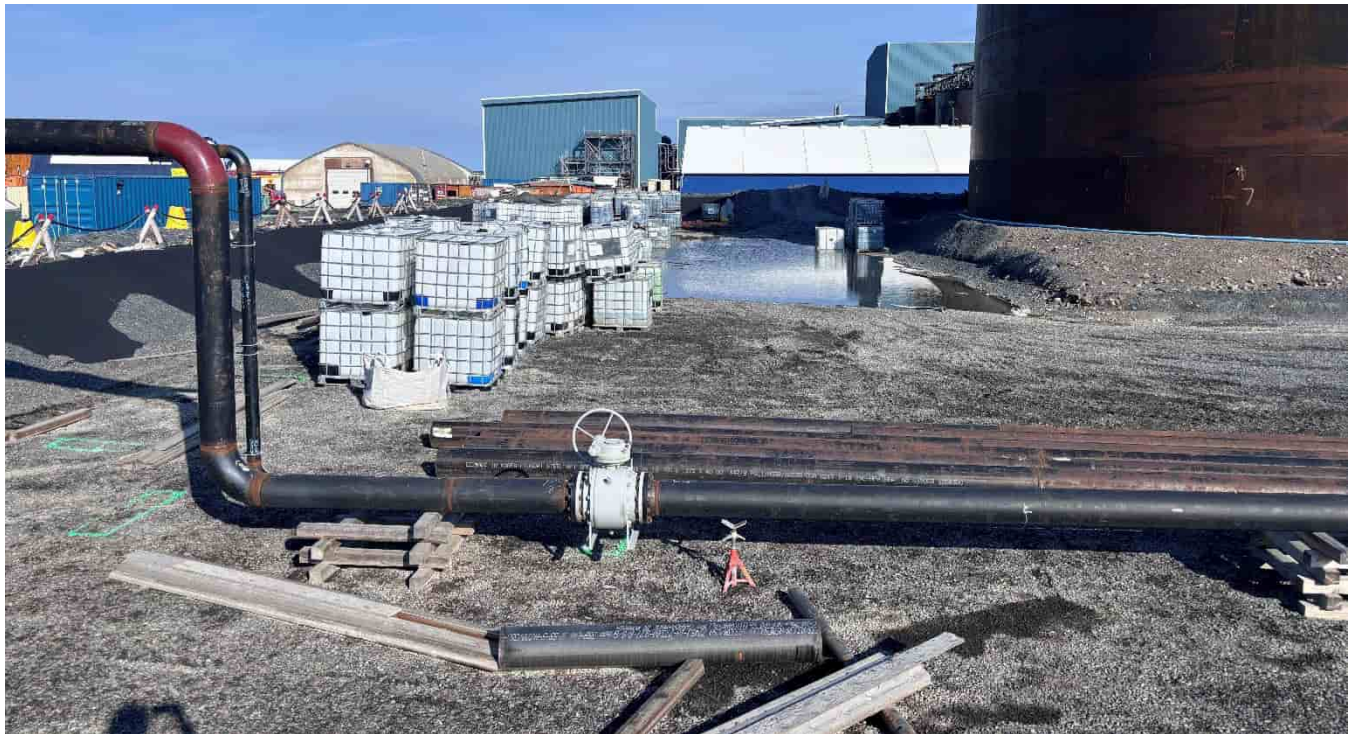
G-352: Tote storage and ponding, looking N

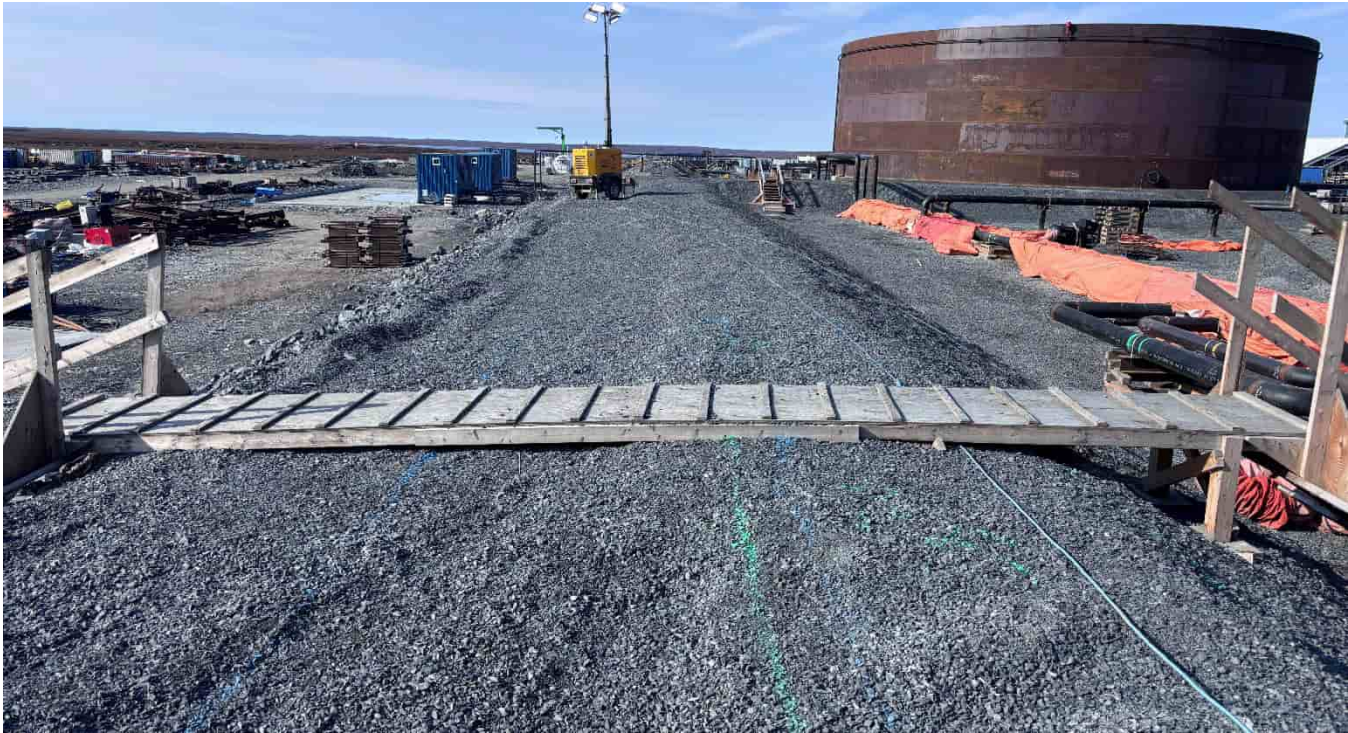
G-362: Southern berm, looking W
