| | | 2025 Annual Geotechnical Inspection | | |
| Job No: CAPR004312<br>Filename: Back River_Goose_2025_AGI_Photoslog.pdf | Back River Project | Date:<br>February 2026 | Approved:<br>JBK | Figure:<br>79 |

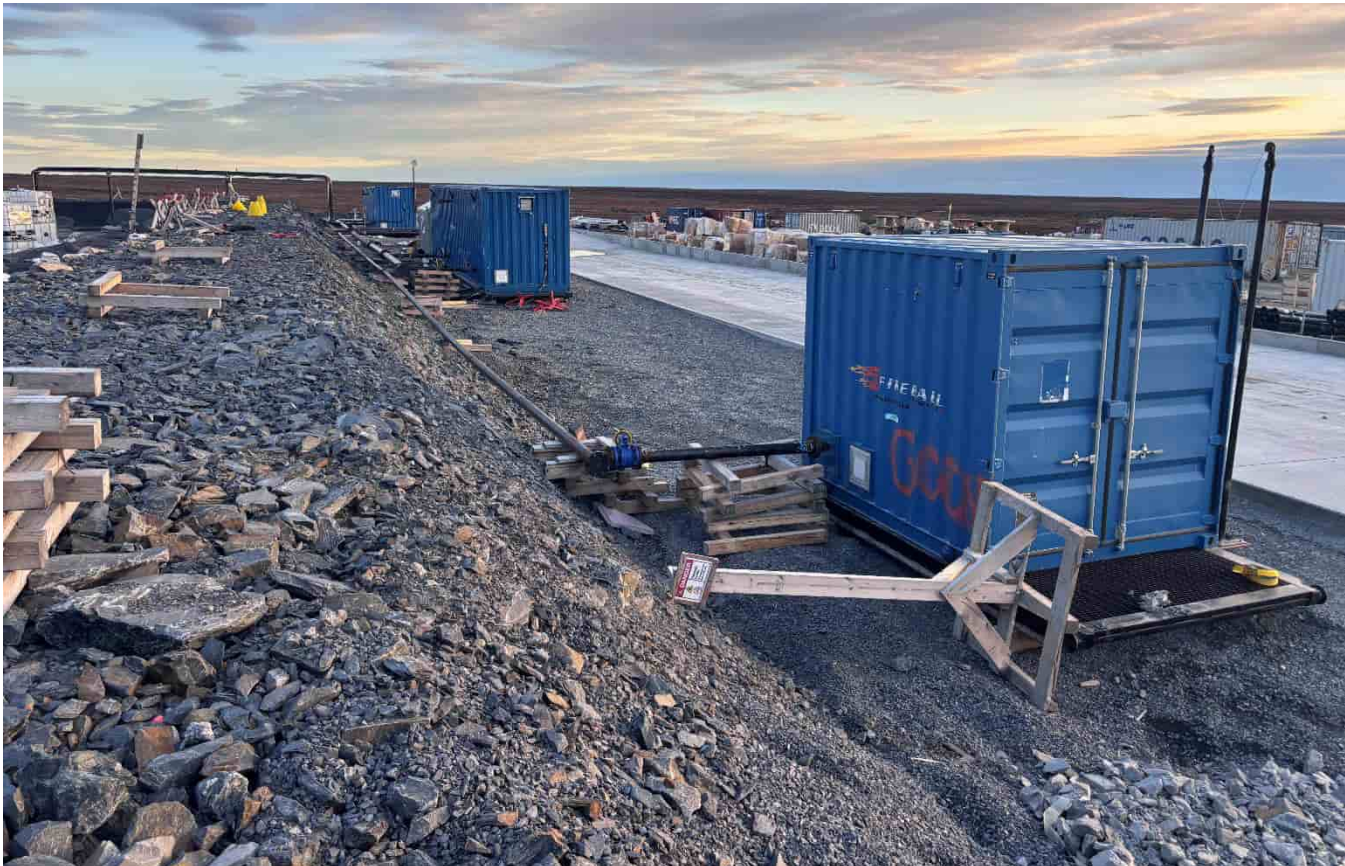
G-375: Fuel transfer area overview, looking SW

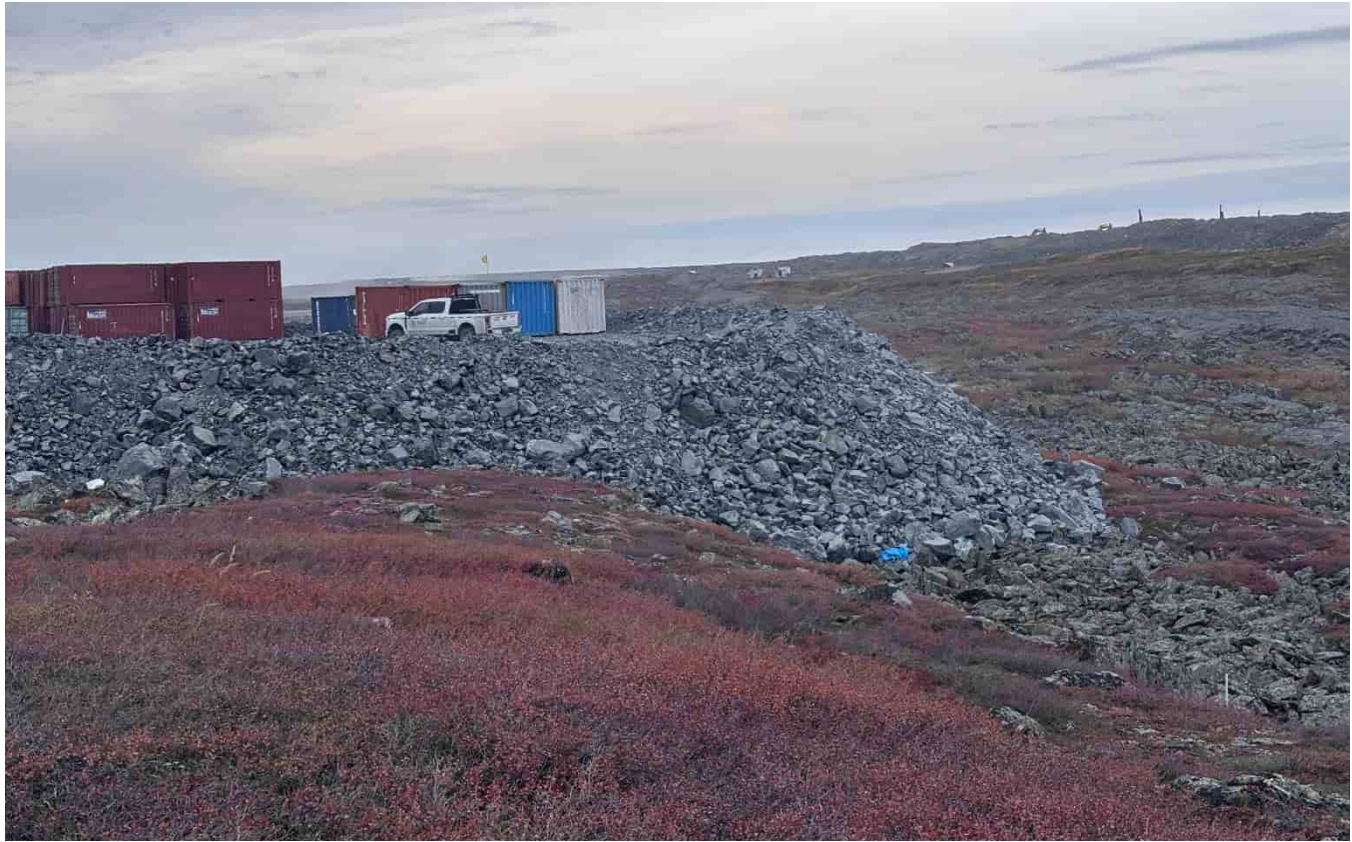
G-388: Laydown pad western corner, looking NW

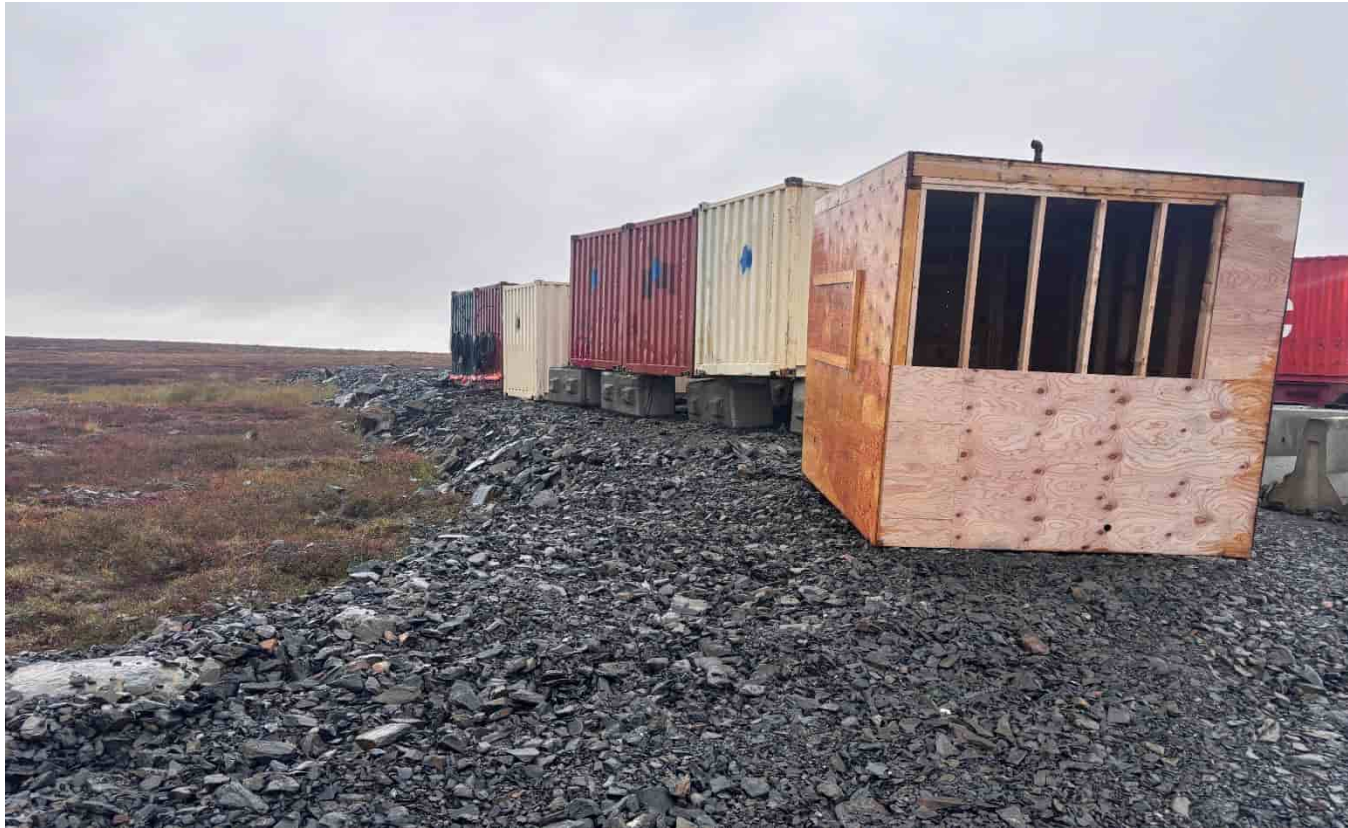
G-390A: North WIR laydown northern pad edge, looking E – Seacans near edge of thinner pad

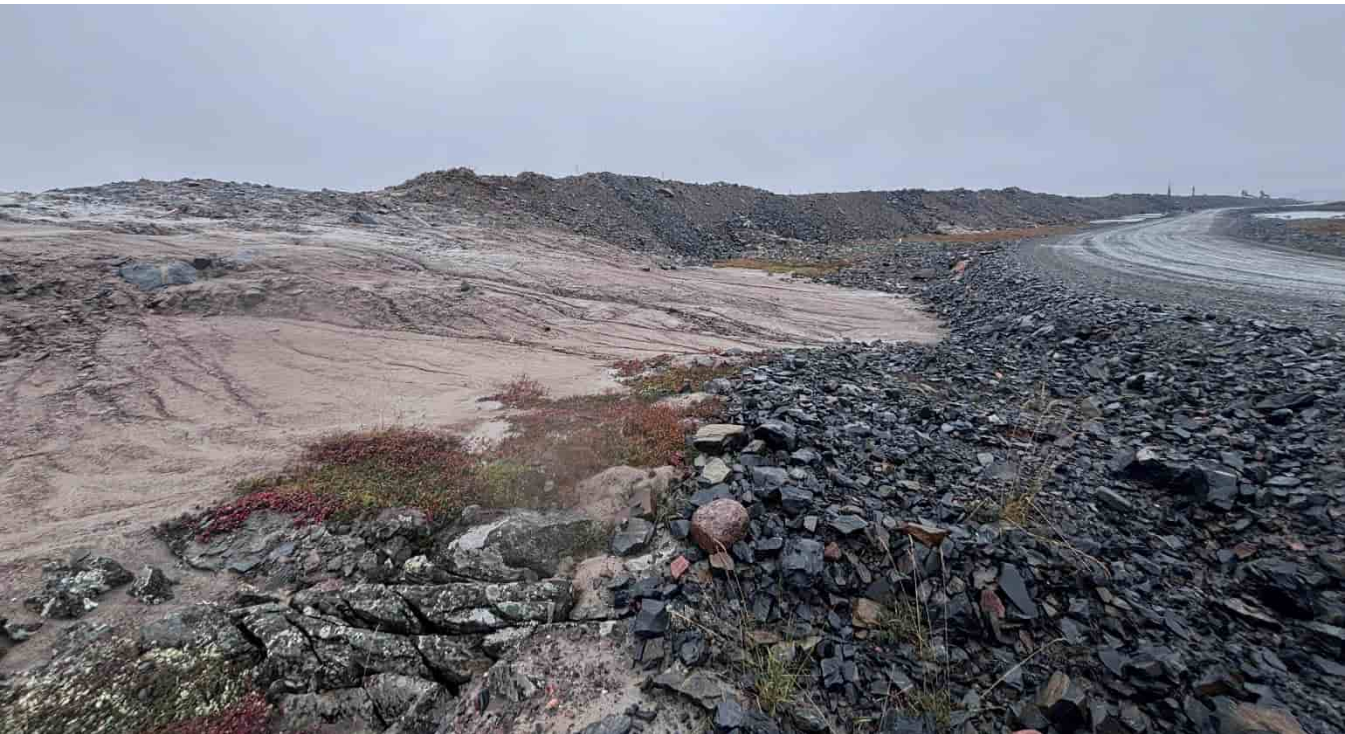
G-409: Stockpile beside road corner

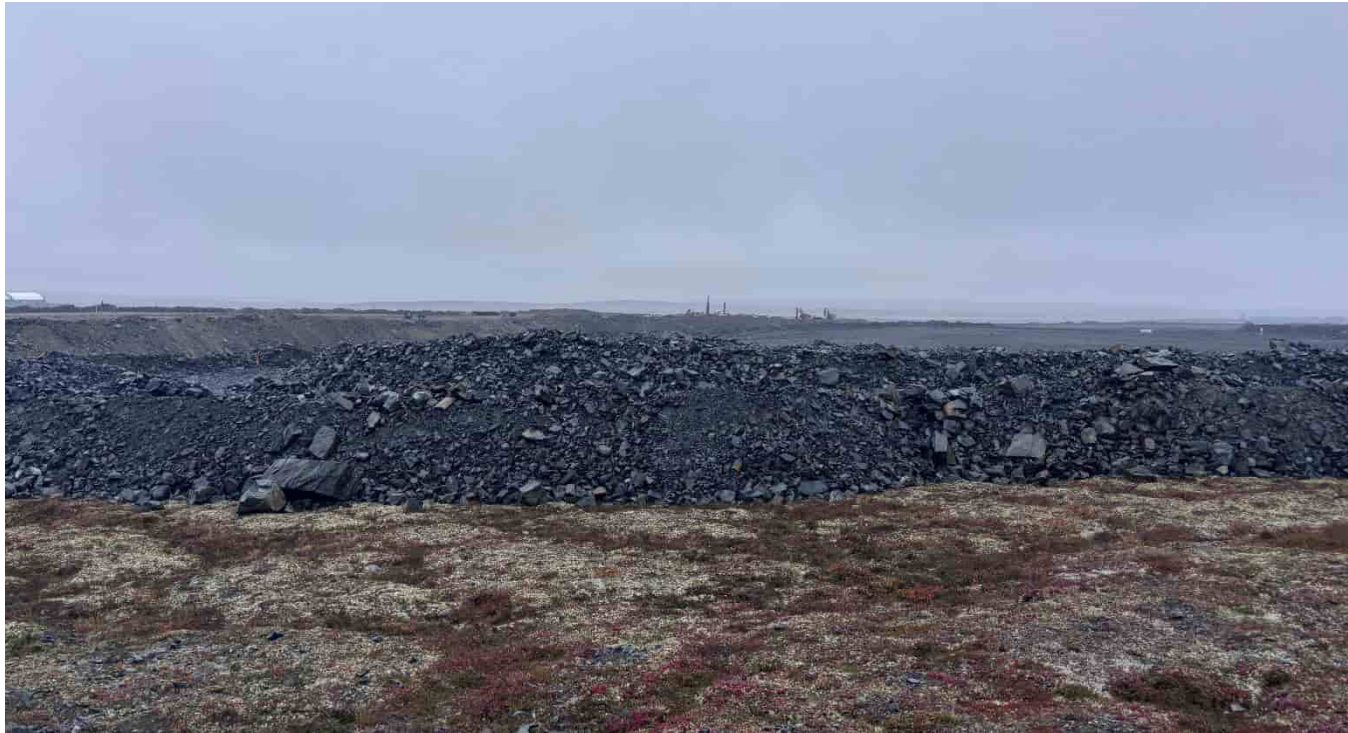
G-410: Rock storage area eastern pad slope, looking W

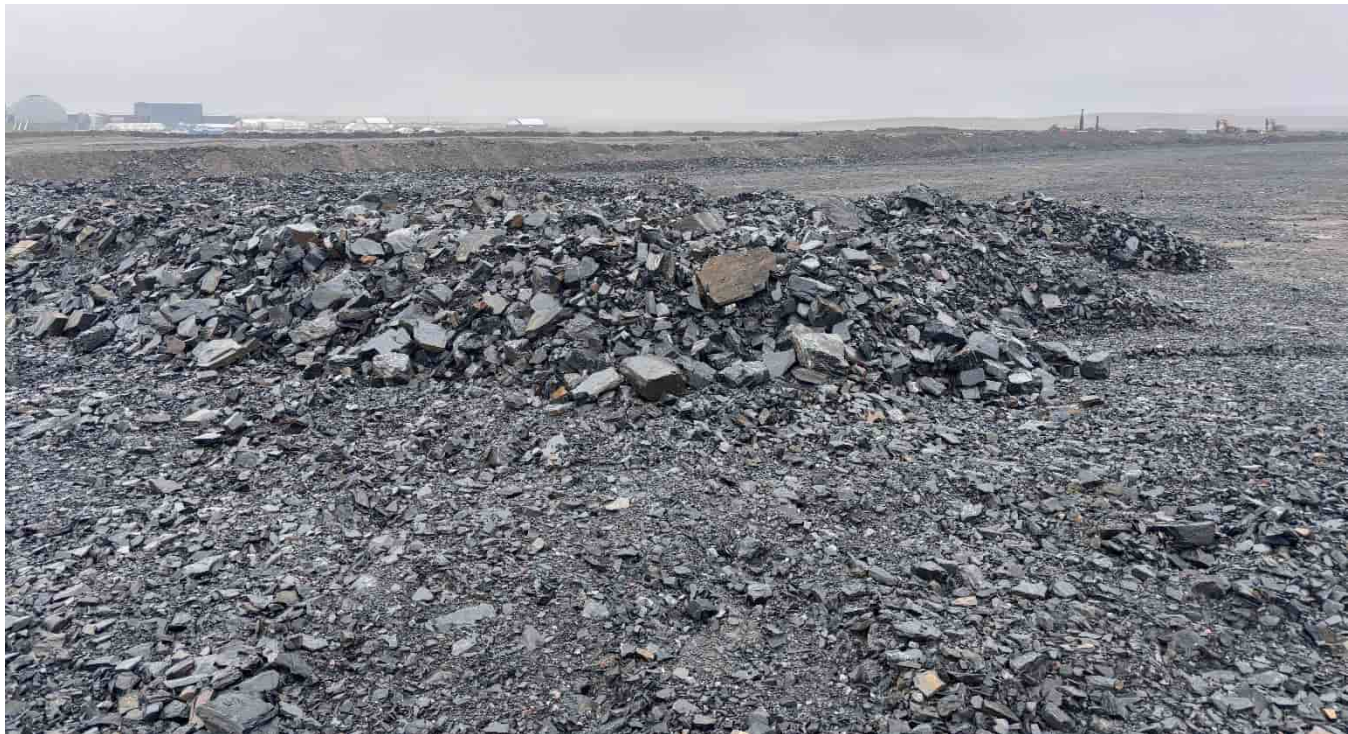
G-412: Rock storage eastern side, looking SW

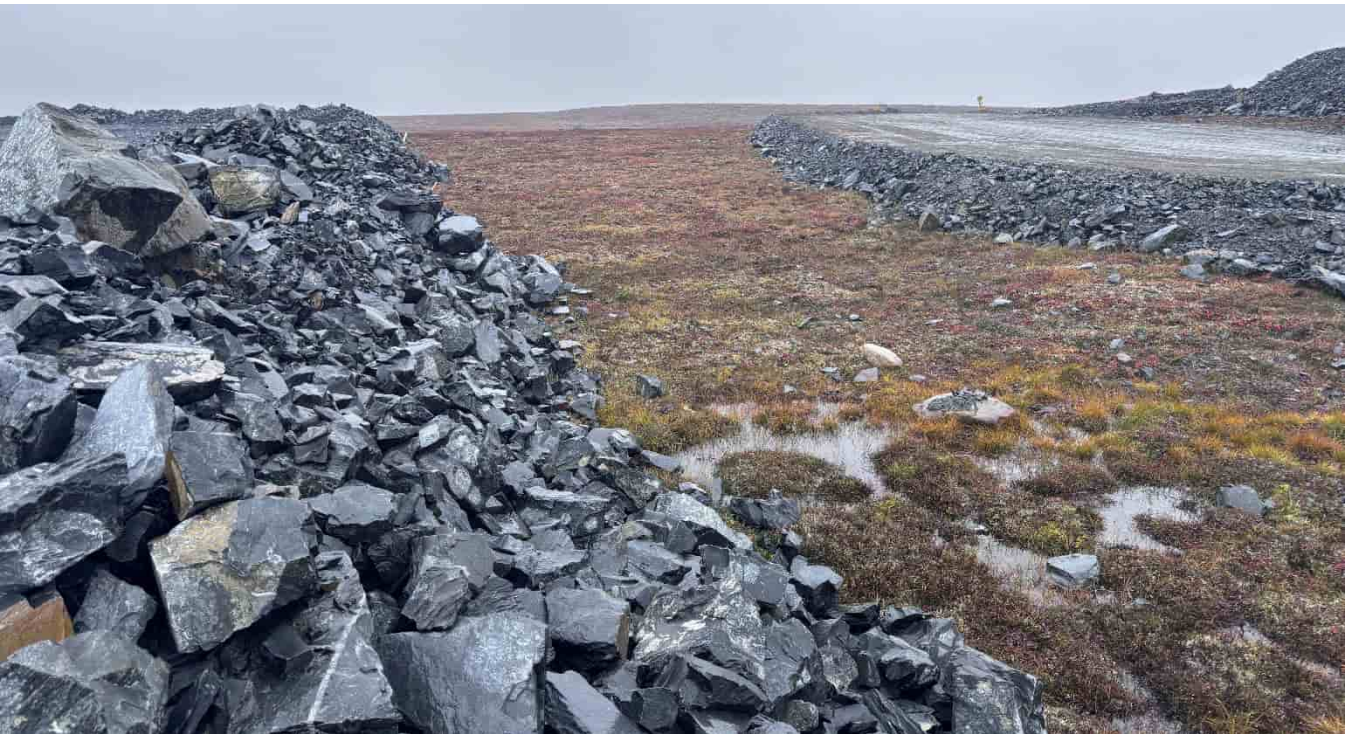
G-413: Rock storage area eastern slope, looking N

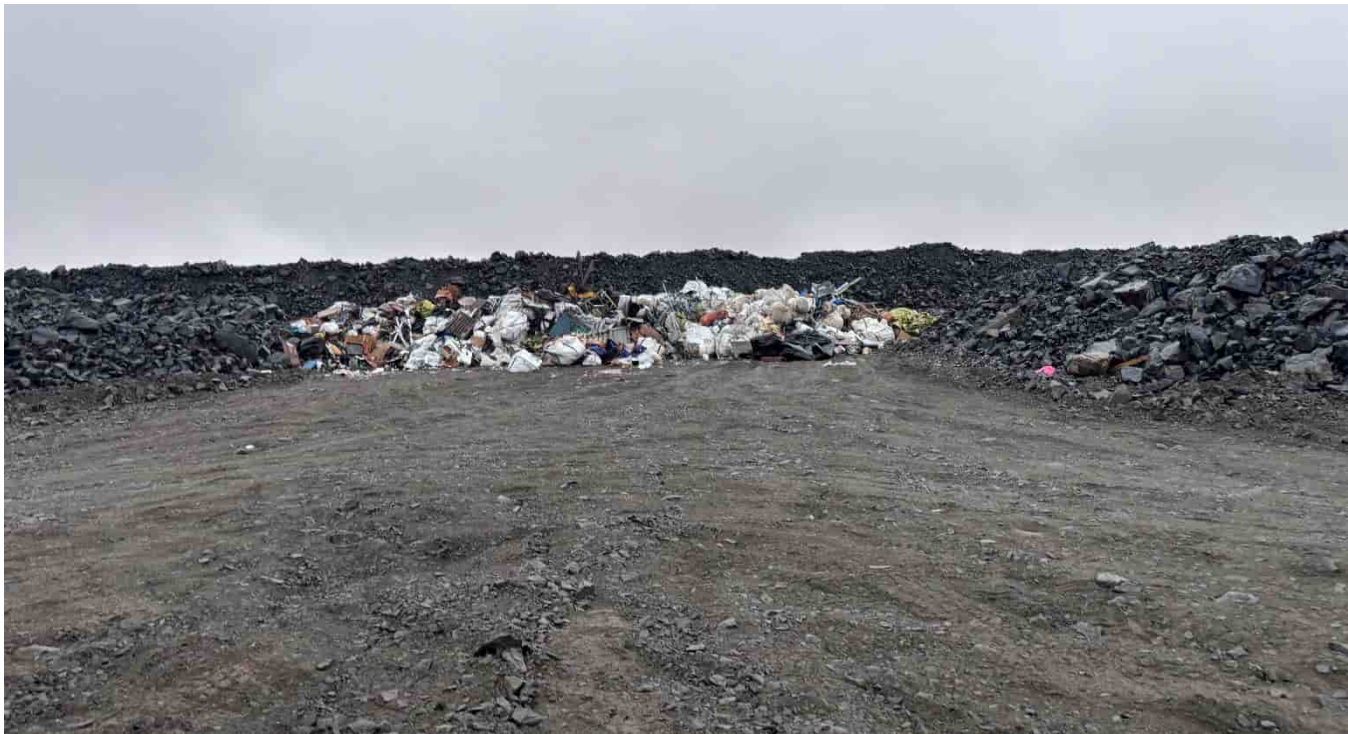
G-420: Garbage disposal area in center of waste rock storage area

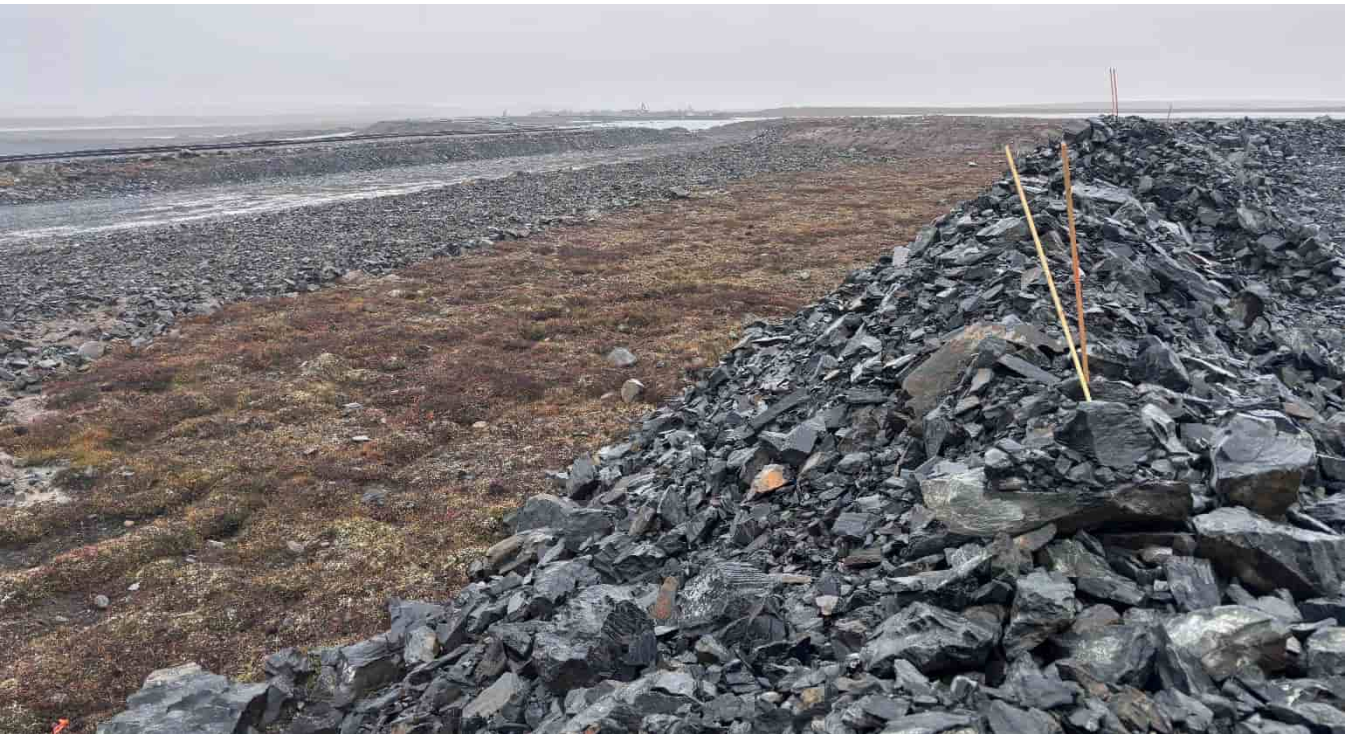
G-421: Rock storage area western pad slope, looking N

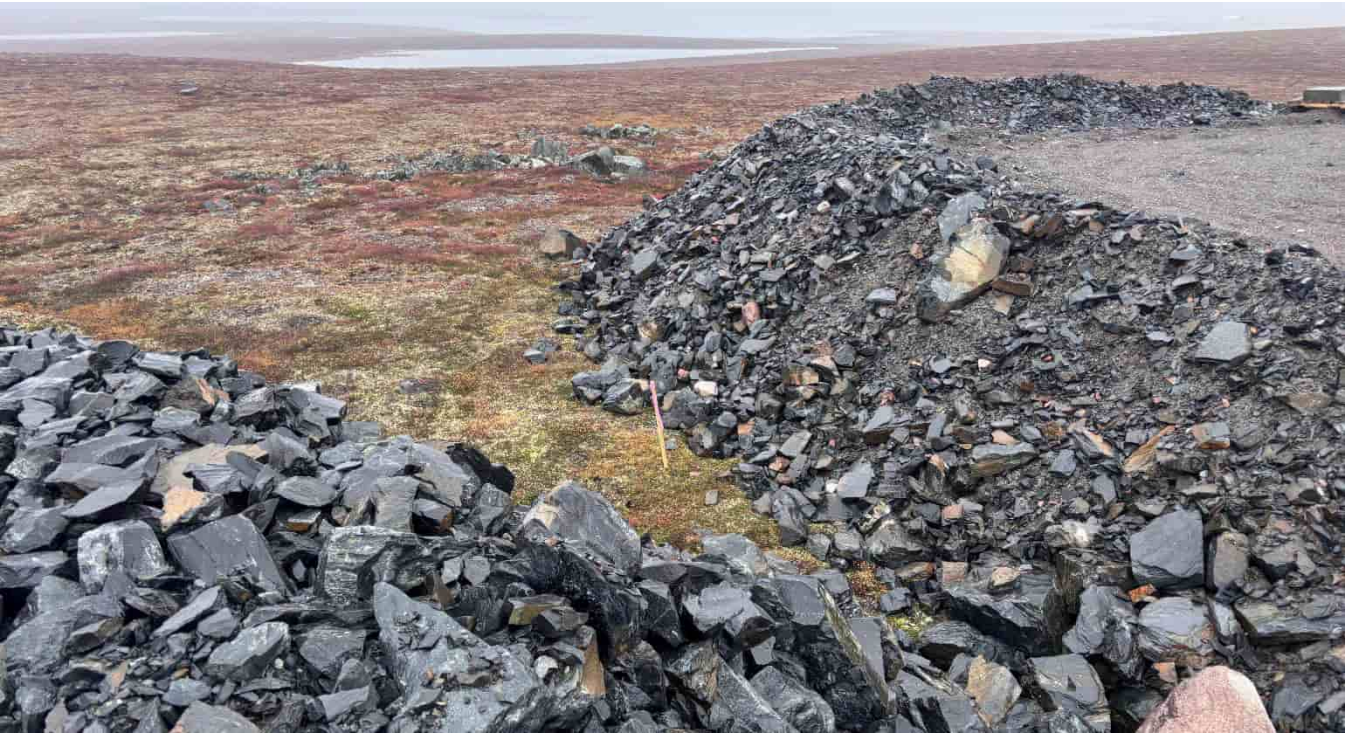
G-430: Western pad slope

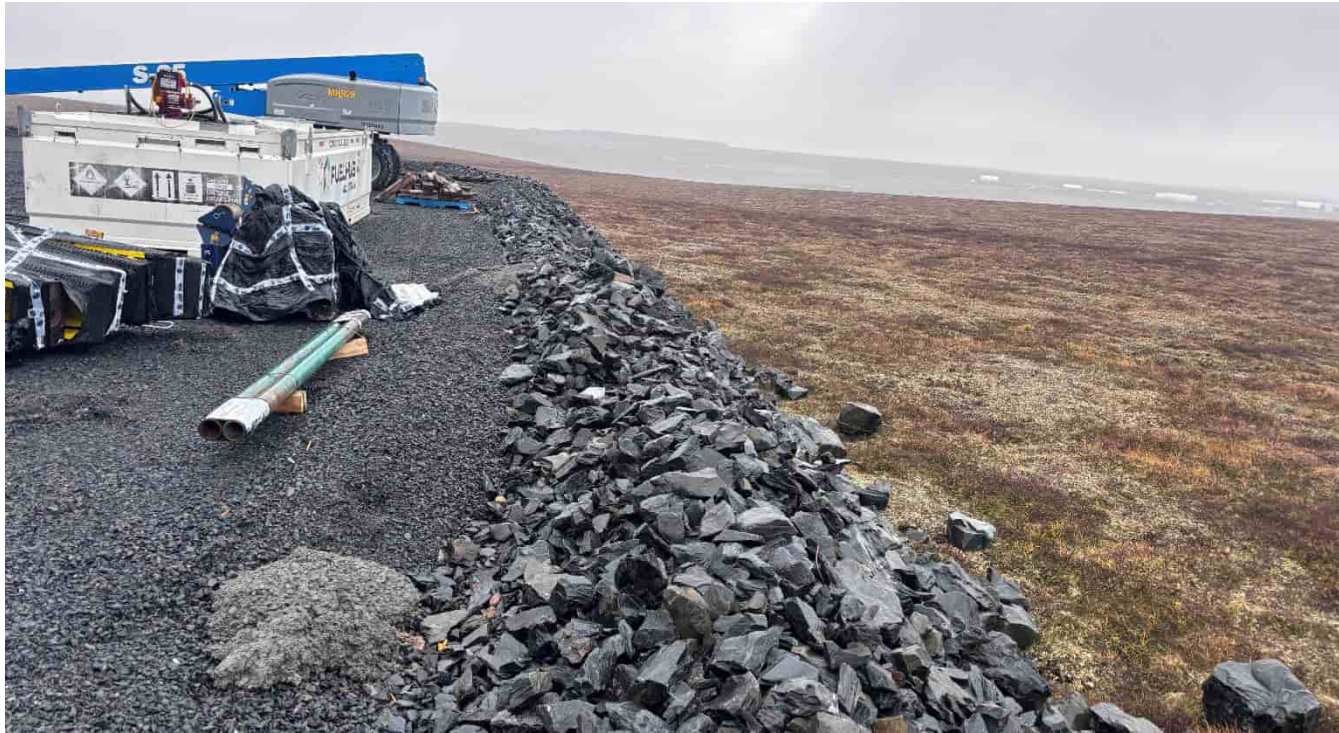
G-433: Eastern slope of emulsion plant pad, looking S

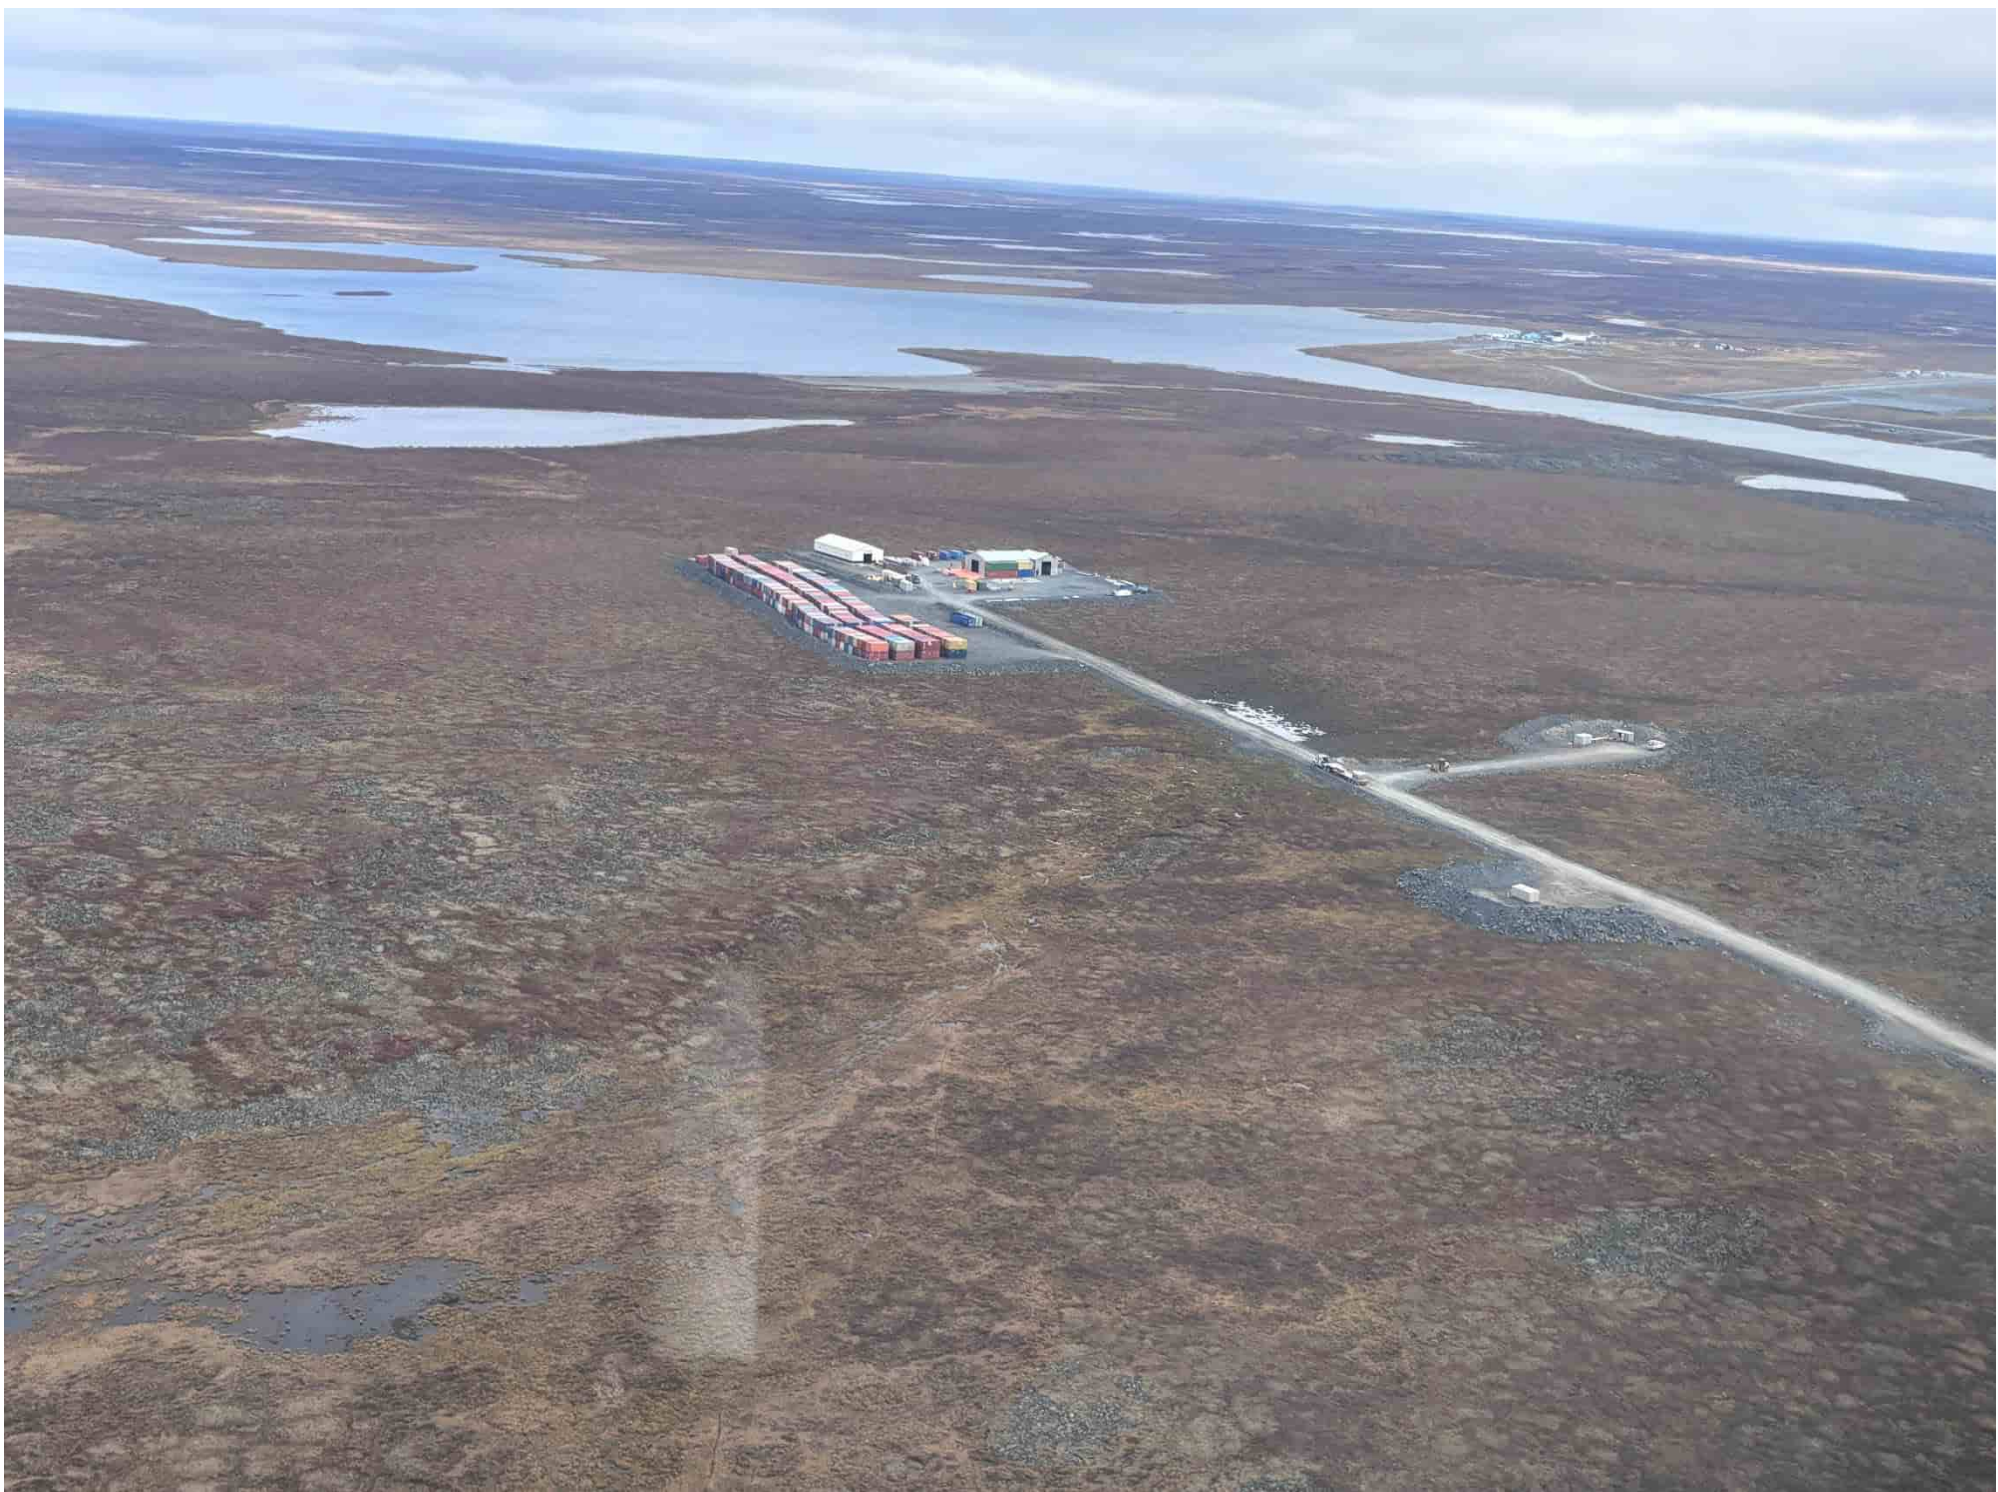
Heli Photo 2: Emulsion Plant and access road, looking E

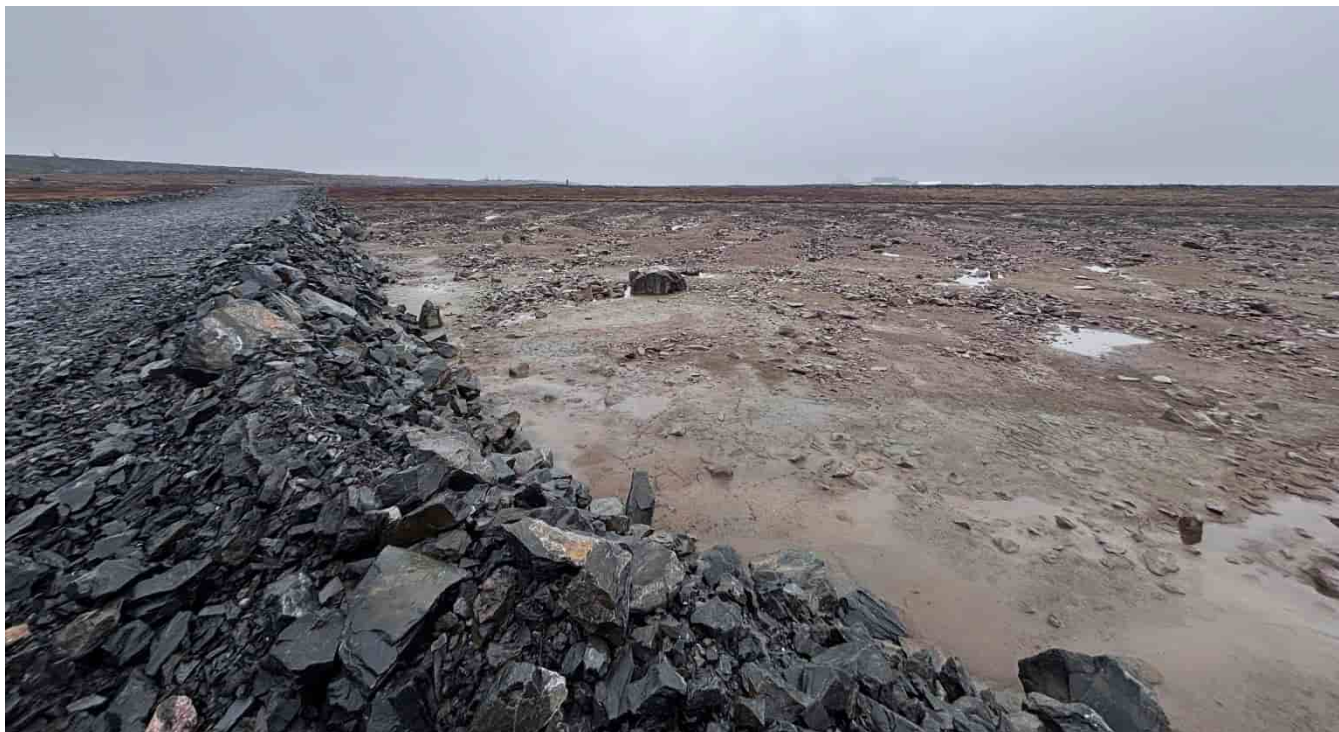
G-450: Looking E along road rockfill from northeastern pond (Round Pond)

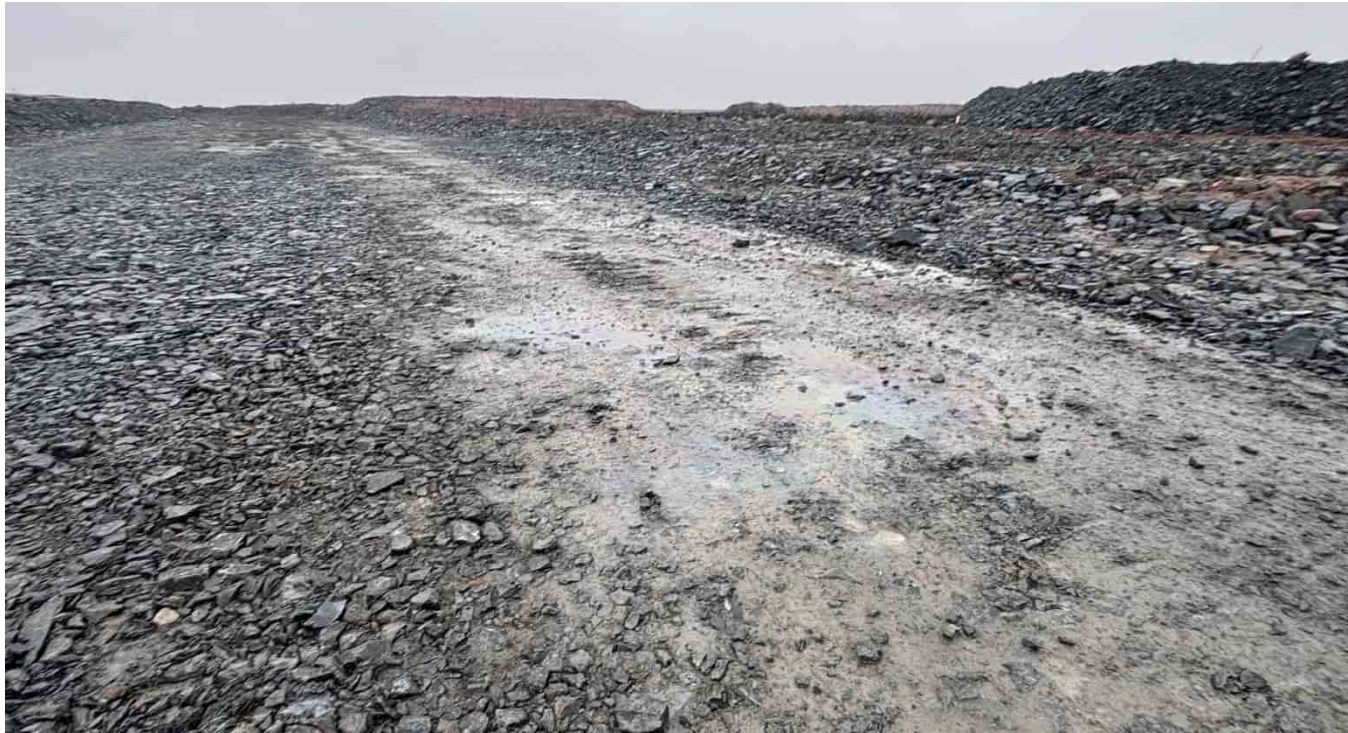
G-454: Primary Pond access road, looking N
