| | | 2025 Annual Geotechnical Inspection | | |
| | | Primary Pond Dam | | |
| Job No: CAPR004312<br>Filename: Back River_Goose_2025_AGI_PhotoLog.pdf | Back River Project | Date:<br>February 2026 | Approved:<br>JBK | Figure:<br>159 |

## **Appendix B      Photolog from 2025 Site Visit – MLA**

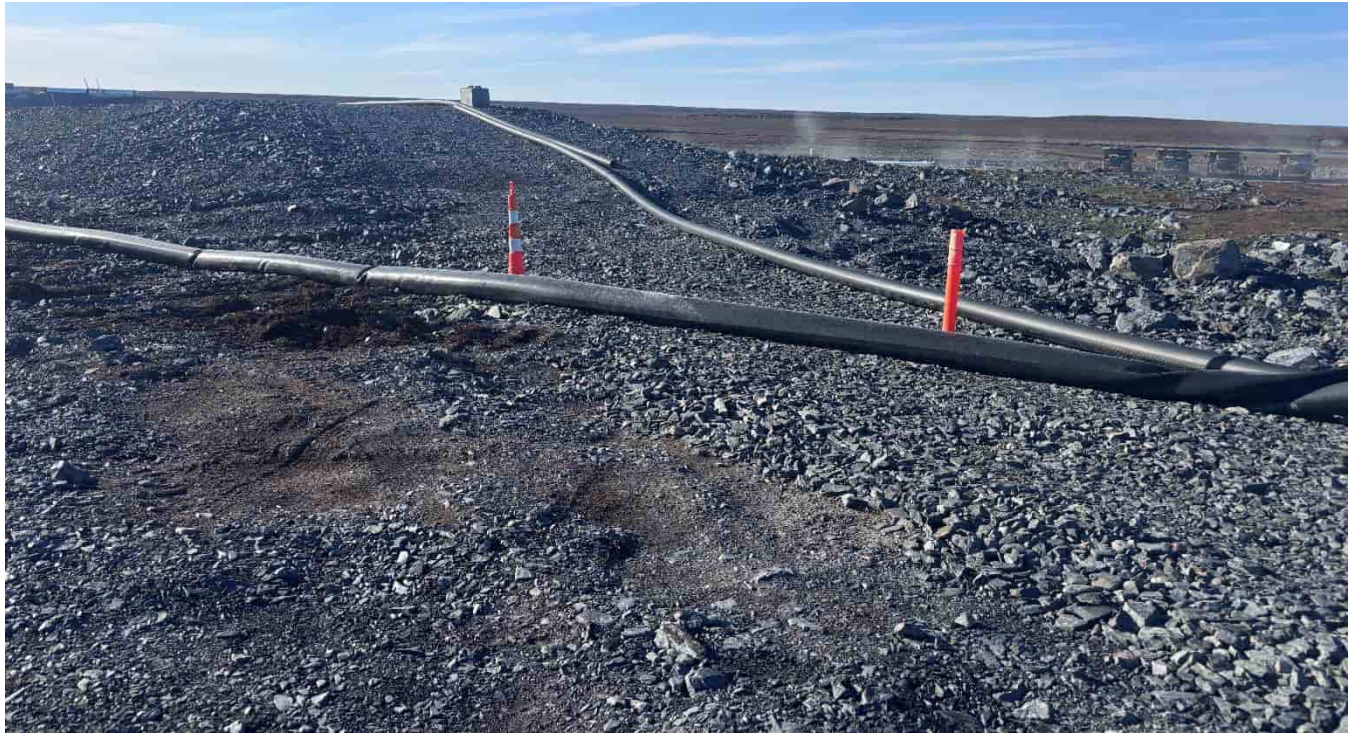
G-462: Pipeline pad north of Primary Pond

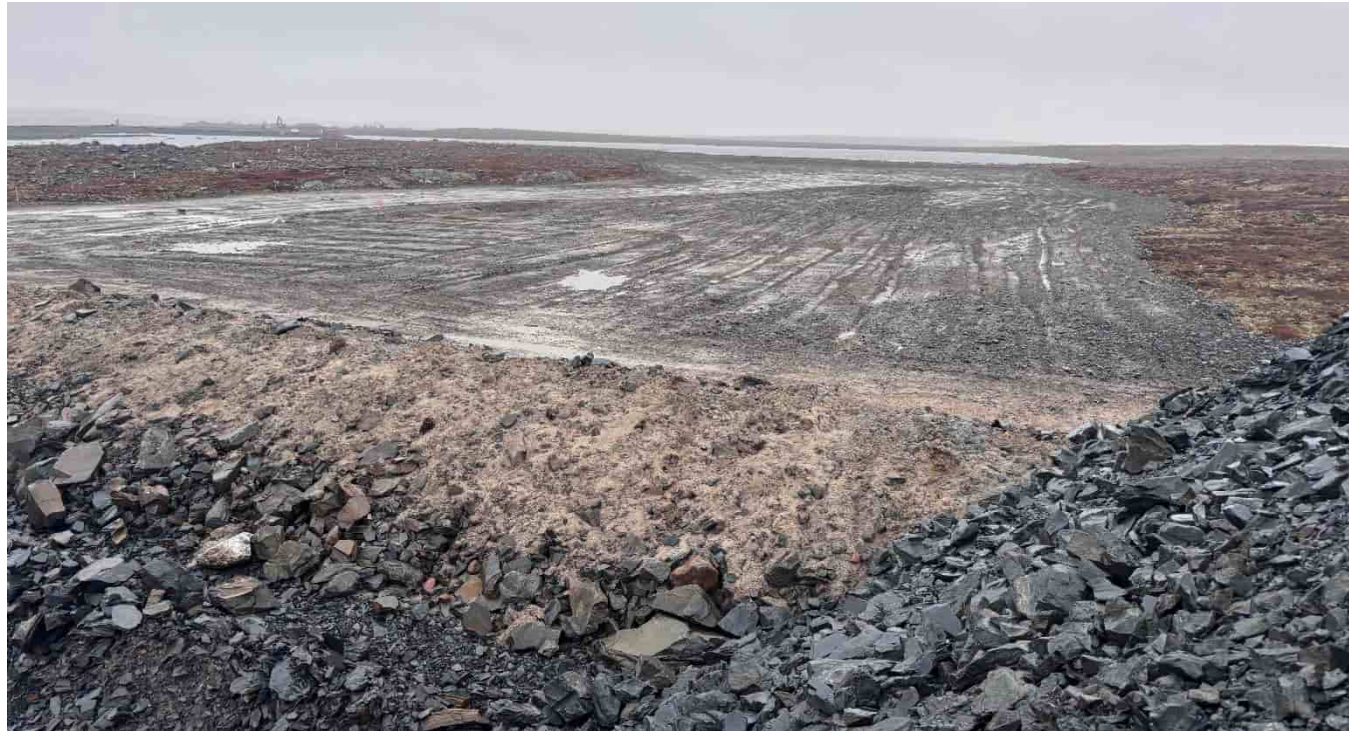
G-489: Overburden fill at northern edge of rock storage area, looking N

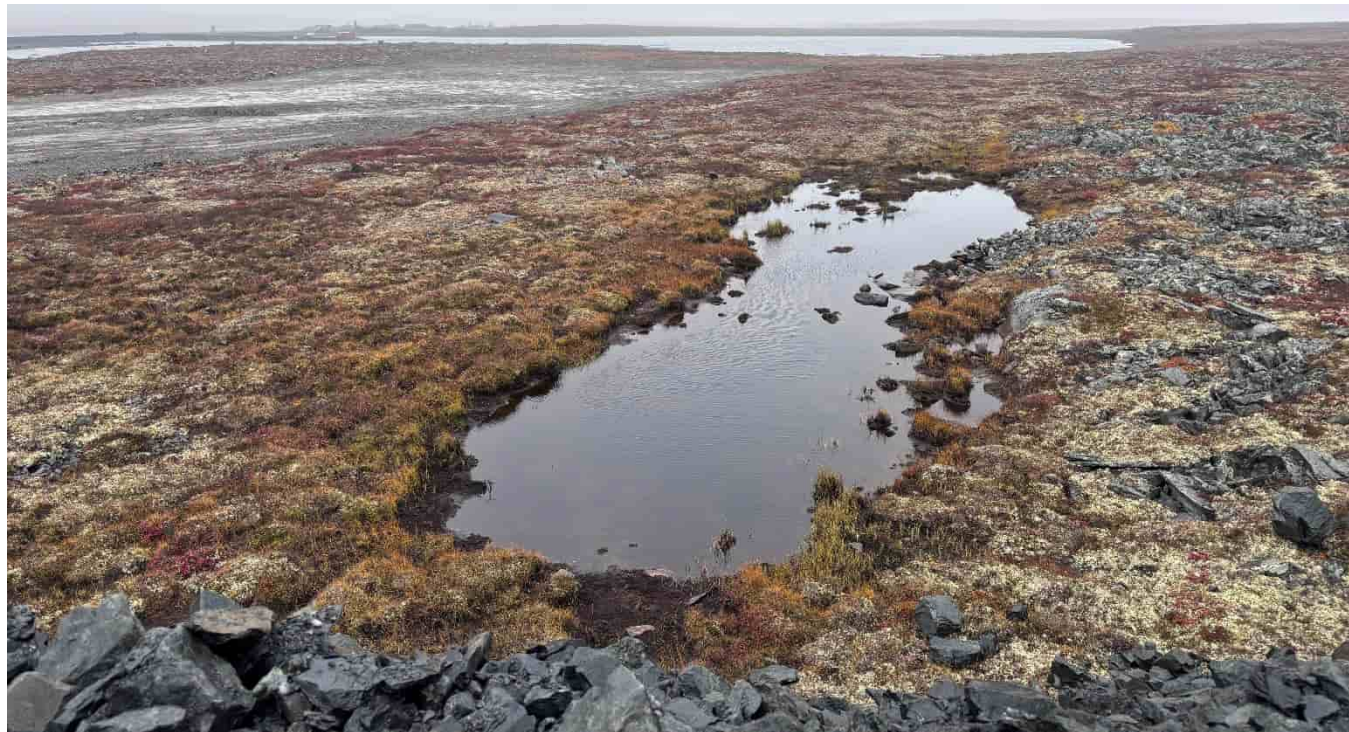
G-491: Pond south of the Primary Pond and east wing

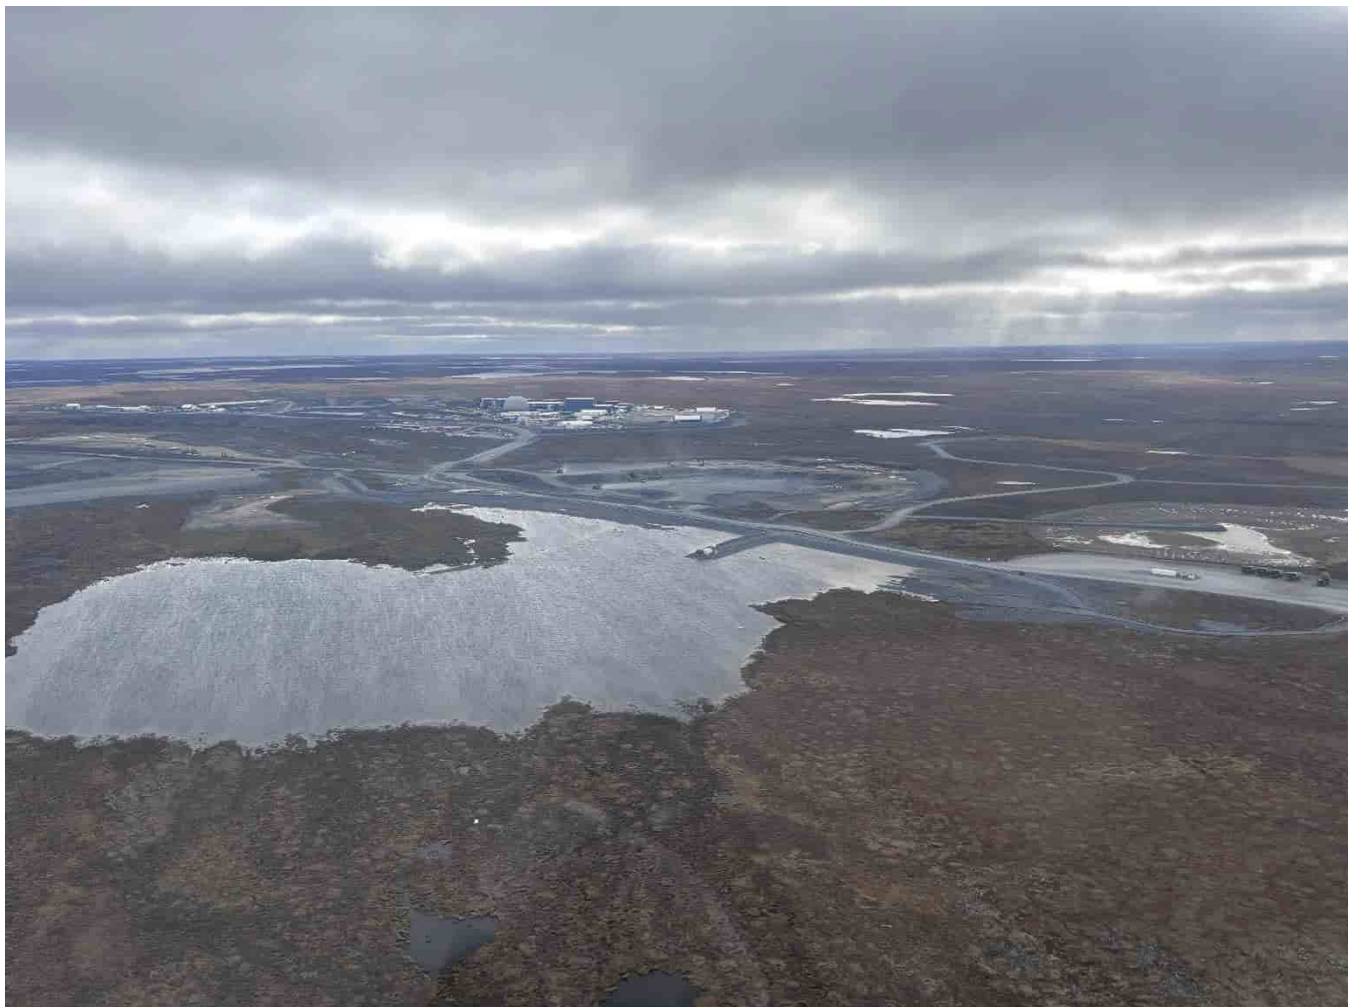
Heli Photo 3: Primary Pond and dam, looking S

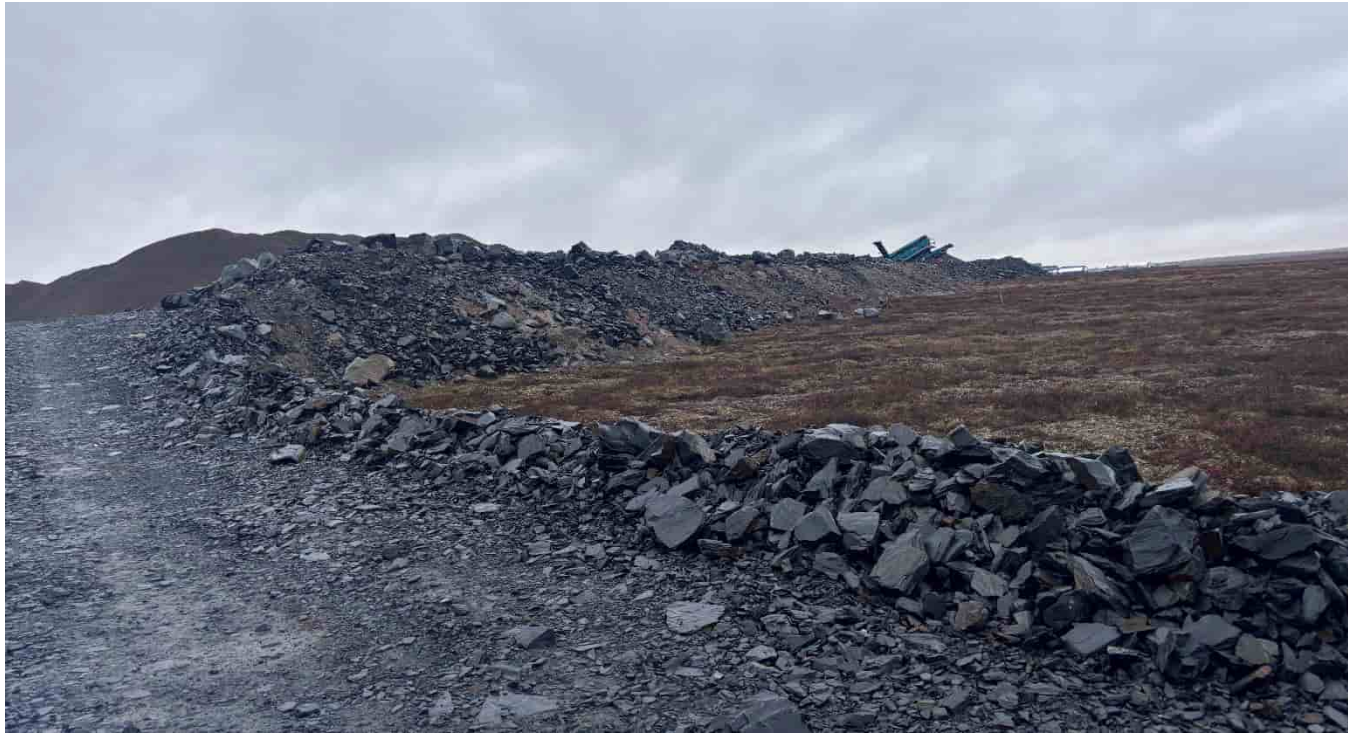
G-496: Llama crusher pad southern slope, looking SE

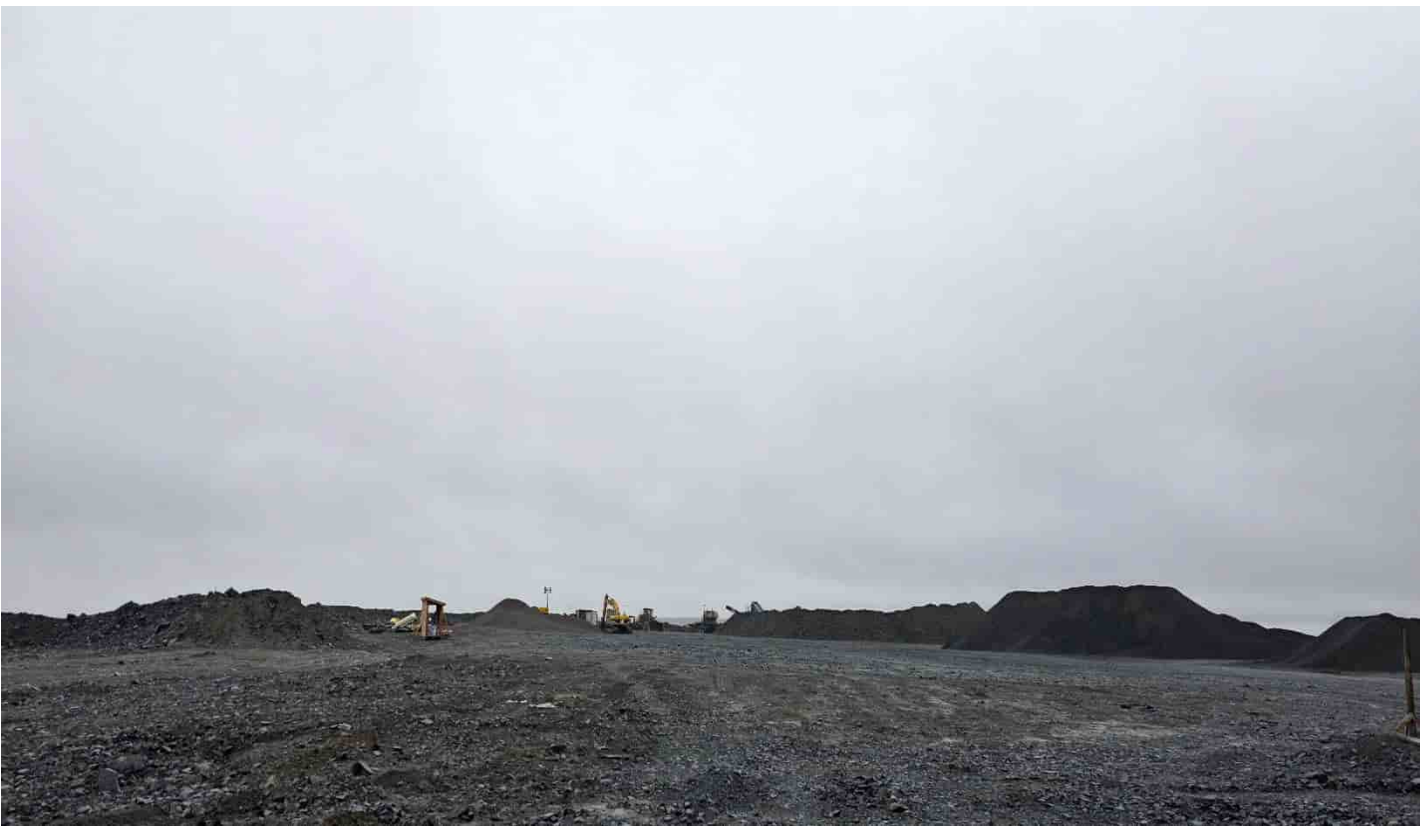
G-500B: Southern end of the Llama crusher pad, looking W from the All-Season Road

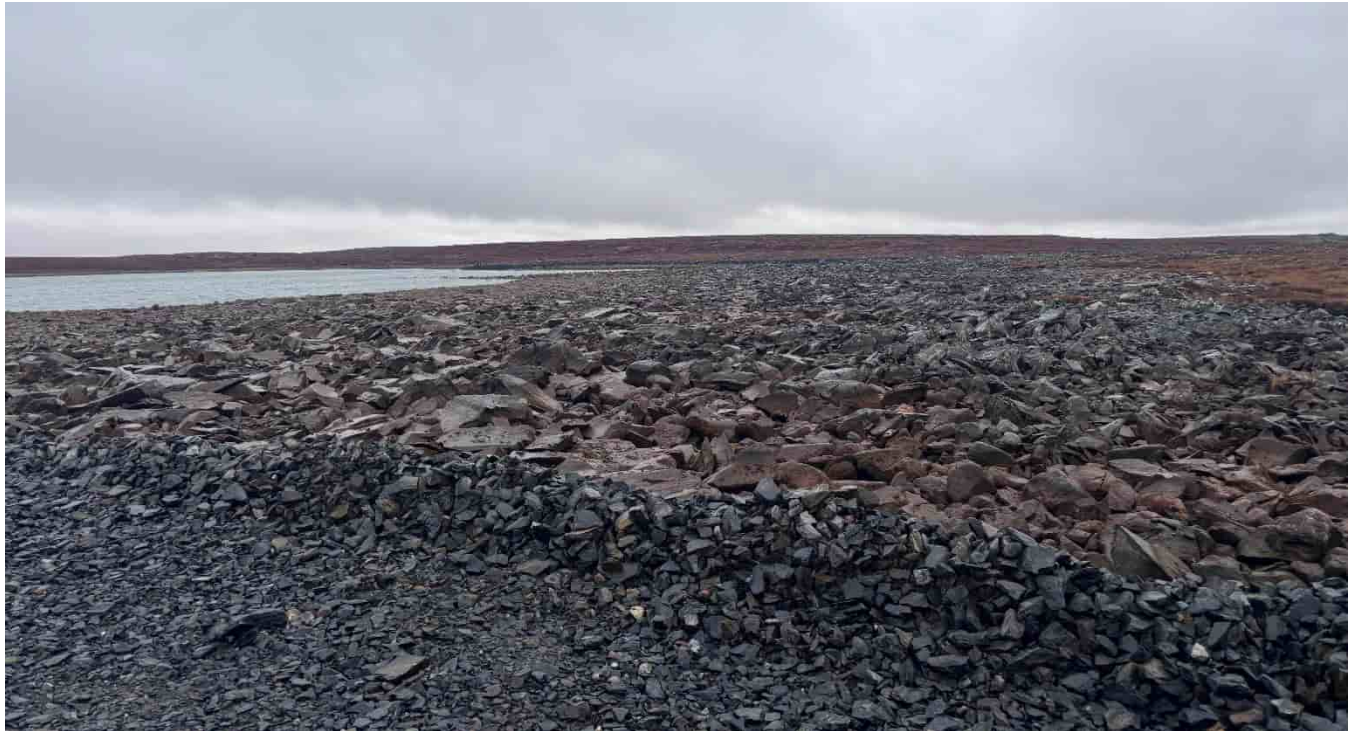
G-501A: Llama Lake from access road, looking N

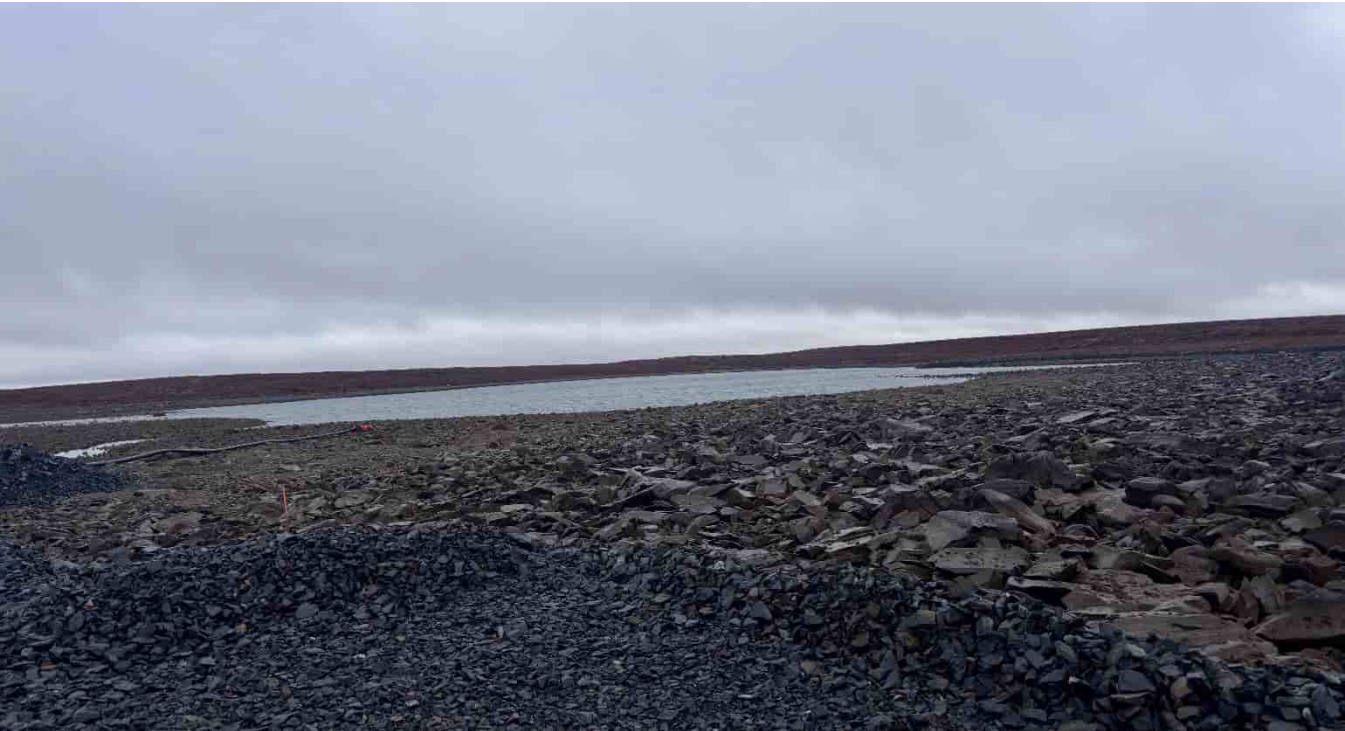
G-501B: Llama Lake from access road, looking NW

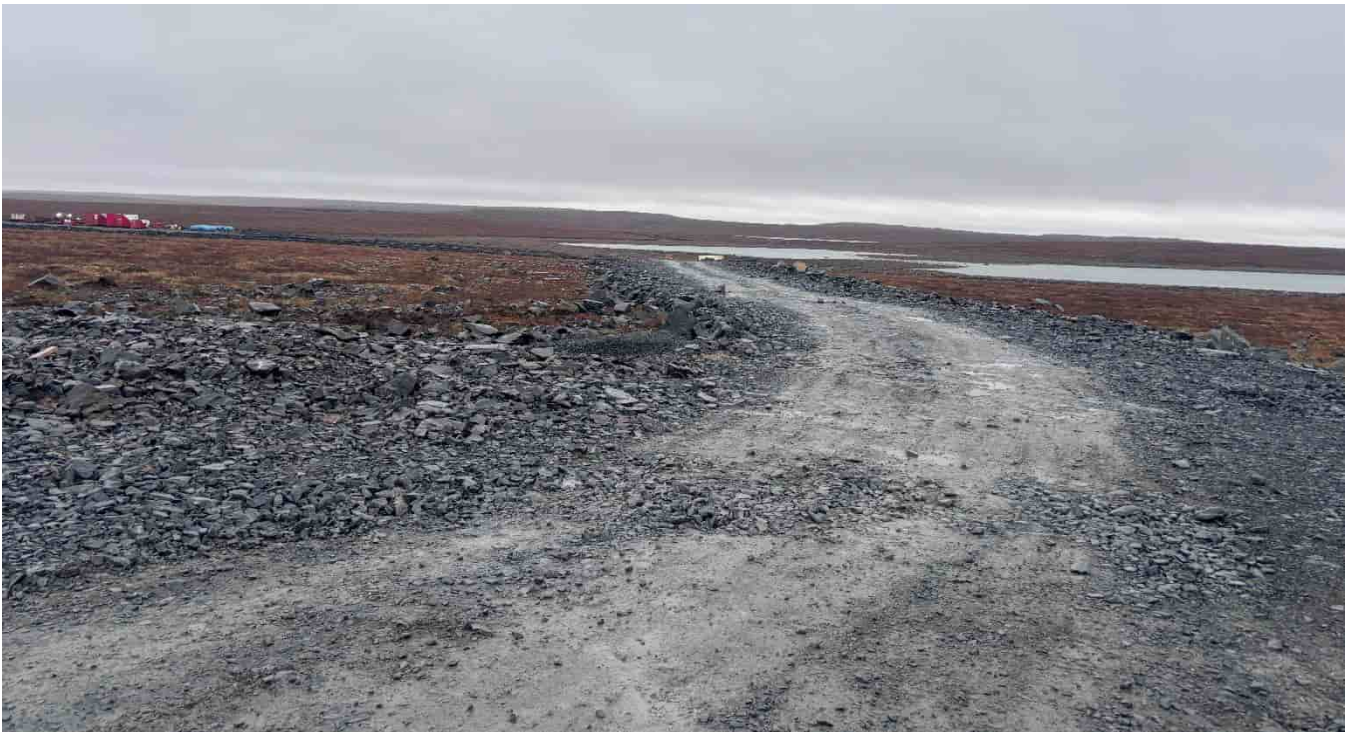
G-505B: Llama Lake access road, looking NW

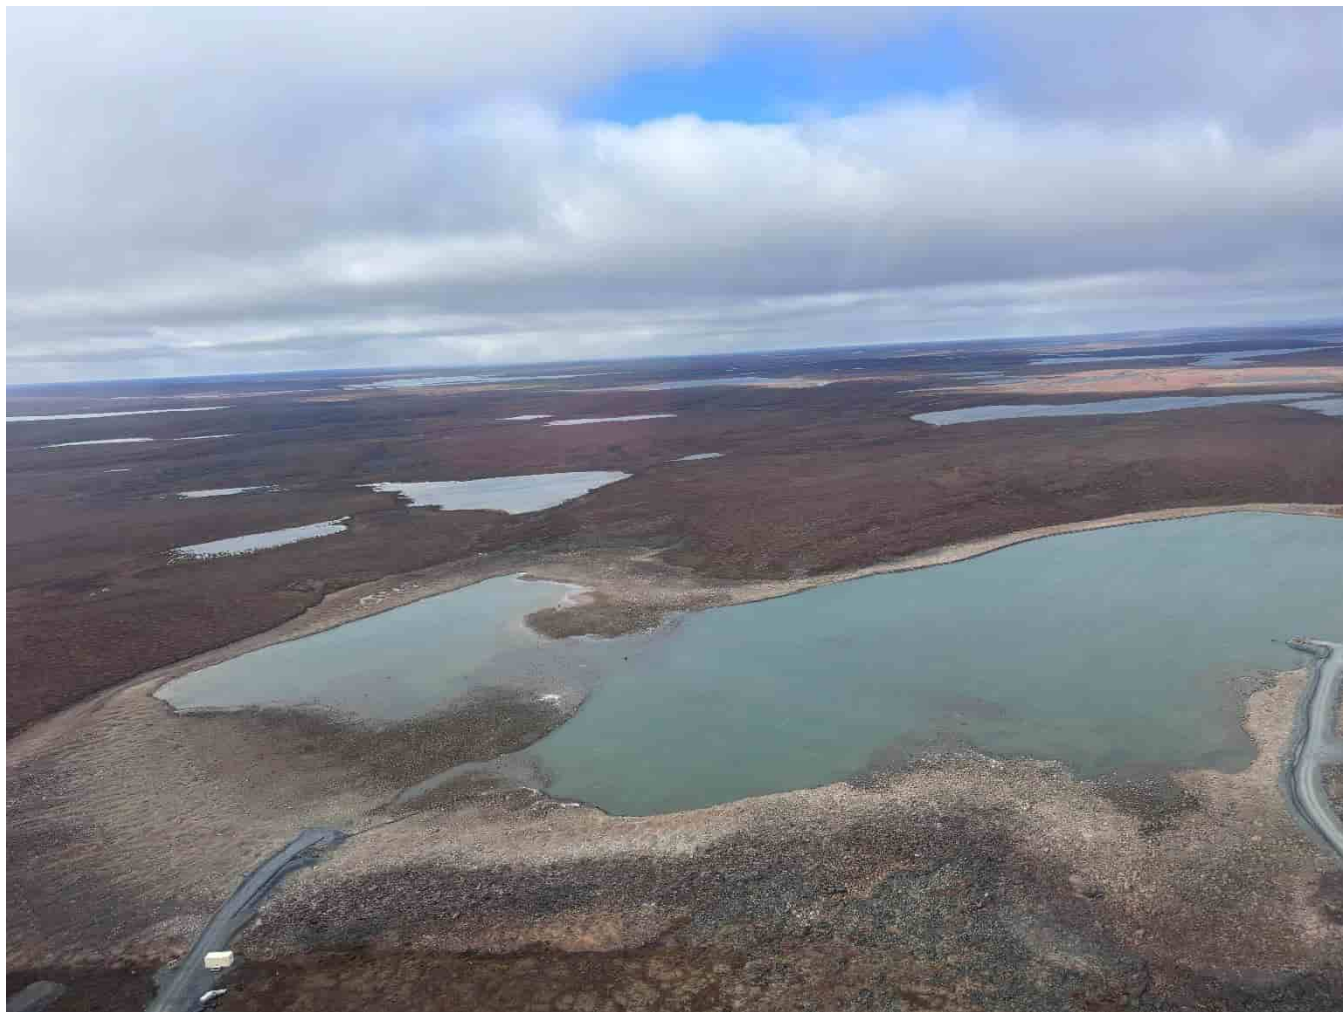
Heli Photo 6: Llama Lake southern access road, looking NW

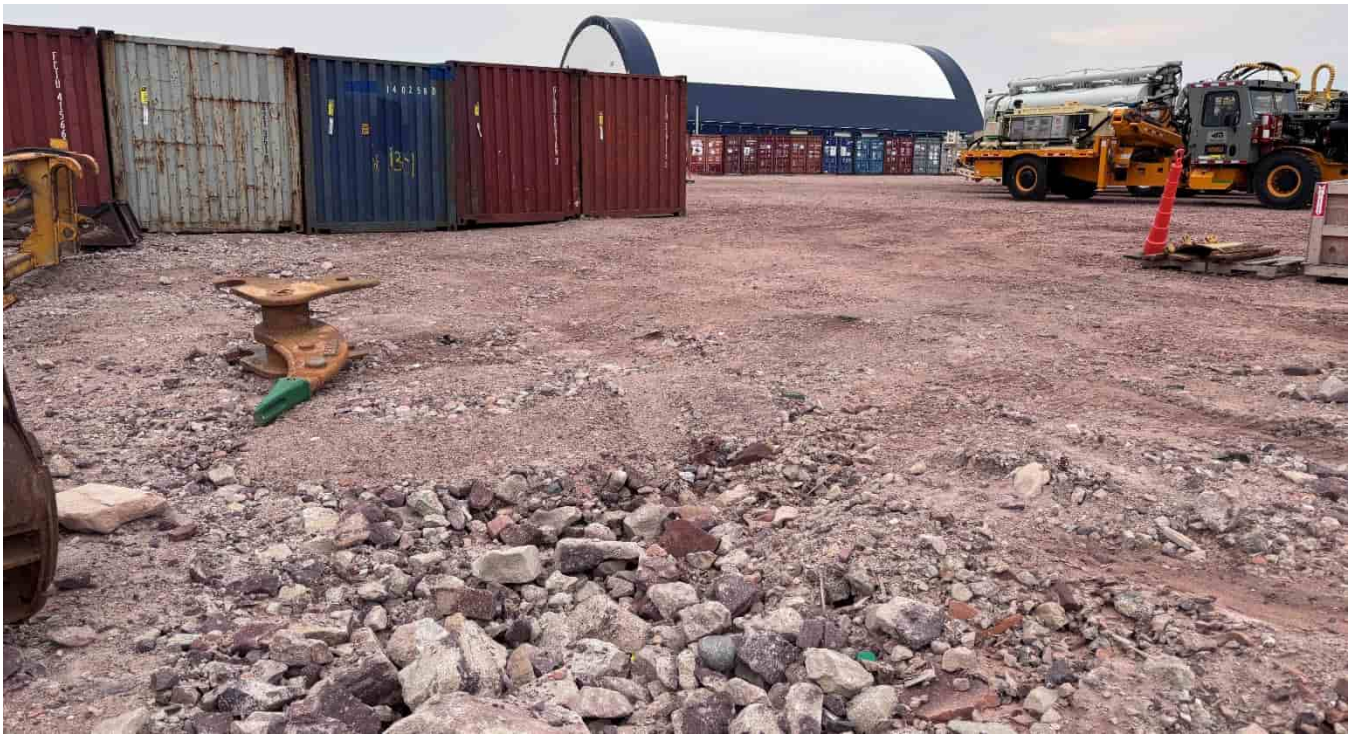
M-12: Laydown area typical surface conditions

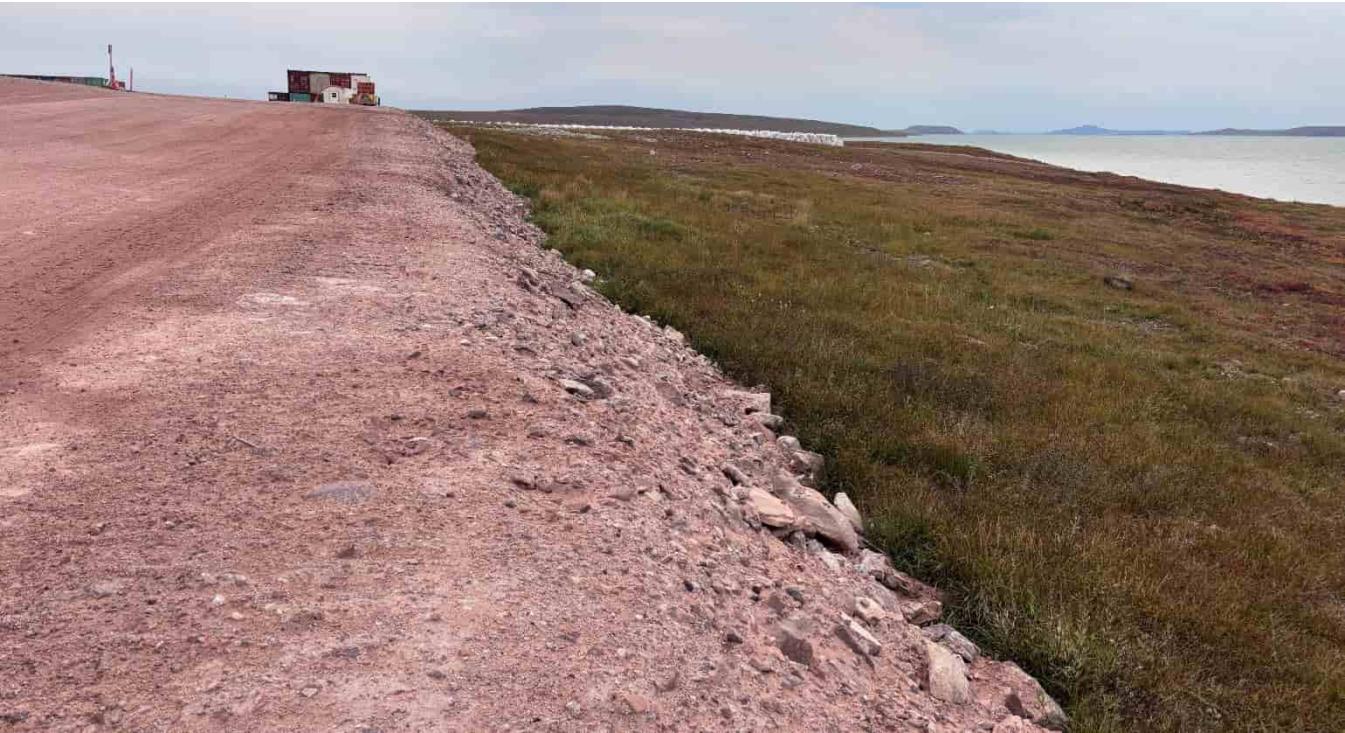
M-14: Northeastern pad slope, looking NW

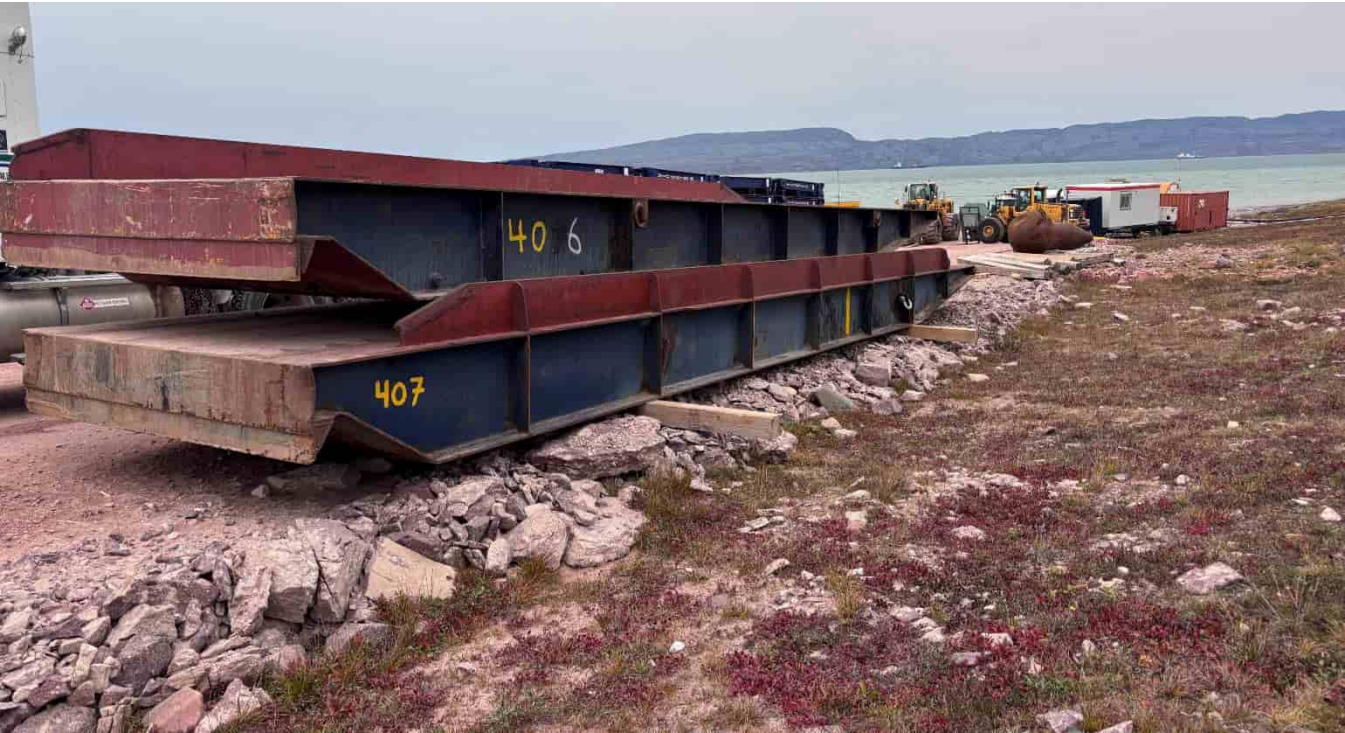
M-18: Shoreline pad

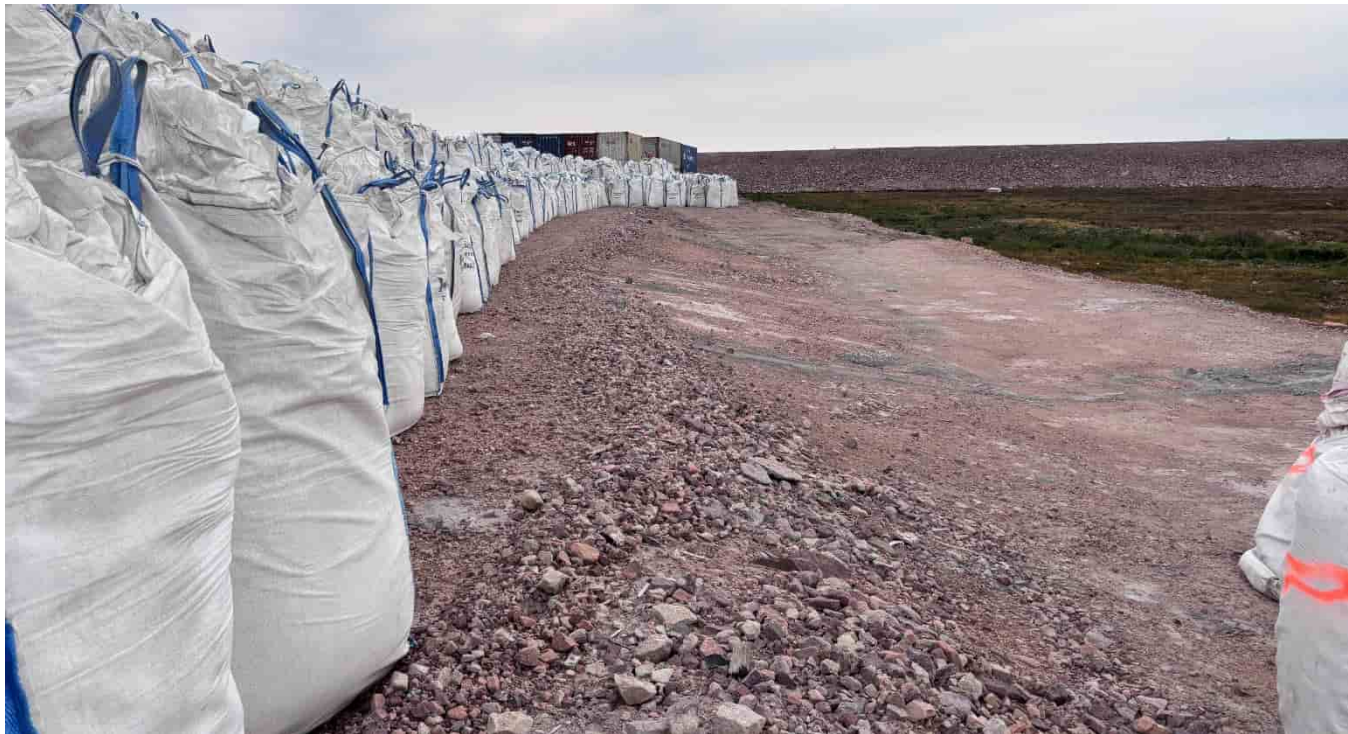
M-30: Bag placement at top of slope, looking SW

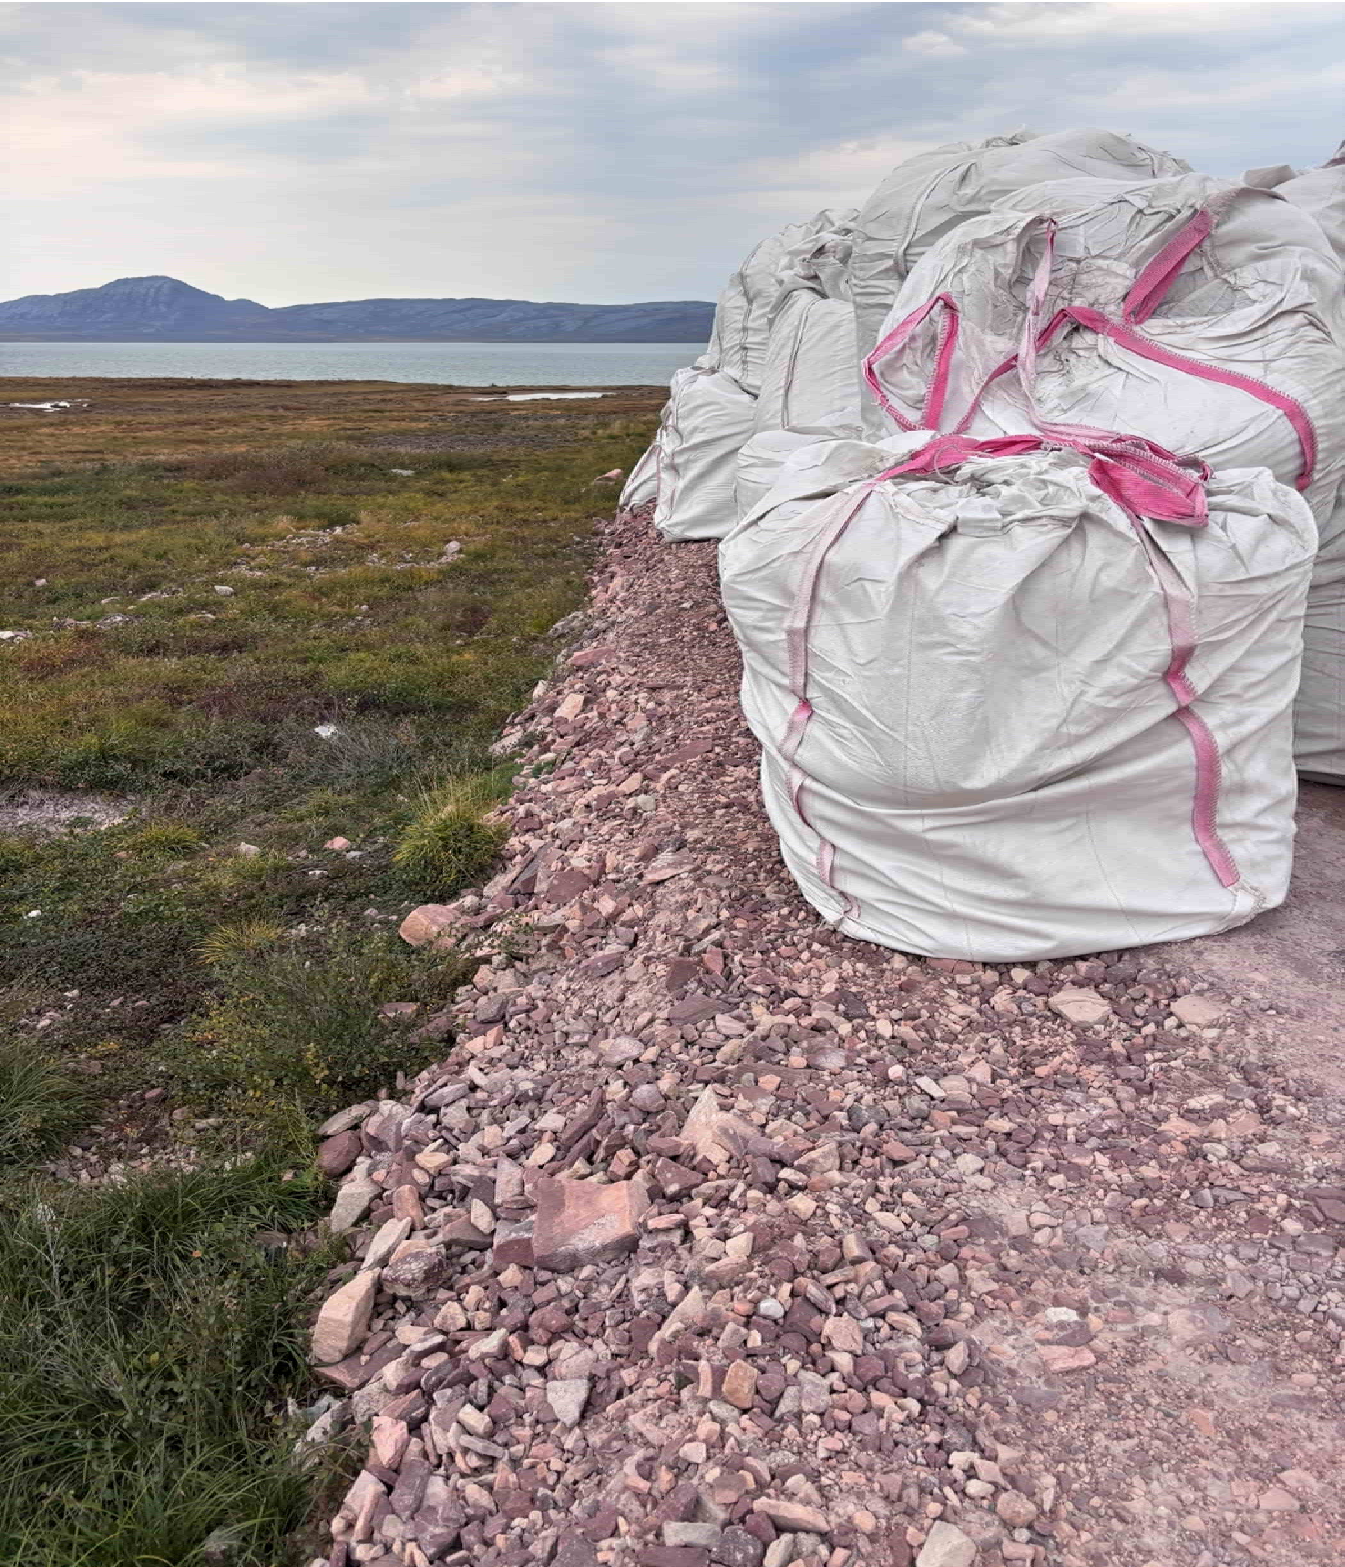
M-31: Bag placement beside edge of pad, looking NE

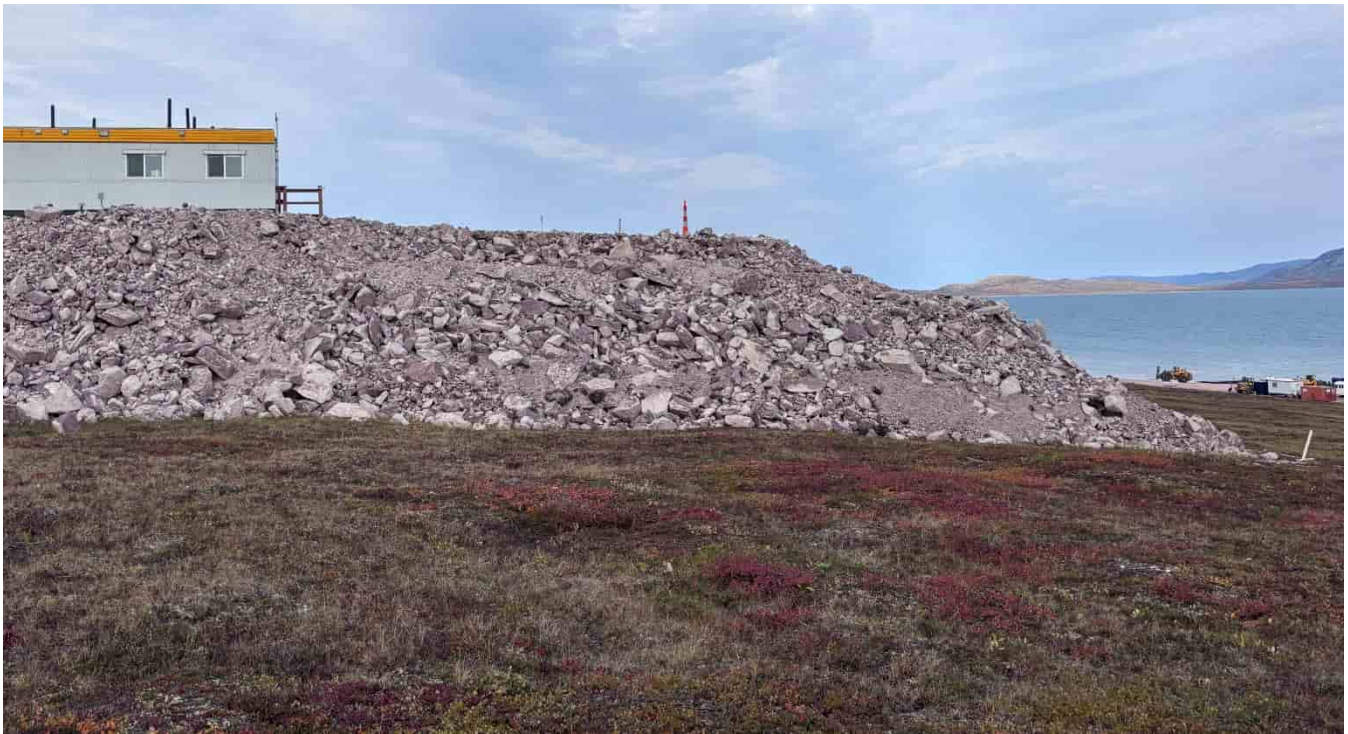
M-48: Eastern corner of main camp pad

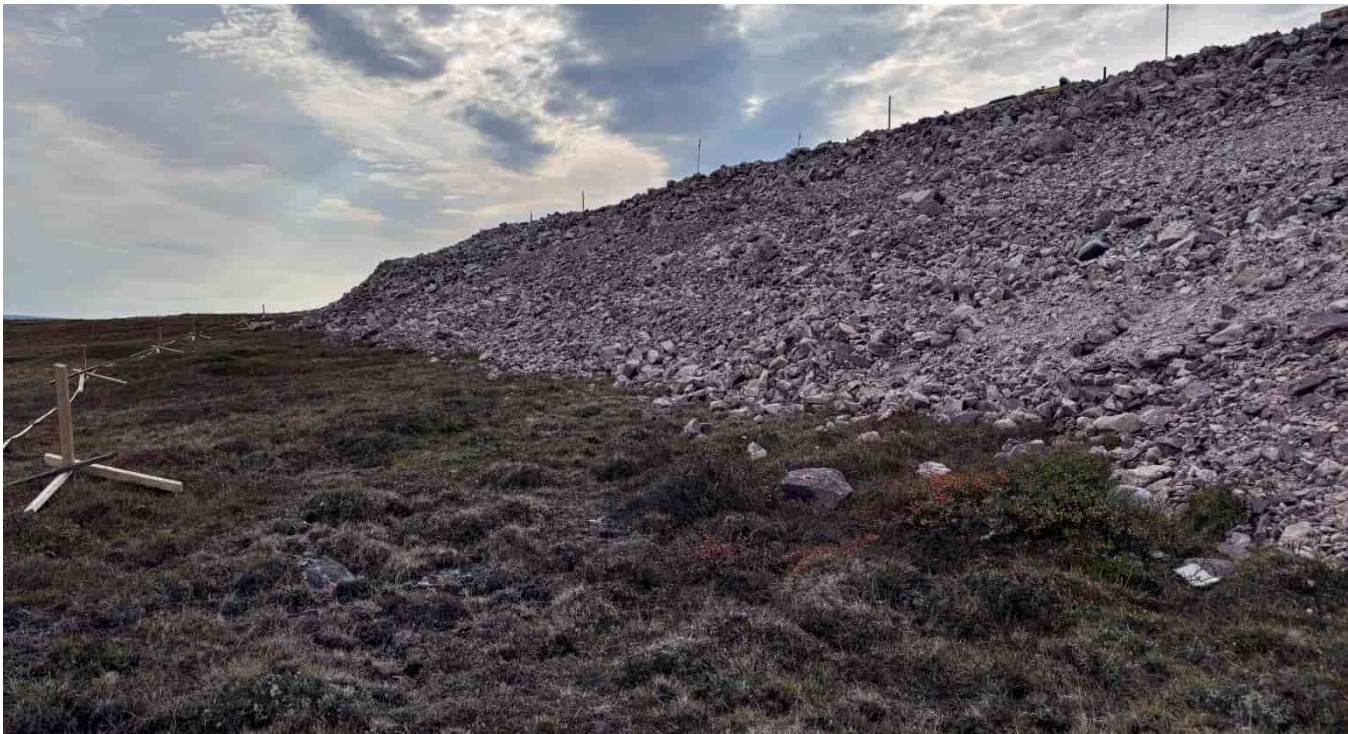
M-51: Eastern pad slope, looking S

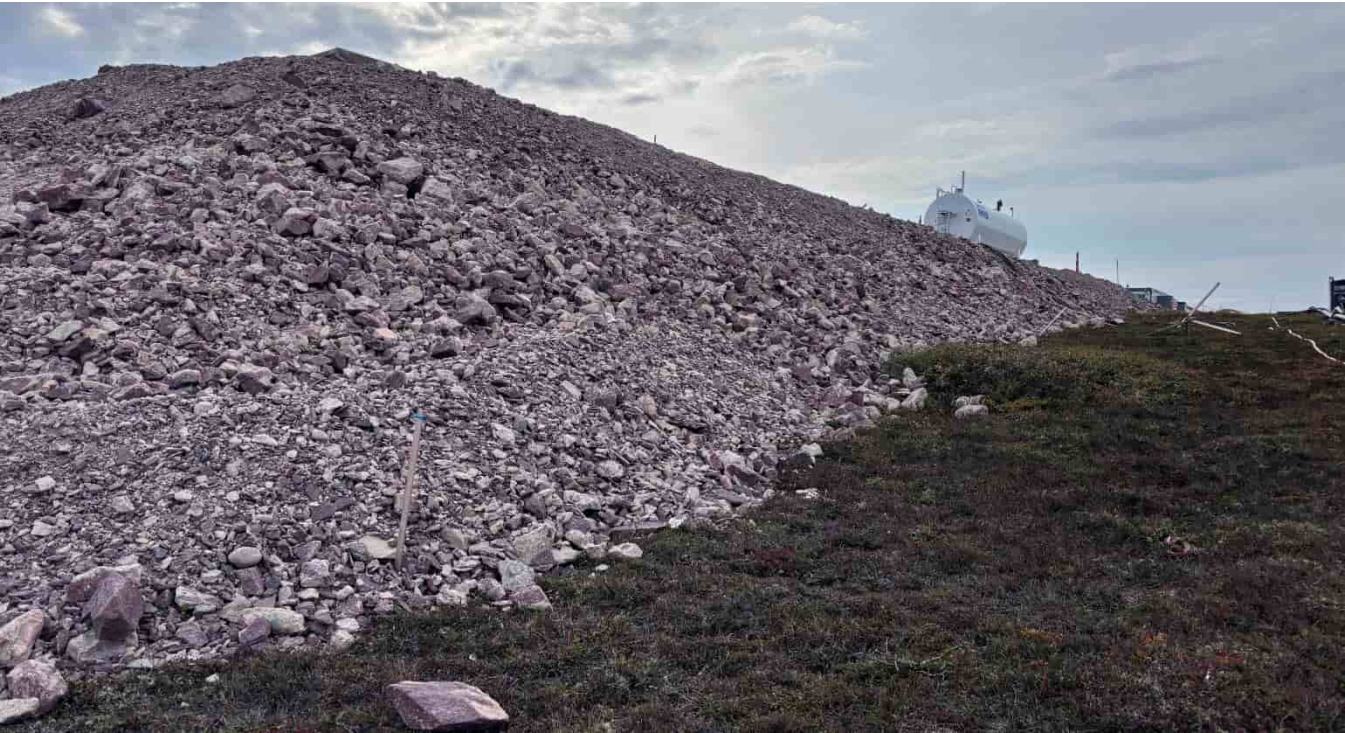
M-53: Camp pad, looking S

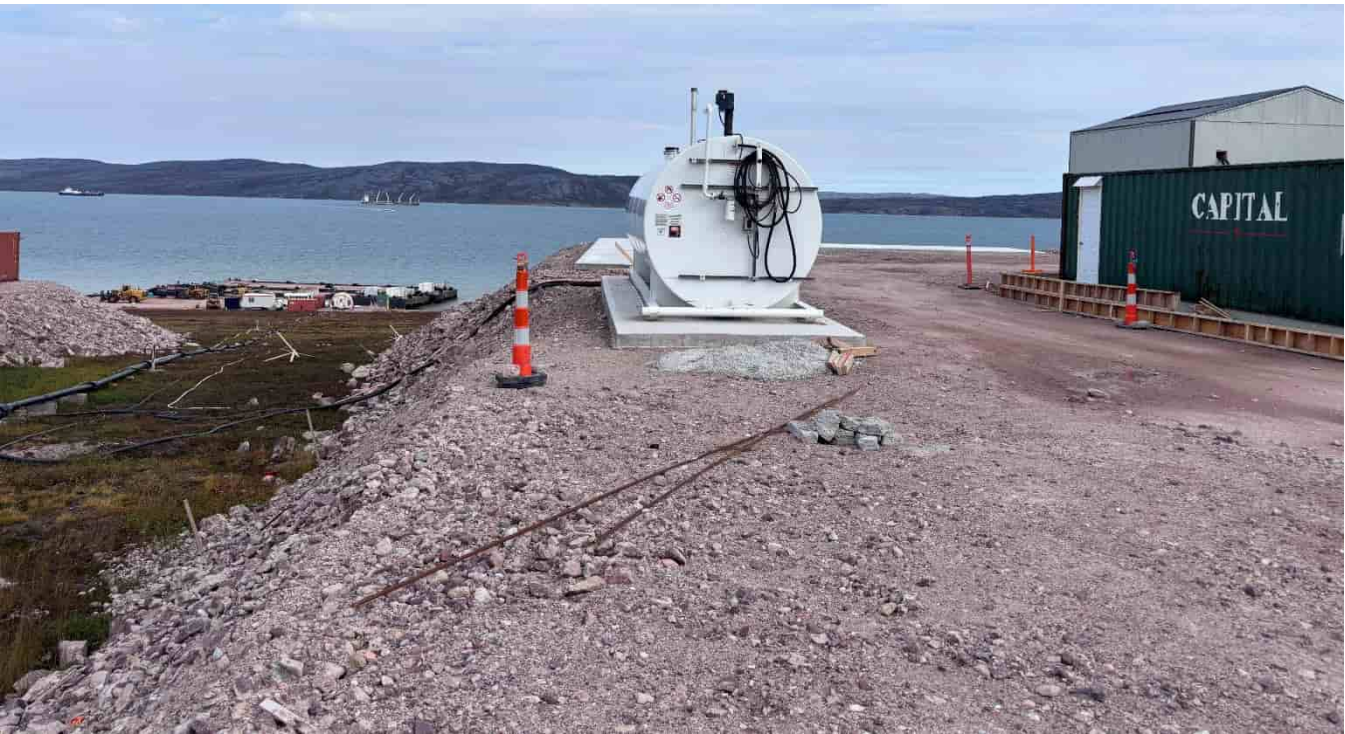
M-55: Camp pad N slope, looking NE

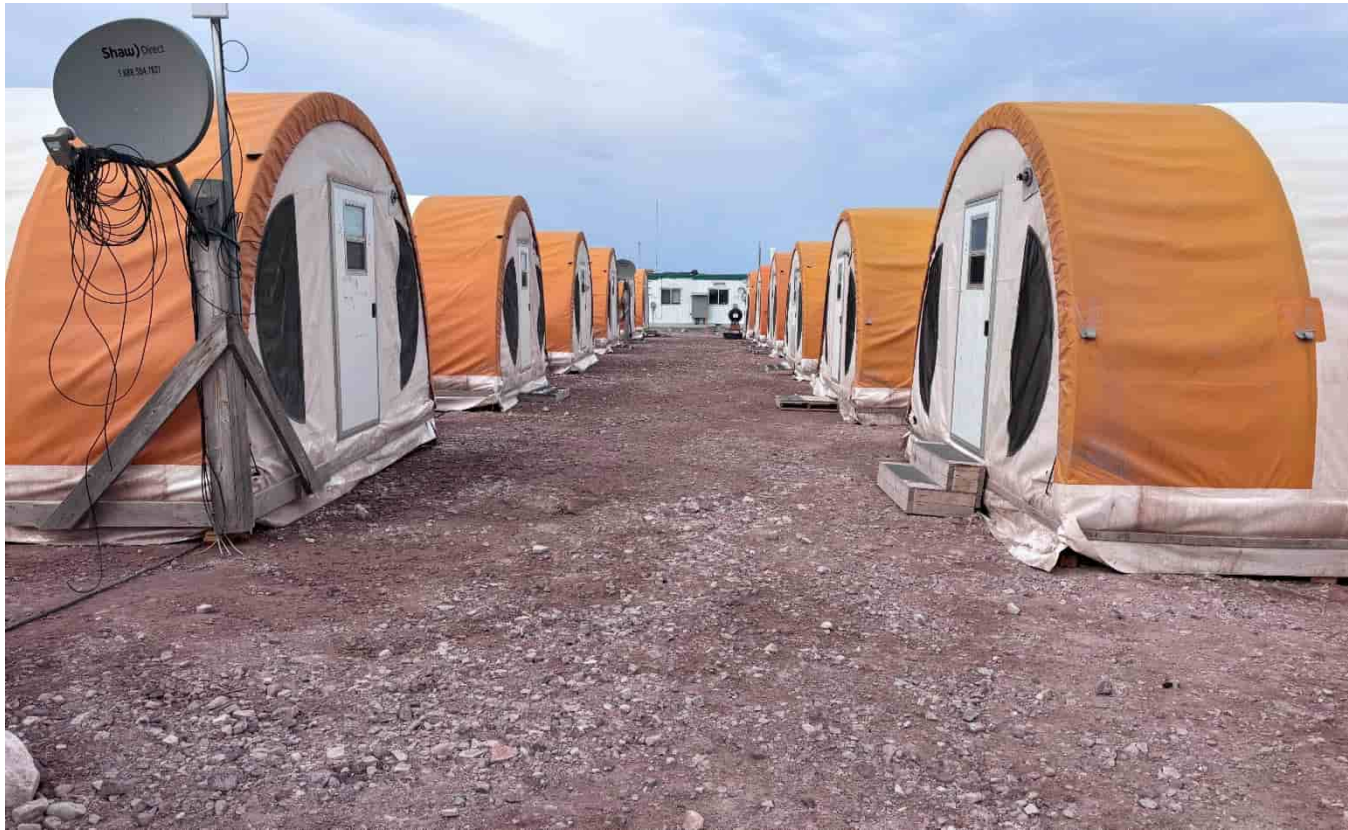
M-63: Camp pad housing
