| | | 2025 Annual Geotechnical Inspection | | |
| | | MLA Airstrip | | |
| Job No: CAPR004312<br>Filename: Back River_MLA_2025_AGI_Photos.pdf | Back River Project | Date:<br>February 2026 | Approved:<br>JBK | Figure:<br>36 |

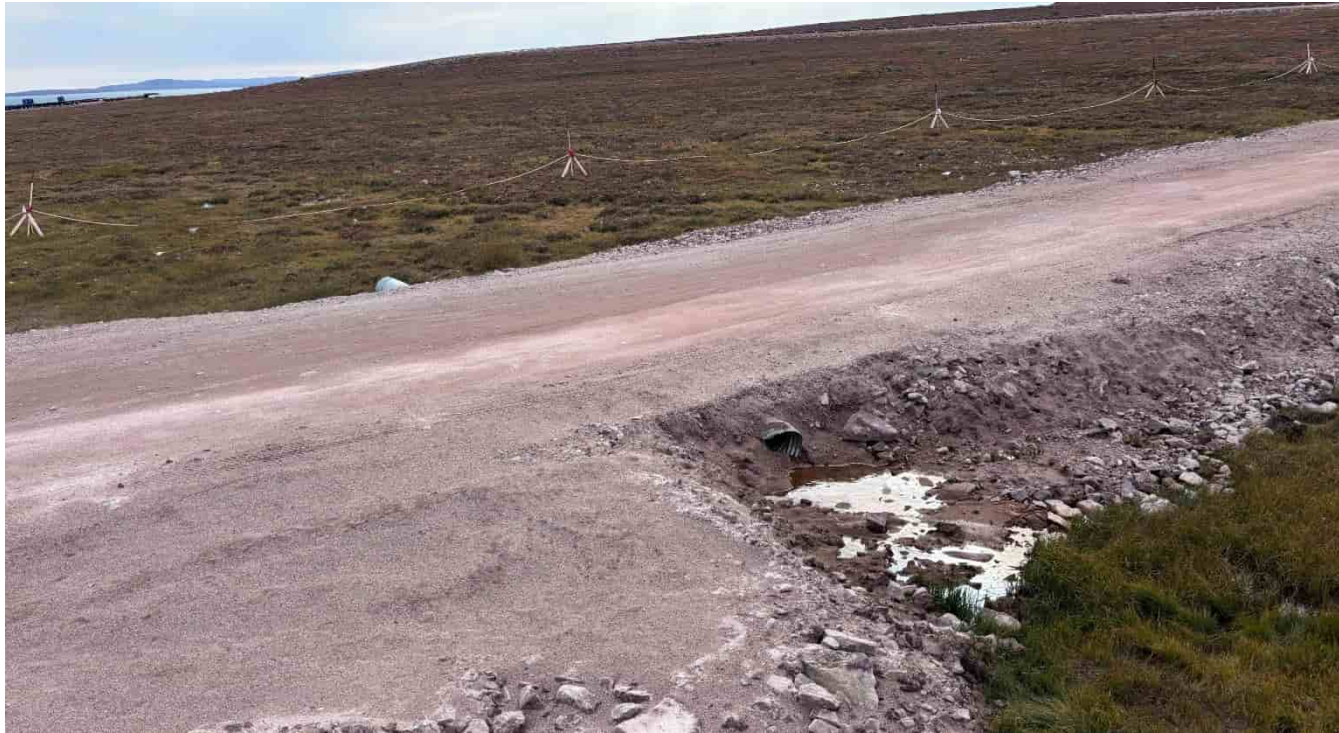
M-106: Ponding beside SE end of airstrip

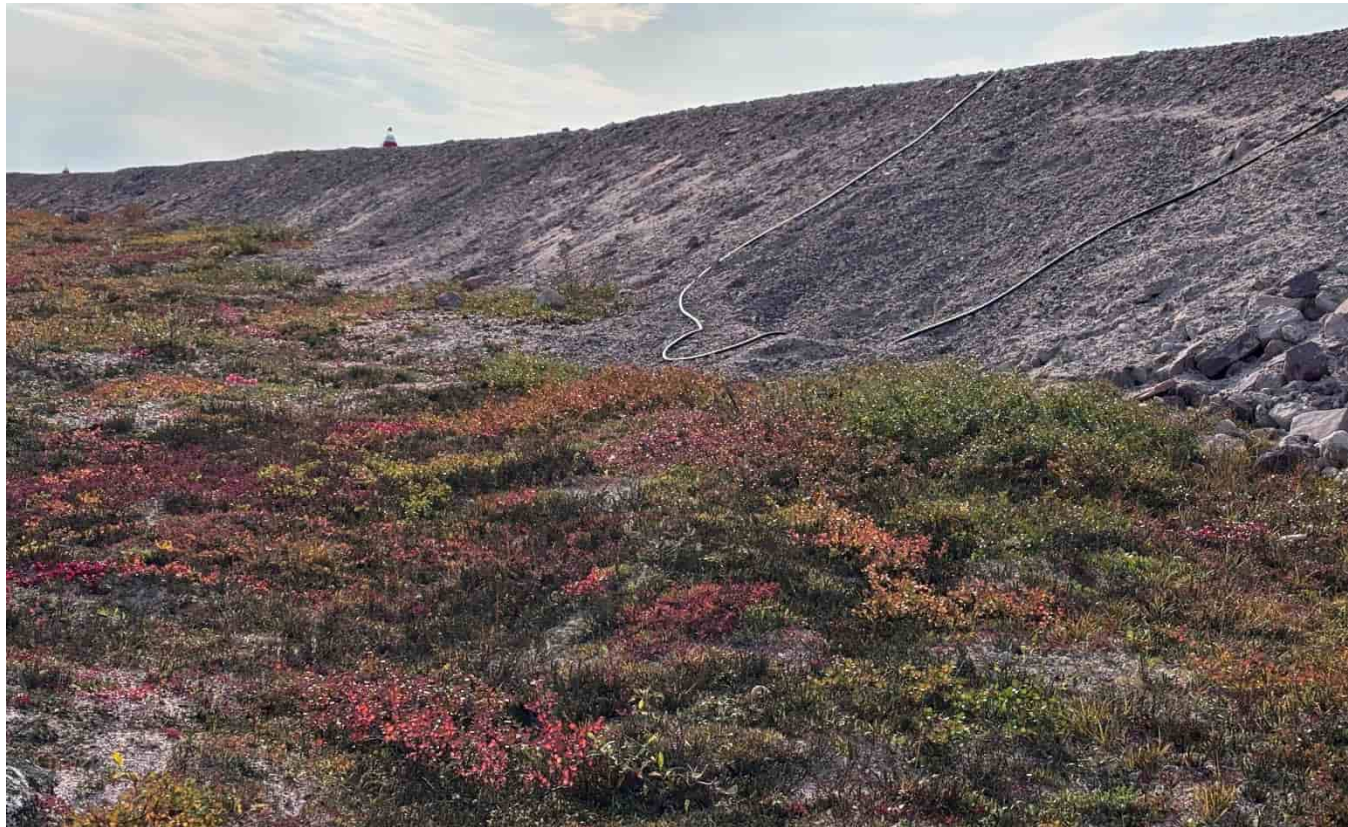
M-116: Airstrip eastern embankment

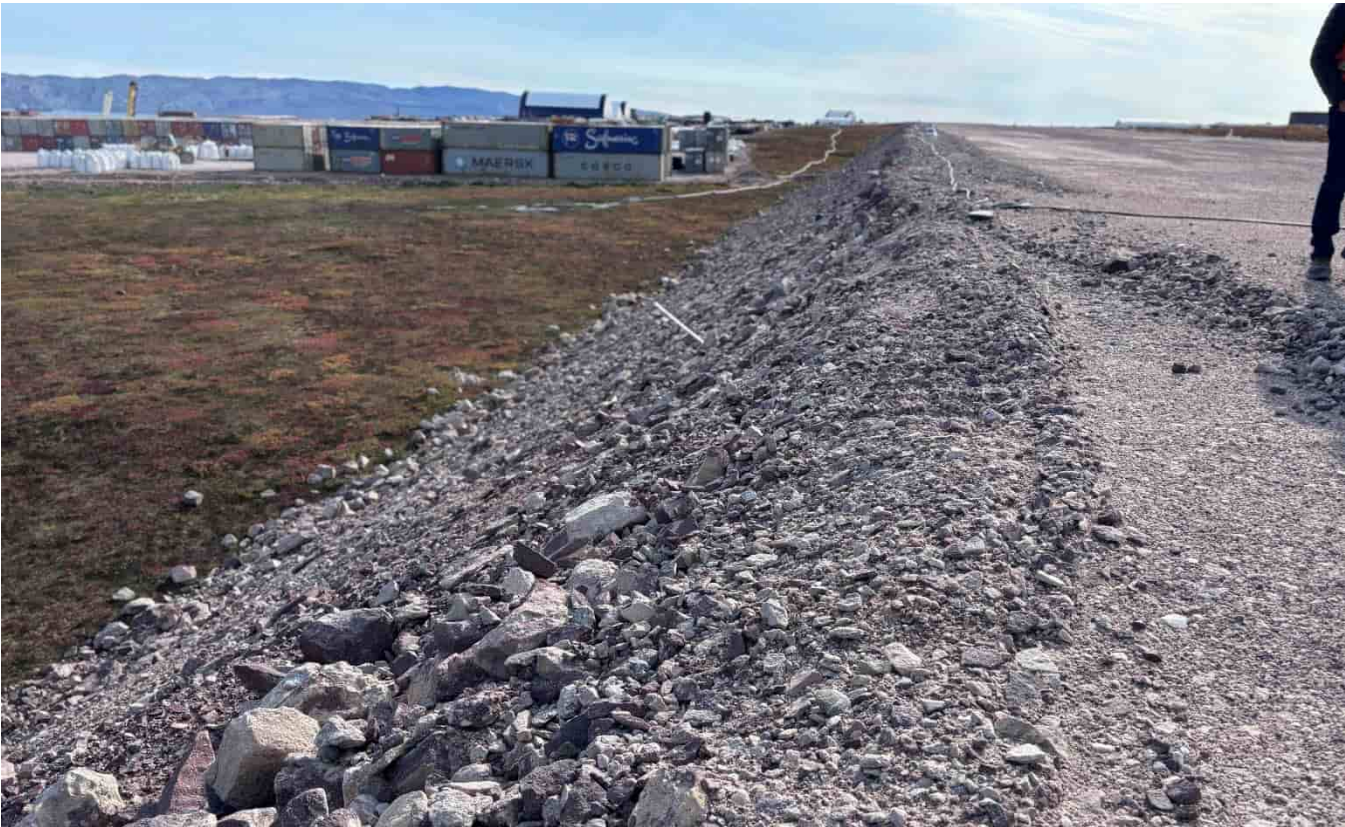
M-117: Airstrip eastern embankment, looking SE

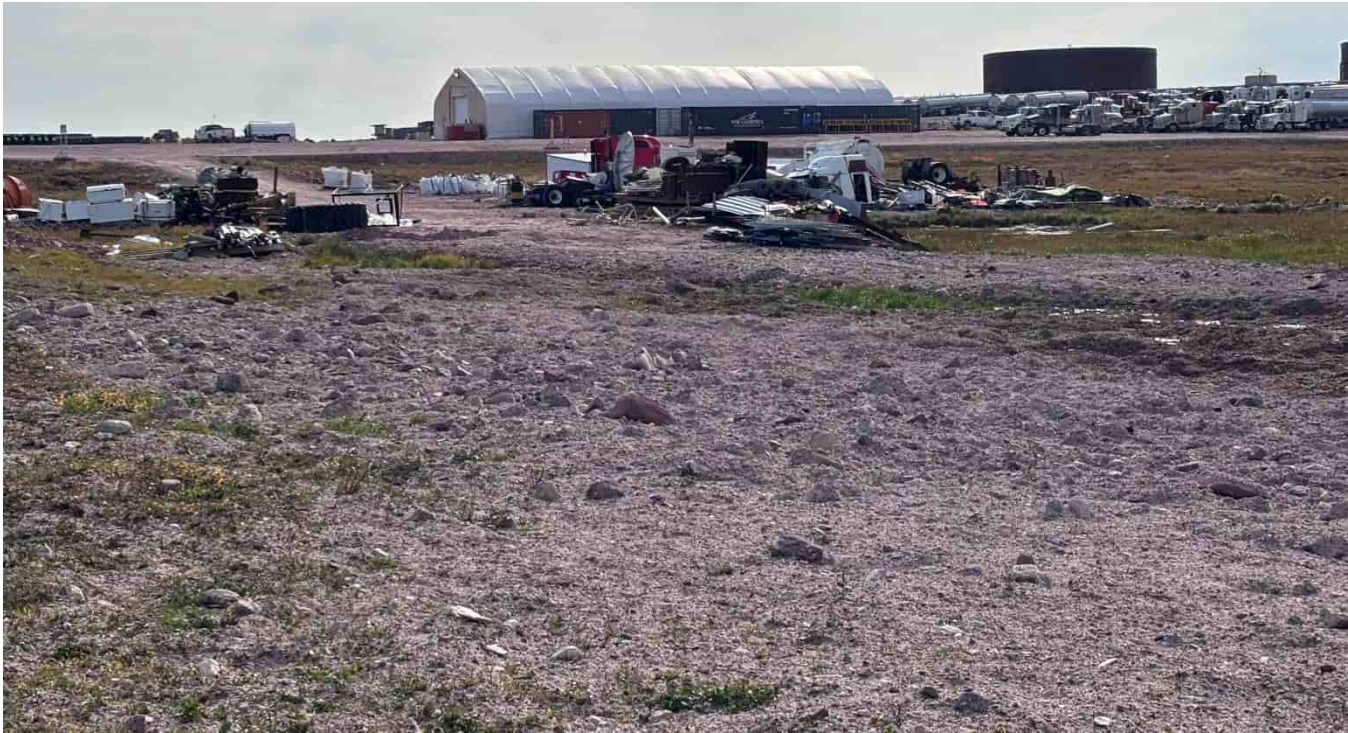
M-119: Former temporary fuel containment area, looking S

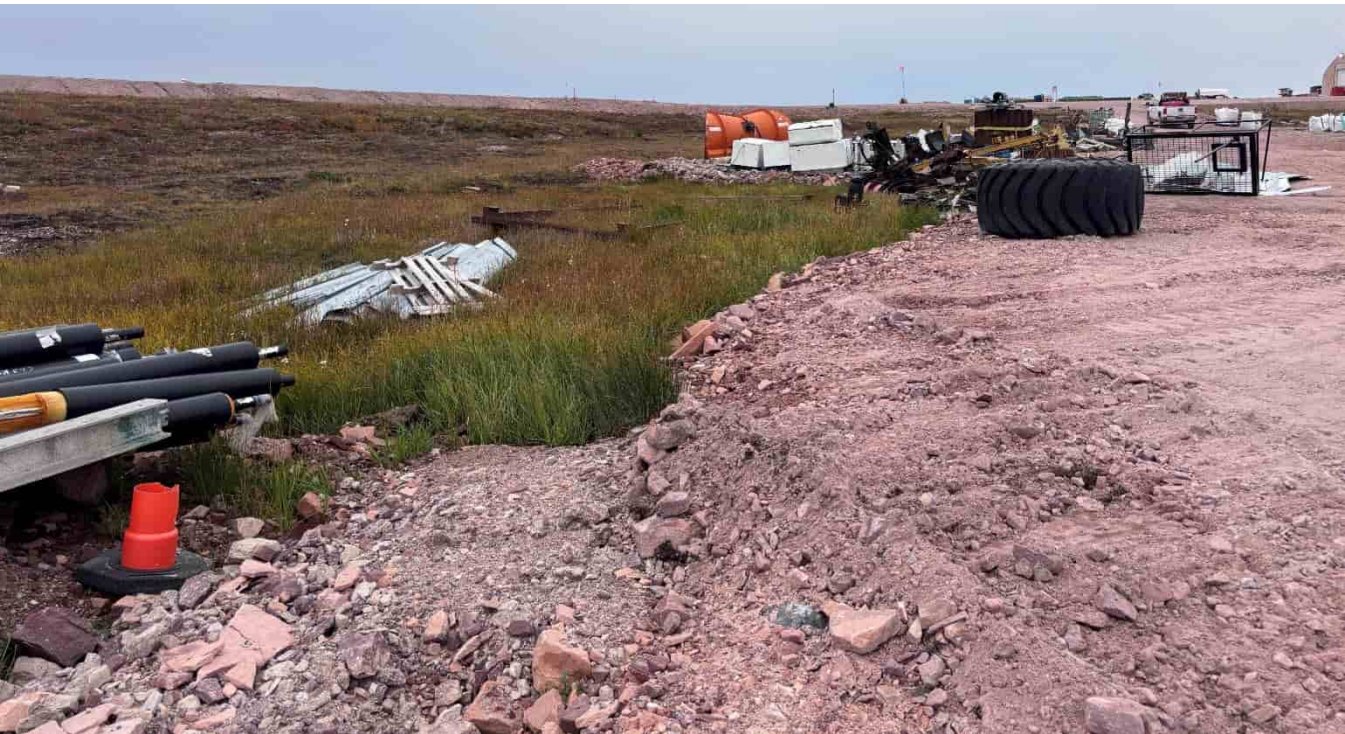
M-125: Laydown directly on tundra, looking SE

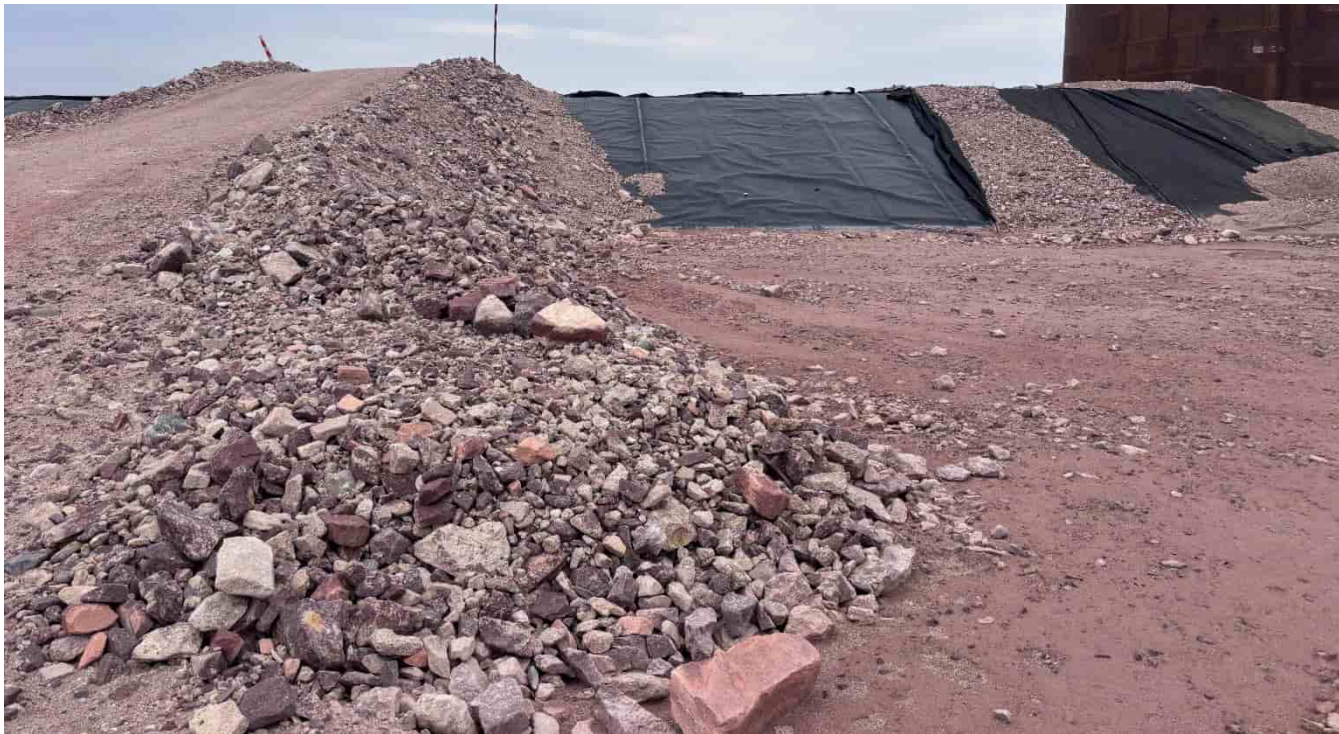
M-143: Southern embankment of entrance to tank farm

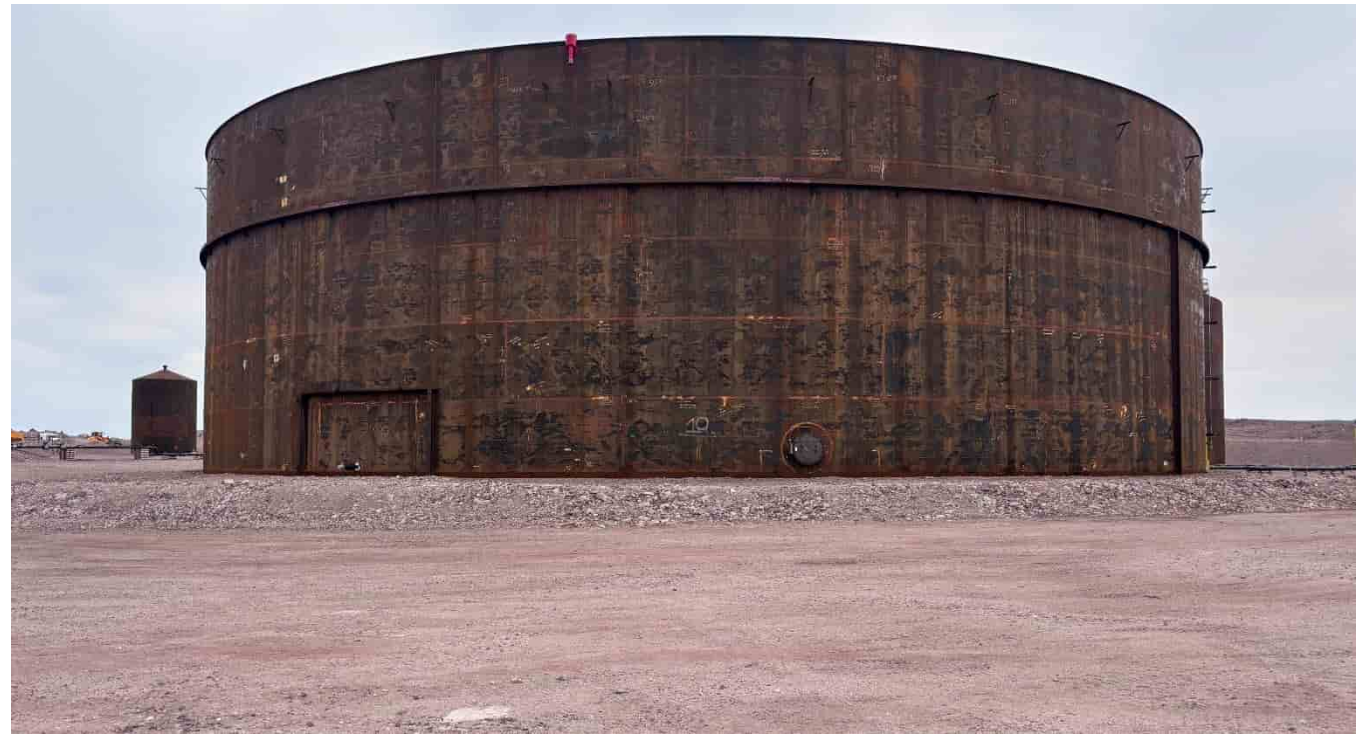
M-144: View of central tank, looking S

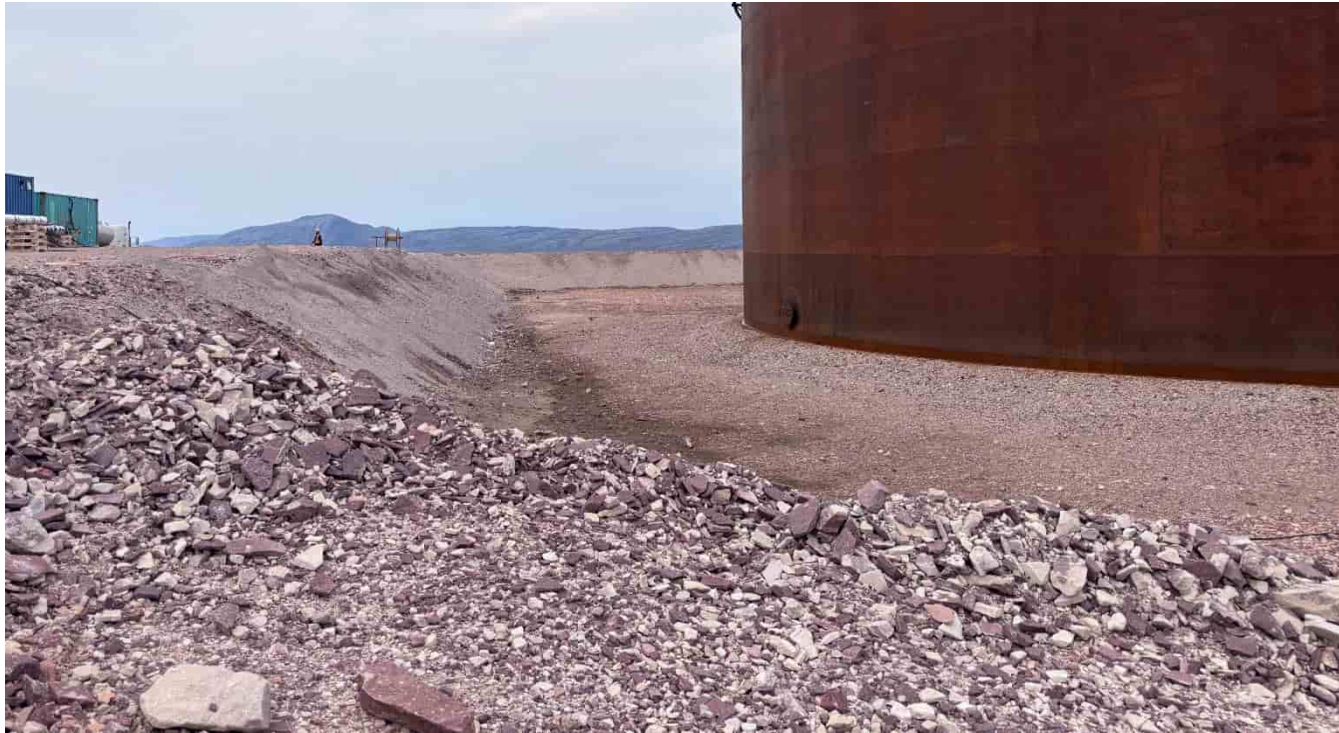
M-149: Western berm, looking N

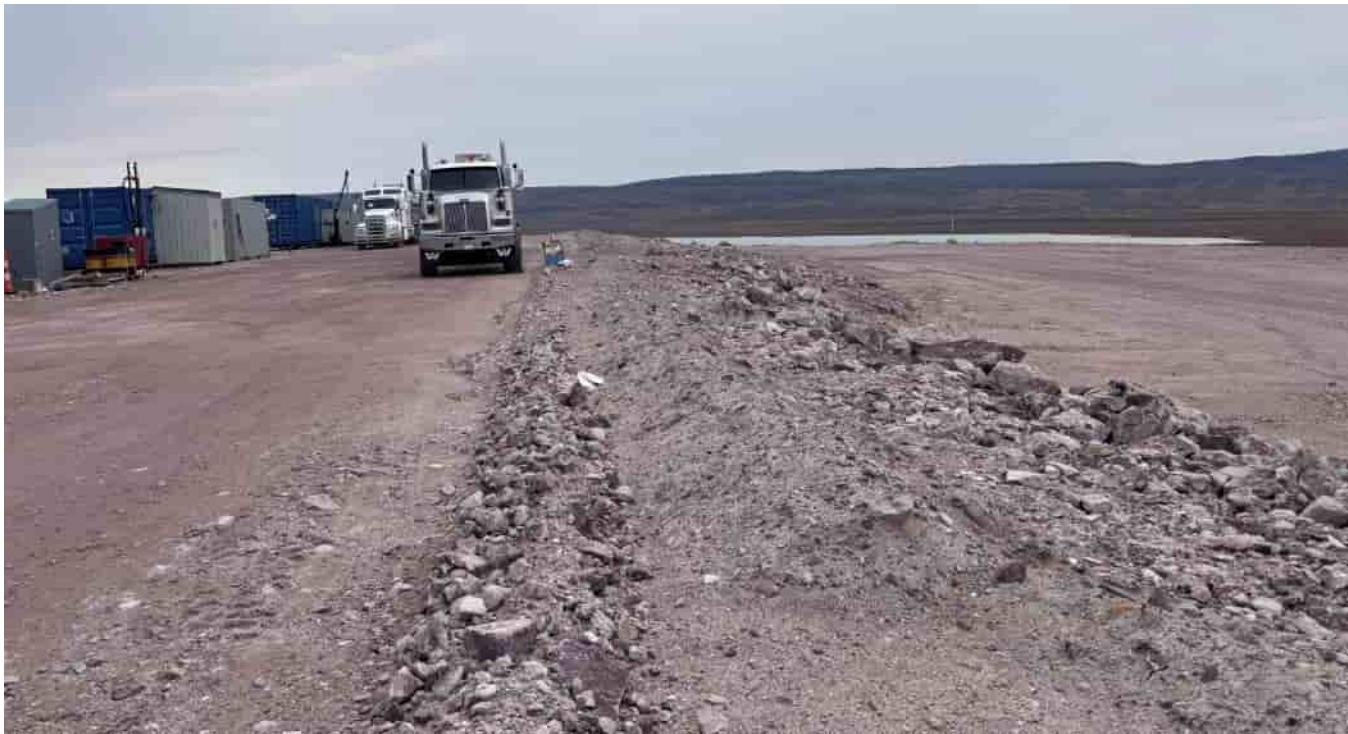
M-158: Fireball Pad, looking S

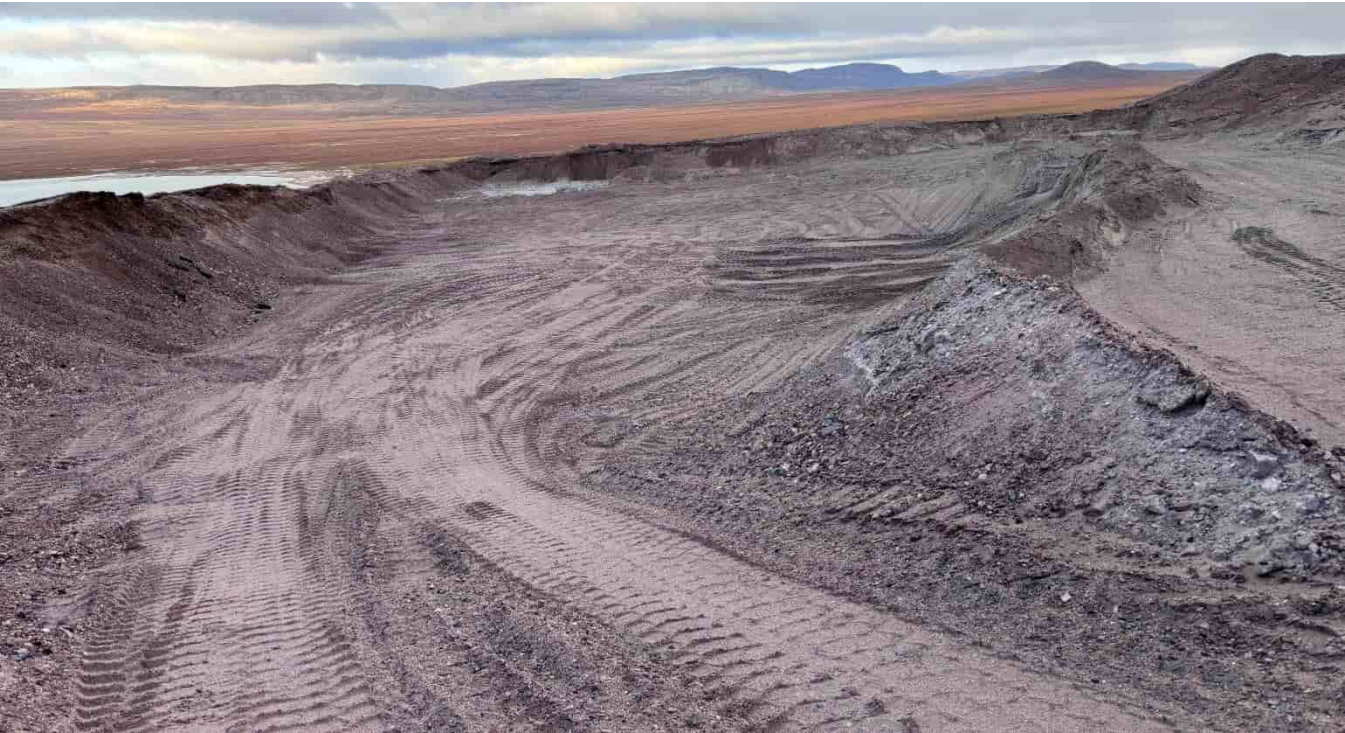
M-161: Sand borrow pit S of tank farm, looking W

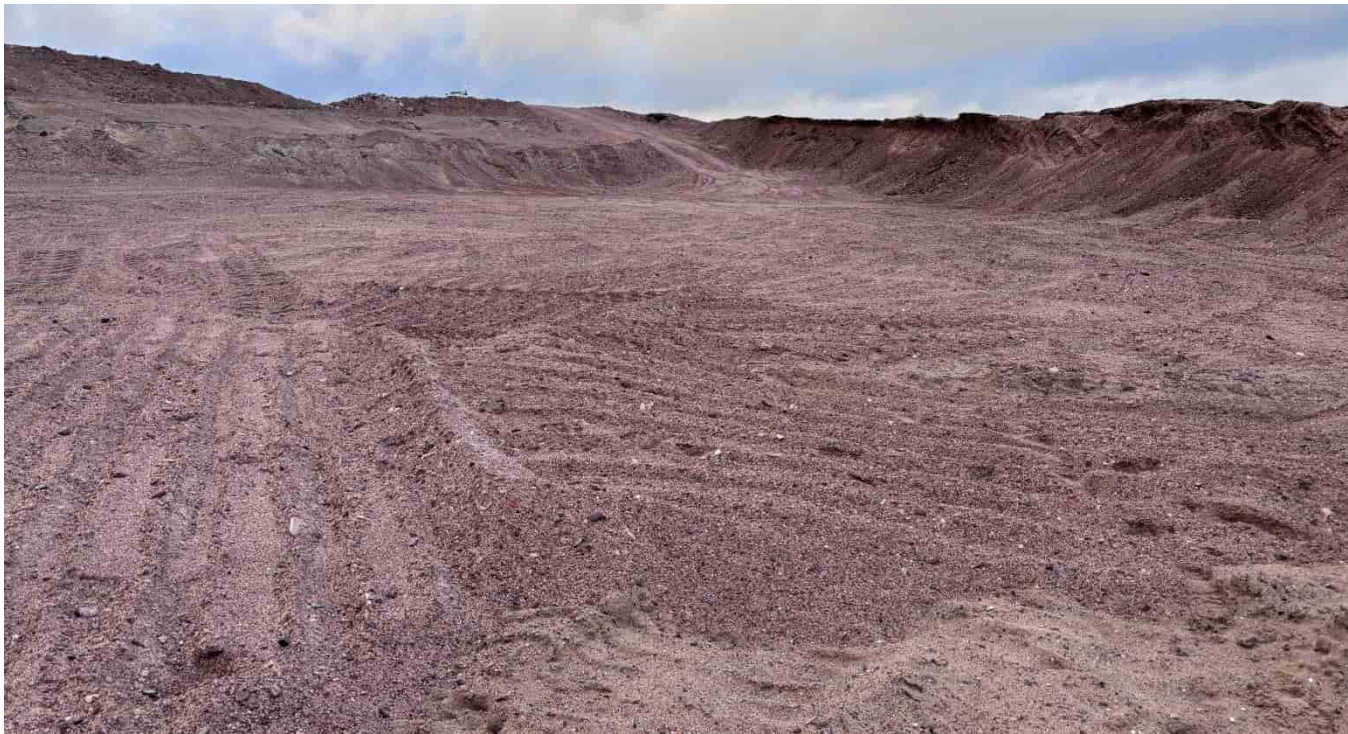
M-162: Sand borrow pit S of tank farm, looking E

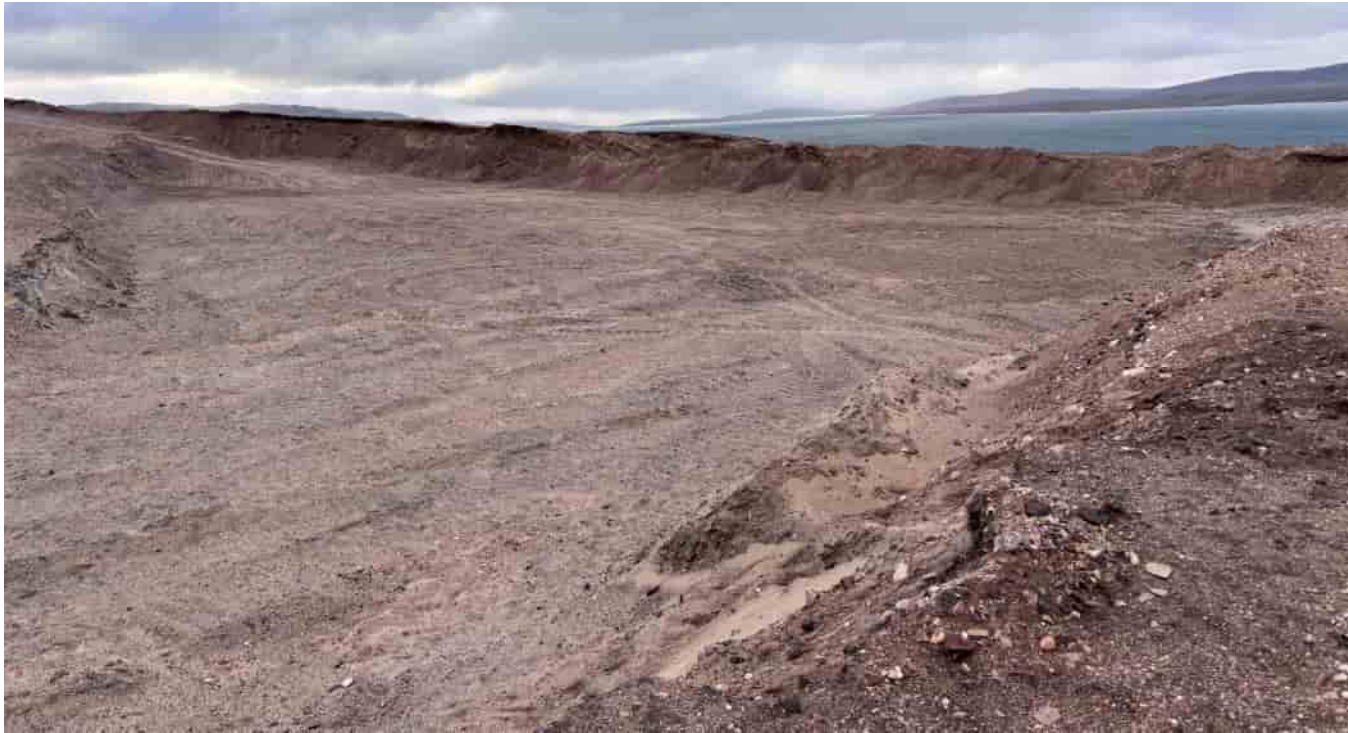
M-164: Sand borrow pit, looking SE

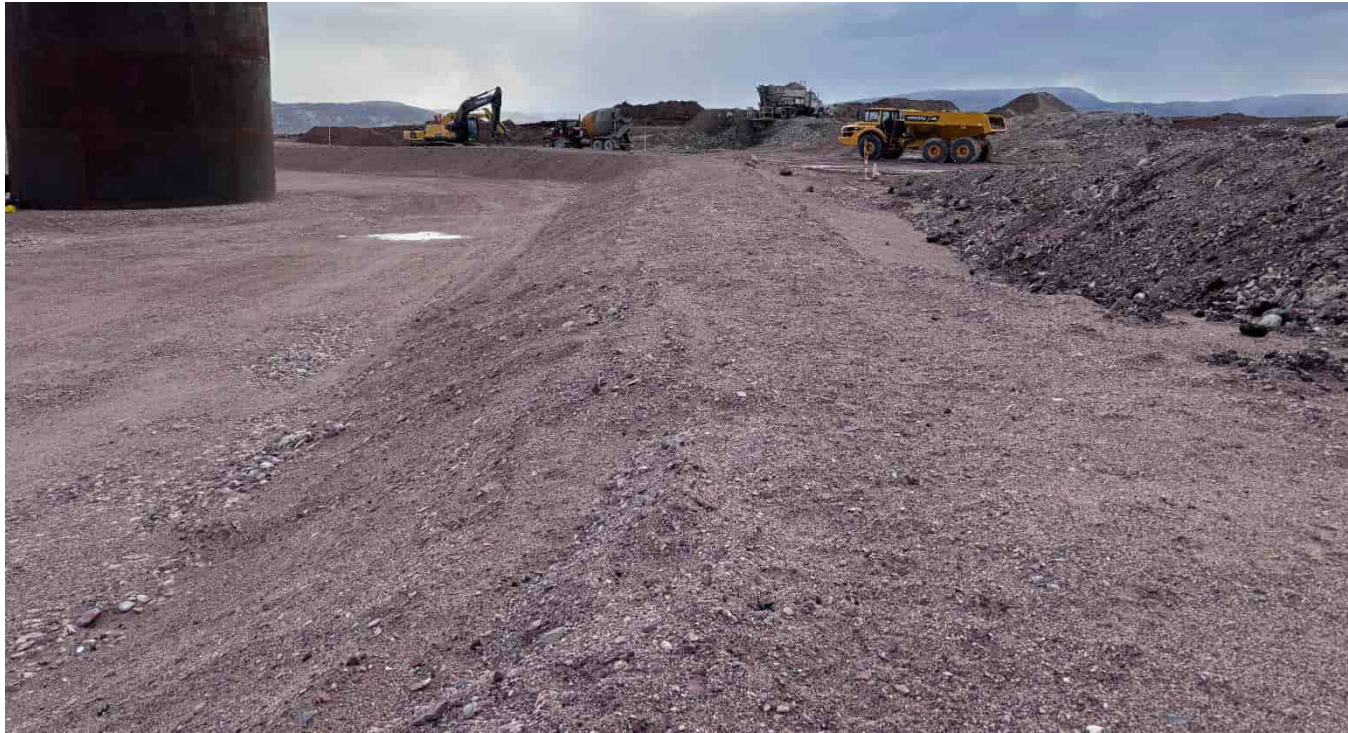
M-171: Southeastern berm, looking NE

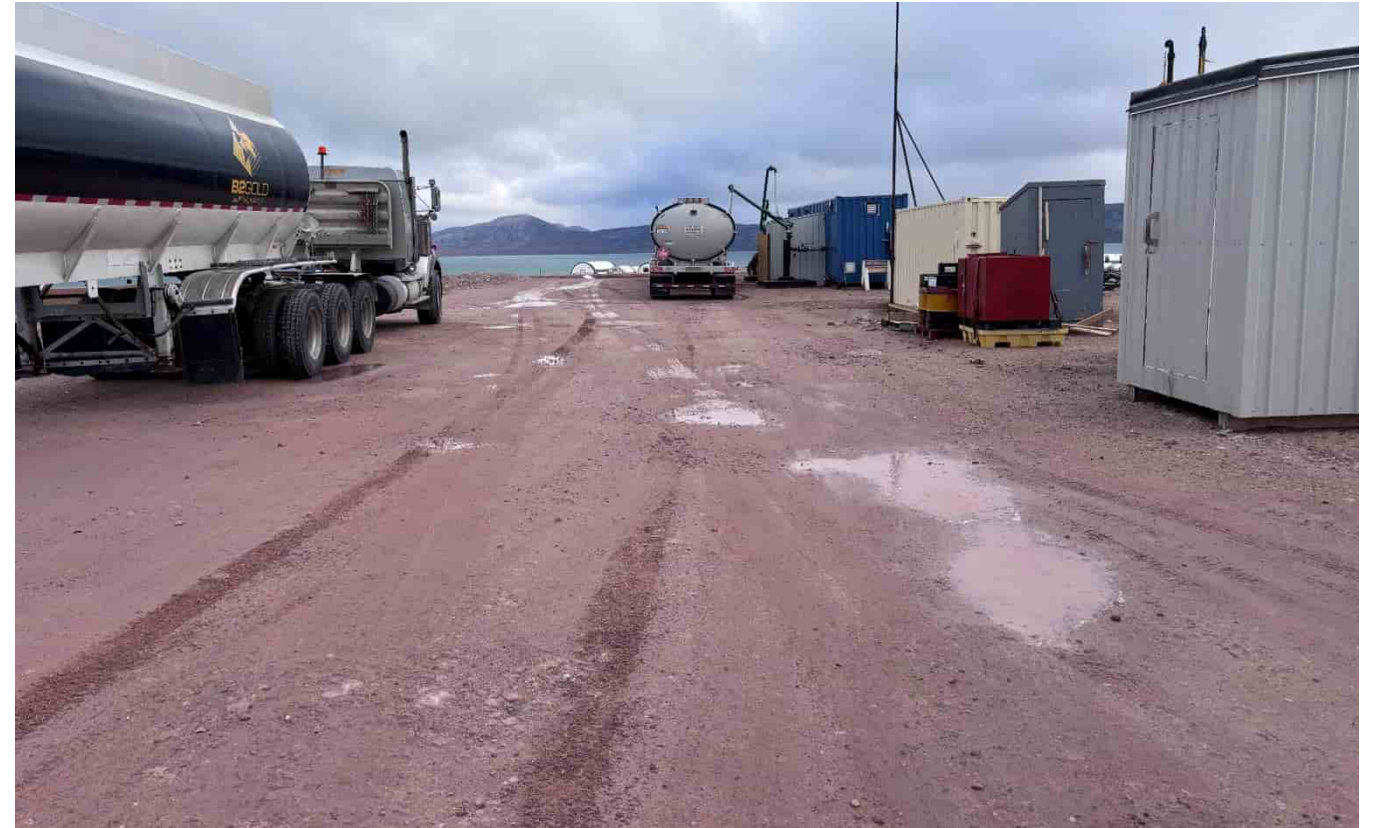
M-176: Fireball pad surface conditions, looking N

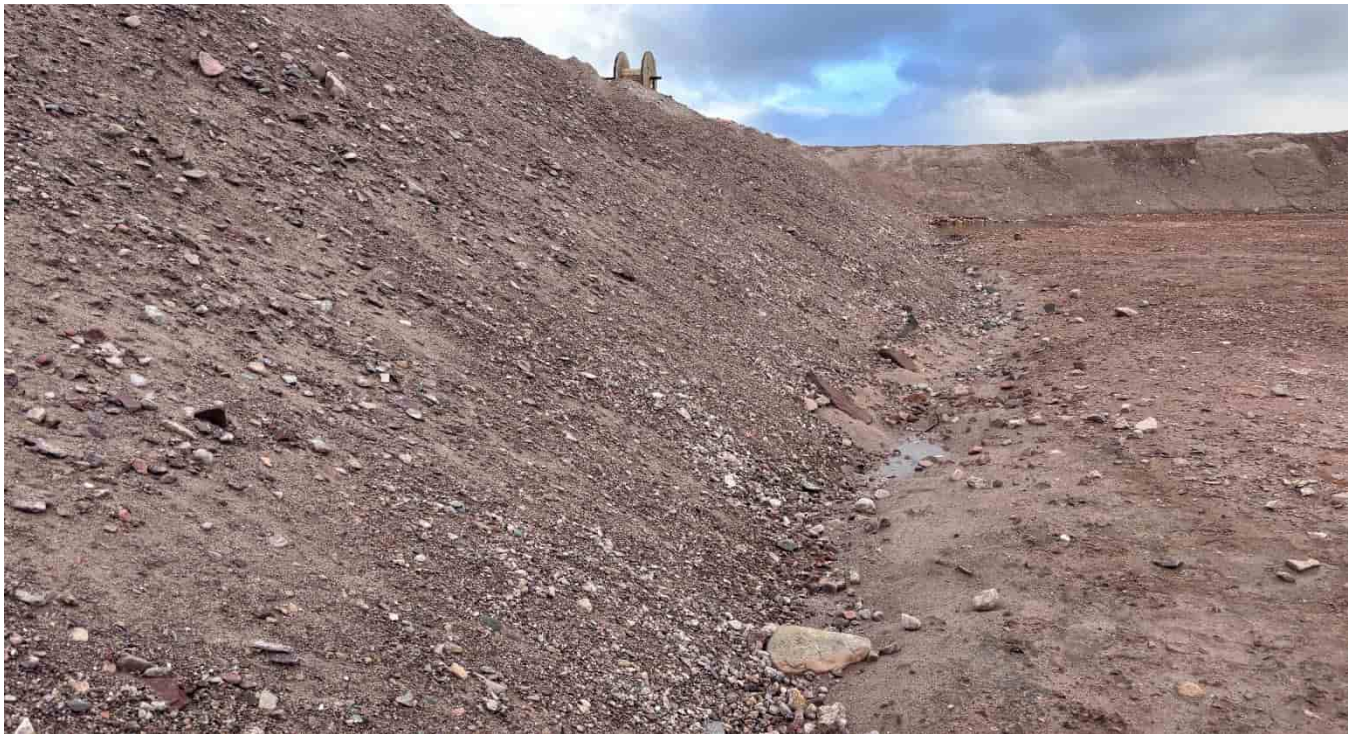
M-183: Western berm, looking N
