### 3. OBSERVATIONS AT SITE

From March 23 to 25, 2026, NIRB staff conducted a site visit to the Goose Property Area, travelled the Winter Ice Road (WIR), and visited the Marine Laydown Area (MLA) of the Back River Project, accompanied by B2Gold Nunavut's environment team. The purpose of the visit was to review construction progress, environmental management practices, and compliance with Project Certificate No. 007, Amendment 01. During the visit, NIRB staff observed ongoing construction, commissioning, and operational activities and held discussions with B2Gold Nunavut personnel regarding environmental monitoring, mitigation measures, and adherence to Project Certificate requirements ([Table 1](#))

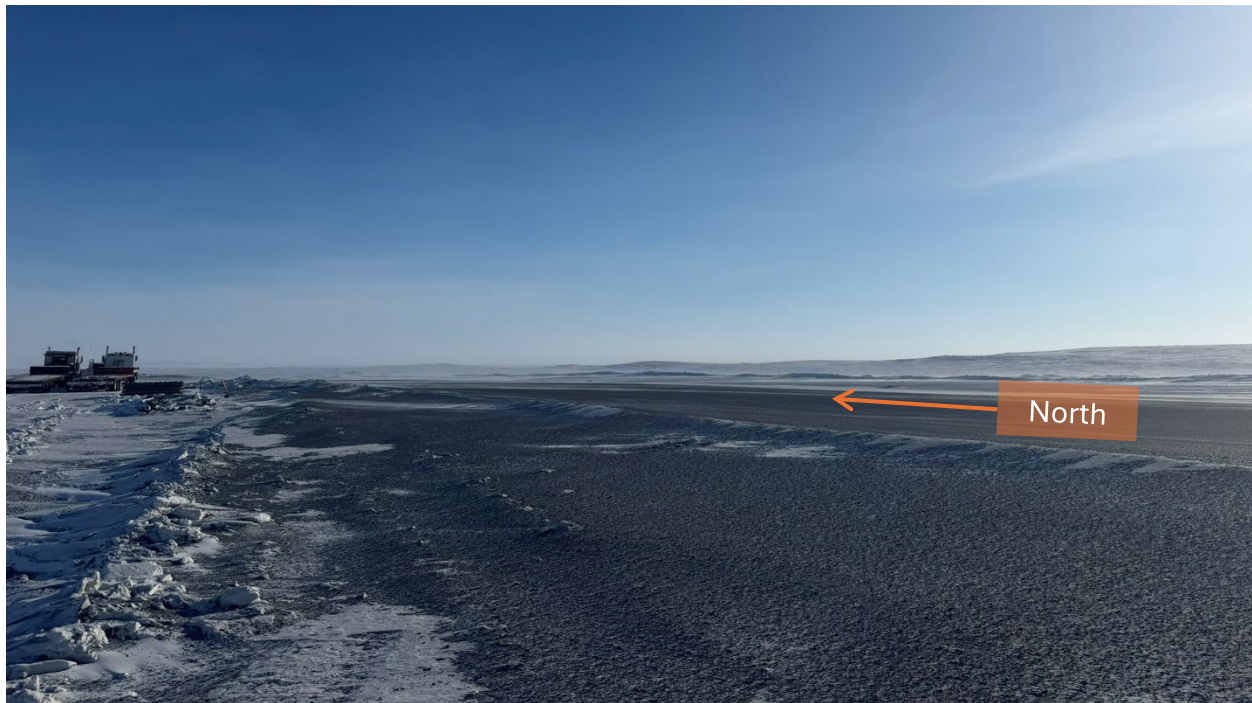
**Photo 1: Airstrip**

<sup>1</sup> Goose Airstrip has undergone multiple construction phases since before 2016, with major extensions and upgrades between 2020 and 2024. Future Expansion may require additional water conveyance infrastructure and completion of the Rascal Diversion Berm and fishway passage.

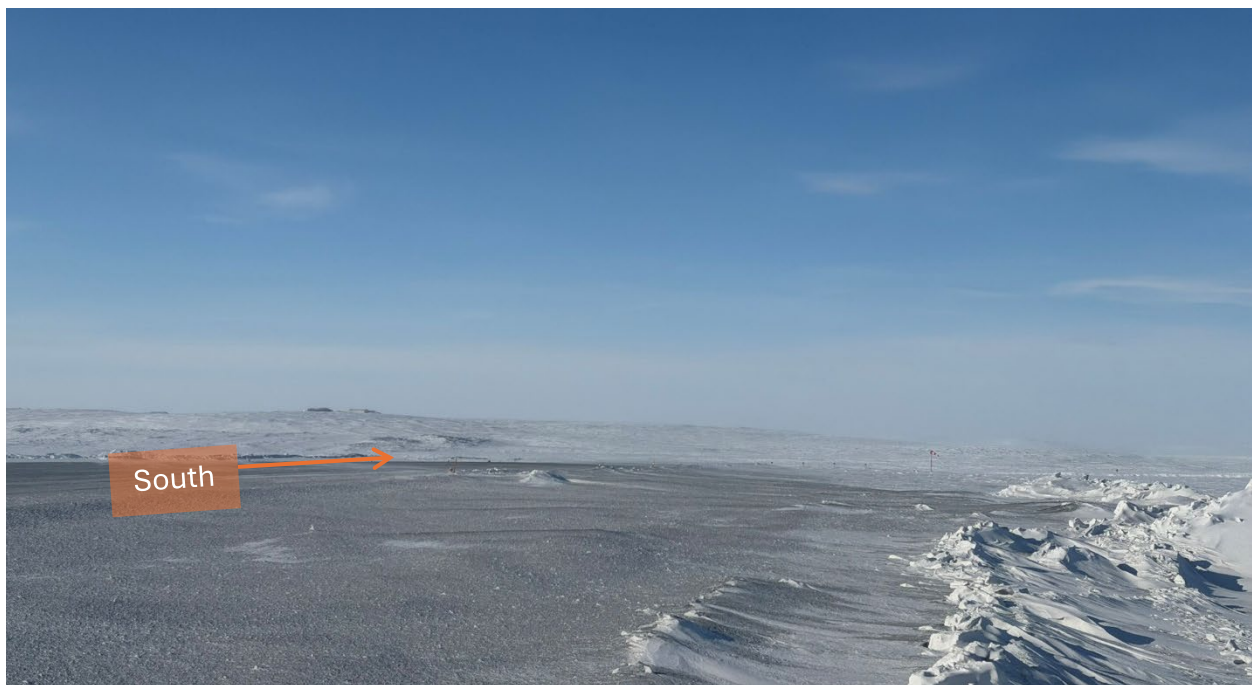
**Photo 2: Airstrip**

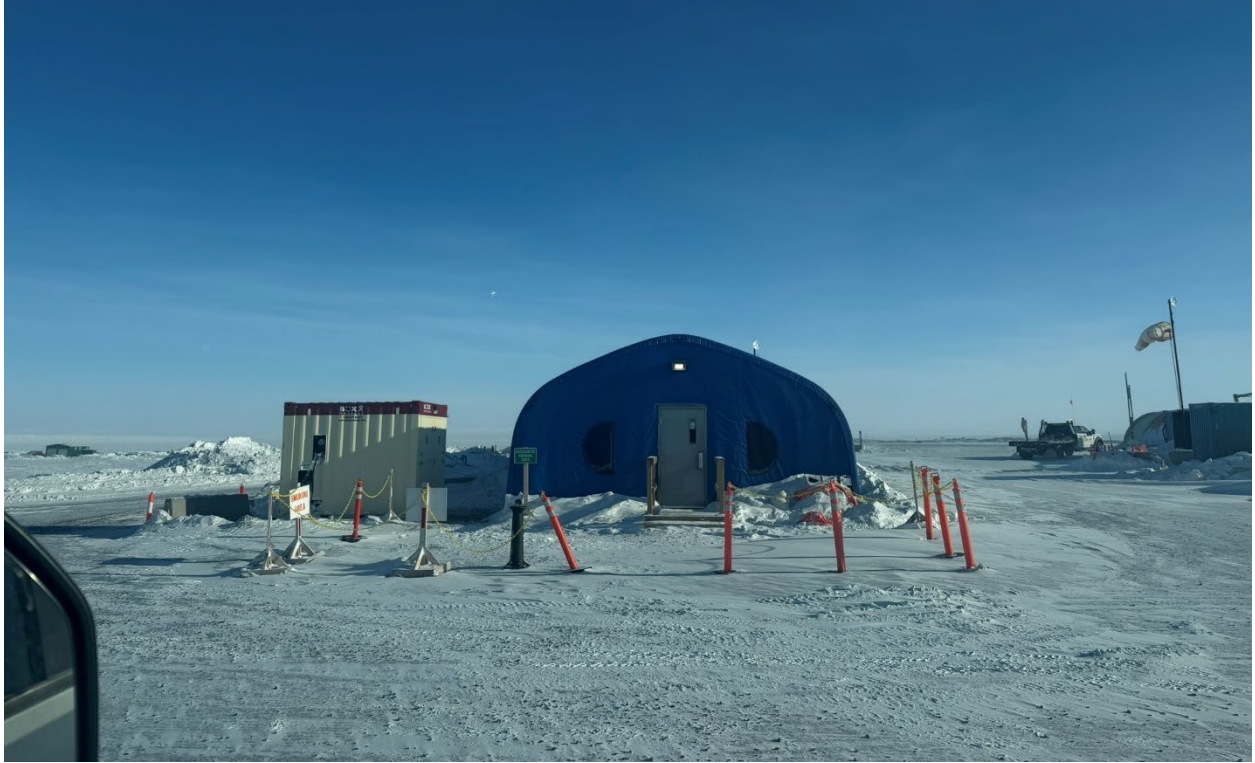
**Photo 3: Security waiting area**

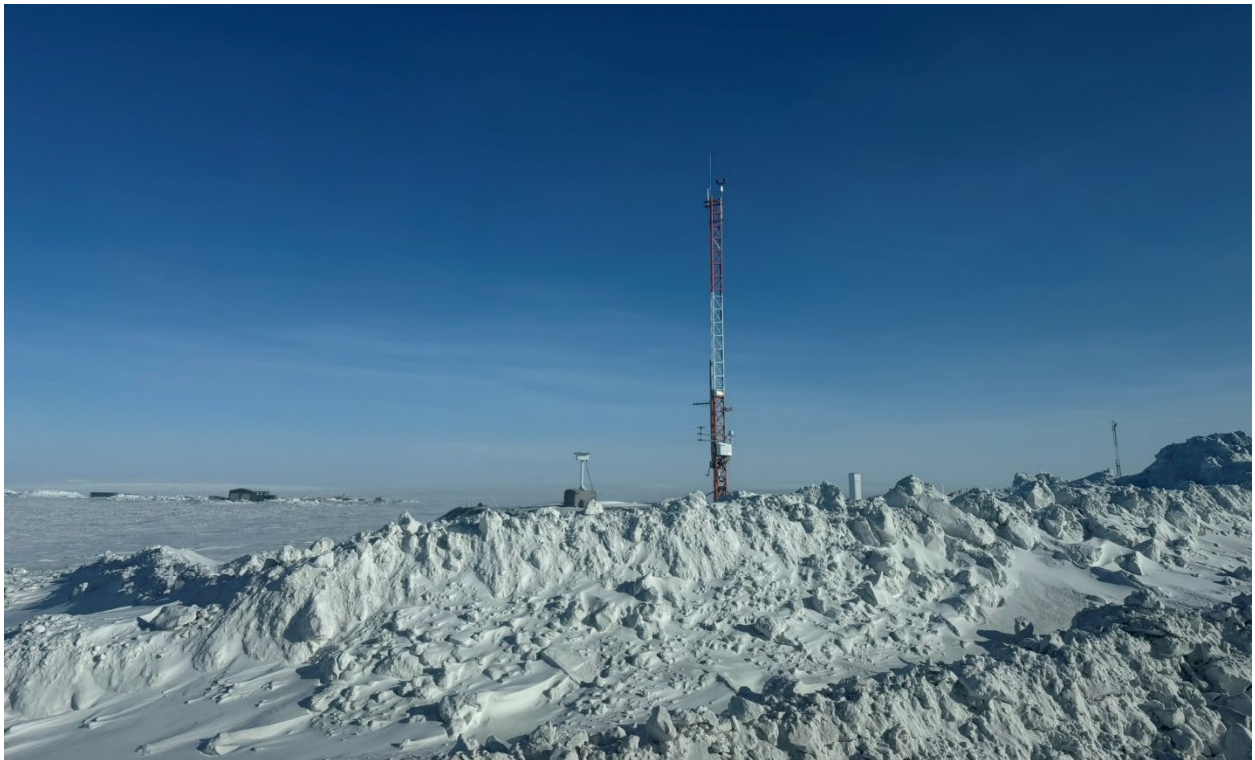
**Photo 4: Communication tower**

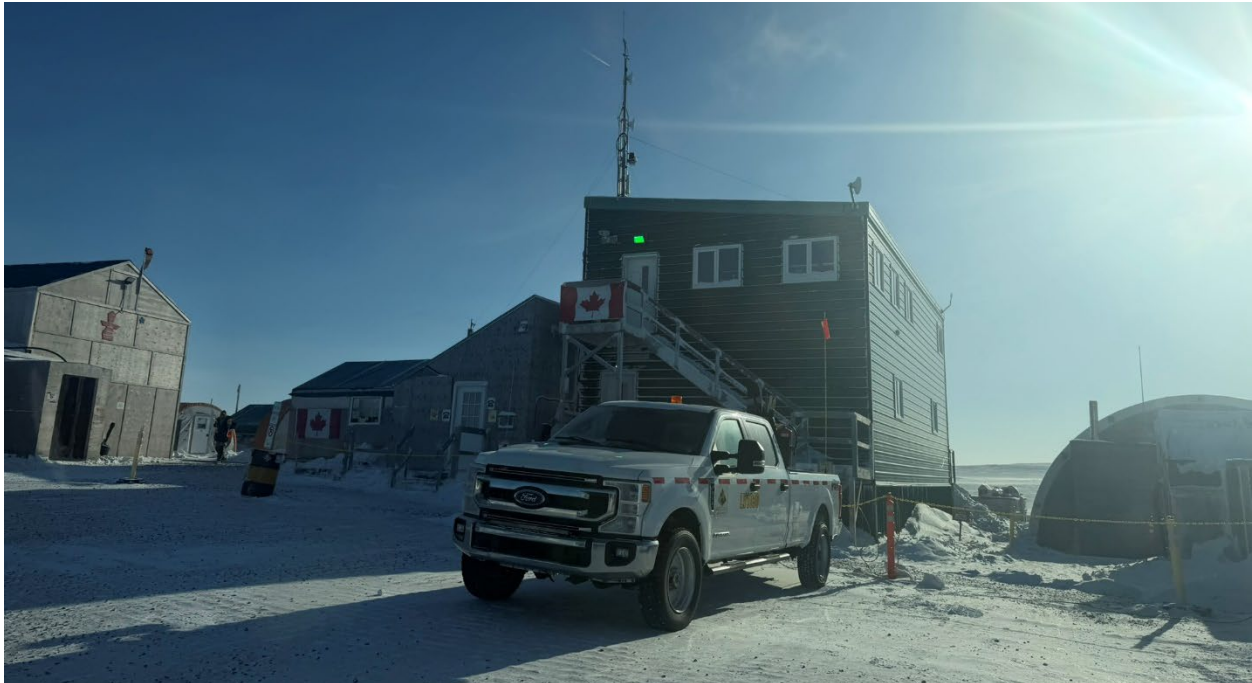
**Photo 5: Air traffic control station**

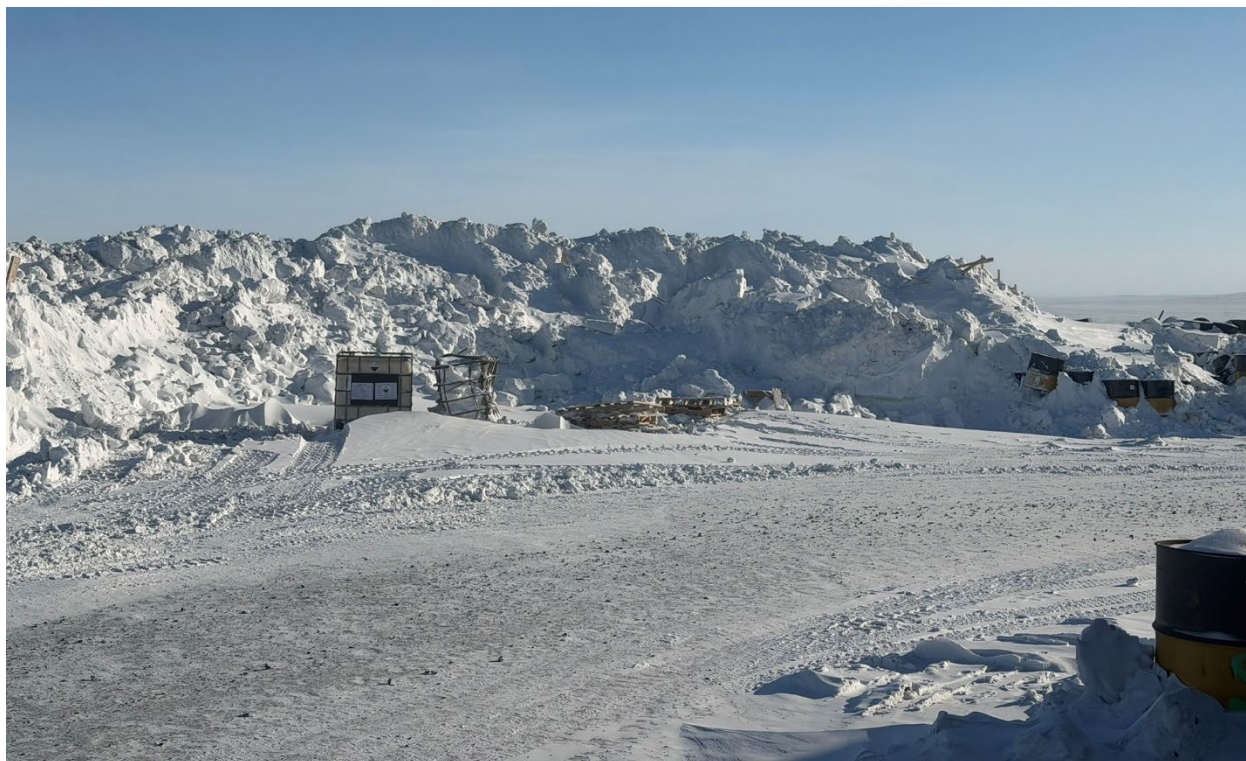
**Photo 11: Empty totes and drums located east of the incinerators**

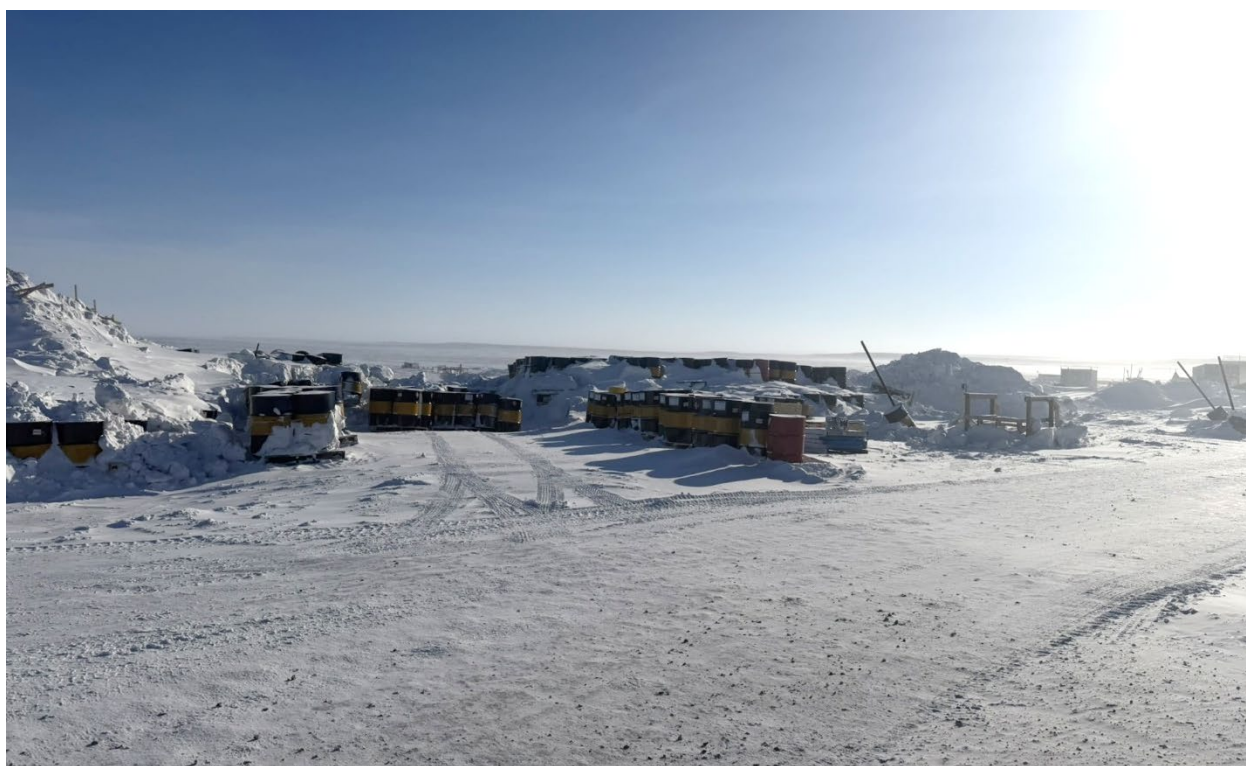
**Photo 12: Empty totes and drums located east of the incinerators**

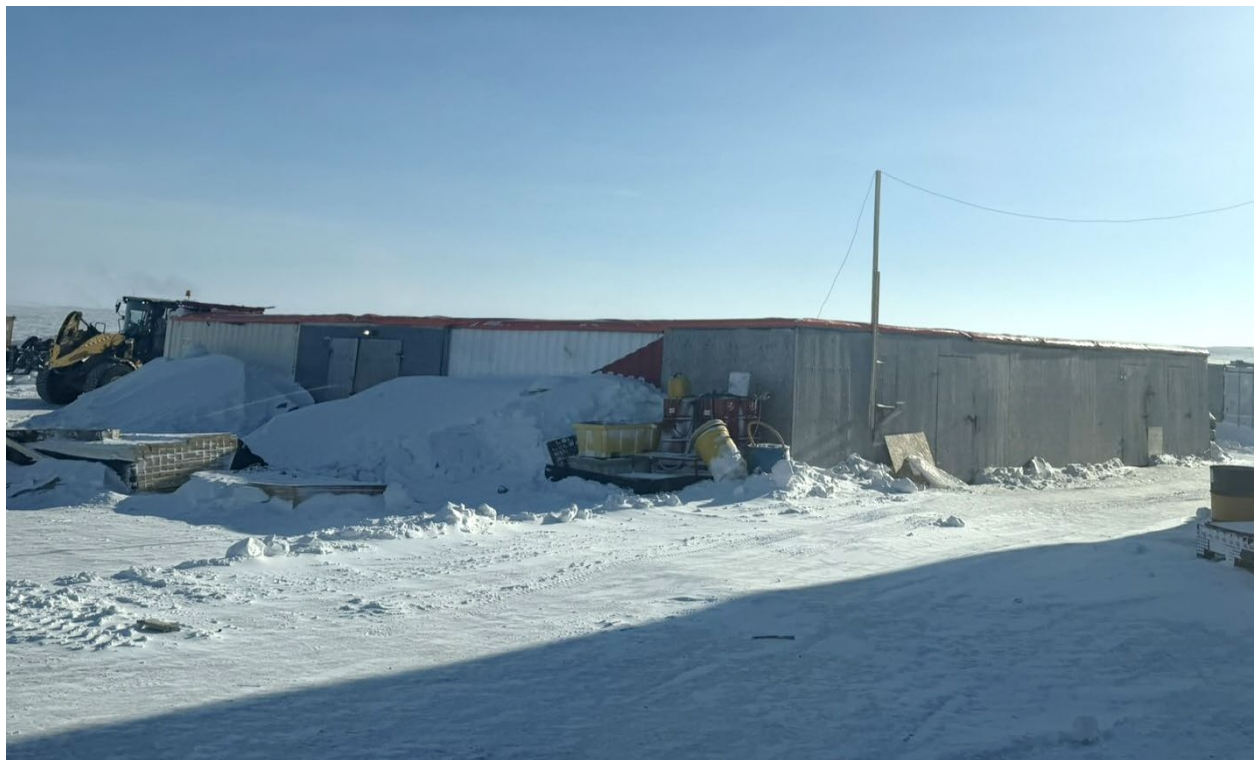
**Photo 16: Major Drilling shop located west of air traffic control building**

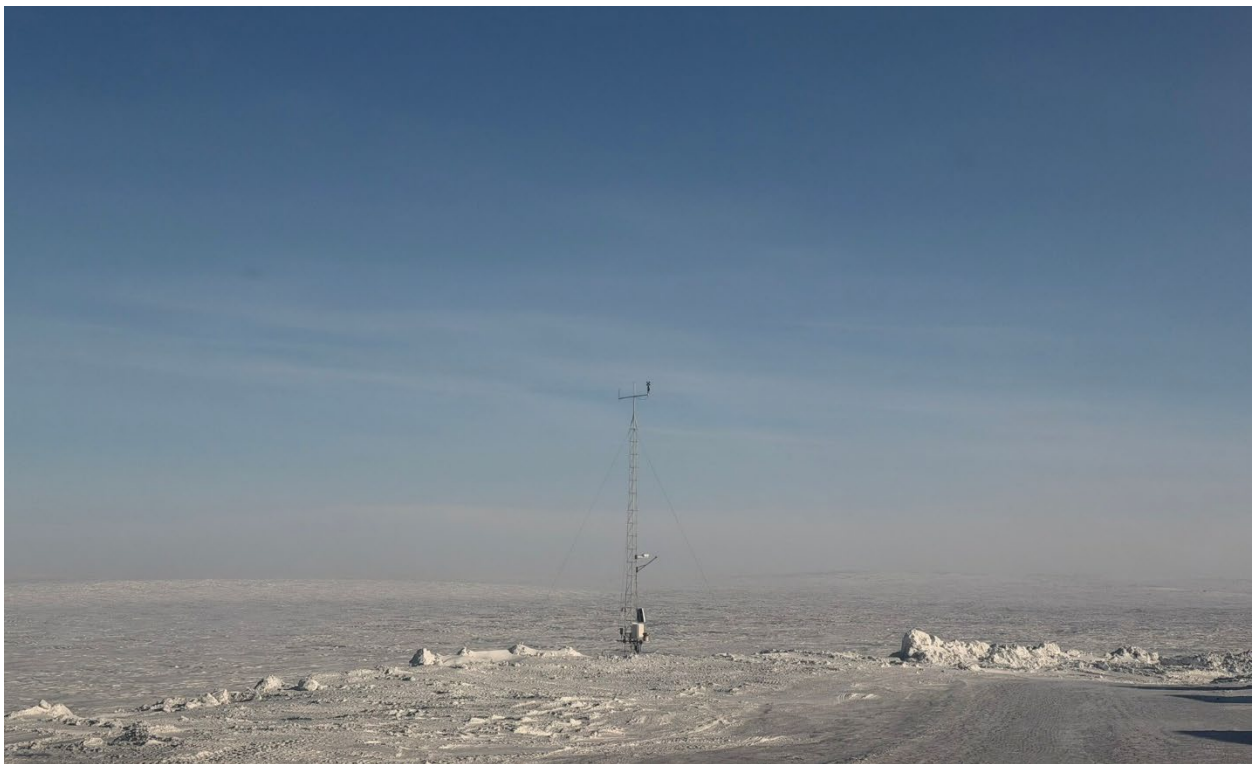
**Photo 22: Goose Lake meteorological station**

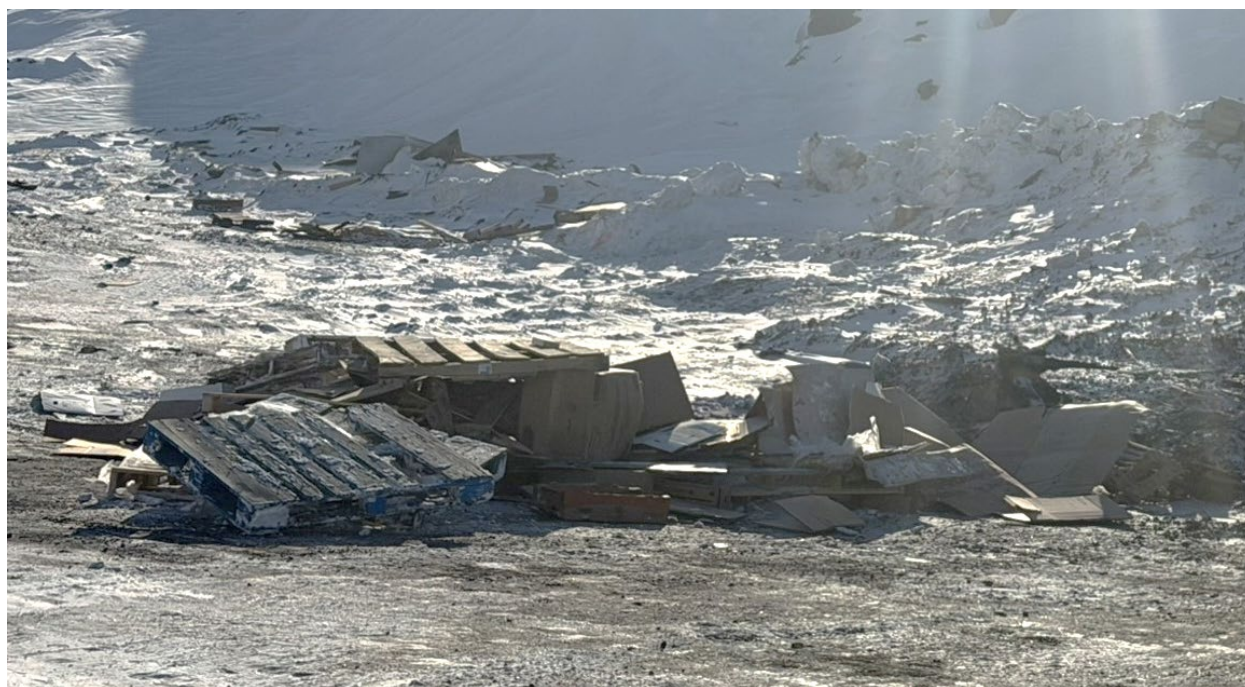
**Photo 26: Close-up of non-hazardous materials prepared for open-air burning**

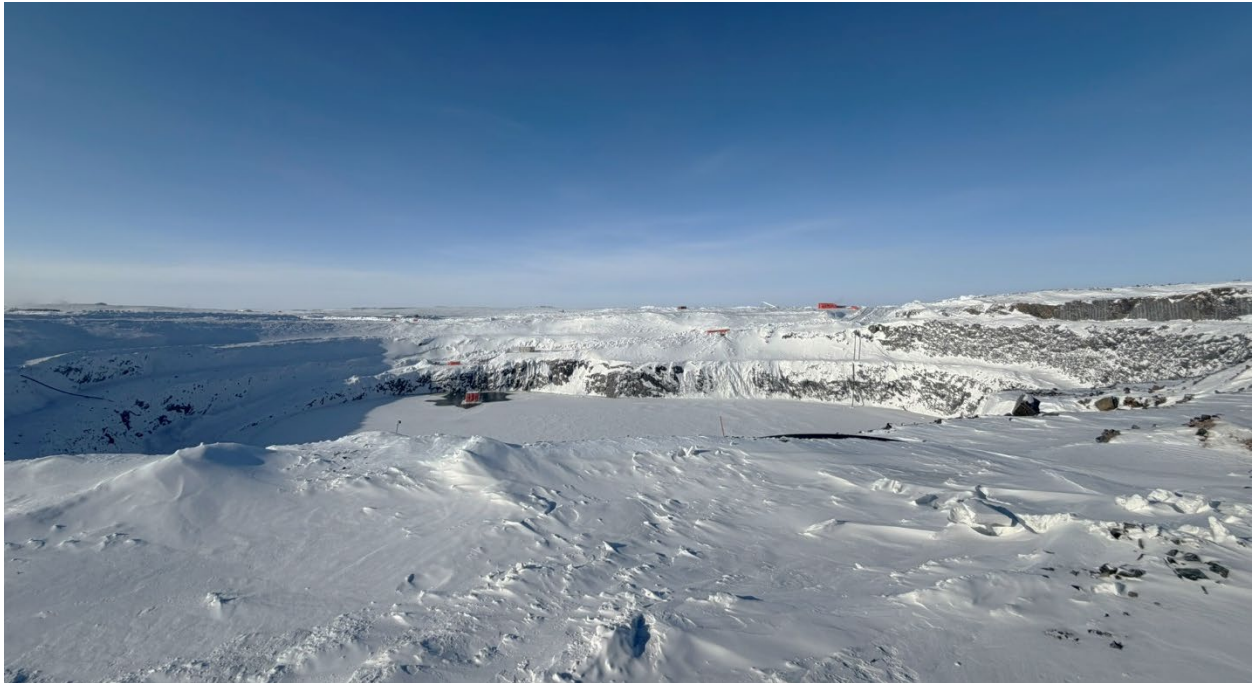
**Photo 27: Echo Pit overview facing north**

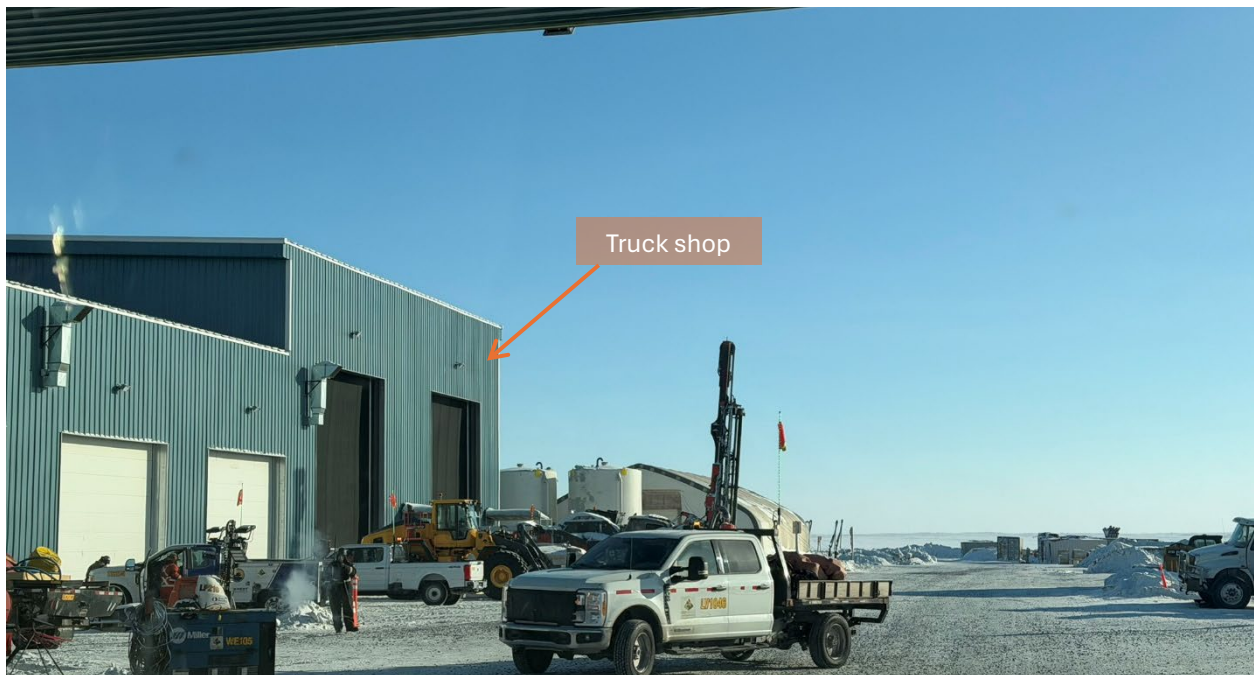
**Photo 30: Entrance to plant pad and truck shop**

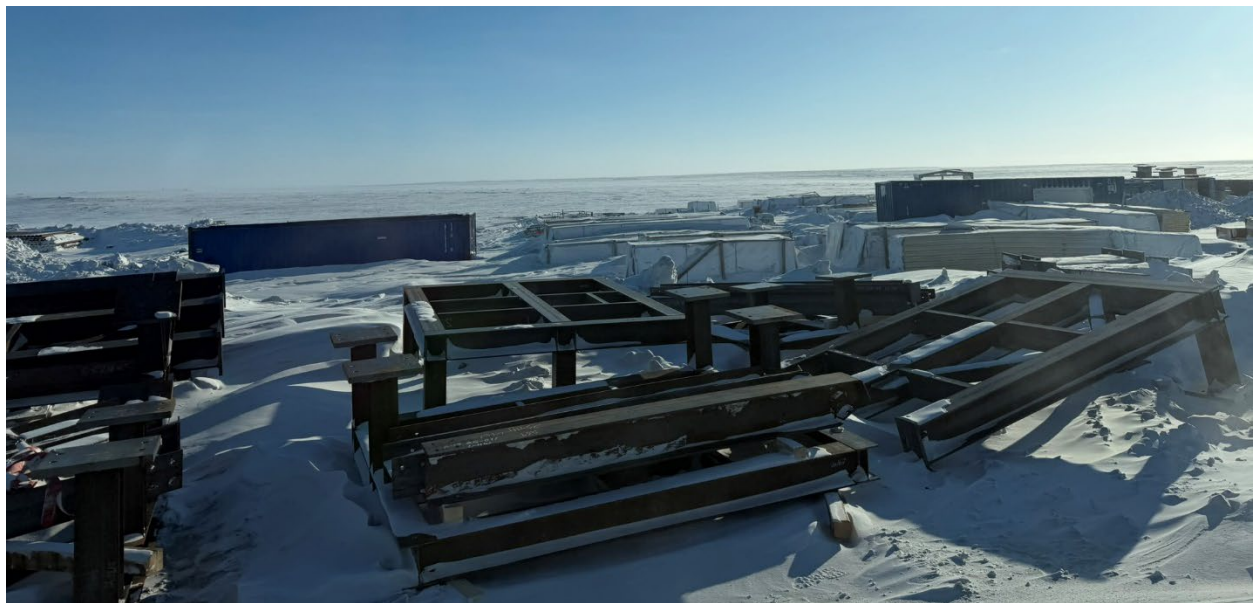
**Photo 32: Laydown areas located south of the Tank farm**

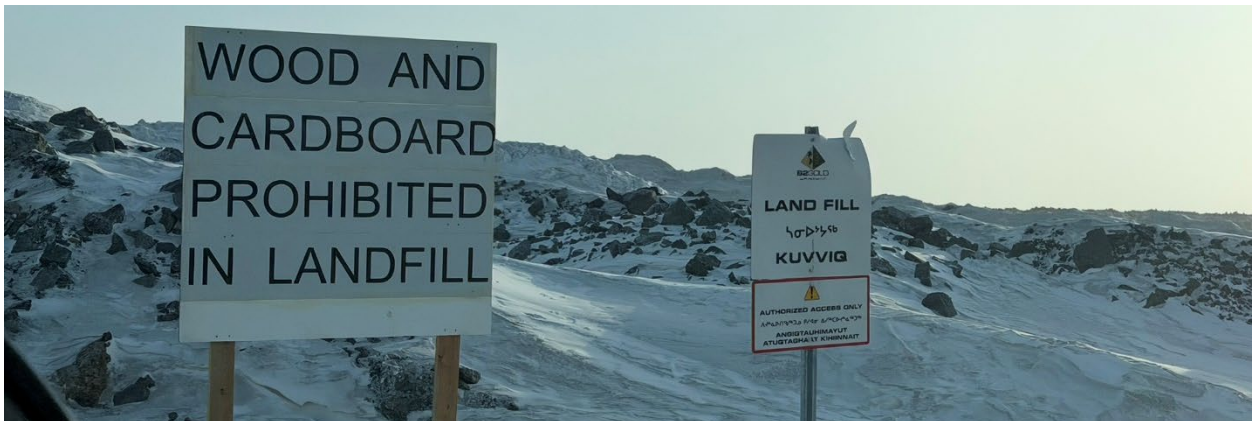
**Photo 50: Landfill area located east of the Umwelt WRSA**

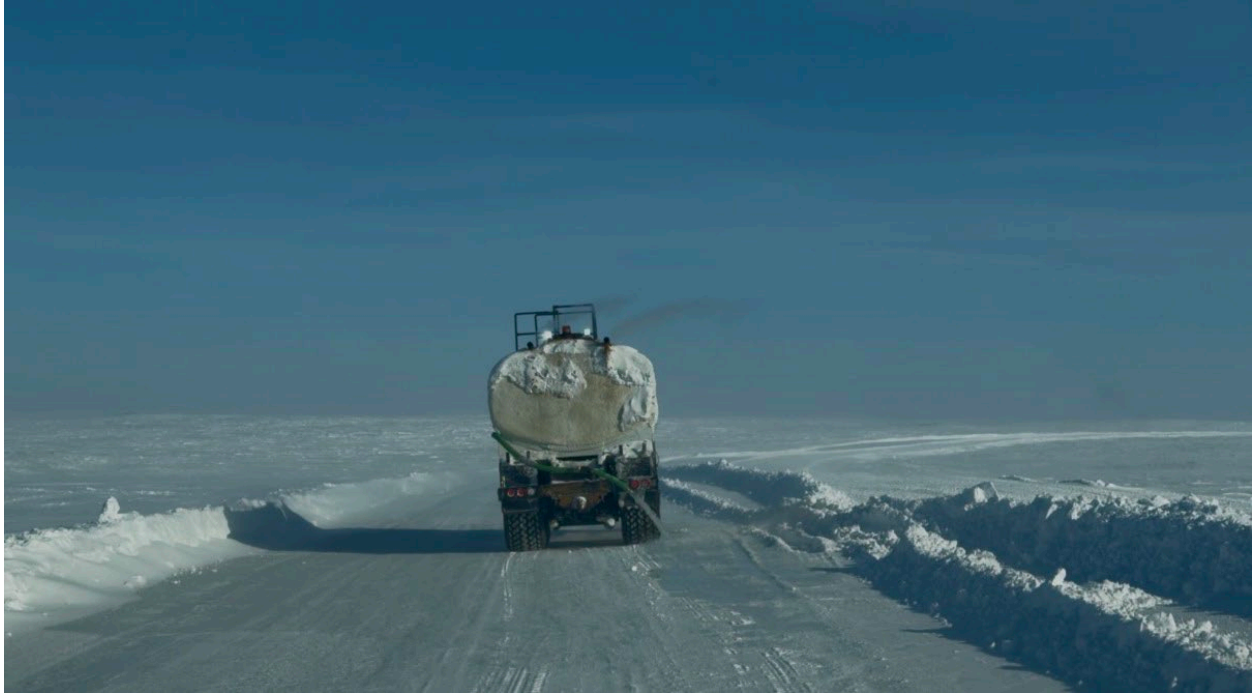
**Photo 78: Water application on Portage P8 to strengthen the winter road surface**

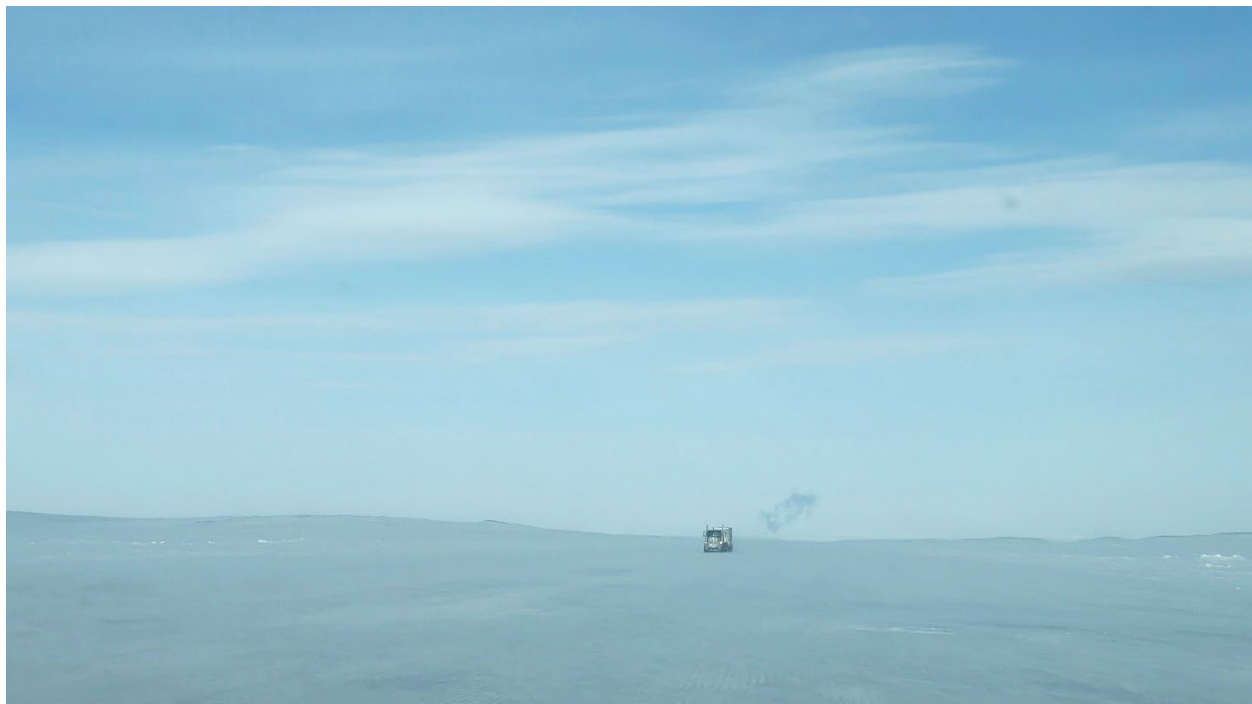
**Photo 85: Southbound truck to Goose Site on lake between Portages 10 and 12 (~ km 30); no delineators present**

- On wide lake sections of the Winter Ice Road, including the lakes between Portages 10 and 12 ([Photo 85 and Photo 87](#)), Portages 13 and 14, Bathurst Lake ([Photo 99](#)), and the ice road extending onto sea ice toward the Arctic Ocean at Bathurst Inlet ([Photo 106, Photo 107, Photo 110, and Photo 111](#)), clear road boundaries and delineators were not consistently observed. The installation of delineators would improve driver guidance during low visibility conditions such as nighttime travel or wind and snow events, and would help ensure vehicles remain within the designated corridor, particularly given that ice strength is greatest along the center of the road.

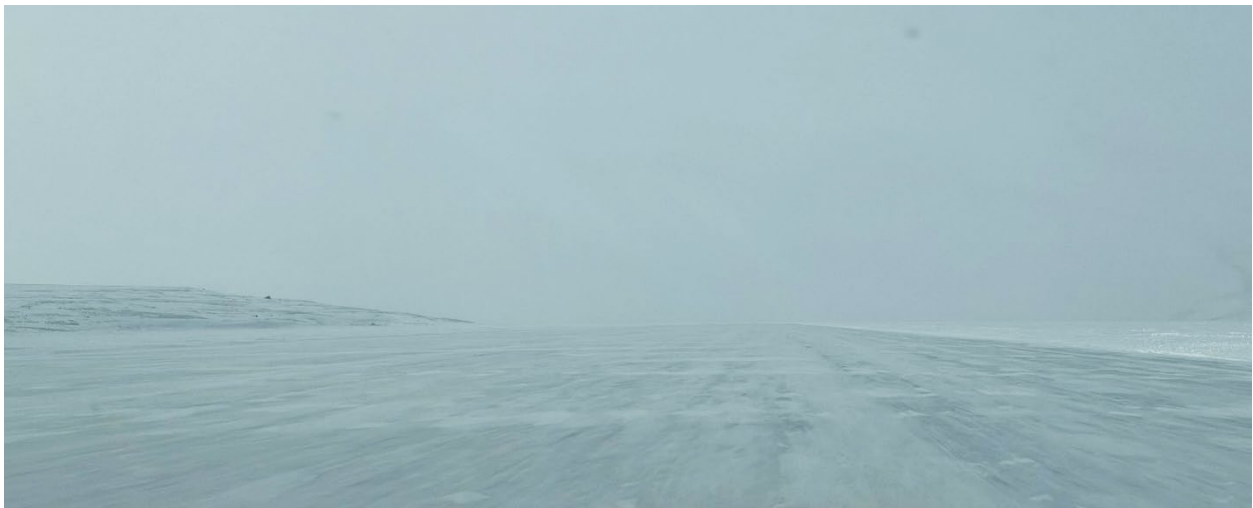
**Photo 107: Sea ice section of the road, northbound view**

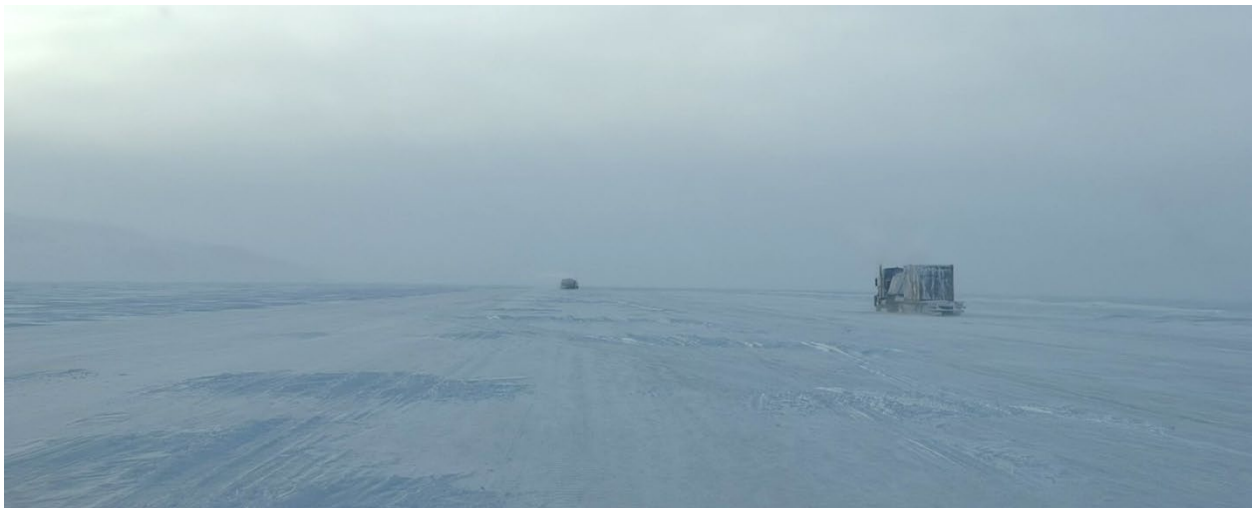
**Photo 110: Truck traffic on sea ice section of the road, southbound view**

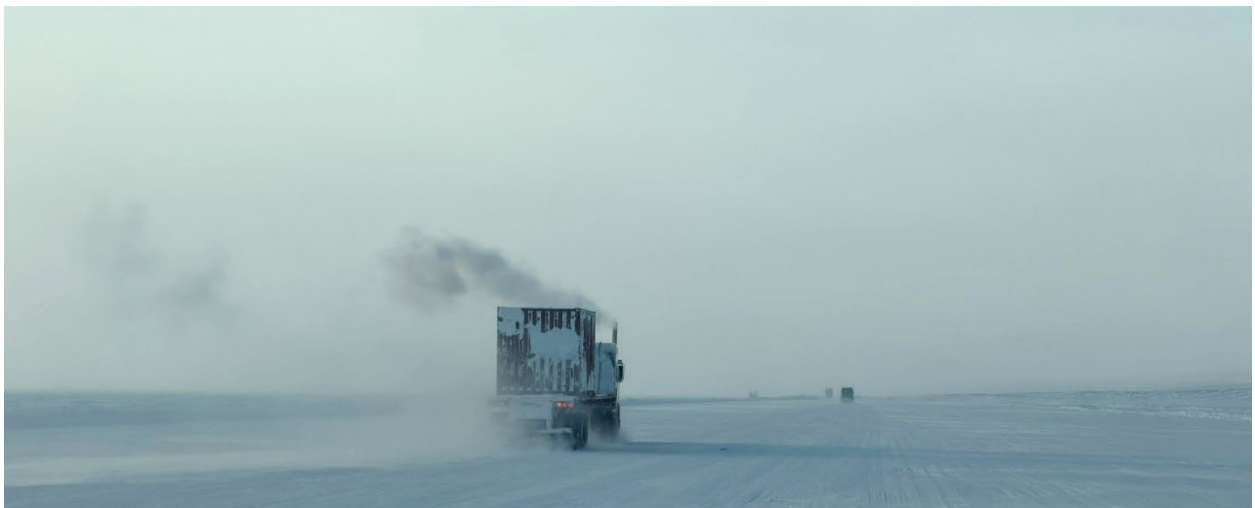
**Photo 111: Truck traffic on sea ice section of the road, southbound view**
