Nunavut Impact Review Board

2024 Site Visit Report for

Mary River Iron Ore Mine Project

January 2025

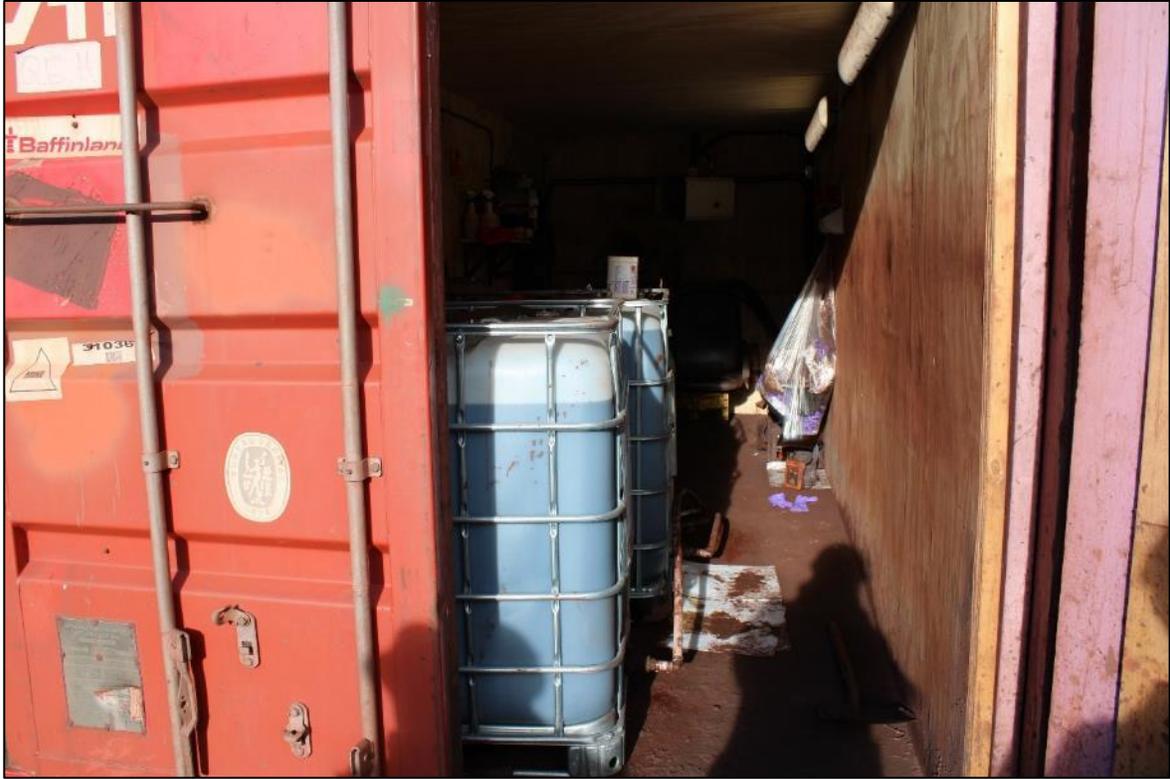
Photo 13: Liquid Dust Suppressant Stored in a Heated seacan next to the Crusher.

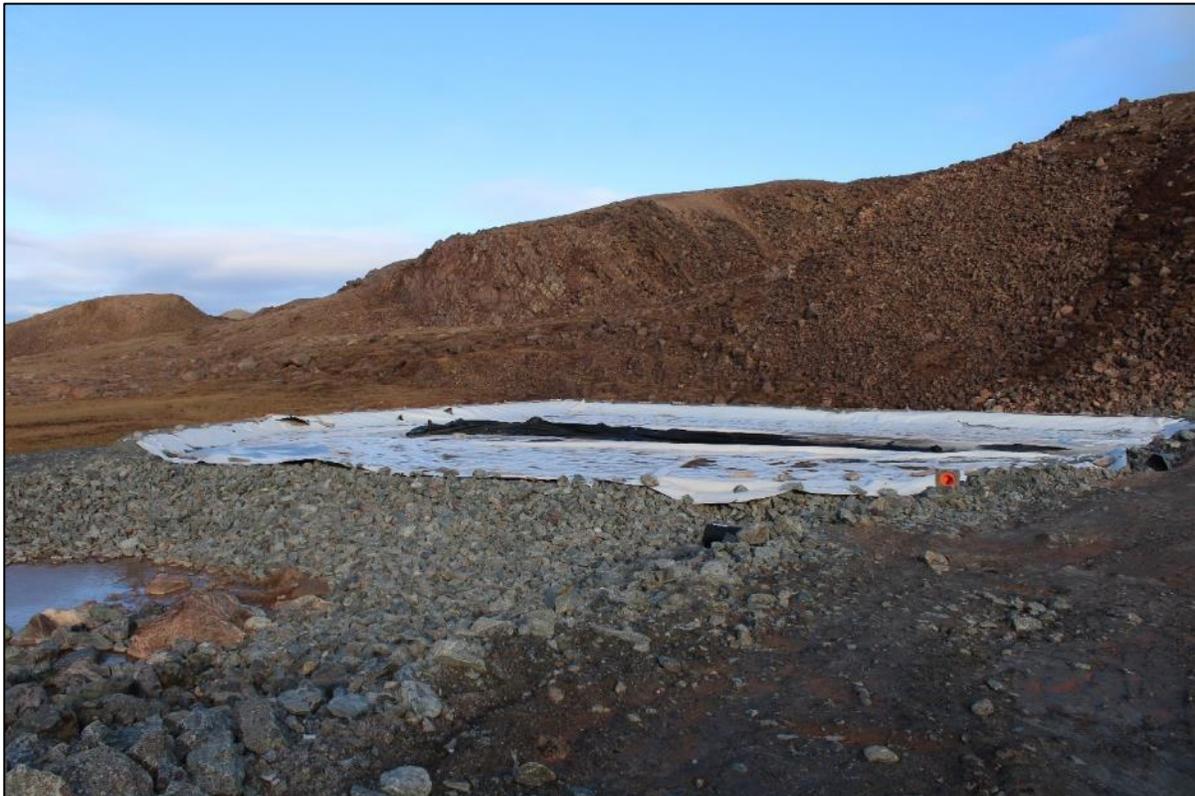
Photo 20: KM 105 Dam Downstream Geotube.

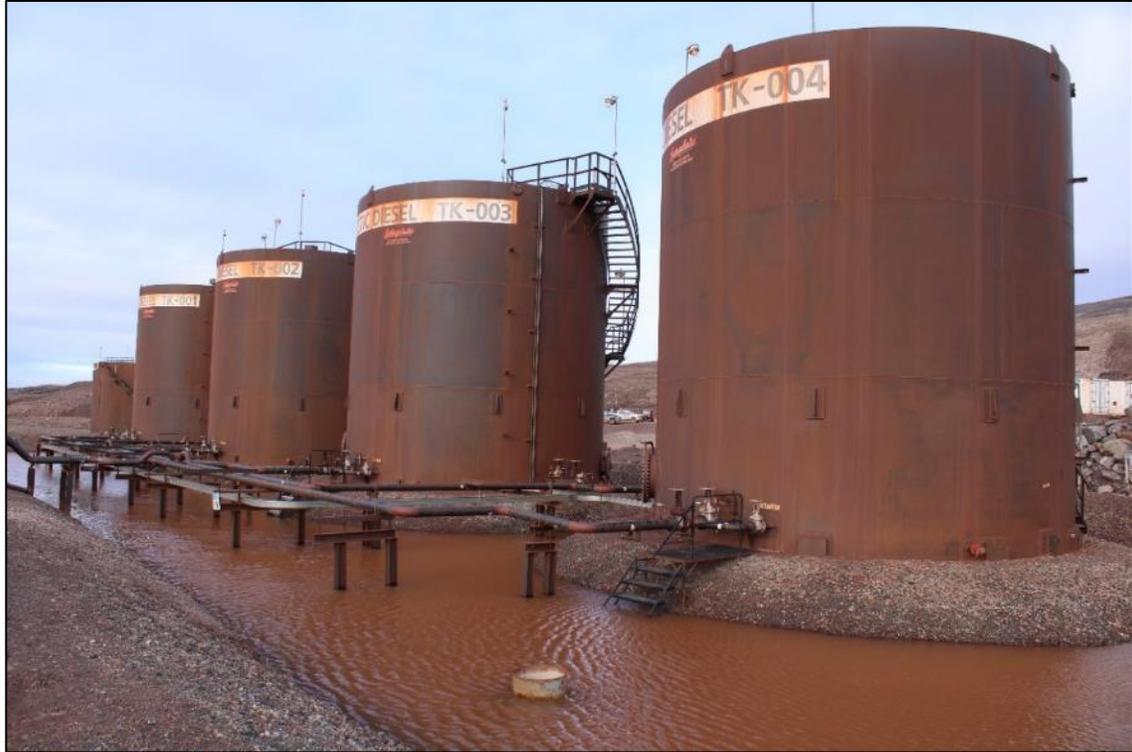
The Mary River Mine Site tank farm appeared clean and organized with adequate secondary containment under the entire facility as well as under potential drip points during fuel filling and storage.

Photo 22: Mine Site Fuel Tank Farm.

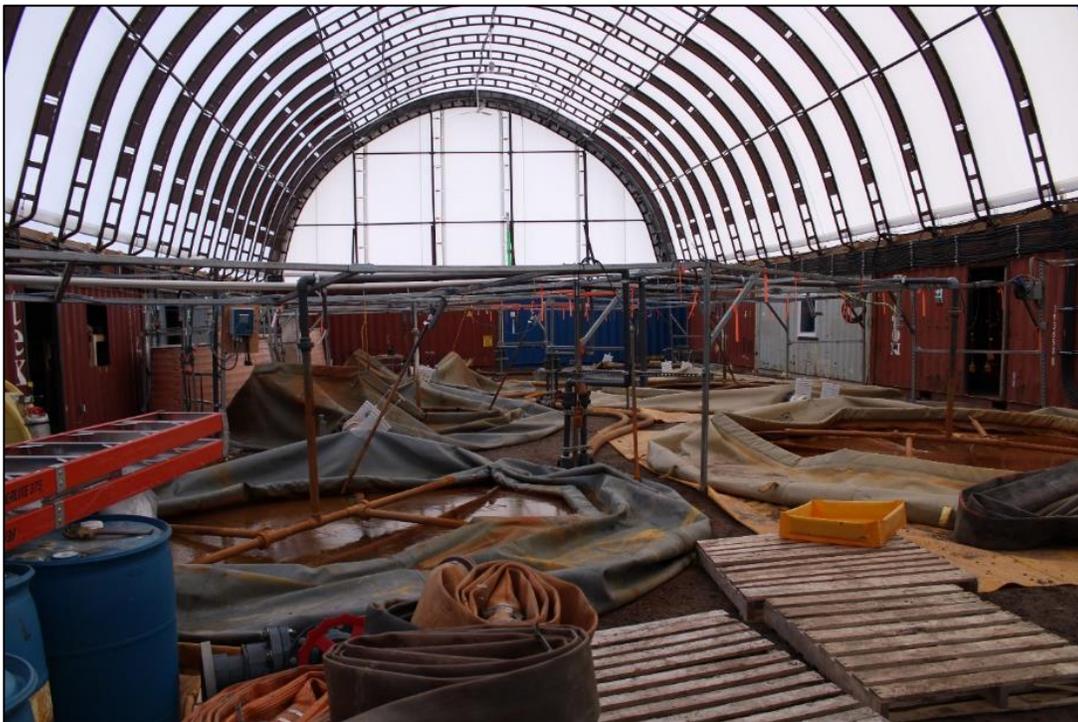
Photo 27: Decommissioned Water Treatment Plant for Run off Water from the Waste Rock Facility.

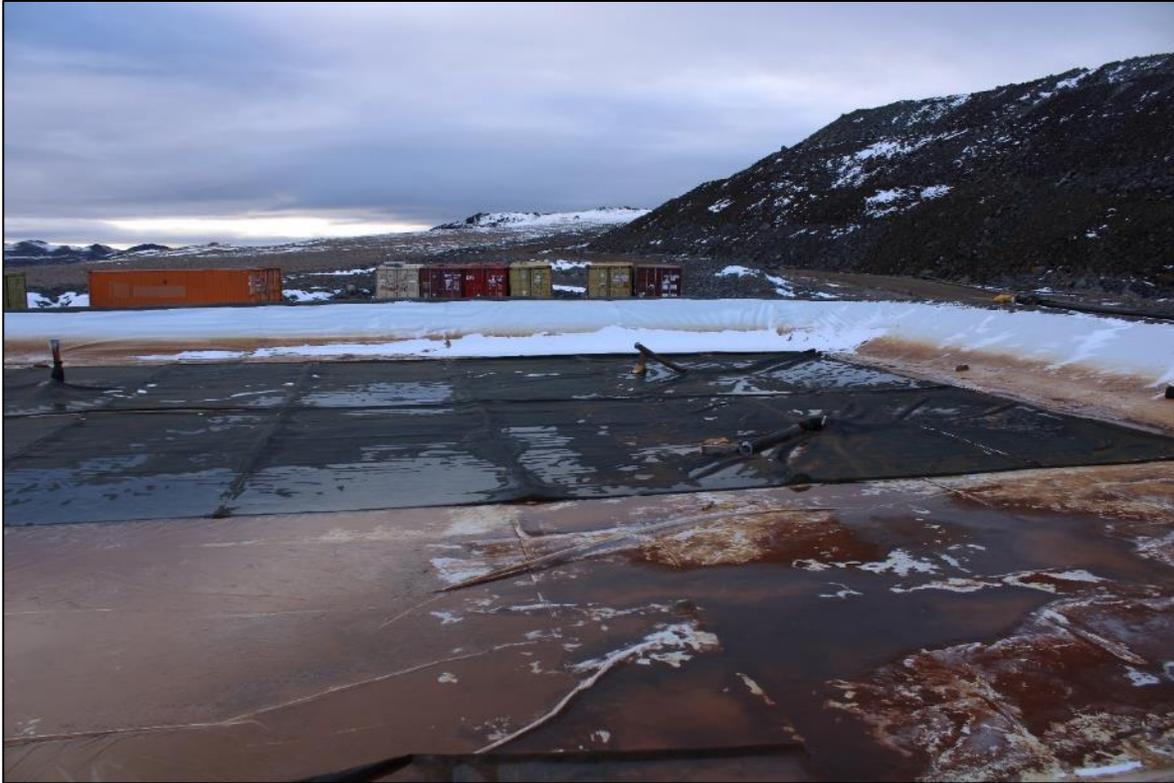
Photo 28: Decommissioned Sedimentation Pond and Geotube from Water Treatment Plant for Run off Water from the Waste Rock Facility.

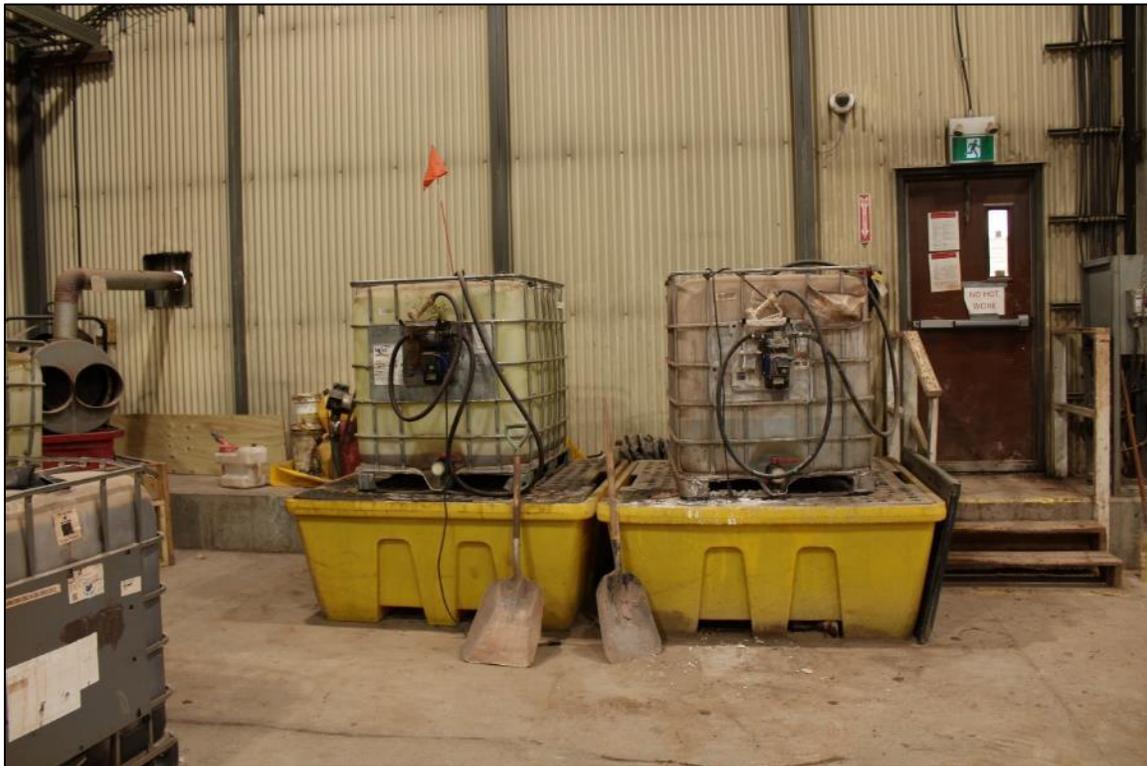
Photo 37: Secondary Containment for Fluid Dispensing Station inside the Incinerator Facility.

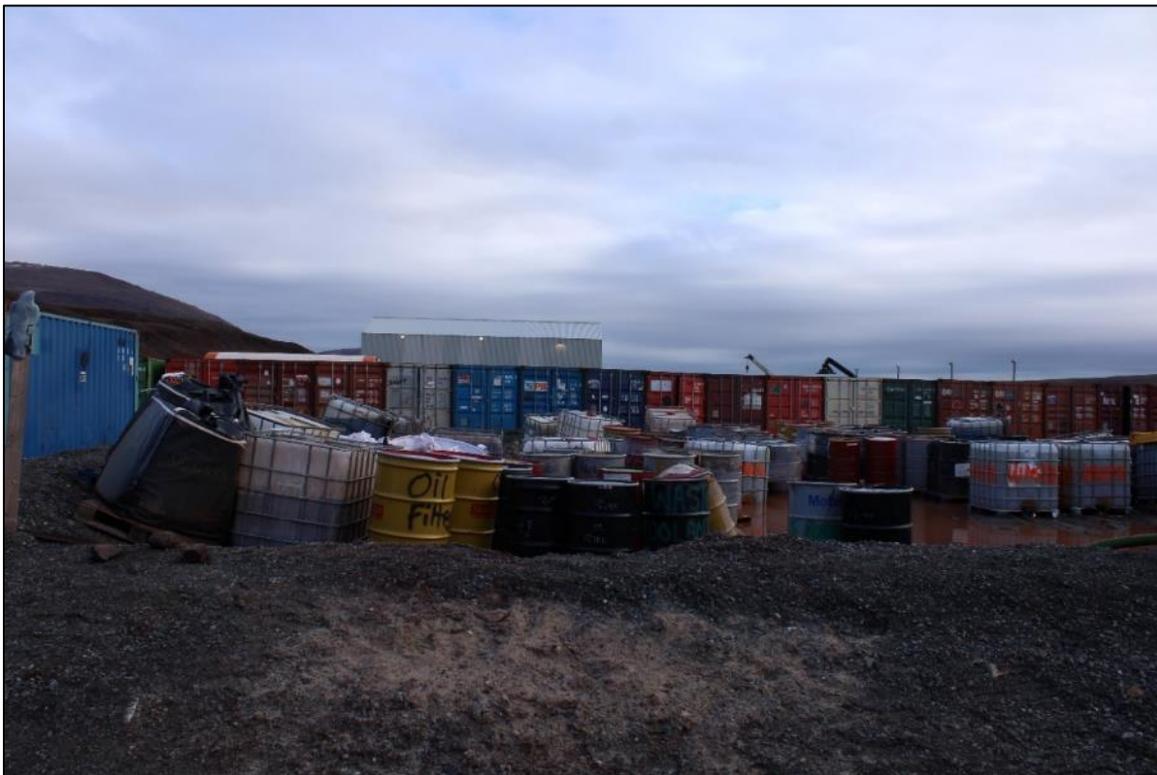
NIRB staff were toured around the waste management facilities at the Mine site and noted that the waste management practices appear to be operating in compliance with the Waste Management Plan and that there were adequate measures in place for waste separation and sorting. When observing the hazardous waste storage area, NIRB staff noted that there were several waste oil totes and fuel barrels stored outside of the secondary containment berm. NIRB staff discussed this with Baffinland along with the recurrence of it since the previous site visit in April 2024. Baffinland staff noted that there were approved plans to expand the berm size and sorting area for their hazardous waste at the Mine site and it was agreed that they would be prioritizing this in the coming months to ensure that all hazardous material is stored in secondary containment.

Photo 39: Hazardous Waste Storage.

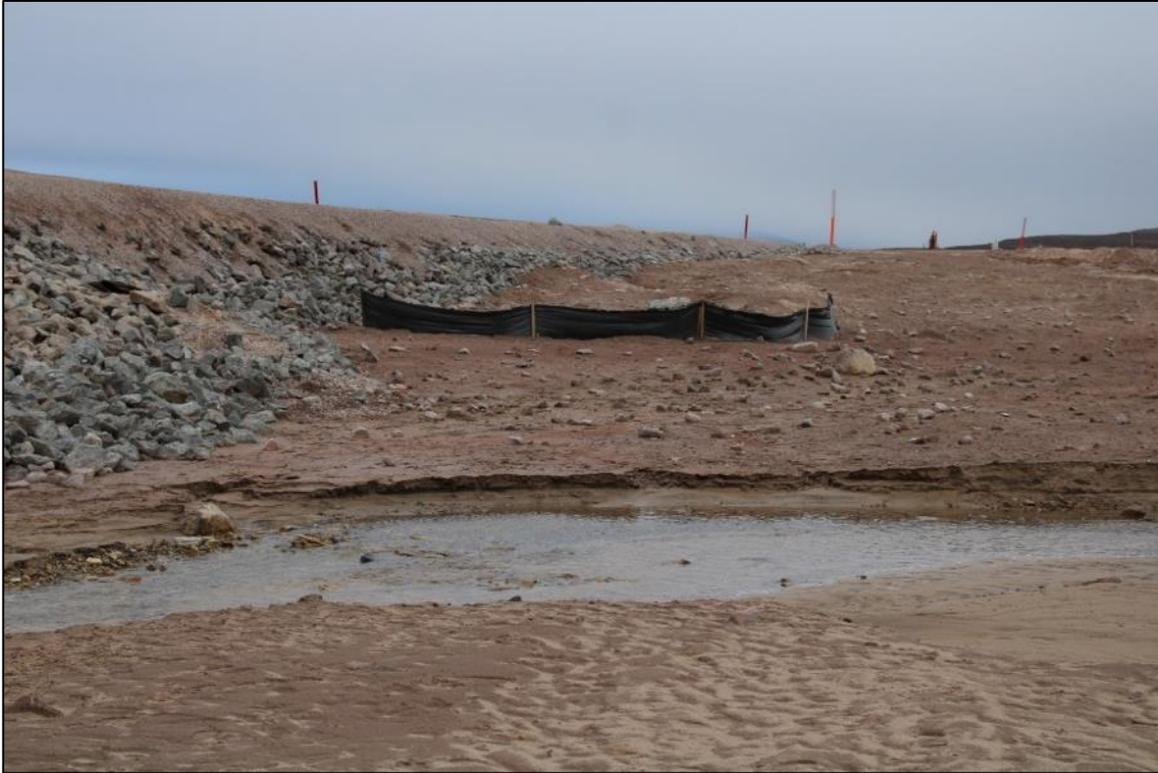
Photo 45: Silt Curtain Installed near the Culverts along the Tote Road.

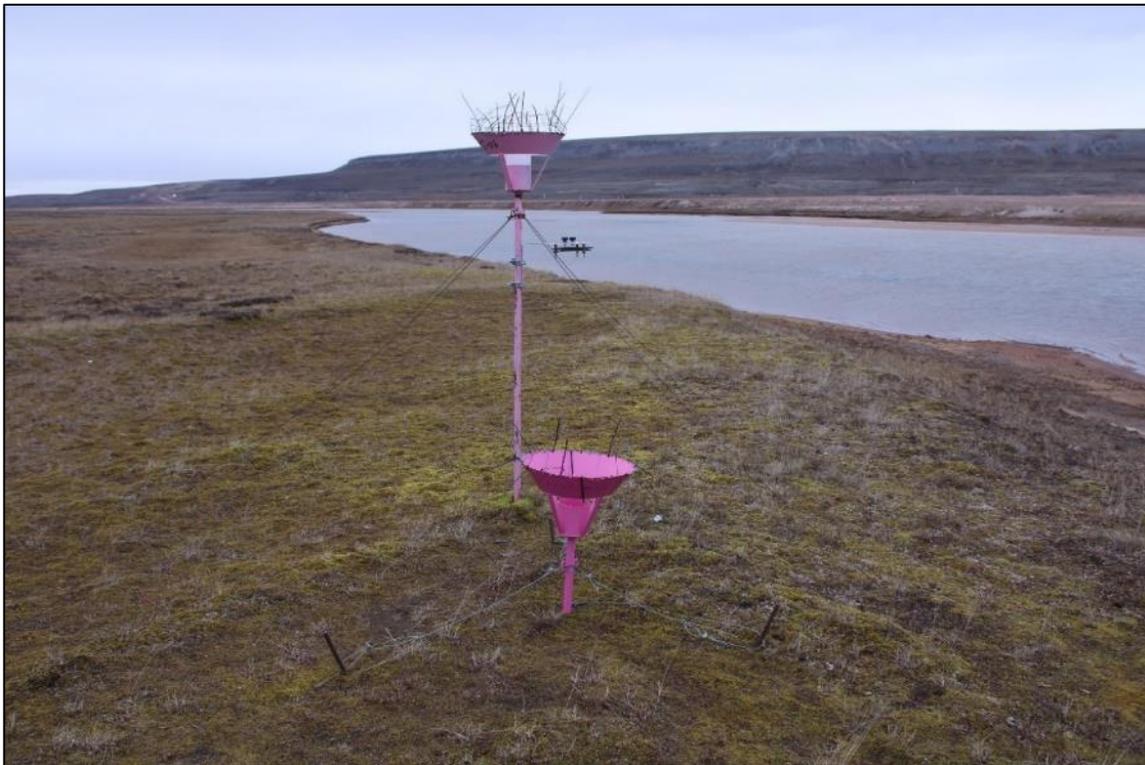
Photo 46: Passive Dust Sampler along the Tote Road.

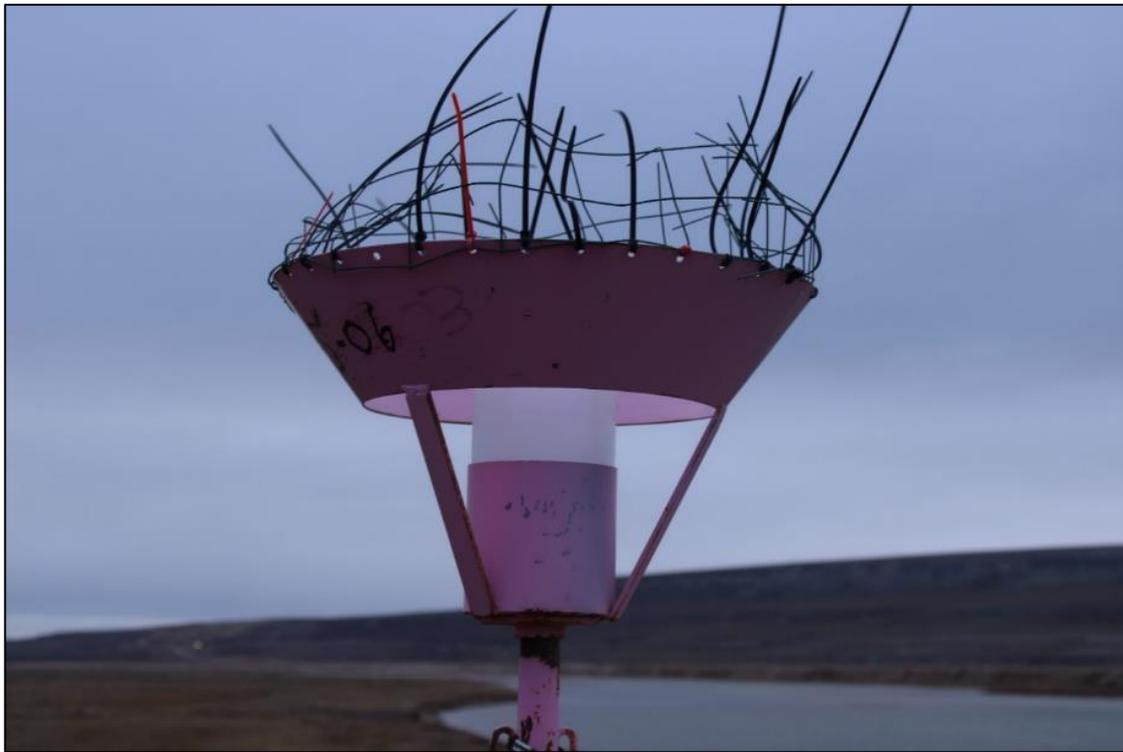
Photo 47: Close-up of Passive Dust Sampler Container.

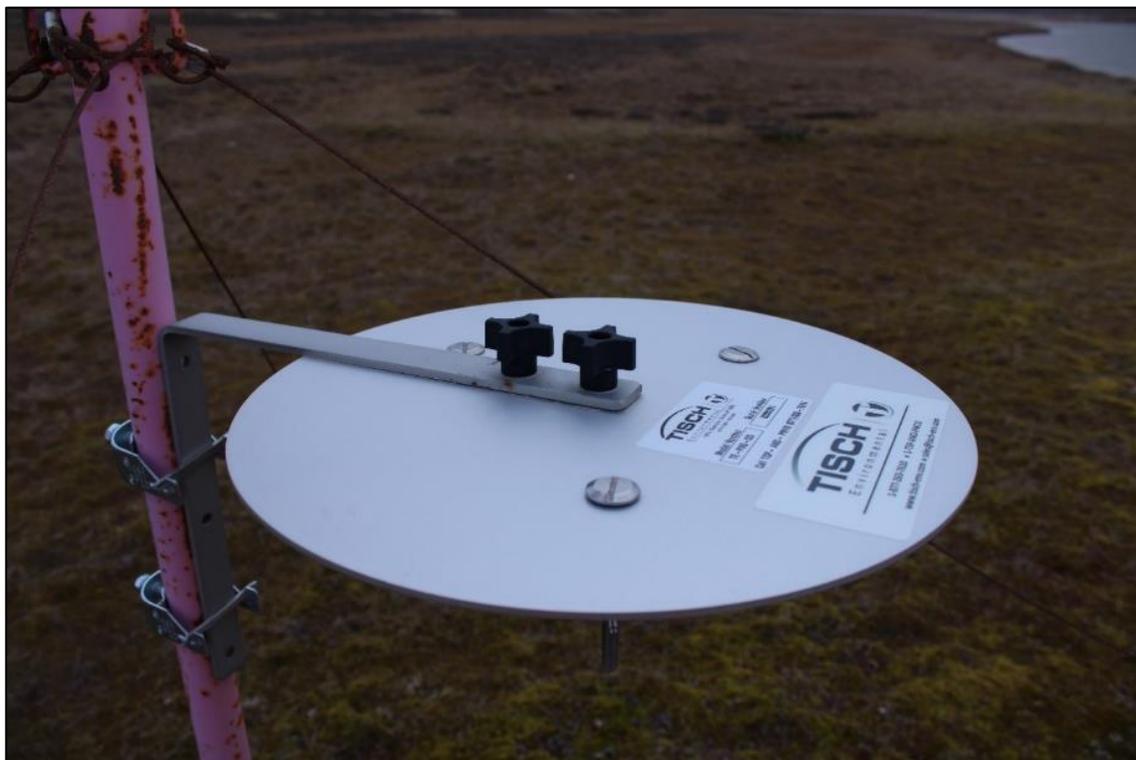
Photo 48: New "Disc Style" Passive Dust Sampler from NRCAN Study.

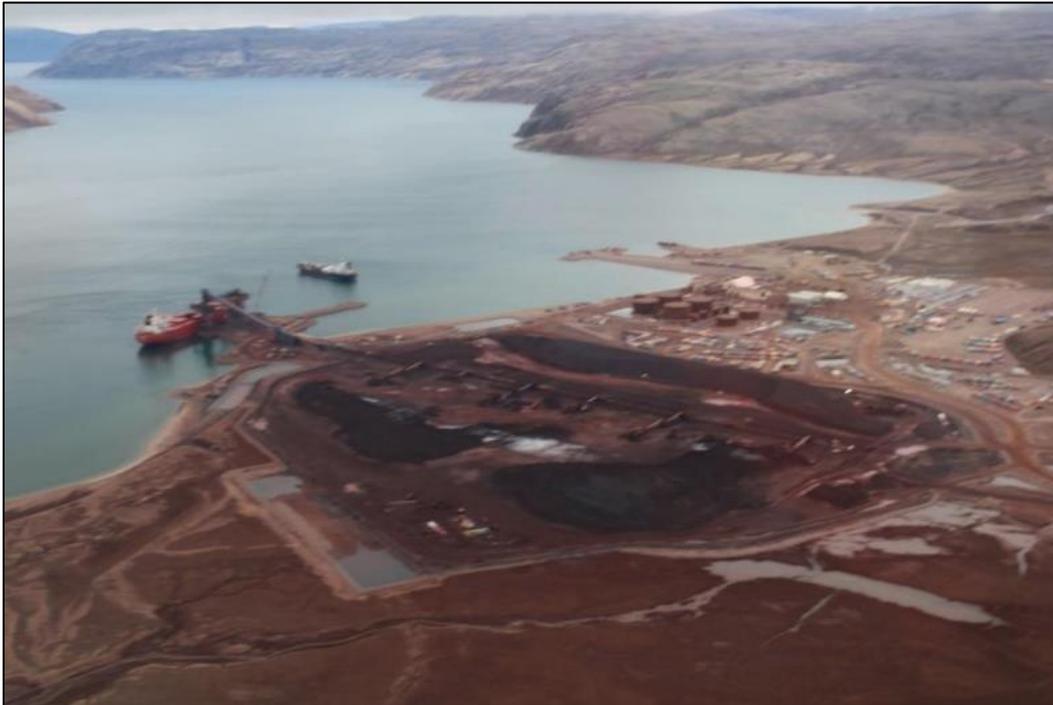
Photo 50: Milne Port Ore Pad and Ship Loader.

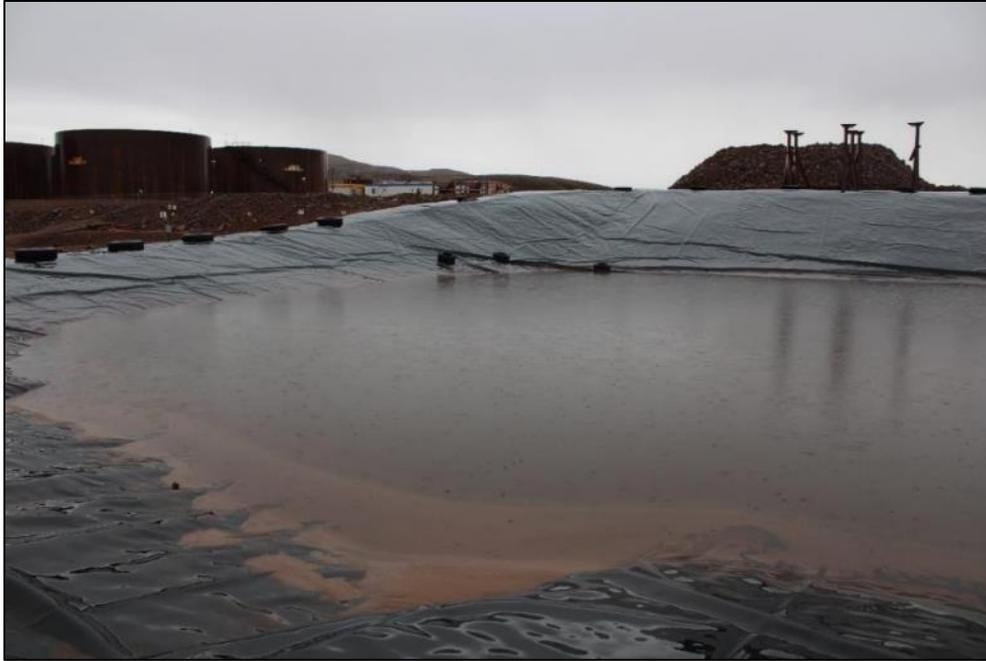
Photo 51: Ore Stockpile North Sedimentation Pond.

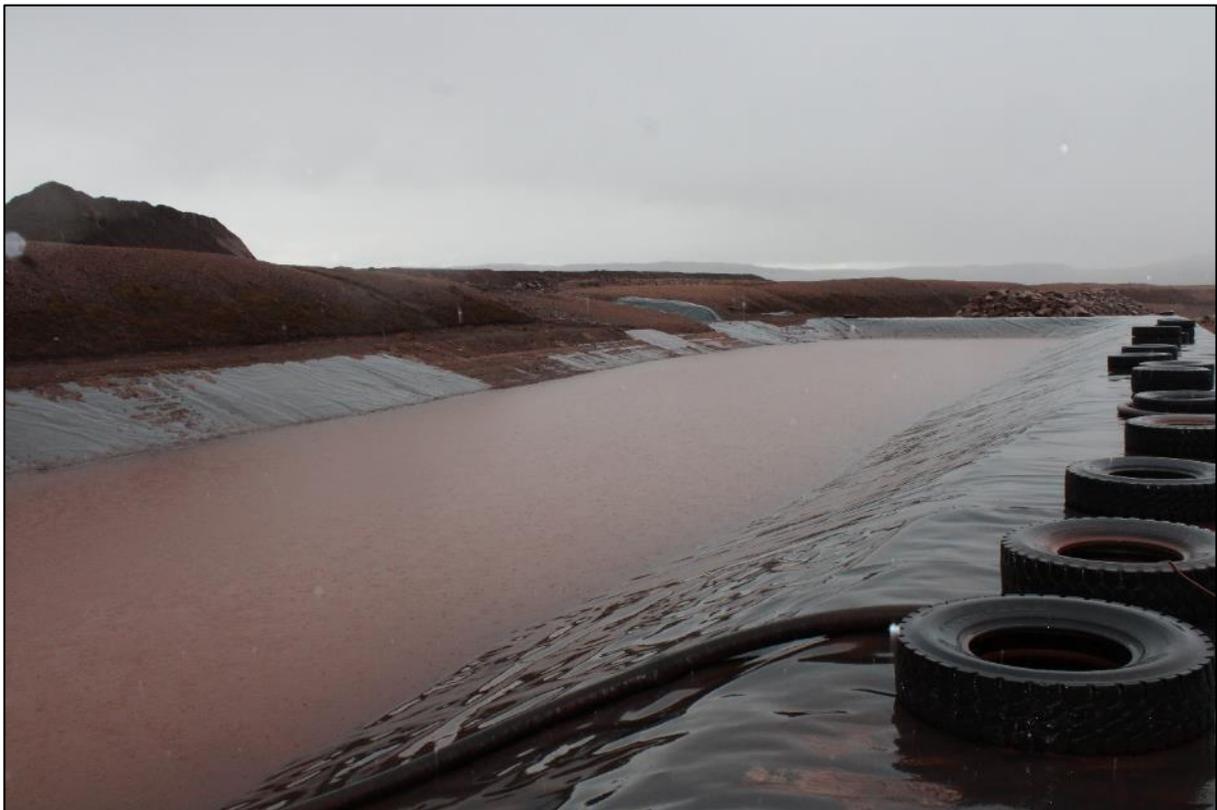
Photo 52: Ore Stockpile West Sedimentation Pond.

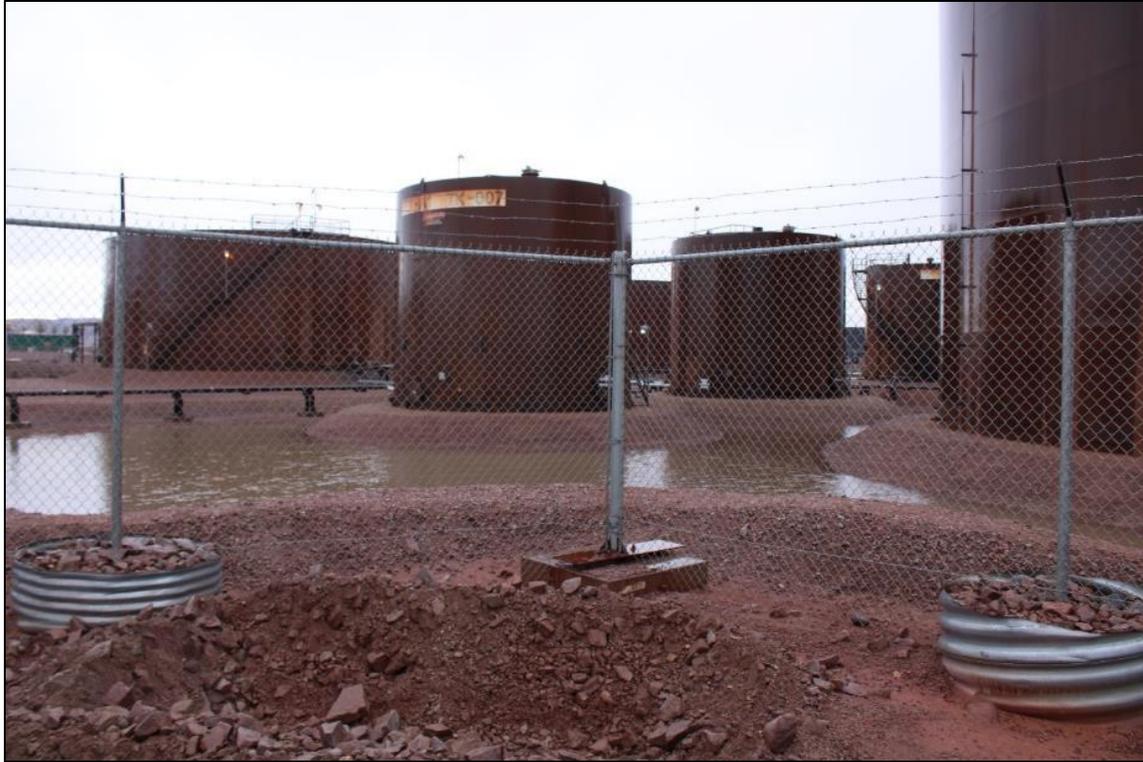
Photo 53: Milne Port Fuel Tank Farm.

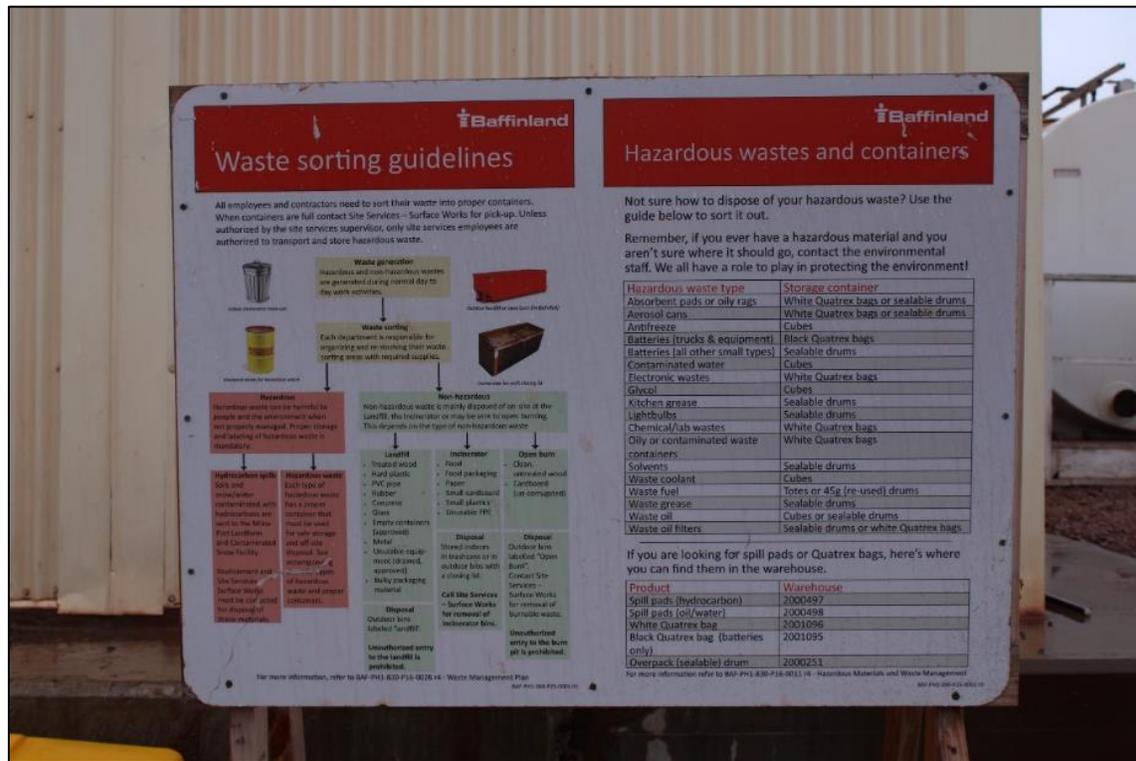
Photo 54: Incinerator Facility Waste Sorting Guidelines.

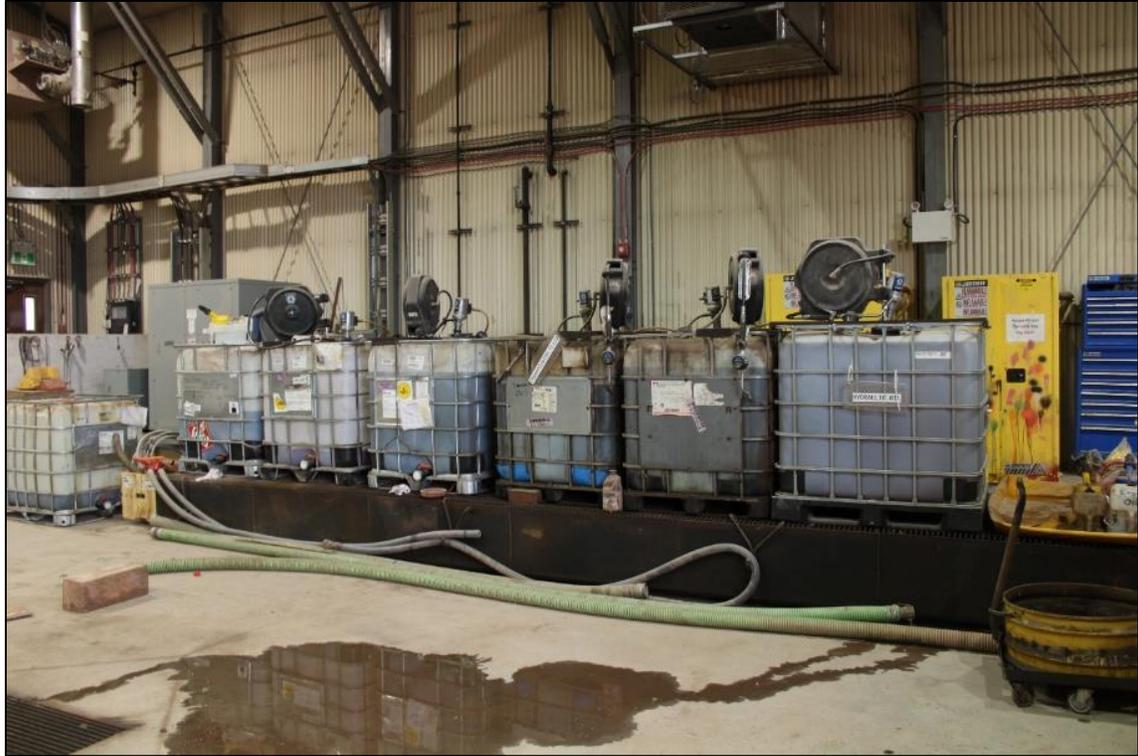
Photo 55: Incinerator Facility Oil Dispensing Area.

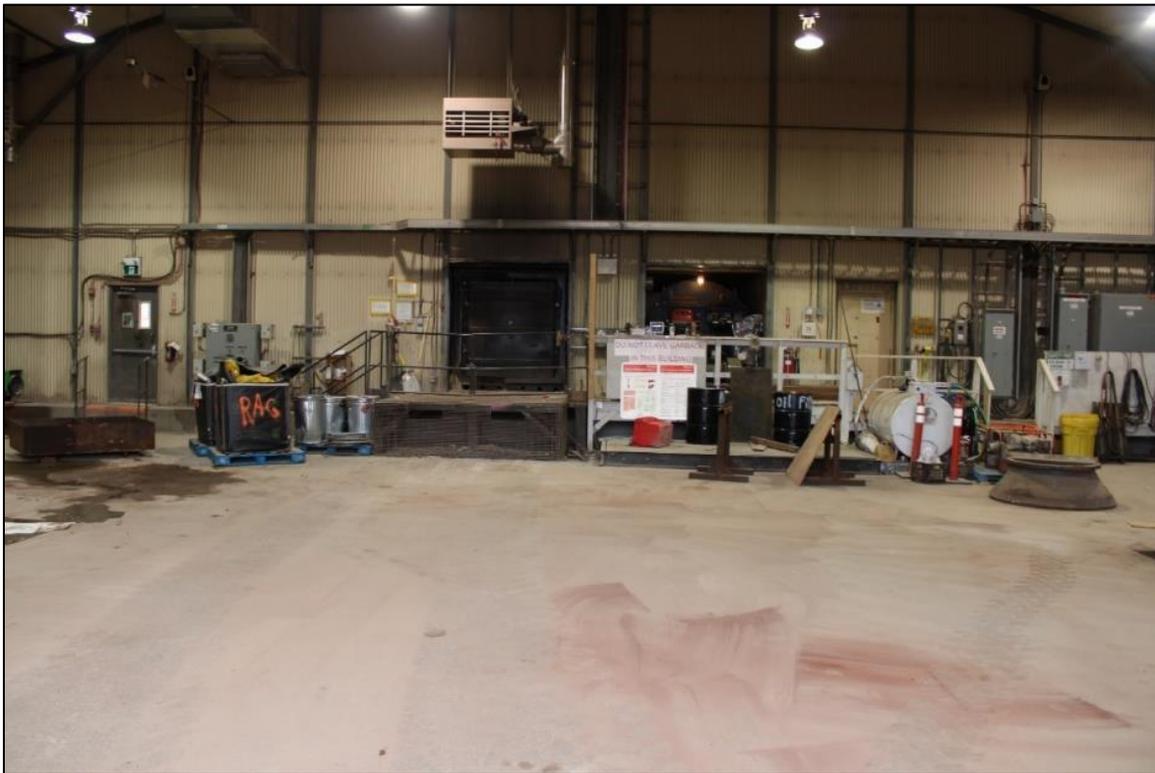
Photo 56: Incinerator Facility.

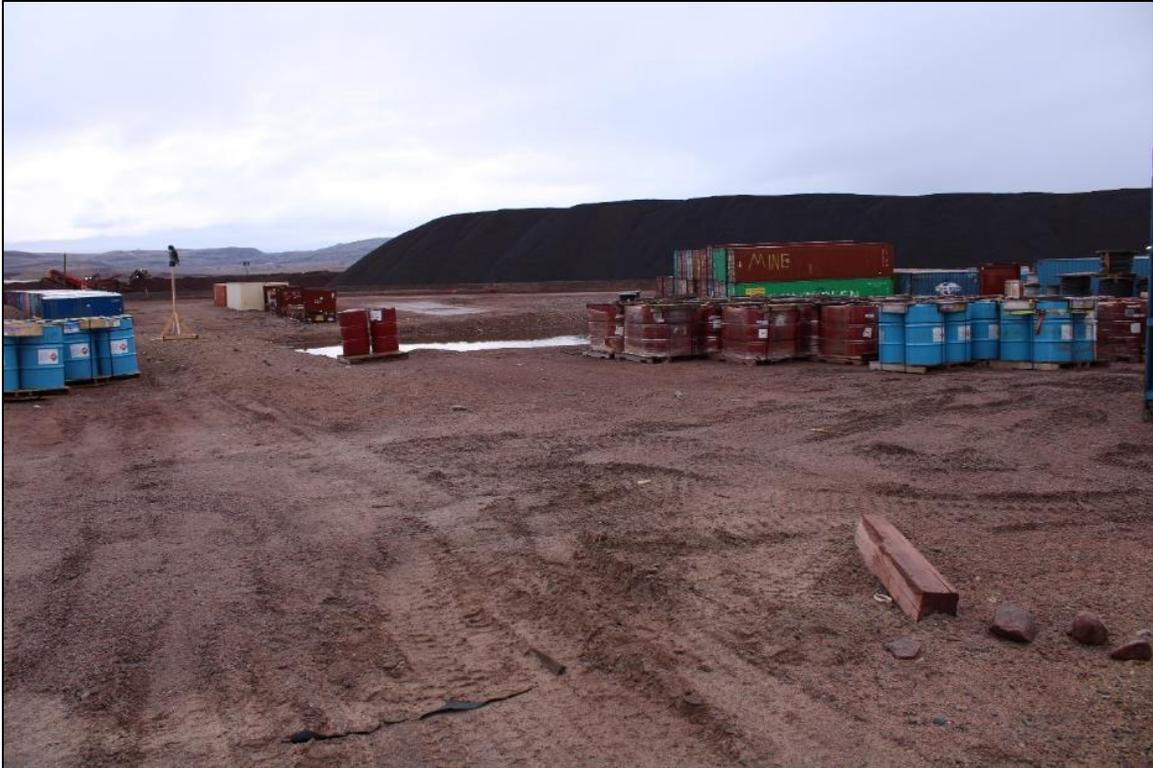
Photo 57: Hazardous Waste Storage Facility.

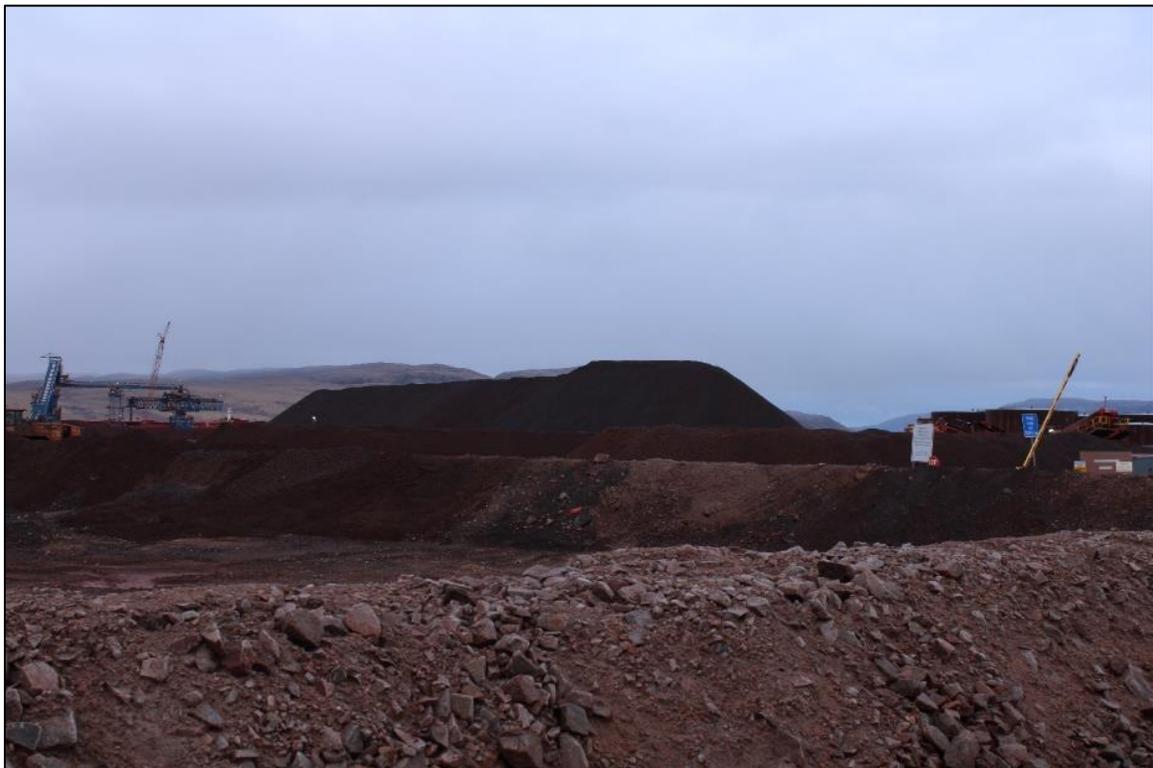
Photo 58: Ore Stockpile during Active Ship loading.

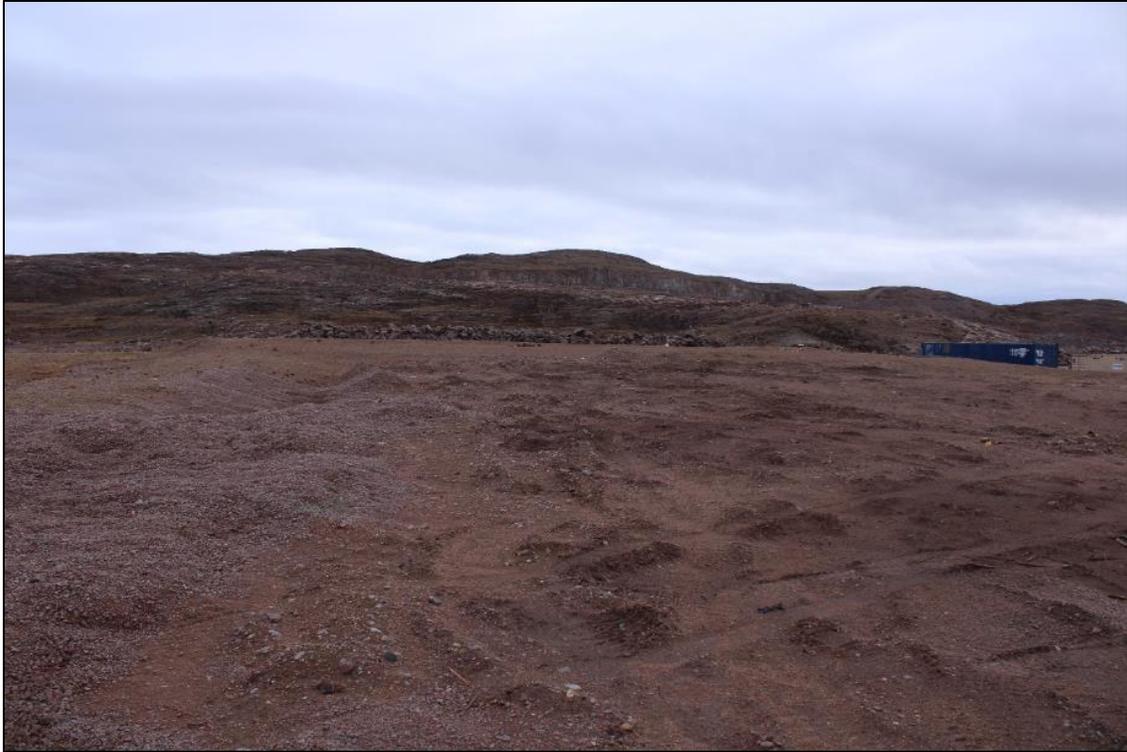
Photo 59: Milne Port Landfarm.

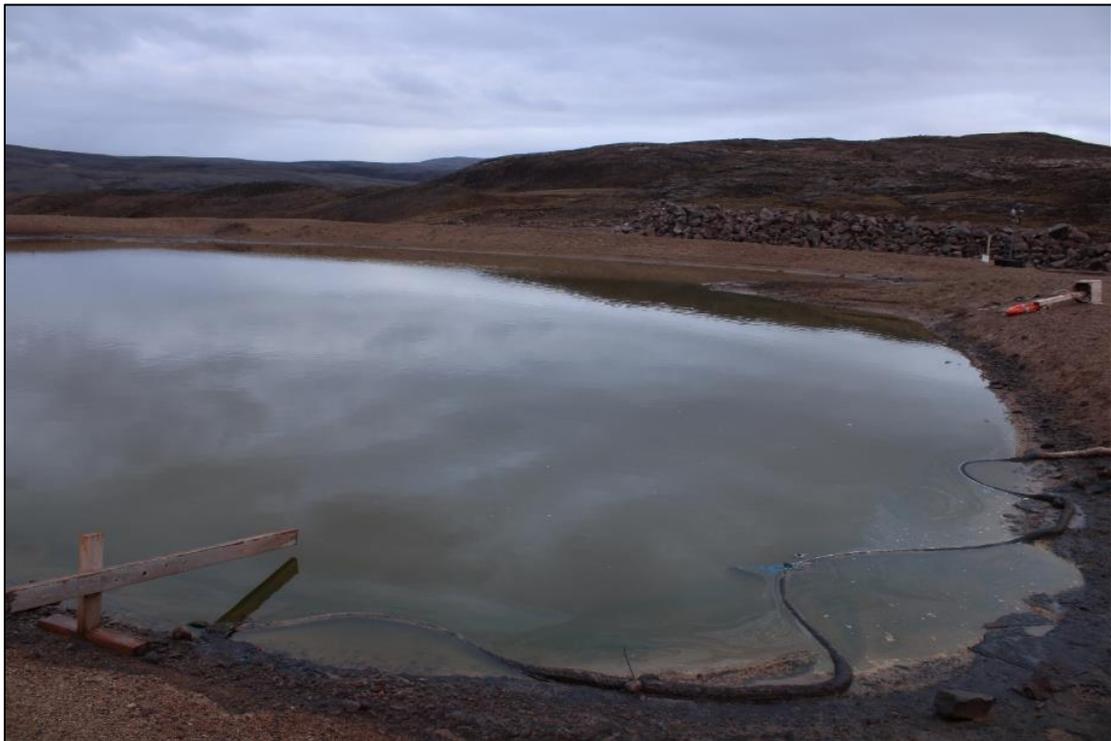
Photo 60: Milne Port Landfarm Oily Water Storage Pond.

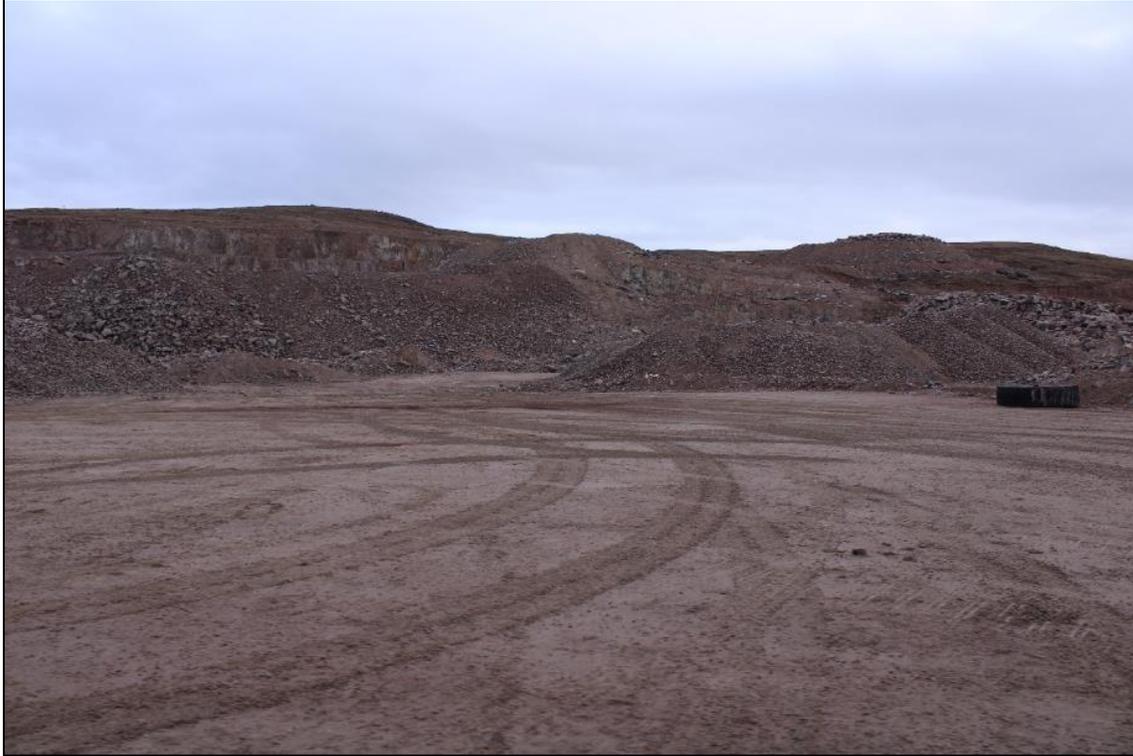
Photo 61: Milne Port Quarry in Limited Use.

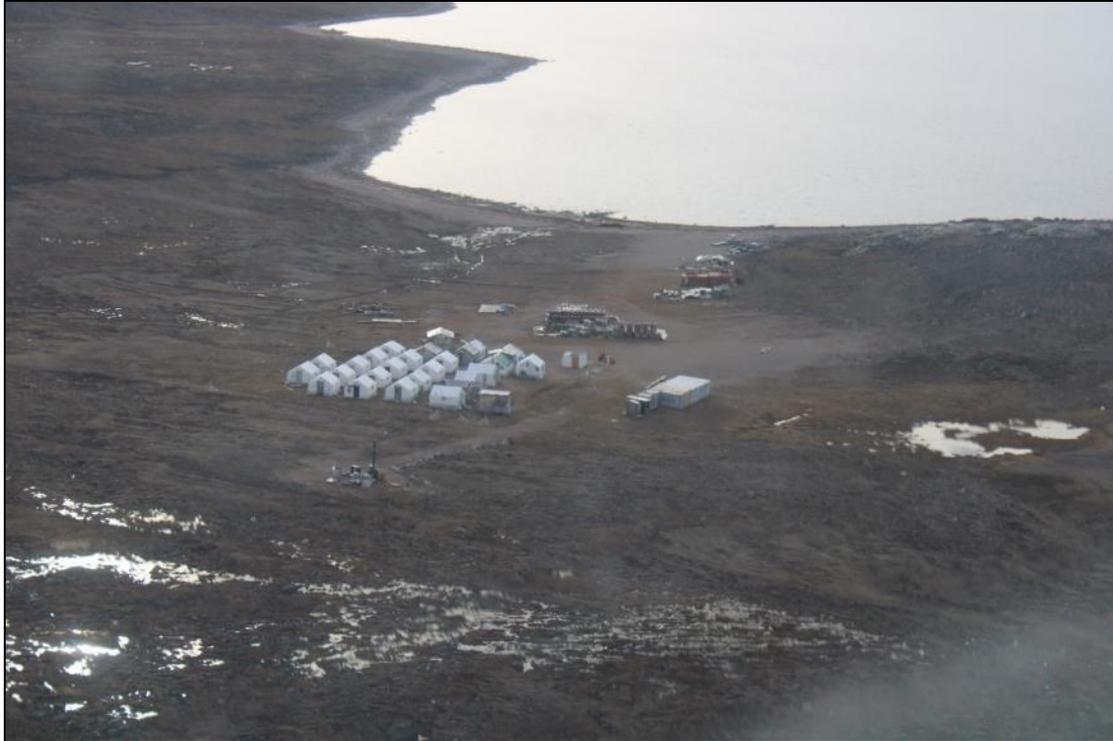
The NIRB staff were taken to Steensby Inlet via Helicopter and noted that the site had been in limited use during the 2024 season. However, NIRB staff noted some garbage accumulation around the infrastructure. It was discussed that it would be beneficial for Baffinland to place burn barrels and garbage disposal areas as well as advertise this to the communities in an effort to reduce waste being deposited at the site by land users. Additionally, there was a substantial amount of fuel stored at Steensby Inlet, although this fuel was in secondary containment, the containment was in poor condition and no longer served the intended purpose. Baffinland indicated that they would be prioritizing this fuel to be back hauled in 2025 as activities at Steensby begin to pick up.

Photo 62: Aerial View of Steensby Camp.

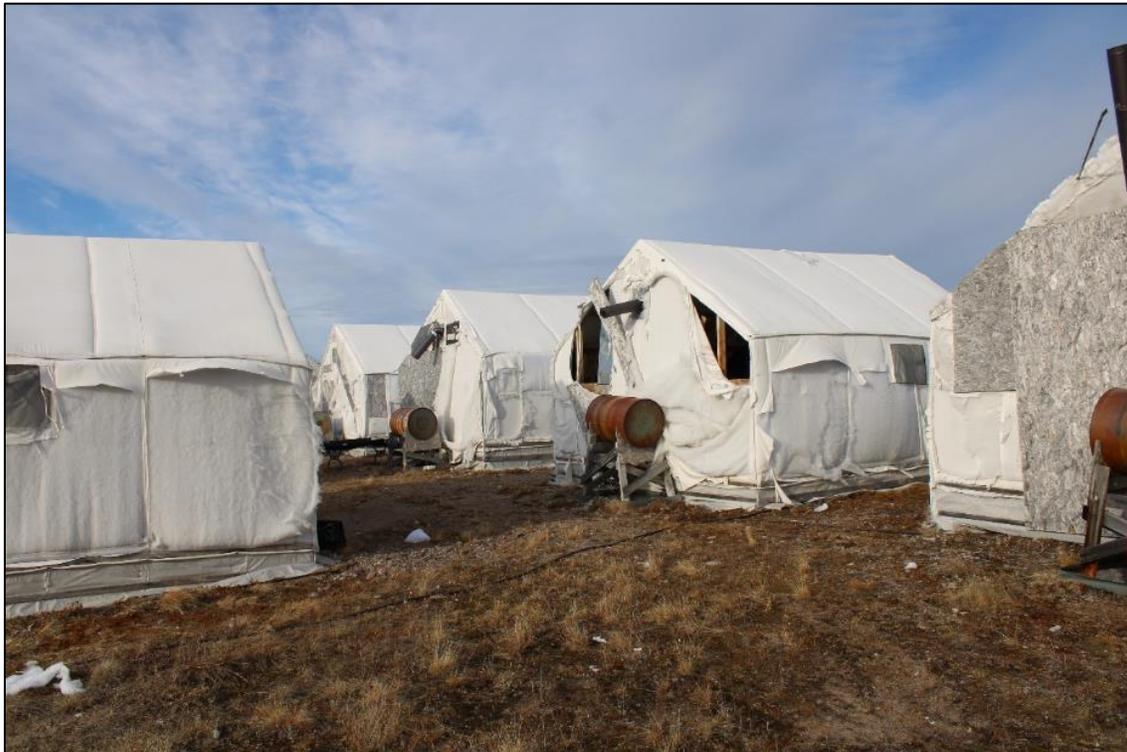
Photo 65: Steensby Camp Accommodations to be Backhauled.

Baffinland staff noted that several of these issues would be addressed immediately; however, the clean up at Steensby Inlet would have to wait until summer of 2025 due to seasonal limitations of accessing the site. The NIRB expects to closely monitor these concerns in future visits and to follow-up on any ongoing areas of concern.

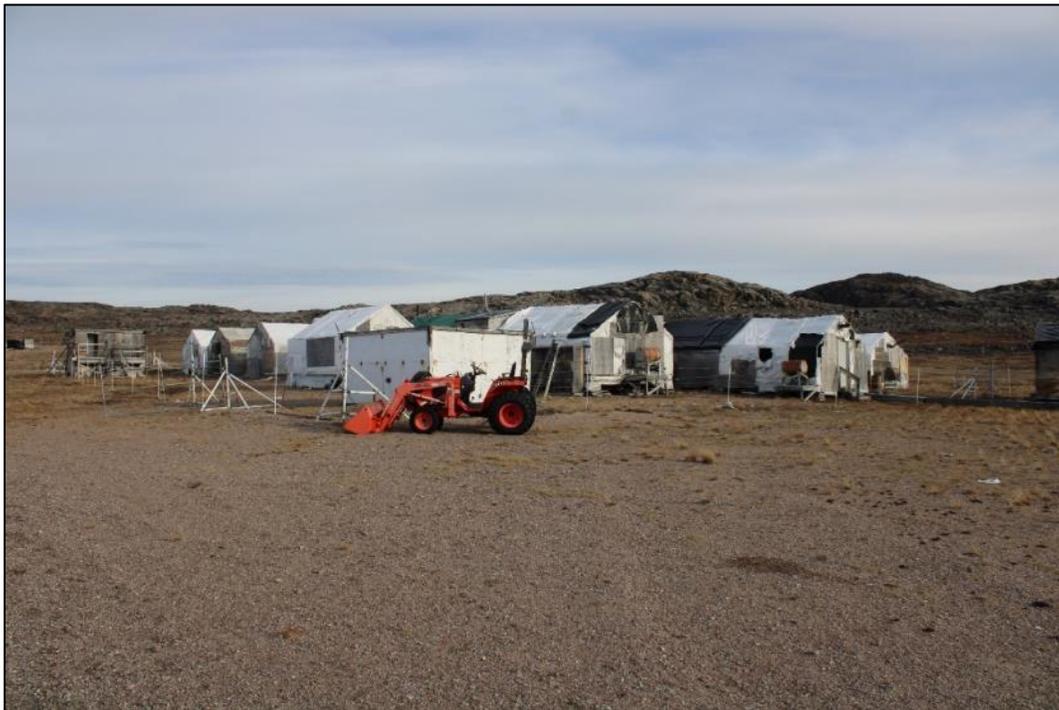
Photo 67: Steensby Camp Accommodations.
