Nunavut Impact Review Board

2025 Site Visit Report

Mary River Project

Report Title: 2025 Site Visit Report Mary River Project

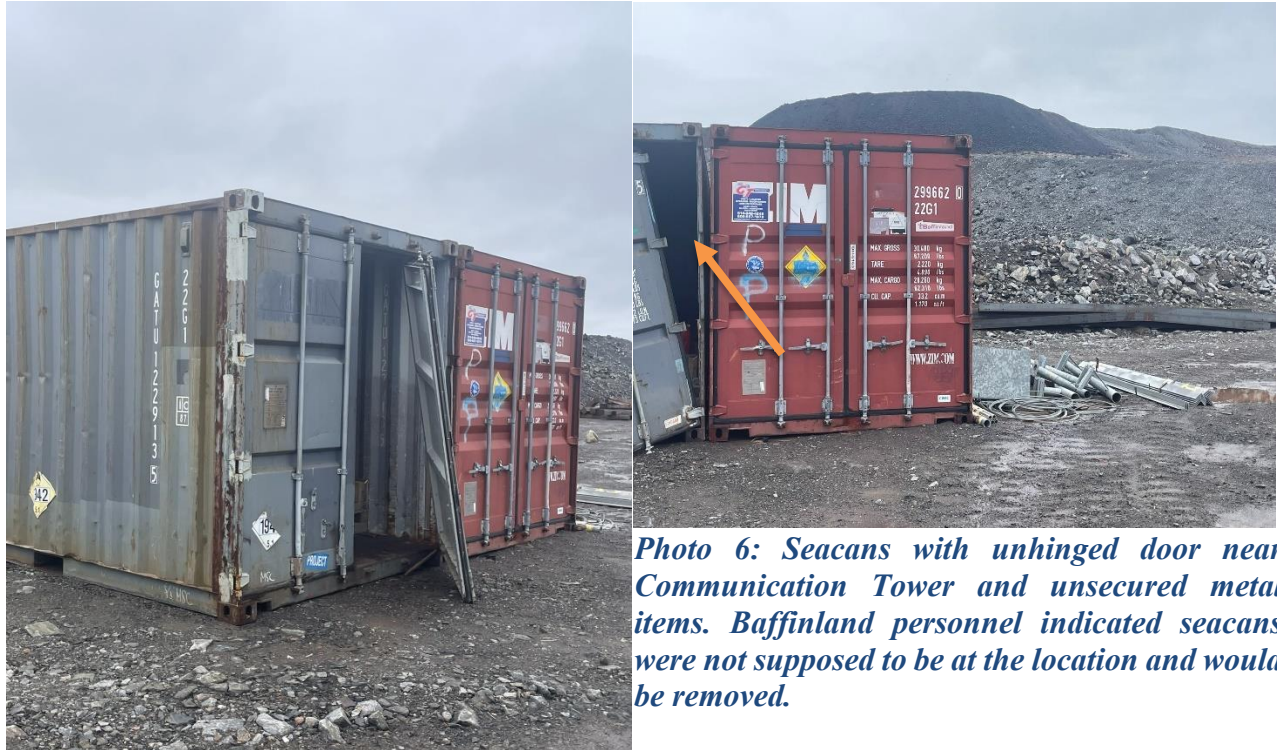
Photo 6: Seacans with unhinged door near Communication Tower and unsecured metal items. Baffinland personnel indicated seacans were not supposed to be at the location and would be removed.

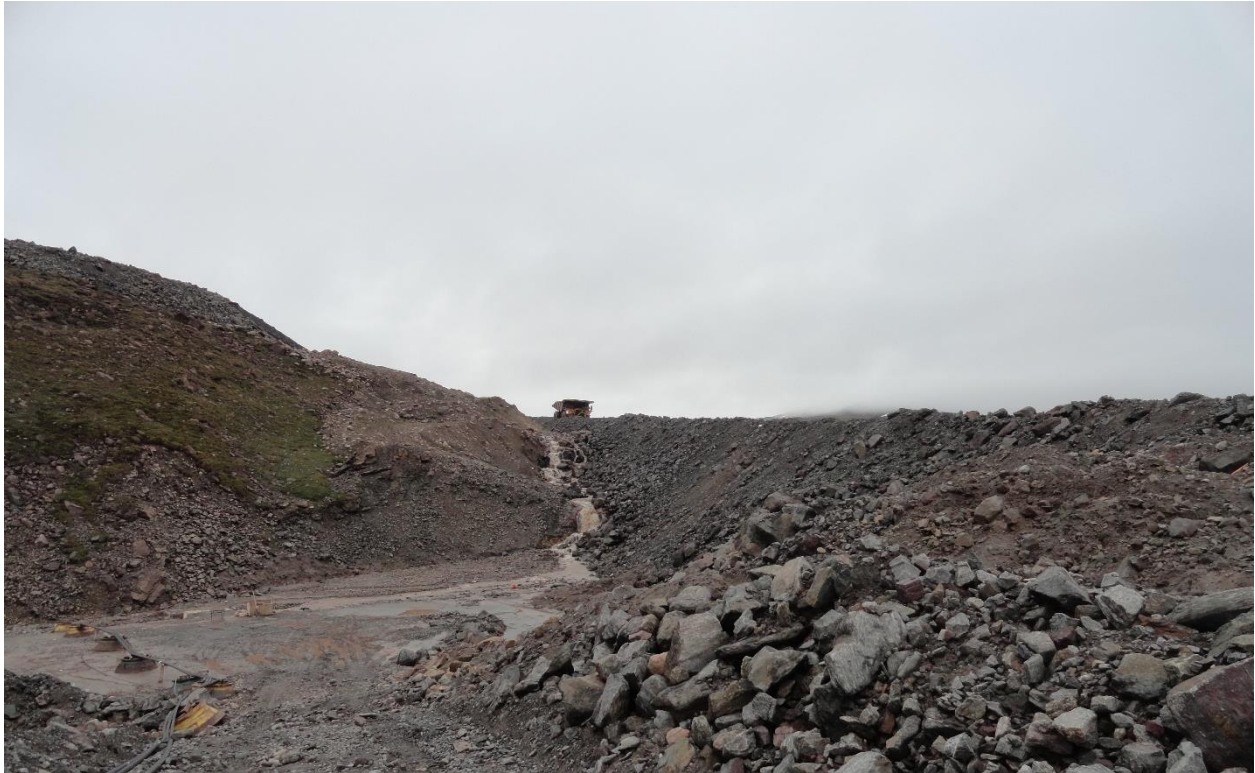
Photo 17: Drainage along the Haul Road

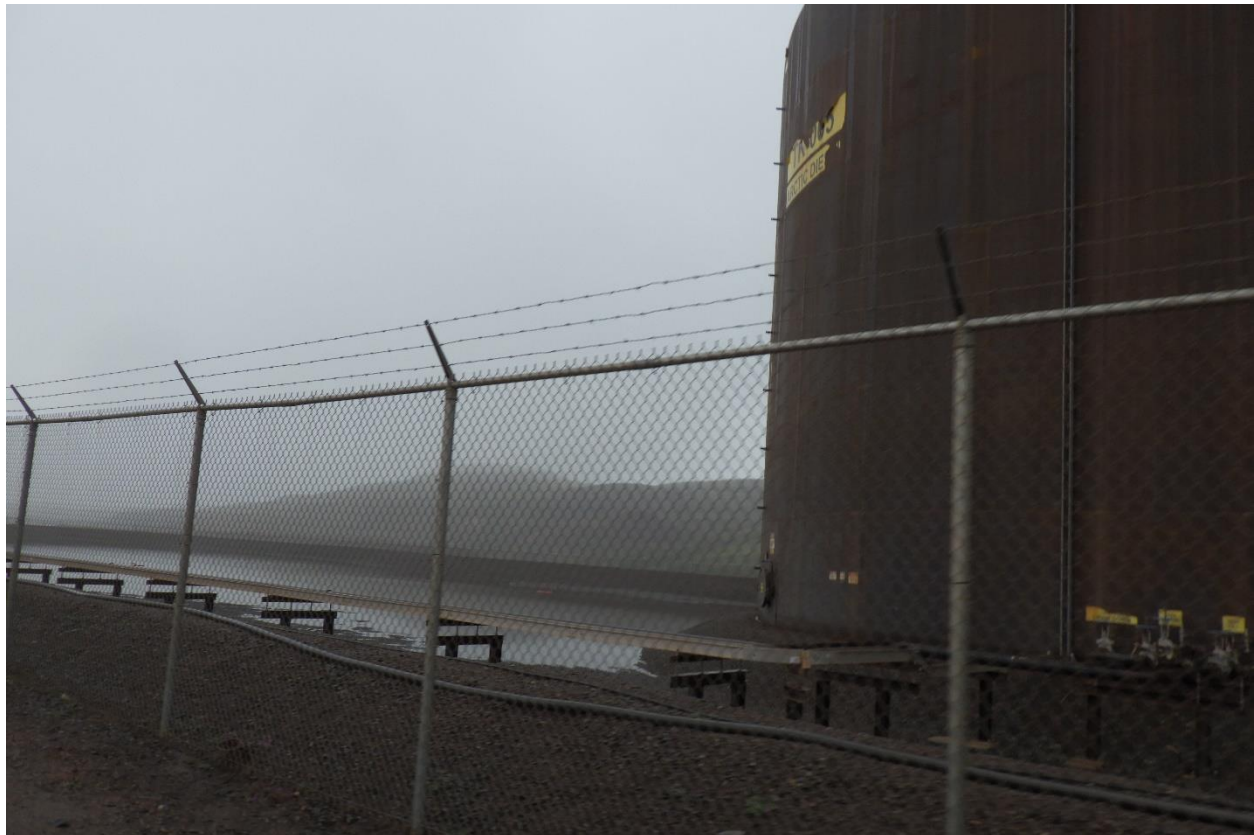
Photo 23: Chain link fence and secondary containment around Fuel tank at MS-03B

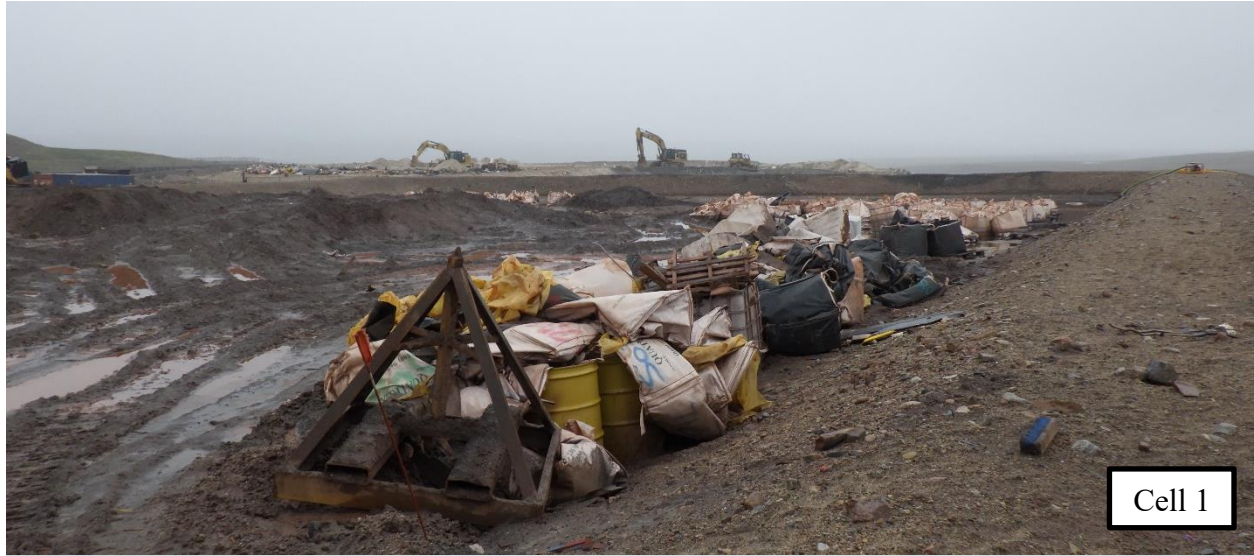
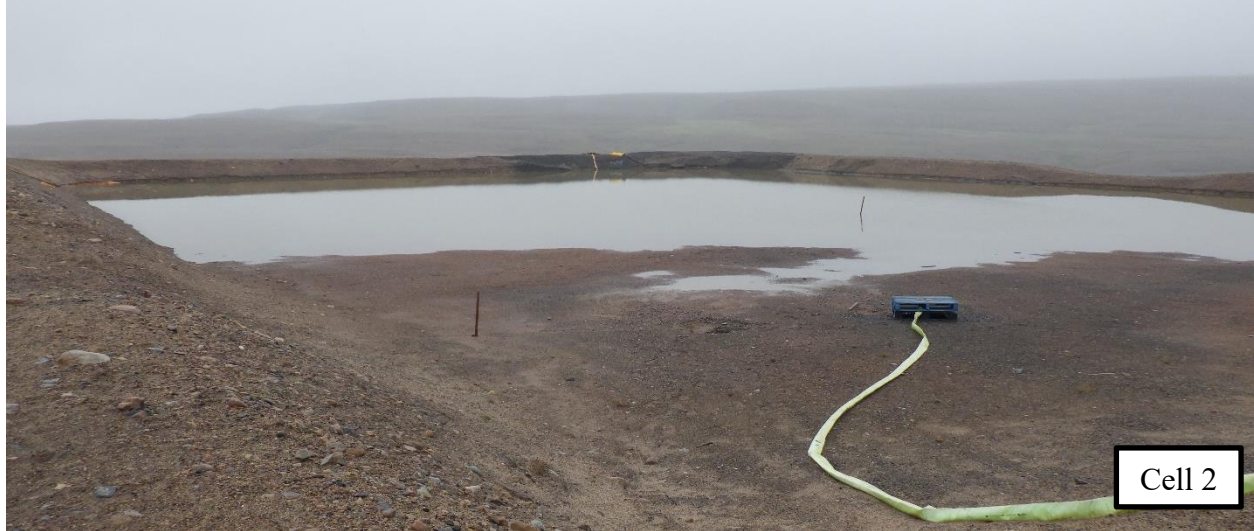
Photo 31: New landfarm cells constructed near the main Landfill Facility

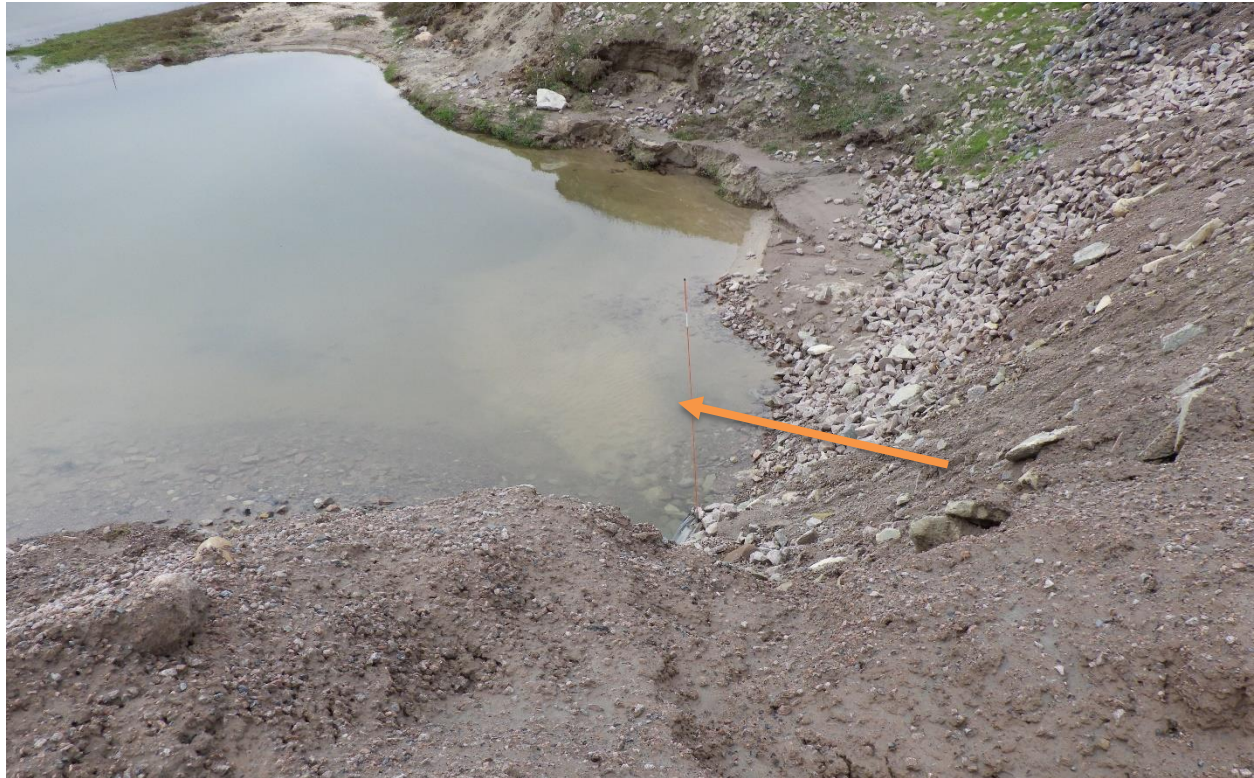
Photo 46: Erosion fence with silt build-up and deterioration at KM 89. Note extreme mudiness of the Tote Road.

- Silt curtains were found deteriorated at multiple locations along the Tote Road, and in some cases were full of sediment, reducing their effectiveness in controlling runoff and protecting nearby water bodies.

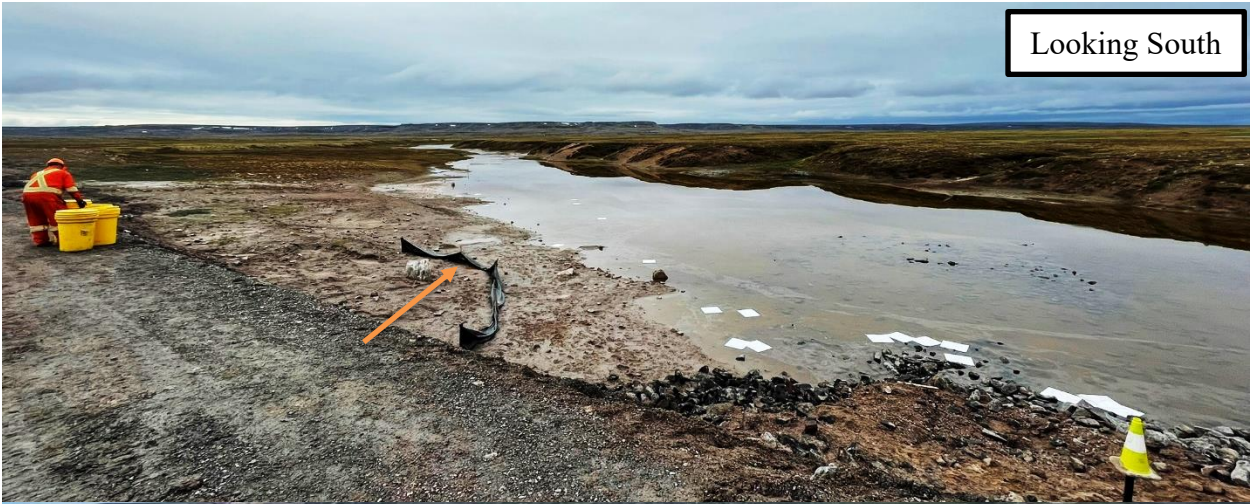
Looking South

Photo 47: Culverts at KM 85

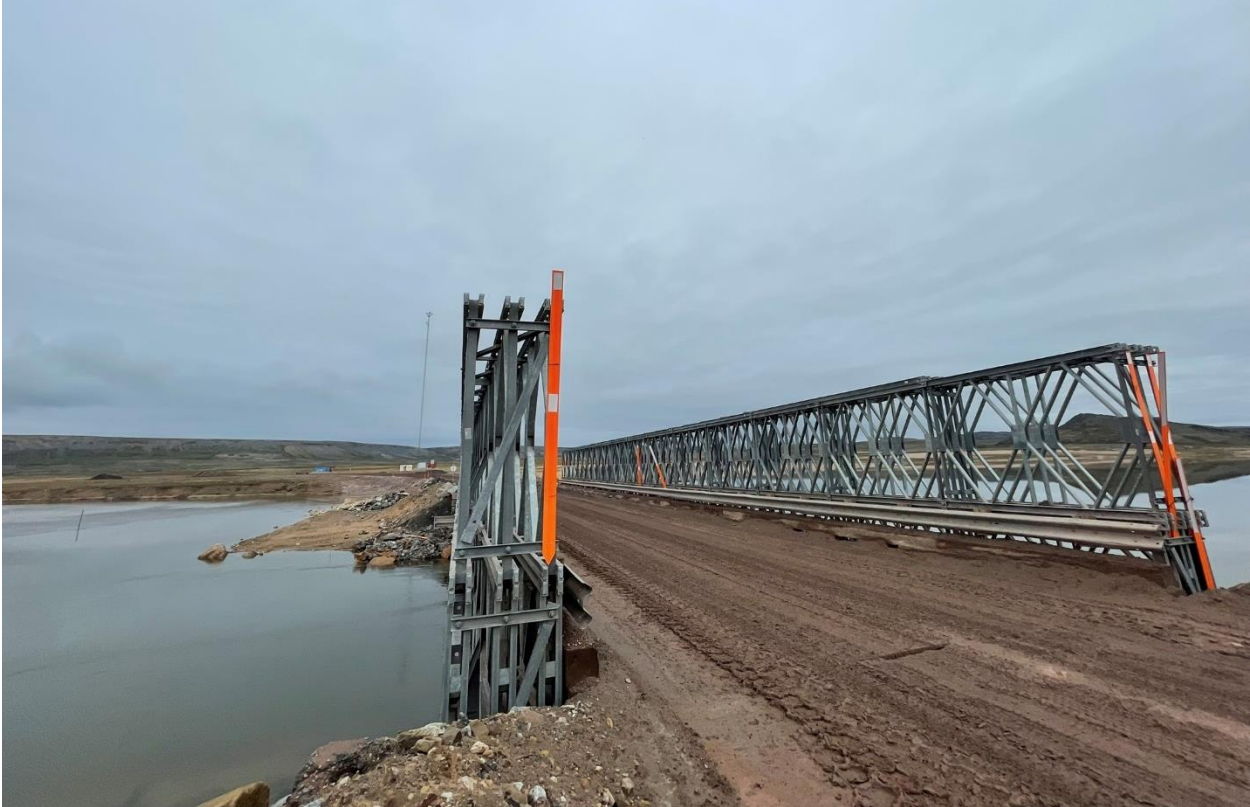
While inspecting the culvert, water levels on both sides of the road prevented NIRB staff from observing the interior of the culverts. While walking on the road above the culverts, NIRB staff noted that the road surface was soft and spongy, with air and water being forced to the surface when pressure was applied, indicating a possible void beneath the road surface. This was brought to the attention of Baffinland staff and they immediately called for the road maintenance personnel to inspect the site.

Photo 50: Road Surface at KM80 showing a soft, spongy surface

- Collapsed culverts at KM 80 of the Tote Road, which were not known at the time of the visit, require urgent, and long-term repair. This, along with ongoing road maintenance challenges following the 2024 rainfall event and soft road conditions north of the mine site, raises concerns about the long-term viability of the road for heavy ore transport.

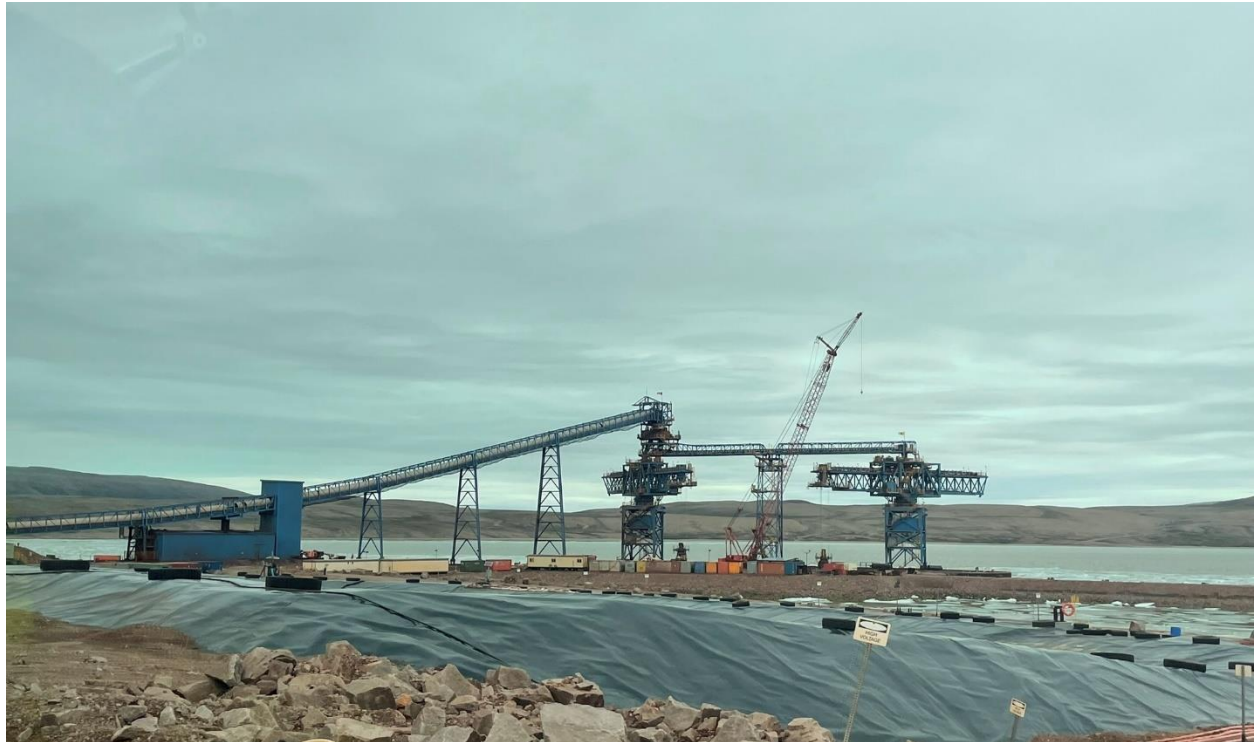
Photo 74: Ship Loader (One operational, second under construction)

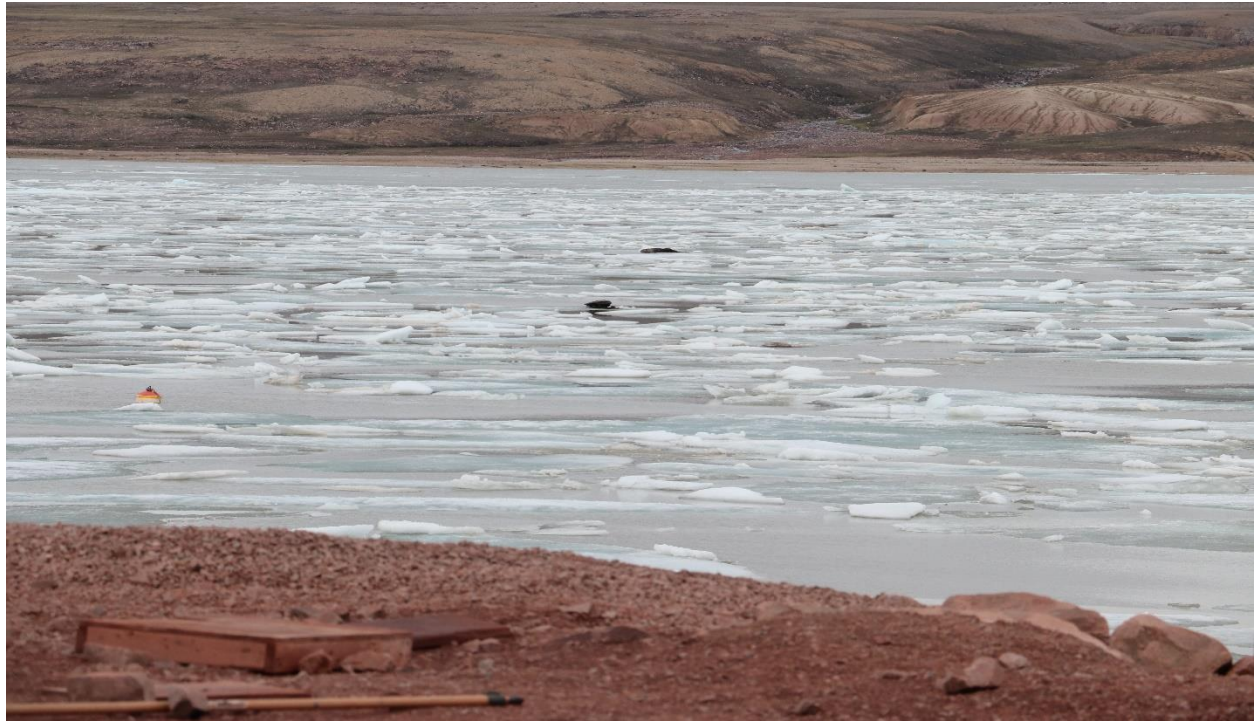
Photo 75: Sea ice conditions at Milne Inlet

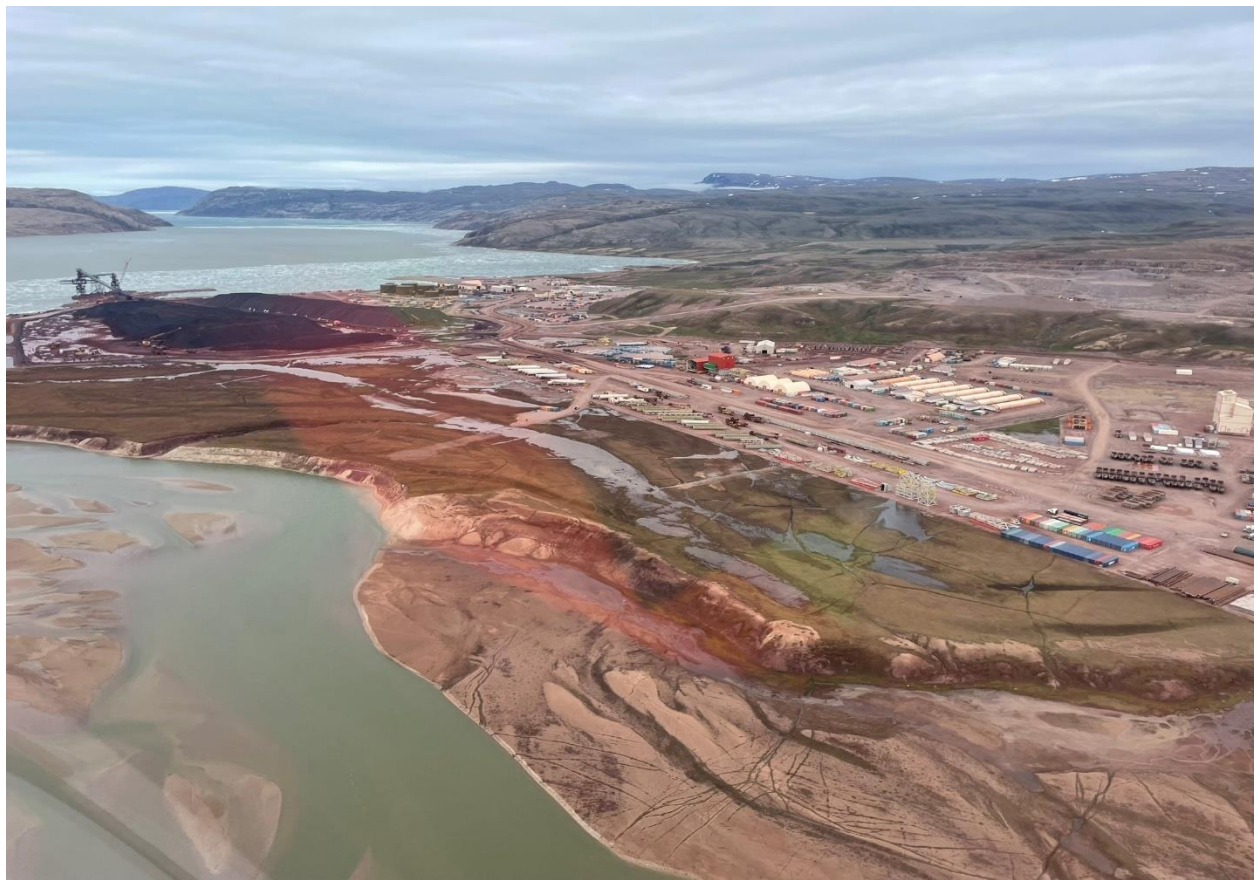
Photo 76: Aerial view of Milne Port Site (2025)
