From April 30 to May 2, 2026, NIRB staff conducted a spring site visit to Baffinland Iron Mines Corporation’s Mary River Project, including the Mine Site, Tote Road, and Milne Port, accompanied by Baffinland environmental staff. The visit focused on observing site activities, environmental management practices, and implementation of Project Certificate requirements. During the visit, NIRB staff observed ongoing operational activities and held discussions with the Proponent regarding environmental monitoring, mitigation measures, and adherence to Project Certificate requirements (Table 1).

3.1. Mine Site

3.2. Tote Road

3.3. Milne Port

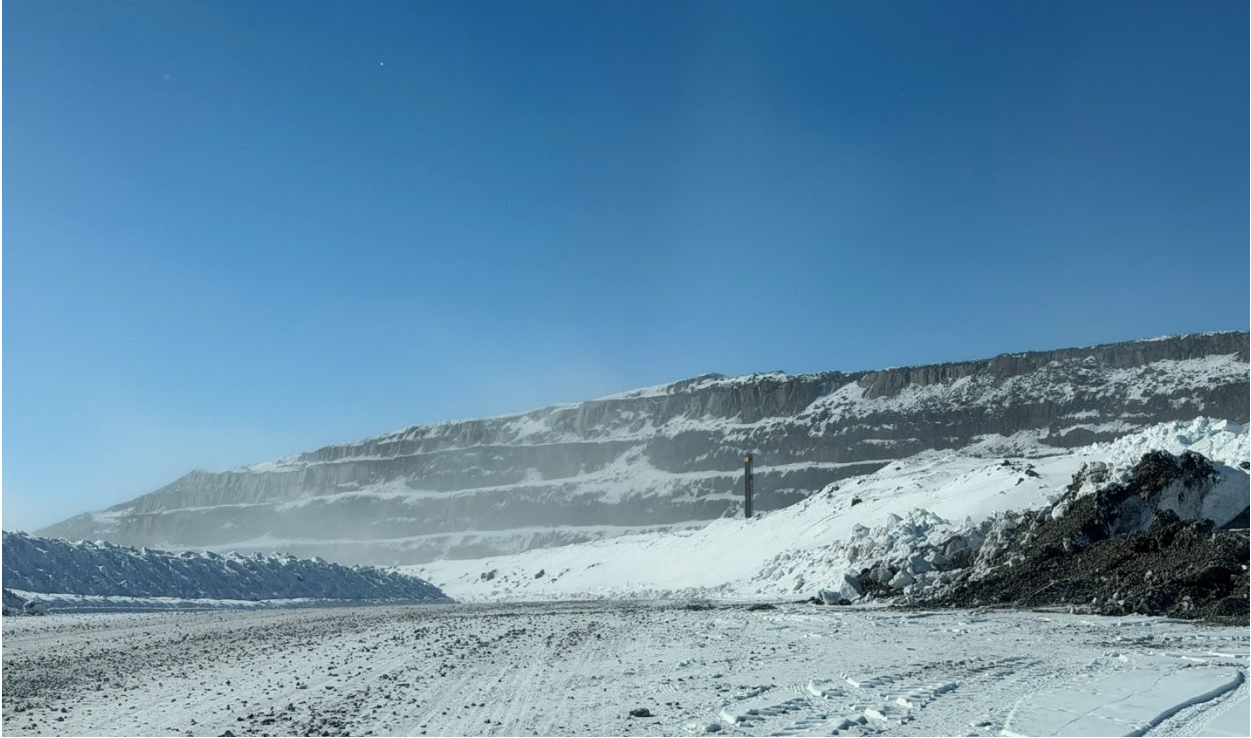
Photo 2: General overview Deposit No.1 looking northwest from Haul Road

¹ Deposit No. 1 is the main open-pit iron ore deposit at the Mary River Mine and serves as the primary source of high-grade ore for current operations. Due to snow cover, cloud conditions, and ongoing operations, a clear overview of the pit and active mining area was not obtained.

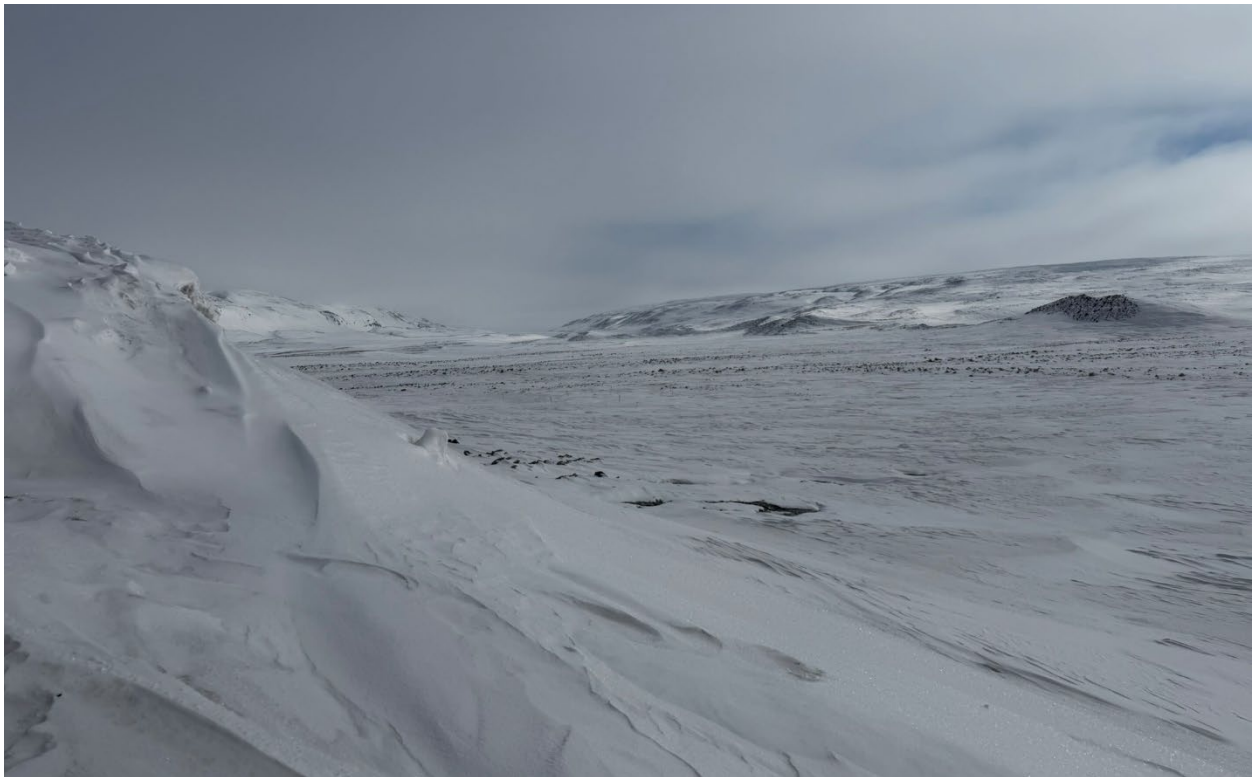
Photo 13: Effluent Discharge Location, facing east (snow-covered, no active discharge observed)

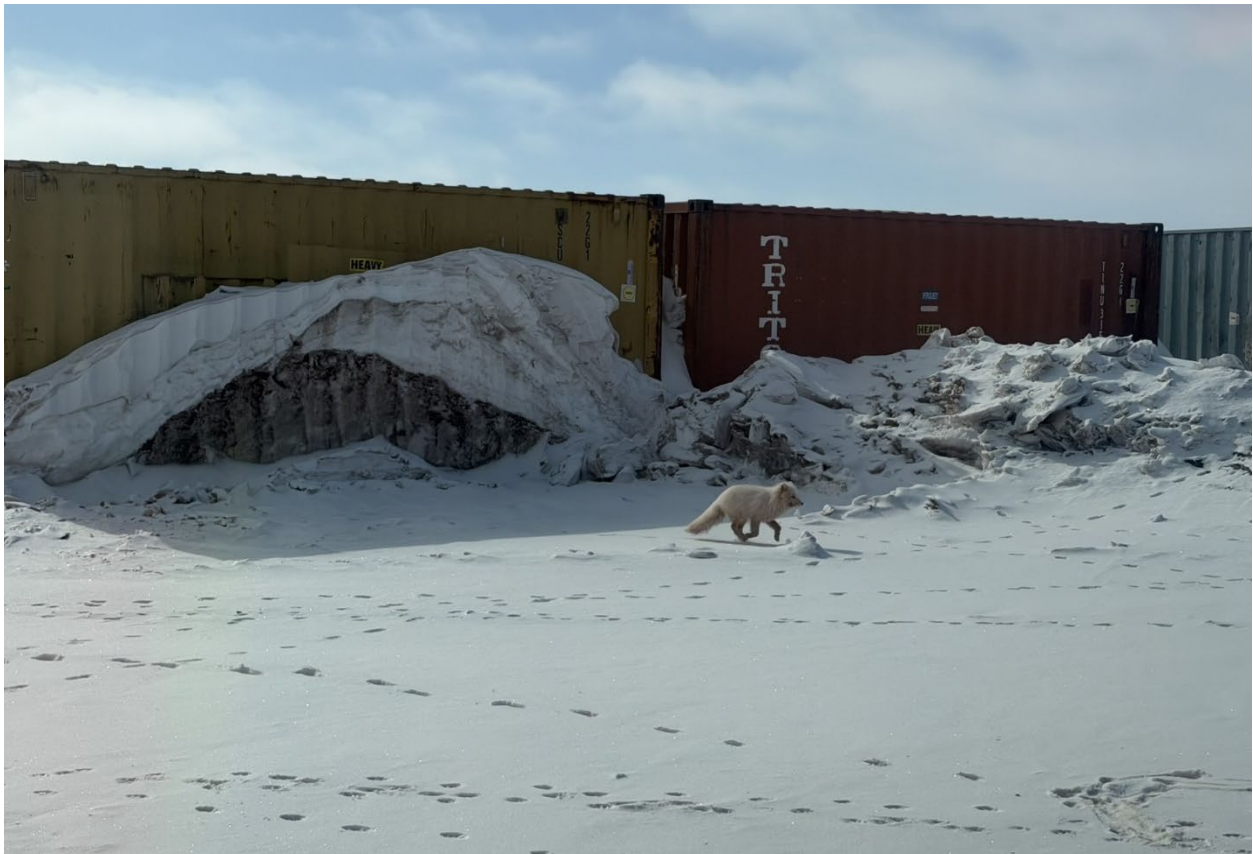
Photo 31: Arctic fox observed near seacans south of the hazardous waste berm

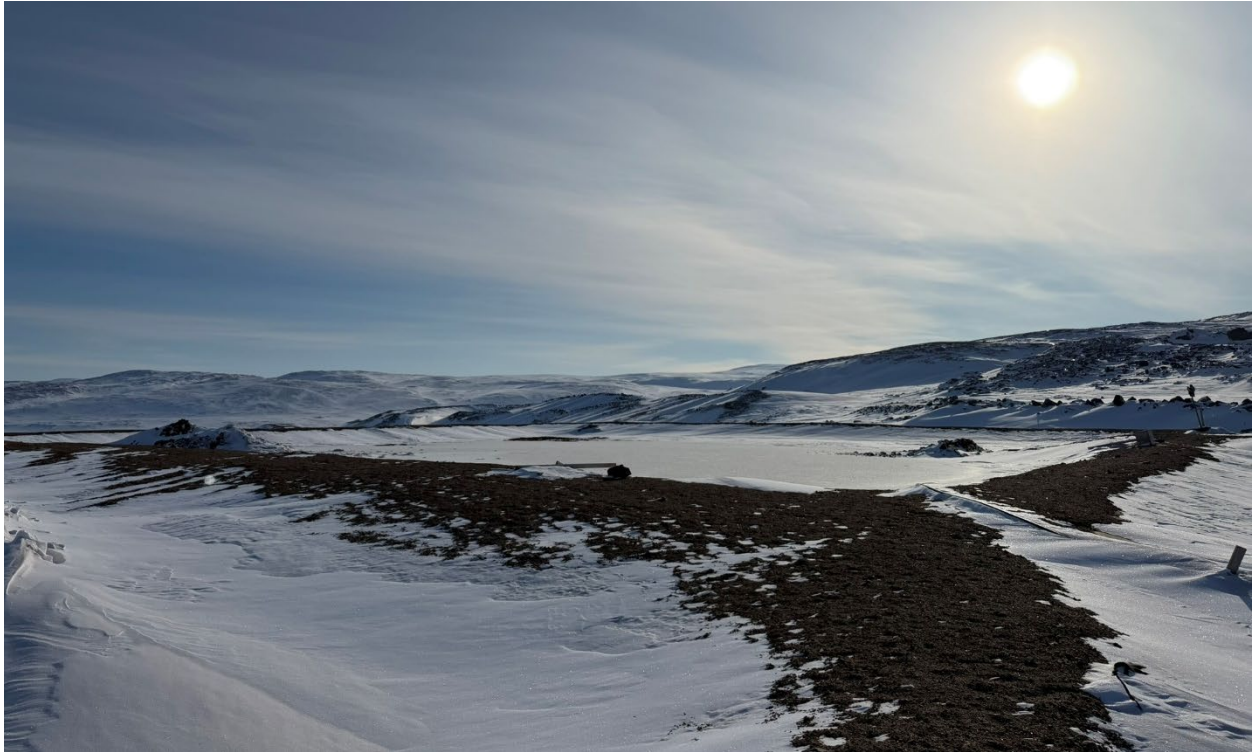
Photo 95: Contaminated Snow Disposal Cell (MP-04A)

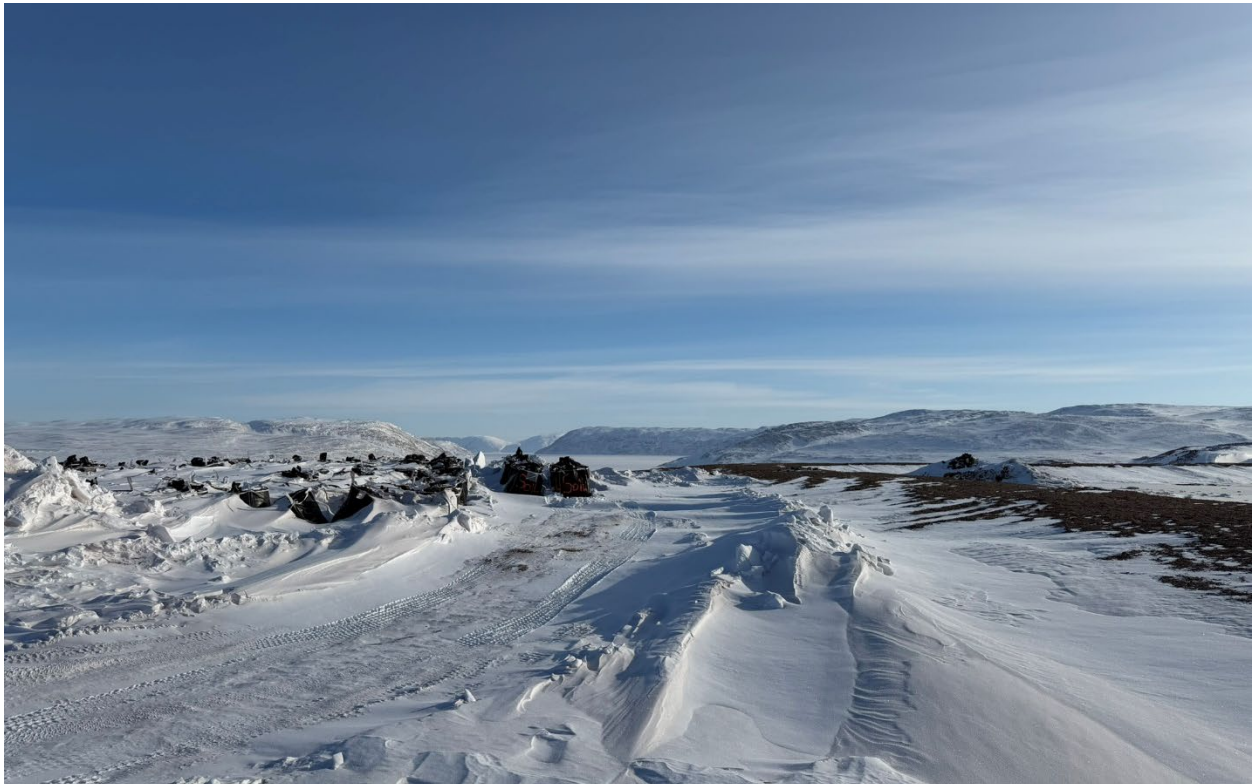
Photo 96: Landfarm (MP-04)

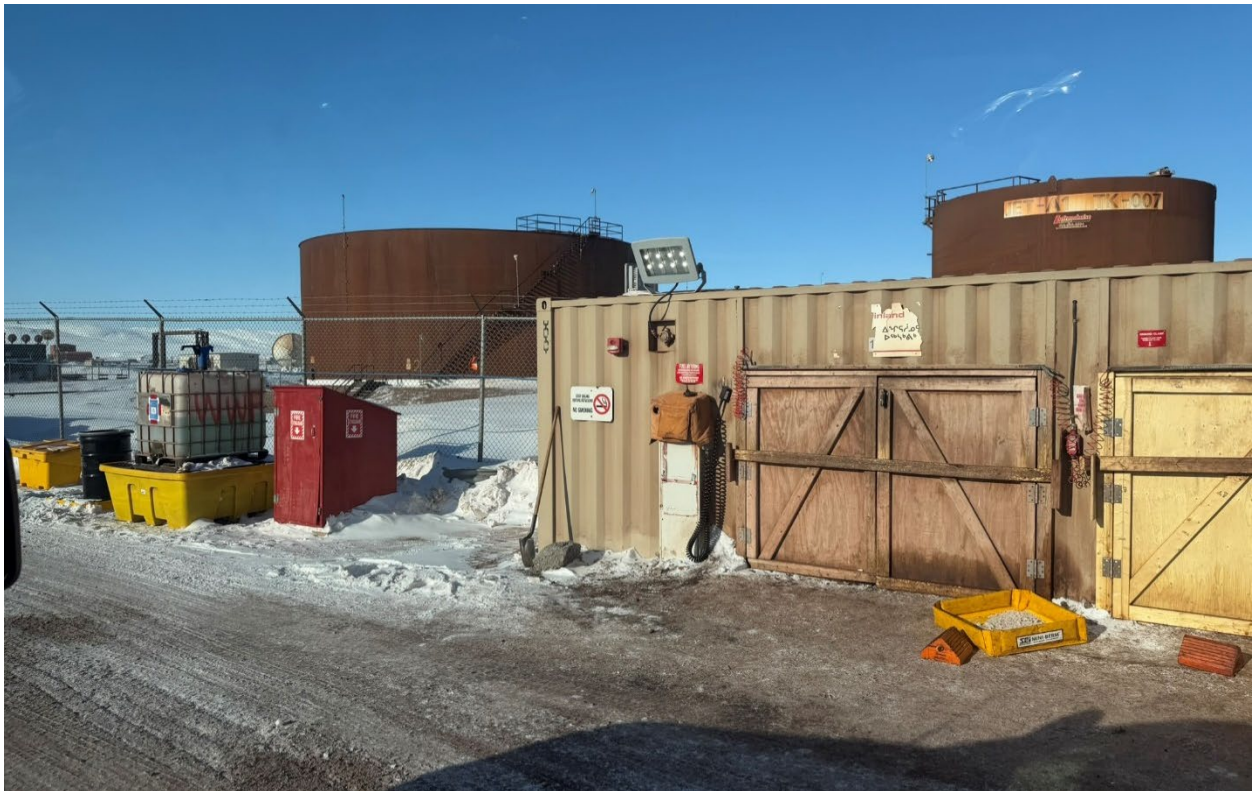
Photo 98: Vehicle fuel module and spill kits

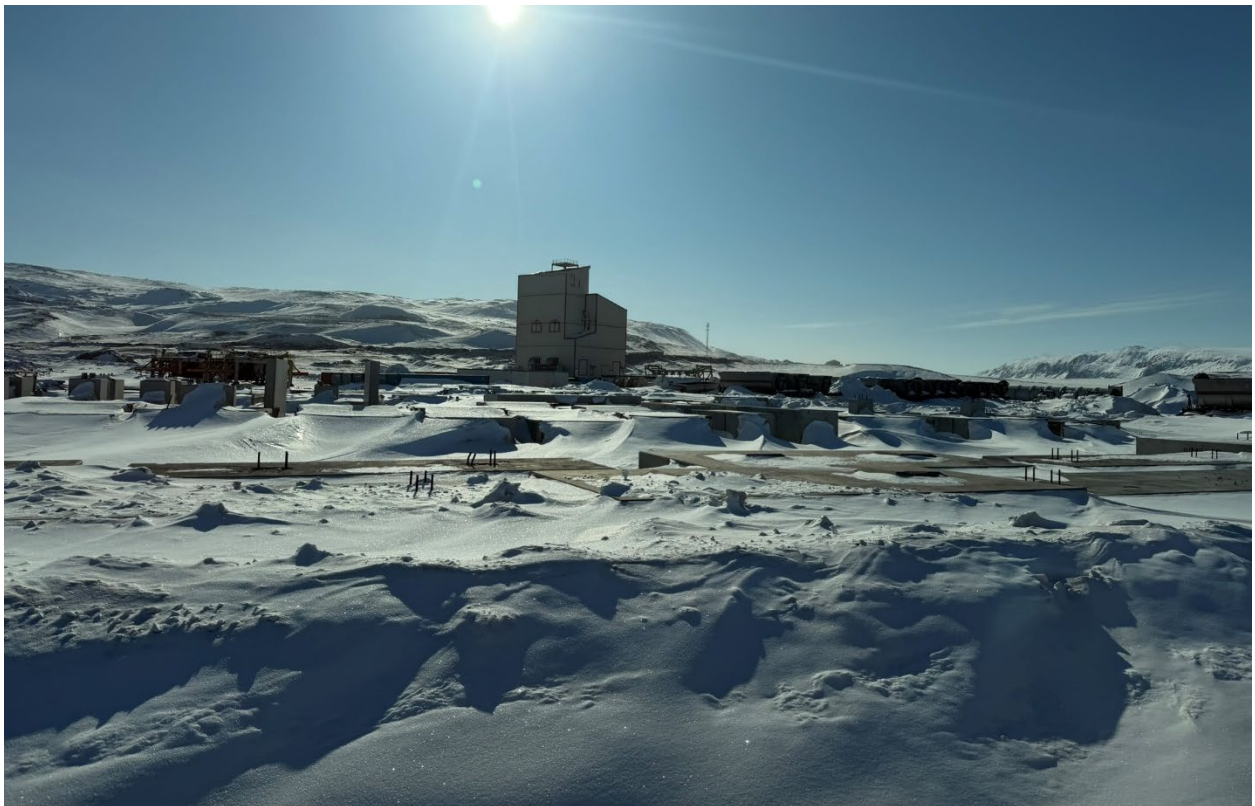
Photo 102: Laydown Pad 6

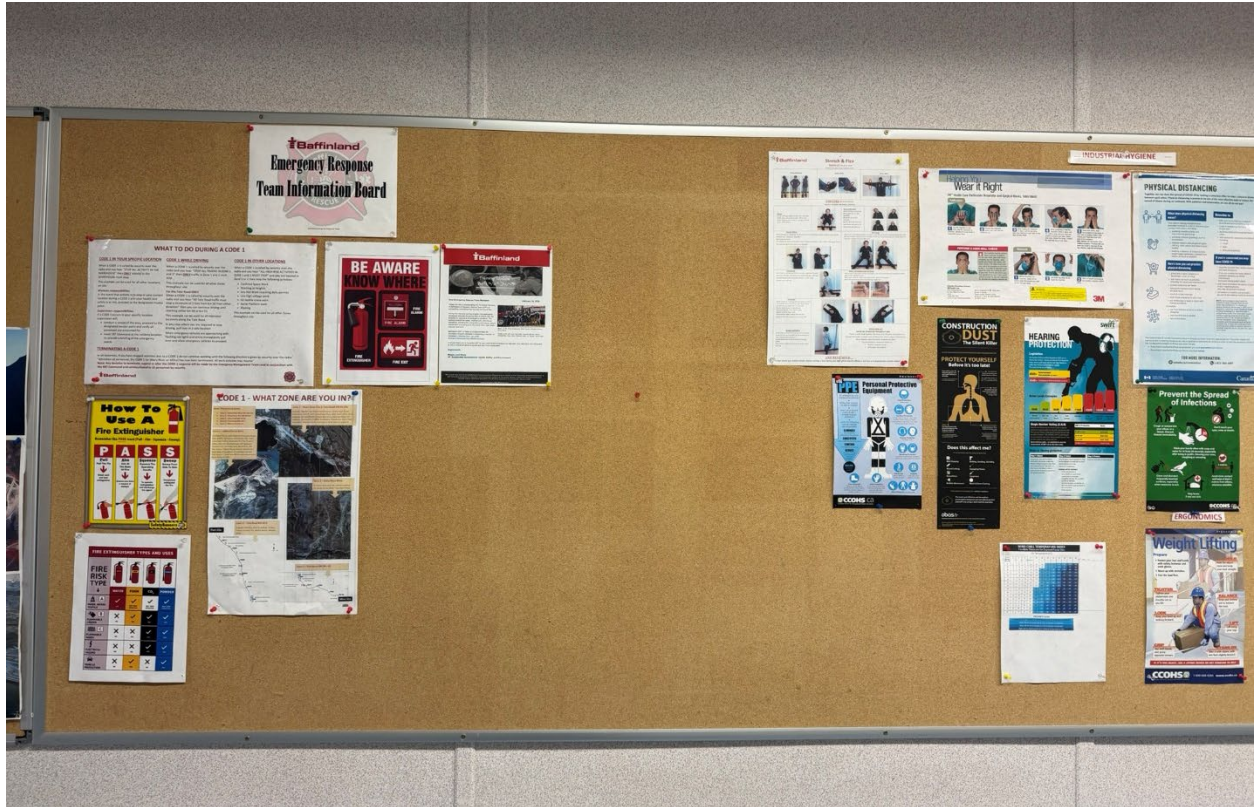
Photo 105: Emergency Response and Industrial Hygiene information board located in hallway
