Non-Hazardous Landfill, Construction Report, Ulu Gold Project Interim Report Draft

SRK Consulting (Canada) Inc.
1CB041.000
September 2022

Project No: 1CB041.000

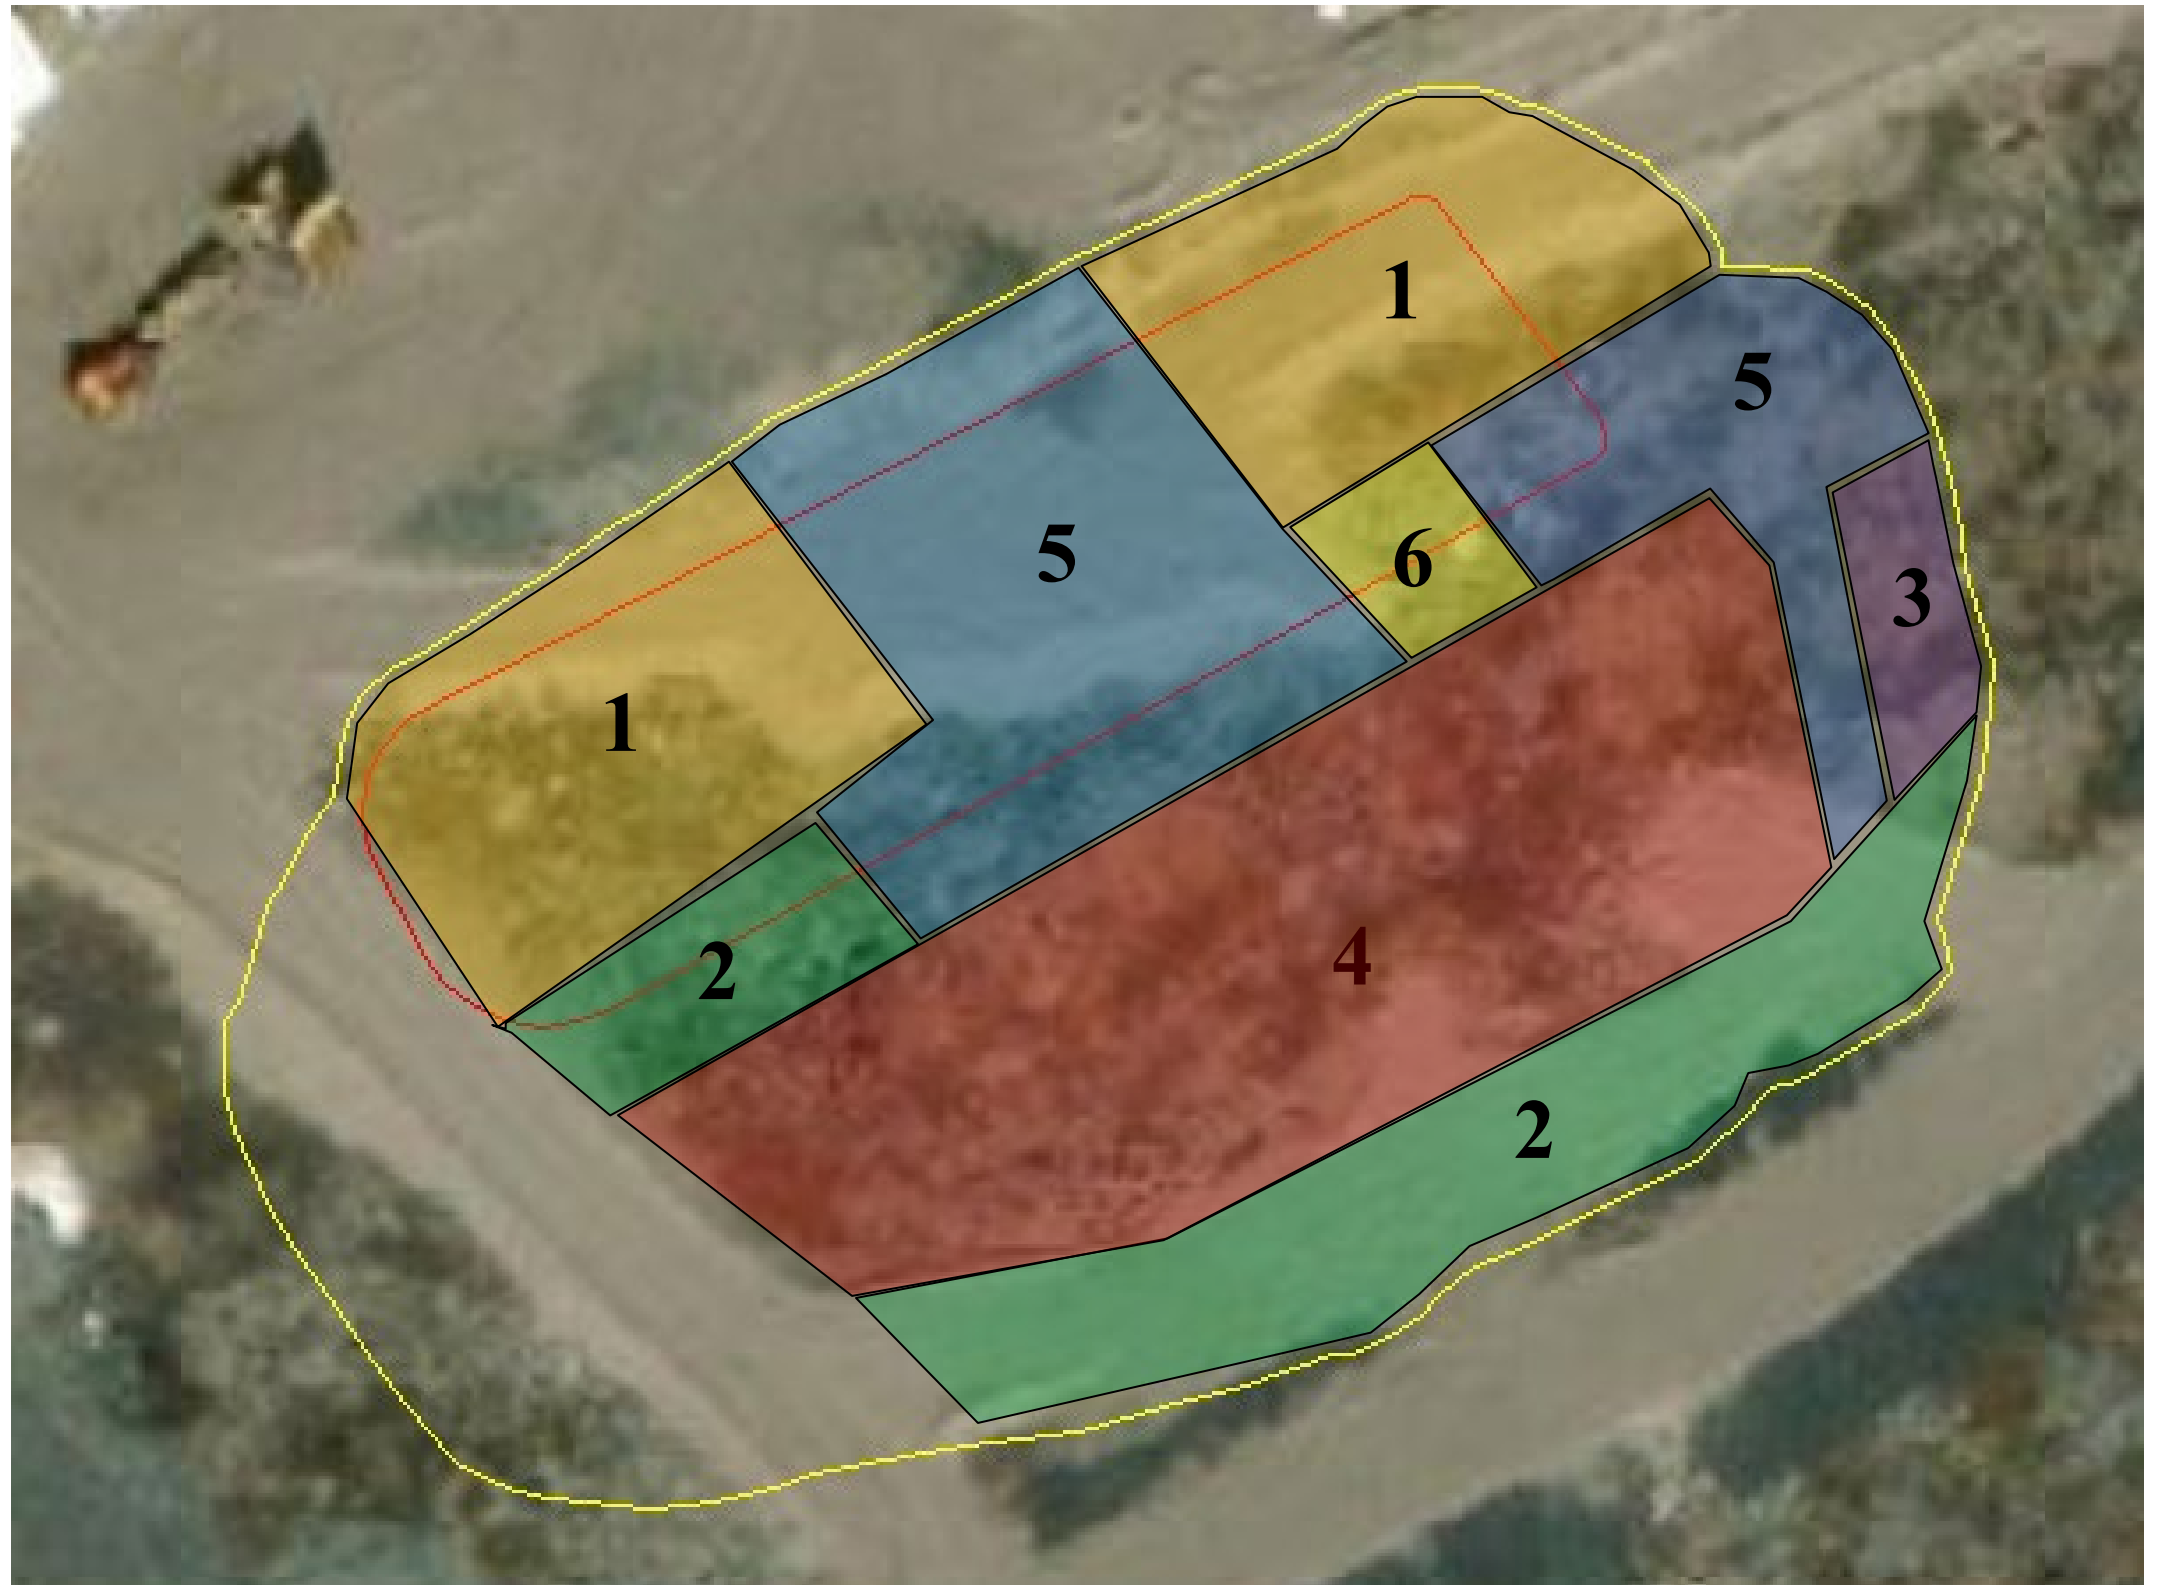
Non-Hazardous Landfill		
		General Waste Placement		
Job No: 1CB041.000 Filename: AppendixC_Ulu_Landfill_Photolog_Rev2_DG.ppt	Ulu Gold Project	Date: September 2022	Approved: DG	Figure: 2

- 1 Container, tanks and miscellaneous waste including steel and tyres.
- 2 Steel sheeting, pipes and deconstructed tanks
- 3 Tyres and miscellaneous waste
- 4 Deconstructed bunk housing and miscellaneous waste
- 5 Cleaned and cut equipment (surface and underground) and generators
- 6 Concrete

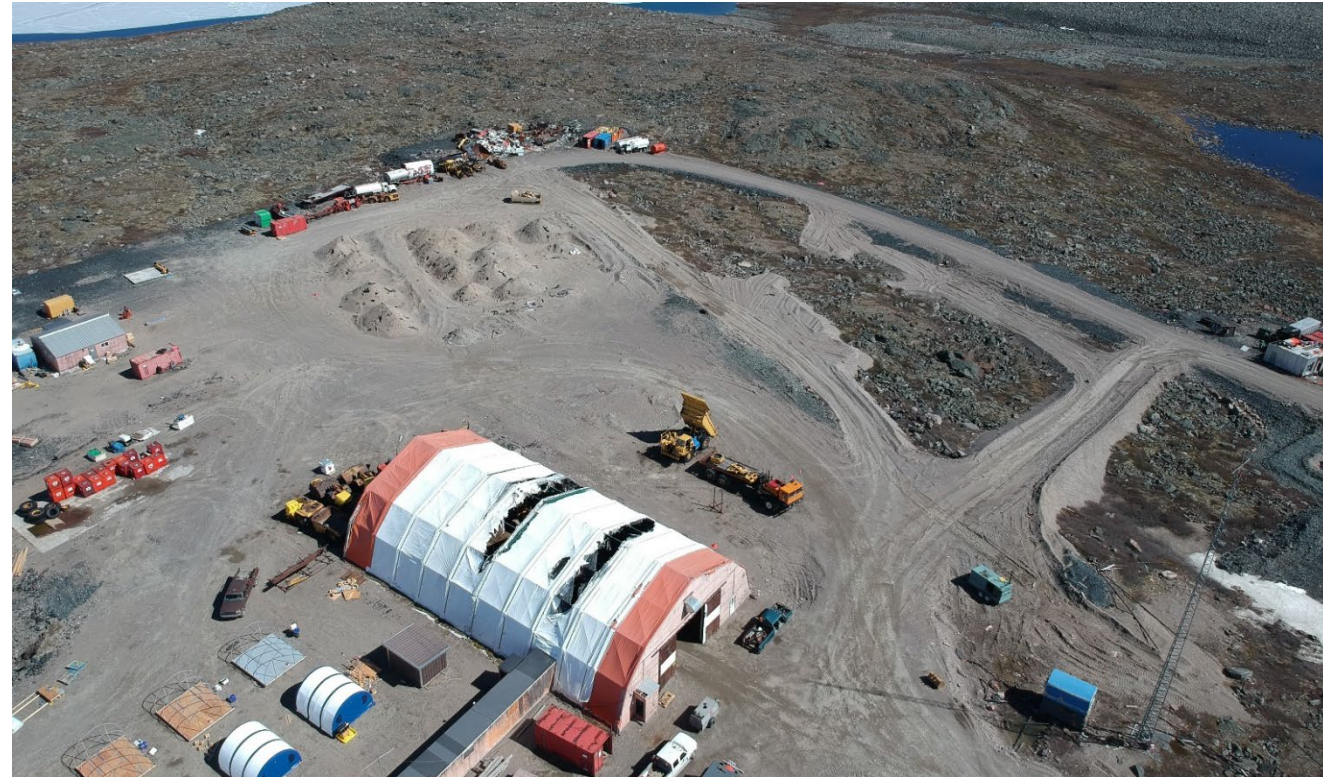
An aerial view of the site on June 24, 2021

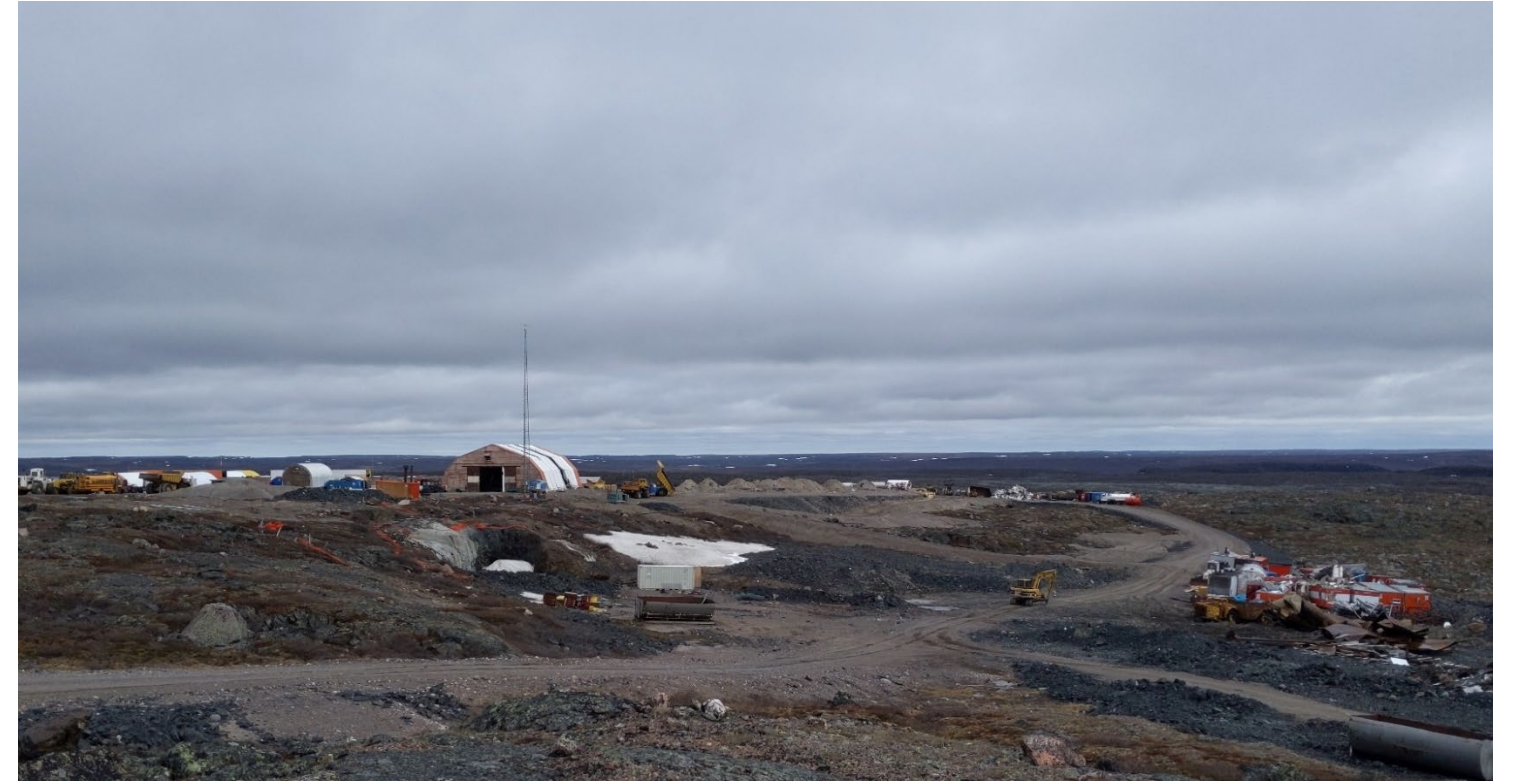
The west side of the site facing east as of June 24, 2021

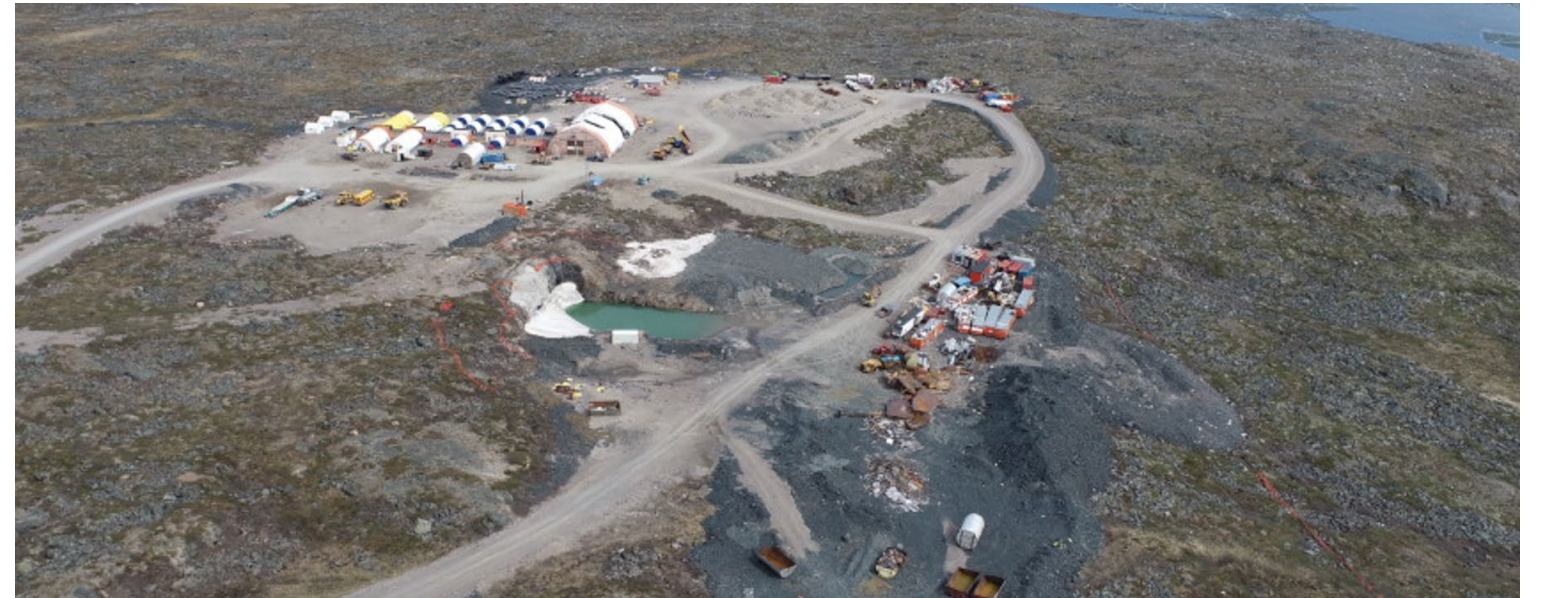
An aerial view of the site on June 26, 2021

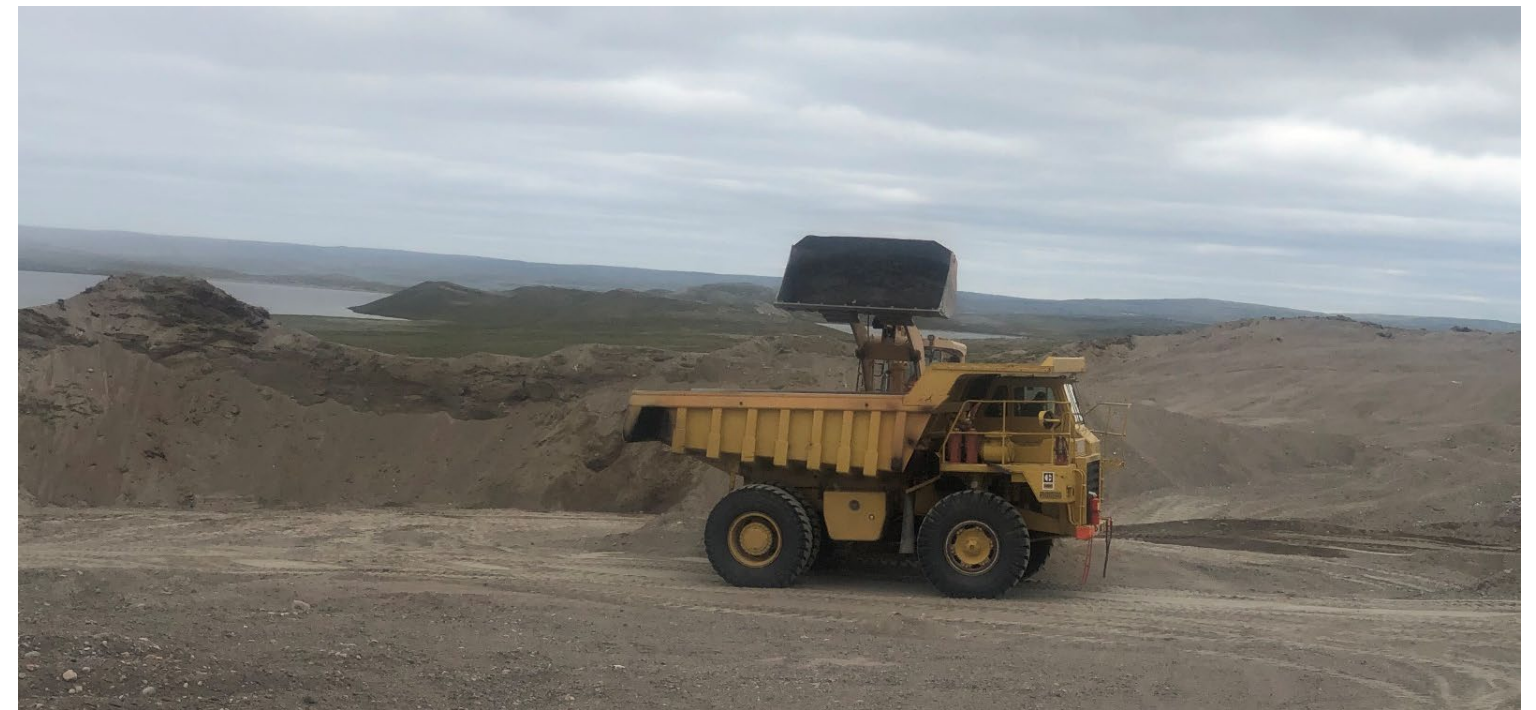
Transporting esker sand on July 18, 2021

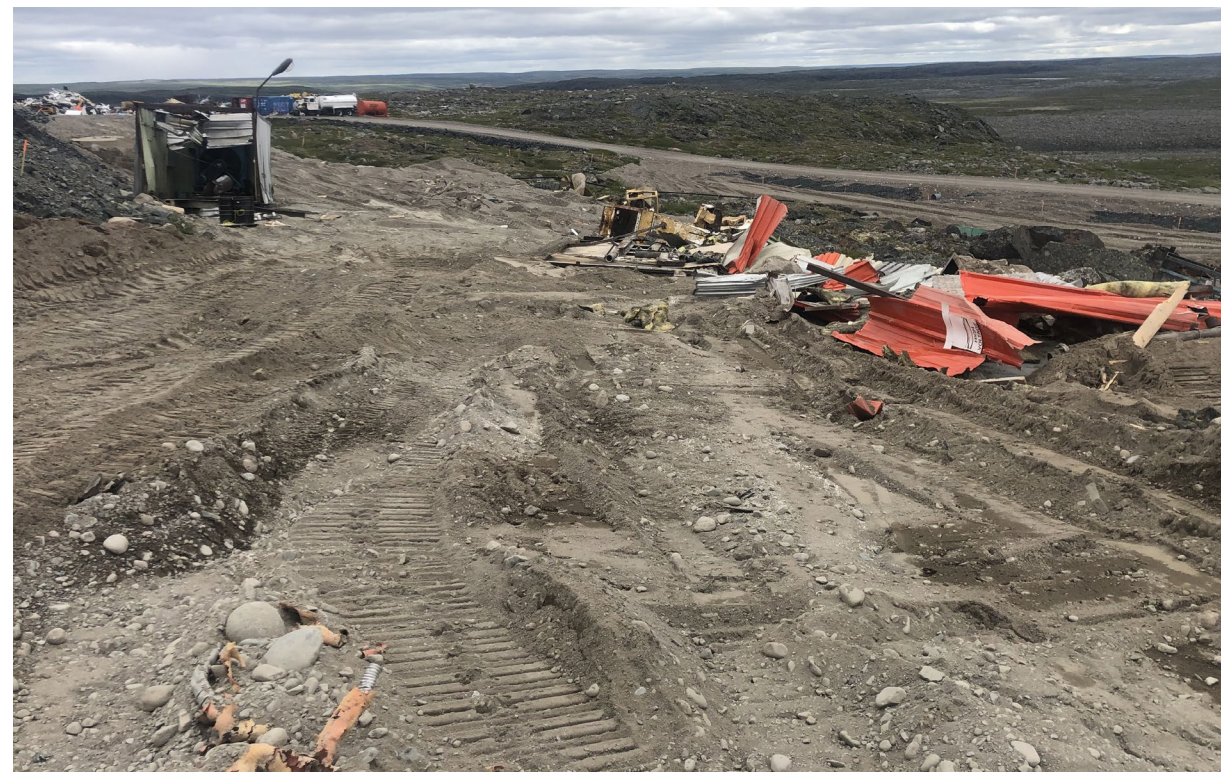
Debris placement and esker cover on July 16, 2021

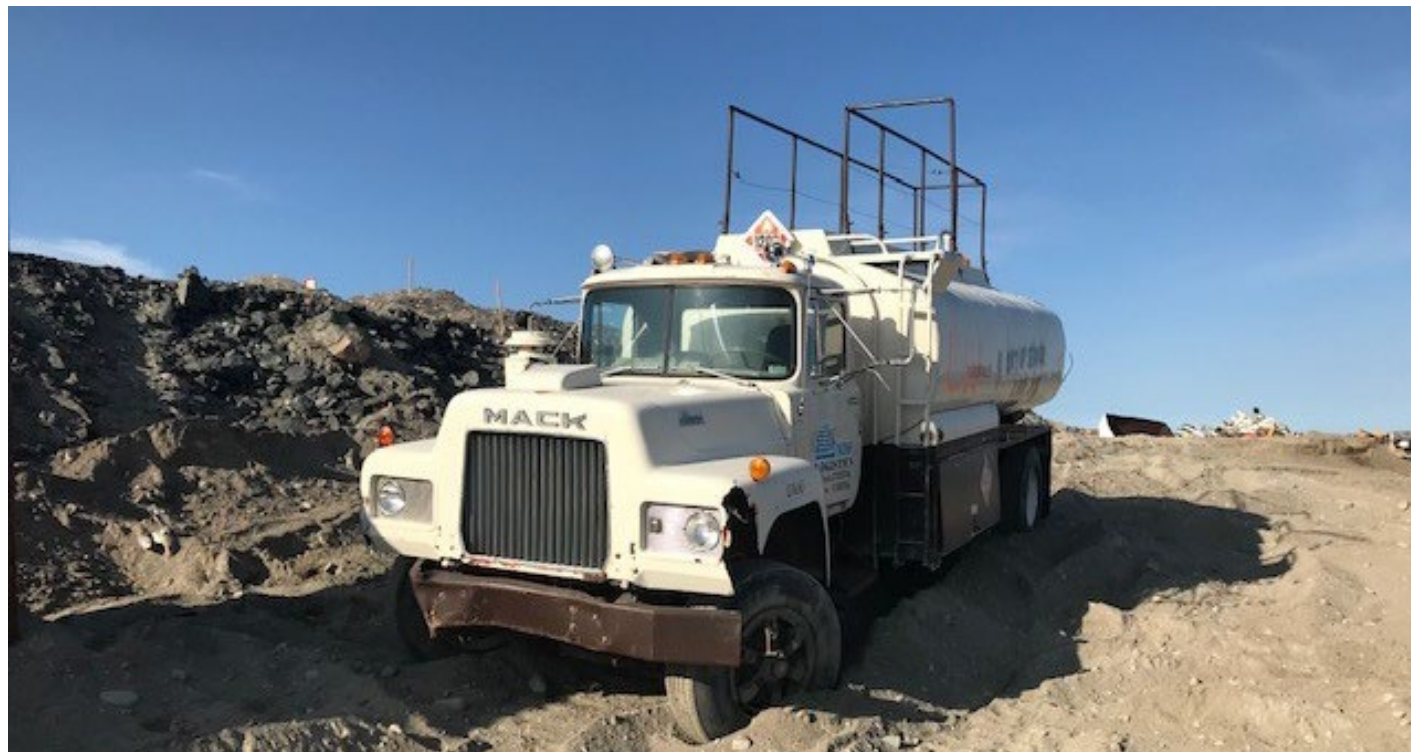
Fuel truck placement in the landfill on July 20, 2021

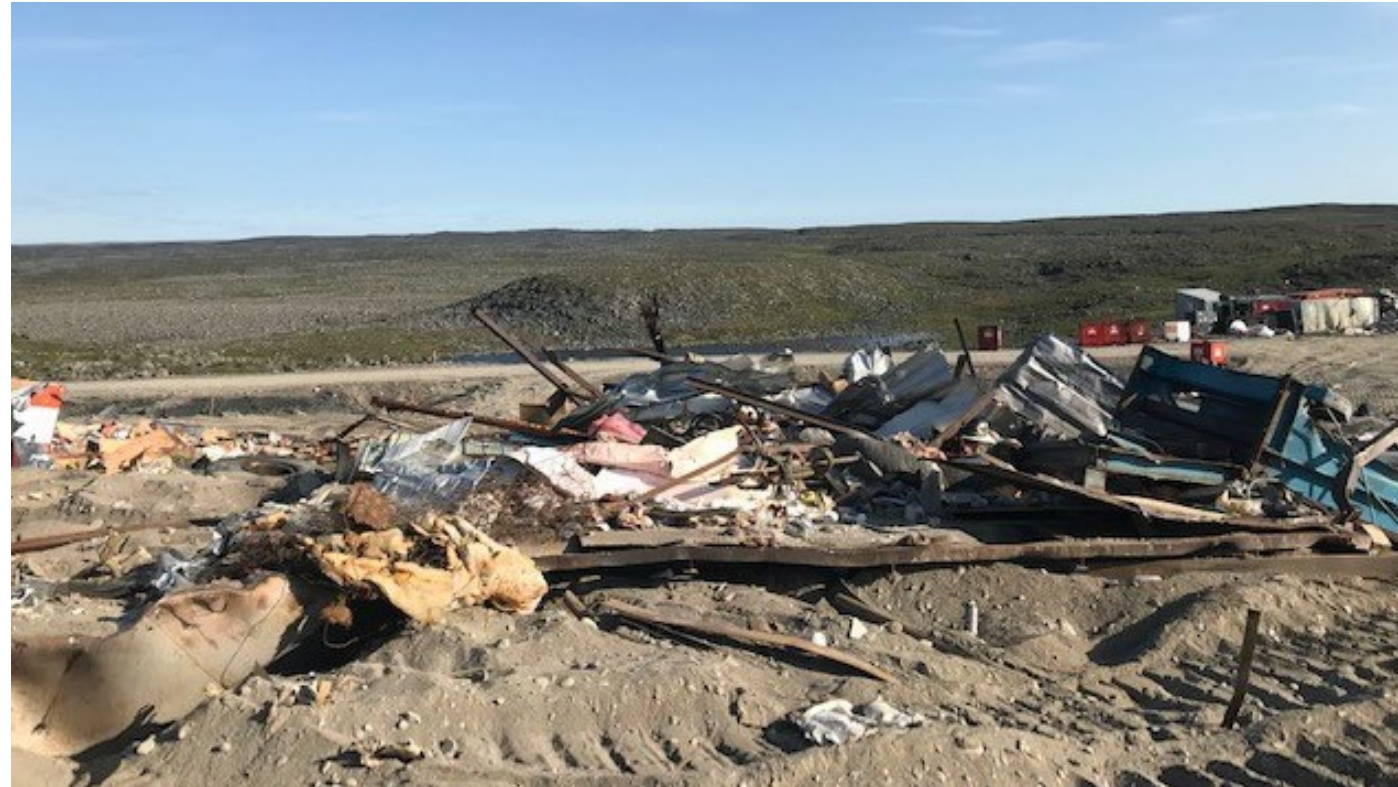
Steel waste placed in the landfill. July 20, 2021

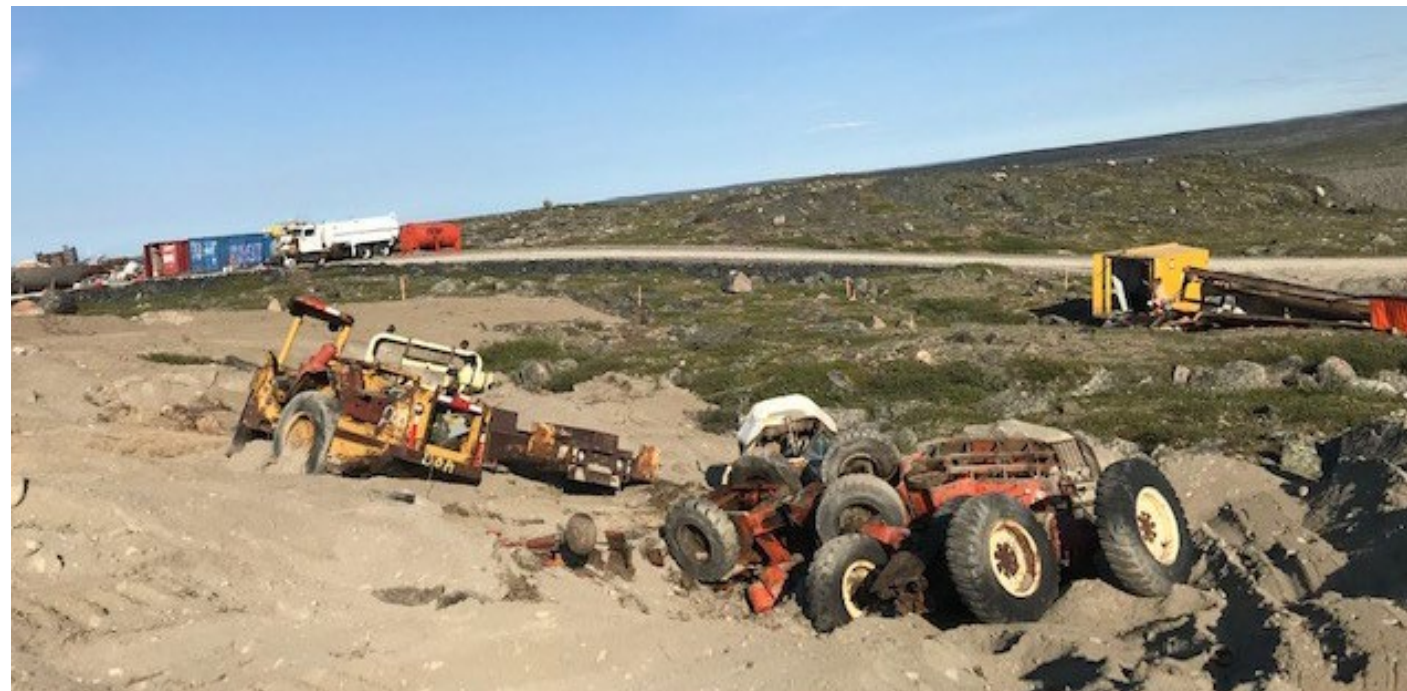
Underground mine equipment placed in the landfill. July 20, 2021

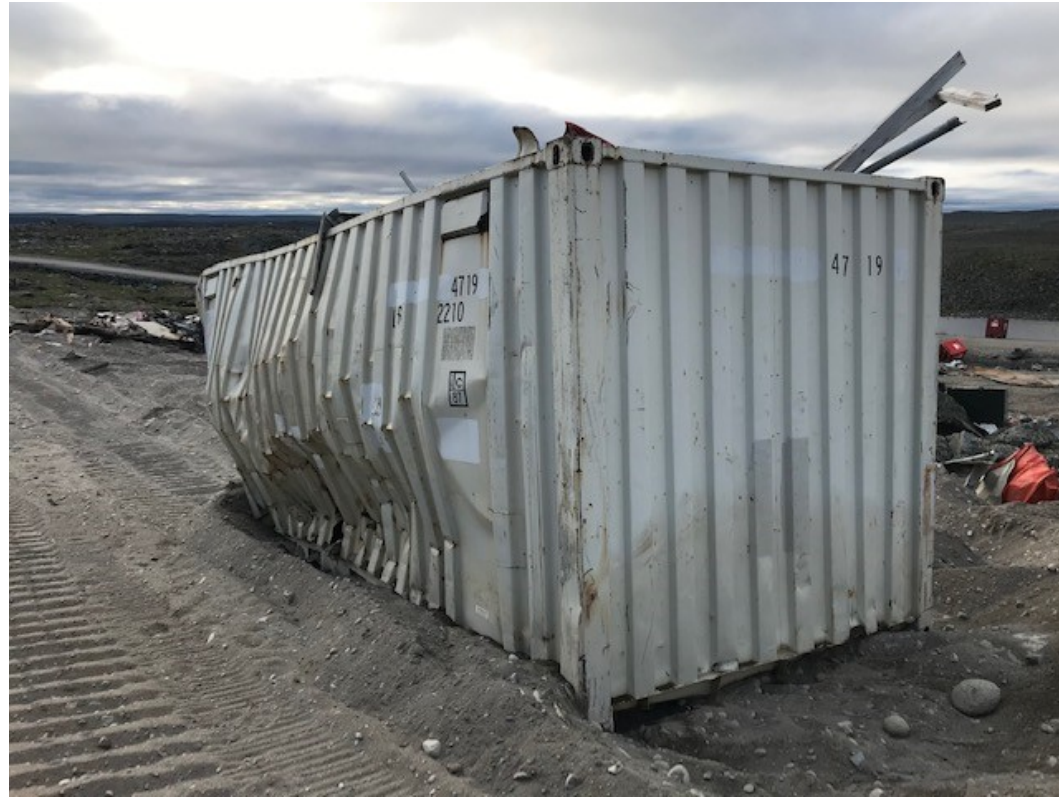
Seacan filled with waste on July 23, 2021

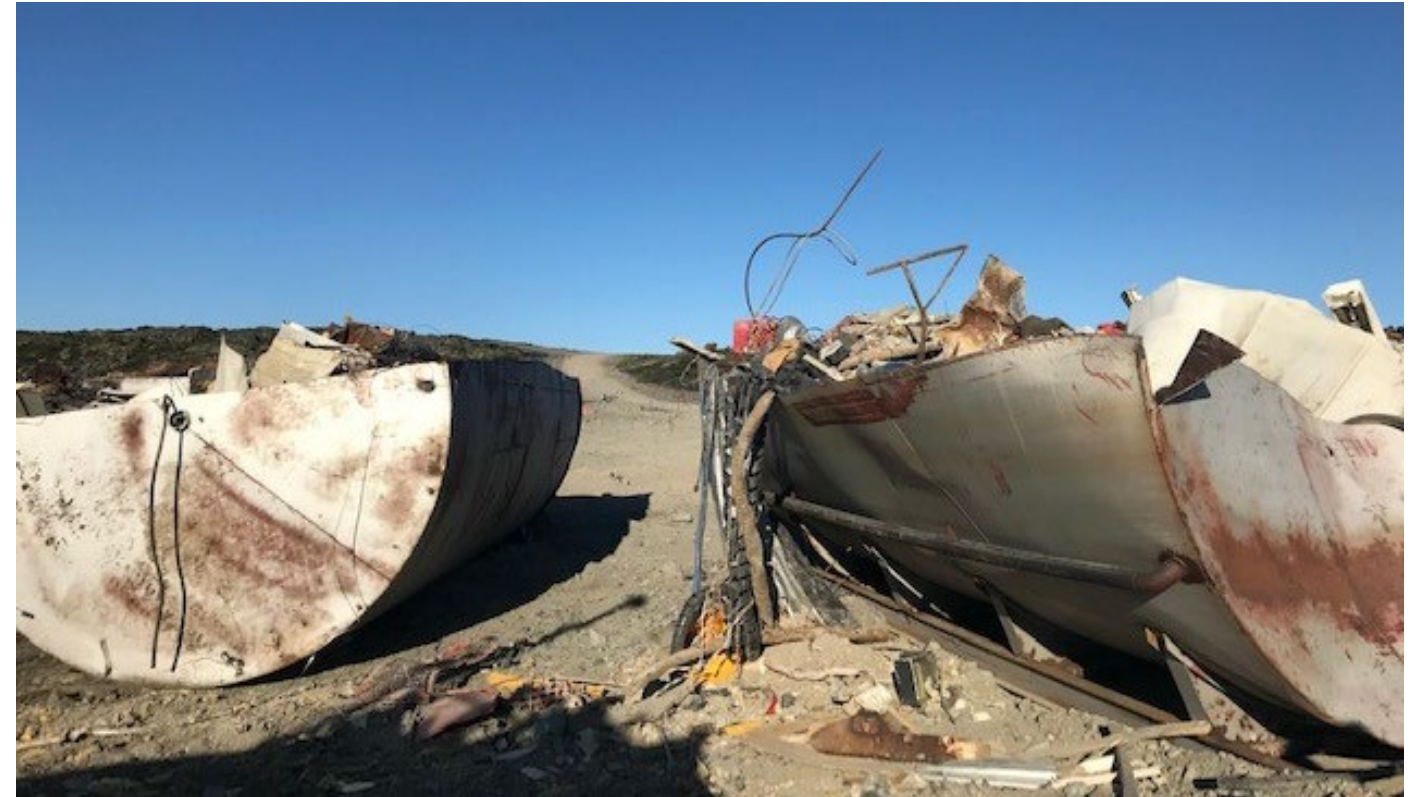
Tanks filled with waste. July 24, 2021

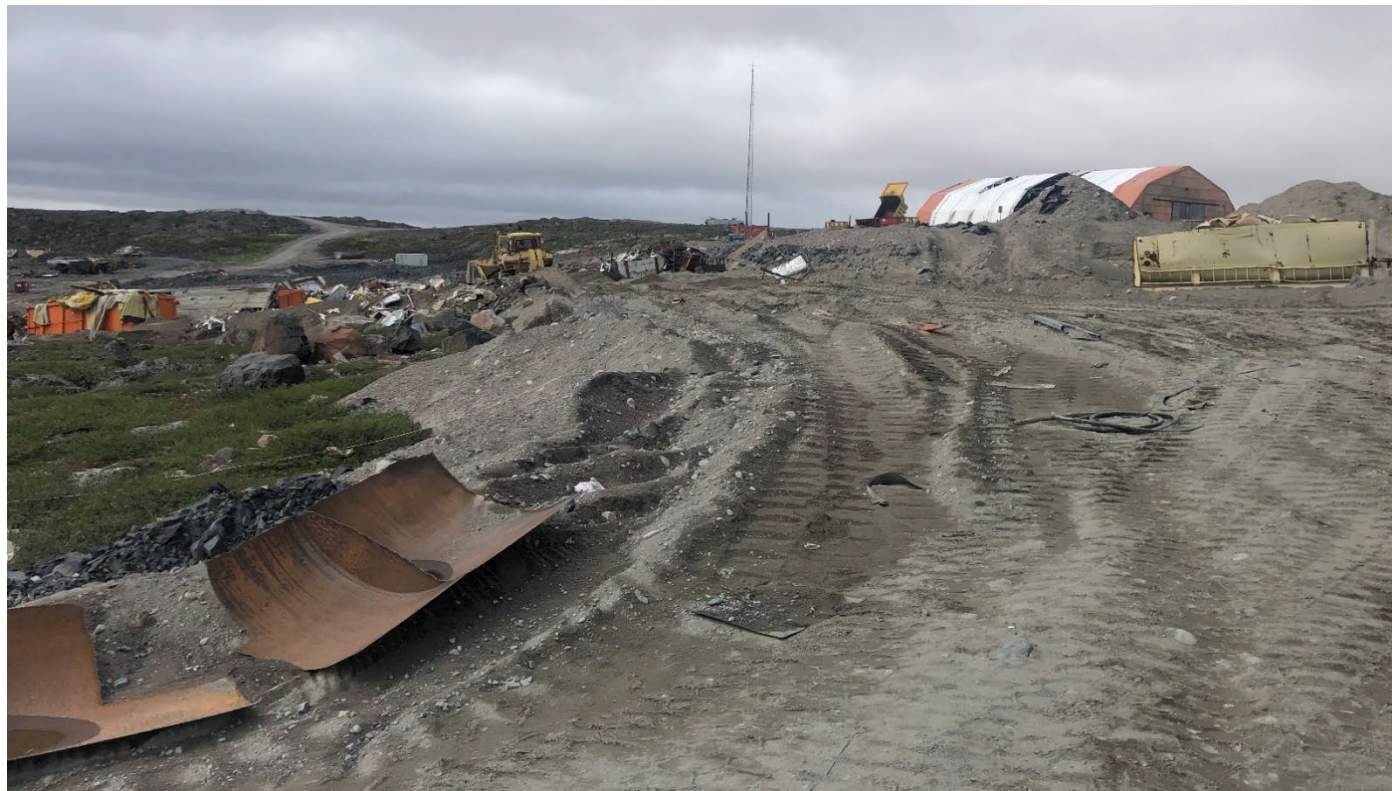
The east side of the site facing west on August 3, 2021

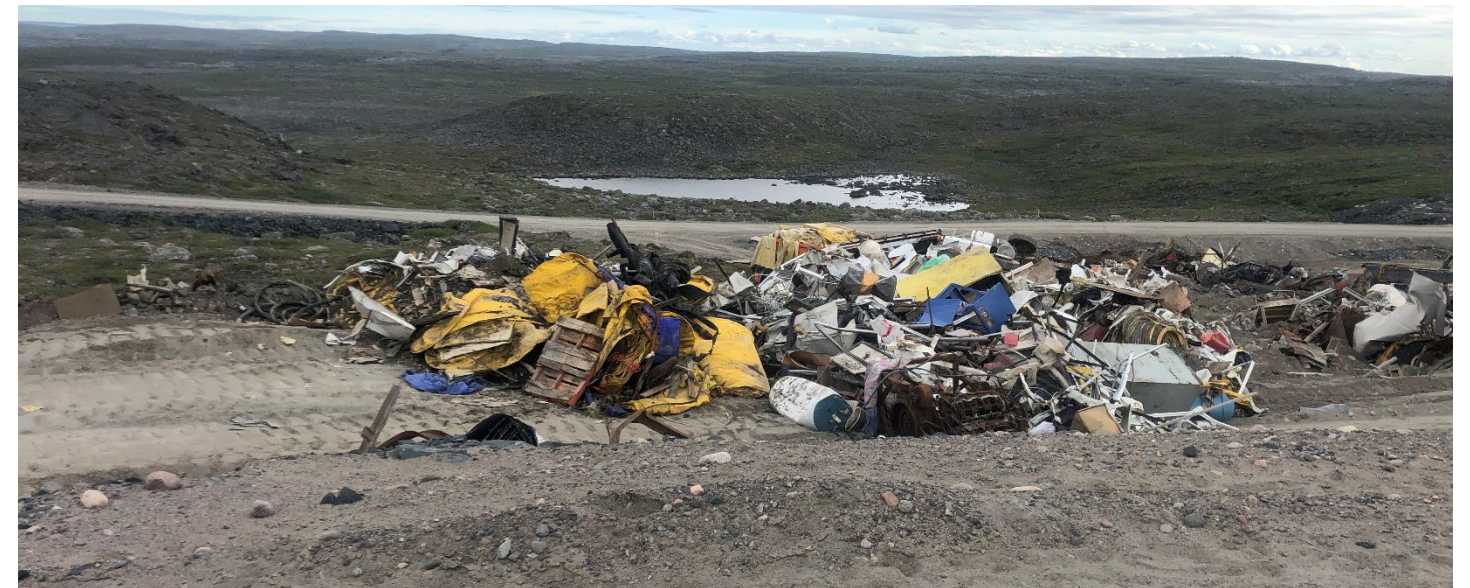
The north side of the site facing south on August 2, 2021

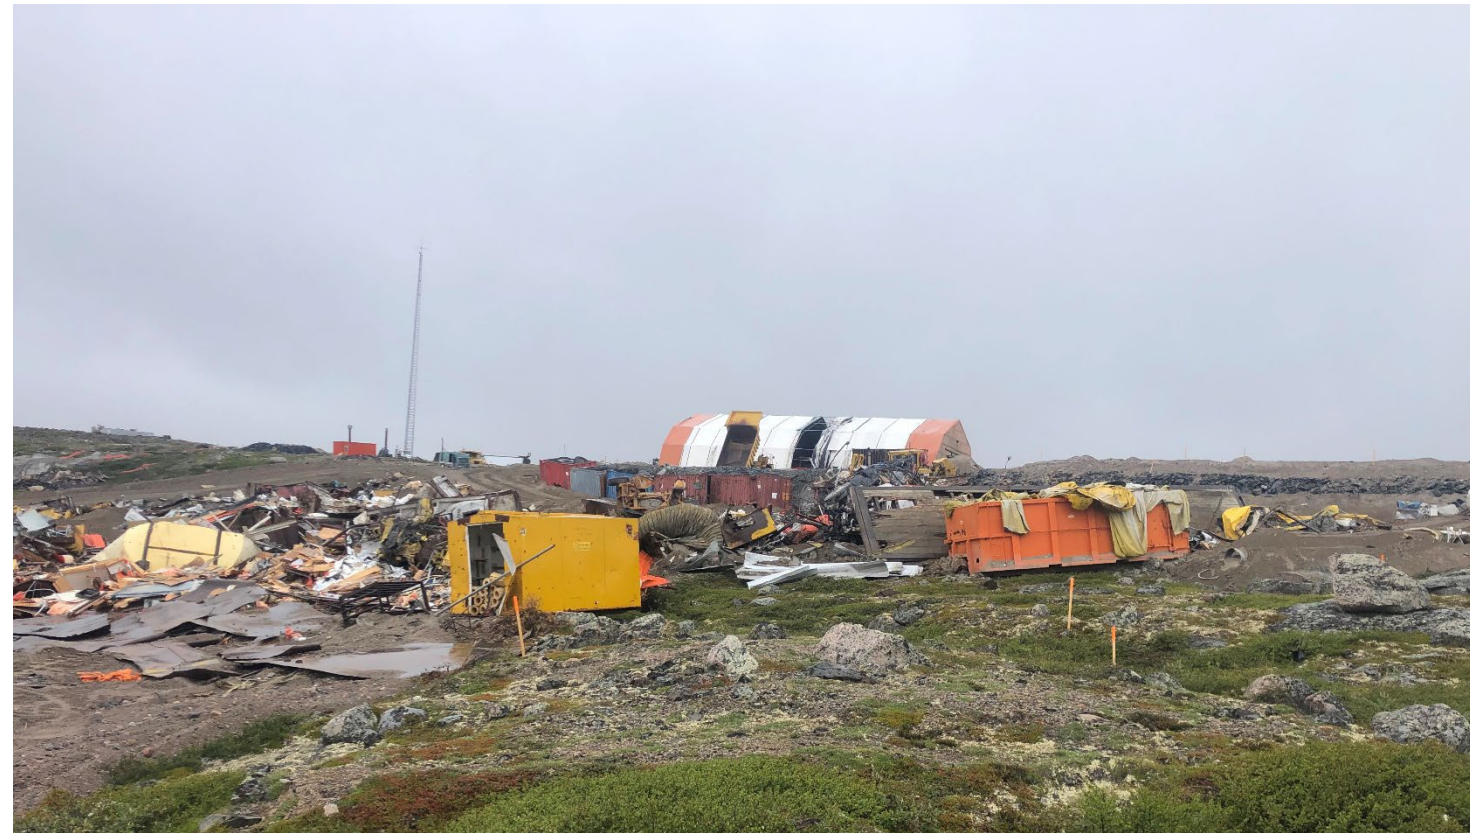
The south side of the site facing north on August 3, 2021

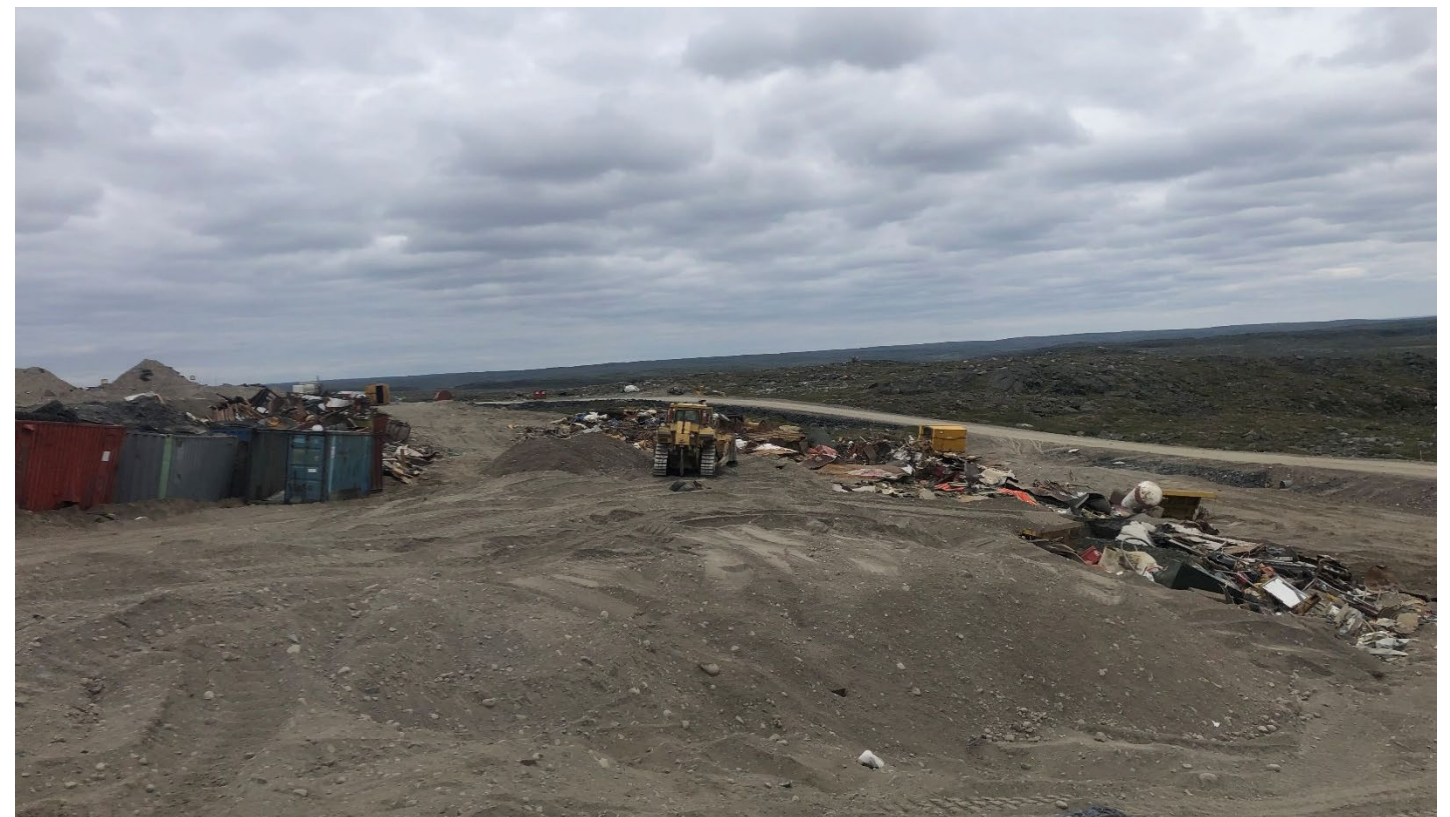
The west side of the site facing east on August 9, 2021

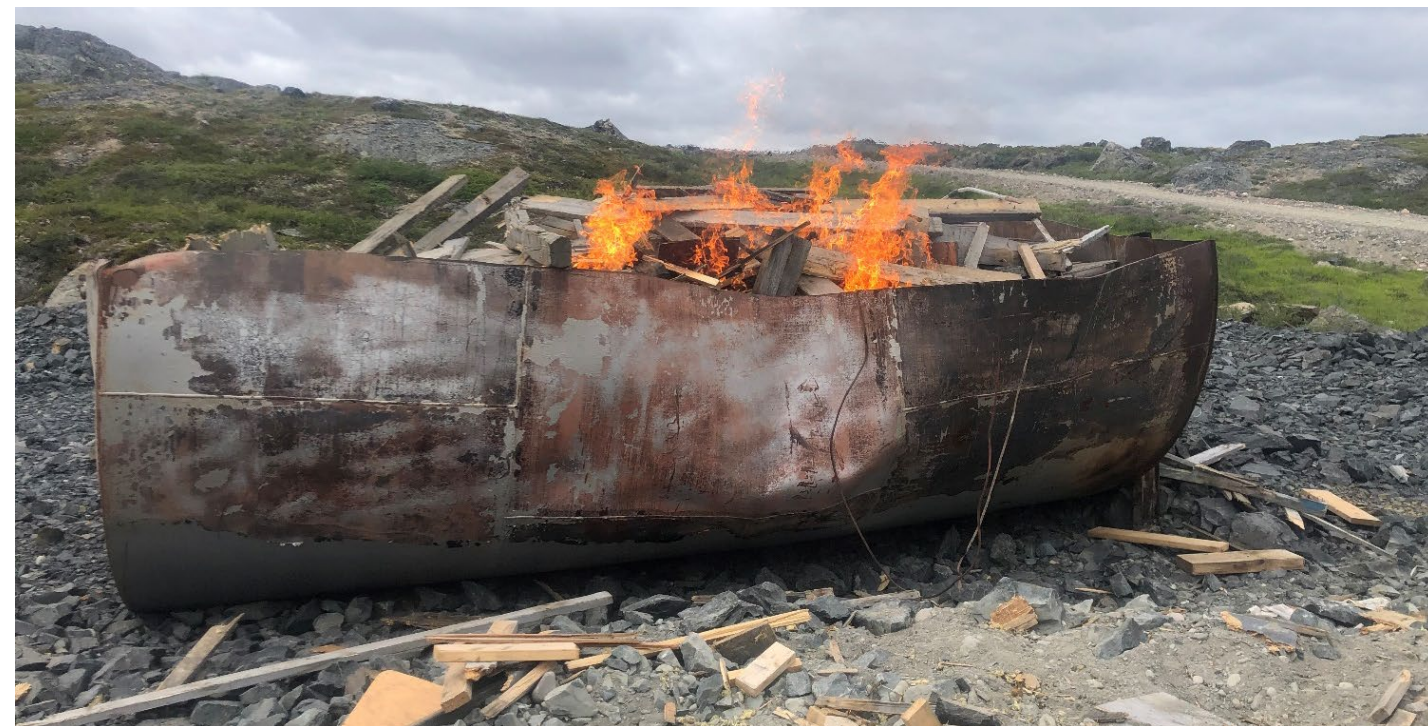
Burning of clean wood on August 9, 2021

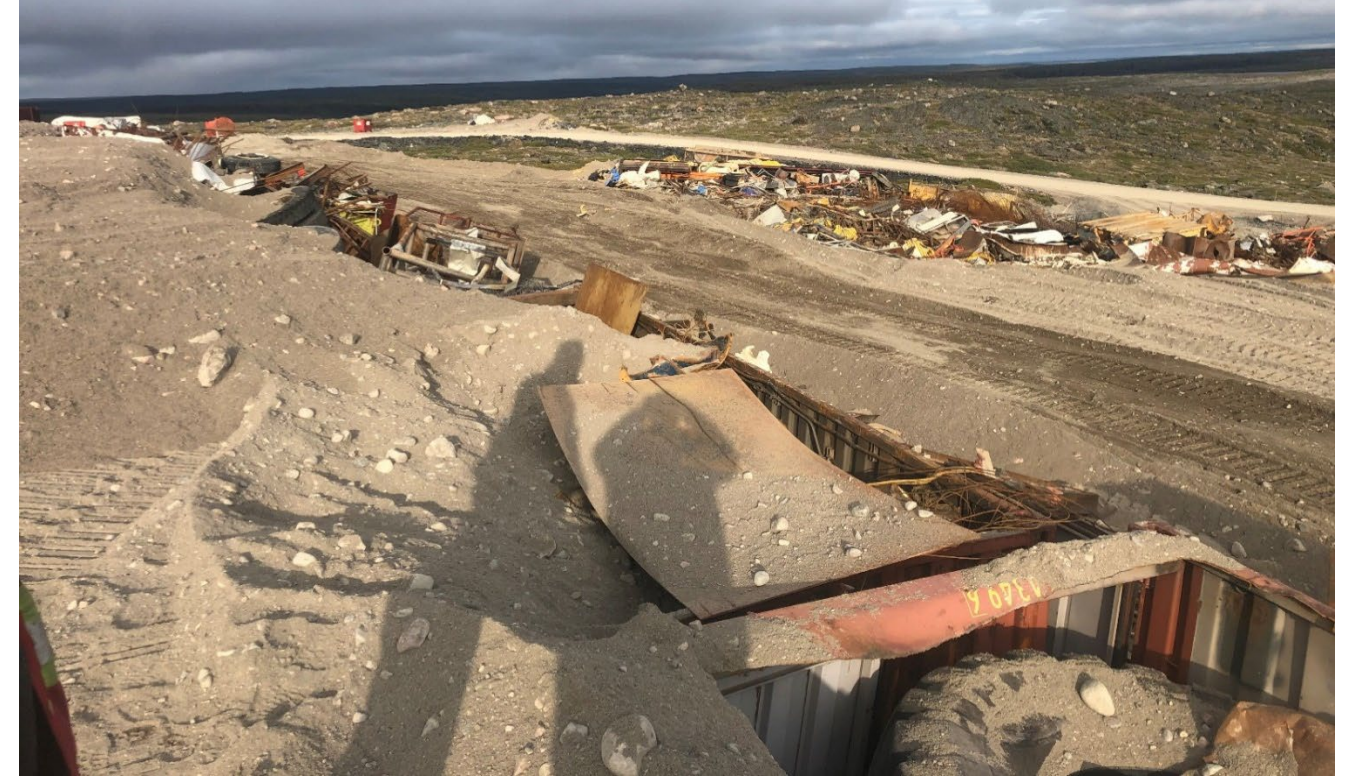
The northwest side of the site facing southeast on August 10, 2021

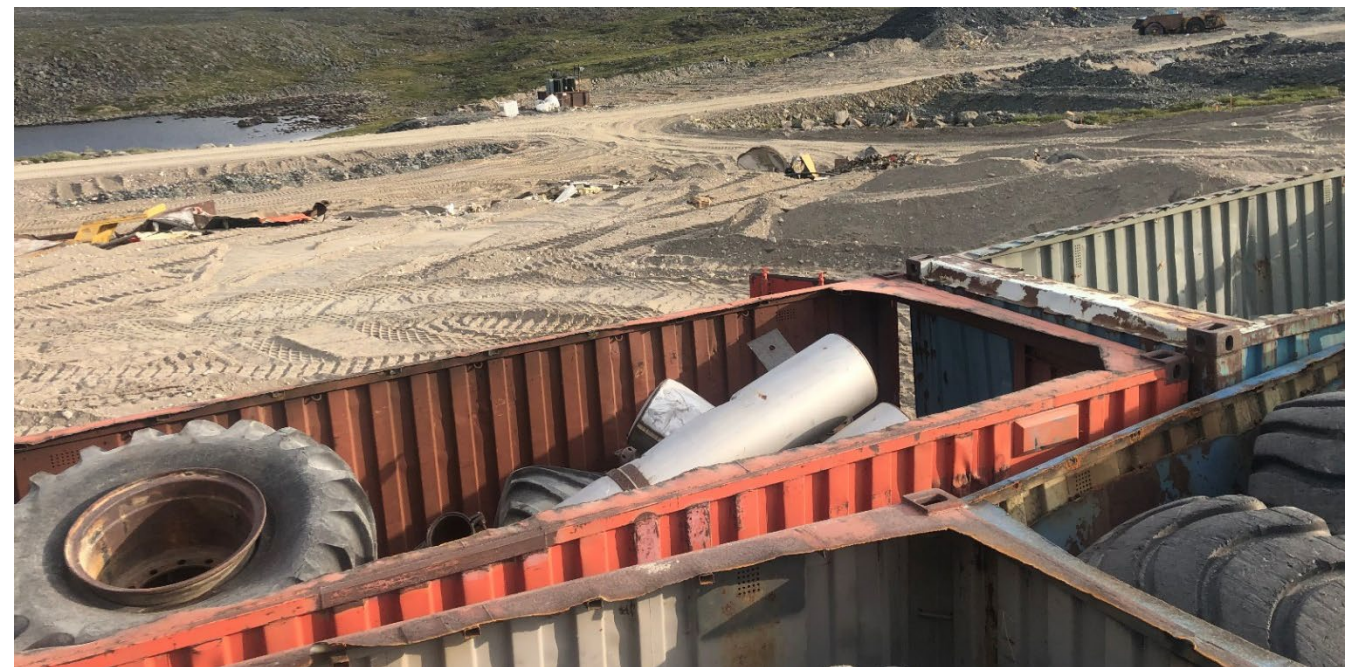
Tires in the shipping containers. August 10, 2021

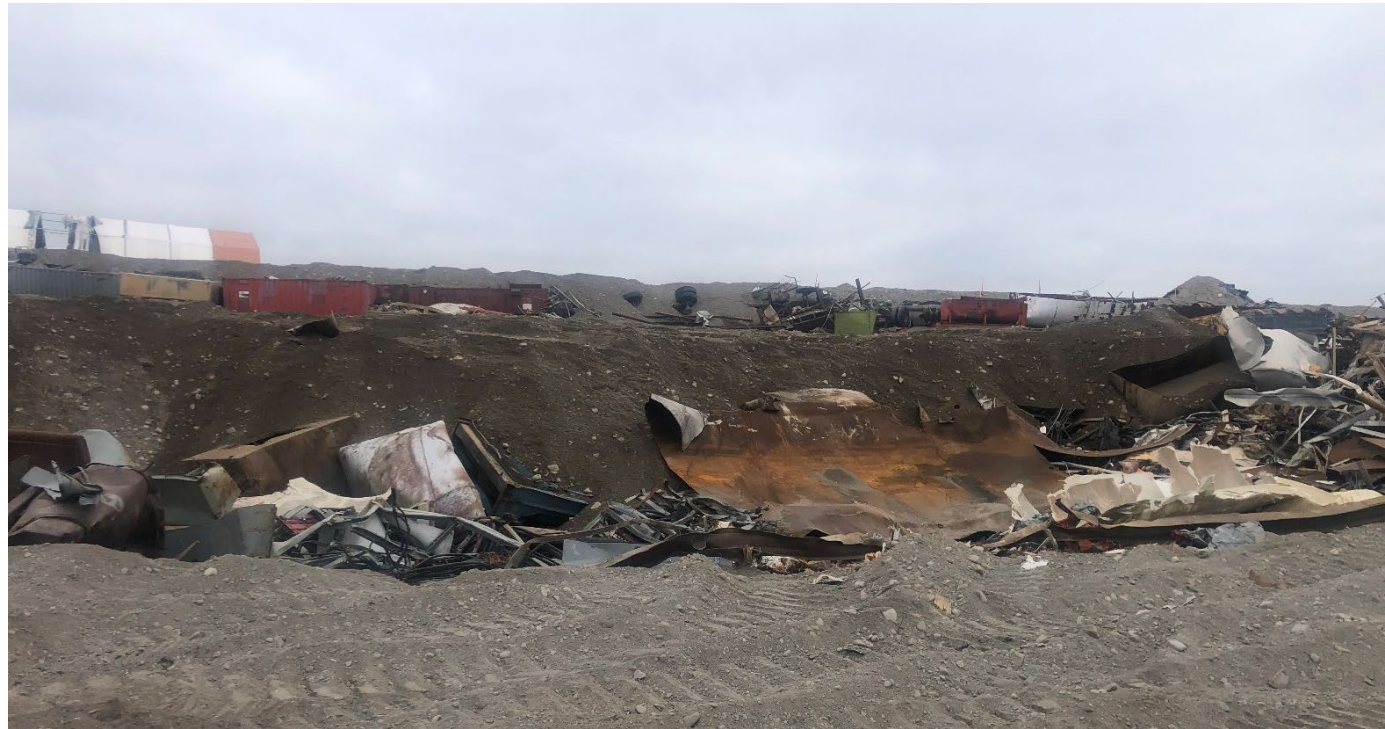
The south side of the site facing north on August 12, 2021
