Non-Hazardous Landfill, Construction Report, Ulu Gold Project Interim Report Draft

SRK Consulting (Canada) Inc.
1CB041.000
September 2022

Project No: 1CB041.000

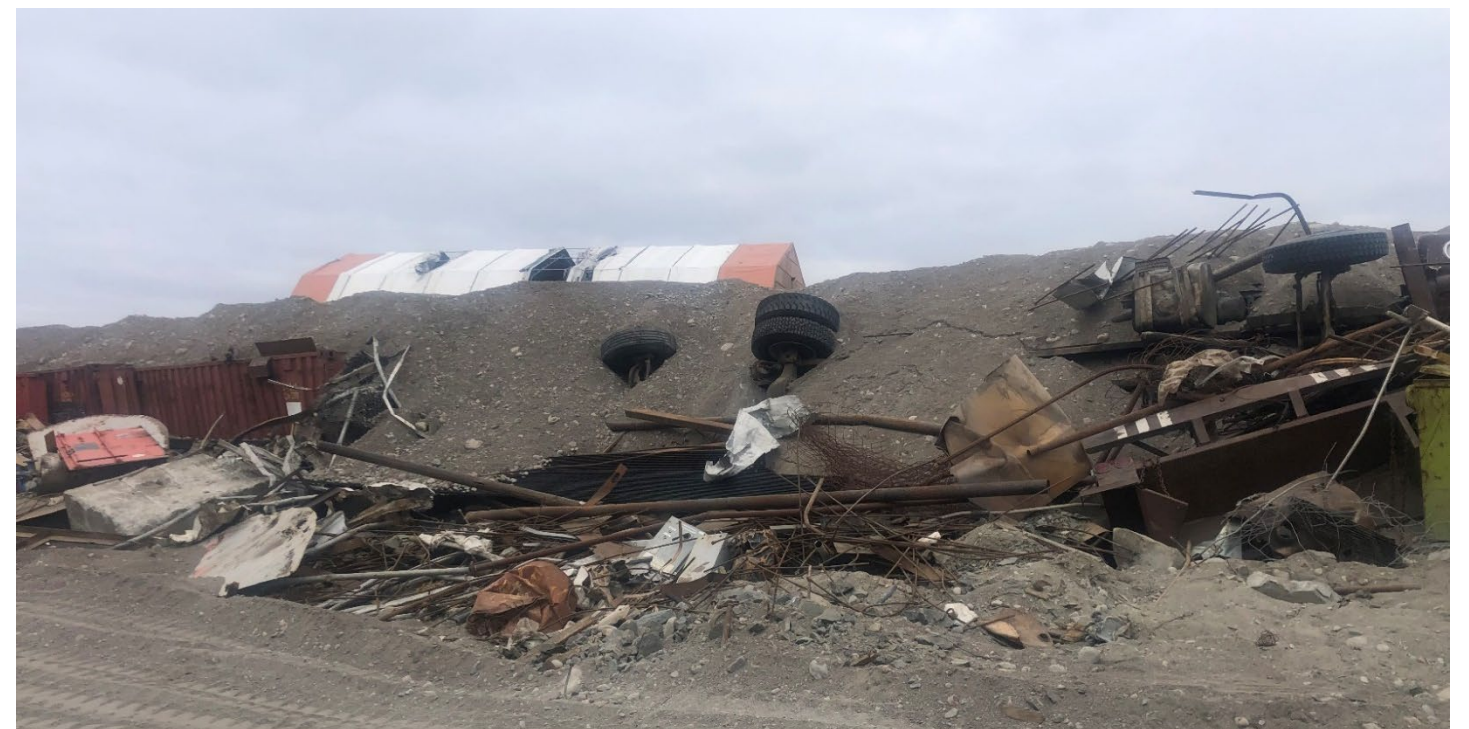
The south side of the site facing north on August 12, 2021

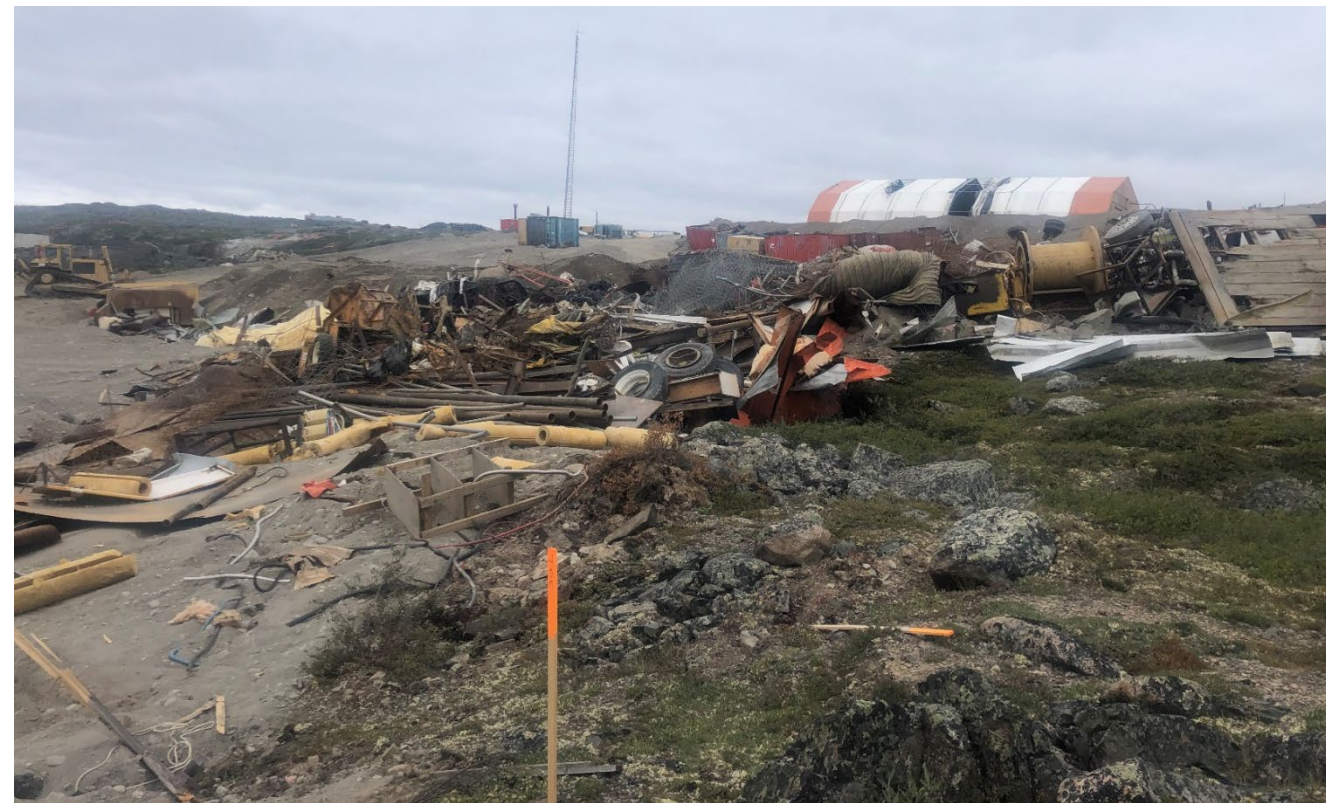
The east side of the site facing west on August 12, 2021

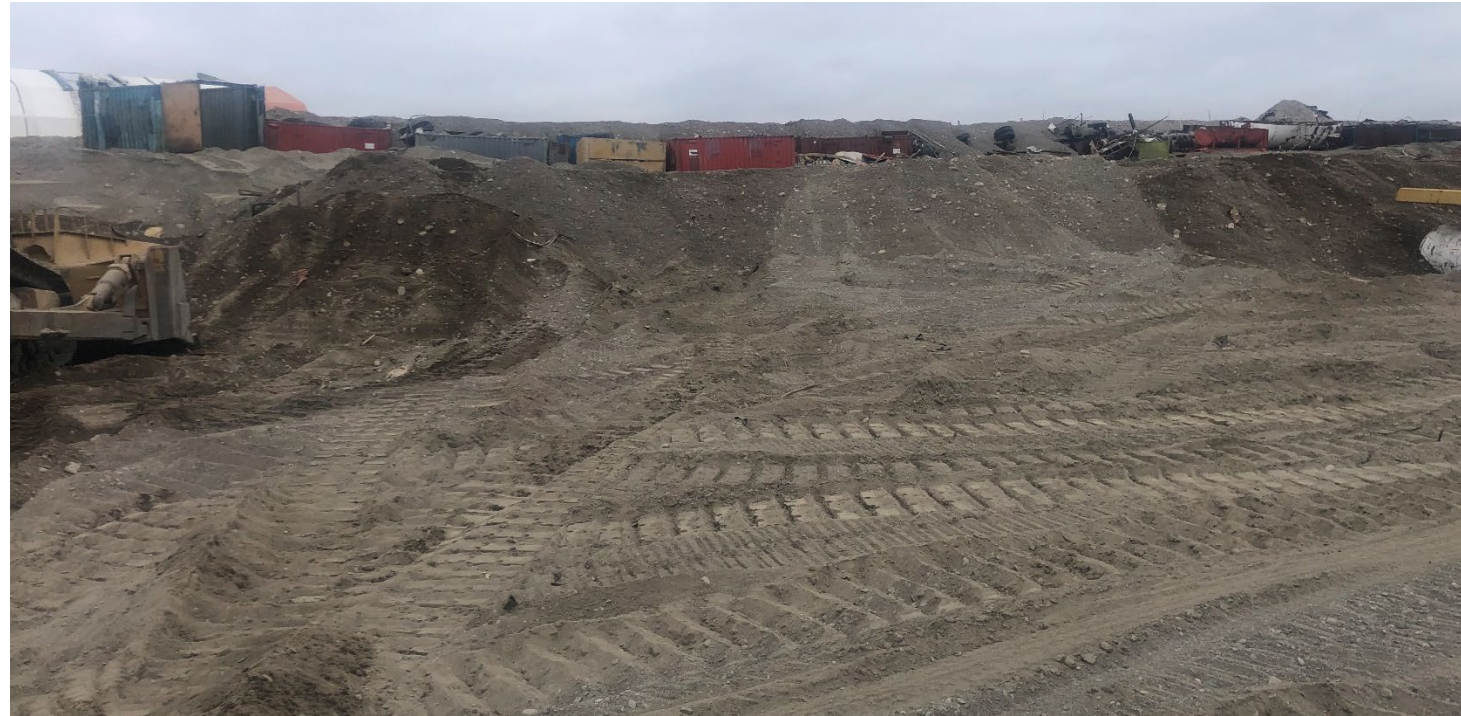
The south side of the site facing north. August 12, 2021

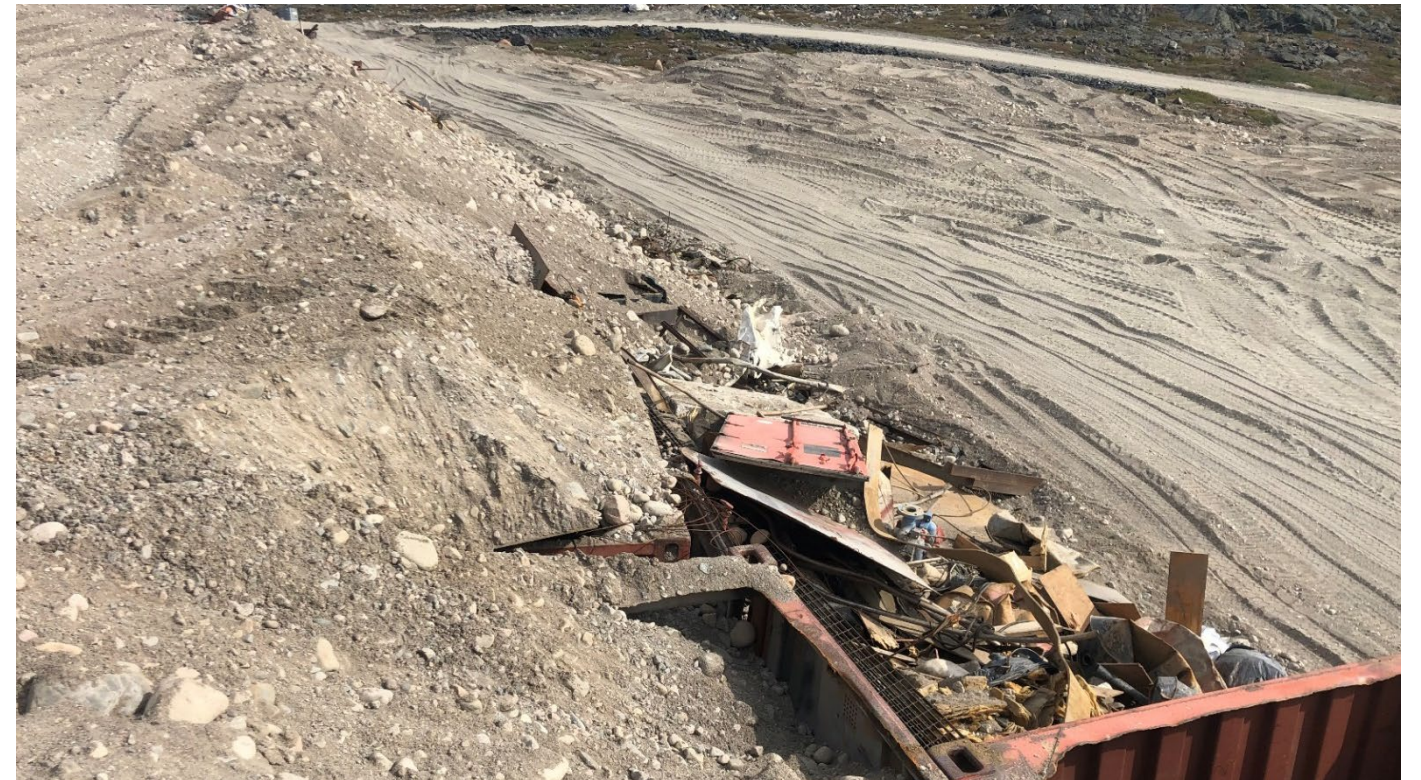
Esker sand cover. August 16, 2021

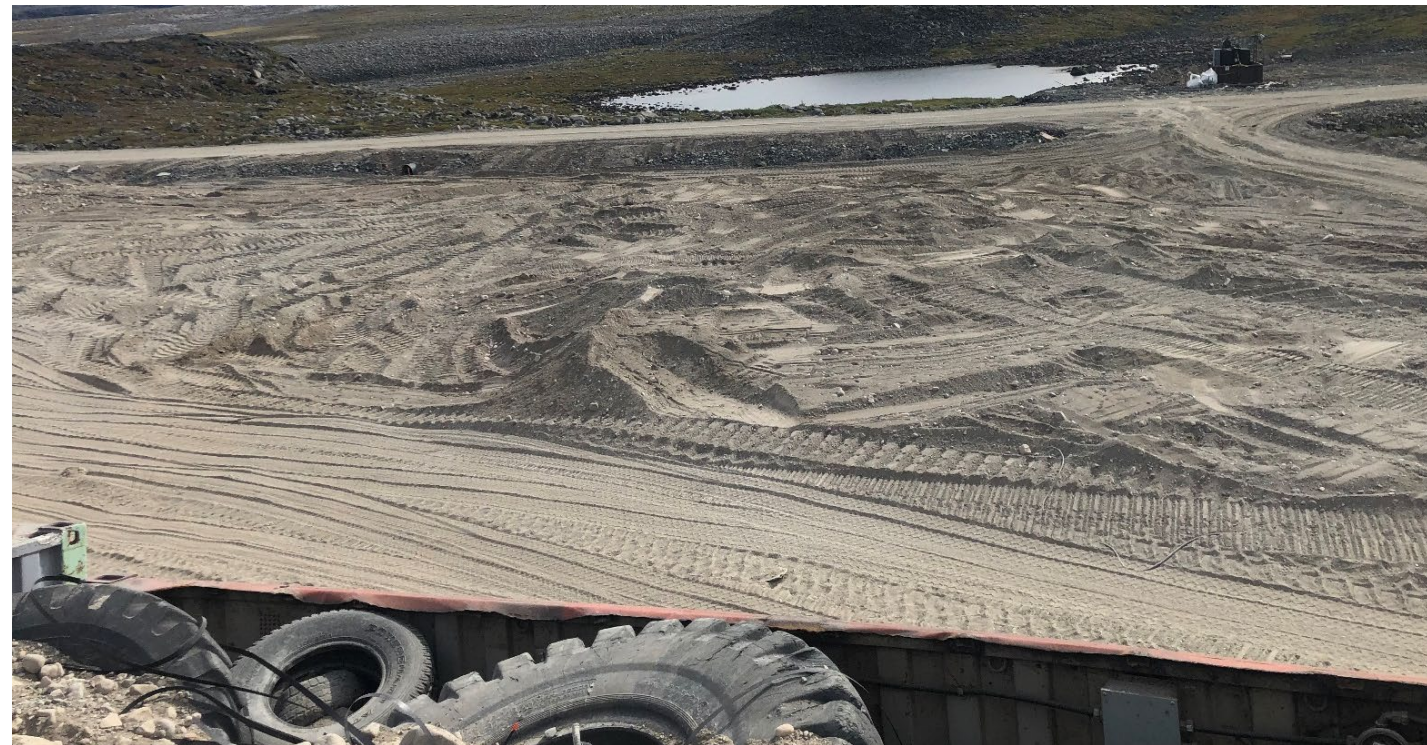
The north side facing south on August 16, 2021

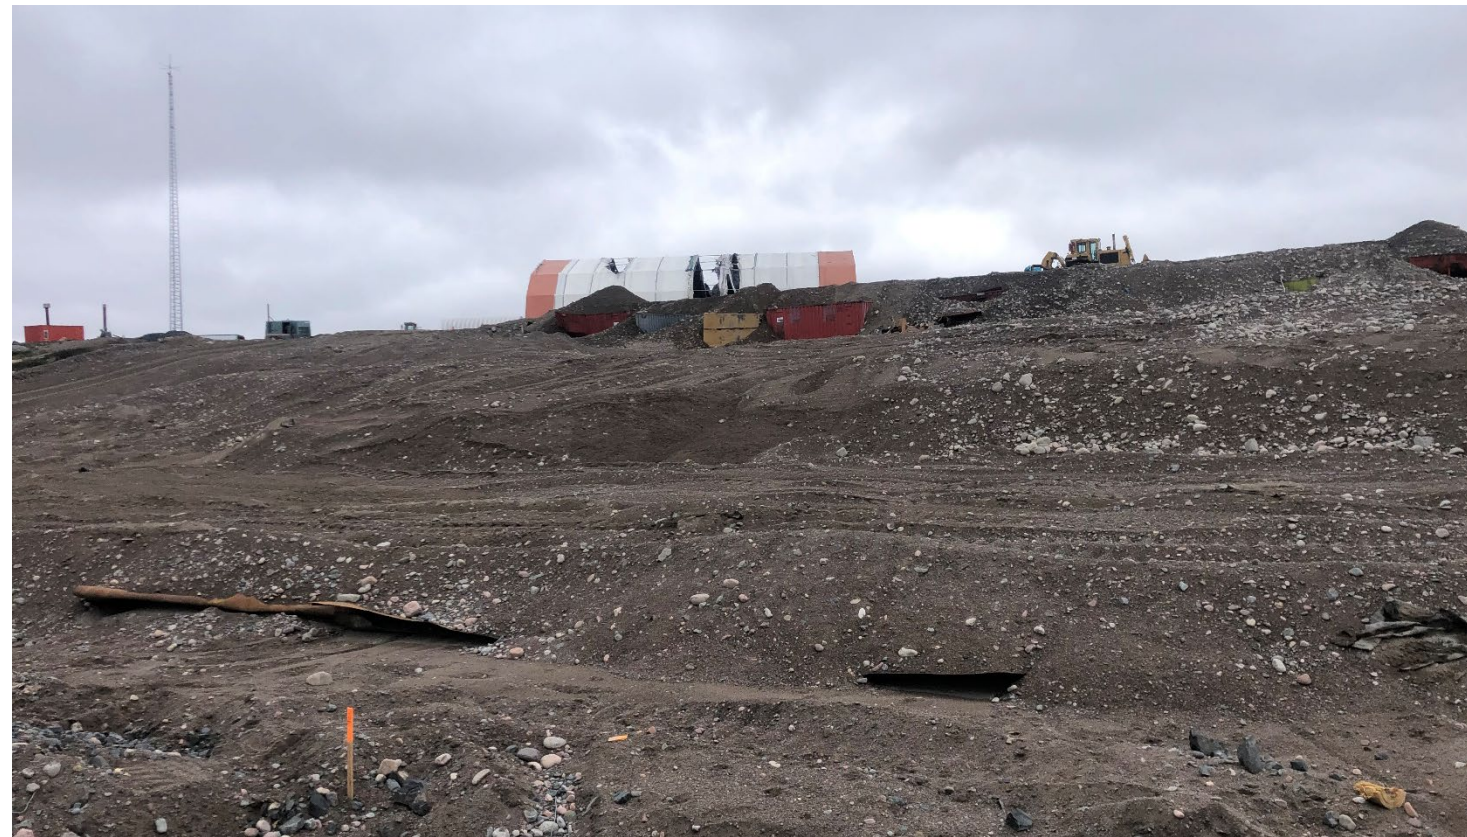
The south side of the site facing north on August 19, 2021
