PROJECT		<b>AGNICO EAGLE MINES LIMITED MEADOWBANK GOLD PROJECT NUNAVUT</b>		
TITLE		<b>VAULT DIKE TEMPERATURE DATA (Aug 1/18 to Aug 21/19)</b>		
	PROJECT No.	PHASE No.		
	DESIGN TD 28AUG14	SCALE	AS SHOWN	REV.
	CADD TD 28AUG14	<b>FIGURE 54</b>		
	CHECK PG 28AUG14			
REVIEW

**APPENDIX D**

**All Weather Private Road**

**AWPR Observations**

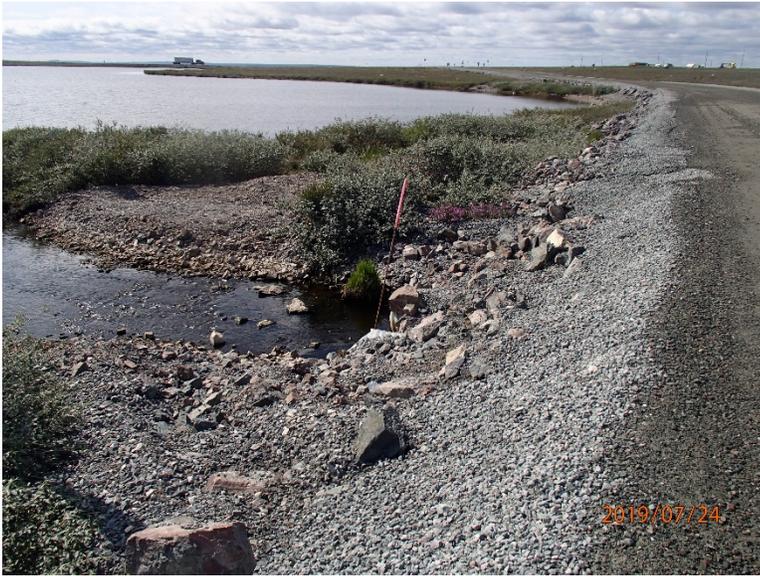
**Photograph D2-1: PRC2 km 0+470**

**Description:** View of the culvert outlet. Good condition.

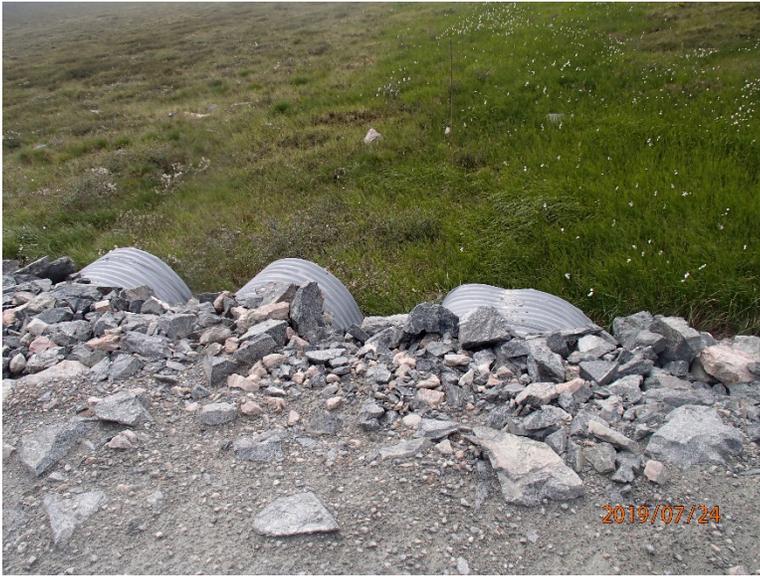
**Photograph D2-5: R-18A km 80+950**

80+200	Quarry 18		In general good condition, south wall is high (about 8 m) with some loose blocks.	14w 627370 /7202154	239
80+950	R-18A	3x1200 mm CSP	In good condition.	14w 627556 /7202800	240
82+500	R-18B	1X600 mm CSP	In good condition, installed above ground surface (water can flow below culvert).	14w 627034 /7203901

**Description:** View of the culverts outlet. In good condition.

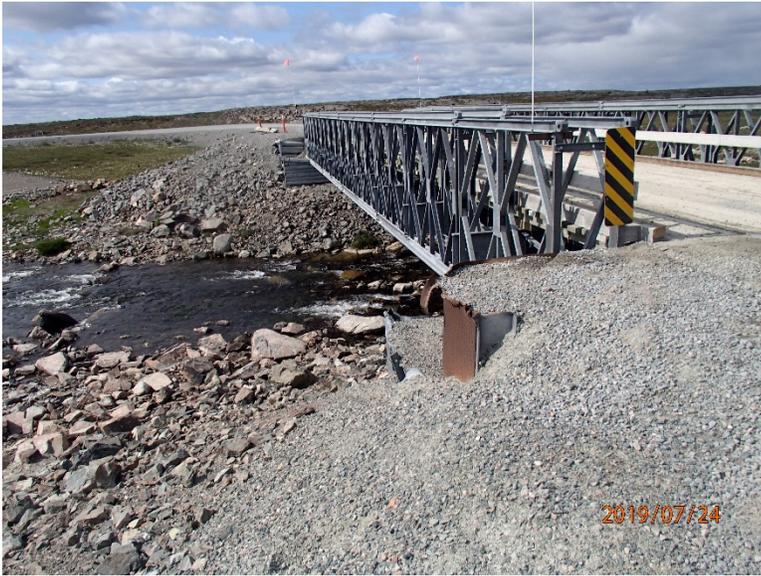
**Photograph D3-1 Bridges 1 – R02 km 8+750**

~5+700	unnamed	1x600 mm CSP	The inlet is buried in gravel. The outlet is in good condition.	14w 644762 /7140728	
8+750	R02 Centre Bridge	30m Acrow Panel Bridge	In general good condition. The two corrugated steel bins at both abutments show deformation under the weight of the bridge.		194: north 195: south

**Description:** Looking at the north abutment. The corrugated steel bin shows deformation under the weight of the bridge.

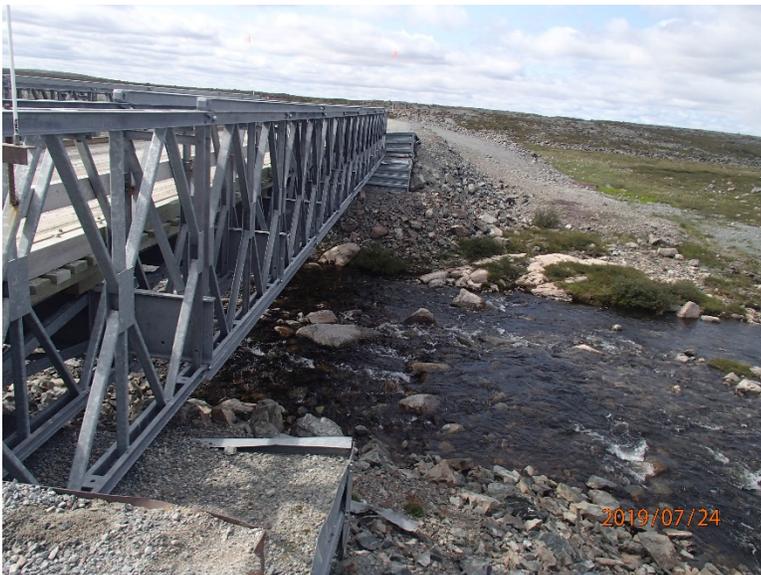
**Photograph D3-2 Bridges 1 – R02 km 8+750**

**Description:** Looking at the south abutment. The corrugated steel bin shows deformation under the weight of the bridge.

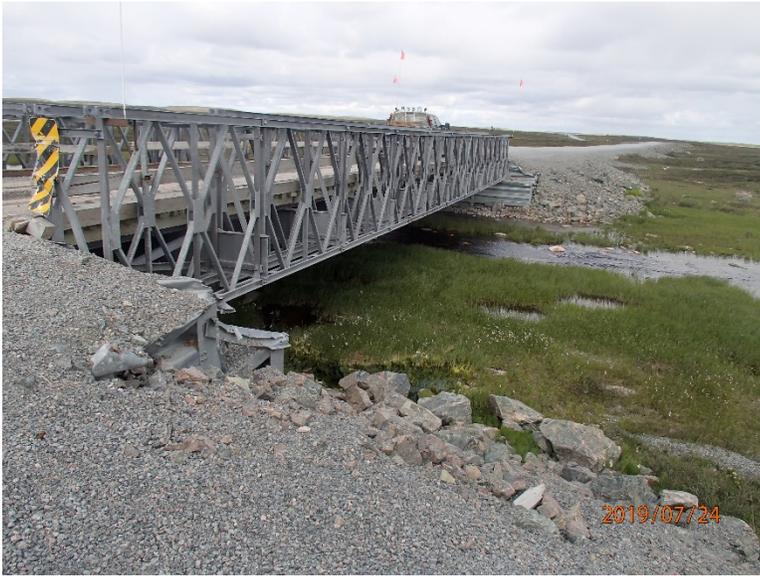
**Photograph D3-3 Bridges 2 – R05 km 17+600**

**Description:** Looking at the north abutment.

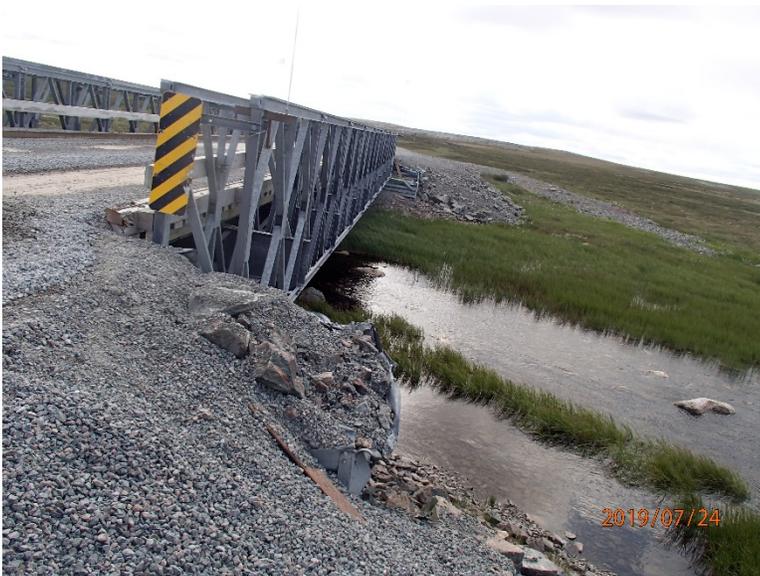
**Photograph D3-4 Bridges 2 – R05 km 17+600**

**Description:** Looking at the south abutment. Minor damage to the bin wall.

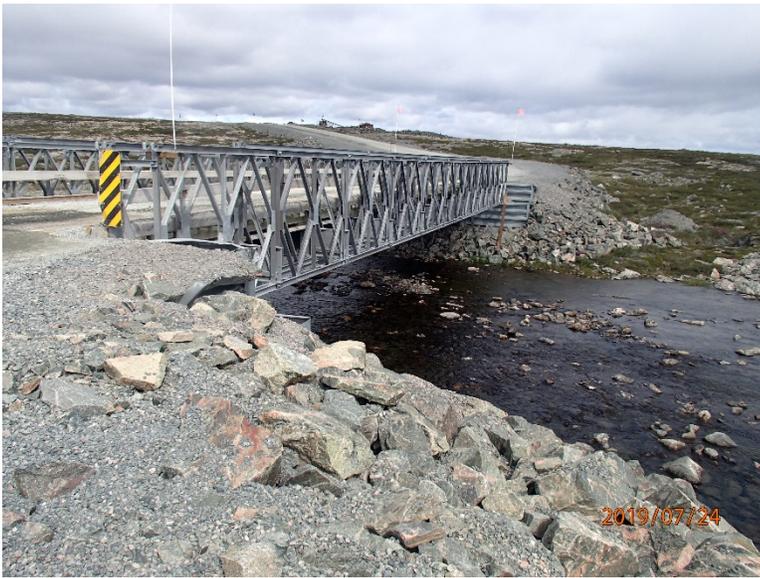
**Photograph D3-5 Bridges 3 – R06 km 23+100**

**Description:** Looking at the north abutment.

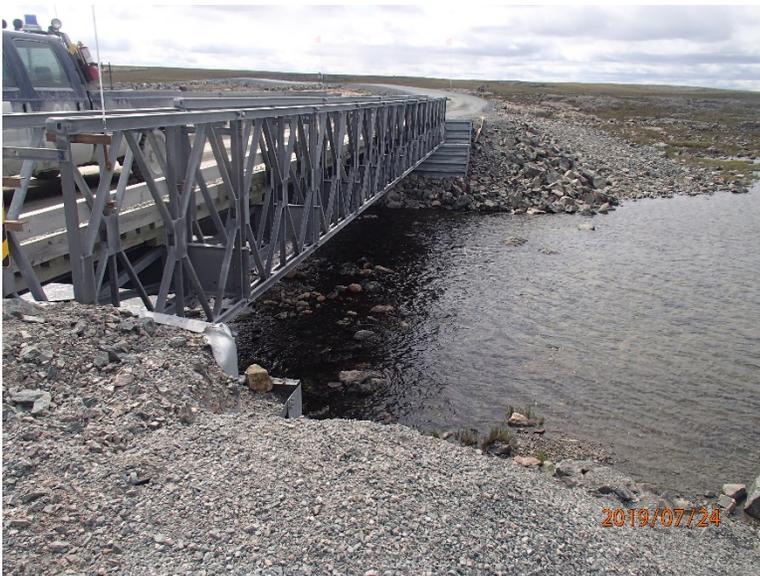
**Photograph D3-6 Bridges 3 – R06 km 23+100**

**Description:** Looking at the south abutment.

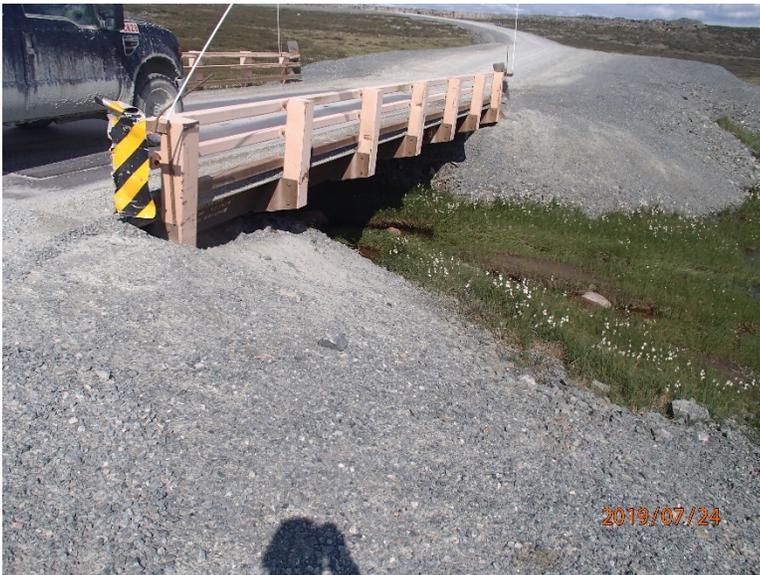
**Photograph D3-7 Bridges 4 – R13 km 62+060**

**Description:** Looking at the north abutment.

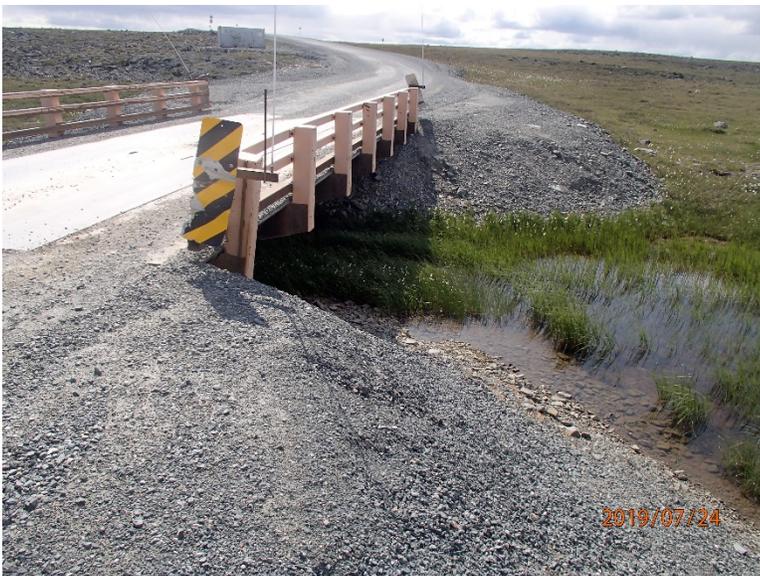
**Photograph D3-8 Bridges 4 – R13 km 62+060**

**Description:** Looking at the south abutment.

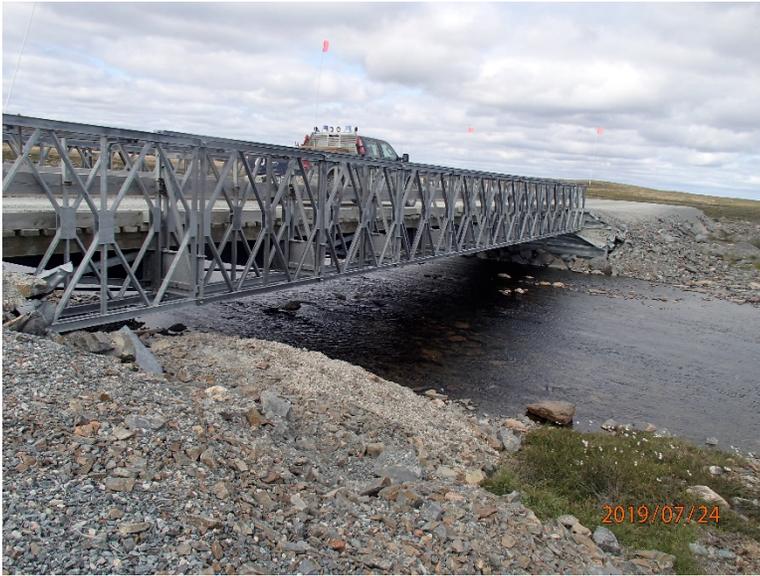
**Photograph D3-9 Bridges 5 – R15 km 69+200**

STATION	NAME	STRUCTURE DESCRIPTION	COMMENTS	GPS COORDINATES	PHOTO
69+200	R15 Centre Bridge	30 m Acrow Panel Bridge	Bin wall of both abutments were observed to be damaged but they are still holding well. The bridge is dipping toward the west side on both north and south abutments. The foundation does not show signs of failure but is slowly settling. Its condition should be monitored.	14w 627469 /7192035	232 : north 233 : south
70+400	Quarry 16		Presence of unstable loose rocks and boulders but in general good condition.	14w 627216 /7193129	234
72+800	Quarry 17		Steep rock wall in stable conditions.	14w 626884 /7195600	
73+800	R16 Centre Bridge	12m Rapid Span Bridge	In good condition	14w 626701 /7196535	235 : north 236 : south
77+440	R-17	1x1200 mm CSP	In good condition	14w 626127 /7199708	
79+500	R18 Centre Bridge	12 m Rapid Span Bridge	In good condition	14w 627270 /7201462	237 : north 238 : south

**Description:** Looking at the north abutment. Damage to the bin wall likely caused during snow removal activities. Bridge is tipping toward the west side on the abutment.

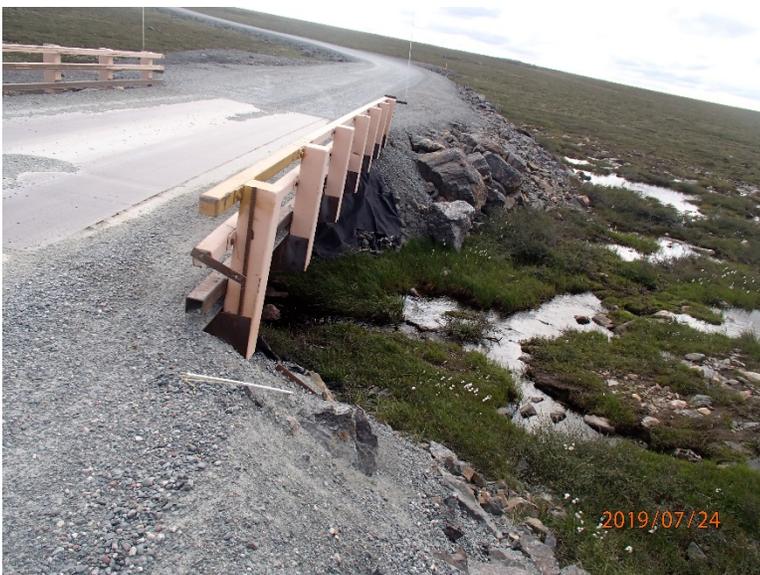
**Photograph D3-12 Bridges 6 – R16 km 73+800**

**Description:** Looking at the south abutment. In good condition.

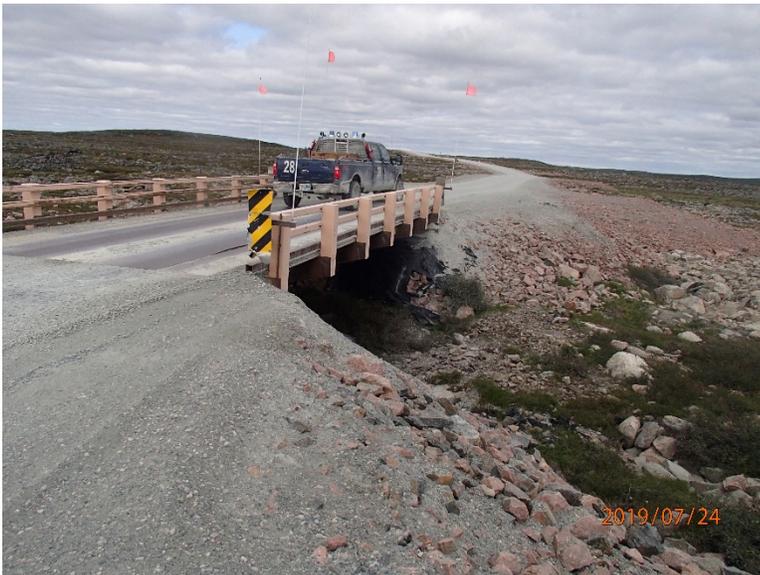
**Photograph D3-13 Bridges 7 – R18 km 79+500**

**Description:** Looking at the north abutment. In good condition.

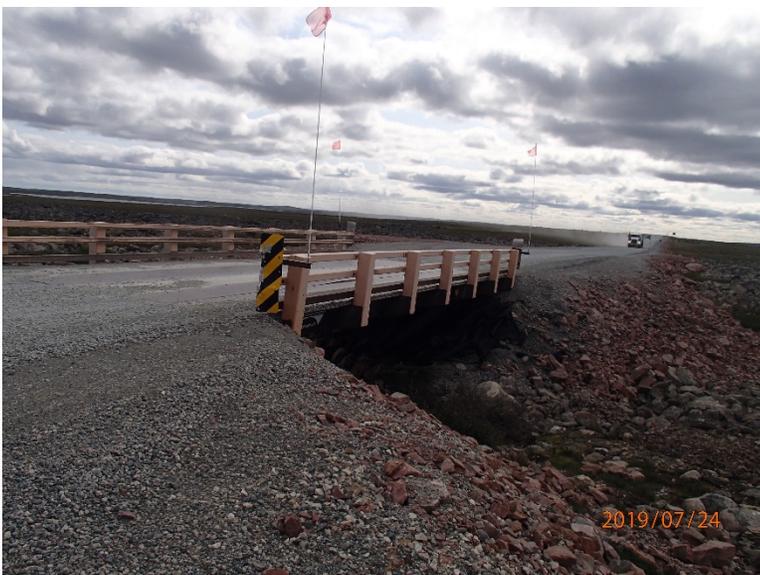
**Photograph D3-14 Bridges 7 – R18 km 79+500**

**Description:** Looking at the south abutment. In good condition.

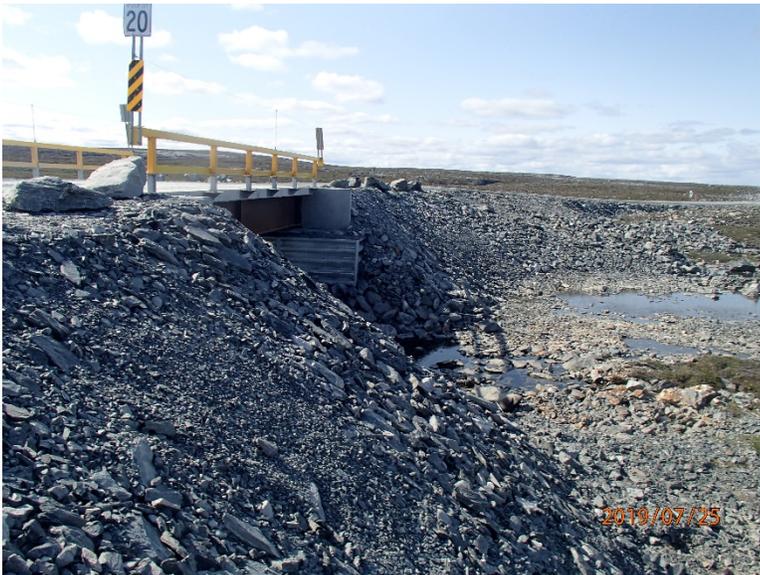
**Photograph E3-1 Bridges 1 – km 3+400**

**Description:** Looking at the north abutment.

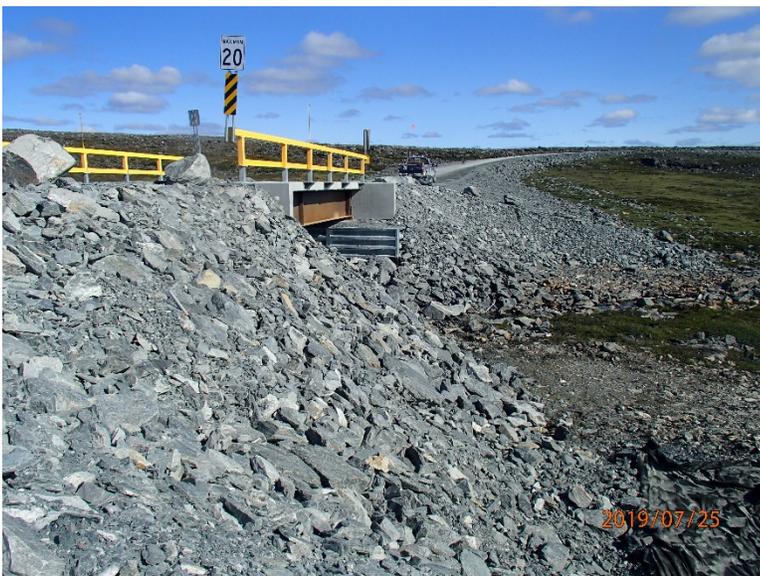
**Photograph E3-2 Bridges 1 – km 3+400**

**Description:** Looking at the south abutment.

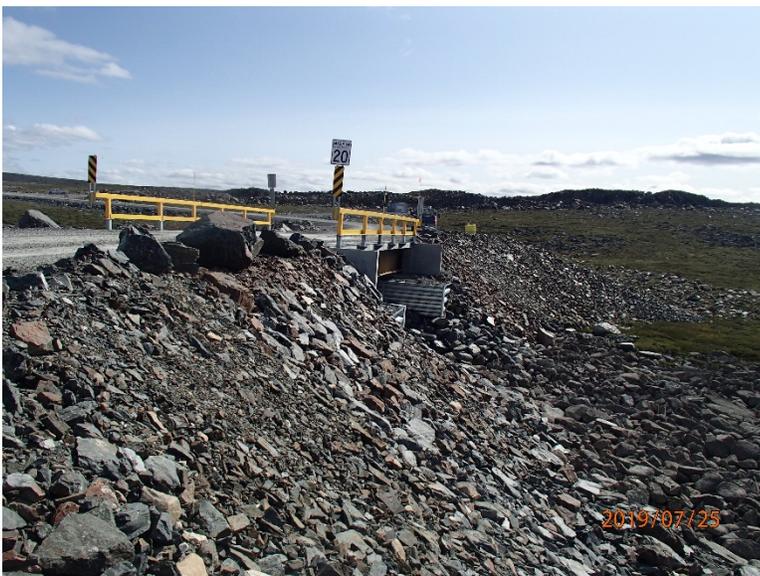
**Photograph E3-4 Bridges 2 – km 10+700**

**Description:** Looking at the south abutment.

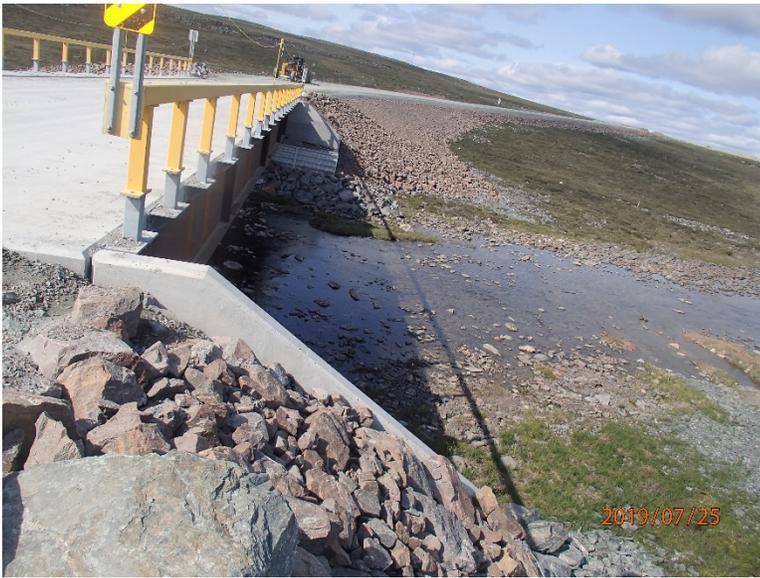
**Photograph E3-5 Bridges 3 – km 16+000**

**Description:** Looking at the north abutment.

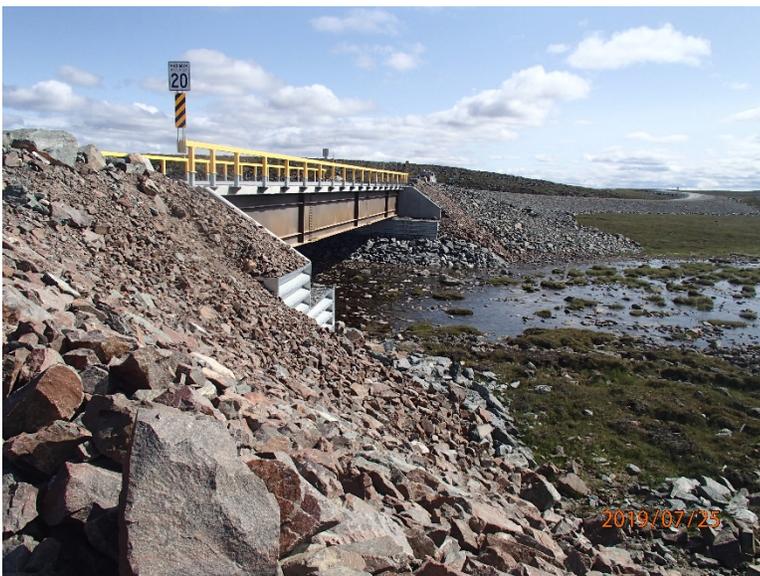
**Photograph E3-6 Bridges 3 – km 16+000**

**Description:** Looking at the south abutment.

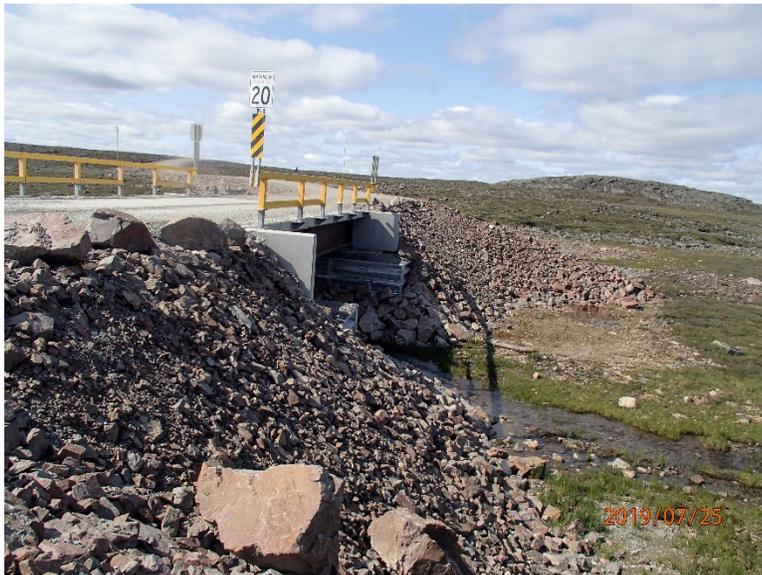
**Photograph E3-7 Bridges 4 – km 20+000**

**Description:** Looking at the north abutment.

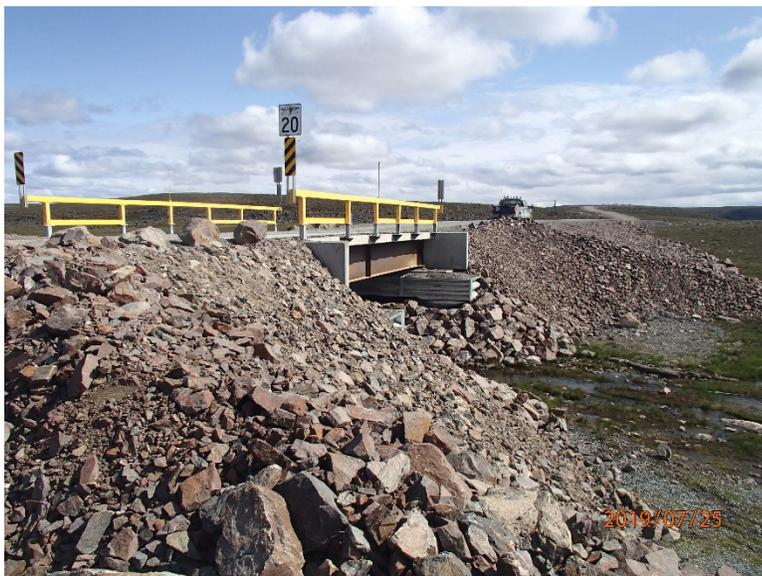
**Photograph E3-8 Bridges 4 – km 20+000**

**Description:** Looking at the south abutment.

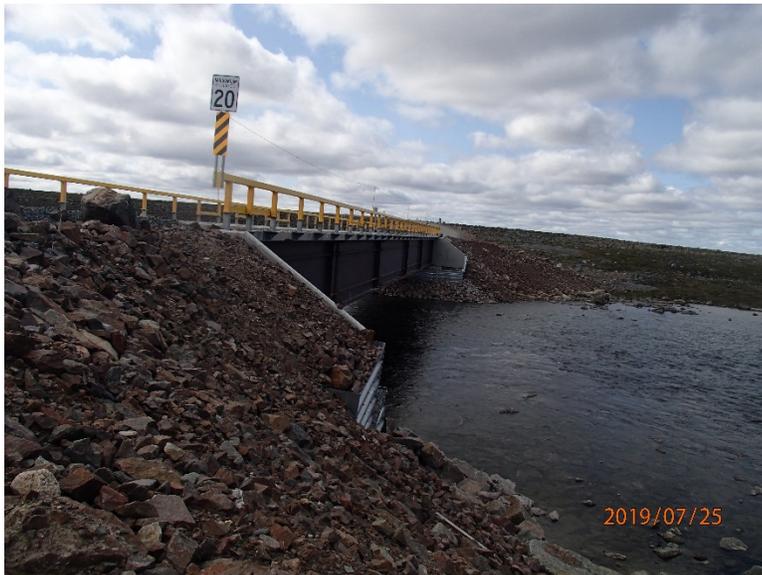
**Photograph E3-9 Bridges 5 – km 23+900**

**Description:** Looking at the north abutment.

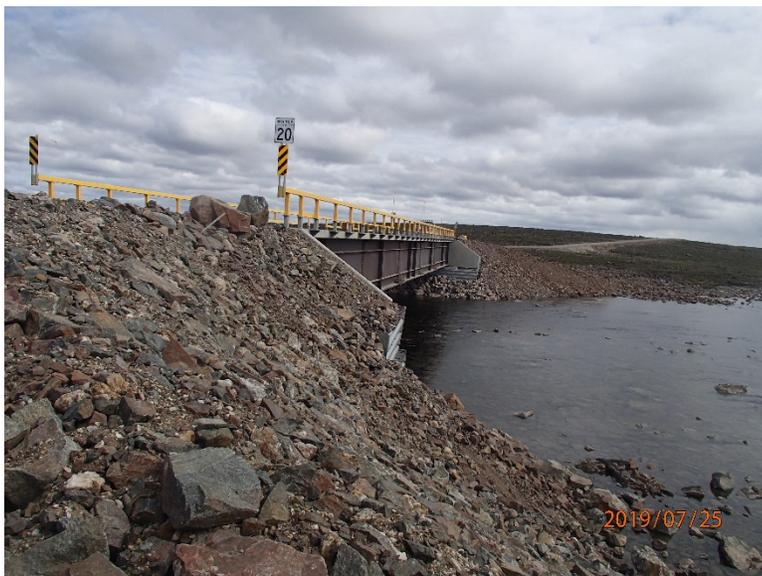
**Photograph E3-10 Bridges 5 – km 23+900**

**Description:** Looking at the south abutment.

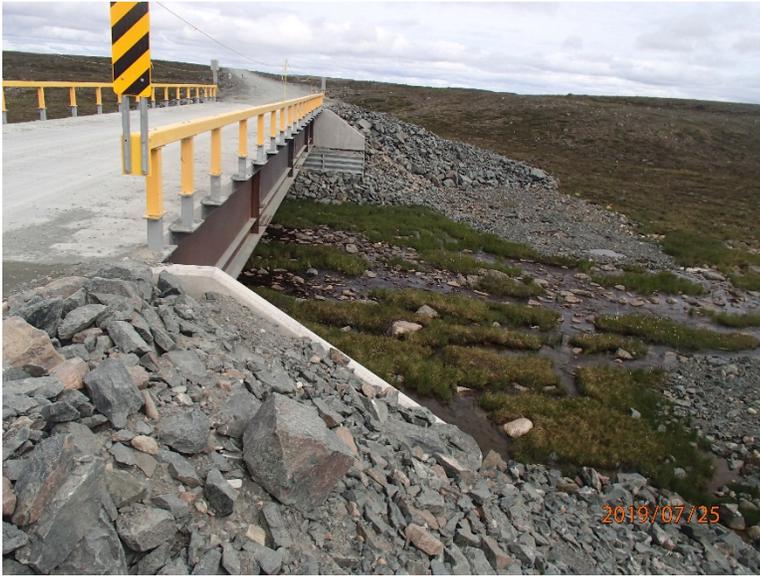
**Photograph E3-17 Bridges 9 – km 44+800**

**Description:** Looking at the north abutment. A crack is present in the concrete on the western side.

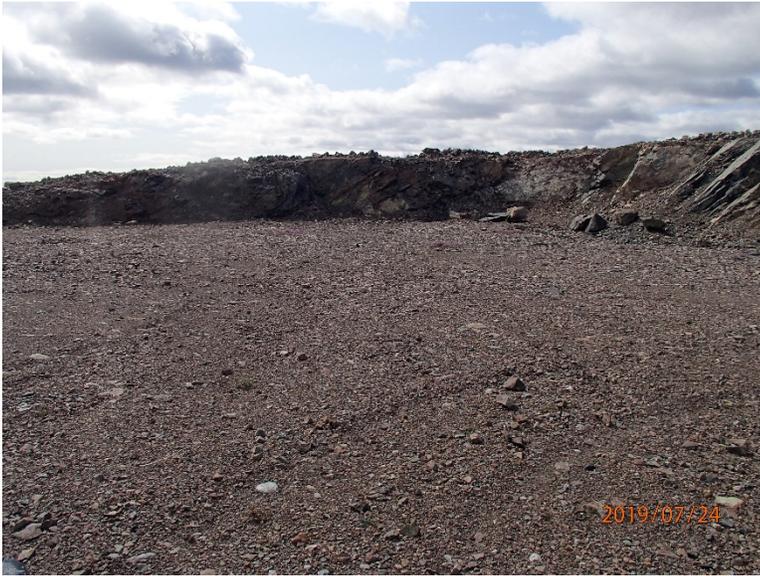
**Photograph F-1: Quarry 1 – km 5+200**

**Description:** Rocks walls are generally clean and stable.

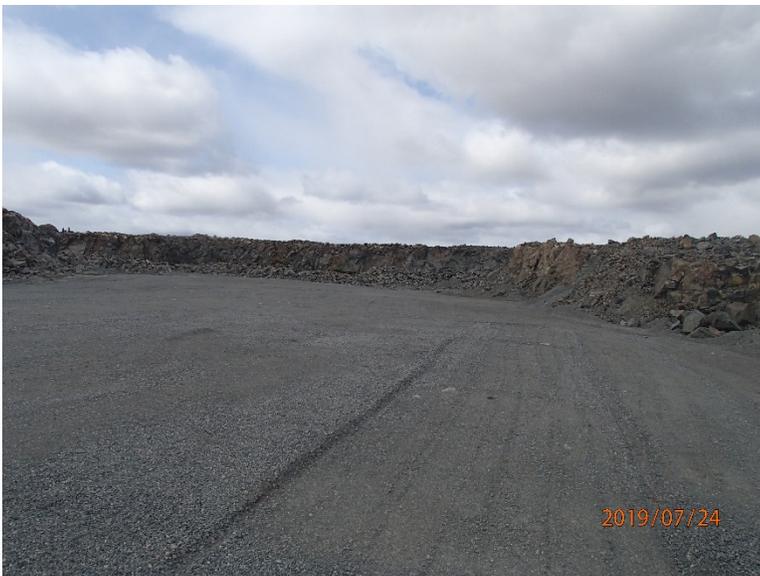
**Photograph F-2: Quarry 2 – km 13+250**

**Description:** The wall is mostly clean. One steep area is unstable and would require cleaning if operations resume.

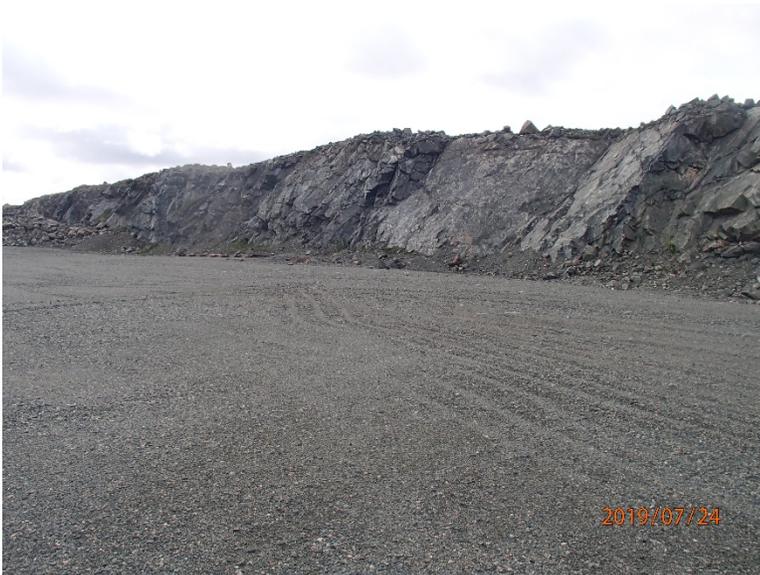
**Photograph F-3: Quarry 3 – km 23+700**

**Description:** View of west wall. In good and stable condition but would need additional cleaning locally.

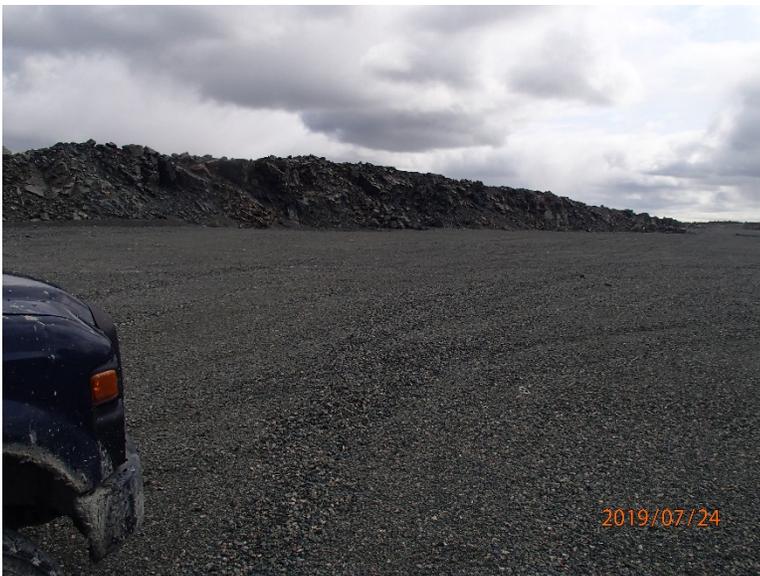
**Photograph F-4: Quarry 3 – km 23+700**

**Description:** View of east wall. In good condition.

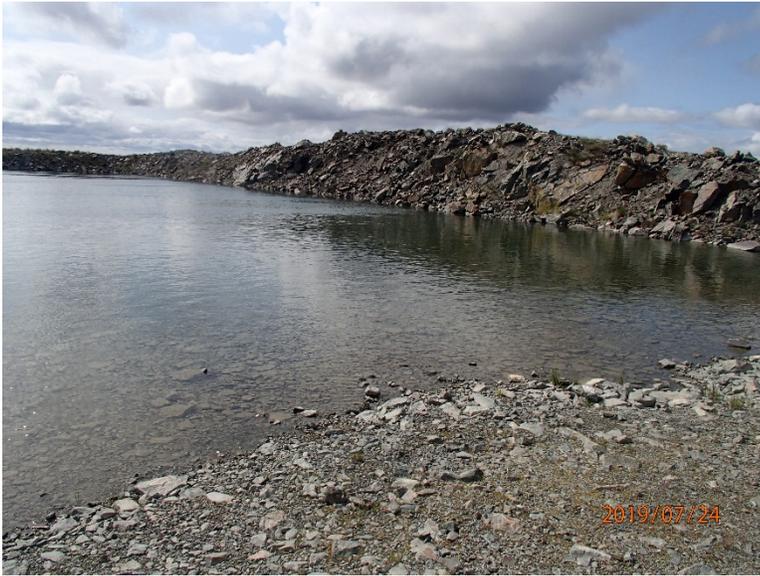
**Photograph F-5: Quarry 4 – km 31+300**

**Description:** Quarry flooded. In good condition.

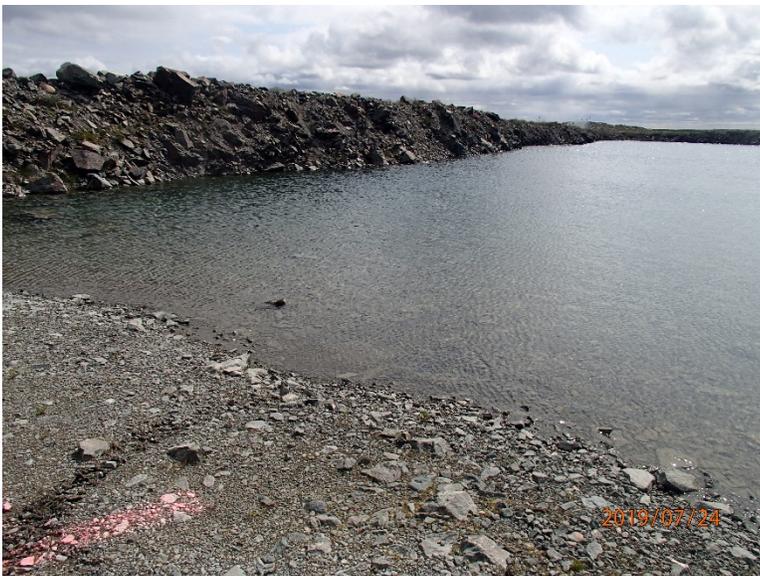
**Photograph F-6: Quarry 4 – km 31+300**

**Description:** Quarry flooded. In good condition.

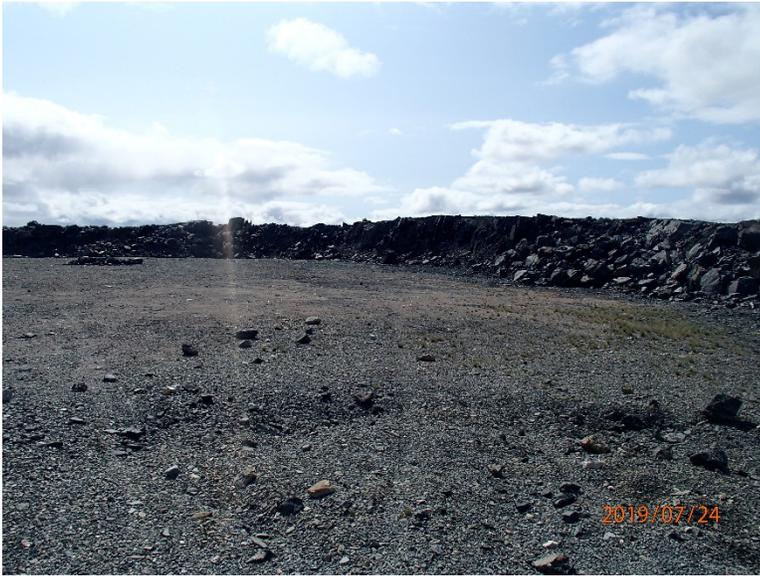
**Photograph F-9: Quarry 6 – km 36+470**

**Description:** View of south and west walls. In good condition.

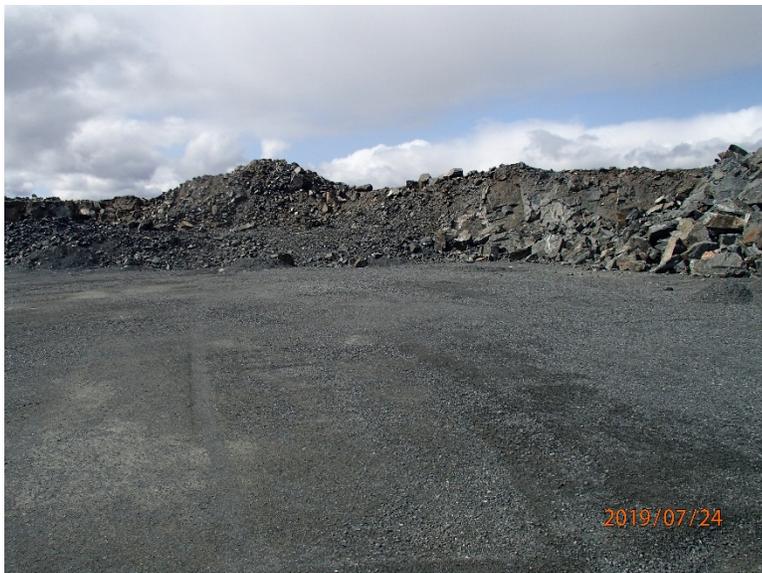
**Photograph F-12: Quarry 8 – km 42+950**

**Description:** View of west wall.

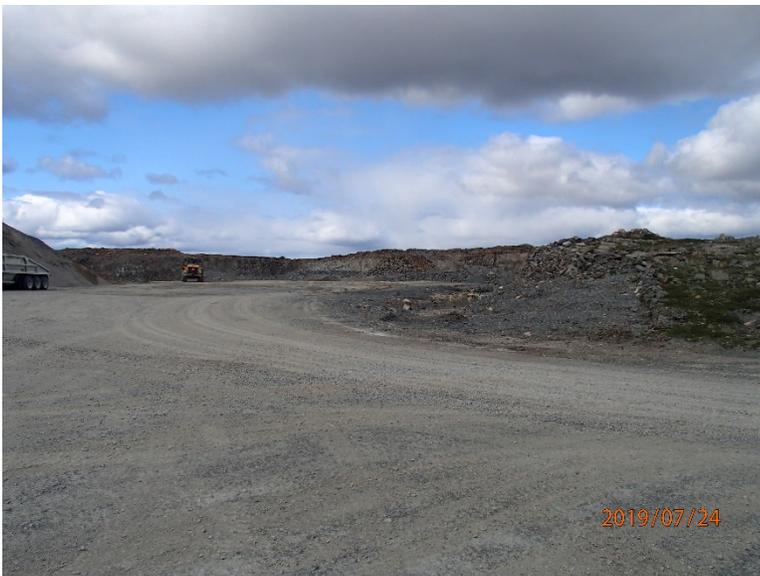
**Photograph F-16: Quarry 11 – km 53+500**

**Description:** View of north and east walls. In good condition.

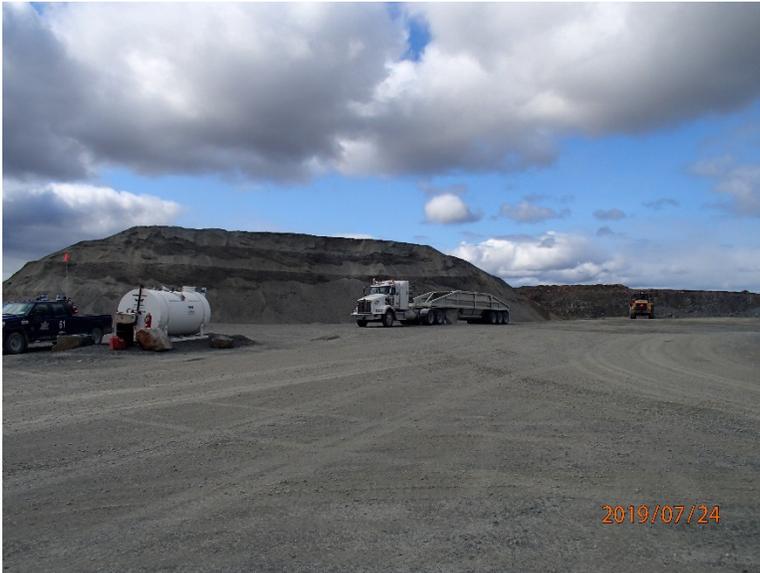
**Photograph F-17: Quarry 11 – km 53+500**

**Description:** View of west and north walls. In good condition.

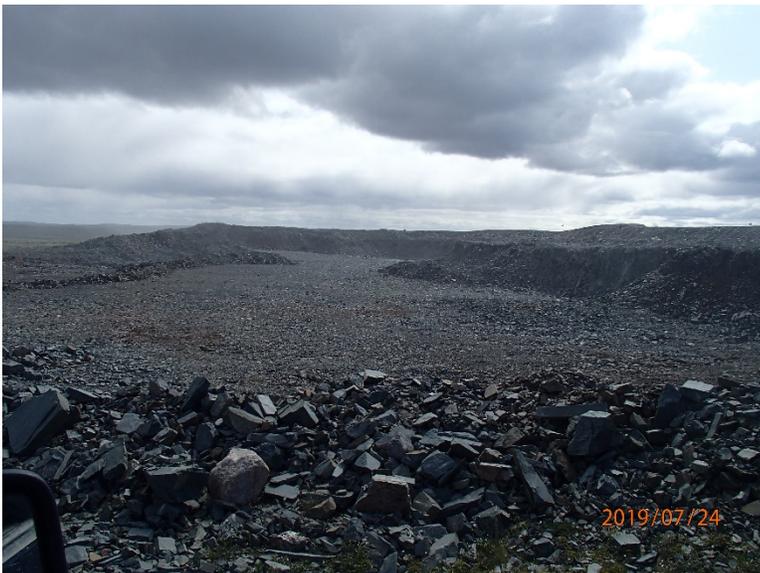
**Photograph F-18: Quarry 12 – km 58+300**

**Description:** In good condition.

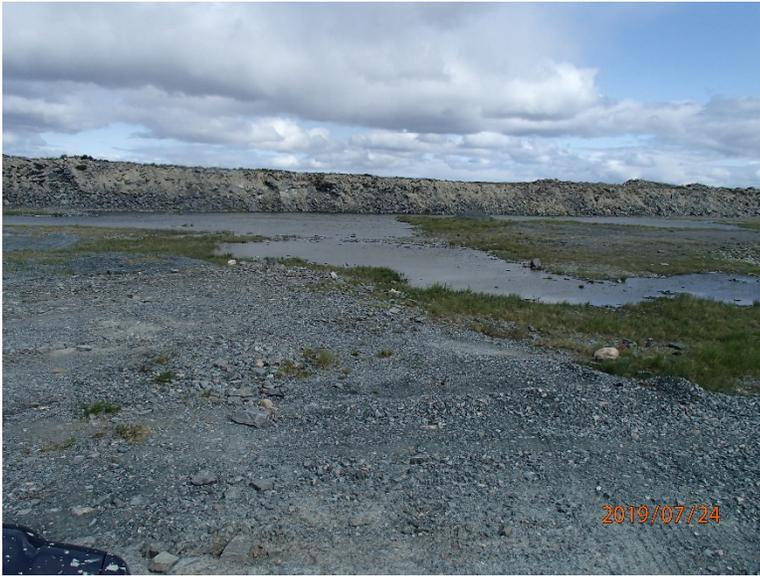
**Photograph F-19: Quarry 13 – km 62+350**

**Description:** View of the south and east walls. In general good condition.

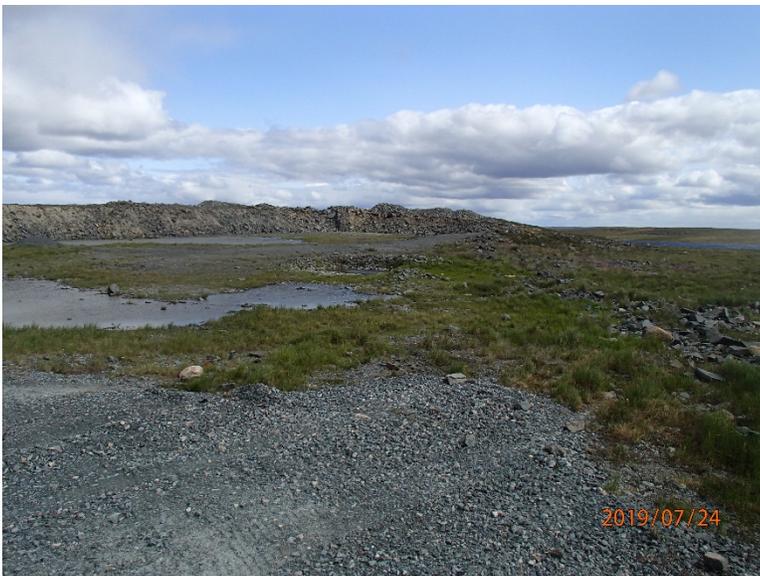
**Photograph F-20: Quarry 13 – km 62+350**

**Description:** View of the west and north walls. In general good condition.

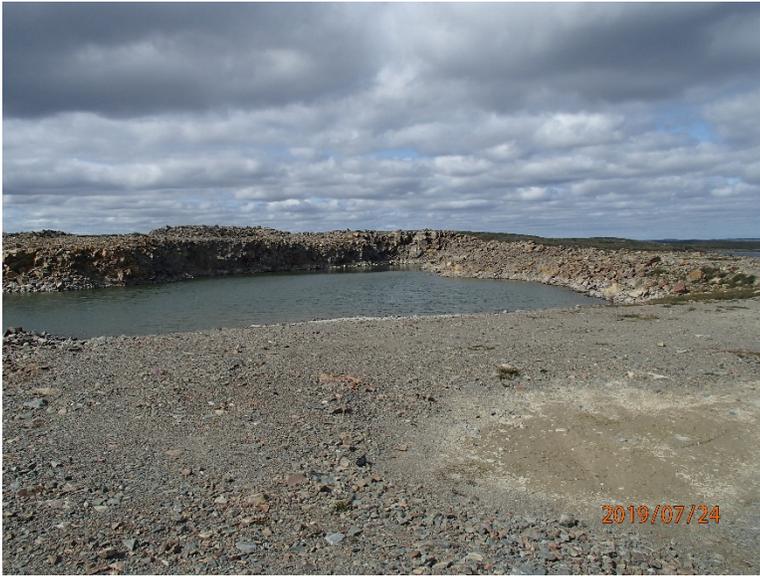
**Photograph F-21: Quarry 14 – km 65+700**

**Description:** View of north and west walls. Quarry flooded.

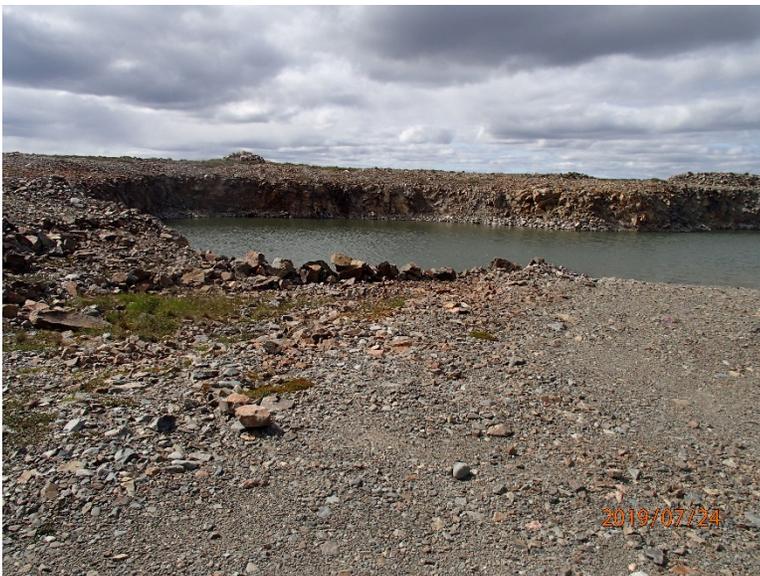
**Photograph F-22: Quarry 14 – km 65+700**

**Description:** View of west and south walls. Quarry flooded.

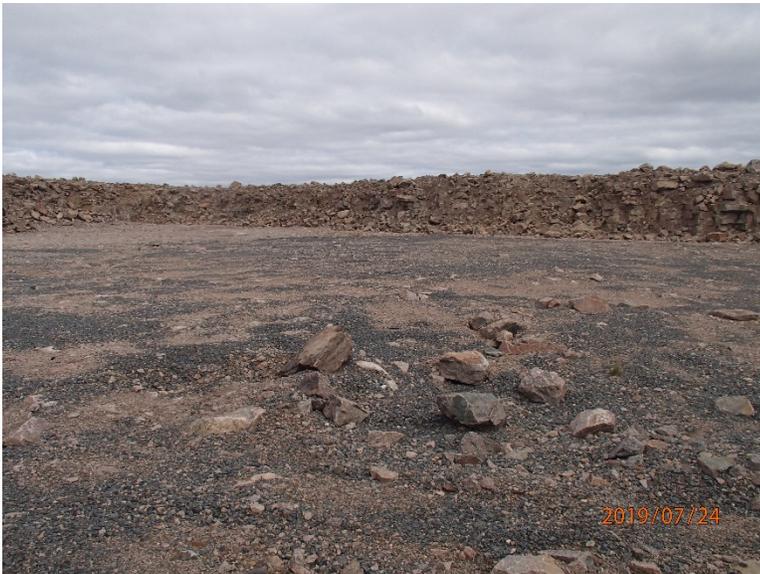
**Photograph F-26: Quarry 20 – km 89+550**

**Description:** In good condition.

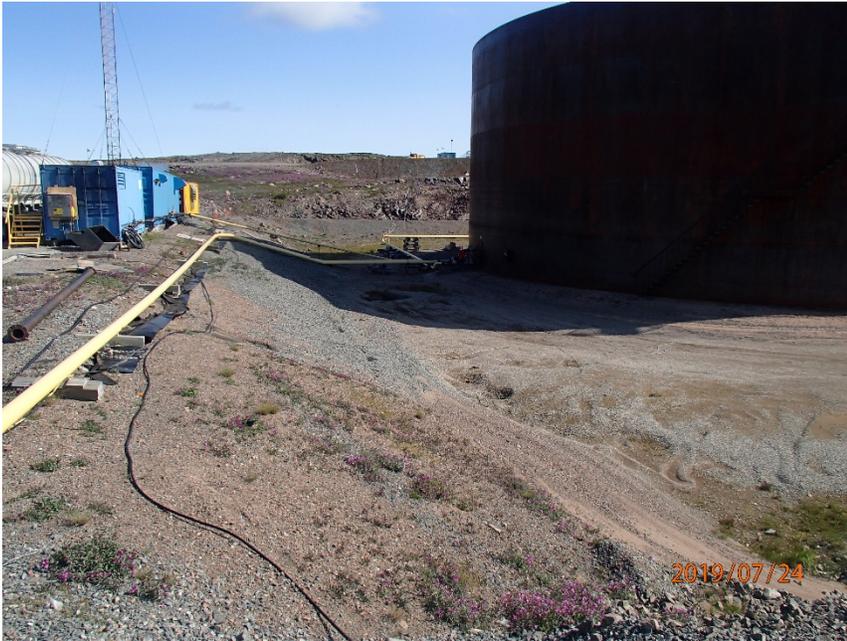
**Photograph G1-1 Baker Lake Tank Farm**

**Description:** From the south side of Tank 1, looking southeast at Tanks 1, 2, 3, and 4. Presence of water ponding.

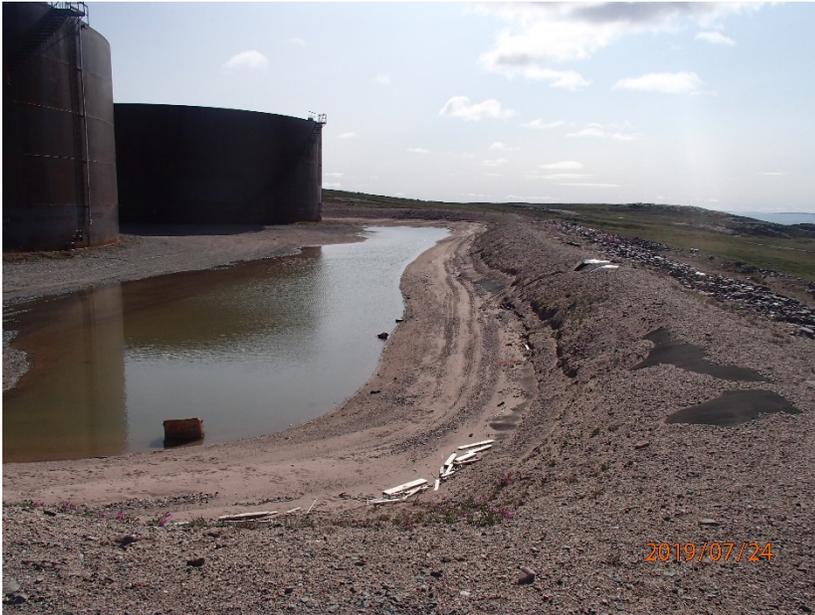
**Photo Number:** 173

**Description:** Looking southwest. The geomembrane between the south side of tank 2 and 3 is damaged.

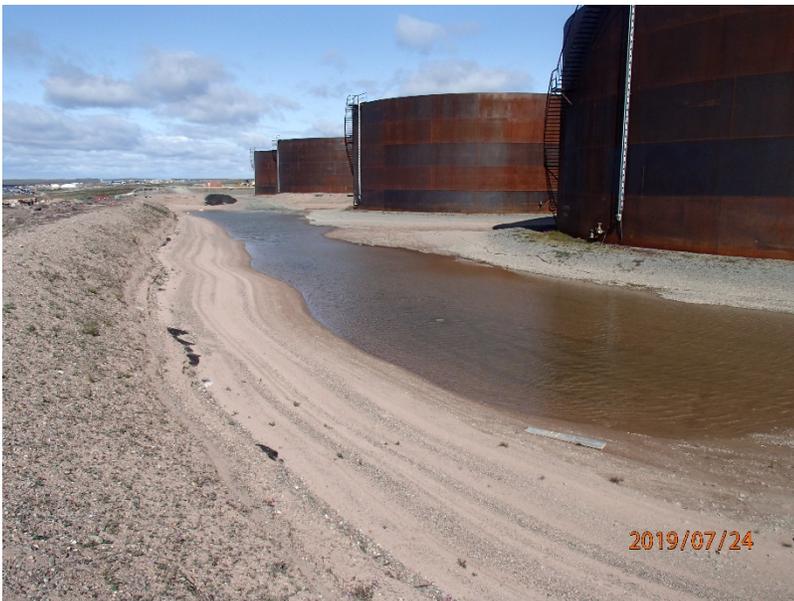
**Photo Number:** 172

**Description:** From the southwestern corner of Tank 3 looking southeast. View of exposed LLDPE and water ponding.

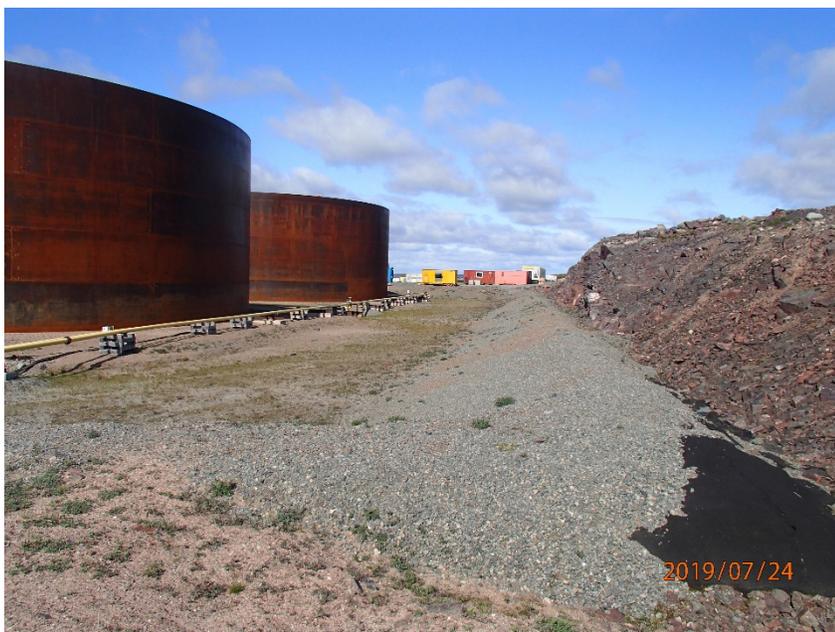
**Photo Number:** 177

**Description:** From the northern side of Tank 4, looking northwest toward Tanks 4, 3, 2, and 1. Presence of exposed liner.

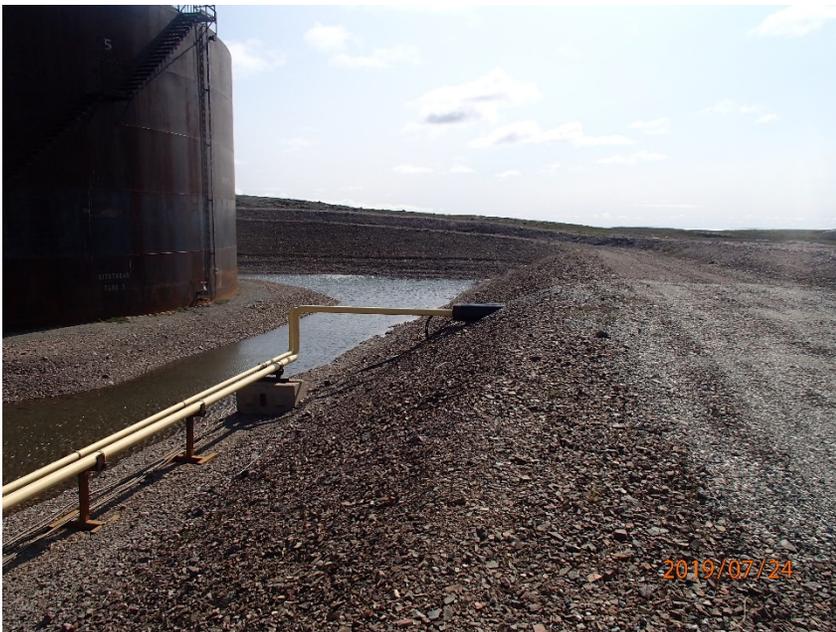
**Photo Number:** 181

**Description:** Looking north between Tanks 5 and 6. Presence of water ponding.

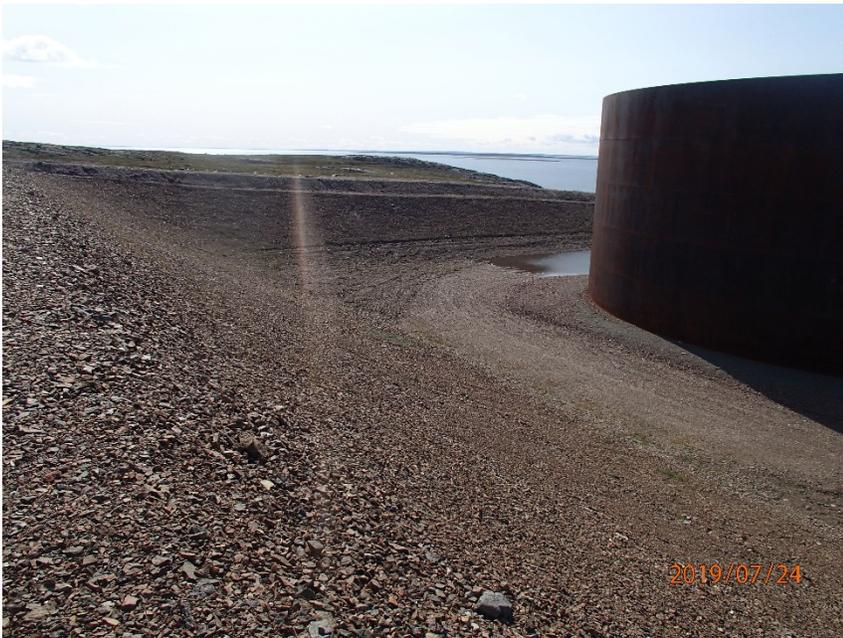
**Photo Number:** 182

**Description:** Looking northeast at the southern side of Tank 6. Presence of water ponding.

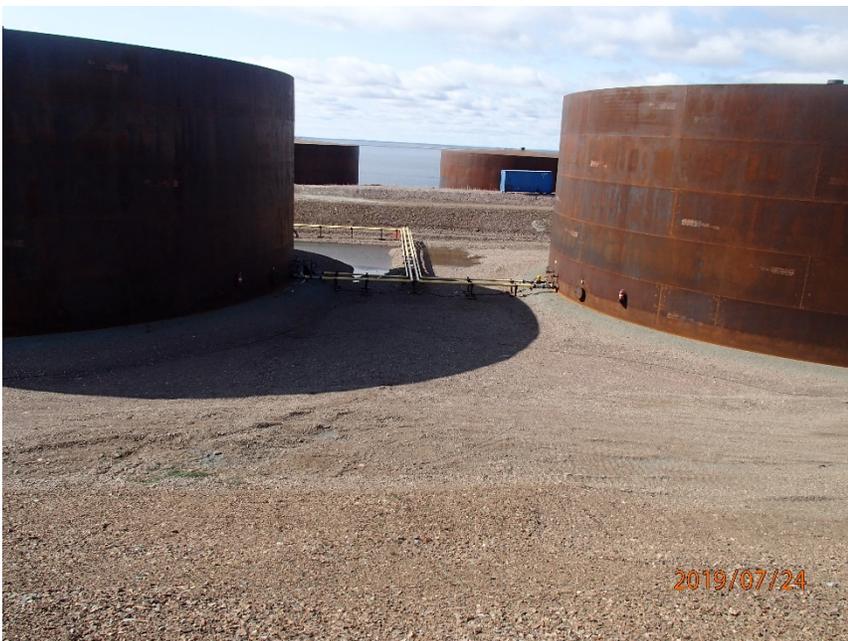
**Photo Number:** 183

**Description:** Looking southeast at the northeastern side of Tank 6. Presence of water ponding.
