PROJECT		<b>AGNICO EAGLE MINES LIMITED MEADOWBANK GOLD PROJECT NUNAVUT</b>		
TITLE		<b>VAULT DIKE TEMPERATURE DATA (Aug 1/18 to Aug 21/19)</b>		
	PROJECT No.	PHASE No.		
	DESIGN TD 28AUG14	SCALE	AS SHOWN	REV.
	CADD TD 28AUG14	<b>FIGURE 54</b>		
	CHECK PG 28AUG14			
REVIEW

**APPENDIX D**

**All Weather Private Road**

**AWPR Observations**

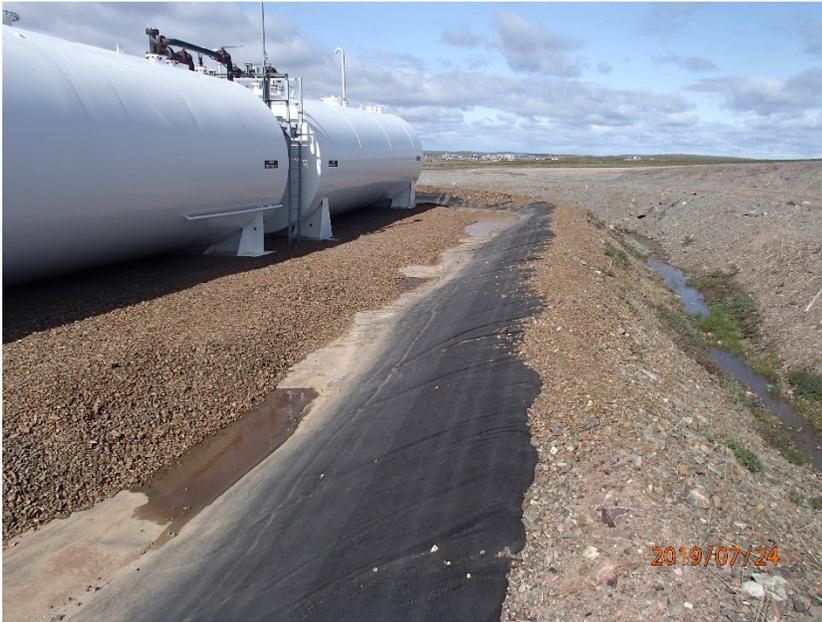
**Photo Number:** 187

**Description:** From the northeastern corner of the Jet A fuel tanks looking south. Presence of exposed geomembrane.

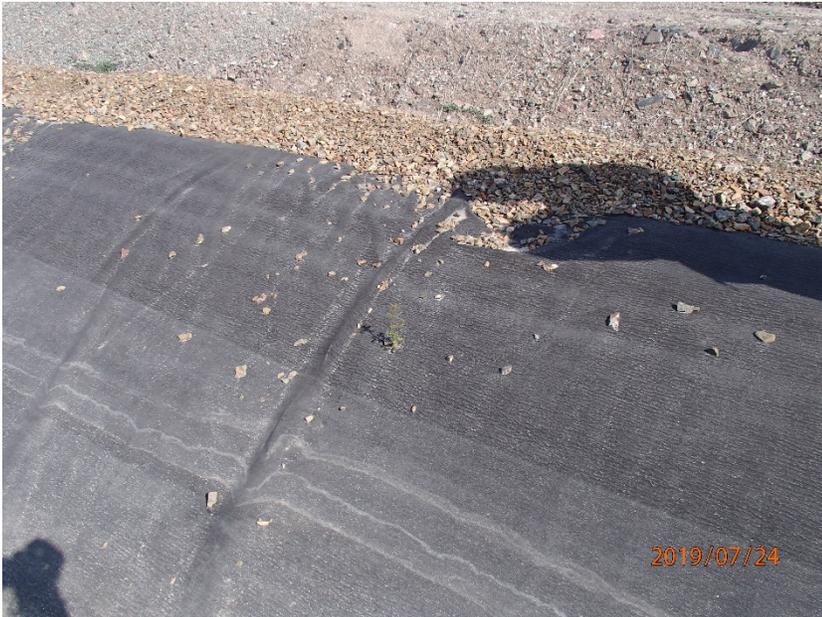
**Photo Number:** 186

**Description:** From the northeastern corner of the Jet A fuel tanks looking west. Presence of exposed geomembrane.

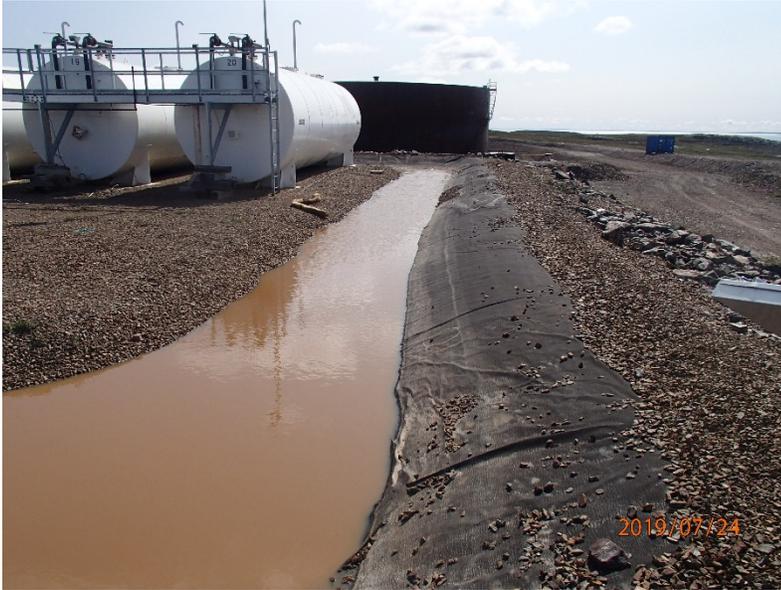
**Photo Number:** 188

**Description:** From the northern side the Jet A fuel tanks looking southwest. Presence of a hole in the geomembrane.

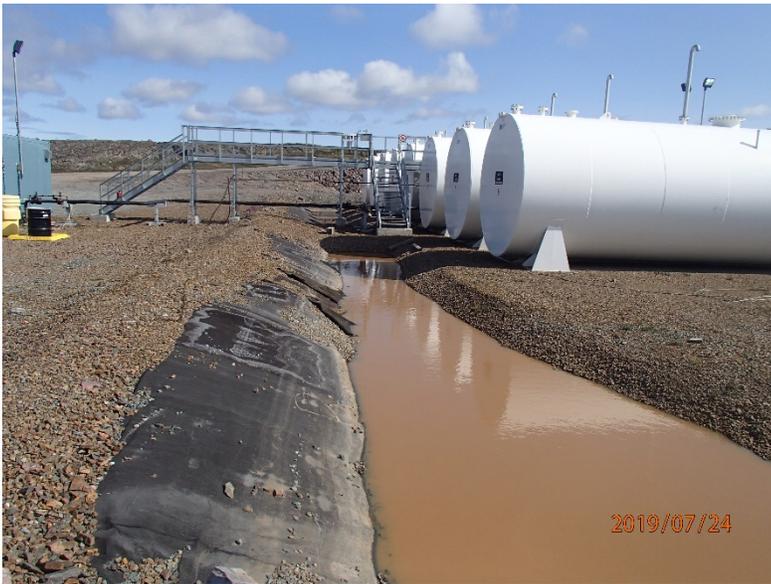
**Photo Number:** 189

**Description:** From the southwestern corner of the Jet A fuel tanks looking east. Presence of exposed geomembrane and water ponding.

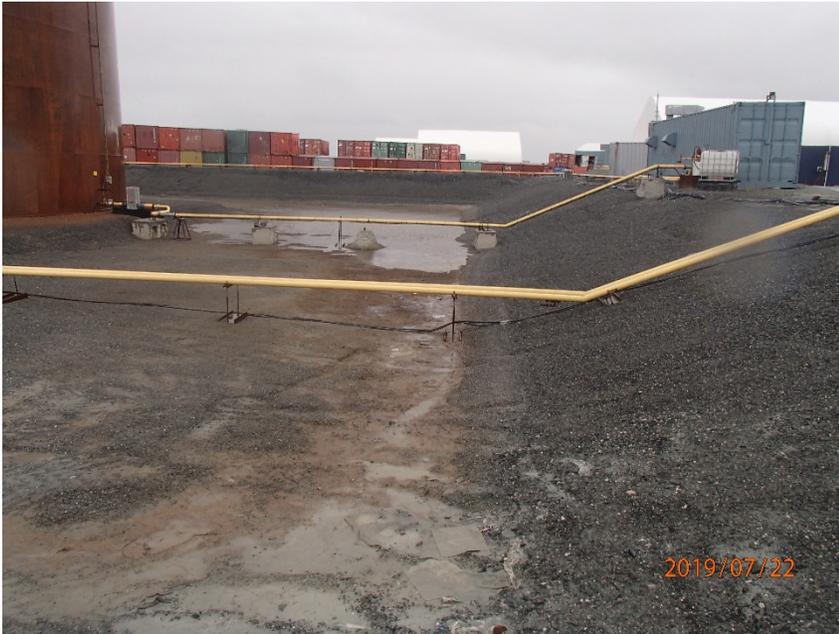
**Photo Number:** 6

**Description:** From the eastern side looking southwest. Presence of water ponding. A pump is installed.

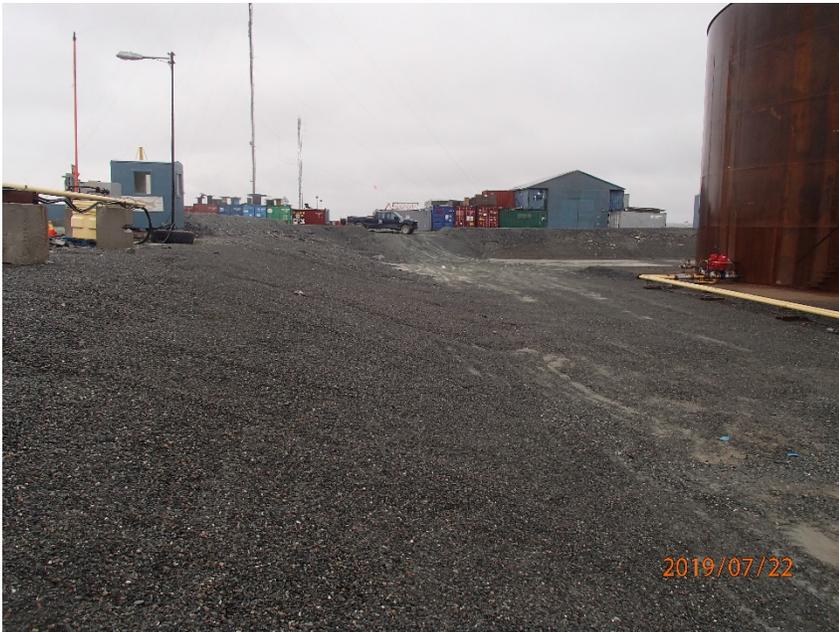
**Photo Number:** 4

**Description:** Looking northeast from the southern corner. Accumulation of water in the eastern corner.

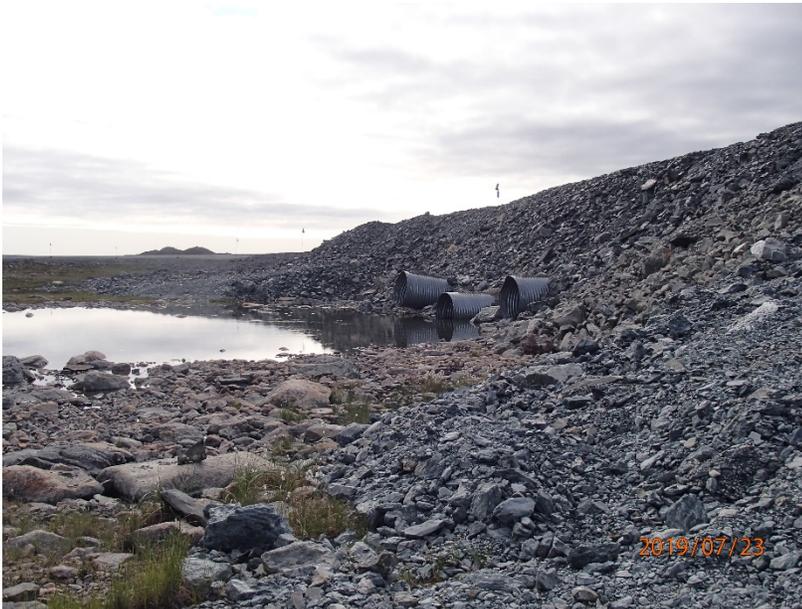
**Photo Number:** 78

**Description:** Looking at the outlet of the three culverts located on Vault Road at 640964E/7217466N. All of them are deformed in the middle.

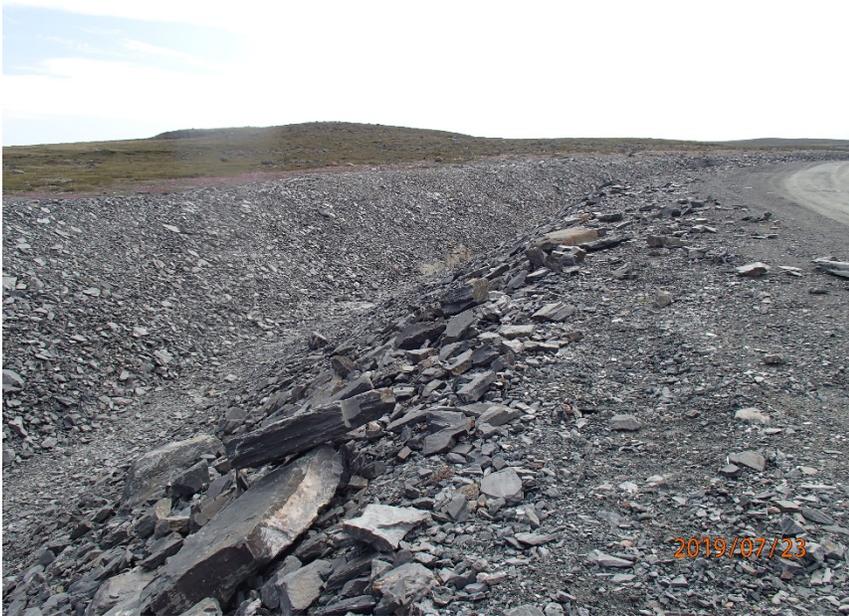
**Photo Number:** 89

**Description:** From the eastern diversion ditch looking northwest.

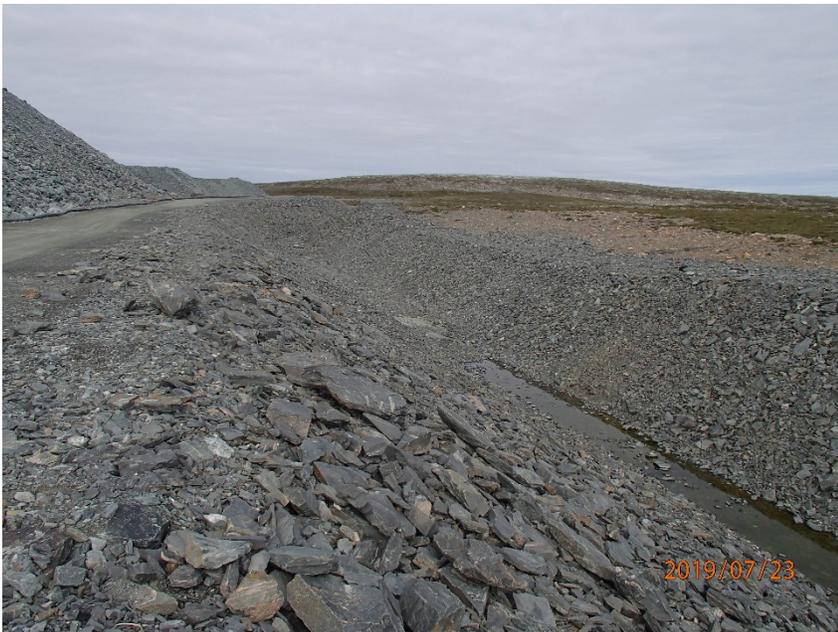
**Photo Number:** 90

**Description:** From the eastern diversion ditch, looking east.

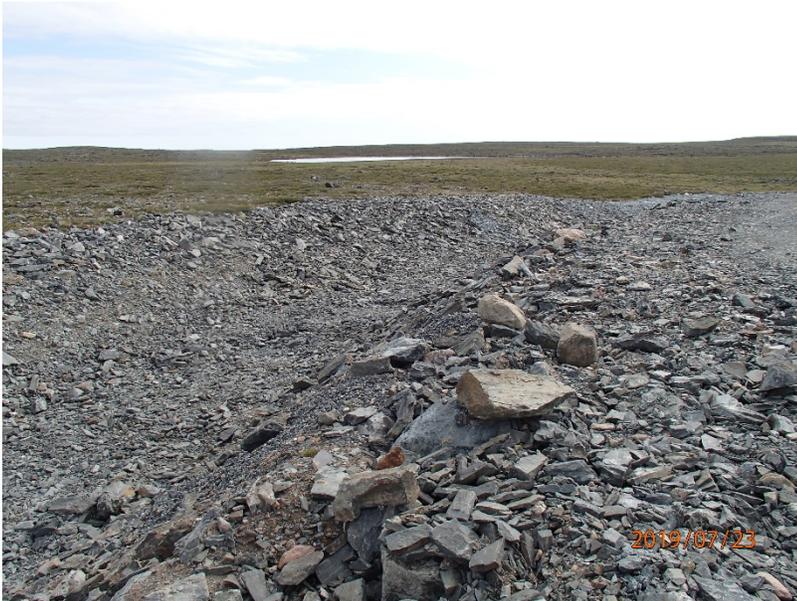
**Photo Number:** 91

**Description:** From the eastern diversion ditch, looking northwest.

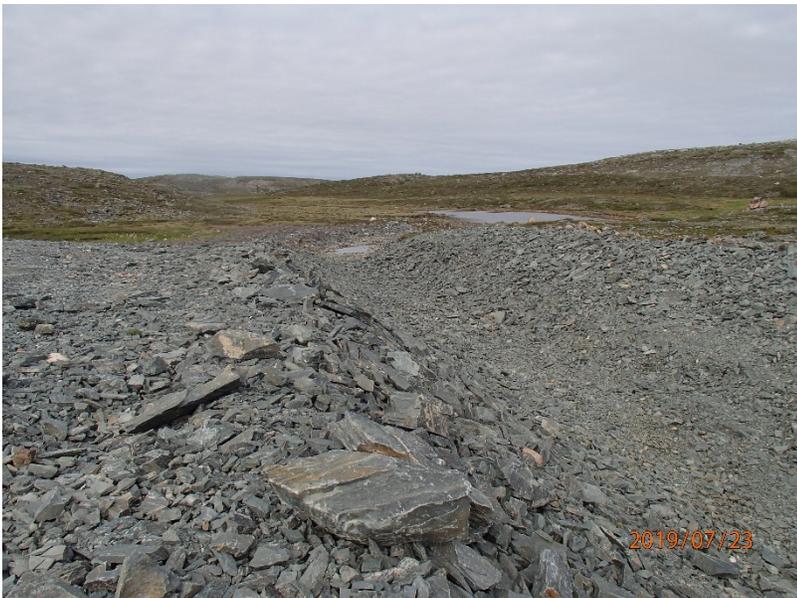
**Photo Number:** 92

**Description:** From the northern diversion ditch looking southeast.

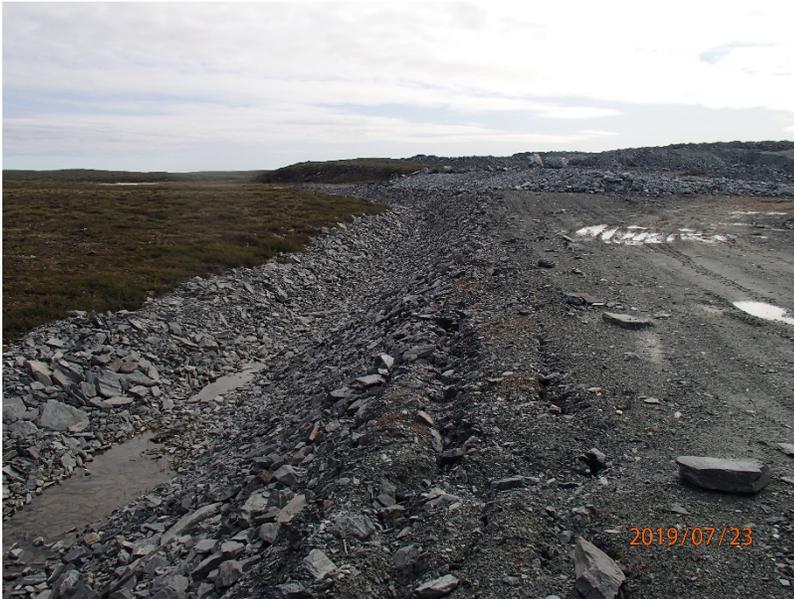
**Photo Number:** 93

**Description:** From the northern diversion ditch looking west.

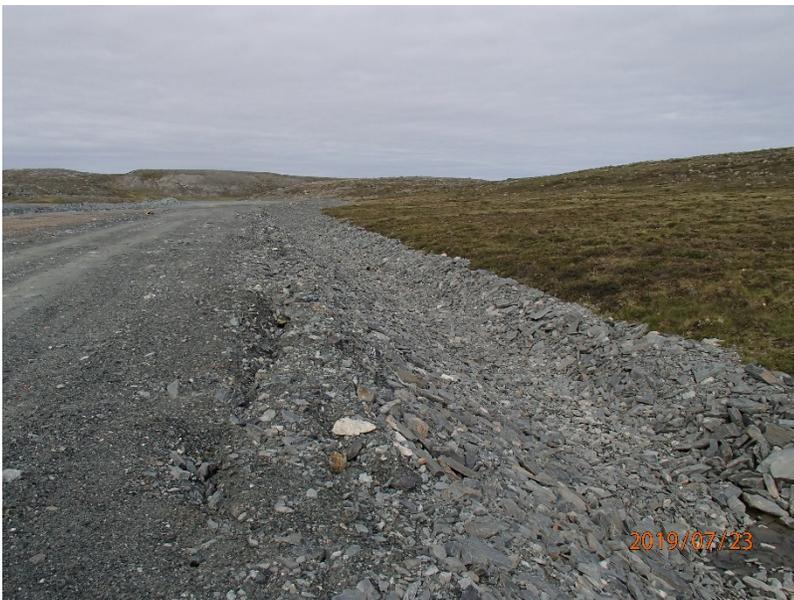
**Photo Number:** 94

From the northern diversion ditch looking east.

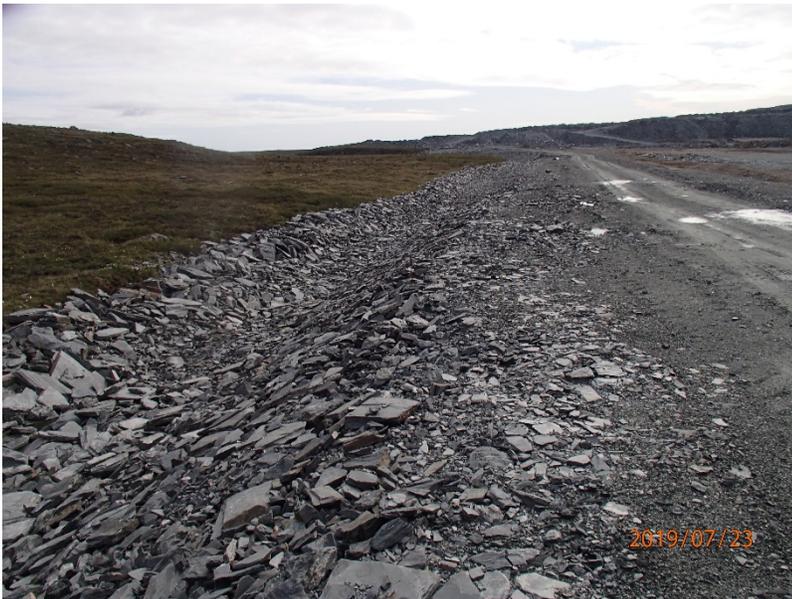
**Photo Number:** 95

From the northern diversion ditch looking west.

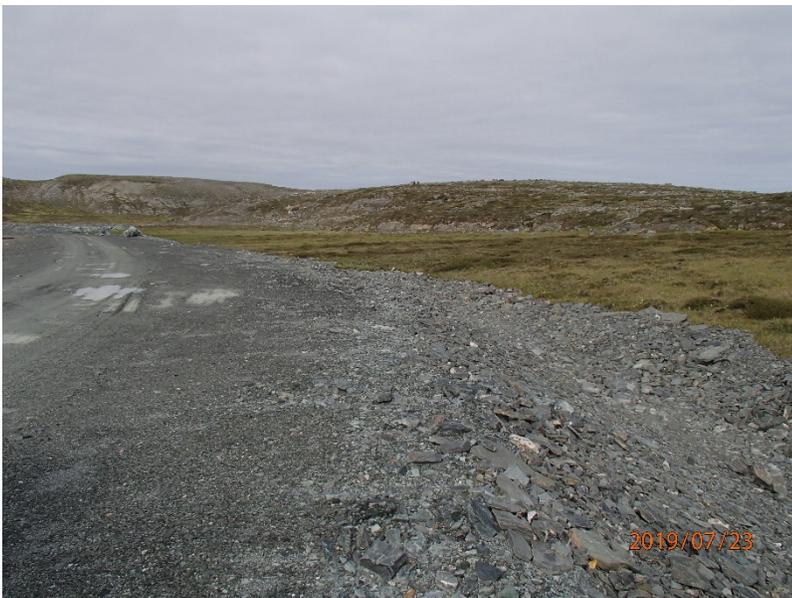
**Photo Number:** 96

**Description:** From the northern diversion ditch looking east.

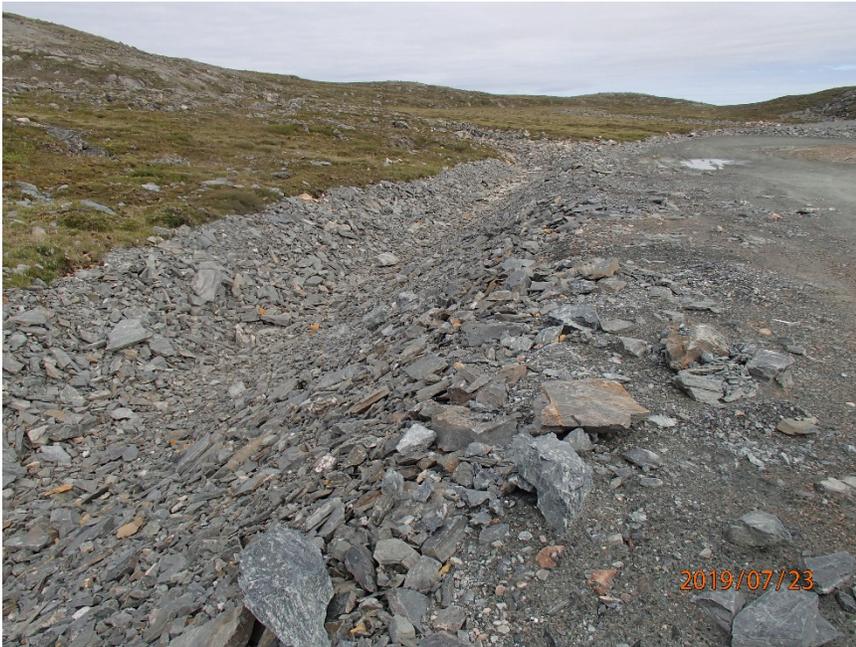
**Photo Number:** 97

**Description:** From the northern diversion ditch looking west.

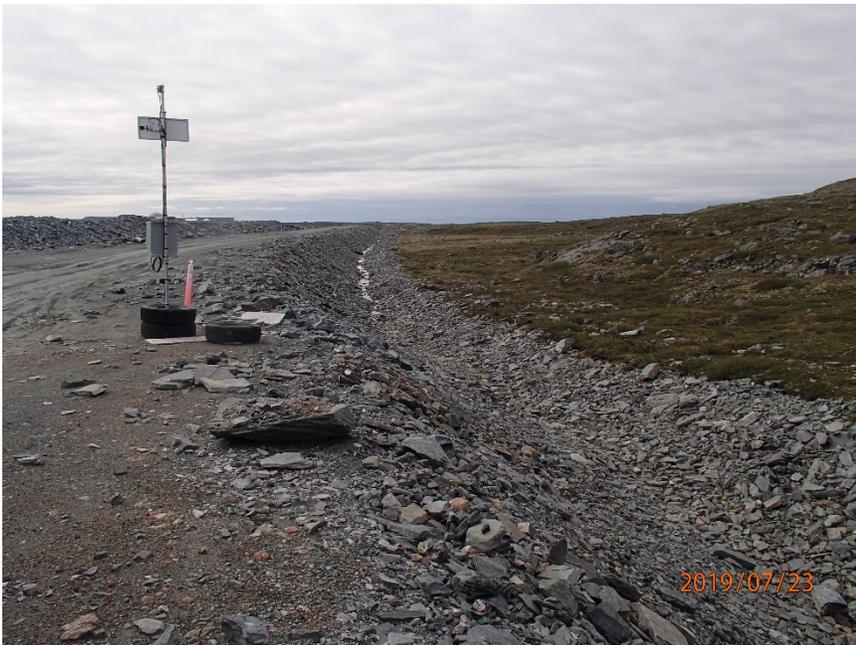
**Photo Number:** 98

**Description:** From 637281E/7216790N, looking north. View of the western diversion ditch.

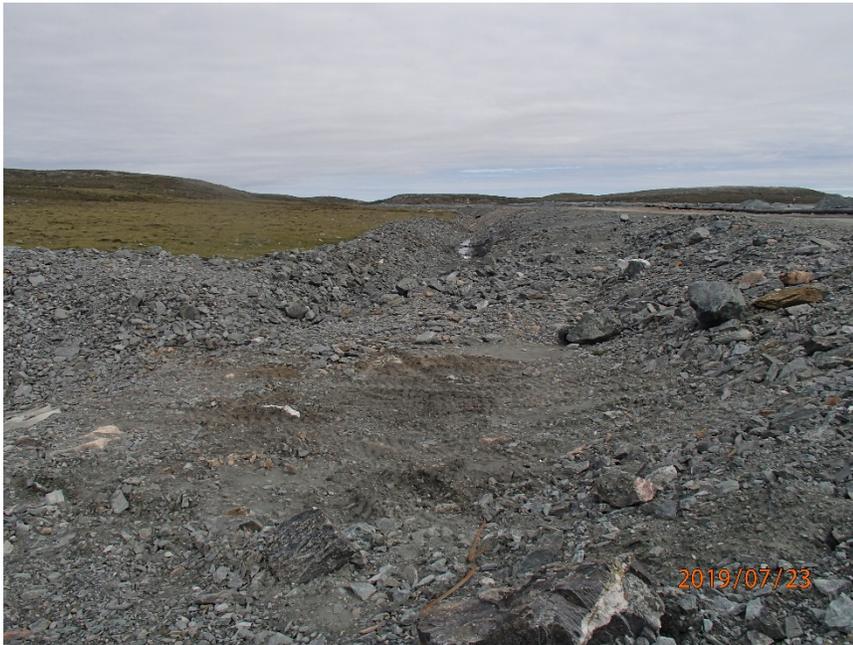
**Photo Number:** 99

**Description:** From 637281E/7216790N, looking south at the western diversion ditch.

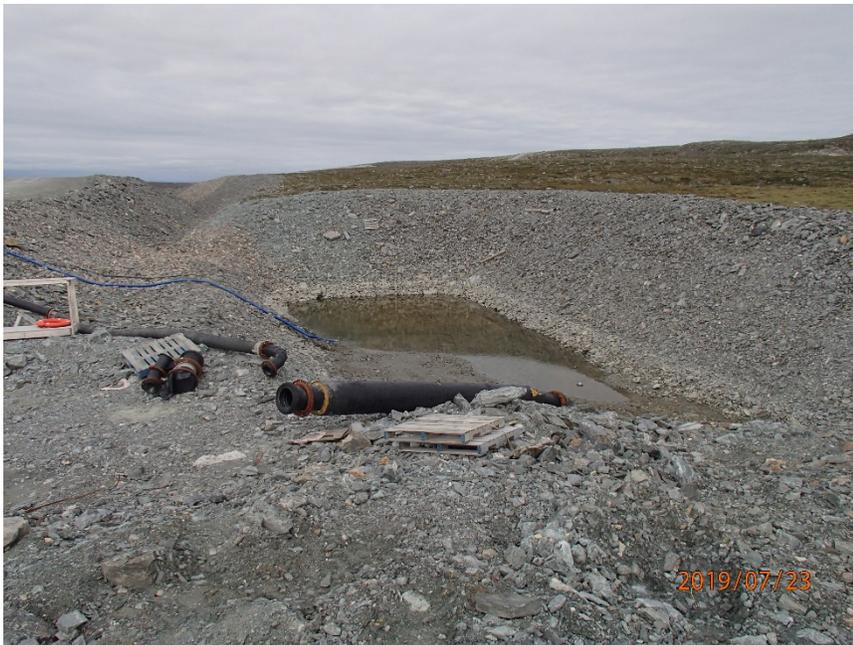
**Photo Number:** 101

**Description:** From 637251E/7216171N, looking north at the western diversion ditch.

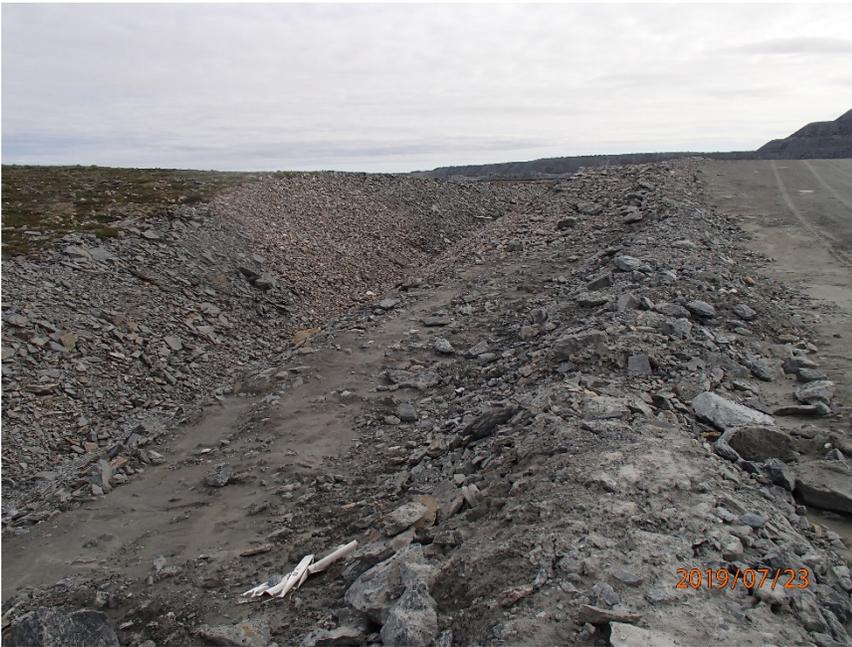
**Photo Number:** 100

**Description:** From 637251E/7216171N, looking west at the western diversion ditch and its retention basin.

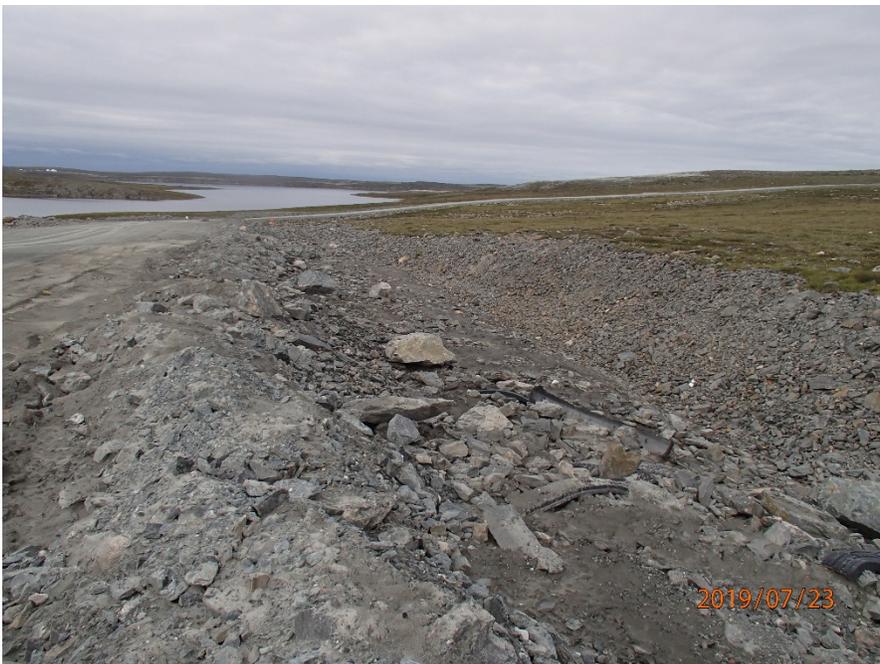
**Photo Number:** 102

**Description:** From 637074E/7216157N, looking east at the western diversion ditch.

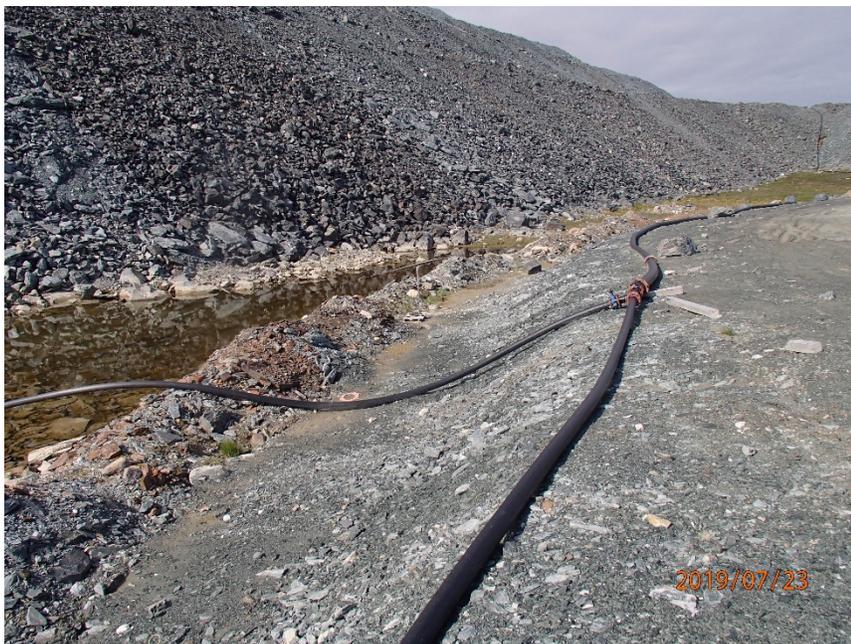
**Photo Number:** 85

**Description:** From the south side of NP2 Lake (north of the diversion ditch) looking west at the RSF till plug.

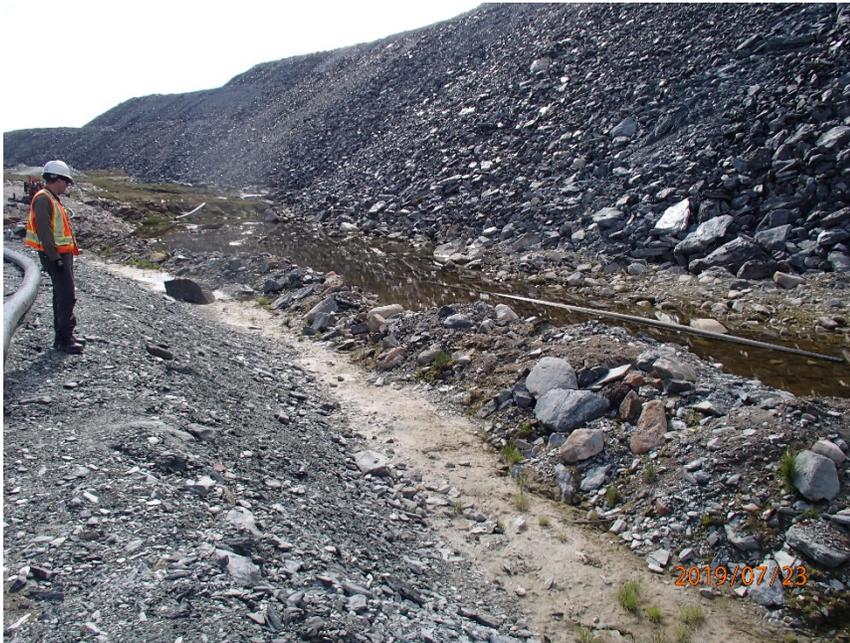
**Photo Number:** 86

**Description:** From the south side of NP2 Lake (south of the diversion ditch) looking west at the RSF till plug.

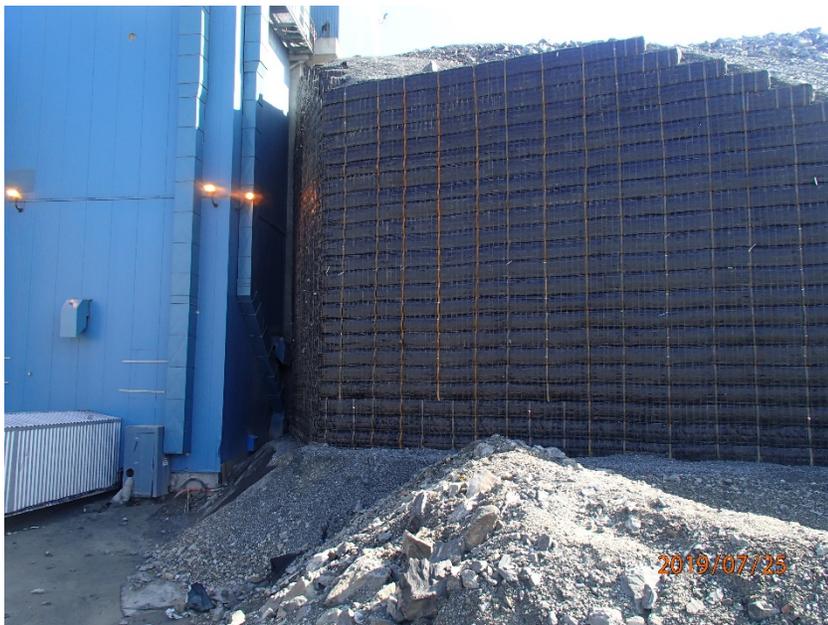
**Photo Number:** 281

**Description:** From the access road, looking southeast at the retaining wall.

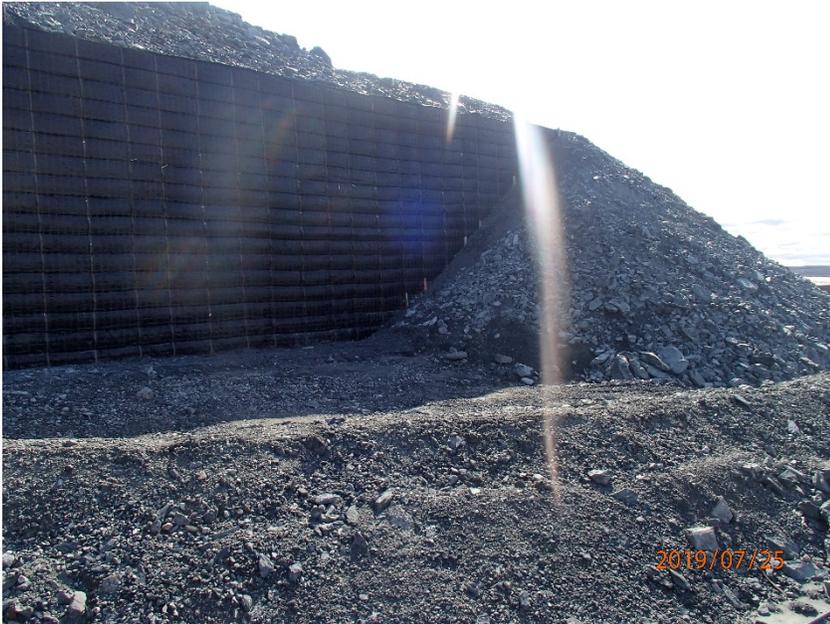
**Photo Number:** 282

**Description:** From the base of the retaining wall, looking south.

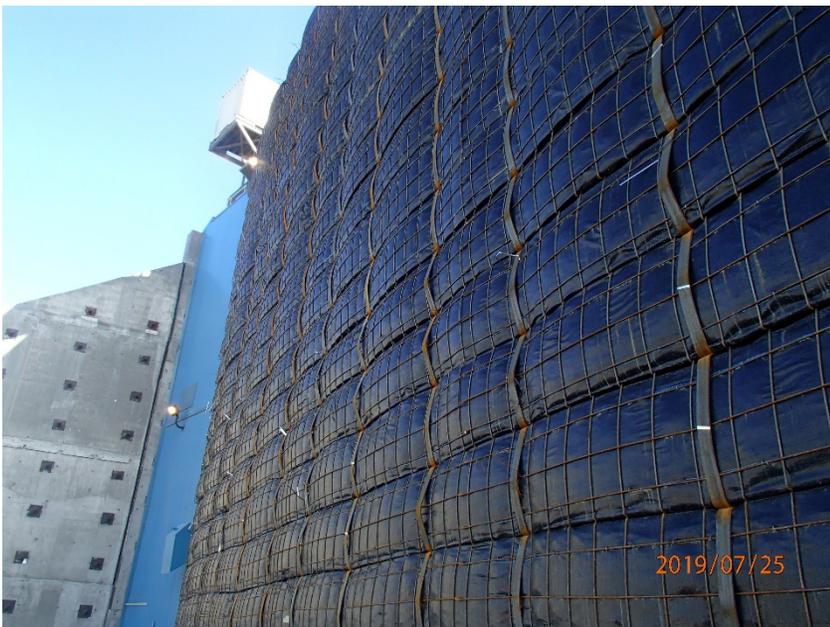
**Photo Number:** 283

**Description:** From the base of the retaining wall, looking southwest.

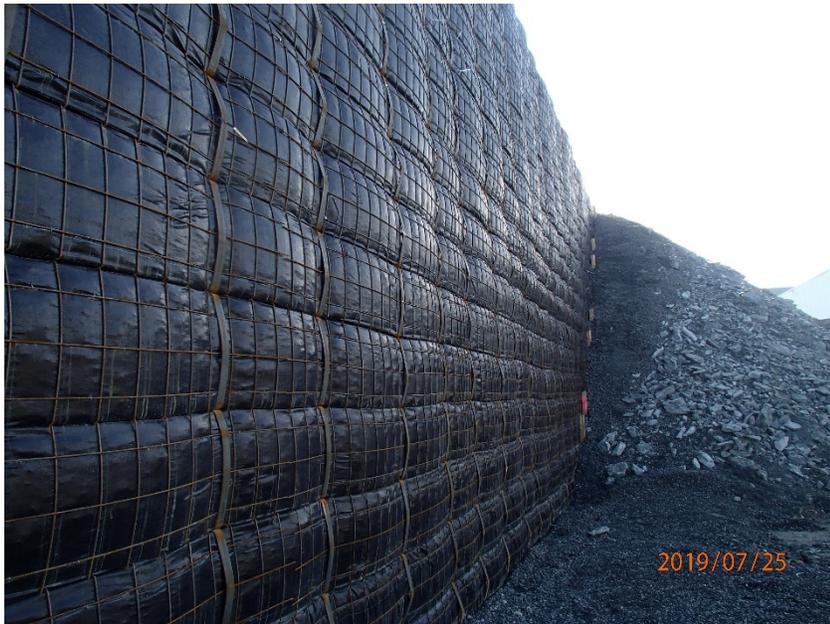
**Photo Number:** 284

**Description:** From the base of the retaining wall, looking southeast.
