Attention **Merle Keefe, Environmental Permitting Manager for Sabina Gold and Silver**
Subject **Goose Project Site – 2021 Annual Geotechnical Inspection**
Project 1CS020.021

The 2021 AGI for the Goose site is the subject of this memorandum.

2021 Annual Inspection

DRAWING TITLE: General Arrangement
Comparison of 2021 Infrastructure to
Final Development Plans

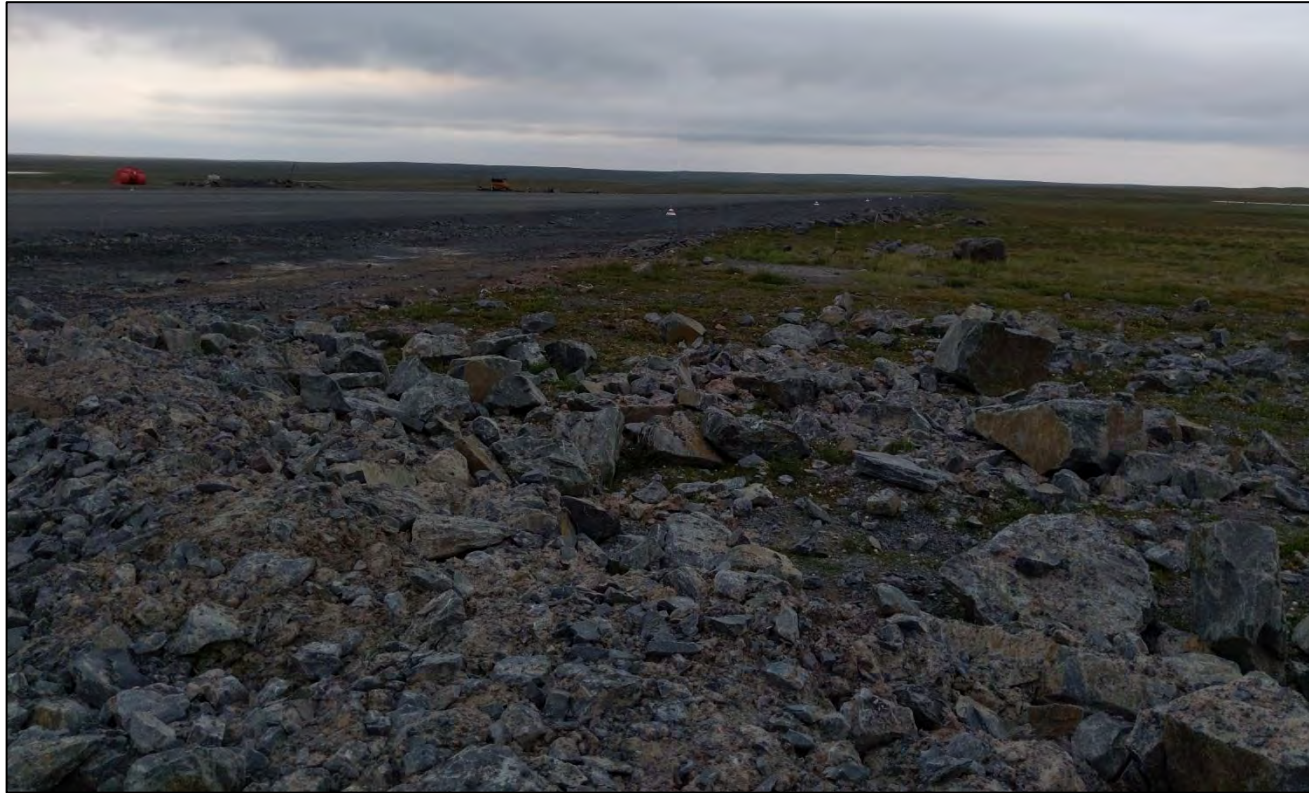
Photo 1 – view looking in southerly direction along airstrip

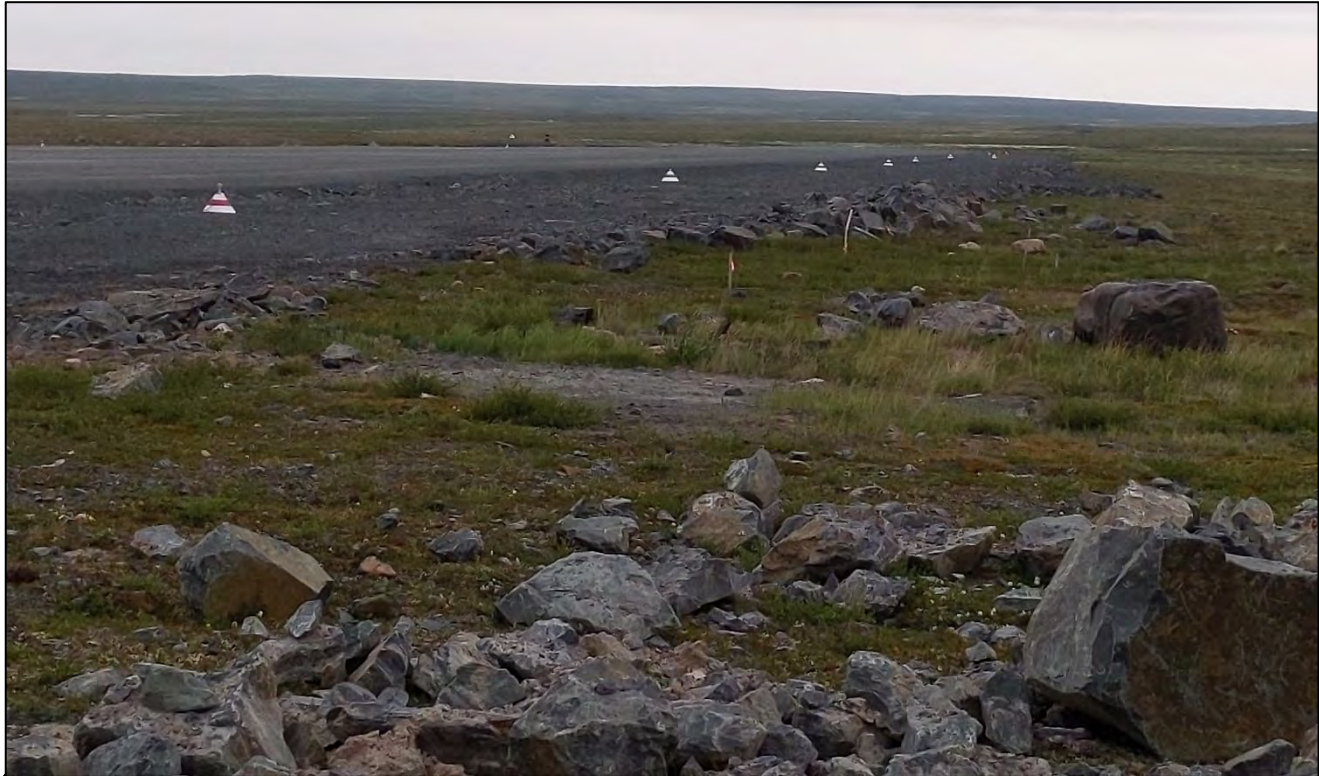
Photo 3 – View looking in southerly direction along airstrip

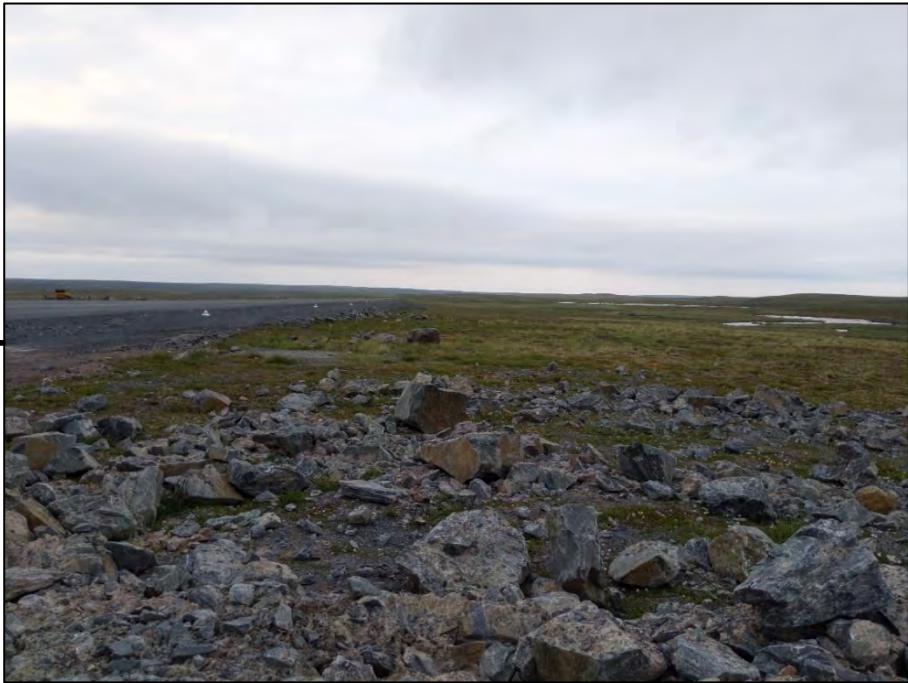
Photo 4 – view looking in southerly direction along airstrip. Note larger natural water bodies on right of photo. Water then flows towards airstrip

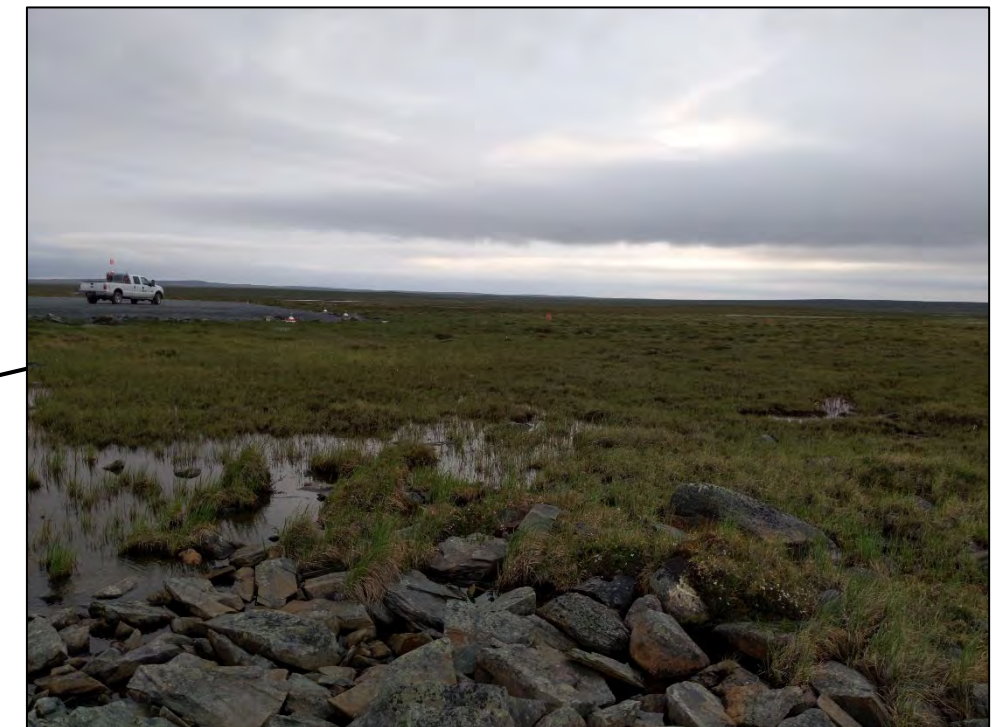
Photo 9 – Water ponded and flowing towards southeast

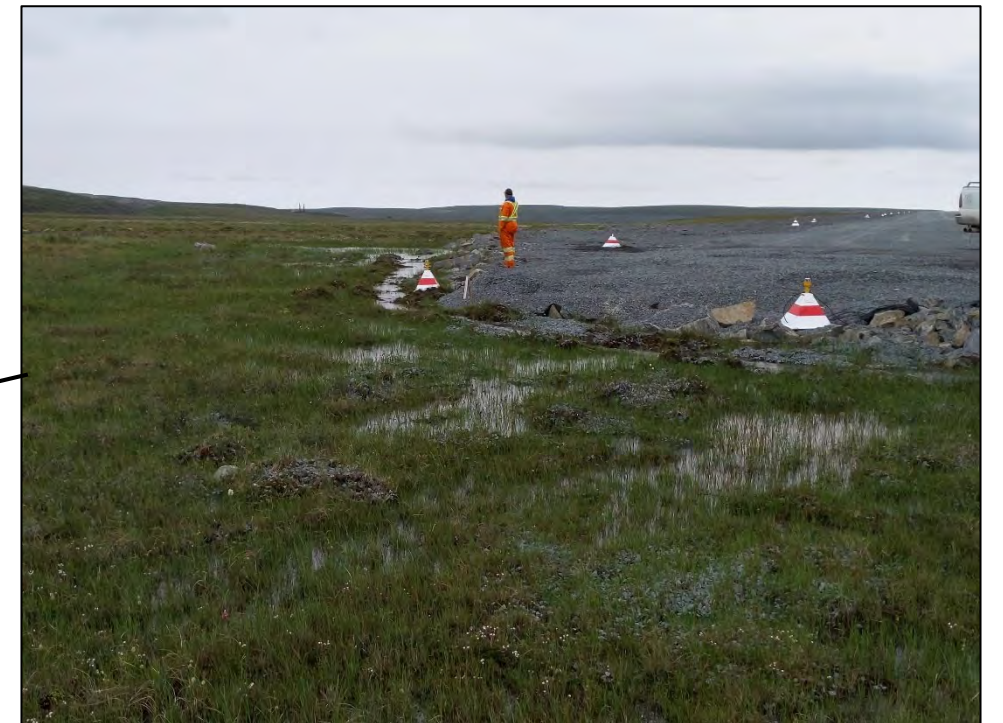
Photo 14 – Water ponding at southern point of airstrip, flow continues southeast

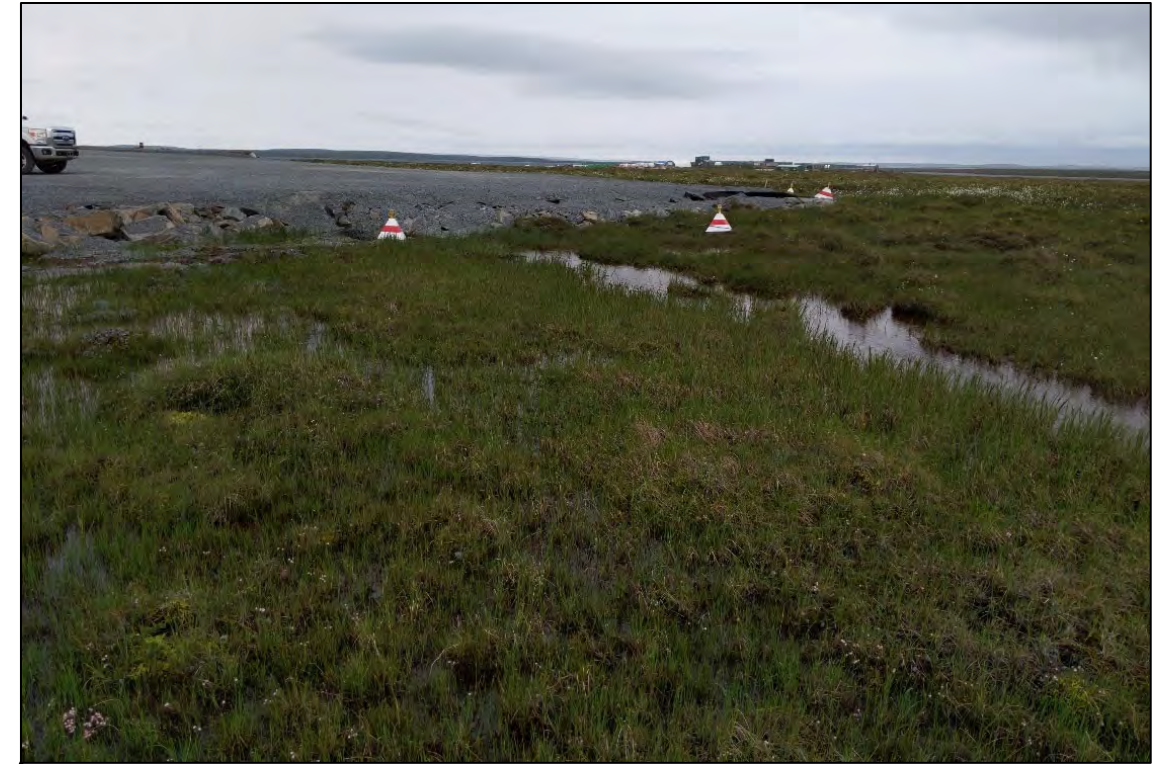
Photo 17 - Water flow away from the airstrip towards the southeast

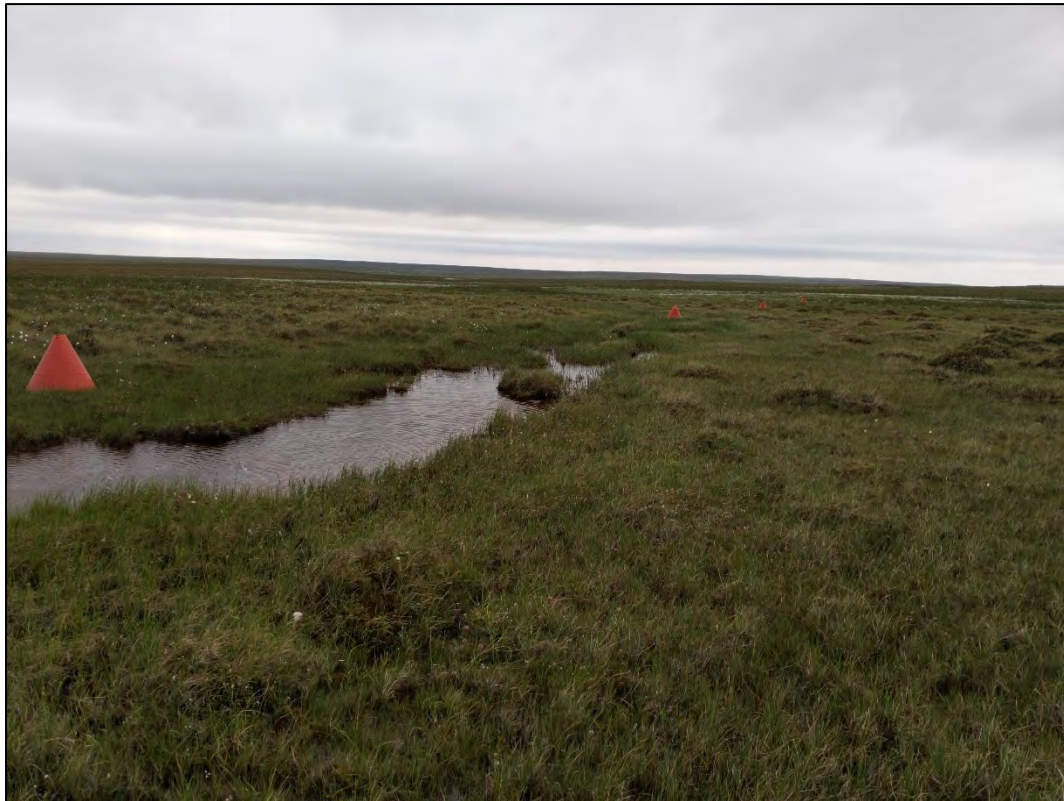
Photo 16 – Water flow away from the airstrip towards the southeast

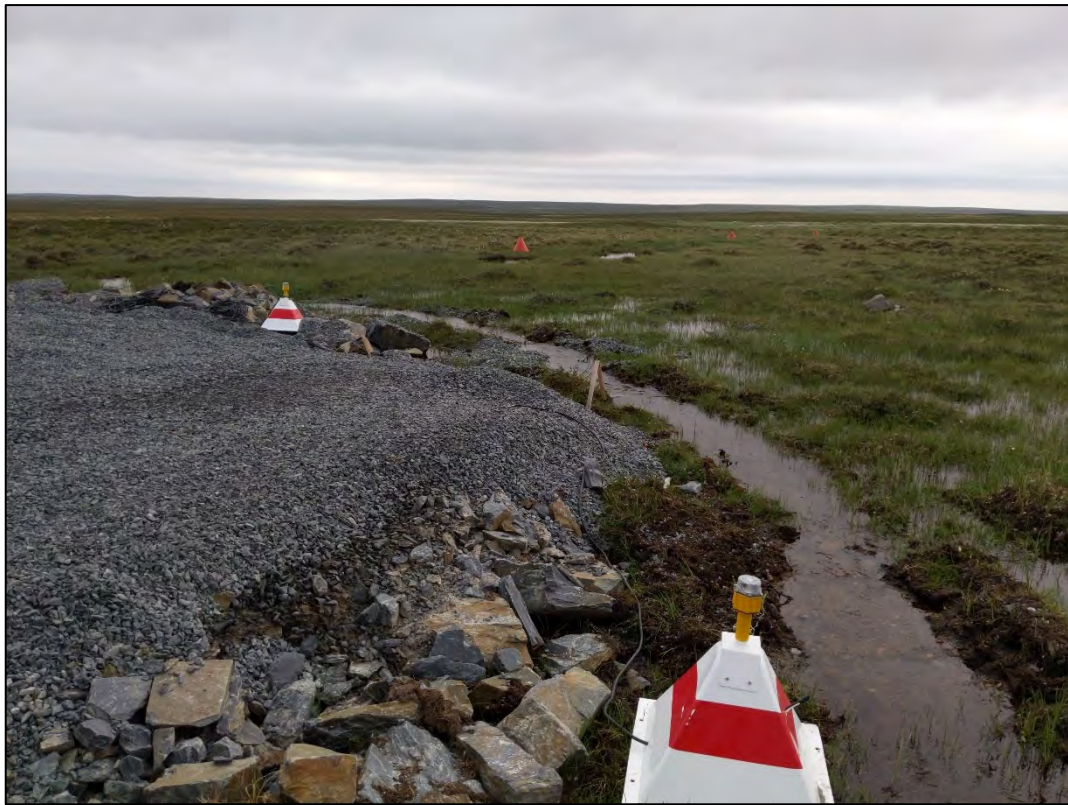
Photo 19 – water flow around airstrip towards southeast

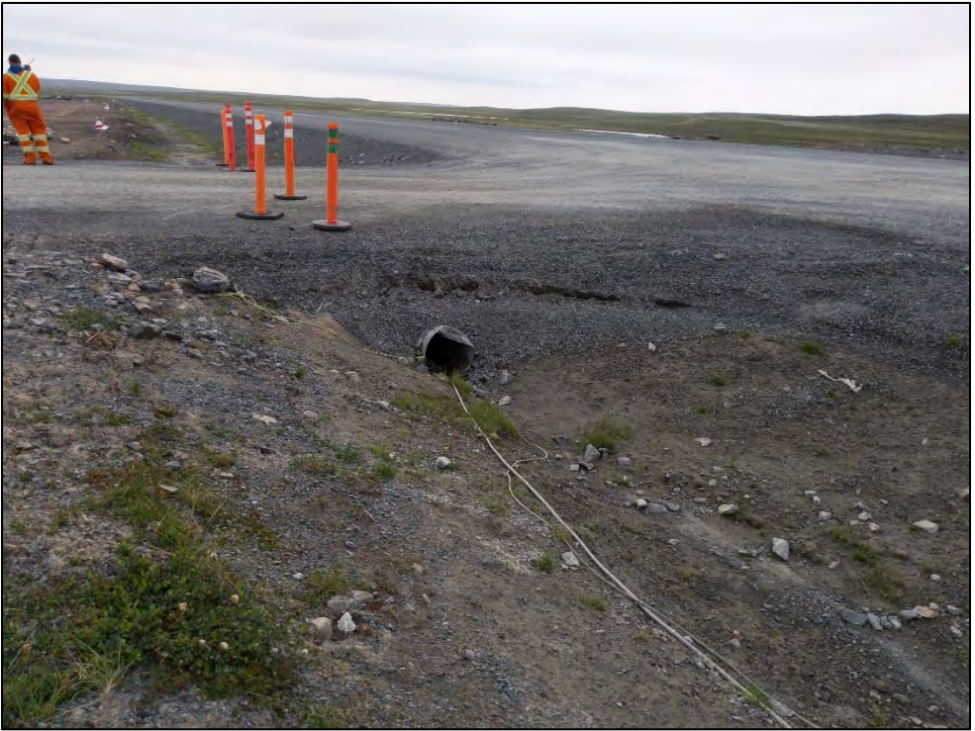
Photo 21 – Culvert along airstrip channel along northern edge

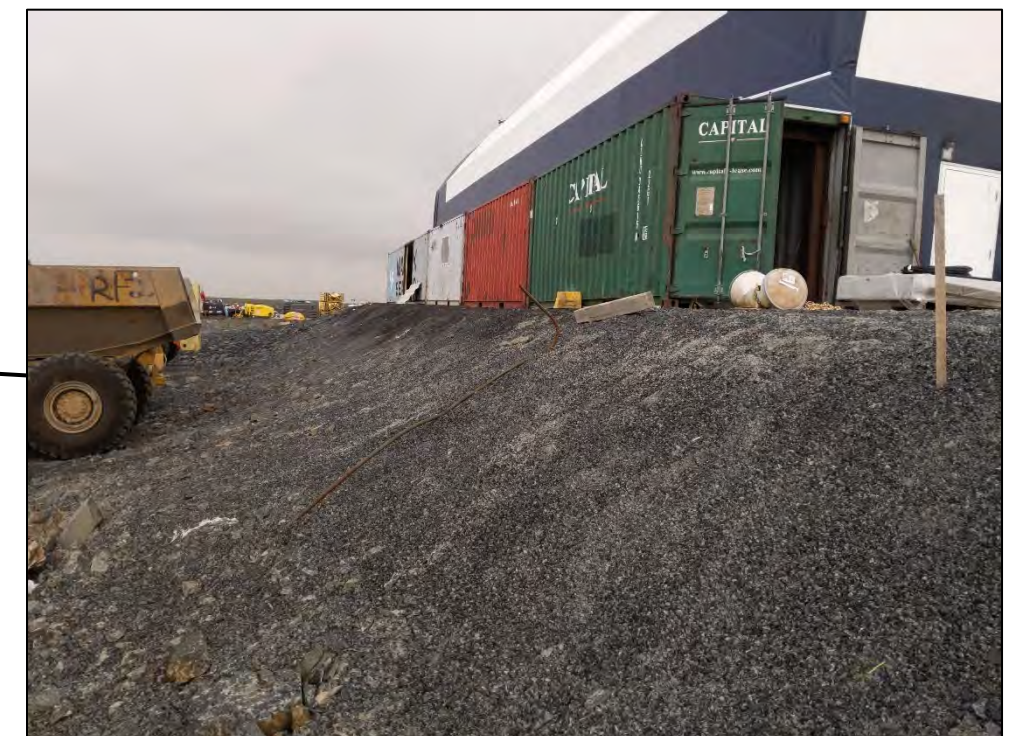
Photo 8 – note portal workshop pad
