**ATTACHMENT C**

# 2022 Piezometric Data

2022 GROUNDWATER MONITORING PROGRAM  
WHALE TAIL MINE, NUNAVUT

**2022 Seepage Survey  
Photographs (provided by Agnico  
Eagle)**

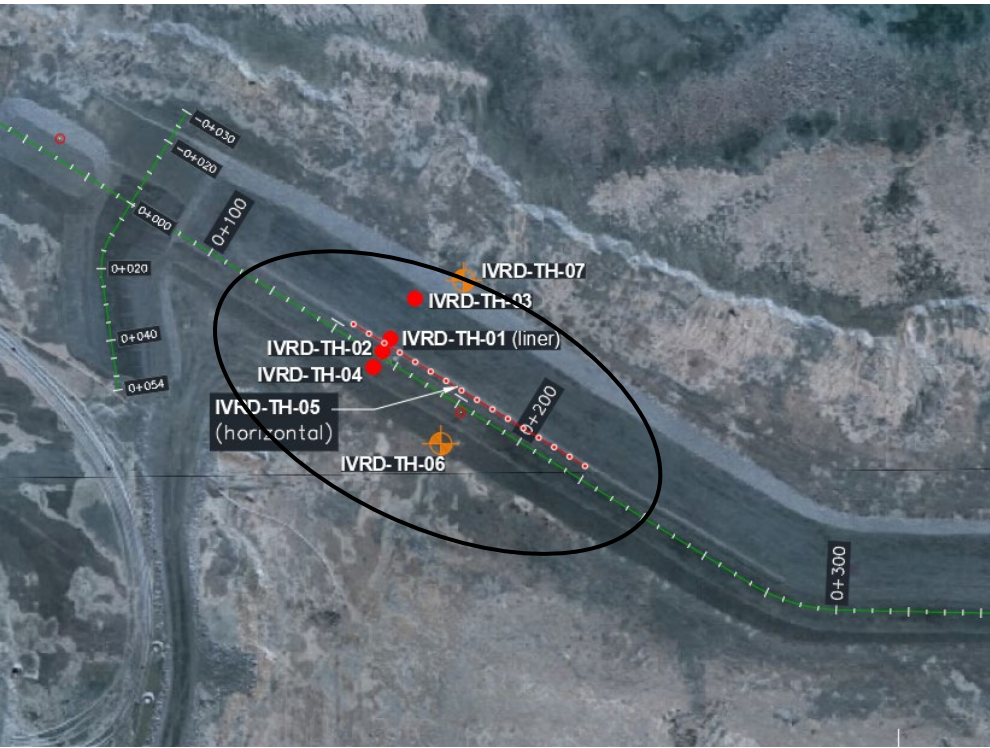
IVR-D1-TH5

NOTE: This TH is horizontal and in Keytrench and must be reflected this way when reading the thermal graph

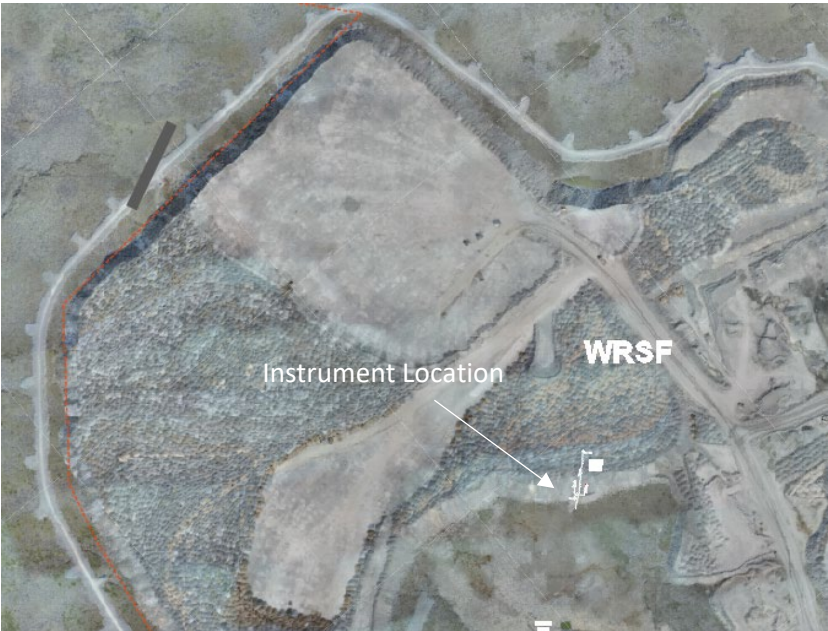
WT WRSF TH2

Last data May 2020

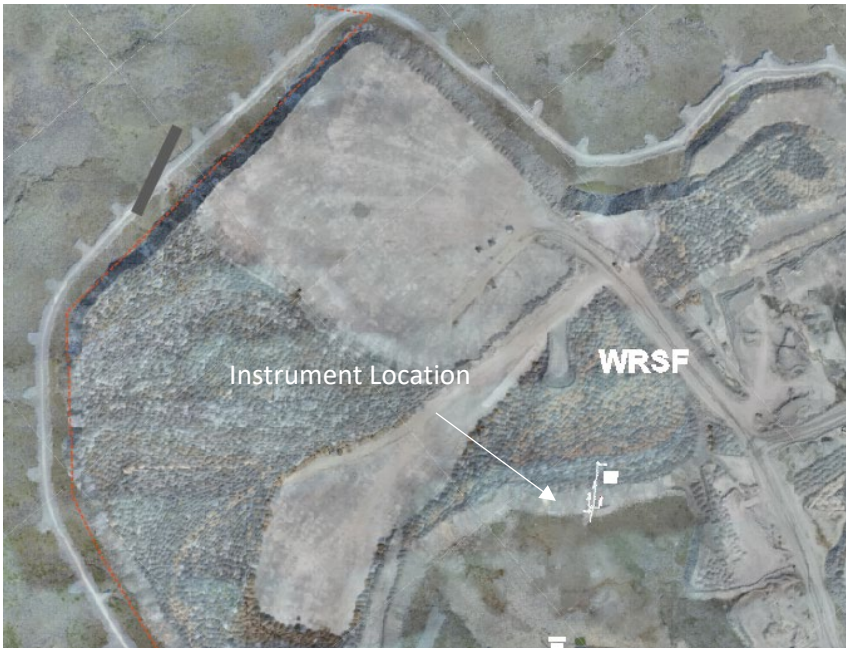
WT WRSF TH3

Thermistor in Waste Rock Elevation 162.042 to 162.812.

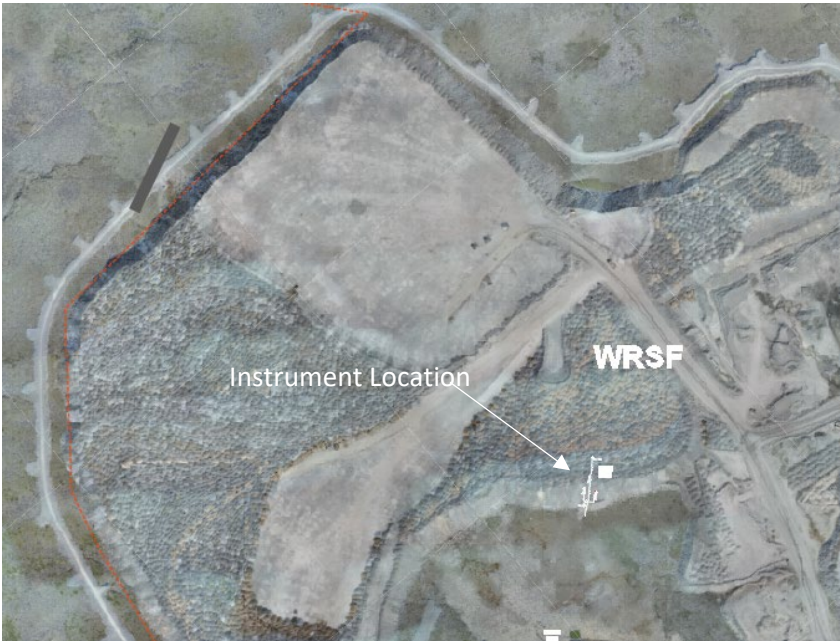
WT WRSF TH4

This instrument is installed horizontally and chart needs to be read accordingly

Beads 3 to 10 are not working

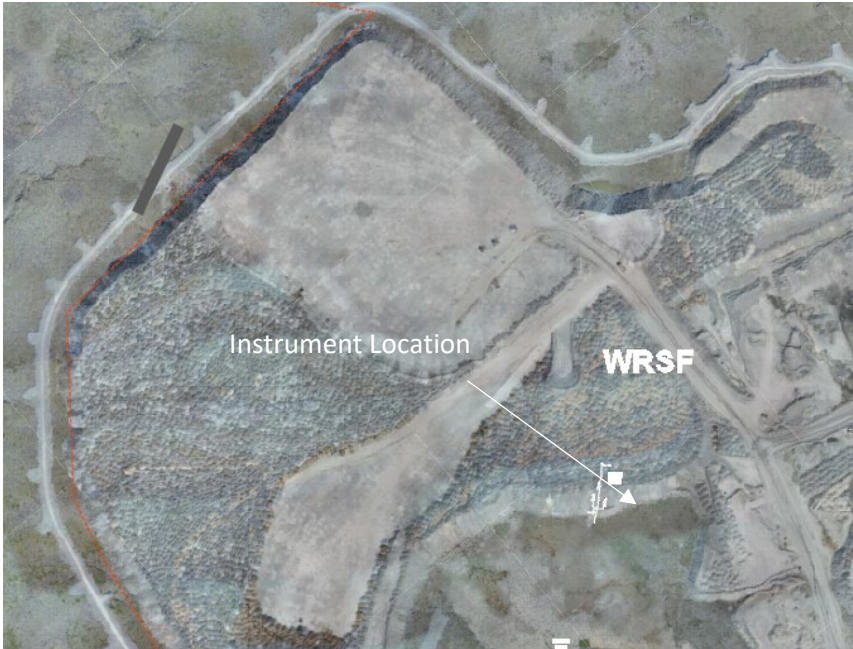
WT WRSF TH5

This instrument is installed horizontally and chart needs to be read accordingly

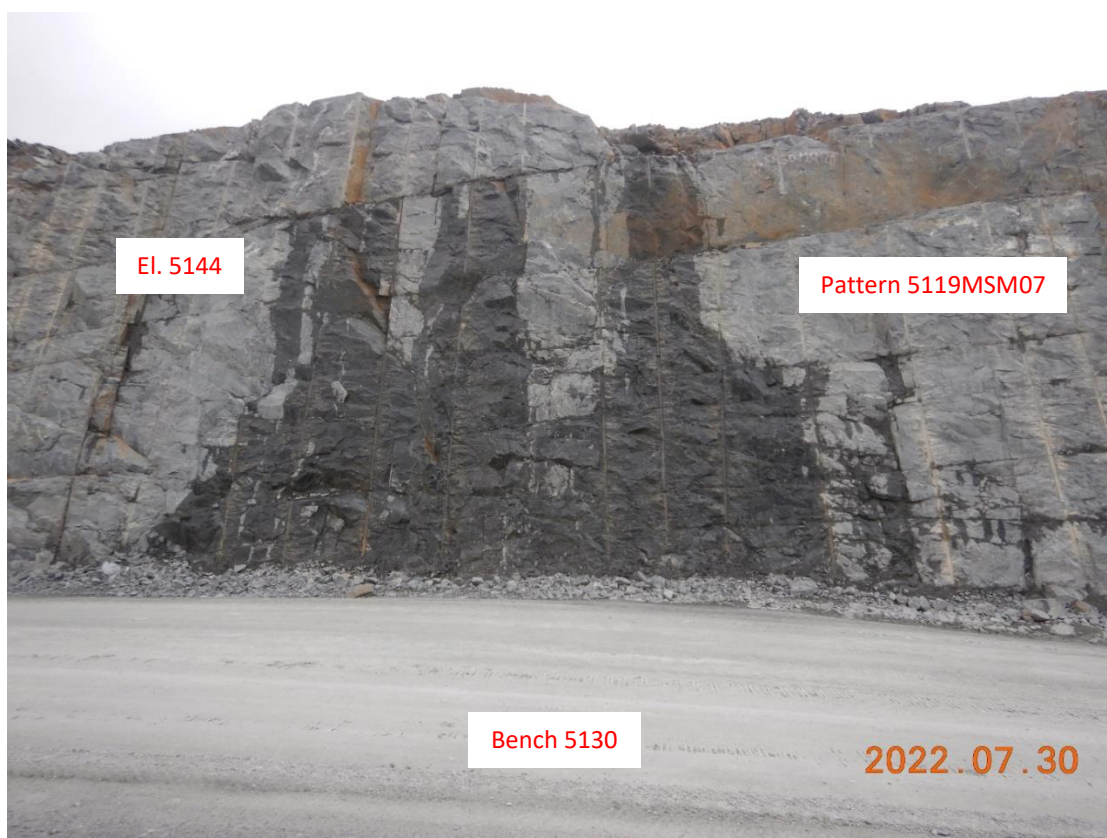
Photo 1: Pit seepage along Whale Tail Pit south wall, concentrated water source type, flowing joint (water source is related to ongoing water management operations), looking south (July 30, 2022).

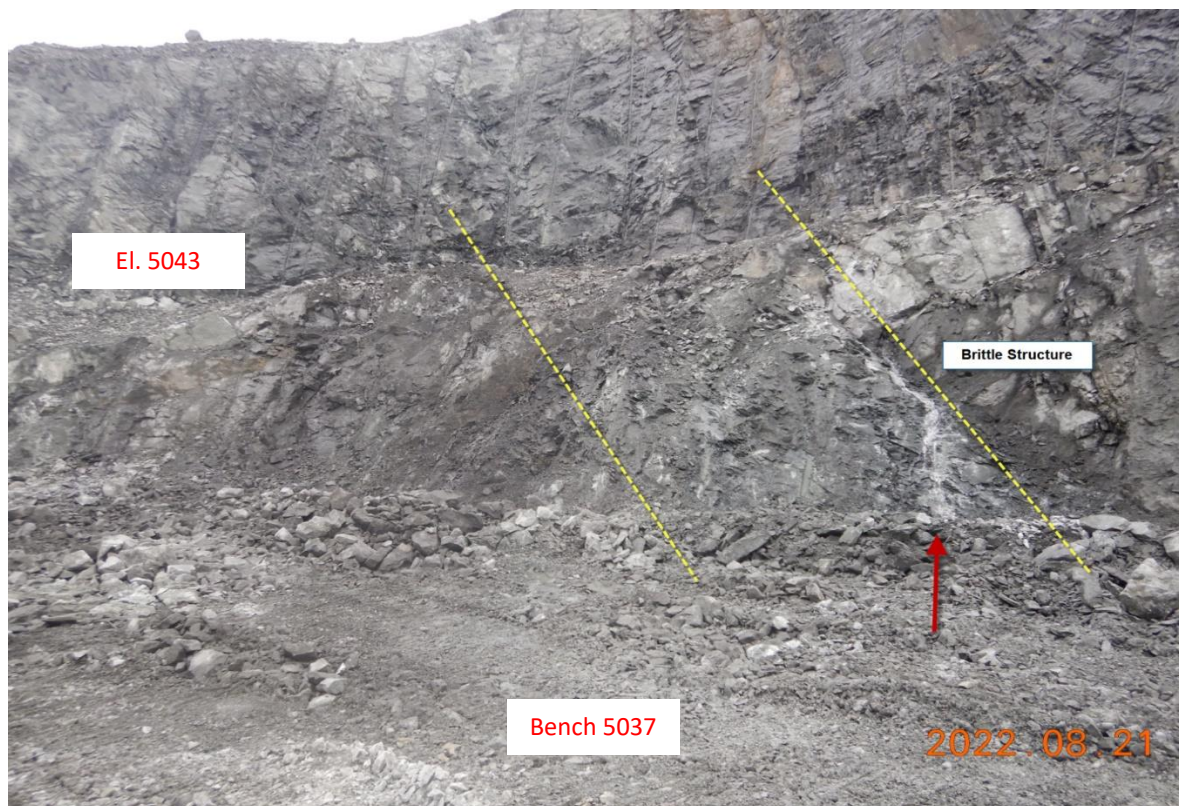
Photo 5: Whale Tail Pit P1, looking southeast; water was flowing steady from the eastern end of WHL P1, and this condition was ongoing for a couple weeks prior to August 21, 2022; water was observed flowing through a brittle structure (see red arrow), and the source is likely the same that forms the ice wall during sub-zero conditions, and flows underneath the ramp and exits through the wall (August 21, 2022).
