Meadowbank and Whale Tail 2022 Annual Geotechnical Inspection

REPORT**2022 Annual Geotechnical Inspection***Meadowbank Complex, Nunavut*

1617-2146800622-5000-RA-Rev0

16 December 2022

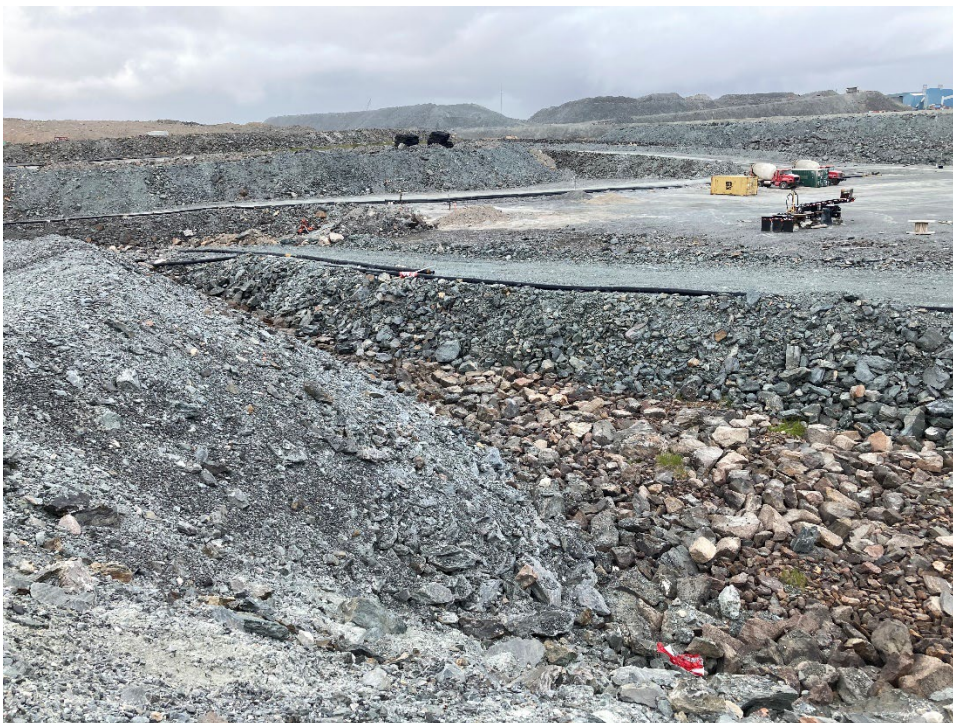
Photograph A1-8 East Dike

Description: From approximately Sta. 60+250, looking west at the downstream side and toe.

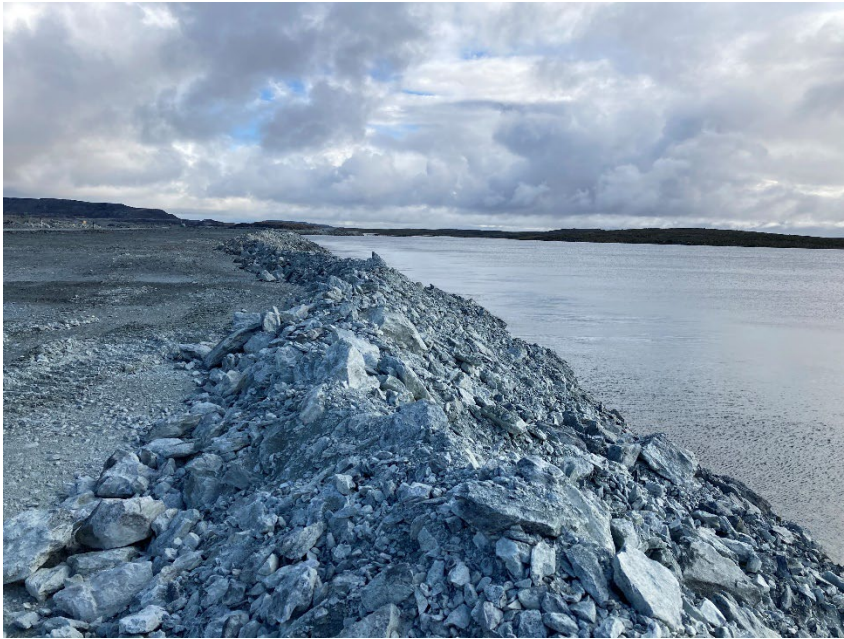
Photo Number: 203

Description: From approximately Sta. 31+080 on the crest, looking southwest at the pond of water at Central Channel seepage at Sta. 31+165.

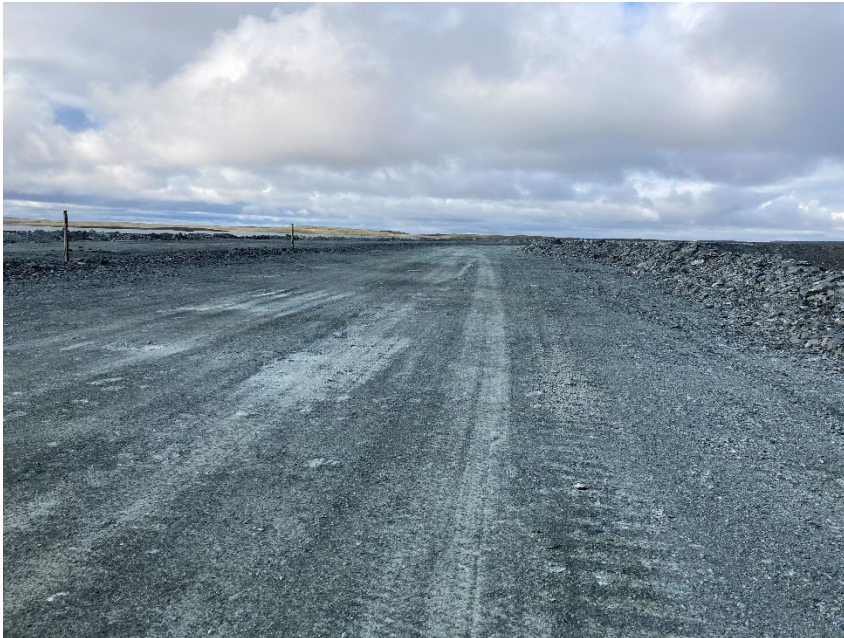
Photo Number: 194

Description: From approximately Sta. 31+280, looking northeast at the crest.
