Full Report Title: Nunavut Impact Review Board Community Update and Site Visit Report
Meadowbank Gold Mine and Whale Tail Pit Projects Agnico Eagle Mines Limited NIRB File No. 03MN107 & 16MN056

Projects: Meadowbank Gold Mine and Whale Tail Pit Projects

Site visit date: July 29-30, 2023

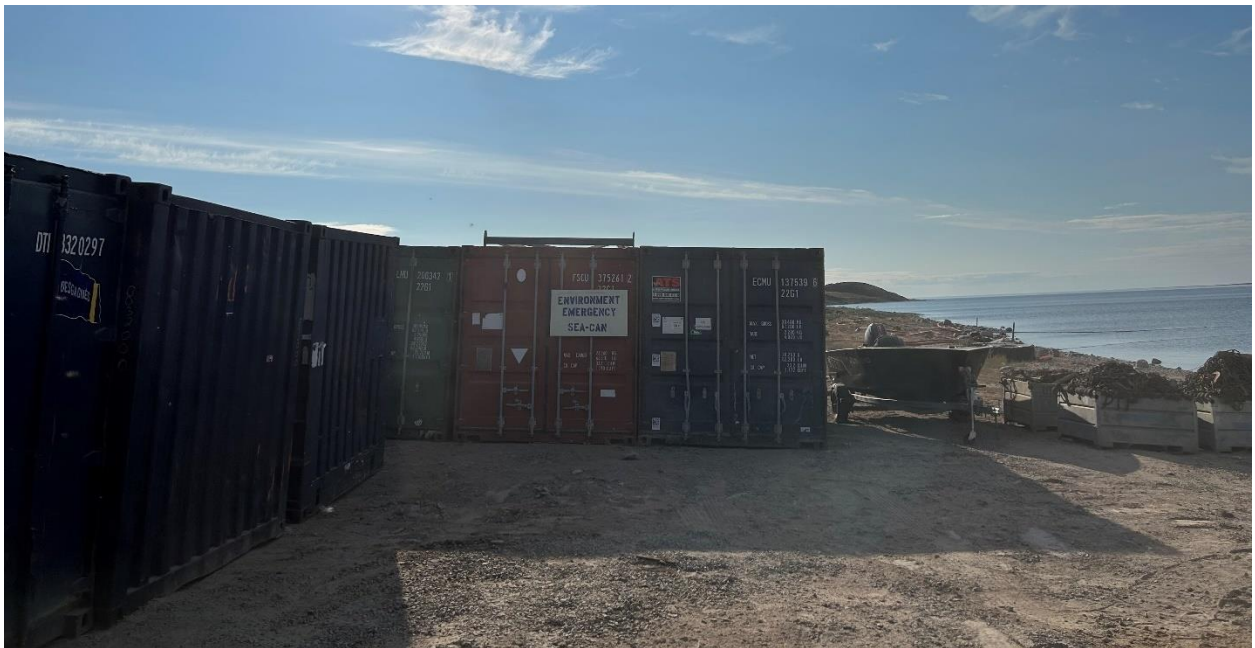
Photo 4: Emergency Spill Response Sea-can beside the dock at the Baker Lake Marshalling Facility.

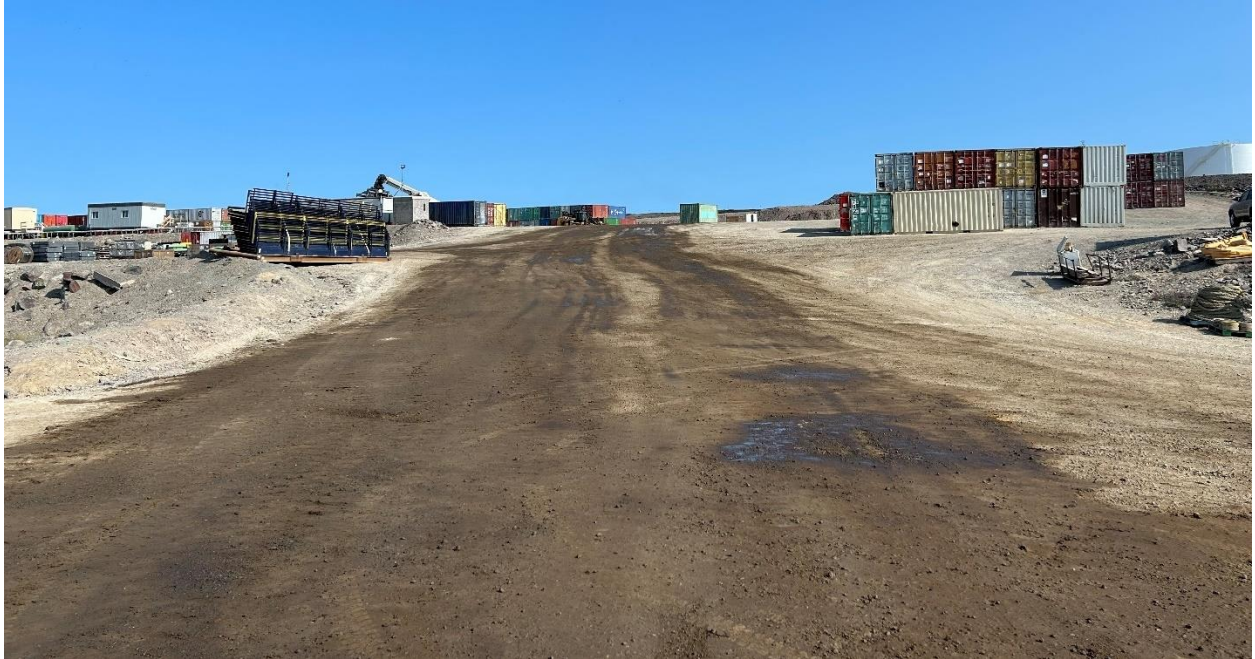
Photo 5: Chemical dust suppression freshly applied to the Baker Lake facilities.

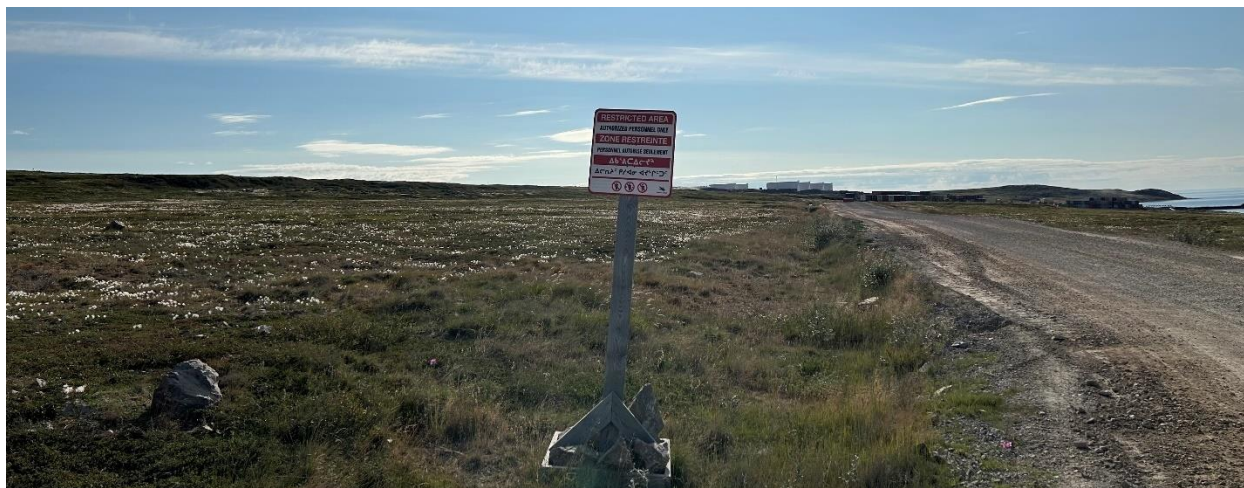
Photo 9: Restricted Road signs in English and Inuktitut were in place on the road leading from the town of Baker Lake to the Baker Lake Marshalling Facility.

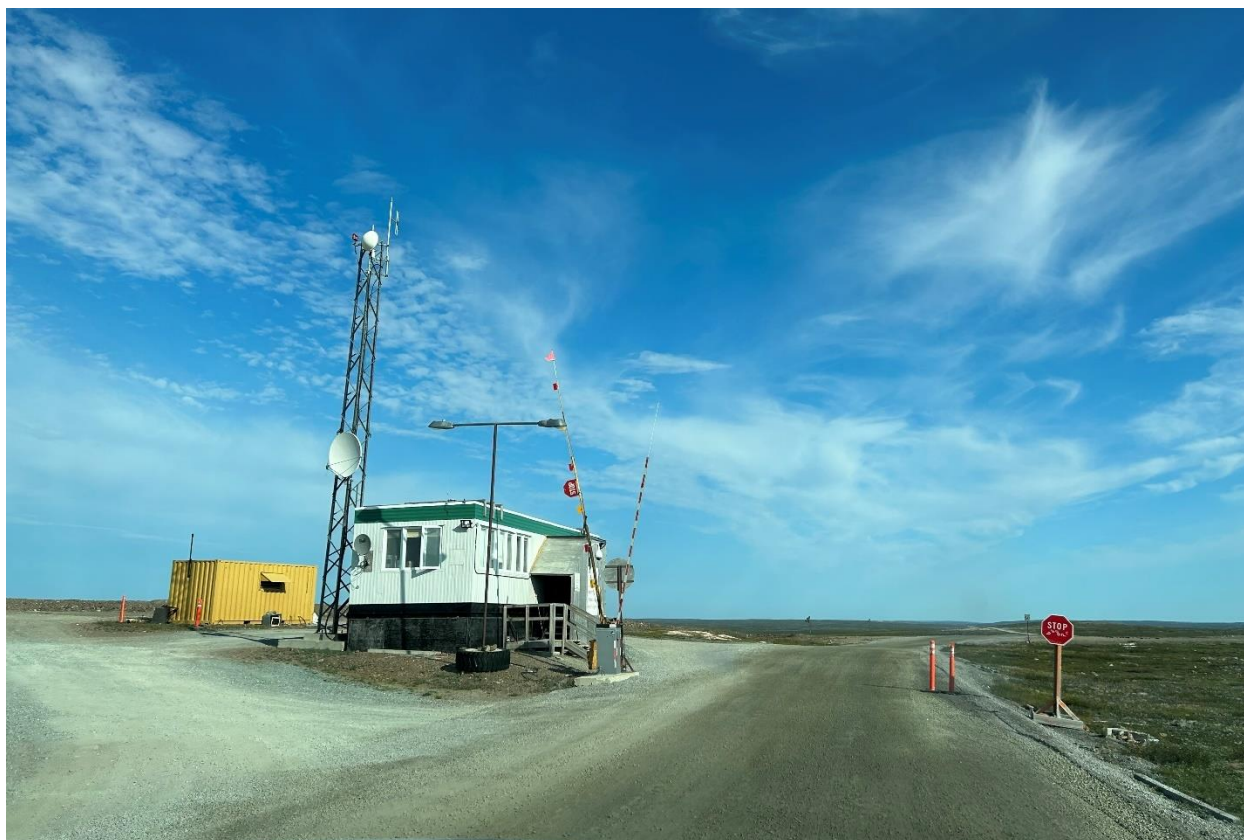
Photo 10: Gatehouse at kilometer 5 of the AWAR. The Gatehouse is staffed 24 hours per day and community members used the road must check in with Gatehouse staff.

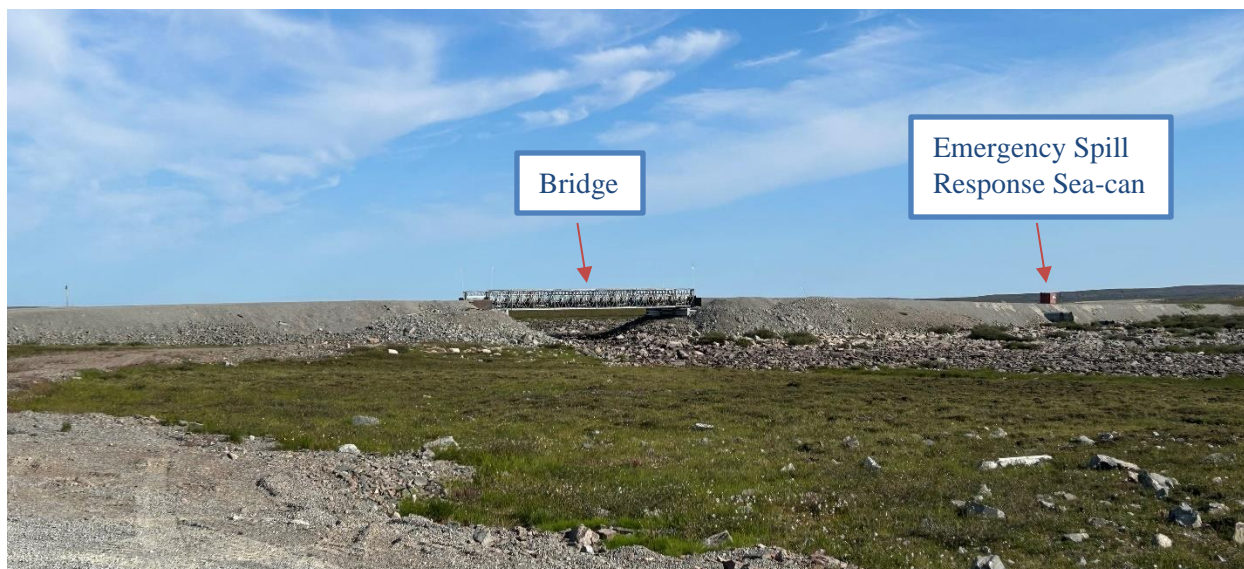
Photo 11: A bridge on the AWAR with associated Emergency Spill Response Sea-can. These sea-cans were observed at each bridge along the road.

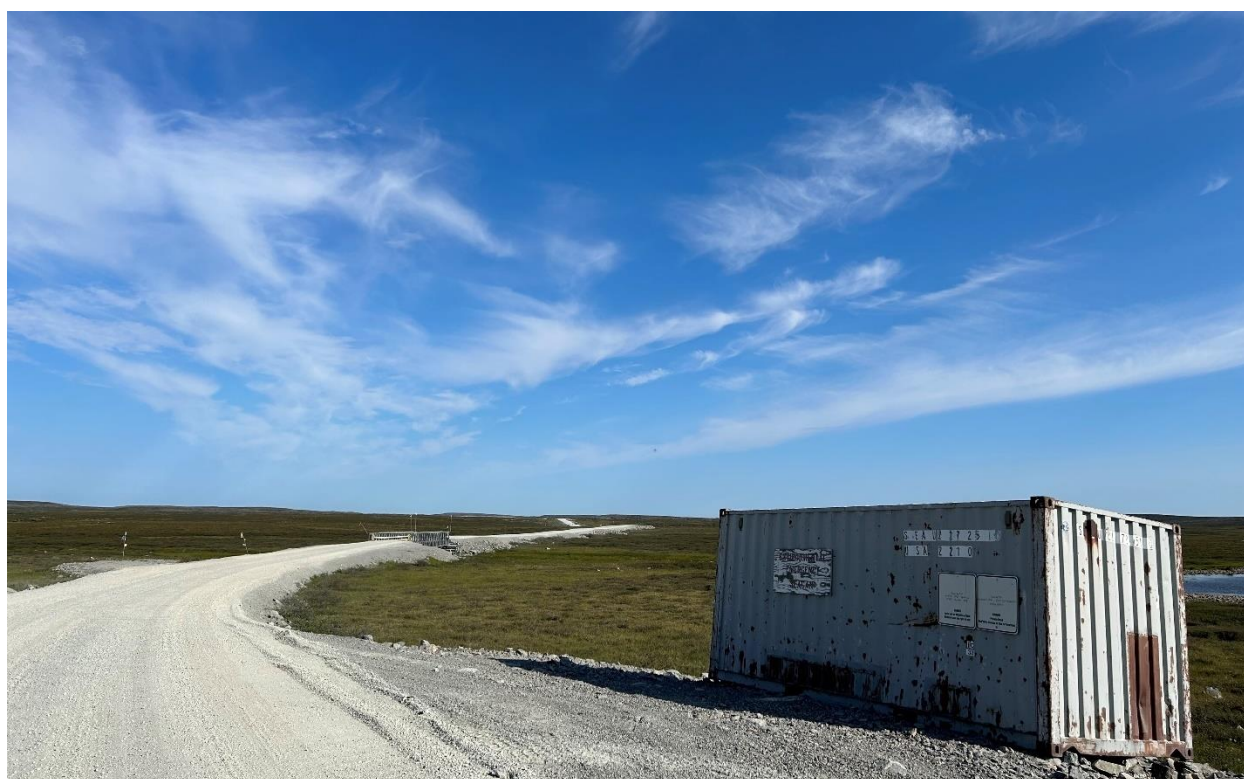
Photo 12: Emergency Spill Response Sea-can on the AWAR.

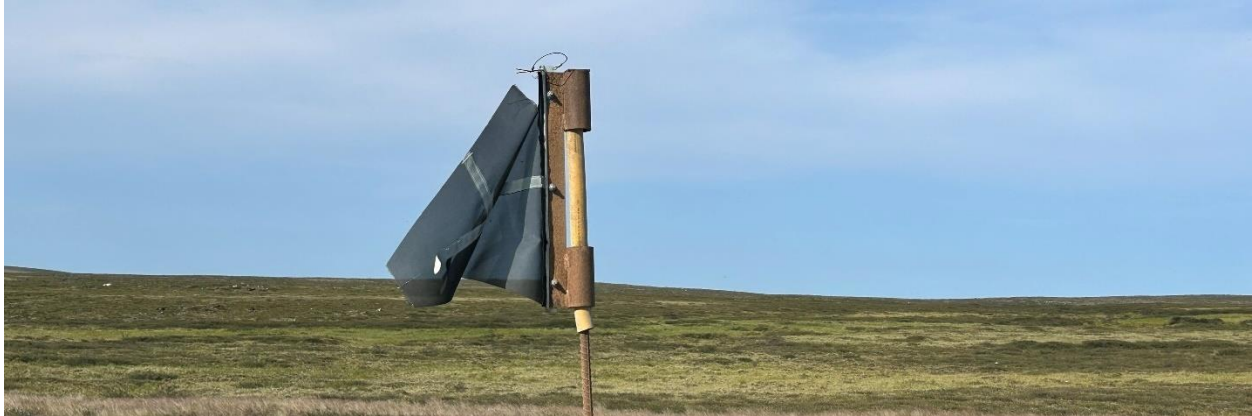
Photo 15: A new initiative by Agnico Eagle to address concerns about rattling noises coming from road flags. This initiative involves the placement of rubber tubing between the flagpole and the metal flag hardware. Analysis on the effectiveness of this initiative has not yet been completed.

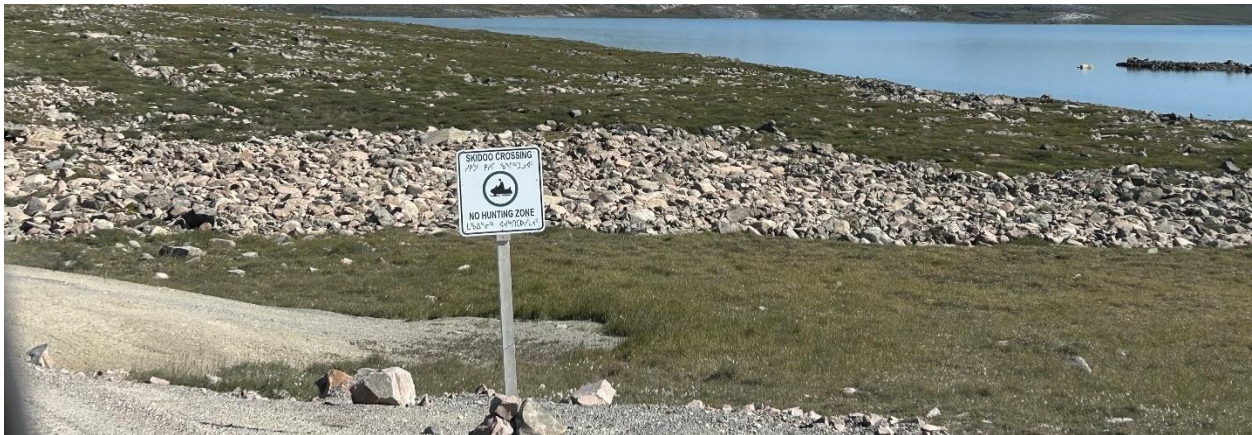
Photo 16: Snowmobile crossing signs in English and Inuktitut were in place along the AWAR.

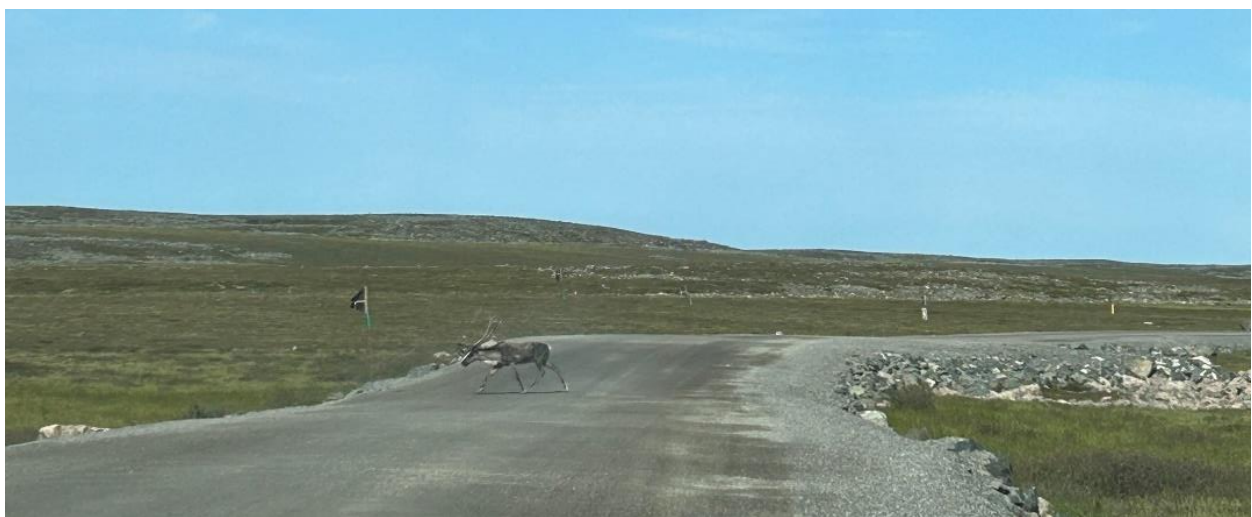
Photo 17: Wildlife have the right of way on all project roads. Agnico Eagle staff followed procedures to park their vehicles and report caribou sightings to dispatch when caribou were encountered.

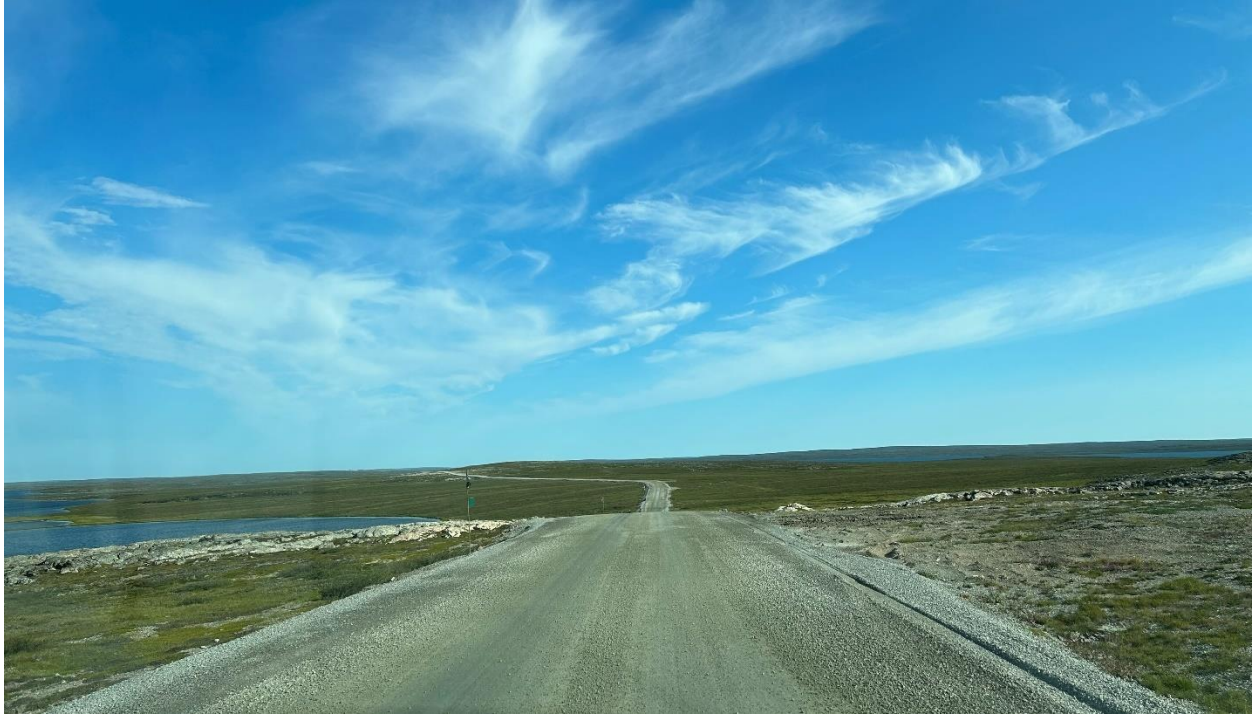
Photo 18: A section of the AWAR that has received chemical dust suppression treatment.

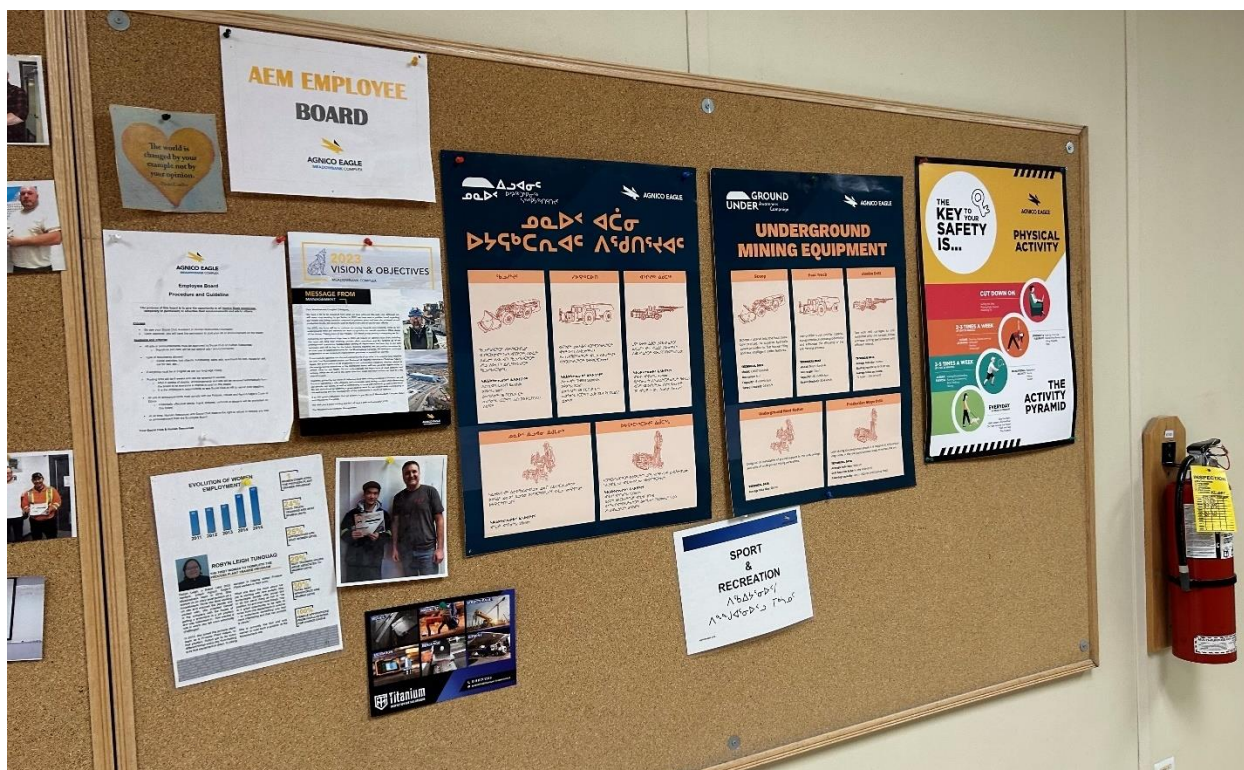
Photo 25: Inuktitut signage can be seen around the Meadowbank Camp.

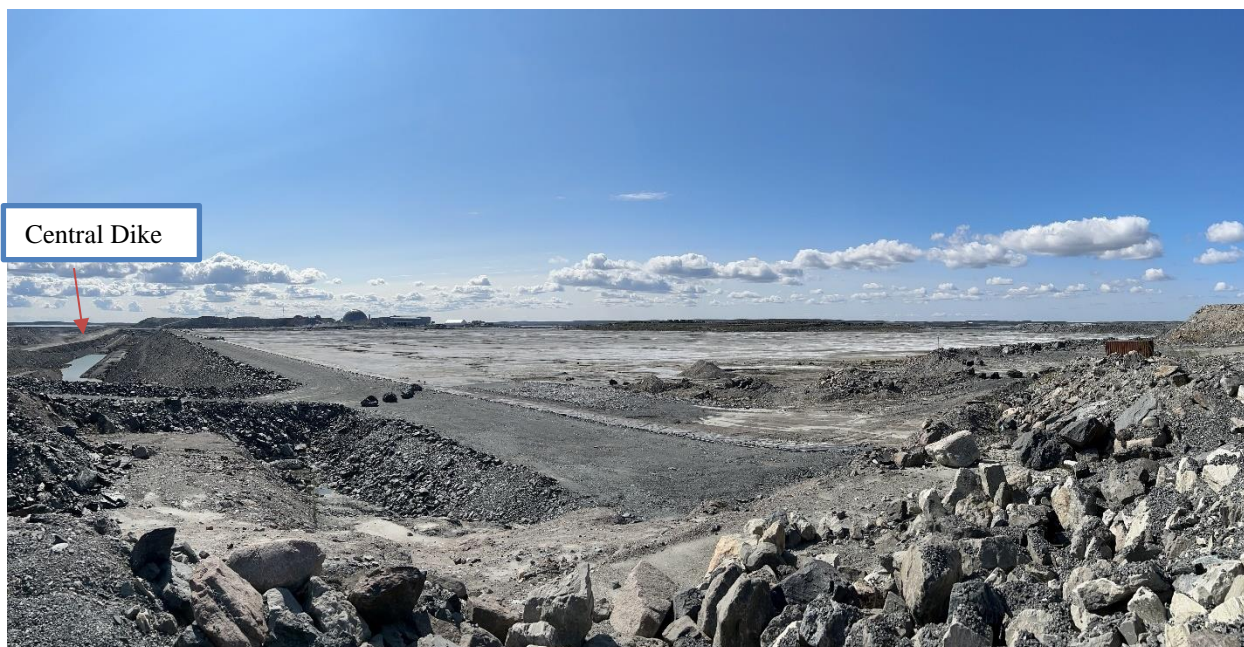
T&C No.*	Topic	Site Observation
Water Quality and Waste Management		
8	Groundwater Monitoring	During the site visit all 5 wells in place were operational. Photo 41 shows one of the wells.
18	Tailings Management Strategy	Tailings were deposited into the South Cell of the tailings facility since 2016 and deposition slowed down in 2019. Between 2019-2021 tailings were disposed of in pit at Goose Pit (Photo 39) and Portage Pit E. After a brief disposal of tailings in the north cell (Photo 29), Agnico Eagle deposited again in Portage Pit E where tailings continued to be deposited (Photo 38).
19	Tailings cover	NIRB staff observed tailings reclamation activities such as the capping of the Goose Pit tailings in 35-40 meters of water as seen in Photo 39 .
21	Weather station	NIRB staff observed the operational weather station at the Meadowbank site (Photo 24).
Waste Management		
25	Managing attraction of carnivores and/or raptors to reduce or eliminate attraction at all landfills and waste storage areas	An operational wildlife/bird deterrent sound cannon was in use at the Meadowbank landfill as seen in Photo 33 . Agnico Eagle staff confirmed that the landfill is inspected weekly by environmental staff for signs of organic material or any items that may attract carnivores and/or raptors. Agnico Eagle staff did not note any issues with carnivores and/or raptors around the landfill. The landfill site can be seen in Photo 32 .

Photo 31: Tailings Storage Facility South Cell.

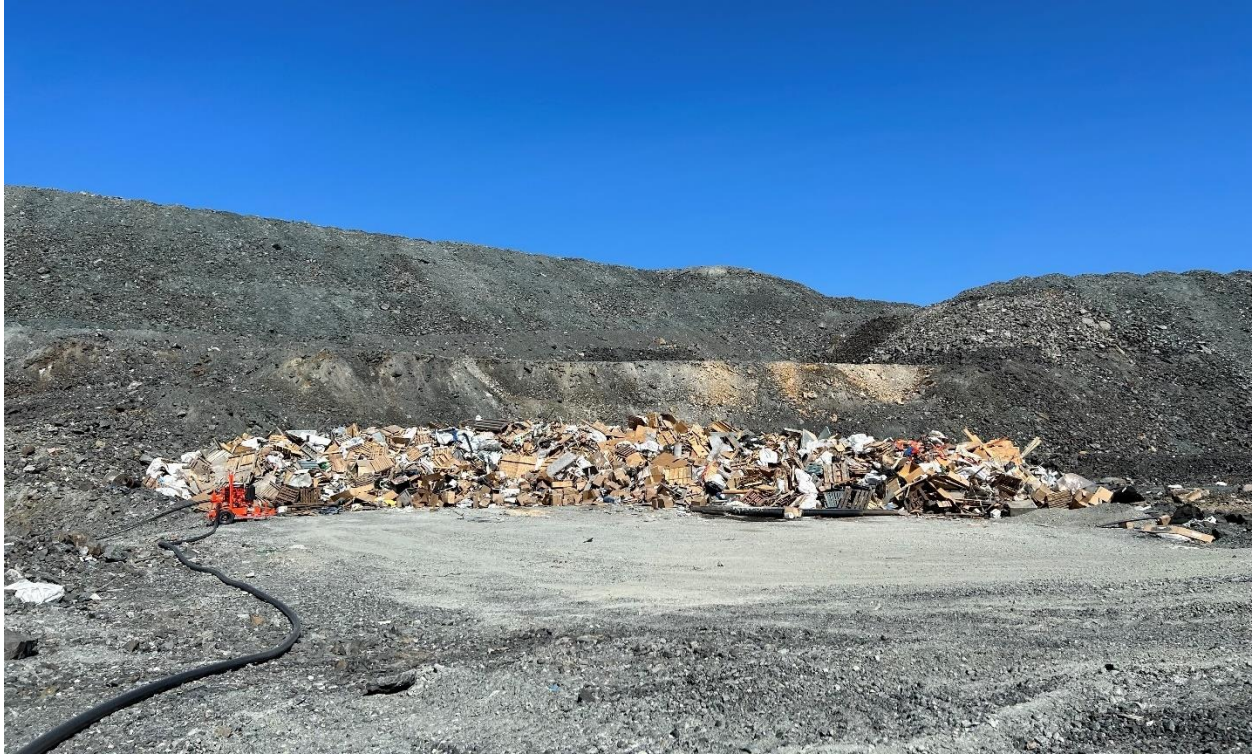
Photo 32: Meadowbank Landfill. The pump of the lefthand side of the image is removing water that collected in the area, which is stored in the Stormwater Management Pond.

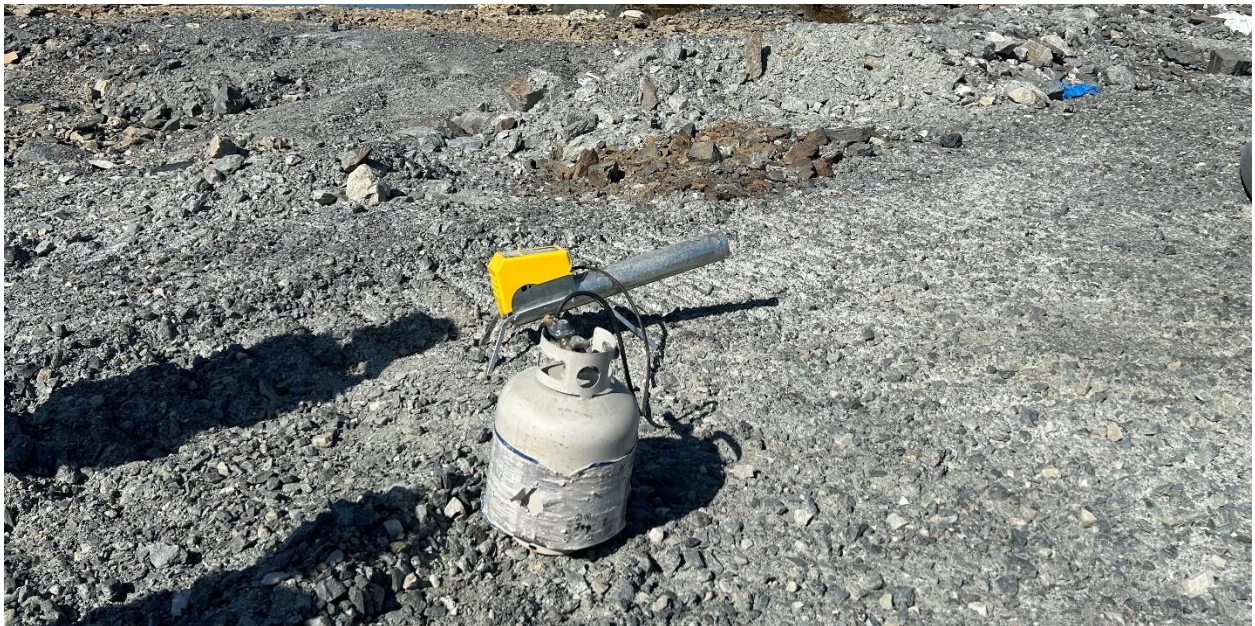
Photo 33: Wildlife deterrent or noise/bird cannon at the landfill site.

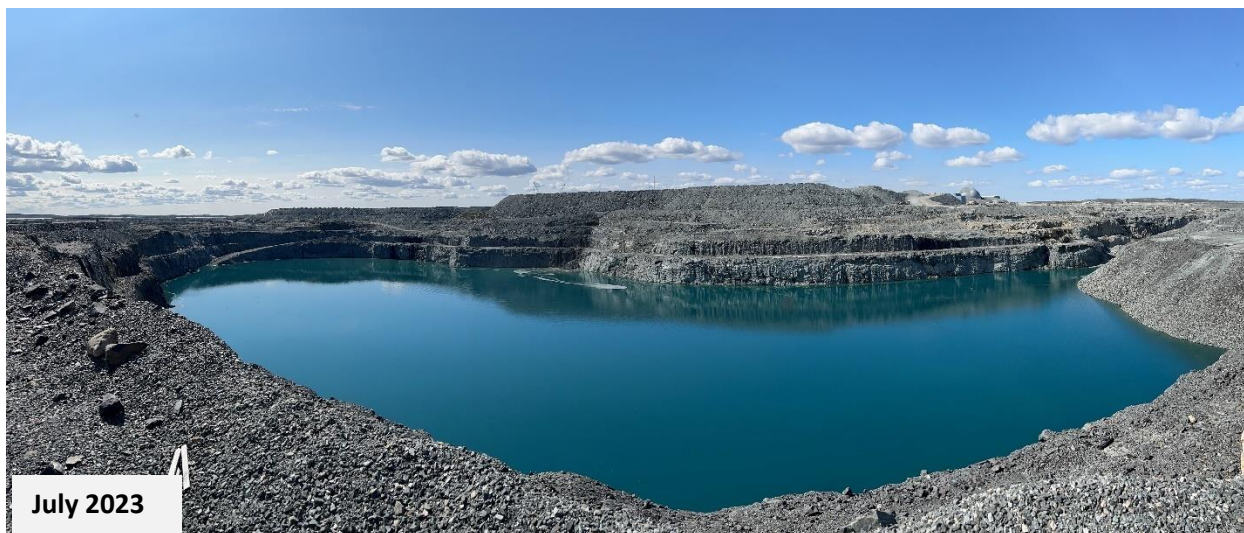
Photo 37: Portage Pit E in 2023. This pit is the primary storage area for tailings in 2023.

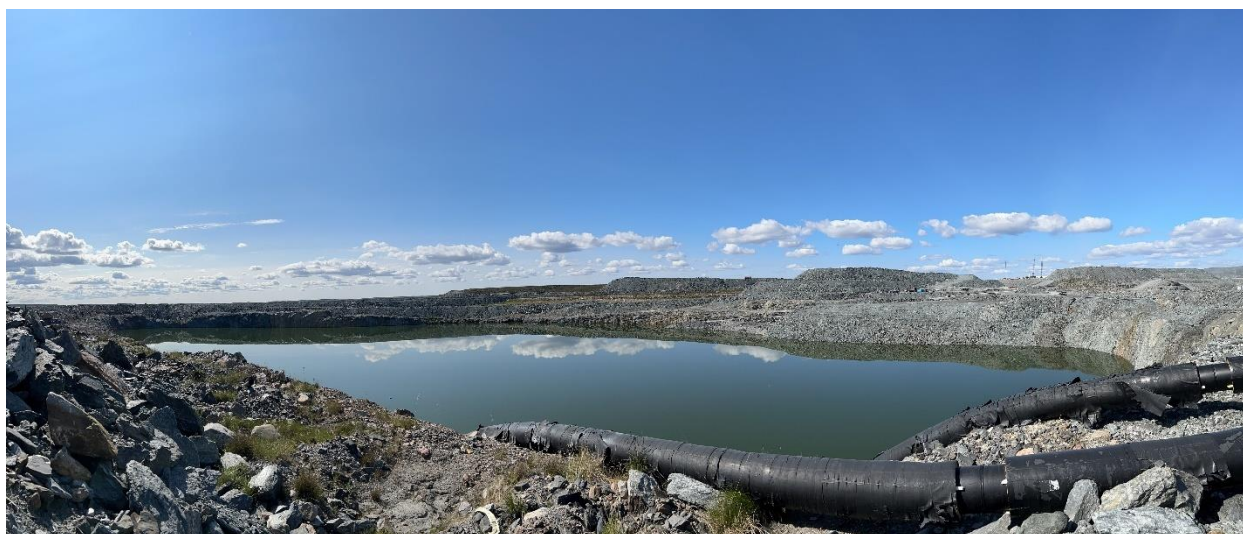
Photo 39: Goose Pit. This pit previously received tailings deposition and is now capped with 35-40 metres of water.

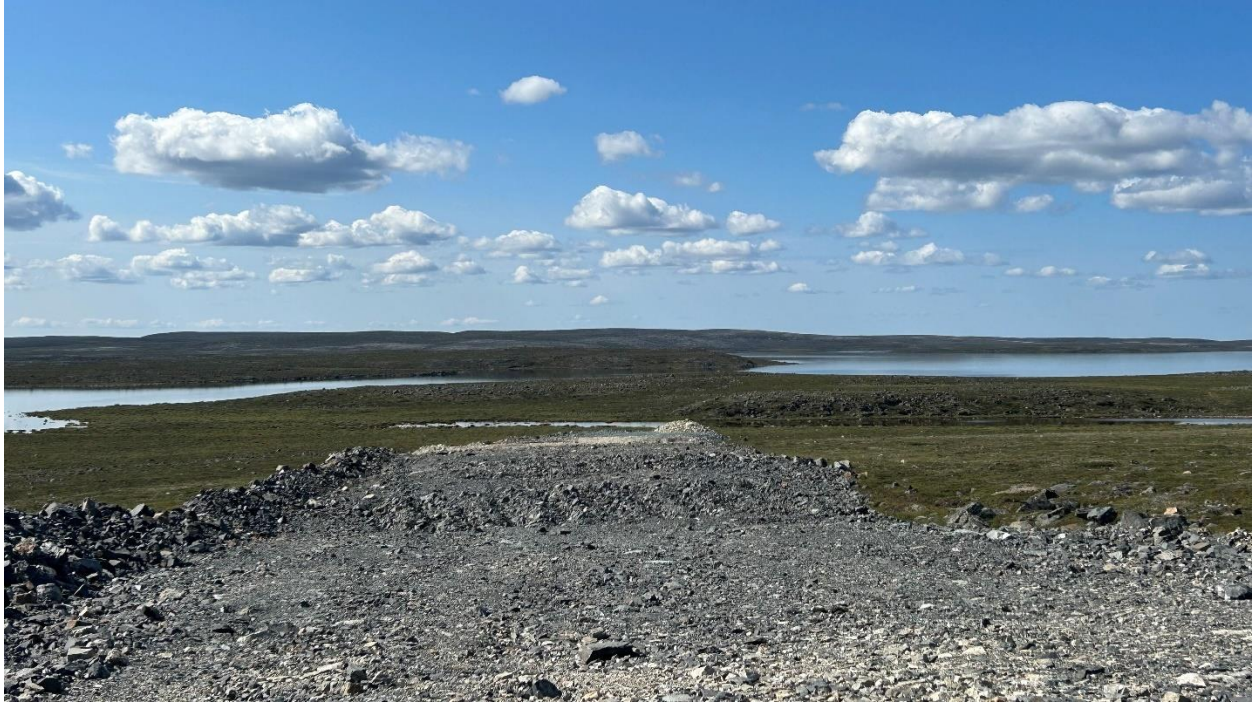
Photo 40: Active revegetation study site. The study was started in 2023, therefore results are not yet visible.

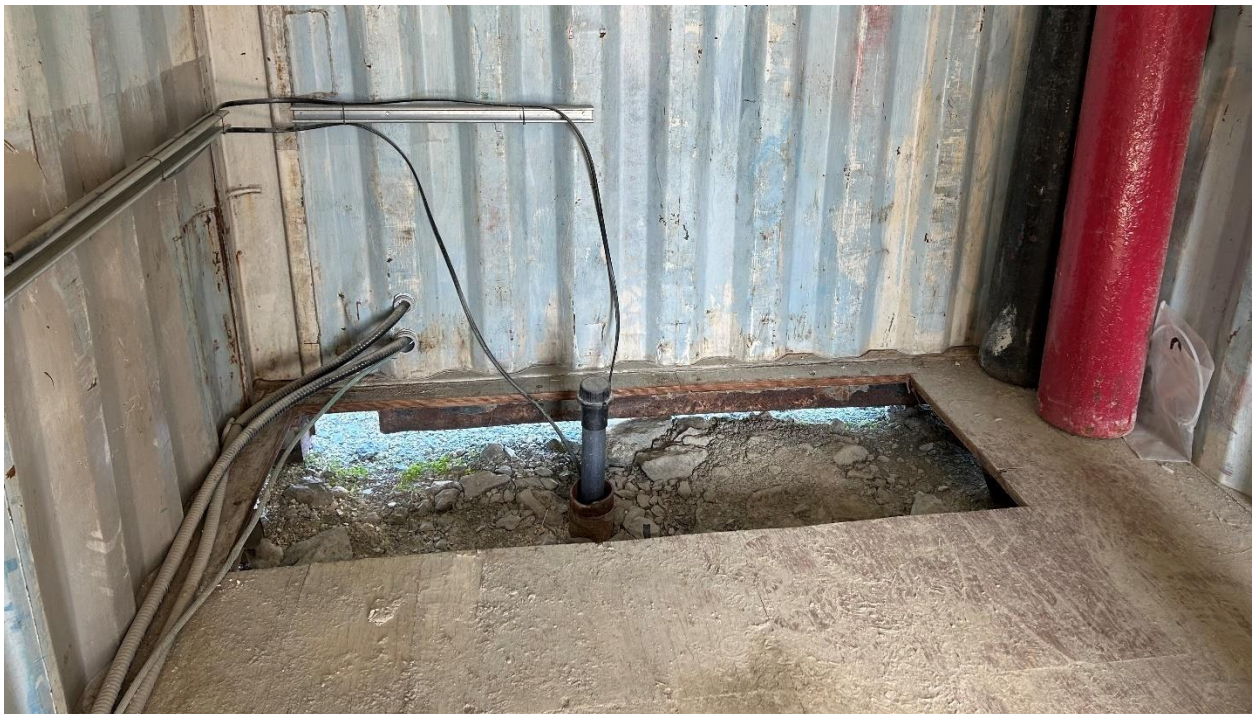
Photo 41: Groundwater Well, 1 of 5 onsite.

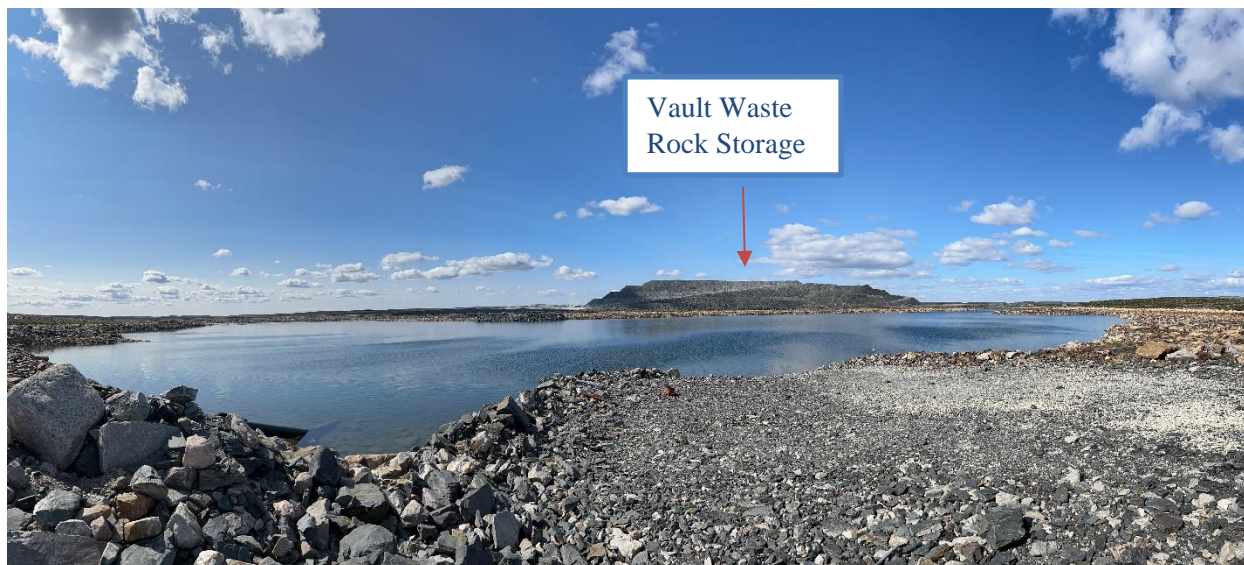
Photo 42: Vault Attenuation Pond and Vault Waste Rock Storage Facility.

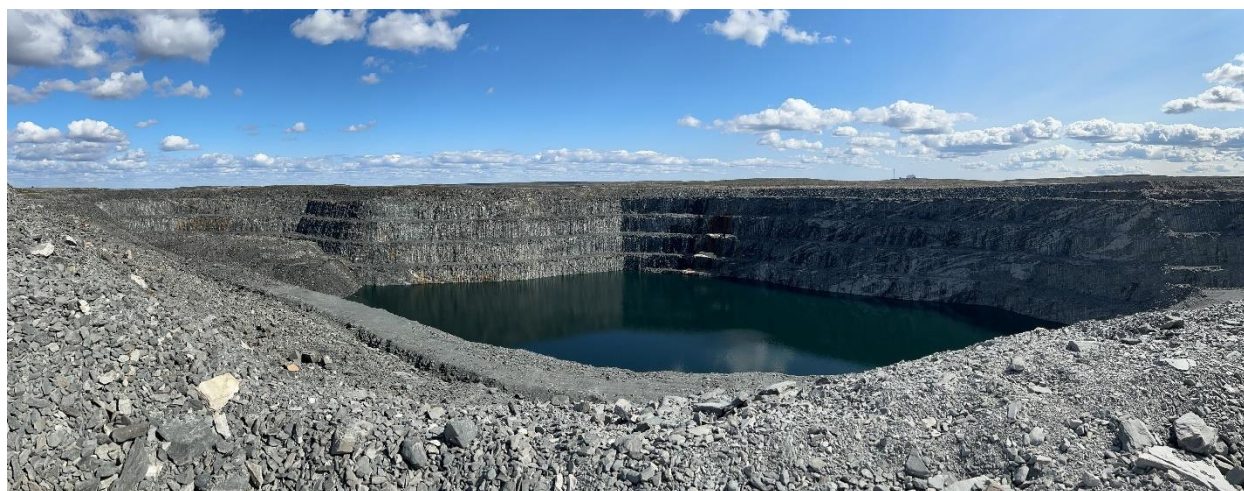
Photo 43: Vault Pit – refilling naturally with water since 2019.

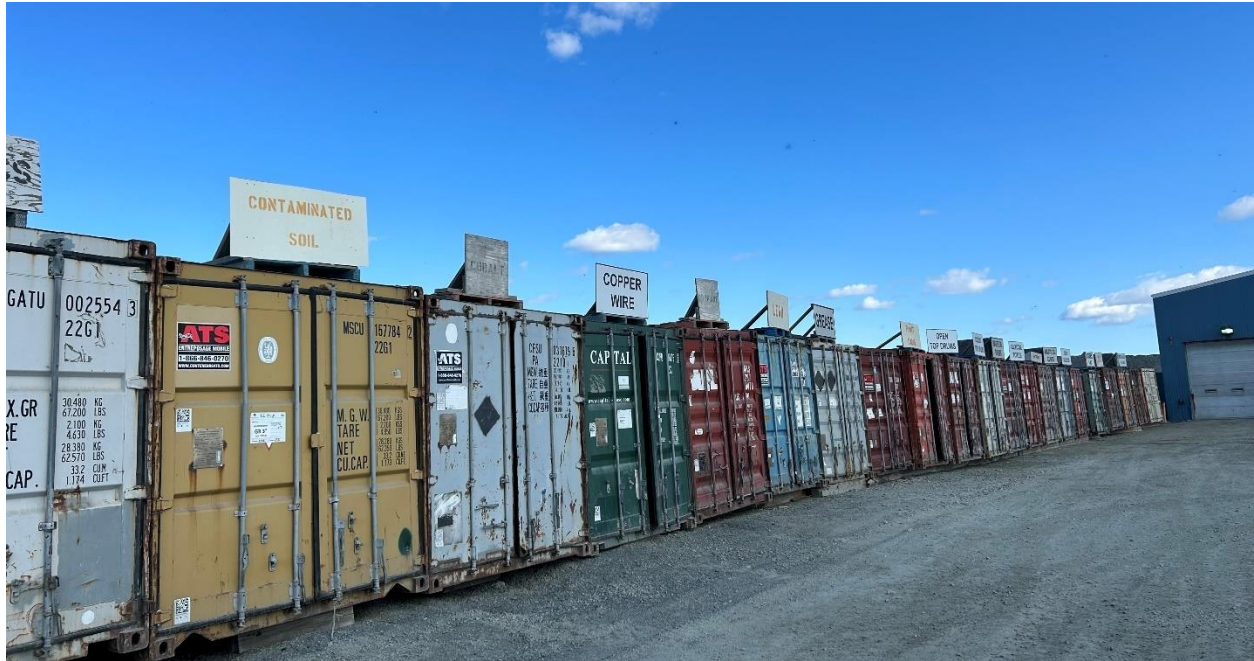
Photo 46: Hazardous materials storage sea-cans at the Meadowbank Site.

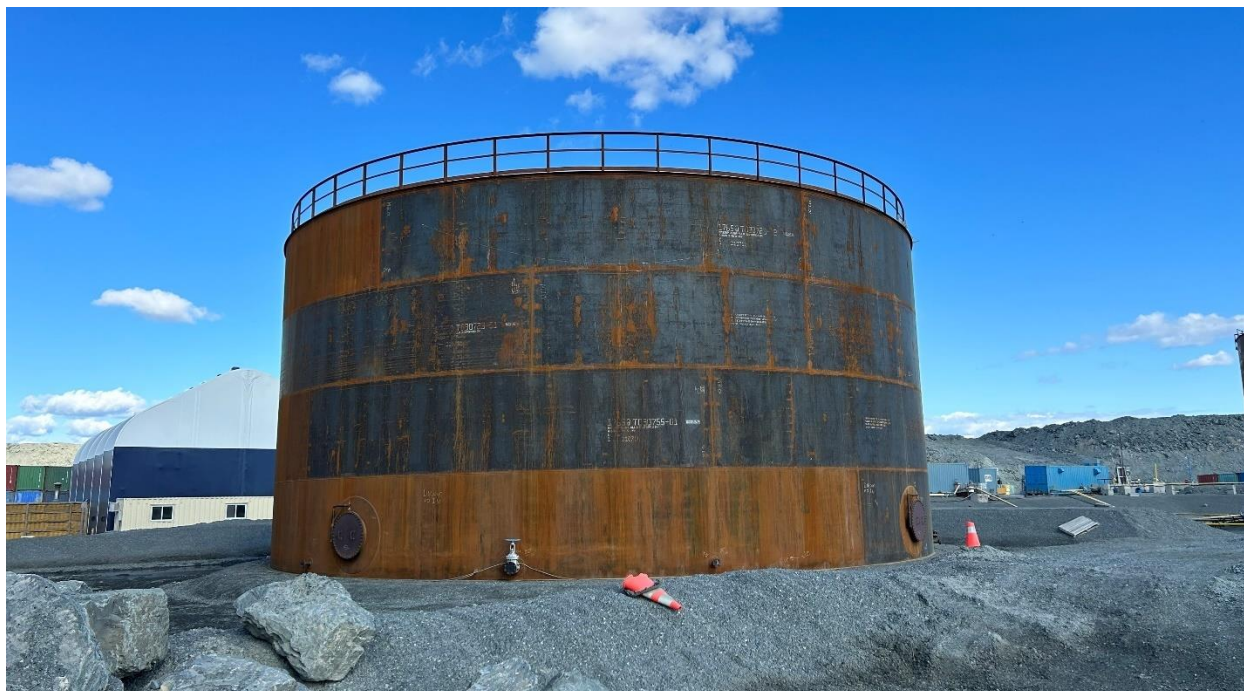
Photo 48: New fuel tank constructed in 2023. The purpose of this tank is to increase onsite fuel storage capacity to reduce reliance on trucking fuel from Baker Lake during caribou migration road closures.

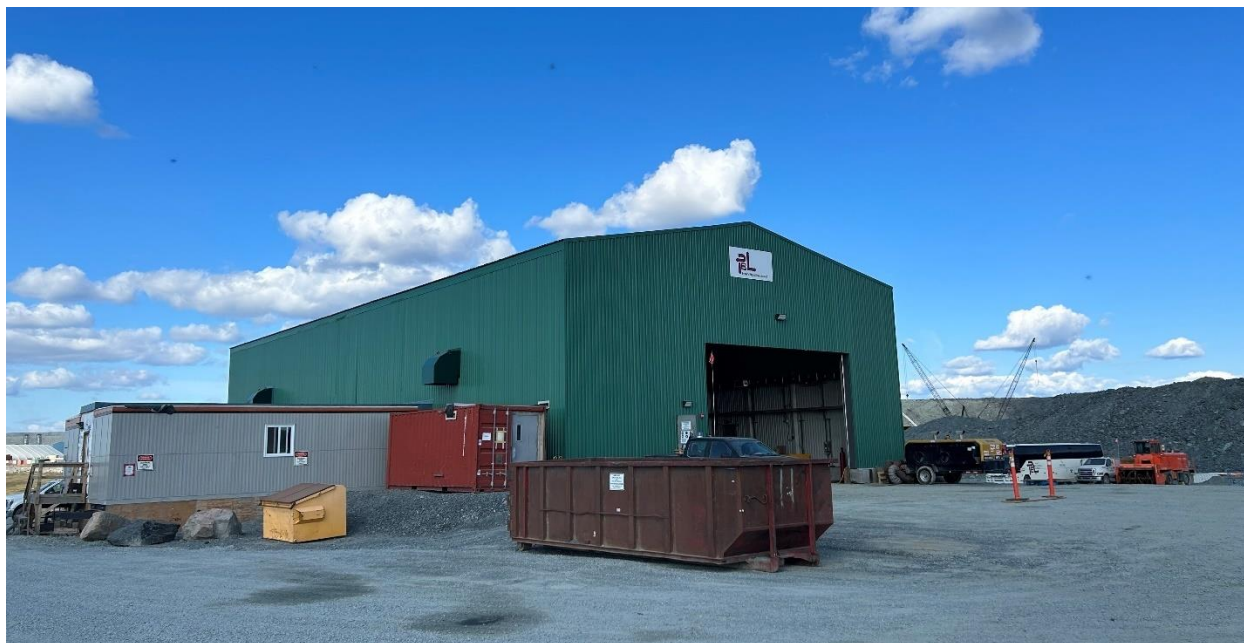
Photo 50: New contractor building constructed in 2023 to replace the burnt building seen during the 2022 site visit.

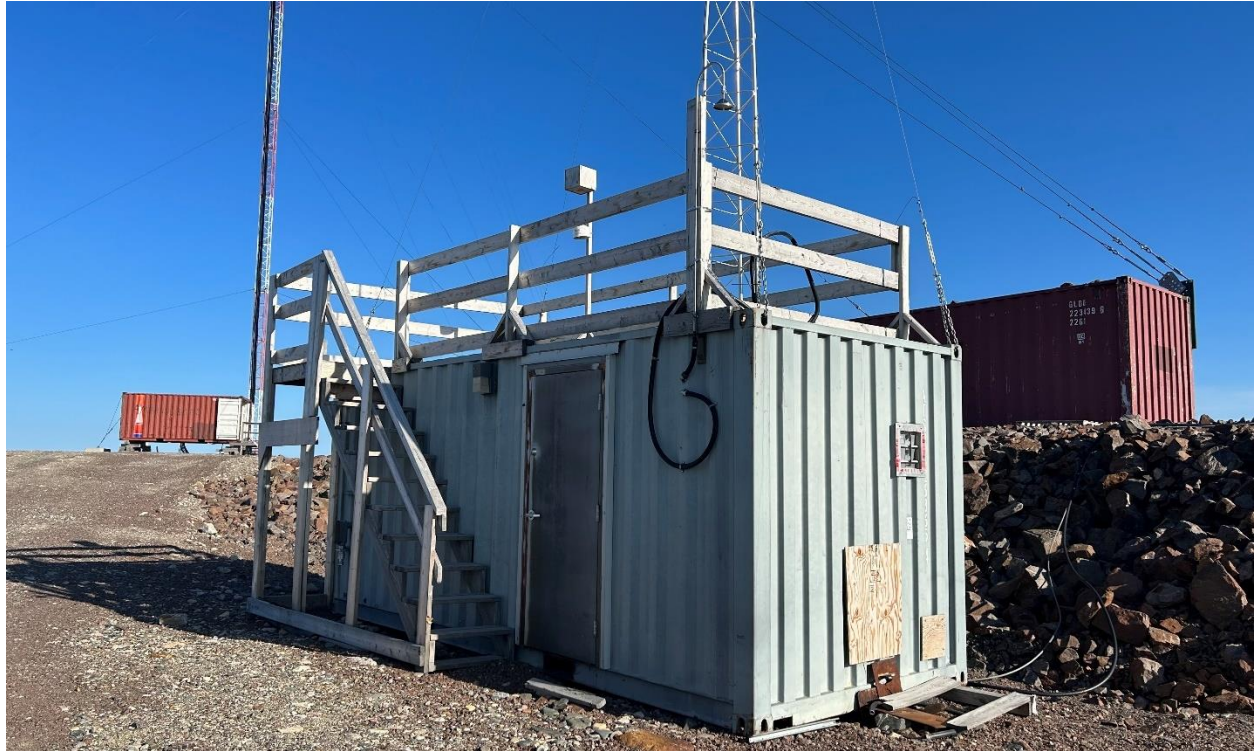
Photo 52: Sea-can housing the active NO₂ monitoring equipment. A Passive NO₂ monitor can be seen on the roof.

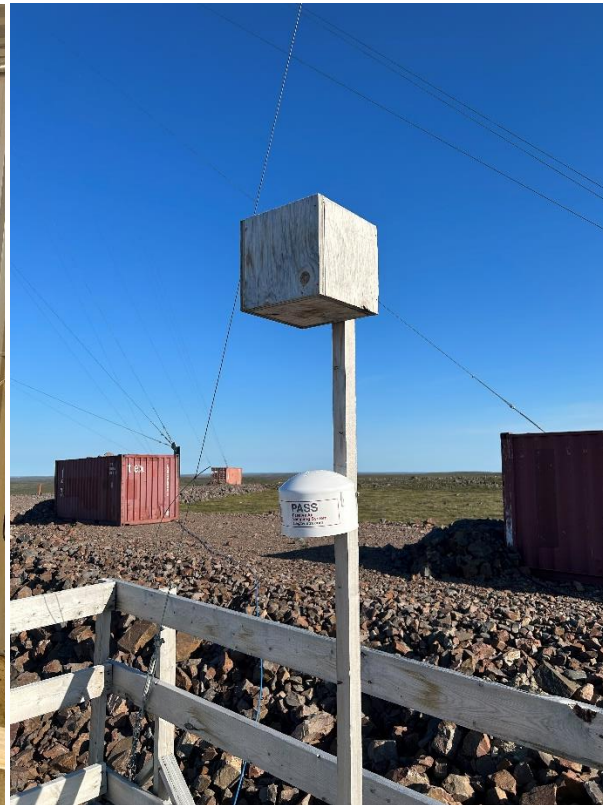
Photo 53 (left): Active NO₂ monitoring equipment with newly installed automatic shutoff switch to prevent equipment failure.

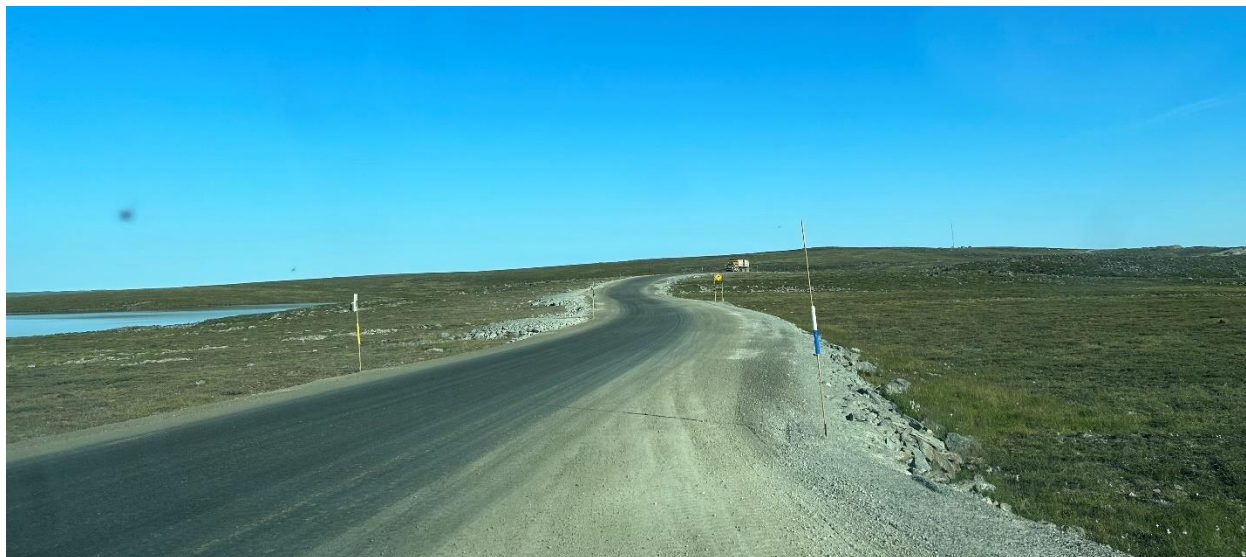
Photo 55: The entirety of the WTHR receives chemical dust suppression treatment.

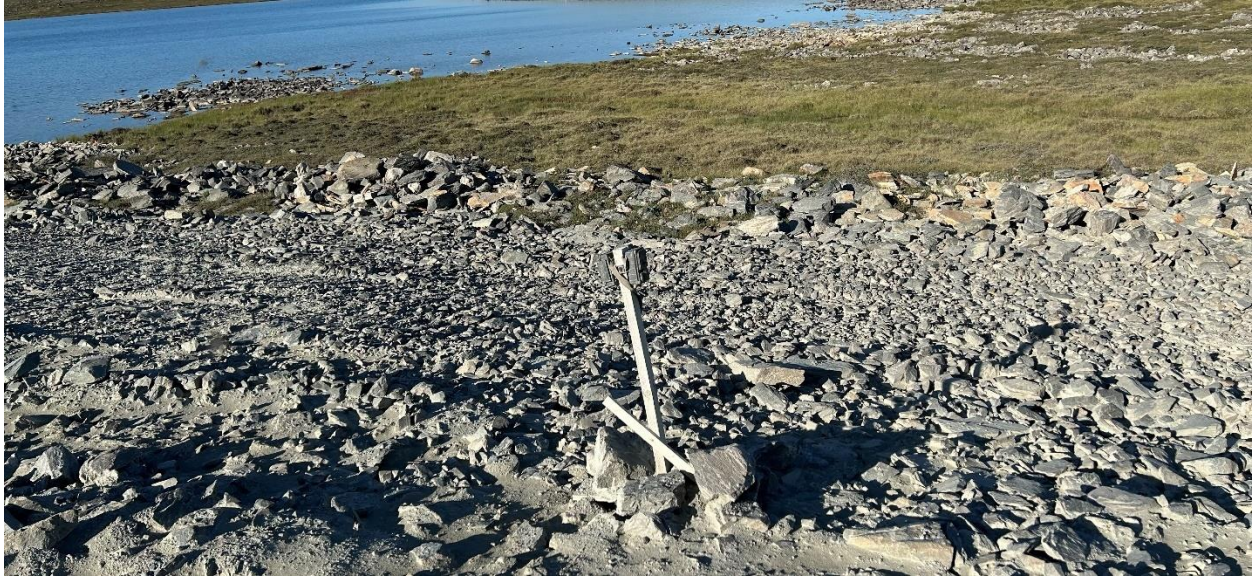
Photo 56: Wildlife cameras in place at several locations along the WTHR.

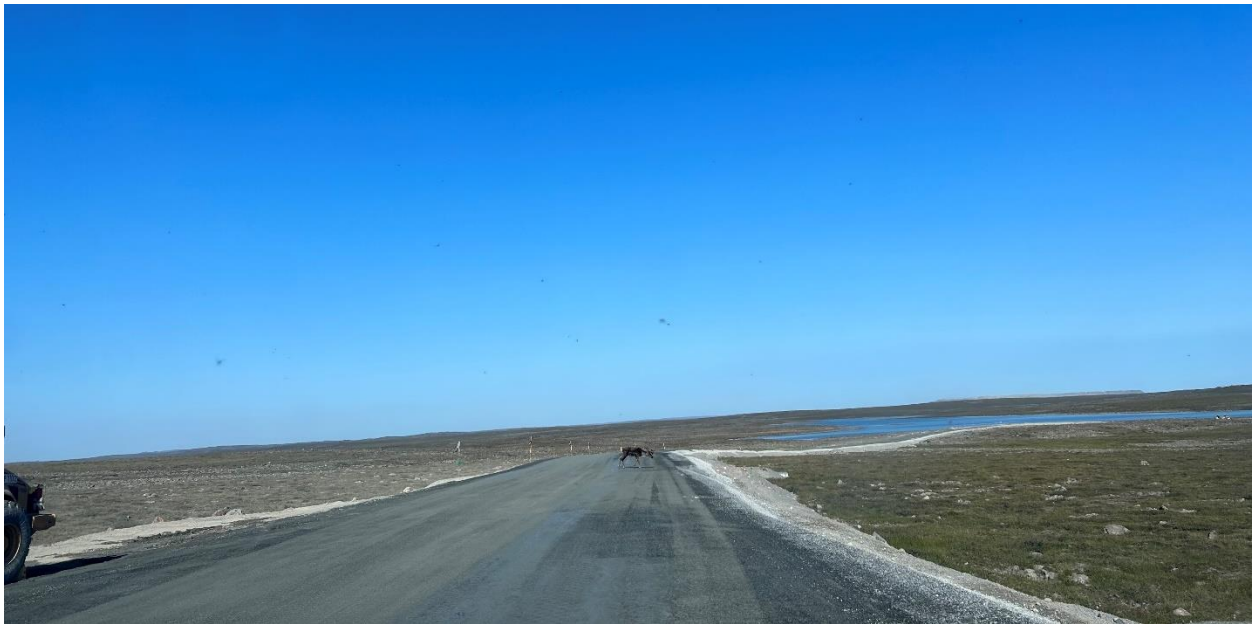
Photo 57: Caribou on the WTHR in a construction zone.
