Full Report Title: Nunavut Impact Review Board Community Update and Site Visit Report
Meadowbank Gold Mine and Whale Tail Pit Projects Agnico Eagle Mines Limited NIRB File No. 03MN107 & 16MN056

Projects: Meadowbank Gold Mine and Whale Tail Pit Projects

Site visit date: July 29-30, 2023

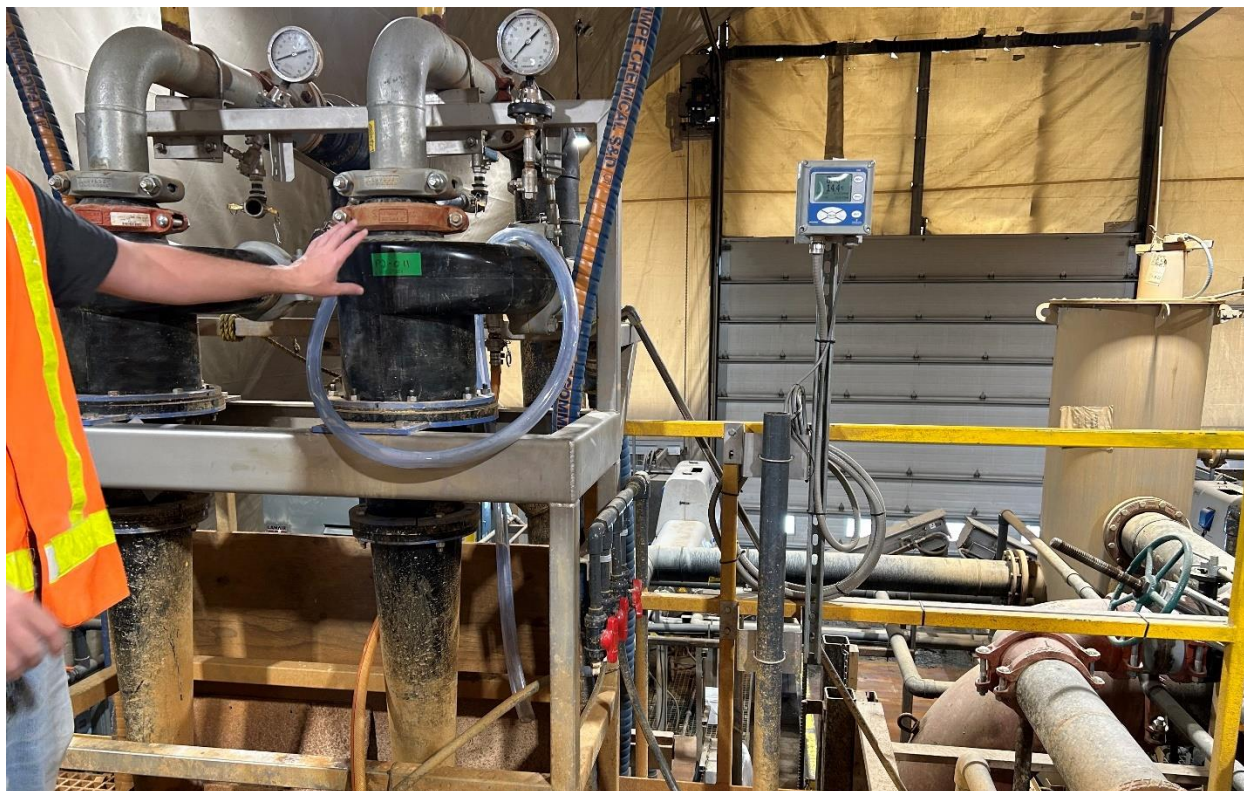
18	Site Water Monitoring	The NIRB observed the Whale Tail Attenuation Pond (Photo 61), IVR Attenuation Pond (Photo 62), and the Water Treatment Facilities (Photo 60) at the Whale Tail site.
Surface Water Hydrology, Surface Water Quality and Sediment Quality		
17	Surface Water Hydrology	Core Receiving Environment Monitoring Program (CREMP) sample locations were observed at Mammoth Lake (Photo 74). Agnico Eagle staff discussed the other samples taken at A20 Lake as well as reference samples taken at Pipe Dream Lake.
Freshwater Aquatic Environment

Photo 60: Water treatment plant at the Whale Tail Site.

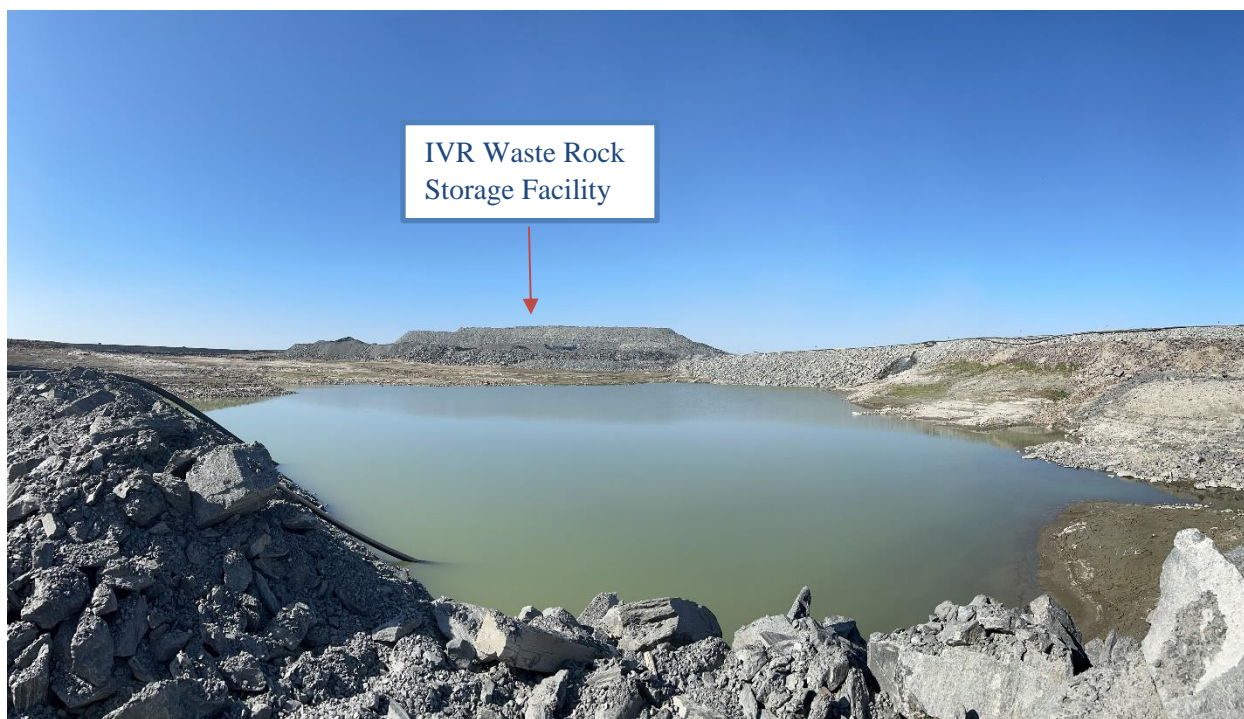
Photo 61: IVR attenuation pond and IVR Waste Rock Storage Facility.

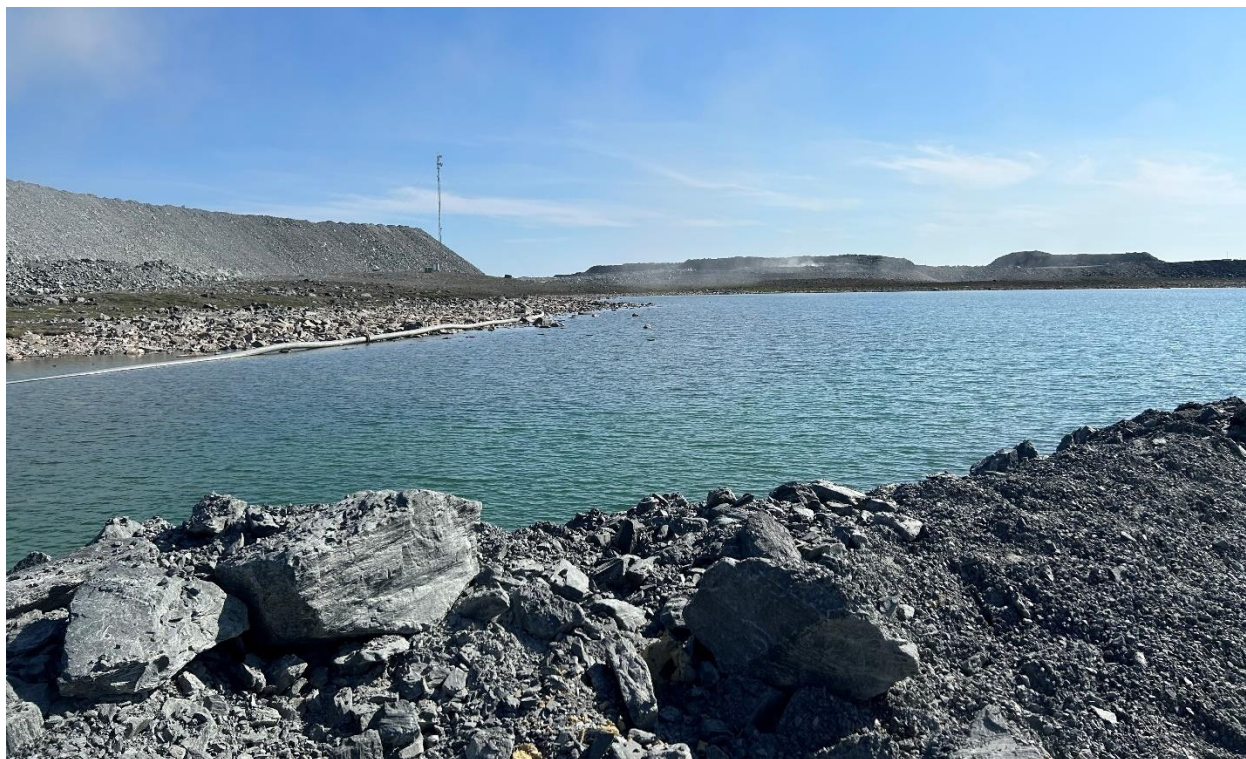
Photo 62: Whale Tail attenuation pond.

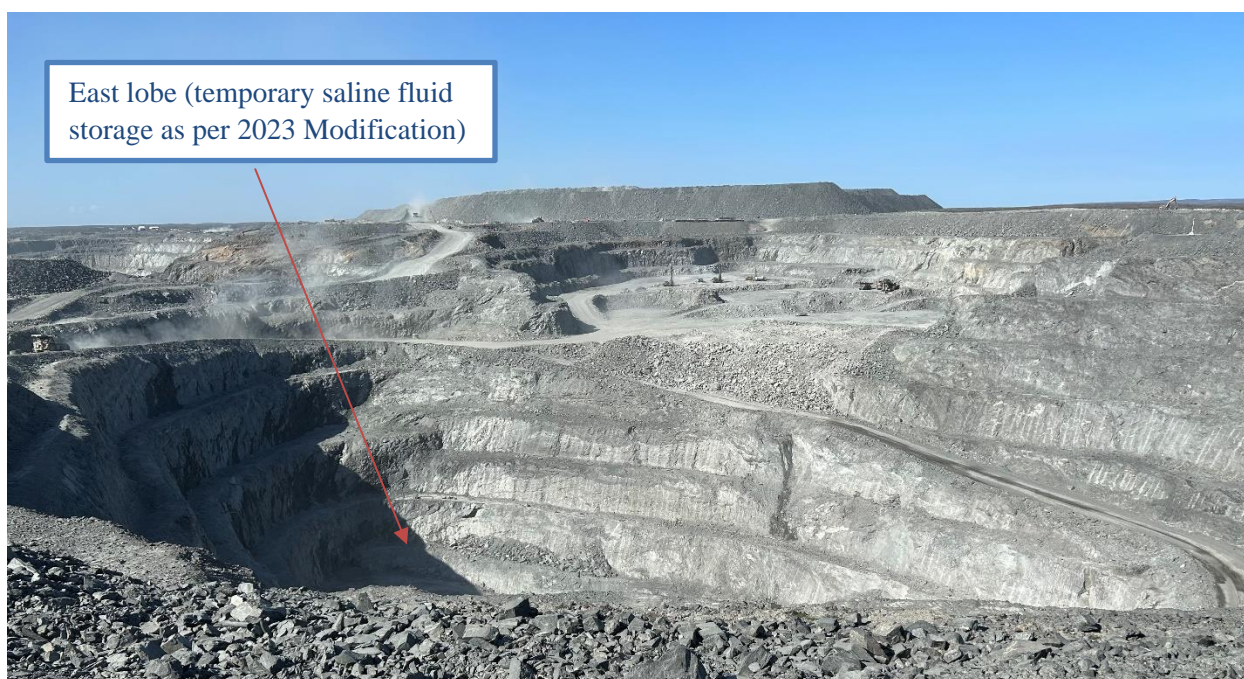
Photo 65: IVR Pit – temporary storage of saline fluid as described in the 2023 modification will occur in the east lobe.

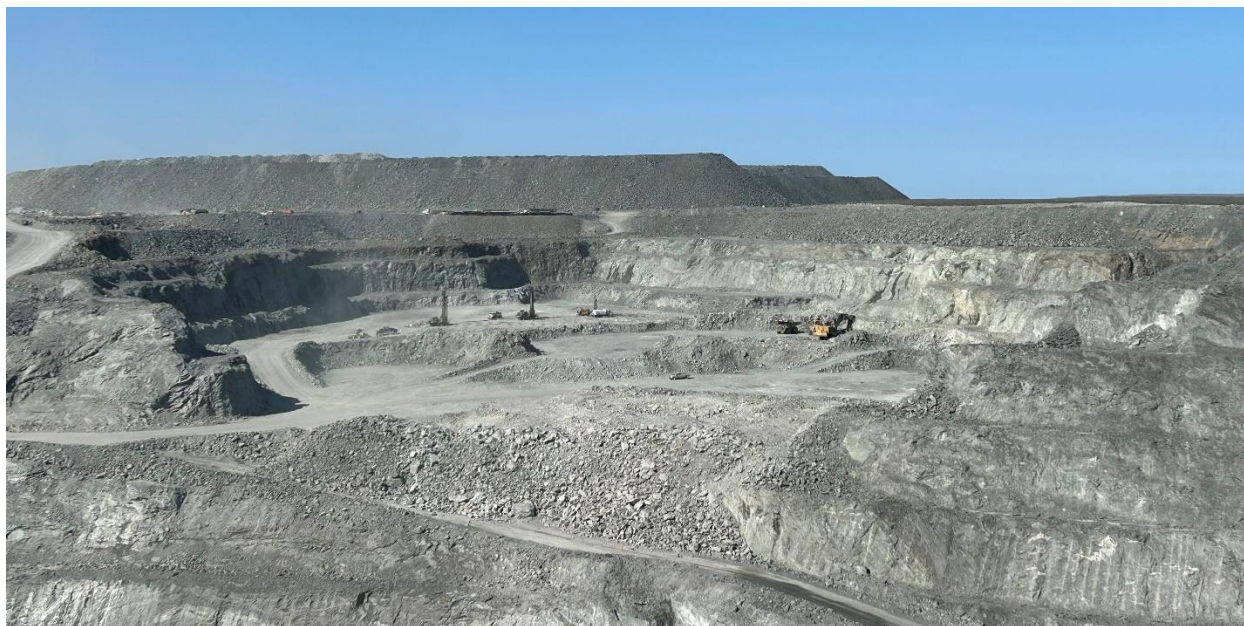
Photo 66: IVR Pit pushback area as per the 2021 Pushbacks Modification.

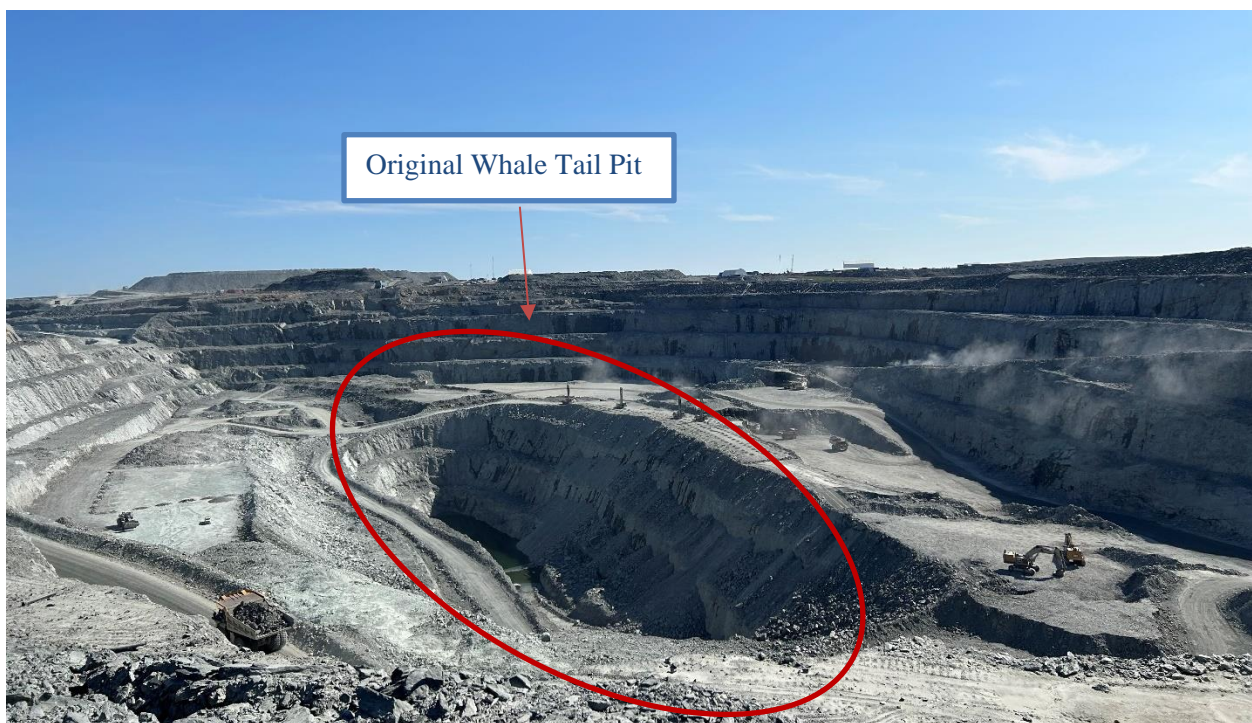
Photo 69: Original Whale Tail Pit shown in red. All surrounding mining has occurred as a part of the Whale Tail Expansion Amendment (Amendment 1).

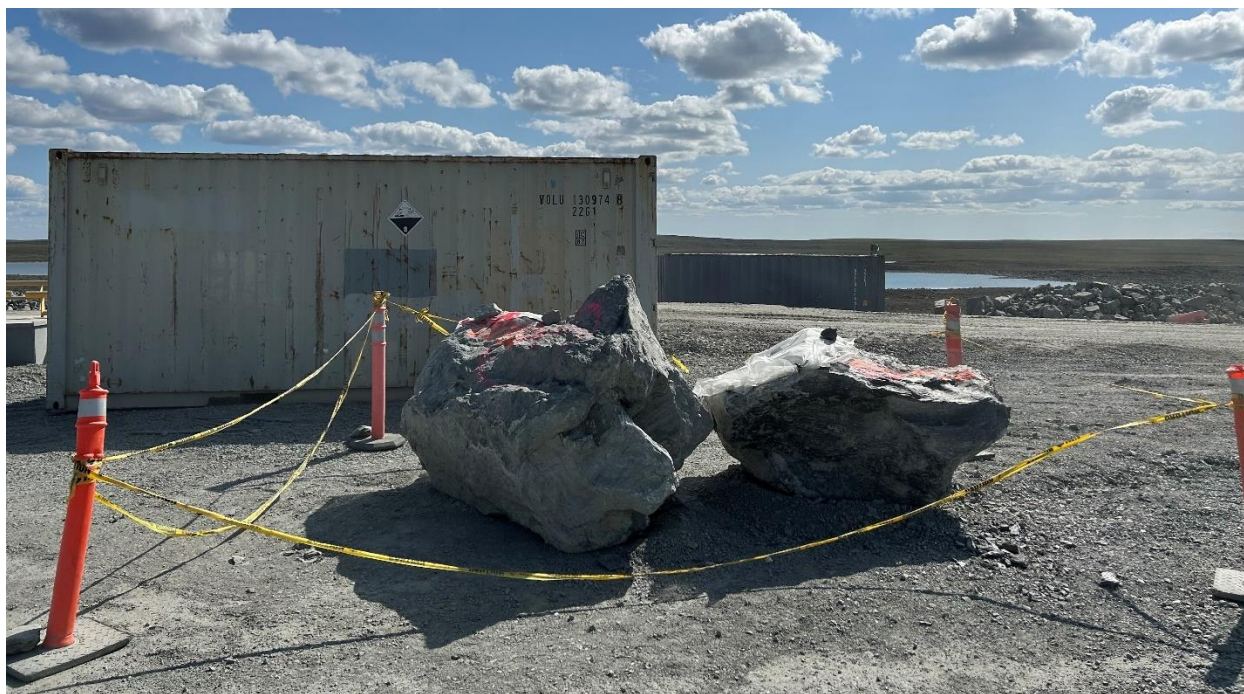
Photo 73: Ongoing closure and reclamation study to measure leaching from waste rock.

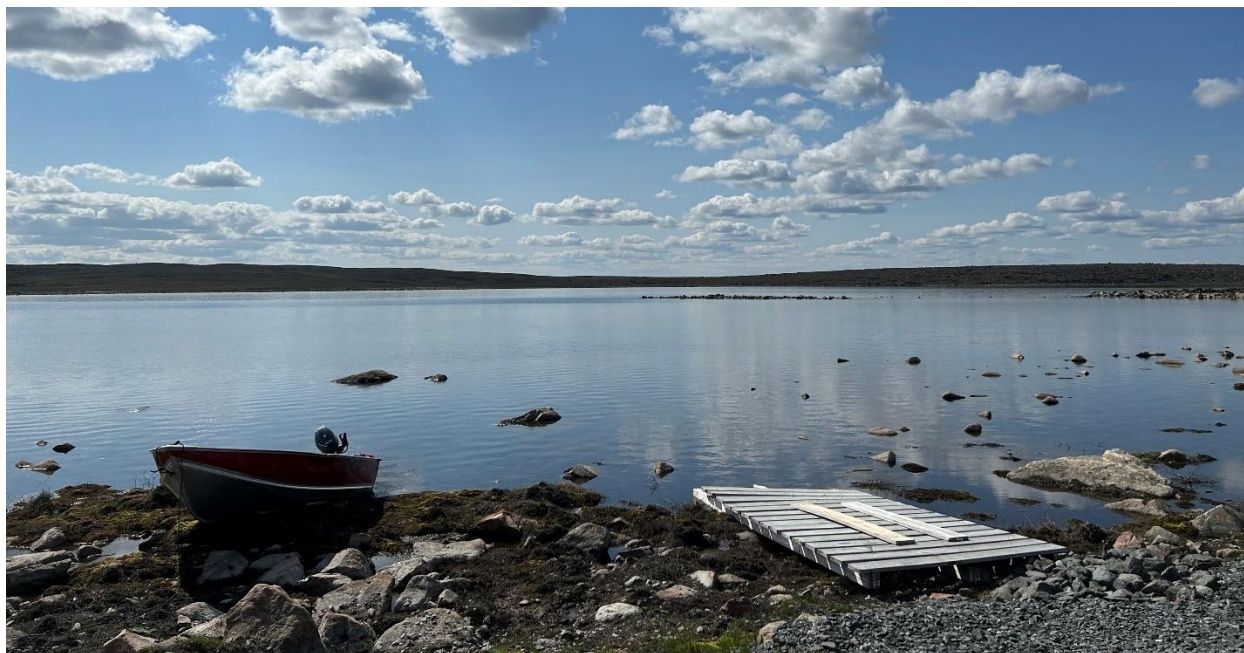
Photo 74: Mammoth Lake contains 2 CREMP sample locations – one at each end of the Lake.
